TS-PIC-20809961S/20909961S
December 2008

AERIAL PHOTOGRAPHIC ANALYSIS OF IRON KING MINE/HUMBOLDT SMELTER SITE

Dewey-Humboldt, Arizona

EPA Region 9

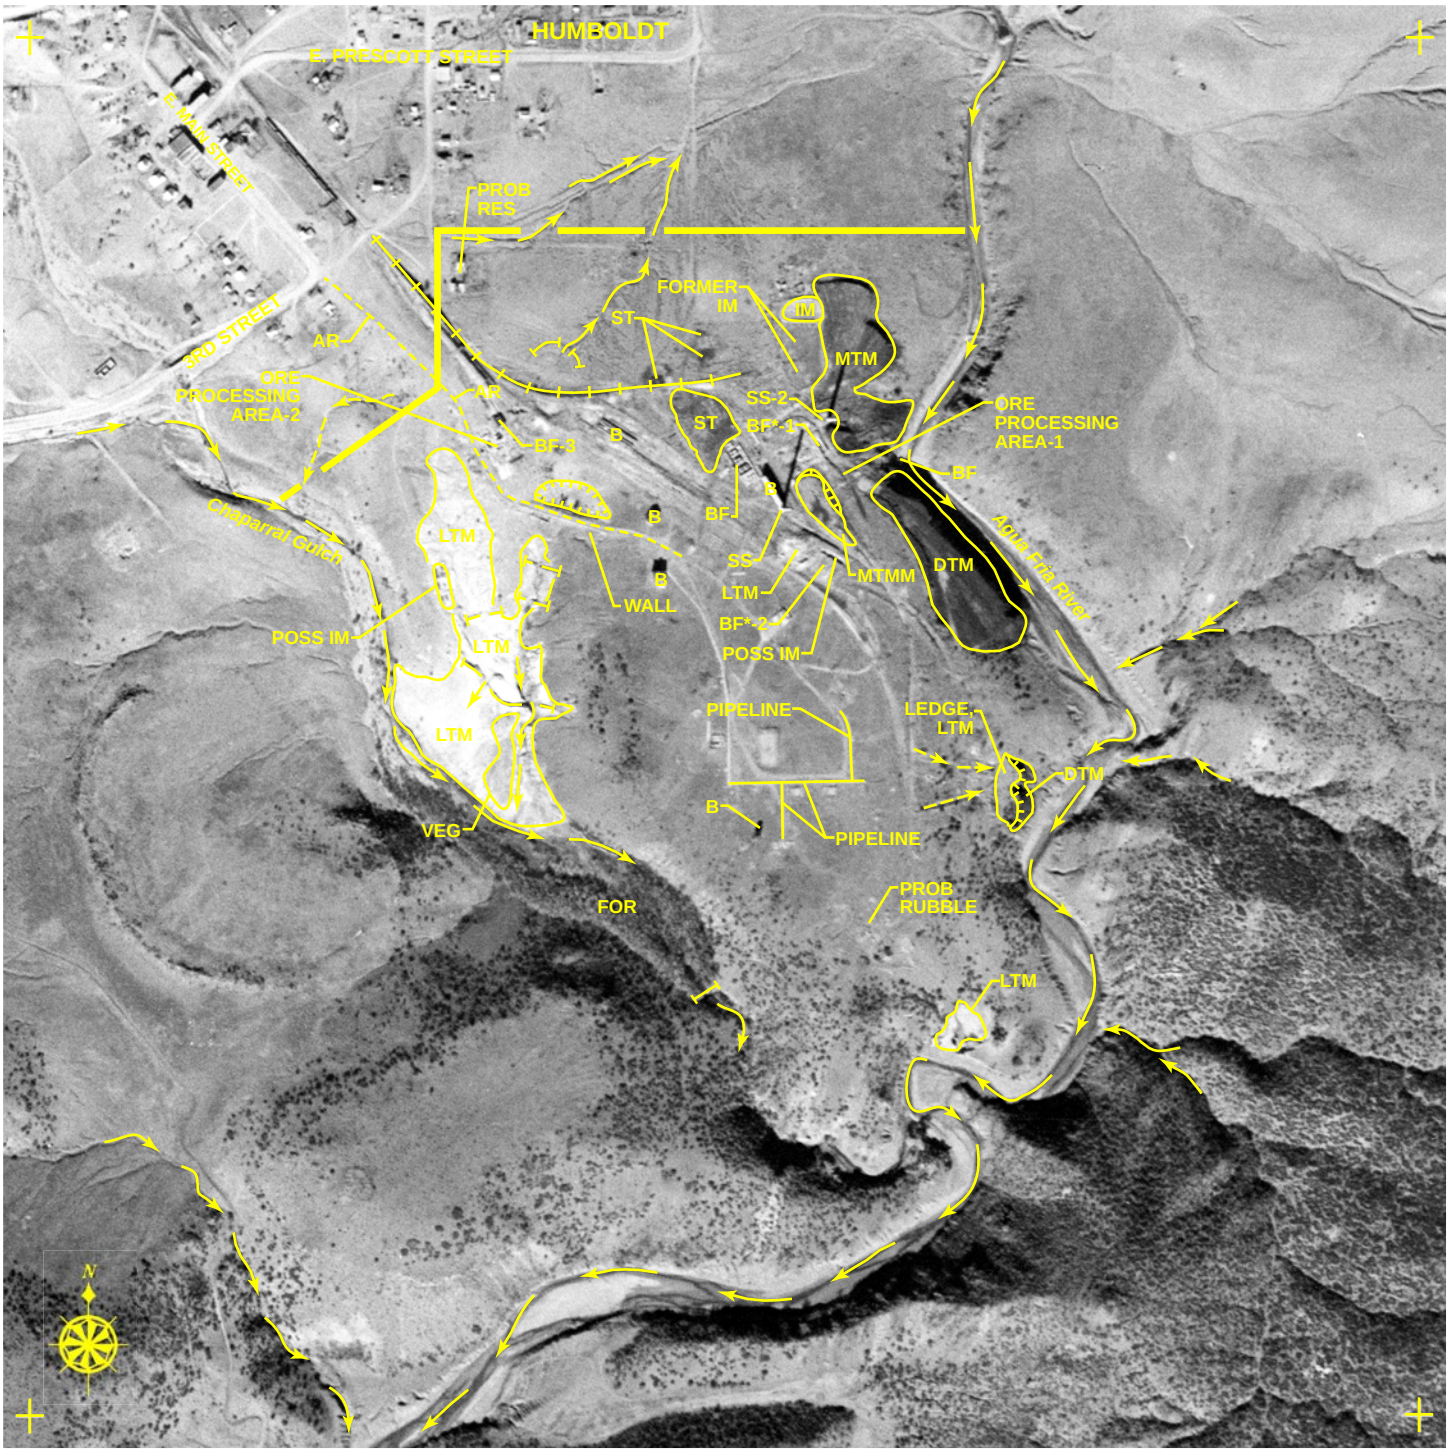
FIGURE 12. HUMBOLDT SMELTER, NOVEMBER 25, 1953. APPROX. SCALE 1:4,500.

NOVEMBER 25, 1953 (FIGURE 12)

Much of the Humboldt Smelter section of the Iron King Mine/Humboldt Smelter site is relatively unchanged since 1940. Most of the buildings and features noted in 1940 remain in place.

Much of the area on and around Ore Processing Area-1 is relatively unchanged since 1940. Each of the two smokestacks remains in place and the mounds of dark- and medium-toned material, located along the Agua Fria River, are relatively unchanged. A building, located north of one of the smokestacks in 1940, has been partially removed and a building foundation is all that remains at the location. Of the three impoundments noted in 1940 west of the medium-toned mound material only the northernmost impoundment appears to be in use. The berms surrounding this impoundment have been improved. Some building foundations and rubble have been removed from the areas around building foundations BF*-1 and BF*-2.

Much of the area on and around Ore Processing Area-2 is relatively unchanged since 1940. The possible vertical tank noted in 1940, however, is no longer in place. The areal extent of the light-toned material that covers the hill side above the Chaparral Gulch has increased. One continuous area of light-toned material now extends down to the Chaparral Gulch. More dams have been placed in the drainage channel leading down to the gulch. All the dams appear to have been breached. Since 1940 three possible contiguous impoundments, which are no longer in use, have been built on the up slope western edge of the light-toned material. A dirt access road (not annotated), which does not appear to have been heavily used recently, leads to the area from the north.

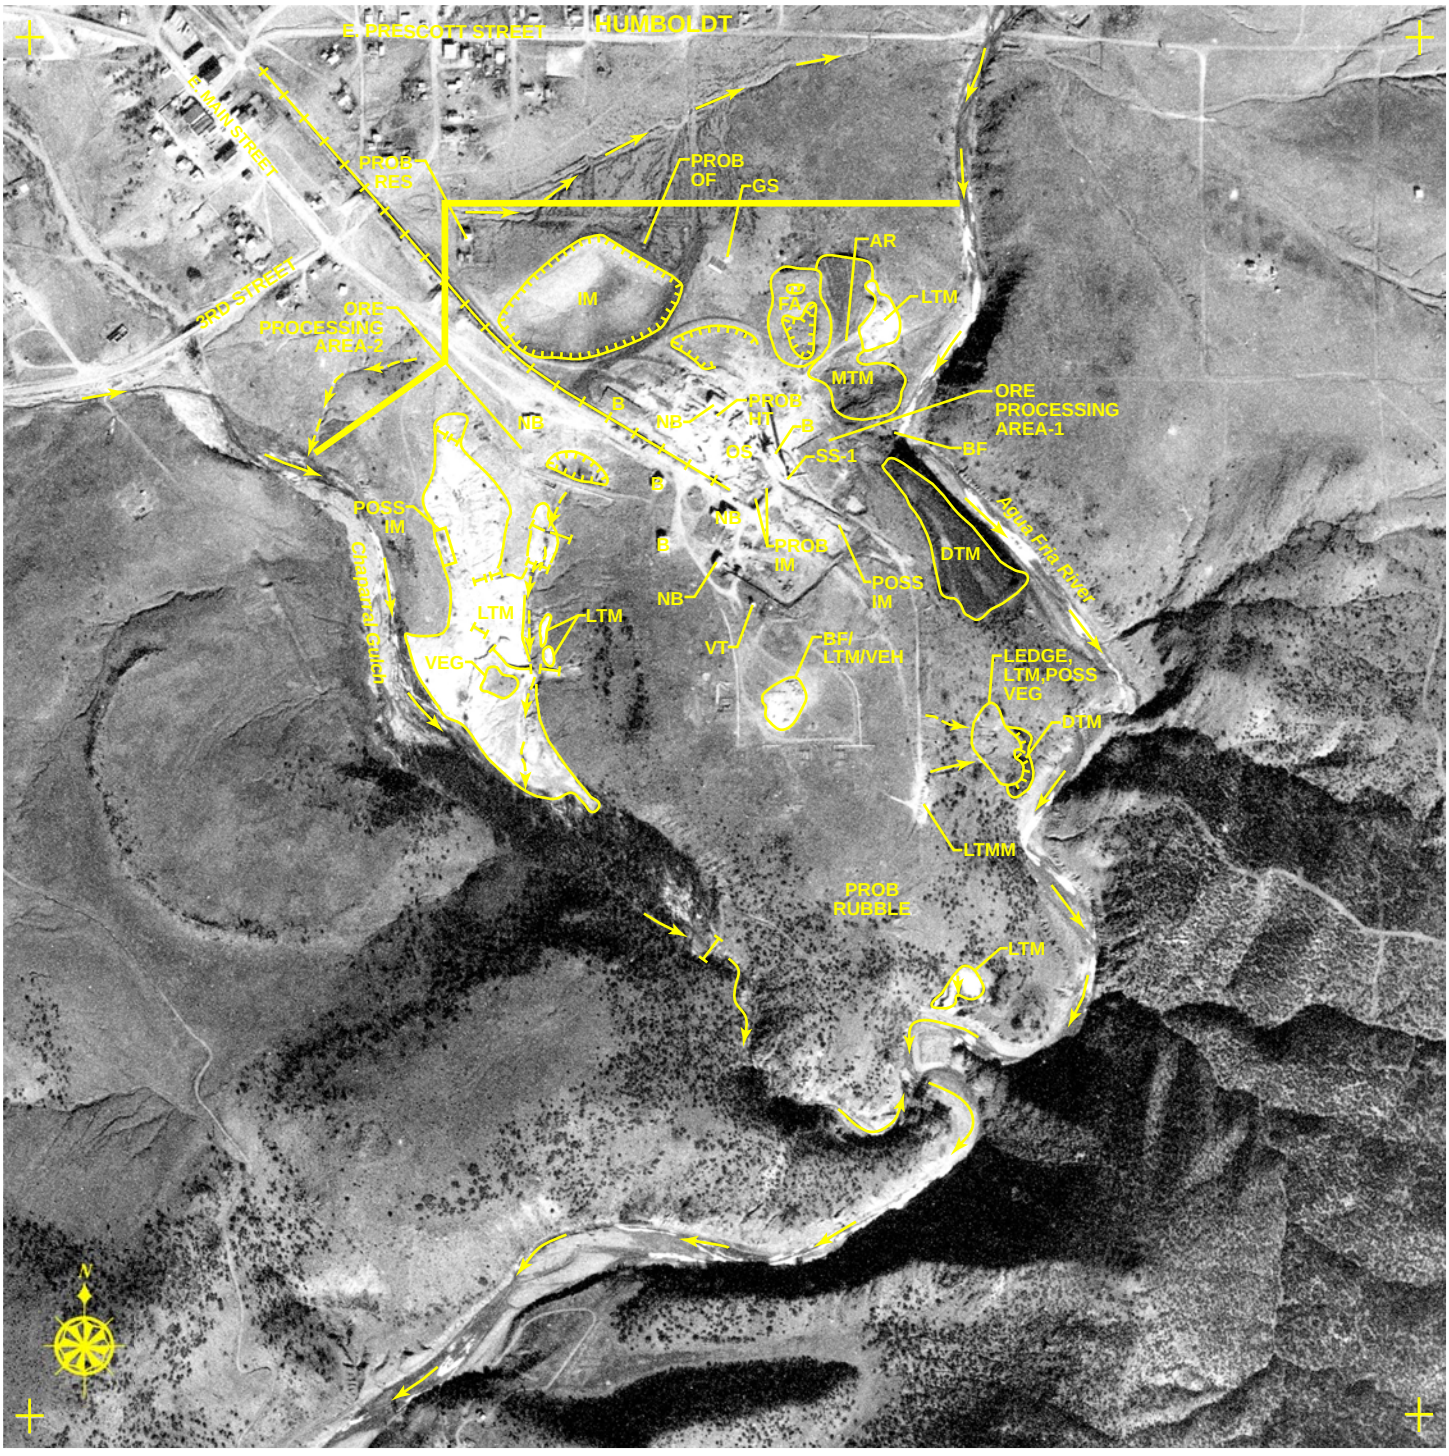
FIGURE 13. HUMBOLDT SMELTER, JANUARY 15, 1964. APPROX. SCALE 1:4,500.

JANUARY 15, 1964 (FIGURE 13)

Ore processing is ongoing at Ore Processing Area-1 in the northern section of the smelter. Ore processing activity in the area appears to be centered on smokestack SS-1. Light-toned material has been spread over the surface of the area around the stack. Three new buildings, a probable horizontal tank, two probable impoundments, and an open storage area containing probable equipment and probable crates are now in this area. Open hopper railcars (not annotated) are on the rail lines in the area. A large impoundment has been excavated and formed in a drainage channel in the northwest corner of the smelter. The impoundment is empty and a probable outfall is located on the north side of the impoundment. Light-toned material has been deposited on top of the mound of medium-toned material located east of the Agua Fria River. An access road, likely used for hauling waste material to the location, leads from the ore processing area west to the top of the mound. The impoundment, noted in 1953 west of the medium-toned mounded material, has been partially covered over with fill material. Smokestack SS-2, noted in place in this area since 1940, has been removed.

Little observable environmentally significant change has occurred on or around Ore Processing Area-2 since 1953. The dams located in the wash leading down to the Chaparral Gulch in this area of the smelter will no longer be annotated or discussed unless significant environmental changes is noted in association with them.

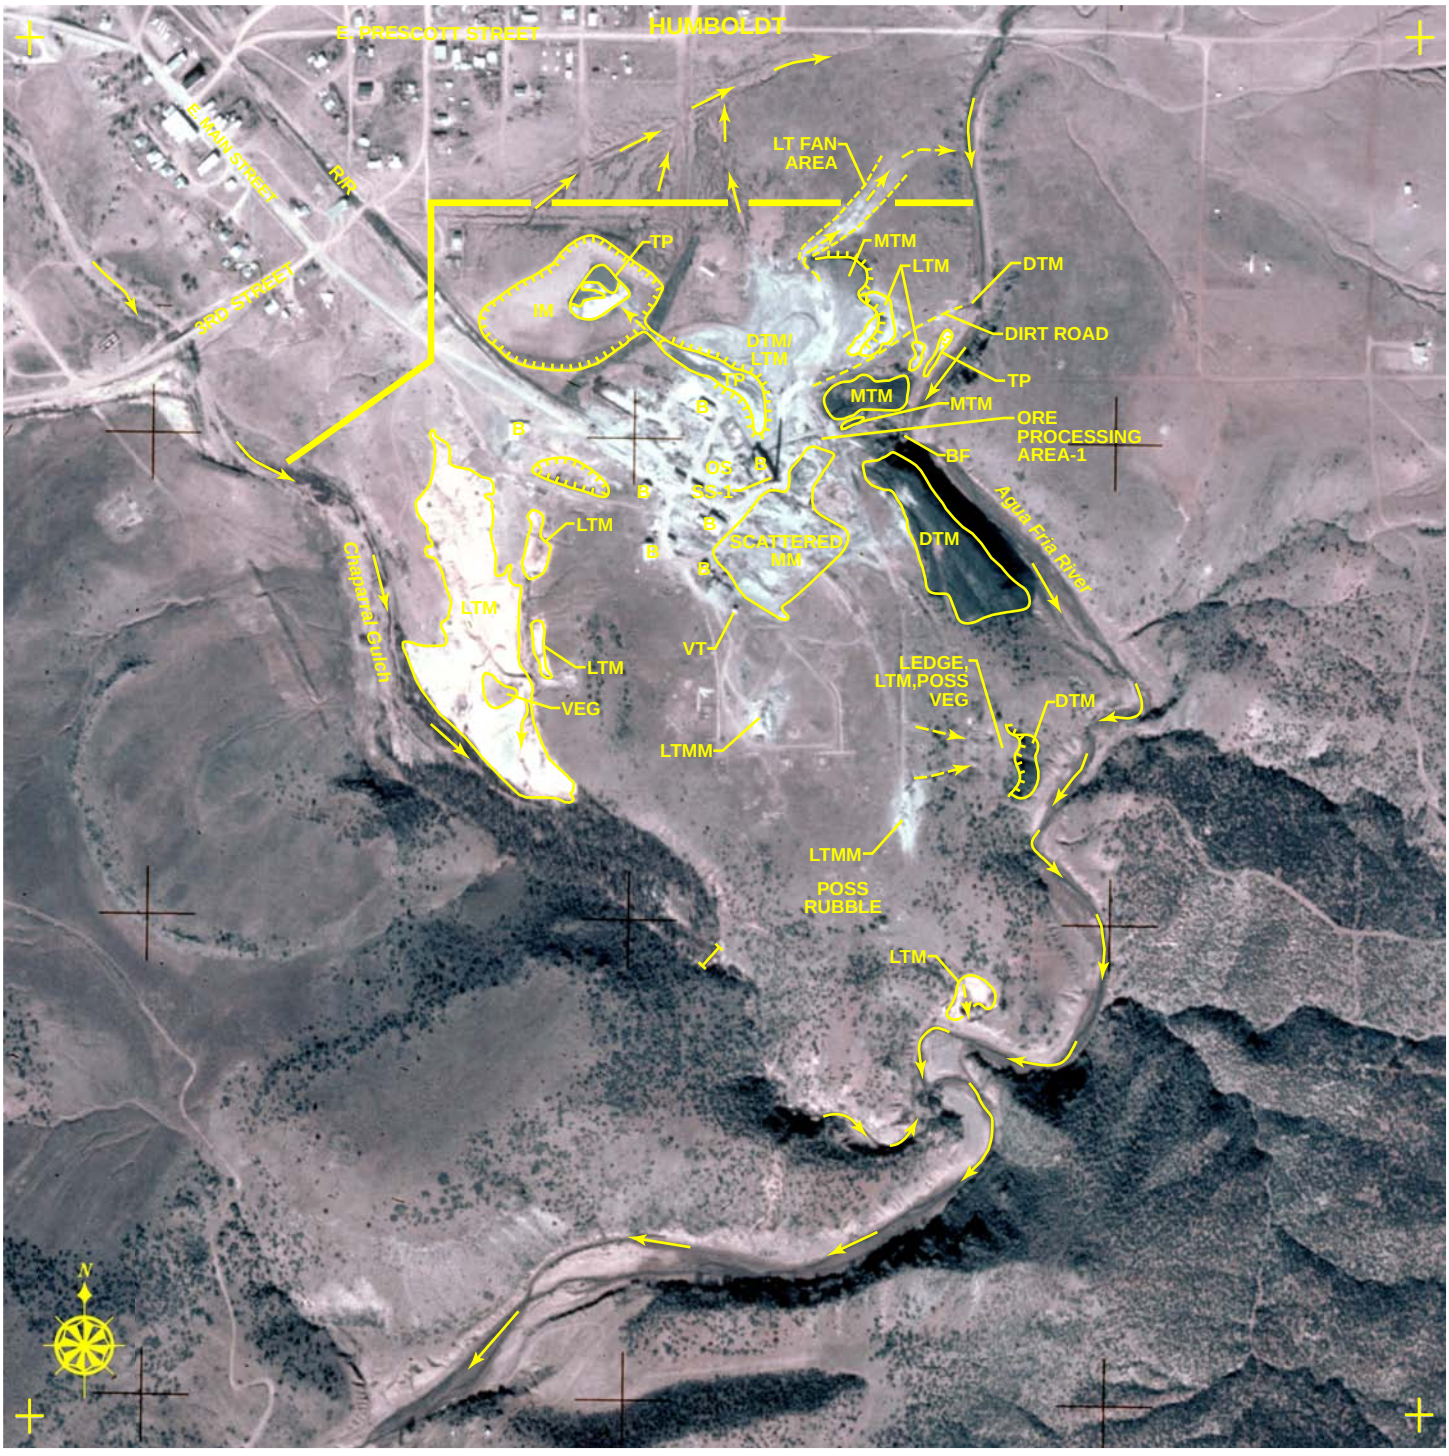
FIGURE 14. HUMBOLDT SMELTER, FEBRUARY 6, 1970. APPROX. SCALE 1:4,500.

FEBRUARY 6, 1970 (FIGURE 14)

Since 1964 ore processing in northern section of the smelter has continued. A linear-shaped tailings pond has been constructed and is in use northwest of smokestack SS-1. The pond appears to be designed to direct the flow of liquid into another tailings pond located in the large impoundment first noted in 1964 in the northwest section of the smelter. The drainage channel connecting the two tailings ponds appears to be blocked at this time. Dark- and light-toned liquid/sludge (not annotated) is in each of the tailings ponds. Light-toned material and dark-toned material has been deposited across the surface of the area east of the two ponds and also on the large mounded of medium-toned material located nearby. The area near the northeast corner of the smelter slopes to the northeast and it appears that material has flowed northward toward the Agua Fria River. A dirt road extends down the hill from the area around smokestack SS-1 to the Agua Fria River. The road ends near a tailings pond that has been constructed along the banks of the river. Light-toned material is visible in the pond (not annotated) and on the hillside above the pond. Since 1964 scattered mounds of light-toned and dark-toned material have been deposited in the area south of smokestack SS-1. The probable horizontal tank and two probable impoundments located near smokestack SS-1 are no longer visible.

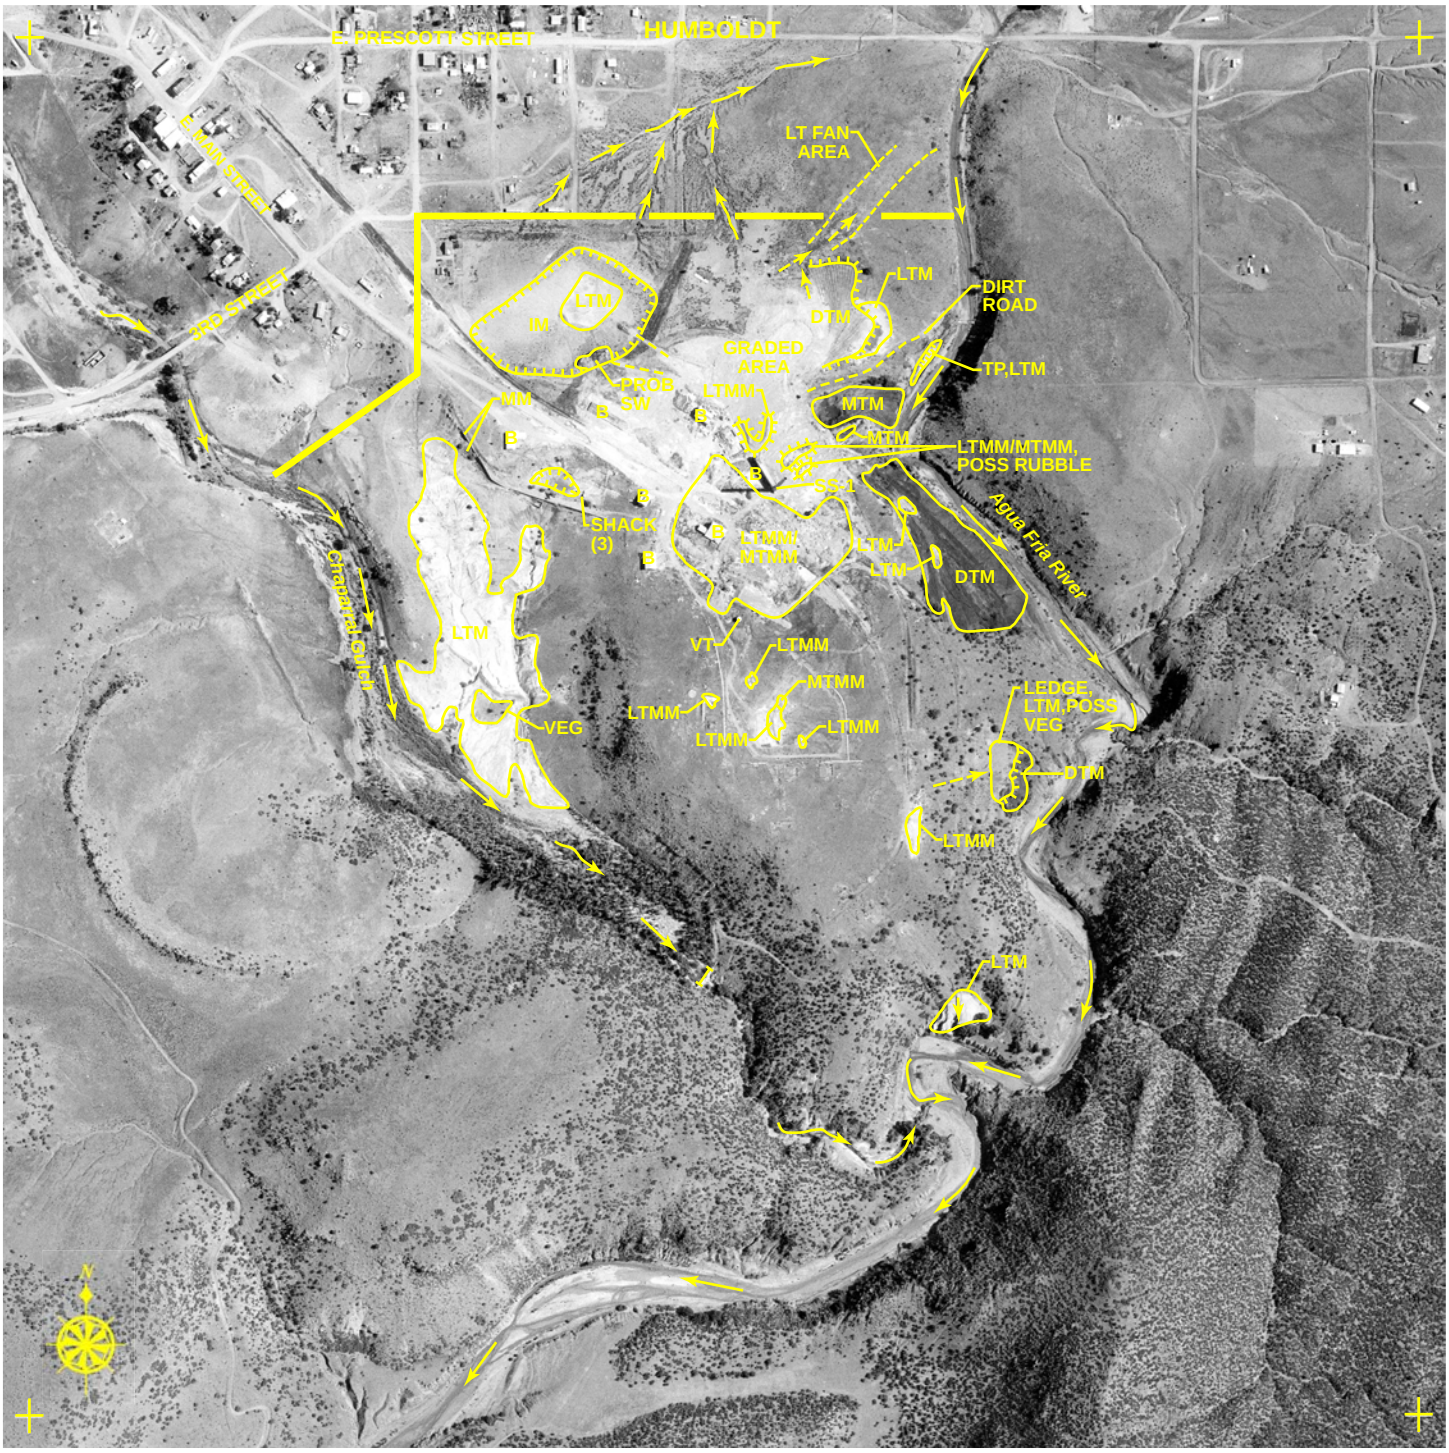
FIGURE 15. HUMBOLDT SMELTER, JUNE 27, 1973. APPROX. SCALE 1:4,500.

JUNE 27, 1973 (FIGURE 15)

Ore Processing Area-1 no longer appears to be in operation. The two tailings ponds located in the north section of the smelter in 1970 are no longer in use. The large impoundment, that contained a tailings pond in 1970, is dry and light-toned material covers part of the bottom of the impoundment. Probable solid waste has been deposited along the southern edge of the large impoundment. The linear tailings pond, situated north of smokestack SS-1 in 1970, has been demolished. The ground surface at the location of the former tailings pond and around the area north of smokestack SS-1 has been graded and light-toned fine-grained material appears to have been spread across the surface. Scattered mounds of light-toned and dark-toned material remain in place in the area south of smokestack SS-1 and mounds of light-toned material have been deposited just north of the smokestack. The tailings pond, located along the banks of the Agua Fria River, does not appear to contain liquid and light-toned material lines the bottom of the pond.

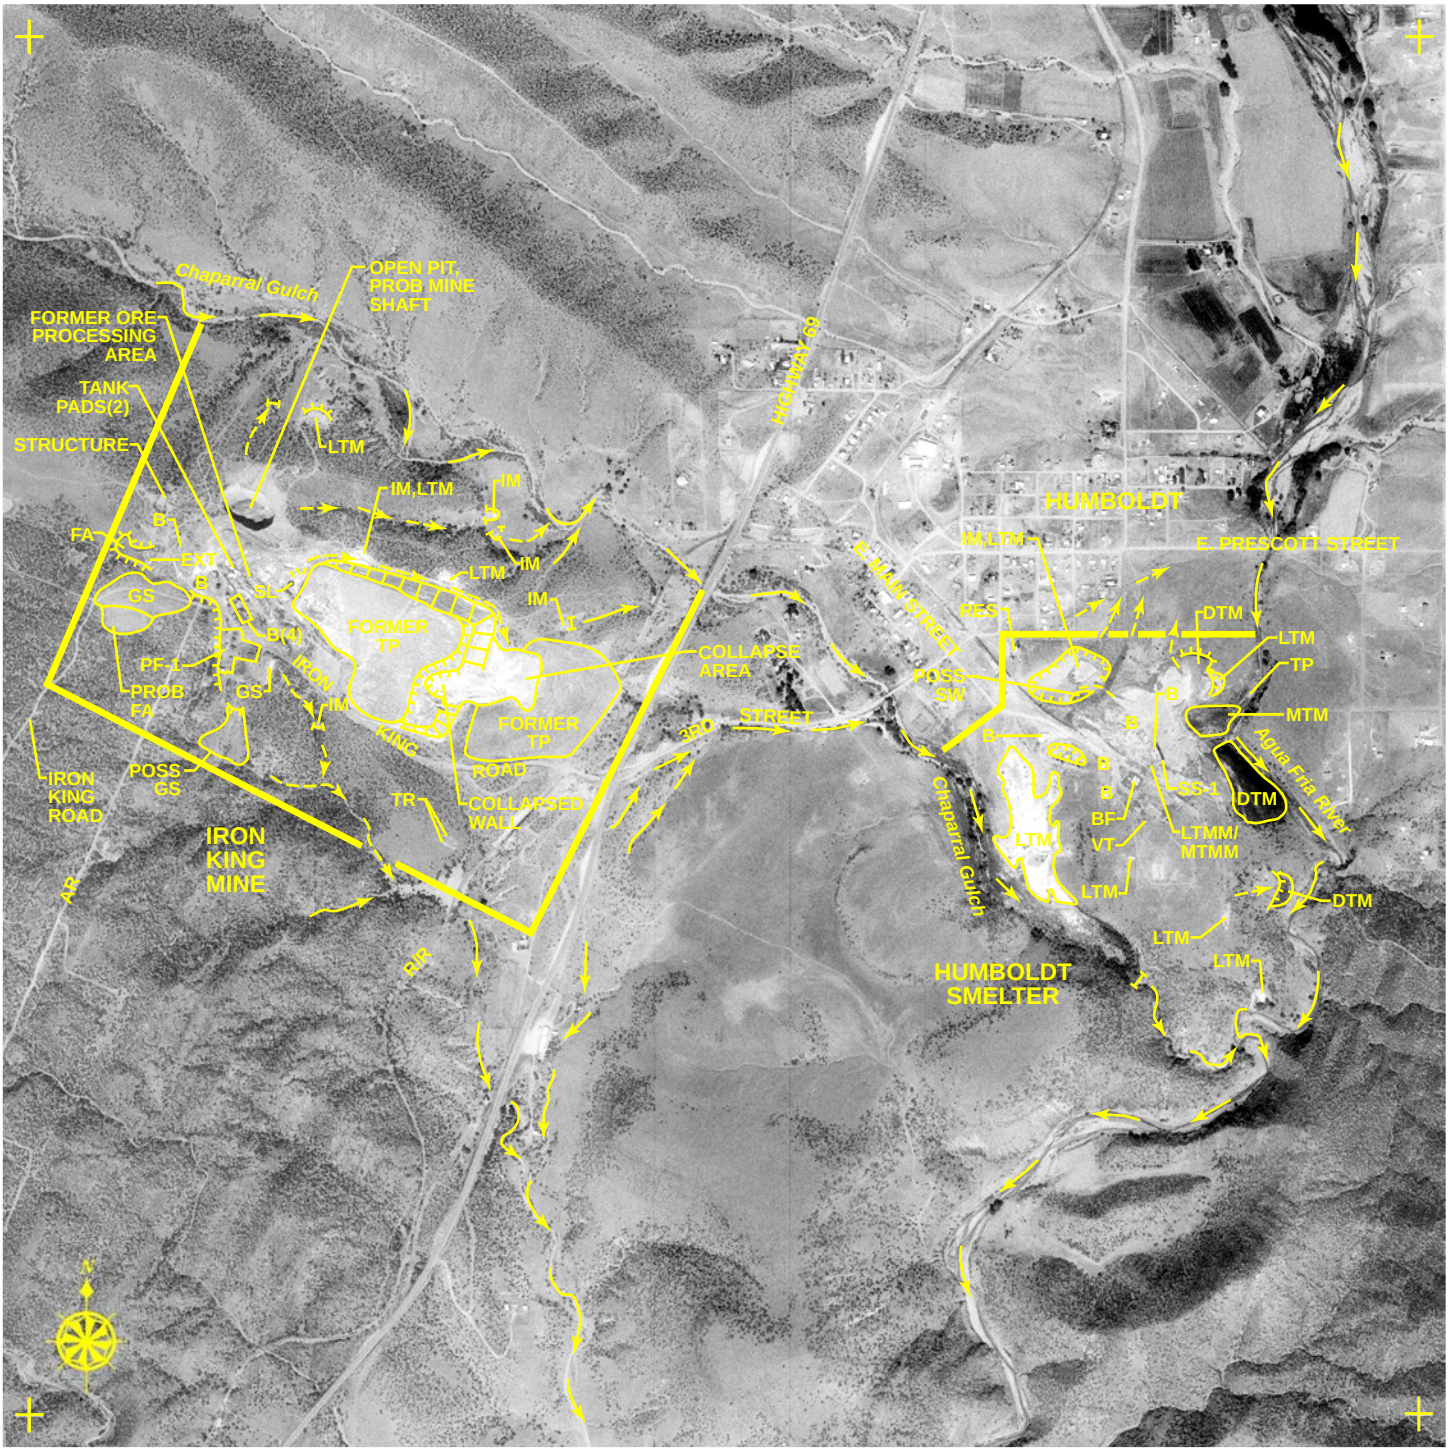
FIGURE 16. IRON KING MINE/HUMBOLDT SMELTER SITE, SEPTEMBER 25, 1980. APPROX. SCALE 1:9,800.

SEPTEMBER 25, 1980 (FIGURE 16)

Little observable environmentally significant change has occurred on the smelter since 1973. A building in the center of the smelter, southwest of smokestack SS-1, has been removed and a building foundation is visible at the location. The tailings pond, located along the banks of the Agua Fria River, is no longer in use. The large impoundment in the north section of the smelter is empty. A dirt road crosses the southern berm and provides access to the bottom of the impoundment. The probable solid waste, located on the southern berm of the impoundment, does not appear to have changed.

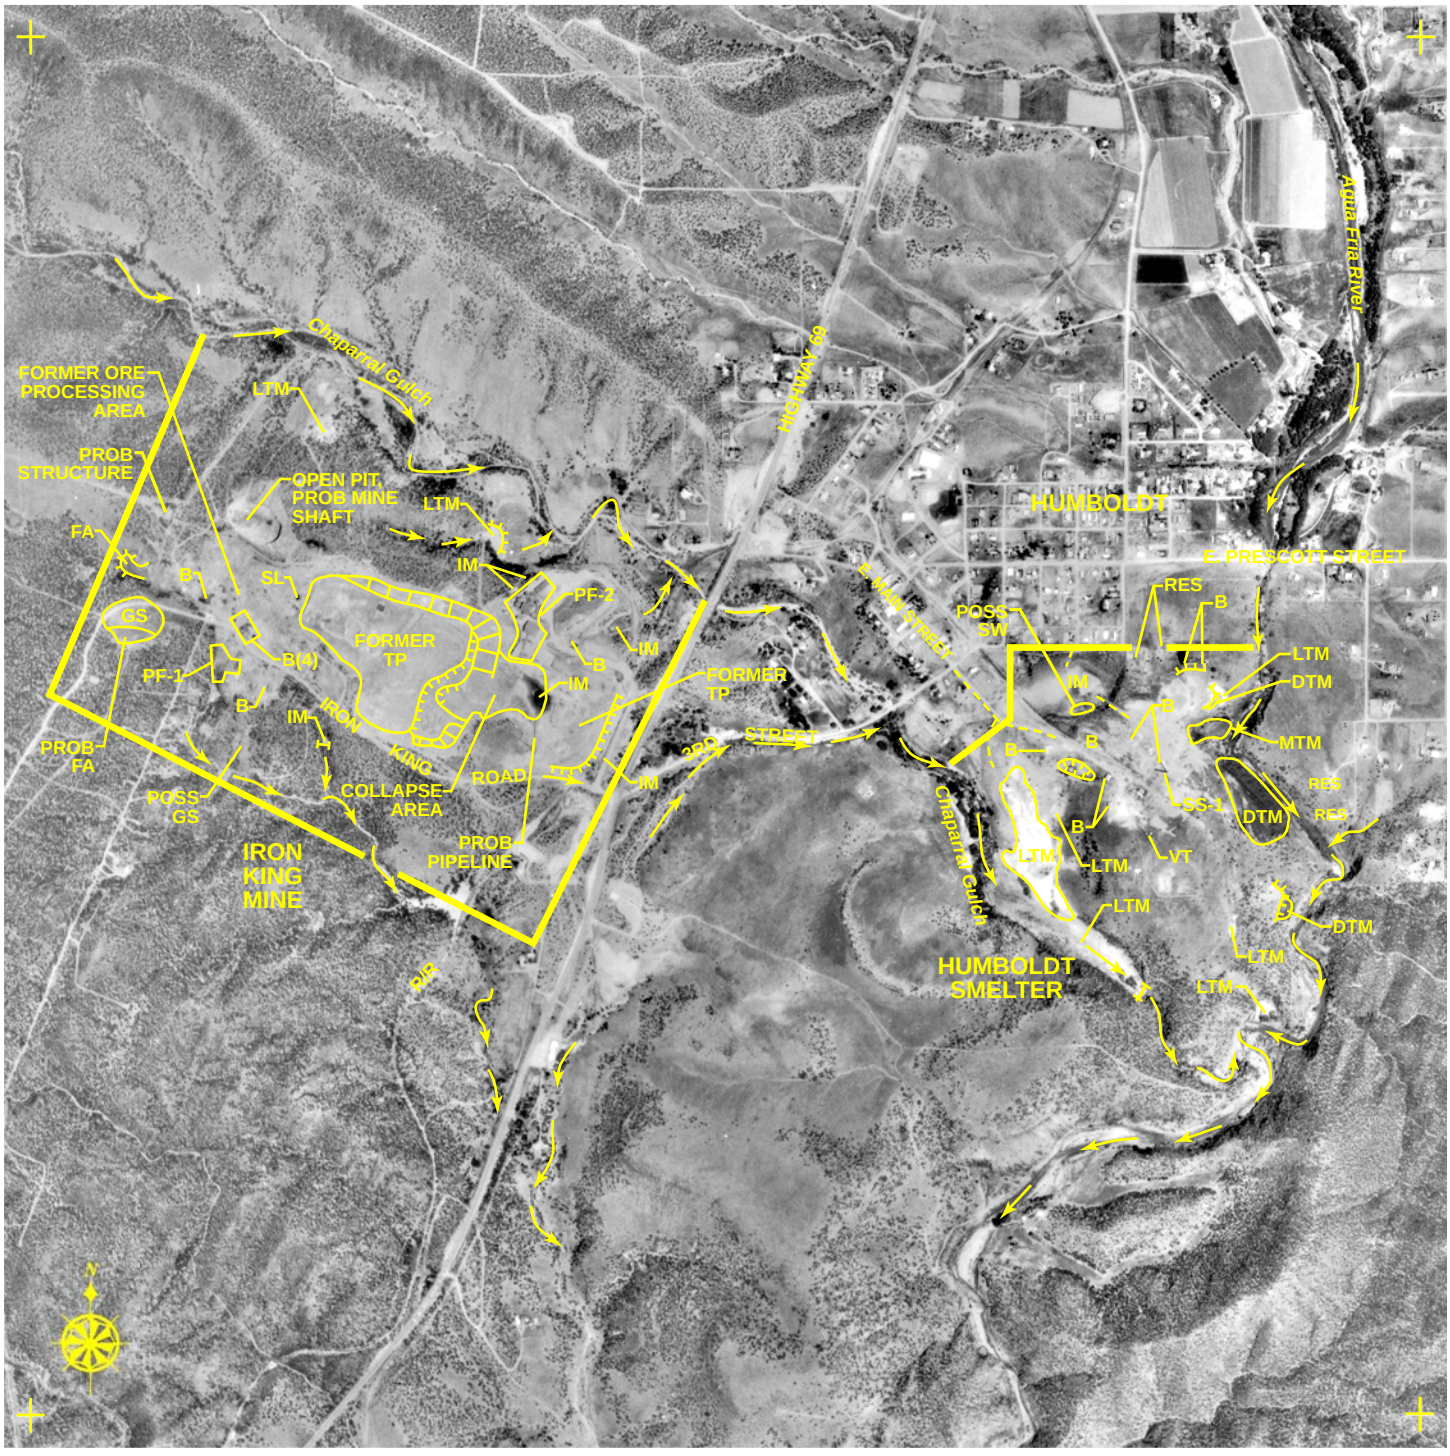
FIGURE 17. IRON KING MINE/HUMBOLDT SMELTER SITE, JUNE 5, 1992. APPROX. SCALE 1:9,800.

JUNE 5, 1992 (FIGURE 17)

Little observable environmentally significant change has occurred on the smelter since 1980. Most of the scattered mounds of light-toned and dark-toned material, in place south of smokestack SS-1 in 1973 and 1980, are no longer visible. Three mounds of medium-toned material (not annotated) have been deposited on the probable solid waste located on the southern berm of the large impoundment. A new dirt road crosses the northern berm of the large impoundment.

Third Street now extends across the northern boundary of the smelter and provides access to the large impoundment. New residences and two out buildings have been built off the site, east of East 3rd Street, along the northern edge of the smelter.

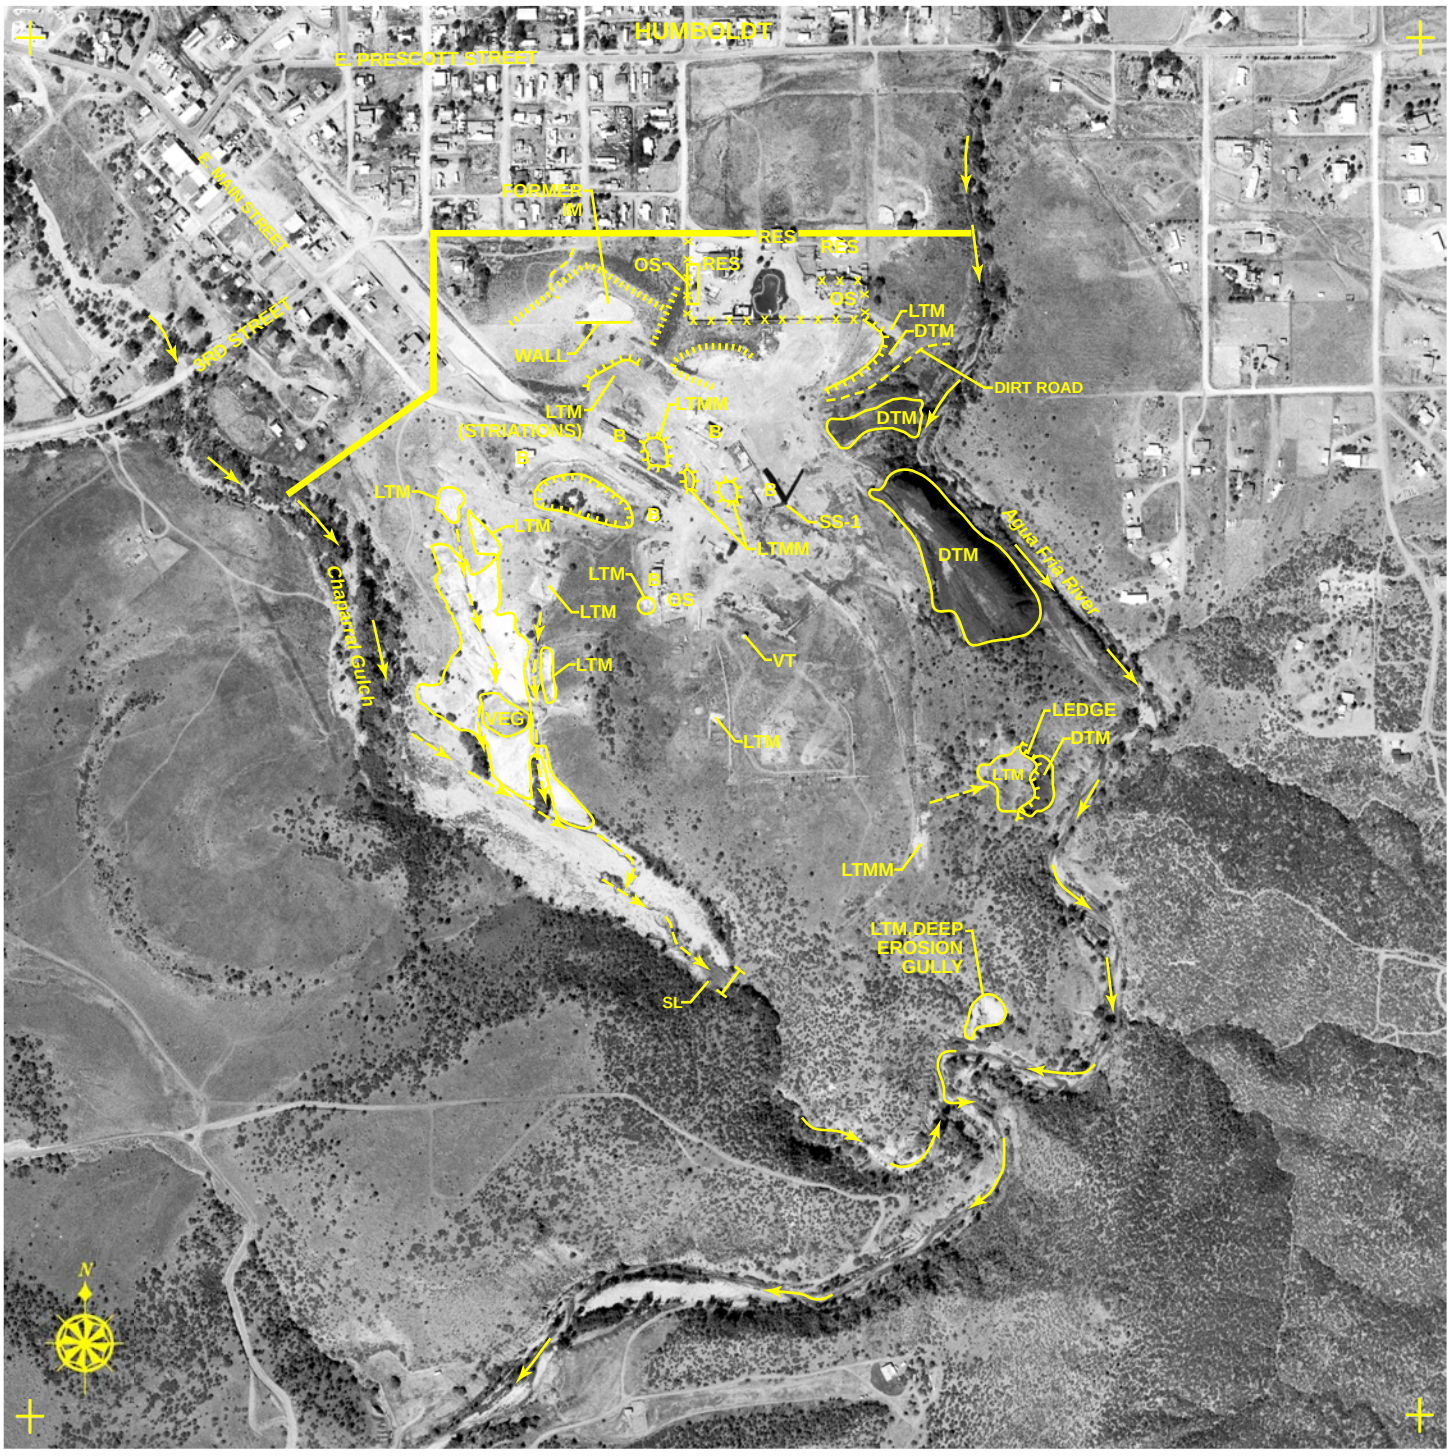
FIGURE 18. HUMBOLDT SMELTER, SEPTEMBER 20, 2003. APPROX. SCALE 1:4,500.

SEPTEMBER 20, 2003 (FIGURE 18)

Little observable environmentally significant change has occurred on the smelter since 1992. The tailings pond, located along the banks of the Agua Fria River, is no longer visible. Vegetation obscures the area. An open storage area housing crates and containers is located in the center of the smelter. Light-toned material has been spread across both the southern berm of the large impoundment and across the area where probable solid was visible in the past on the southern berm of the large impoundment. A wall has been built across the bottom of the impoundment and a dirt access road crosses the northern berm of the impoundment.

There are now three residences along the northeast border of the smelter. A fence separates the residences from the smelter. Nearby an open storage area (crates and containers) has been placed on the dark-toned mounded material that had been in place at the location since at least 1940.
