Field Report for Airborne Data Collected In Support of US EPA Region 6 Intercontinental Terminals Company LLC Fire 1 April 2019

Data Results Flight 17, 1 April 2019

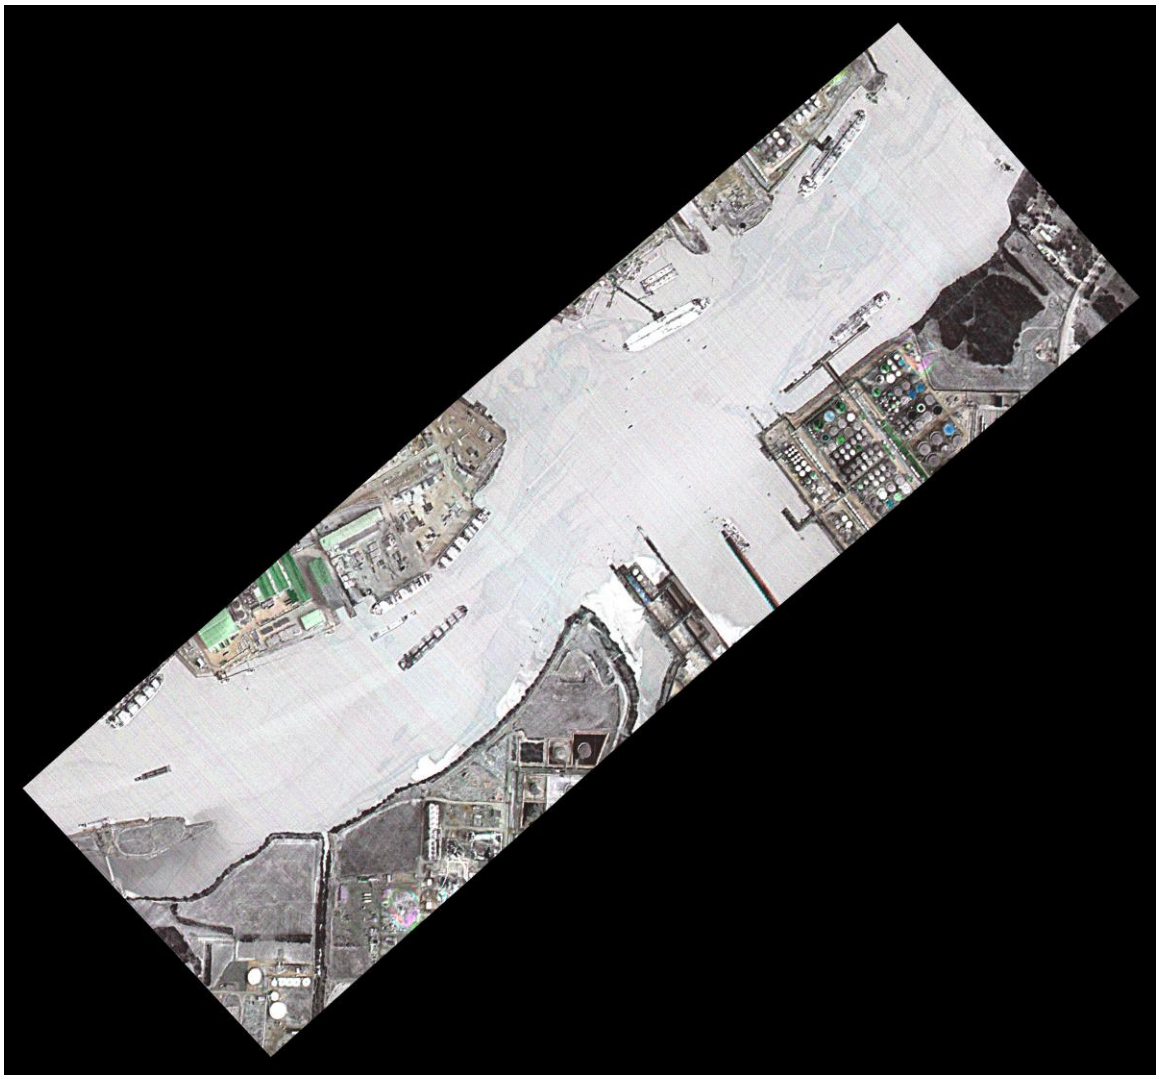
A total of 1 test and 6 data passes were made in the proximity of the impacted tank farm and also in extended areas surrounding the site and infrared line scanner images were generated for each pass. Figure 3 shows a typical 3-band infrared image obtained from data collected for Run 3. IR imagery of the tank farm indicates that all tanks are at ambient temperature other than IR solar heating. As with the flight on 31 March 2019 with tanks in the NE corner of the farm are the coolest.

An IR image of the confluence area is given in Figure 4. Boomed oil can be seen against the booms and light sheen is present in the main channel. There appears to be sheen leaking from the southern section of booms on the ship channel.

Figure 3: IR image of ITC data for 1 April 2019, Flight 17 Run 5

Figure 4: IR Image of Contained Oil 1 April 2019, Fight 17, Run 7

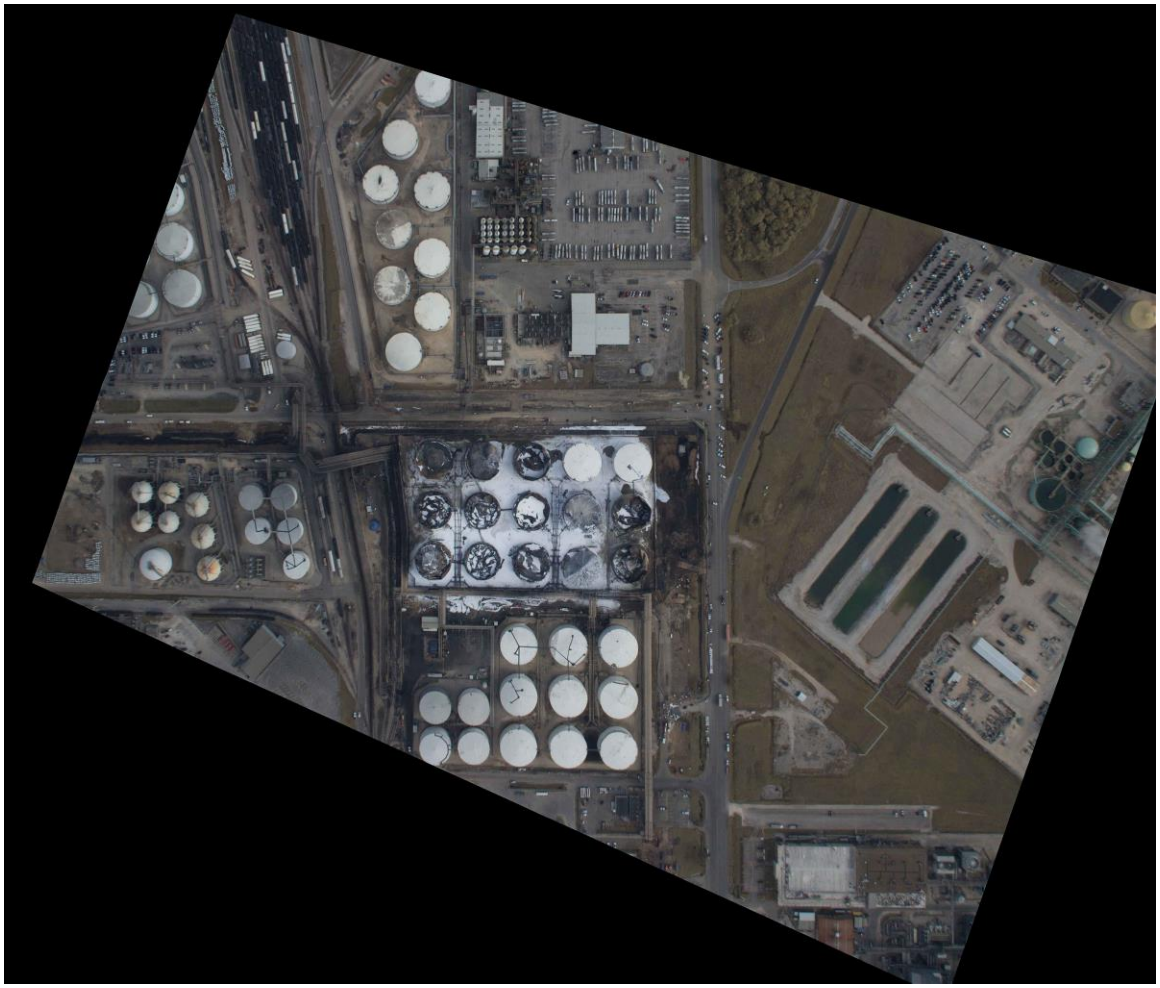
A full set of high resolution aerial digital photography was collected as part of the flight. Figure 5 shows a representative overhead image collected as part of each pass over the tank farm. Analysis of the image shows that several of the tanks appear to have the tops removed or collapsed. An oblique image of the tank farm confirms the status of the area (figure 6).

Figure 5: Aerial Image of the Tank Farm, 1 April 2019, Flight 17

Figure 6: Oblique Image of the Tank Farm, 1 April 2019 Flight 17

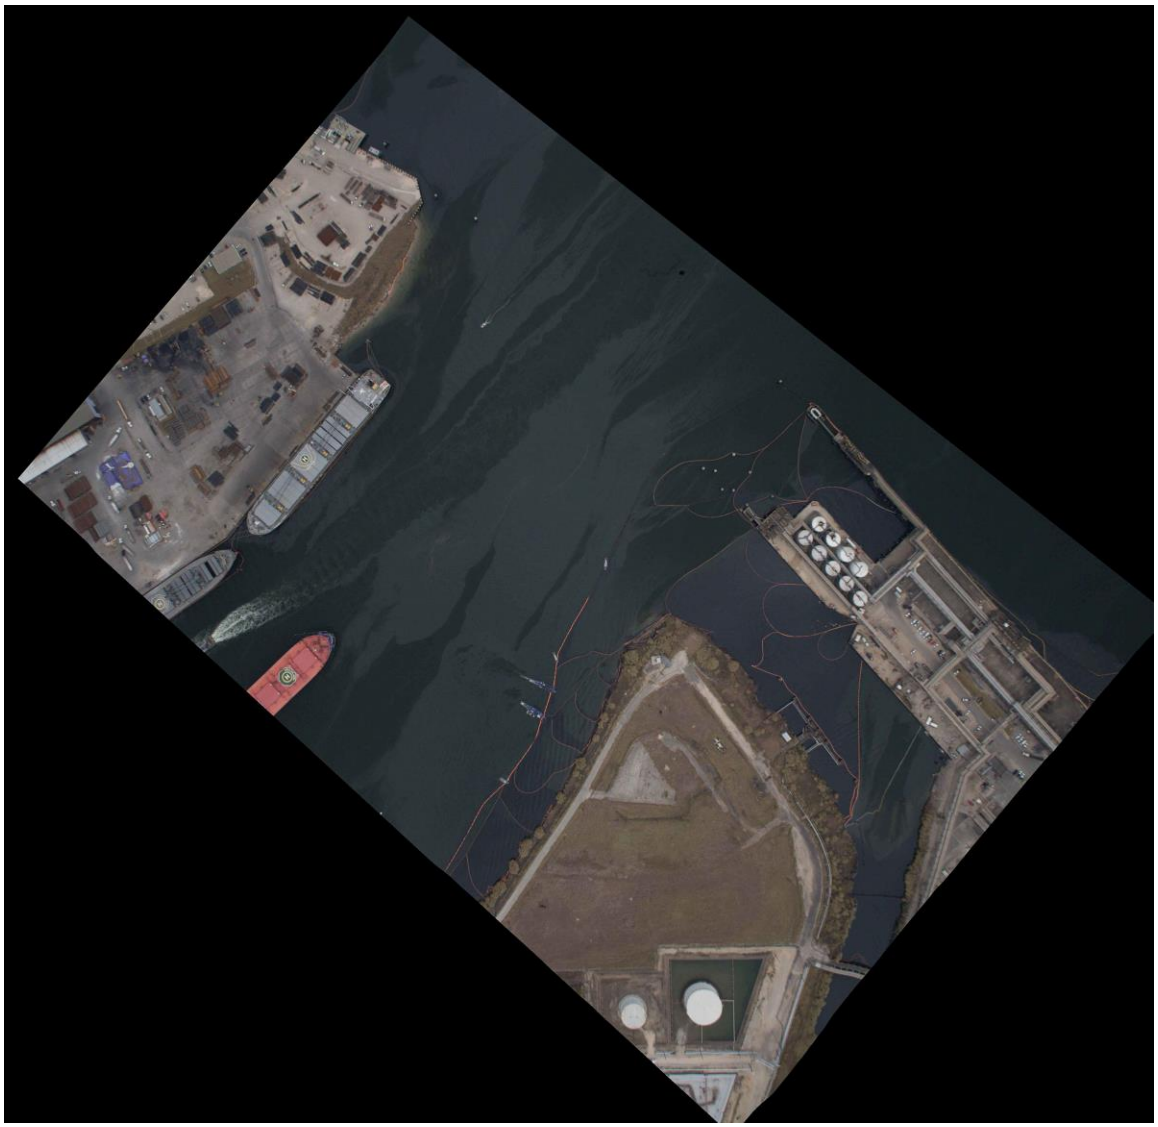
An aerial image of the confluence area is shown in Figure 7. Numerous booms continue to be used to secure the release with produce still present in the upper booms. The image shows the presence of sheen throughout the main channel. An oblique of the same area

confirms the findings in the aerial view with sheen present in the lower booms and main channel (figure 8).

Figure 7: Aerial Image of the Ship Channel Boom Area, 1 April 2019, Flight 17

Figure 8: Oblique Image of the Ship Channel Boom Area, 1 April 2019, Flight 17
