Field Report for Airborne Data Collected In Support of US EPA Region 6 Intercontinental Terminals Company LLC Fire 2 April 2019

Data Results Flight 18, 2 April 2019

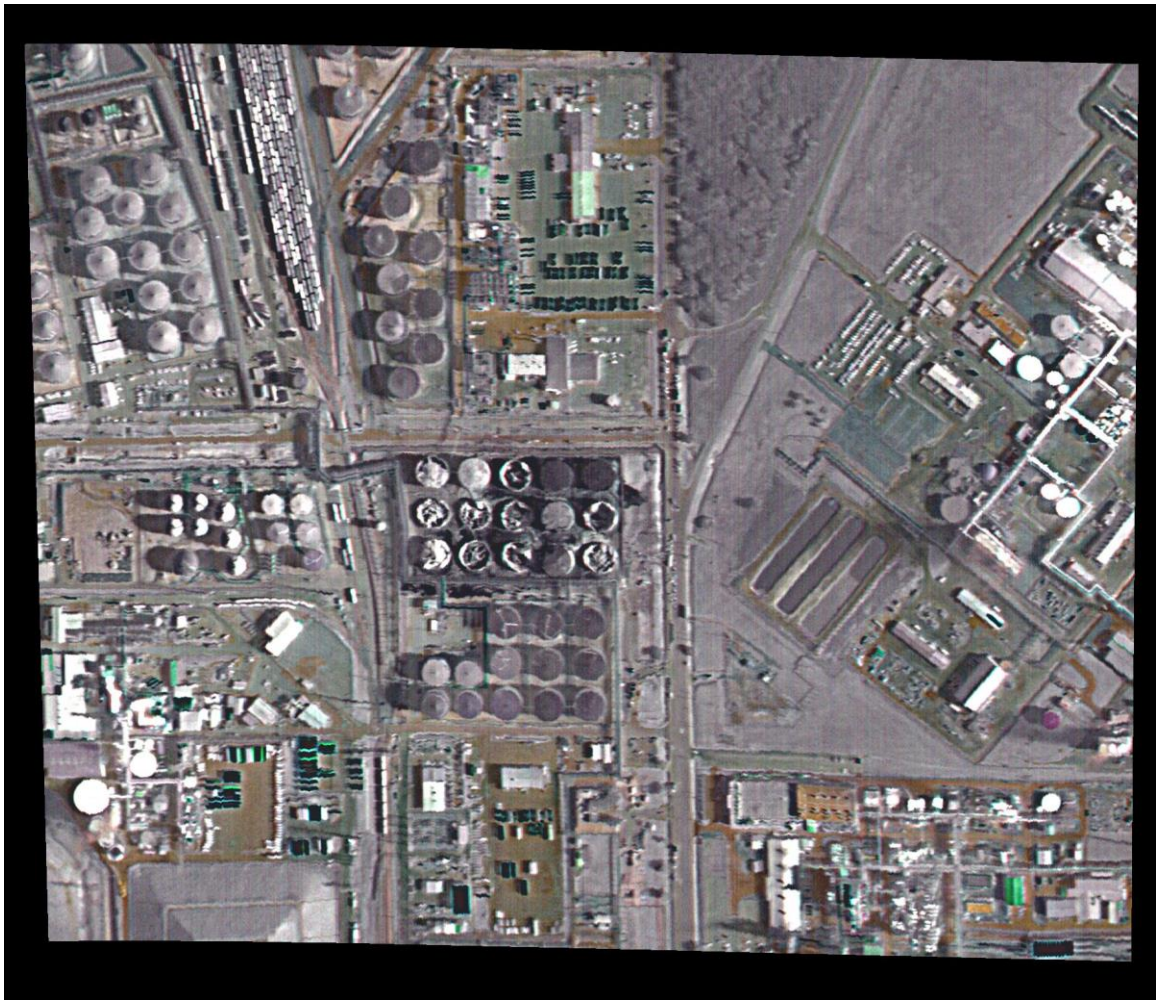
A total of 1 test and 6 data passes were made in the proximity of the impacted tank farm and also in extended areas surrounding the site and infrared line scanner images were generated for each pass. Figure 3 shows a typical 3-band infrared image obtained from data collected for Run 5. IR imagery of the tank farm indicates that all tanks are at ambient temperature other than IR solar heating on portions of the western structures.

Figure 3: IR image of ITC data for 2 April 2019, Flight 18, Run 5

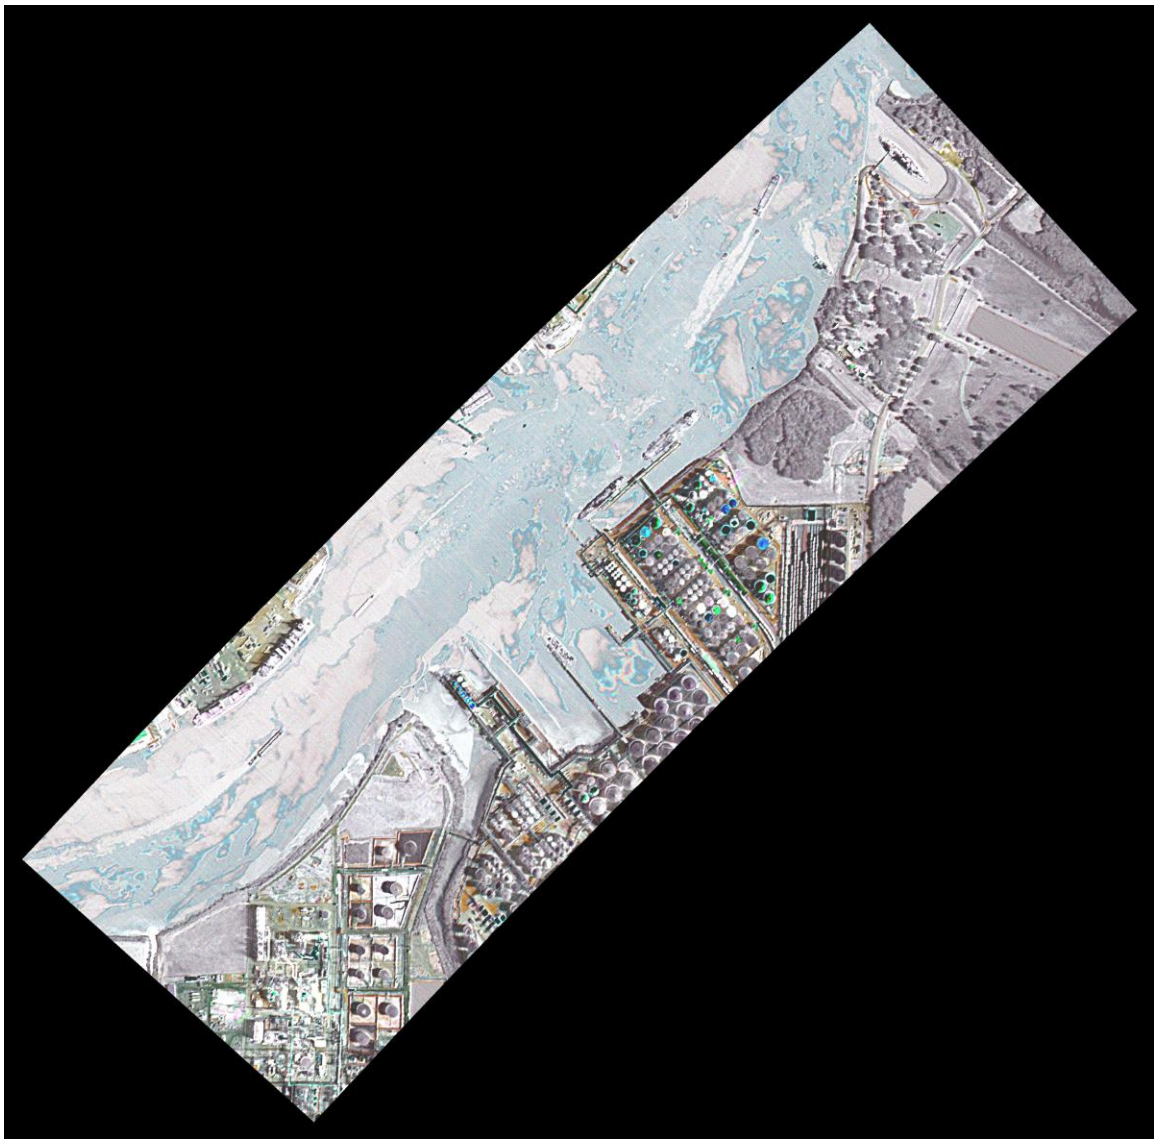
An IR image of the confluence area is given in Figure 4. Boomed oil can be seen within the boom structures with light sheen present in the main channel. A small amount of sheen appears to be leaking in the northeast most structure.

Figure 4: IR Image of Contained Oil 2 April 2019, Fight 18, Run 6

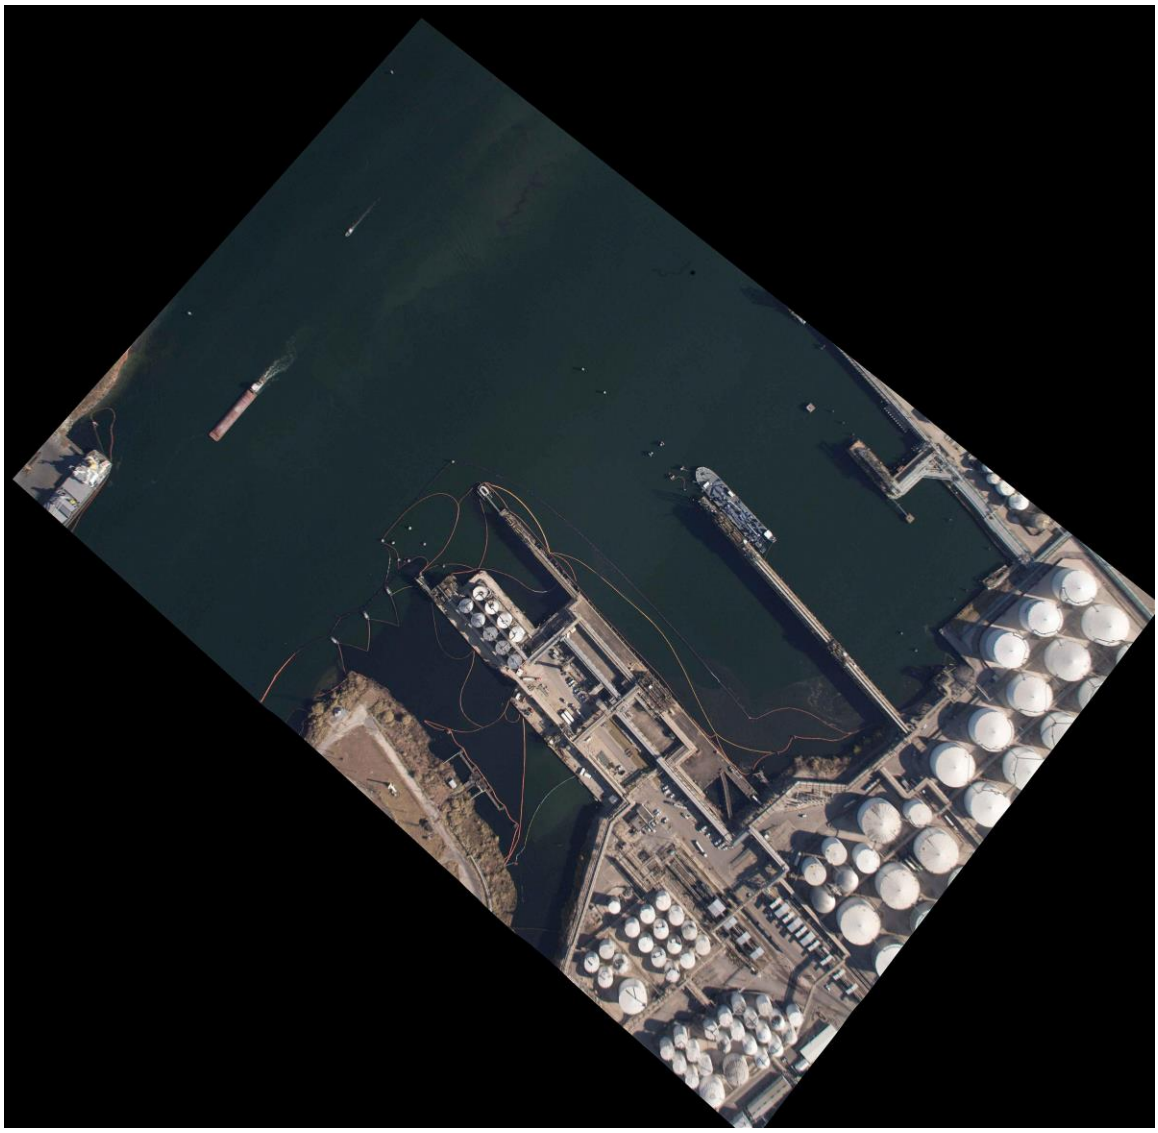
Figure 7 is an aerial image of the confluence area. As with prior flights, the boom network is clearly evident as is the trapped product behind the booms (visible as black material). No leakage of product or sheen past the booms is evident. An oblique of the

Figure 7: Aerial Image of the Ship Channel Boom Area, 2 April 2019, Flight 18
