Field Report for Airborne Data Collected In Support of US EPA Region 6 Intercontinental Terminals Company LLC Fire 28 March 2019

Data Results Flight 15, 28 March 2019

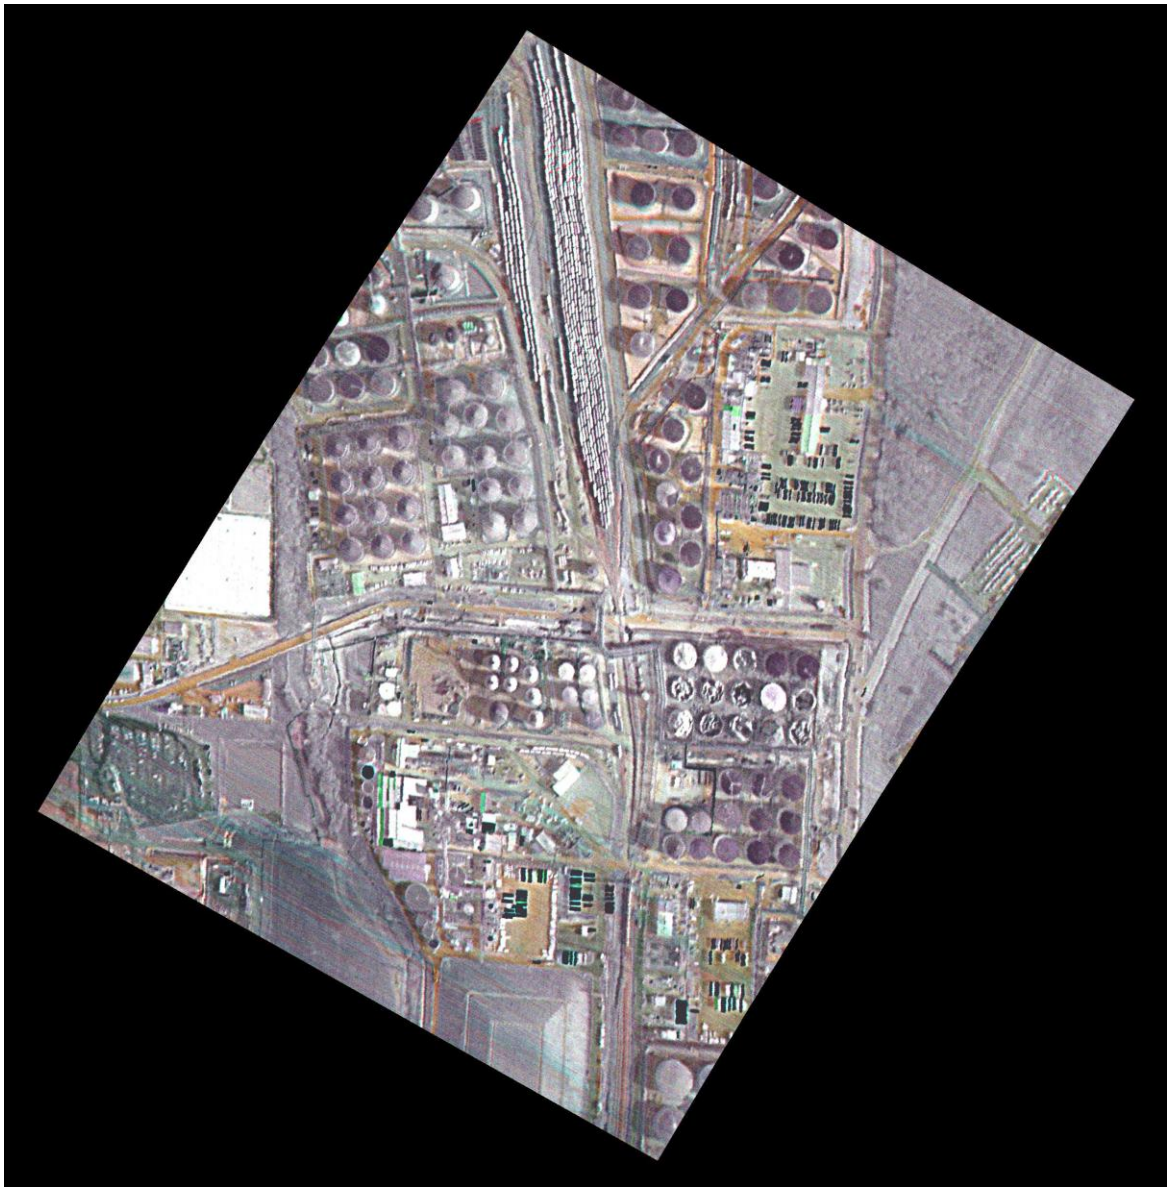
Figure 3: IR image of ITC data for 28 March 2019, Flight 15 Run 2

A total of 1 test and 7 data passes were made in the proximity of the impacted tank farm and also in extended areas surrounding the site and infrared line scanner images were generated for each pass. Figure 3 shows a typical 3-band infrared image obtained from data collected for Run 3. IR imagery is showing no change from flight 14 indicating that the tank farm is stable. A thermal image of the tank farm shows no significant difference

from previous missions again indicating that tank surfaces are at or near ambient temperature (some solar heating is occurring). As with other thermal images, note that the bottom right in the image is the NW due to the image being inverted.

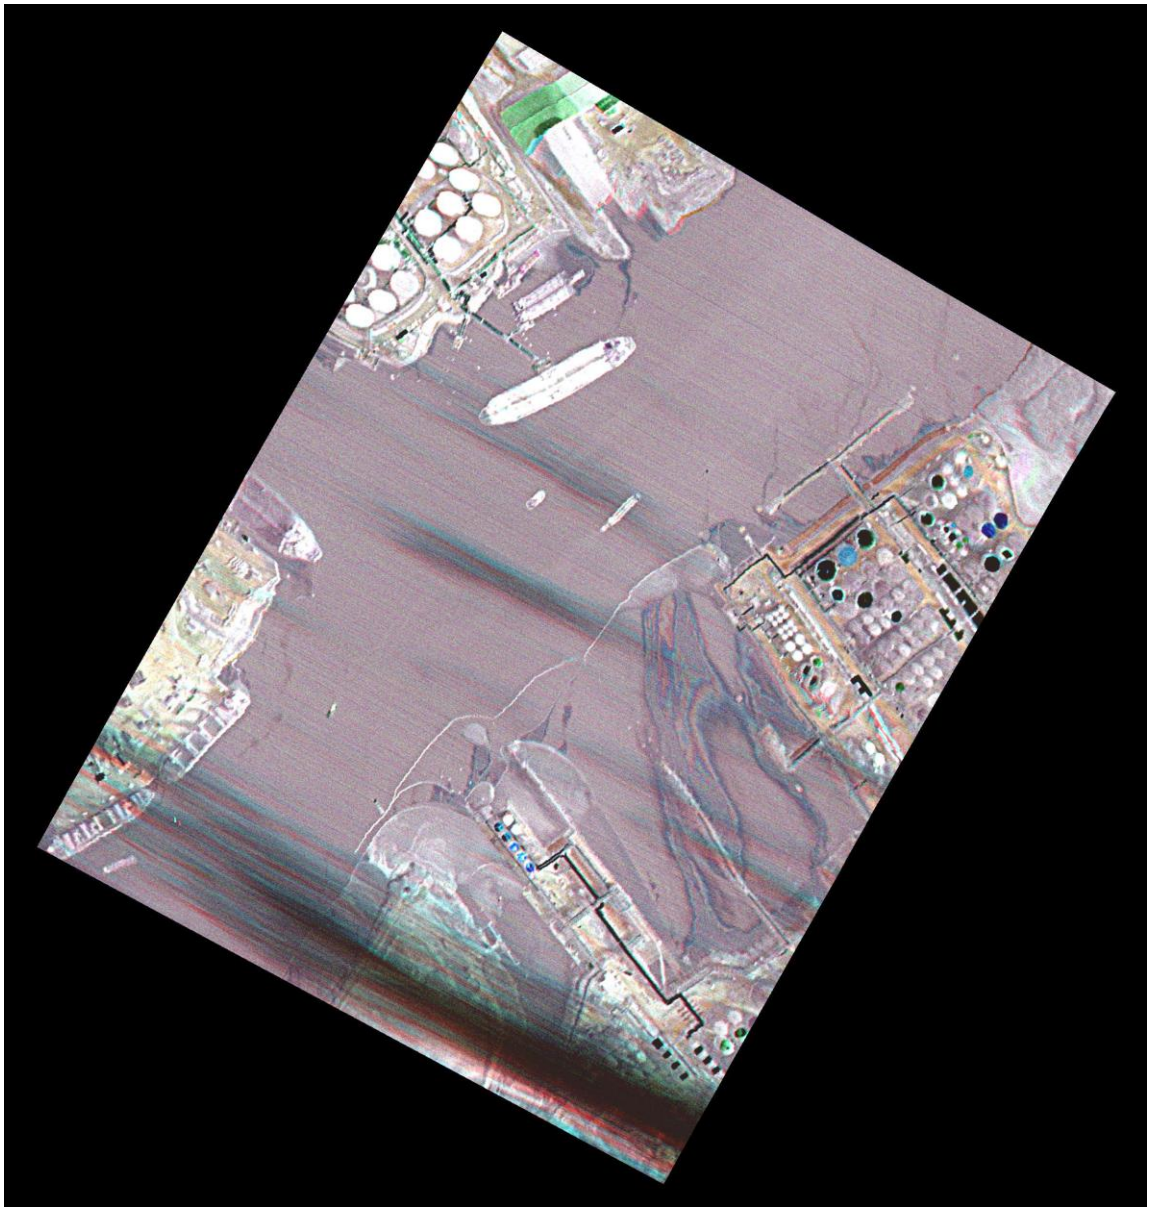
Figure 5: IR Image of Contained Oil 28 March 2019, Fight 15, Run 7

An IR image of the confluence area is given in Figure 5. It should be noted that the banding in the image are low level clouds. As with prior missions, the boom structure and trapped product are evident. Little boom leakage is present in this image.

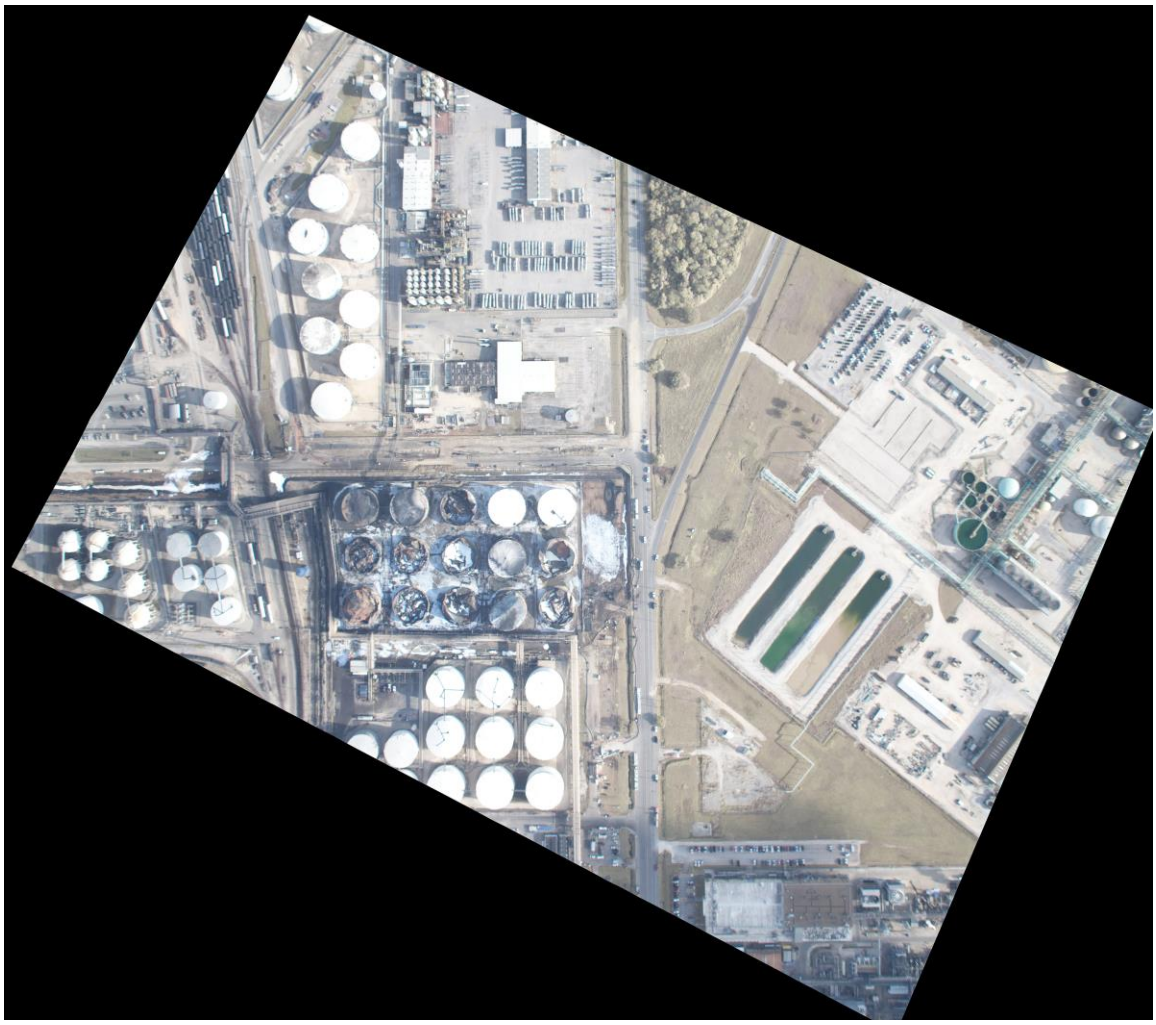
Figure 6: Aerial Image of the Tank Farm, 28 March 2019, Flight 15

A full set of high resolution aerial digital photography was collected as part of the flight. Figure 6 shows a representative overhead image collected as part of each pass over the tank farm. Visible imagery on Flight 15 was of poorer quality than previous missions due to low level clouds and haze in the area. Analysis of the image shows no noticeable change from prior images, again indicating that the scene is stable. An aerial image of the confluence area is shown in Figure 7. Trapped product appears to be

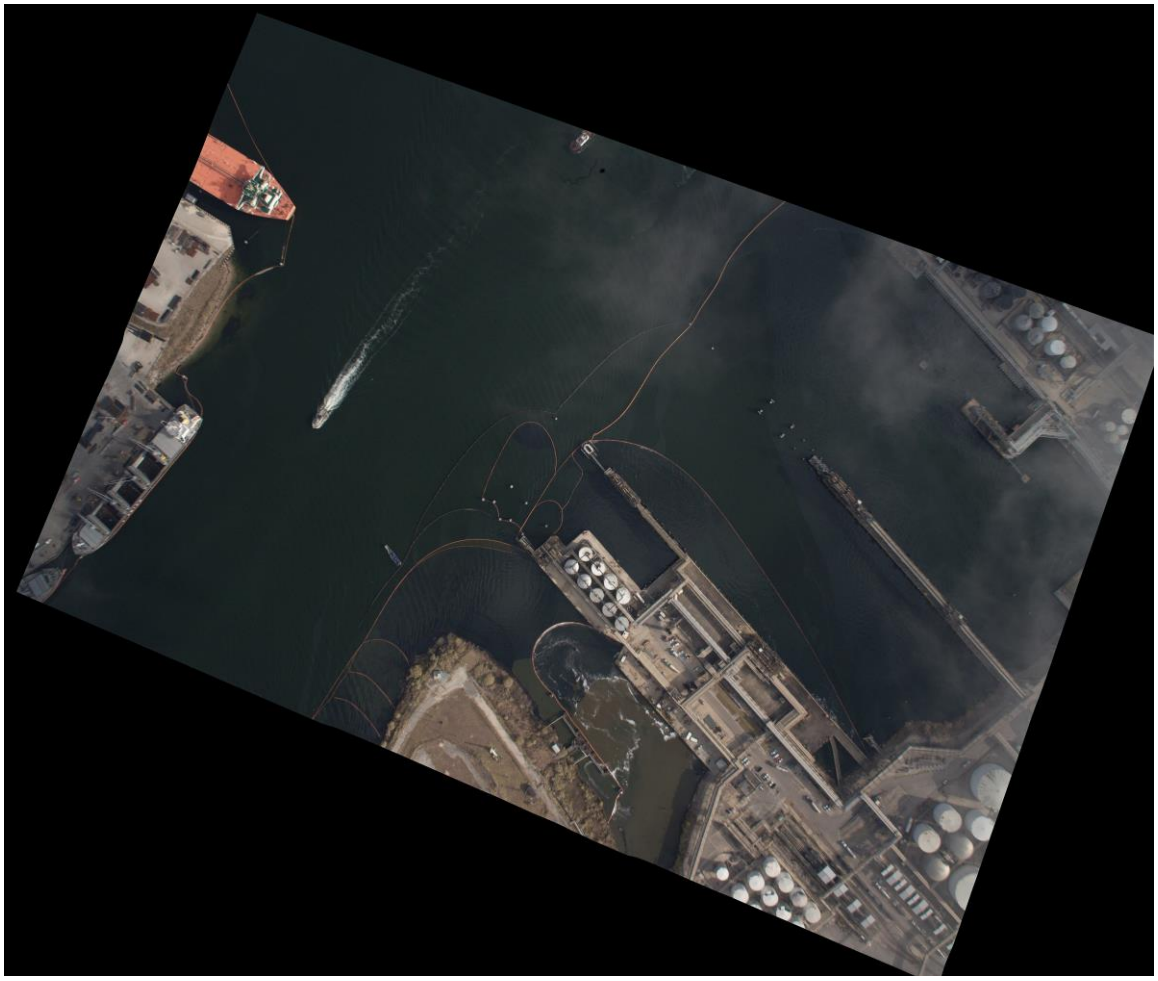
Figure 7: Aerial Image of the Ship Channel Boom Area, 28 March 2019, Flight 15

primarily present at the upstream boom and no boom leakage is evident. An oblique of the same area confirms the presence of trapped material in the upstream boom (Figure 8). The white signature present on the overhead and IR is actually boat wakes. Product containment appears to be solid in the oblique.
