Field Report for Airborne Data Collected In Support of US EPA Region 6 Intercontinental Terminals Company LLC Fire 3 April 2019

Data Results Flight 20, 3 April 2019

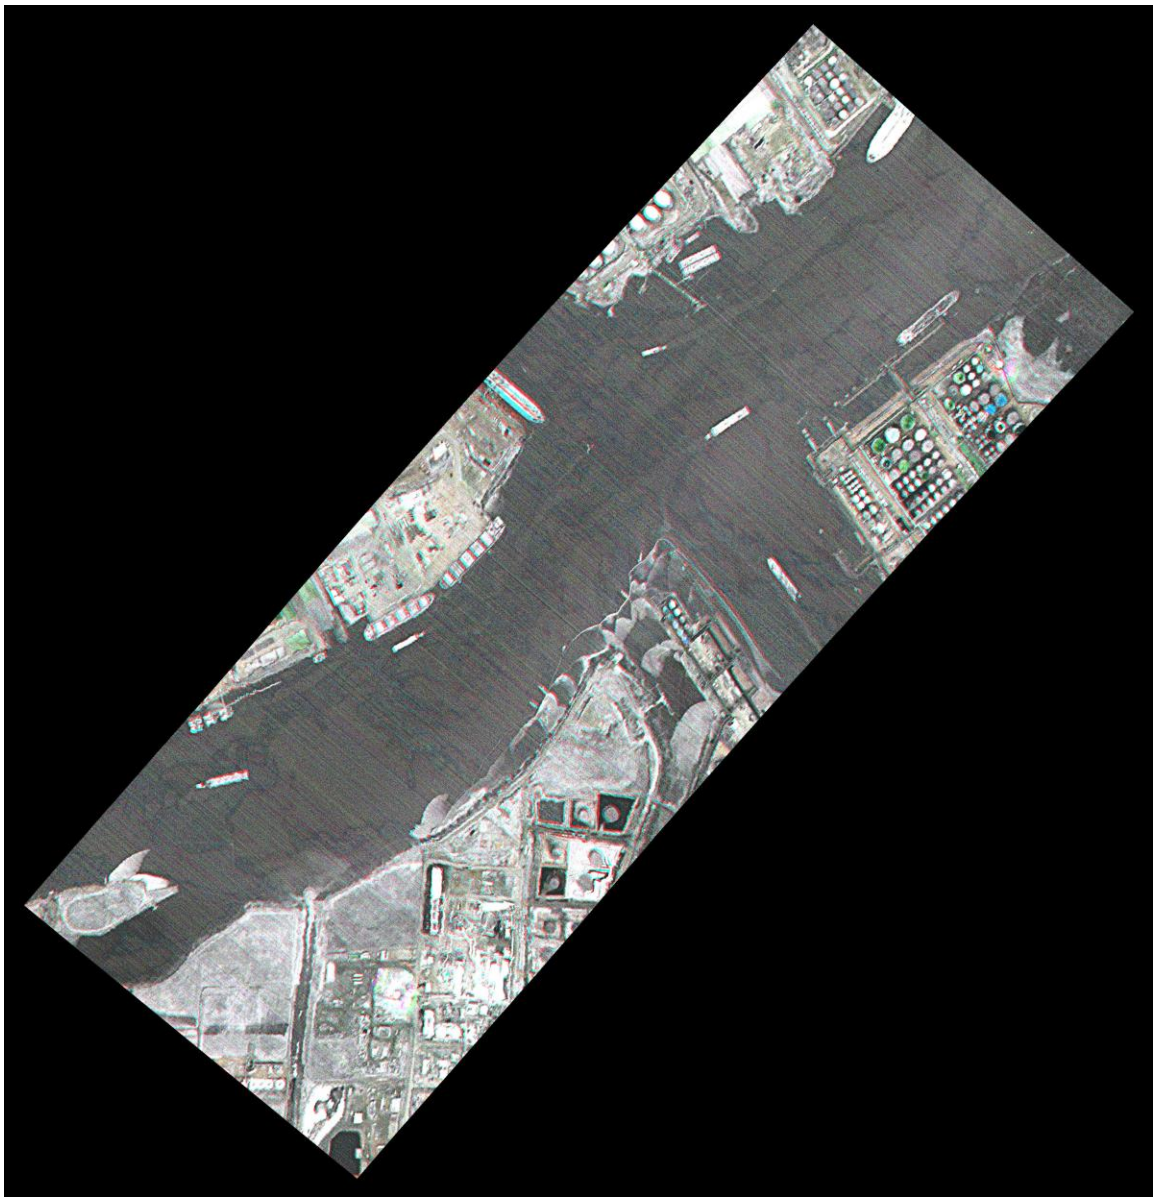
Figure 4: IR Image of Contained Oil 3 April 2019, Fight 20, Run 6

An IR image of the confluence area is given in Figure 4. Product continues to be present within the boom structure. A small amount of sheen appears to be leaking in the northeast most structure.

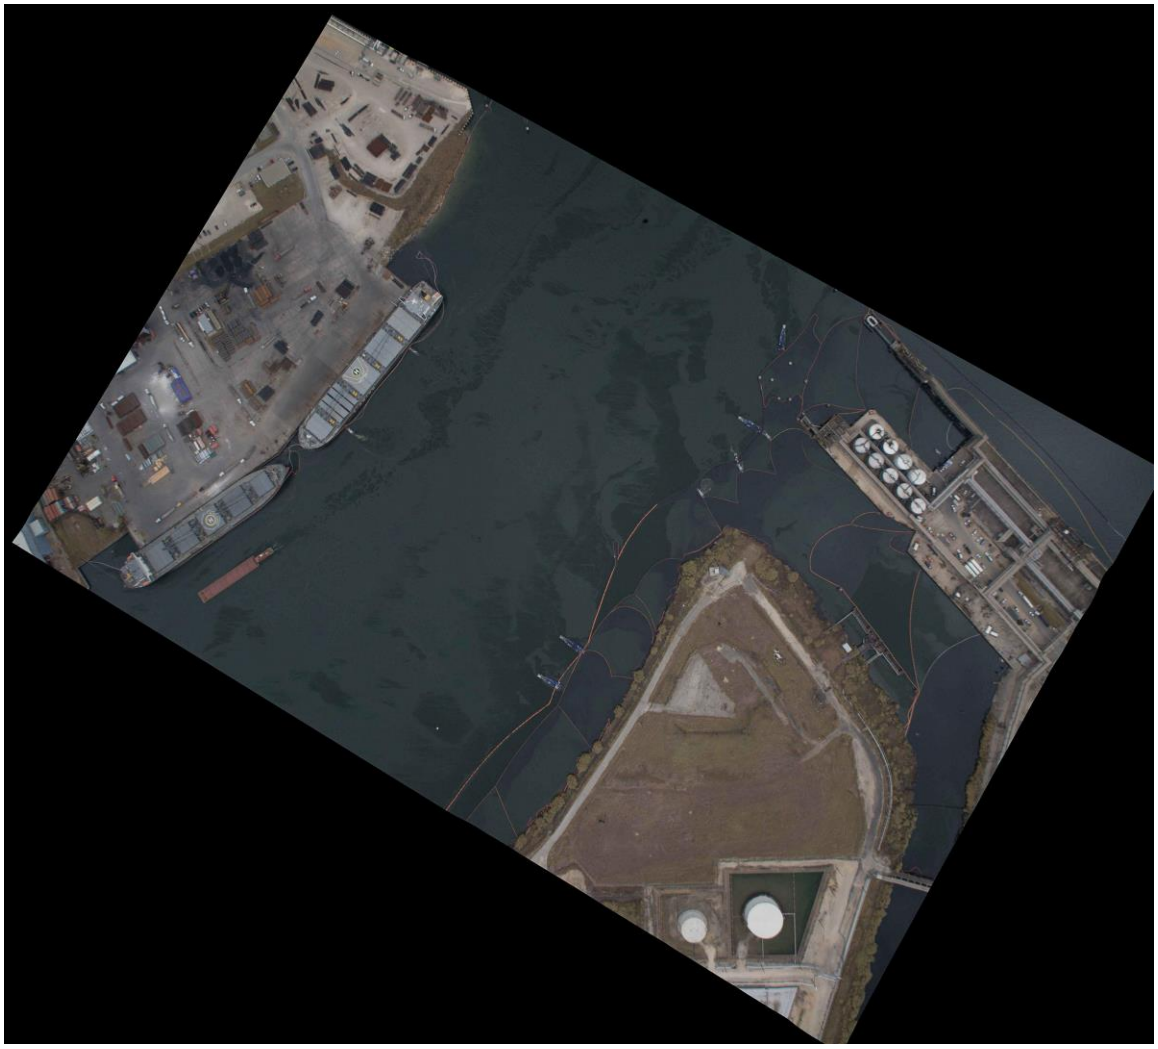
Figure 7: Aerial Image of the Ship Channel Boom Area, 3 April 2019, Flight 20

Figure 7 is an aerial image of the confluence area. As with prior flights, the boom network is clearly evident as is the trapped product behind the booms (visible as black material). There does not appear to be a significant change in the amount of trapped material from the previous mission. No significant leakage of product or sheen is present. An oblique of the same area confirms that most of the boom structure is holding product other than a small leakage of material in the northeast corner of the boomed area (Figure 8).
