Field Report for Airborne Data Collected In Support of US EPA Region 6 Intercontinental Terminals Company LLC Fire 8 April 2019

Data Results Flight 21, 8 April 2019

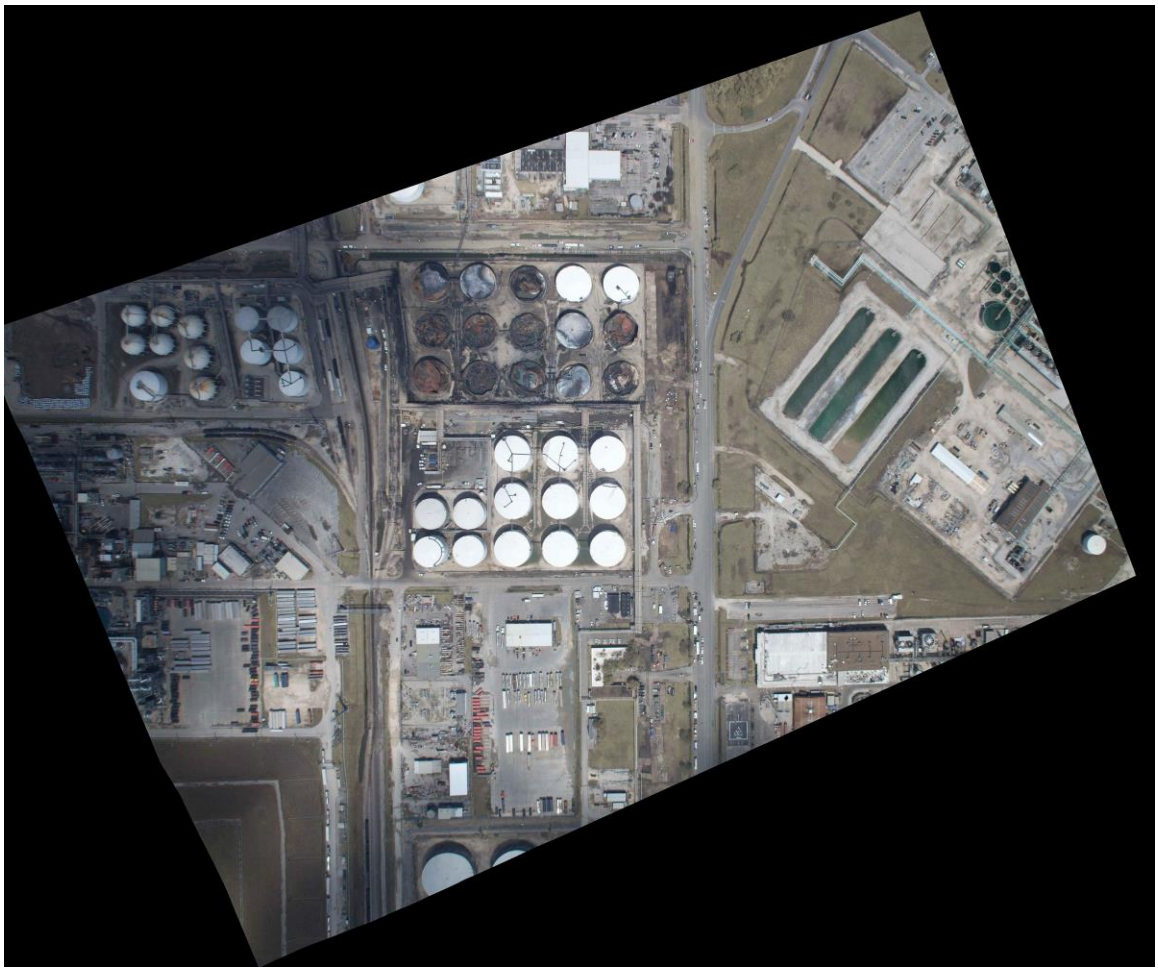
Figure 6: Aerial Image of the Tank Farm, 8 April 2019, Flight 21

A full set of high resolution aerial digital photography was collected as part of the flight. Figure 6 shows a representative overhead image collected as part of each pass over the tank farm. Analysis of the image shows no change from imagery collected on 3 April 2019. The dark hue on the left side of the image is a cloud shadow. Figure 7 shows an oblique image of the tank farm and confirms no change from the 3 April 2019 flight.

The confluence area aerial image is given in figure 9. Examination of the image shows a small amount of dark product trapped in the channel booms. No significant leakage of product or sheen is present. An oblique of the confluence area confirms that material is located on the outside of the channel booms (most likely pushed into position by the wind). No sheen is evident in the image.
