RE: Category N Baseline Environmental Assessment  
Former Power Station and Copper Ore Processing Facility  
Lake Linden (Torch Lake Township), Michigan

On behalf of Meninc, Incorporated, Coleman Engineering Company is pleased to submit this Baseline Environmental Assessment for the Former Power Station in Lake Linden, Michigan.

**PHASE I ENVIRONMENTAL SITE ASSESSMENT**

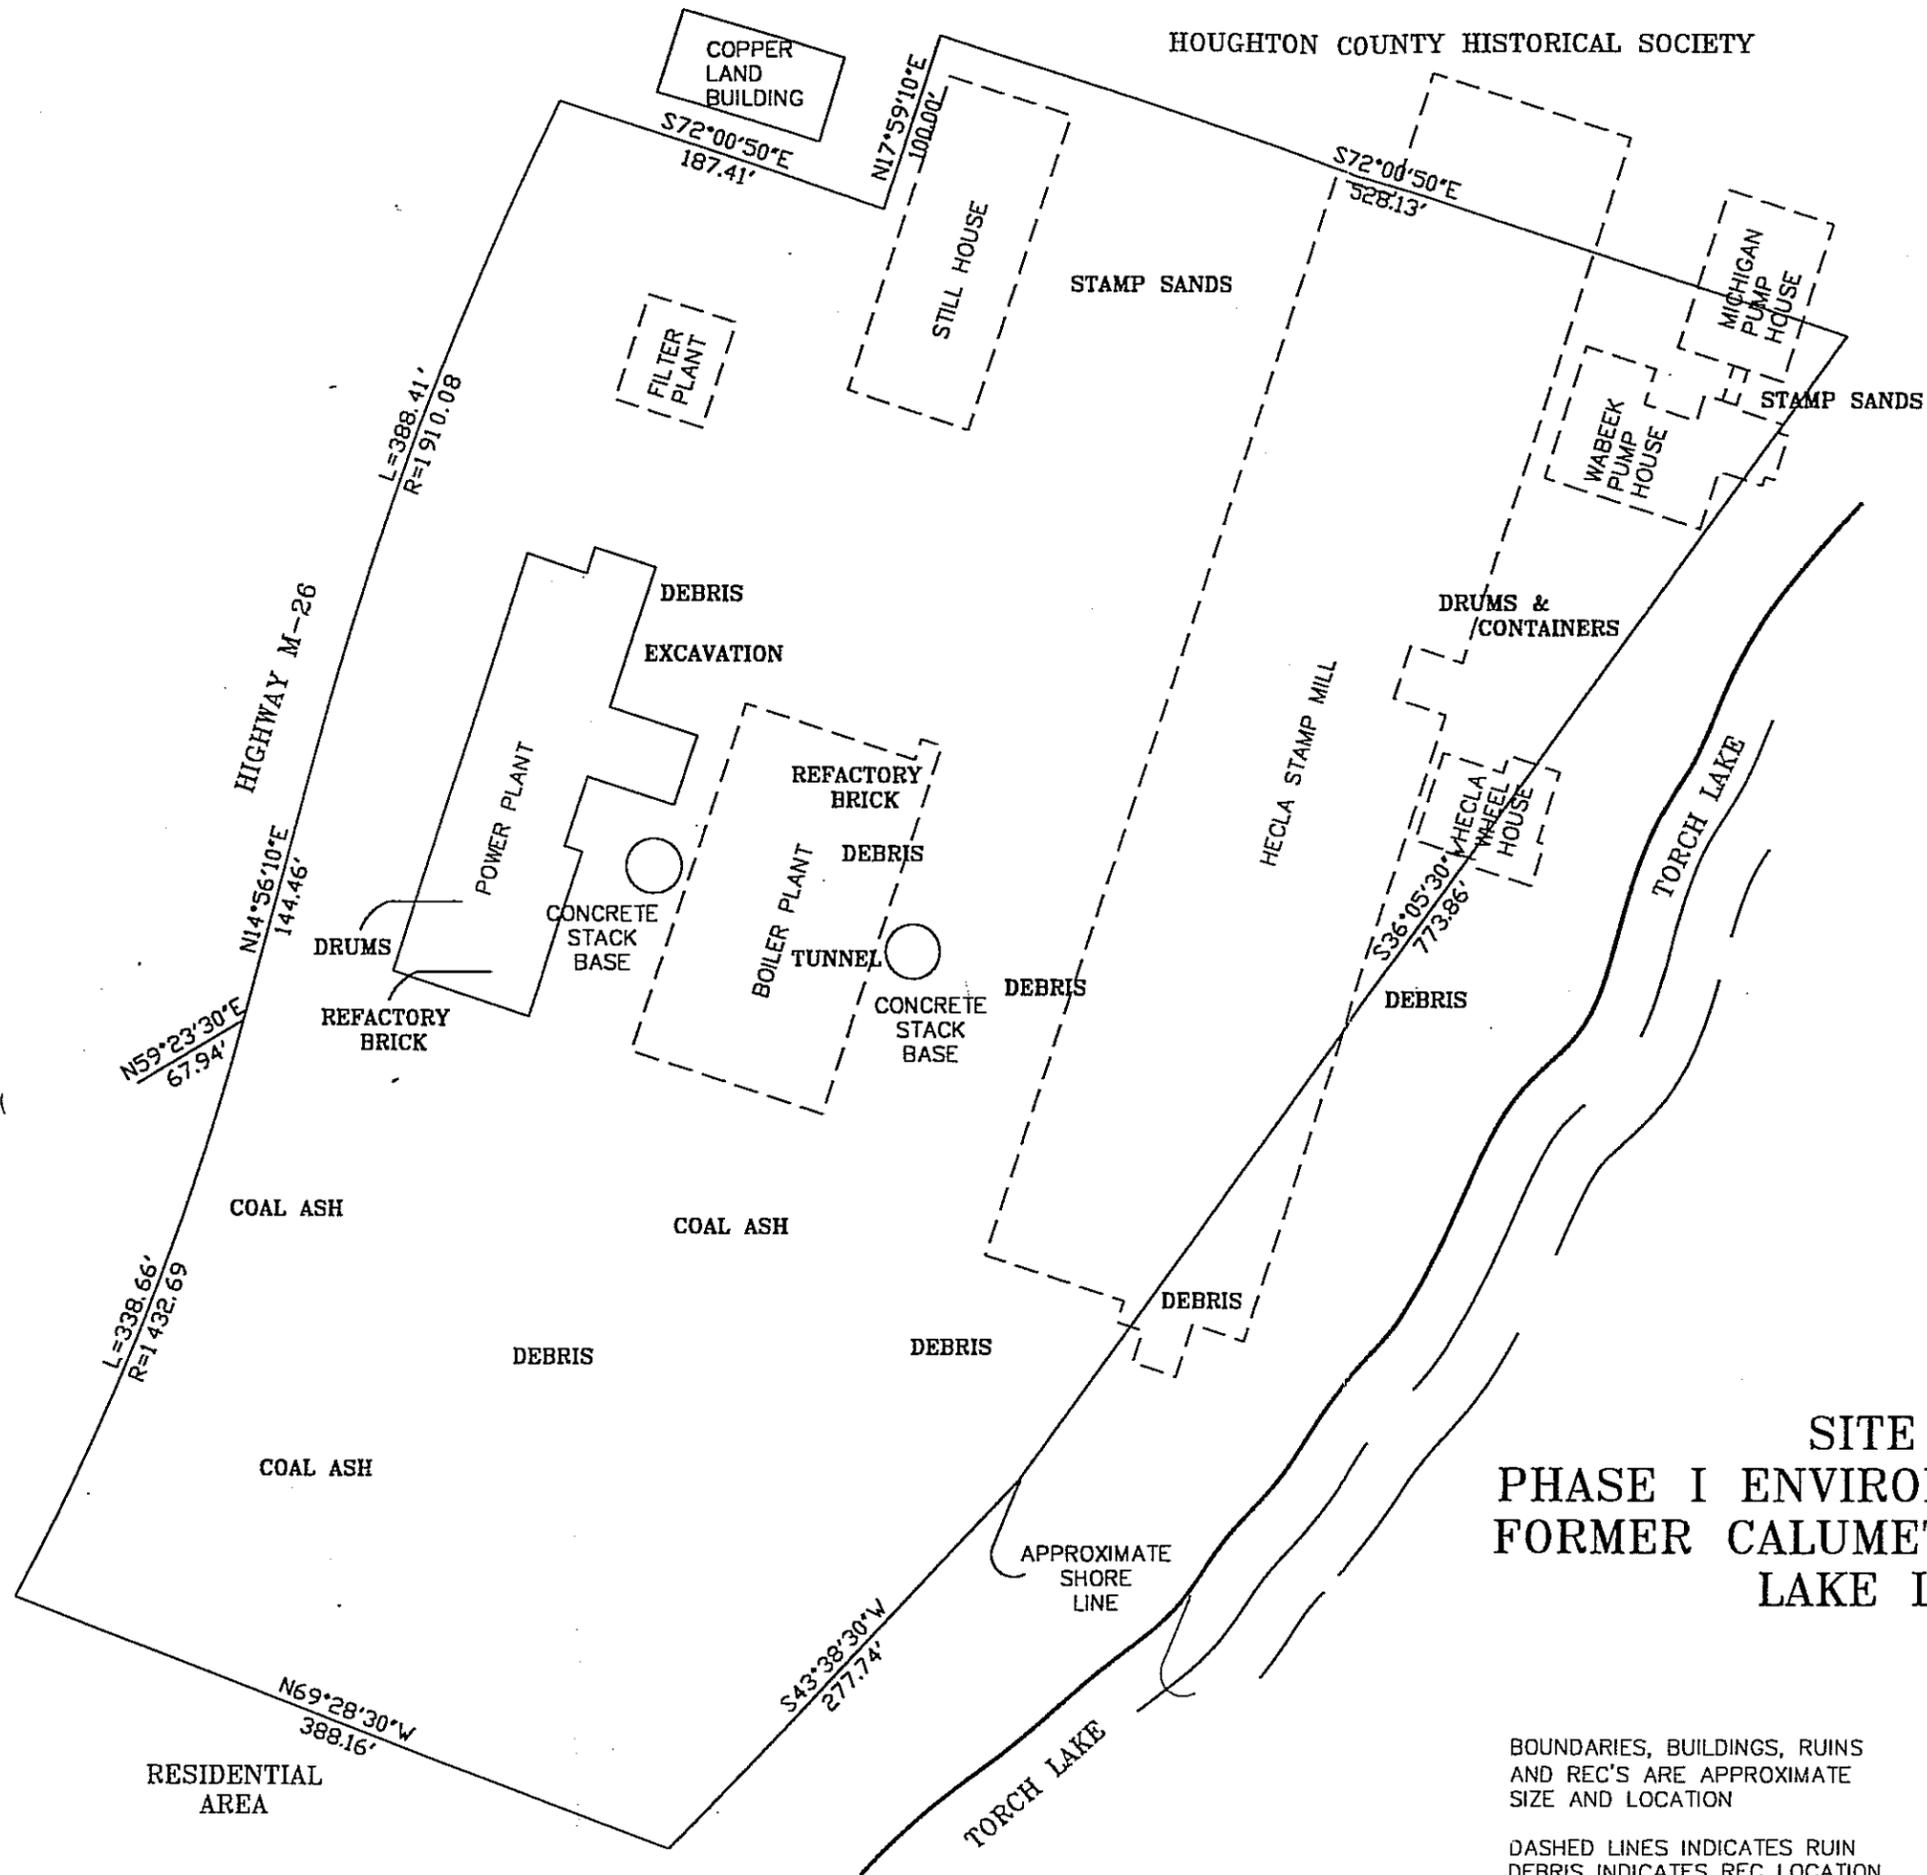
SITE FEATURES MAP  
 PHASE I ENVIRONMENTAL SITE ASSESSMENT  
 FORMER CALUMET & HECLA POWER STATION  
 LAKE LINDEN, MICHIGAN  
 FIGURE 4

BOUNDARIES, BUILDINGS, RUINS  
 AND REC'S ARE APPROXIMATE  
 SIZE AND LOCATION  
 DASHED LINES INDICATES RUIN  
 DEBRIS INDICATES REC LOCATION

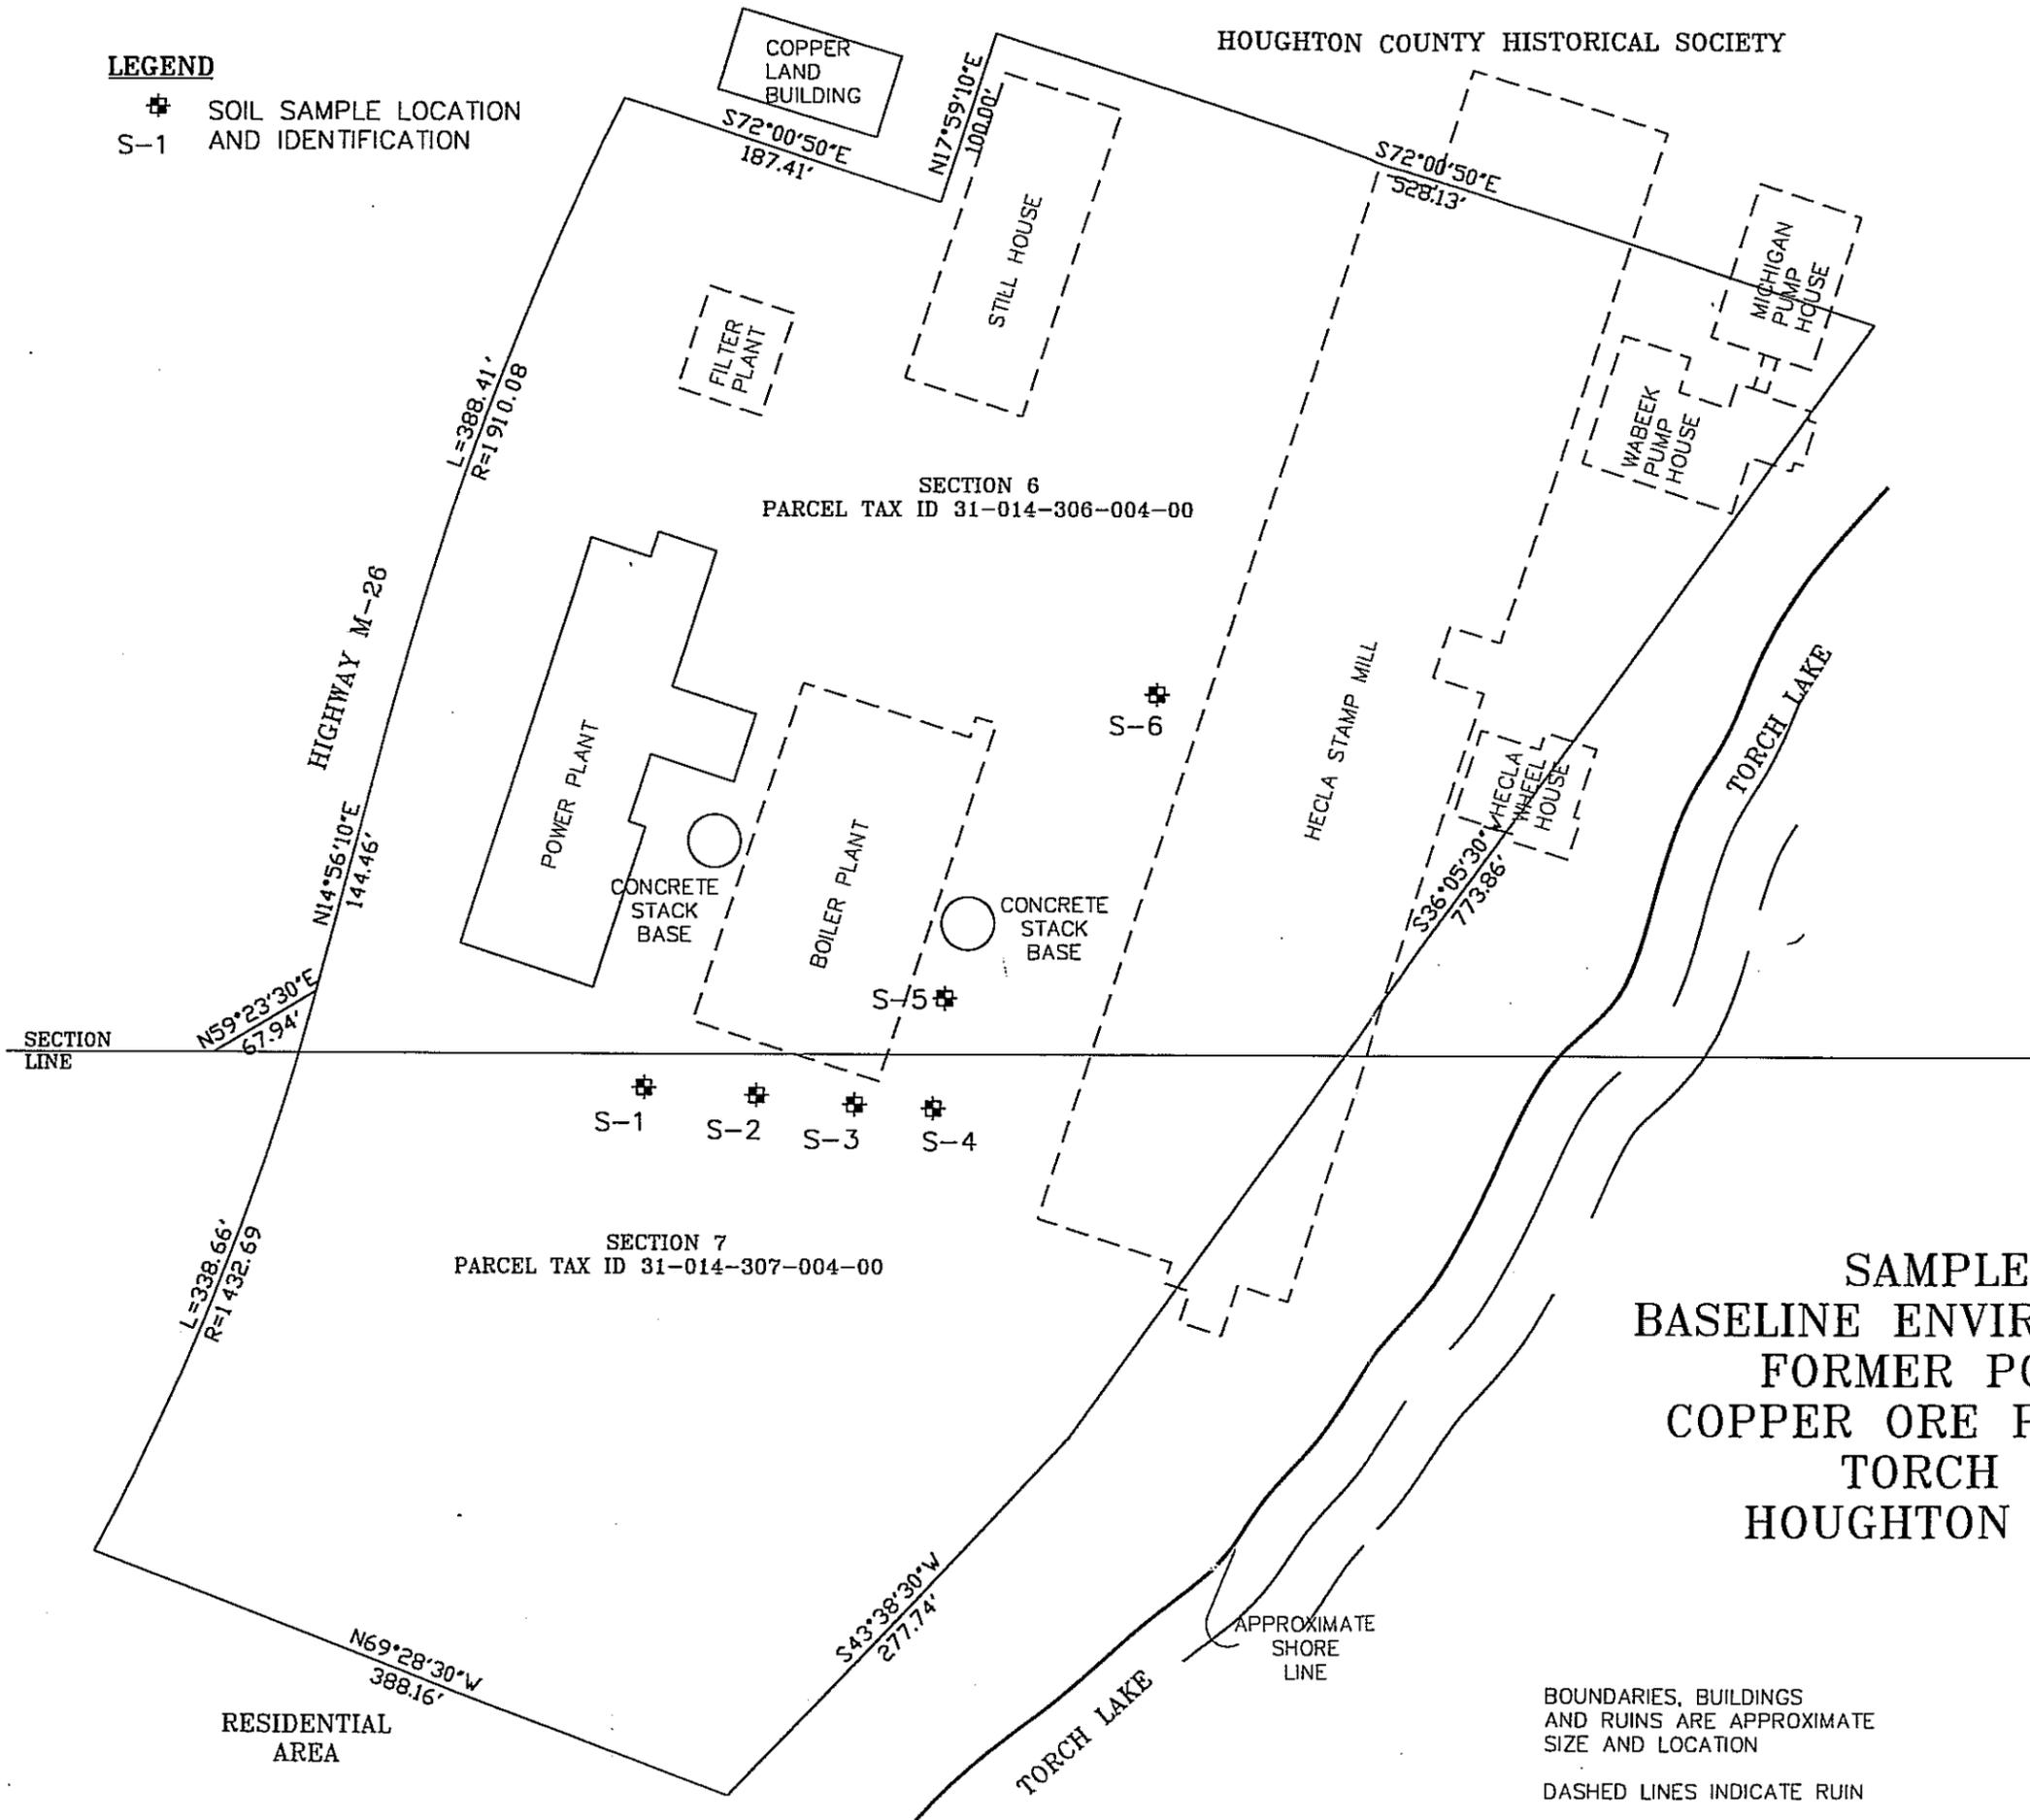
**SAMPLE LOCATION MAP  
 BASELINE ENVIRONMENTAL ASSESSMENT  
 FORMER POWER STATION AND  
 COPPER ORE PROCESSING FACILITIES  
 TORCH LAKE TOWNSHIP  
 HOUGHTON COUNTY, MICHIGAN  
 FIGURE 4**

The results of soil sample analysis indicate that soil at the subject property has been impacted at levels exceeding applicable *Residential and Commercial I, Part 201, Generic Cleanup Criteria and Screening Levels*, MDEQ Operational Memorandum No 18, NREPA, 1994 PA 451, Part 201, as amended. In completing the Phase II ESA field sampling effort, areas which were known to have surface deposits of ash were focused upon. Sample analysis results are considered to be reflective of those areas sampled. There are, however, several different materials exposed on the surface of the site, including stamp sands. General observations regarding the location of various surface features is presented in Attachment A, Figure 5. Because of the documented metals impact, the subject property can be classified as a "Facility" per NREPA, 1994 PA 451, Part 201, as amended.

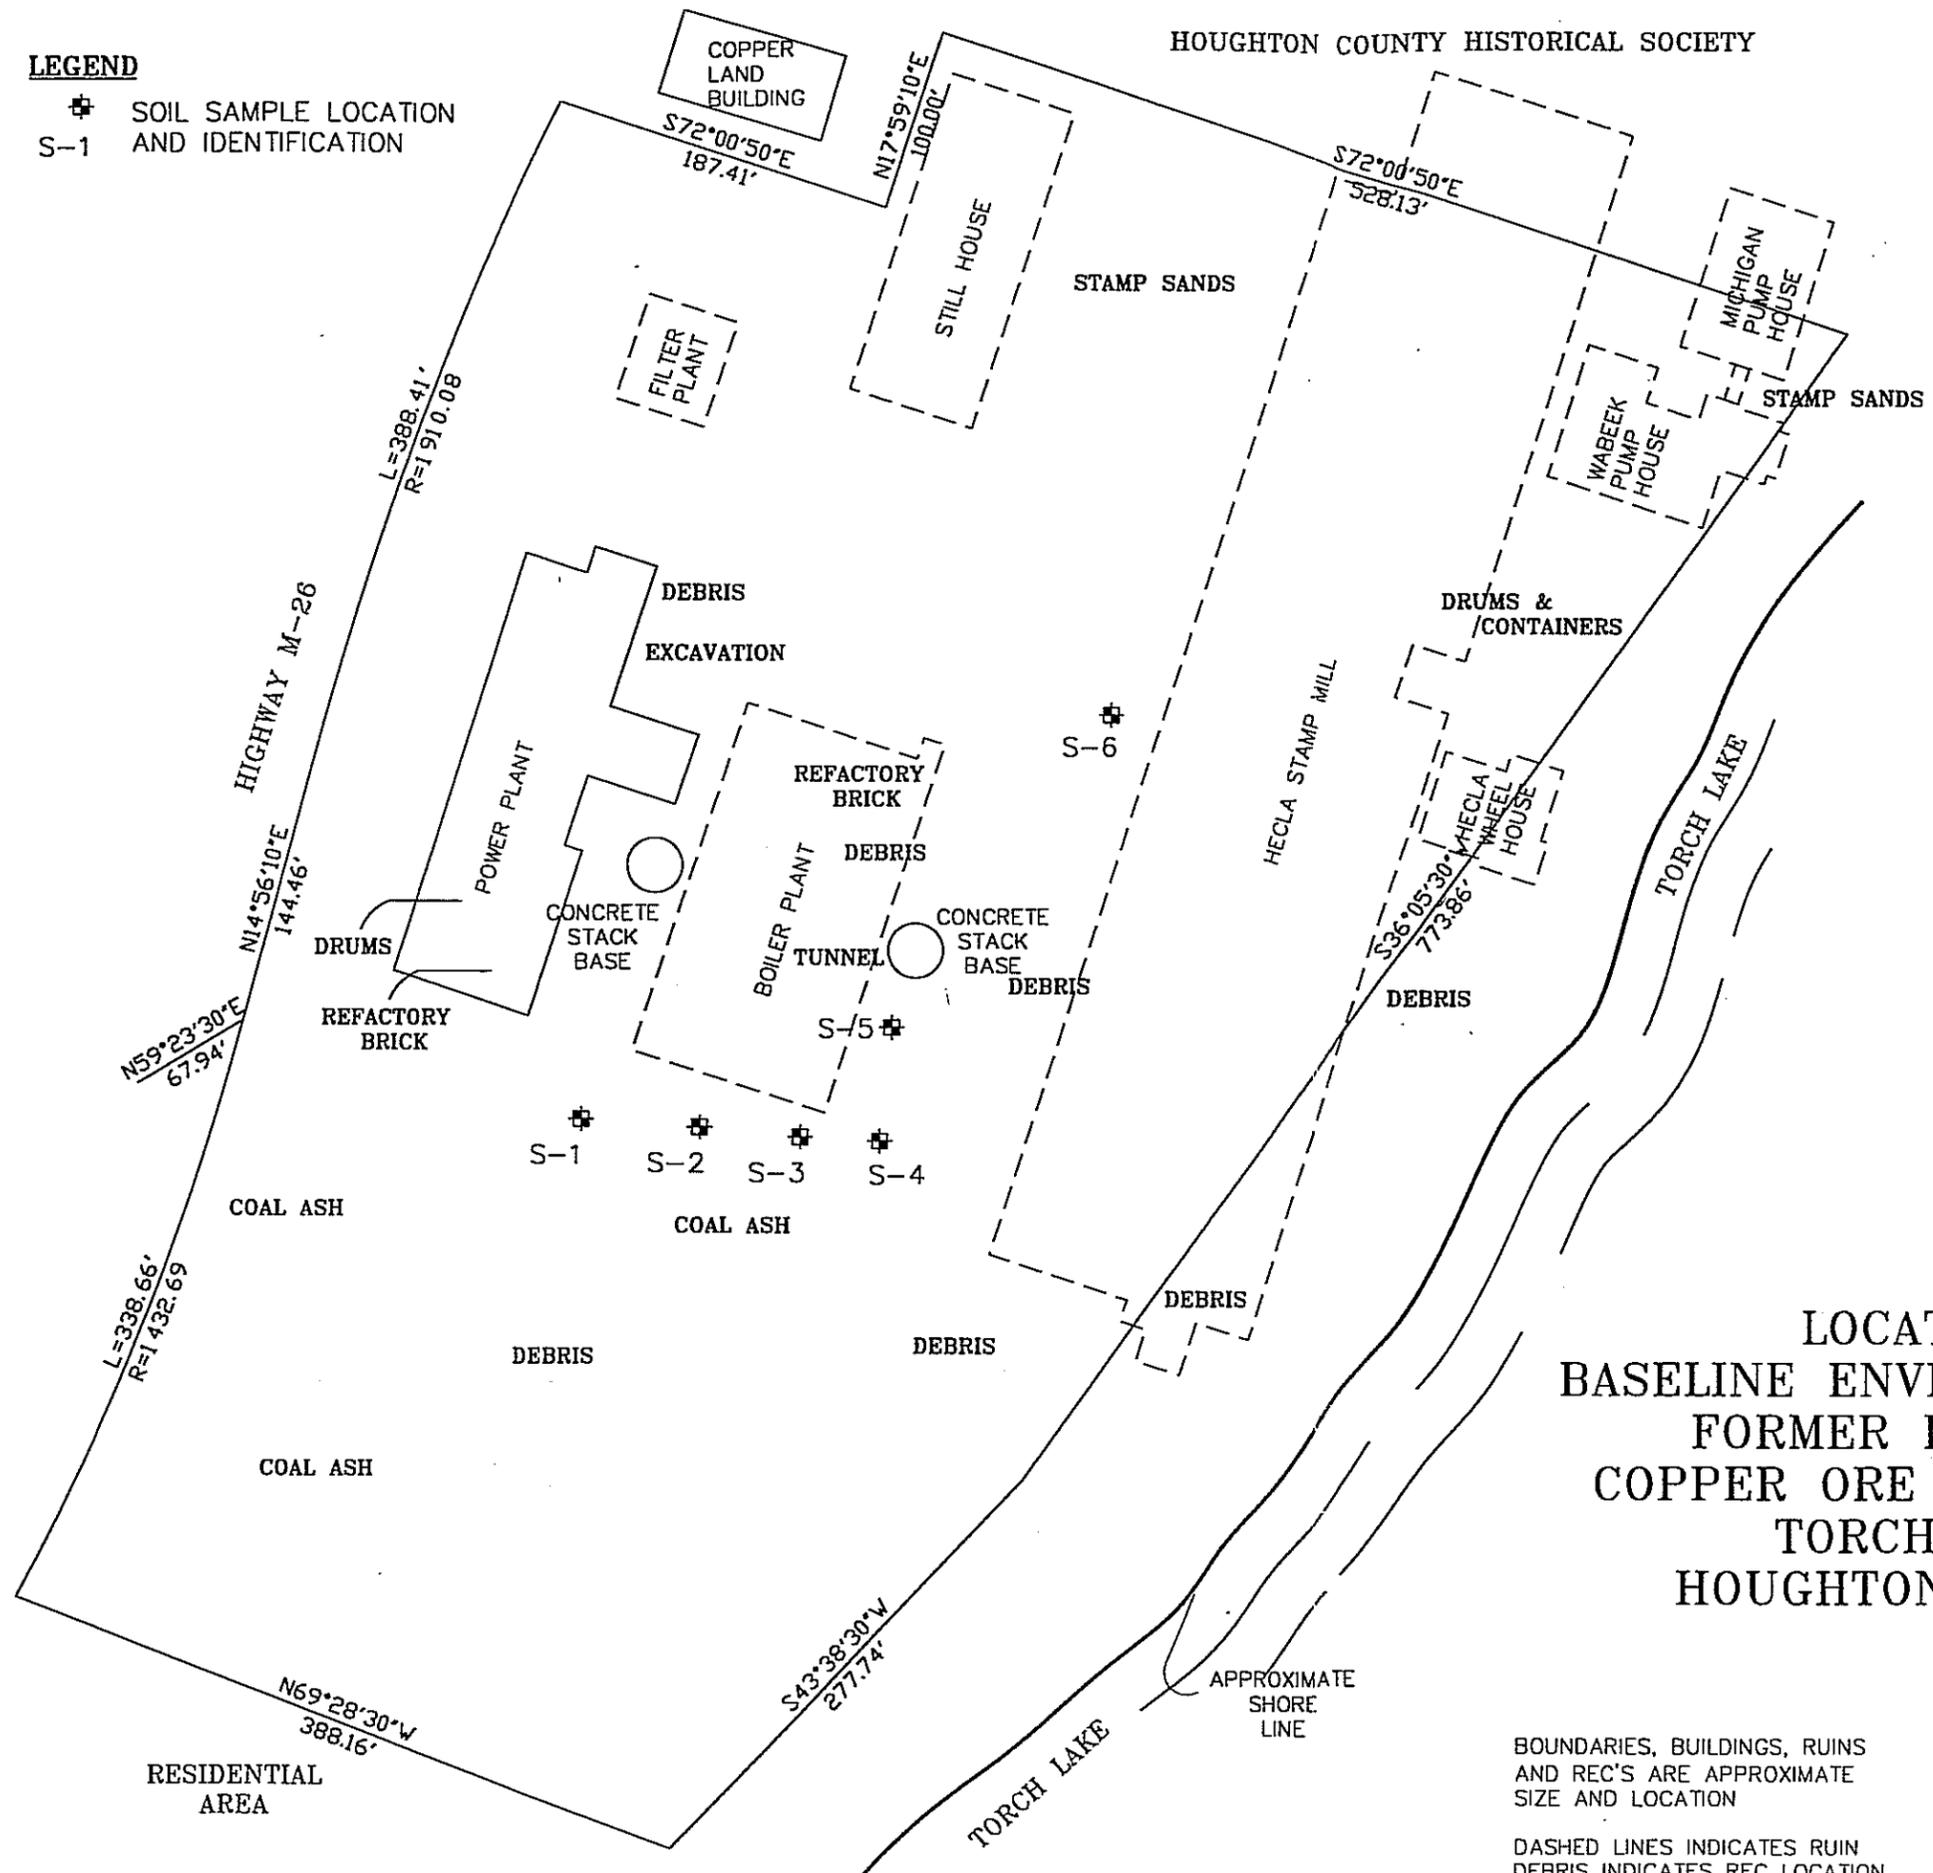
LOCATION OF IMPACT  
 BASELINE ENVIRONMENTAL ASSESSMENT  
 FORMER POWER STATION AND  
 COPPER ORE PROCESSING FACILITIES  
 TORCH LAKE TOWNSHIP  
 HOUGHTON COUNTY, MICHIGAN  
 FIGURE 5

Several abandoned containers have been found on the subject property. The abandoned containers that have been identified consist of steel drums in two general locations on the property. One drum was observed to be floating in the water, which is present within the basement of the former power plant building (see Attachment C, photo #7). Several other drums most of which are crushed and all of which are rusted, were observed among partially buried debris found on the east portion of the site near the shore of Torch Lake (see Attachment C, photo # 11). For personnel safety reasons, the drum located within the basement of the former power plant building can not be accessed. The drums observed among the partially buried debris in the east portion of the site have been determined to be empty. Form EQP 4476, "Notice Regarding Discarded or Abandoned Containers" has been completed for the intact drums observed, and can be found in Attachment E. The locations of the discarded and abandoned drums are displayed on Figure 5, which can be found in Attachment A.
