June 15, 2011

**Subject: Final Emergency Response Letter Report
Midville Train Derailment
Midville, Burke County, Georgia
EPA Contract No. EP-W-05-054
TDD No. TTEMI-05-001-0140**

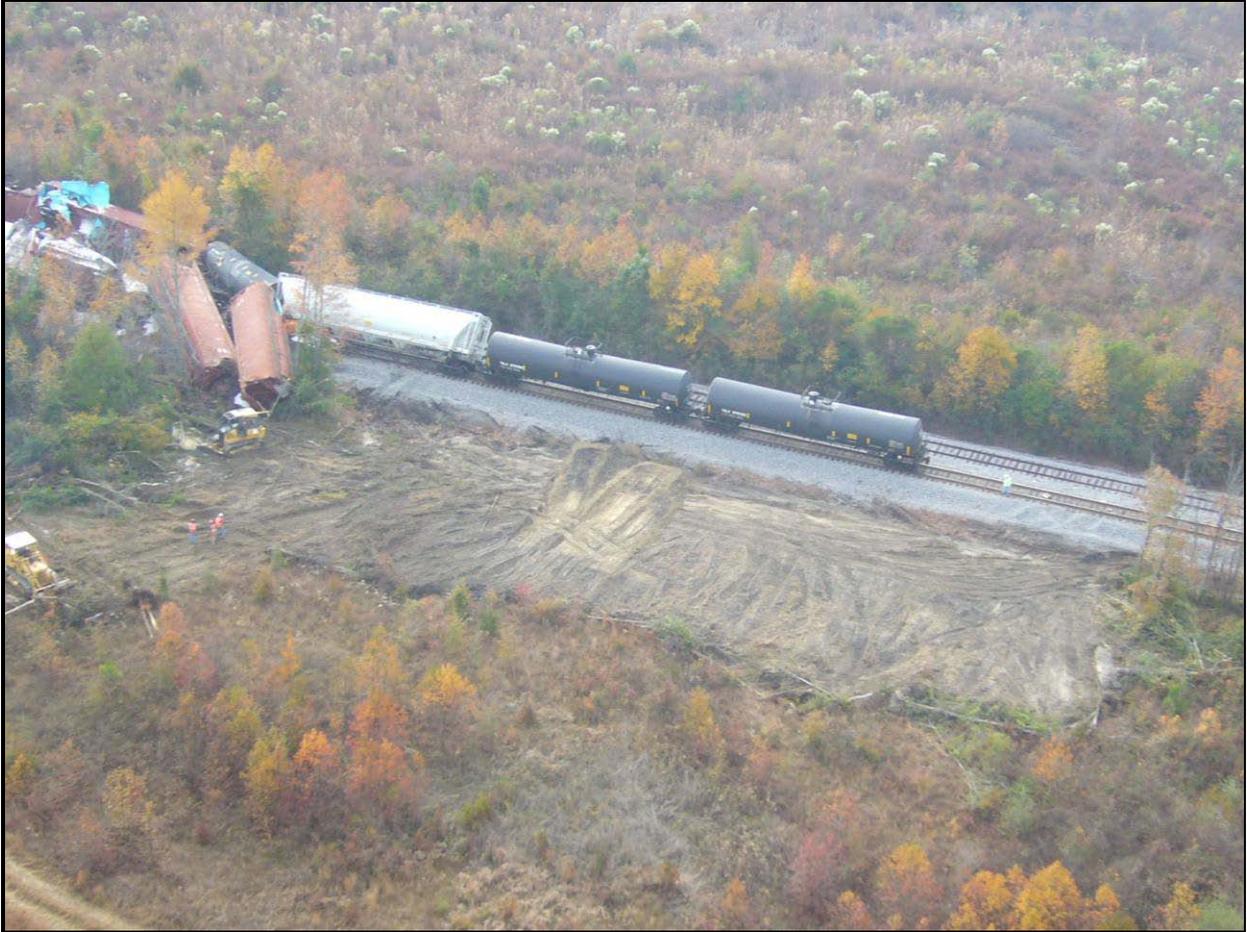
OFFICIAL PHOTOGRAPH NO. 4
U.S. ENVIRONMENTAL PROTECTION AGENCY

Subject: Car staging area developed at the west end of the derailment site to the north of the railroad tracks.

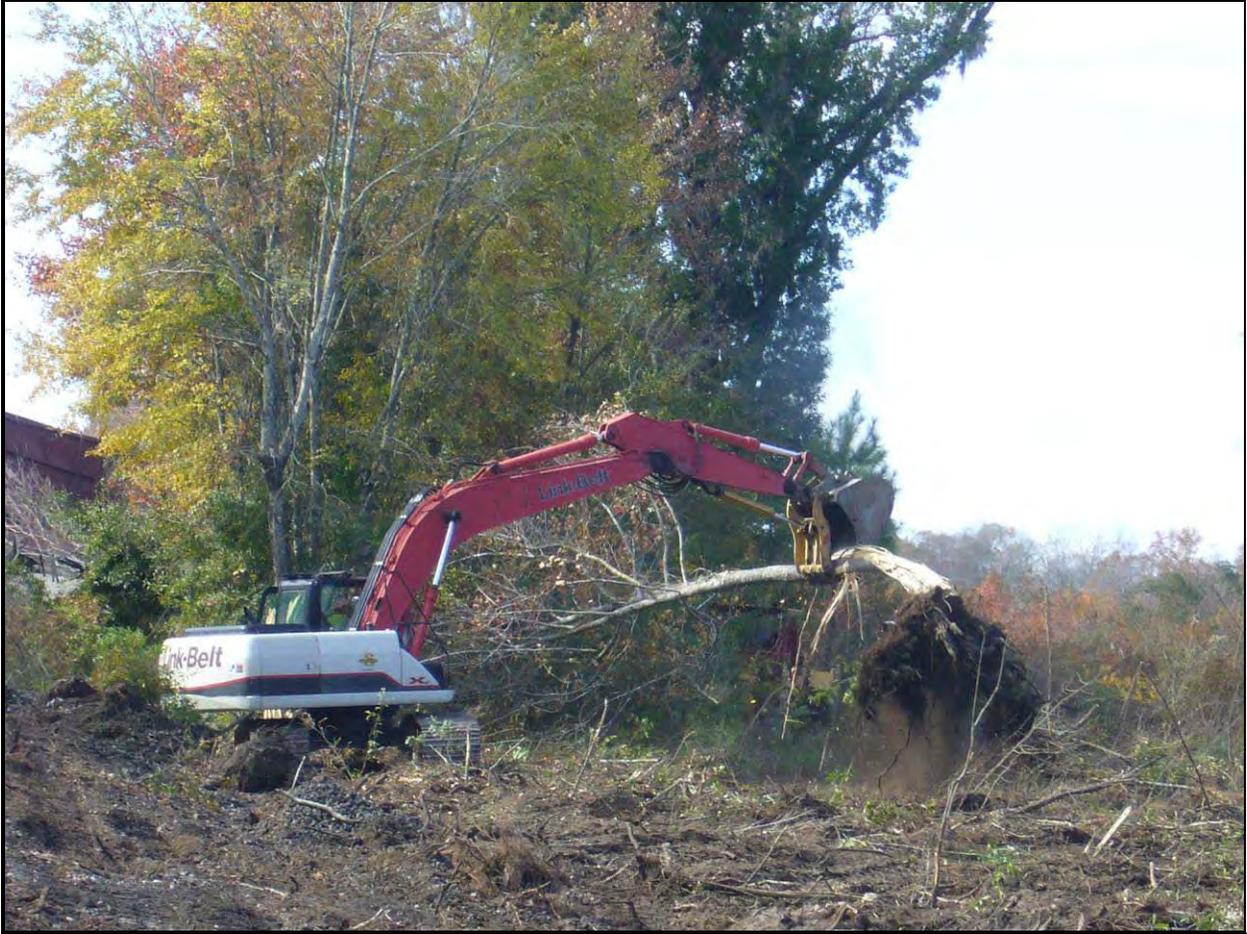
OFFICIAL PHOTOGRAPH NO. 5
U.S. ENVIRONMENTAL PROTECTION AGENCY

Subject: Wrecking crew clearing wooded area to gain access to the derailment.

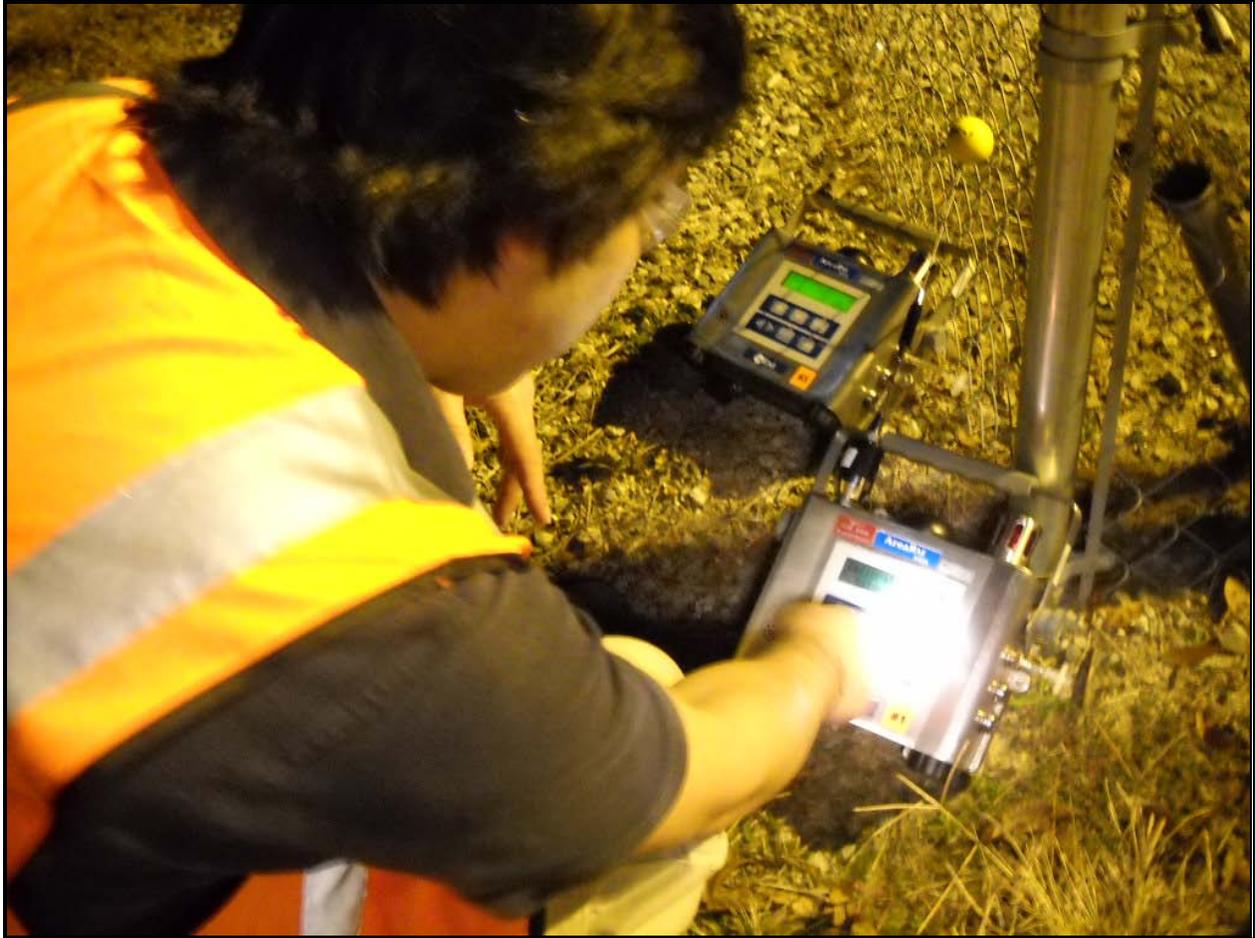
**OFFICIAL PHOTOGRAPH NO. 9
U.S. ENVIRONMENTAL PROTECTION AGENCY**

Subject: Tetra Tech performs battery replacement and fresh air calibration on AreaRAE Unit #1 located on the western perimeter of the site; specifically located near corner of 1st Avenue and Alice Street, across from 191 1st Avenue. Air monitoring activities continued through the night along with train wrecking operations.
