Technical Memorandum

TO: Brian M. Kelly, Acting Chief, Region V United States Environmental Protection Agency
FROM: Bryan Mullins, LATA-KEMRON Remediation, LLC.
SUBJECT: Proposed Path Forward at the Chevy in the Hole Site – Parcel A, Flint, Michigan
DATE: November 7, 2011

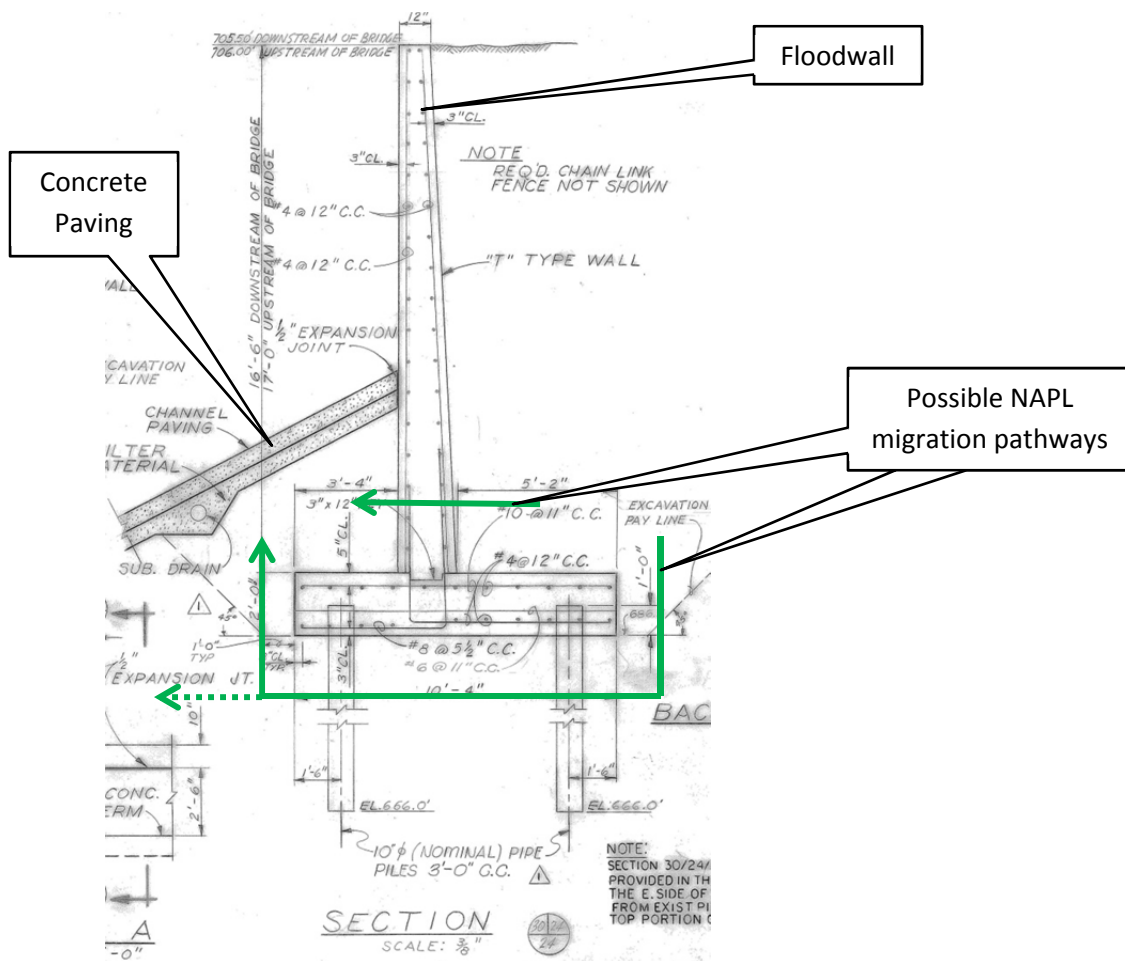
Observations: A majority of the caulking/sealing agent were found to be missing from horizontal and vertical construction joints of the concrete paving. Several joints were visibly eroding with vegetation growing in them. Absorbent booms/socks installed at construction joint located between Outfalls #67 and #68. When flushed with river water, oily sheen flowed from the joint into the river. The same occurred for all vertical construction joints located west of the booms installed at the joint between Outfalls #67 and #68. Because the floodwall and concrete paving are distinct structures, the sheen at the concrete paving joints indicates that NAPL has migrated either beneath or through the floodwall and pooled in the space between the water side of the floodwall and the bottom of the concrete paving. See the detail below from the USACE Channel As-Built.

Proposed Action: Seal all construction joints of the wall adjacent to Parcel A. Joints that are leaking oily sheen will be sealed to prevent on-going NAPL migration into the river, and joints that are not currently leaking oily sheen will be sealed to prevent future migration of NAPL into the river.

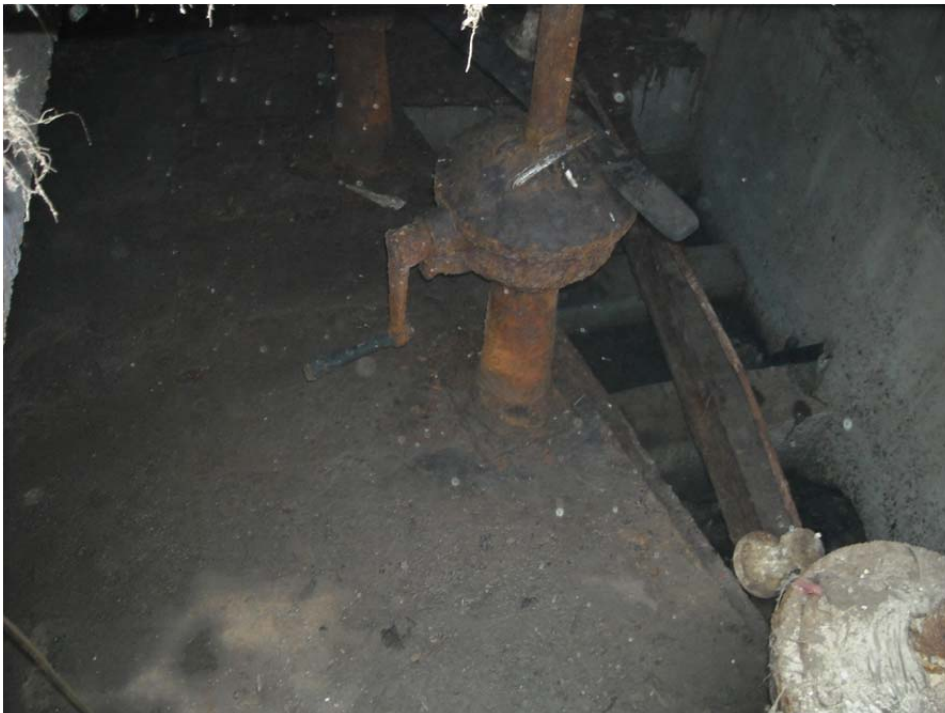
Hand cranks associated
with sanitary sewer valves
located below
