MAINE DEPARTMENT OF ENVIRONMENTAL PROTECTION
OIL & HAZARDOUS MATERIALS REPORT

Spill Number: P-534-2011

Subject/Owner: COLUMBIA MILL (FORMER) - -

Location Type Business - Industrial {ID}
Name COLUMBIA MILL (HERITAGE PARK)
Street Address 3 MILL ST @ ANDROSCOGGIN RIVER
MCD Town LEWISTON
Local Name LEWISTON
State/Province ME

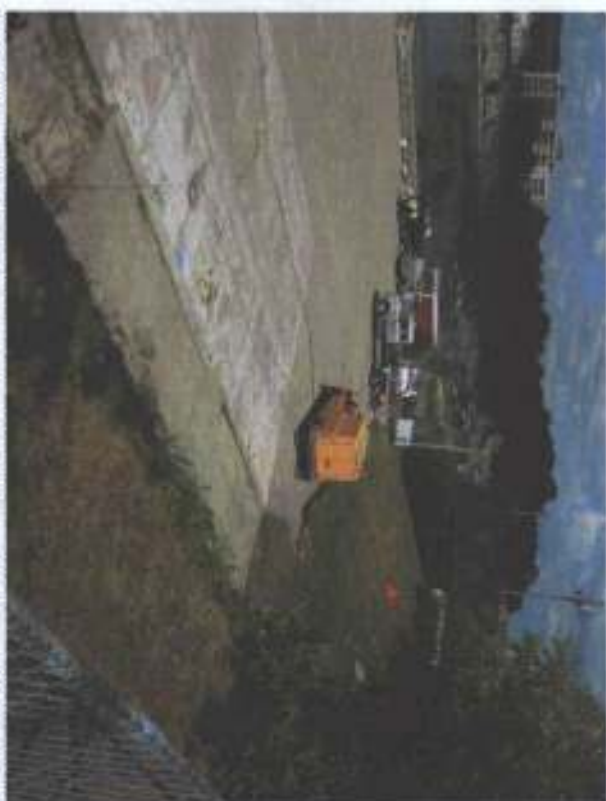
7. 7/13/11: From Mill Street, looking down at the Heritage Park (former Columbia Mill) parking lot at the incident location and MDEP and EPI vehicles. The arrow at upper right shows the location of the 2" product piping for the former 12,000-gal. Libbey Mill UST that EPI was sucking out (see photos 17 & 19 below).

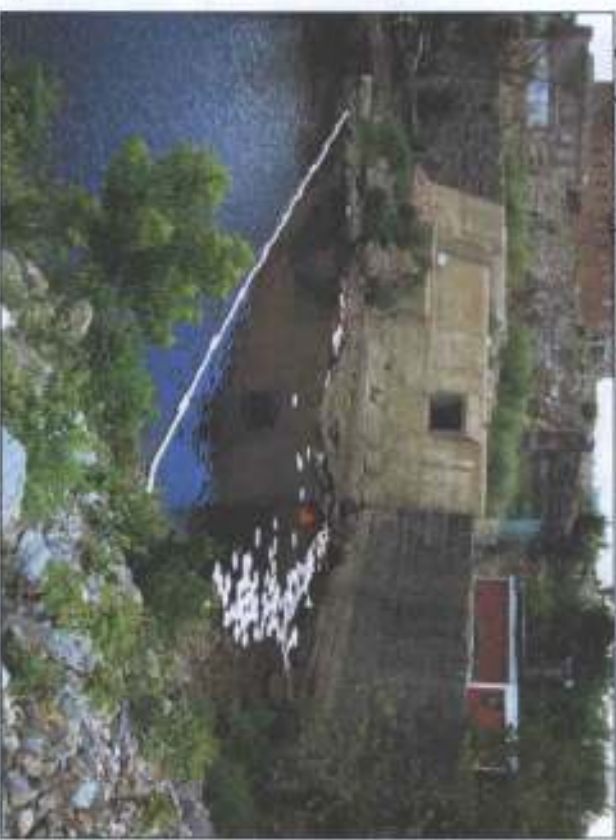
16. Wed, 7/13/11: Looking NE down at the discharge area from the concrete chamber under the red shed building. Upper center is a concrete raceway for mill water. Other, bricked-up, raceways are also present at far left.

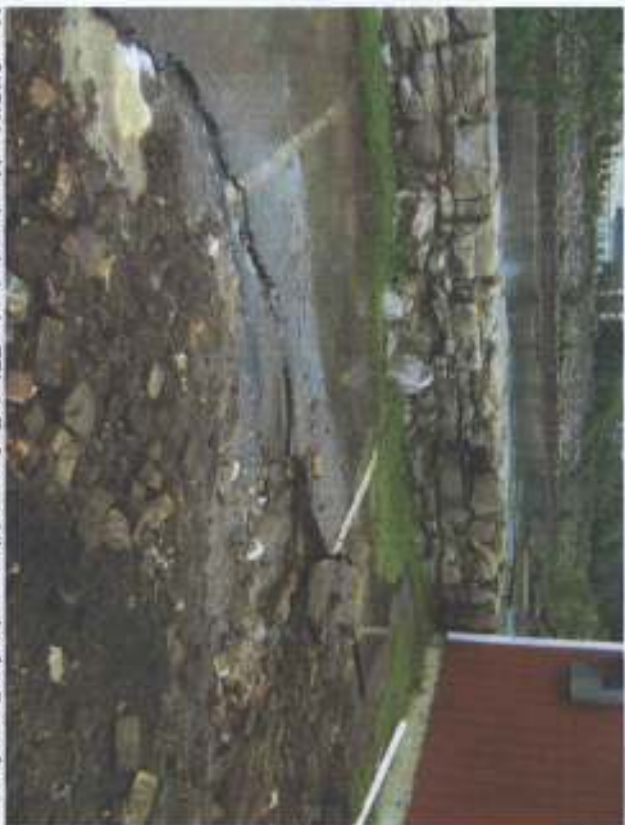
27. Mon. 8/15/11: Morning photos by EPI staff of several thousands of gallons of water being flushed by L-A Water Dept, draining into the test pit locations. Photo by EPI staff.

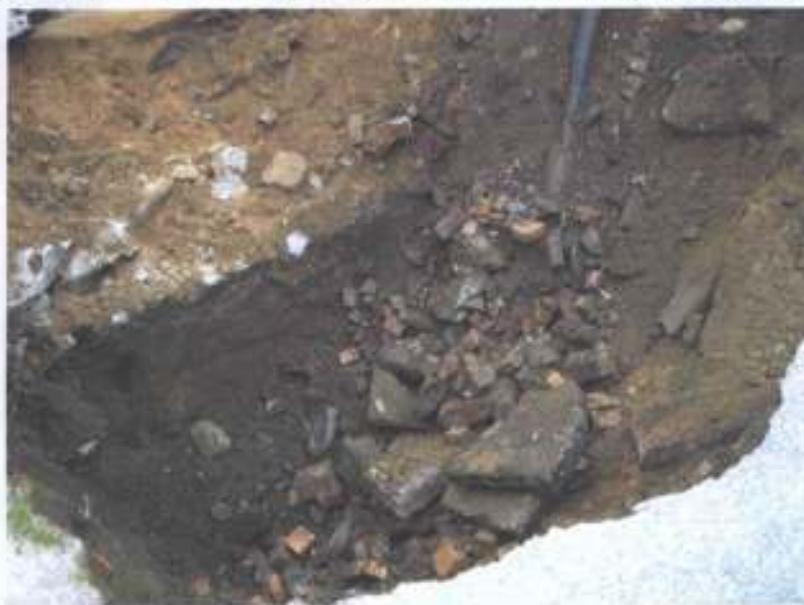
34. Thurs. 8/11/11: TP-1 Excavating Test Pits, representative fill encountered consisting of bricks, coal ash, pieces of concrete, pipes and machinery parts. TP-1 hit refusal at 4' bg.

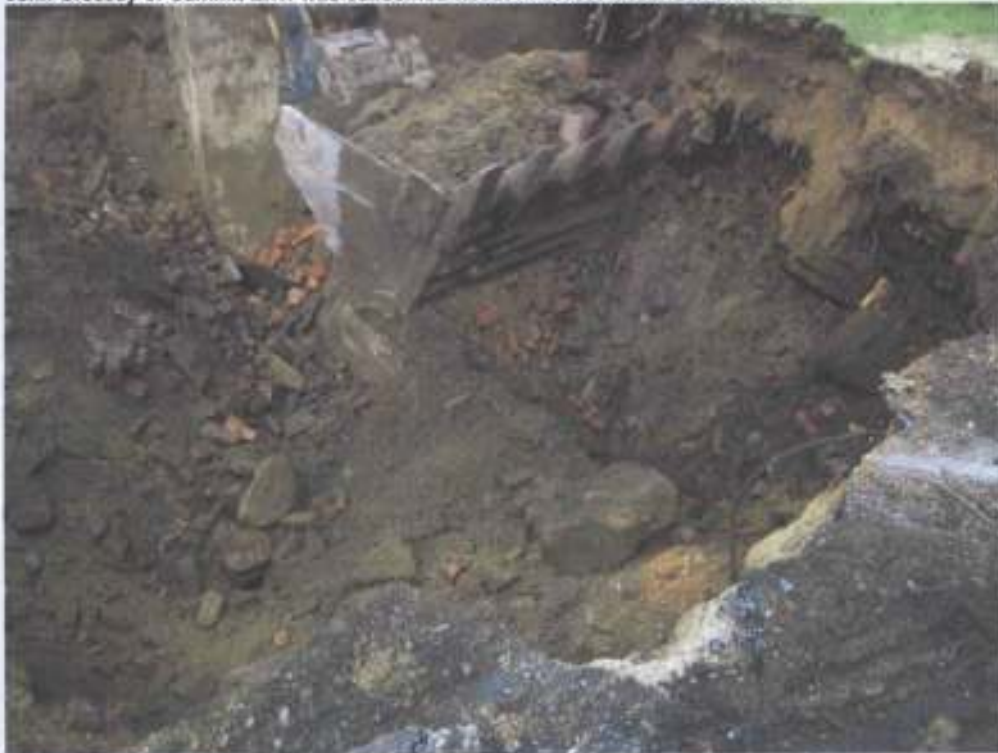
39.

Thurs. 8/11/11: Continuing TP-

3 to the right (north) on the east side of the chamber through brick debris.

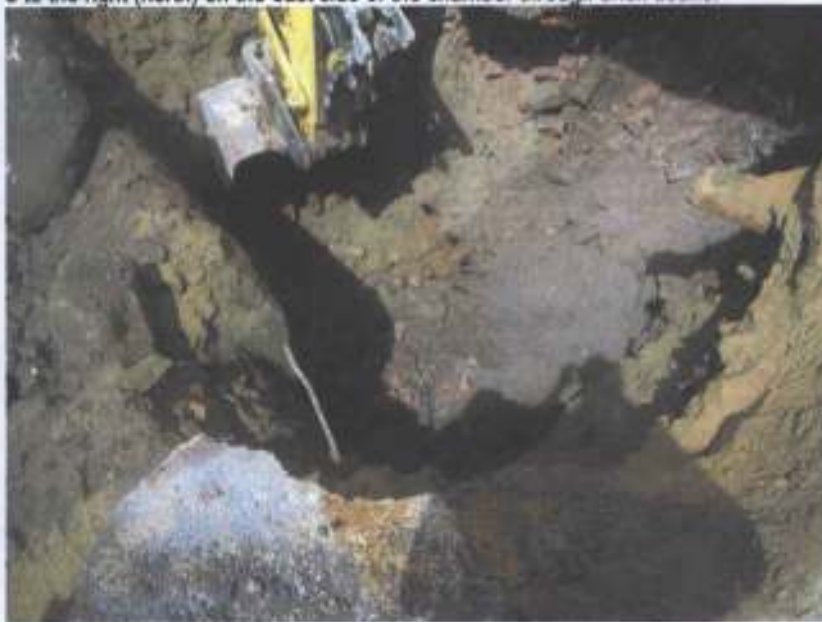
40.

Thurs. 8/11/11: Digging through ash and brick.

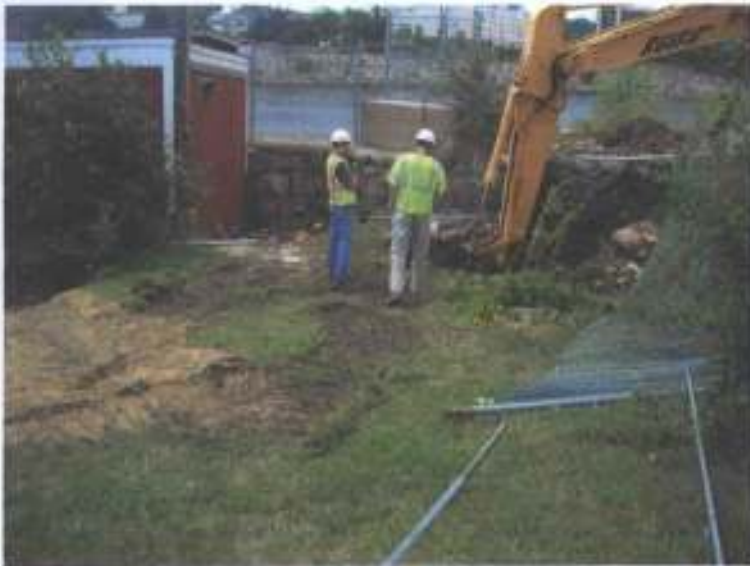
43. Thurs. 8/11/11: A fence was taken down and TP-4 in the former penstock being excavated. The stone wall in the background is the former NW wall of the Columbia Mill with the former Cowan Pond and Libbey Mill penstock on the other side.

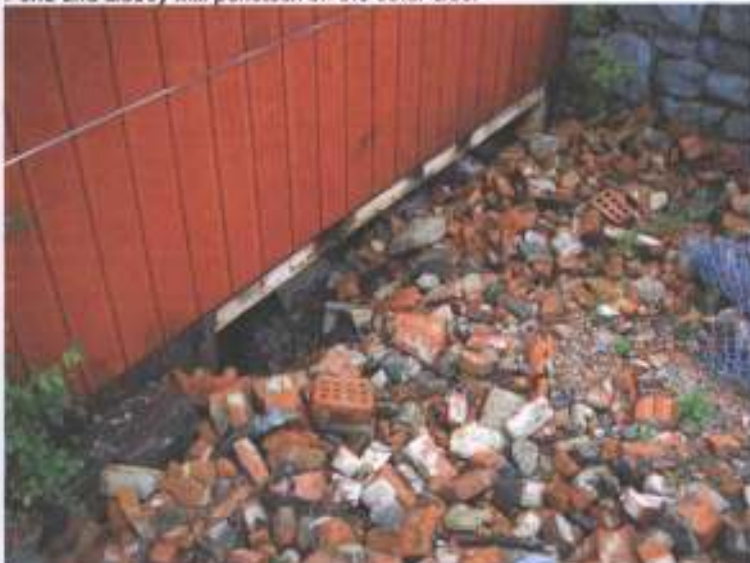
44. Tues. 8/16/11: the apparent penstock route along the north wall of the Columbia Mill building into the chamber under the red shed. Peering down under the shed we could see into the upper chamber clogged with brick debris.

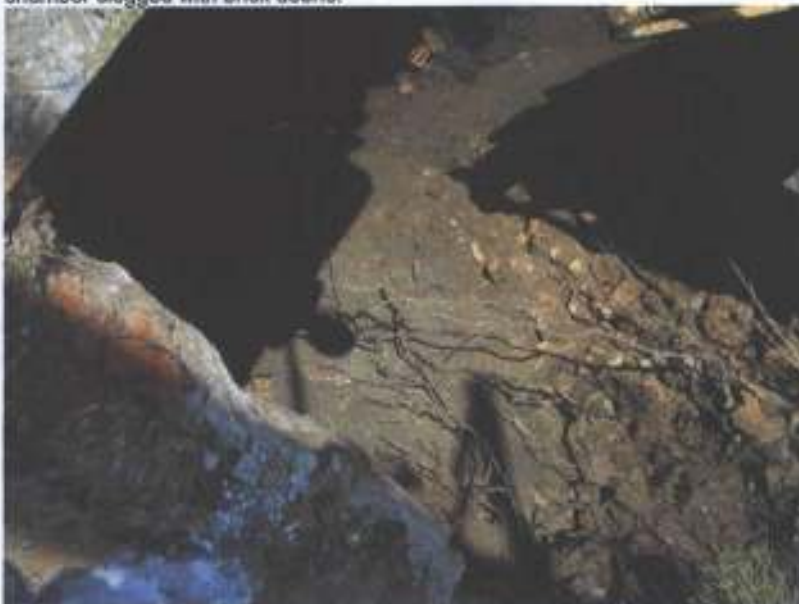
45. Thurs. 8/11/11: Soil within Test Pit TP-4, the apparent old penstock route under the Columbia mill building.

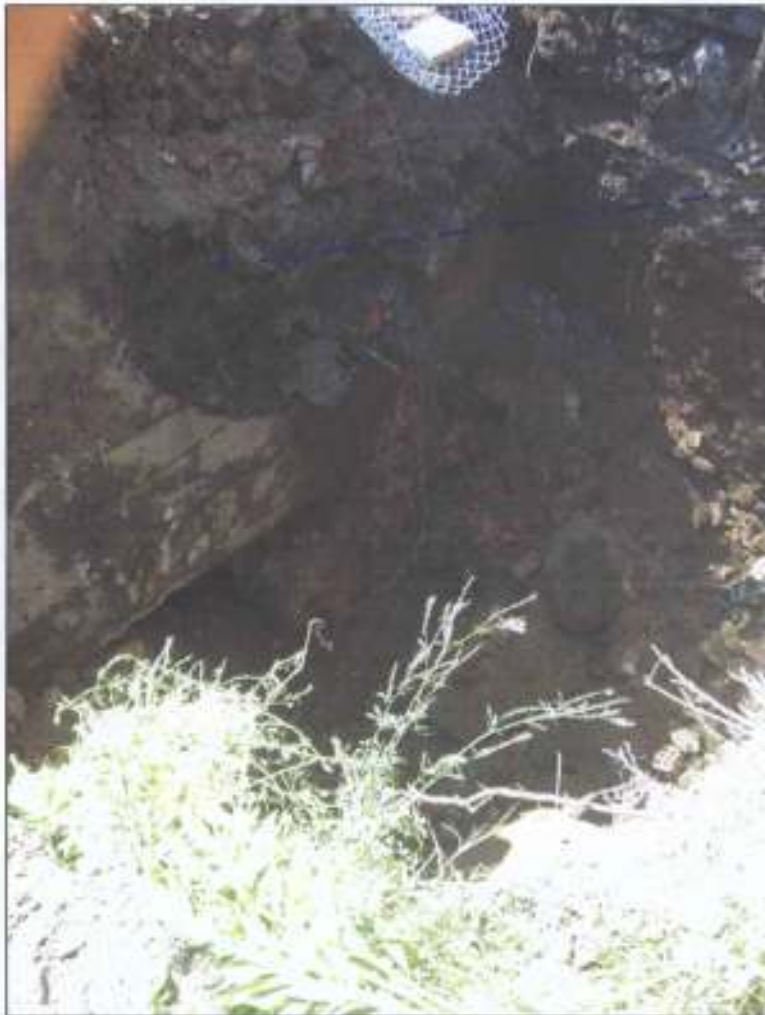
46. Thurs. 8/11/11: TP-4 with the deeper of the two concrete structures that appeared to be pipe (penstock) cradles going into the chamber under the red building. The grade of the pipe and water flow direction is denoted by the dashed arrow. Note the brick debris common the all the test pits in this area.

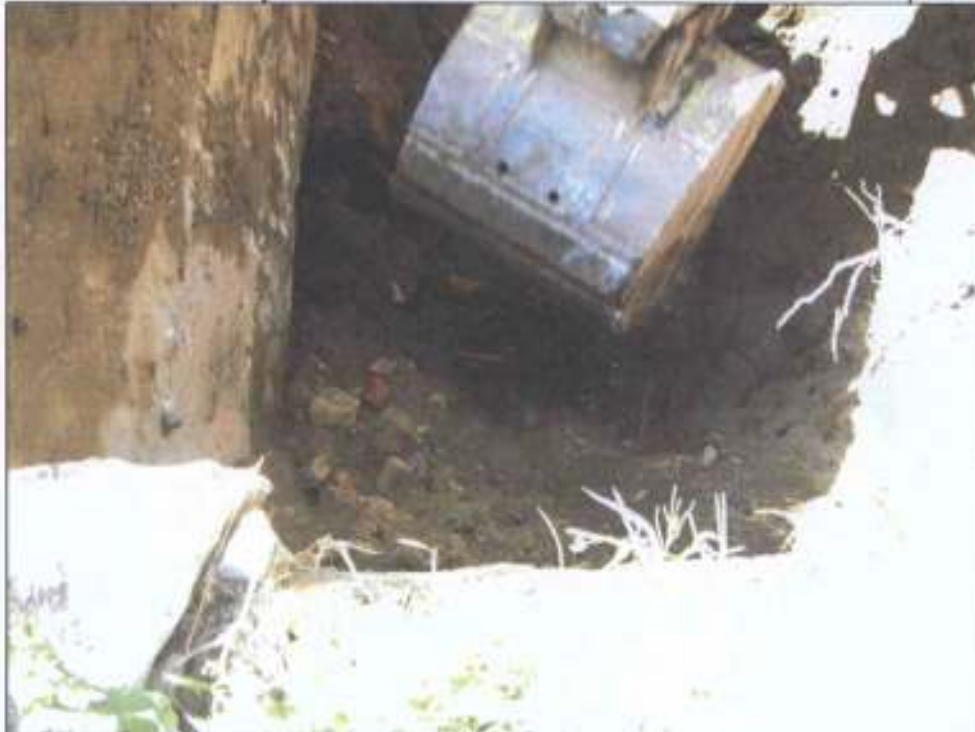
47. Thurs. 8/11/11: The excavator scraped bedrock bottom at about 15' bg in TP-4.

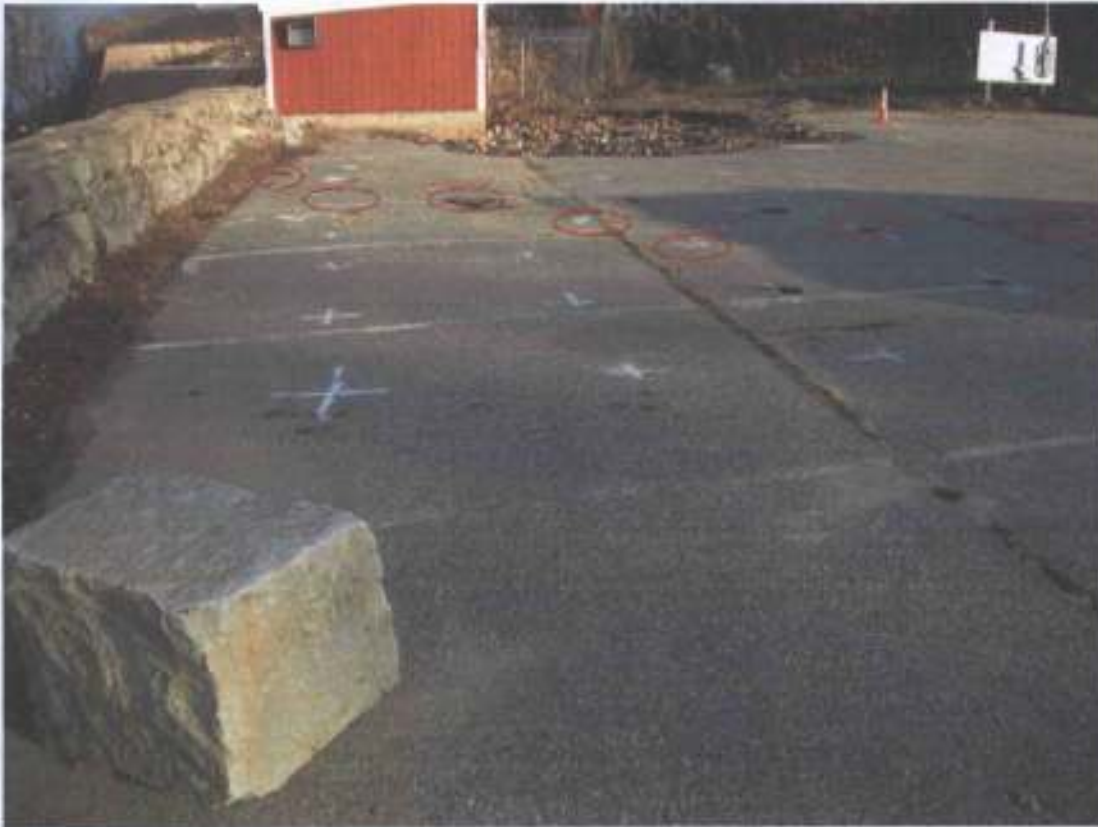
59.

over borings area.

11/2/11: Looking N

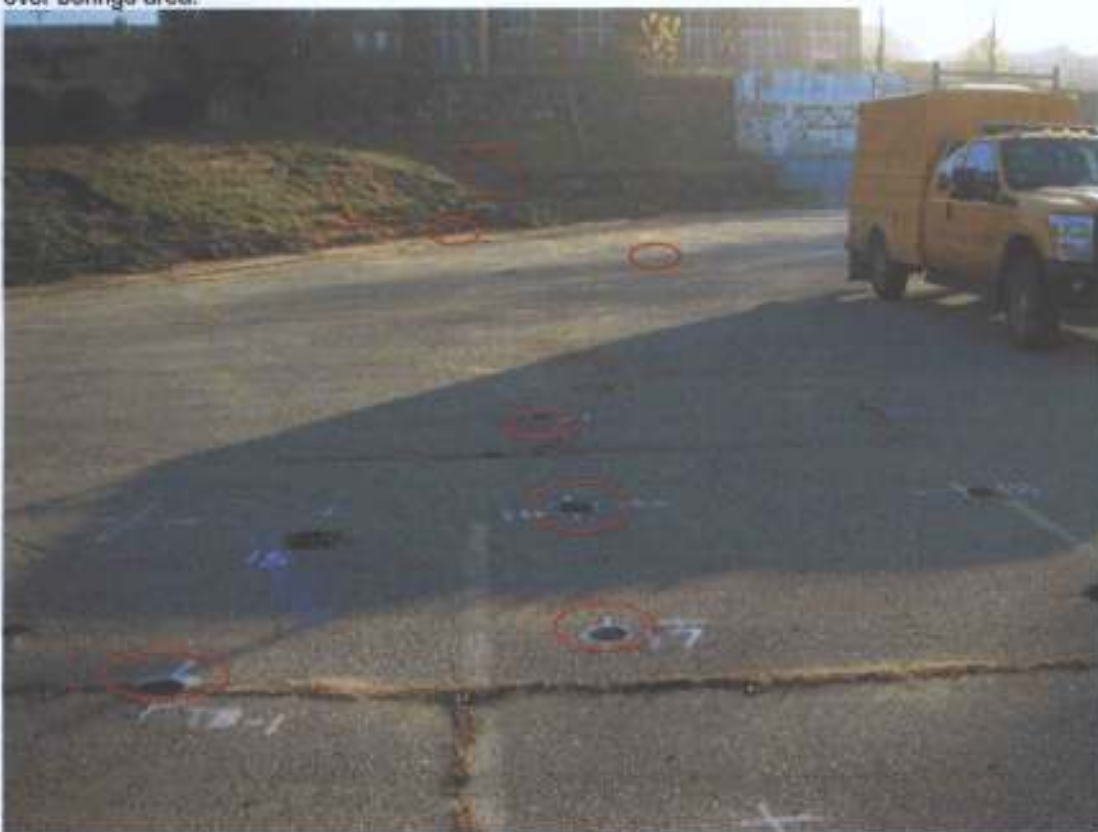
60.

east over borings toward the CMP Lewiston Steam Plant facility.

11/2/11: Looking

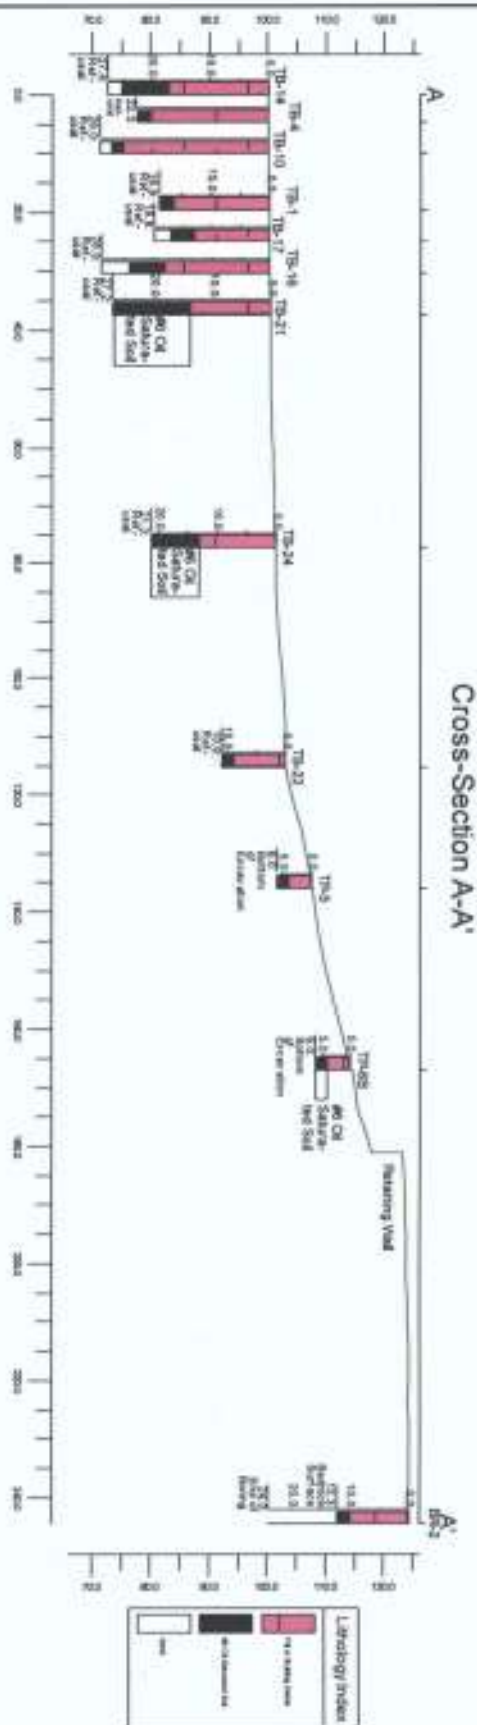
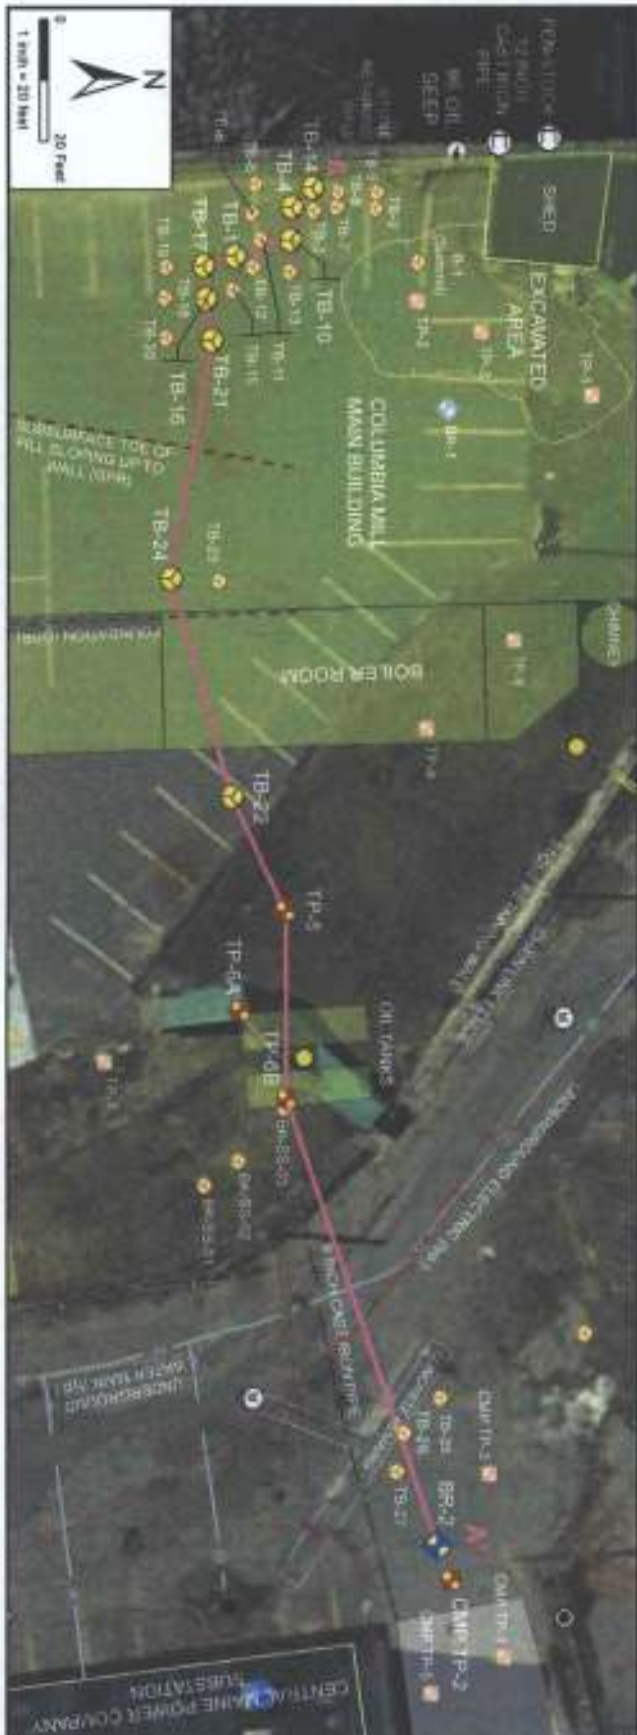
P-541-11 TEST BORING DATA

#6 OIL SATURATED SOIL

- TB-2: 14.8' bg, hit refusal. Dark ash, no oil
- TB-3: 2.6' bg bit hand metal? could not drill thru.
not rebar on thick oil tank shell.
Move over to next 5'
- TB-4: refusal @ 22.5', smooth drilling. Ash soil @ 8-10' bg. Black oil sat. soil, groundwater. sample
- TB-5: 4.5' hit metal, scrap, could not get thru.
- TB-6: closer to wall, 1' away. Black ash found, wet down to 28' bg. No LNAPL.
- TB-7: moving back between #2 and #3. About 4.5' to 5' bg. hit rock refusal, stopped, moving closer to wall.
- TB-8: Down to 20' bg, thru coarse ash, no serious refusal. No oil. (Odor of oil but that leftover on auger?)
- TB-9: 16' to bedrock. No oil
