**Environmental and Occupational  
Consulting and Training, Inc.**

**PHOTOS-**

Boiler Building and  
Turbine Building  
Main floor  
Cogswell Property LLC  
431 Helen Ave.  
Otsego, MI 49078

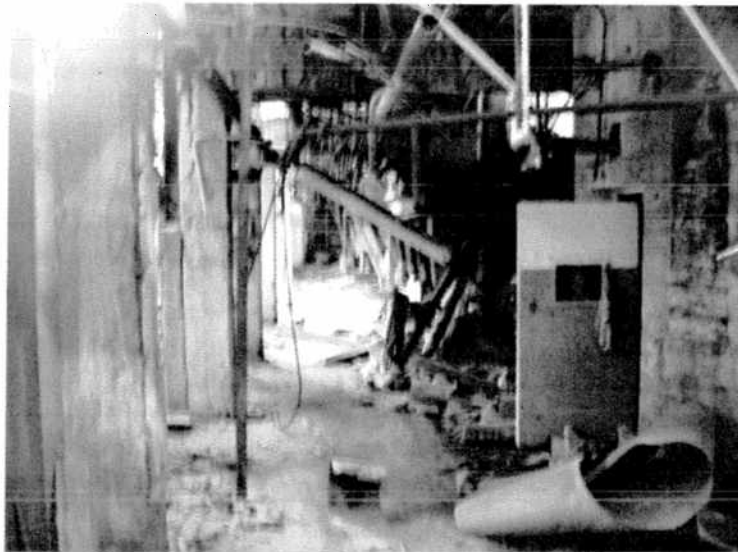
7495-20 In the basement of the boiler building looking east on the north side.

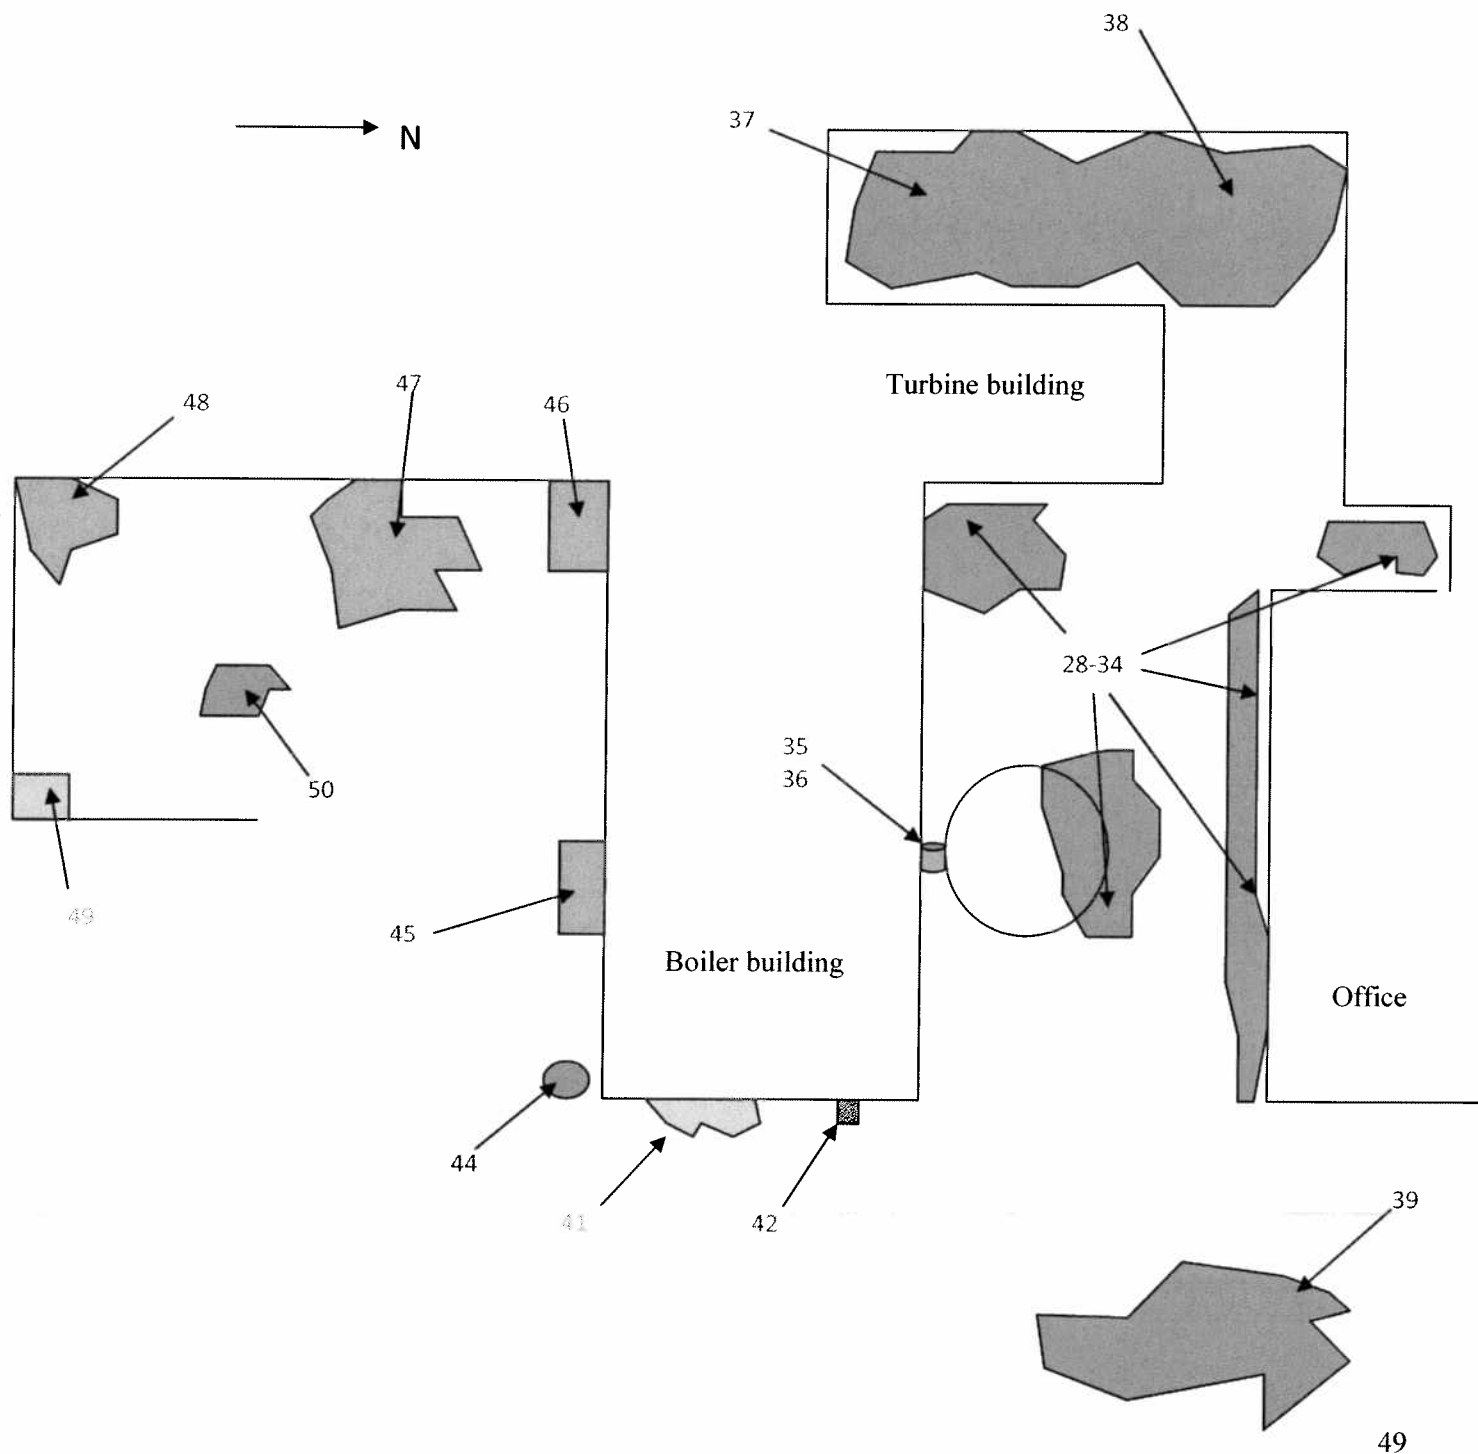
Boiler Building and  
Turbine Building  
Exterior  
Debris Fields and  
Sample Locations  
Cogswell Property LLC  
431 Helen Ave.  
Otsego, MI 49078

Trace Asbestos samples
