**Subject: Final Comprehensive Environmental Response, Compensation, and Liability Act
(CERCLA) Removal Action Report
ESB (Exide) Fund Lead
Atlanta, Fulton County, Georgia
EPA Contract No. EP-W-05-054
TDD No. TTEMI-05-001-0002**

**CERCLA REMOVAL ACTION REPORT
ESB (EXIDE) FUND LEAD
ATLANTA, FULTON COUNTY, GEORGIA
EPA CONTRACT NO. EP-W-05-054
TDD NO. TTEMI-05-001-0002**

Final Report

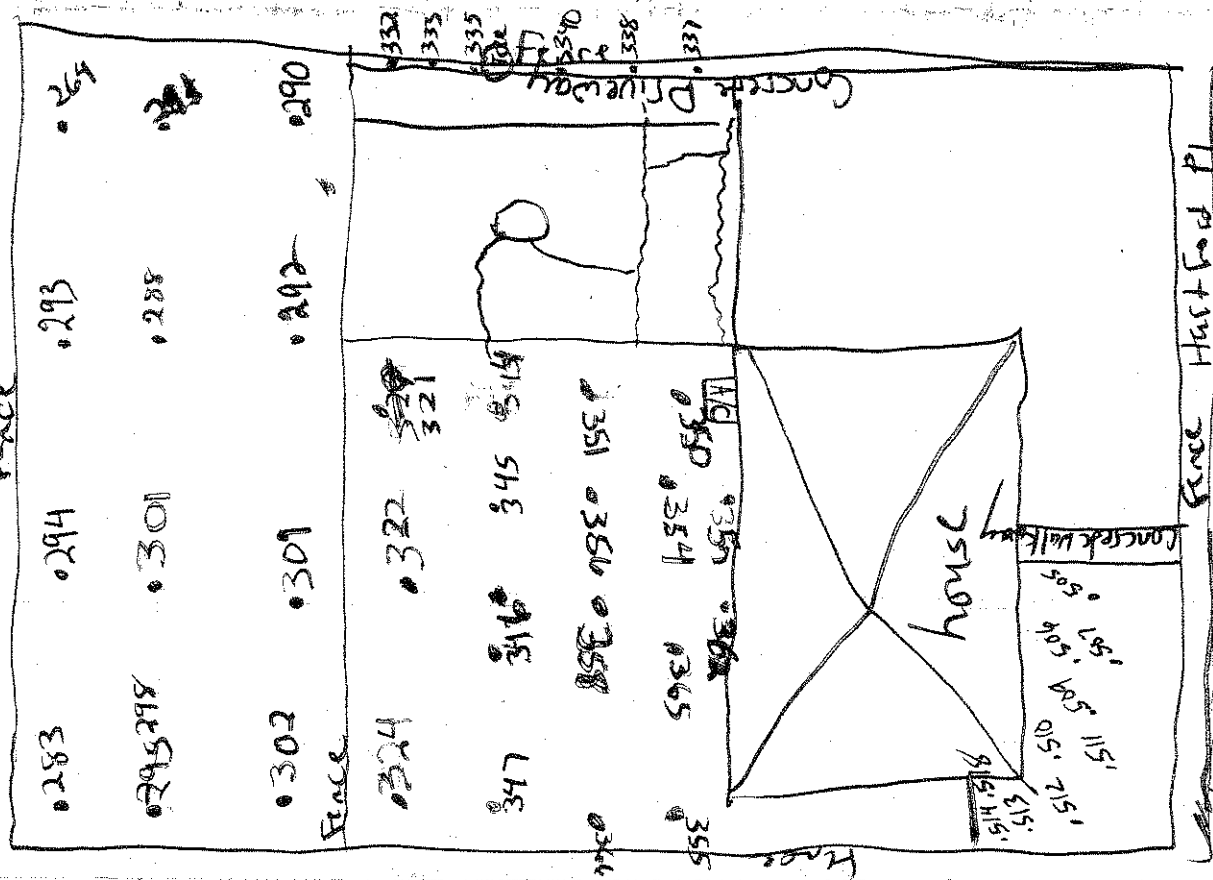
790 Hartford Pl.

0920 Natasha speaks with EPA Lucas regarding her driveway. Additional damage is visibly evident and she wants it fixed. EPA Lucas assures her it will be fixed.

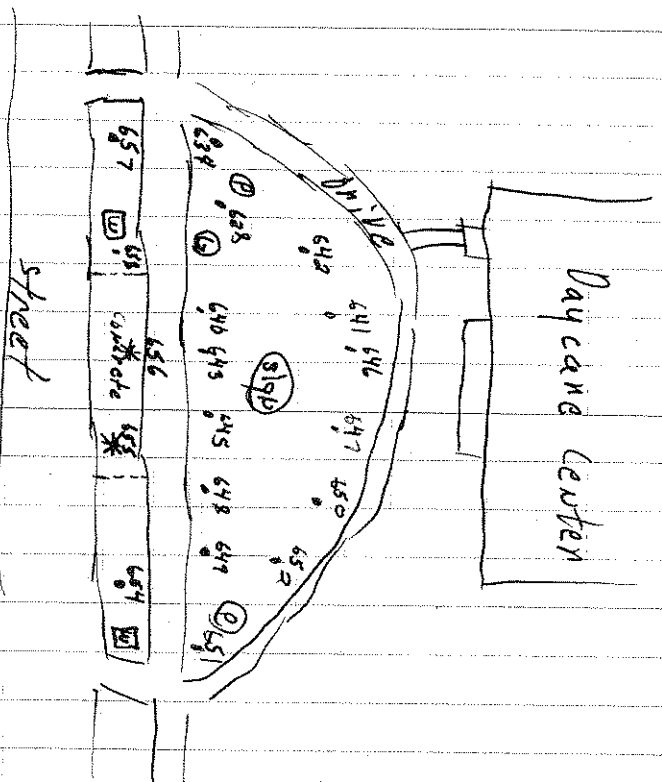
Baycare Center

From this point back is concrete, we unable to dig further. *655 shows the use of this depth. All readings marked with * are hot.

1025 CMC is unable to dig a greater depth on the soil located to the east of the sidewalk because concrete is mixed in with the dirt. This is noted on the map on the previous page. This area had Pb concentrations above 350 ppm.

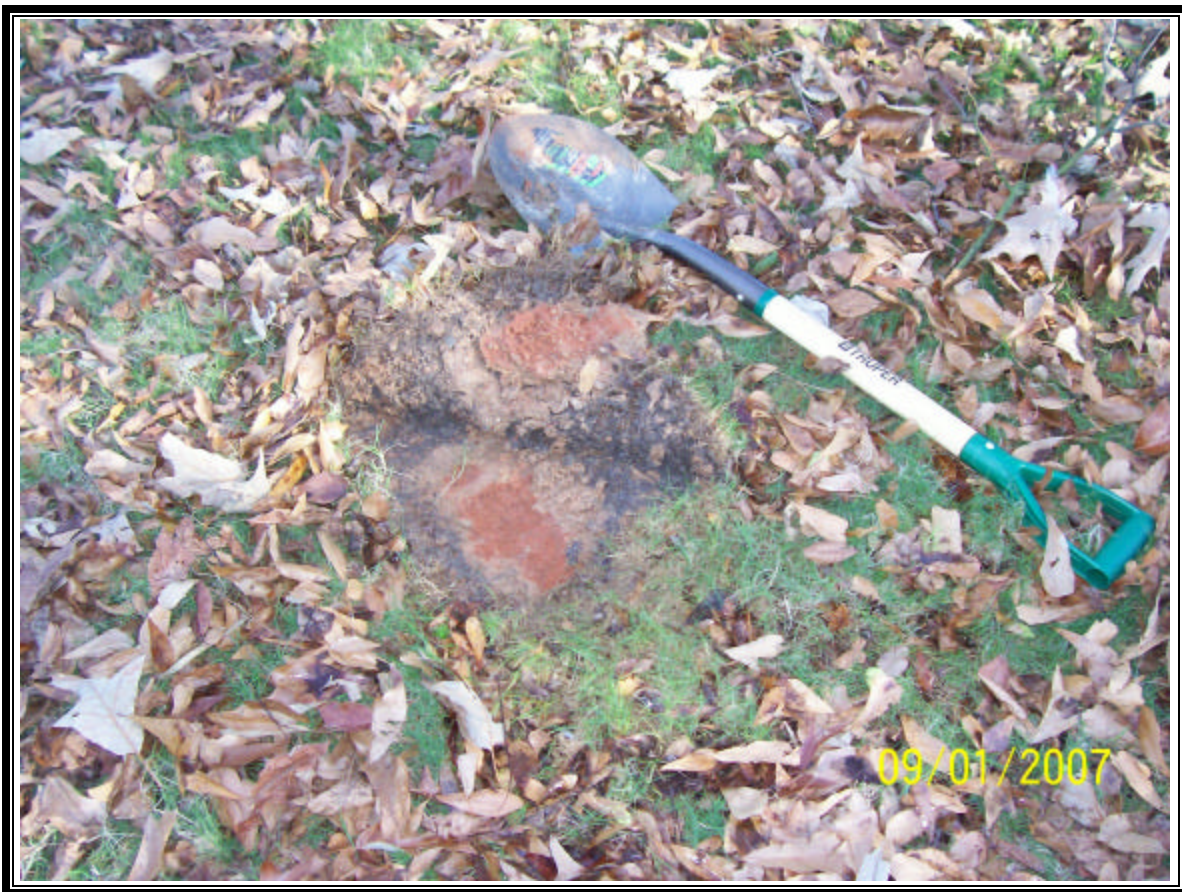
OFFICIAL PHOTOGRAPH NO. 16
U.S. ENVIRONMENTAL PROTECTION AGENCY

In some cases, it was necessary to collect confirmation samples after a property had already been backfilled and sod was in place. The sample collection procedure consisted of peeling back sod from an area of approximately 1 ft² and removing the backfill down to the excavation layer, which was obvious because of differences in color between the natural clay soil and the backfill material. This process is documented in the logbook notes (see Appendix C) and photographic log (see Photograph No. 16 in Appendix D).
