## Appendix C

### Photo Documentation

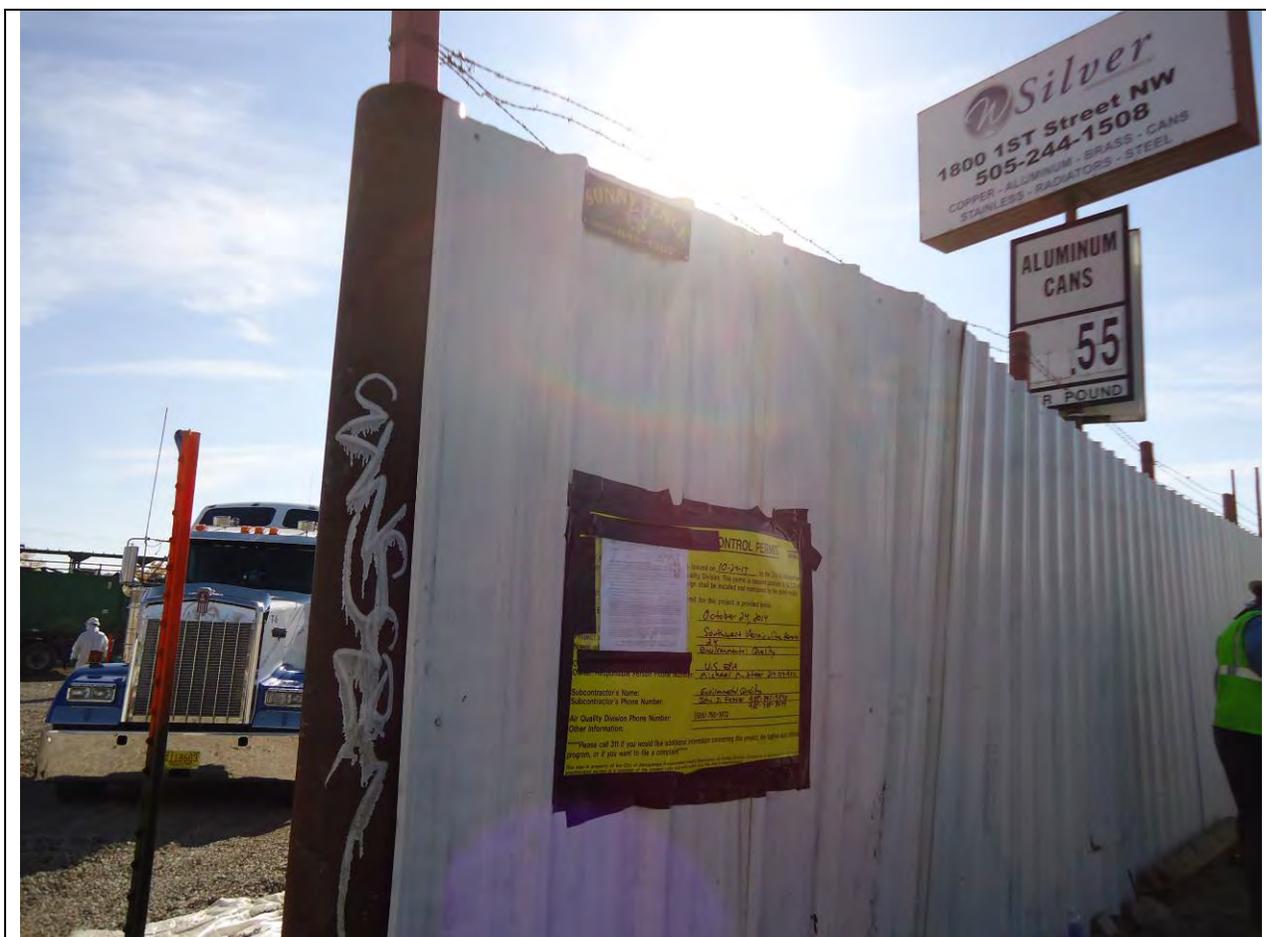
<b>Logbook Photo #</b>	DSC00600
<b>US EPA ID / Task Order Number</b>	CERCLIS: NMN000607041 / TDD No: 1/DYNAMAC-077-13-001
<b>Site</b>	Southwest Vermiculite (Removal 2)
<b>Location Address</b>	1800 1 <sup>st</sup> Street, NW
<b>City, State</b>	Albuquerque, New Mexico 87102
<b>County</b>	Bernalillo
<b>Direction/Orientation</b>	SE
<b>Date</b>	11/13/13
<b>Time</b>	1012
<b>Photographer</b>	N. Biscocho (START)
<b>Witness</b>	J. Koehnen (START)
<b>Description:</b>	Public notice sign posted at the entrance of the Recycling facility for the duration of the clean-up activities.

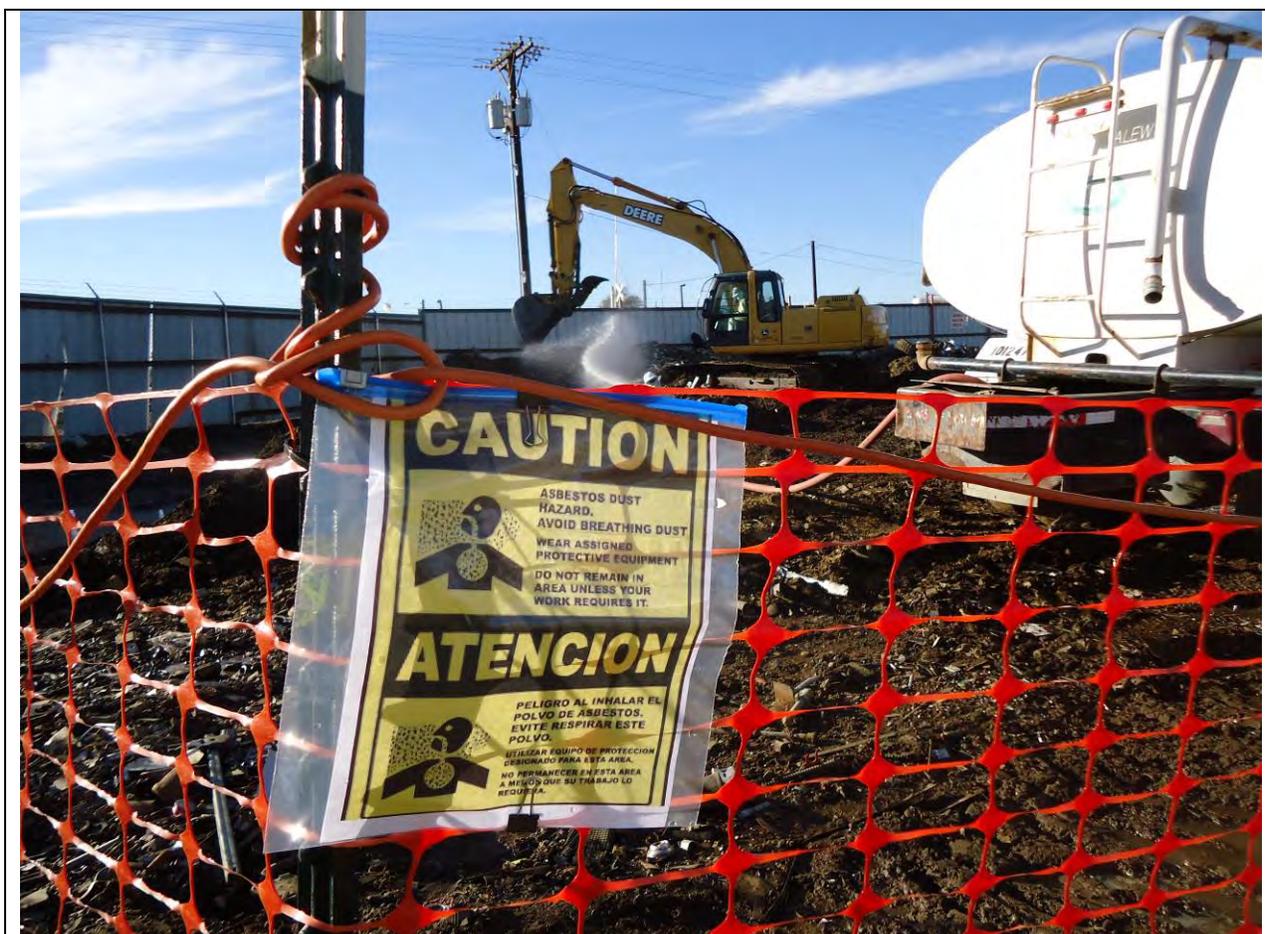
<b>Logbook Photo #</b>	DSC00570
<b>US EPA ID / Task Order Number</b>	CERCLIS: NMN000607041 / TDD No: 1/DYNAMAC-077-13-001
<b>Site</b>	Southwest Vermiculite (Removal 2)
<b>Location Address</b>	1800 1 <sup>st</sup> Street, NW
<b>City, State</b>	Albuquerque, New Mexico 87102
<b>County</b>	Bernalillo
<b>Direction/Orientation</b>	SE
<b>Date</b>	11/08/13
<b>Time</b>	1723
<b>Photographer</b>	N. Biscocho (START)
<b>Witness</b>	J. Koehnen (START)
<b>Description:</b>	View of one sign posted around the excavation zones for the duration of the clean-up activities.

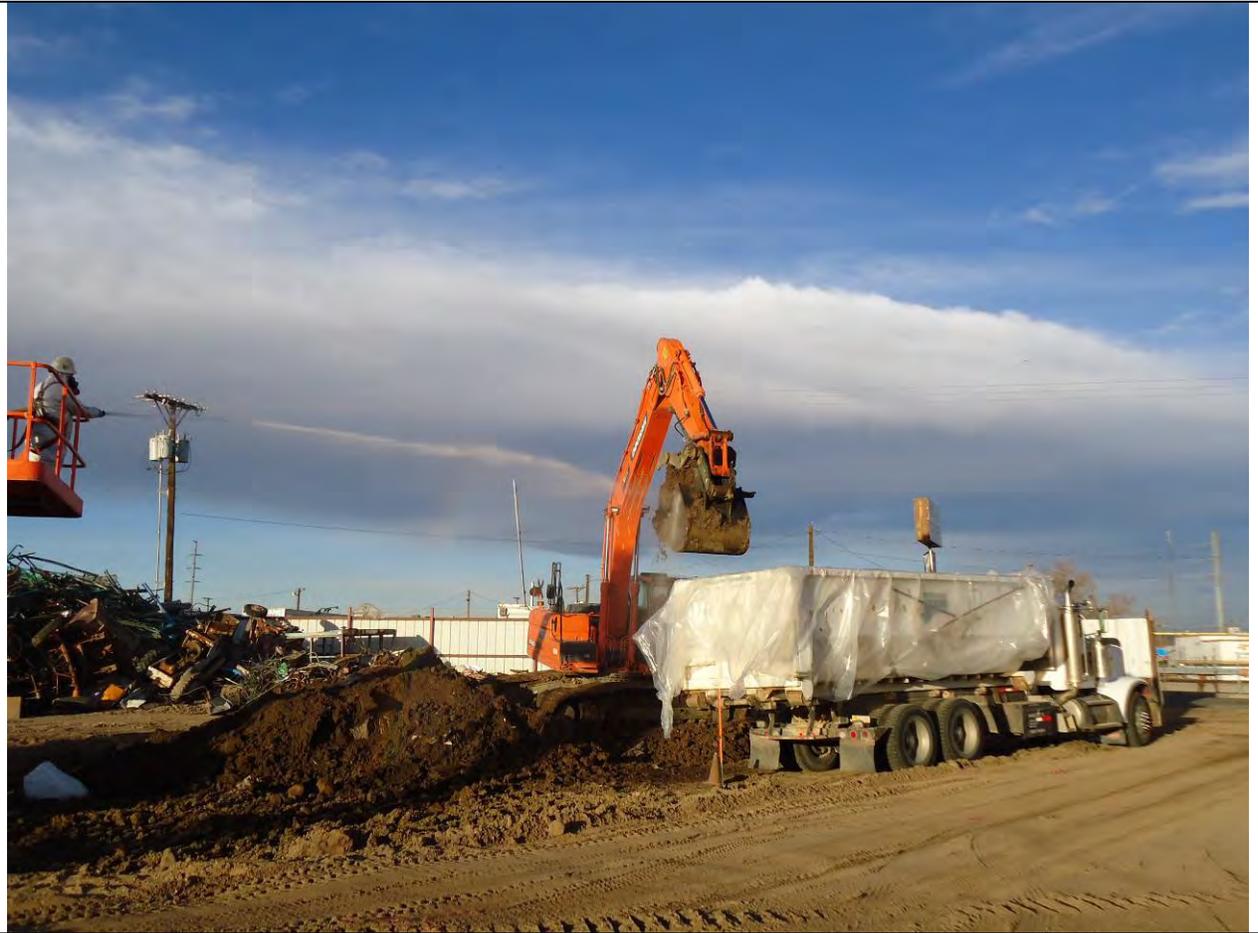
<b>Logbook Photo #</b>	DSC1010
<b>US EPA ID / Task Order Number</b>	CERCLIS: NMN000607041 / TDD No: 1/DYNAMAC-077-13-001
<b>Site</b>	Southwest Vermiculite (Removal 2)
<b>Location Address</b>	1800 1 <sup>st</sup> Street, NW
<b>City, State</b>	Albuquerque, New Mexico 87102
<b>County</b>	Bernalillo
<b>Direction/Orientation</b>	SE
<b>Date</b>	1/28/14
<b>Time</b>	0750
<b>Photographer</b>	N. Biscocho (START)
<b>Witness</b>	J. Koehnen (START)
<b>Description:</b>	
Loading of contaminated soil from Area A into disposal trucks. Dust suppression in progress.

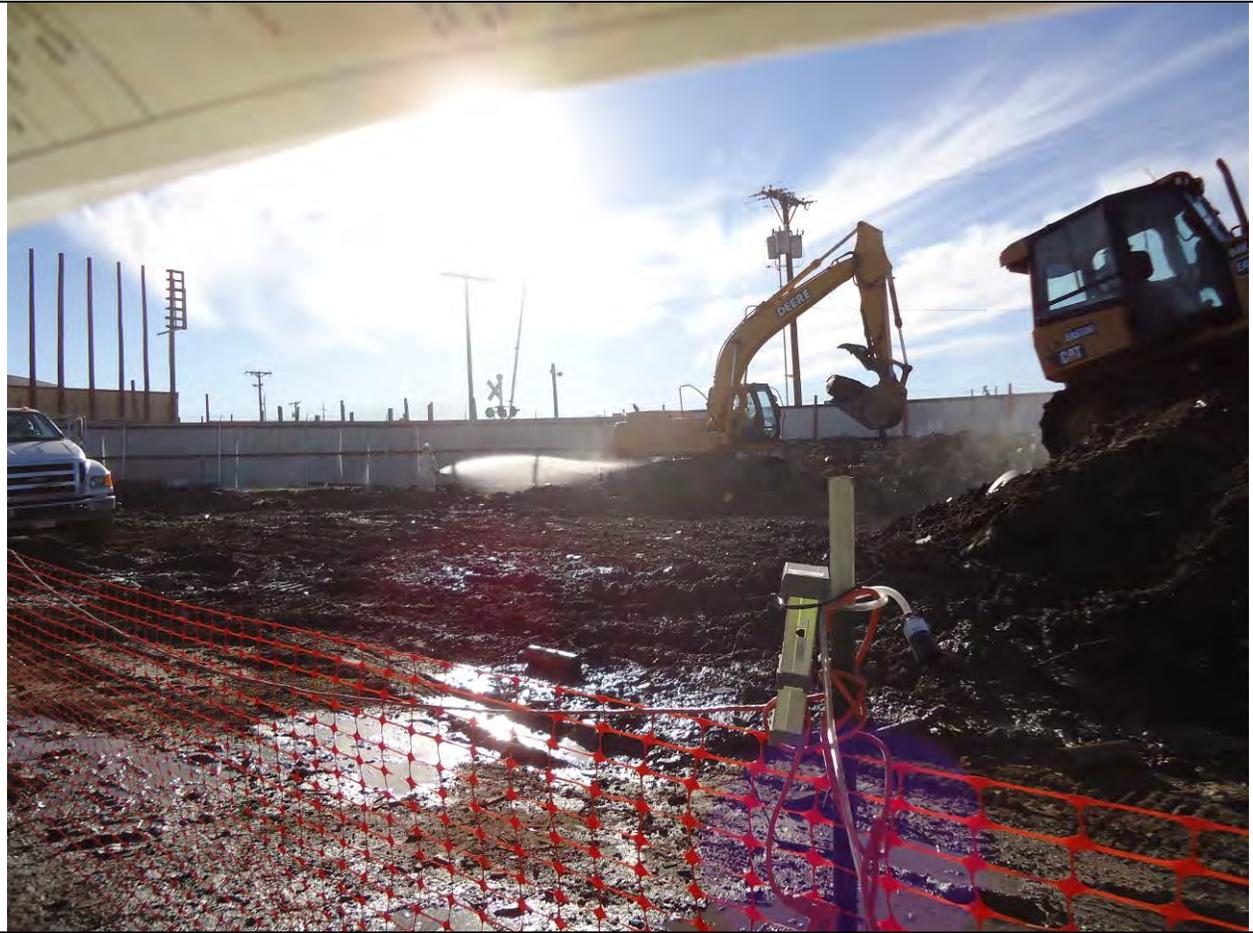
<b>Logbook Photo #</b>	DSC00567
<b>US EPA ID / Task Order Number</b>	CERCLIS: NMN000607041 / TDD No: 1/DYNAMAC-077-13-001
<b>Site</b>	Southwest Vermiculite (Removal 2)
<b>Location Address</b>	1800 1 <sup>st</sup> Street, NW
<b>City, State</b>	Albuquerque, New Mexico 87102
<b>County</b>	Bernalillo
<b>Direction/Orientation</b>	SW
<b>Date</b>	11/8/13
<b>Time</b>	1719
<b>Photographer</b>	N. Biscocho (START)
<b>Witness</b>	J. Koehnen (START)
<b>Description:</b>	
View of Station 2: air sample and air monitor (see figures for location of Station 2).

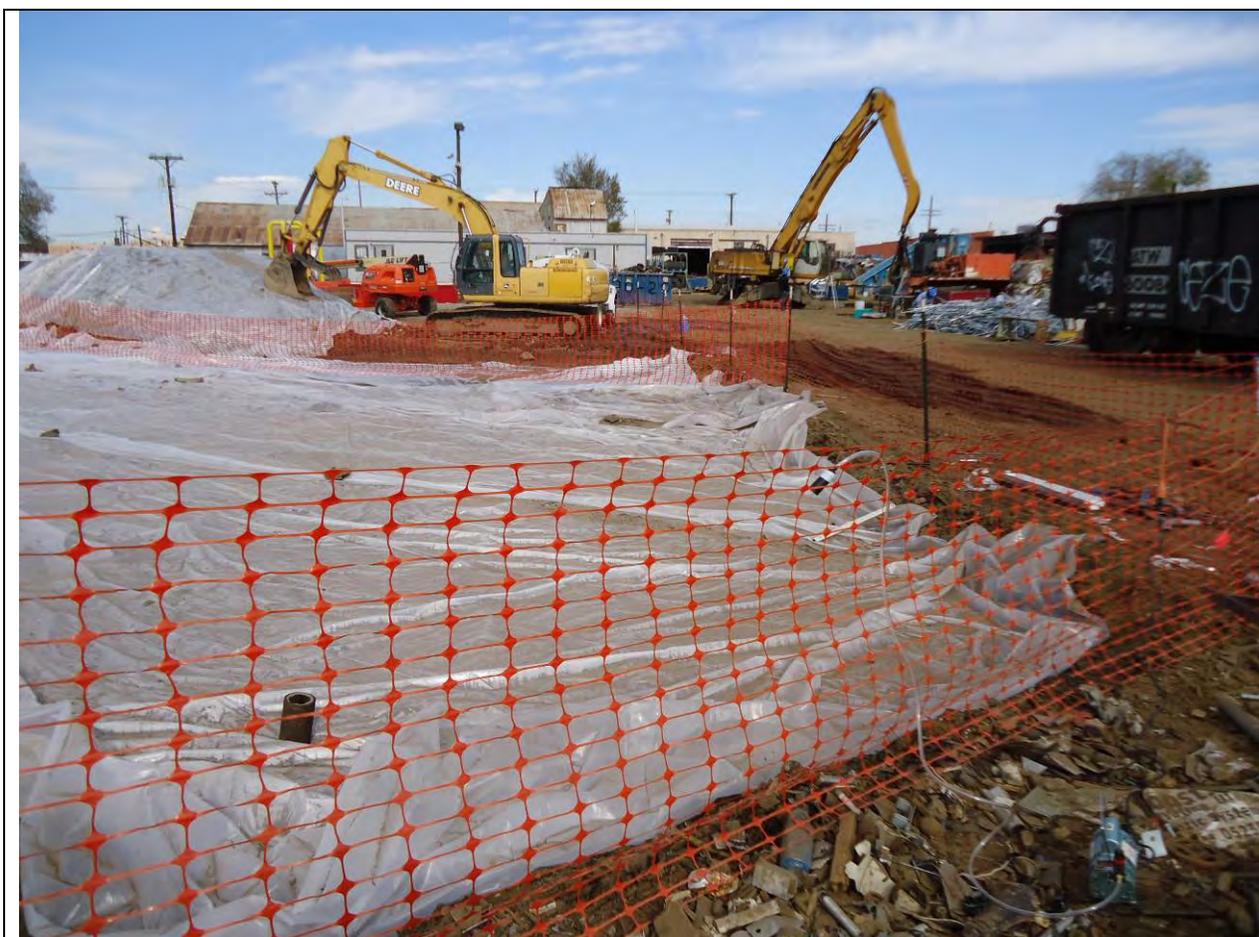
<b>Logbook Photo #</b>	DSC00611
<b>US EPA ID / Task Order Number</b>	CERCLIS: NMN000607041 / TDD No: 1/DYNAMAC-077-13-001
<b>Site</b>	Southwest Vermiculite (Removal 2)
<b>Location Address</b>	1800 1 <sup>st</sup> Street, NW
<b>City, State</b>	Albuquerque, New Mexico 87102
<b>County</b>	Bernalillo
<b>Direction/Orientation</b>	N
<b>Date</b>	11/14/13
<b>Time</b>	1204
<b>Photographer</b>	N. Biscocho (START)
<b>Witness</b>	J. Koehnen (START)
<b>Description:</b>	View of Station 3: air sample (see figures for location of Station 3).

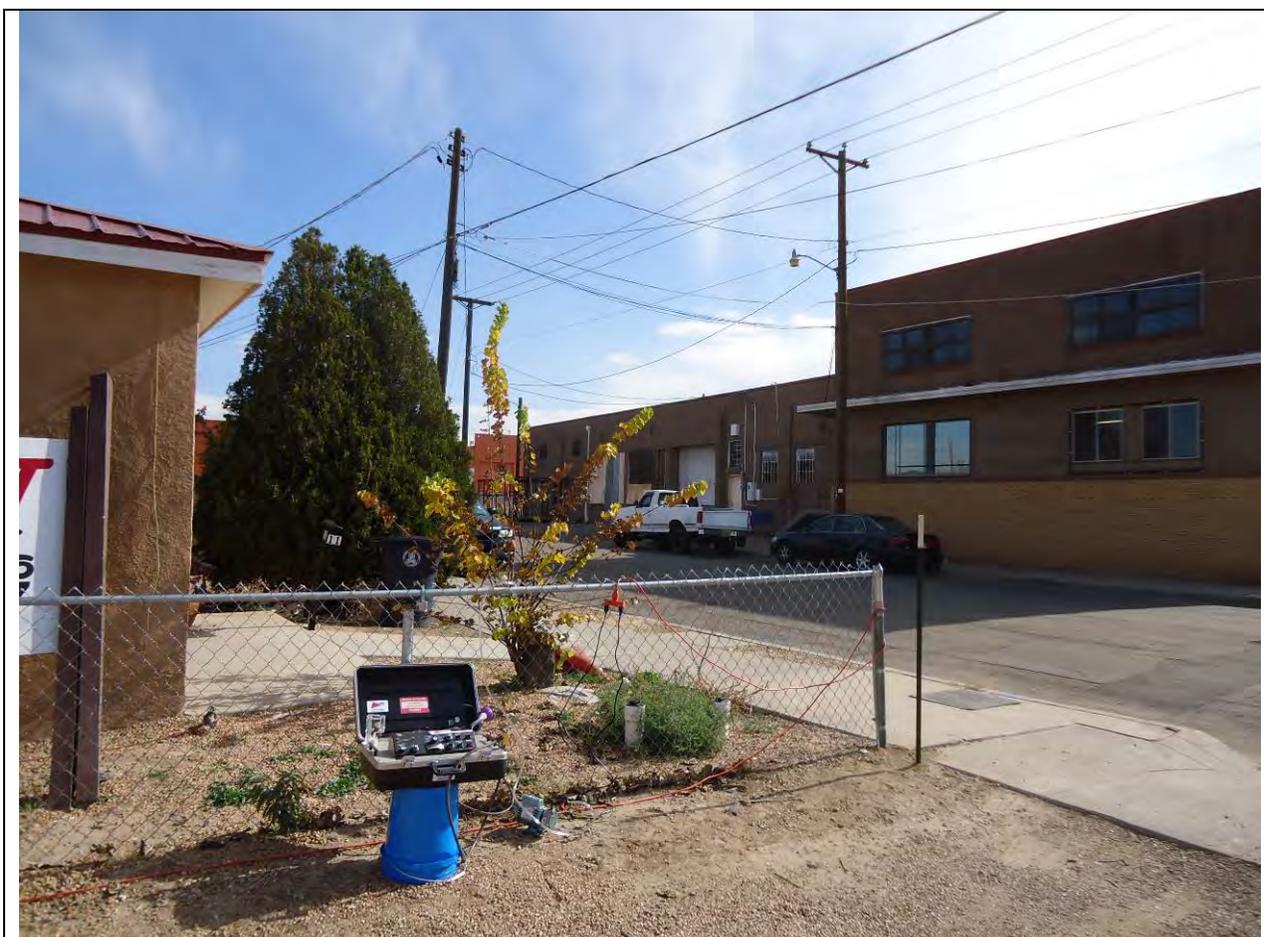
<b>Logbook Photo #</b>	DSC00613
<b>US EPA ID / Task Order Number</b>	CERCLIS: NMN000607041 / TDD No: 1/DYNAMAC-077-13-001
<b>Site</b>	Southwest Vermiculite (Removal 2)
<b>Location Address</b>	1800 1 <sup>st</sup> Street, NW
<b>City, State</b>	Albuquerque, New Mexico 87102
<b>County</b>	Bernalillo
<b>Direction/Orientation</b>	SE
<b>Date</b>	11/14/13
<b>Time</b>	1217
<b>Photographer</b>	N. Biscocho (START)
<b>Witness</b>	J. Koehnen (START)

View of Station 4: air sample and air monitor Fibrous Aerosol Monitor (FAM-1). Note that the FAM-1 was situated between the nearest residence and the site. (see figures for location of Station 4).

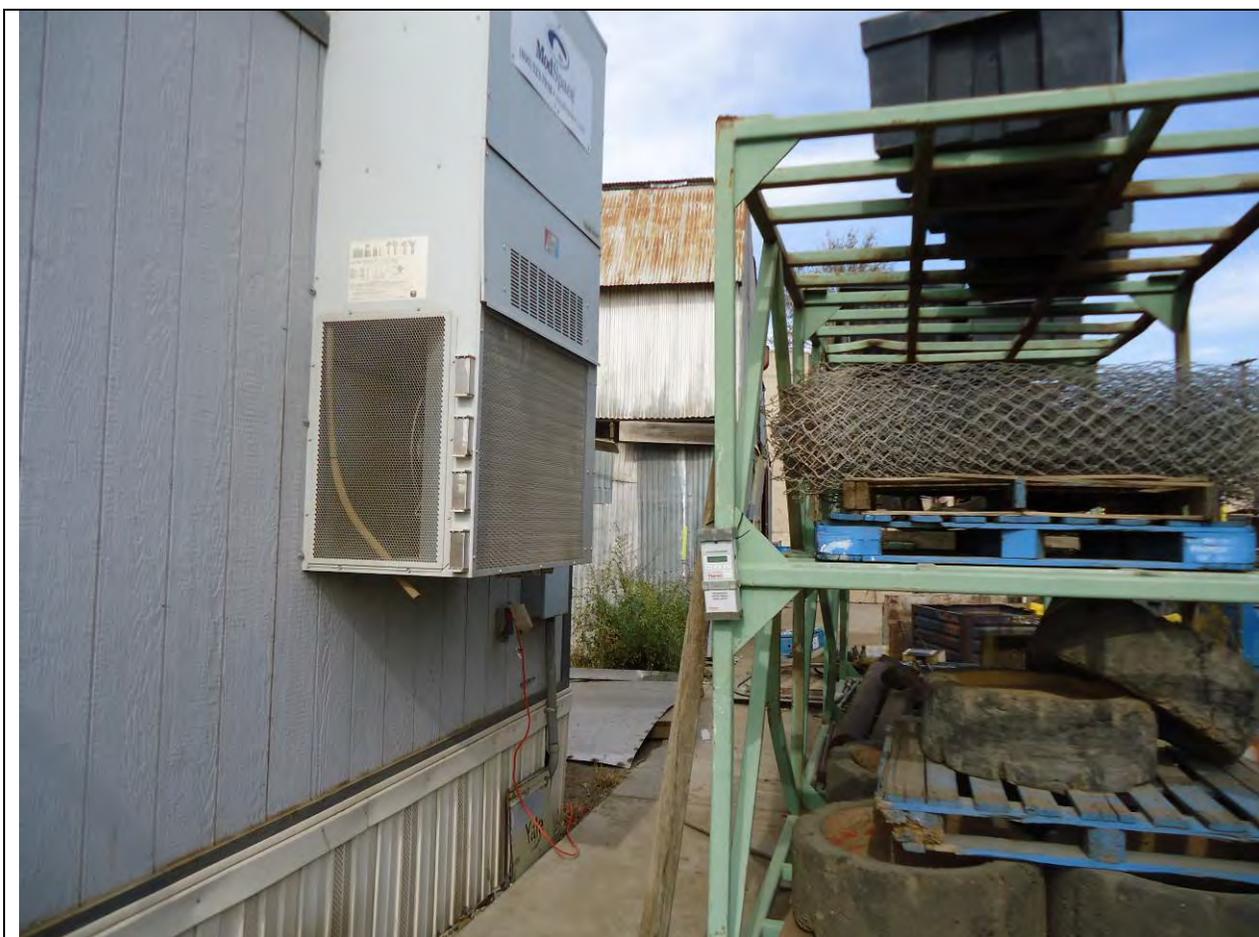
<b>Logbook Photo #</b>	DSC00612
<b>US EPA ID / Task Order Number</b>	CERCLIS: NMN000607041 / TDD No: 1/DYNAMAC-077-13-001
<b>Site</b>	Southwest Vermiculite (Removal 2)
<b>Location Address</b>	1800 1 <sup>st</sup> Street, NW
<b>City, State</b>	Albuquerque, New Mexico 87102
<b>County</b>	Bernalillo
<b>Direction/Orientation</b>	N
<b>Date</b>	11/14/13
<b>Time</b>	1206
<b>Photographer</b>	N. Biscocho (START)
<b>Witness</b>	J. Koehnen (START)
<b>Description:</b>	View of Station 5: air monitor (see figures for location of Station 5).

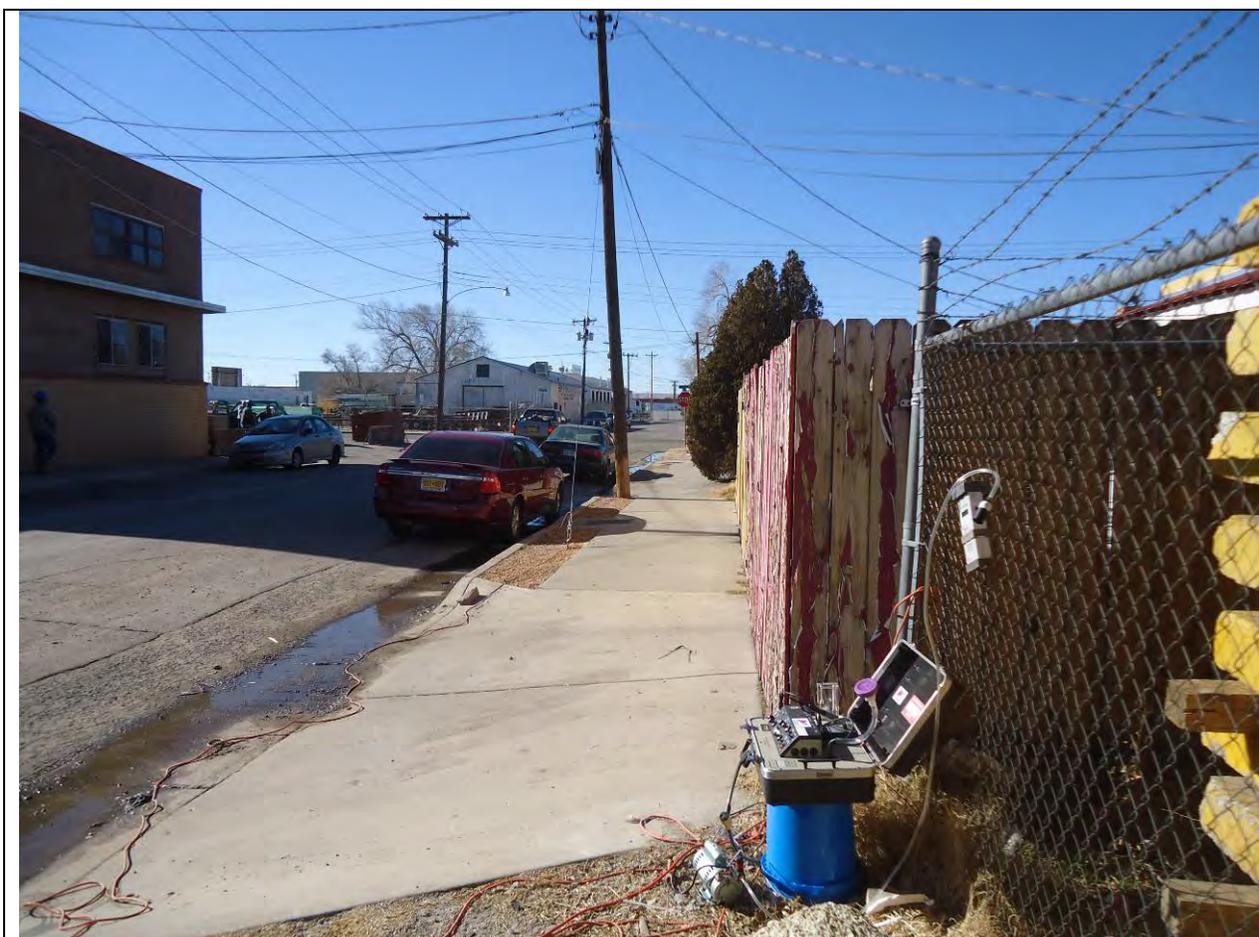
<b>Logbook Photo #</b>	DSC00887
<b>US EPA ID / Task Order Number</b>	CERCLIS: NMN000607041 / TDD No: 1/DYNAMAC-077-13-001
<b>Site</b>	Southwest Vermiculite (Removal 2)
<b>Location Address</b>	1800 1 <sup>st</sup> Street, NW
<b>City, State</b>	Albuquerque, New Mexico 87102
<b>County</b>	Bernalillo
<b>Direction/Orientation</b>	W
<b>Date</b>	1/13/14
<b>Time</b>	1337
<b>Photographer</b>	N. Biscocho (START)
<b>Witness</b>	J. Koehnen (START)

View of Station 10: air sample and air monitor Fibrous Aerosol Monitor (FAM-1). Note that the FAM-1 was situated between the nearest residence and the site. (see figures for location of Station 10).

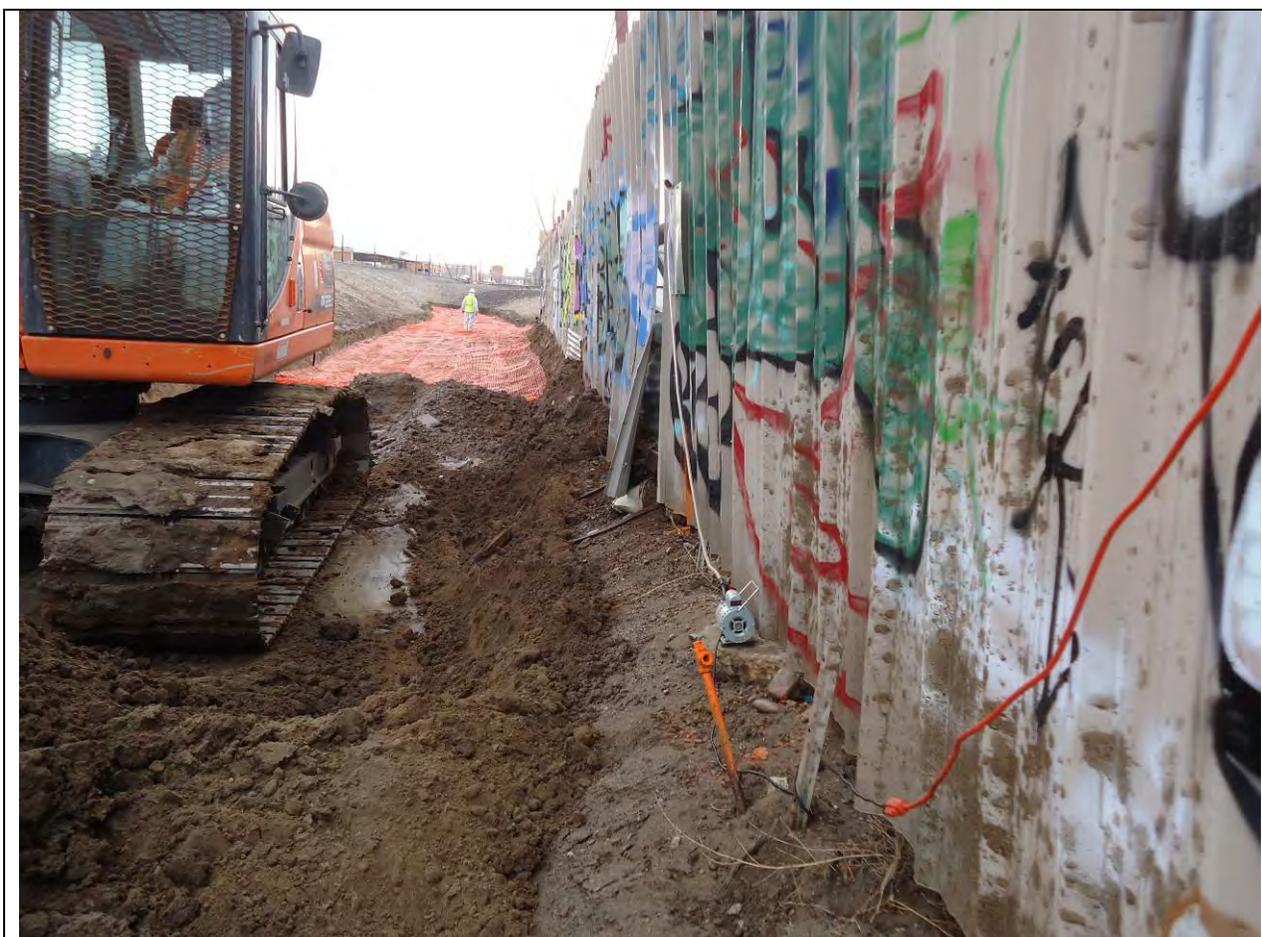
<b>Logbook Photo #</b>	DSC00819
<b>US EPA ID / Task Order Number</b>	CERCLIS: NMN000607041 / TDD No: 1/DYNAMAC-077-13-001
<b>Site</b>	Southwest Vermiculite (Removal 2)
<b>Location Address</b>	1800 1 <sup>st</sup> Street, NW
<b>City, State</b>	Albuquerque, New Mexico 87102
<b>County</b>	Bernalillo
<b>Direction/Orientation</b>	S
<b>Date</b>	1/7/14
<b>Time</b>	1529
<b>Photographer</b>	N. Biscocho (START)
<b>Witness</b>	J. Koehnen (START)
<b>Description:</b>	View of Station 11: air sample (see figures for location of Station 11).

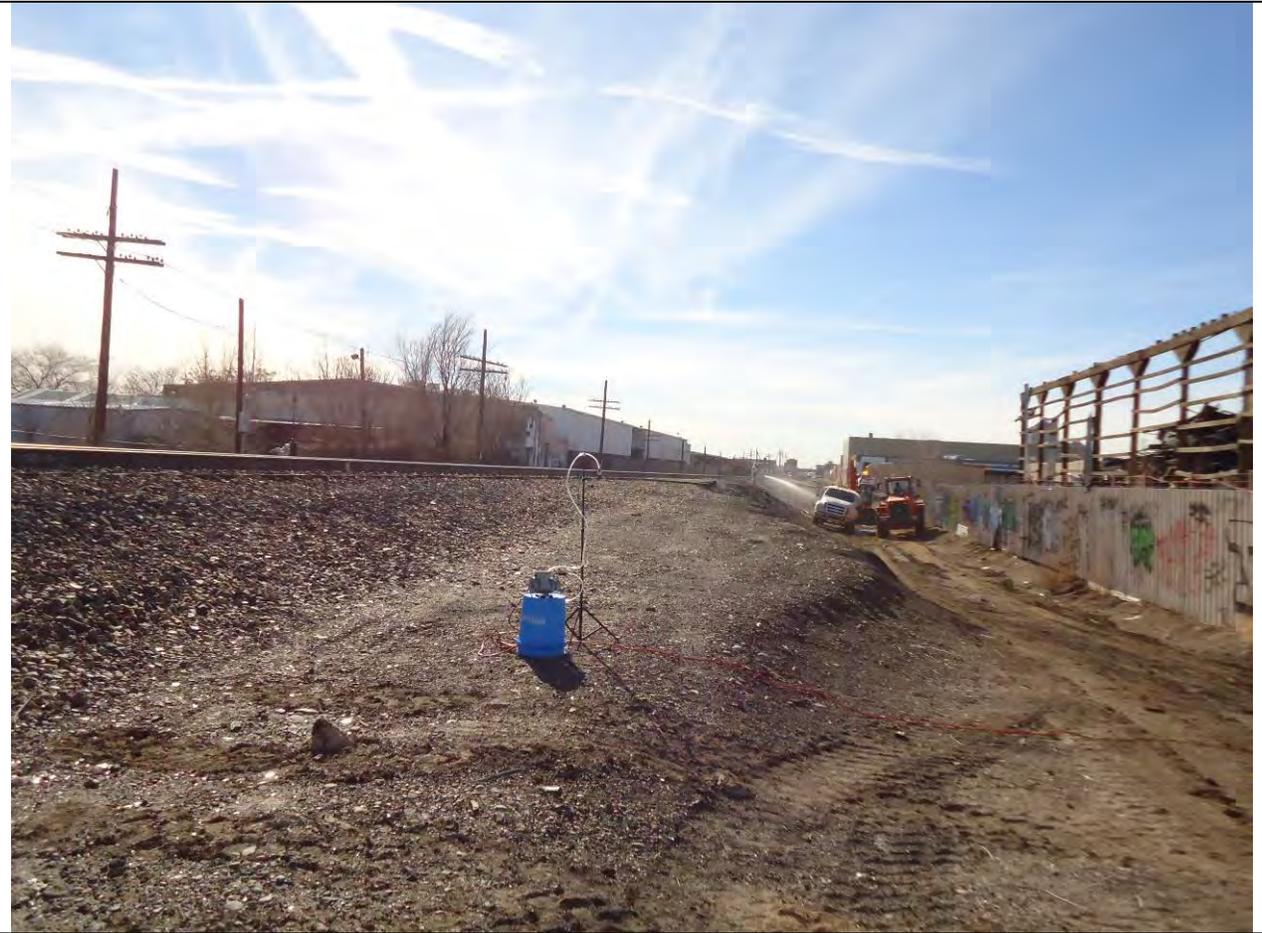
<b>Logbook Photo #</b>	DSC00813
<b>US EPA ID / Task Order Number</b>	CERCLIS: NMN000607041 / TDD No: 1/DYNAMAC-077-13-001
<b>Site</b>	Southwest Vermiculite (Removal 2)
<b>Location Address</b>	1800 1 <sup>st</sup> Street, NW
<b>City, State</b>	Albuquerque, New Mexico 87102
<b>County</b>	Bernalillo
<b>Direction/Orientation</b>	S
<b>Date</b>	1/7/14
<b>Time</b>	1115
<b>Photographer</b>	N. Biscocho (START)
<b>Witness</b>	J. Koehnen (START)
<b>Description:</b>	
View of Station 12: air sample (see figures for location of Station 12).

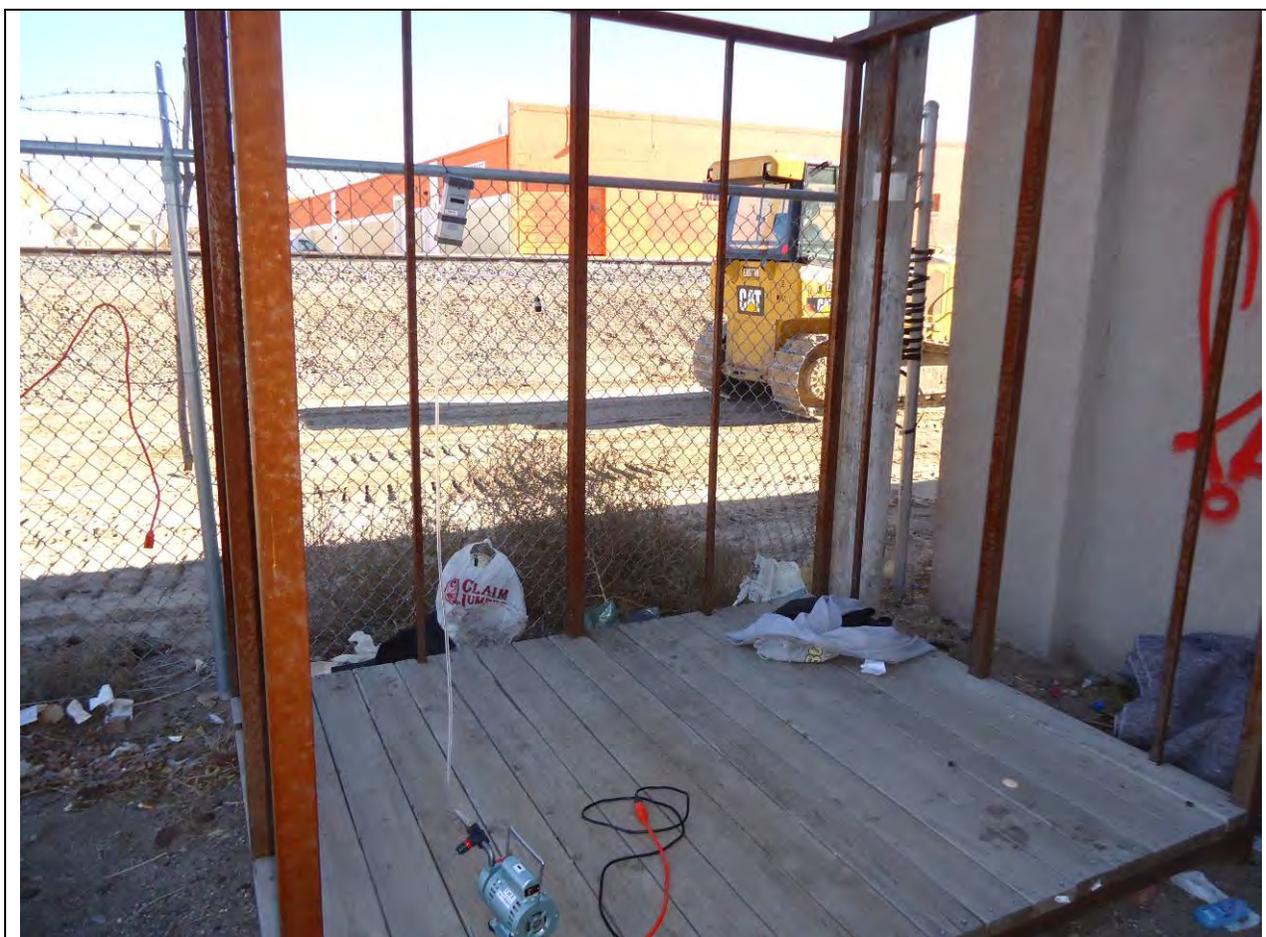
<b>Logbook Photo #</b>	DSC00886
<b>US EPA ID / Task Order Number</b>	CERCLIS: NMN000607041 / TDD No: 1/DYNAMAC-077-13-001
<b>Site</b>	Southwest Vermiculite (Removal 2)
<b>Location Address</b>	1800 1 <sup>st</sup> Street, NW
<b>City, State</b>	Albuquerque, New Mexico 87102
<b>County</b>	Bernalillo
<b>Direction/Orientation</b>	E
<b>Date</b>	1/13/14
<b>Time</b>	1536
<b>Photographer</b>	N. Biscocho (START)
<b>Witness</b>	J. Koehnen (START)
<b>Description:</b>	View of Station 13: air sample and air monitor (see figures for location of Station 13).

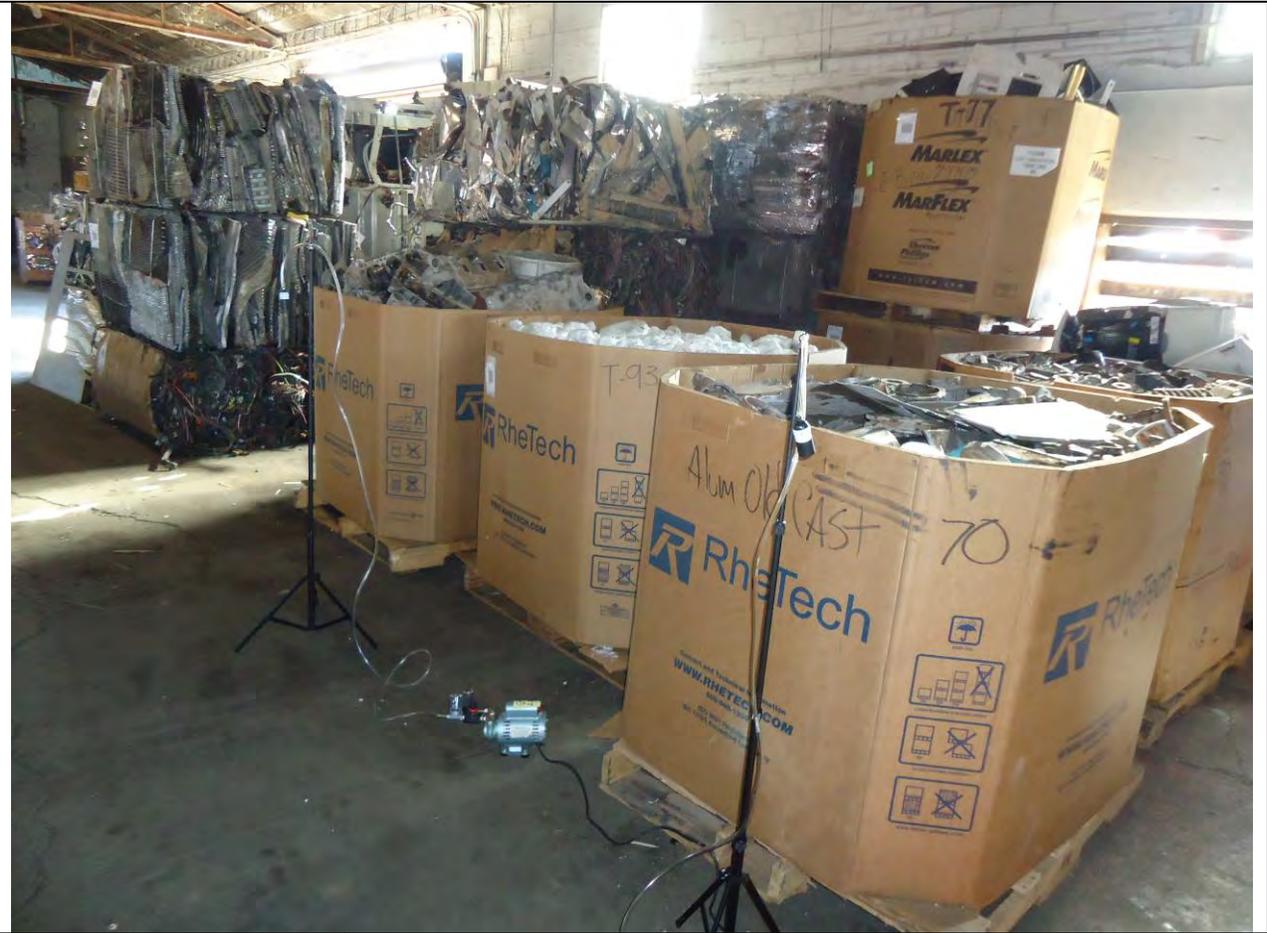
<b>Logbook Photo #</b>	DSC00713
<b>US EPA ID / Task Order Number</b>	CERCLIS: NMN000607041 / TDD No: 1/DYNAMAC-077-13-001
<b>Site</b>	Southwest Vermiculite (Removal 2)
<b>Location Address</b>	1800 1 <sup>st</sup> Street, NW
<b>City, State</b>	Albuquerque, New Mexico 87102
<b>County</b>	Bernalillo
<b>Direction/Orientation</b>	SE
<b>Date</b>	12/9/13
<b>Time</b>	1138
<b>Photographer</b>	N. Biscocho (START)
<b>Witness</b>	J. Koehnen (START)
<b>Description:</b>	View of indoor air sample station and co-located/duplicate sample inside the auxiliary warehouse at W. Silver Recycling facility.

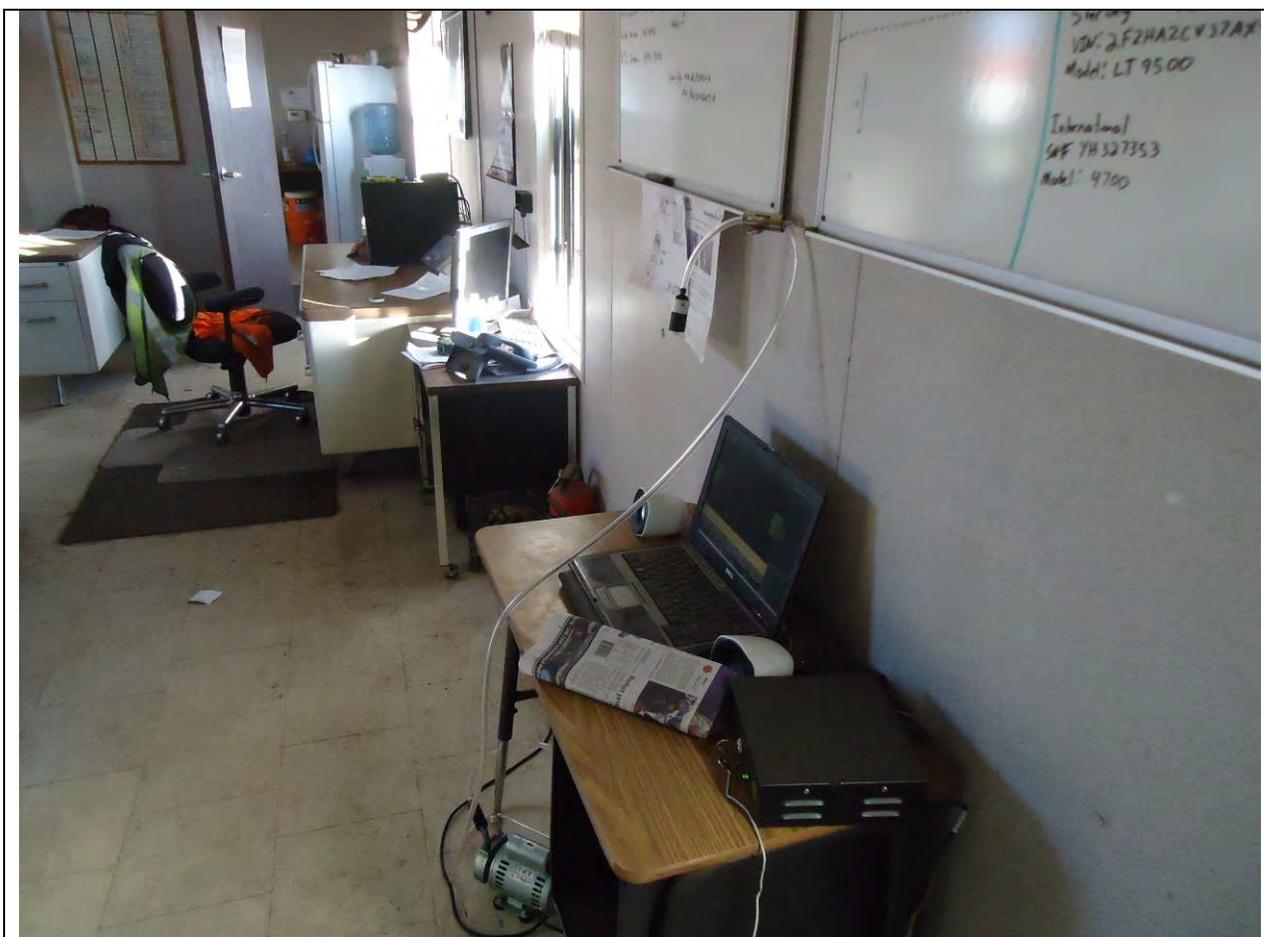
<b>Logbook Photo #</b>	DSC00965
<b>US EPA ID / Task Order Number</b>	CERCLIS: NMN000607041 / TDD No: 1/DYNAMAC-077-13-001
<b>Site</b>	Southwest Vermiculite (Removal 2)
<b>Location Address</b>	1800 1 <sup>st</sup> Street, NW
<b>City, State</b>	Albuquerque, New Mexico 87102
<b>County</b>	Bernalillo
<b>Direction/Orientation</b>	E
<b>Date</b>	1/23/14
<b>Time</b>	1604
<b>Photographer</b>	N. Biscocho (START)
<b>Witness</b>	J. Koehnen (START)
<b>Description:</b>	Indoor air sampling at SWV W. Silver Recycling Trailer/Scale Office.

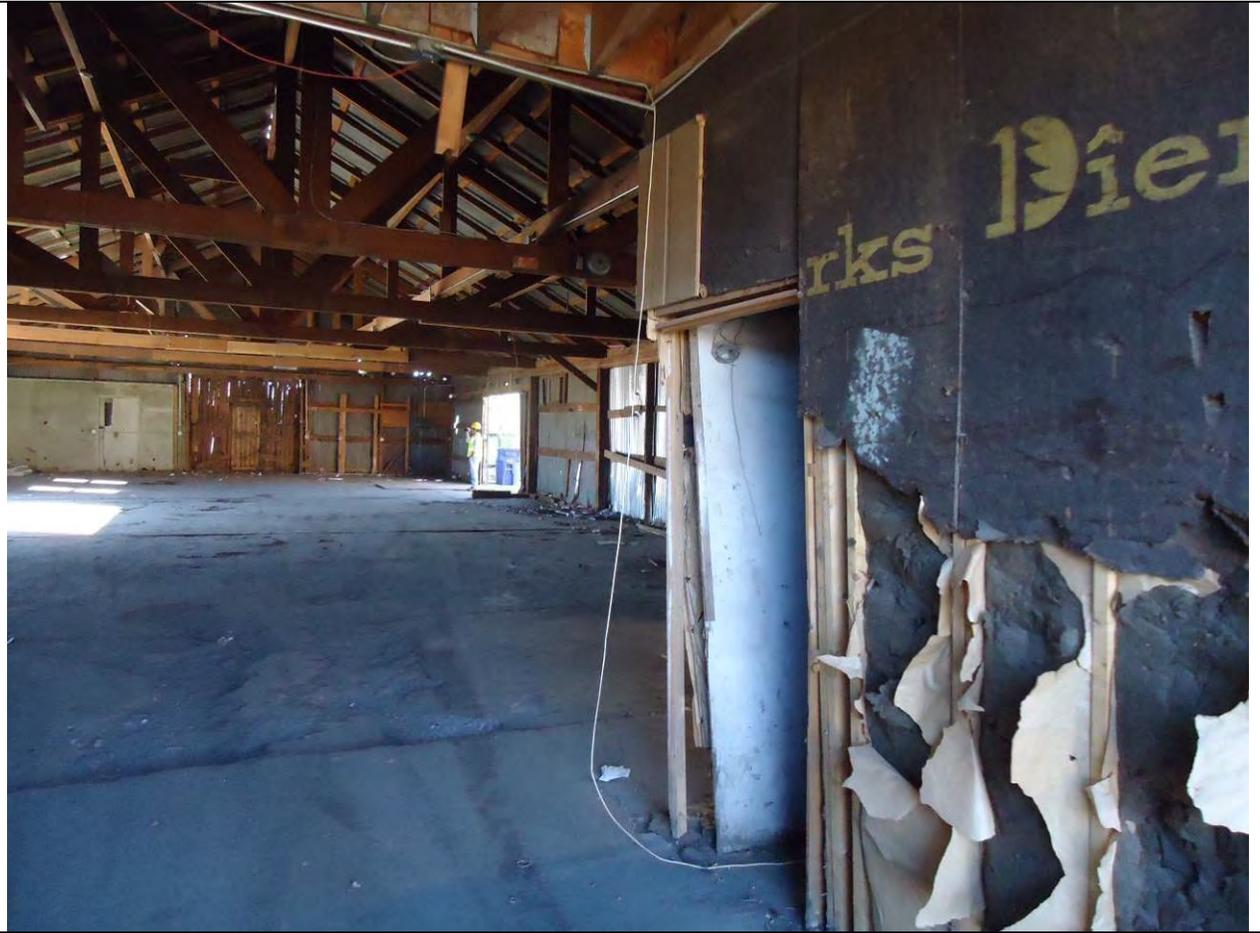
<b>Logbook Photo #</b>	DSC00550
<b>US EPA ID / Task Order Number</b>	CERCLIS: NMN000607041 / TDD No: 1/DYNAMAC-077-13-001
<b>Site</b>	Southwest Vermiculite (Removal 2)
<b>Location Address</b>	1800 1 <sup>st</sup> Street, NW
<b>City, State</b>	Albuquerque, New Mexico 87102
<b>County</b>	Bernalillo
<b>Direction/Orientation</b>	West
<b>Date</b>	11/6/13
<b>Time</b>	1550
<b>Photographer</b>	N. Biscocho (START)
<b>Witness</b>	J. Koehnen (START)
<b>Description:</b>	
Interior of Exfoliation building in advance of abatement.

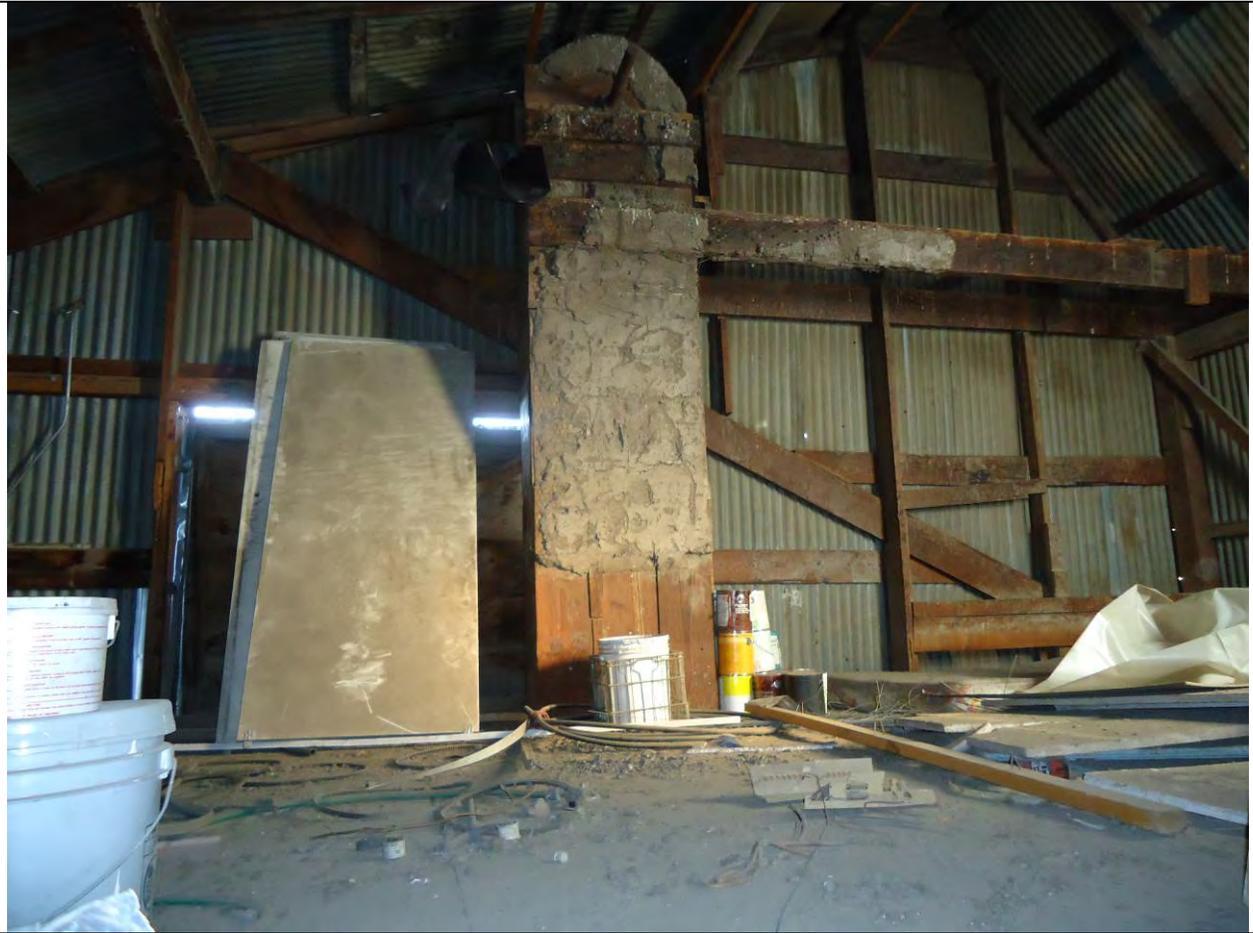
<b>Logbook Photo #</b>	DSC00603
<b>US EPA ID / Task Order Number</b>	CERCLIS: NMN000607041 / TDD No: 1/DYNAMAC-077-13-001
<b>Site</b>	Southwest Vermiculite (Removal 2)
<b>Location Address</b>	1800 1 <sup>st</sup> Street, NW
<b>City, State</b>	Albuquerque, New Mexico 87102
<b>County</b>	Bernalillo
<b>Direction/Orientation</b>	East
<b>Date</b>	11/13/13
<b>Time</b>	1501
<b>Photographer</b>	N. Biscocho (START)
<b>Witness</b>	J. Koehnen (START)
<b>Description:</b>	Interior of Exfoliation building (2 <sup>nd</sup> floor) in advance of abatement.

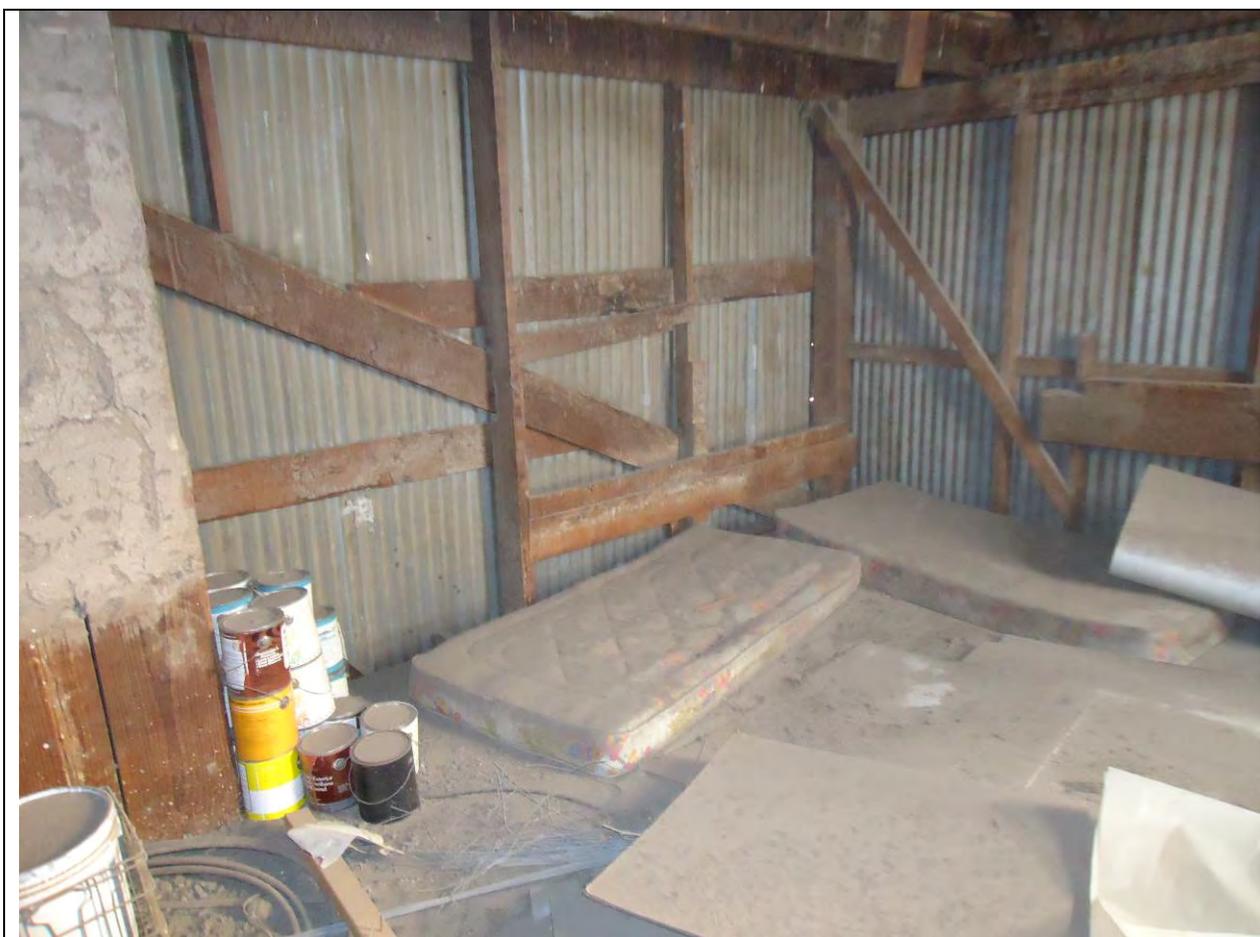
<b>Logbook Photo #</b>	DSC00604
<b>US EPA ID / Task Order Number</b>	CERCLIS: NMN000607041 / TDD No: 1/DYNAMAC-077-13-001
<b>Site</b>	Southwest Vermiculite (Removal 2)
<b>Location Address</b>	1800 1 <sup>st</sup> Street, NW
<b>City, State</b>	Albuquerque, New Mexico 87102
<b>County</b>	Bernalillo
<b>Direction/Orientation</b>	SE
<b>Date</b>	11/13/14
<b>Time</b>	1510
<b>Photographer</b>	N. Biscocho (START)
<b>Witness</b>	J. Koehnen (START)
<b>Description:</b>	Interior of Exfoliation building (2 <sup>nd</sup> floor) in advance of abatement.

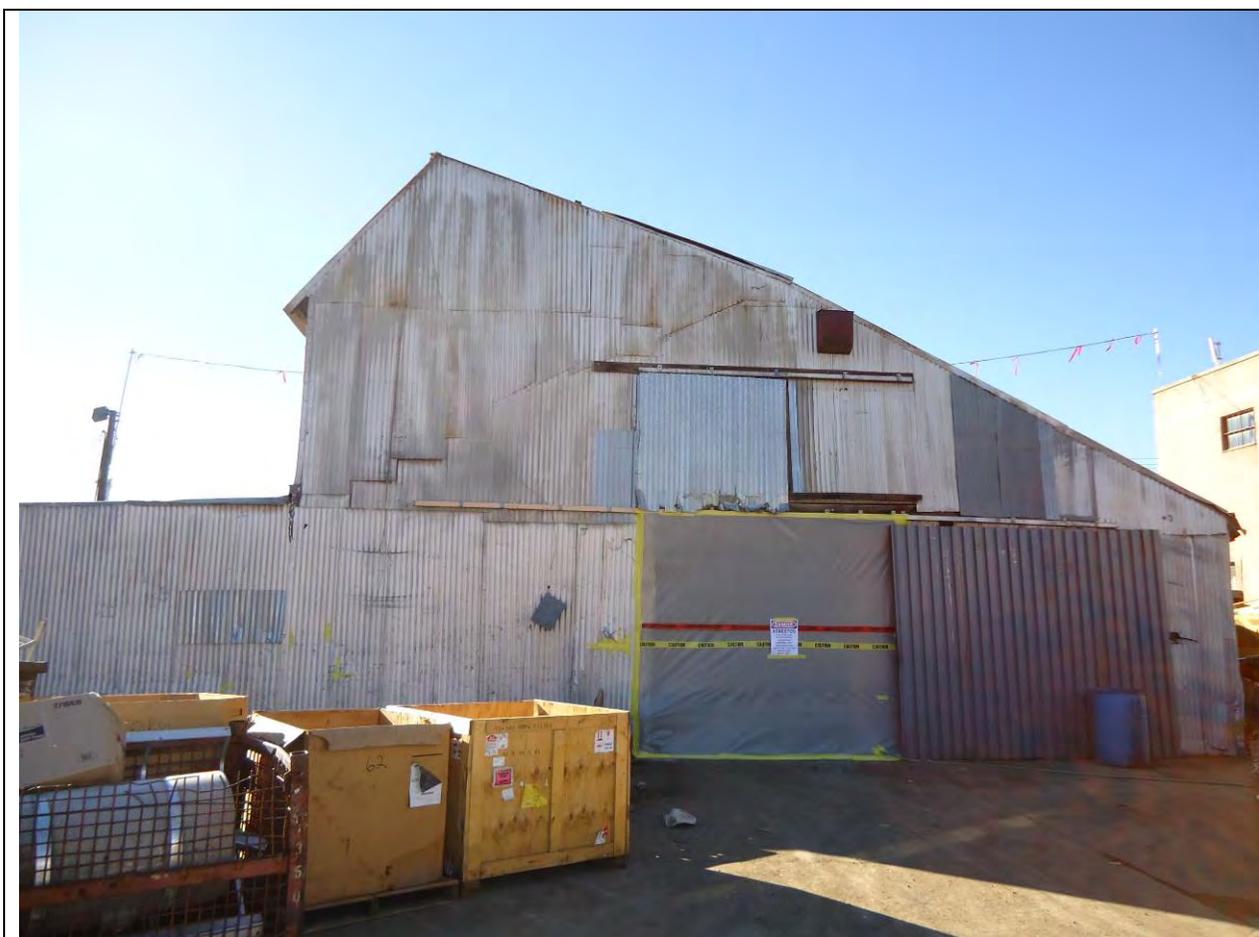
<b>Logbook Photo #</b>	DSC00581
<b>US EPA ID / Task Order Number</b>	CERCLIS: NMN000607041 / TDD No: 1/DYNAMAC-077-13-001
<b>Site</b>	Southwest Vermiculite (Removal 2)
<b>Location Address</b>	1800 1 <sup>st</sup> Street, NW
<b>City, State</b>	Albuquerque, New Mexico 87102
<b>County</b>	Bernalillo
<b>Direction/Orientation</b>	W
<b>Date</b>	11/11/13
<b>Time</b>	1640
<b>Photographer</b>	N. Biscocho (START)
<b>Witness</b>	J. Koehnen (START)
<b>Description:</b>	Abatement contractor crew set-up during the abatement activities inside the Exfoliation building.
