## Appendix C

### Photo Documentation

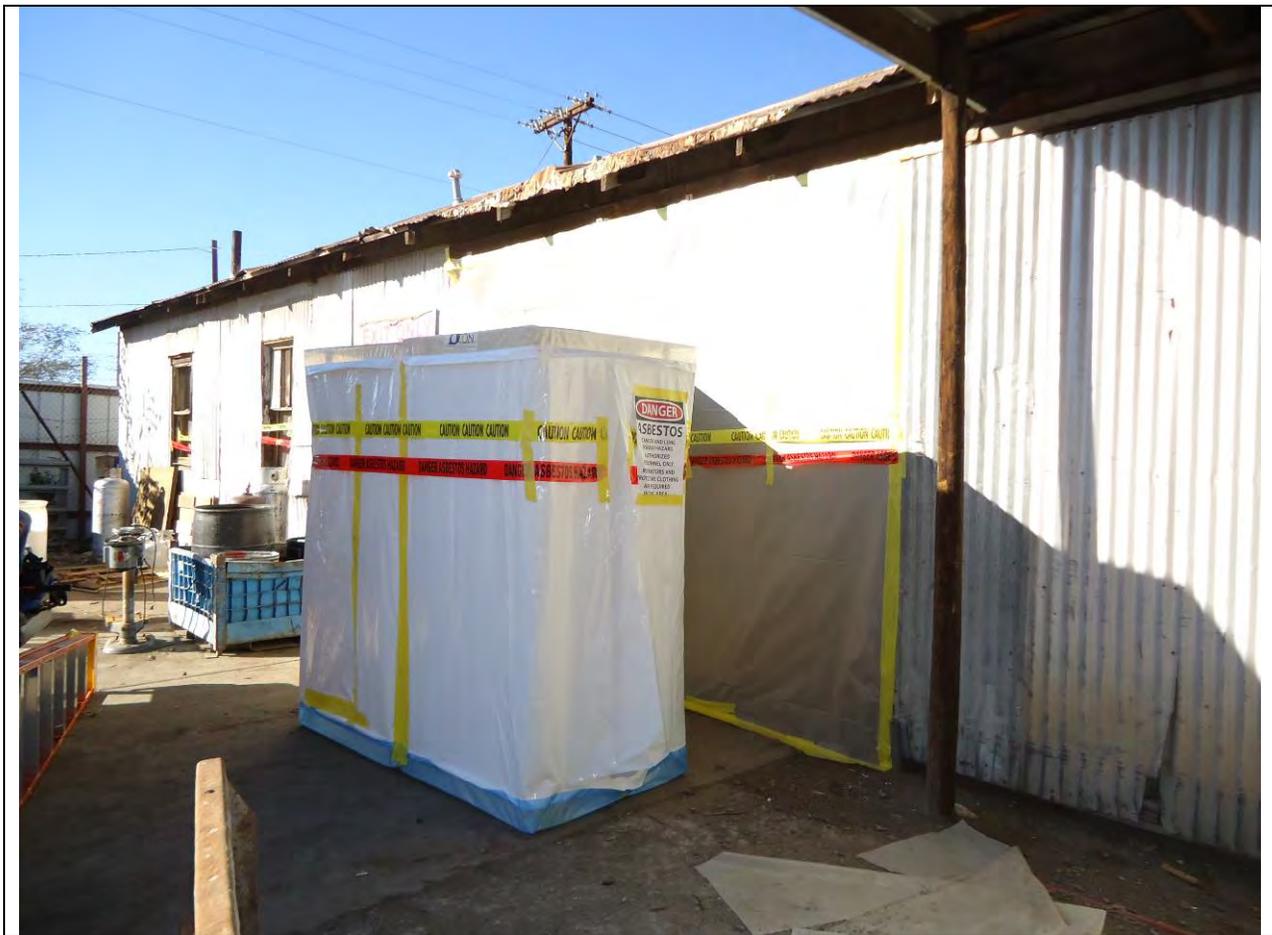
<b>Logbook Photo #</b>	DSC00583
<b>US EPA ID / Task Order Number</b>	CERCLIS: NMN000607041 / TDD No: 1/DYNAMAC-077-13-001
<b>Site</b>	Southwest Vermiculite (Removal 2)
<b>Location Address</b>	1800 1 <sup>st</sup> Street, NW
<b>City, State</b>	Albuquerque, New Mexico 87102
<b>County</b>	Bernalillo
<b>Direction/Orientation</b>	NW
<b>Date</b>	11/11/13
<b>Time</b>	1537
<b>Photographer</b>	N. Biscocho (START)
<b>Witness</b>	J. Koehnen (START)
<b>Description:</b>	Abatement contractor crew set-up during the abatement activities inside the Exfoliation building.

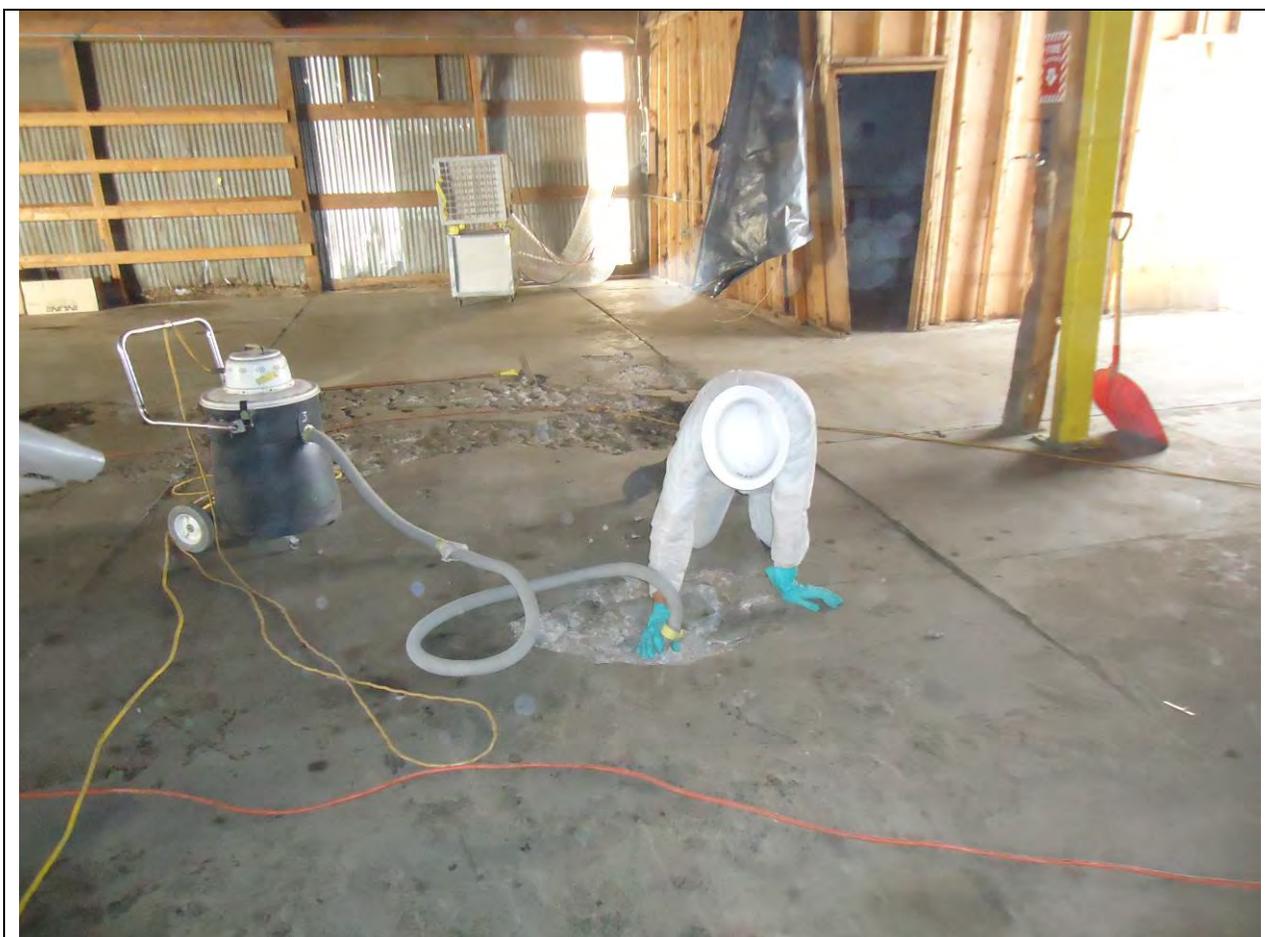
<b>Logbook Photo #</b>	DSC00601
<b>US EPA ID / Task Order Number</b>	CERCLIS: NMN000607041 / TDD No: 1/DYNAMAC-077-13-001
<b>Site</b>	Southwest Vermiculite (Removal 2)
<b>Location Address</b>	1800 1 <sup>st</sup> Street, NW
<b>City, State</b>	Albuquerque, New Mexico 87102
<b>County</b>	Bernalillo
<b>Direction/Orientation</b>	NE
<b>Date</b>	11/13/14
<b>Time</b>	1438
<b>Photographer</b>	N. Biscocho (START)
<b>Witness</b>	J. Koehnen (START)
<b>Description:</b>	Abatement contractor during the clean-up activities inside the Exfoliation building.

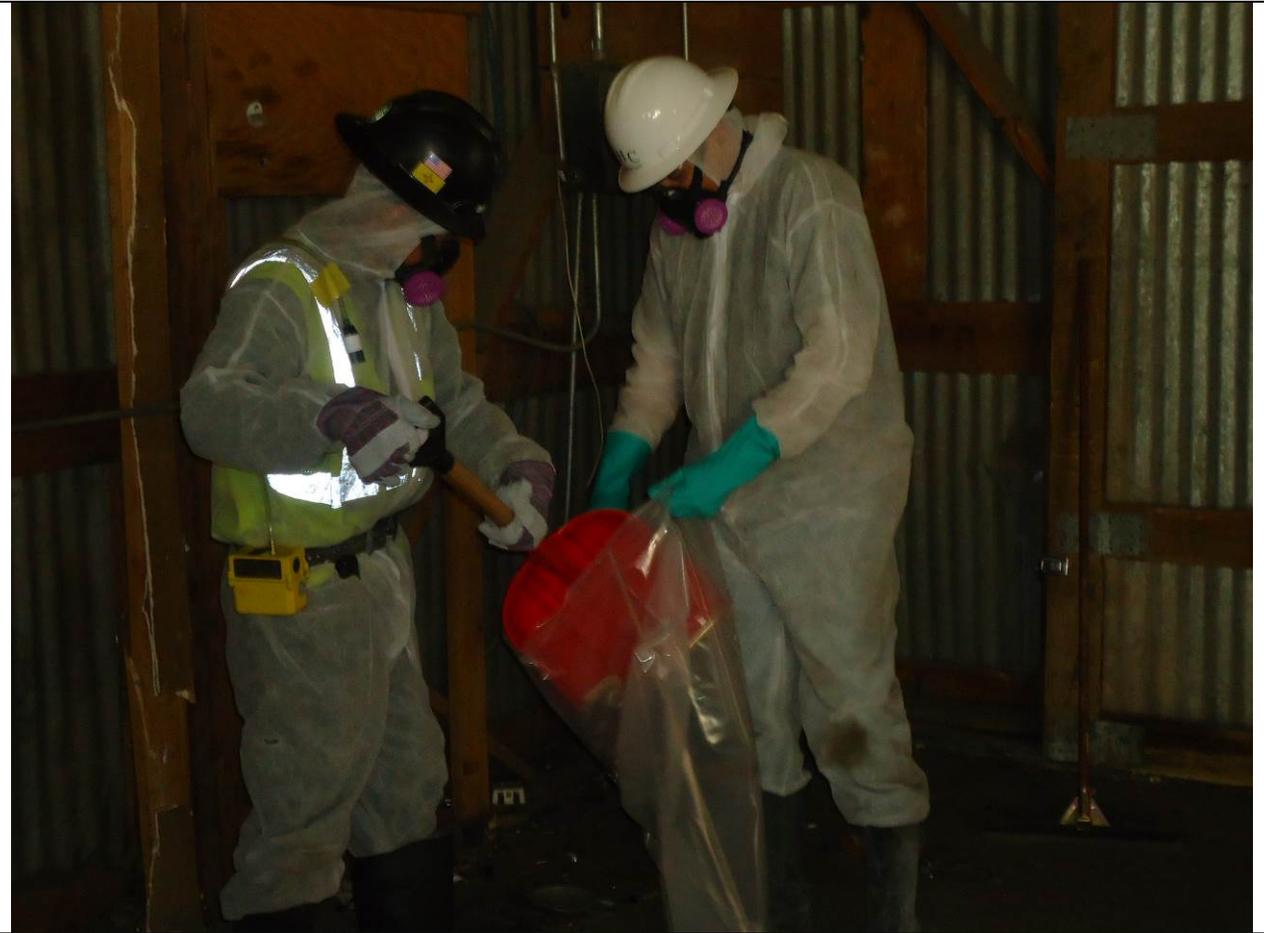
<b>Logbook Photo #</b>	DCS00585
<b>US EPA ID / Task Order Number</b>	CERCLIS: NMN000607041 / TDD No: 1/DYNAMAC-077-13-001
<b>Site</b>	Southwest Vermiculite (Removal 2)
<b>Location Address</b>	1800 1 <sup>st</sup> Street, NW
<b>City, State</b>	Albuquerque, New Mexico 87102
<b>County</b>	Bernalillo
<b>Direction/Orientation</b>	N/A
<b>Date</b>	11/11/14
<b>Time</b>	1538
<b>Photographer</b>	N. Biscocho (START)
<b>Witness</b>	J. Koehnen (START)
<b>Description:</b>	Abatement contractor during the clean-up activities inside the Exfoliation building.

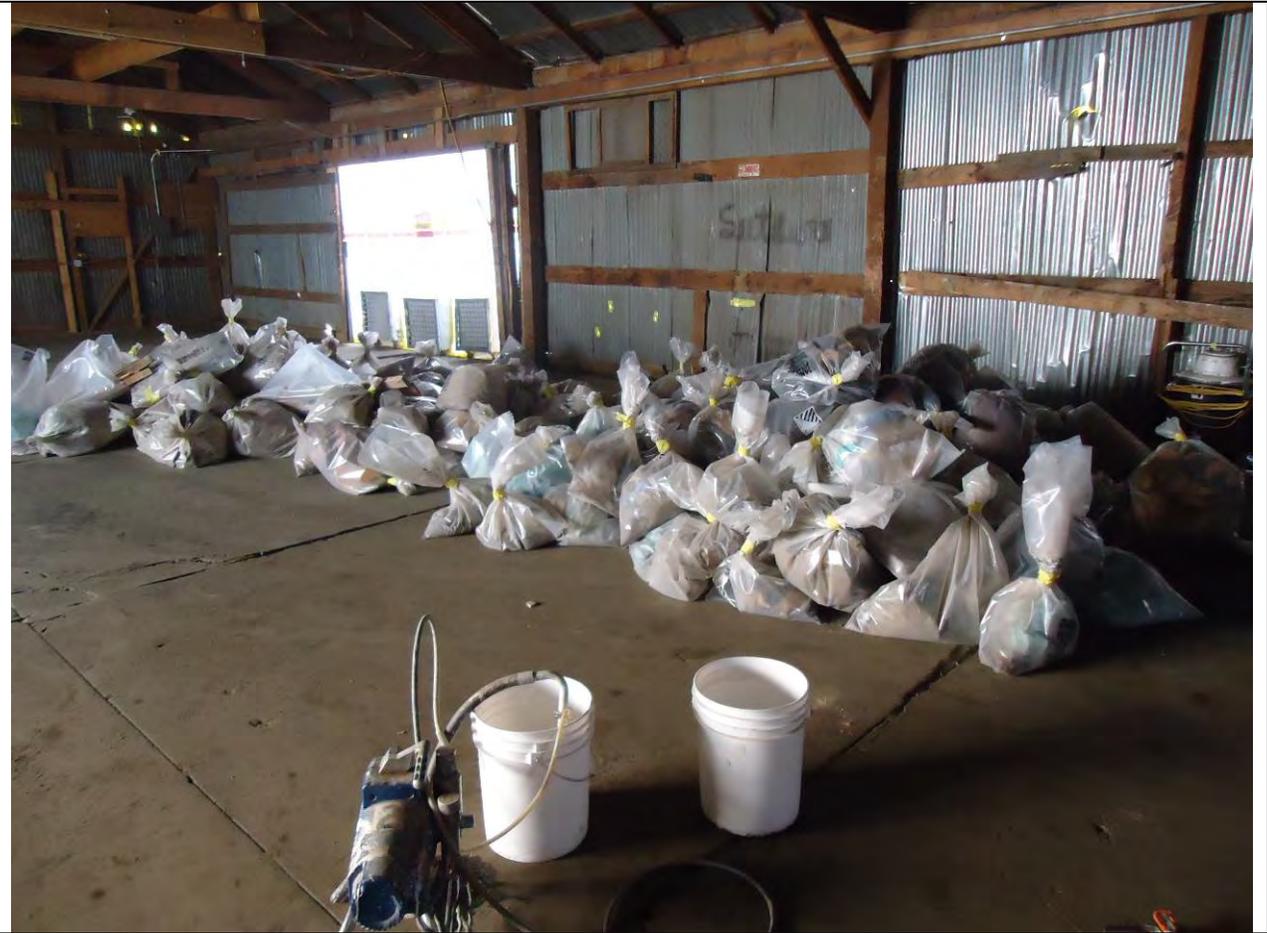
<b>Logbook Photo #</b>	DSC00602
<b>US EPA ID / Task Order Number</b>	CERCLIS: NMN000607041 / TDD No: 1/DYNAMAC-077-13-001
<b>Site</b>	Southwest Vermiculite (Removal 2)
<b>Location Address</b>	1800 1 <sup>st</sup> Street, NW
<b>City, State</b>	Albuquerque, New Mexico 87102
<b>County</b>	Bernalillo
<b>Direction/Orientation</b>	NW
<b>Date</b>	11/13/13
<b>Time</b>	1439
<b>Photographer</b>	N. Biscocho (START)
<b>Witness</b>	J. Koehnen (START)
<b>Description:</b>	Bags of contaminated material during the abatement activities inside the Exfoliation building.

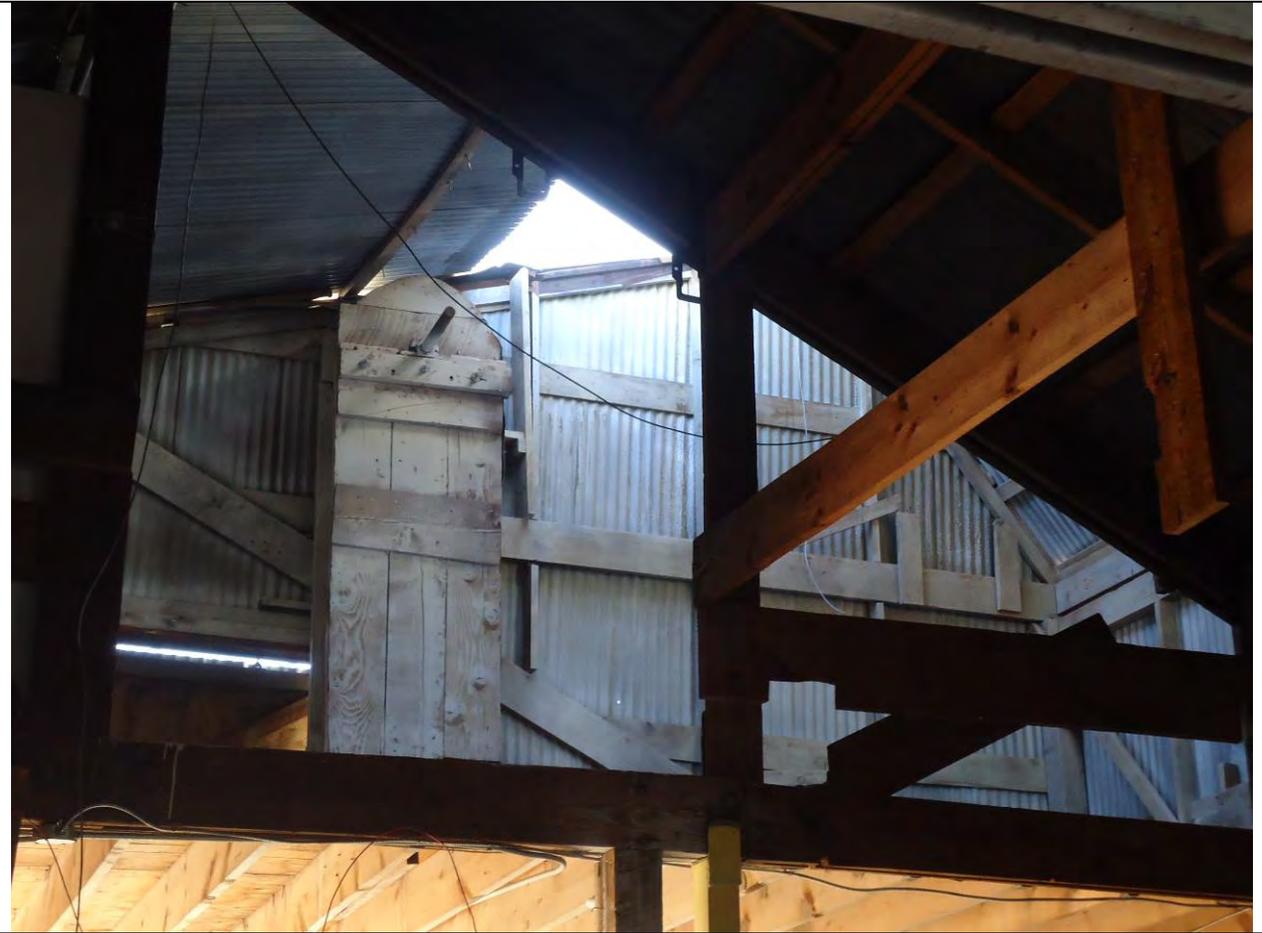
<b>Logbook Photo #</b>	DSC00659
<b>US EPA ID / Task Order Number</b>	CERCLIS: NMN000607041 / TDD No: 1/DYNAMAC-077-13-001
<b>Site</b>	Southwest Vermiculite (Removal 2)
<b>Location Address</b>	1800 1 <sup>st</sup> Street, NW
<b>City, State</b>	Albuquerque, New Mexico 87102
<b>County</b>	Bernalillo
<b>Direction/Orientation</b>	E
<b>Date</b>	12/2/13
<b>Time</b>	0840
<b>Photographer</b>	N. Biscocho (START)
<b>Witness</b>	J. Koehnen (START)
<b>Description:</b>	
<p>Post-abatement photo inside the exfoliation building. Second floor loft of the west side of the exfoliation building.</p>

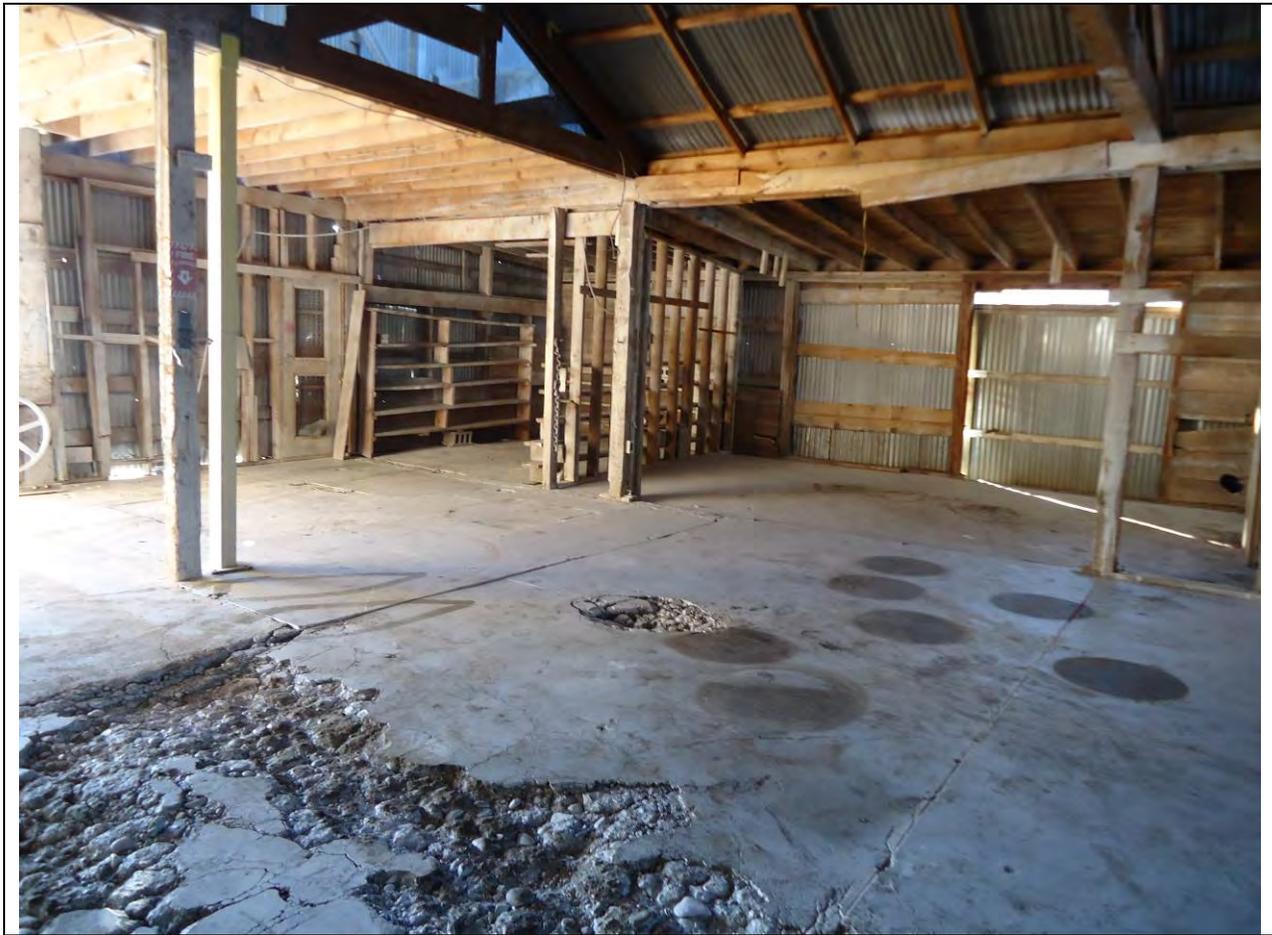
<b>Logbook Photo #</b>	DSC00660
<b>US EPA ID / Task Order Number</b>	CERCLIS: NMN000607041 / TDD No: 1/DYNAMAC-077-13-001
<b>Site</b>	Southwest Vermiculite (Removal 2)
<b>Location Address</b>	1800 1 <sup>st</sup> Street, NW
<b>City, State</b>	Albuquerque, New Mexico 87102
<b>County</b>	Bernalillo
<b>Direction/Orientation</b>	SE
<b>Date</b>	12/2/13
<b>Time</b>	0840
<b>Photographer</b>	N. Biscocho (START)
<b>Witness</b>	J. Koehnen (START)
<b>Description:</b>	Post-abatement photo inside the exfoliation building. Frist floor of the exfoliation building.

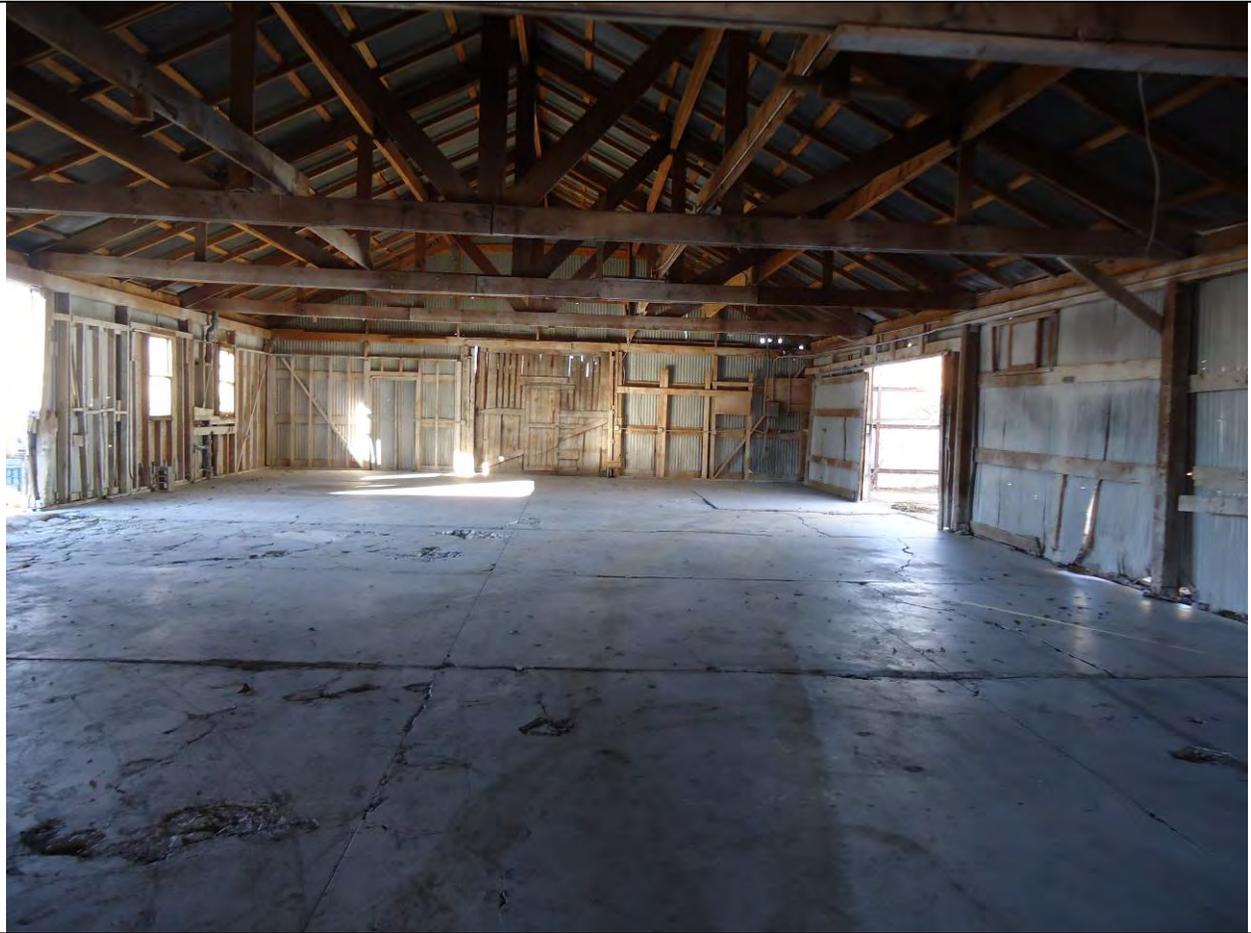
<b>Logbook Photo #</b>	DSC00661
<b>US EPA ID / Task Order Number</b>	CERCLIS: NMN000607041 / TDD No: 1/DYNAMAC-077-13-001
<b>Site</b>	Southwest Vermiculite (Removal 2)
<b>Location Address</b>	1800 1 <sup>st</sup> Street, NW
<b>City, State</b>	Albuquerque, New Mexico 87102
<b>County</b>	Bernalillo
<b>Direction/Orientation</b>	W
<b>Date</b>	12/2/14
<b>Time</b>	0841
<b>Photographer</b>	N. Biscocho (START)
<b>Witness</b>	J. Koehnen (START)
<b>Description:</b>	
Post-abatement photo inside the exfoliation building. Frist floor of the exfoliation building.

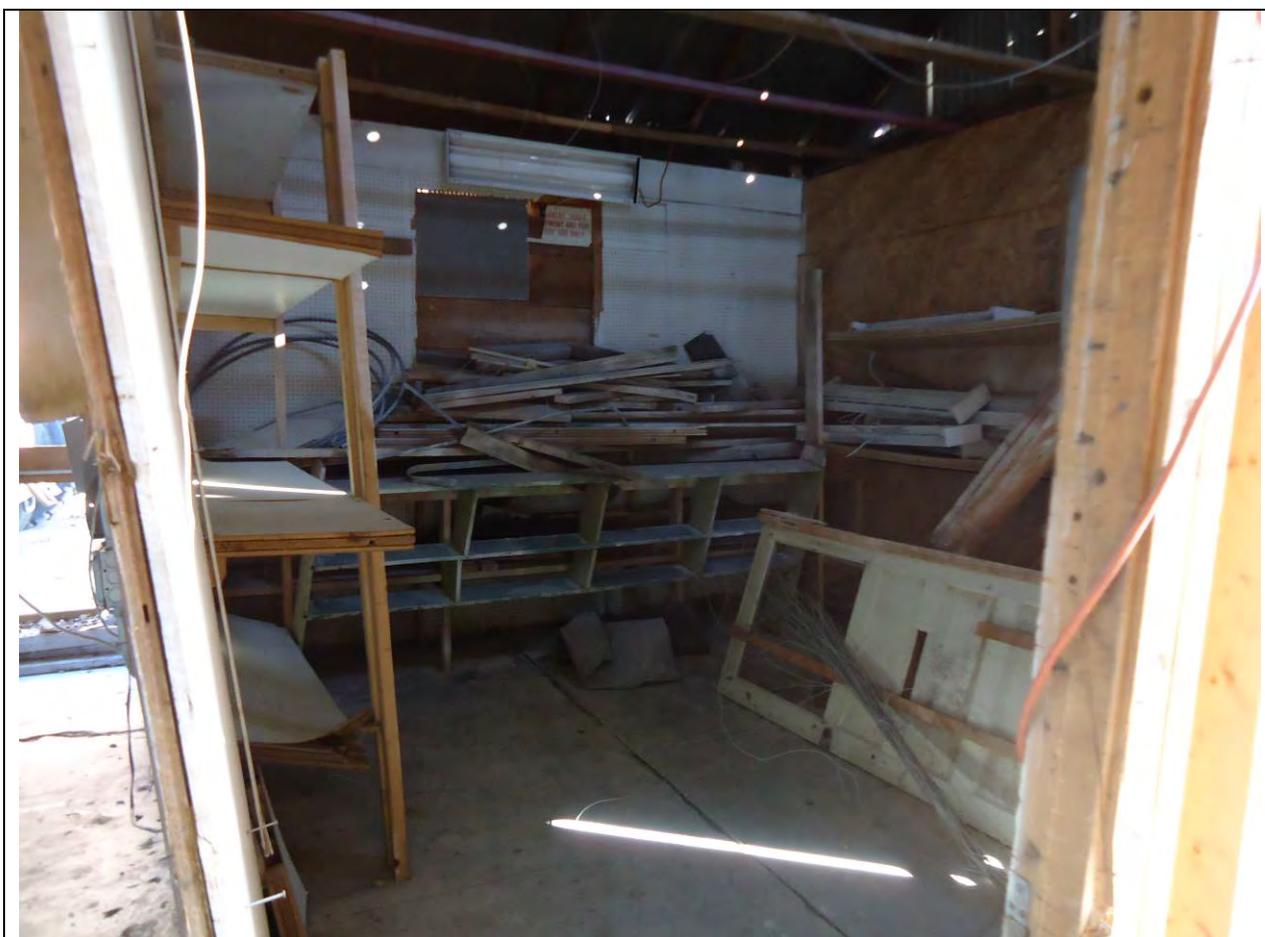
<b>Logbook Photo #</b>	DSC00664
<b>US EPA ID / Task Order Number</b>	CERCLIS: NMN000607041 / TDD No: 1/DYNAMAC-077-13-001
<b>Site</b>	Southwest Vermiculite (Removal 2)
<b>Location Address</b>	1800 1 <sup>st</sup> Street, NW
<b>City, State</b>	Albuquerque, New Mexico 87102
<b>County</b>	Bernalillo
<b>Direction/Orientation</b>	NE
<b>Date</b>	12/2/13
<b>Time</b>	0841
<b>Photographer</b>	N. Biscocho (START)
<b>Witness</b>	J. Koehnen (START)
<b>Description:</b>	
<p>Post-abatement photo inside the exfoliation building. Room on the east side of the exfoliation building on the Frist floor</p>

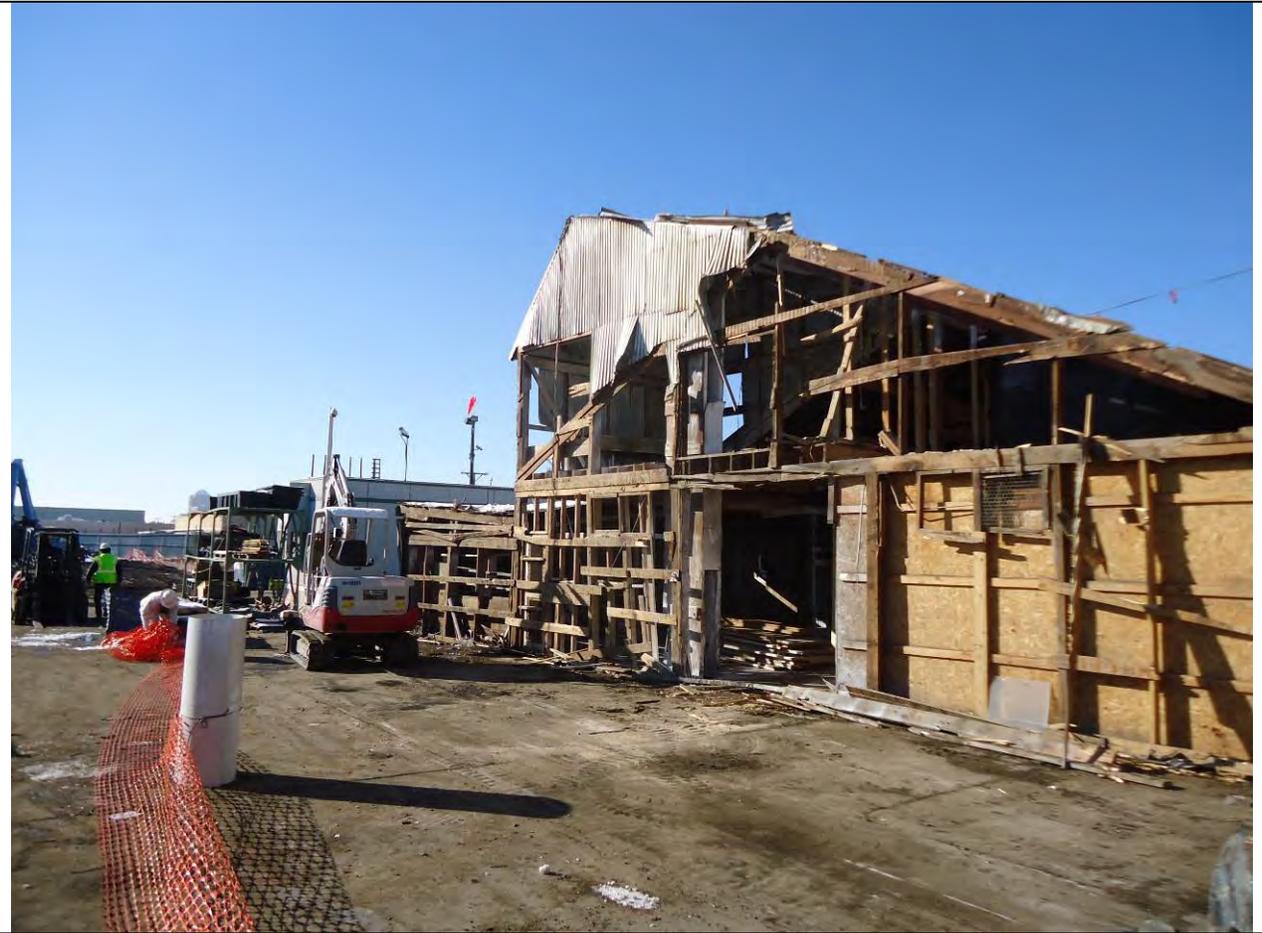
<b>Logbook Photo #</b>	DSC00689
<b>US EPA ID / Task Order Number</b>	CERCLIS: NMN000607041 / TDD No: 1/DYNAMAC-077-13-001
<b>Site</b>	Southwest Vermiculite (Removal 2)
<b>Location Address</b>	1800 1 <sup>st</sup> Street, NW
<b>City, State</b>	Albuquerque, New Mexico 87102
<b>County</b>	Bernalillo
<b>Direction/Orientation</b>	SW
<b>Date</b>	12/6/13
<b>Time</b>	0945
<b>Photographer</b>	N. Biscocho (START)
<b>Witness</b>	J. Koehnen (START)
<b>Description:</b>	Dismantling side walls and roof for recycling, prior to the building demolition of the exfoliation building.

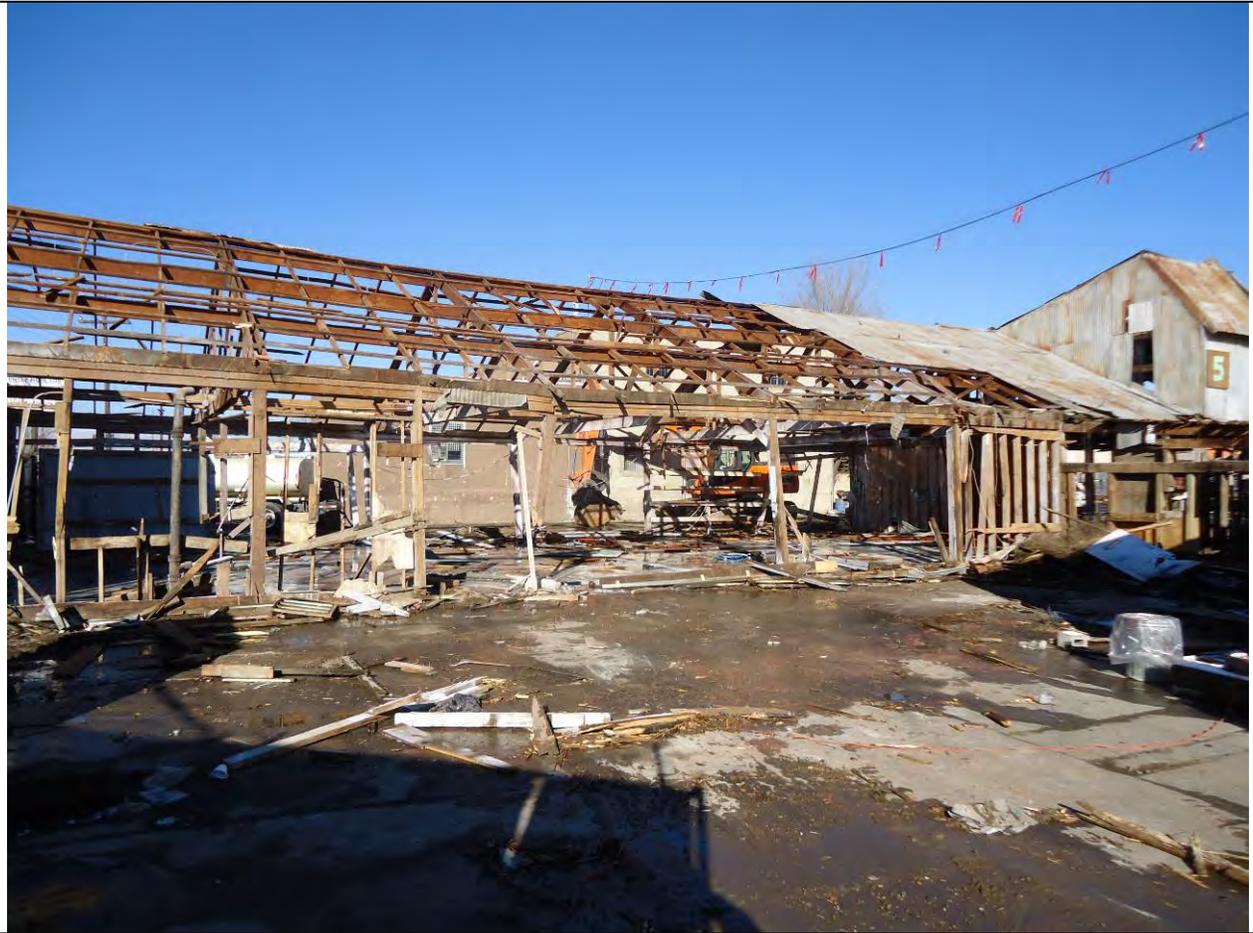
<b>Logbook Photo #</b>	DSC00692
<b>US EPA ID / Task Order Number</b>	CERCLIS: NMN000607041 / TDD No: 1/DYNAMAC-077-13-001
<b>Site</b>	Southwest Vermiculite (Removal 2)
<b>Location Address</b>	1800 1 <sup>st</sup> Street, NW
<b>City, State</b>	Albuquerque, New Mexico 87102
<b>County</b>	Bernalillo
<b>Direction/Orientation</b>	NE
<b>Date</b>	12/6/13
<b>Time</b>	1417
<b>Photographer</b>	N. Biscocho (START)
<b>Witness</b>	J. Koehnen (START)
<b>Description:</b>	Dismantling side walls and roof for recycling, prior to the building demolition of the exfoliation building.

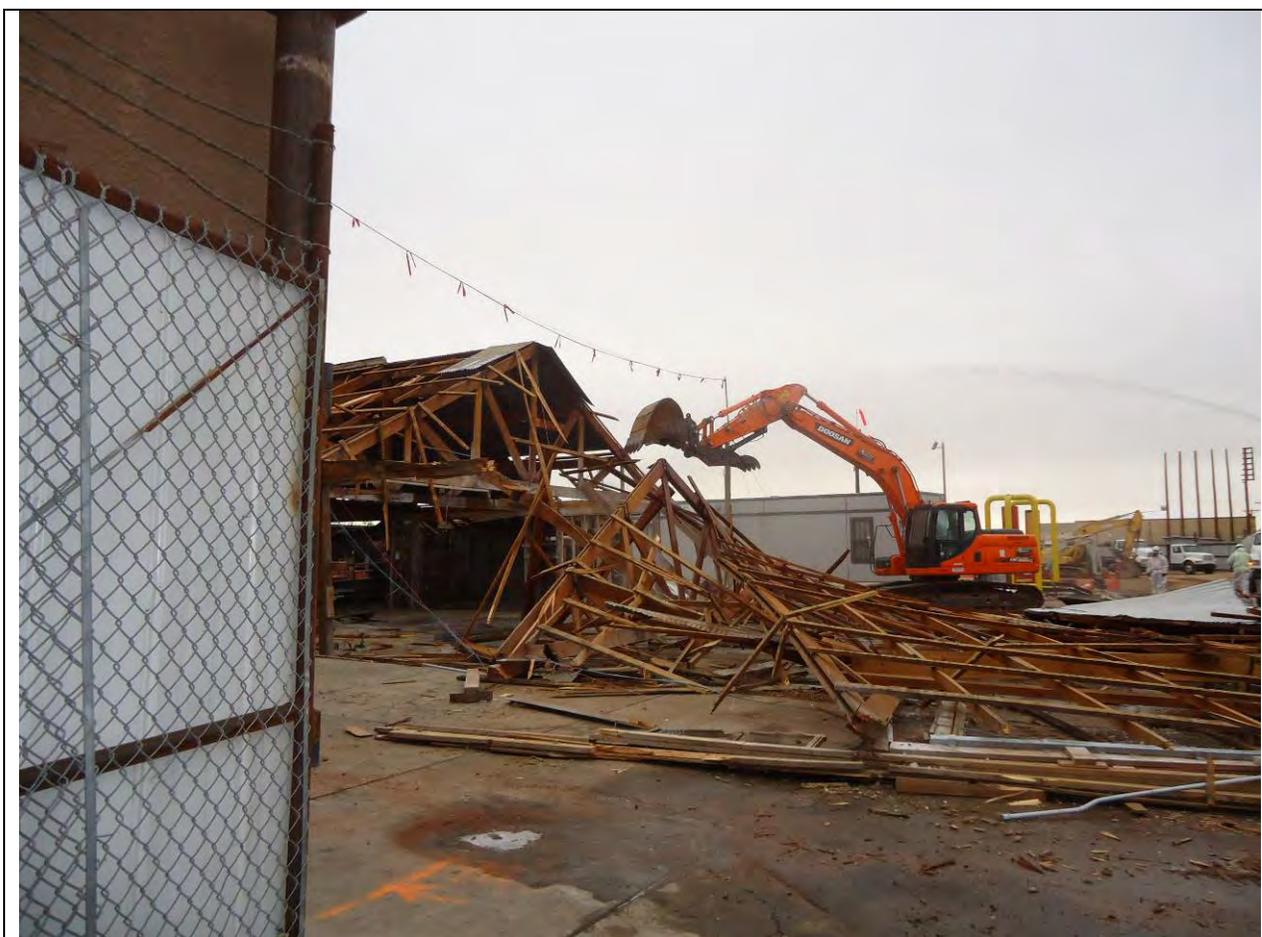
<b>Logbook Photo #</b>	DSC00695
<b>US EPA ID / Task Order Number</b>	CERCLIS: NMN000607041 / TDD No: 1/DYNAMAC-077-13-001
<b>Site</b>	Southwest Vermiculite (Removal 2)
<b>Location Address</b>	1800 1 <sup>st</sup> Street, NW
<b>City, State</b>	Albuquerque, New Mexico 87102
<b>County</b>	Bernalillo
<b>Direction/Orientation</b>	S
<b>Date</b>	12/7/13
<b>Time</b>	1326
<b>Photographer</b>	N. Biscocho (START)
<b>Witness</b>	J. Koehnen (START)
<b>Description:</b>	Building demolition of the exfoliation building. Dust suppression in progress.

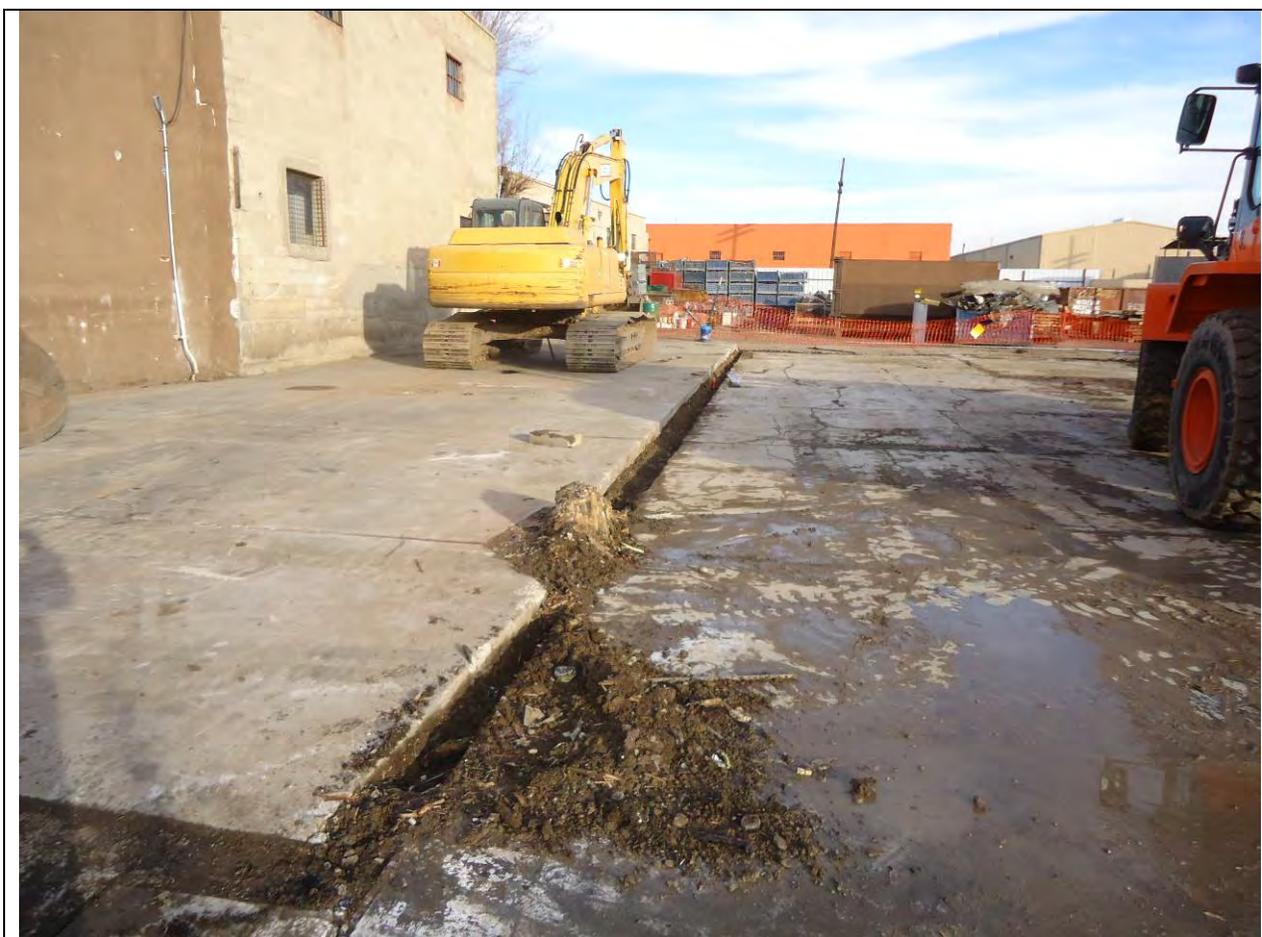
<b>Logbook Photo #</b>	DSC00725
<b>US EPA ID / Task Order Number</b>	CERCLIS: NMN000607041 / TDD No: 1/DYNAMAC-077-13-001
<b>Site</b>	Southwest Vermiculite (Removal 2)
<b>Location Address</b>	1800 1 <sup>st</sup> Street, NW
<b>City, State</b>	Albuquerque, New Mexico 87102
<b>County</b>	Bernalillo
<b>Direction/Orientation</b>	E
<b>Date</b>	12/10/13
<b>Time</b>	1531
<b>Photographer</b>	N. Biscocho (START)
<b>Witness</b>	J. Koehnen (START)
<b>Description:</b>	
Excavated and soil confirmation samples collected at grid (Area A, Grid-001), adjacent to and north of the former exfoliation building.

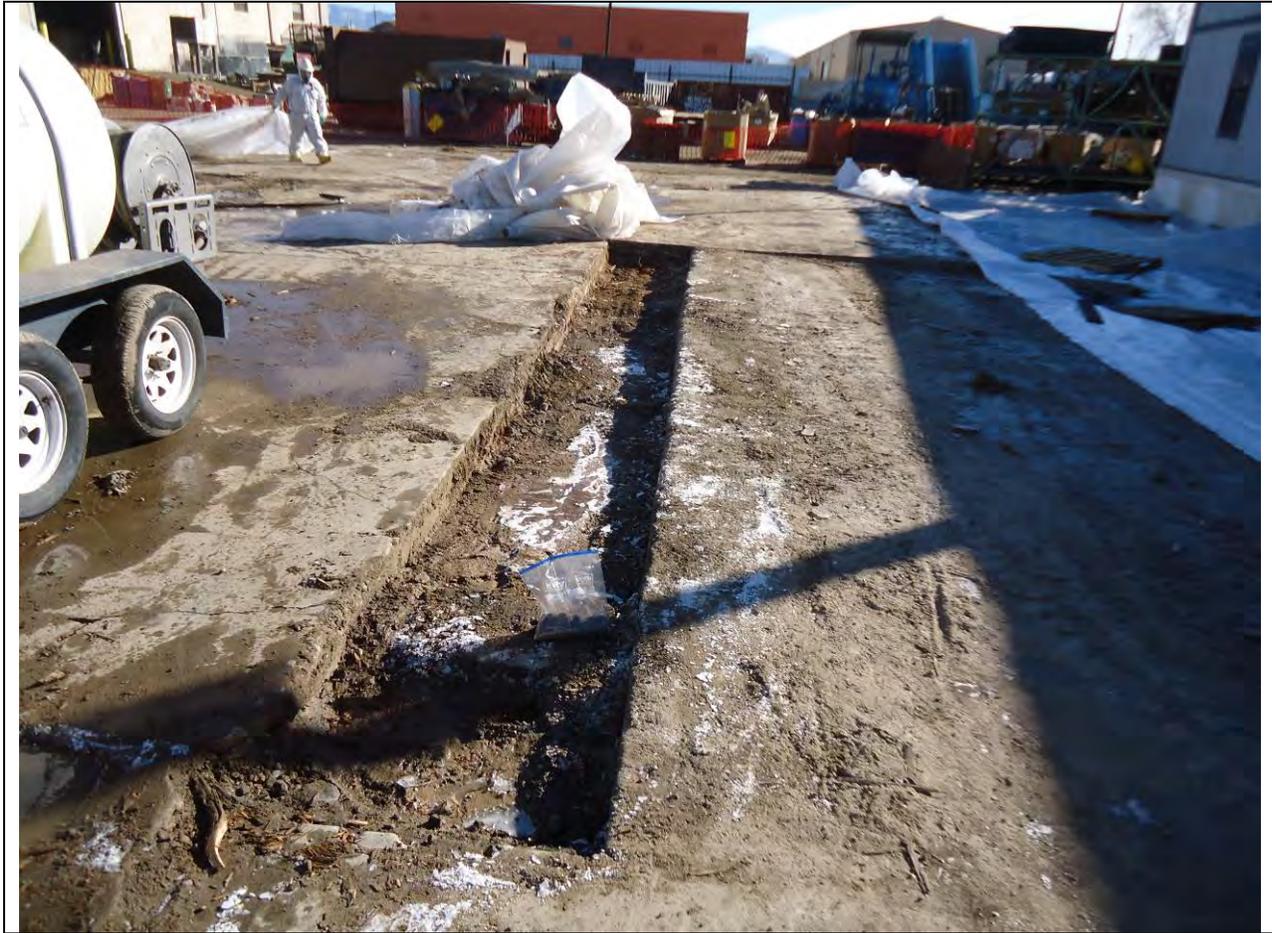
<b>Logbook Photo #</b>	DSC00727
<b>US EPA ID / Task Order Number</b>	CERCLIS: NMN000607041 / TDD No: 1/DYNAMAC-077-13-001
<b>Site</b>	Southwest Vermiculite (Removal 2)
<b>Location Address</b>	1800 1 <sup>st</sup> Street, NW
<b>City, State</b>	Albuquerque, New Mexico 87102
<b>County</b>	Bernalillo
<b>Direction/Orientation</b>	E
<b>Date</b>	12/11/13
<b>Time</b>	0951
<b>Photographer</b>	N. Biscocho (START)
<b>Witness</b>	J. Koehnen (START)
<b>Description:</b>	
<p>Excavated and soil confirmation samples collected at grid (Area A, Grid-002), adjacent to and south of the former exfoliation building. <i>Note: this is only partial excavation and confirmation sample on Grid-002, see next photo for the remainder of Grid-002.</i></p>

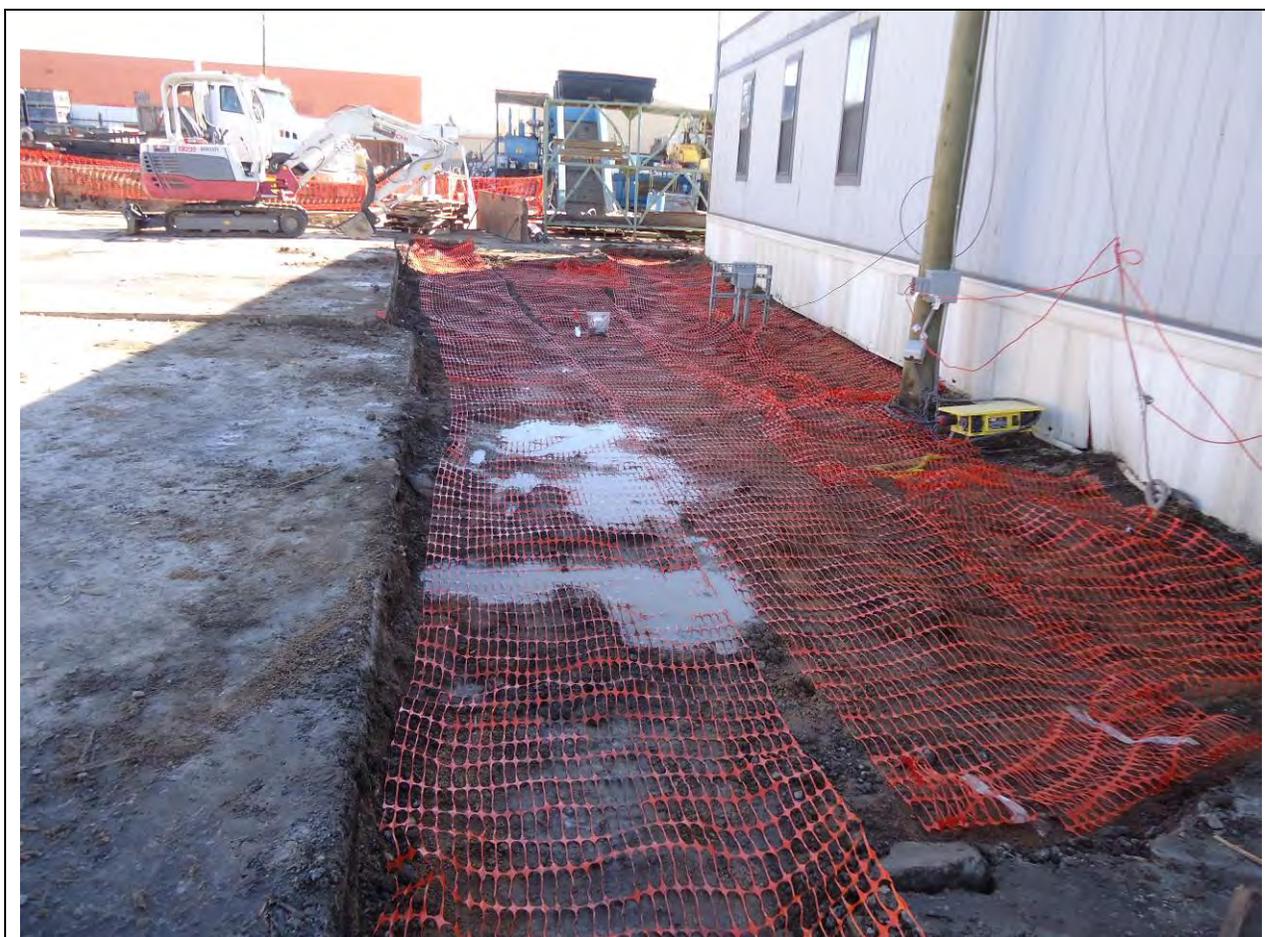
Excavated and soil confirmation samples collected at grid (Area A, Grid-002), adjacent to and south of the former exfoliation building. *Note: this is only partial excavation and confirmation sample on Grid-002, see previous photo for the remainder of Grid-002.*

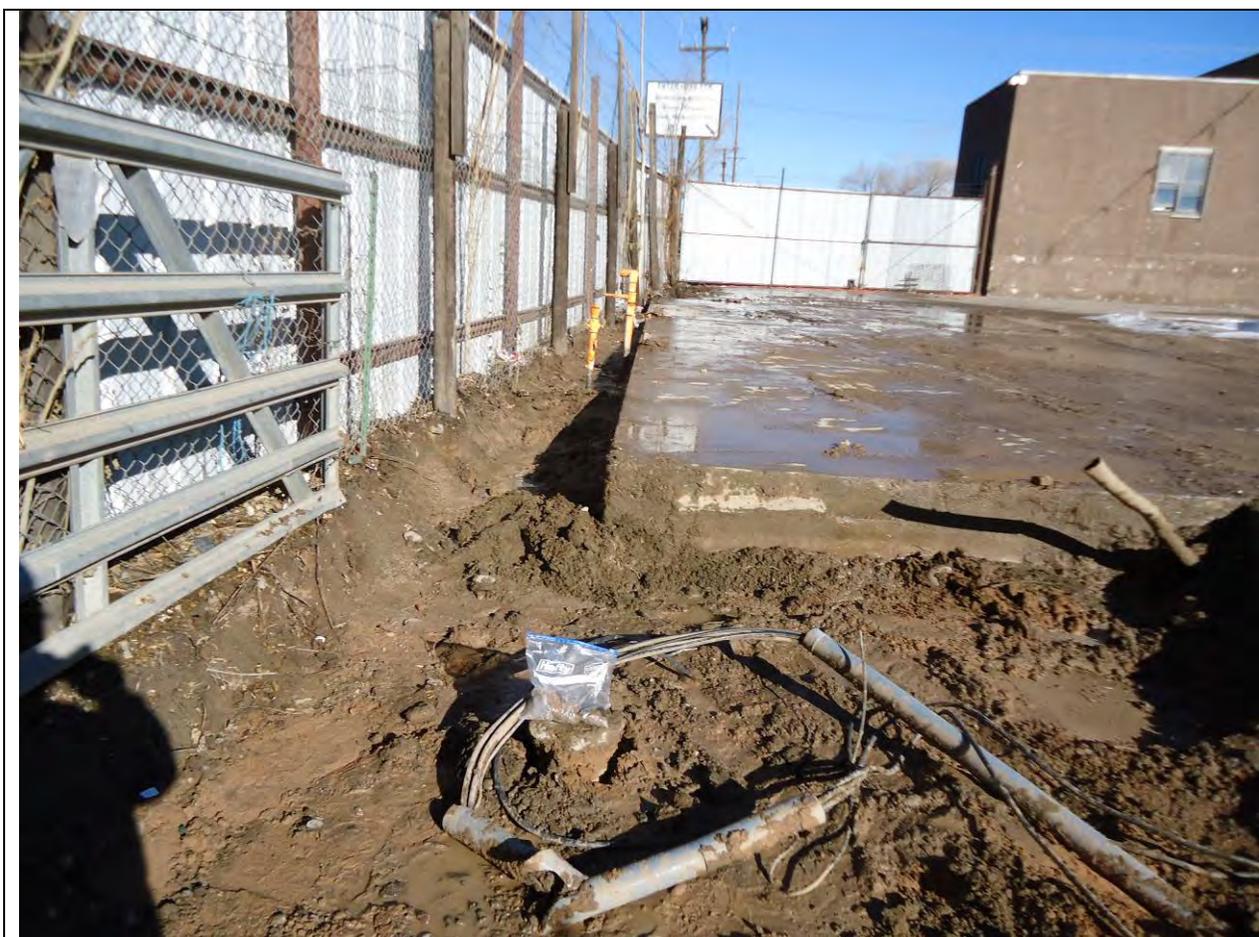
<b>Logbook Photo #</b>	DSC00726
<b>US EPA ID / Task Order Number</b>	CERCLIS: NMN000607041 / TDD No: 1/DYNAMAC-077-13-001
<b>Site</b>	Southwest Vermiculite (Removal 2)
<b>Location Address</b>	1800 1 <sup>st</sup> Street, NW
<b>City, State</b>	Albuquerque, New Mexico 87102
<b>County</b>	Bernalillo
<b>Direction/Orientation</b>	N
<b>Date</b>	12/11/13
<b>Time</b>	0951
<b>Photographer</b>	N. Biscocho (START)
<b>Witness</b>	J. Koehnen (START)
<b>Description:</b>	Excavated and soil confirmation samples collected at grid (Area A, Grid-003), adjacent to and west of the former exfoliation building.

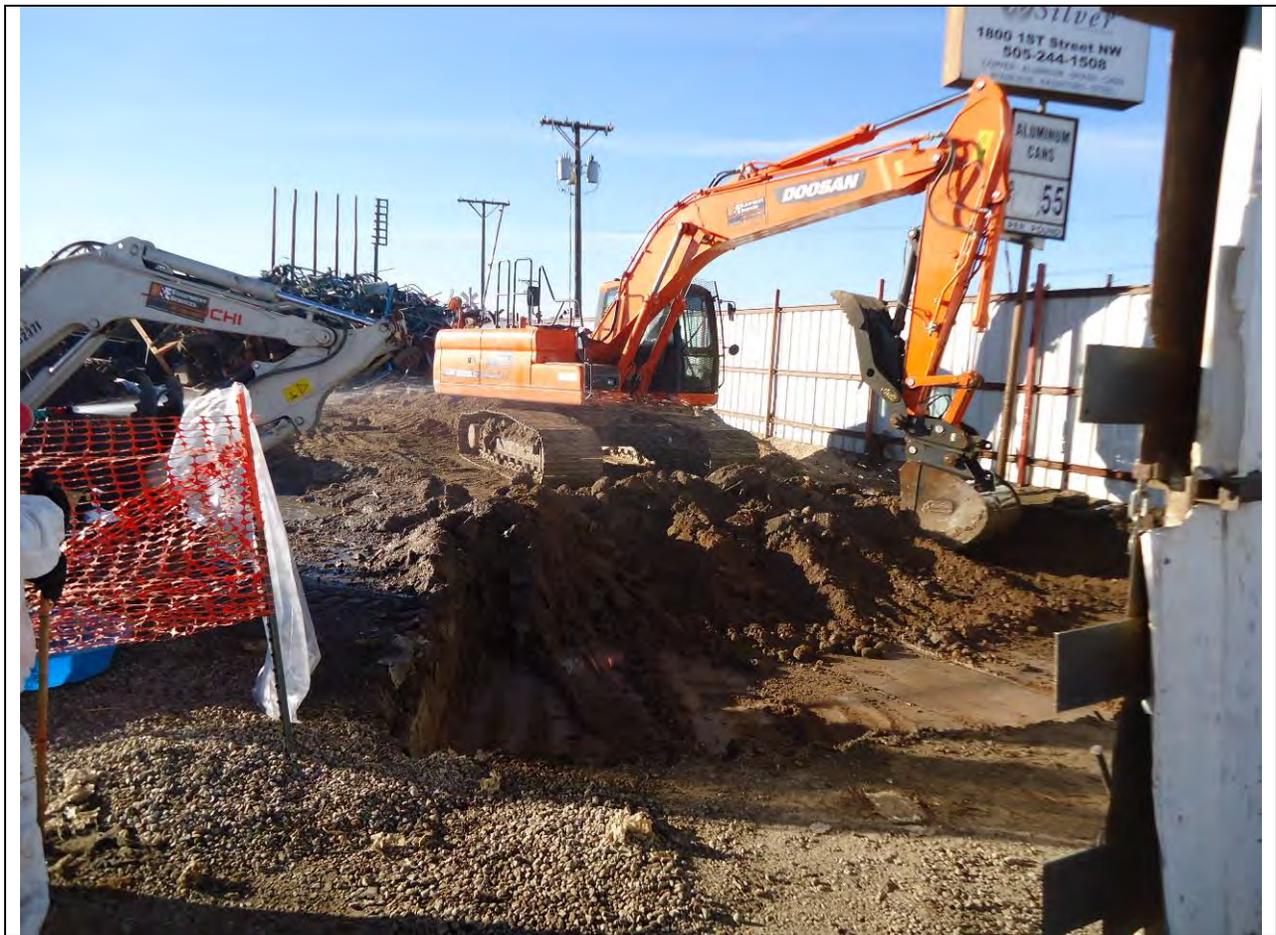
<b>Logbook Photo #</b>	DSC00753
<b>US EPA ID / Task Order Number</b>	CERCLIS: NMN000607041 / TDD No: 1/DYNAMAC-077-13-001
<b>Site</b>	Southwest Vermiculite (Removal 2)
<b>Location Address</b>	1800 1 <sup>st</sup> Street, NW
<b>City, State</b>	Albuquerque, New Mexico 87102
<b>County</b>	Bernalillo
<b>Direction/Orientation</b>	S
<b>Date</b>	12/16/13
<b>Time</b>	0845
<b>Photographer</b>	N. Biscocho (START)
<b>Witness</b>	J. Koehnen (START)
<b>Description:</b>	Excavation activities at Area A, Grid A – Southwest. Dust suppression in progress.

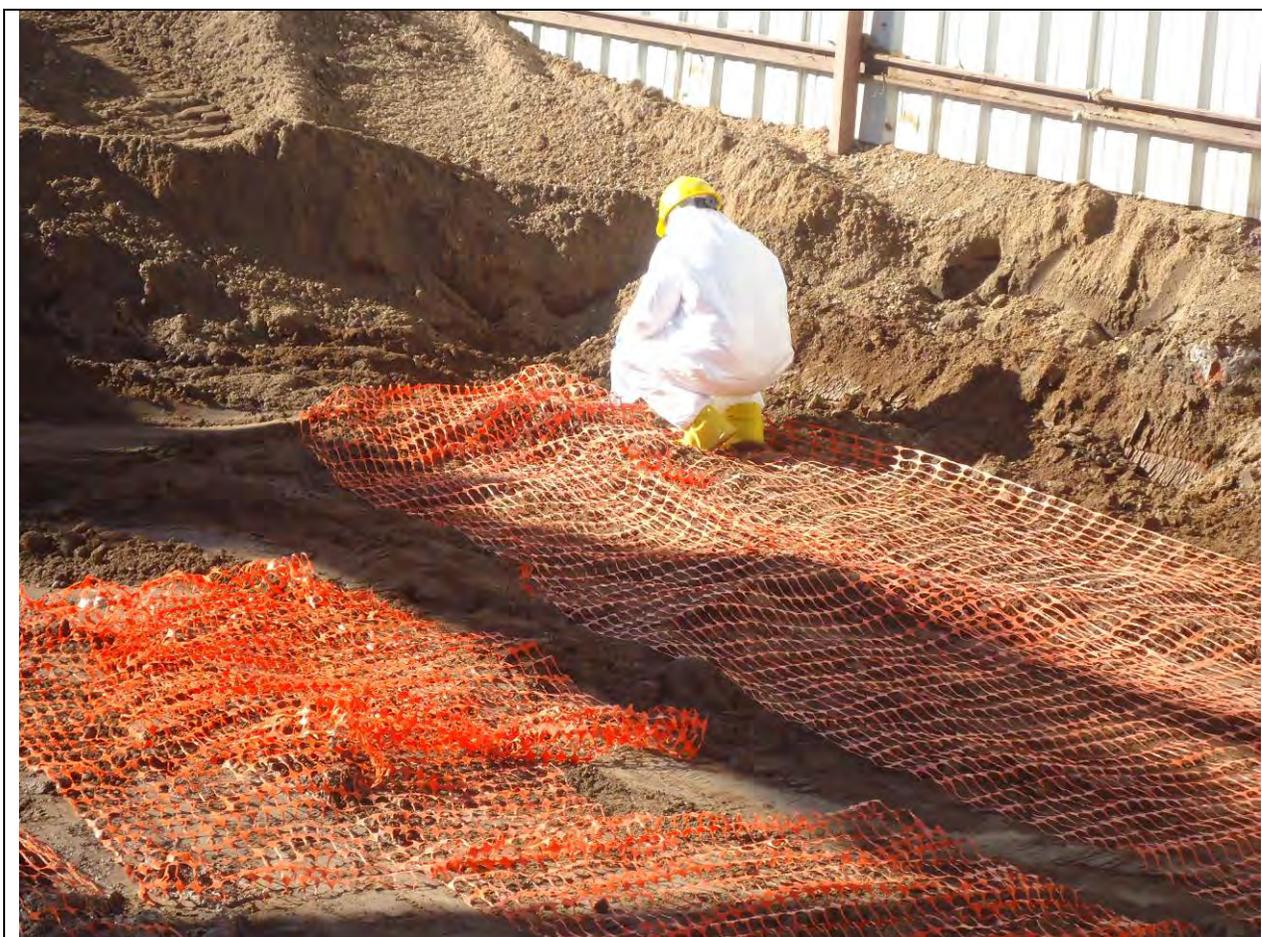
<b>Logbook Photo #</b>	DSC00754
<b>US EPA ID / Task Order Number</b>	CERCLIS: NMN000607041 / TDD No: 1/DYNAMAC-077-13-001
<b>Site</b>	Southwest Vermiculite (Removal 2)
<b>Location Address</b>	1800 1 <sup>st</sup> Street, NW
<b>City, State</b>	Albuquerque, New Mexico 87102
<b>County</b>	Bernalillo
<b>Direction/Orientation</b>	SW
<b>Date</b>	12/16/13
<b>Time</b>	1002
<b>Photographer</b>	N. Biscocho (START)
<b>Witness</b>	J. Koehnen (START)
<b>Description:</b>	Confirmation soil sampling (5-pt composite) after a two-foot removal at Area A, Grid A – Southwest.
