## Appendix C

### Photo Documentation

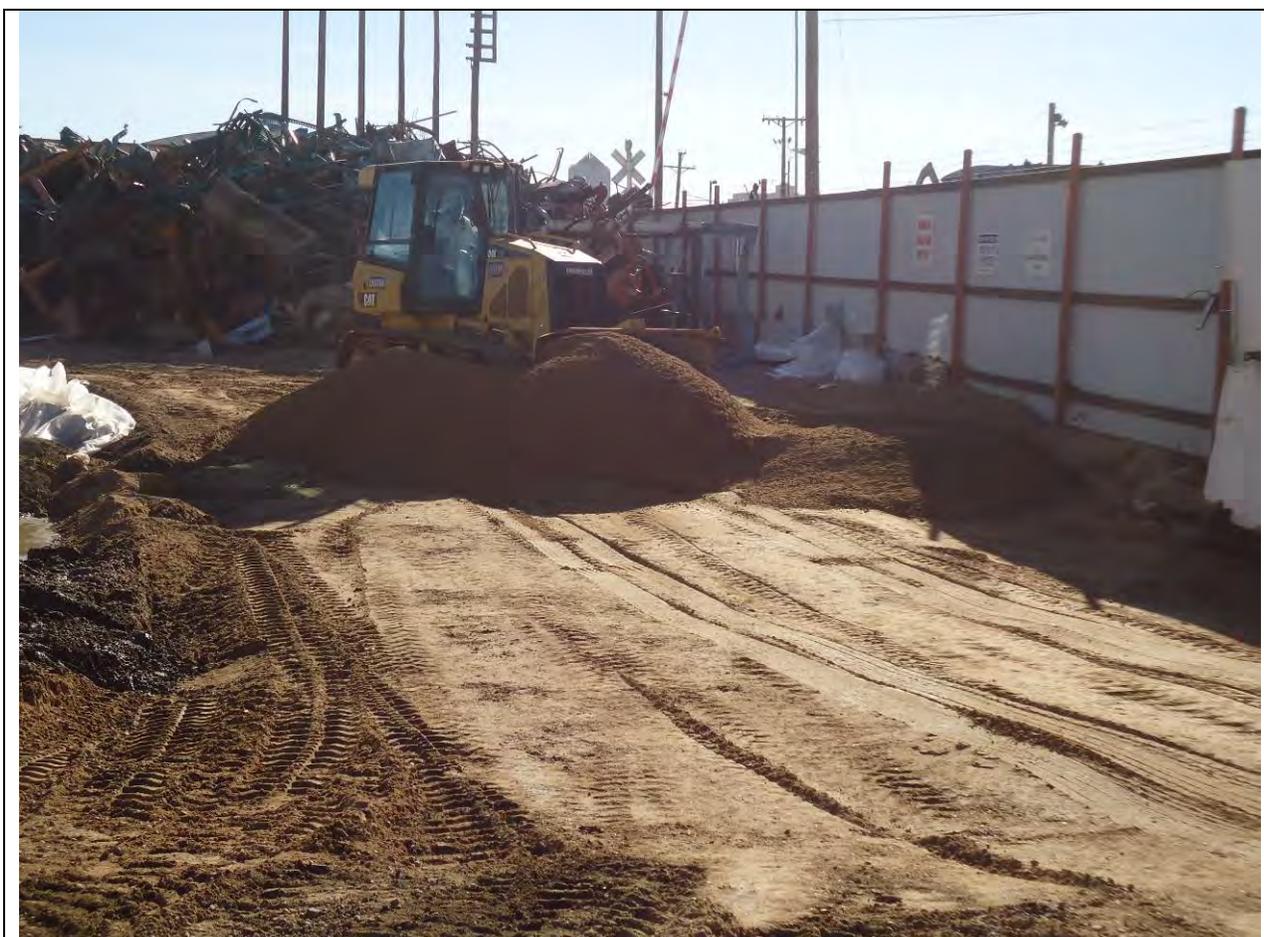
<b>Logbook Photo #</b>	DSC00756
<b>US EPA ID / Task Order Number</b>	CERCLIS: NMN000607041 / TDD No: 1/DYNAMAC-077-13-001
<b>Site</b>	Southwest Vermiculite (Removal 2)
<b>Location Address</b>	1800 1 <sup>st</sup> Street, NW
<b>City, State</b>	Albuquerque, New Mexico 87102
<b>County</b>	Bernalillo
<b>Direction/Orientation</b>	S
<b>Date</b>	12/16/13
<b>Time</b>	1356
<b>Photographer</b>	N. Biscocho (START)
<b>Witness</b>	J. Koehnen (START)
<b>Description:</b>	Backfill activities at Area A, Grid A – Southwest after a two-foot removal.

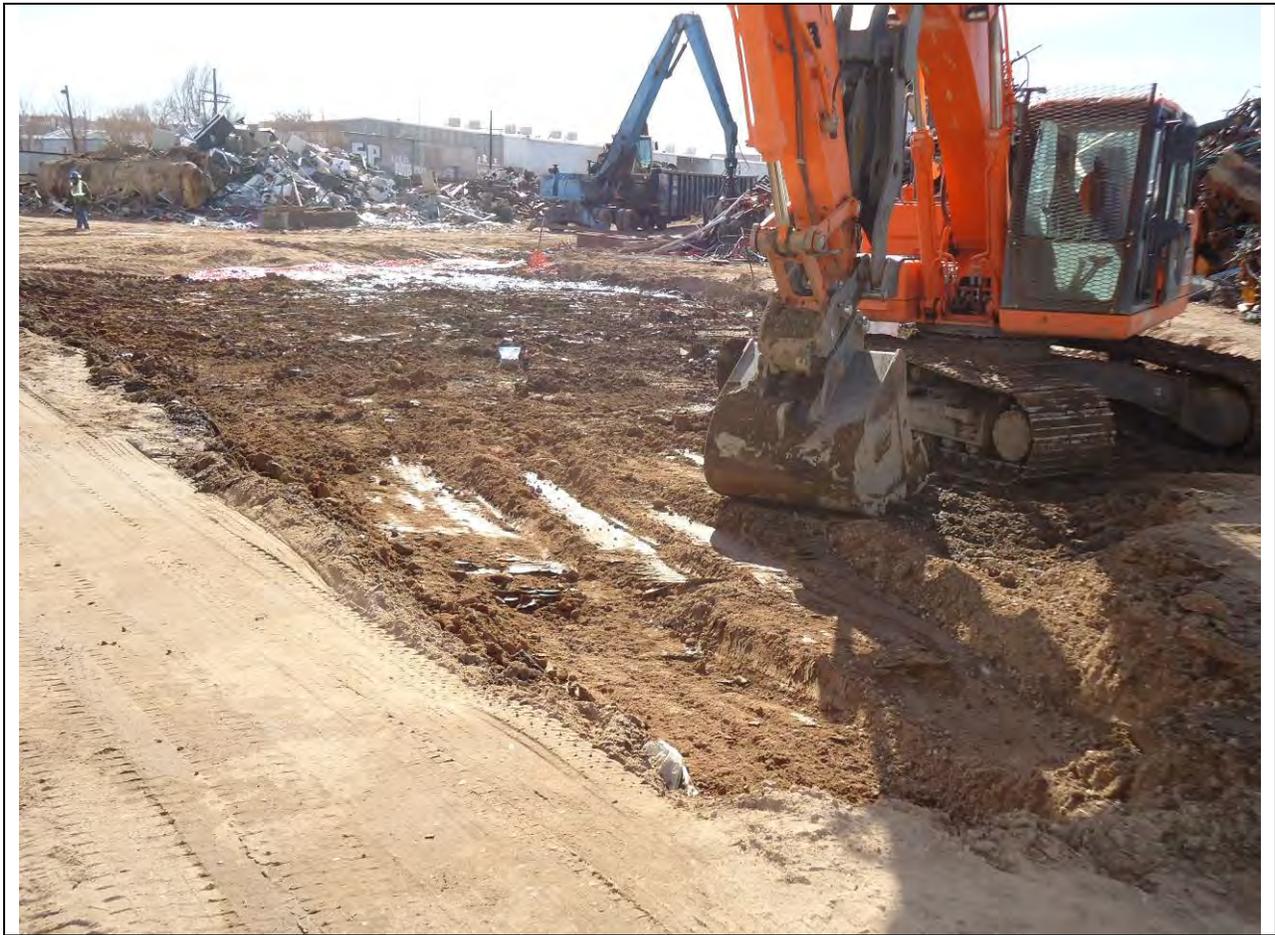
**Description:**  
View of excavated area in the central portion of Area A, Grid A following collection of the soil confirmation sample.

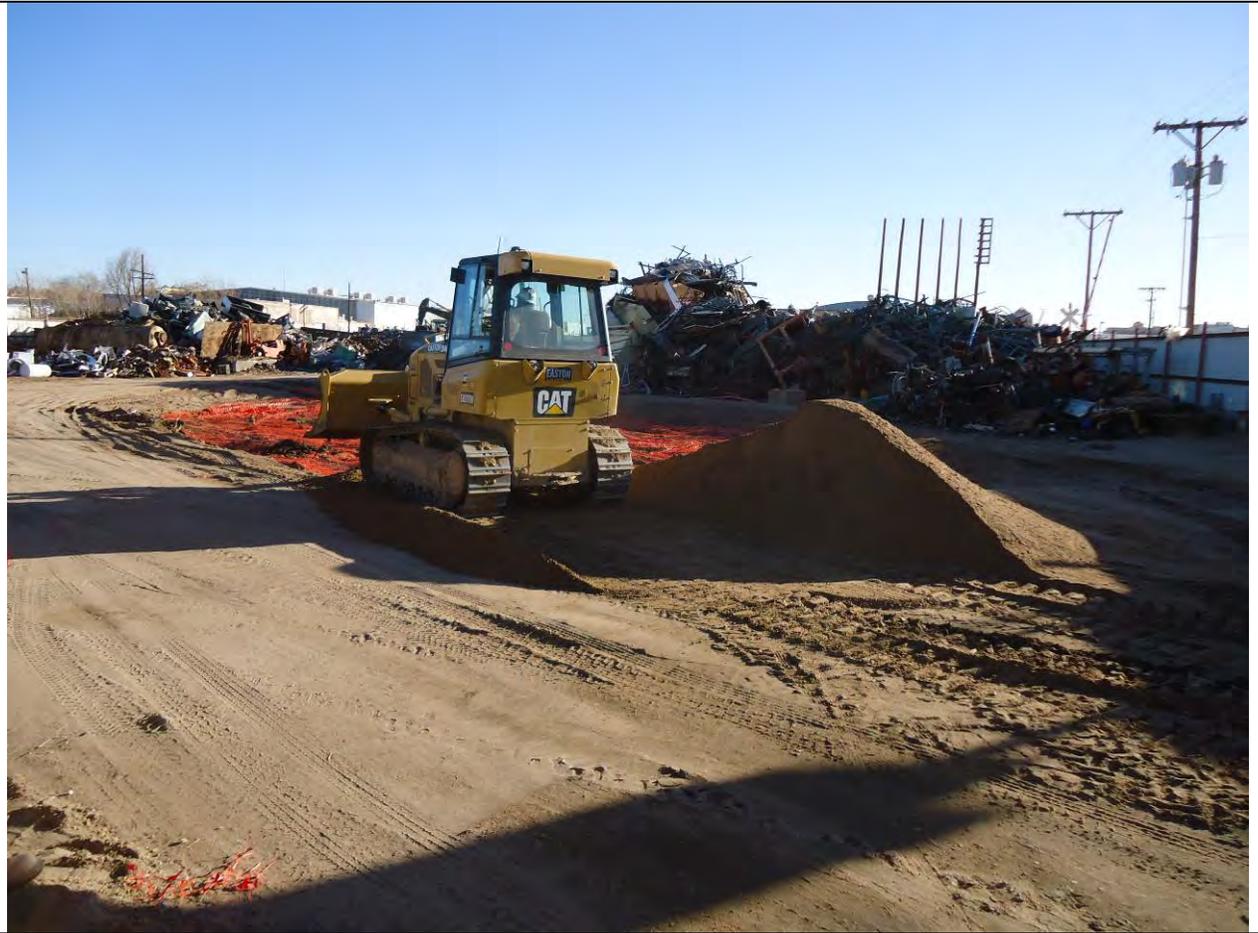
<b>Logbook Photo #</b>	DSC01018
<b>US EPA ID / Task Order Number</b>	CERCLIS: NMN000607041 / TDD No: 1/DYNAMAC-077-13-001
<b>Site</b>	Southwest Vermiculite (Removal 2)
<b>Location Address</b>	1800 1 <sup>st</sup> Street, NW
<b>City, State</b>	Albuquerque, New Mexico 87102
<b>County</b>	Bernalillo
<b>Direction/Orientation</b>	SW
<b>Date</b>	1/28/14
<b>Time</b>	1559
<b>Photographer</b>	N. Biscocho (START)
<b>Witness</b>	J. Koehnen (START)
<b>Description:</b>	
Backfill activities in the excavated area in the central portion of Area A, Grid A following collection of the soil confirmation sample.

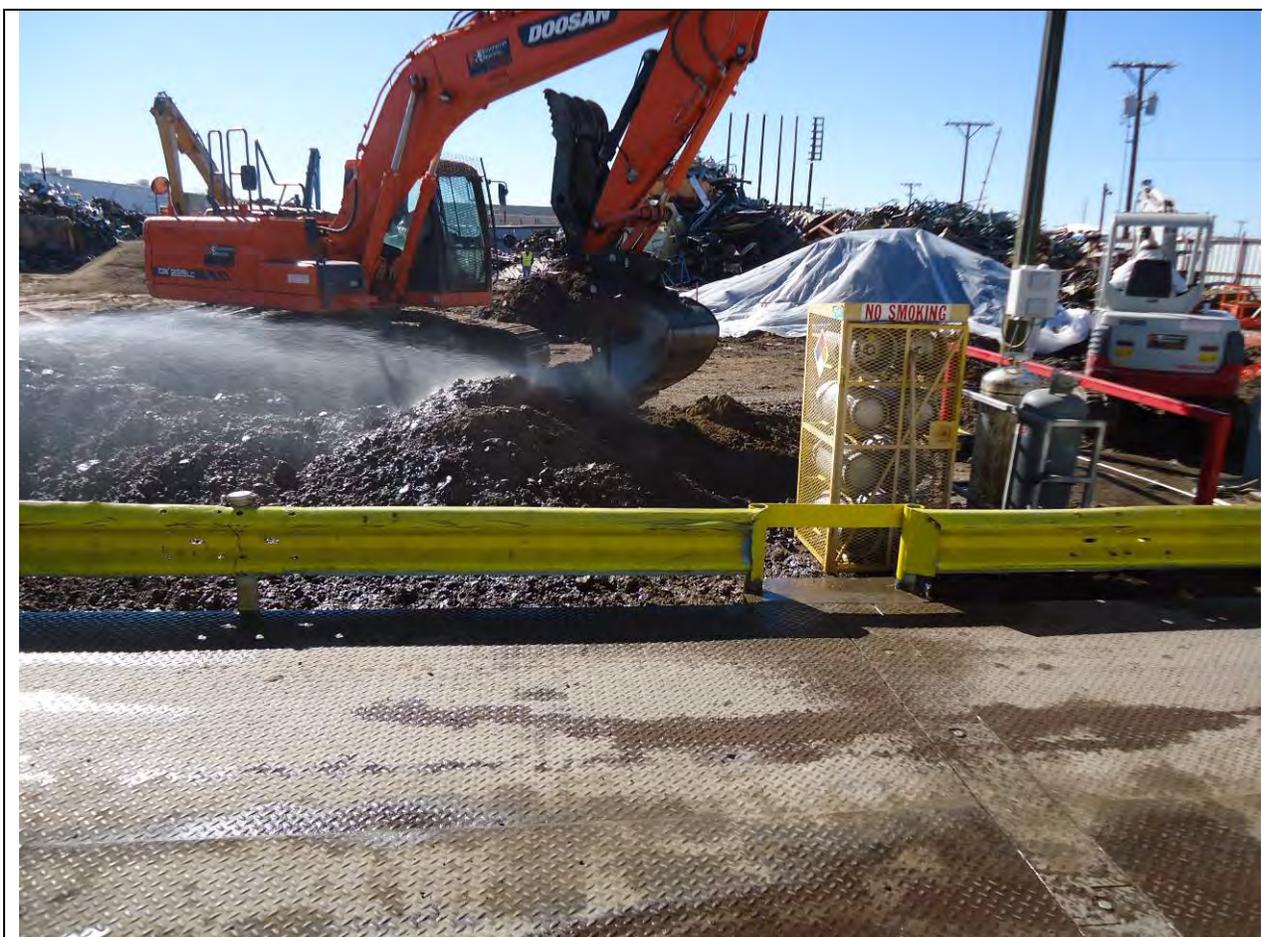
<b>Logbook Photo #</b>	DSC00988
<b>US EPA ID / Task Order Number</b>	CERCLIS: NMN000607041 / TDD No: 1/DYNAMAC-077-13-001
<b>Site</b>	Southwest Vermiculite (Removal 2)
<b>Location Address</b>	1800 1 <sup>st</sup> Street, NW
<b>City, State</b>	Albuquerque, New Mexico 87102
<b>County</b>	Bernalillo
<b>Direction/Orientation</b>	S
<b>Date</b>	1/26/14
<b>Time</b>	1054
<b>Photographer</b>	N. Biscocho (START)
<b>Witness</b>	J. Koehnen (START)
<b>Description:</b>	Excavation and dust suppression activities in Area A, Grid A - North

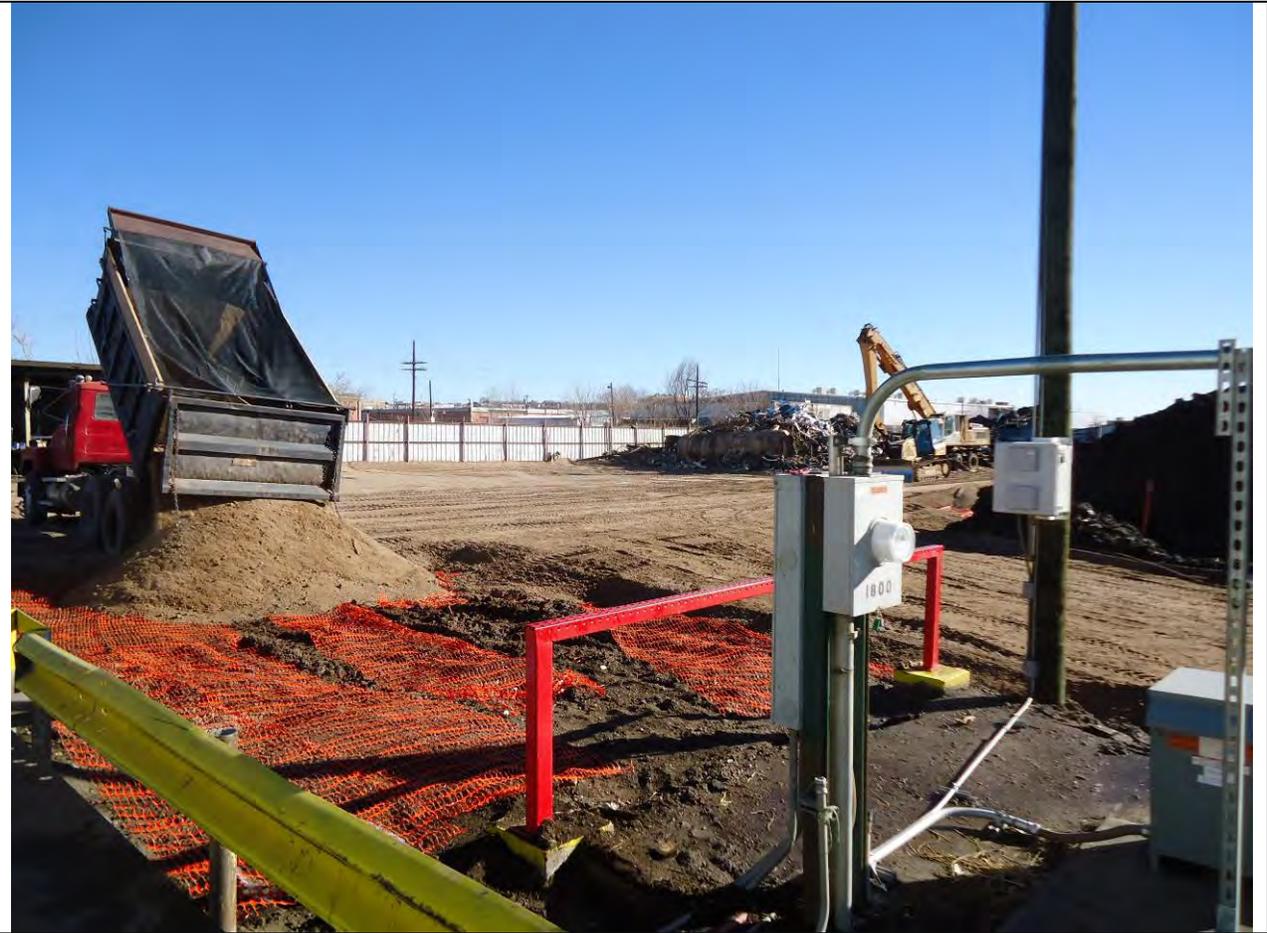
<b>Logbook Photo #</b>	DSC00997
<b>US EPA ID / Task Order Number</b>	CERCLIS: NMN000607041 / TDD No: 1/DYNAMAC-077-13-001
<b>Site</b>	Southwest Vermiculite (Removal 2)
<b>Location Address</b>	1800 1 <sup>st</sup> Street, NW
<b>City, State</b>	Albuquerque, New Mexico 87102
<b>County</b>	Bernalillo
<b>Direction/Orientation</b>	SE
<b>Date</b>	1/26/14
<b>Time</b>	1454
<b>Photographer</b>	N. Biscocho (START)
<b>Witness</b>	J. Koehnen (START)
<b>Description:</b>	Backfill activities at Area A, Grid A – North after excavation activities.

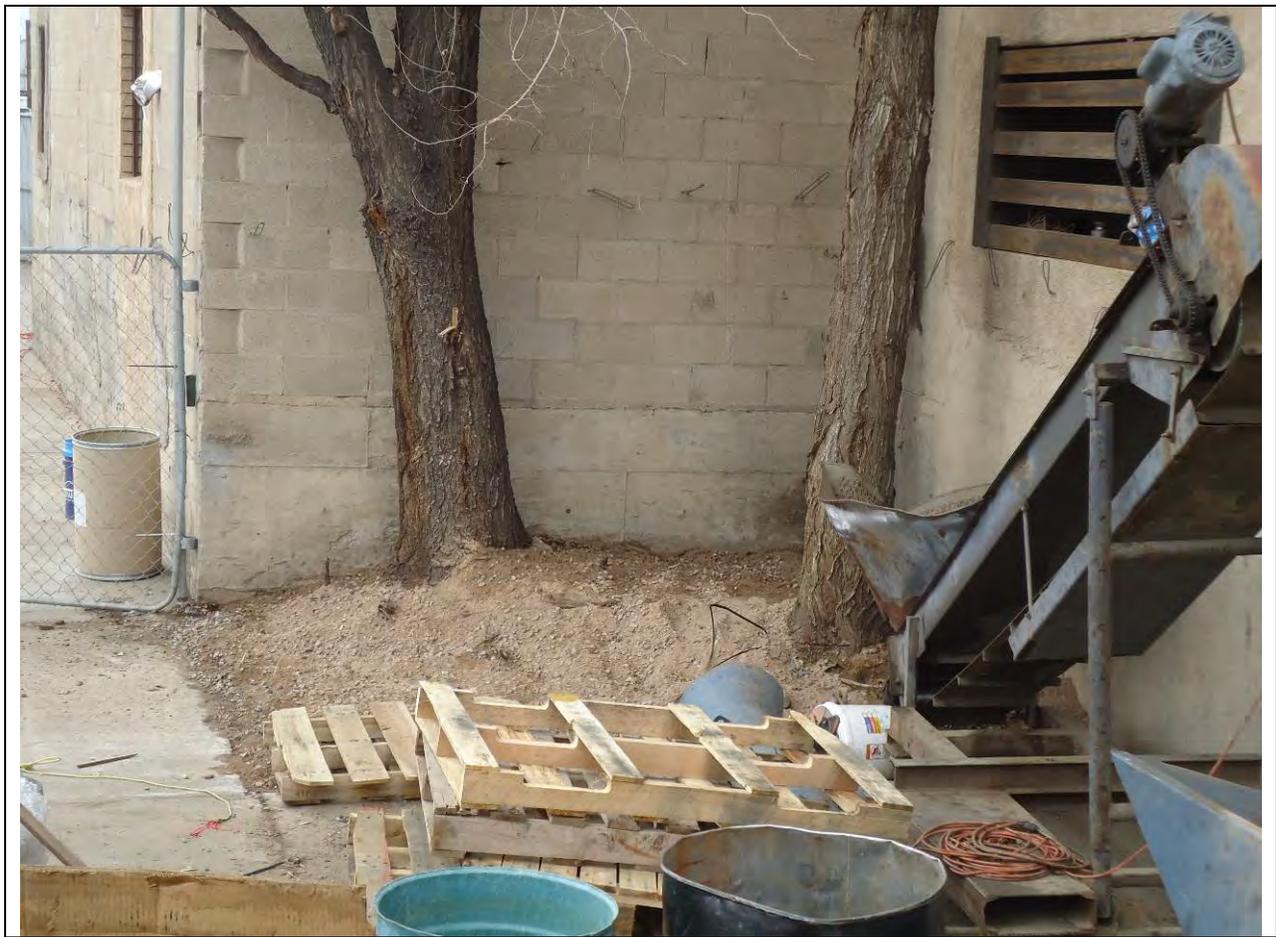
<b>Logbook Photo #</b>	DSC00795
<b>US EPA ID / Task Order Number</b>	CERCLIS: NMN000607041 / TDD No: 1/DYNAMAC-077-13-001
<b>Site</b>	Southwest Vermiculite (Removal 2)
<b>Location Address</b>	1800 1 <sup>st</sup> Street, NW
<b>City, State</b>	Albuquerque, New Mexico 87102
<b>County</b>	Bernalillo
<b>Direction/Orientation</b>	W
<b>Date</b>	12/21/13
<b>Time</b>	1410
<b>Photographer</b>	N. Biscocho (START)
<b>Witness</b>	J. Koehnen (START)
<b>Description:</b>	Backfilled Area A, Grid-019 after excavation and confirmation sample collected. See next photo for the remaining section of Area A, Grid-019.

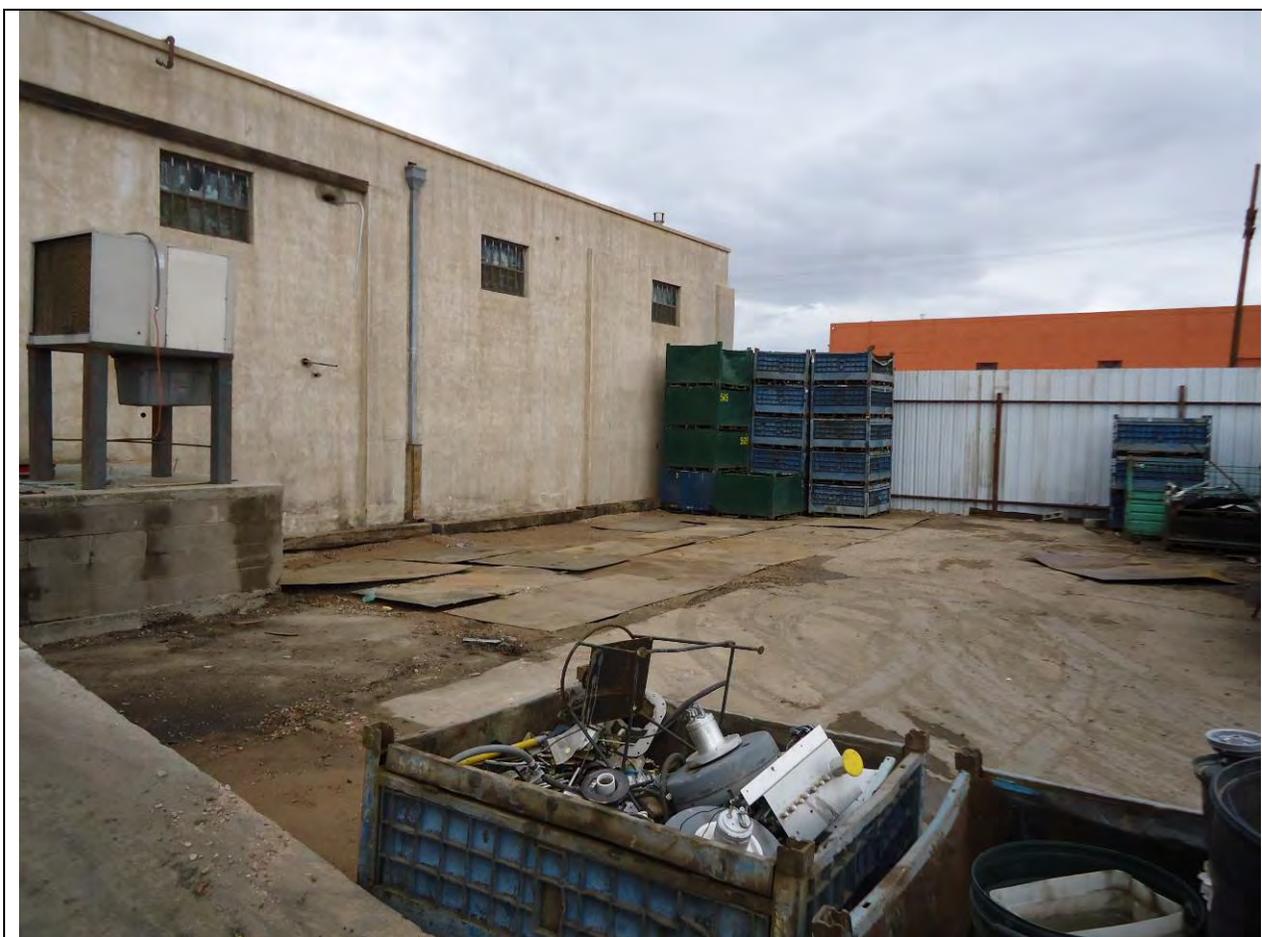
<b>Logbook Photo #</b>	DSC00794
<b>US EPA ID / Task Order Number</b>	CERCLIS: NMN000607041 / TDD No: 1/DYNAMAC-077-13-001
<b>Site</b>	Southwest Vermiculite (Removal 2)
<b>Location Address</b>	1800 1 <sup>st</sup> Street, NW
<b>City, State</b>	Albuquerque, New Mexico 87102
<b>County</b>	Bernalillo
<b>Direction/Orientation</b>	NE
<b>Date</b>	12/21/13
<b>Time</b>	1410
<b>Photographer</b>	N. Biscocho (START)
<b>Witness</b>	J. Koehnen (START)
<b>Description:</b>	Backfilled Area A, Grid-019 after excavation and confirmation sample collected. See previous photo for the remaining section of Area A, Grid-019.

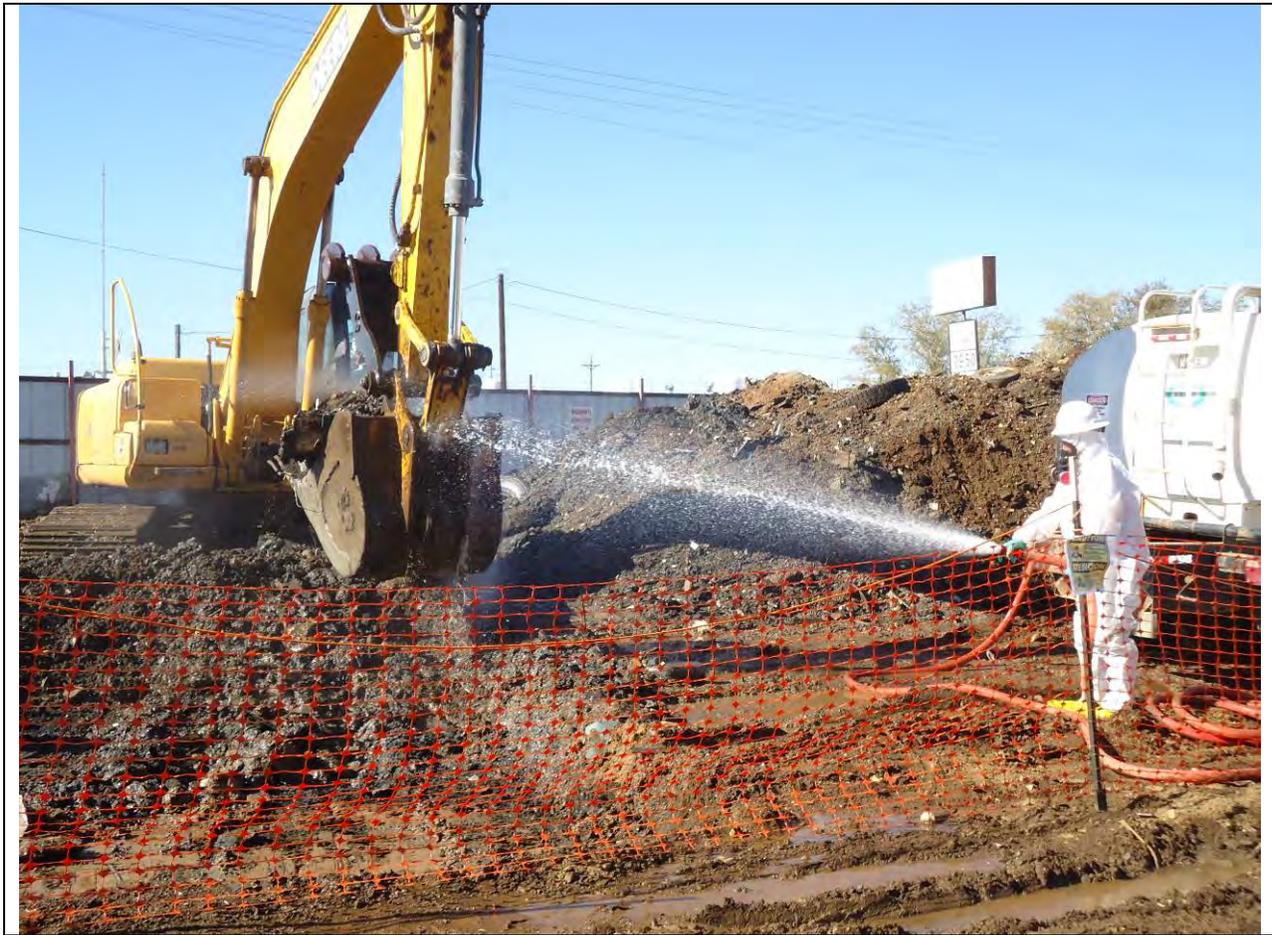
<b>Logbook Photo #</b>	DSC00575
<b>US EPA ID / Task Order Number</b>	CERCLIS: NMN000607041 / TDD No: 1/DYNAMAC-077-13-001
<b>Site</b>	Southwest Vermiculite (Removal 2)
<b>Location Address</b>	1800 1 <sup>st</sup> Street, NW
<b>City, State</b>	Albuquerque, New Mexico 87102
<b>County</b>	Bernalillo
<b>Direction/Orientation</b>	W
<b>Date</b>	11/9/13
<b>Time</b>	1310
<b>Photographer</b>	N. Biscocho (START)
<b>Witness</b>	J. Koehnen (START)
<b>Description:</b>	Excavation with dust suppression activities at Area A, Grid B – North.

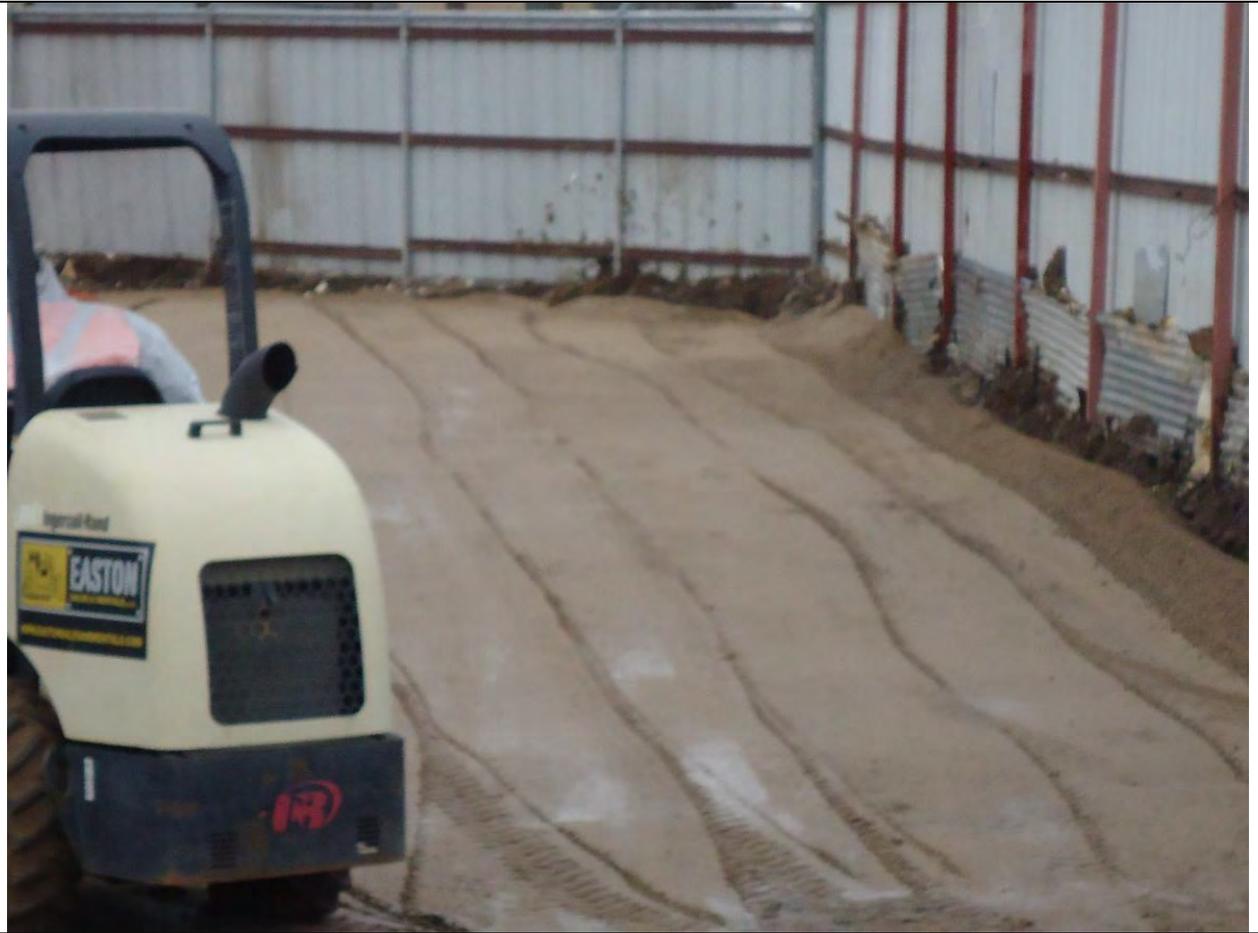
<b>Logbook Photo #</b>	DSC00652
<b>US EPA ID / Task Order Number</b>	CERCLIS: NMN000607041 / TDD No: 1/DYNAMAC-077-13-001
<b>Site</b>	Southwest Vermiculite (Removal 2)
<b>Location Address</b>	1800 1 <sup>st</sup> Street, NW
<b>City, State</b>	Albuquerque, New Mexico 87102
<b>County</b>	Bernalillo
<b>Direction/Orientation</b>	11/22/13
<b>Date</b>	S
<b>Time</b>	1438
<b>Photographer</b>	N. Biscocho (START)
<b>Witness</b>	J. Koehnen (START)
<b>Description:</b>	
Backfilling and grading activities in Area A, Grid B – North.

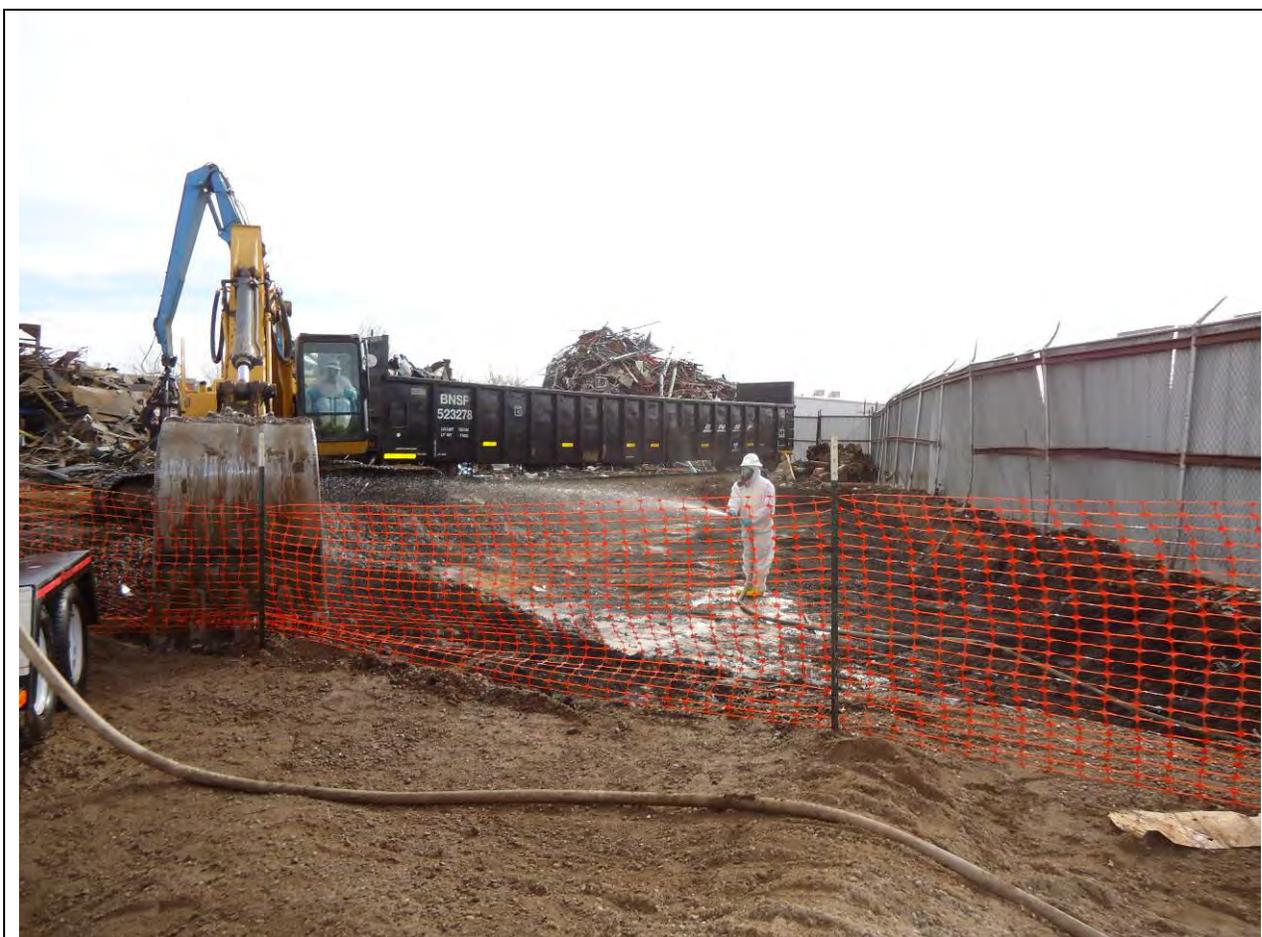
<b>Logbook Photo #</b>	DSC00677
<b>US EPA ID / Task Order Number</b>	CERCLIS: NMN000607041 / TDD No: 1/DYNAMAC-077-13-001
<b>Site</b>	Southwest Vermiculite (Removal 2)
<b>Location Address</b>	1800 1 <sup>st</sup> Street, NW
<b>City, State</b>	Albuquerque, New Mexico 87102
<b>County</b>	Bernalillo
<b>Direction/Orientation</b>	SW
<b>Date</b>	12/4/13
<b>Time</b>	1117
<b>Photographer</b>	N. Biscocho (START)
<b>Witness</b>	J. Koehnen (START)
<b>Description:</b>	Excavation with dust suppression activities at Area A, Grid B – South.

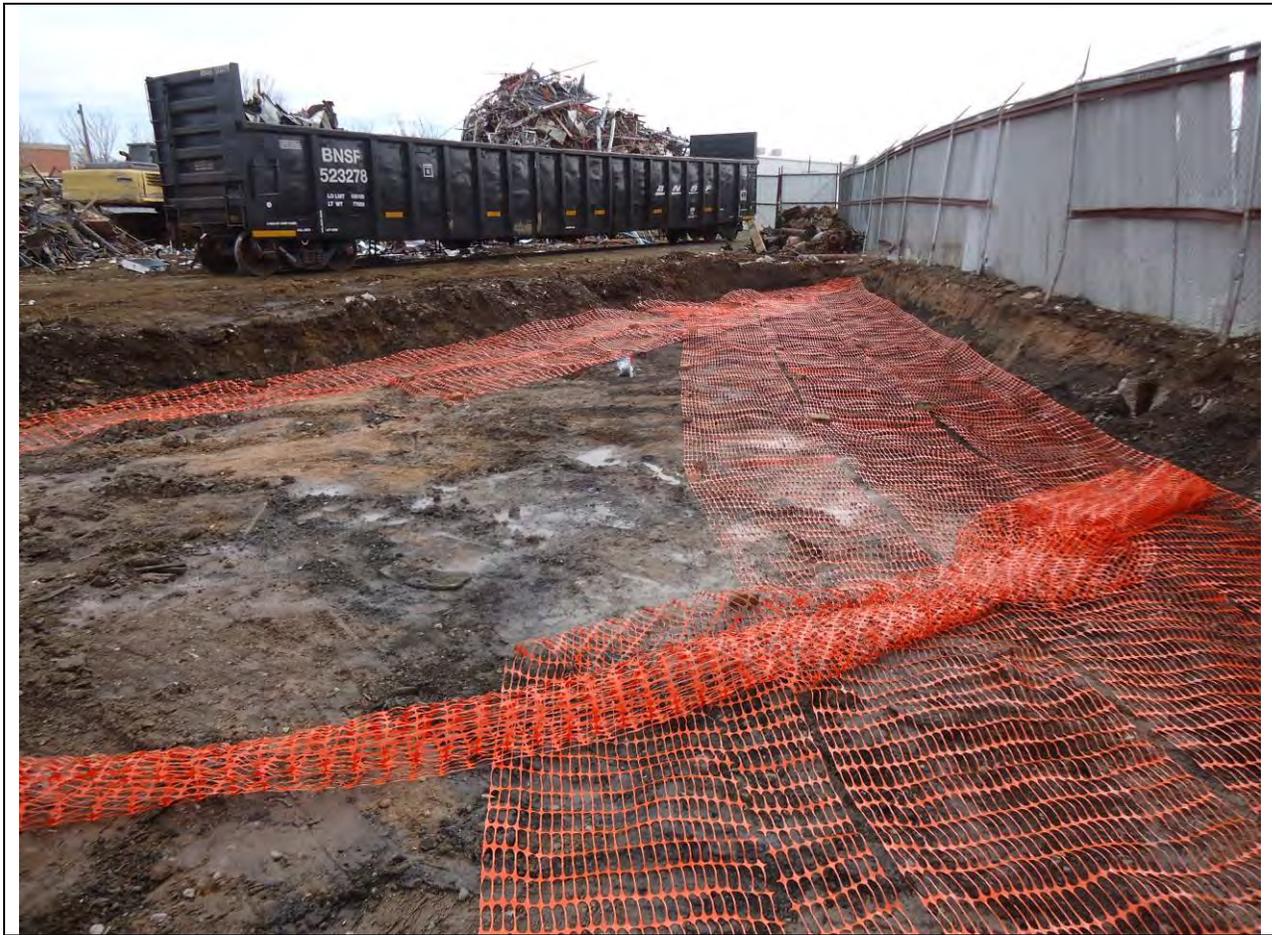
<b>Logbook Photo #</b>	DSC00680
<b>US EPA ID / Task Order Number</b>	CERCLIS: NMN000607041 / TDD No: 1/DYNAMAC-077-13-001
<b>Site</b>	Southwest Vermiculite (Removal 2)
<b>Location Address</b>	1800 1 <sup>st</sup> Street, NW
<b>City, State</b>	Albuquerque, New Mexico 87102
<b>County</b>	Bernalillo
<b>Direction/Orientation</b>	SW
<b>Date</b>	12/4/13
<b>Time</b>	1228
<b>Photographer</b>	N. Biscocho (START)
<b>Witness</b>	J. Koehnen (START)
<b>Description:</b>	Confirmation sample after a two-foot removal on Area A, Grid B – North.

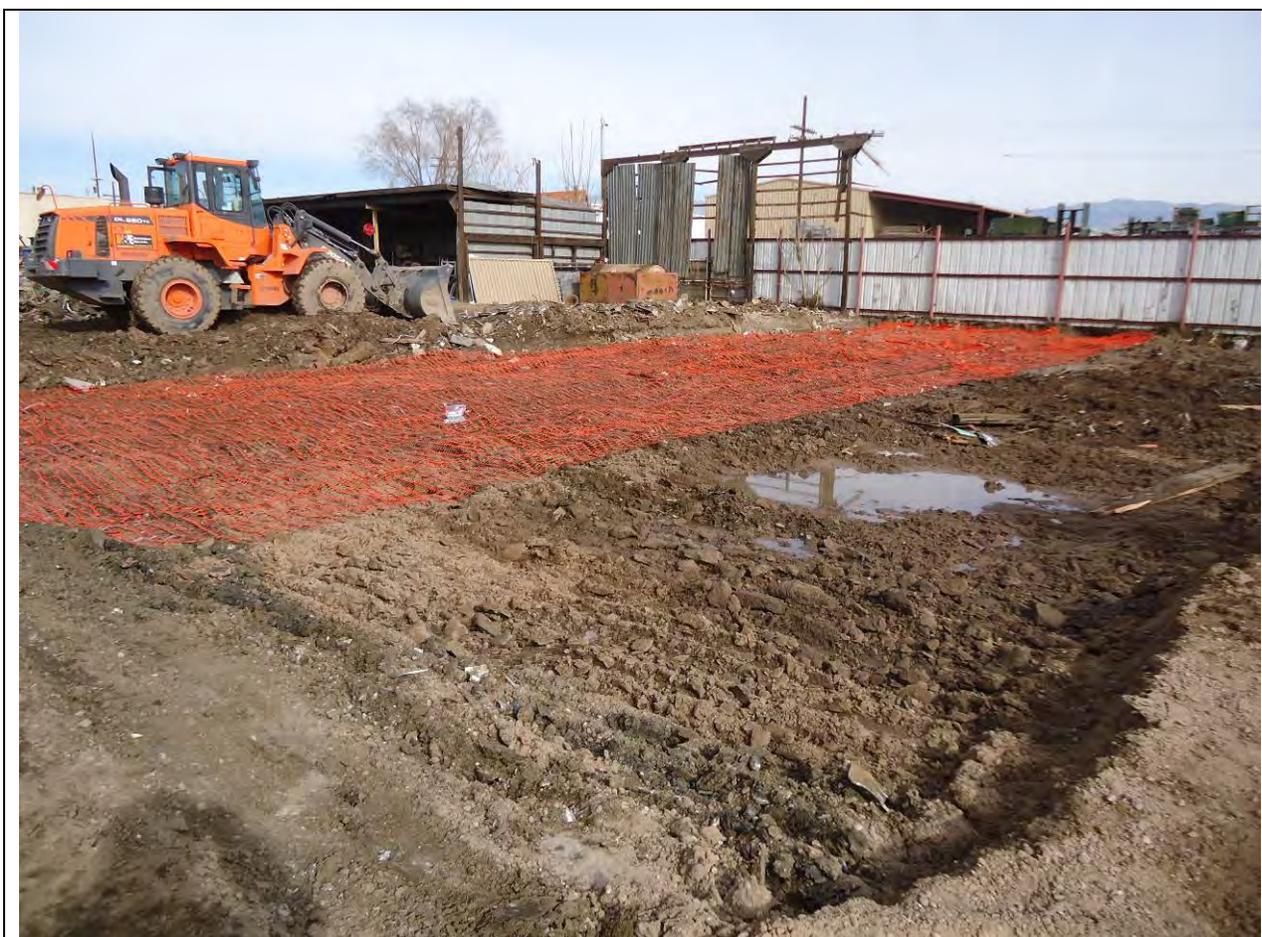
<b>Logbook Photo #</b>	DSC00971
<b>US EPA ID / Task Order Number</b>	CERCLIS: NMN000607041 / TDD No: 1/DYNAMAC-077-13-001
<b>Site</b>	Southwest Vermiculite (Removal 2)
<b>Location Address</b>	1800 1 <sup>st</sup> Street, NW
<b>City, State</b>	Albuquerque, New Mexico 87102
<b>County</b>	Bernalillo
<b>Direction/Orientation</b>	NE
<b>Date</b>	1/24/14
<b>Time</b>	1600
<b>Photographer</b>	N. Biscocho (START)
<b>Witness</b>	J. Koehnen (START)
<b>Description:</b>	Confirmation soil sampling (5 pt composite) after a two-foot removal on Area A, Grid C – South.

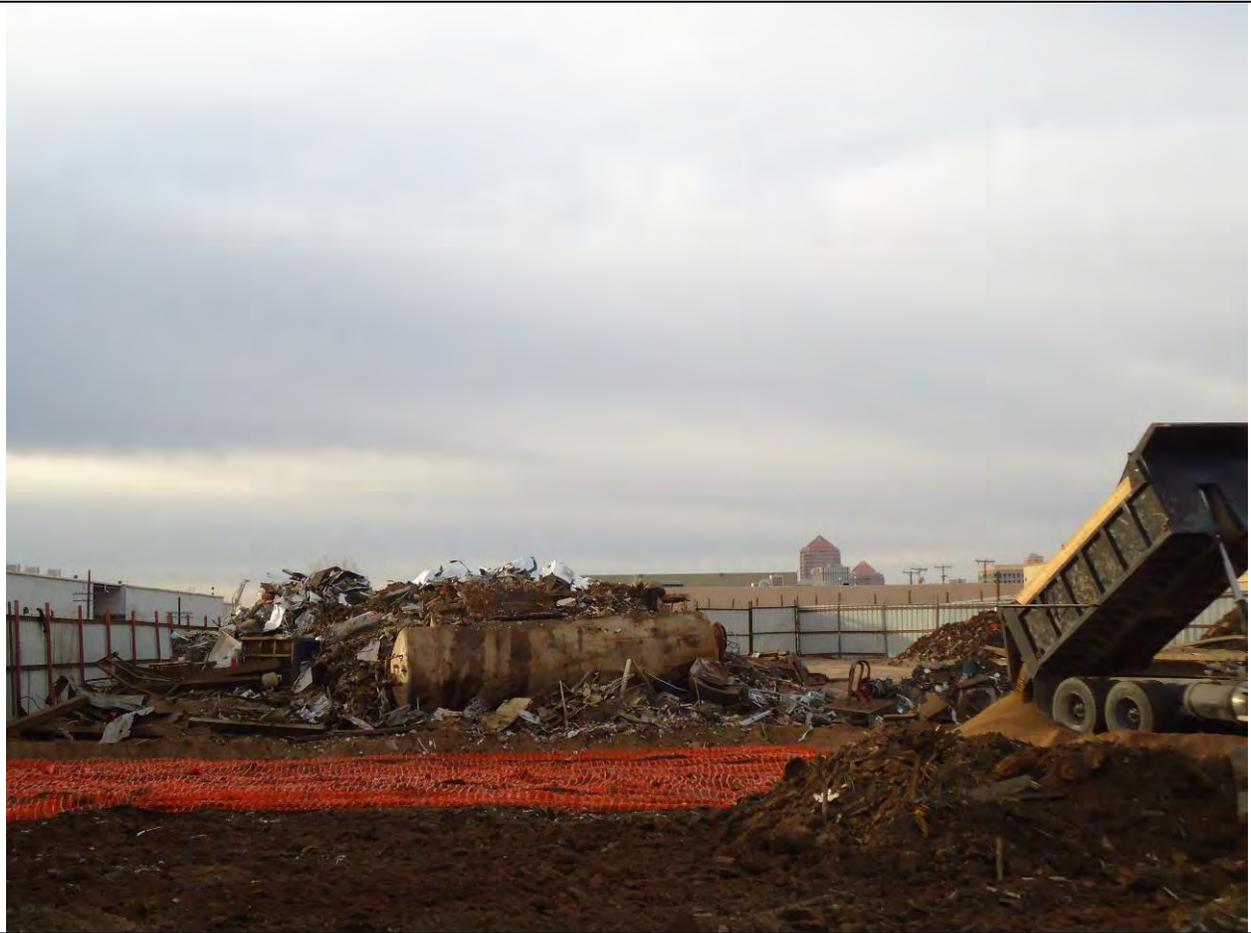
<b>Logbook Photo #</b>	DSC00976
<b>US EPA ID / Task Order Number</b>	CERCLIS: NMN000607041 / TDD No: 1/DYNAMAC-077-13-001
<b>Site</b>	Southwest Vermiculite (Removal 2)
<b>Location Address</b>	1800 1 <sup>st</sup> Street, NW
<b>City, State</b>	Albuquerque, New Mexico 87102
<b>County</b>	Bernalillo
<b>Direction/Orientation</b>	S
<b>Date</b>	1/25/14
<b>Time</b>	0807
<b>Photographer</b>	N. Biscocho (START)
<b>Witness</b>	J. Koehnen (START)
<b>Description:</b>	
Backfilling activities after a two-foot removal and confirmation soil sampling in Area A, Grid C – South.

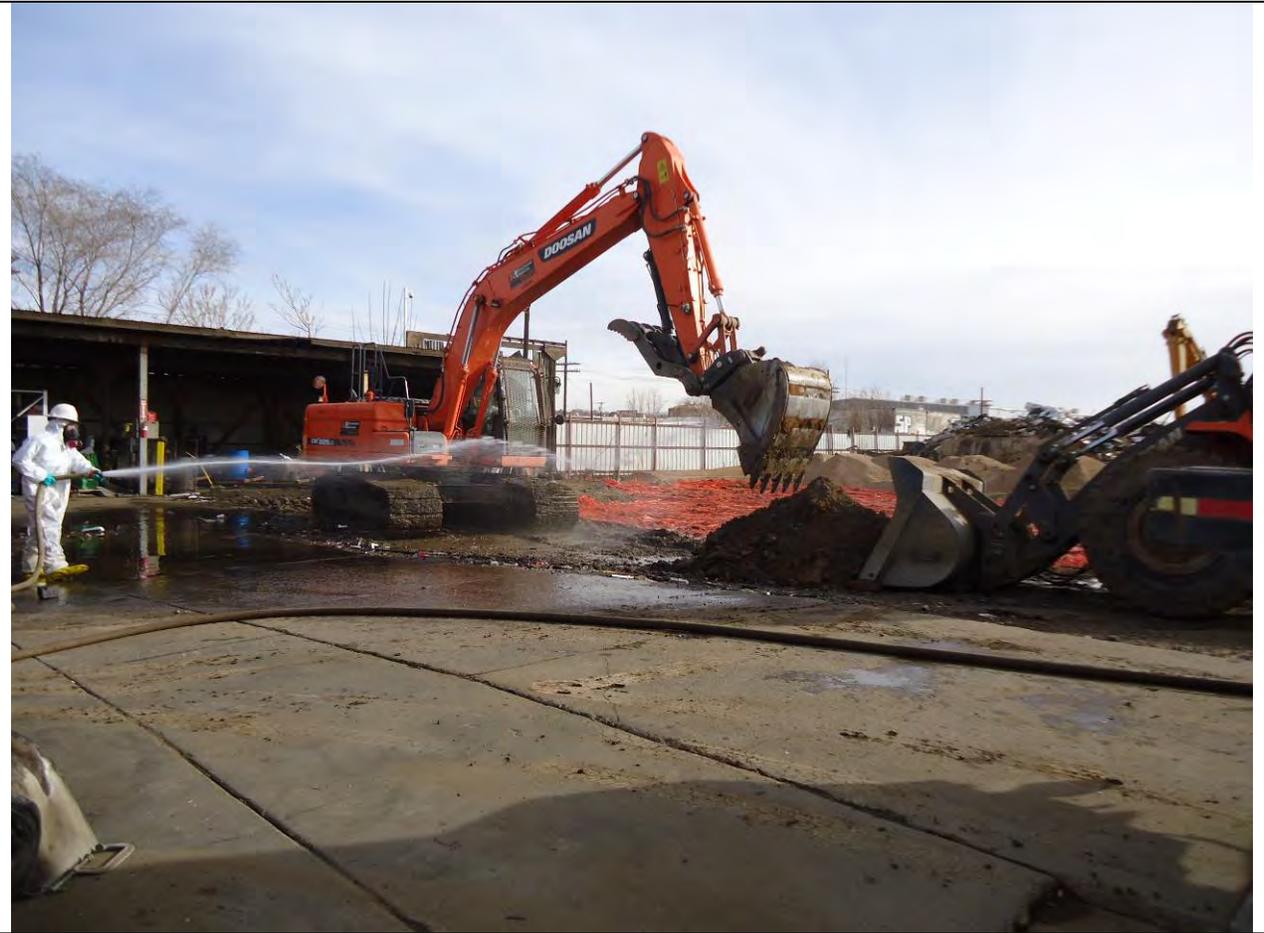
<b>Logbook Photo #</b>	DSC00979
<b>US EPA ID / Task Order Number</b>	CERCLIS: NMN000607041 / TDD No: 1/DYNAMAC-077-13-001
<b>Site</b>	Southwest Vermiculite (Removal 2)
<b>Location Address</b>	1800 1 <sup>st</sup> Street, NW
<b>City, State</b>	Albuquerque, New Mexico 87102
<b>County</b>	Bernalillo
<b>Direction/Orientation</b>	SE
<b>Date</b>	1/25/14
<b>Time</b>	1500
<b>Photographer</b>	N. Biscocho (START)
<b>Witness</b>	J. Koehnen (START)
<b>Description:</b>	Excavation (24" bgs) and dust suppression activities in Area A, Grid C – North.

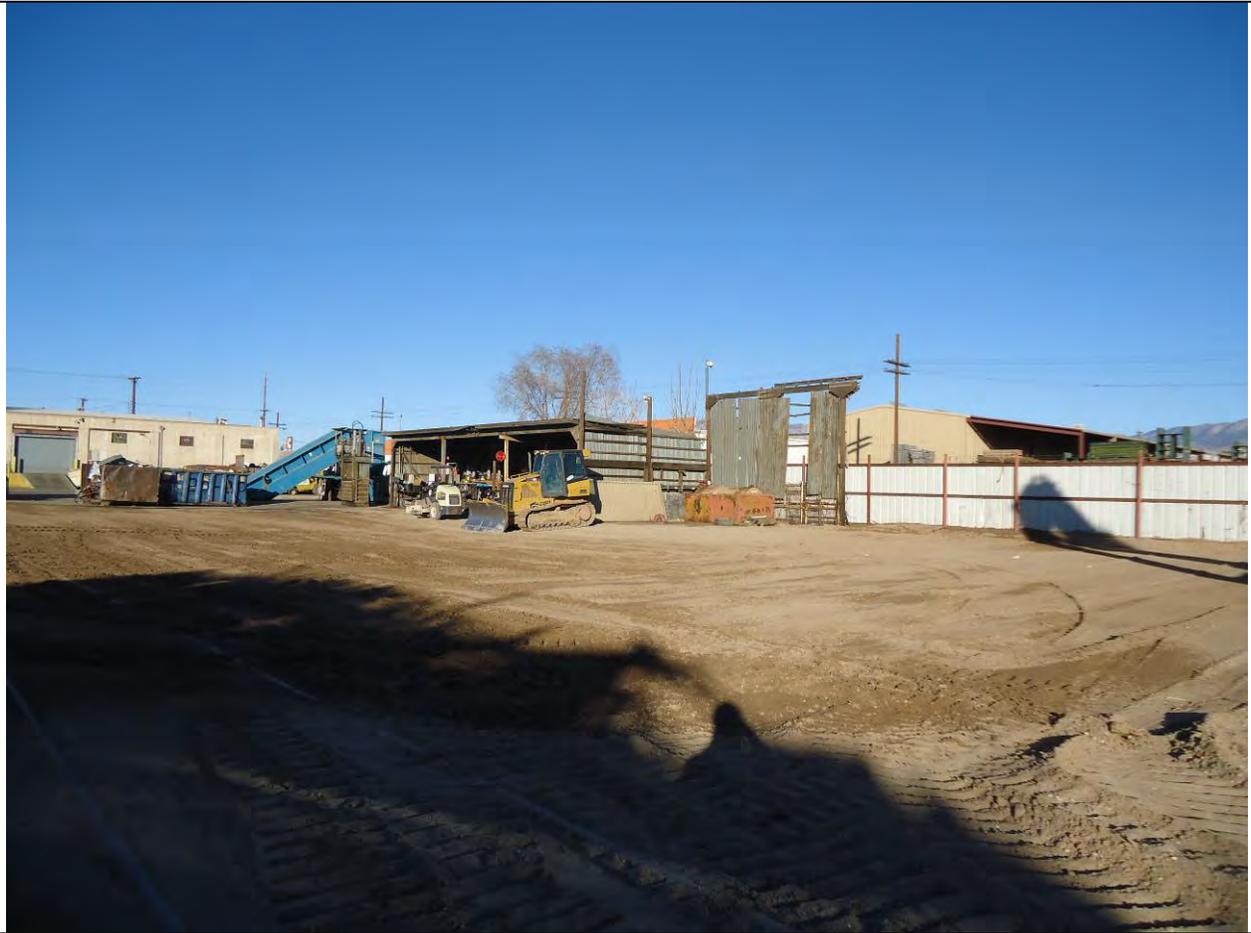
<b>Logbook Photo #</b>	DSC01000
<b>US EPA ID / Task Order Number</b>	CERCLIS: NMN000607041 / TDD No: 1/DYNAMAC-077-13-001
<b>Site</b>	Southwest Vermiculite (Removal 2)
<b>Location Address</b>	1800 1 <sup>st</sup> Street, NW
<b>City, State</b>	Albuquerque, New Mexico 87102
<b>County</b>	Bernalillo
<b>Direction/Orientation</b>	NE
<b>Date</b>	1/26/14
<b>Time</b>	1608
<b>Photographer</b>	N. Biscocho (START)
<b>Witness</b>	J. Koehnen (START)
<b>Description:</b>	View of Area A, Grid C backfilled and soil grading activities after a 24"bgs removal.

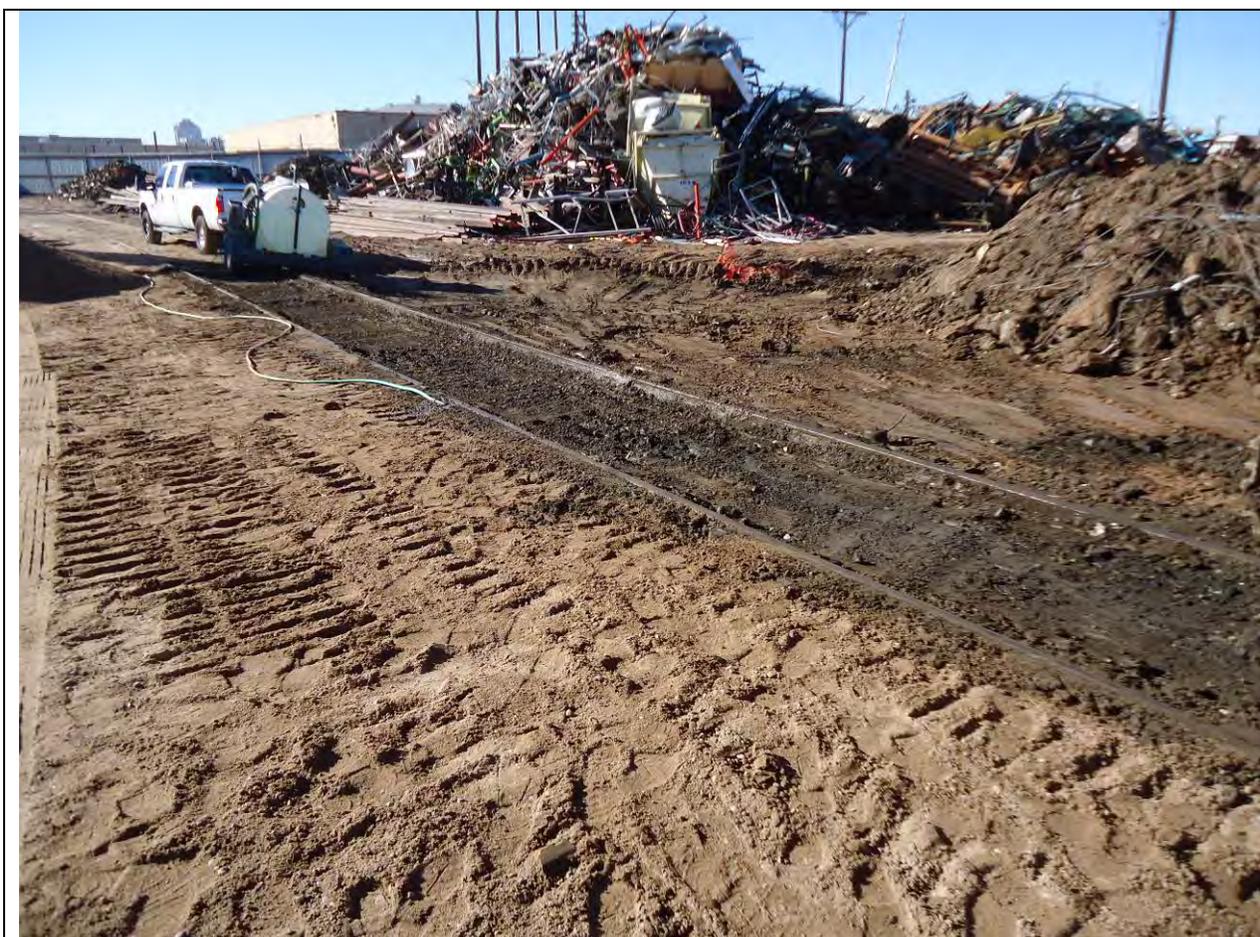
<b>Logbook Photo #</b>	DSC986
<b>US EPA ID / Task Order Number</b>	CERCLIS: NMN000607041 / TDD No: 1/DYNAMAC-077-13-001
<b>Site</b>	Southwest Vermiculite (Removal 2)
<b>Location Address</b>	1800 1 <sup>st</sup> Street, NW
<b>City, State</b>	Albuquerque, New Mexico 87102
<b>County</b>	Bernalillo
<b>Direction/Orientation</b>	SW
<b>Date</b>	1/26/14
<b>Time</b>	1001
<b>Photographer</b>	N. Biscocho (START)
<b>Witness</b>	J. Koehnen (START)
<b>Description:</b>	
Excavated Area A, Grid C - West

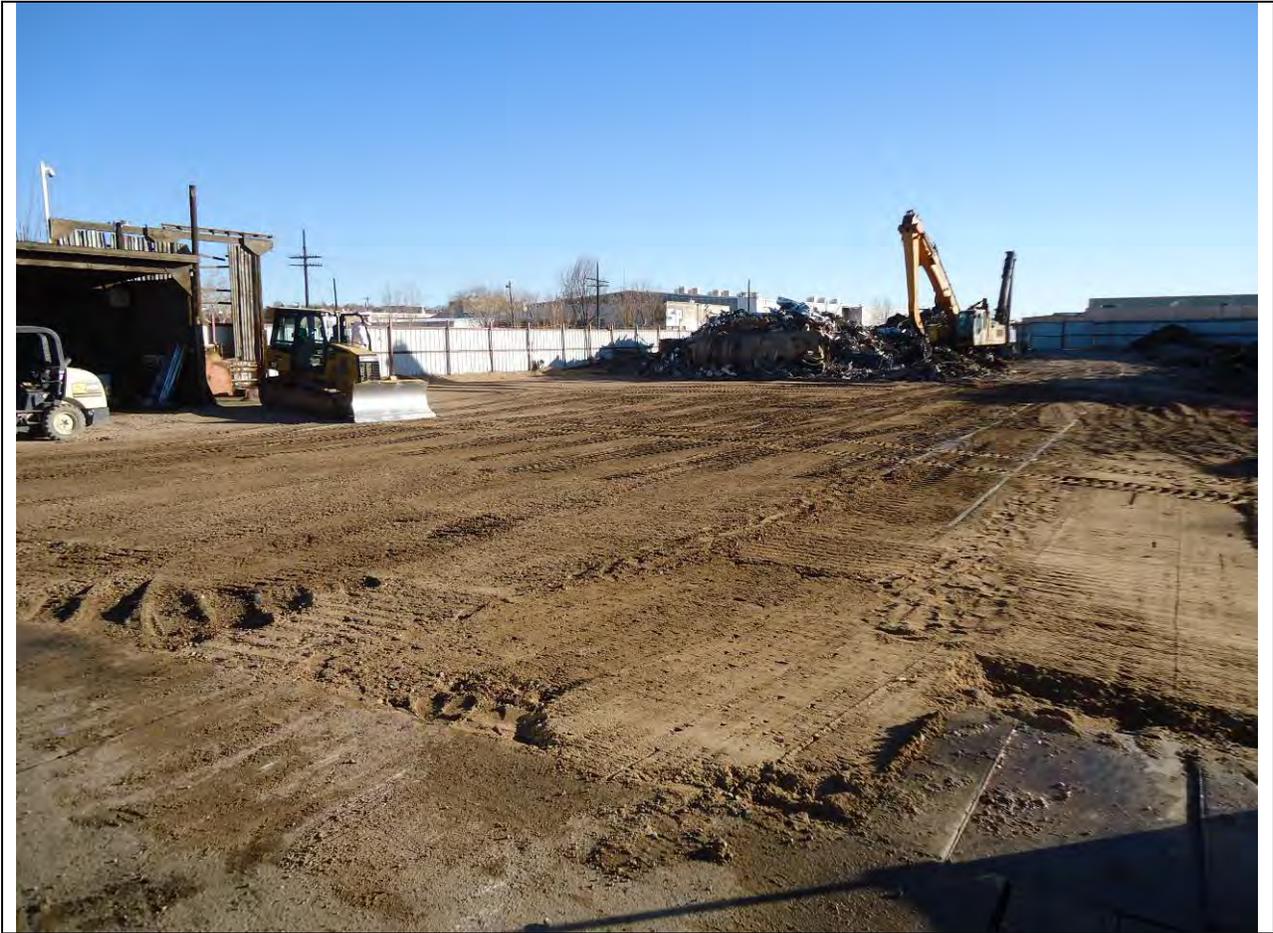
<b>Logbook Photo #</b>	DSC0998
<b>US EPA ID / Task Order Number</b>	CERCLIS: NMN000607041 / TDD No: 1/DYNAMAC-077-13-001
<b>Site</b>	Southwest Vermiculite (Removal 2)
<b>Location Address</b>	1800 1 <sup>st</sup> Street, NW
<b>City, State</b>	Albuquerque, New Mexico 87102
<b>County</b>	Bernalillo
<b>Direction/Orientation</b>	SE
<b>Date</b>	1/26/14
<b>Time</b>	1606
<b>Photographer</b>	N. Biscocho (START)
<b>Witness</b>	J. Koehnen (START)
<b>Description:</b>	Backfilled Area A, Grid C - West
