## Appendix C

### Photo Documentation

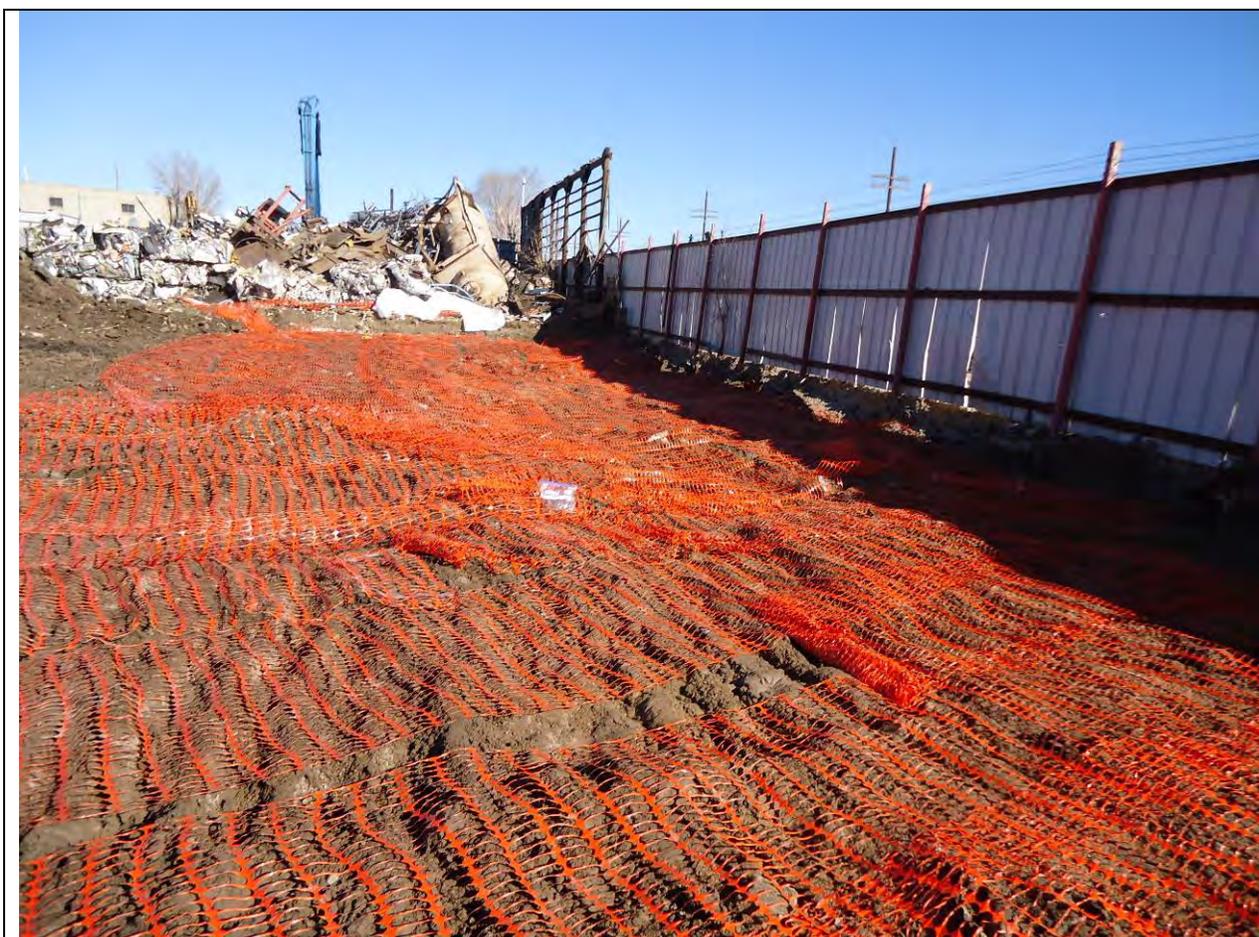
<b>Logbook Photo #</b>	DSC00928
<b>US EPA ID / Task Order Number</b>	CERCLIS: NMN000607041 / TDD No: 1/DYNAMAC-077-13-001
<b>Site</b>	Southwest Vermiculite (Removal 2)
<b>Location Address</b>	1800 1 <sup>st</sup> Street, NW
<b>City, State</b>	Albuquerque, New Mexico 87102
<b>County</b>	Bernalillo
<b>Direction/Orientation</b>	NE
<b>Date</b>	1/19/14
<b>Time</b>	1036
<b>Photographer</b>	N. Biscocho (START)
<b>Witness</b>	J. Koehnen (START)
<b>Description:</b>	Confirmation soil sampling (5pt composite) after a 24"bgs removal on Area A, Grid D - East

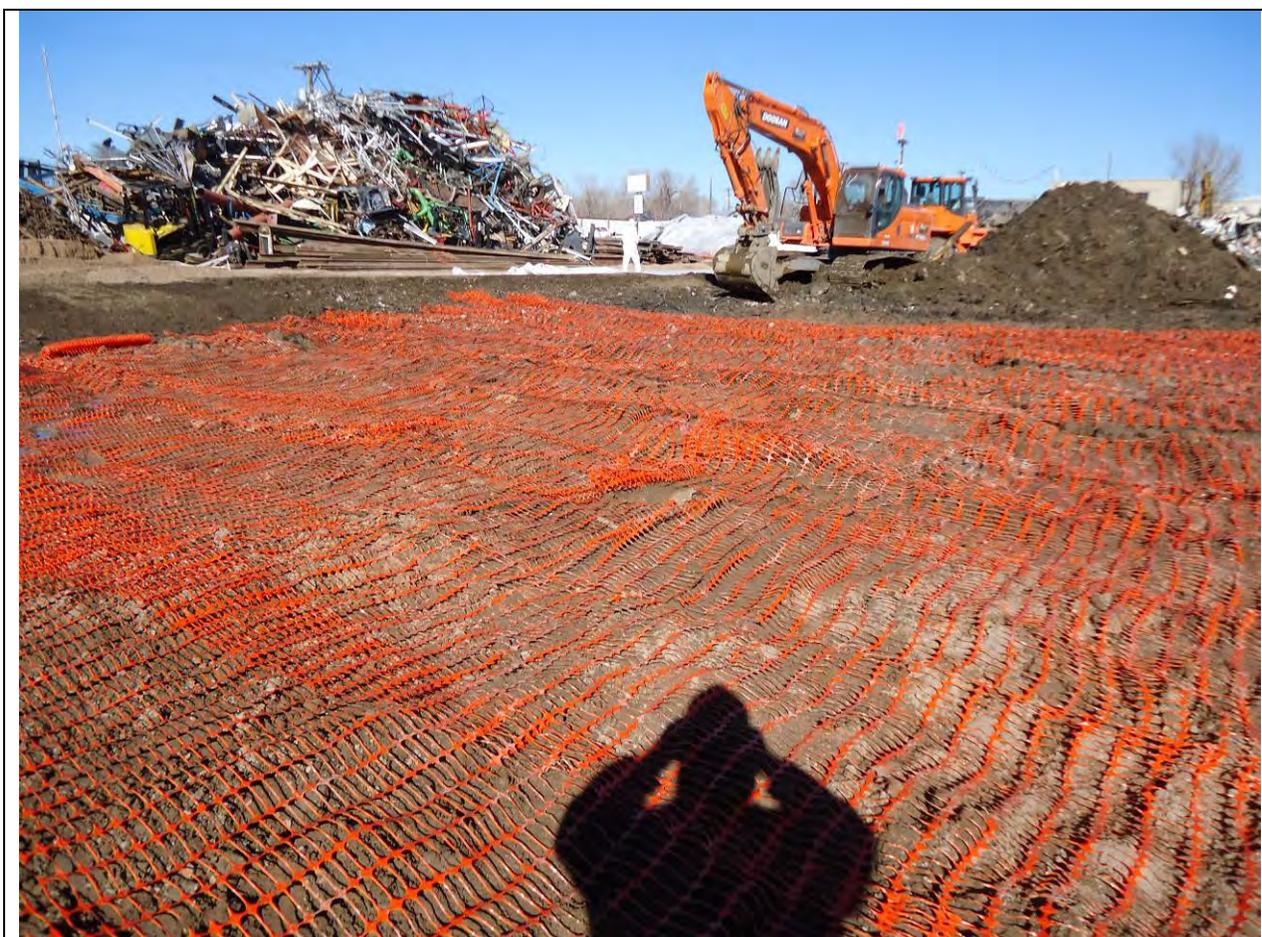
<b>Logbook Photo #</b>	DSC00930
<b>US EPA ID / Task Order Number</b>	CERCLIS: NMN000607041 / TDD No: 1/DYNAMAC-077-13-001
<b>Site</b>	Southwest Vermiculite (Removal 2)
<b>Location Address</b>	1800 1 <sup>st</sup> Street, NW
<b>City, State</b>	Albuquerque, New Mexico 87102
<b>County</b>	Bernalillo
<b>Direction/Orientation</b>	NW
<b>Date</b>	1/19/14
<b>Time</b>	1039
<b>Photographer</b>	N. Biscocho (START)
<b>Witness</b>	J. Koehnen (START)
<b>Description:</b>	Confirmation soil sampling (5pt composite) after a 24"bgs removal on Area A, Grid D - Middle

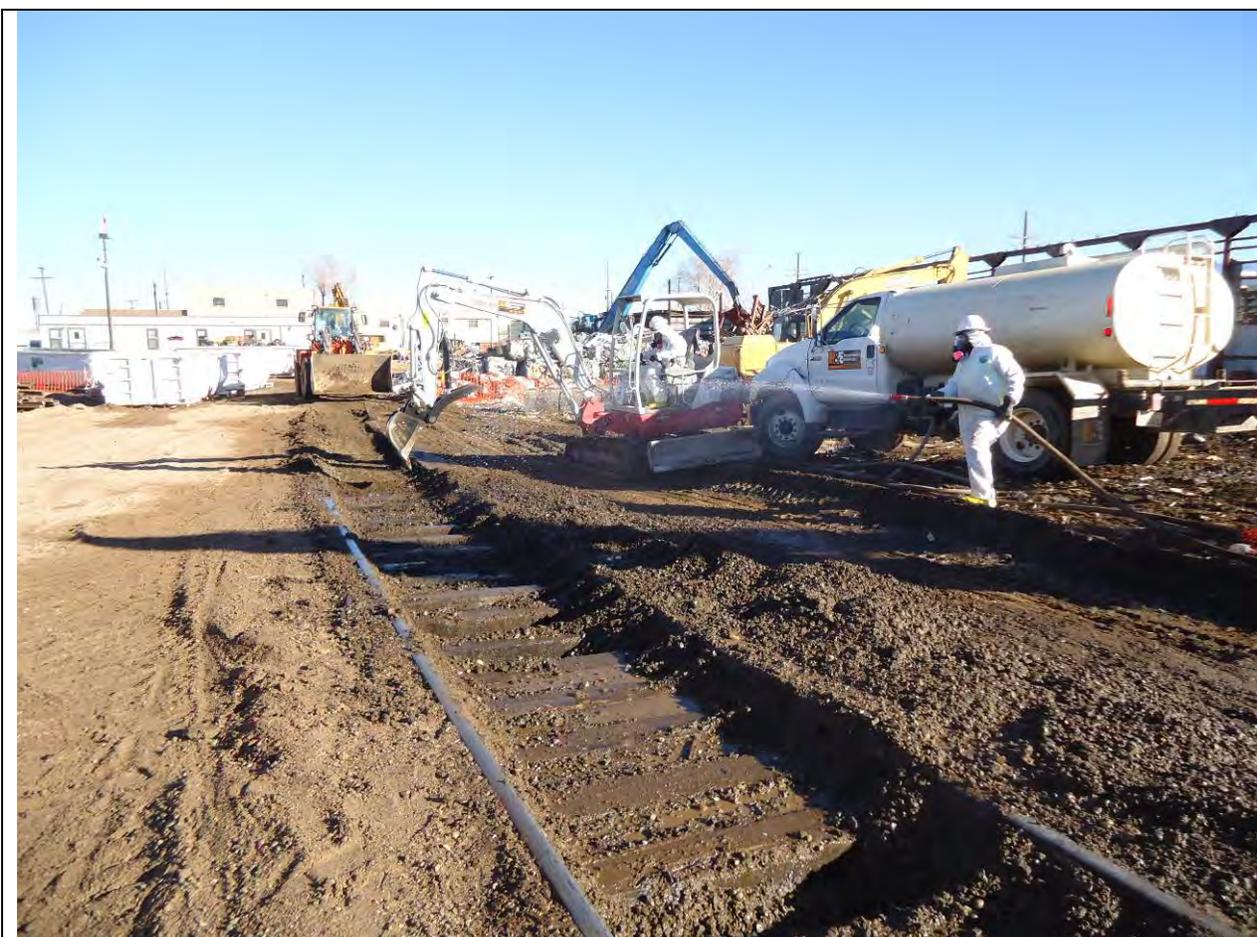
<b>Logbook Photo #</b>	DSC00913
<b>US EPA ID / Task Order Number</b>	CERCLIS: NMN000607041 / TDD No: 1/DYNAMAC-077-13-001
<b>Site</b>	Southwest Vermiculite (Removal 2)
<b>Location Address</b>	1800 1 <sup>st</sup> Street, NW
<b>City, State</b>	Albuquerque, New Mexico 87102
<b>County</b>	Bernalillo
<b>Direction/Orientation</b>	NE
<b>Date</b>	1/18/14
<b>Time</b>	0925
<b>Photographer</b>	N. Biscocho (START)
<b>Witness</b>	J. Koehnen (START)
<b>Description:</b>	Excavation and dust suppression activities in Area A, Grid D – West, including soil in the rail spur.

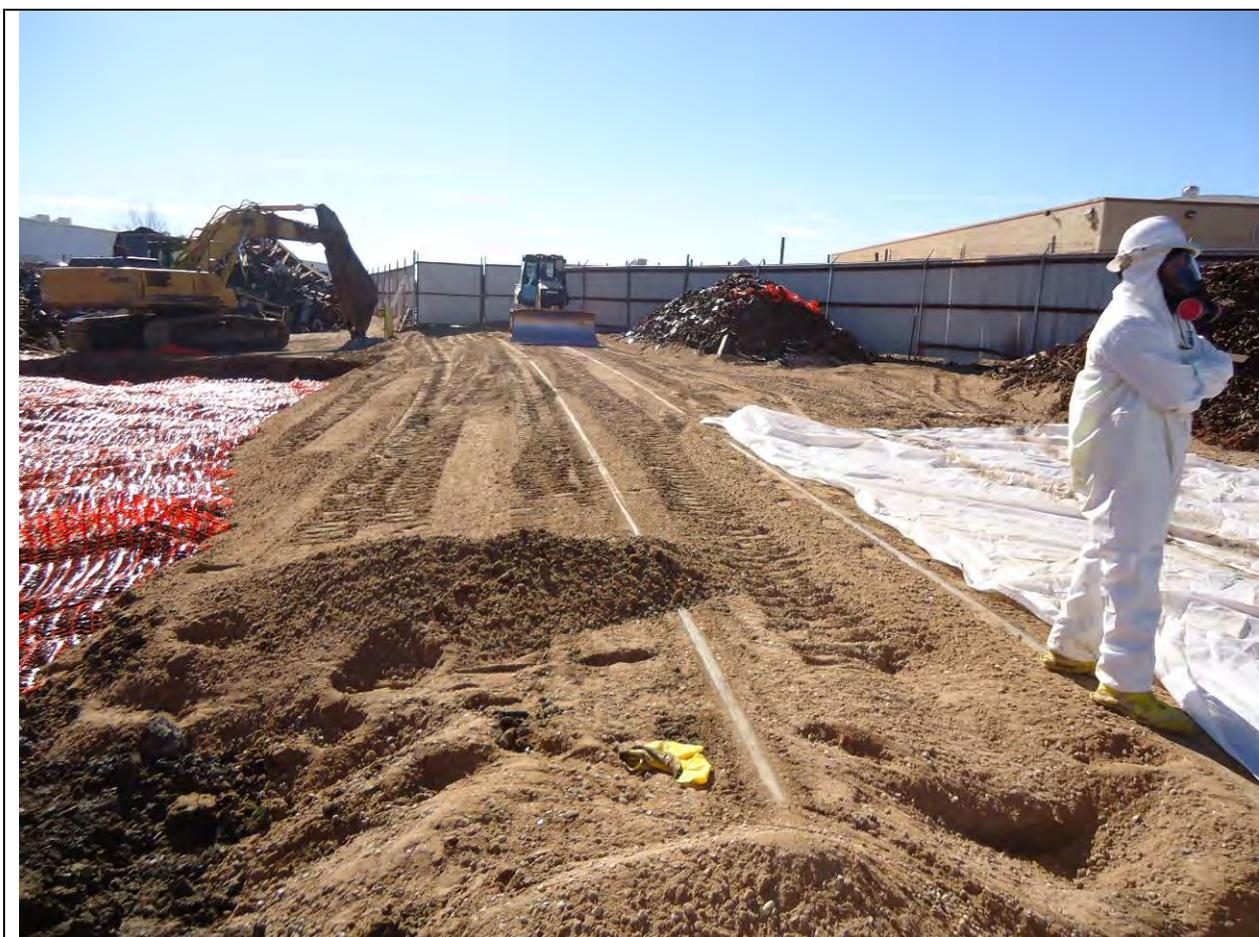
<b>Logbook Photo #</b>	DSC00933
<b>US EPA ID / Task Order Number</b>	CERCLIS: NMN000607041 / TDD No: 1/DYNAMAC-077-13-001
<b>Site</b>	Southwest Vermiculite (Removal 2)
<b>Location Address</b>	1800 1 <sup>st</sup> Street, NW
<b>City, State</b>	Albuquerque, New Mexico 87102
<b>County</b>	Bernalillo
<b>Direction/Orientation</b>	S
<b>Date</b>	1/19/14
<b>Time</b>	1134
<b>Photographer</b>	N. Biscocho (START)
<b>Witness</b>	J. Koehnen (START)
<b>Description:</b>	Backfill and soil grading activities on Area A, Grid D – West.

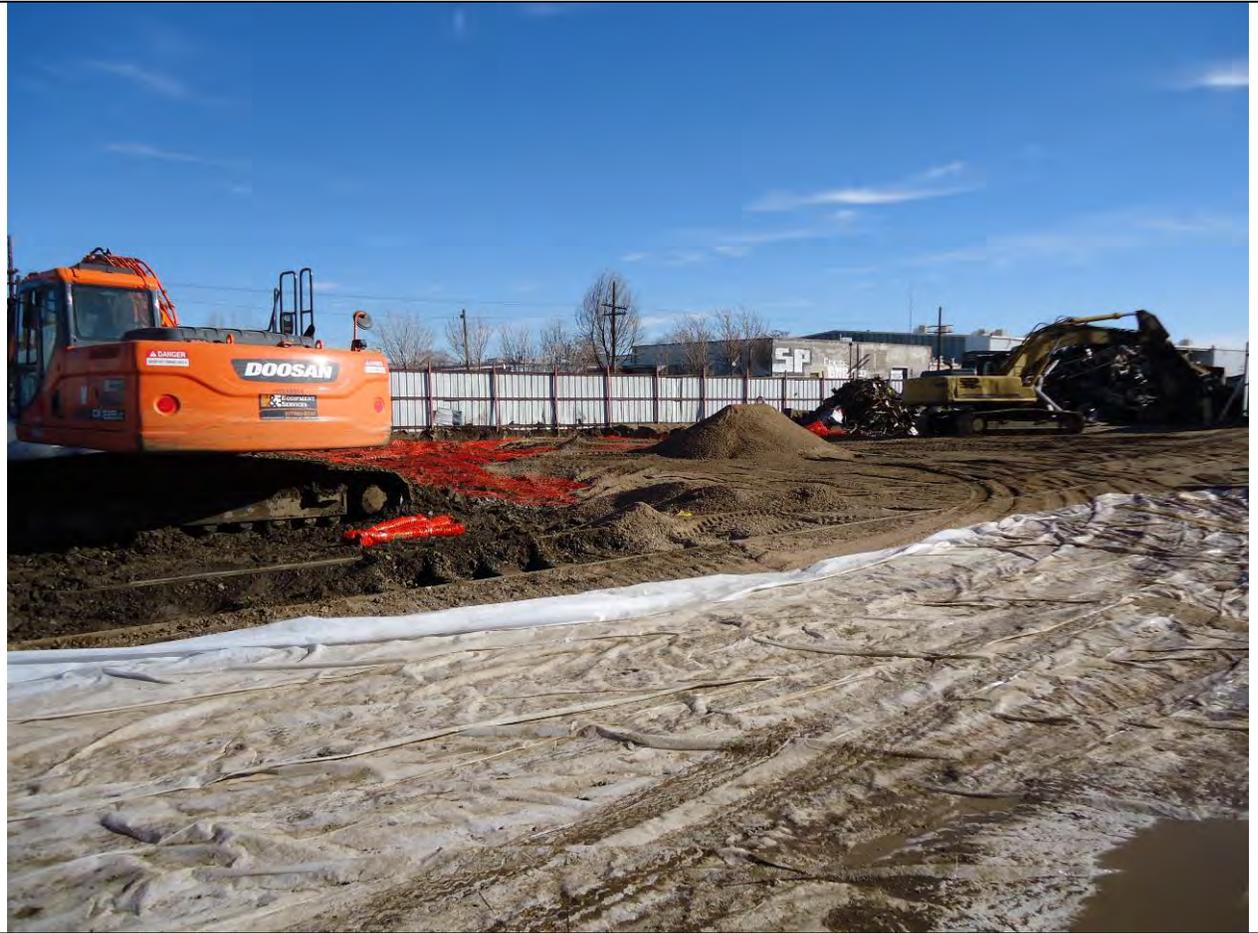
<b>Logbook Photo #</b>	DSC00934
<b>US EPA ID / Task Order Number</b>	CERCLIS: NMN000607041 / TDD No: 1/DYNAMAC-077-13-001
<b>Site</b>	Southwest Vermiculite (Removal 2)
<b>Location Address</b>	1800 1 <sup>st</sup> Street, NW
<b>City, State</b>	Albuquerque, New Mexico 87102
<b>County</b>	Bernalillo
<b>Direction/Orientation</b>	SE
<b>Date</b>	1/19/14
<b>Time</b>	1446
<b>Photographer</b>	N. Biscocho (START)
<b>Witness</b>	J. Koehnen (START)
<b>Description:</b>	Backfill activities on Area A, Grid D – East and Middle.

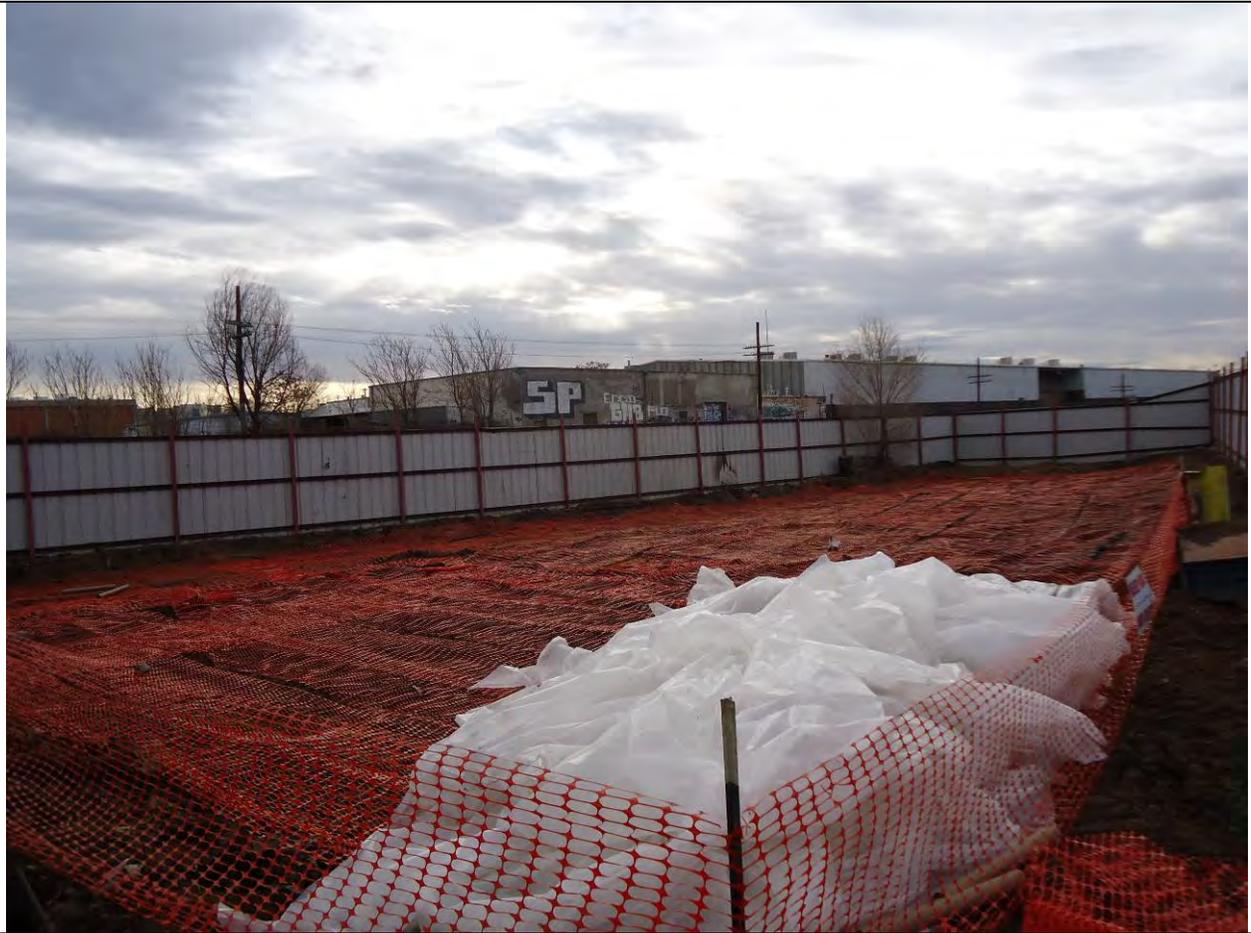
<b>Logbook Photo #</b>	DSC00766
<b>US EPA ID / Task Order Number</b>	CERCLIS: NMN000607041 / TDD No: 1/DYNAMAC-077-13-001
<b>Site</b>	Southwest Vermiculite (Removal 2)
<b>Location Address</b>	1800 1 <sup>st</sup> Street, NW
<b>City, State</b>	Albuquerque, New Mexico 87102
<b>County</b>	Bernalillo
<b>Direction/Orientation</b>	SE
<b>Date</b>	12/20/13
<b>Time</b>	0856
<b>Photographer</b>	N. Biscocho (START)
<b>Witness</b>	J. Koehnen (START)

**Description:**

Excavated Area A, Grid E and confirmation samples collected prior to backfill activities. Partial grid, see next photo for the remainder of Area A, Grid E.

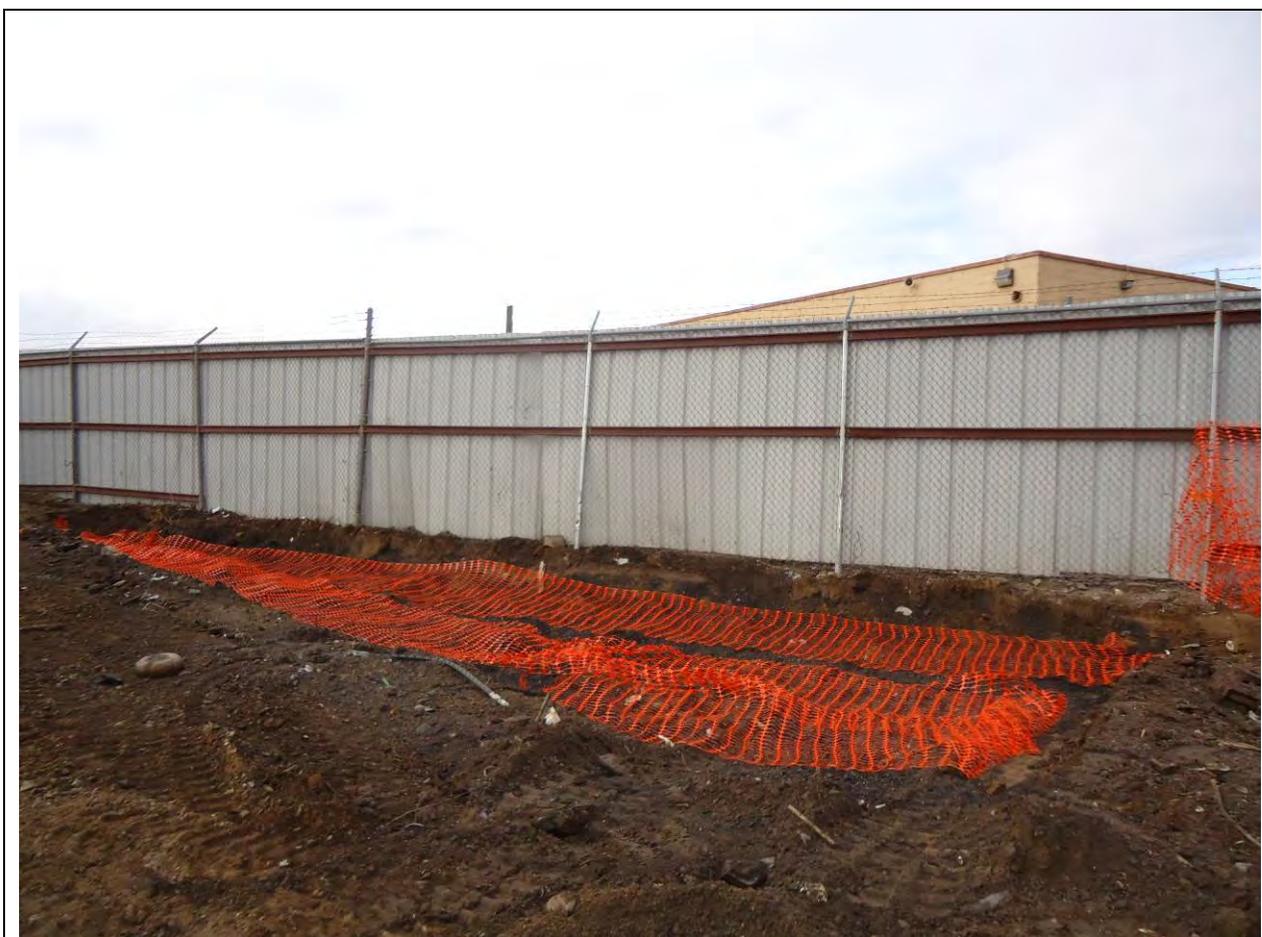
<b>Logbook Photo #</b>	DSC00767
<b>US EPA ID / Task Order Number</b>	CERCLIS: NMN000607041 / TDD No: 1/DYNAMAC-077-13-001
<b>Site</b>	Southwest Vermiculite (Removal 2)
<b>Location Address</b>	1800 1 <sup>st</sup> Street, NW
<b>City, State</b>	Albuquerque, New Mexico 87102
<b>County</b>	Bernalillo
<b>Direction/Orientation</b>	SW
<b>Date</b>	12/20/13
<b>Time</b>	0856
<b>Photographer</b>	N. Biscocho (START)
<b>Witness</b>	J. Koehnen (START)
<b>Description:</b>	
Excavated Area A, Grid E and confirmation samples collected prior to backfill activities. Partial grid, see previous photo for the remainder of Area A, Grid E.

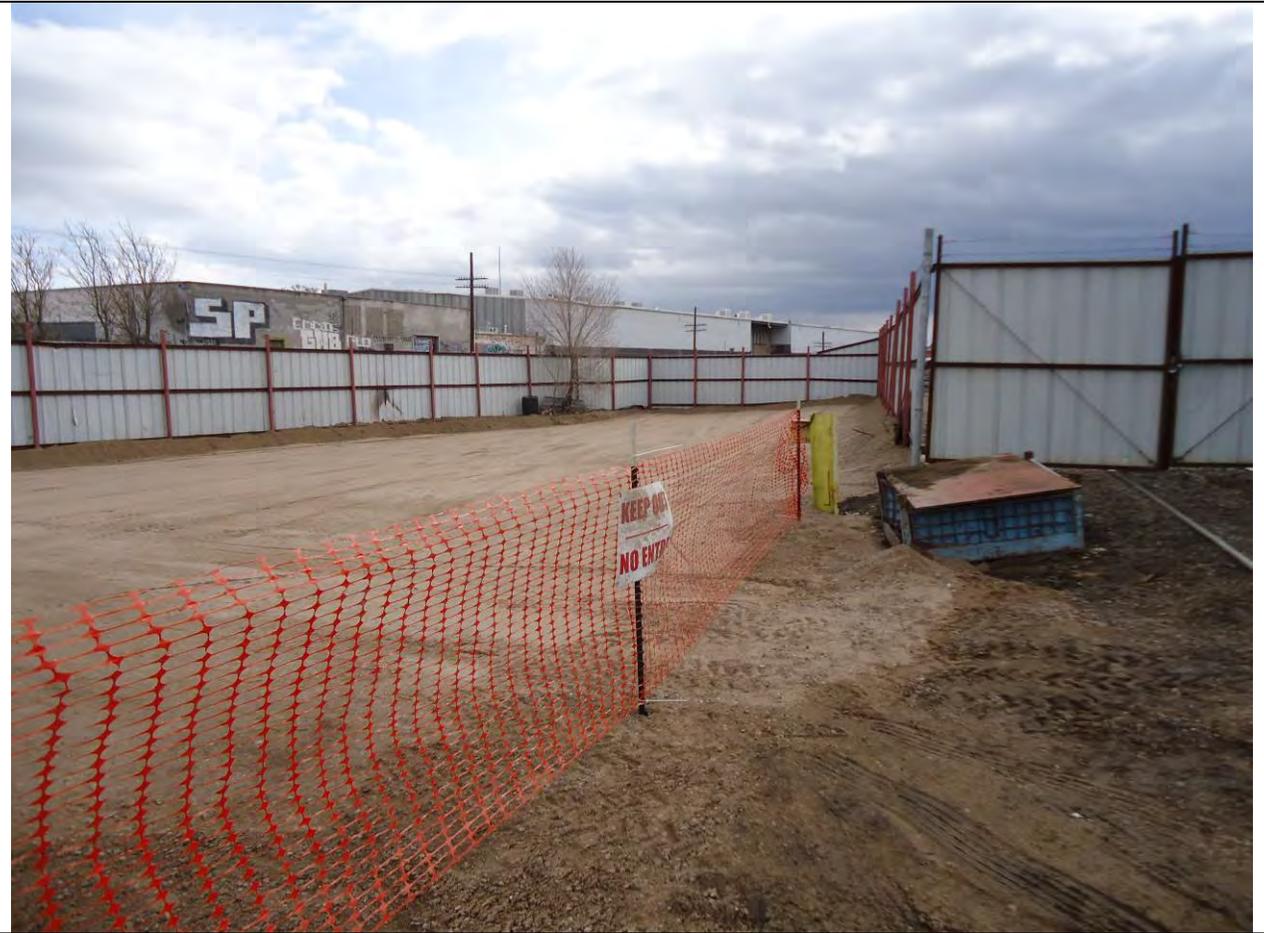
<b>Logbook Photo #</b>	DSC00788
<b>US EPA ID / Task Order Number</b>	CERCLIS: NMN000607041 / TDD No: 1/DYNAMAC-077-13-001
<b>Site</b>	Southwest Vermiculite (Removal 2)
<b>Location Address</b>	1800 1 <sup>st</sup> Street, NW
<b>City, State</b>	Albuquerque, New Mexico 87102
<b>County</b>	Bernalillo
<b>Direction/Orientation</b>	SE
<b>Date</b>	12/21/13
<b>Time</b>	1252
<b>Photographer</b>	N. Biscocho (START)
<b>Witness</b>	J. Koehnen (START)
<b>Description:</b>	<p>Area A, Grid E backfilled after excavation and confirmation samples collected.            Partial grid, see next photo for the remainder of Area A, Grid E.</p>

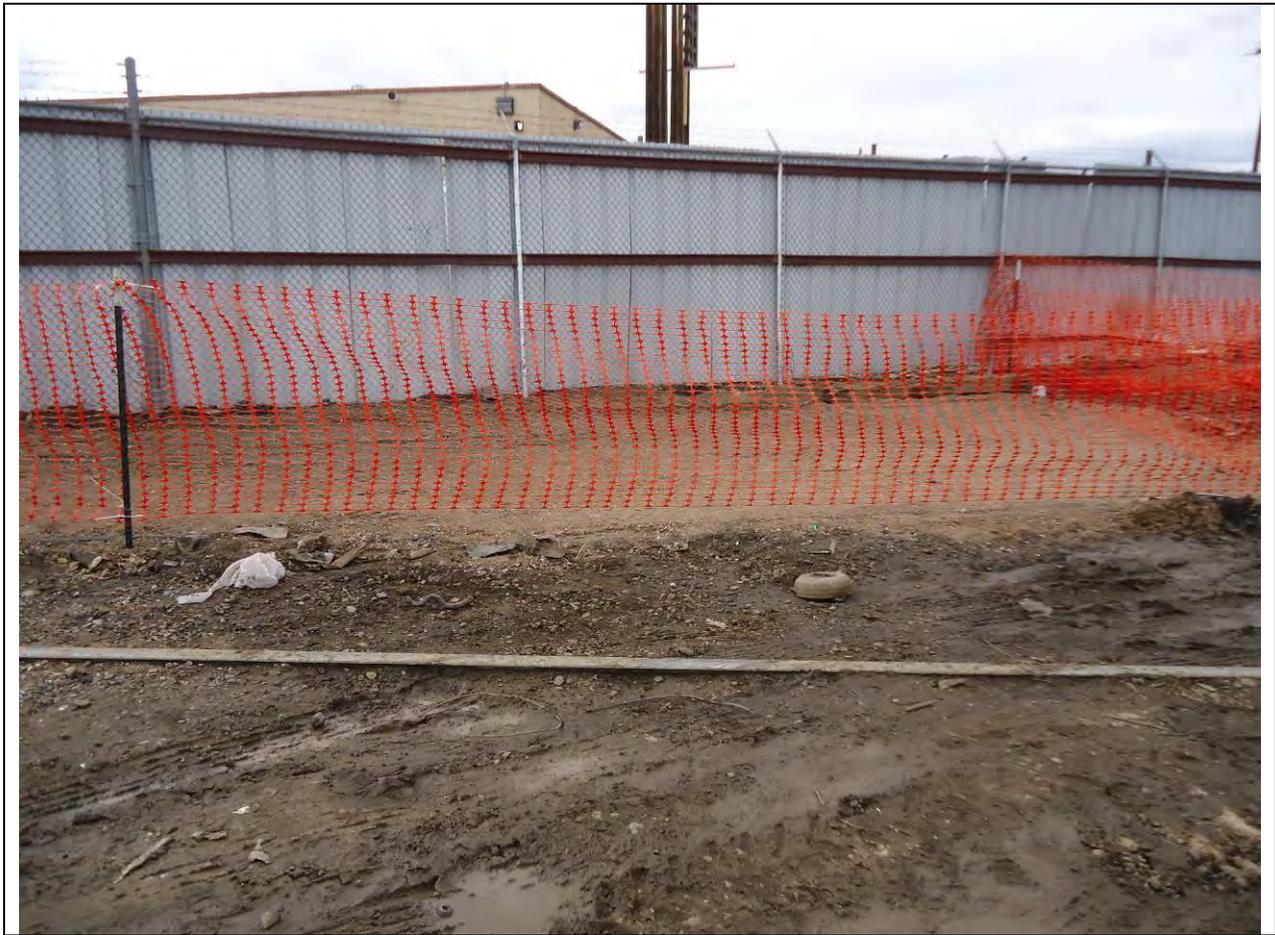
<b>Logbook Photo #</b>	DSC00790
<b>US EPA ID / Task Order Number</b>	CERCLIS: NMN000607041 / TDD No: 1/DYNAMAC-077-13-001
<b>Site</b>	Southwest Vermiculite (Removal 2)
<b>Location Address</b>	1800 1 <sup>st</sup> Street, NW
<b>City, State</b>	Albuquerque, New Mexico 87102
<b>County</b>	Bernalillo
<b>Direction/Orientation</b>	W
<b>Date</b>	12/21/13
<b>Time</b>	1253
<b>Photographer</b>	N. Biscocho (START)
<b>Witness</b>	J. Koehnen (START)
<b>Description:</b>	
<p>Area A, Grid E backfilled after excavation and confirmation samples collected.            Partial grid, see previous photo for the remainder of Area A, Grid E.</p>

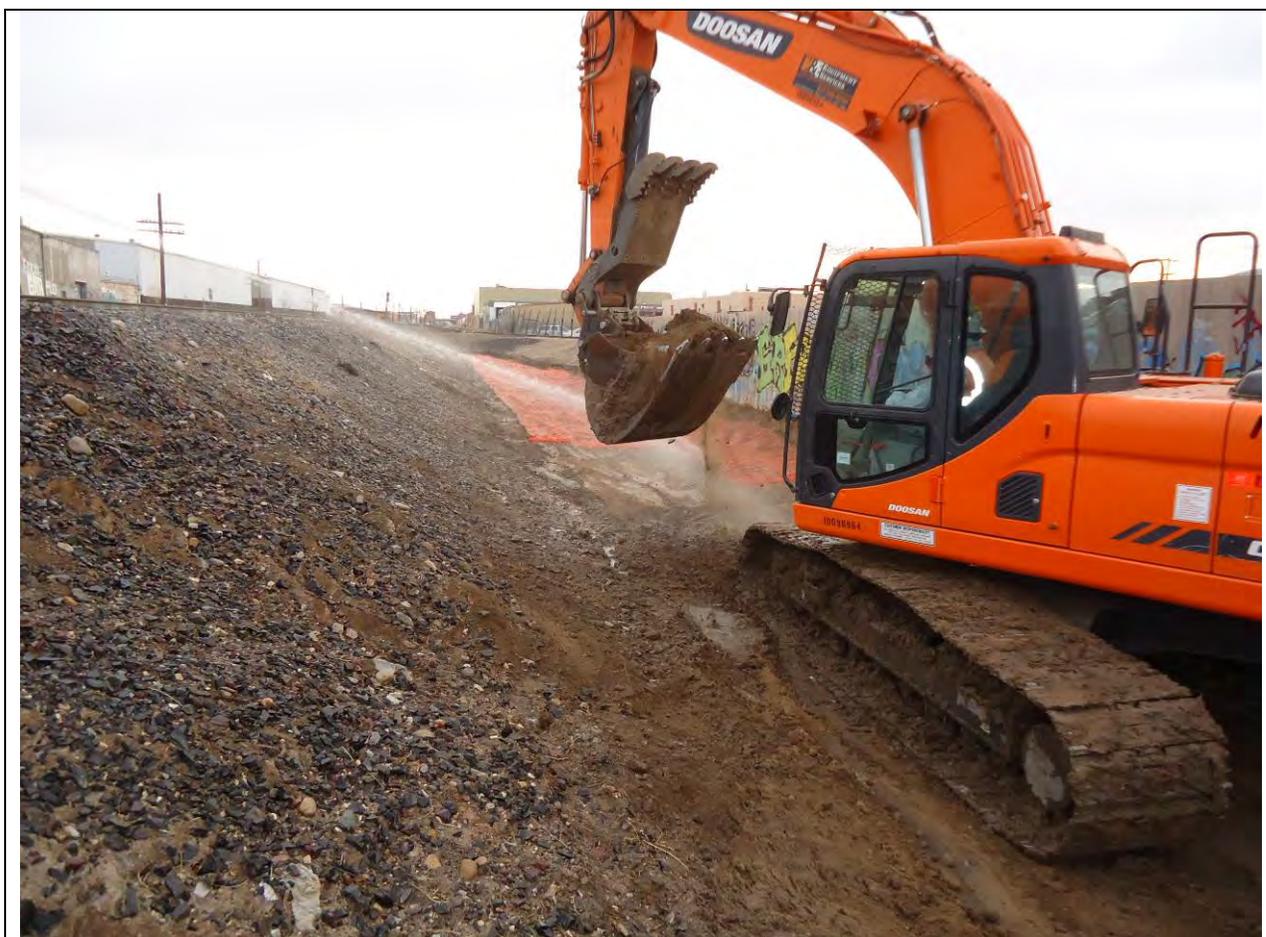
<b>Logbook Photo #</b>	DSC00821
<b>US EPA ID / Task Order Number</b>	CERCLIS: NMN000607041 / TDD No: 1/DYNAMAC-077-13-001
<b>Site</b>	Southwest Vermiculite (Removal 2)
<b>Location Address</b>	1800 1 <sup>st</sup> Street, NW
<b>City, State</b>	Albuquerque, New Mexico 87102
<b>County</b>	Bernalillo
<b>Direction/Orientation</b>	S
<b>Date</b>	1/7/14
<b>Time</b>	1529
<b>Photographer</b>	N. Biscocho (START)
<b>Witness</b>	J. Koehnen (START)
<b>Description:</b>	
Excavation and dust suppression activities in Area B – NM DOT Rail Road Right-of-Way.

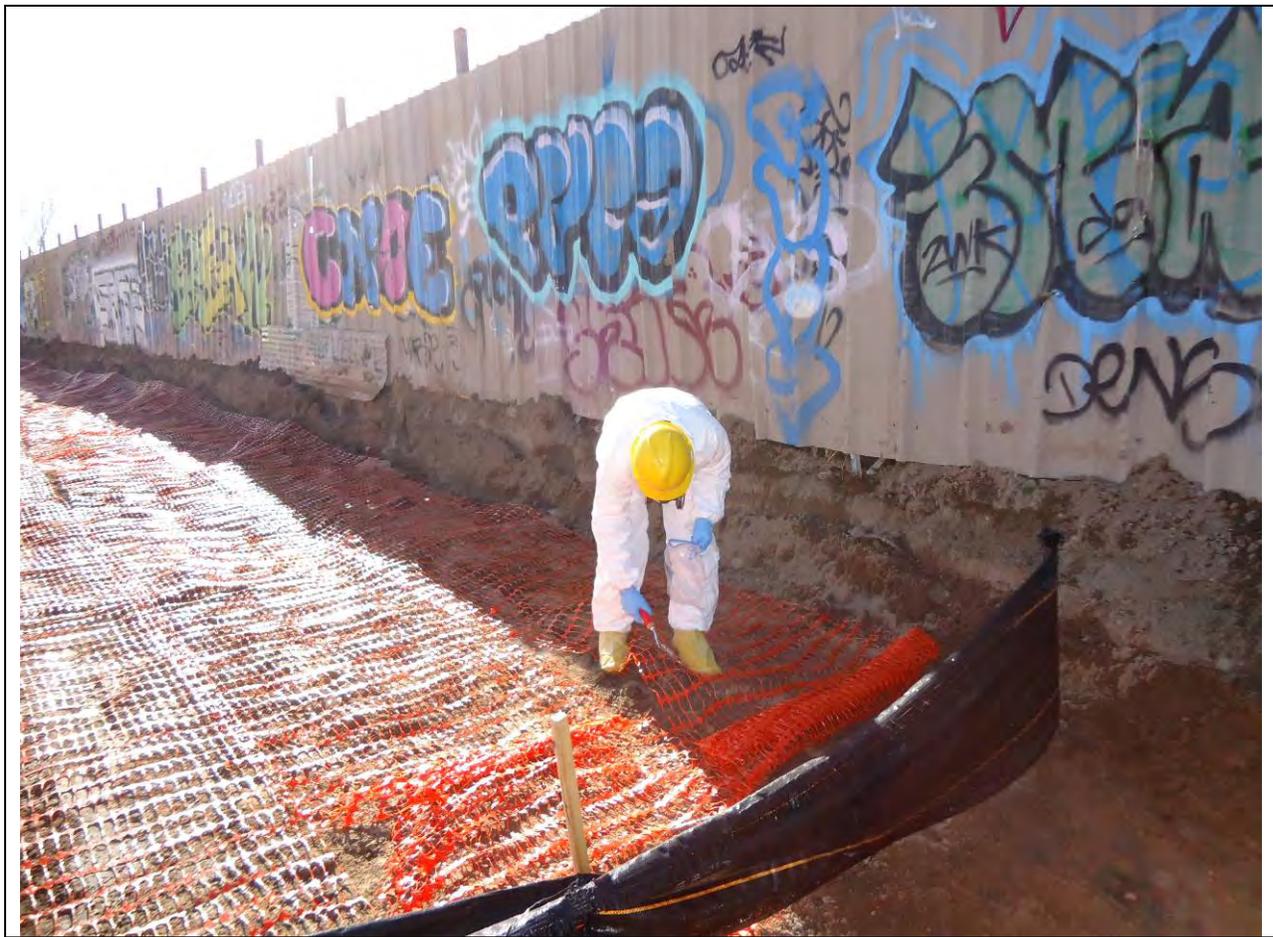
<b>Logbook Photo #</b>	DSC00839
<b>US EPA ID / Task Order Number</b>	CERCLIS: NMN000607041 / TDD No: 1/DYNAMAC-077-13-001
<b>Site</b>	Southwest Vermiculite (Removal 2)
<b>Location Address</b>	1800 1 <sup>st</sup> Street, NW
<b>City, State</b>	Albuquerque, New Mexico 87102
<b>County</b>	Bernalillo
<b>Direction/Orientation</b>	SW
<b>Date</b>	1/8/14
<b>Time</b>	1341
<b>Photographer</b>	N. Biscocho (START)
<b>Witness</b>	J. Koehnen (START)
<b>Description:</b>	Confirmation soil sampling activities in Area B – NM DOT Rail Road Right-of-Way.

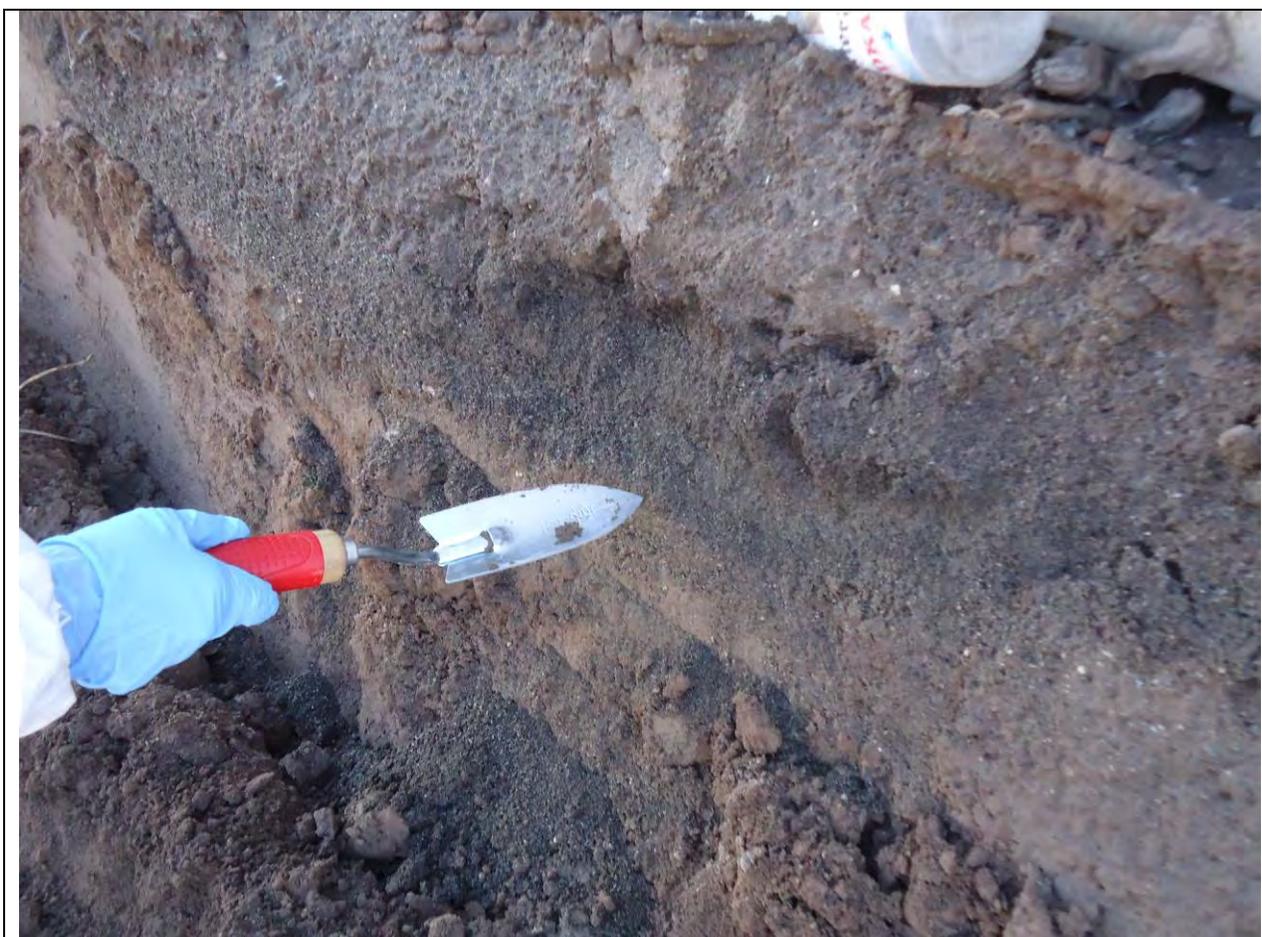
<b>Logbook Photo #</b>	DSC00843
<b>US EPA ID / Task Order Number</b>	CERCLIS: NMN000607041 / TDD No: 1/DYNAMAC-077-13-001
<b>Site</b>	Southwest Vermiculite (Removal 2)
<b>Location Address</b>	1800 1 <sup>st</sup> Street, NW
<b>City, State</b>	Albuquerque, New Mexico 87102
<b>County</b>	Bernalillo
<b>Direction/Orientation</b>	SW
<b>Date</b>	1/8/14
<b>Time</b>	1351
<b>Photographer</b>	N. Biscocho (START)
<b>Witness</b>	J. Koehnen (START)
<b>Description:</b>	
View of a vein of possible vermiculite located along Area B, Grids 013 and 014, after excavation activities. The sample is in Area B – NM Rail Road Right-of-Way. A sample was sent to the lab for analysis.

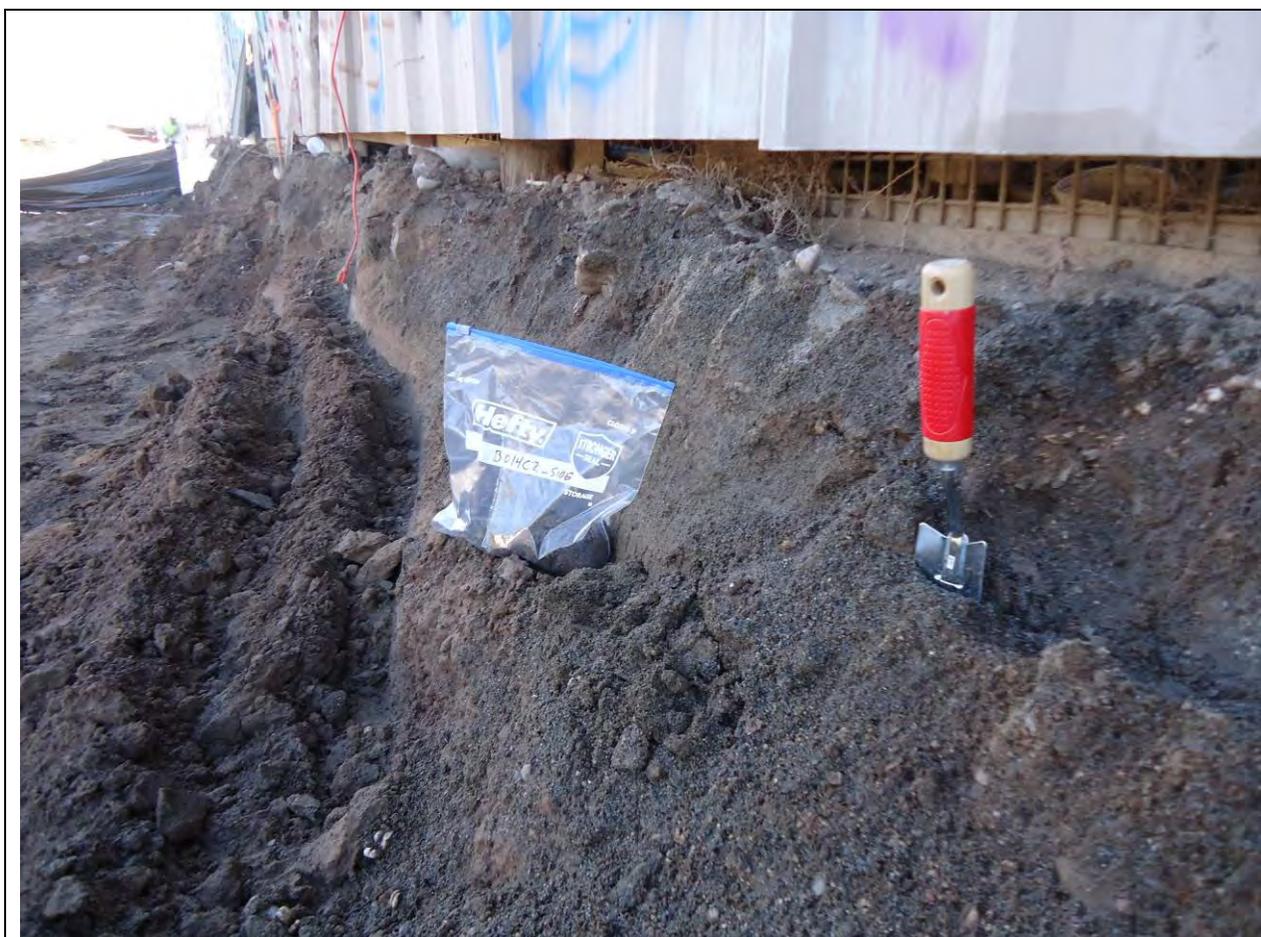
<b>Logbook Photo #</b>	DSC00845
<b>US EPA ID / Task Order Number</b>	CERCLIS: NMN000607041 / TDD No: 1/DYNAMAC-077-13-001
<b>Site</b>	Southwest Vermiculite (Removal 2)
<b>Location Address</b>	1800 1 <sup>st</sup> Street, NW
<b>City, State</b>	Albuquerque, New Mexico 87102
<b>County</b>	Bernalillo
<b>Direction/Orientation</b>	S
<b>Date</b>	1/8/14
<b>Time</b>	1445
<b>Photographer</b>	N. Biscocho (START)
<b>Witness</b>	J. Koehnen (START)
<b>Description:</b>	View of a vein of possible vermiculite located along Area B, Grids 013 and 014, after excavation activities. The sample is in Area B – NM Rail Road Right-of-Way. A sample was sent to the lab for analysis.

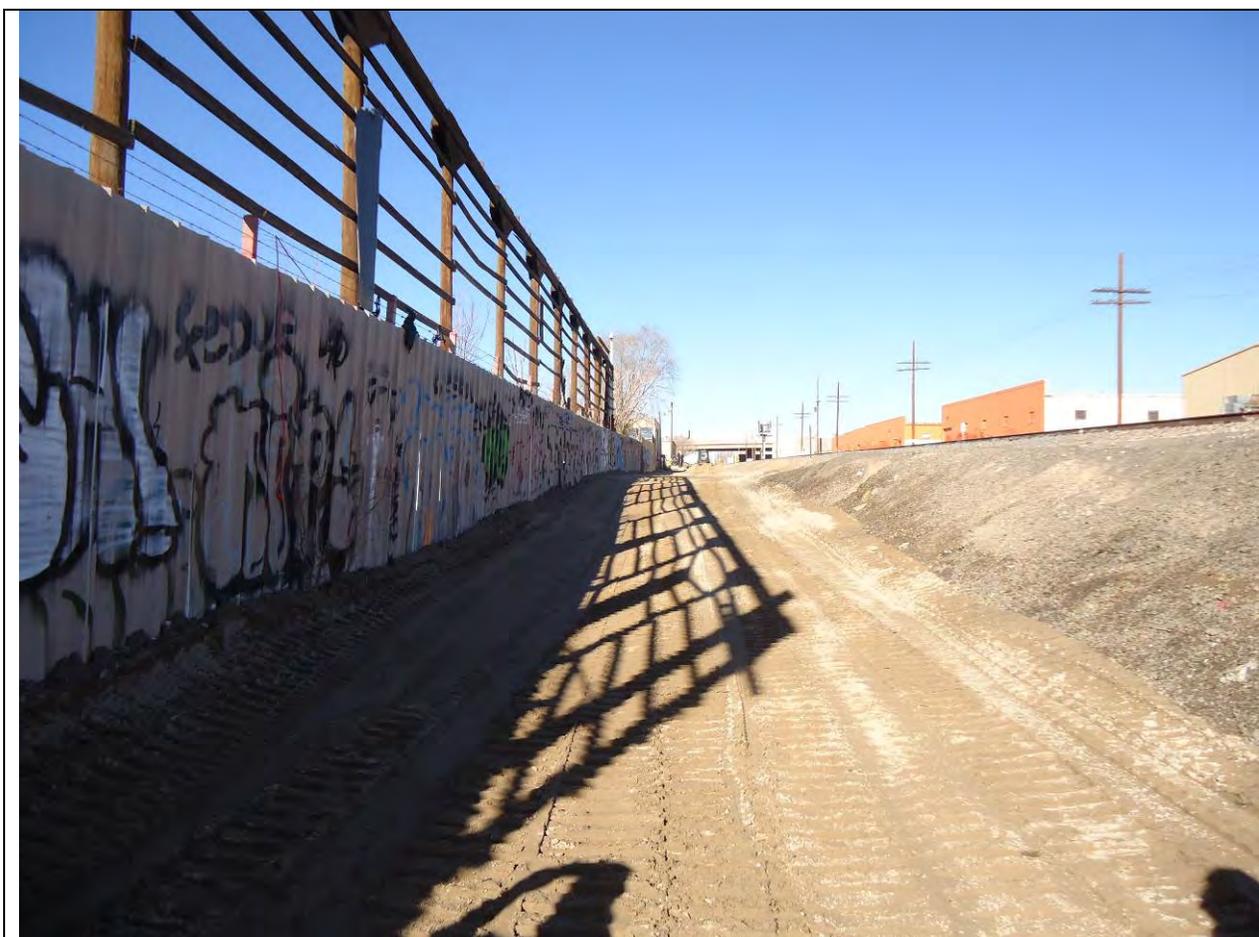
<b>Logbook Photo #</b>	DSC00891
<b>US EPA ID / Task Order Number</b>	CERCLIS: NMN000607041 / TDD No: 1/DYNAMAC-077-13-001
<b>Site</b>	Southwest Vermiculite (Removal 2)
<b>Location Address</b>	1800 1 <sup>st</sup> Street, NW
<b>City, State</b>	Albuquerque, New Mexico 87102
<b>County</b>	Bernalillo
<b>Direction/Orientation</b>	N
<b>Date</b>	1/15/14
<b>Time</b>	1405
<b>Photographer</b>	N. Biscocho (START)
<b>Witness</b>	J. Koehnen (START)
<b>Description:</b>	
Area B – NMDOT Rail Road Right-of-Way backfilled after excavation and soil confirmation activities.

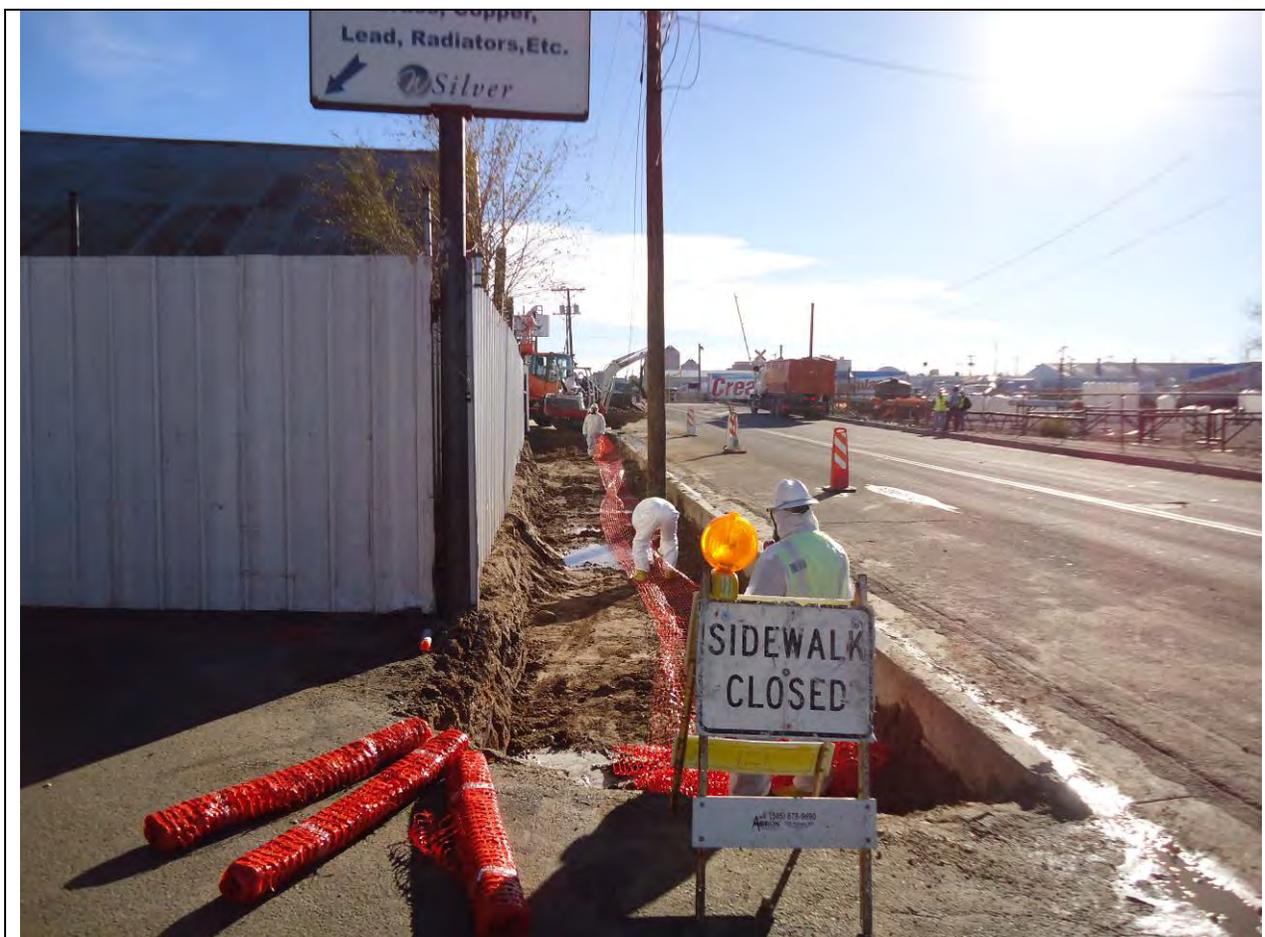
<b>Logbook Photo #</b>	DC00673
<b>US EPA ID / Task Order Number</b>	CERCLIS: NMN000607041 / TDD No: 1/DYNAMAC-077-13-001
<b>Site</b>	Southwest Vermiculite (Removal 2)
<b>Location Address</b>	1800 1 <sup>st</sup> Street, NW
<b>City, State</b>	Albuquerque, New Mexico 87102
<b>County</b>	Bernalillo
<b>Direction/Orientation</b>	S
<b>Date</b>	12/3/13
<b>Time</b>	1444
<b>Photographer</b>	N. Biscocho (START)
<b>Witness</b>	J. Koehnen (START)
<b>Description:</b>	Confirmation soil sampling (5-pt composite) after a two-foot removal on Area E, Grid 001 (City of Albuquerque, Right-of-Way).

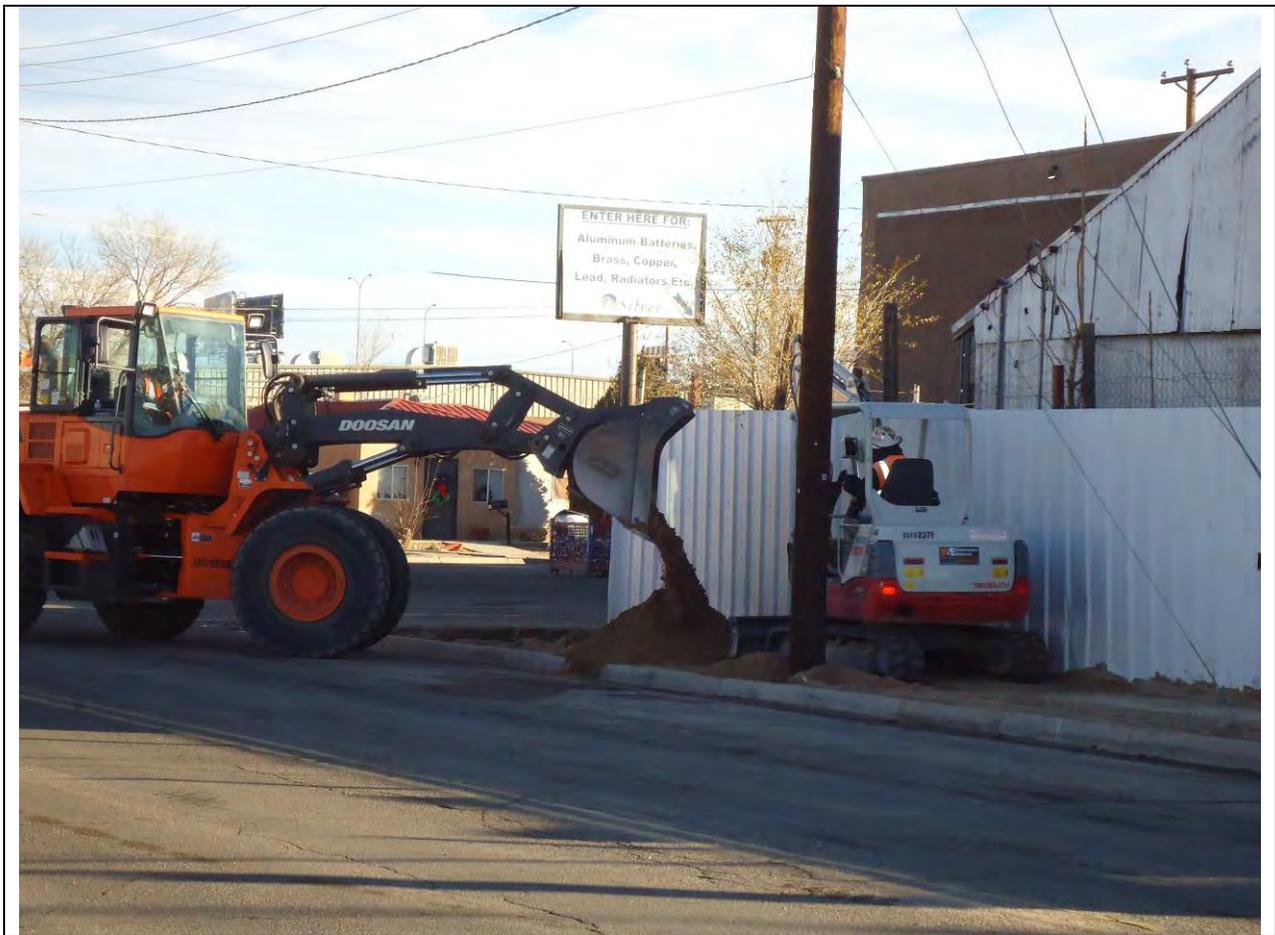
<b>Logbook Photo #</b>	DSC00676
<b>US EPA ID / Task Order Number</b>	CERCLIS: NMN000607041 / TDD No: 1/DYNAMAC-077-13-001
<b>Site</b>	Southwest Vermiculite (Removal 2)
<b>Location Address</b>	1800 1 <sup>st</sup> Street, NW
<b>City, State</b>	Albuquerque, New Mexico 87102
<b>County</b>	Bernalillo
<b>Direction/Orientation</b>	NE
<b>Date</b>	12/4/13
<b>Time</b>	0818
<b>Photographer</b>	N. Biscocho (START)
<b>Witness</b>	J. Koehnen (START)
<b>Description:</b>	Backfill activities after excavation and confirmation soil sampling on Area E, Grid 001 (City of Albuquerque, Right-of-Way).

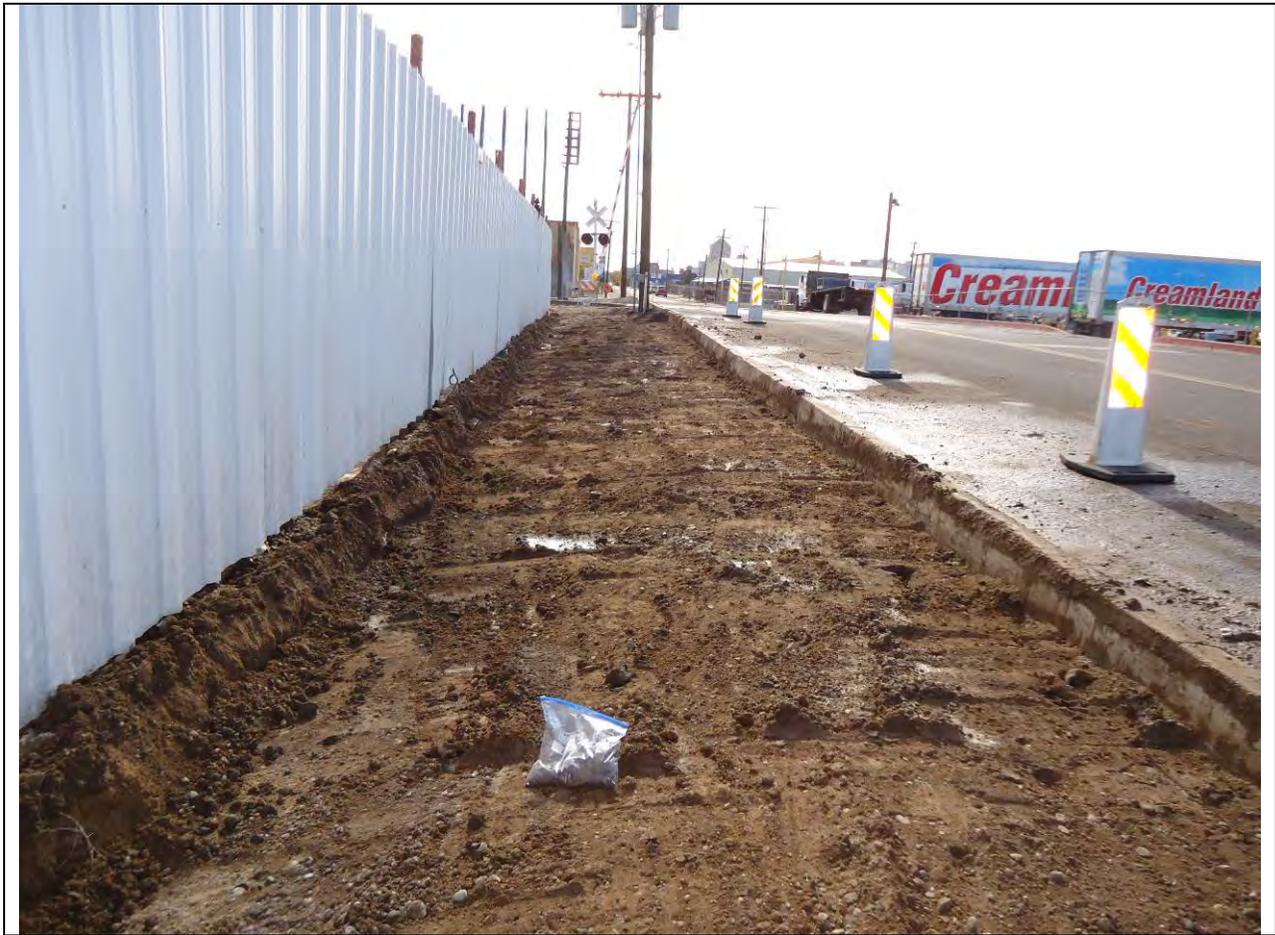
<b>Logbook Photo #</b>	DSC00643
<b>US EPA ID / Task Order Number</b>	CERCLIS: NMN000607041 / TDD No: 1/DYNAMAC-077-13-001
<b>Site</b>	Southwest Vermiculite (Removal 2)
<b>Location Address</b>	1800 1 <sup>st</sup> Street, NW
<b>City, State</b>	Albuquerque, New Mexico 87102
<b>County</b>	Bernalillo
<b>Direction/Orientation</b>	S
<b>Date</b>	11/19/13
<b>Time</b>	1236
<b>Photographer</b>	N. Biscocho (START)
<b>Witness</b>	J. Koehnen (START)
<b>Description:</b>	Confirmation soil sampling (5-pt composite) after a one-foot removal on Area E, Grid 002 (City of Albuquerque, Right-of-Way).
