## Appendix C

### Photo Documentation

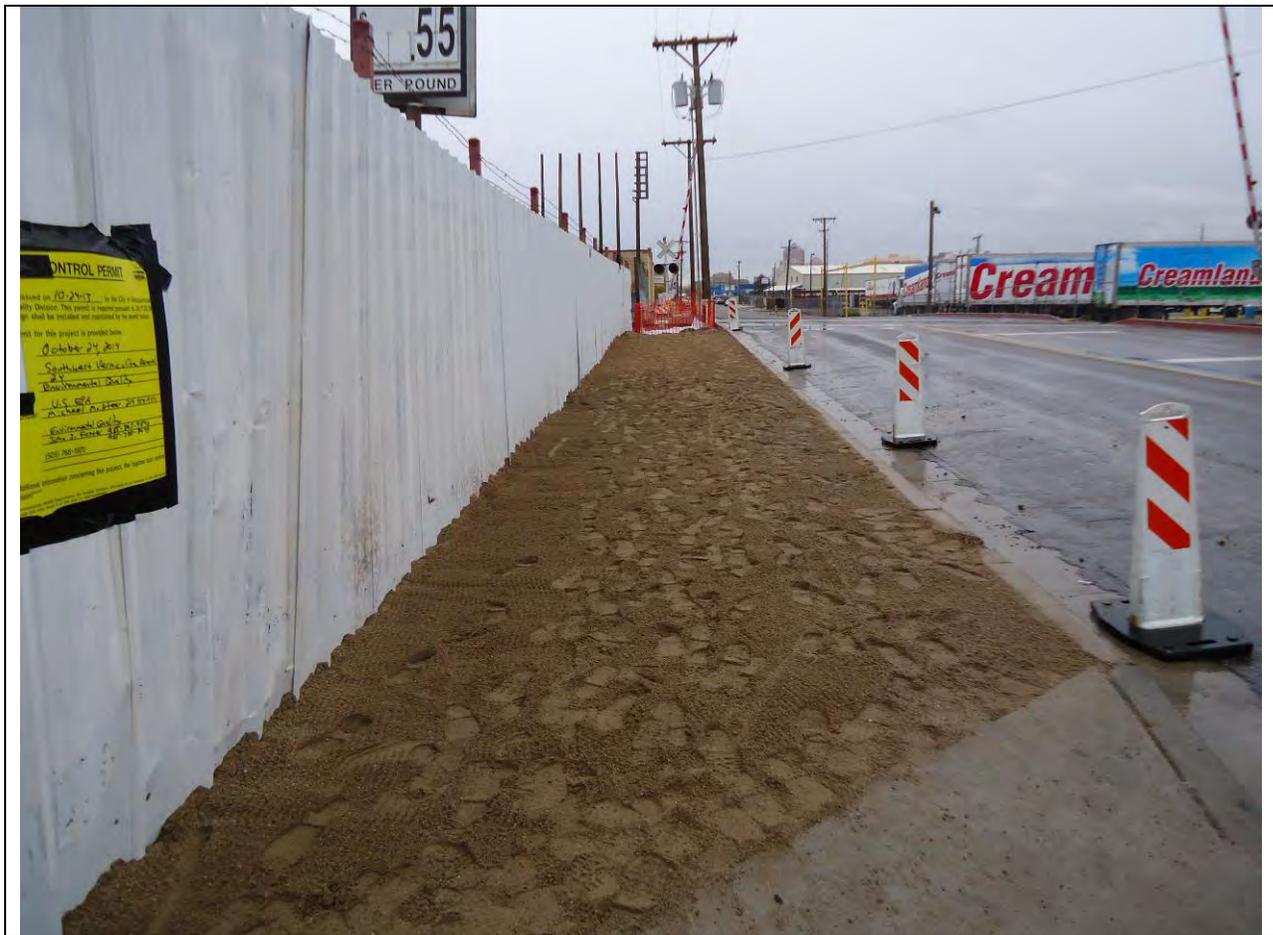
<b>Logbook Photo #</b>	DSC00645
<b>US EPA ID / Task Order Number</b>	CERCLIS: NMN000607041 / TDD No: 1/DYNAMAC-077-13-001
<b>Site</b>	Southwest Vermiculite (Removal 2)
<b>Location Address</b>	1800 1 <sup>st</sup> Street, NW
<b>City, State</b>	Albuquerque, New Mexico 87102
<b>County</b>	Bernalillo
<b>Direction/Orientation</b>	S
<b>Date</b>	11/20/13
<b>Time</b>	1556
<b>Photographer</b>	N. Biscocho (START)
<b>Witness</b>	J. Koehnen (START)
<b>Description:</b>	Area E, Grid 002 (City of Albuquerque, Right-of-Way) backfilled after excavation and confirmation soil sampling.

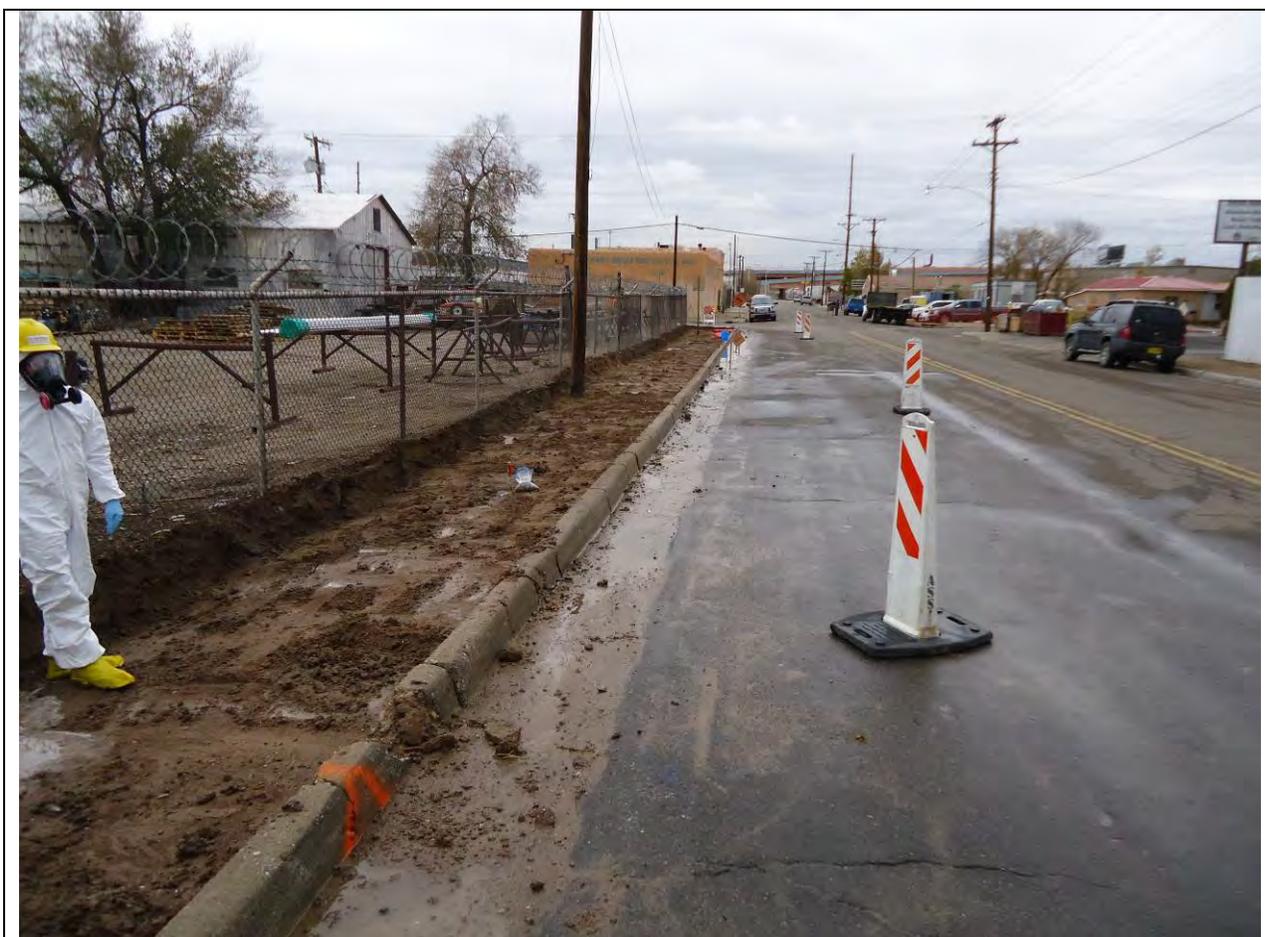
<b>Logbook Photo #</b>	DSC00647
<b>US EPA ID / Task Order Number</b>	CERCLIS: NMN000607041 / TDD No: 1/DYNAMAC-077-13-001
<b>Site</b>	Southwest Vermiculite (Removal 2)
<b>Location Address</b>	1800 1 <sup>st</sup> Street, NW
<b>City, State</b>	Albuquerque, New Mexico 87102
<b>County</b>	Bernalillo
<b>Direction/Orientation</b>	N
<b>Date</b>	11/21/13
<b>Time</b>	1122
<b>Photographer</b>	N. Biscocho (START)
<b>Witness</b>	J. Koehnen (START)
<b>Description:</b>	Confirmation soil sampling (5-pt composite) after a one-foot removal on Area E, Grid 006 (City of Albuquerque, Right-of-Way).

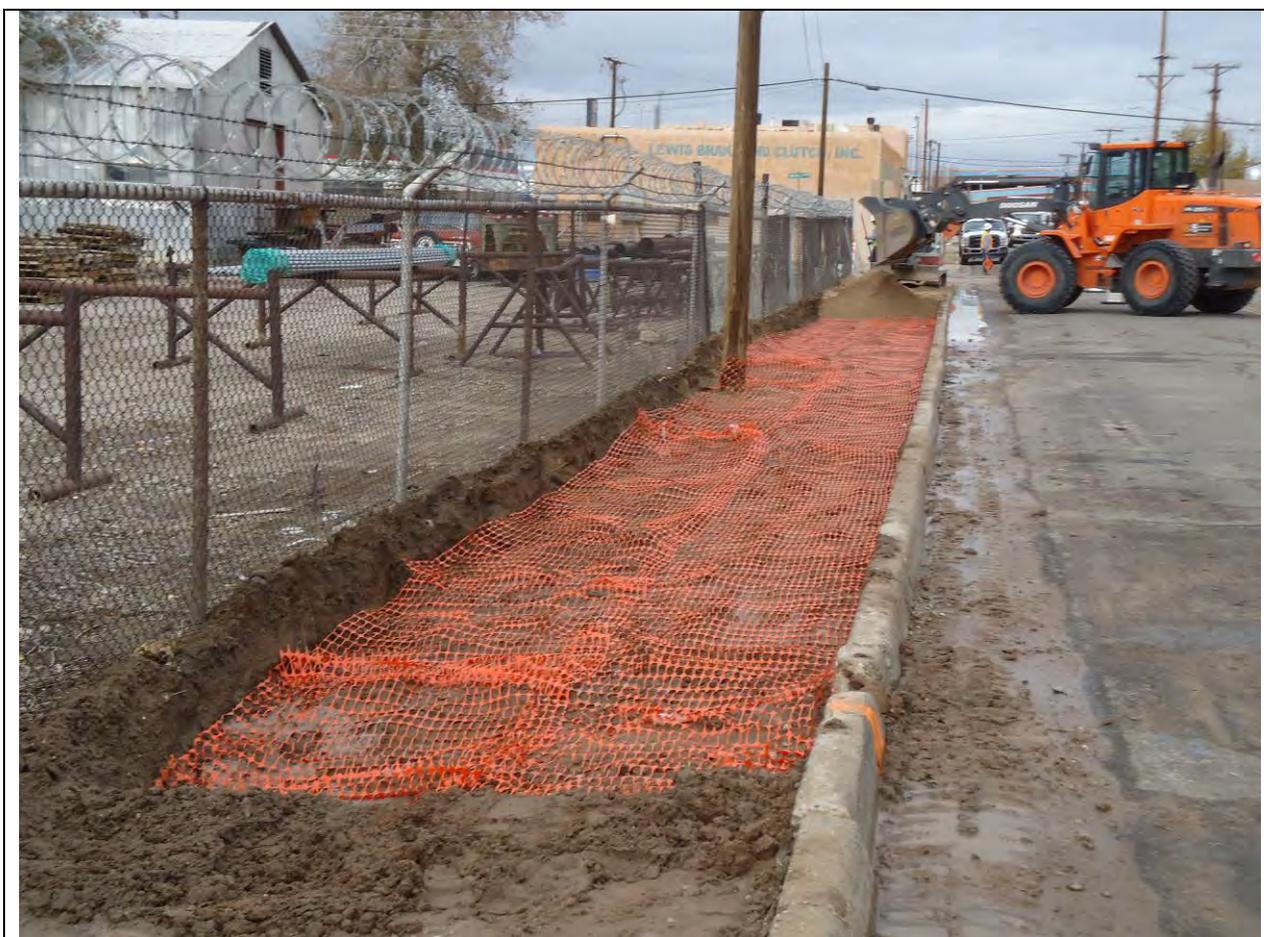
<b>Logbook Photo #</b>	DSC00649
<b>US EPA ID / Task Order Number</b>	CERCLIS: NMN000607041 / TDD No: 1/DYNAMAC-077-13-001
<b>Site</b>	Southwest Vermiculite (Removal 2)
<b>Location Address</b>	1800 1 <sup>st</sup> Street, NW
<b>City, State</b>	Albuquerque, New Mexico 87102
<b>County</b>	Bernalillo
<b>Direction/Orientation</b>	N
<b>Date</b>	11/21/13
<b>Time</b>	1252
<b>Photographer</b>	N. Biscocho (START)
<b>Witness</b>	J. Koehnen (START)
<b>Description:</b>	Backfill activities on Area E, Grid 006 (City of Albuquerque, Right-of-Way) after excavation and soil confirmation sampling.

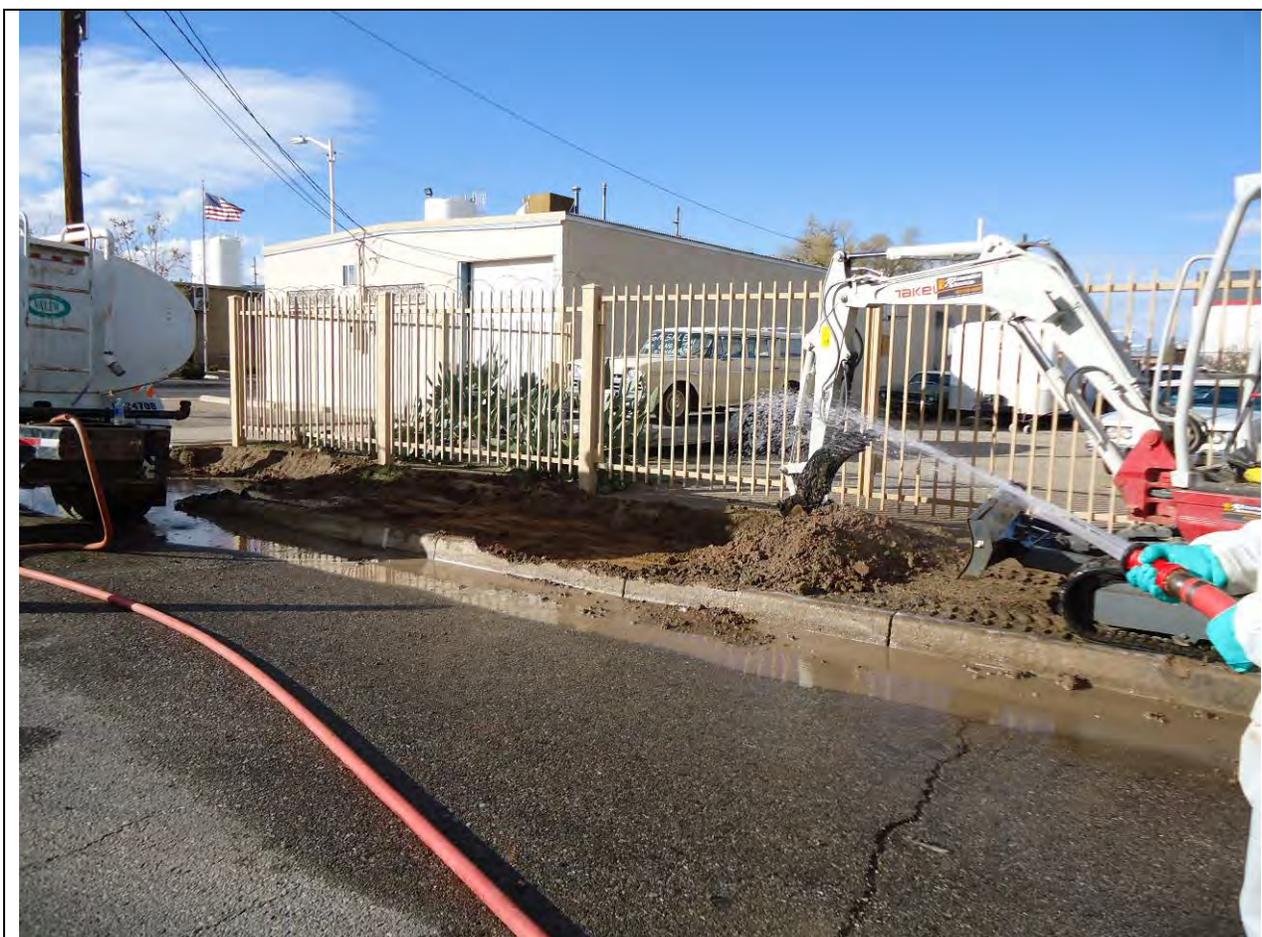
<b>Logbook Photo #</b>	DSC00630
<b>US EPA ID / Task Order Number</b>	CERCLIS: NMN000607041 / TDD No: 1/DYNAMAC-077-13-001
<b>Site</b>	Southwest Vermiculite (Removal 2)
<b>Location Address</b>	1800 1 <sup>st</sup> Street, NW
<b>City, State</b>	Albuquerque, New Mexico 87102
<b>County</b>	Bernalillo
<b>Direction/Orientation</b>	NW
<b>Date</b>	11/16/14
<b>Time</b>	1449
<b>Photographer</b>	N. Biscocho (START)
<b>Witness</b>	J. Koehnen (START)
<b>Description:</b>	Excavation activities on Area E, Grids 010 and 011 (City of Albuquerque, Right-of-Way). Dust suppression in progress.

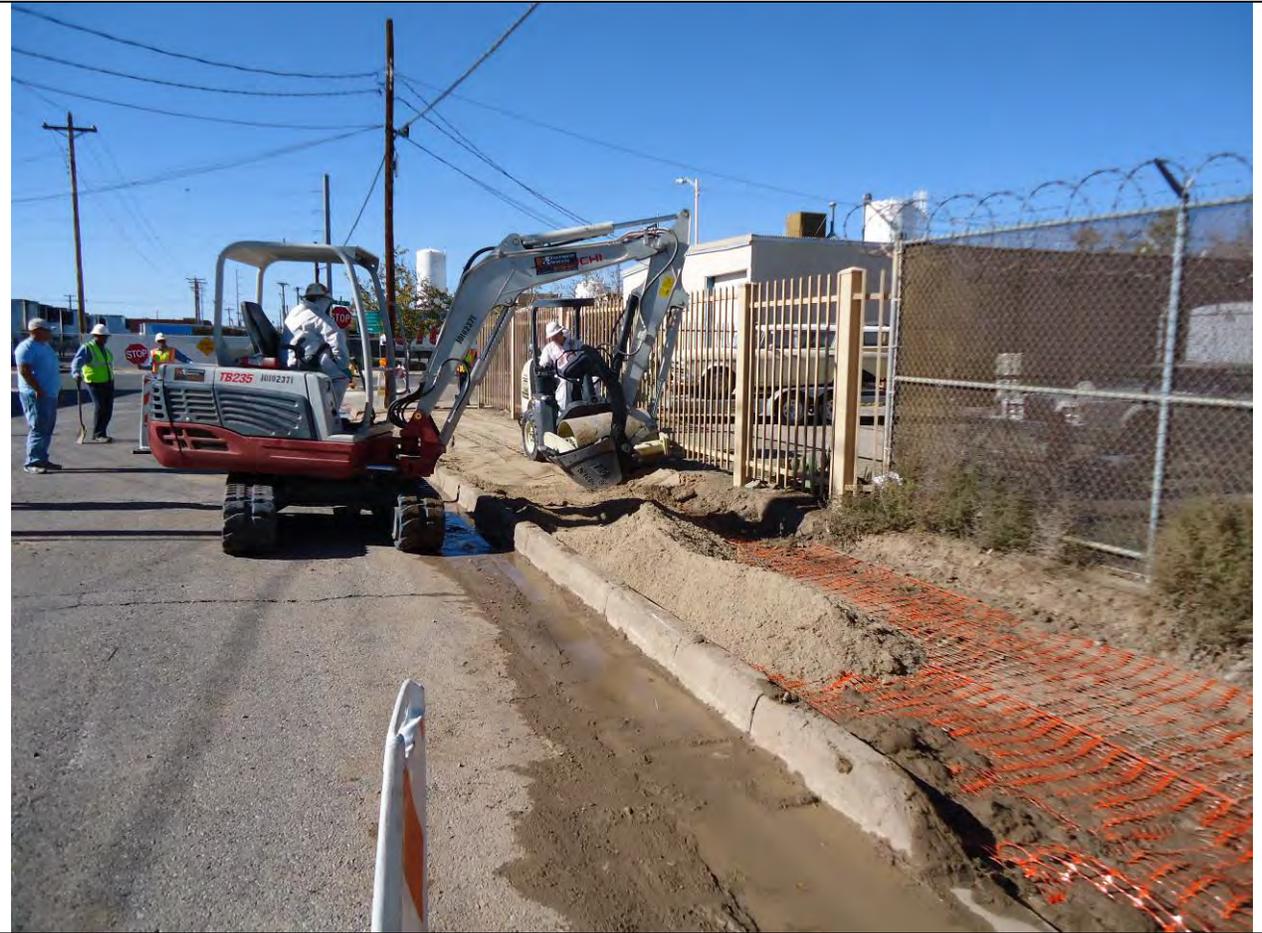
<b>Logbook Photo #</b>	DSC00632
<b>US EPA ID / Task Order Number</b>	CERCLIS: NMN000607041 / TDD No: 1/DYNAMAC-077-13-001
<b>Site</b>	Southwest Vermiculite (Removal 2)
<b>Location Address</b>	1800 1 <sup>st</sup> Street, NW
<b>City, State</b>	Albuquerque, New Mexico 87102
<b>County</b>	Bernalillo
<b>Direction/Orientation</b>	NW
<b>Date</b>	11/17/13
<b>Time</b>	1230
<b>Photographer</b>	N. Biscocho (START)
<b>Witness</b>	J. Koehnen (START)
<b>Description:</b>	Backfill activities after excavation and confirmation samples collected on Area E, Grids 010 and 011 (City of Albuquerque, Right-of-Way).

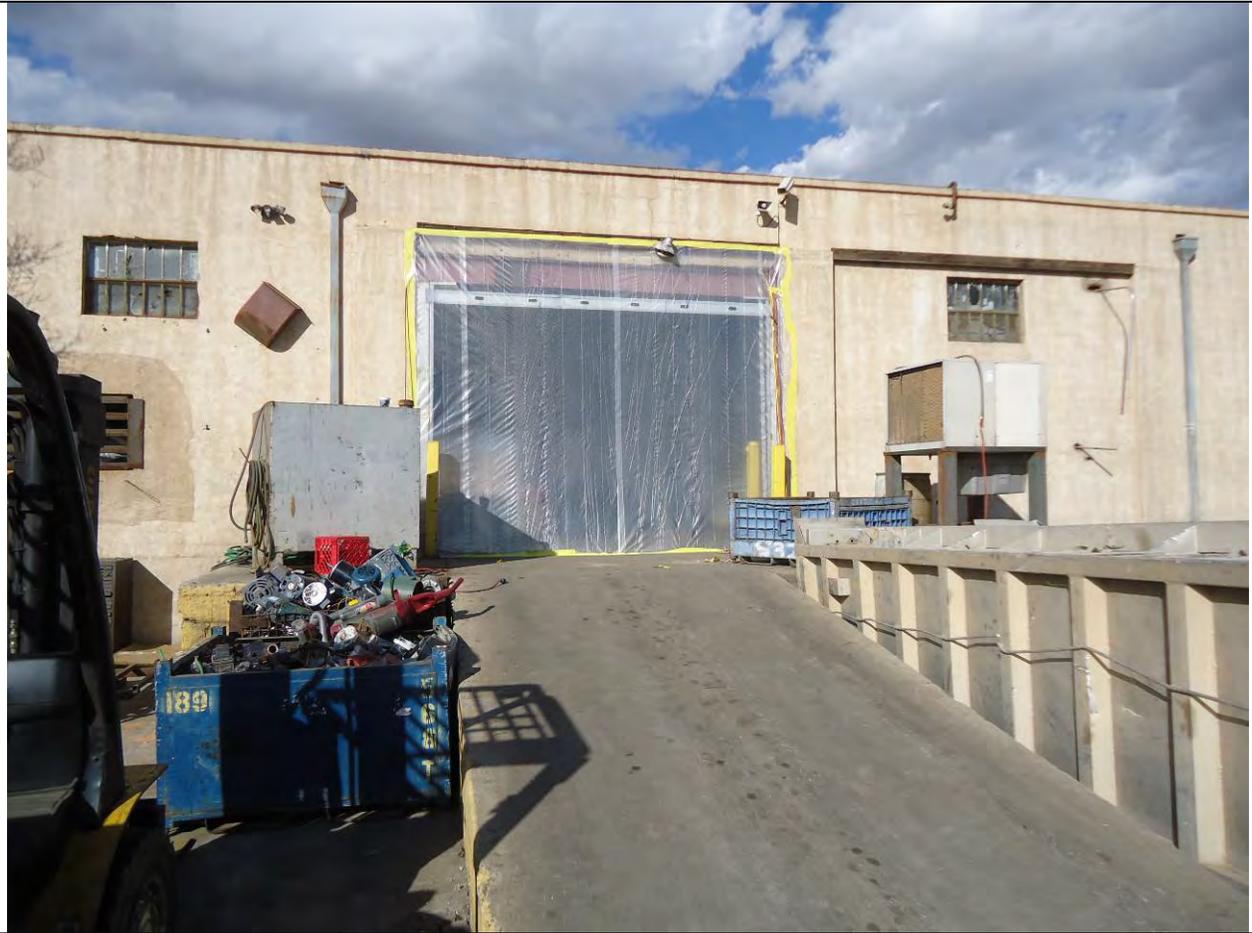
<b>Logbook Photo #</b>	DSC01103
<b>US EPA ID / Task Order Number</b>	CERCLIS: NMN000607041 / TDD No: 1/DYNAMAC-077-13-001
<b>Site</b>	Southwest Vermiculite (Removal 2)
<b>Location Address</b>	1800 1 <sup>st</sup> Street, NW
<b>City, State</b>	Albuquerque, New Mexico 87102
<b>County</b>	Bernalillo
<b>Direction/Orientation</b>	N
<b>Date</b>	2/10/14
<b>Time</b>	1452
<b>Photographer</b>	J. Koehnen (START)
<b>Witness</b>	D. Edgington (ERRS)
<b>Description:</b>	Abatement contractor set-up during the abatement clean-up inside the W. Silver Recycling warehouse.

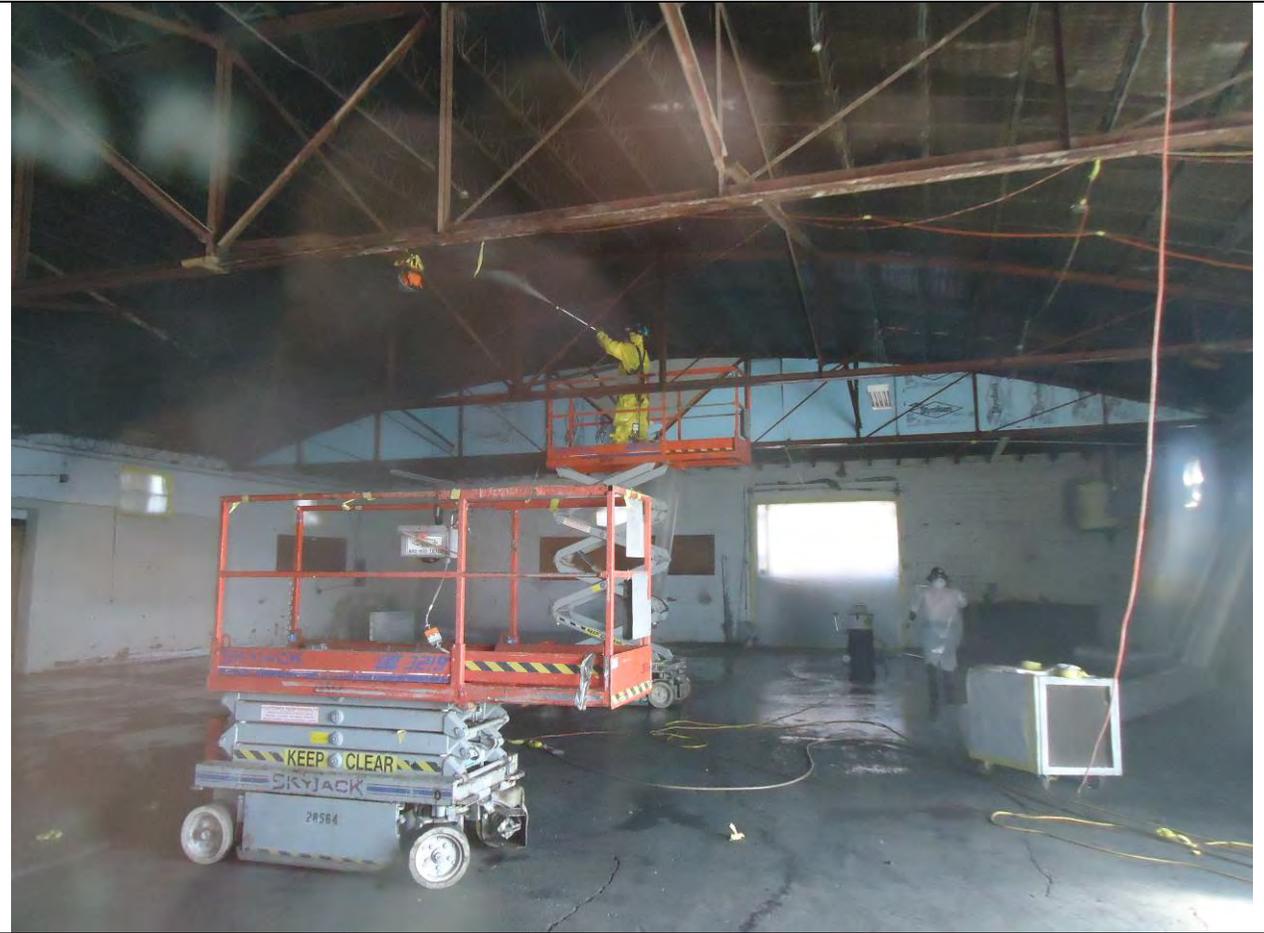
<b>Logbook Photo #</b>	DSC01124
<b>US EPA ID / Task Order Number</b>	CERCLIS: NMN000607041 / TDD No: 1/DYNAMAC-077-13-001
<b>Site</b>	Southwest Vermiculite (Removal 2)
<b>Location Address</b>	1800 1 <sup>st</sup> Street, NW
<b>City, State</b>	Albuquerque, New Mexico 87102
<b>County</b>	Bernalillo
<b>Direction/Orientation</b>	E
<b>Date</b>	2/13/14
<b>Time</b>	1334
<b>Photographer</b>	J. Koehnen (START)
<b>Witness</b>	D. Edgington (ERRS)
<b>Description:</b>	Abatement contractor during the clean-up inside the W. Silver Recycling main warehouse.

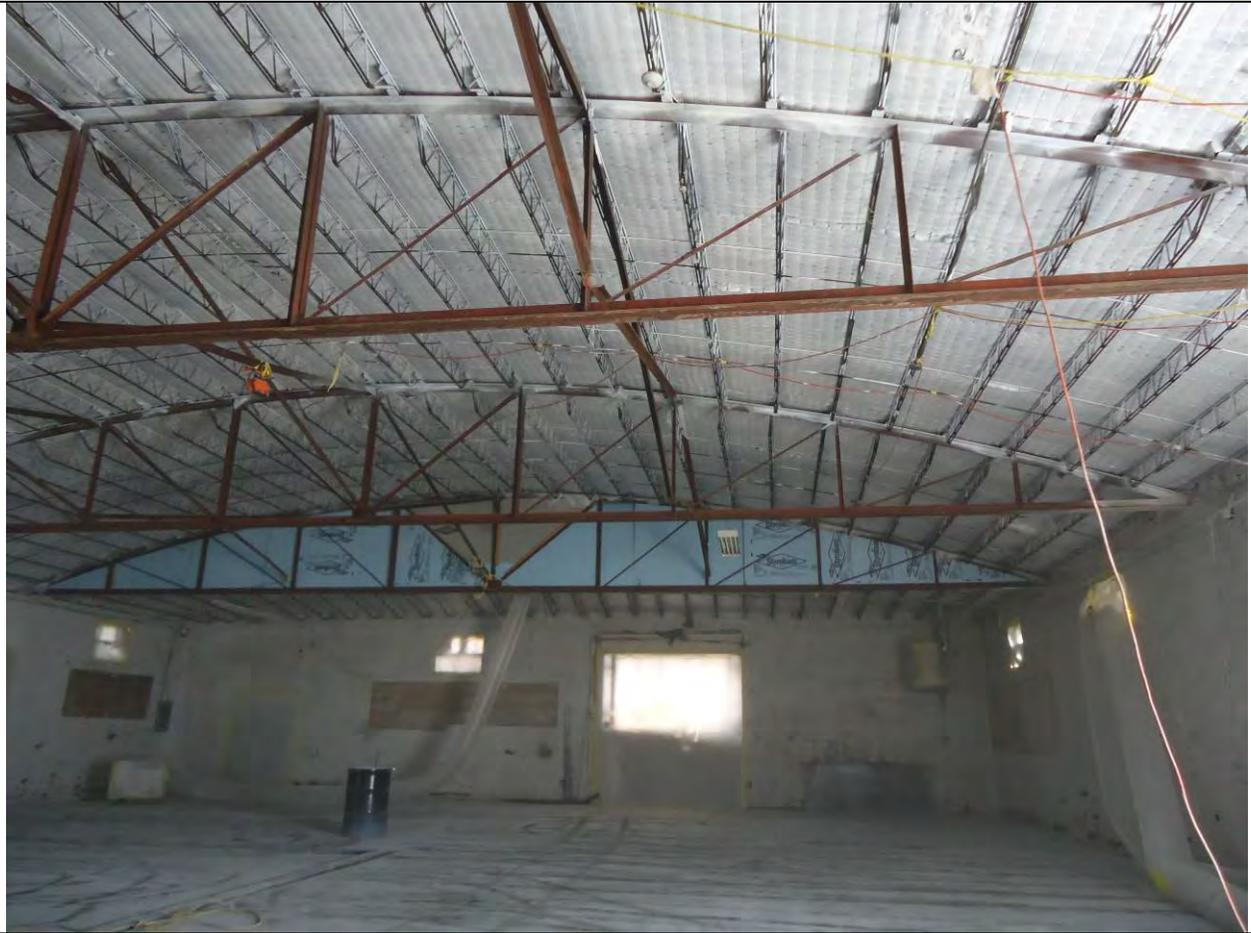
<b>Logbook Photo #</b>	DSC01167
<b>US EPA ID / Task Order Number</b>	CERCLIS: NMN000607041 / TDD No: 1/DYNAMAC-077-13-001
<b>Site</b>	Southwest Vermiculite (Removal 2)
<b>Location Address</b>	1800 1 <sup>st</sup> Street, NW
<b>City, State</b>	Albuquerque, New Mexico 87102
<b>County</b>	Bernalillo
<b>Direction/Orientation</b>	E
<b>Date</b>	2/19/11
<b>Time</b>	1141
<b>Photographer</b>	J. Koehnen (START)
<b>Witness</b>	D. Edgington (ERRS)
<b>Description:</b>	
<p>White latex-type encapsulate ("AsbetoSafe" brand) was sprayed on the ceiling and walls after the pressure wash.</p>

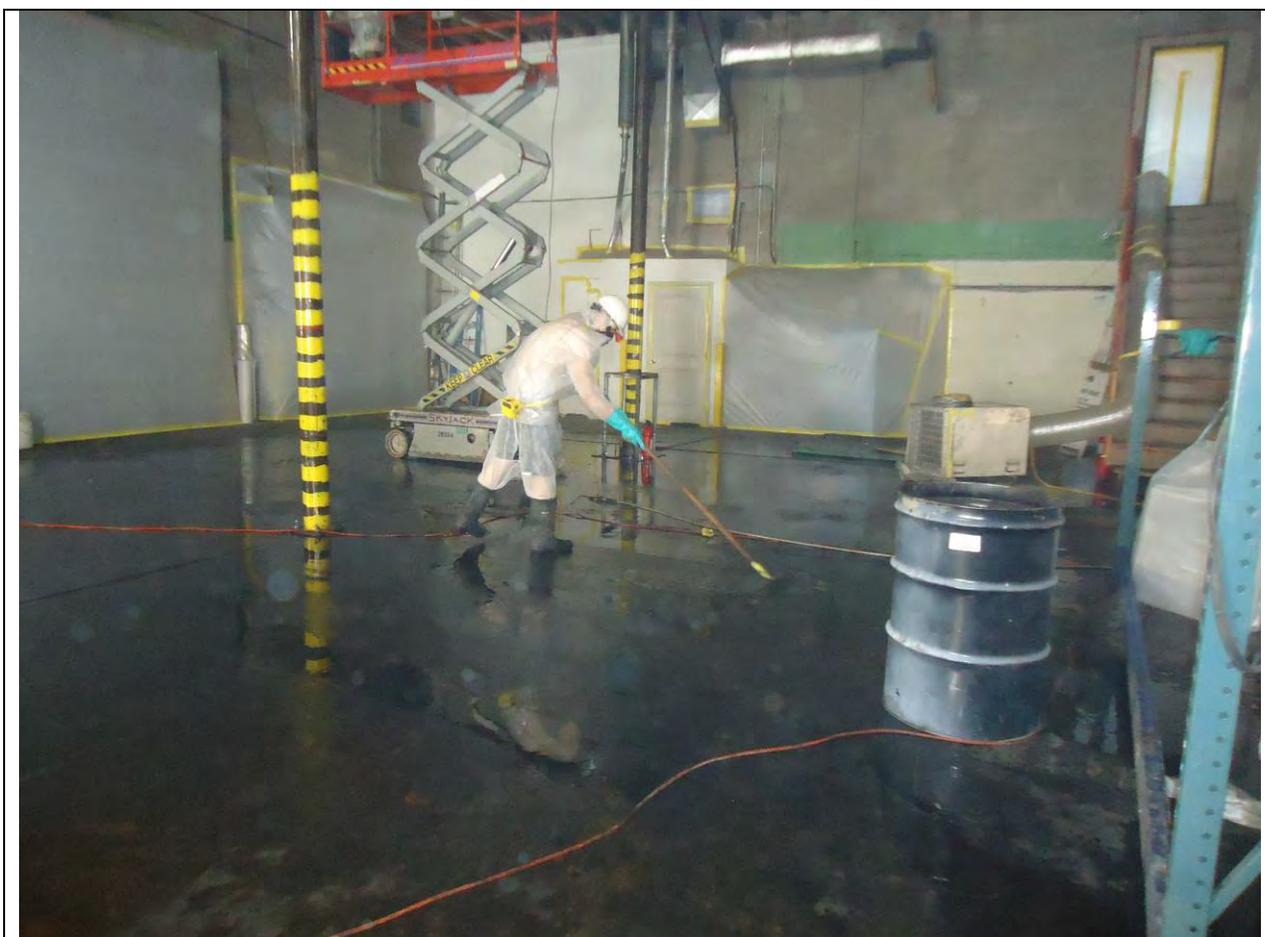
<b>Logbook Photo #</b>	DSC01209
<b>US EPA ID / Task Order Number</b>	CERCLIS: NMN000607041 / TDD No: 1/DYNAMAC-077-13-001
<b>Site</b>	Southwest Vermiculite (Removal 2)
<b>Location Address</b>	1800 1 <sup>st</sup> Street, NW
<b>City, State</b>	Albuquerque, New Mexico 87102
<b>County</b>	Bernalillo
<b>Direction/Orientation</b>	NW
<b>Date</b>	2/25/14
<b>Time</b>	0954
<b>Photographer</b>	J. Koehnen (START)
<b>Witness</b>	D. Edgington (ERRS)
<b>Description:</b>	Asbestos abatement contractor continue to clean-up inside the W. Silver Recycling auxiliary warehouse.

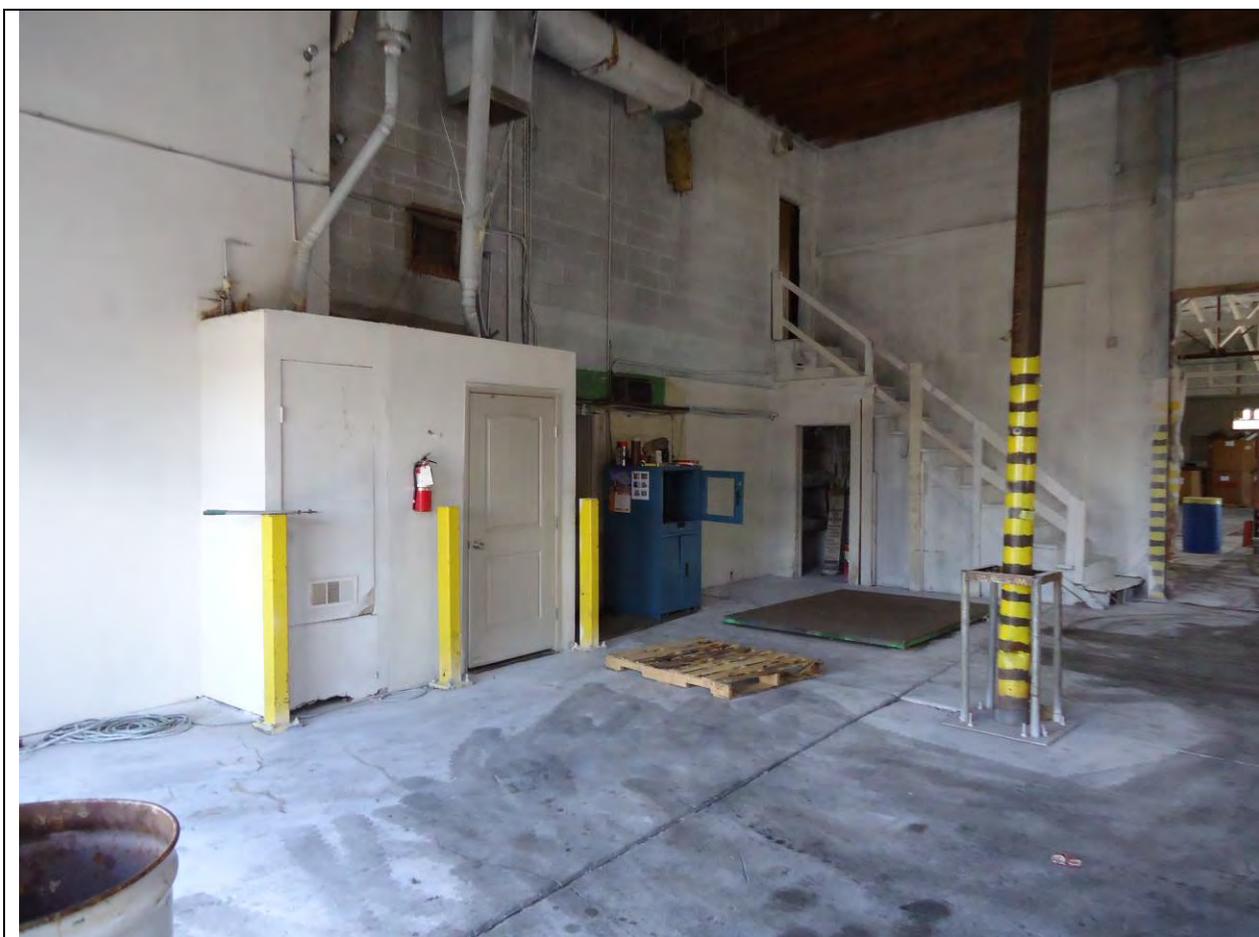
<b>Logbook Photo #</b>	DSC01233
<b>US EPA ID / Task Order Number</b>	CERCLIS: NMN000607041 / TDD No: 1/DYNAMAC-077-13-001
<b>Site</b>	Southwest Vermiculite (Removal 2)
<b>Location Address</b>	1800 1 <sup>st</sup> Street, NW
<b>City, State</b>	Albuquerque, New Mexico 87102
<b>County</b>	Bernalillo
<b>Direction/Orientation</b>	NE
<b>Date</b>	2/28/14
<b>Time</b>	1253
<b>Photographer</b>	J. Koehnen (START)
<b>Witness</b>	D. Edgington (ERRS)
<b>Description:</b>	
<p>White latex-type encapsulate ("AsbetoSafe" brand) was sprayed on the walls after the pressure wash in the auxiliary warehouse at W. Silver Recycling..</p>

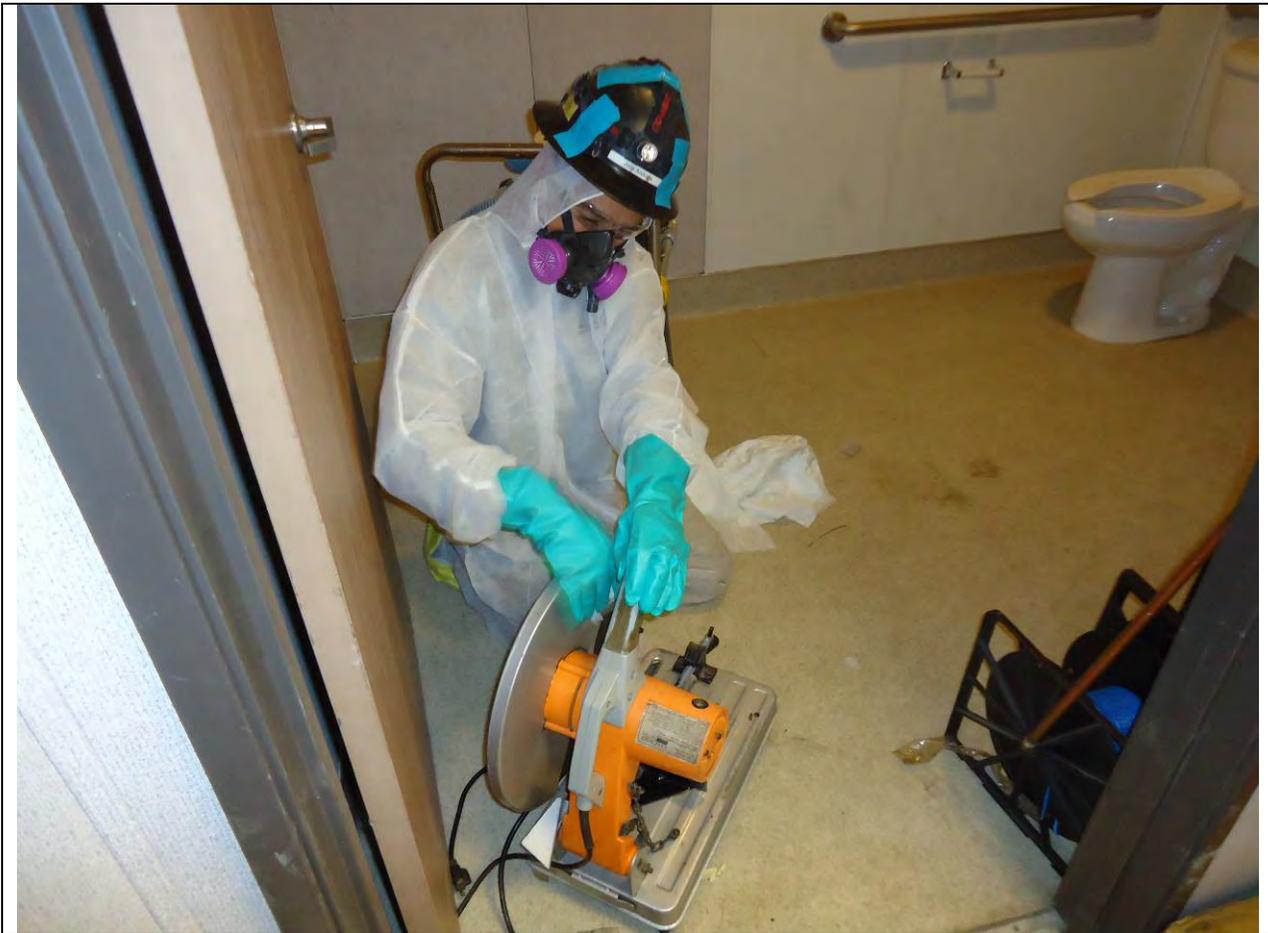
<b>Logbook Photo #</b>	DSC01050
<b>US EPA ID / Task Order Number</b>	CERCLIS: NMN000607041 / TDD No: 1/DYNAMAC-077-13-001
<b>Site</b>	Southwest Vermiculite (Removal 2)
<b>Location Address</b>	1800 1 <sup>st</sup> Street, NW
<b>City, State</b>	Albuquerque, New Mexico 87102
<b>County</b>	Bernalillo
<b>Direction/Orientation</b>	NE
<b>Date</b>	2/1/14
<b>Time</b>	1359
<b>Photographer</b>	J. Koehnen (START)
<b>Witness</b>	D. Edgington (ERRS)
<b>Description:</b>	Abatement contractors conducting clean-up efforts inside the W. Silver Recycling Trailer/Scale Office.

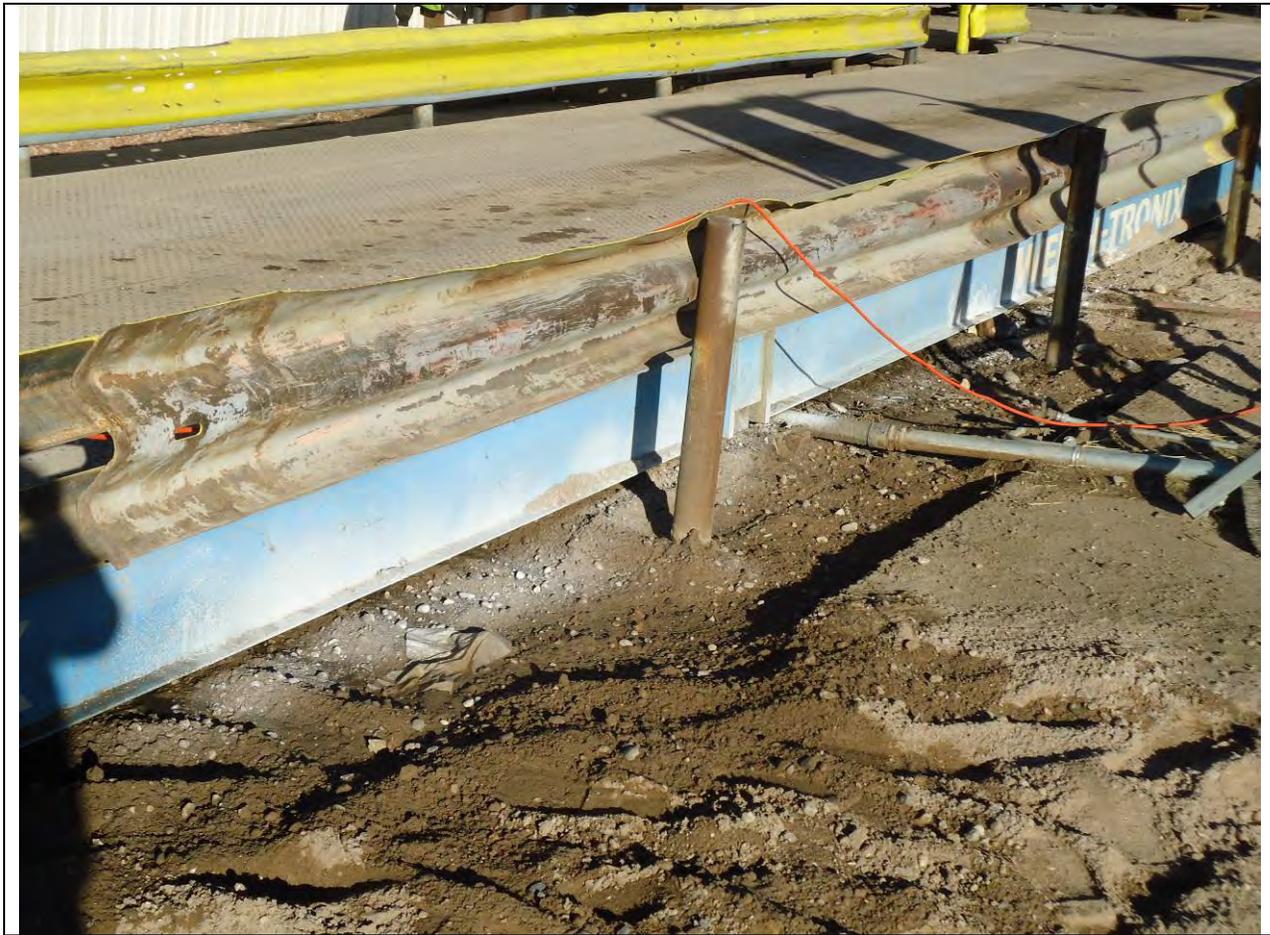
<b>Logbook Photo #</b>	DSC01019
<b>US EPA ID / Task Order Number</b>	CERCLIS: NMN000607041 / TDD No: 1/DYNAMAC-077-13-001
<b>Site</b>	Southwest Vermiculite (Removal 2)
<b>Location Address</b>	1800 1 <sup>st</sup> Street, NW
<b>City, State</b>	Albuquerque, New Mexico 87102
<b>County</b>	Bernalillo
<b>Direction/Orientation</b>	NE
<b>Date</b>	1/28/14
<b>Time</b>	1600
<b>Photographer</b>	N. Biscocho (START)
<b>Witness</b>	J. Koehnen (START)
<b>Description:</b>	<p>An asbestos encapsulate was placed on the soil around/adjacent to the W. Silver scale and trailer.</p>

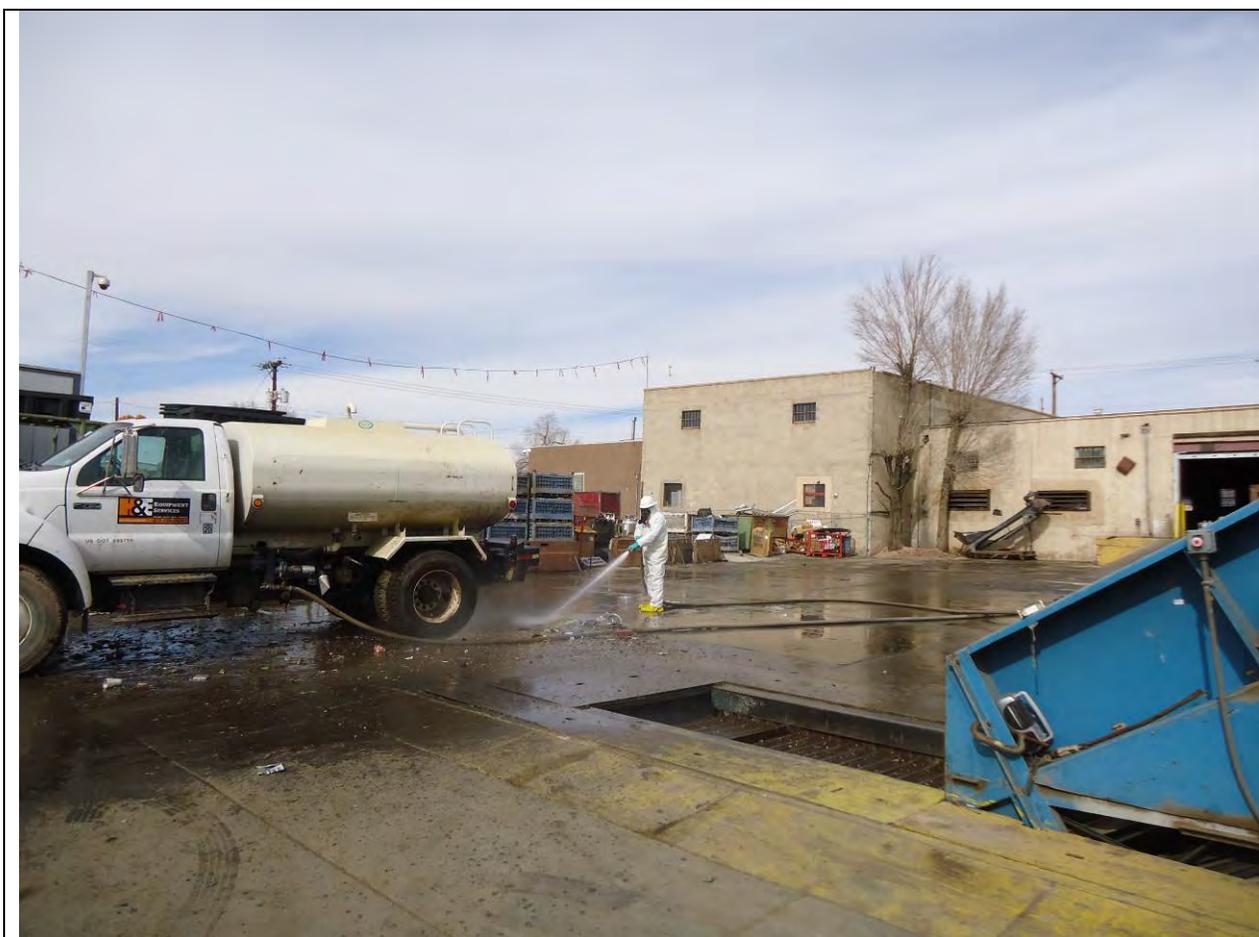
<b>Logbook Photo #</b>	DSC00978
<b>US EPA ID / Task Order Number</b>	CERCLIS: NMN000607041 / TDD No: 1/DYNAMAC-077-13-001
<b>Site</b>	Southwest Vermiculite (Removal 2)
<b>Location Address</b>	1800 1 <sup>st</sup> Street, NW
<b>City, State</b>	Albuquerque, New Mexico 87102
<b>County</b>	Bernalillo
<b>Direction/Orientation</b>	NW
<b>Date</b>	1/25/14
<b>Time</b>	1145
<b>Photographer</b>	N. Biscocho (START)
<b>Witness</b>	J. Koehnen (START)
<b>Description:</b>	Power washing concrete pad between the W. Silver warehouse and the scrap yard area.

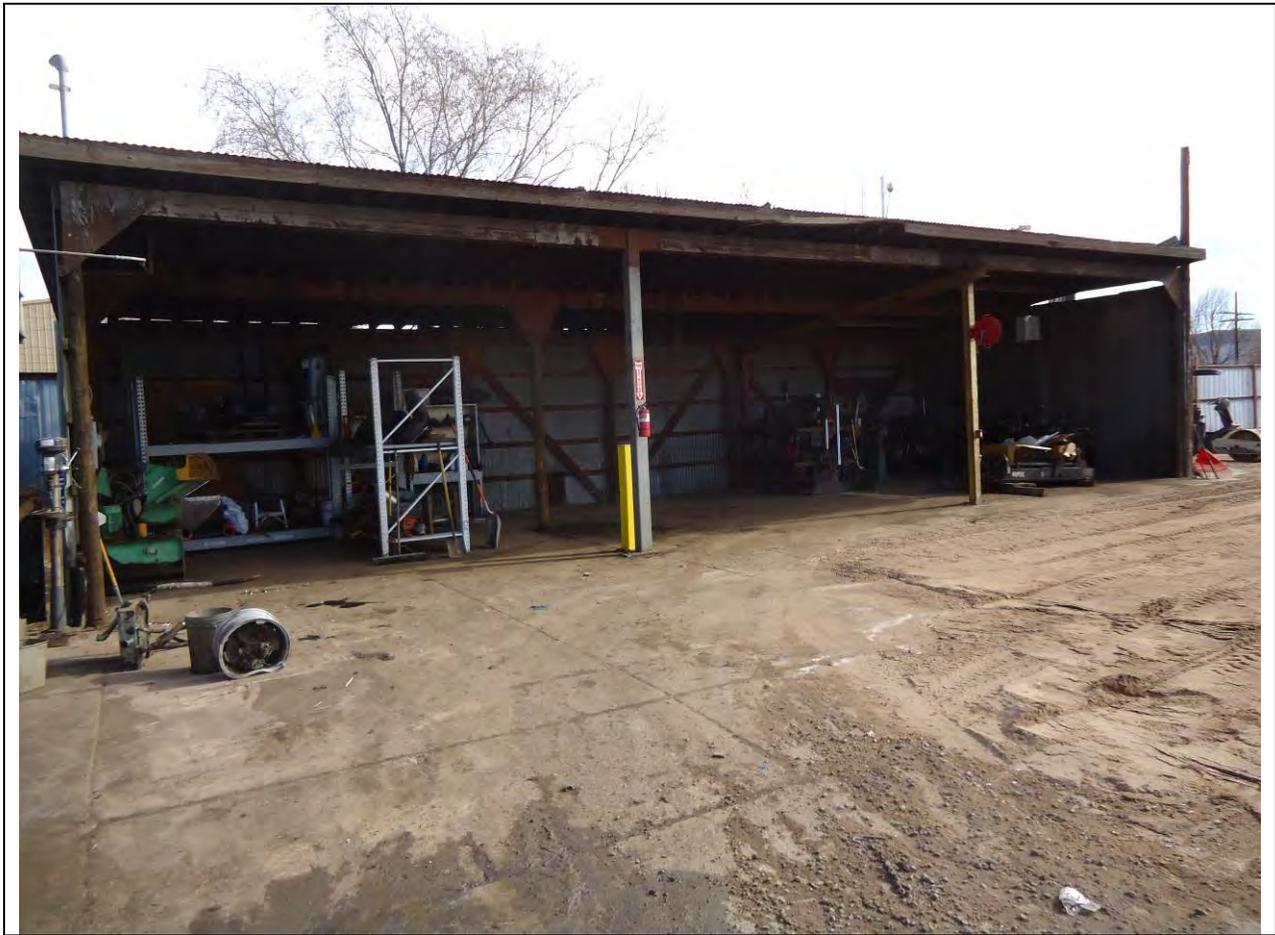
<b>Logbook Photo #</b>	DSC01006
<b>US EPA ID / Task Order Number</b>	CERCLIS: NMN000607041 / TDD No: 1/DYNAMAC-077-13-001
<b>Site</b>	Southwest Vermiculite (Removal 2)
<b>Location Address</b>	1800 1 <sup>st</sup> Street, NW
<b>City, State</b>	Albuquerque, New Mexico 87102
<b>County</b>	Bernalillo
<b>Direction/Orientation</b>	SE
<b>Date</b>	1/27/14
<b>Time</b>	1340
<b>Photographer</b>	N. Biscocho (START)
<b>Witness</b>	J. Koehnen (START)
<b>Description:</b>	Mechanic shed area, located on the east side of the scrap yard area of W. Sliver Recycling, after the pressure wash.

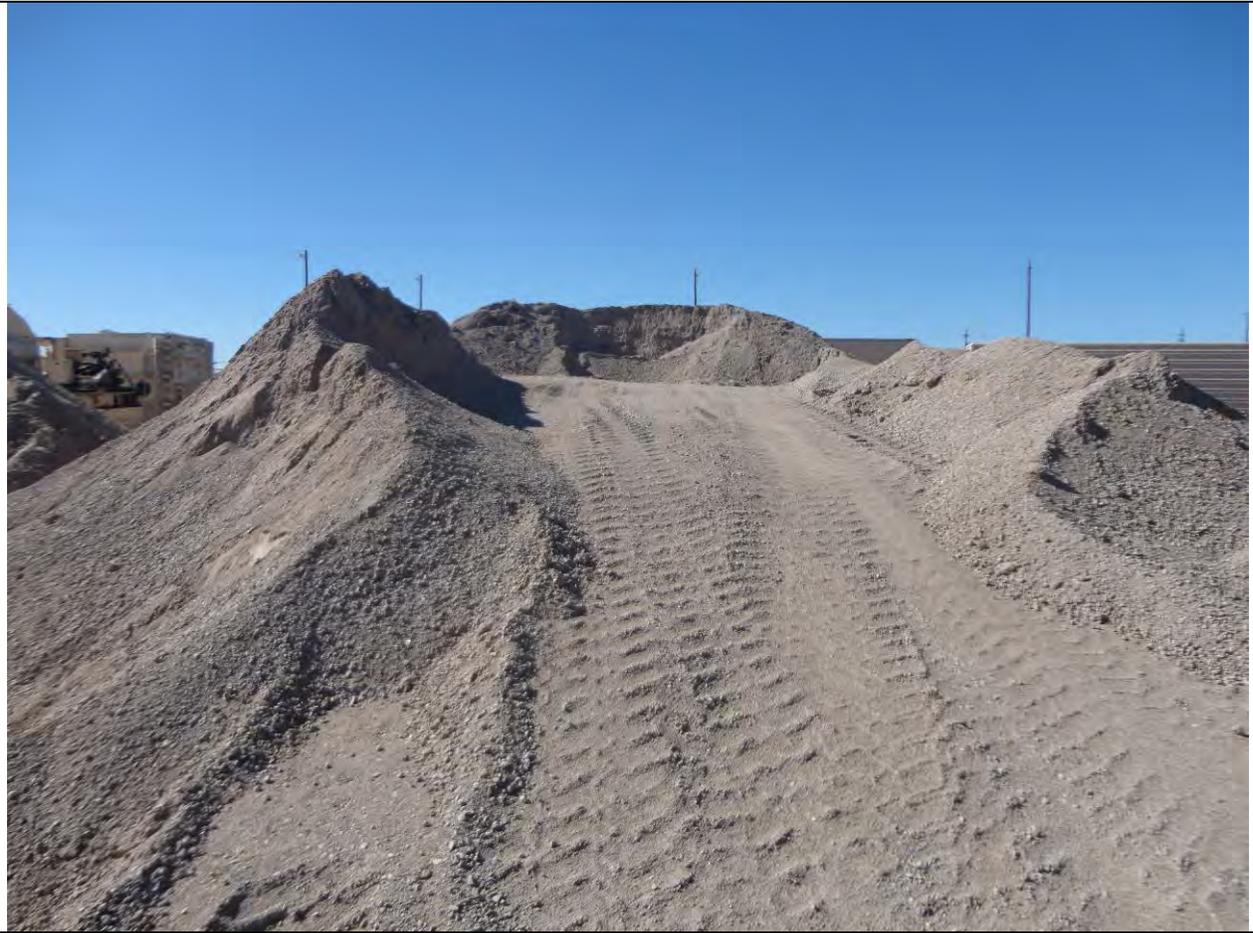
<b>Logbook Photo #</b>	DSC04190
<b>US EPA ID / Task Order Number</b>	CERCLIS: NMN000607041 / TDD No: 1/DYNAMAC-077-13-001
<b>Site</b>	Southwest Vermiculite (Removal 2)
<b>Location Address</b>	1800 1 <sup>st</sup> Street, NW
<b>City, State</b>	Albuquerque, New Mexico 87102
<b>County</b>	Bernalillo
<b>Direction/Orientation</b>	N/A
<b>Date</b>	11/11/13
<b>Time</b>	1209
<b>Photographer</b>	J. Koehnen (START)
<b>Witness</b>	N/A
<b>Description:</b>	
Backfill and crushed rocks source location in Albuquerque, NM

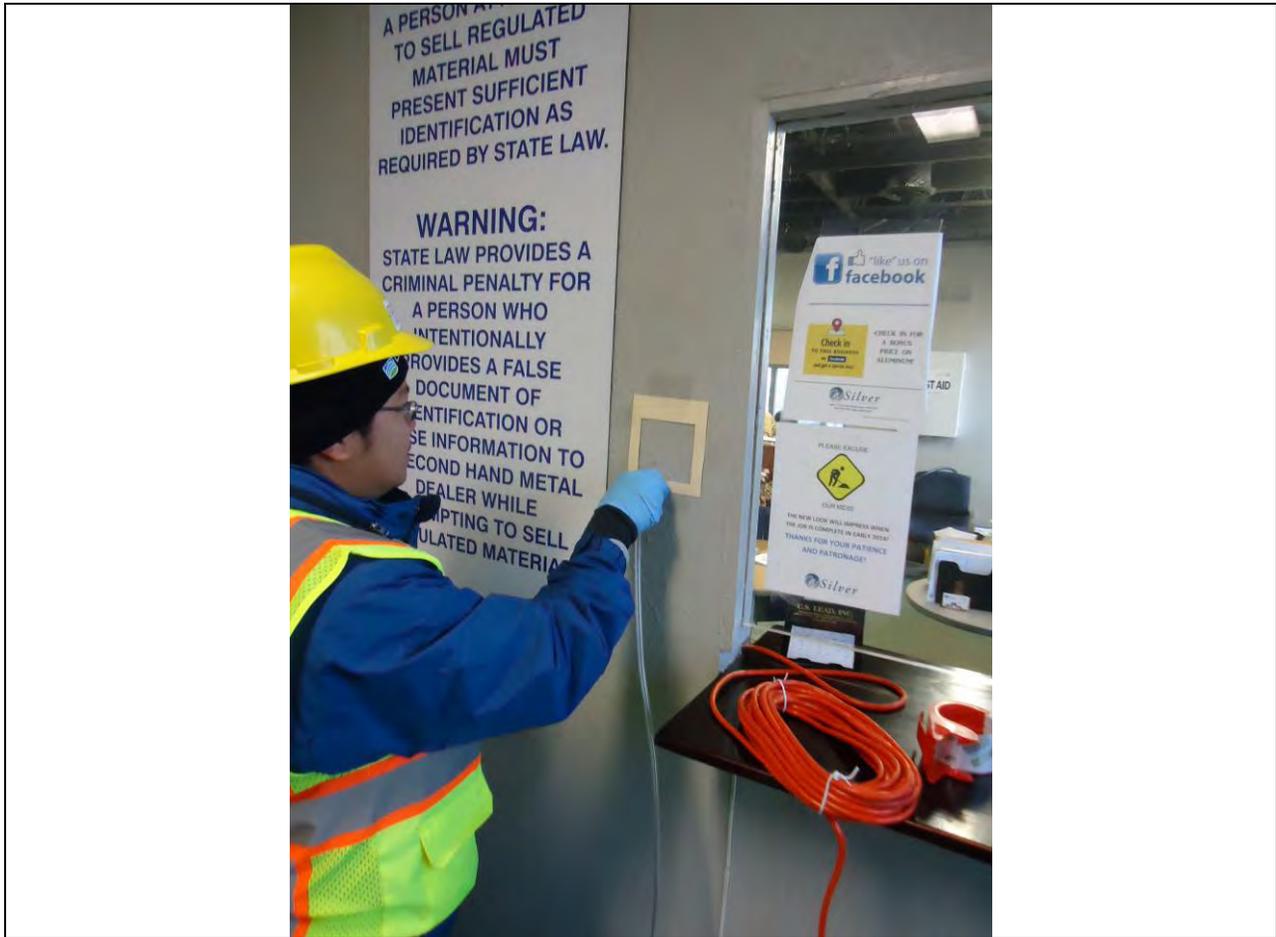
<b>Logbook Photo #</b>	DSC00700
<b>US EPA ID / Task Order Number</b>	CERCLIS: NMN000607041 / TDD No: 1/DYNAMAC-077-13-001
<b>Site</b>	Southwest Vermiculite (Removal 2)
<b>Location Address</b>	1800 1 <sup>st</sup> Street, NW
<b>City, State</b>	Albuquerque, New Mexico 87102
<b>County</b>	Bernalillo
<b>Direction/Orientation</b>	SE
<b>Date</b>	12/9/13
<b>Time</b>	0920
<b>Photographer</b>	J. Koehnen (START)
<b>Witness</b>	N. Biscocho (START)
<b>Description:</b>	View of indoor dust sampling in SWV Main Office – Entry Wall (Sample SWVDust_MOD2).

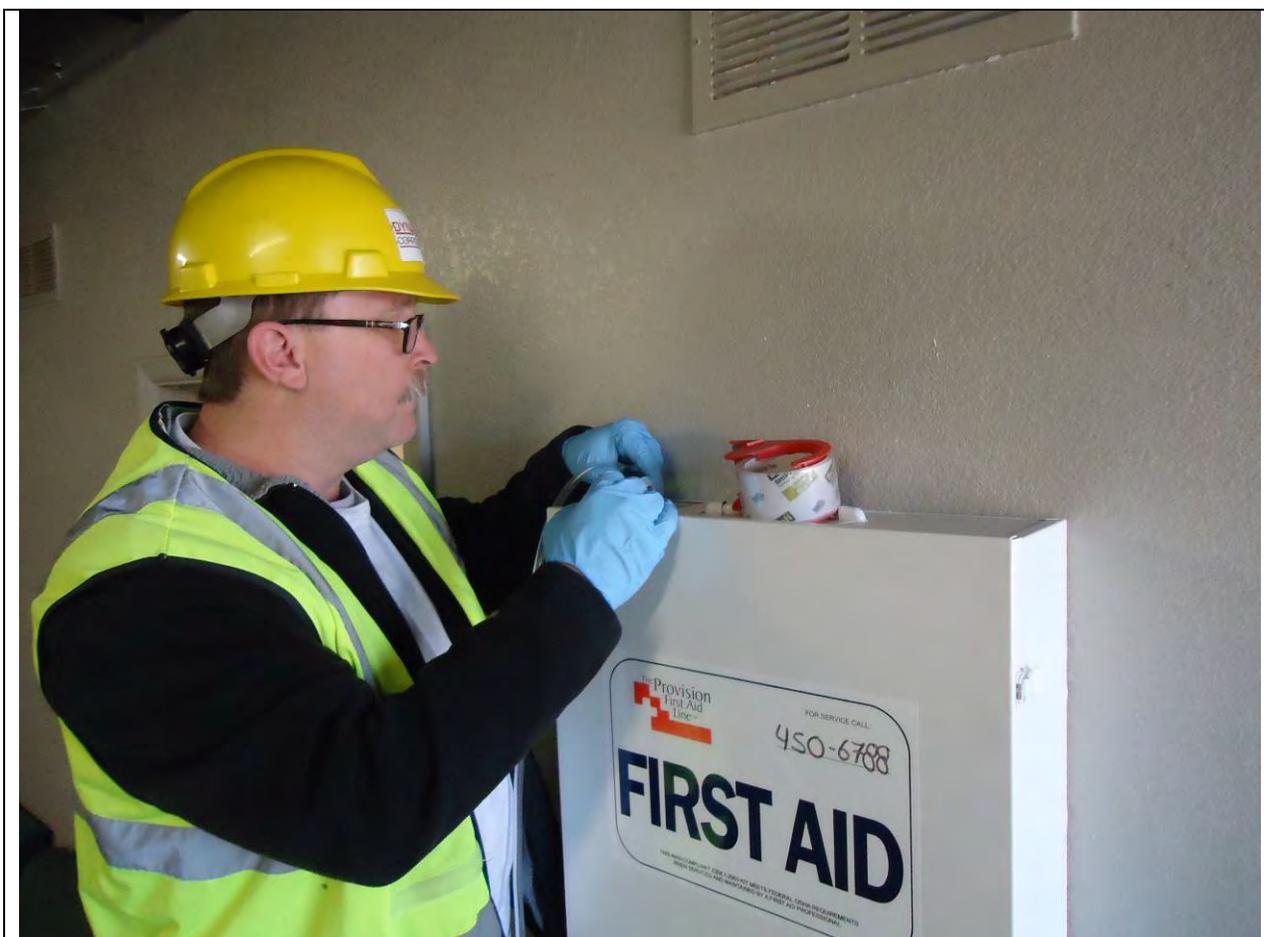
<b>Logbook Photo #</b>	DSC00703
<b>US EPA ID / Task Order Number</b>	CERCLIS: NMN000607041 / TDD No: 1/DYNAMAC-077-13-001
<b>Site</b>	Southwest Vermiculite (Removal 2)
<b>Location Address</b>	1800 1 <sup>st</sup> Street, NW
<b>City, State</b>	Albuquerque, New Mexico 87102
<b>County</b>	Bernalillo
<b>Direction/Orientation</b>	SW
<b>Date</b>	12/9/13
<b>Time</b>	0929
<b>Photographer</b>	J. Koehnen (START)
<b>Witness</b>	N. Biscocho (START)
<b>Description:</b>	View of indoor dust sampling inside the SWV Main Office – Top of First Aid Kit (sample SWVDust_MOD3).
