## Appendix C

### Photo Documentation

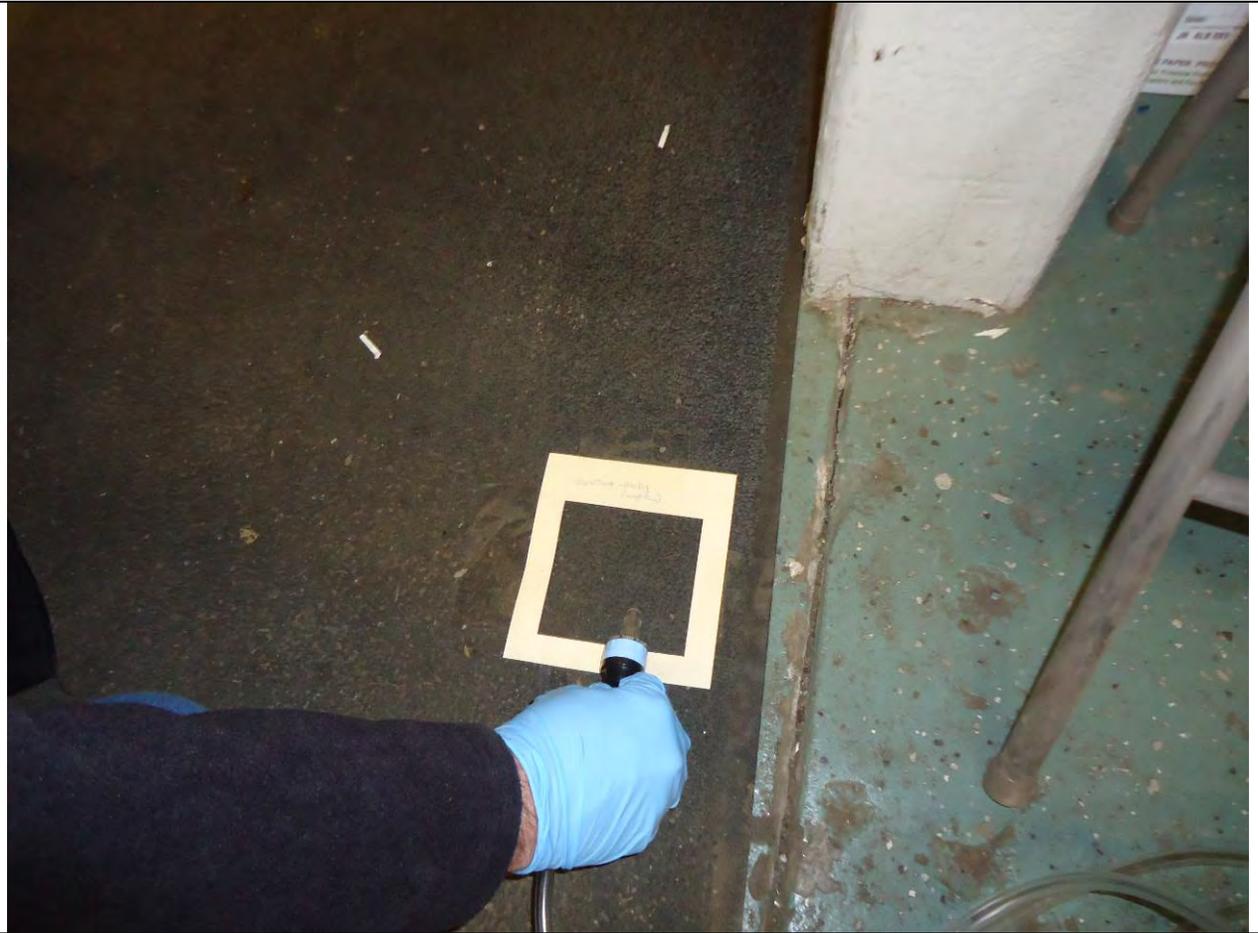
<b>Logbook Photo #</b>	DSC00705
<b>US EPA ID / Task Order Number</b>	CERCLIS: NMN000607041 / TDD No: 1/DYNAMAC-077-13-001
<b>Site</b>	Southwest Vermiculite (Removal 2)
<b>Location Address</b>	1800 1 <sup>st</sup> Street, NW
<b>City, State</b>	Albuquerque, New Mexico 87102
<b>County</b>	Bernalillo
<b>Direction/Orientation</b>	Down
<b>Date</b>	12/9/13
<b>Time</b>	0938
<b>Photographer</b>	J. Koehnen (START)
<b>Witness</b>	N. Biscocho (START)
<b>Description:</b>	
View of indoor dust sampling location in SWV Mail Office – Carpet Rug (SWVDust_MOD1)

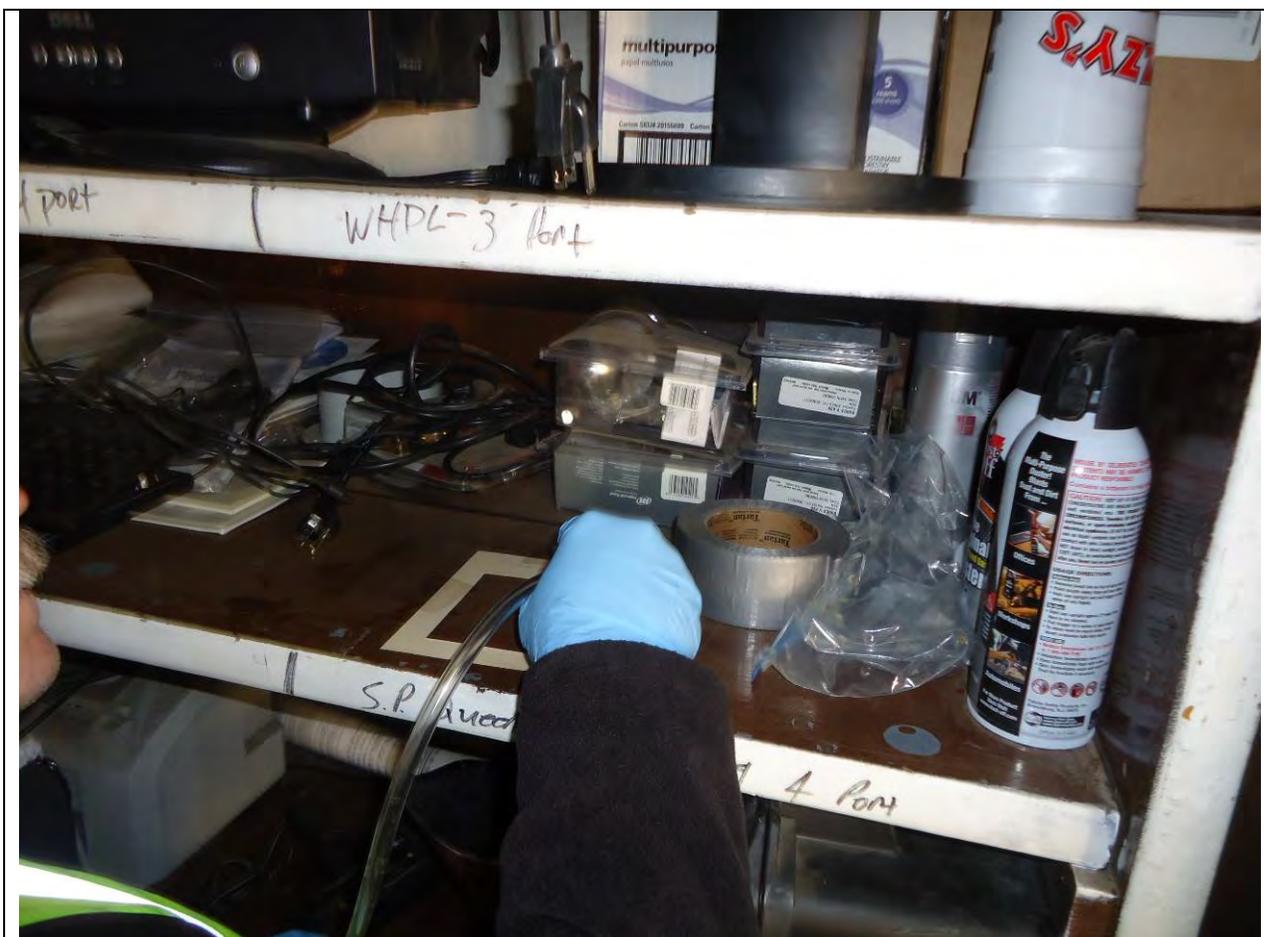
<b>Logbook Photo #</b>	DSC00706
<b>US EPA ID / Task Order Number</b>	CERCLIS: NMN000607041 / TDD No: 1/DYNAMAC-077-13-001
<b>Site</b>	Southwest Vermiculite (Removal 2)
<b>Location Address</b>	1800 1 <sup>st</sup> Street, NW
<b>City, State</b>	Albuquerque, New Mexico 87102
<b>County</b>	Bernalillo
<b>Direction/Orientation</b>	SE
<b>Date</b>	12/9/13
<b>Time</b>	0945
<b>Photographer</b>	J. Koehnen (START)
<b>Witness</b>	N. Biscocho (START)
<b>Description:</b>	View of indoor dust sampling in SWV PM Office - Electrical/Network Closet (East of office) (Sample No. SWVDust_POD1)

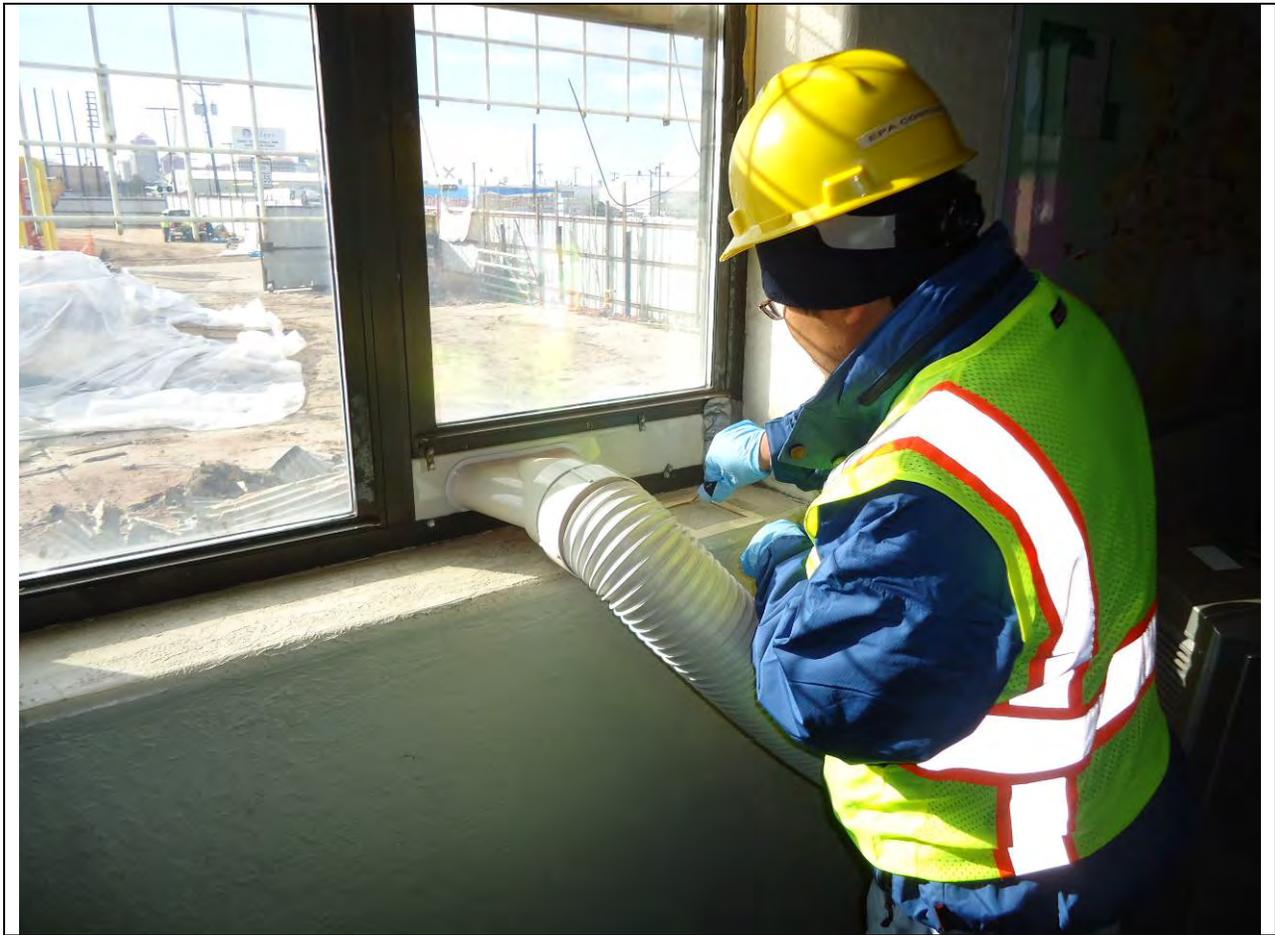
<b>Logbook Photo #</b>	DSC00708
<b>US EPA ID / Task Order Number</b>	CERCLIS: NMN000607041 / TDD No: 1/DYNAMAC-077-13-001
<b>Site</b>	Southwest Vermiculite (Removal 2)
<b>Location Address</b>	1800 1 <sup>st</sup> Street, NW
<b>City, State</b>	Albuquerque, New Mexico 87102
<b>County</b>	Bernalillo
<b>Direction/Orientation</b>	SW
<b>Date</b>	12/9/13
<b>Time</b>	0952
<b>Photographer</b>	J. Koehnen (START)
<b>Witness</b>	N. Biscocho (START)
<b>Description:</b>	View of indoor sampling at SWV PM Office - Window Sill (South) (Sample SWVDust_POD2).

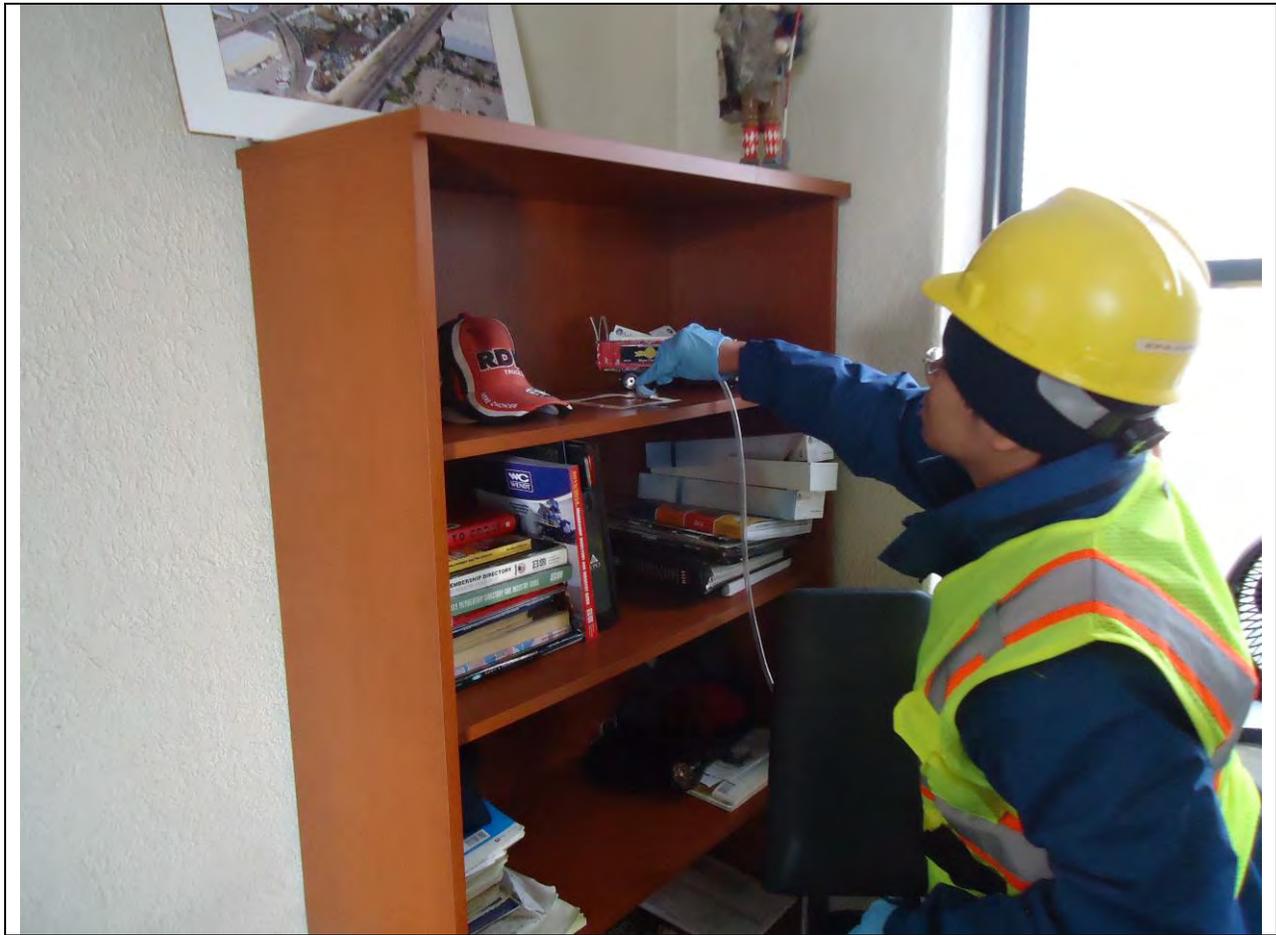
<b>Logbook Photo #</b>	DSC00710
<b>US EPA ID / Task Order Number</b>	CERCLIS: NMN000607041 / TDD No: 1/DYNAMAC-077-13-001
<b>Site</b>	Southwest Vermiculite (Removal 2)
<b>Location Address</b>	1800 1 <sup>st</sup> Street, NW
<b>City, State</b>	Albuquerque, New Mexico 87102
<b>County</b>	Bernalillo
<b>Direction/Orientation</b>	NW
<b>Date</b>	12/9/13
<b>Time</b>	0956
<b>Photographer</b>	J. Koehnen (START)
<b>Witness</b>	D N. Bischocho (START)
<b>Description:</b>	View of indoor dust sampling at SWV PM Office - Bookshelf (NW) (Sample SWVDust_POD3).

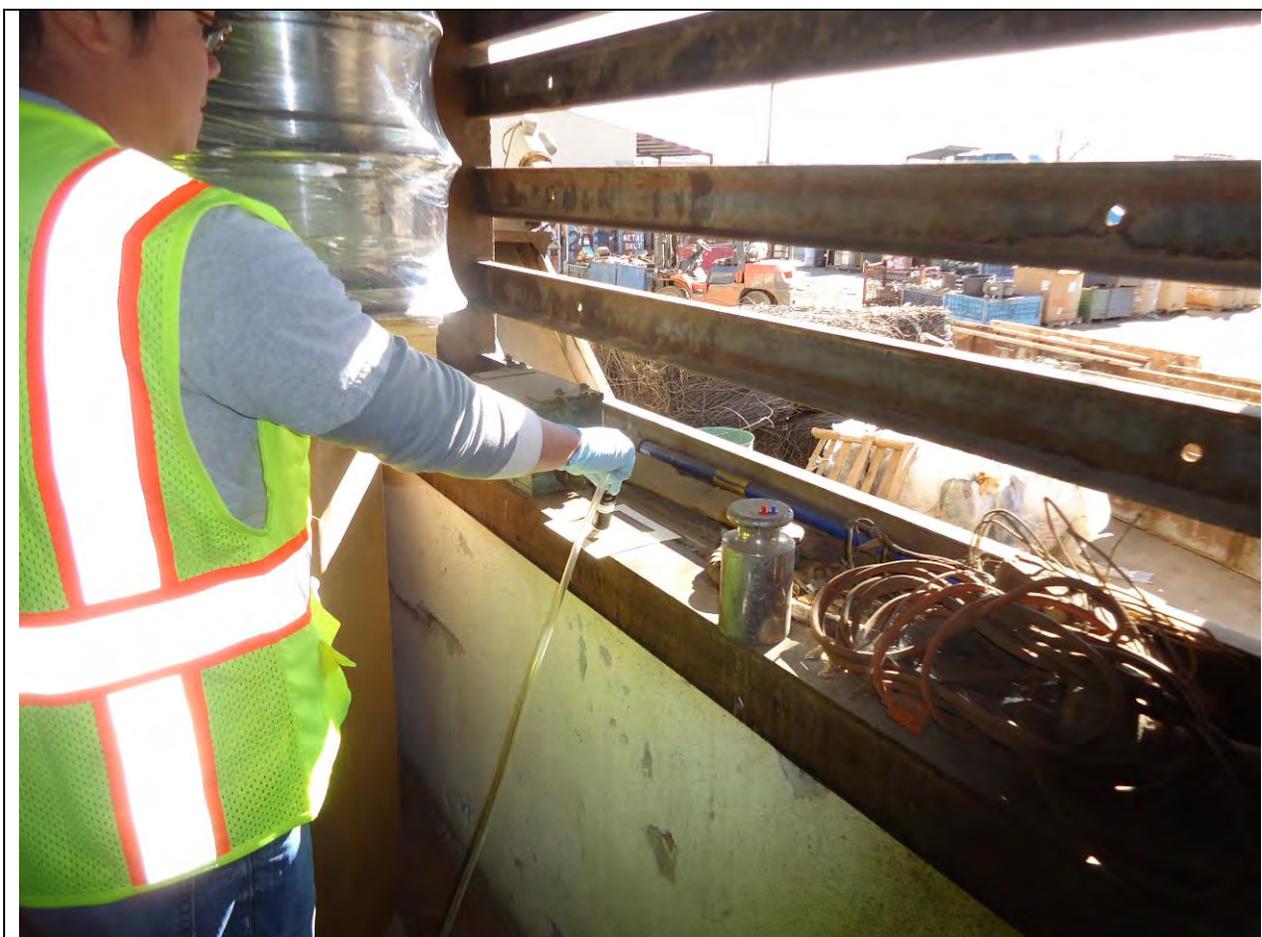
<b>Logbook Photo #</b>	DSC00769
<b>US EPA ID / Task Order Number</b>	CERCLIS: NMN000607041 / TDD No: 1/DYNAMAC-077-13-001
<b>Site</b>	Southwest Vermiculite (Removal 2)
<b>Location Address</b>	1800 1 <sup>st</sup> Street, NW
<b>City, State</b>	Albuquerque, New Mexico 87102
<b>County</b>	Bernalillo
<b>Direction/Orientation</b>	SE
<b>Date</b>	12/20/13
<b>Time</b>	1134
<b>Photographer</b>	J. Koehnen (START)
<b>Witness</b>	N. Biscocho (START)
<b>Description:</b>	Indoor dust sampling at SWV Main Warehouse (Window Sill - South) (Sample SWVDust_WARD01).

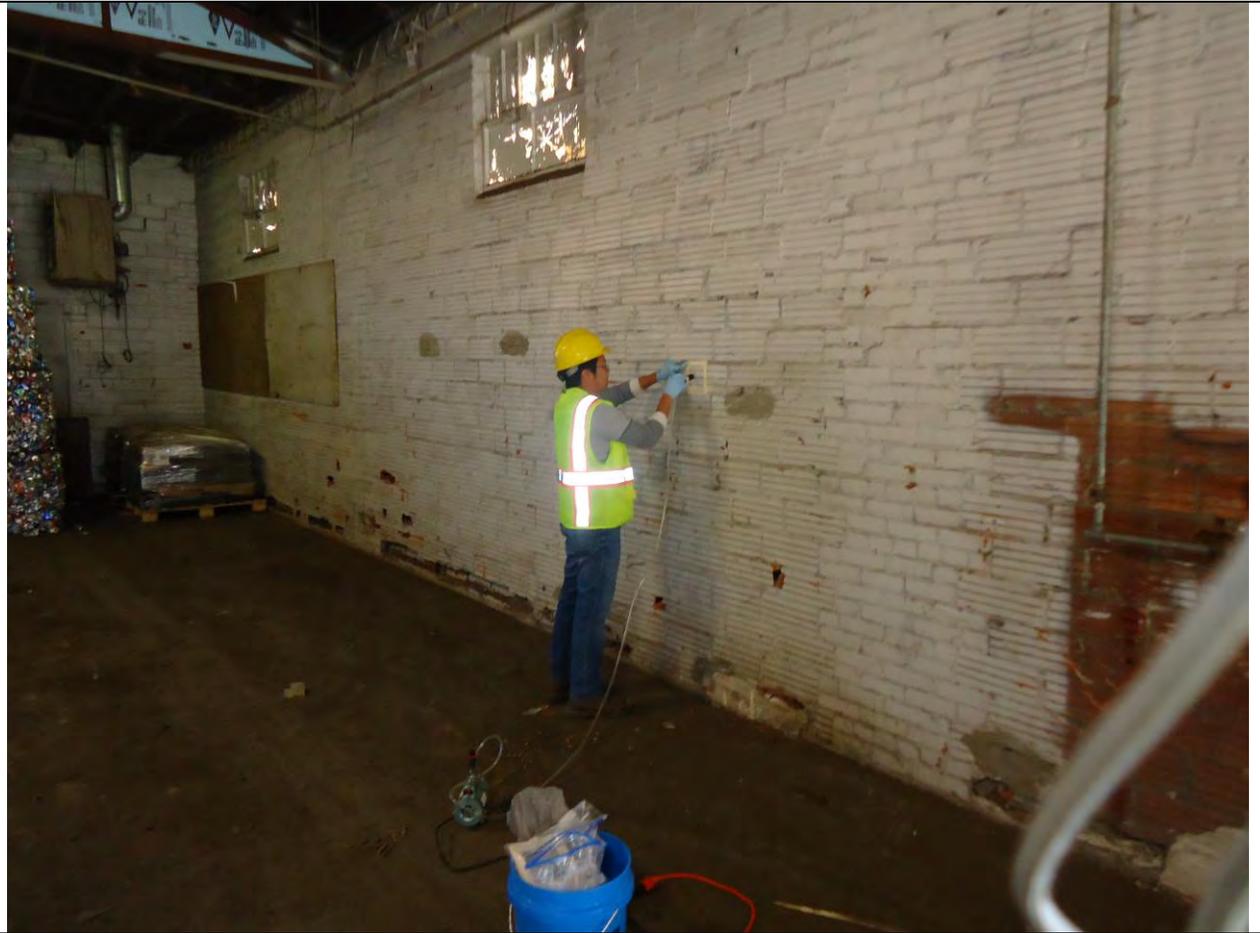
<b>Logbook Photo #</b>	DSC00771
<b>US EPA ID / Task Order Number</b>	CERCLIS: NMN000607041 / TDD No: 1/DYNAMAC-077-13-001
<b>Site</b>	Southwest Vermiculite (Removal 2)
<b>Location Address</b>	1800 1 <sup>st</sup> Street, NW
<b>City, State</b>	Albuquerque, New Mexico 87102
<b>County</b>	Bernalillo
<b>Direction/Orientation</b>	SE
<b>Date</b>	12/20/13
<b>Time</b>	1140
<b>Photographer</b>	J. Koehnen (START)
<b>Witness</b>	N. Biscocho (START)
<b>Description:</b>	
Indoor dust sampling at SWV Main Warehouse (Wall - South) (sample SWVDust_WARD02).

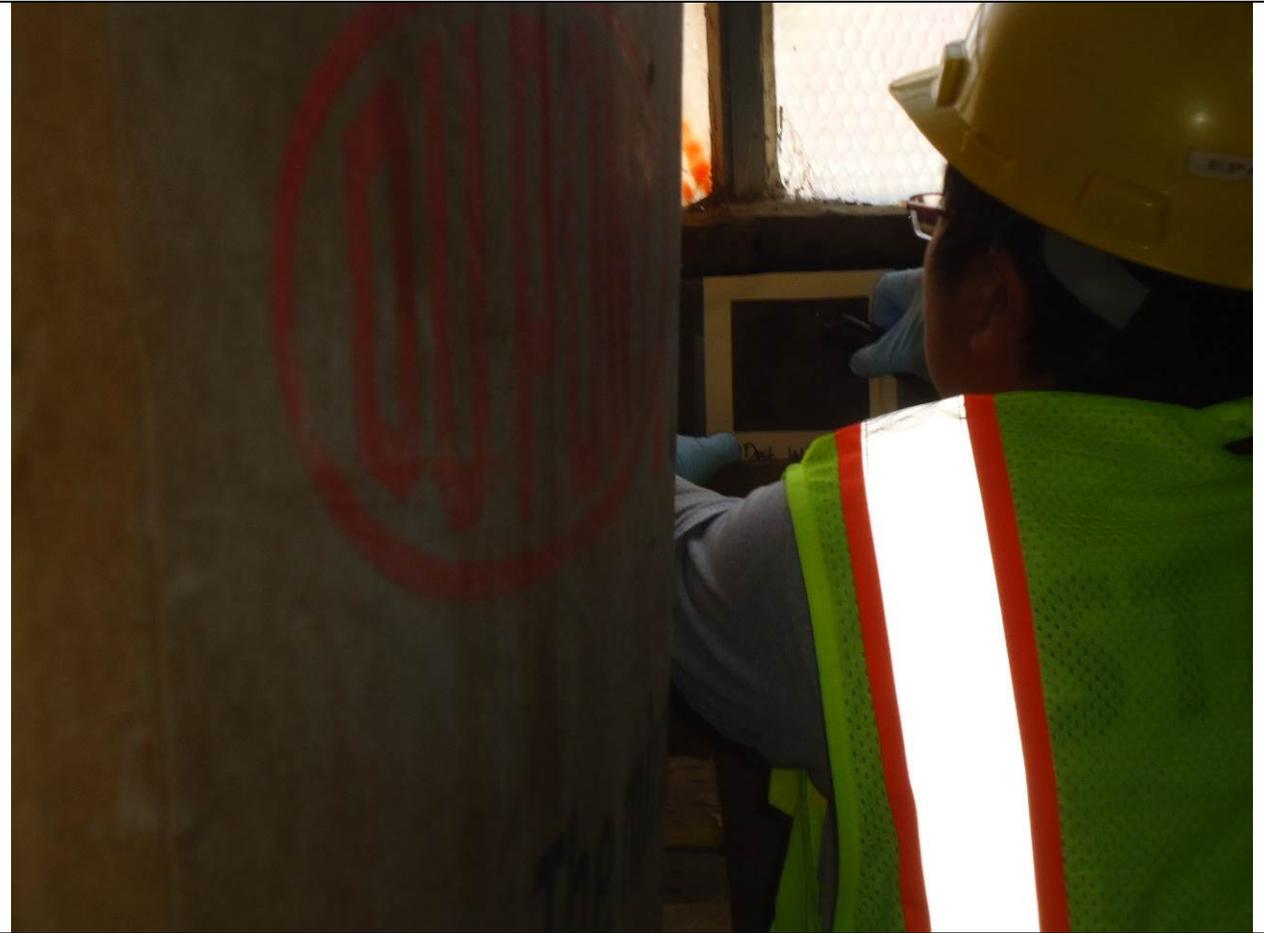
<b>Logbook Photo #</b>	DSC00772
<b>US EPA ID / Task Order Number</b>	CERCLIS: NMN000607041 / TDD No: 1/DYNAMAC-077-13-001
<b>Site</b>	Southwest Vermiculite (Removal 2)
<b>Location Address</b>	1800 1 <sup>st</sup> Street, NW
<b>City, State</b>	Albuquerque, New Mexico 87102
<b>County</b>	Bernalillo
<b>Direction/Orientation</b>	E
<b>Date</b>	12/20/13
<b>Time</b>	1150
<b>Photographer</b>	J. Koehnen (START)
<b>Witness</b>	N. Biscocho (START)
<b>Description:</b>	
Indoor dust sampling at SWV Main Warehouse (Wall - East) (Sample SWVDust_WARD03).

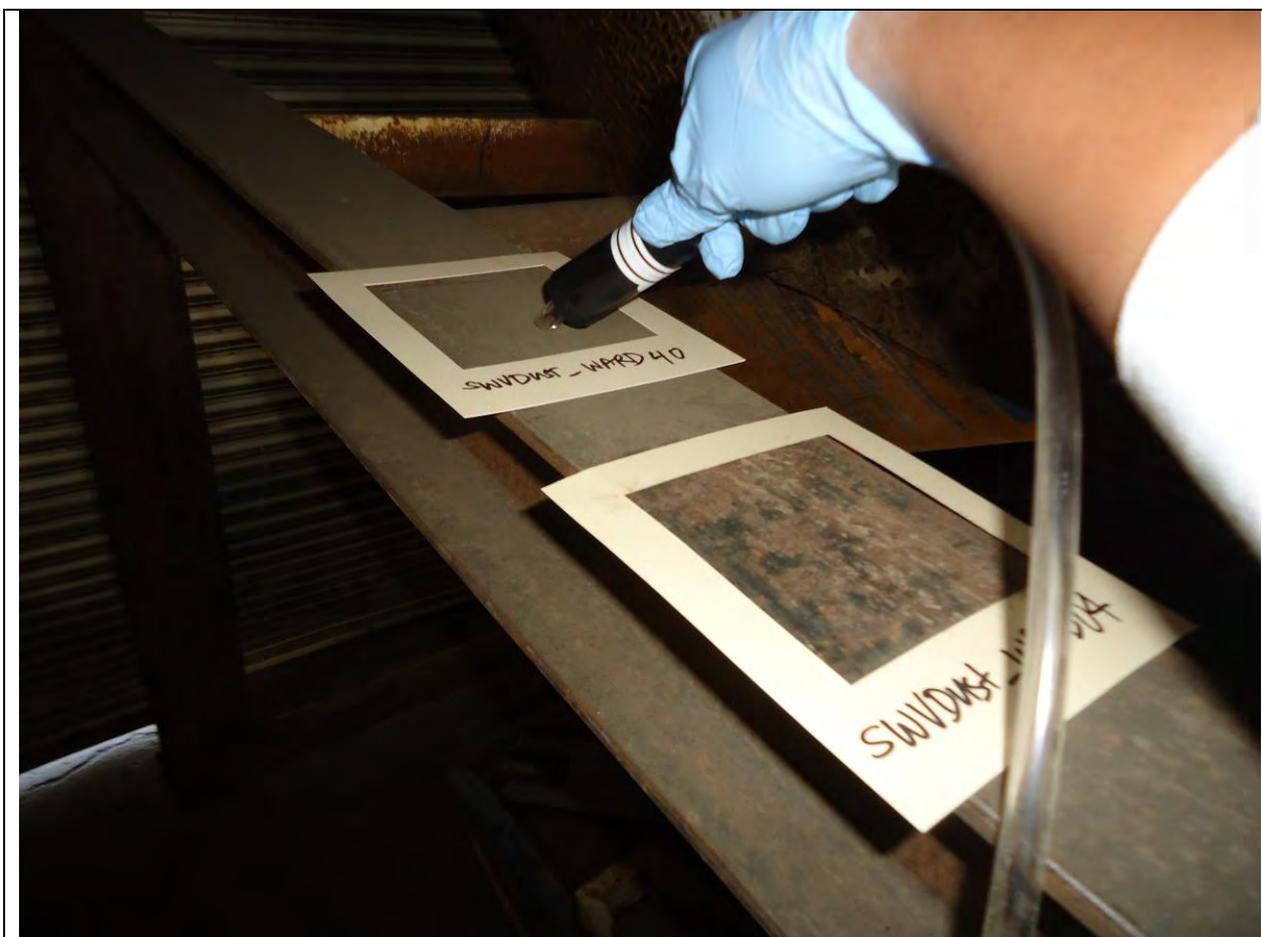
<b>Logbook Photo #</b>	DSC00776
<b>US EPA ID / Task Order Number</b>	CERCLIS: NMN000607041 / TDD No: 1/DYNAMAC-077-13-001
<b>Site</b>	Southwest Vermiculite (Removal 2)
<b>Location Address</b>	1800 1 <sup>st</sup> Street, NW
<b>City, State</b>	Albuquerque, New Mexico 87102
<b>County</b>	Bernalillo
<b>Direction/Orientation</b>	N
<b>Date</b>	12/20/13
<b>Time</b>	1203
<b>Photographer</b>	J. Koehnen (START)
<b>Witness</b>	N. Biscocho (START)
<b>Description:</b>	Indoor dust sampling at SWV Main Warehouse (Hopper Brace - North) (Samples SWVDust_WARD04 and Duplicate SWVDust_WARD40).

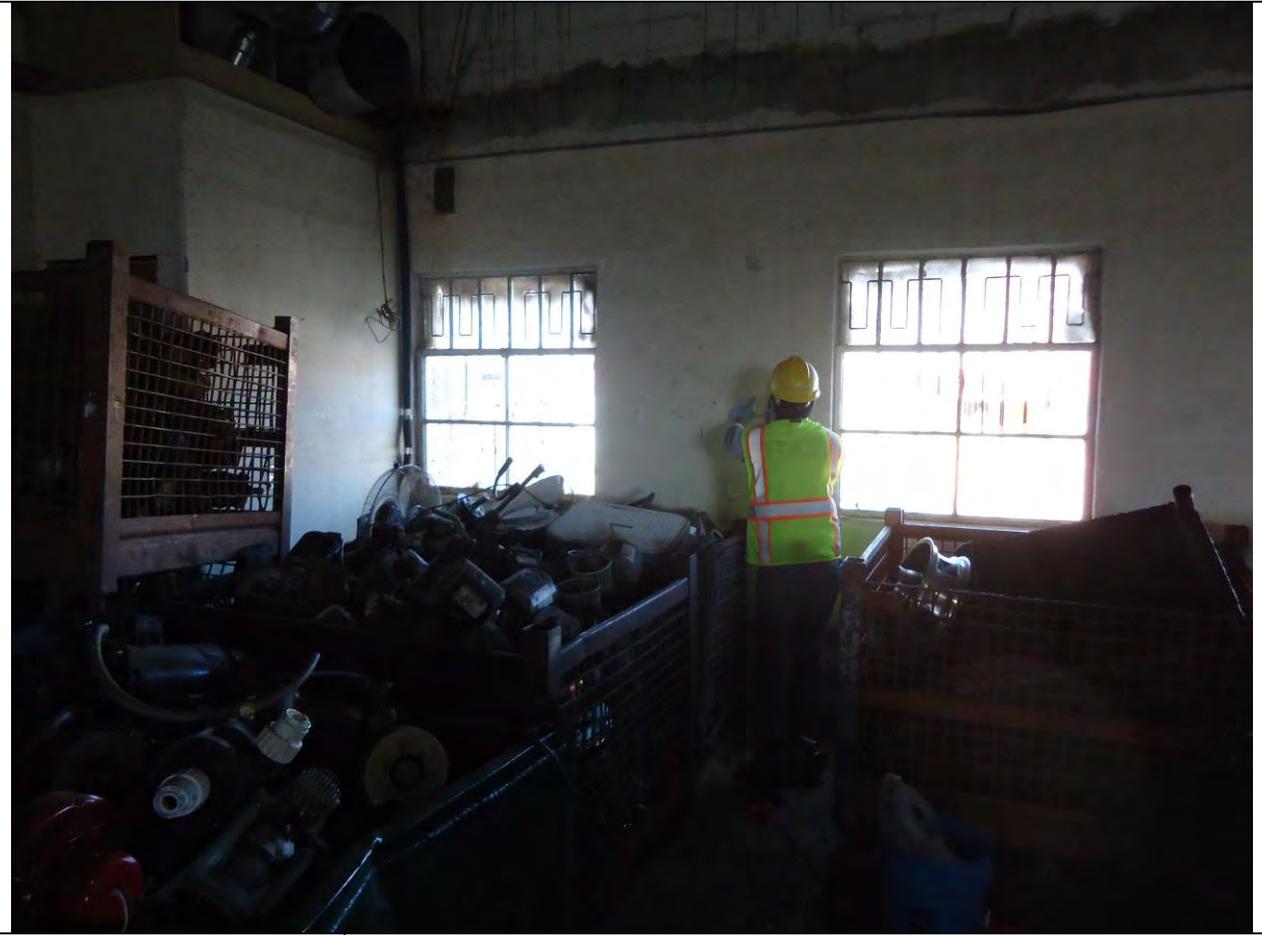
<b>Logbook Photo #</b>	DSC00778
<b>US EPA ID / Task Order Number</b>	CERCLIS: NMN000607041 / TDD No: 1/DYNAMAC-077-13-001
<b>Site</b>	Southwest Vermiculite (Removal 2)
<b>Location Address</b>	1800 1 <sup>st</sup> Street, NW
<b>City, State</b>	Albuquerque, New Mexico 87102
<b>County</b>	Bernalillo
<b>Direction/Orientation</b>	N
<b>Date</b>	12/20/13
<b>Time</b>	1212
<b>Photographer</b>	J. Koehnen (START)
<b>Witness</b>	N. Biscocho (START)
<b>Description:</b>	Indoor dust sampling at SWV Auxillary Warehouse - West (Wall - North) (Sample SWV_WARD05).

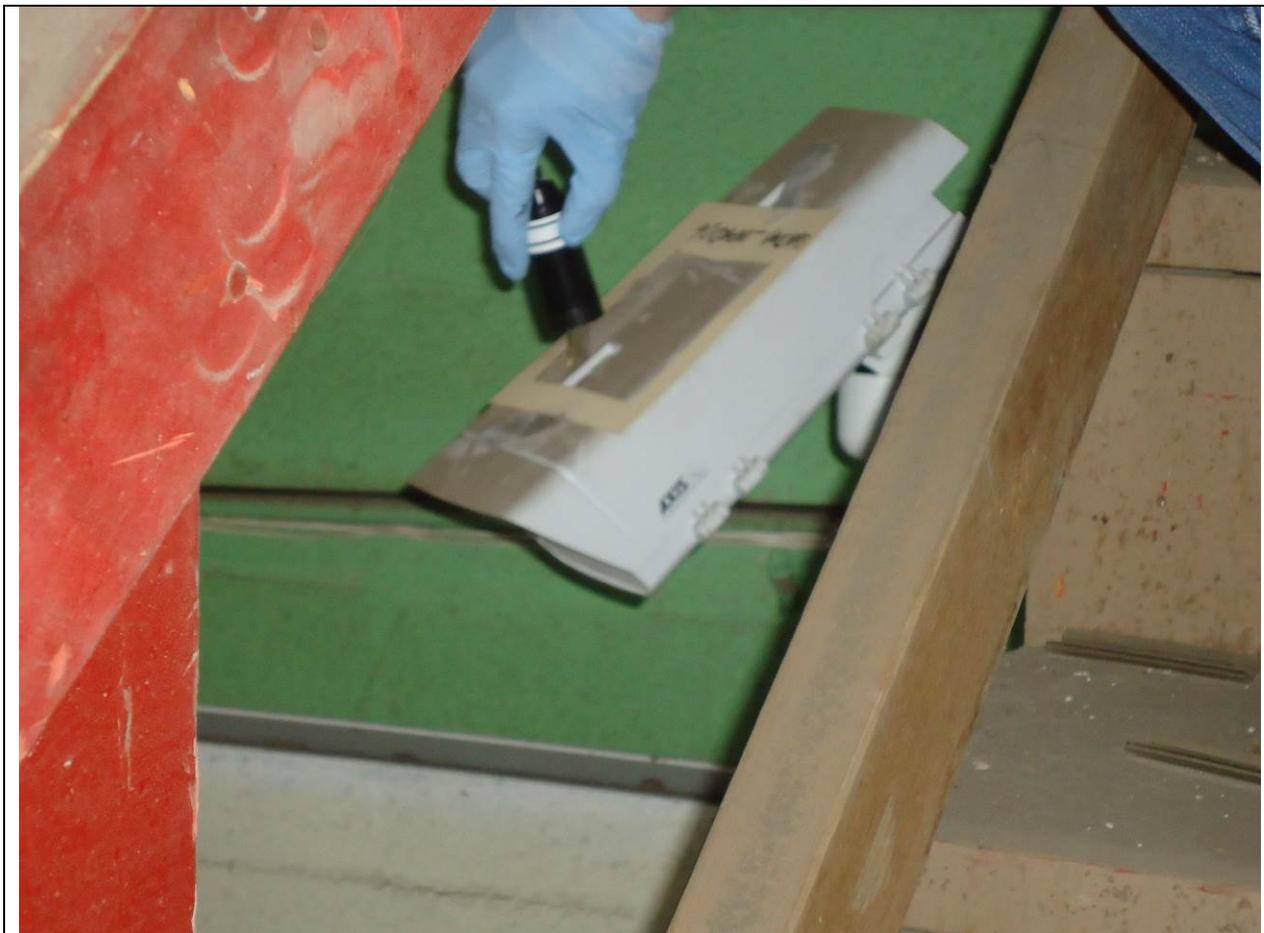
<b>Logbook Photo #</b>	DSC00779
<b>US EPA ID / Task Order Number</b>	CERCLIS: NMN000607041 / TDD No: 1/DYNAMAC-077-13-001
<b>Site</b>	Southwest Vermiculite (Removal 2)
<b>Location Address</b>	1800 1 <sup>st</sup> Street, NW
<b>City, State</b>	Albuquerque, New Mexico 87102
<b>County</b>	Bernalillo
<b>Direction/Orientation</b>	NW
<b>Date</b>	12/20/13
<b>Time</b>	1220
<b>Photographer</b>	J. Koehnen (START)
<b>Witness</b>	N. Biscocho (START)
<b>Description:</b>	
Indoor dust sampling at SWV Auxillary Warehouse - West (Security Camera) (Sample SWVDust_WARD06).

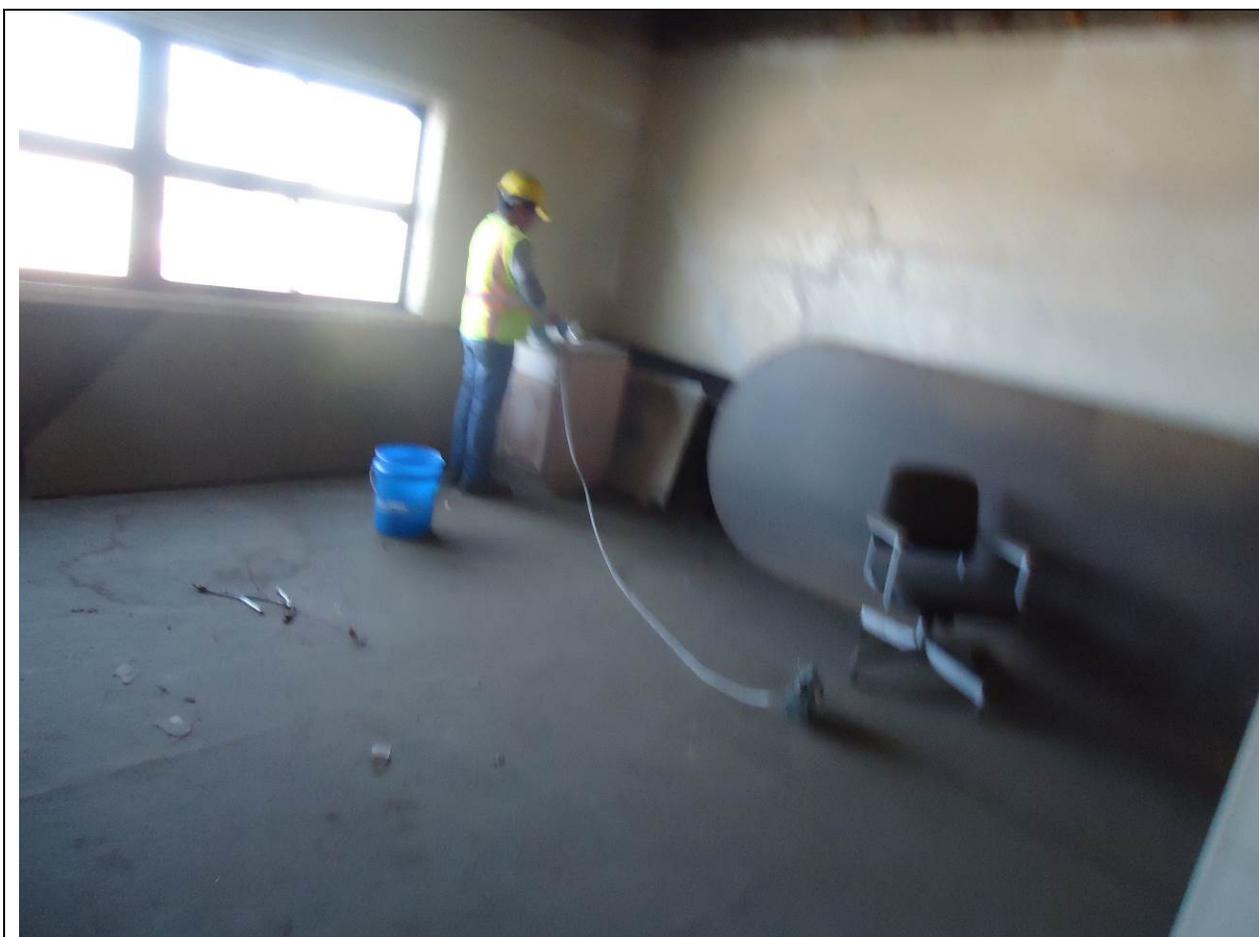
<b>Logbook Photo #</b>	DSC00781
<b>US EPA ID / Task Order Number</b>	CERCLIS: NMN000607041 / TDD No: 1/DYNAMAC-077-13-001
<b>Site</b>	Southwest Vermiculite (Removal 2)
<b>Location Address</b>	1800 1 <sup>st</sup> Street, NW
<b>City, State</b>	Albuquerque, New Mexico 87102
<b>County</b>	Bernalillo
<b>Direction/Orientation</b>	NE
<b>Date</b>	12/20/13
<b>Time</b>	1225
<b>Photographer</b>	J. Koehnen (START)
<b>Witness</b>	N. Biscocho (START)
<b>Description:</b>	
Indoor dust sampling at SWV Auxillary Warehouse - West (2nd Floor Vanity shelf) (Sample No. SWVDust)WARD07).

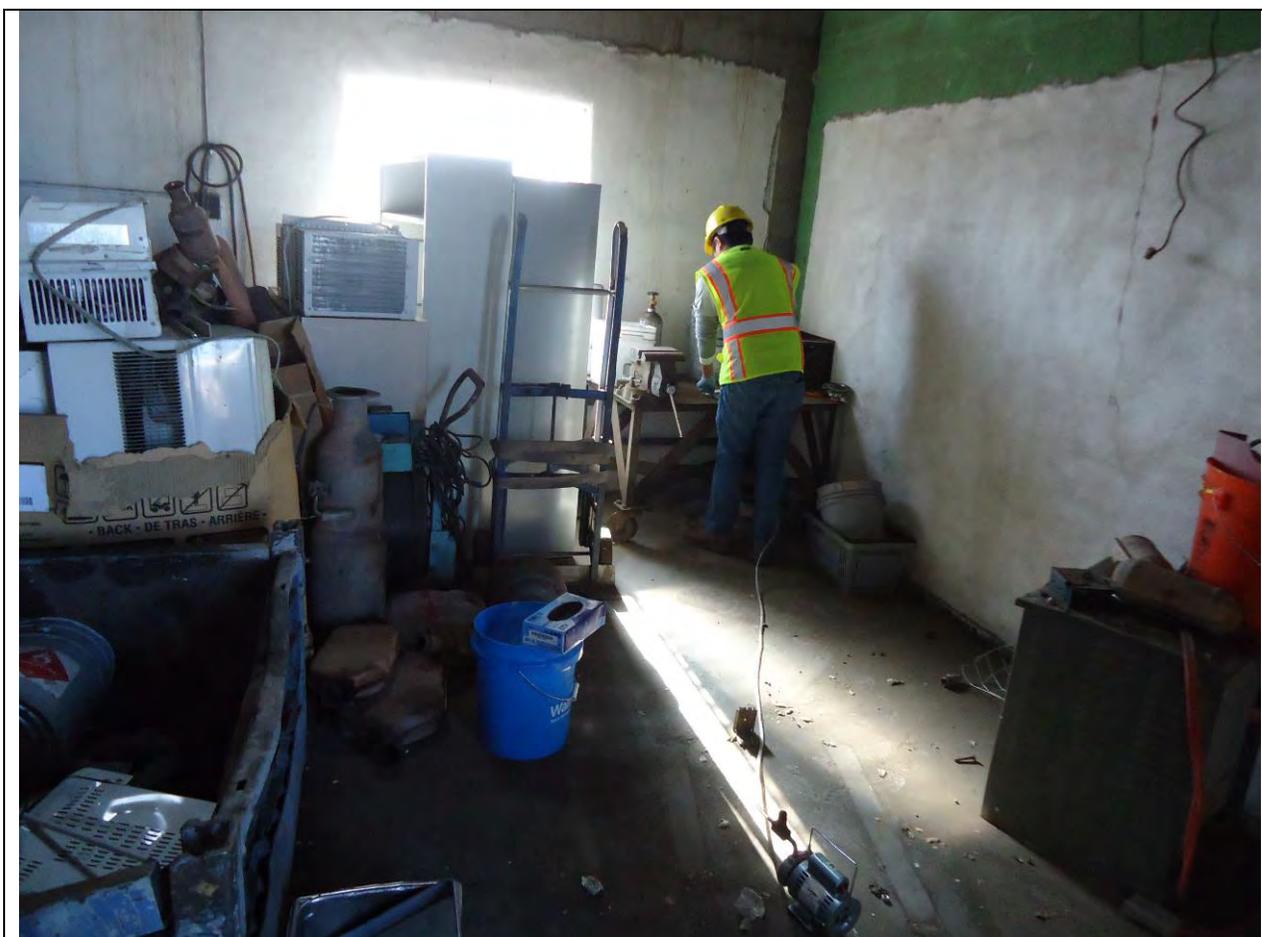
<b>Logbook Photo #</b>	DSC00784
<b>US EPA ID / Task Order Number</b>	CERCLIS: NMN000607041 / TDD No: 1/DYNAMAC-077-13-001
<b>Site</b>	Southwest Vermiculite (Removal 2)
<b>Location Address</b>	1800 1 <sup>st</sup> Street, NW
<b>City, State</b>	Albuquerque, New Mexico 87102
<b>County</b>	Bernalillo
<b>Direction/Orientation</b>	SW
<b>Date</b>	12/20/13
<b>Time</b>	1233
<b>Photographer</b>	J. Koehnen (START)
<b>Witness</b>	N. Biscocho (START)
<b>Description:</b>	Indoor dust sampling at SWV Auxillary Warehouse - West (Work bench - SW) (Sample No. SWVDust_WARD08).

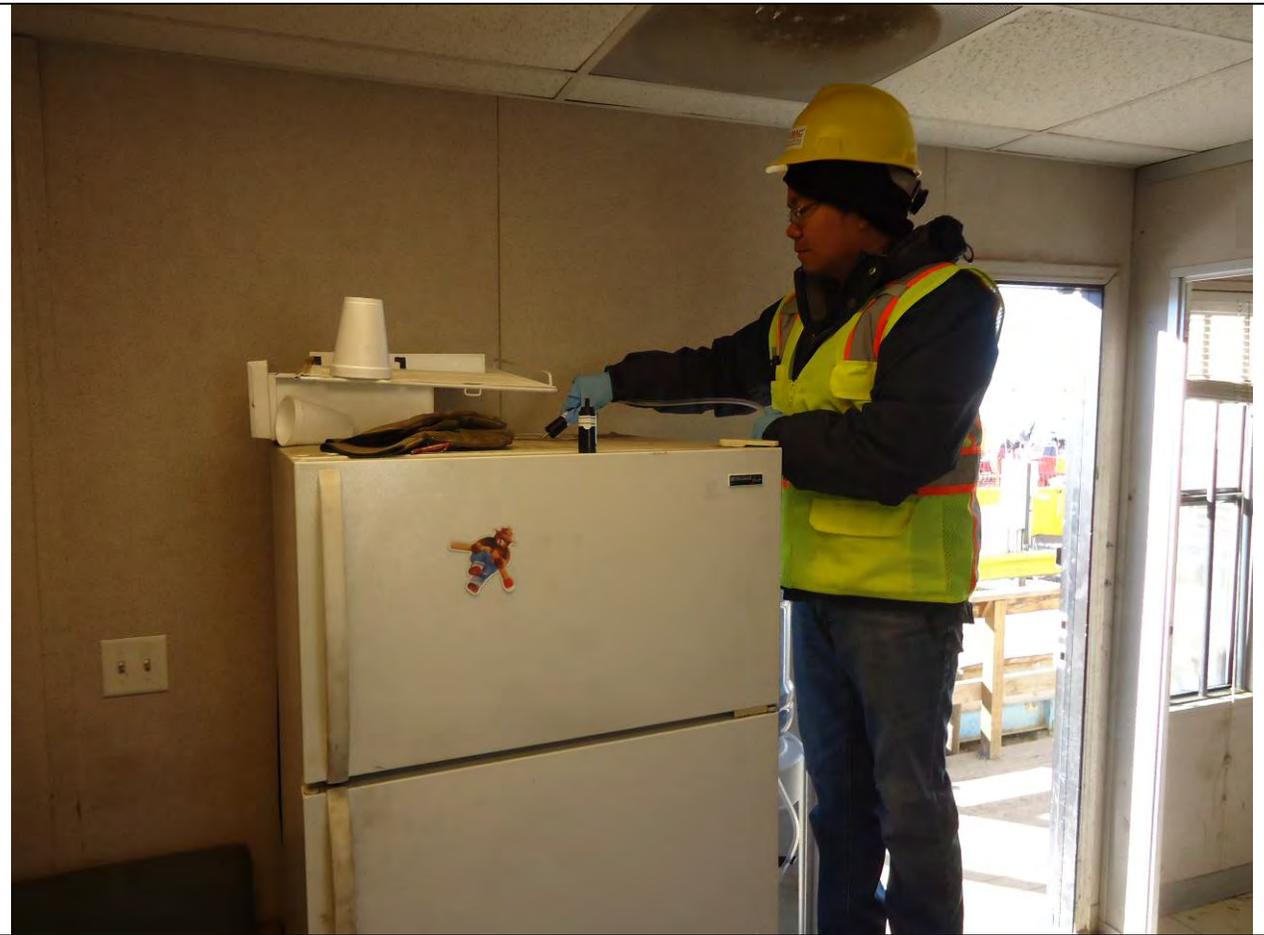
<b>Logbook Photo #</b>	DSC00870
<b>US EPA ID / Task Order Number</b>	CERCLIS: NMN000607041 / TDD No: 1/DYNAMAC-077-13-001
<b>Site</b>	Southwest Vermiculite (Removal 2)
<b>Location Address</b>	1800 1 <sup>st</sup> Street, NW
<b>City, State</b>	Albuquerque, New Mexico 87102
<b>County</b>	Bernalillo
<b>Direction/Orientation</b>	SW
<b>Date</b>	1/11/14
<b>Time</b>	0938
<b>Photographer</b>	J. Koehnen (START)
<b>Witness</b>	N. Biscocho (START)
<b>Description:</b>	Indoor dust sampling at SWV W. Silver Trailer Scale Office (Top of Refrigerator - South side of Office) (Sample Nos. SWVDust_WSTrail01 and Duplicate SWVDust_WSTrail10).

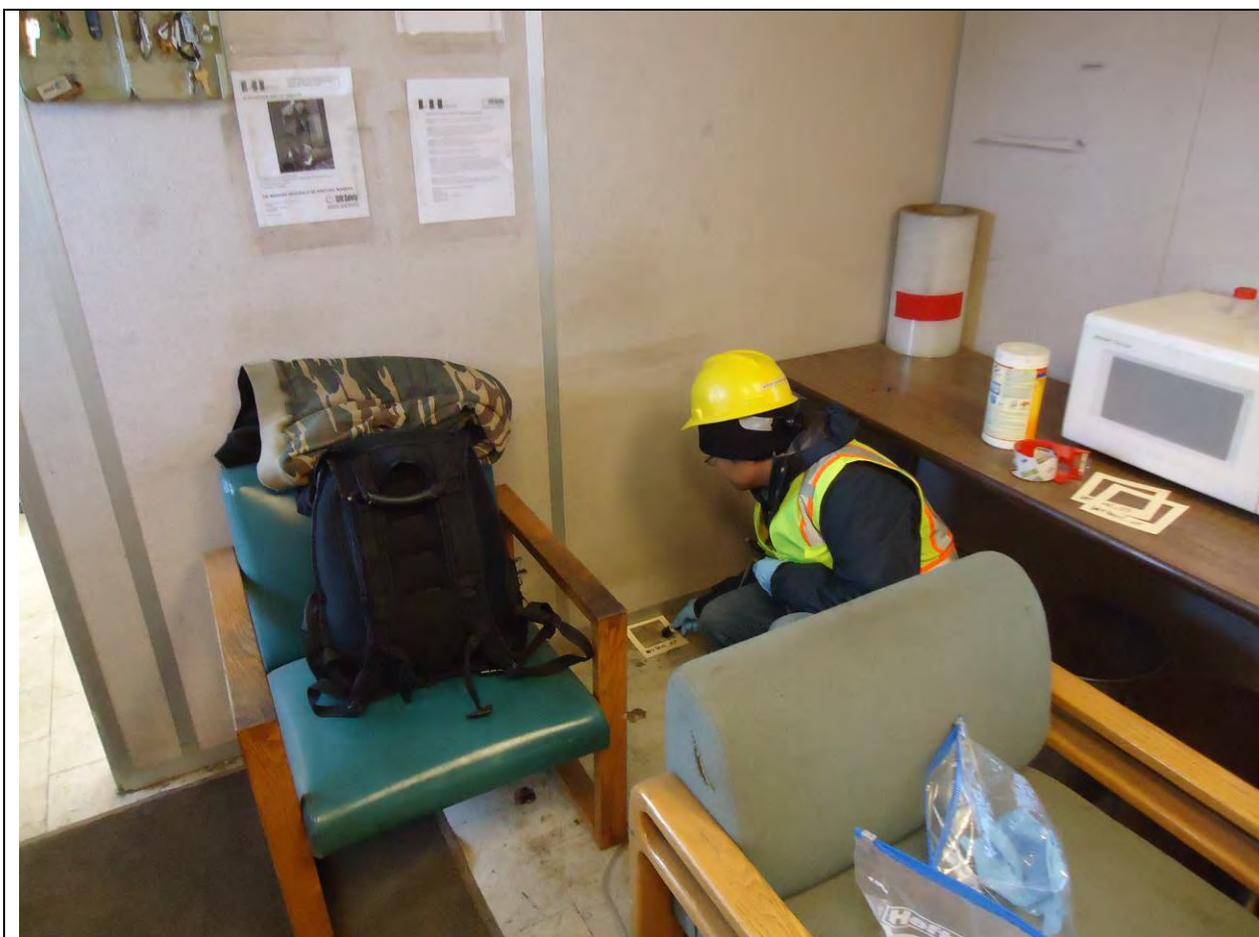
<b>Logbook Photo #</b>	DSC00873
<b>US EPA ID / Task Order Number</b>	CERCLIS: NMN000607041 / TDD No: 1/DYNAMAC-077-13-001
<b>Site</b>	Southwest Vermiculite (Removal 2)
<b>Location Address</b>	1800 1 <sup>st</sup> Street, NW
<b>City, State</b>	Albuquerque, New Mexico 87102
<b>County</b>	Bernalillo
<b>Direction/Orientation</b>	NW
<b>Date</b>	1/11/14
<b>Time</b>	0951
<b>Photographer</b>	J. Koehnen (START)
<b>Witness</b>	N. Biscocho (START)
<b>Description:</b>	Indoor dust sampling at SWV W. Silver Trailer Scale Office (Floor by south main entrance on the east side of the trailer) (Sample No. SWVDust_WSTrail02).

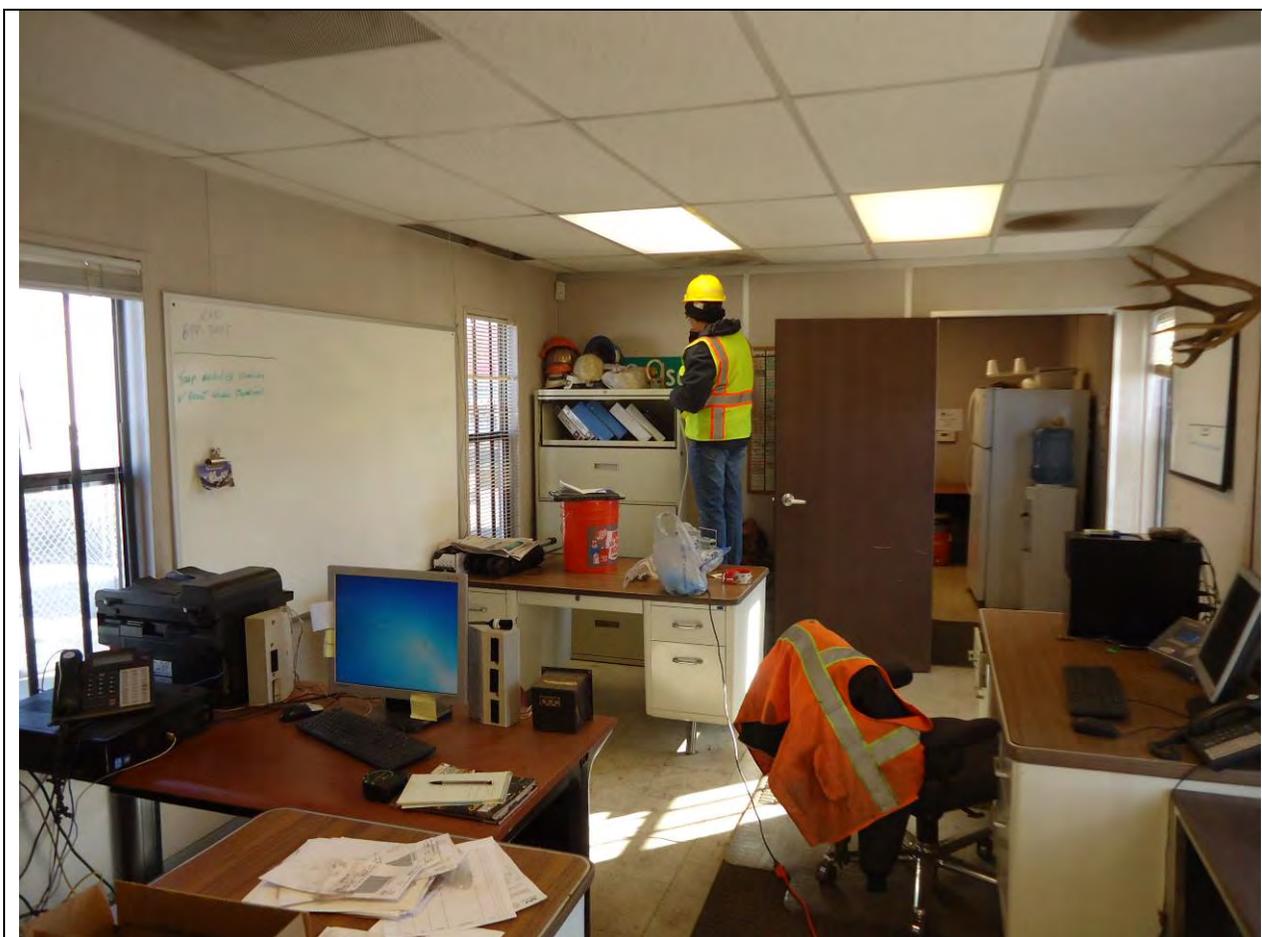
<b>Logbook Photo #</b>	DSC00875
<b>US EPA ID / Task Order Number</b>	CERCLIS: NMN000607041 / TDD No: 1/DYNAMAC-077-13-001
<b>Site</b>	Southwest Vermiculite (Removal 2)
<b>Location Address</b>	1800 1 <sup>st</sup> Street, NW
<b>City, State</b>	Albuquerque, New Mexico 87102
<b>County</b>	Bernalillo
<b>Direction/Orientation</b>	E
<b>Date</b>	1/11/14
<b>Time</b>	0959
<b>Photographer</b>	J. Koehnen (START)
<b>Witness</b>	N. Biscocho (START)
<b>Description:</b>	Indoor sampling at SWV W. Silver Trailer Scale Office (Bookshelf - Middle Part of trailer) (Sample No. SWVDust_WSTrail03).

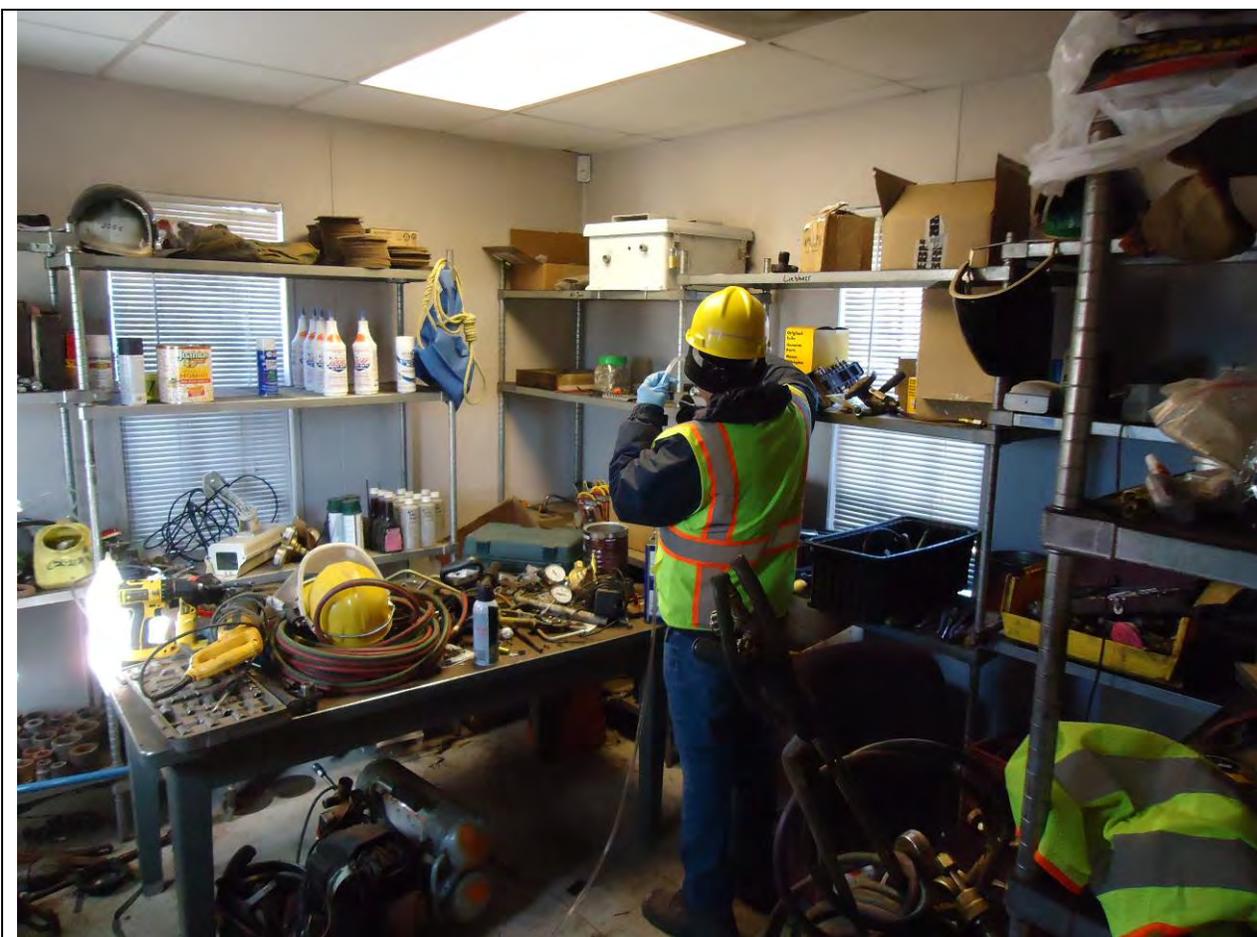
<b>Logbook Photo #</b>	DSC00877
<b>US EPA ID / Task Order Number</b>	CERCLIS: NMN000607041 / TDD No: 1/DYNAMAC-077-13-001
<b>Site</b>	Southwest Vermiculite (Removal 2)
<b>Location Address</b>	1800 1 <sup>st</sup> Street, NW
<b>City, State</b>	Albuquerque, New Mexico 87102
<b>County</b>	Bernalillo
<b>Direction/Orientation</b>	NW
<b>Date</b>	1/11/14
<b>Time</b>	1005
<b>Photographer</b>	J. Koehnen (START)
<b>Witness</b>	N. Biscocho (START)
<b>Description:</b>	Indoor dust sampling at SWV W. Silver Trailer Scale Office (Tools room - west of trailer) (Sample No. SWVDust_WSTrail04).

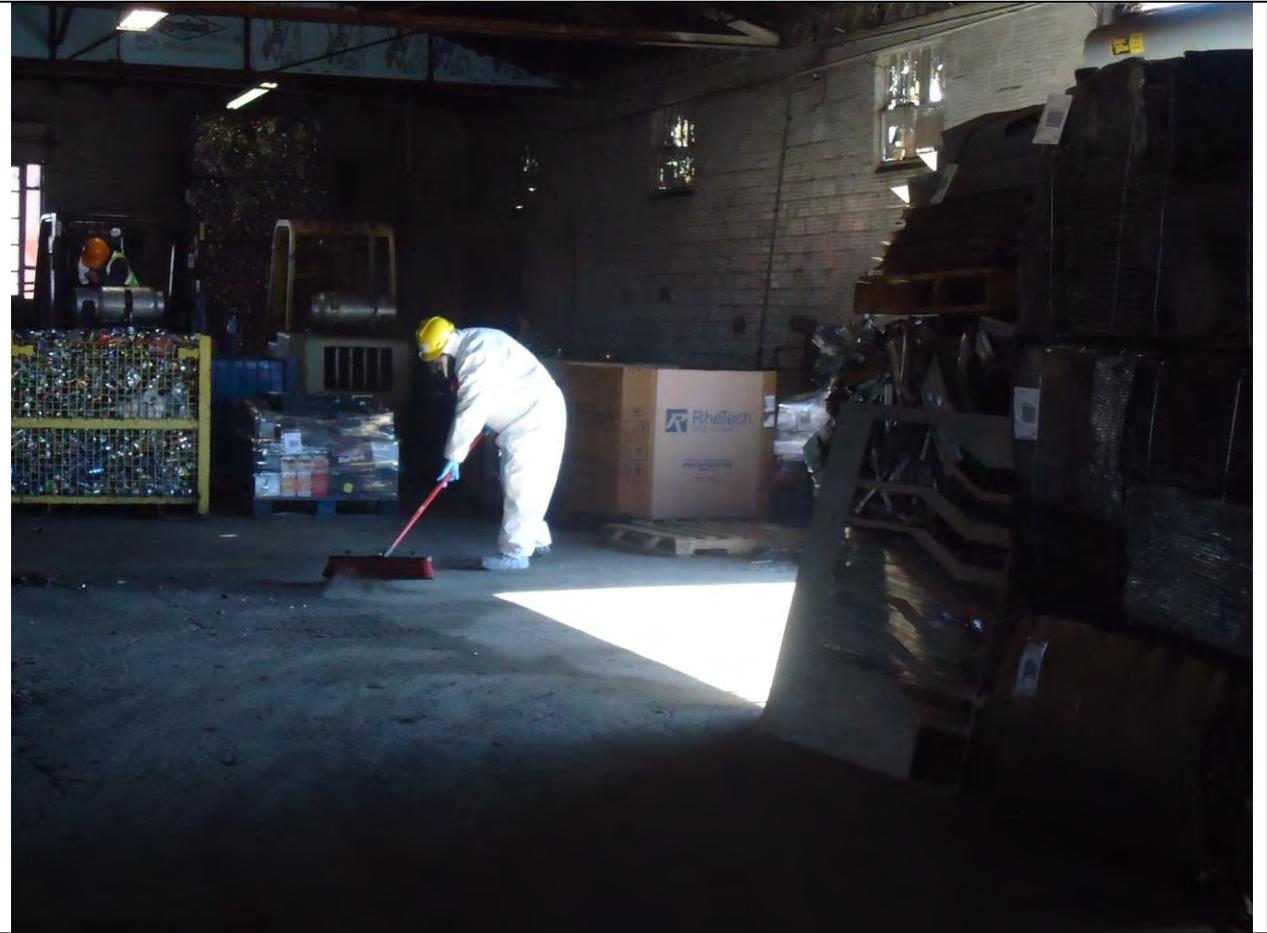
<b>Logbook Photo #</b>	DSC00717
<b>US EPA ID / Task Order Number</b>	CERCLIS: NMN000607041 / TDD No: 1/DYNAMAC-077-13-001
<b>Site</b>	Southwest Vermiculite (Removal 2)
<b>Location Address</b>	1800 1 <sup>st</sup> Street, NW
<b>City, State</b>	Albuquerque, New Mexico 87102
<b>County</b>	Bernalillo
<b>Direction/Orientation</b>	SE
<b>Date</b>	12/9/13
<b>Time</b>	1150
<b>Photographer</b>	J. Koehnen (START)
<b>Witness</b>	S. Cowan (START)
<b>Description:</b>	
View of bulk dust sampling inside W. Silver Recycling warehouse.
