## Appendix C

### Photo Documentation

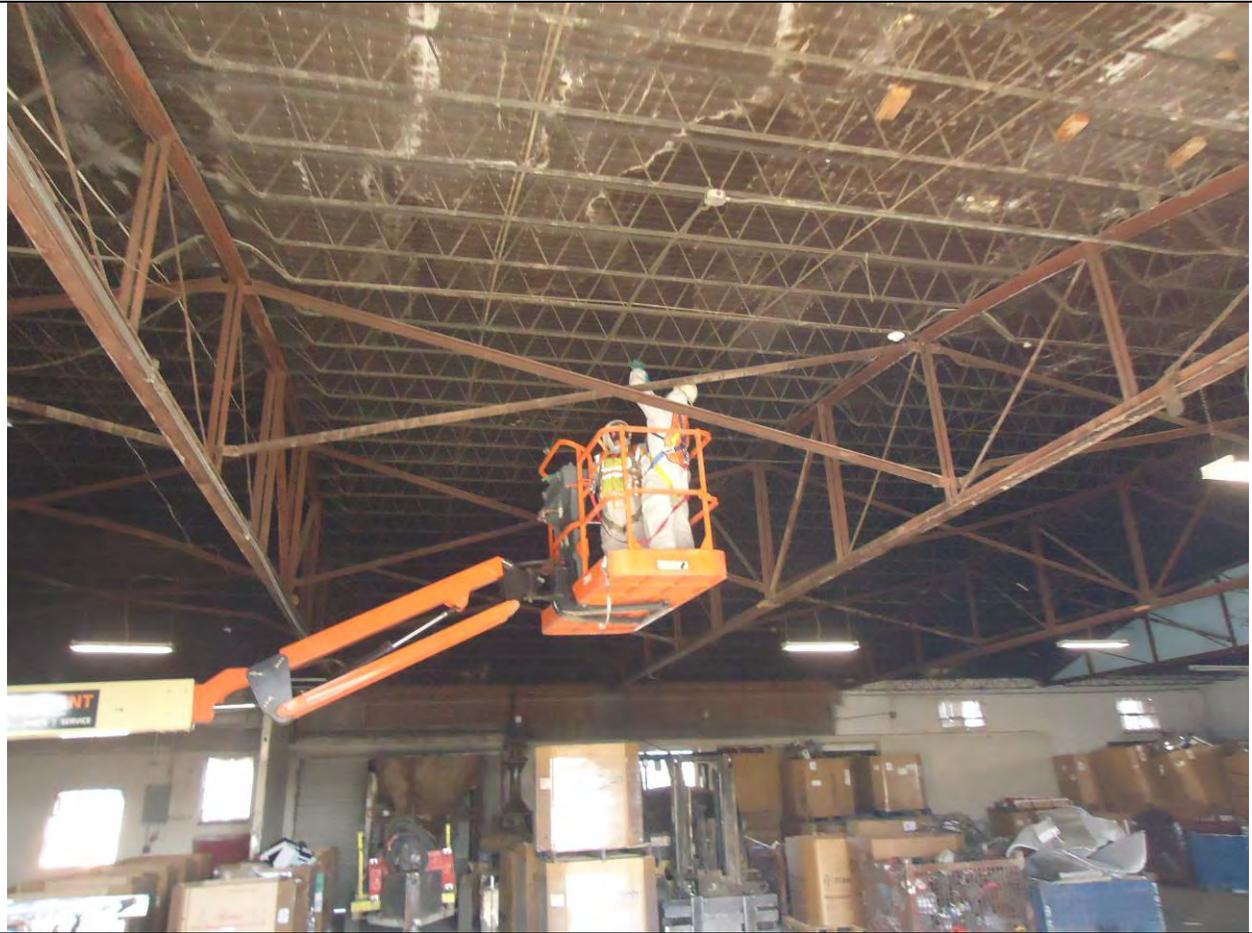
<b>Logbook Photo #</b>	DSC00848
<b>US EPA ID / Task Order Number</b>	CERCLIS: NMN000607041 / TDD No: 1/DYNAMAC-077-13-001
<b>Site</b>	Southwest Vermiculite (Removal 2)
<b>Location Address</b>	1800 1 <sup>st</sup> Street, NW
<b>City, State</b>	Albuquerque, New Mexico 87102
<b>County</b>	Bernalillo
<b>Direction/Orientation</b>	N
<b>Date</b>	1/9/14
<b>Time</b>	0926
<b>Photographer</b>	J. Koehnen (START)
<b>Witness</b>	N. Biscocho (START)
<b>Description:</b>	
Bulk sampling (Impacted and unimpacted ceiling insulation) inside the W. Silver Recycling Main Warehouse (Samples SWV2_WARC01 and SWV2_WARC02).

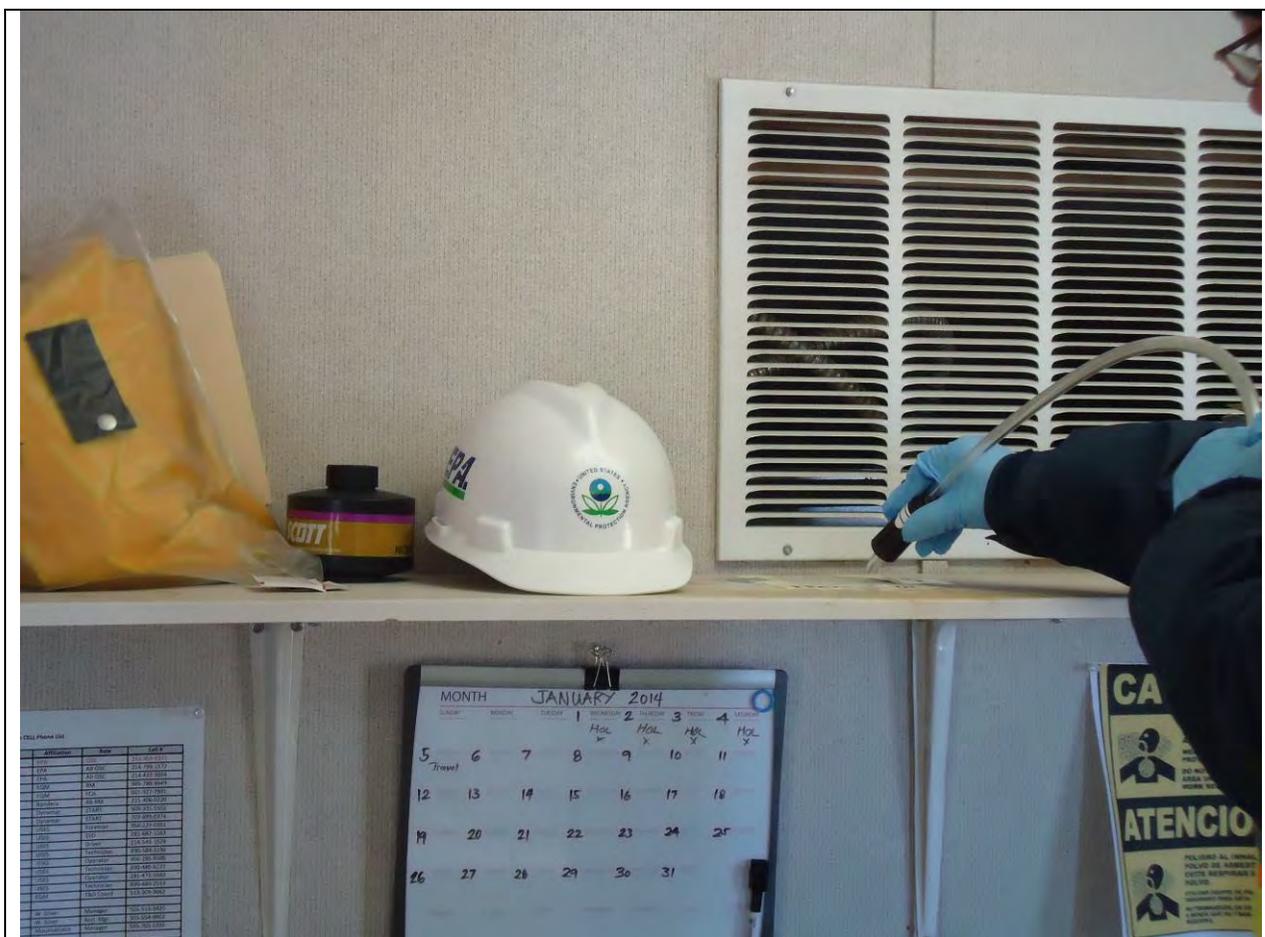
<b>Logbook Photo #</b>	DSC0882
<b>US EPA ID / Task Order Number</b>	CERCLIS: NMN000607041 / TDD No: 1/DYNAMAC-077-13-001
<b>Site</b>	Southwest Vermiculite (Removal 2)
<b>Location Address</b>	1800 1 <sup>st</sup> Street, NW
<b>City, State</b>	Albuquerque, New Mexico 87102
<b>County</b>	Bernalillo
<b>Direction/Orientation</b>	S
<b>Date</b>	1/11/14
<b>Time</b>	1030
<b>Photographer</b>	J. Koehnen (START)
<b>Witness</b>	N. Biscocho (START)
<b>Description:</b>	Indoor dust sampling at EPA Field Office - Bookshelf by intake vent on EPA/START shared office - South side of trailer (SWVDust_EPATrail01).

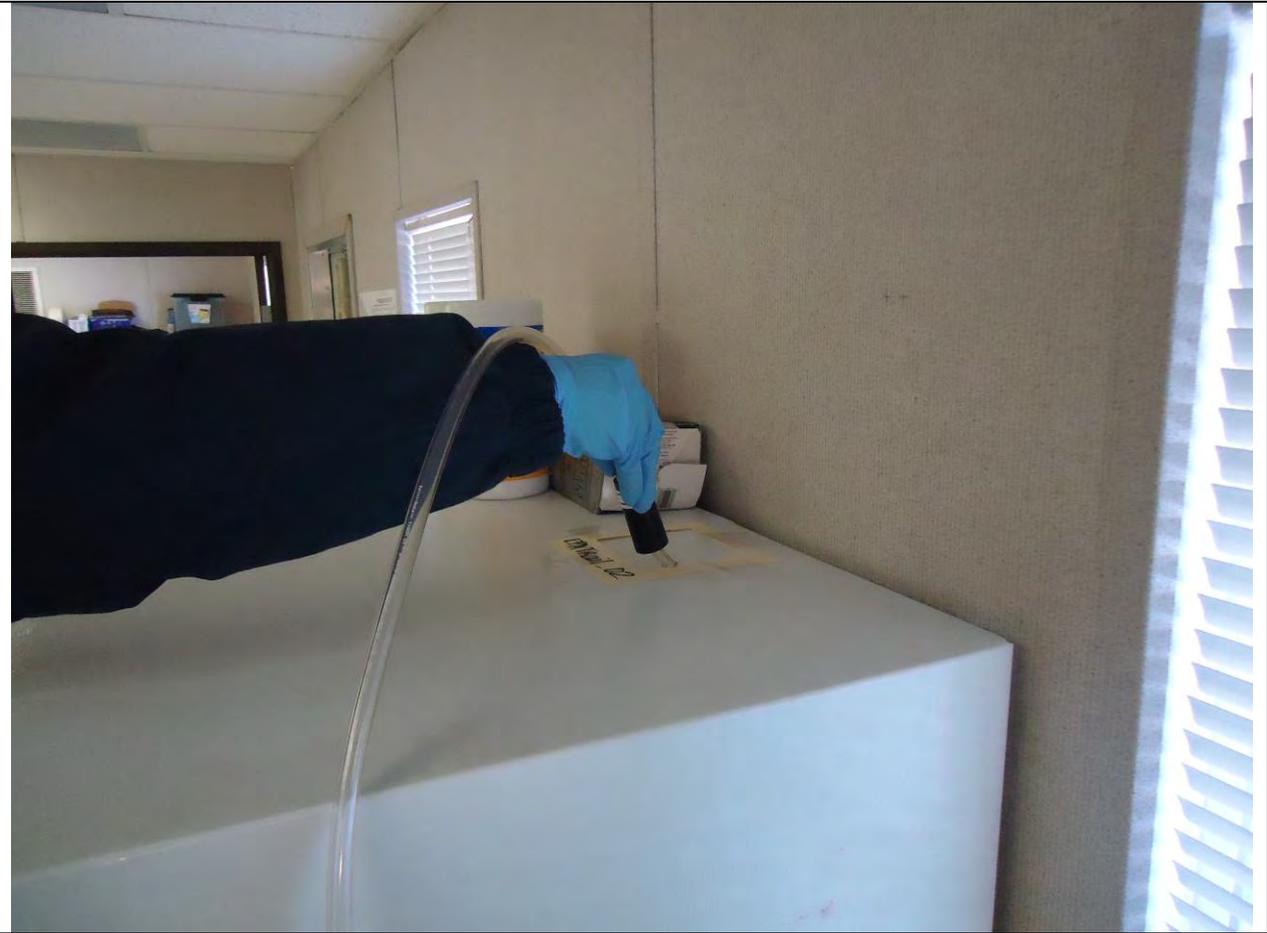
<b>Logbook Photo #</b>	DSC00880
<b>US EPA ID / Task Order Number</b>	CERCLIS: NMN000607041 / TDD No: 1/DYNAMAC-077-13-001
<b>Site</b>	Southwest Vermiculite (Removal 2)
<b>Location Address</b>	1800 1 <sup>st</sup> Street, NW
<b>City, State</b>	Albuquerque, New Mexico 87102
<b>County</b>	Bernalillo
<b>Direction/Orientation</b>	SW
<b>Date</b>	1/11/14
<b>Time</b>	1024
<b>Photographer</b>	J. Koehnen (START)
<b>Witness</b>	N. Biscocho (START)
<b>Description:</b>	
Indoor dust sampling at EPA Field Office - Top of refrigerator (middle section of trailer) (SWVDust_EPATrail02).

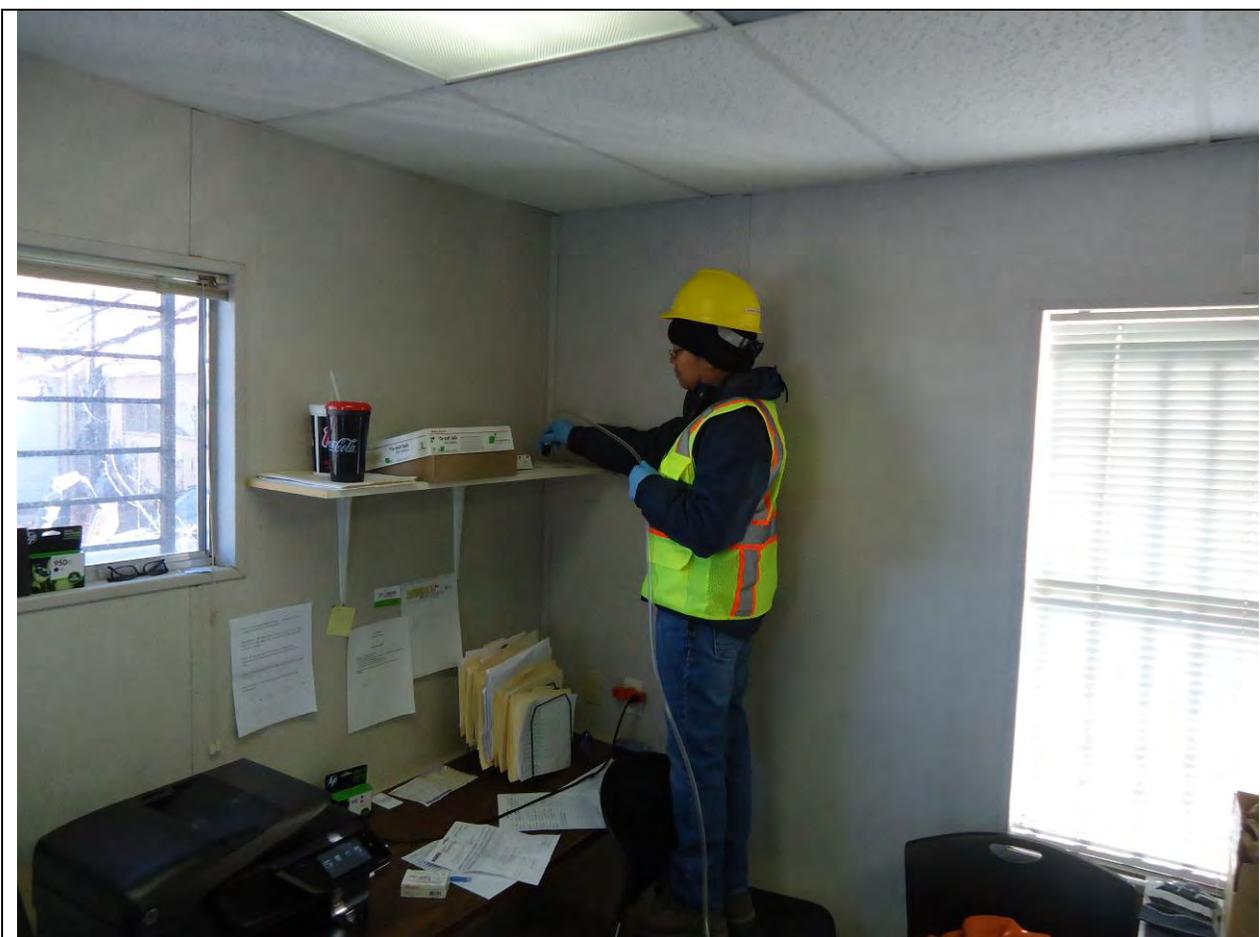
<b>Logbook Photo #</b>	DSC00879
<b>US EPA ID / Task Order Number</b>	CERCLIS: NMN000607041 / TDD No: 1/DYNAMAC-077-13-001
<b>Site</b>	Southwest Vermiculite (Removal 2)
<b>Location Address</b>	1800 1 <sup>st</sup> Street, NW
<b>City, State</b>	Albuquerque, New Mexico 87102
<b>County</b>	Bernalillo
<b>Direction/Orientation</b>	NE
<b>Date</b>	1/11/14
<b>Time</b>	1018
<b>Photographer</b>	J. Koehnen (START)
<b>Witness</b>	N. Biscocho (START)
<b>Description:</b>	Indoor dust sampling at EPA Field Office - Bookshelf on ERRS office - North side of trailer (Sample SWVDust_EPATrail03).

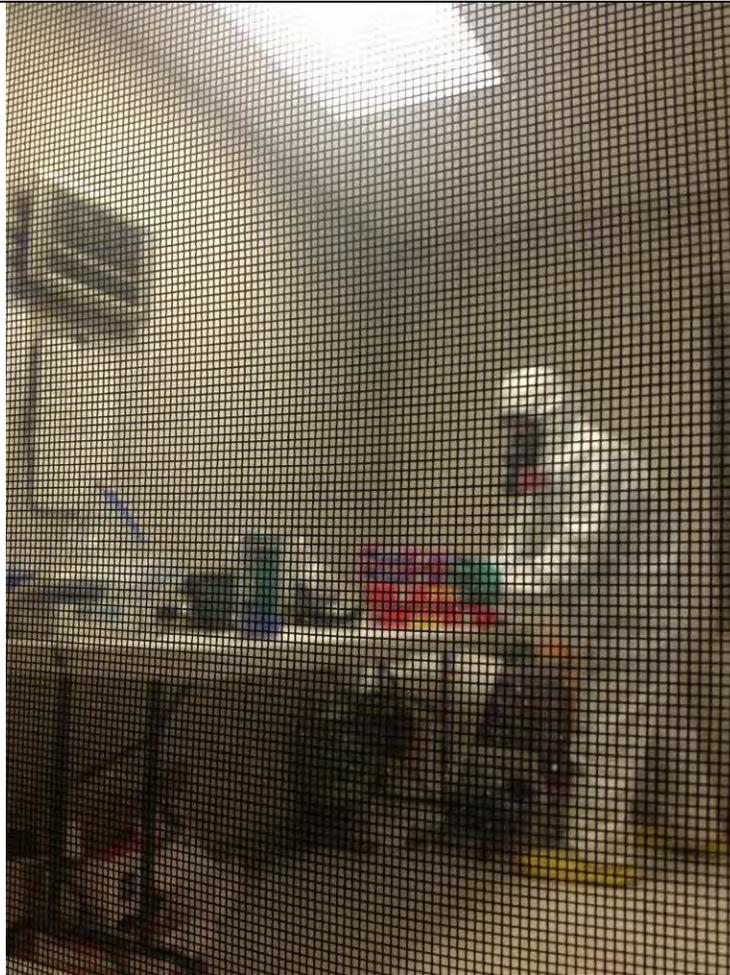
<b>Logbook Photo #</b>	NB0004
<b>US EPA ID / Task Order Number</b>	CERCLIS: NMN000607041 / TDD No: 1/DYNAMAC-077-13-001
<b>Site</b>	Southwest Vermiculite (Removal 2)
<b>Location Address</b>	1800 1 <sup>st</sup> Street, NW
<b>City, State</b>	Albuquerque, New Mexico 87102
<b>County</b>	Bernalillo
<b>Direction/Orientation</b>	NE
<b>Date</b>	1/16/14
<b>Time</b>	1800
<b>Photographer</b>	N. Biscocho (START)
<b>Witness</b>	J. Koehnen (START)
<b>Description:</b>	
View into EPA Field Office Trailer as Decontamination is conducted.

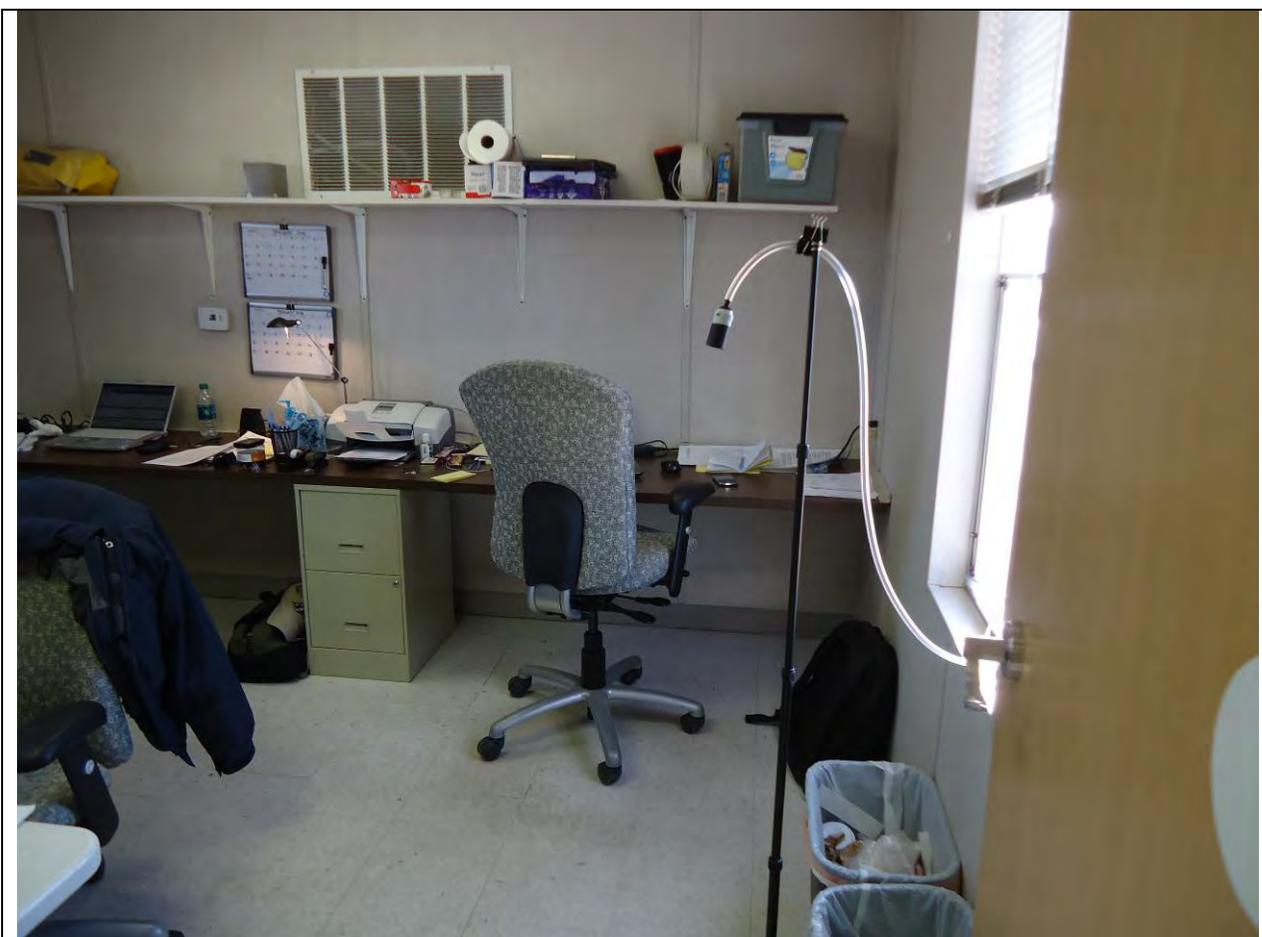
<b>Logbook Photo #</b>	DSC00961
<b>US EPA ID / Task Order Number</b>	CERCLIS: NMN000607041 / TDD No: 1/DYNAMAC-077-13-001
<b>Site</b>	Southwest Vermiculite (Removal 2)
<b>Location Address</b>	1800 1 <sup>st</sup> Street, NW
<b>City, State</b>	Albuquerque, New Mexico 87102
<b>County</b>	Bernalillo
<b>Direction/Orientation</b>	S
<b>Date</b>	1/23/14
<b>Time</b>	1412
<b>Photographer</b>	N. Biscocho (START)
<b>Witness</b>	J. Koehnen (START)
<b>Description:</b>	Indoor air sampling at EPA Field Office Trailer.

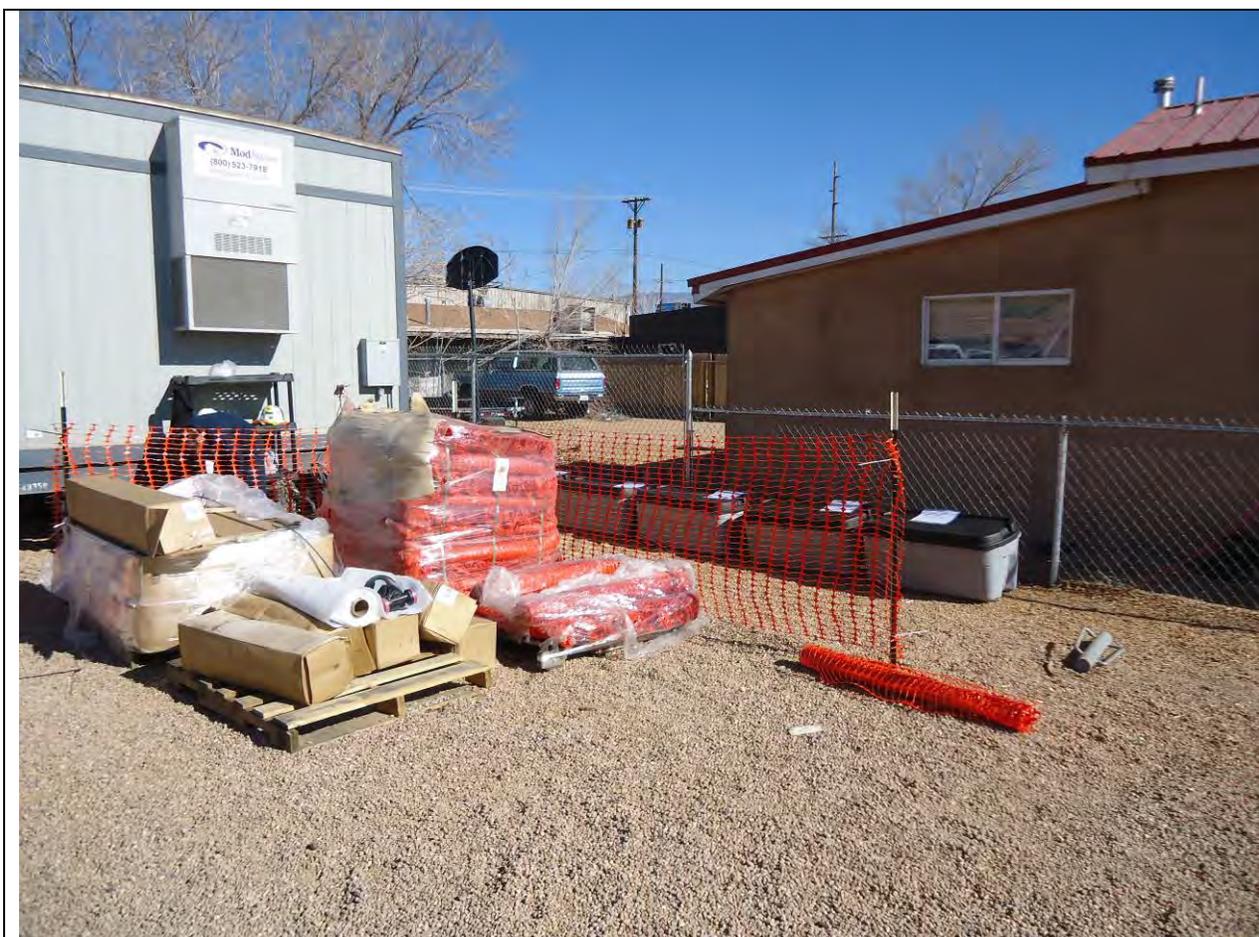
<b>Logbook Photo #</b>	DSC00905
<b>US EPA ID / Task Order Number</b>	CERCLIS: NMN000607041 / TDD No: 1/DYNAMAC-077-13-001
<b>Site</b>	Southwest Vermiculite (Removal 2)
<b>Location Address</b>	1800 1 <sup>st</sup> Street, NW
<b>City, State</b>	Albuquerque, New Mexico 87102
<b>County</b>	Bernalillo
<b>Direction/Orientation</b>	NE
<b>Date</b>	1/17/14
<b>Time</b>	1153
<b>Photographer</b>	J. Koehnen (START)
<b>Witness</b>	N. Biscocho (START)
<b>Description:</b>	Decontamination set-up at EPA Field Office Trailer.

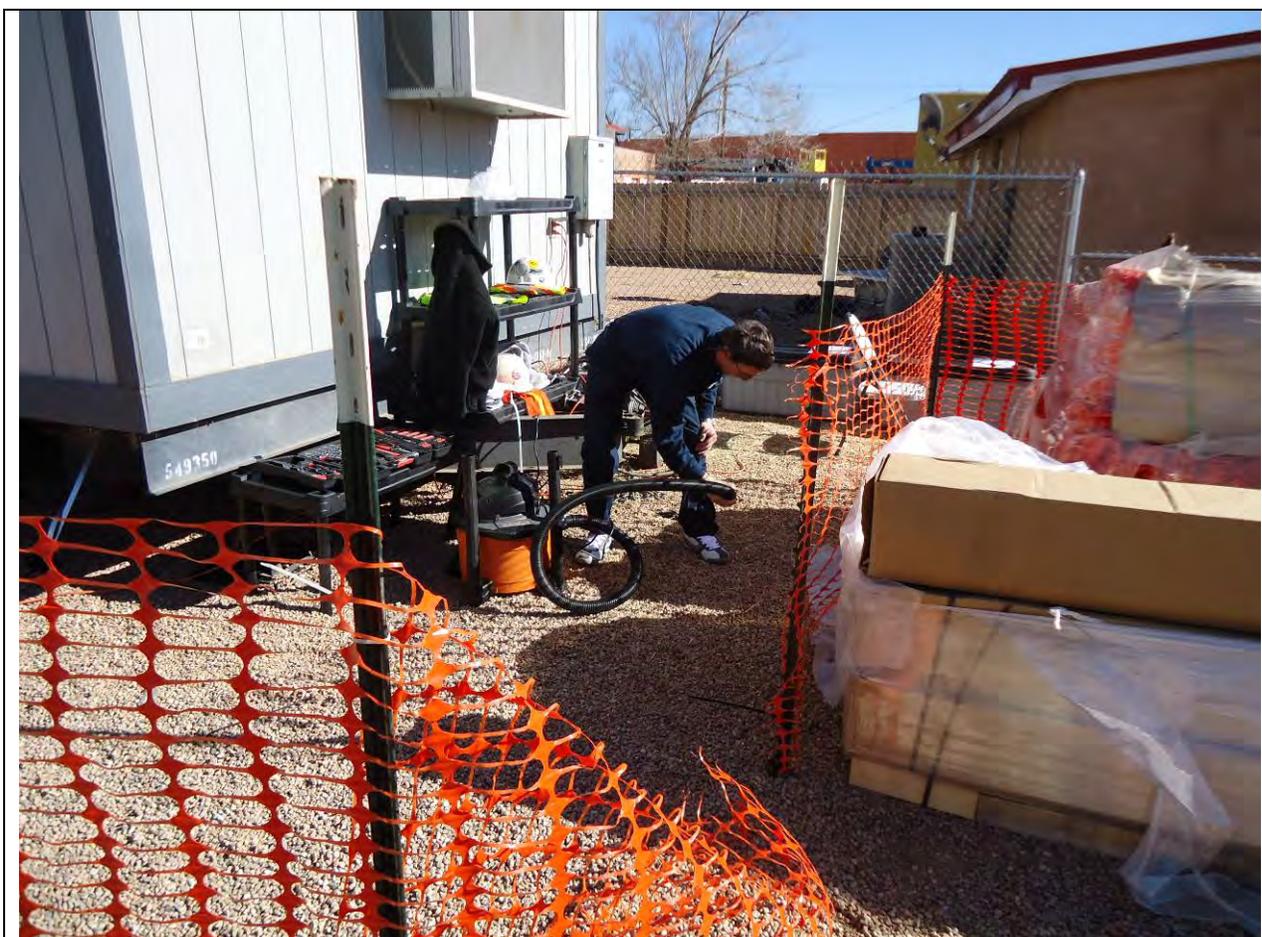
<b>Logbook Photo #</b>	DSC00906
<b>US EPA ID / Task Order Number</b>	CERCLIS: NMN000607041 / TDD No: 1/DYNAMAC-077-13-001
<b>Site</b>	Southwest Vermiculite (Removal 2)
<b>Location Address</b>	1800 1 <sup>st</sup> Street, NW
<b>City, State</b>	Albuquerque, New Mexico 87102
<b>County</b>	Bernalillo
<b>Direction/Orientation</b>	NE
<b>Date</b>	1/17/14
<b>Time</b>	1154
<b>Photographer</b>	J. Koehnen (START)
<b>Witness</b>	N. Biscocho (START)
<b>Description:</b>	View of ERRS conducting personal decontamination procedures prior to entering the EPA Field Office Trailer.
