# **Incident Action Plan**

## ***Millard Anhydrous Ammonia Release***

**06/09/2014**

**Richland, Mississippi**

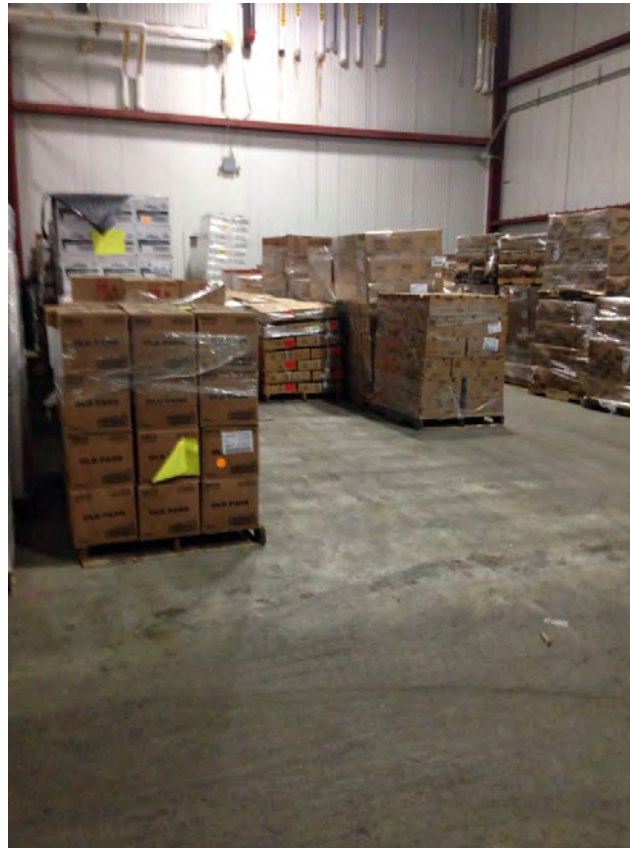
Siera Type	Event (Observation)	
Primary ID	Prep for hotwork	
Secondary ID		
Location	Freezer in facility 32.25529098510742, -90.15574645996094	
Initials	Kelly Scribner	
Comments	Removing palettes from area for cutting.

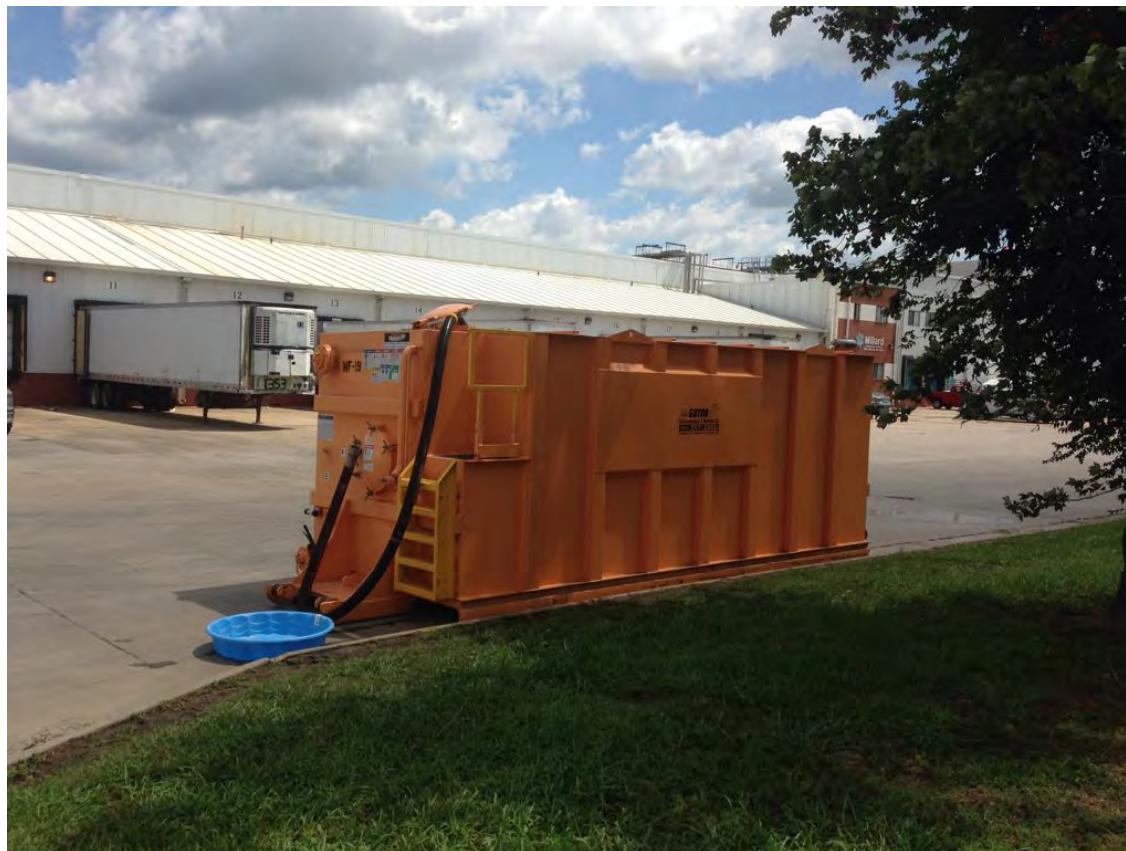
Siera Type	Survey (Frac Tank)	
Primary ID	MF-19	
Secondary ID		
Location	Frac tank located on south side of facility perimeter 32.25371551513672, -90.15523529052734	
Initials	Travis Sartain	Google Map data ©2014 Google aGlobe, U.S. Geological Survey, USDA Farm Service Agency
Comments	Workers asked CTEH personnel to take readings around frac tank that had been pumped into, all reading taken showed no detections and were entered into real-time

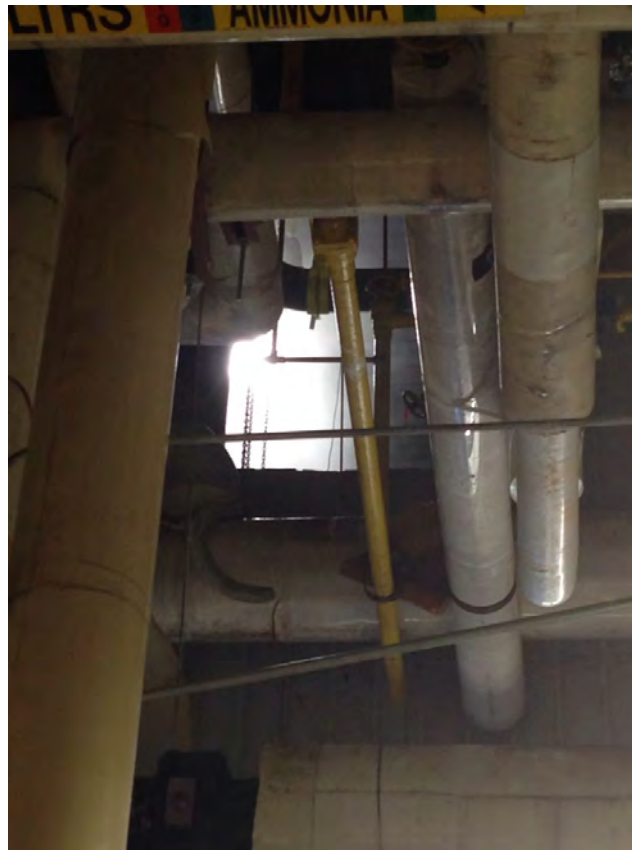
Siera Type	Event (Observation)	
Primary ID	Cutting	
Secondary ID		
Location	Incident site. 32.25459671020508, -90.15596771240234	
Initials	Kelly Scribner	
Comments	Cutting wall between freezer and mechanical room.
