MEMORANDUM FOR FILE

SUBJECT: ARGONAUT TAILINGS STORAGE DAM - INITIAL INSPECTION

SUBJECT: Argonaut Multiple Arch Dam, Jackson, California

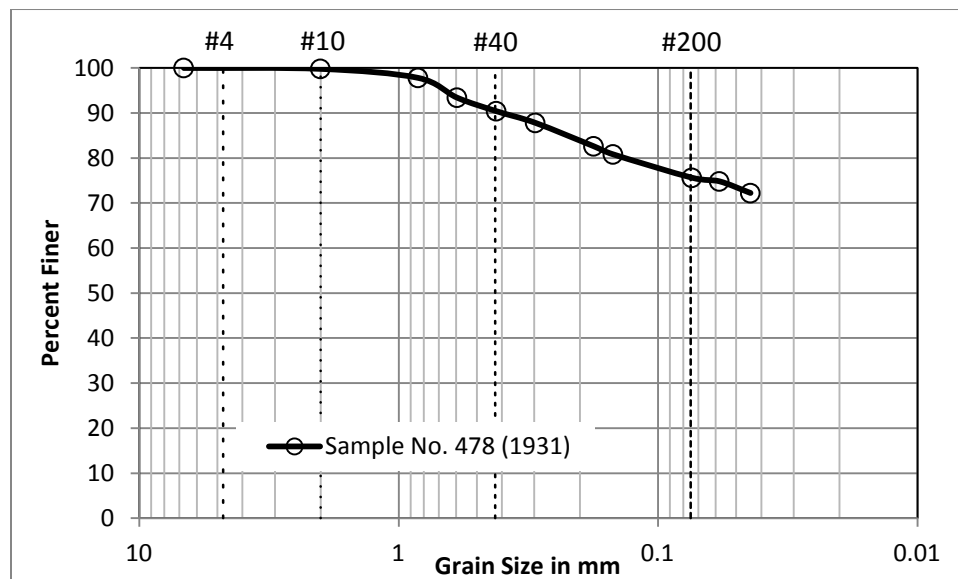
A gradation test was also done on the 1931 composite sample and is shown in the chart below. It can be seen that 75% passes the No. 200 sieve and is most likely a non-plastic silt. Twenty-five percent of the sample is sand, of which 15% would be considered fine sand (passing sieve # 40), and 10% medium sand (ASTM D2487).

highly erodible, of low unit weight and probably very low shear strength. Engineering properties of the tailings and the concrete materials should be determined by collecting undisturbed samples and conducting lab tests.

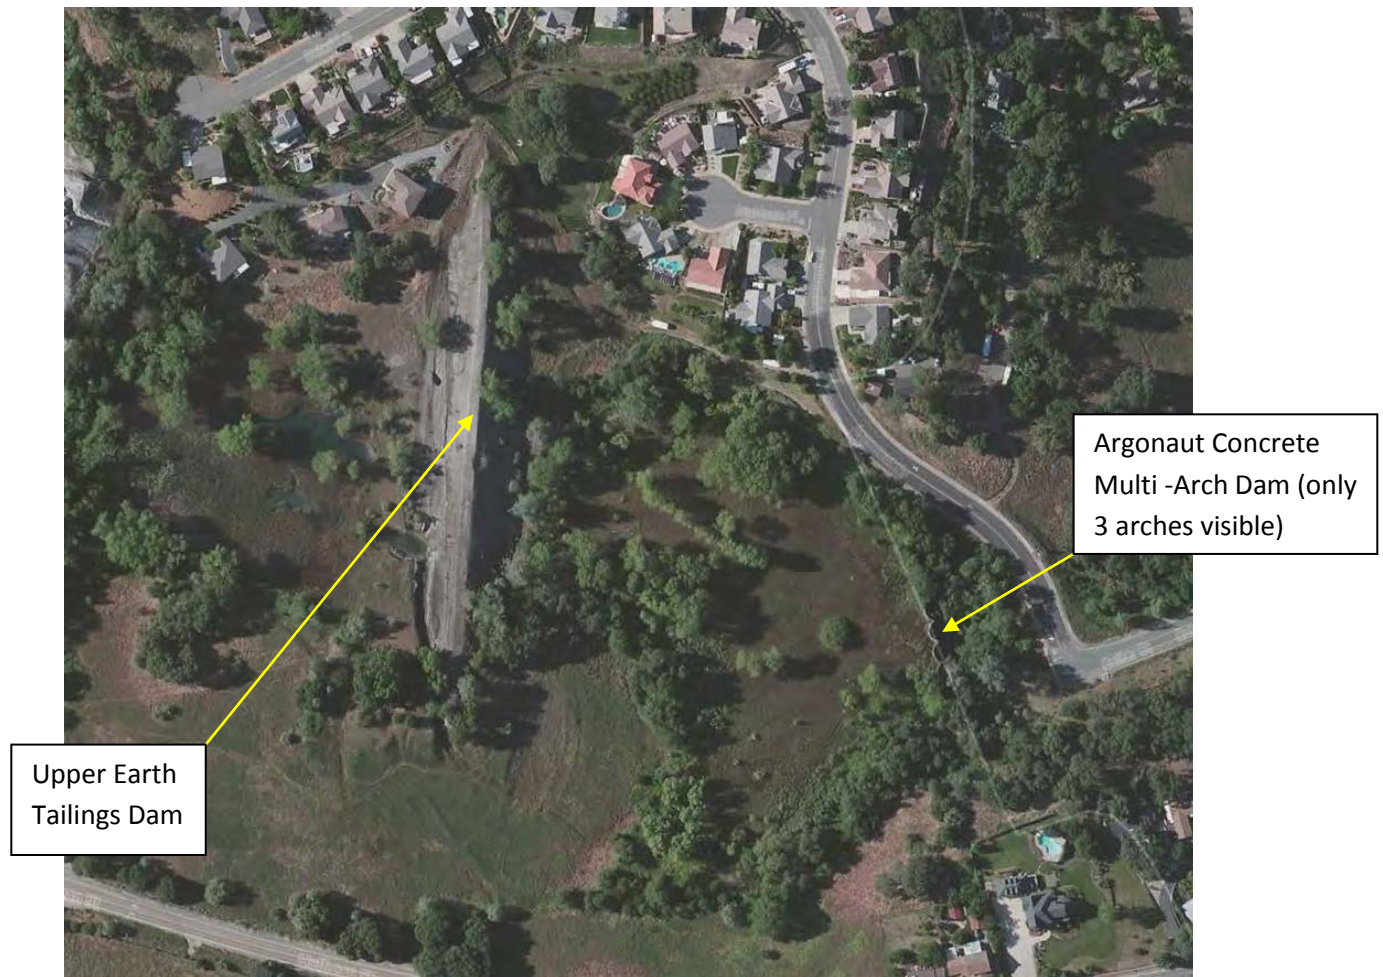
2. Background. The location of the concrete arch dam can be seen in aerial **Photo 1**, with State Plane coordinates of approximately 6,910,797 E, and 1,892,649 N (feet - NAD83). The undersigned contacted the California Division of Safety of Dams (DSOD) to review any existing documents on the dam. DSOD had pulled a file from archive storage that had some good information on the dam which included several inspection and design documents from the 1930s. The file also included a recent assessment by DSOD in 2003 that reiterated the dam was removed from state jurisdiction on 30 May 1933, "because inspection found that the reservoir storage capacity was less than 15 acre-feet due to the mine tailings deposits" (Ref. 2). State documents from 1932 indicate the dam was completed in 1916, had a height of 46 feet, a crest length of 392 feet, and a crest elevation of 1364 feet (MSL) (Refs. 3 & 4). The crest length of the dam has been reported differently in various documents.

Photo 1. Aerial View of Argonaut Dam (~2012).

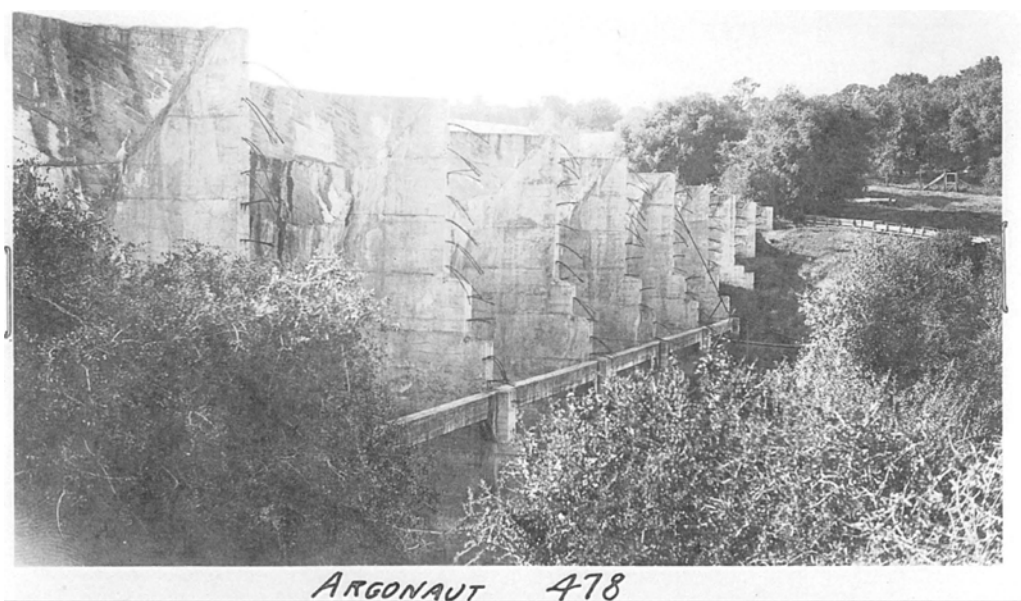
Photo 2. View from Downstream Right Abutment Looking Towards Left Abutment (1931).

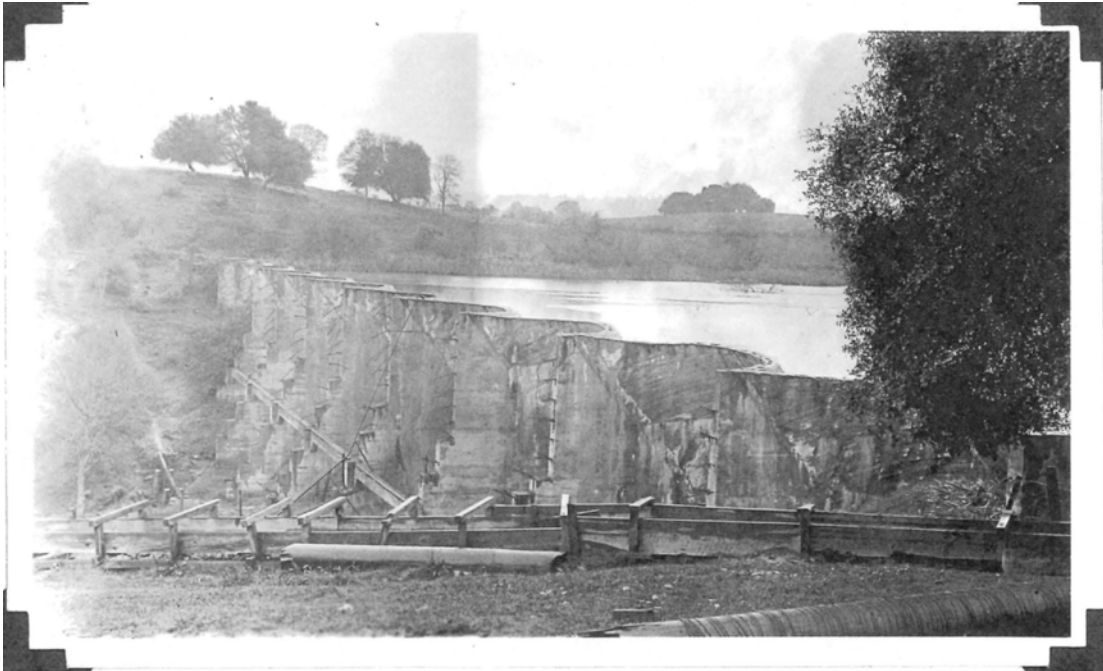
Photo 3. View from Downstream Left Abutment Looking Towards Right Abutment. Spillway Sluice Box in Foreground. Concrete-Box Spillway Not Shown. (1931).
