MEMORANDUM FOR: Dam Safety Section (ATTN: K. Pattermann)

SUBJECT: ARGONAUT TAILINGS STORAGE DAM - SECOND INSPECTION

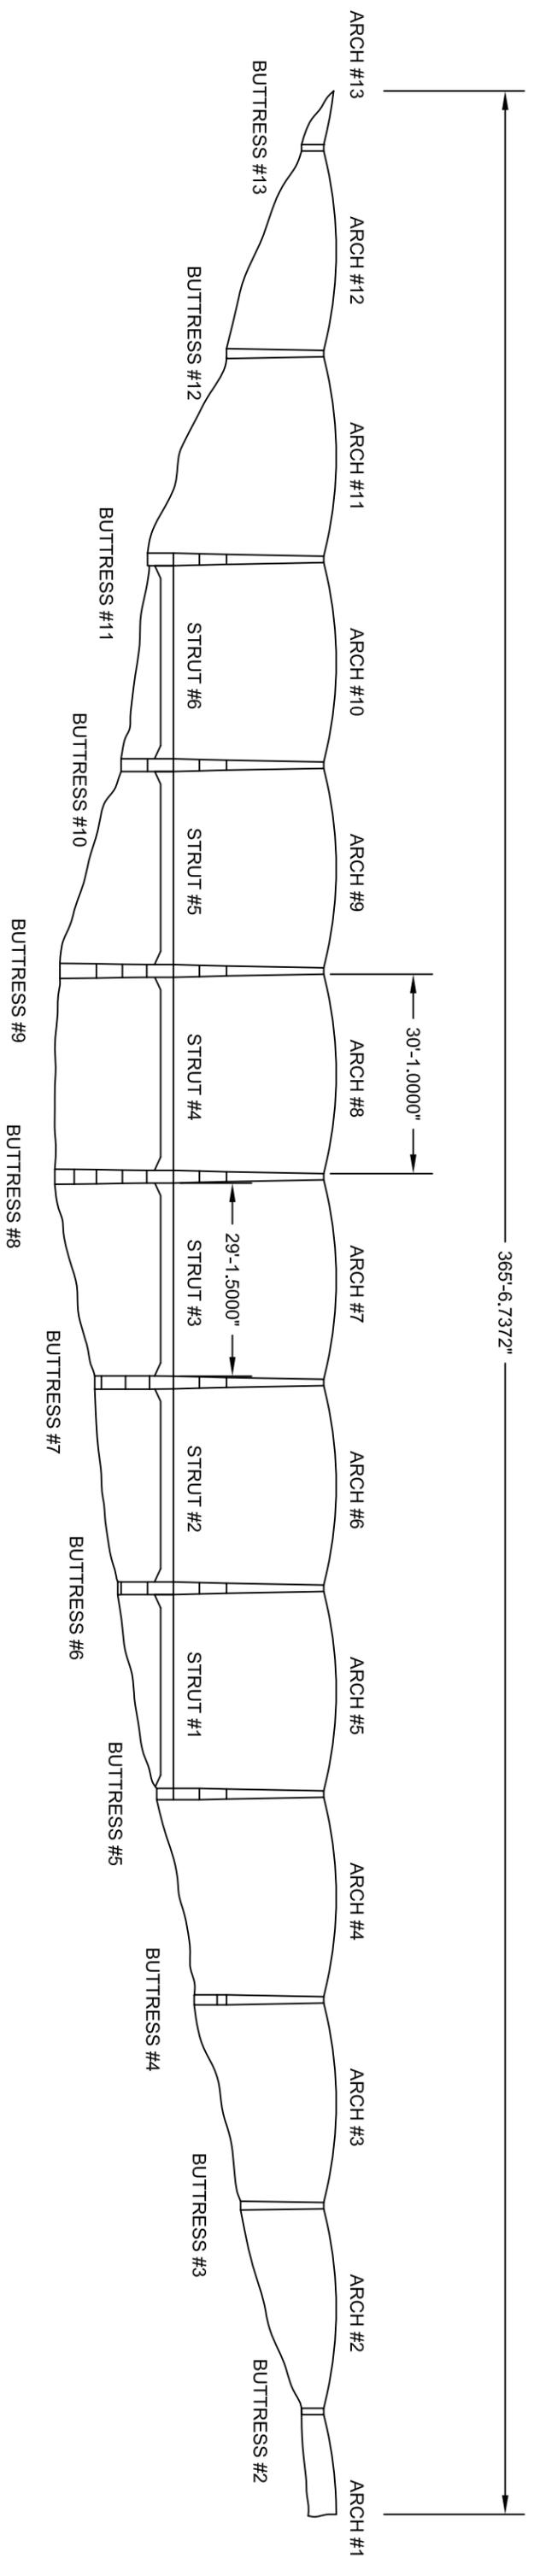
UPSTREAM ELEVATION VIEW

Appendix B provides an upstream elevation view of the dam with the arches, buttresses, and struts all numbered and locations identified.
