ARGONAUT DAM STABILITY AND RETROFIT ALTERNATIVE INVESTIGATION JACKSON, CA

PHASE I TECHNICAL REPORT

January 6, 2015

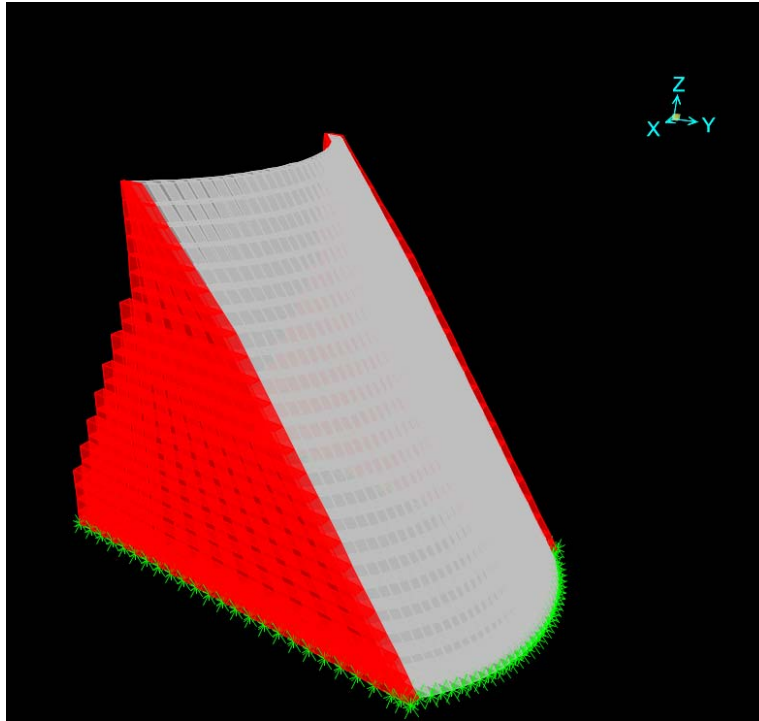
An attempt was made to maintain an aspect ratio of 3:1 for all solids throughout the model. However, due to geometrical constraints this rule may have been exceeded in some locations. It is also important to note that the tie beams that spanned between the buttress walls were not included into the model due to their distressed state. The figure below illustrates the final model created.

Figure 10. Finite Element Model of Arch #8

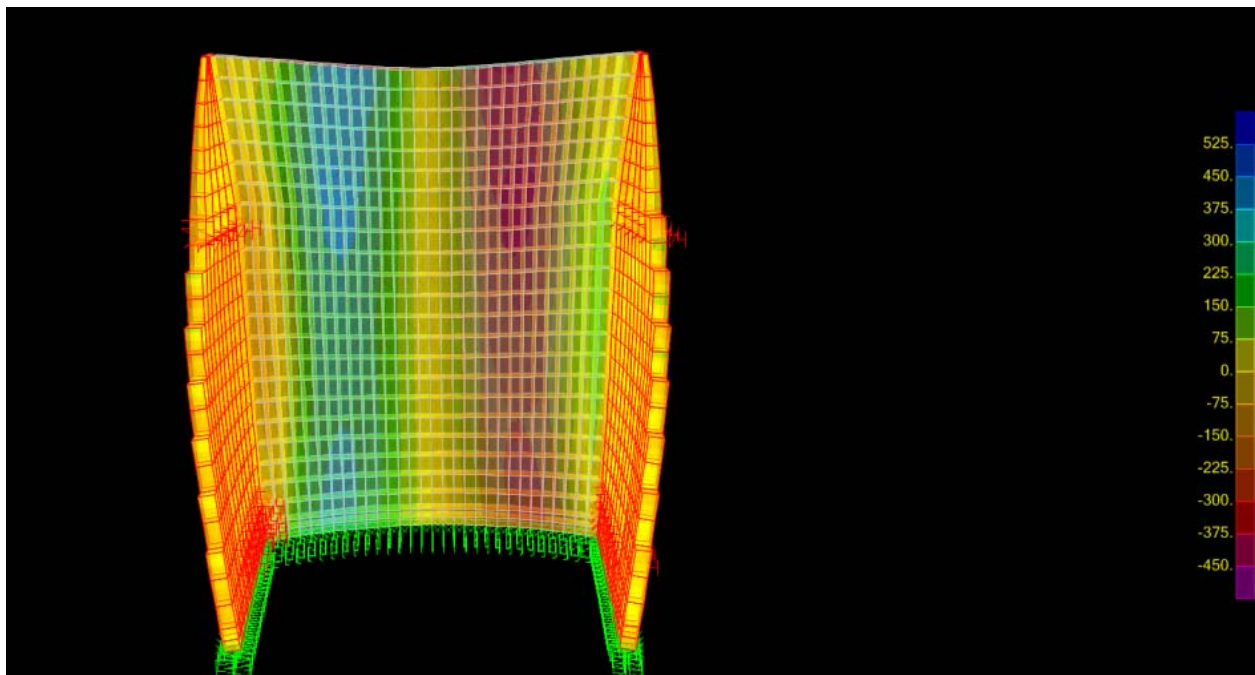
The analysis of the tallest concrete arch section revealed failure in several stability checks. The most concerning of these failures was sliding shear through the concrete cross section. The analysis was performed using a finite element model (FEM), which evaluated the tributary arch section for four different load cases that involved both static and dynamic loadings. It is recommended that the dam undergo a 35% design evaluation, which will compare various repair methods that can be used to stabilize the dam against the four load cases evaluated within this report.

Figure 14. Shear Stress in Arch (psi)

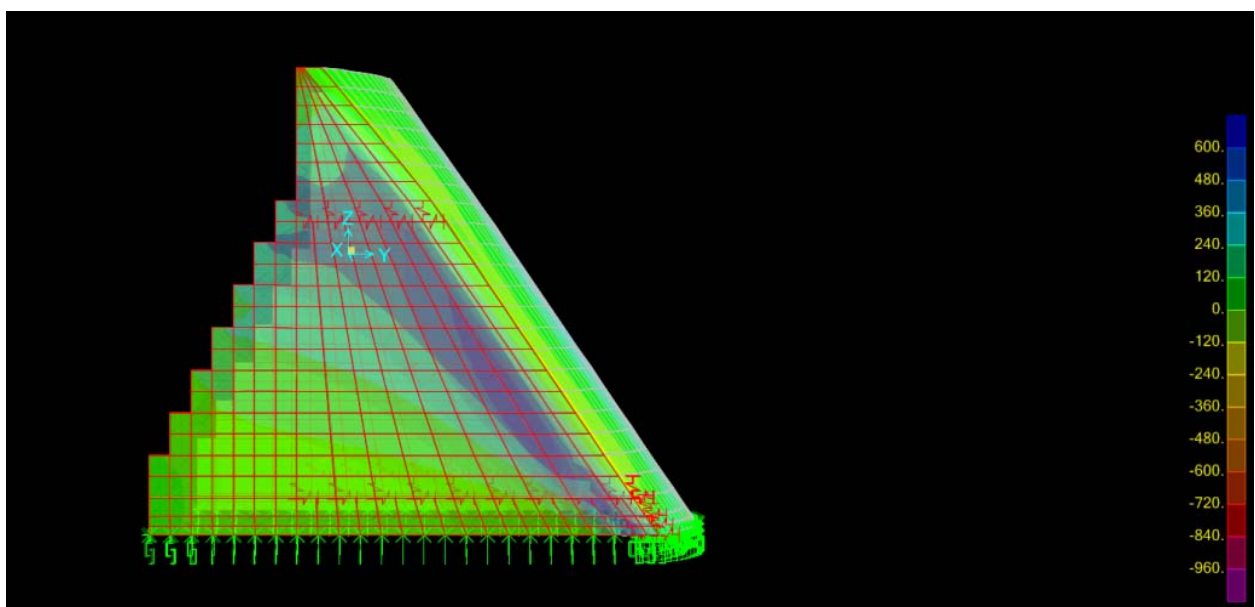
Figure 15. Shear Stress in the Buttress Wall (psi)
