RECORD OF INSPECTION OF DAM

NAME OF DAM Argonaut

ARGONAUT MINE TAILINGS DAM, JACKSON, CALIFORNIA

ARGONAUT DAM #478

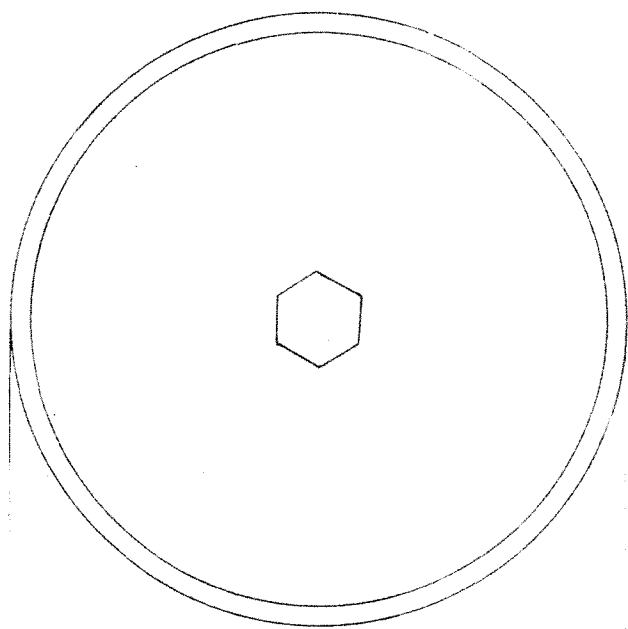
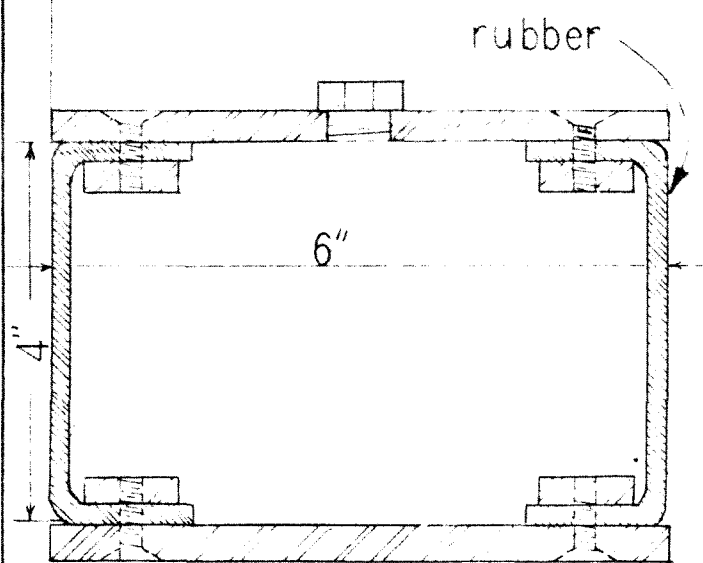
Fig. 1

The apparatus consisted of a number of special pieces as follows. A mould constructed of rubber tubing 6 inches in diameter and 4 inches net height the ends of which were closed by circular steel plates. The upper of these steel plates was provided with a screw plug for filling and emptying the mould. (Fig. 1)

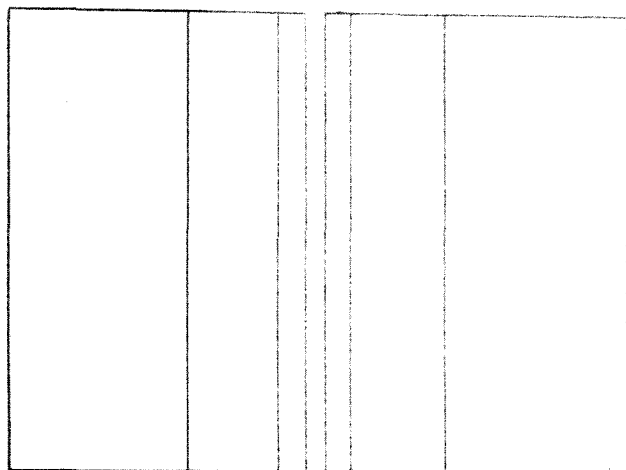
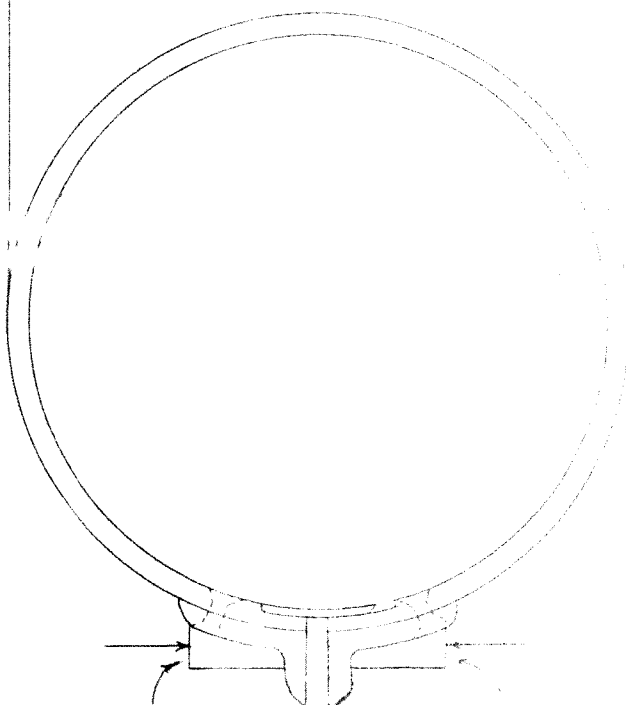
Fig. 2

The rubber mould was inserted into a steel cylinder open at both ends. (Fig. 2) This cylinder was split along a vertical element so that lateral expansion of the material in the rubber mould would tend to increase the opening along this split side. On both sides of the split, angles were riveted to the walls of the cylinder and a small hydraulic jack provided with a pressure gage was used to measure the magnitude of the force tending to enlarge the cylinder. The split steel cylinder with rubber mould were placed in the testing machine and lateral pressures read from the pressure gage of the jack were recorded together with the corresponding vertical loads due to the testing machine.

jack applied here

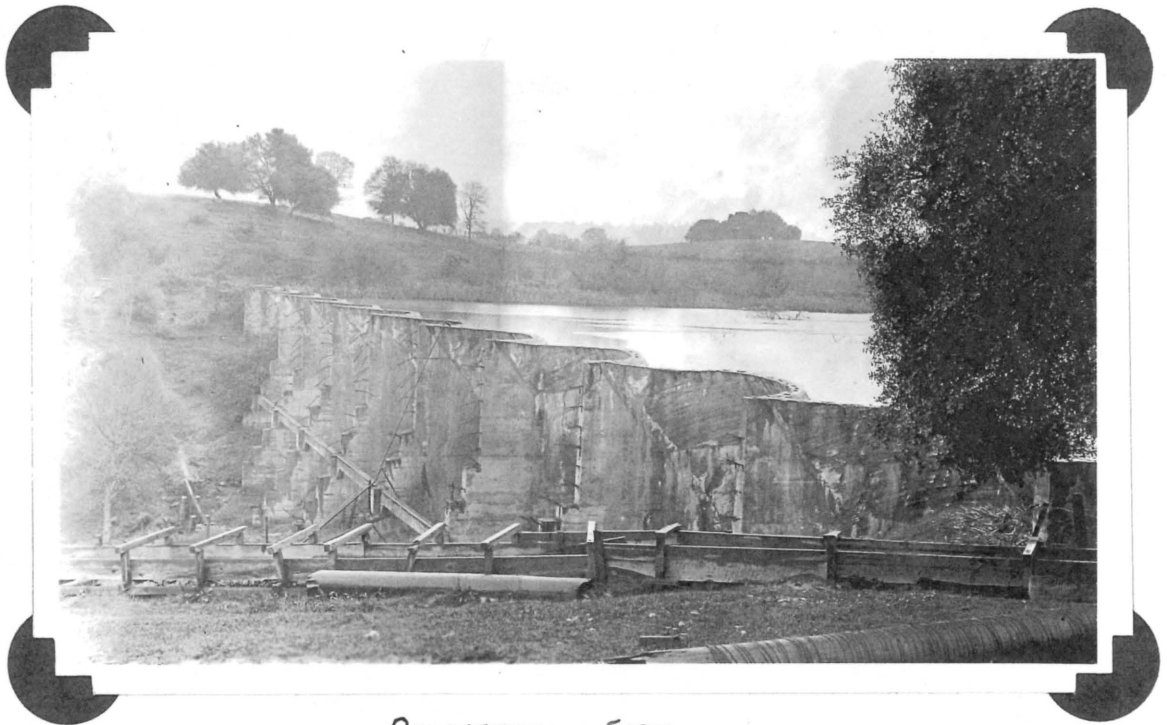
ARGONAUT MINE DAM.
No. 478
March 24, 1931.
G.MCK.

DOWNSTREAM SIDE.

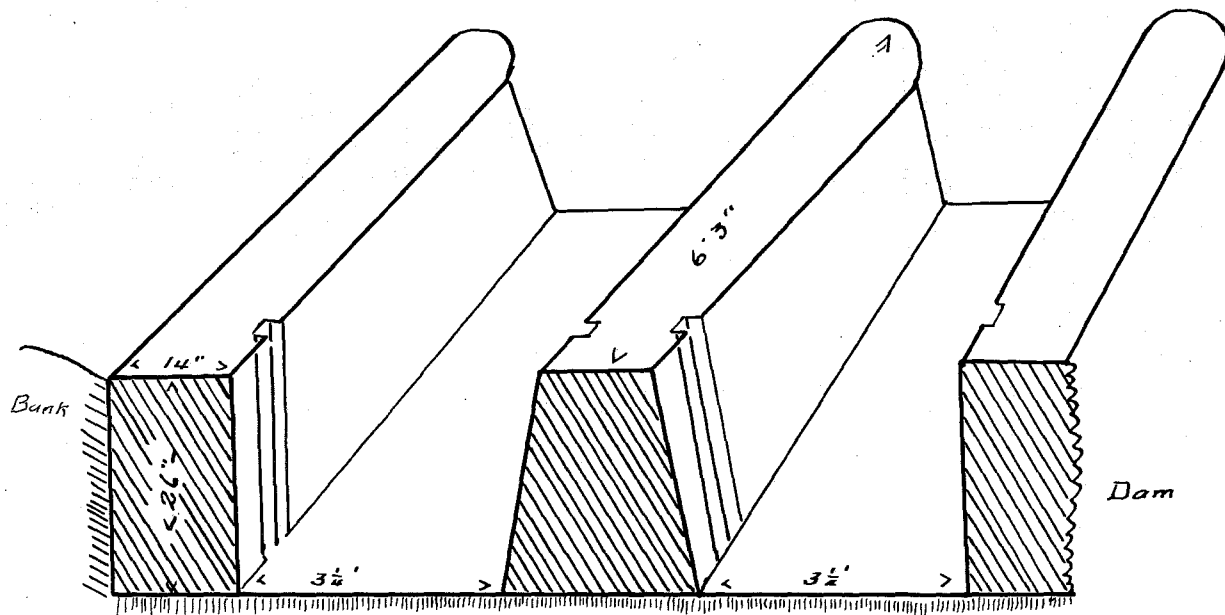
Sketch of
SPILLWAY
ARGONAUT DAM

REMARKS: INSPECTIONS: W.H. HOLMES, G.E. GOUDALL
1/16/30 - 5-25-30. - NEARLY ALL ARCHES SHOW CRACKS AT EXTRADOS AT ABUTMENTS. SEVERAL BUTTRESSES SHOW DIAGONAL CRACKS STARTING FROM HAUNCHES OF ARCHES AND EXTENDING INTO BUTTRESSES FOR ABOUT HALF OF LENGTH. FEW LEAKS THRU ARCHES. SOFTENED SOIL AT BUTTRESSES. S.A. HART - 5-14-30 - LEAKAGE THRU THE DAM FACE. SPILLWAY CHOKED WITH GROWTH.
