April 19, 2016

**Re: Old Saratoga Hospital Structural Evaluation
Providence, New York
Ryan Biggs | Clark Davis Project 11373
ER Purchase Order # 11490**

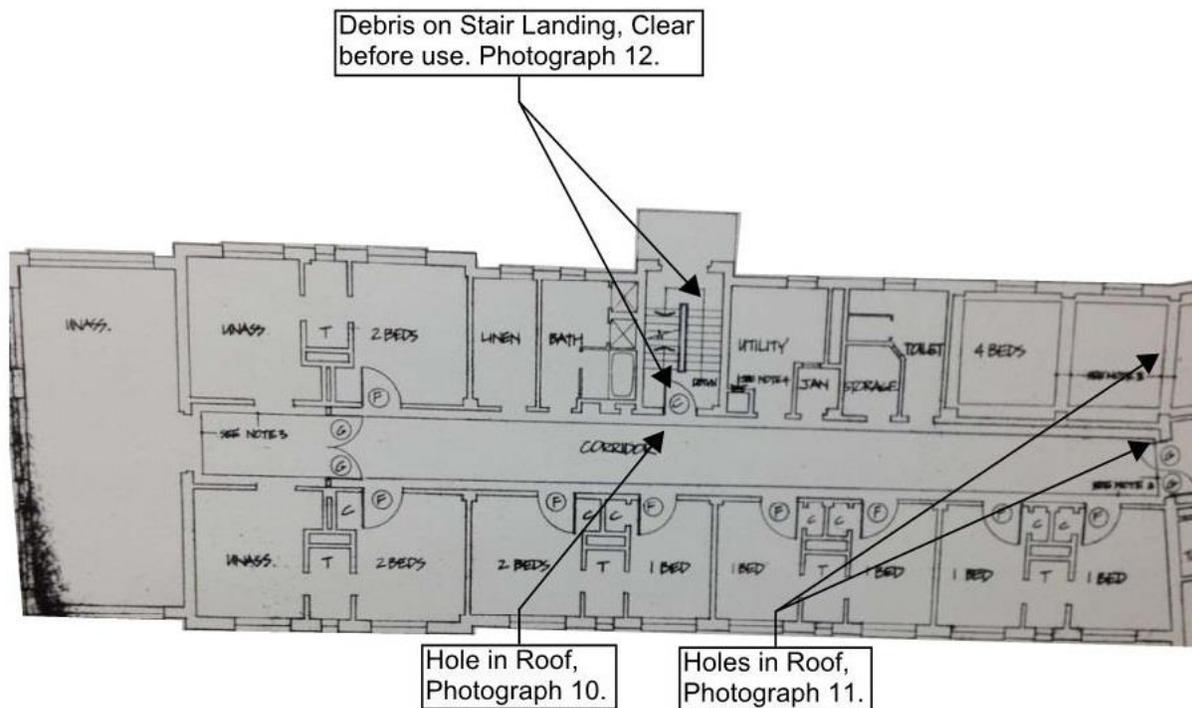
Figure 1 - West Wing Main Hospital

Photographs 10, 11, and 12 are referenced from Figure 1 – West Wing Main Hospital.

Photographs 10 and 11 indicate areas of local roof decking collapse. No occupancy should be allowed on the roof of the West Wing Main Hospital. See discussion of Figure 6 for further information. Where occupancy is required on the second floor in the area of an existing roof hole, precautions against falling debris (roof decking, ceiling framing, etc.) must be taken. Loose material should be removed and overhead protection in the form of shielding or shoring should be installed.

Photograph 12 shows building debris on the risers and landings of the steel stair. All debris should be removed from the stair framing prior to use to avoid overload and hazards due to tripping or falling material.

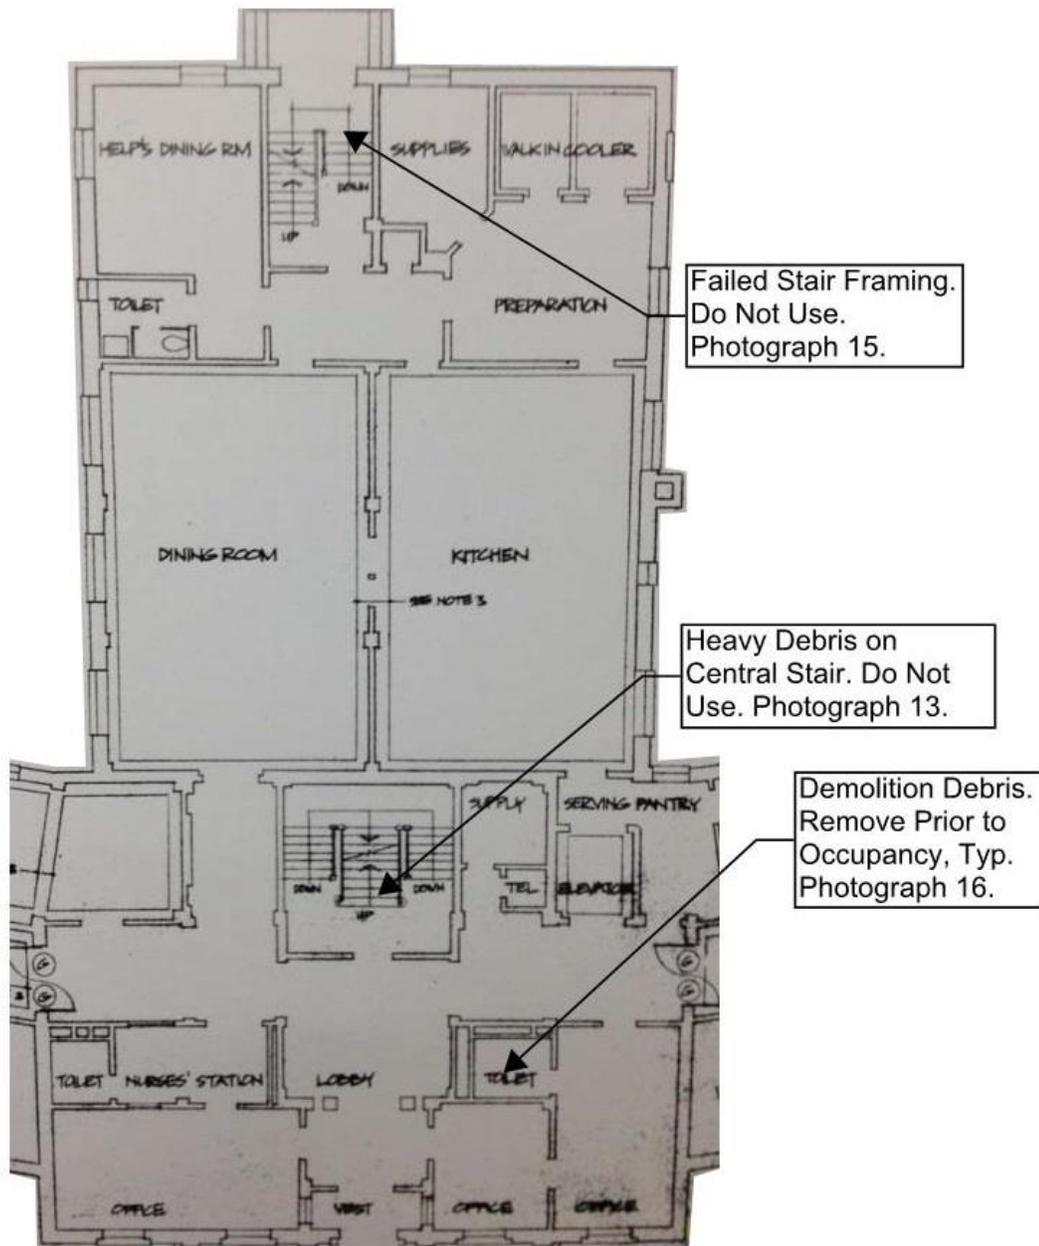
Figure 2 - Central Core Main Hospital - First Floor

Photographs 13, 15 and 16 are referenced from Figure 2 – Central Core Main Hospital – First Floor. Photographs 14 and 17 are referenced from Figure 3 – Central Core Main Hospital – Second Floor.

Steel stairs in the central building area are not in a safe or usable condition. Photographs 13 and 14 show heavy debris collapse at the main grand staircase, which prohibited visual observation of the condition of the steel and does not allow for safe pedestrian access. Clearing of building debris to allow structural evaluation of the integrity of this stair by a registered professional engineer is required prior to use.

Photograph 15 shows collapse of the stair framing in the northmost back-stage area caused by extensive rust and deterioration of the steel treads and connection clips. Replacement of the deteriorated and failed steel framing and evaluation of the other existing treads of this stair is the minimum required remedial measure to allow use. Design of remedial framing for this stair should be provided by a registered professional engineer.

Significant demolition debris is present in the central core area as shown in Photograph 16. If asbestos abatement activities are required within the vicinity of present debris, (approximately 10 foot radius outside of debris area), the debris should be removed prior to conducting abatement work to avoid overload of the floor framing.

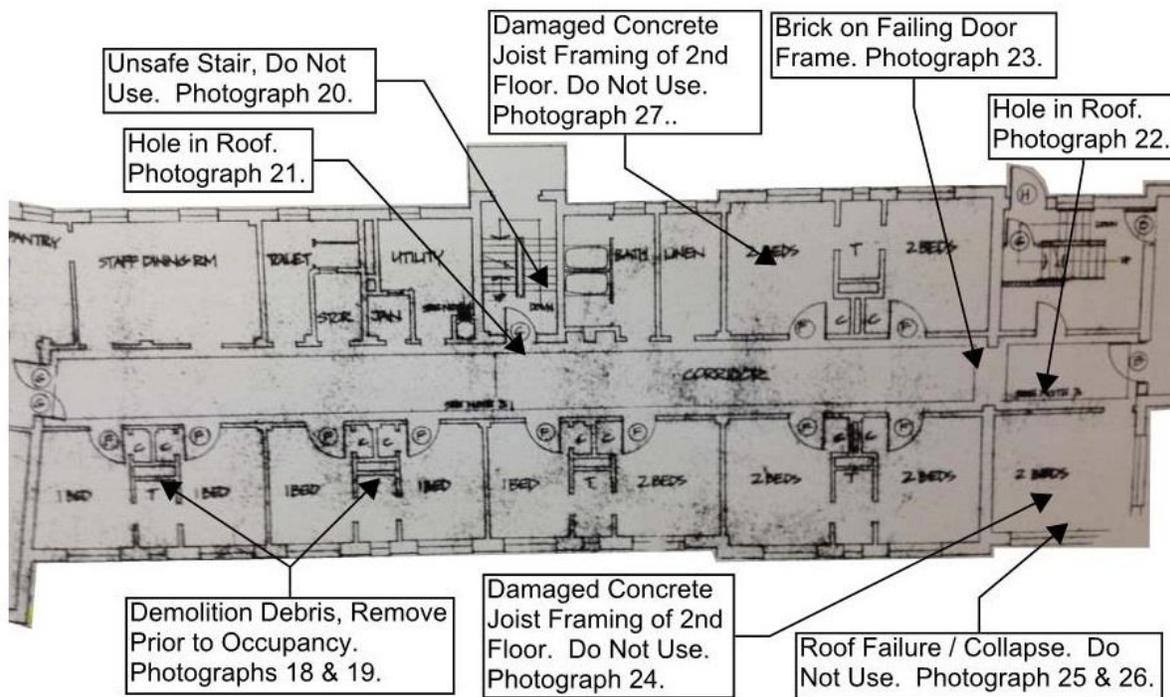
Figure 4 - East Wing Main Hospital

Photographs 18 to 27 are referenced from Figure 4 – East Wing Main Hospital.

Significant demolition debris is present in the East Wing area as shown in Photographs 18 and 19. If asbestos abatement activities are required within the vicinity of present debris, (approximately 10 foot radius outside of debris area), the debris should be removed prior to conducting abatement work to avoid overload of the floor framing.

The staircase located at mid-length of the East Wing Main Hospital is not safe for use. Photograph 20 shows the deterioration of the steel clips supporting the treads and risers, which has compromised the load-carrying capacity of the framing. Repair or replacement of deteriorated steel components is required prior to use and occupancy of this stair. Remedial structural framing should be provided by a registered professional engineer.

Photographs 21 and 22 indicate areas of local roof decking collapse. No occupancy should be allowed on the roof in the East Wing Main Hospital. Where occupancy is required on the second floor in the area of an existing roof hole, precautions against falling debris (roof decking, ceiling framing, etc.) must be taken. Loose material should be removed and overhead protection in the form of shielding or shoring should be installed.

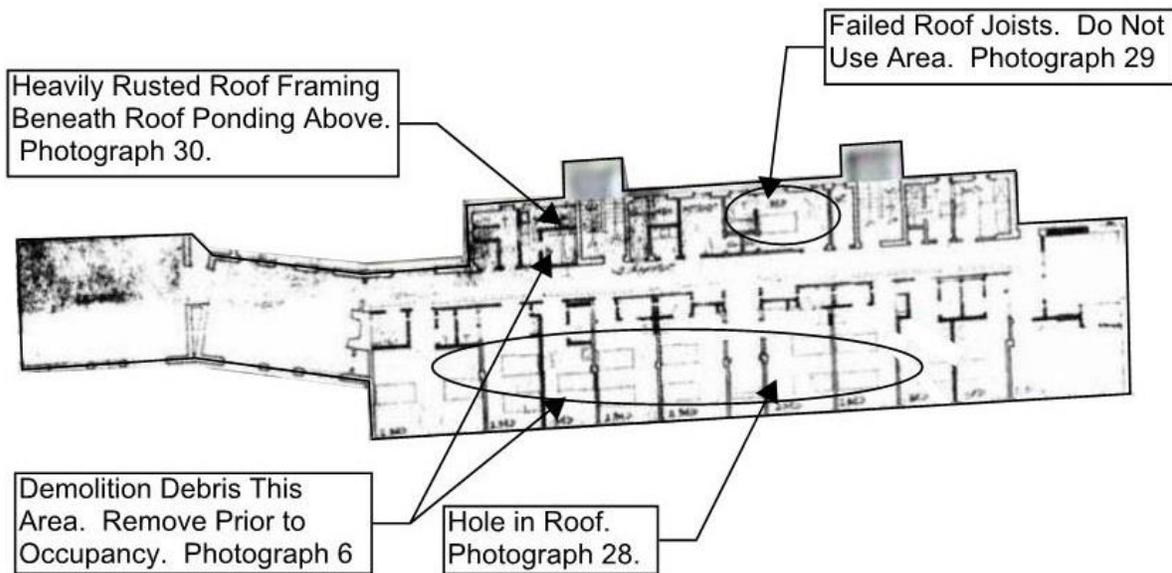
Figure 5 - Eastern Children's Wing

Photographs 6, 28, 29, and 30 are referenced from Figure 5 – Eastern Children's Wing.

Significant demolition debris is present in the Eastern Children's Wing area as shown in Photograph 6. If asbestos abatement activities are required within the vicinity of present debris, (approximately 10 foot radius outside of debris area), the debris should be removed prior to conducting abatement work to avoid overload of the floor framing.

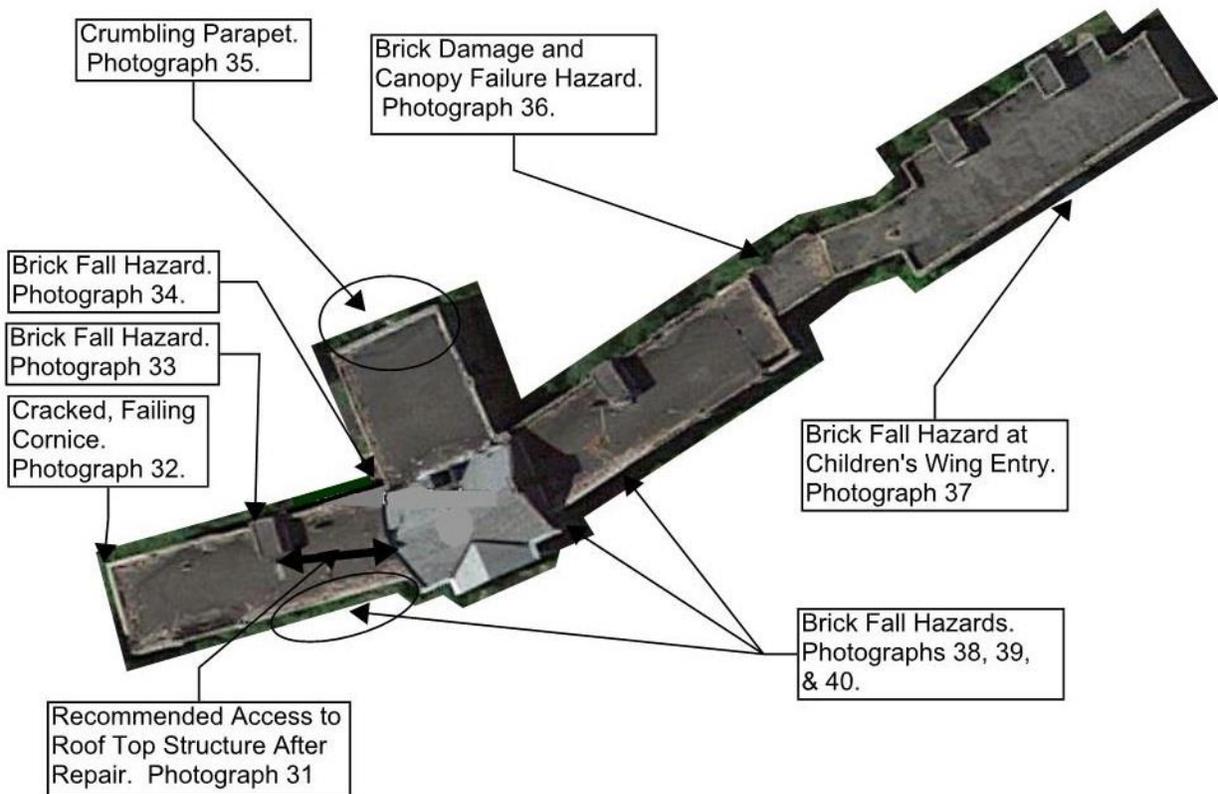
Figure 6 - Roof Plan

Photographs 31 to 40 are referenced from Figure 6 – Roof Plan.

Photograph 31 shows an access path, indicated by footprints in the snow above a main roof beam, from the West Wing stair to the Central Roof Top Structure. Two local roof deck collapses have occurred in this area. However, the steel joist framing has not been significantly compromised and is still capable of supporting load. If asbestos remediation activities require access to the roof top structure, temporary structural decking must be provided over collapsed roof deck areas to provide safe access. This temporary decking may bear directly on the steel joist and beam framing below, which does not exhibit a significant degree of deterioration and is safe for pedestrian traffic. Design of a temporary structural decking system should be provided by a registered professional engineer.
