# Appendix A

## Current Site Photographs, Iron King Mine – Humboldt Smelter Superfund Site

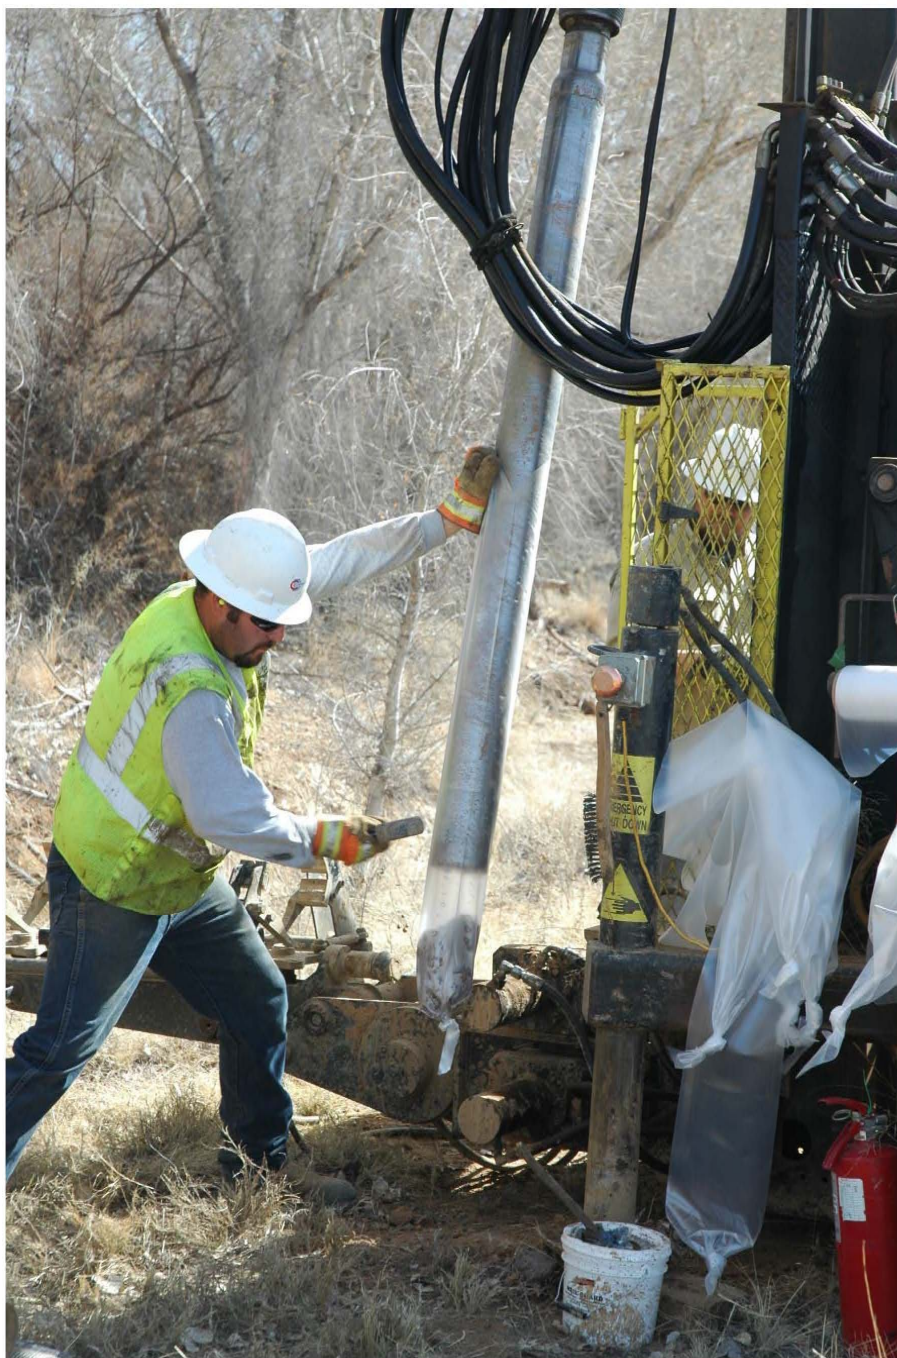
*Photo DSC\_0615: Photos during investigation: depicting percussion drill rig used to obtain cores from the ground in area of the Humboldt Smelter*

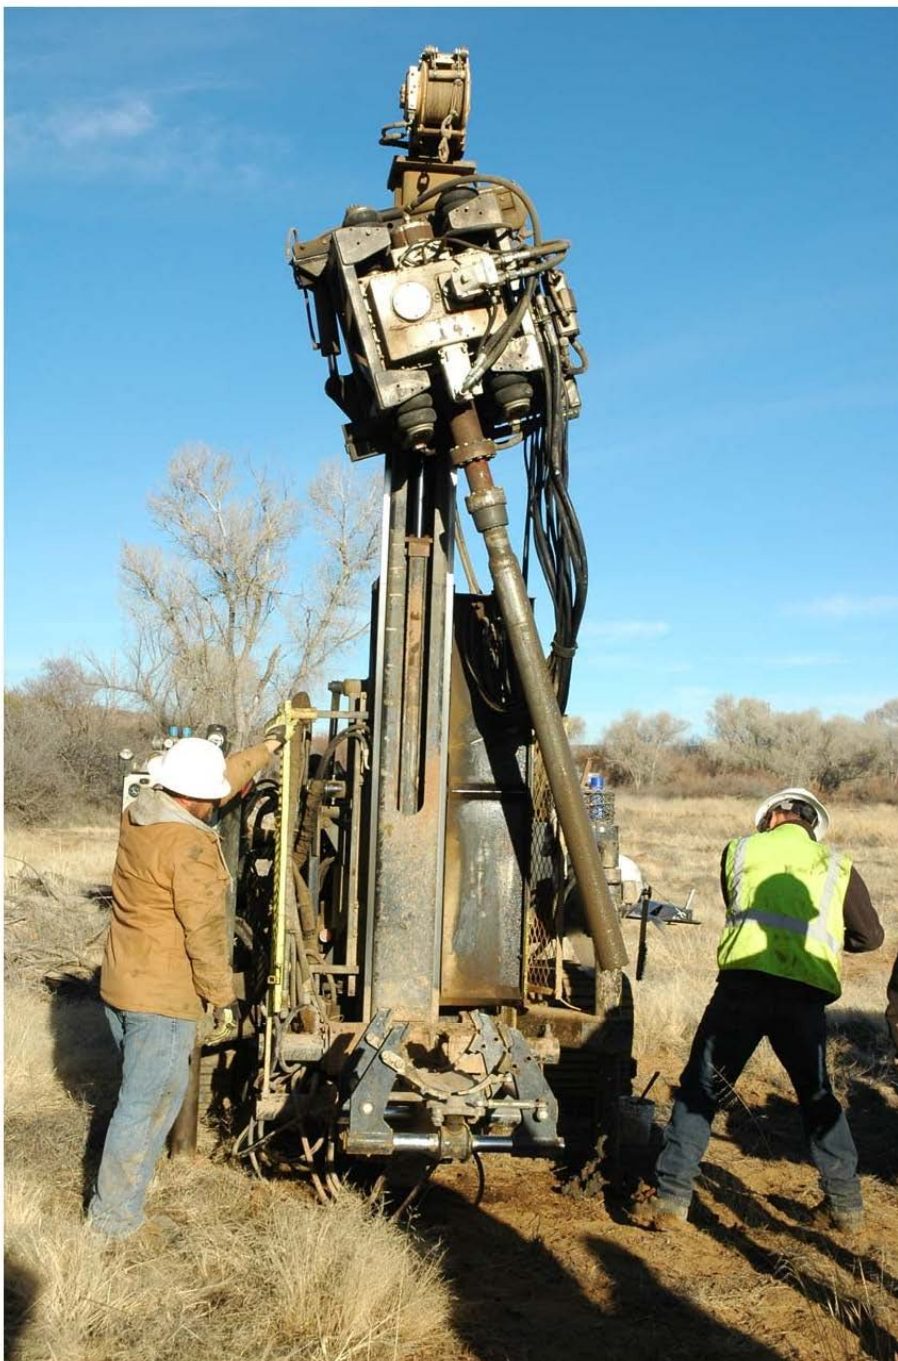
*Photo DSC\_0643: Photos during investigation: depicting percussion drill rig used to obtain cores from the ground in the Iron King Mine Blow Out Path*

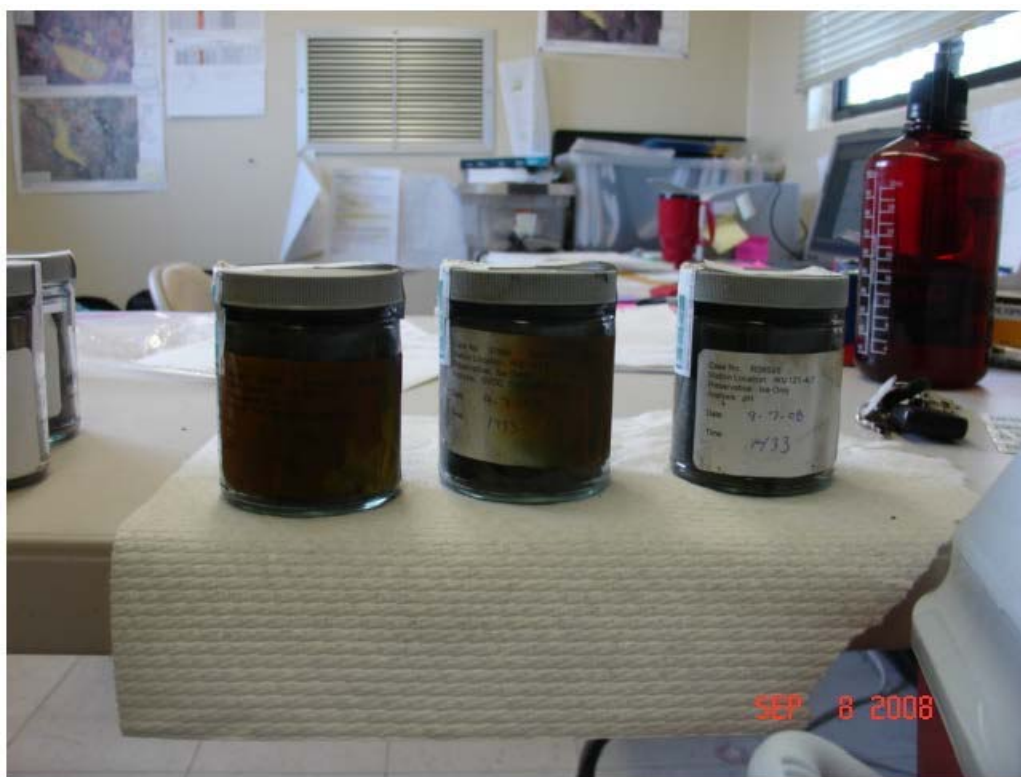
*Photo DSC00116: Core samples prior to shipment to laboratory*
