MEMORANDUM

SUBJECT: Approval and Funding for an Emergency Removal Action at the Bear Hollow Mercury Site, Park City, Summit County, Utah, pursuant to the On-Scene Coordinator's delegated authority under CERCLA Section 104.

Re: Bear Hollow Mercury – Draft Letter Report
Park City, Summit County, UT
TDD: 001/1606-15
DCN: W0384.1A.01081
WO#: 20408.012.001.0384.00

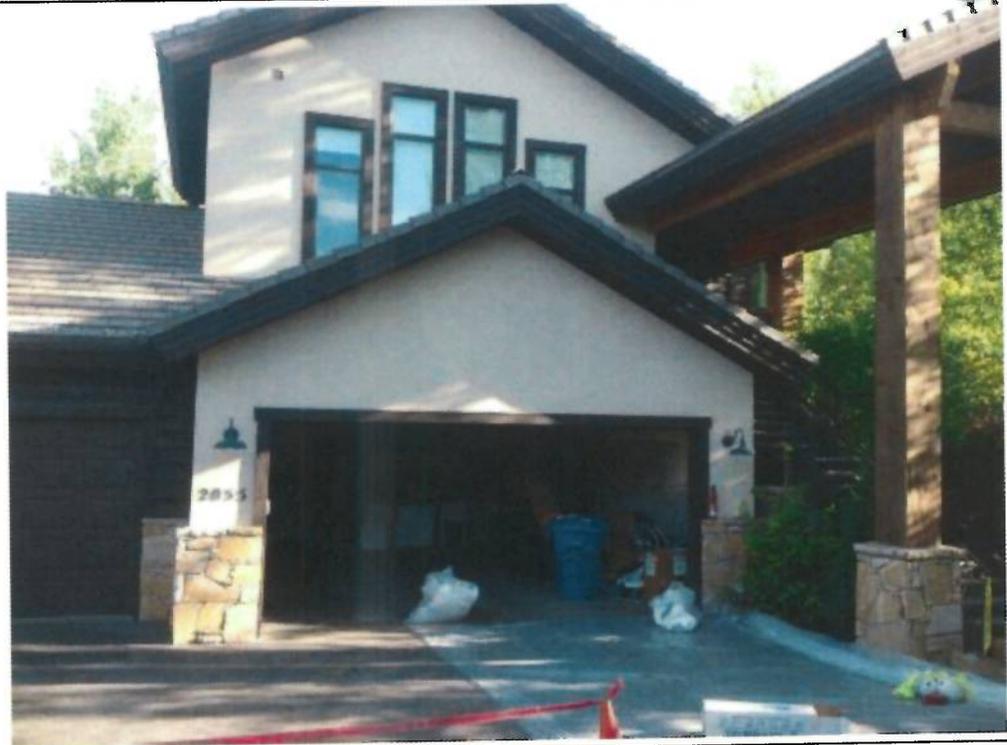
Photo No. 1	Date: 06/08/2016
Photo Coordinates	
Lat	
Long	
Direction Photo Taken:	
Description: Driveway area used for staging. Main house entry via stairs on photo right.

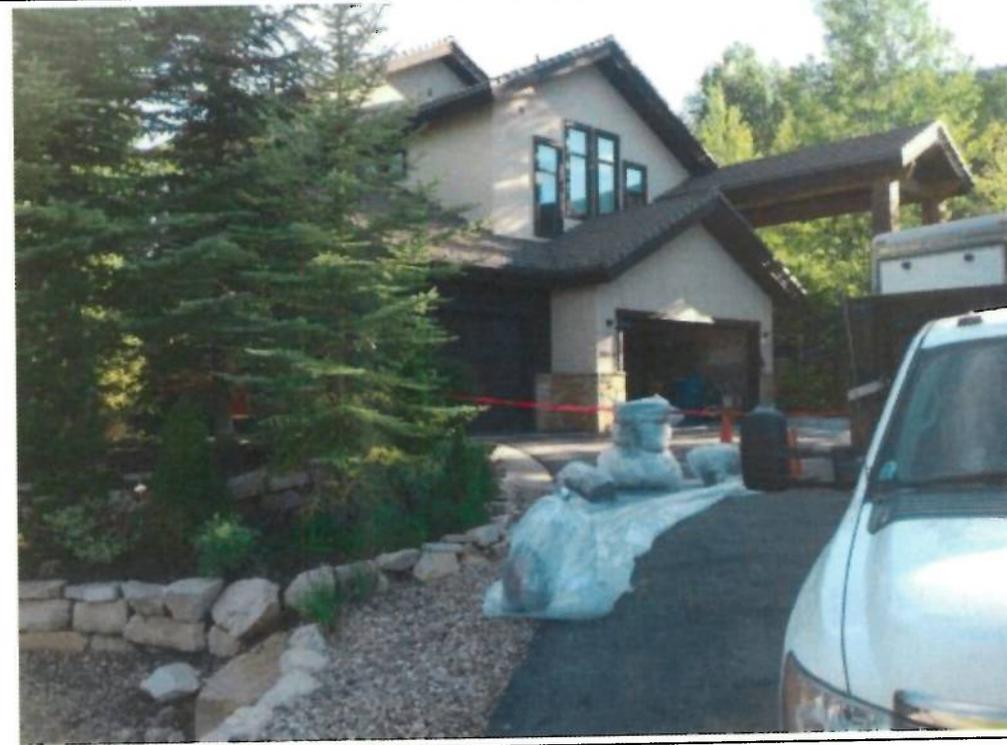
Photo No. 2	Date: 06/08/2016
Photo Coordinates	
Lat	
Long	
Direction Photo Taken:	
Description: Entry driveway from street.

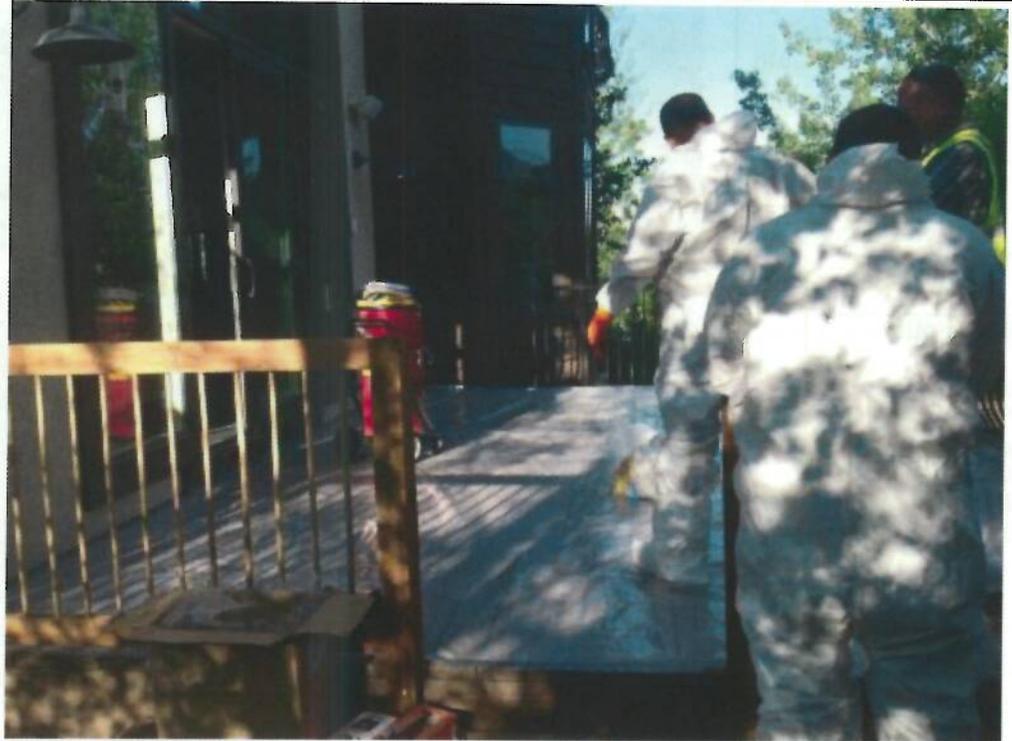
Wood deck at rear of house. Visqueen placed on deck to protect. Sliding doors on deck are entry to kitchen/sitting area. Grandfather clock on immediate right of sliding door inside house.

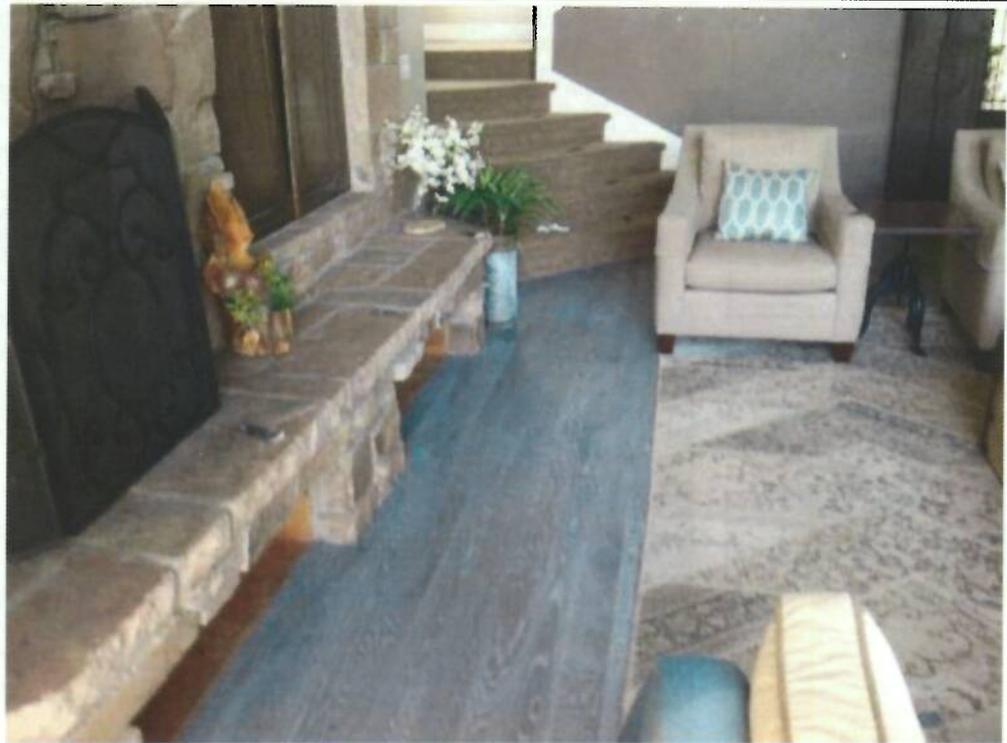
Photo No.
4

Panoramic 1 of 4. East side of sitting area opposite of kitchen.

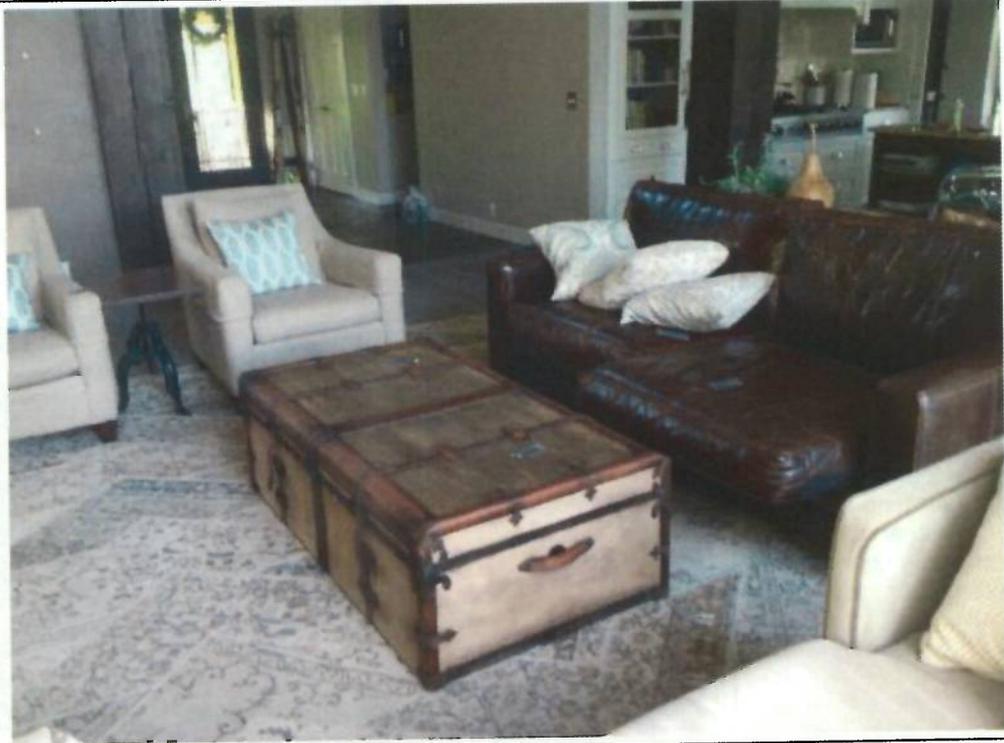
Photo No. 5	Date: 06/08/2016
Photo Coordinates	
Lat	
Long	
Direction Photo Taken:	
Description: Panoramic 2 of 4. Sitting area. Kitchen in photo right background. Duct tape labels on items indicate mercury readings (mg/m3).

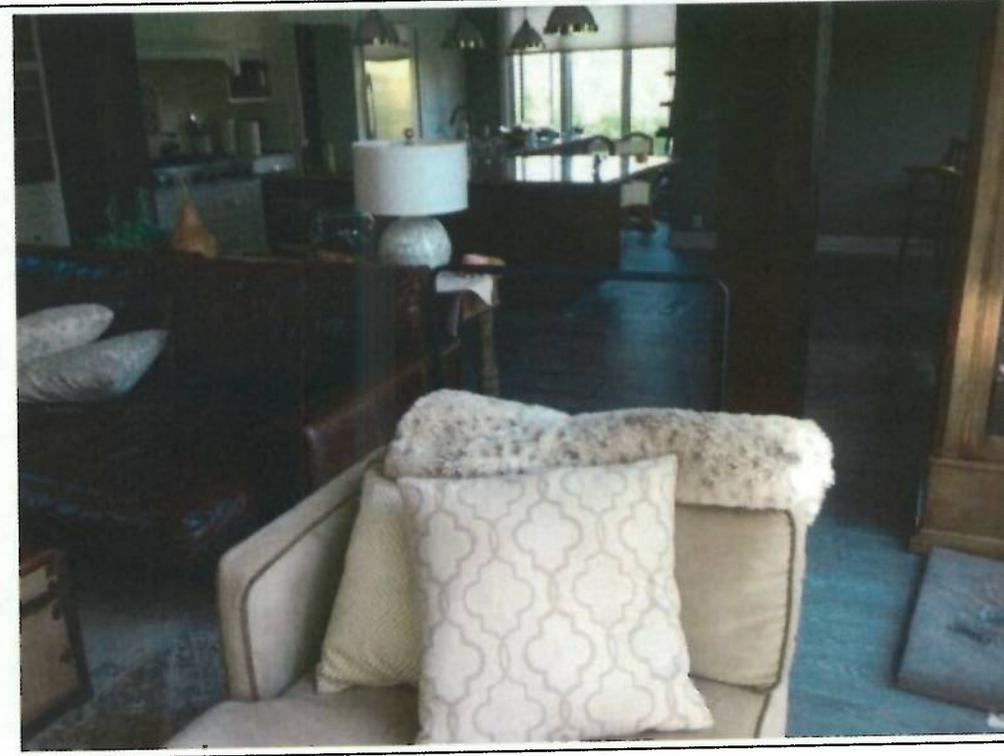
Photo No. 6	Date: 06/08/2016
Photo Coordinates	
Lat	
Long	
Direction Photo Taken:	
Description: Panoramic 3 of 4. Sitting area. Kitchen in background. Grandfather clock visible at photo right. Duct tape labels on items indicate mercury readings (mg/m3).

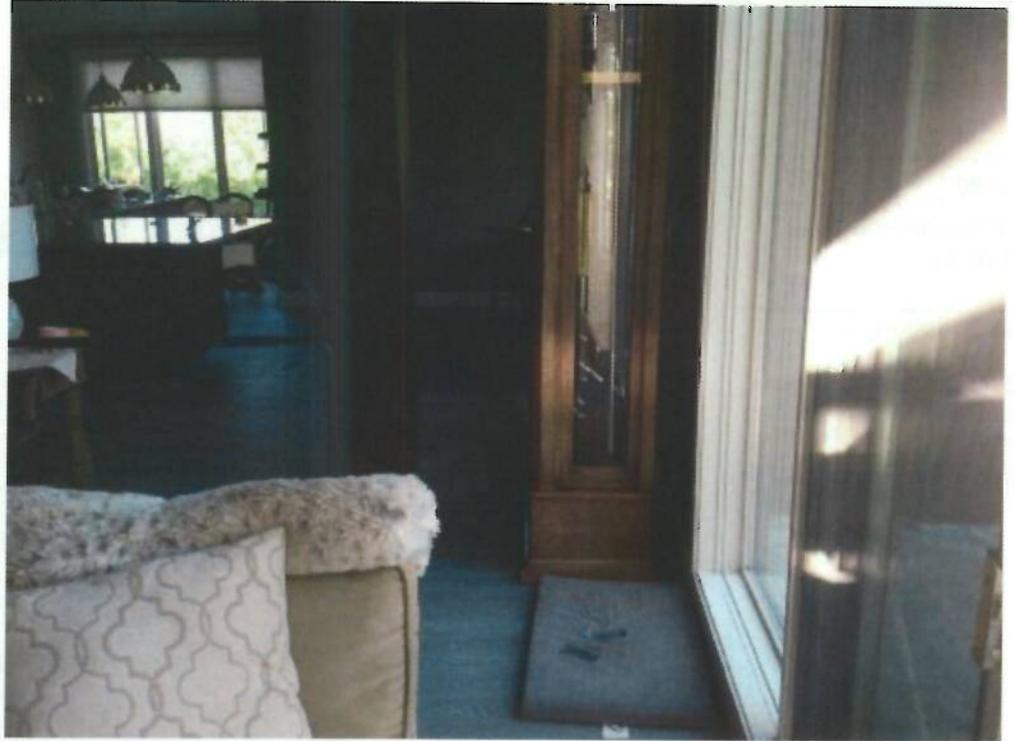
Photo No. 7	Date: 06/08/2016
Photo Coordinates	
Lat	
Long	
Direction Photo Taken:	
Description: Panoramic 4 of 4. Grandfather clock. Sliding door in photo right leads to rear deck. Duct tape labels on items indicate mercury readings (mg/m3).

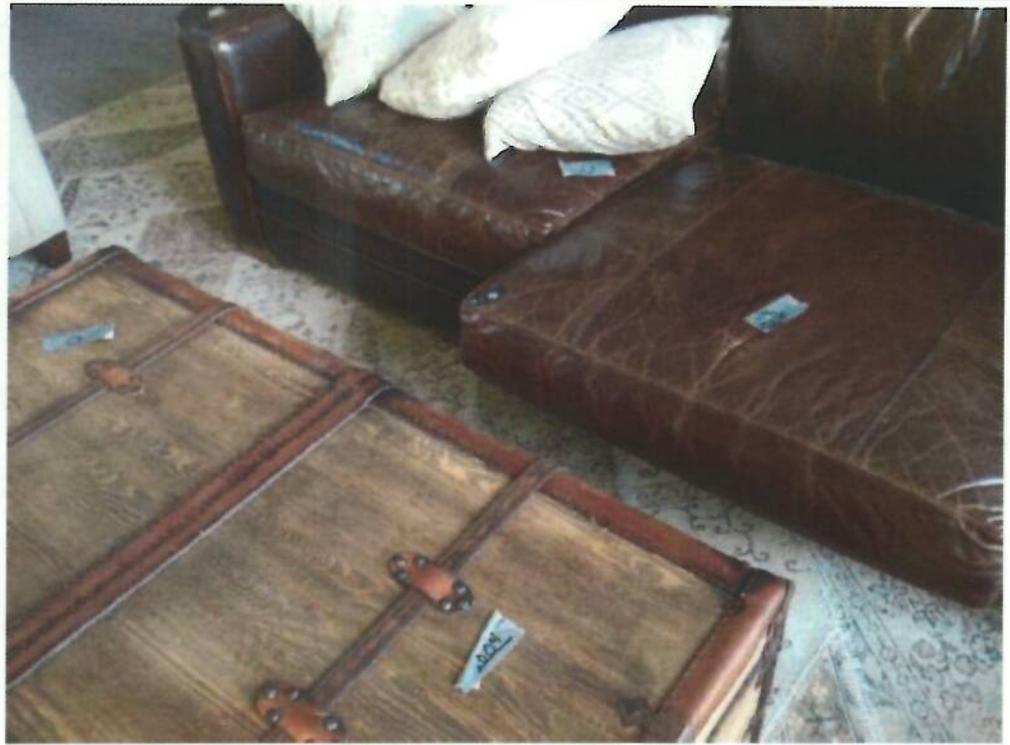
Photo No. 8	Date: 06/08/2016
Photo Coordinates	
Lat	
Long	
Direction Photo Taken:	
Description: Sitting area. Duct tape labels on items indicate mercury readings (mg/m3).

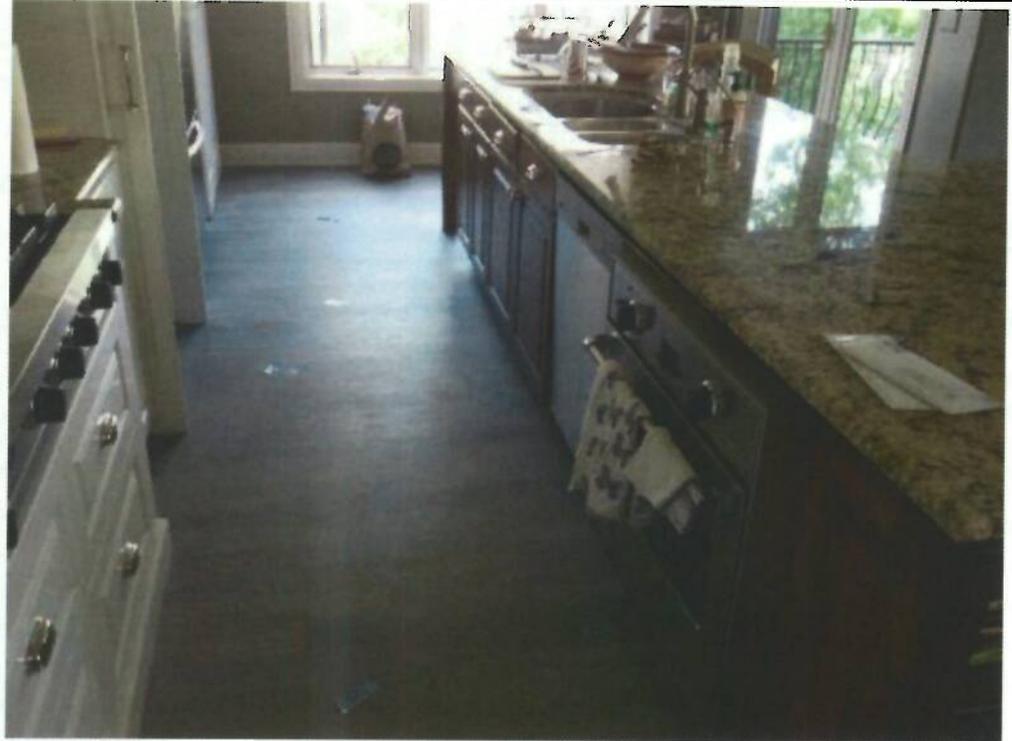
Photo No. 11	Date: 06/08/2016
Photo Coordinates	
Lat	
Long	
Direction Photo Taken:	
Description: Kitchen area. Duct tape labels on items indicate mercury readings (mg/m3).

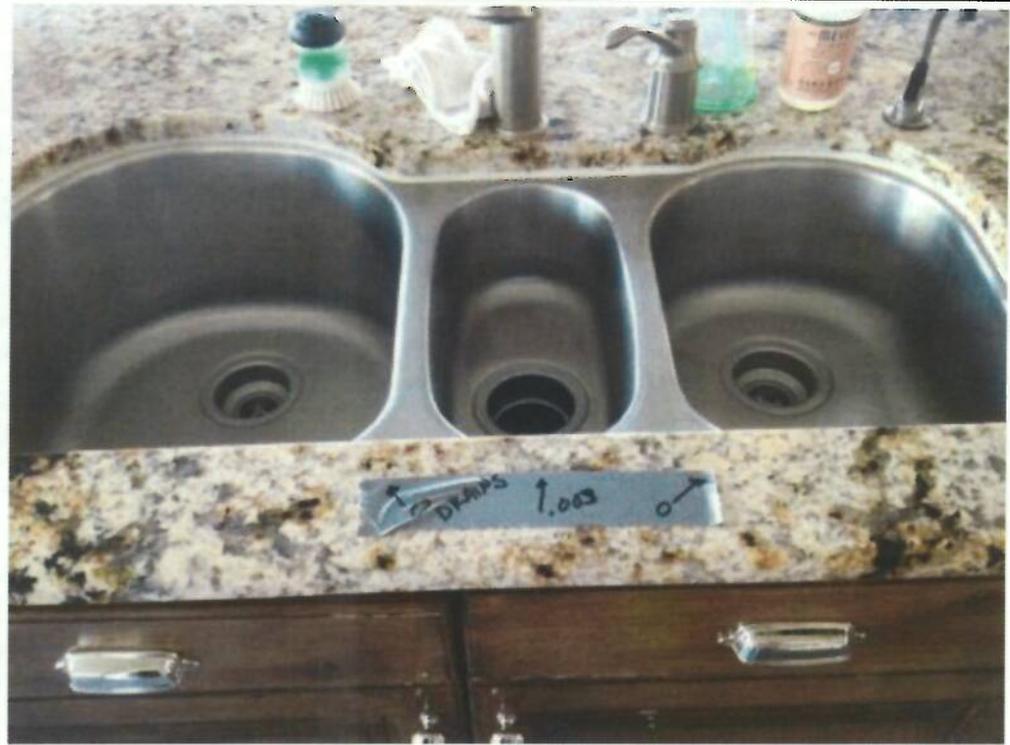
Photo No. 12	Date: 06/08/2016
Photo Coordinates	
Lat	
Long	
Direction Photo Taken:	
Description: Kitchen sink. Duct tape labels on items indicate mercury readings (mg/m3). Garbage disposal in center sink.

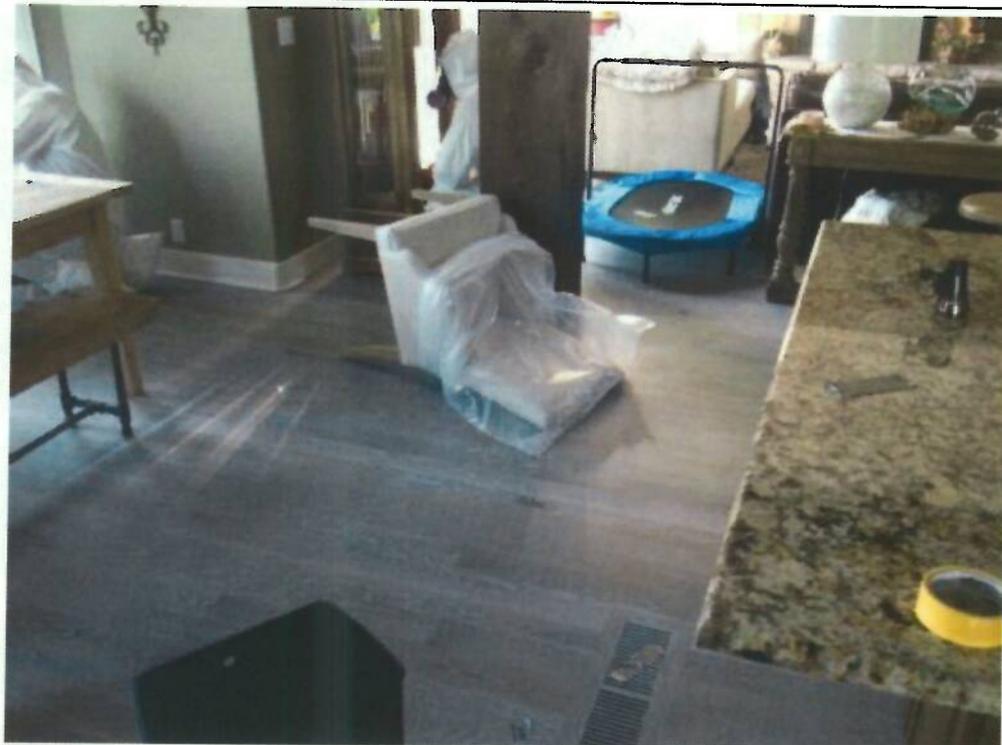
Photo No. 15	Date: 06/08/2016
Photo Coordinates	
Lat	
Long	
Direction Photo Taken:	
Description: Sitting area view toward the northeast. Duct tape labels on items indicate mercury readings (mg/m3). Bagging eating area upholstered chairs.

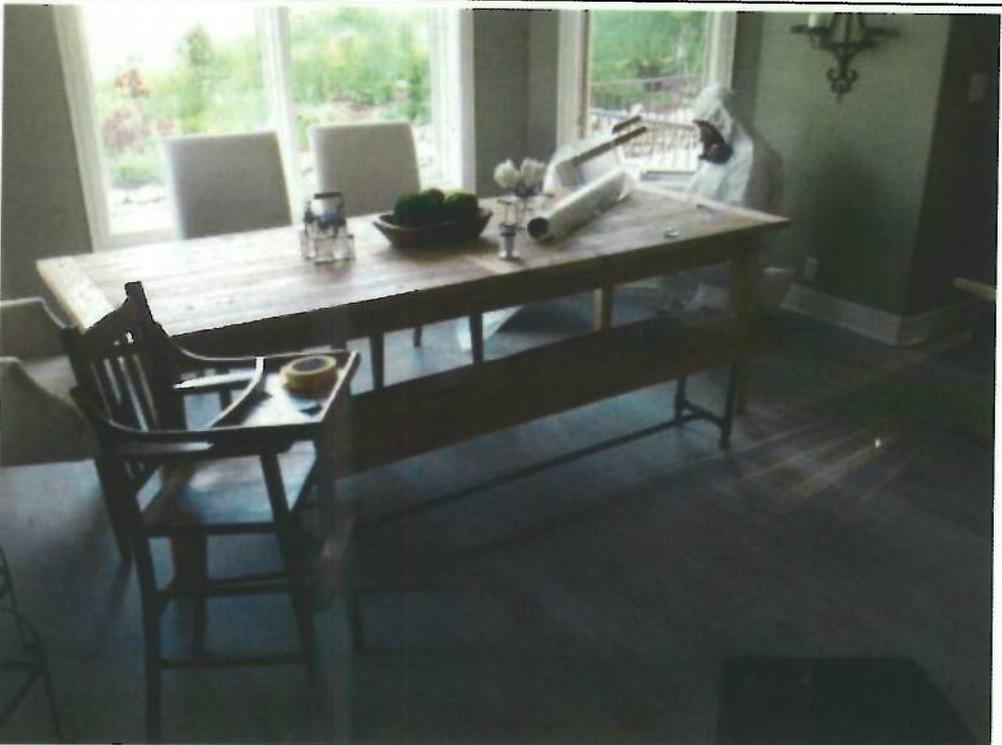
Photo No. 16	Date: 06/08/2016
Photo Coordinates	
Lat	
Long	
Direction Photo Taken:	
Description: Dining area adjacent to kitchen. Baby high chair in foreground.

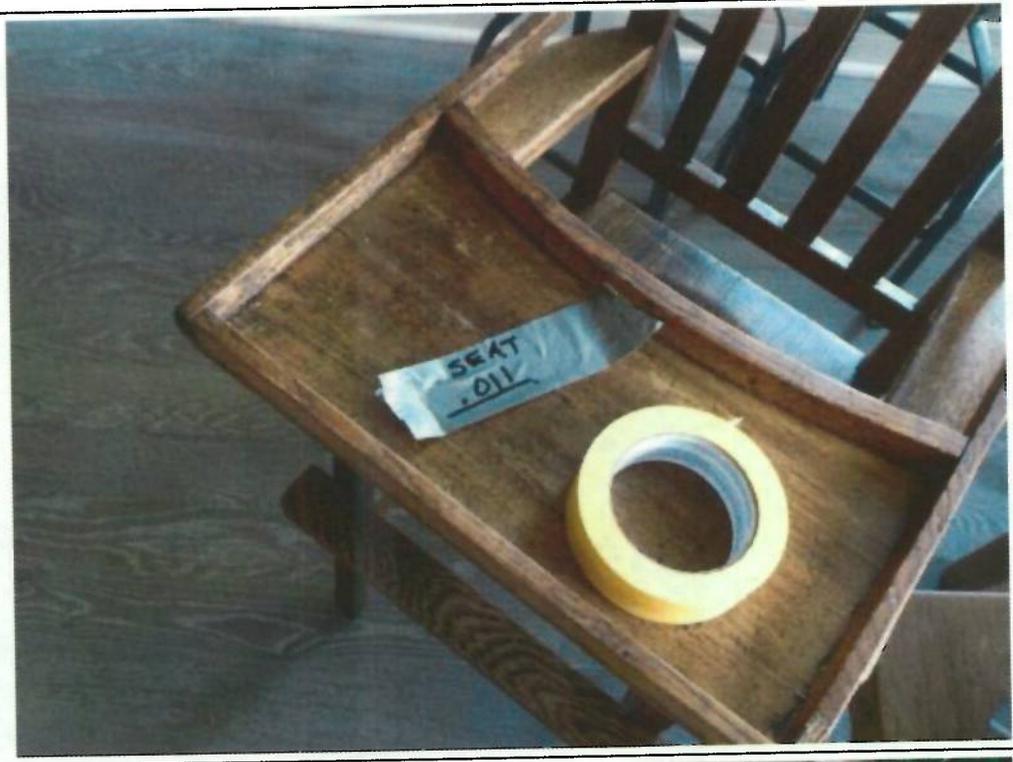
Photo No. 17	Date: 06/08/2016
Photo Coordinates	
Lat	
Long	
Direction Photo Taken:	
Description: High chair in dining area. Duct tape labels on items indicate mercury readings (mg/m3).

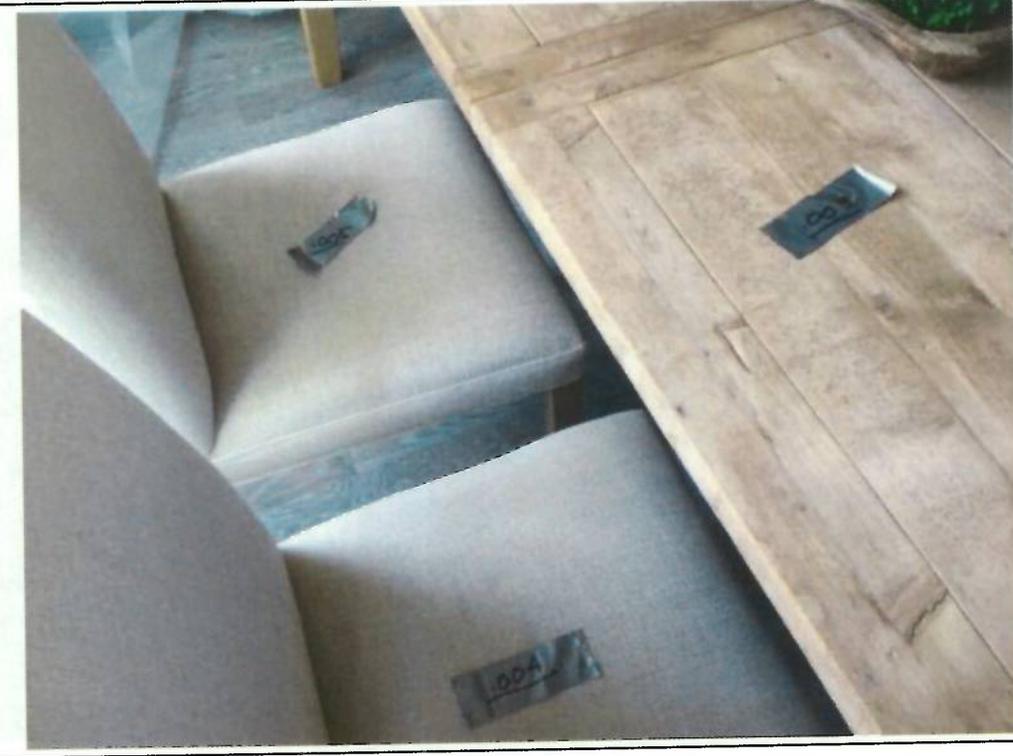
Photo No. 18	Date: 06/08/2016
Photo Coordinates	
Lat	
Long	
Direction Photo Taken:	
Description: Dining area table/chairs. Duct tape labels on items indicate mercury readings (mg/m3).

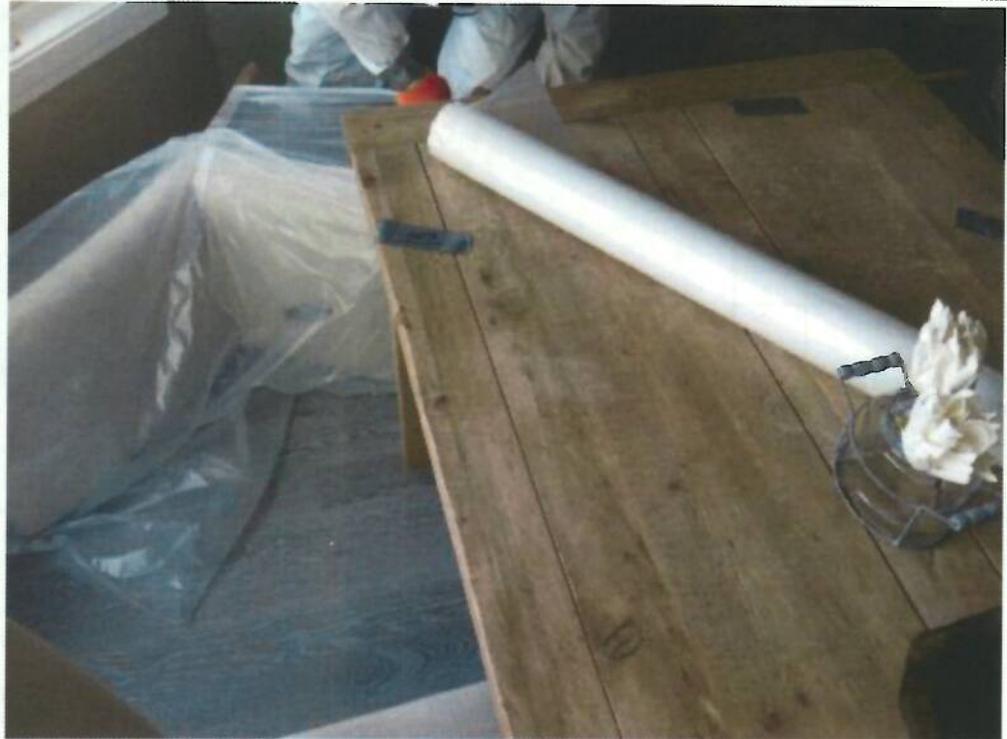
Photo No. 19	Date: 06/08/2016
Photo Coordinates	
Lat	
Long	
Direction Photo Taken:	
Description: Dining area table. Duct tape labels on items indicate mercury readings (mg/m3).

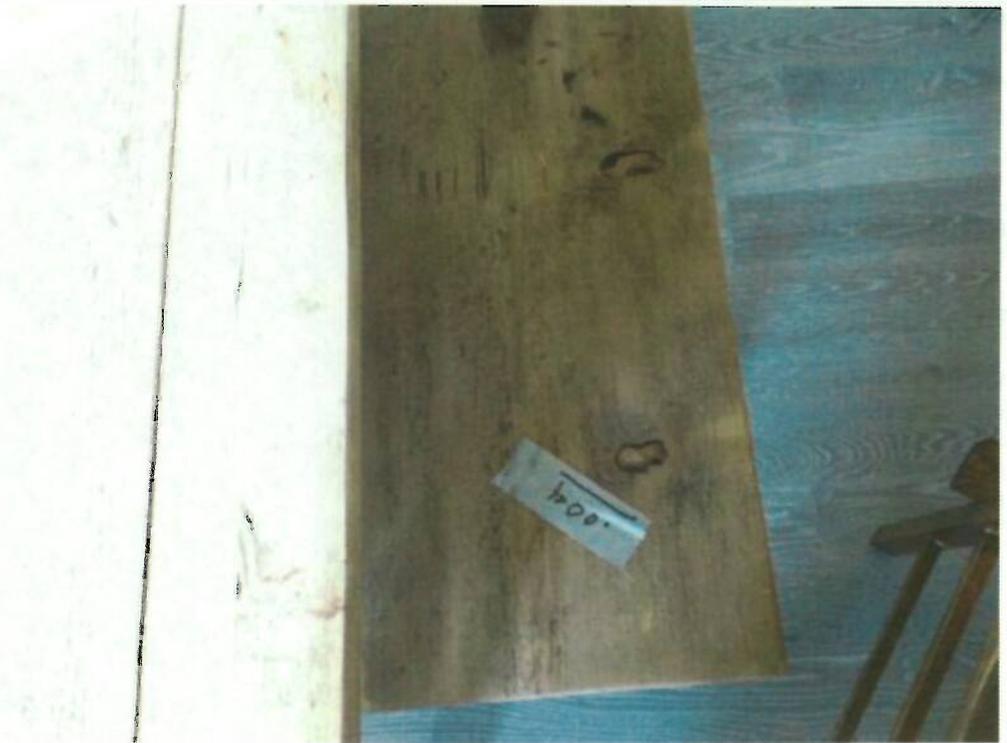
Photo No. 20	Date: 06/08/2016
Photo Coordinates	
Lat	
Long	
Direction Photo Taken:	
Description: Dining area table and bench seat. Duct tape labels on items indicate mercury readings (mg/m3).

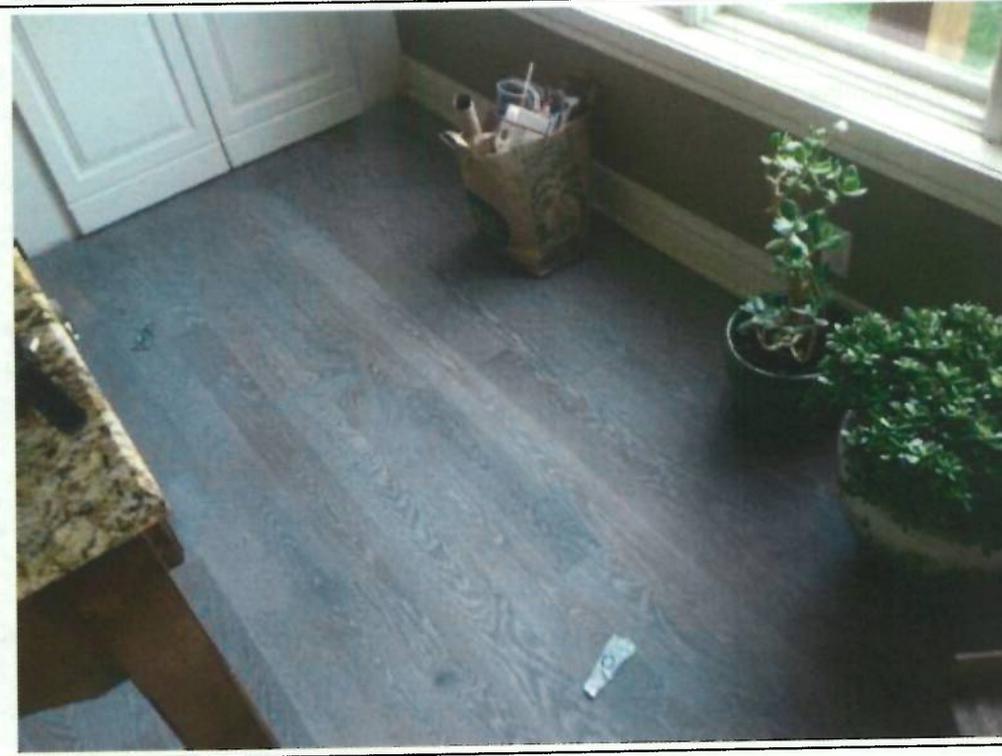
Photo No. 22	Date: 06/08/2016
Photo Coordinates	
Lat	
Long	
Direction Photo Taken:	
Description: Western-most floor area in kitchen. Duct tape labels on items indicate mercury readings (mg/m3).

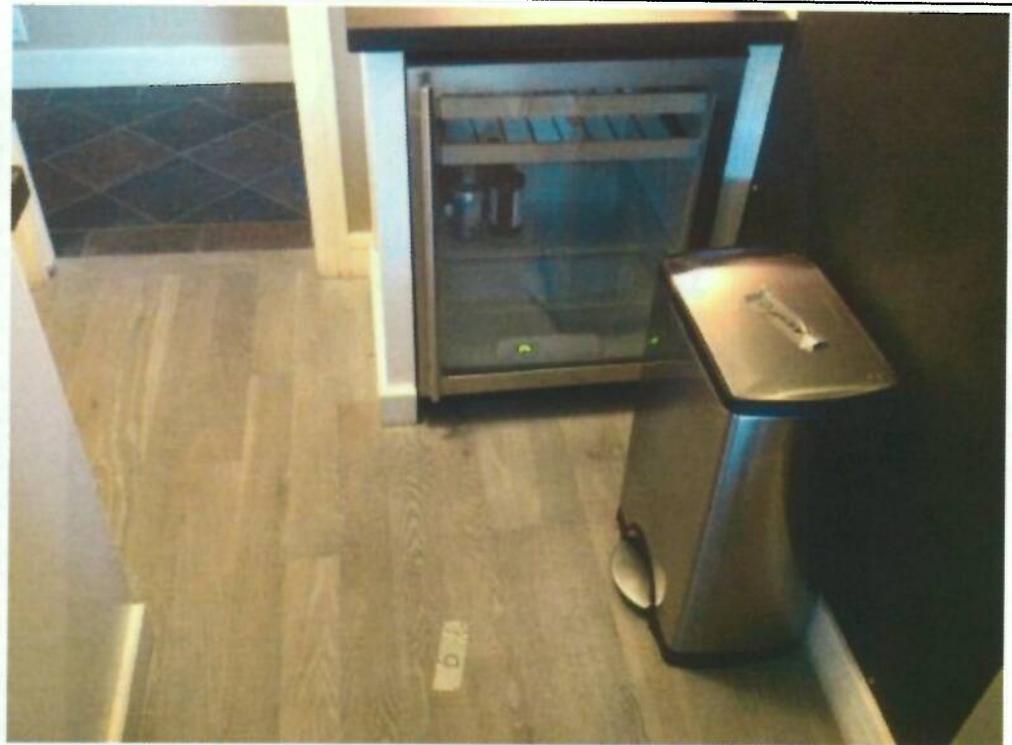
Butler pantry off kitchen. Duct tape labels on items indicate mercury readings (mg/m3).

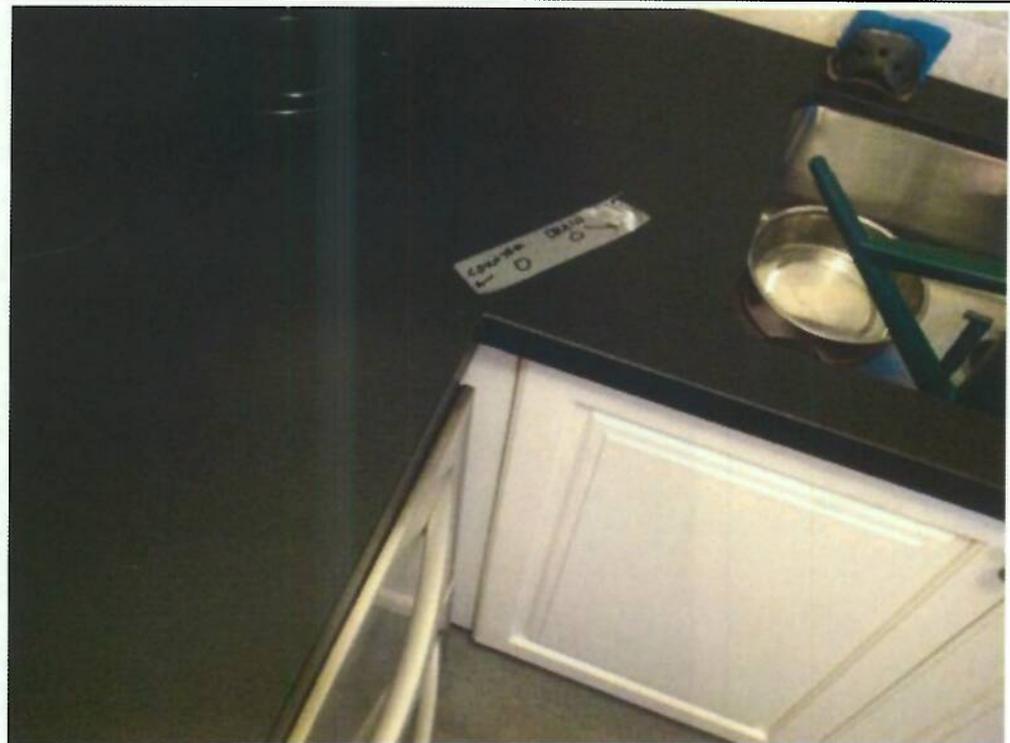
Photo No.
24 **Date:**
06/08/2016

Butler pantry off kitchen. Duct tape labels on items indicate mercury readings (mg/m3).

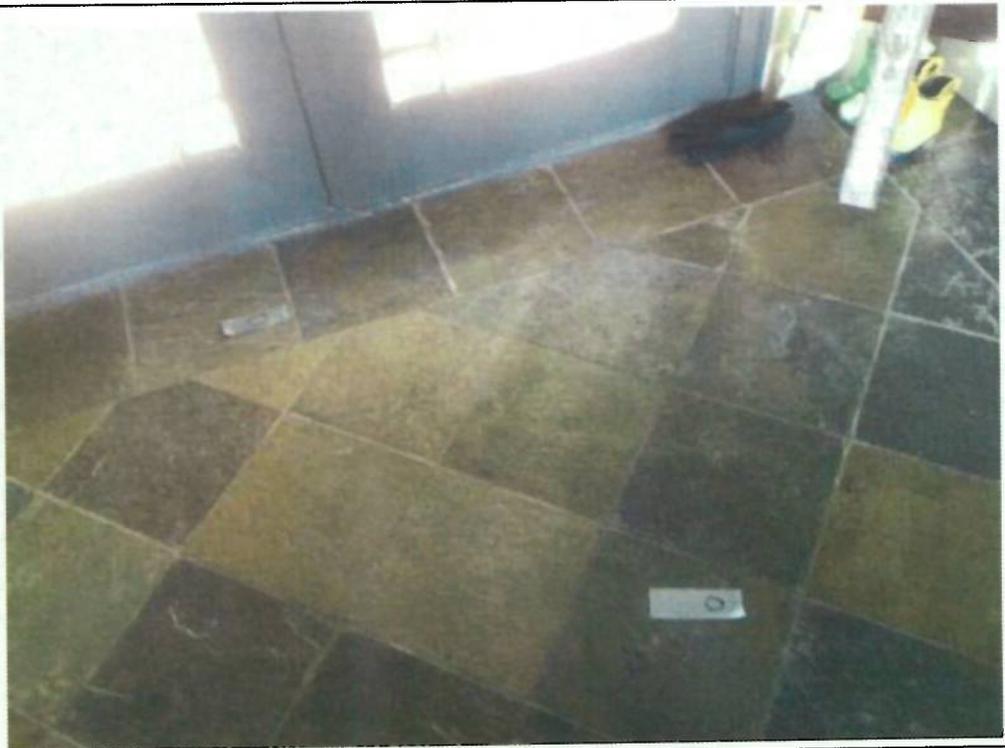
Main entrance hall, front door. Duct tape labels on items indicate mercury readings (mg/m3).

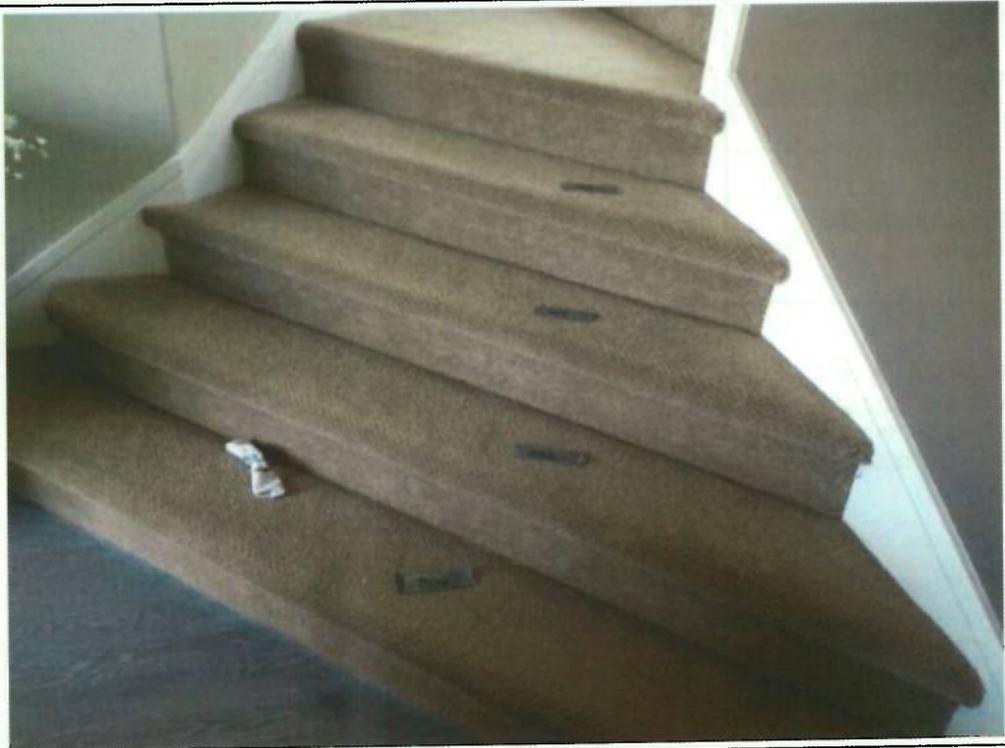
Photo No.
26

Stairway to upper floor from main floor sitting area. Duct tape labels on items indicate mercury readings (mg/m3).

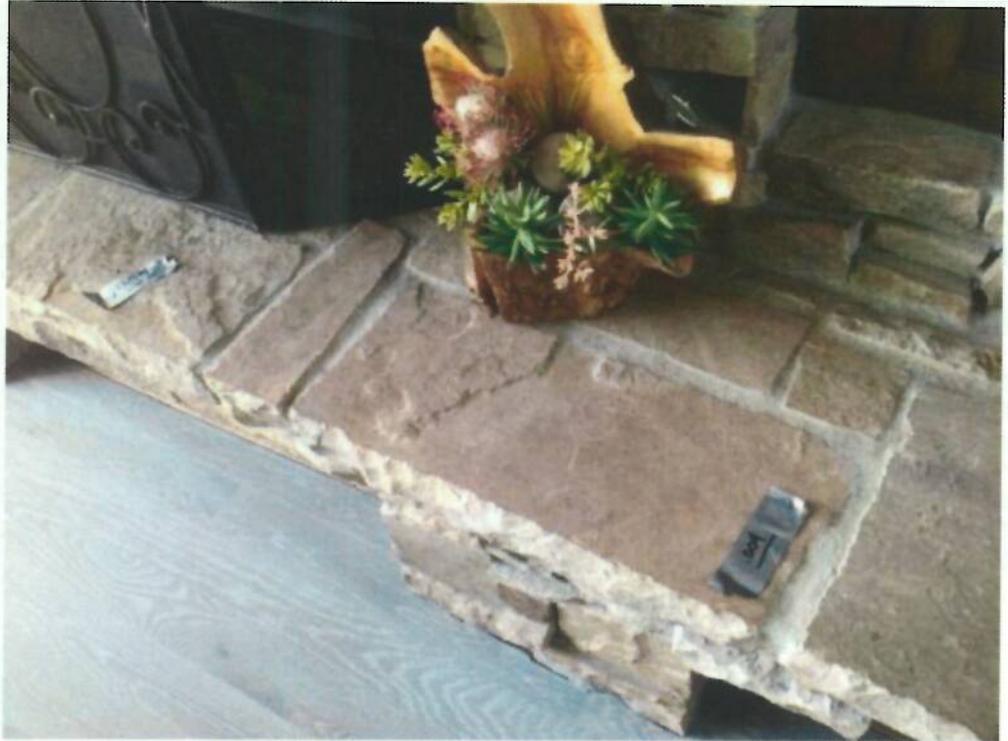
Photo No. 27	Date: 06/08/2016
Photo Coordinates	
Lat	
Long	
Direction Photo Taken:	
Description: Sitting area fire place/hearth. Duct tape labels on items indicate mercury readings (mg/m3).

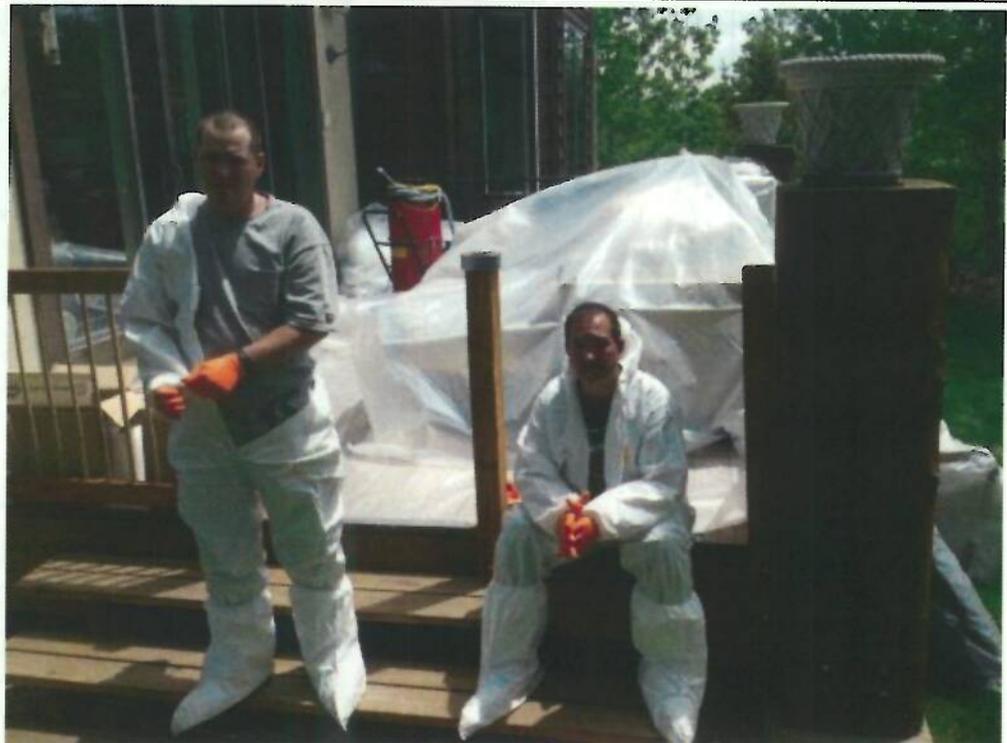
Entry personnel, level C PPE.

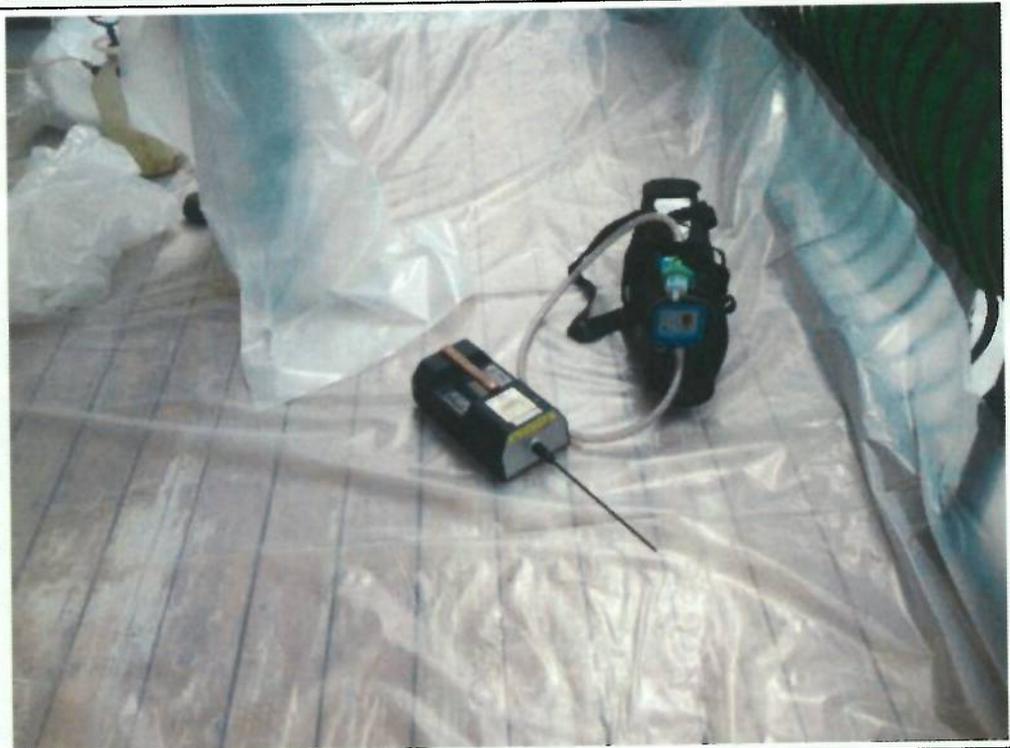
Mercury detection instruments used on site. Jerome instrument on left, Lumex instrument on right.
