Re: Jumbo Mine – Letter Report
Montezuma, Summit County, Colorado
TDD: 1706-12
DCN: W0499.1A.01572
WO#: 20408.012.001.0499.00

The United States Environmental Protection Agency (U.S. EPA) tasked the Weston Solutions, Inc., (WESTON®) Superfund Technical Assessment and Response Team (START) under Technical Direction Document (TDD) 0001/1706-12 to support U.S. EPA's site assessment and removal action at the Jumbo Mine site (the Site) in Montezuma, Summit County, Colorado. The removal action was initiated after it was determined that significant metal loading was being introduced to the Snake River from the draining Jumbo Mine adit and subsequent waste rock pile.

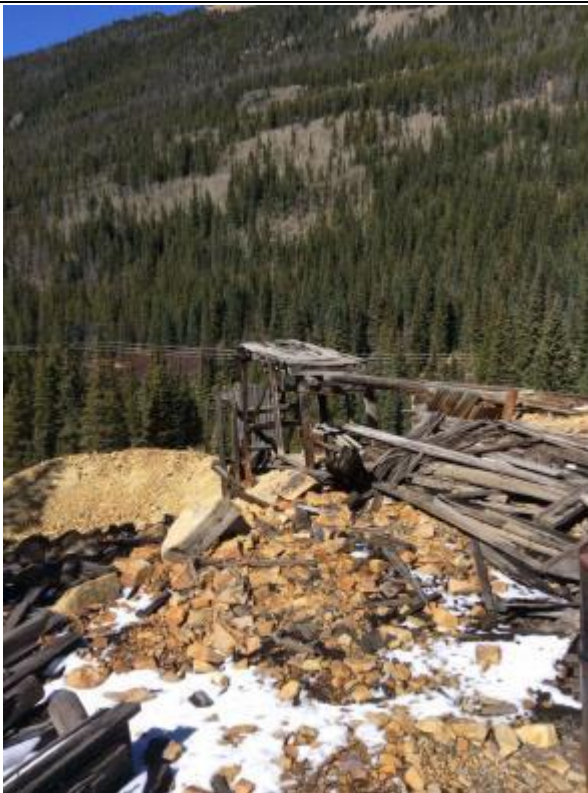
Photo No. 11	Date: 10/10/2017

Direction Photo Taken:		
Description: Existing structures remaining from historic mining activities at the Jumbo Mine site.		
Photo No. 12	Date: 10/10/2017

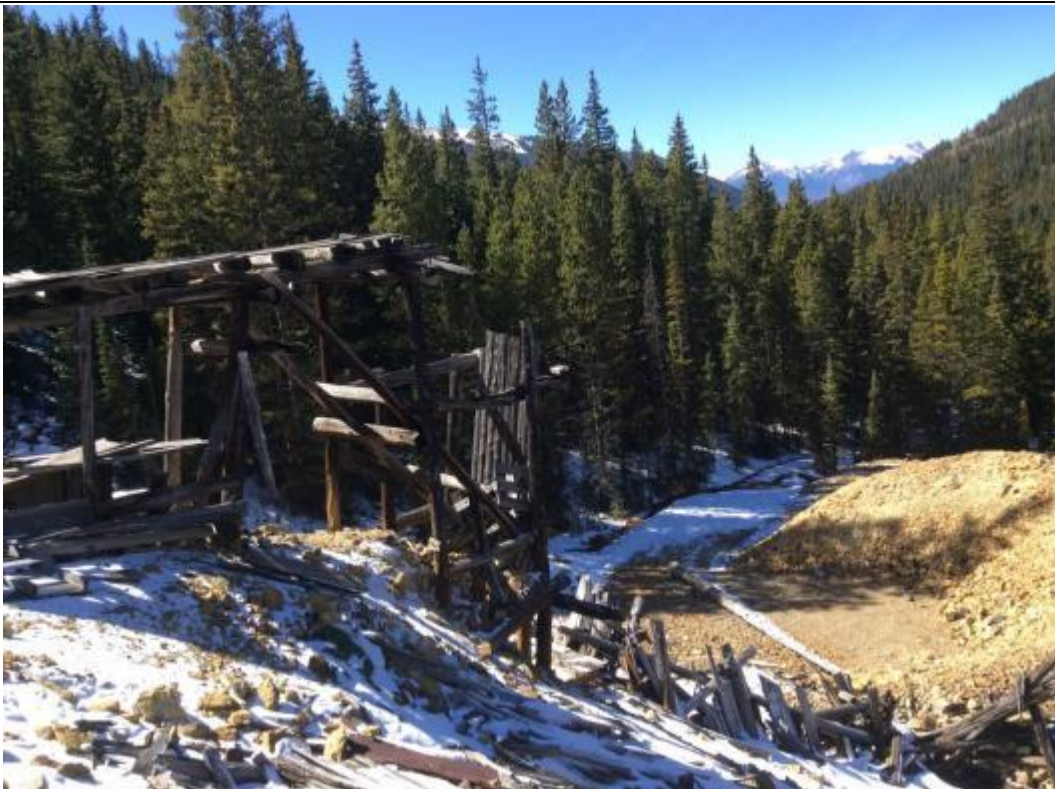
Direction Photo Taken:		
Description: Existing structures remaining from historic mining activities at the Jumbo Mine site.

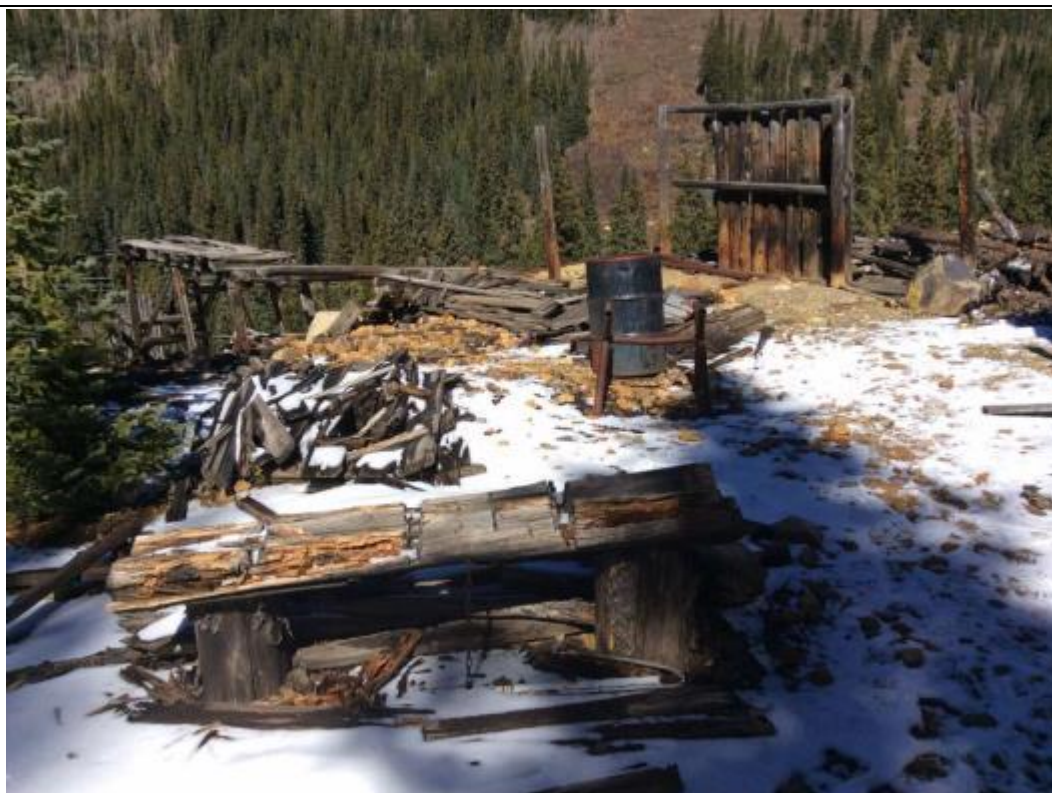
Photo No.
13

Existing structures remaining from historic mining activities at the Jumbo Mine site.

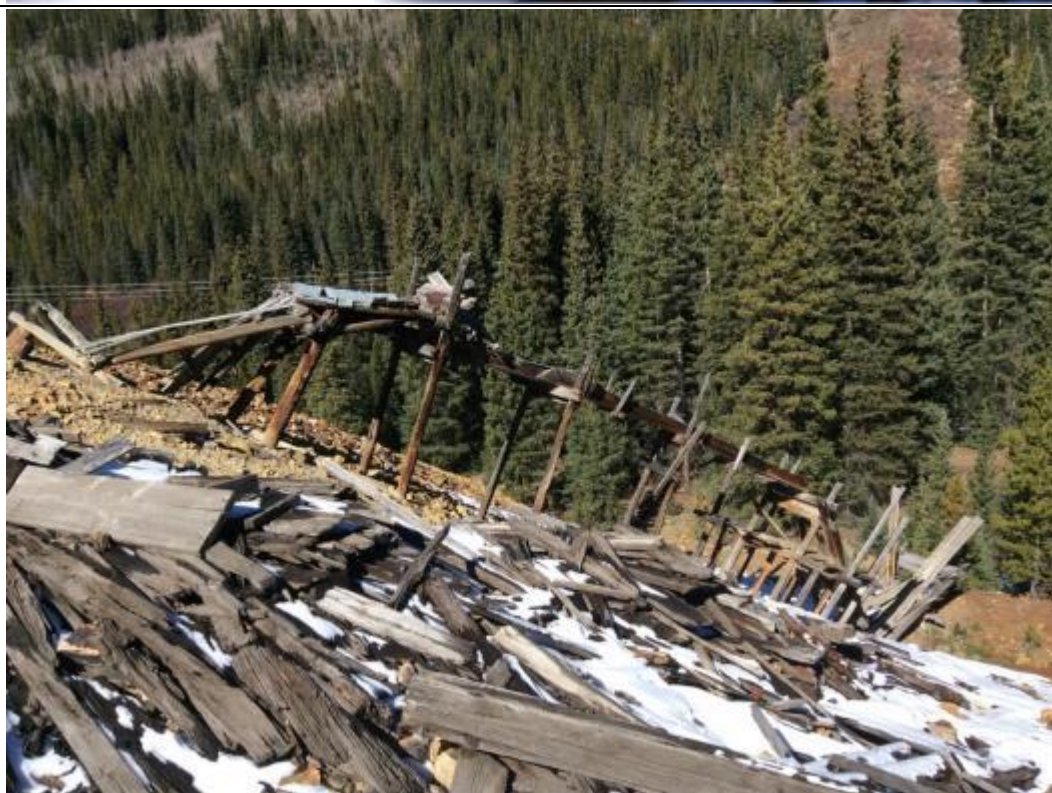
Photo No.
14

Existing structures remaining from historic mining activities at the Jumbo Mine site.

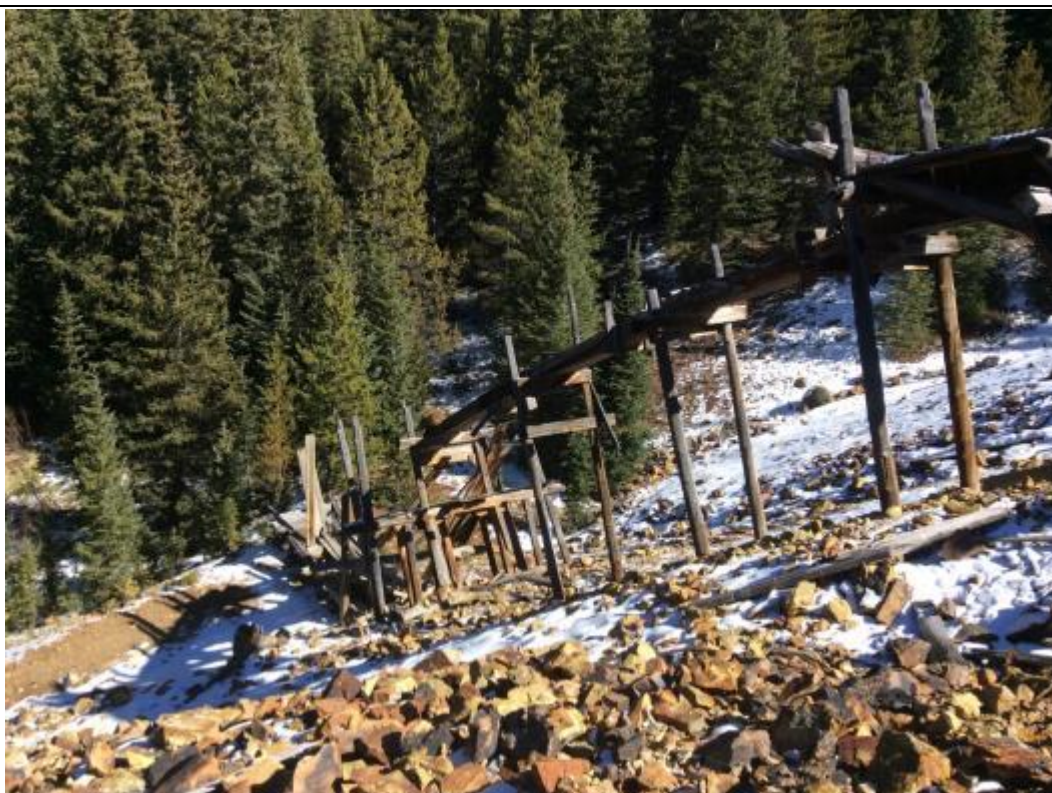
Photo No.
15

Existing structures remaining from historic mining activities at the Jumbo Mine site.

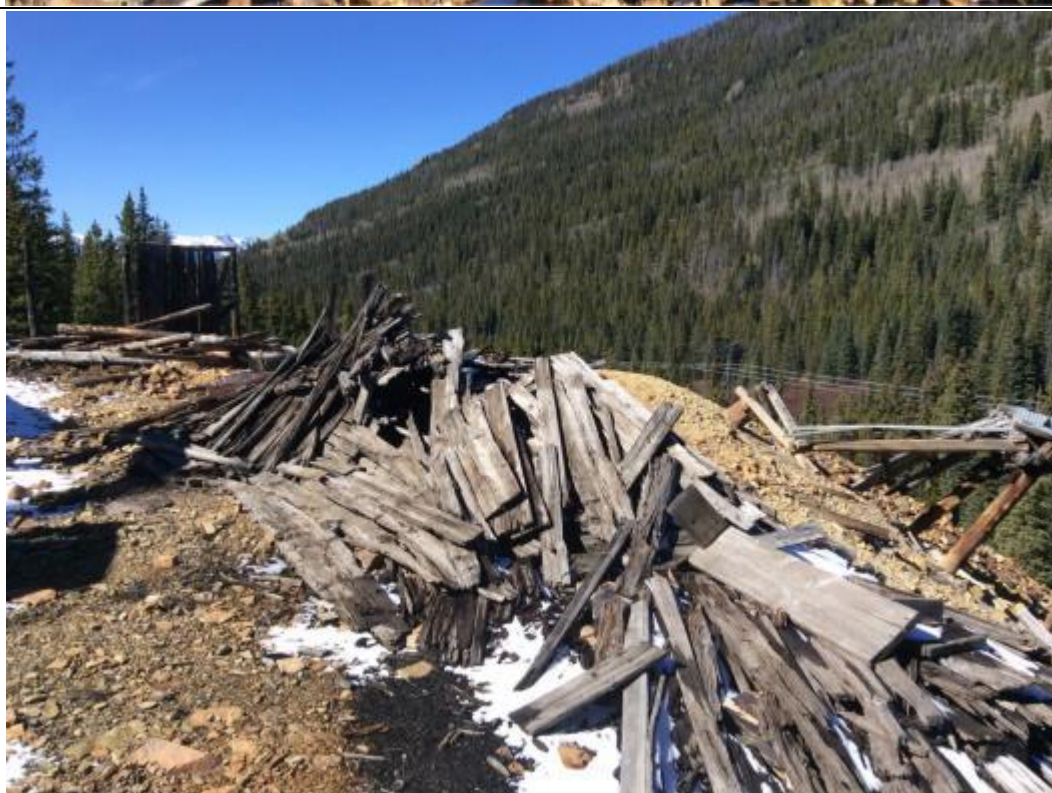
Photo No.
16

Existing structures remaining from historic mining activities at the Jumbo Mine site.

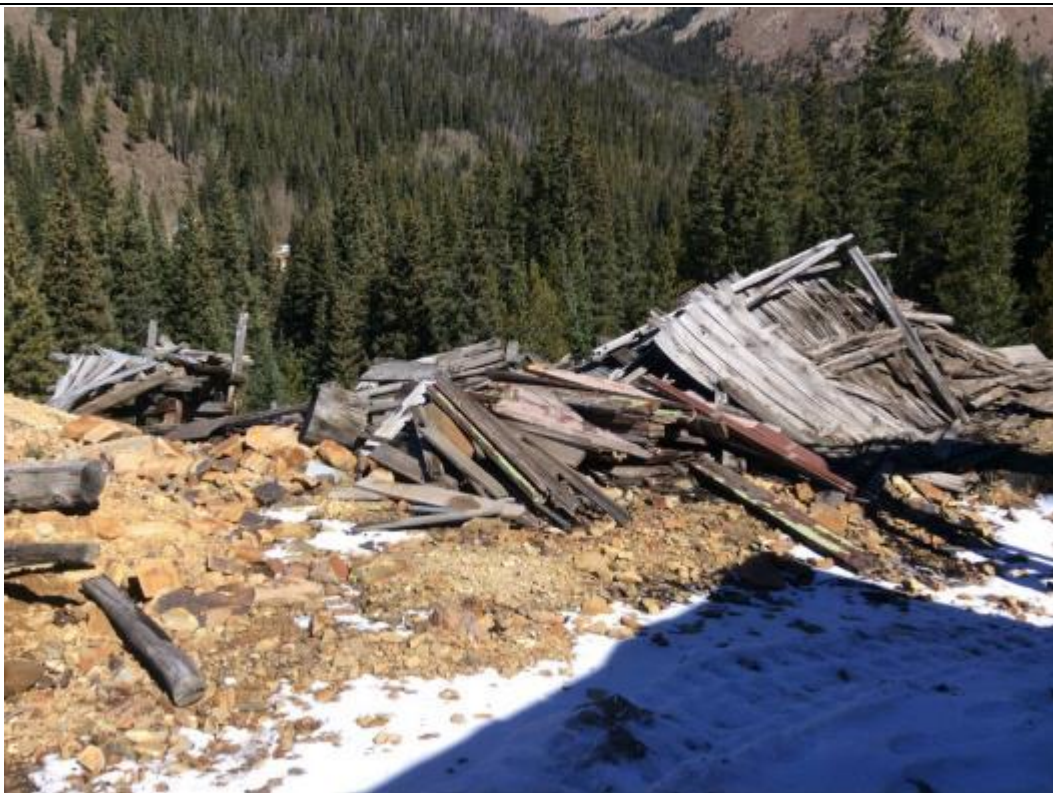
Photo No. 17	Date: 10/10/2017

Direction Photo Taken:		
Description: Existing structures remaining from historic mining activities at the Jumbo Mine site.

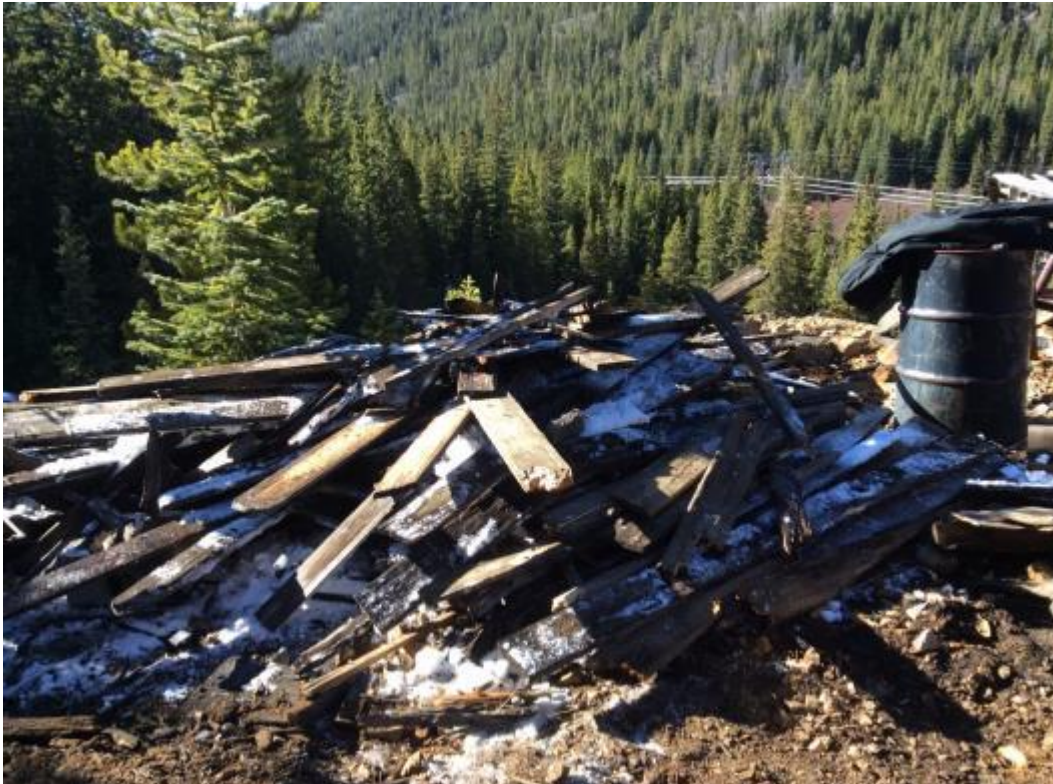
Photo No. 18	Date: 10/10/2017

Direction Photo Taken:		
Description: Existing structures remaining from historic mining activities at the Jumbo Mine site.

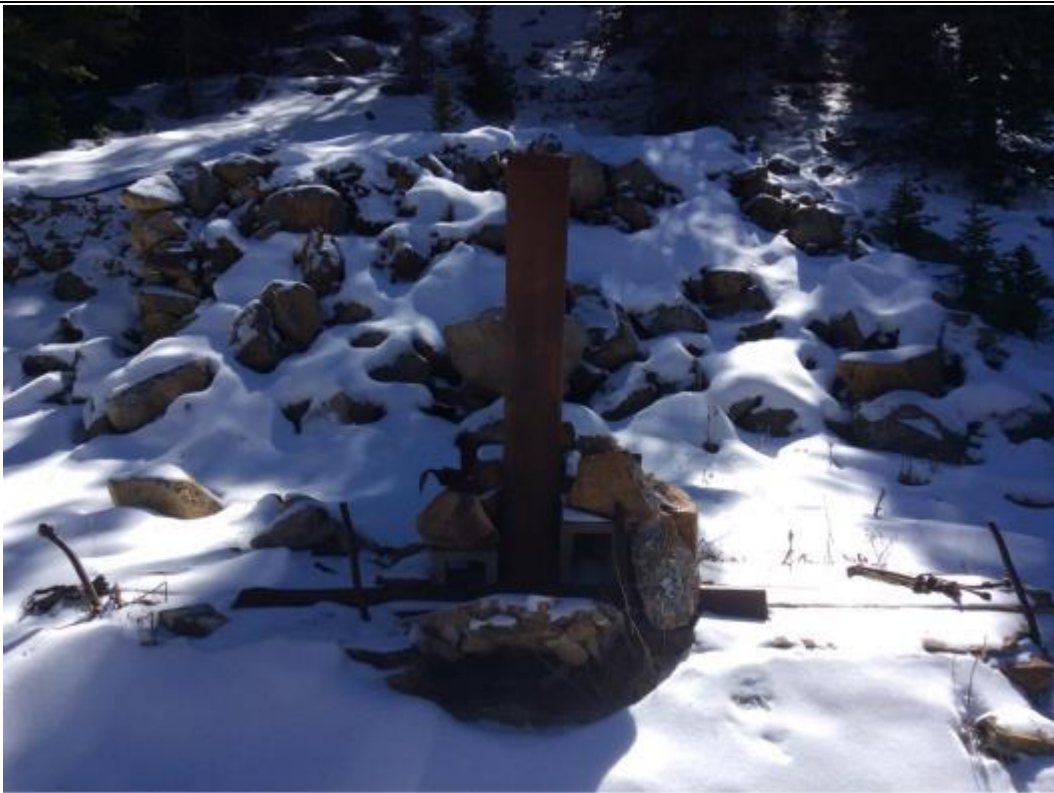
Photo No. 19	Date: 10/10/2017

Direction Photo Taken:		
Description: Existing structures remaining from historic mining activities at the Jumbo Mine site.		
Photo No. 20	Date: 10/10/2017
