**Subject: Targeted Brownfields Assessment Survey Report for Asbestos, Lead-Based Paint, and Polychlorinated Biphenyls at Mead Hansen Building, 408 S. 8th Street, St. Joseph, Buchanan County, Missouri**  
**U.S. EPA Region 7, START 4, Contract No. EP S7 13 06, Task Order No. 0002.043**  
**Task Monitor: Todd Davis, EPA On-Scene Coordinator**

**TARGETED BROWNFIELDS ASSESSMENT  
SURVEY REPORT FOR ASBESTOS, LEAD-BASED PAINT, AND POLYCHLORINATED  
BIPHENYLS**

**MEAD HANSEN BUILDING  
408 S. 8<sup>th</sup> STREET  
ST. JOSEPH, MISSOURI**

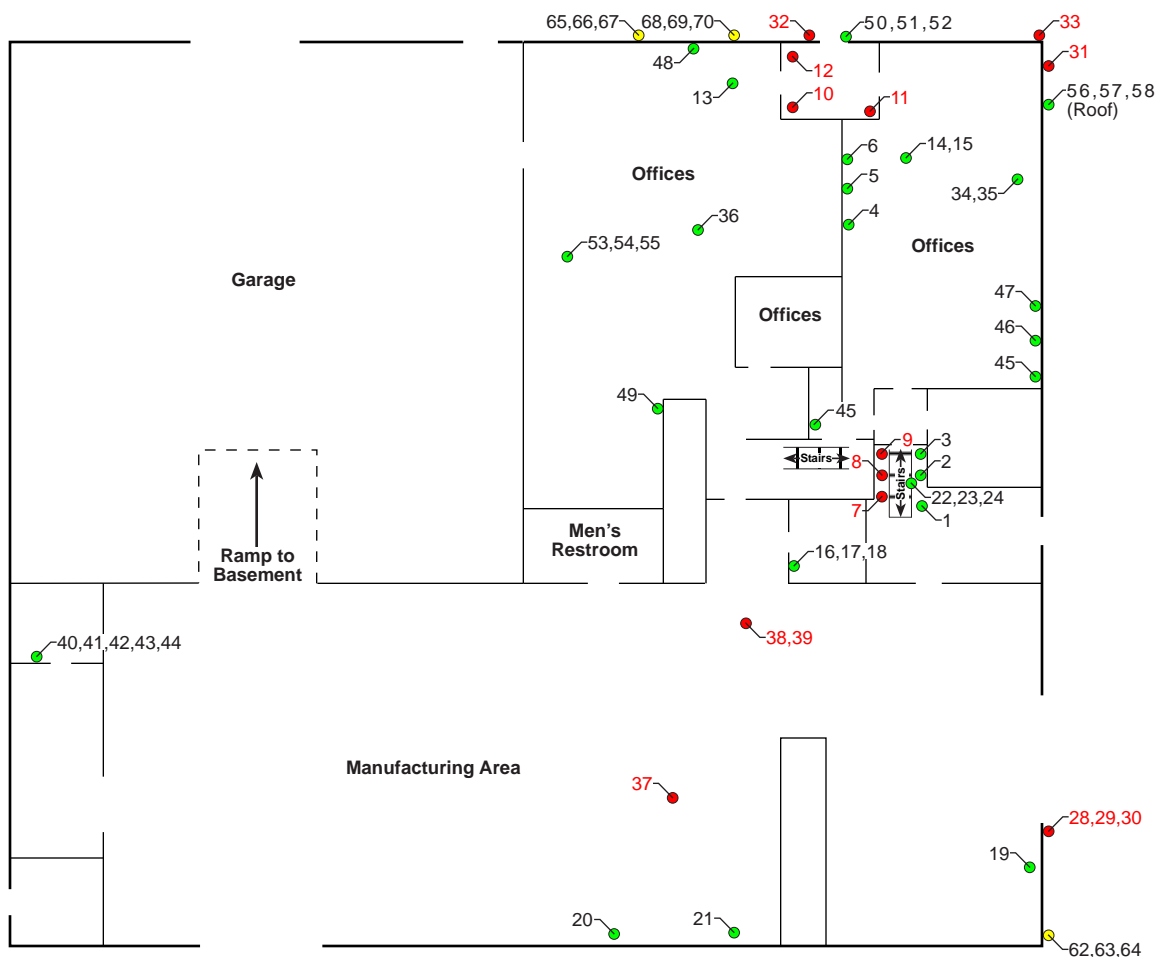
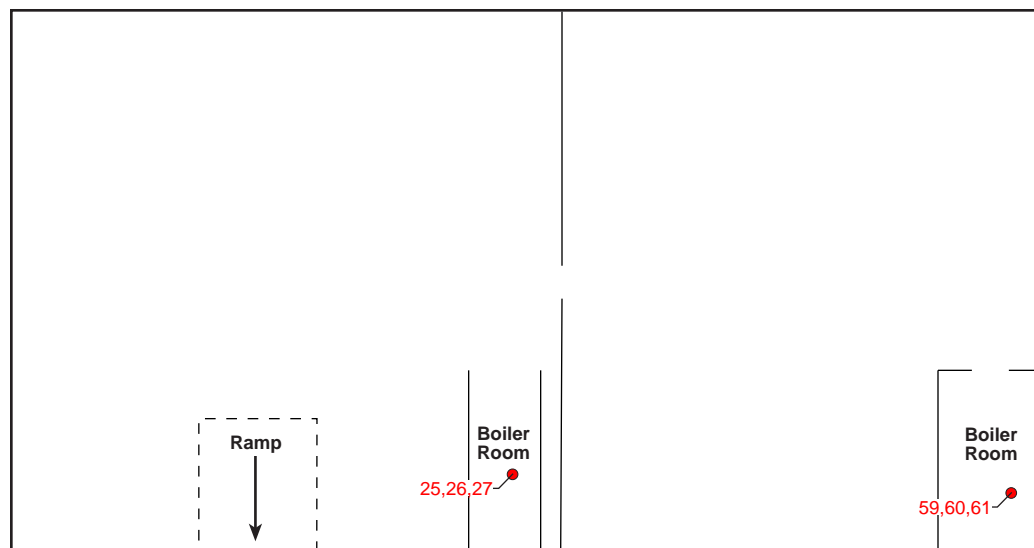
Key	Sample No.
Asbestos	
1	CT1-1
2	CT1-2
3	CT1-3
4	WM-1
5	WM-2
6	WM-3
7	FT-1
8	FT-2
9	FT-3
10	LIN-1
11	LIN-2
12	LIN-3
13	TERR-1
14	TERR-2
15	TERR-3
16	WG-1
17	WG-2
18	WG-3
19	WG1-1
20	WG1-2
21	WG1-3
22	FT1-1
23	FT1-2
24	FT1-3
25	IN-1
26	IN-2
27	IN-3
28	Transite-1
29	Transite-2
30	Transite-3
31	WM1-1
32	WM1-2
33	WM1-3
34	CT-1
35	CT-2
36	CT-3
37	Airocell-1
38	Airocell-2
39	Airocell-3
40	DW-1
41	DW-2
42	DW-3
43	DW-4
44	DW-5
45	PLSC-1
46	PLSC-2
47	PLSC-3
48	PLSC-4
49	PLSC-5
50	DC-1
51	DC-2
52	DC-3
53	PLS-1
54	PLS-2
55	PLS-3
56	RM-1
57	RM-2
58	RM-3
59	J-1
60	J-2
61	J-3
62	C4-1
63	C4-2
64	C4-3
65	DC-2-1
66	DC-2-2
67	DC-2-3
68	C1-1
69	C1-2
70	C1-3

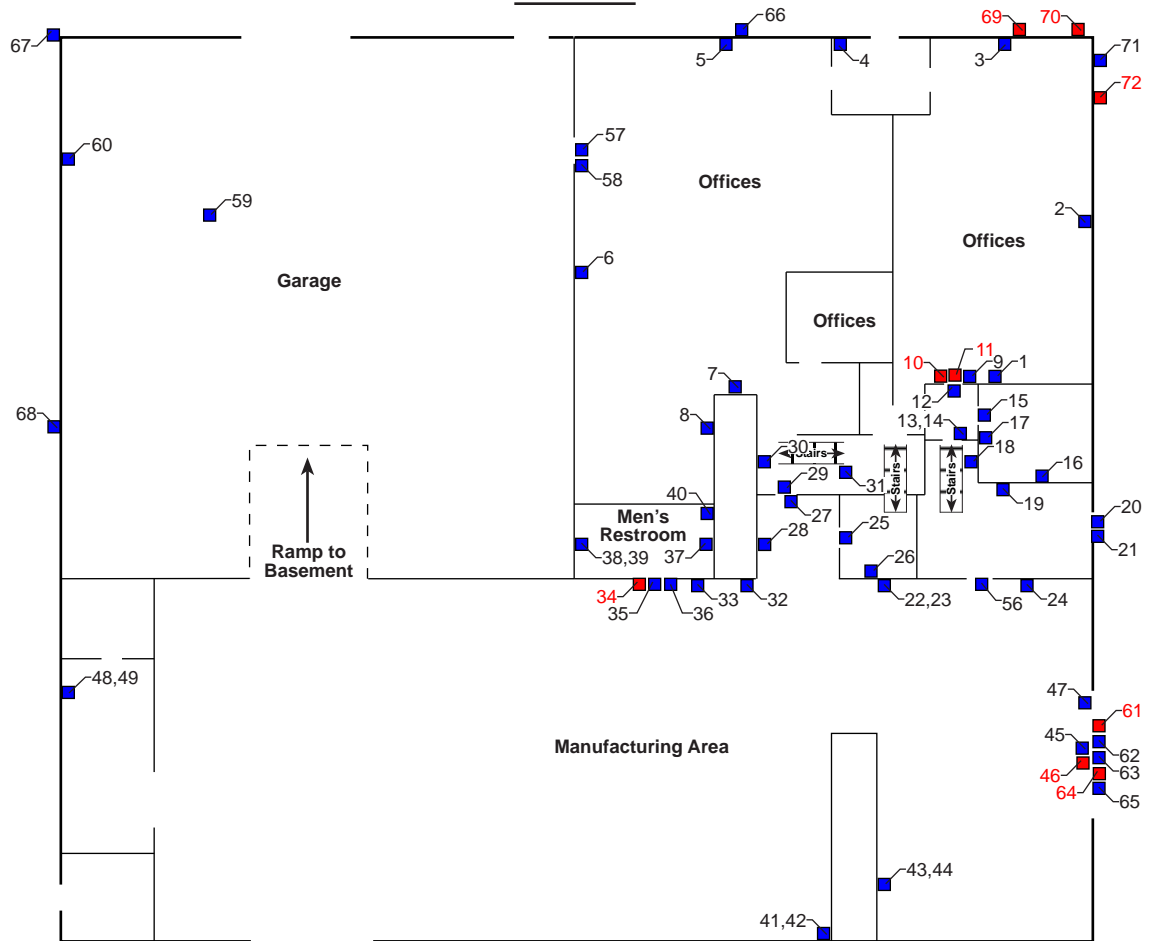
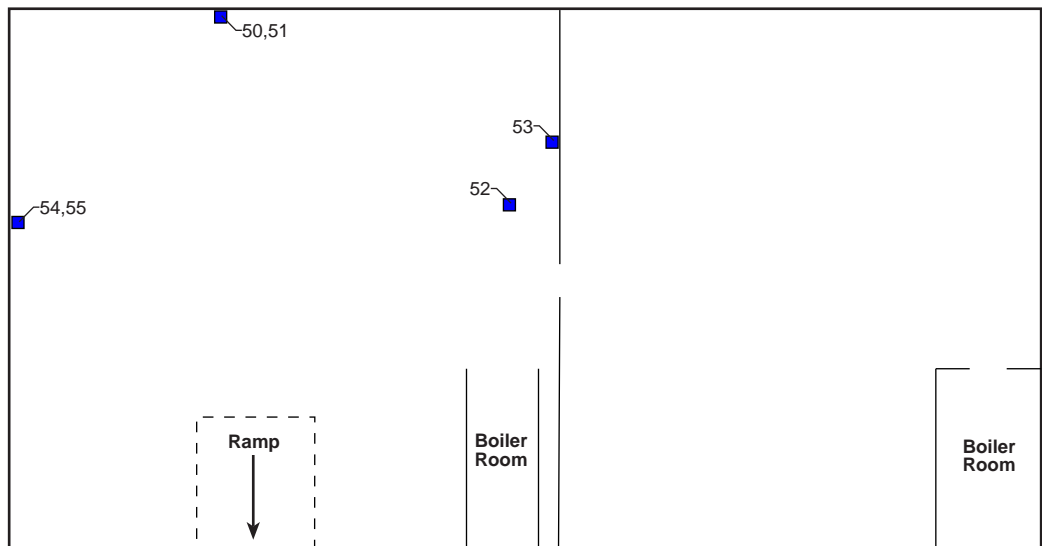
Sample No.
Lead
1
2
3
4
5
6
7
8
9
10
11
12
13
14
15
16
17
18
19
20
21
22
23
24
25
26
27
28
29
30
31
32
33
34
35
36
37
38
39
40
41
42
43
44
45
46
47
48
49
50
51
52
53
54
55
56
57
58
59
60
61
62
63
64
65
66
67
68
69
70
71
72

HUD considers LBP as paint with lead levels above 1.0 mg/cm<sup>2</sup>. If demolition or renovation will or could impact the LBP surfaces, Tetra Tech recommends that the contractor conducting the demolition or renovation comply with Occupational Safety and Health Administration (OSHA) Lead in Construction Standard, Title 29 of *Code of Federal Regulations* (CFR), Part 1926.62. If the materials containing LBP are removed during demolition or renovation activities, a sample should be collected from the debris pile for a Toxicity Characteristic Leaching Procedure (TCLP) analysis (Title 40 CFR 261.24); representative samples should be collected and analyzed for all eight metals specified in 40 CFR Part 261.24 (arsenic, barium, cadmium, chromium, lead, mercury, selenium, and silver). This would allow determination of the proper method of disposal of the materials. Prior to demolition or renovation, the demolition or renovation contractor should remove peeling and chipping paint from any damaged LBP surfaces on the walls at the Site's building.
