**Subject: Analysis of Brownfields Cleanup Alternatives
Old St. Elizabeth Hospital, Hannibal, Missouri
EPA Region 7, START 4, Contract No. EP-S7-13-06, Task Order No. 0002.048
Task Monitor: Todd Davis, Site Assessment Manager**

ANALYSIS OF BROWNFIELDS CLEANUP ALTERNATIVES

**OLD ST. ELIZABETH HOSPITAL
HANNIBAL, MISSOURI**

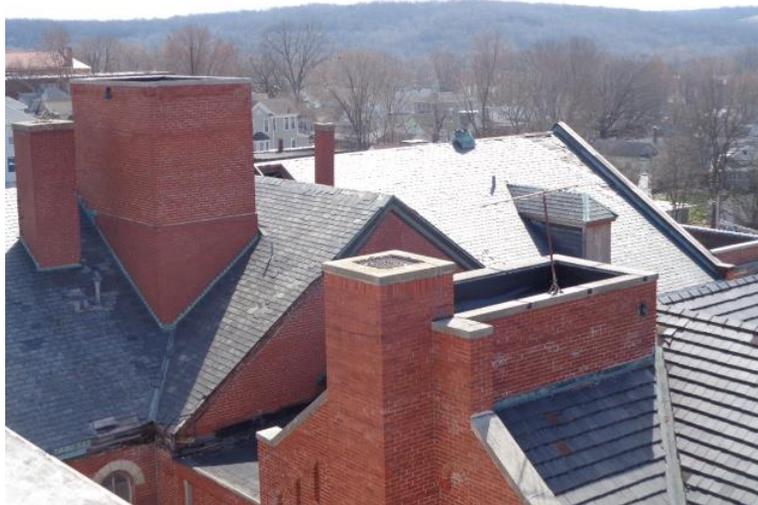
TETRA TECH PROJECT NO. 103X9025140002.048 Direction: Southeast	DESCRIPTION	This photograph shows the slate tile roof and asbestos-containing roof tar of the main building	2
	CLIENT	U.S. Environmental Protection Agency Region 7	Date
	PHOTOGRAPHER	Kaitlyn Mitchell	3/30/2018

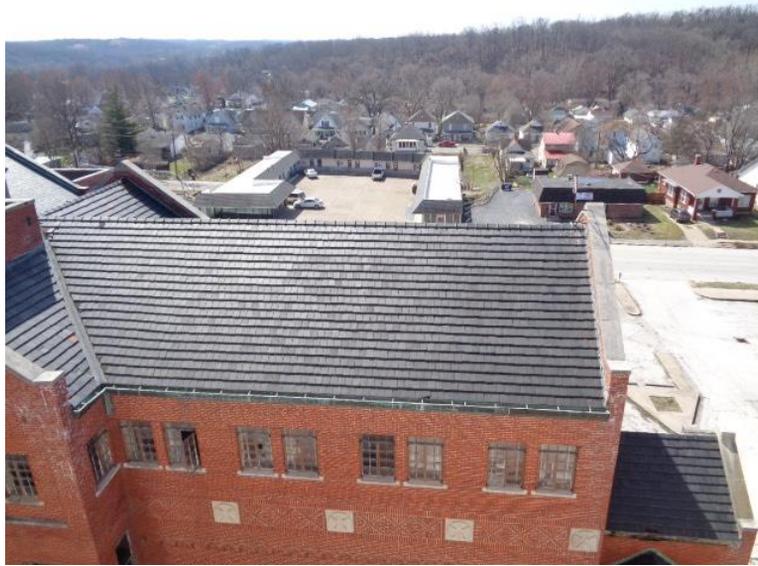
TETRA TECH PROJECT NO. 103X9025140002.048 Direction: South	DESCRIPTION	This photograph shows the slate tile roof and asbestos-containing roof tar on the chapel portion of the main building.	3
	CLIENT	U.S. Environmental Protection Agency Region 7	Date
	PHOTOGRAPHER	Kaitlyn Mitchell	3/30/2018

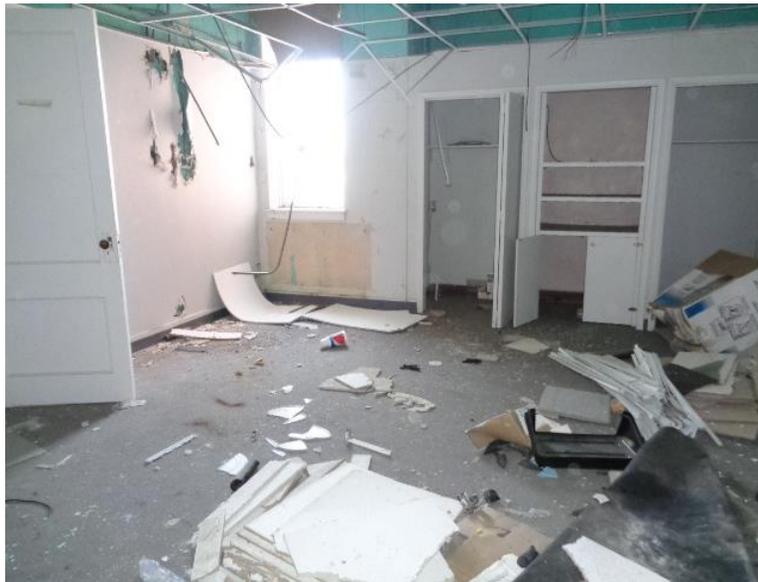
TETRA TECH PROJECT NO. 103X9025140002.048 Direction: NA	DESCRIPTION	This photograph shows carpet with associated mastic, plaster and associated skim coat, and ceiling tile on the 1 st floor of the main building.	4
	CLIENT	U.S. Environmental Protection Agency Region 7	Date
	PHOTOGRAPHER	Kaitlyn Mitchell	3/30/2018

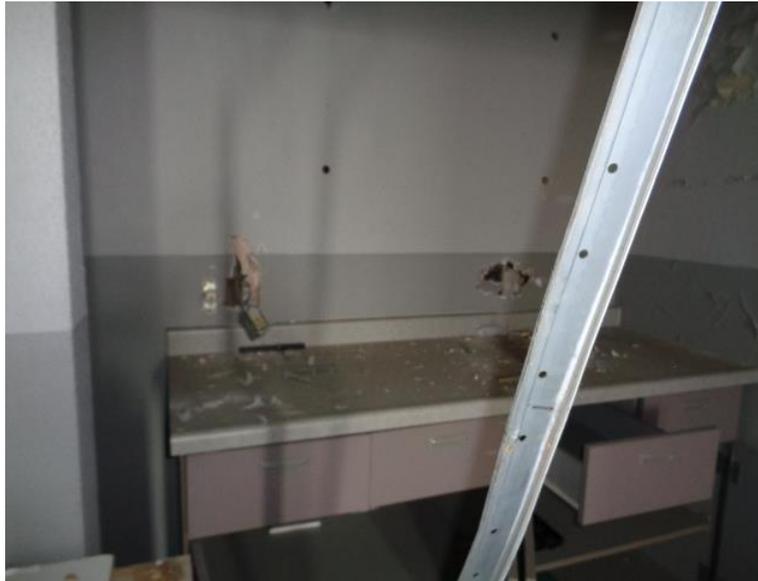
TETRA TECH PROJECT NO. 103X9025140002.048 Direction: NA	DESCRIPTION	This photograph shows pink drywall in the 1 st floor south offices of the main building.	5
	CLIENT	U.S. Environmental Protection Agency Region 7	Date
	PHOTOGRAPHER	Kaitlyn Mitchell	3/30/2018

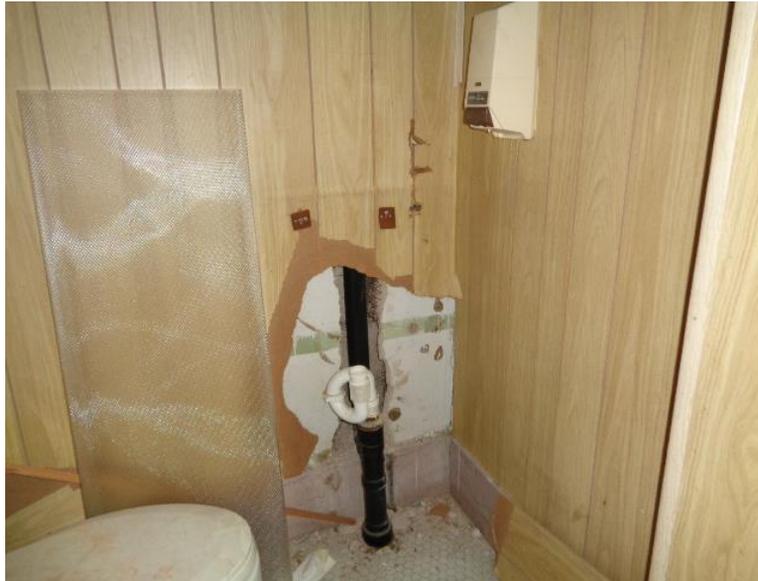
TETRA TECH PROJECT NO. 103X9025140002.048 Direction: NA	DESCRIPTION	This photograph shows yellow wall mastic behind wood paneling in the 1 st floor south offices of the main building.	7
	CLIENT	U.S. Environmental Protection Agency Region 7	Date
	PHOTOGRAPHER	Kaitlyn Mitchell	3/30/2018

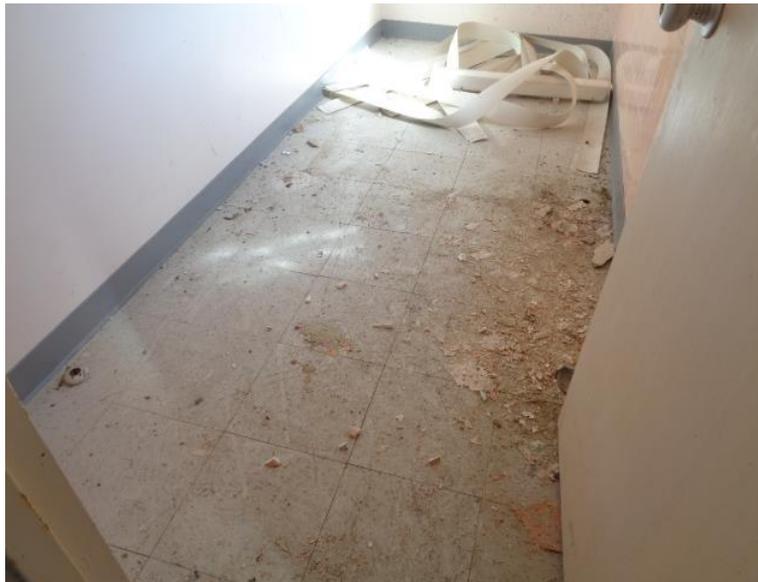
TETRA TECH PROJECT NO. 103X9025140002.048 Direction: NA	DESCRIPTION	This photograph shows 12" x 12" white floor tile and 4" grey cove base with associated mastic in a 1 st floor bathroom of the main building.	8
	CLIENT	U.S. Environmental Protection Agency Region 7	Date
	PHOTOGRAPHER	Kaitlyn Mitchell	3/30/2018

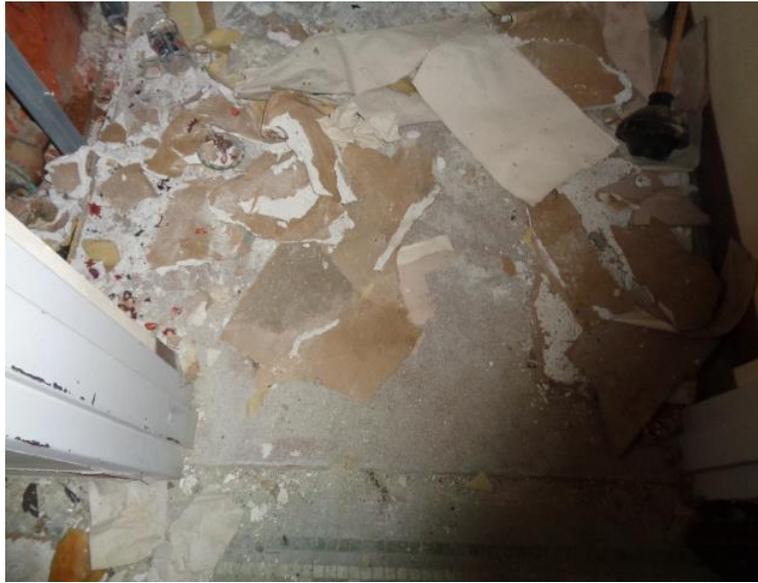
TETRA TECH PROJECT NO. 103X9025140002.048 Direction: NA	DESCRIPTION	This photograph shows off-white pebble pattern linoleum in a 2 nd -floor patient bathroom of the main building.	9
	CLIENT	U.S. Environmental Protection Agency Region 7	Date
	PHOTOGRAPHER	Kaitlyn Mitchell	3/30/2018

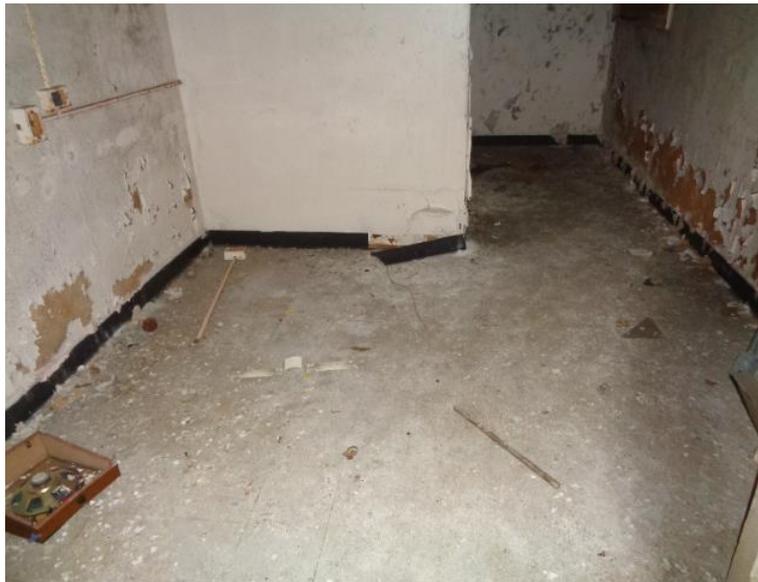
TETRA TECH PROJECT NO. 103X9025140002.048 Direction: NA	DESCRIPTION	This photograph shows 9" x 9" tan floor tile and 4" brown cove base and associated mastic in the basement bathroom of the main building.	12
	CLIENT	U.S. Environmental Protection Agency Region 7	Date
	PHOTOGRAPHER	Kaitlyn Mitchell	3/30/2018

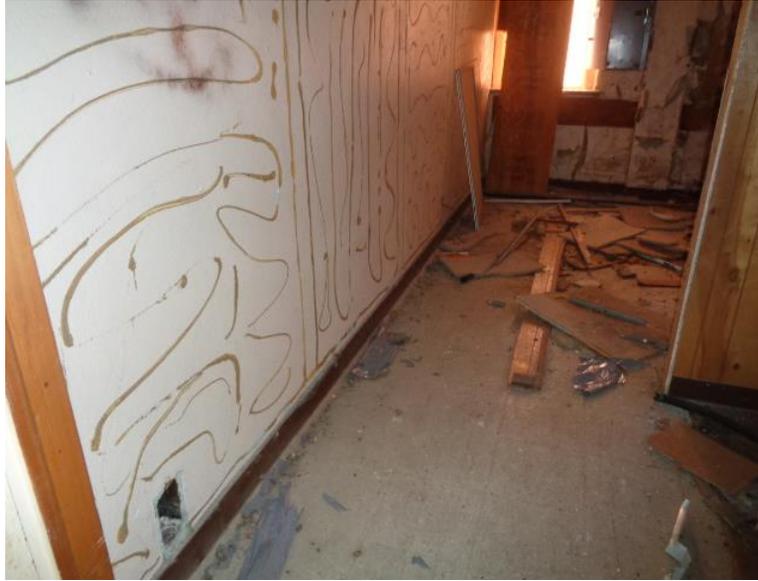
TETRA TECH PROJECT NO. 103X9025140002.048 Direction: NA	DESCRIPTION	This photograph shows yellow wall mastic behind wood paneling and 12" x 12" off-white floor tile in a 3 rd -floor patient room of the main building.	13
	CLIENT	U.S. Environmental Protection Agency Region 7	Date
	PHOTOGRAPHER	Kaitlyn Mitchell	3/30/2018

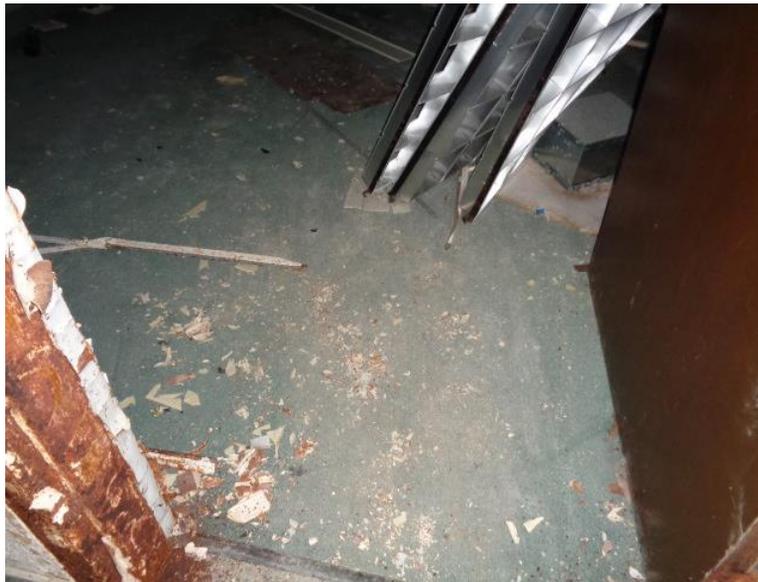
TETRA TECH PROJECT NO. 103X9025140002.048 Direction: NA	DESCRIPTION	This photograph shows carpet and associated mastic in the basement of the main building.	16
	CLIENT	U.S. Environmental Protection Agency Region 7	Date
	PHOTOGRAPHER	Kaitlyn Mitchell	3/30/2018

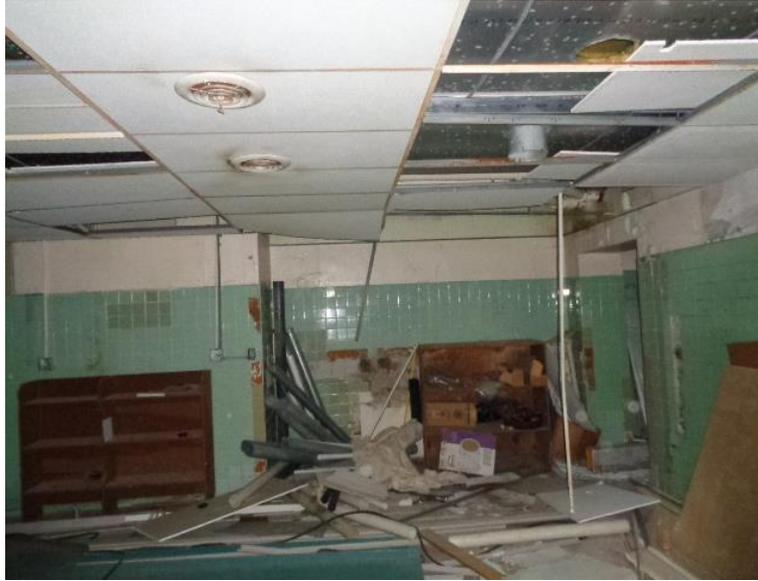
TETRA TECH PROJECT NO. 103X9025140002.048 Direction: NA	DESCRIPTION	This photograph shows 2' x 4' gypsum ceiling tile in the basement of the main building.	17
	CLIENT	U.S. Environmental Protection Agency Region 7	Date
	PHOTOGRAPHER	Kaitlyn Mitchell	3/30/2018

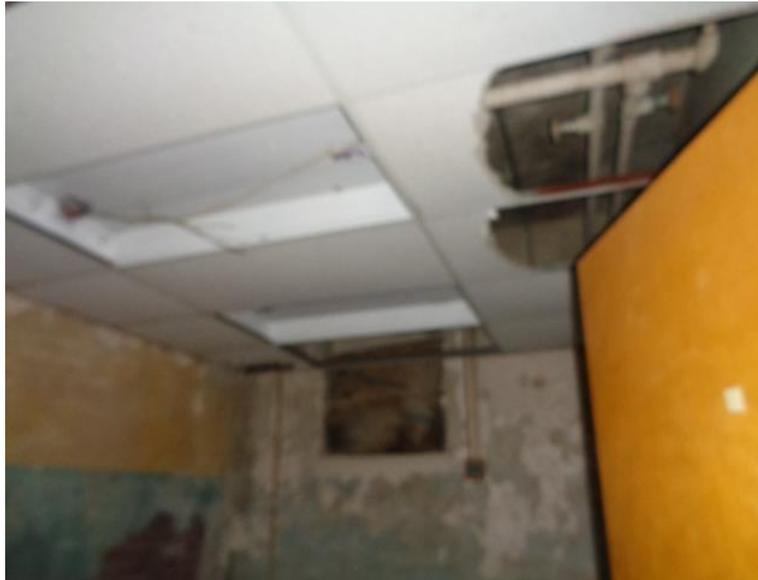
TETRA TECH PROJECT NO. 103X9025140002.048 Direction: NA	DESCRIPTION	This photograph shows 2' x 4' ceiling tile (pinhole and fissured) in the basement of the main building.	18
	CLIENT	U.S. Environmental Protection Agency Region 7	Date
	PHOTOGRAPHER	Kaitlyn Mitchell	3/30/2018

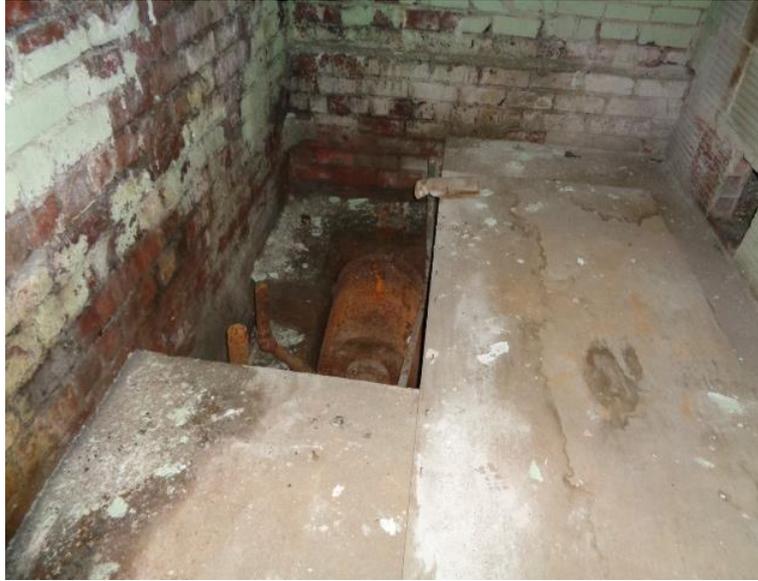
TETRA TECH PROJECT NO. 103X9025140002.048 Direction: NA	DESCRIPTION	This photograph shows a tank beneath the floor in the boiler room of the main building.	21
	CLIENT	U.S. Environmental Protection Agency Region 7	Date
	PHOTOGRAPHER	Kaitlyn Mitchell	3/30/2018

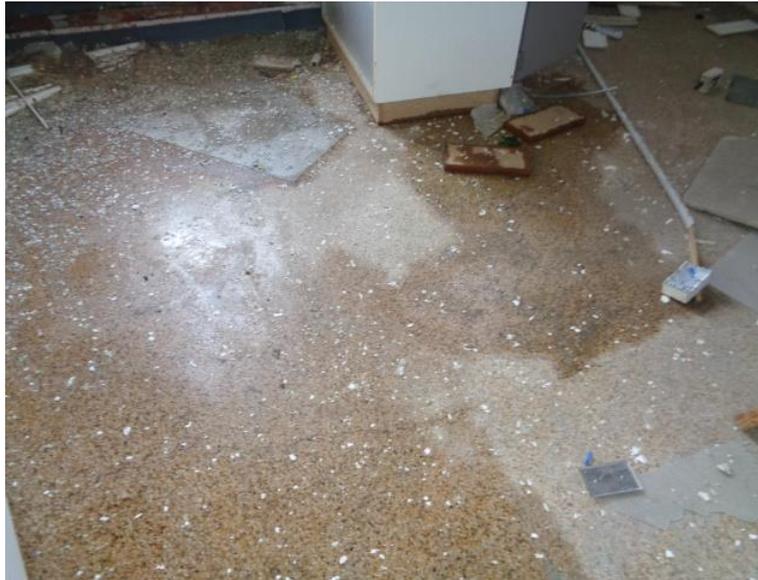
TETRA TECH PROJECT NO. 103X9025140002.048 Direction: NA	DESCRIPTION	This photograph shows brown terrazzo flooring in the main building.	22
	CLIENT	U.S. Environmental Protection Agency Region 7	Date
	PHOTOGRAPHER	Kaitlyn Mitchell	3/30/2018

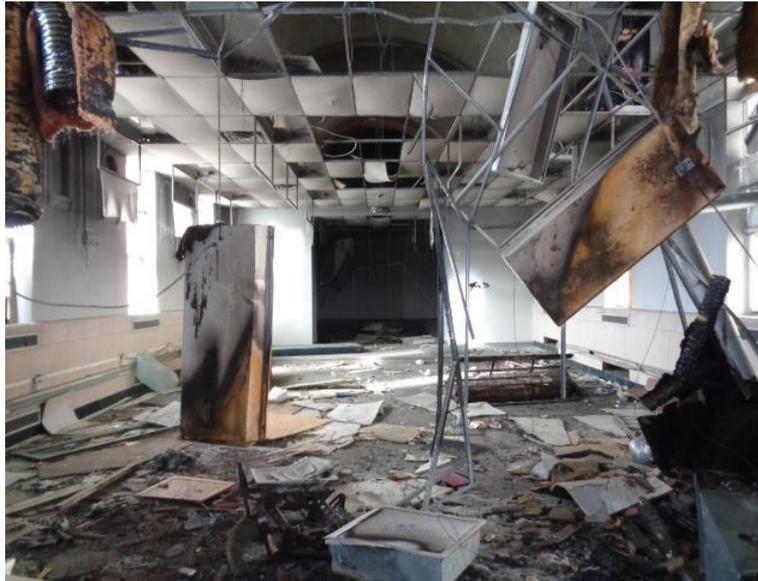
TETRA TECH PROJECT NO. 103X9025140002.048 Direction: NA	DESCRIPTION	This photograph shows fiberglass ceiling tiles and plaster and associated skim coat in the chapel of the main building.	23
	CLIENT	U.S. Environmental Protection Agency Region 7	Date
	PHOTOGRAPHER	Kaitlyn Mitchell	3/30/2018

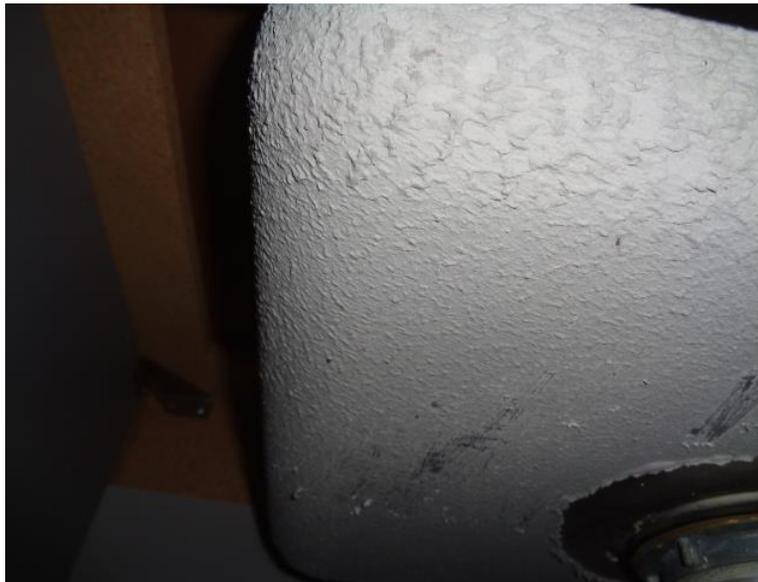
TETRA TECH PROJECT NO. 103X9025140002.048 Direction: NA	DESCRIPTION	This photograph shows sink undercoat in the 1 st -floor south offices of the main building.	24
	CLIENT	U.S. Environmental Protection Agency Region 7	Date
	PHOTOGRAPHER	Kaitlyn Mitchell	3/30/2018

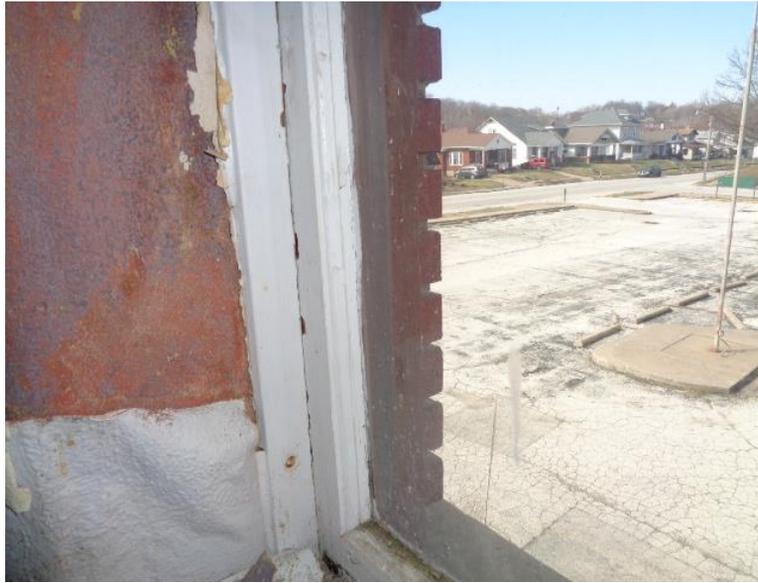
TETRA TECH PROJECT NO. 103X9025140002.048 Direction: NA	DESCRIPTION	This photograph shows window glaze on windows of the main building.	25
	CLIENT	U.S. Environmental Protection Agency Region 7	Date
	PHOTOGRAPHER	Kaitlyn Mitchell	3/30/2018

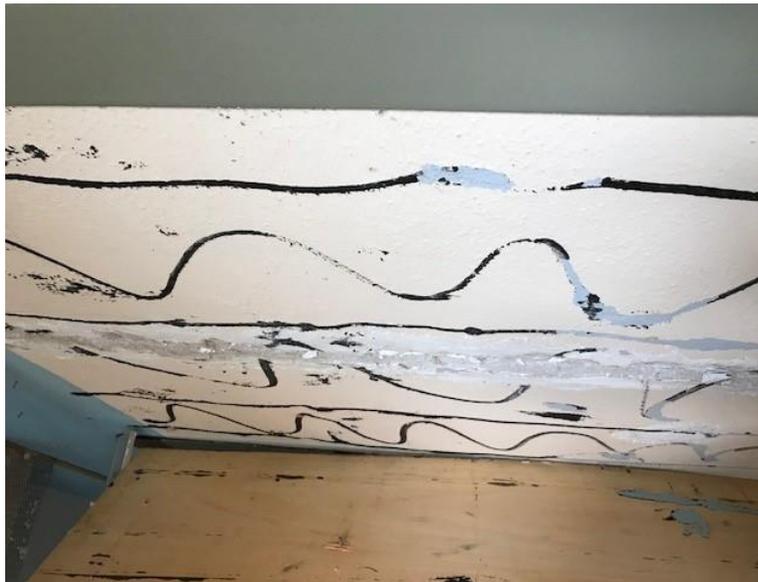
TETRA TECH PROJECT NO. 103X9025140002.048 Direction: NA	DESCRIPTION	This photograph shows black wall mastic in a 2 nd -floor patient room of the main building.	26
	CLIENT	U.S. Environmental Protection Agency Region 7	Date
	PHOTOGRAPHER	Kaitlyn Mitchell	3/30/2018

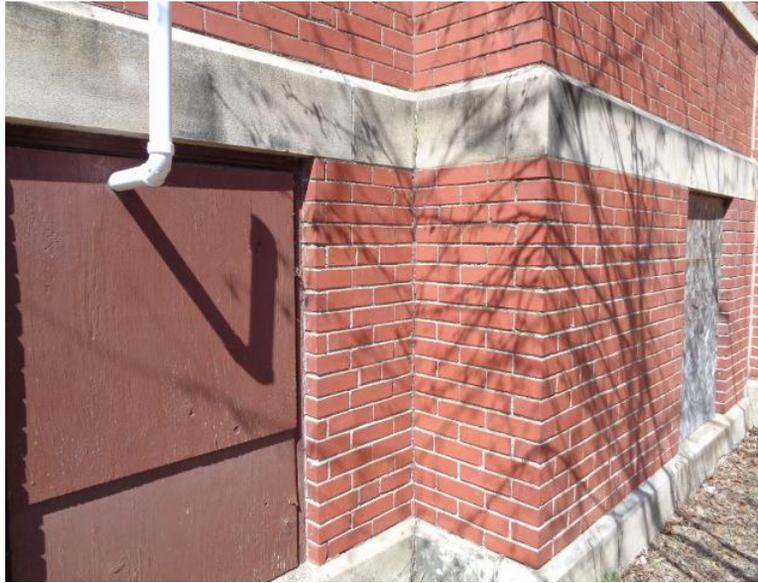
TETRA TECH PROJECT NO. 103X9025140002.048 Direction: NA	DESCRIPTION	This photograph shows expansion caulk on the exterior of the main building.	27
	CLIENT	U.S. Environmental Protection Agency Region 7	Date
	PHOTOGRAPHER	Kaitlyn Mitchell	3/30/2018

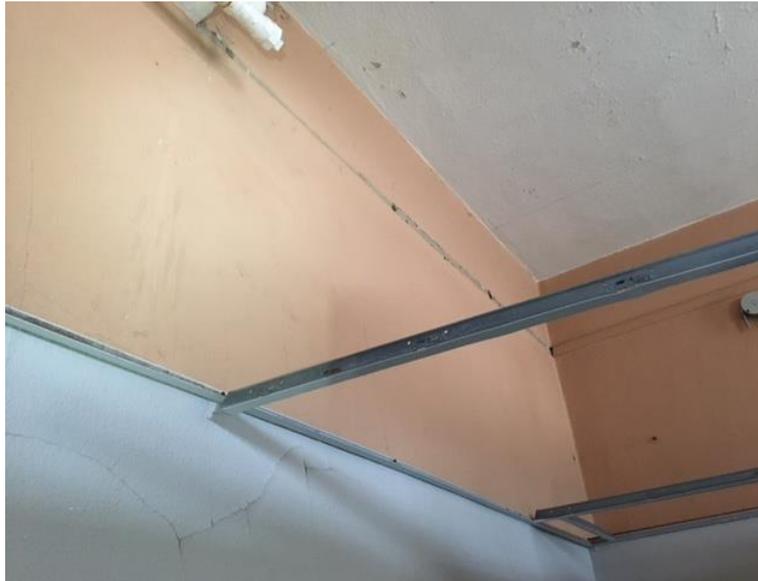
TETRA TECH PROJECT NO. 103X9025140002.048 Direction: NA	DESCRIPTION	This photograph shows peach LBP on walls in the 1 st -floor southeast rooms of the main building.	31
	CLIENT	U.S. Environmental Protection Agency Region 7	Date
	PHOTOGRAPHER	Jeffrey Mitchell	2/27/2018

Alternative 3—removal by renovation/demolition—is the recommended cleanup alternative for LBP associated with the main building, north building, and southwest building. Building materials containing LBP would be demolished and disposed of as demolition waste. This alternative could be implemented by general construction/demolition workers. Based on presence of lead, construction/demolition work must accord with Occupational Safety and Health Administration (OSHA) guidelines for protection of workers.

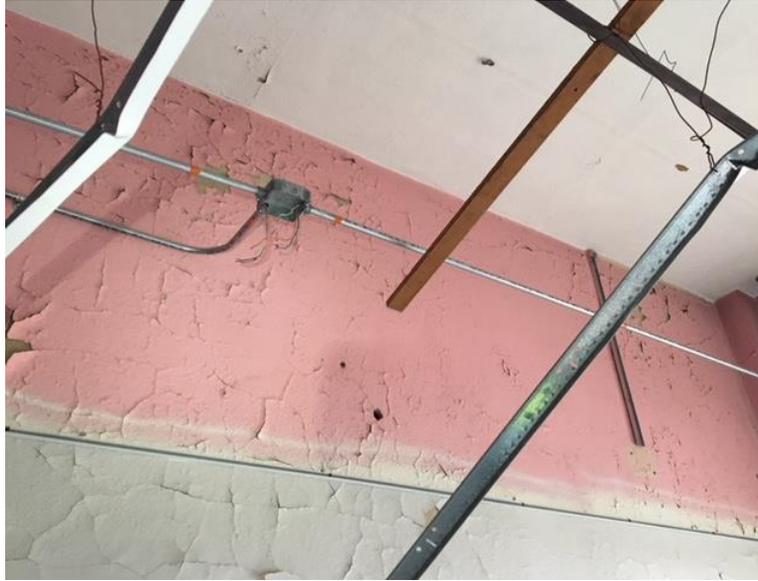
TETRA TECH PROJECT NO. 103X9025140002.048 Direction: NA	DESCRIPTION	This photograph shows pink LBP on walls in the 1 st -floor east rooms of the main building.	33
	CLIENT	U.S. Environmental Protection Agency Region 7	Date
	PHOTOGRAPHER	Jeffrey Mitchell	2/27/2018

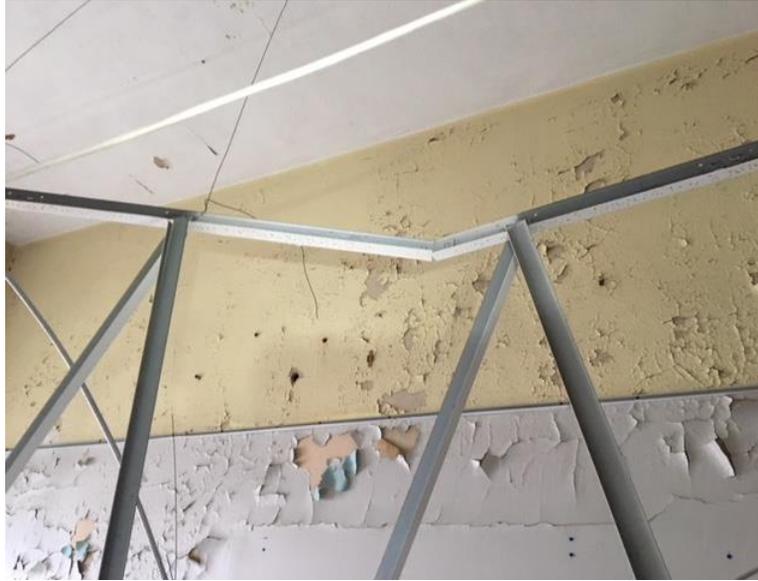
TETRA TECH PROJECT NO. 103X9025140002.048 Direction: NA	DESCRIPTION	This photograph shows yellow LBP on walls in the 1 st -floor east rooms of the main building.	35
	CLIENT	U.S. Environmental Protection Agency Region 7	Date
	PHOTOGRAPHER	Jeffrey Mitchell	2/27/2018

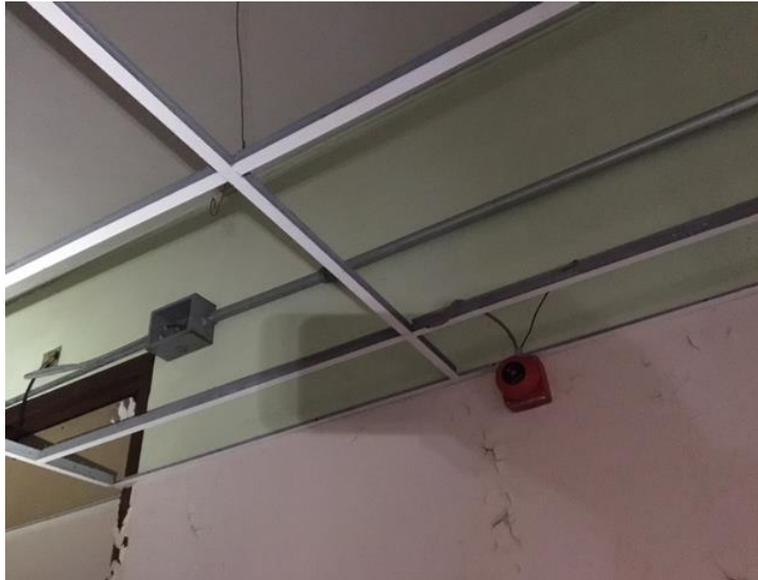
TETRA TECH PROJECT NO. 103X9025140002.048 Direction: NA	DESCRIPTION	This photograph shows green LBP on walls in the 1 st -floor north hallway and west room of the main building.	36
	CLIENT	U.S. Environmental Protection Agency Region 7	Date
	PHOTOGRAPHER	Jeffrey Mitchell	2/27/2018

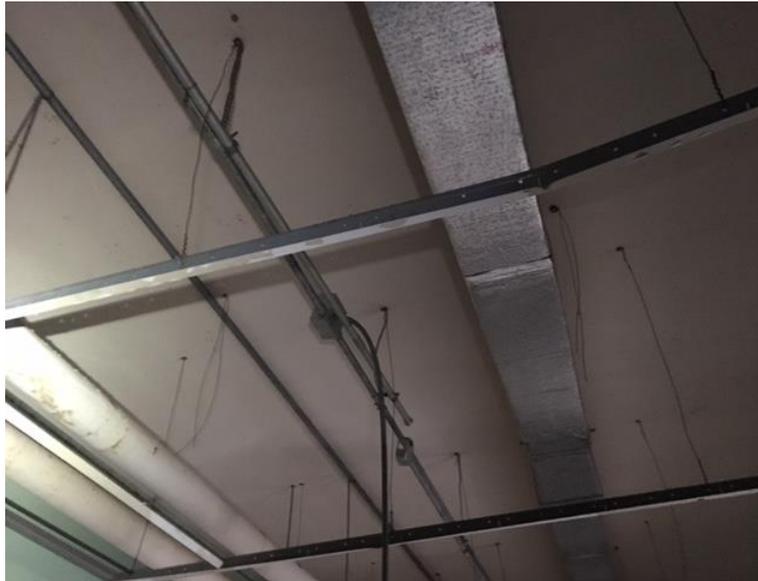
TETRA TECH PROJECT NO. 103X9025140002.048 Direction: NA	DESCRIPTION	This photograph shows beige LBP on the ceiling in the 2 nd -floor north hallway of the main building.	39
	CLIENT	U.S. Environmental Protection Agency Region 7	Date
	PHOTOGRAPHER	Jeffrey Mitchell	2/27/2018

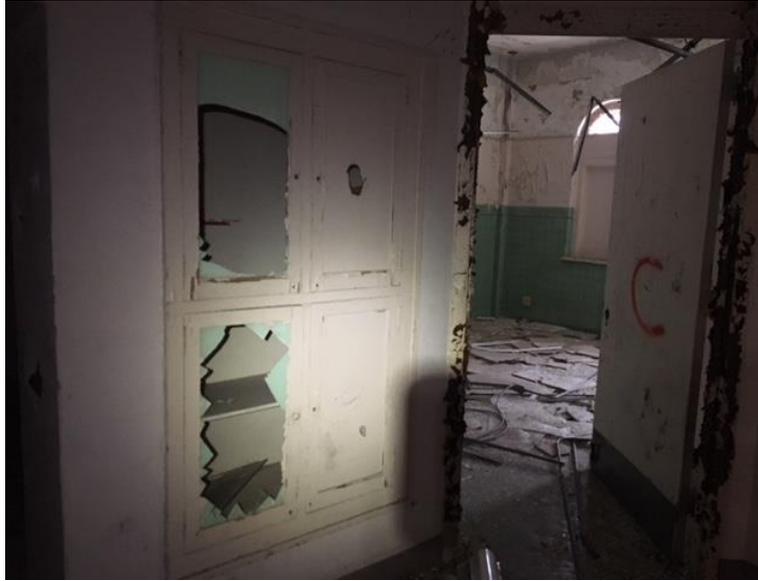
TETRA TECH PROJECT NO. 103X9025140002.048 Direction: NA	DESCRIPTION	This photograph shows beige LBP on cabinets in the 3 rd -floor north hallway of the main building.	45
	CLIENT	U.S. Environmental Protection Agency Region 7	Date
	PHOTOGRAPHER	Jeffrey Mitchell	2/27/2018

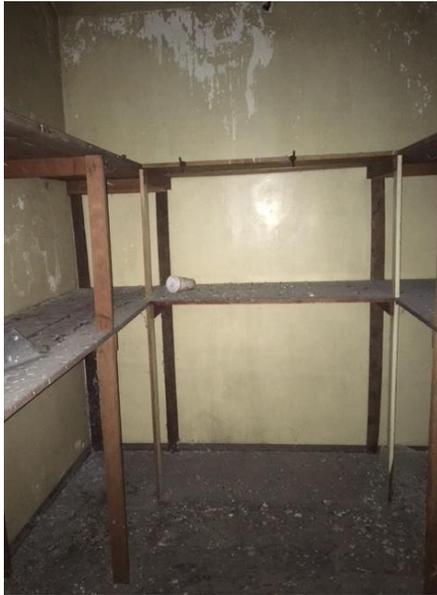
TETRA TECH PROJECT NO. 103X9025140002.048 Direction: NA	DESCRIPTION	This photograph shows yellow LBP on walls in the attic closet of the main building.	47
	CLIENT	U.S. Environmental Protection Agency Region 7	Date
	PHOTOGRAPHER	Jeffrey Mitchell	2/27/2018

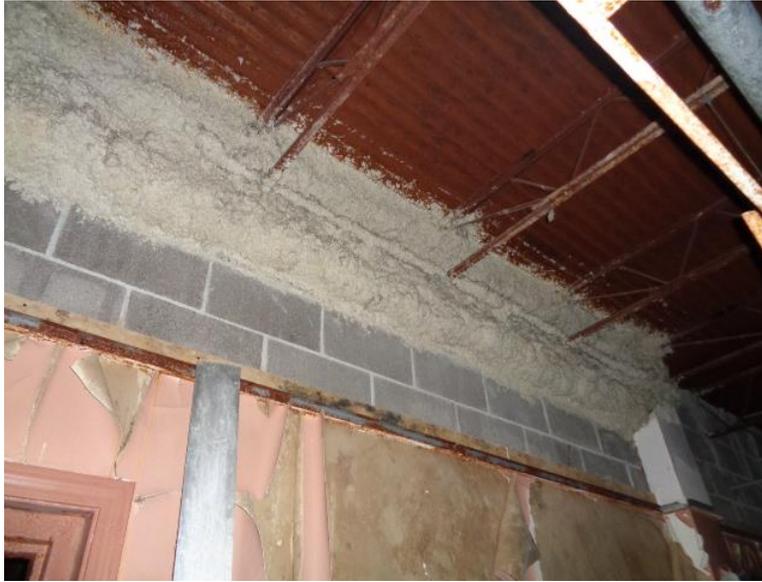
TETRA TECH PROJECT NO. 103X9025140002.048 Direction: NA	DESCRIPTION	This photograph shows fire proofing on the 2 nd floor of the 5-story building.	49
	CLIENT	U.S. Environmental Protection Agency Region 7	Date
	PHOTOGRAPHER	Kaitlyn Mitchell	3/30/2018

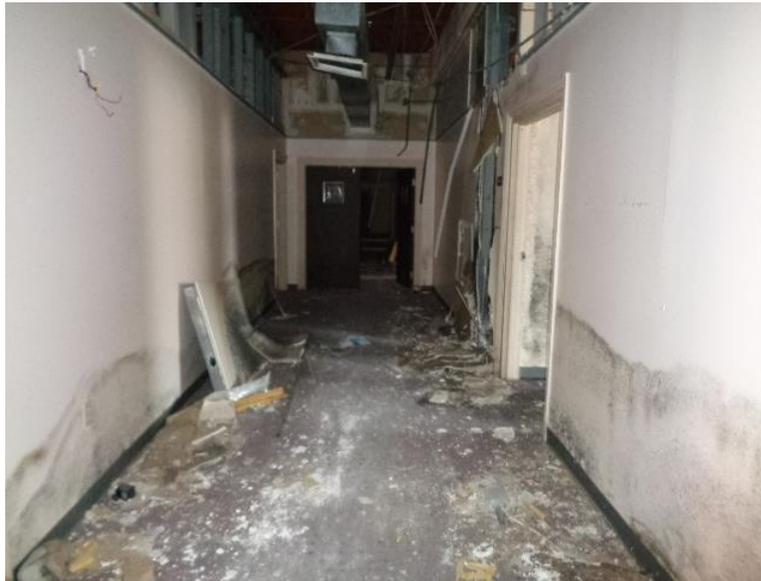
TETRA TECH PROJECT NO. 103X9025140002.048 Direction: NA	DESCRIPTION	This photograph shows drywall and associated joint compound, carpet and associated mastic, and 4" black cove base and associated mastic in the 2 nd -floor hallway of the 5-story building.	50
	CLIENT	U.S. Environmental Protection Agency Region 7	Date
	PHOTOGRAPHER	Kaitlyn Mitchell	3/30/2018

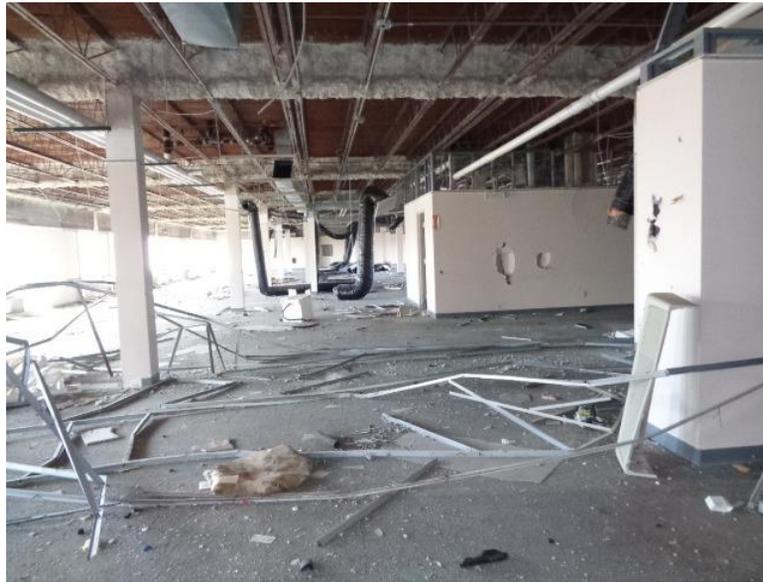
TETRA TECH PROJECT NO. 103X9025140002.048 Direction: NA	DESCRIPTION	This photograph shows carpet and associated mastic, 4" dark grey cove base and associated mastic, and fire proofing on the 4 th floor of the 5-story building.	55
	CLIENT	U.S. Environmental Protection Agency Region 7	Date
	PHOTOGRAPHER	Kaitlyn Mitchell	3/30/2018

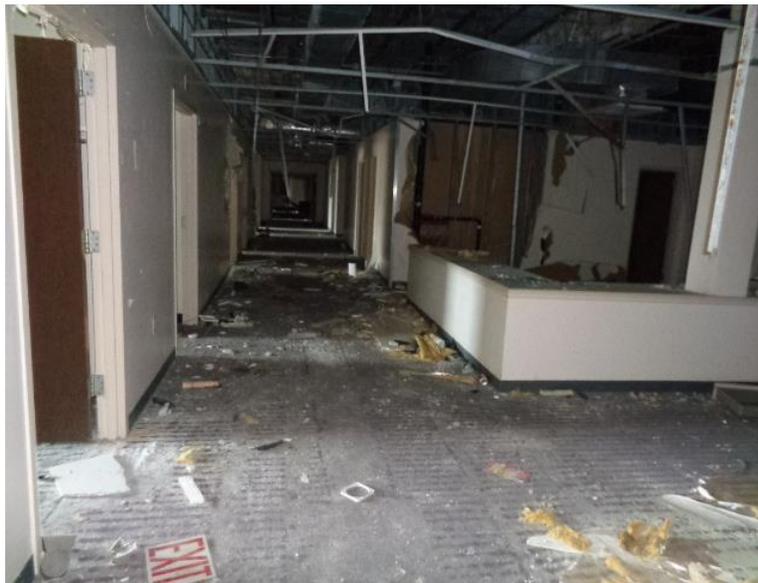
TETRA TECH PROJECT NO. 103X9025140002.048 Direction: NA	DESCRIPTION	This photograph shows drywall and associated joint compound, carpet and associated mastic, and 4" black cove base and associated mastic in the 5 th -floor hallway of the 5-story building.	56
	CLIENT	U.S. Environmental Protection Agency Region 7	Date
	PHOTOGRAPHER	Kaitlyn Mitchell	3/30/2018

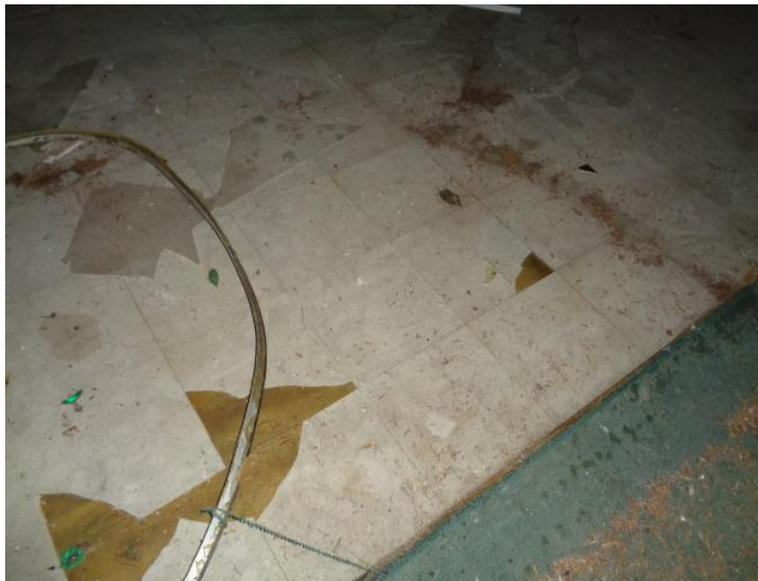
TETRA TECH PROJECT NO. 103X9025140002.048 Direction: NA	DESCRIPTION	This photograph shows 12" x 12" off-white floor tile on the 1 st floor near the elevators of the 5-story building.	58
	CLIENT	U.S. Environmental Protection Agency Region 7	Date
	PHOTOGRAPHER	Kaitlyn Mitchell	3/30/2018

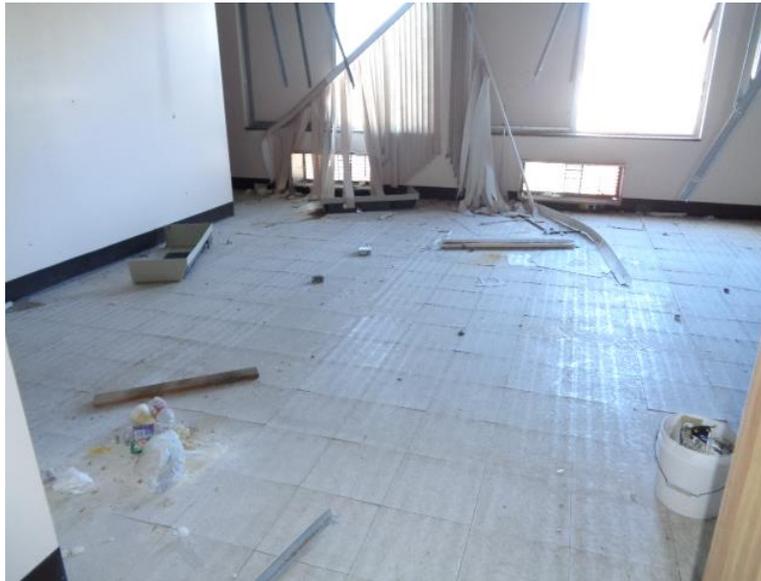
TETRA TECH PROJECT NO. 103X9025140002.048 Direction: NA	DESCRIPTION	This photograph shows 12" x 12" white with tan streaks floor tile in the 5 th -floor northwest room of the 5-story building.	60
	CLIENT	U.S. Environmental Protection Agency Region 7	Date
	PHOTOGRAPHER	Kaitlyn Mitchell	3/30/2018

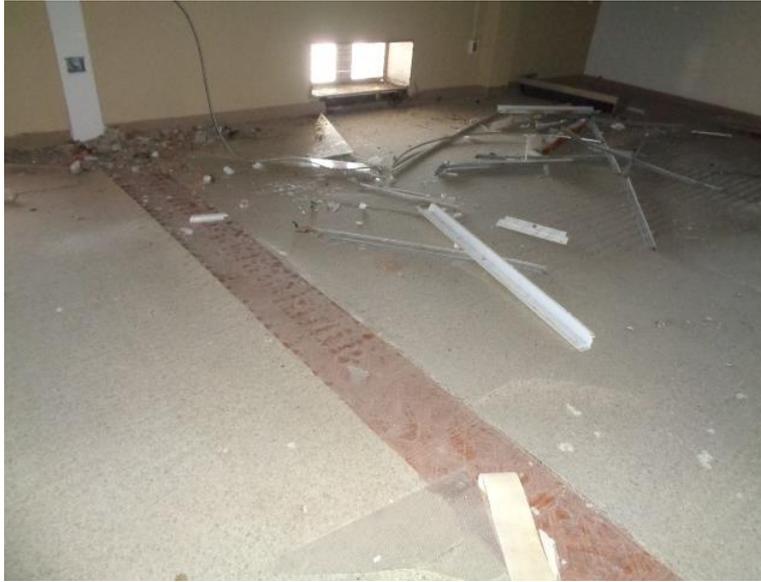
TETRA TECH PROJECT NO. 103X9025140002.048 Direction: NA	DESCRIPTION	This photograph shows 12" x 12" "wood" floor tile in a 5 th -floor office of the 5-story building.	61
	CLIENT	U.S. Environmental Protection Agency Region 7	Date
	PHOTOGRAPHER	Kaitlyn Mitchell	3/30/2018

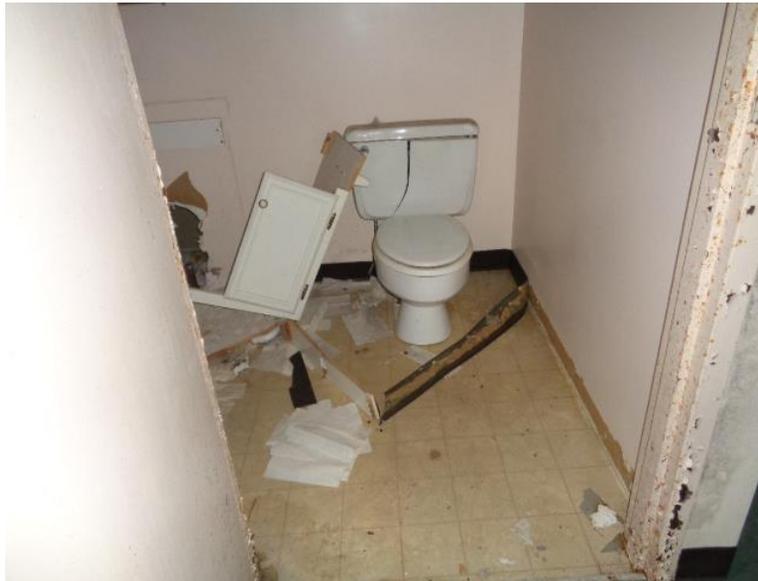
TETRA TECH PROJECT NO. 103X9025140002.048 Direction: NA	DESCRIPTION	This photograph shows white squares linoleum in a 1 st -floor bathroom of the 5-story building.	64
	CLIENT	U.S. Environmental Protection Agency Region 7	Date
	PHOTOGRAPHER	Kaitlyn Mitchell	3/30/2018

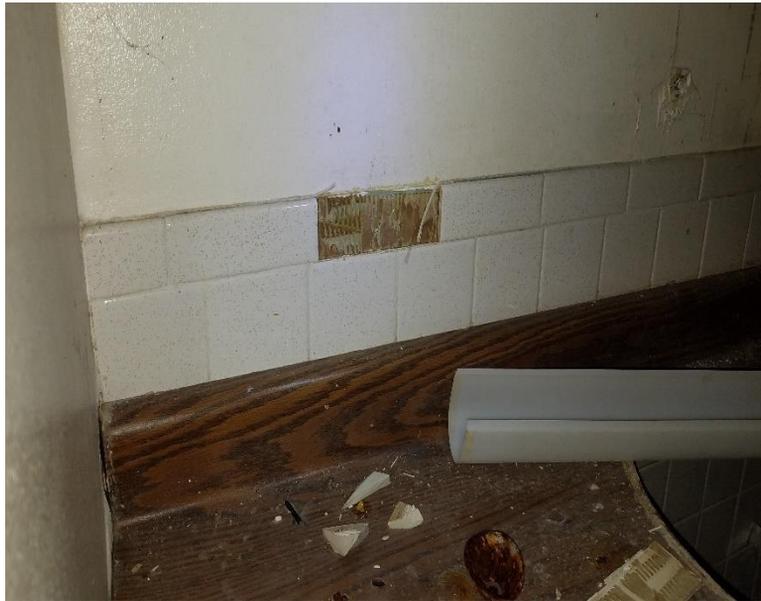
TETRA TECH PROJECT NO. 103X9025140002.048 Direction: NA	DESCRIPTION	This photograph shows ceramic tile and associated mastic in a 1 st -floor bathroom of the 5-story building.	66
	CLIENT	U.S. Environmental Protection Agency Region 7	Date
	PHOTOGRAPHER	Kaitlyn Mitchell	3/30/2018

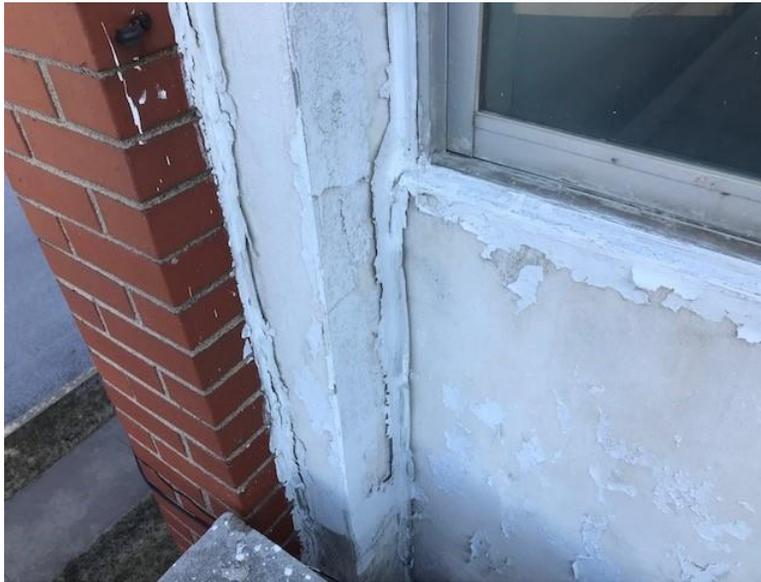
TETRA TECH PROJECT NO. 103X9025140002.048 Direction: NA	DESCRIPTION	This photograph shows window and expansion caulk on the exterior of the 5-story building.	69
	CLIENT	U.S. Environmental Protection Agency Region 7	Date
	PHOTOGRAPHER	Kaitlyn Mitchell	3/30/2018

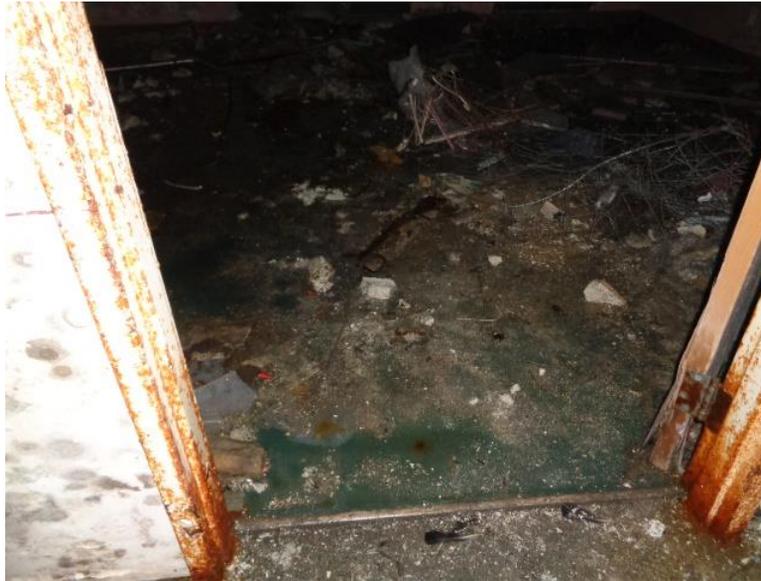
TETRA TECH PROJECT NO. 103X9025140002.048 Direction: NA	DESCRIPTION	This photograph shows carpet and associated mastic in the basement of the north building.	72
	CLIENT	U.S. Environmental Protection Agency Region 7	Date
	PHOTOGRAPHER	Kaitlyn Mitchell	3/30/2018

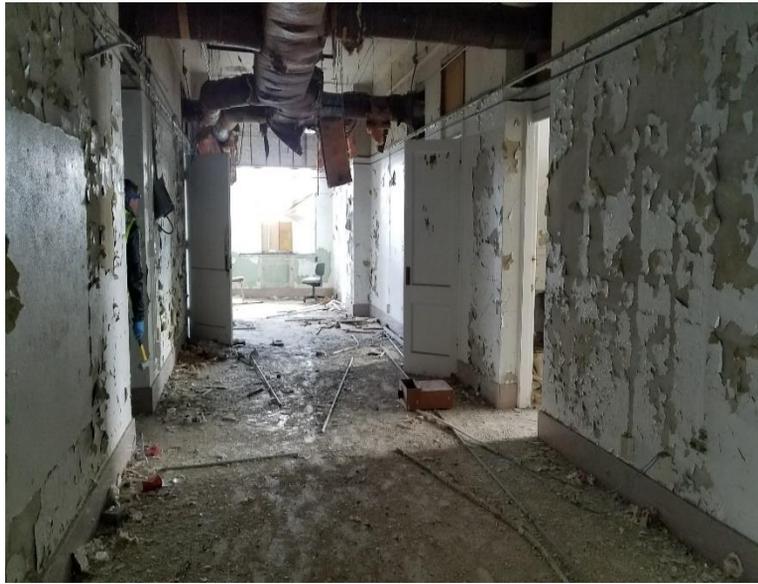
TETRA TECH PROJECT NO. 103X9025140002.048 Direction: NA	DESCRIPTION	This photograph shows plaster and associated skim coat and terrazzo floors on the 3 rd floor of the north building.	73
	CLIENT	U.S. Environmental Protection Agency Region 7	Date
	PHOTOGRAPHER	Kaitlyn Mitchell	3/6/2018

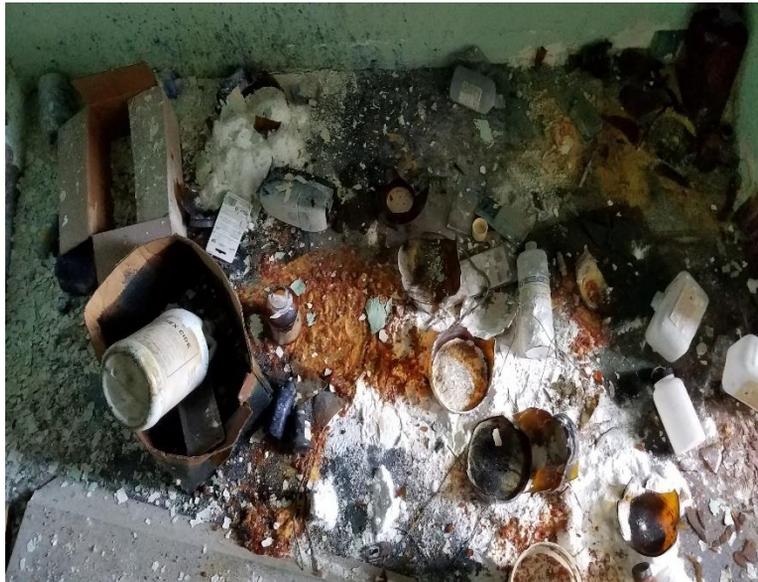
TETRA TECH PROJECT NO. 103X9025140002.048 Direction: NA	DESCRIPTION	This photograph shows spilled chemicals on the 3 rd floor of the north building.	74
	CLIENT	U.S. Environmental Protection Agency Region 7	Date
	PHOTOGRAPHER	Kaitlyn Mitchell	3/6/2018

Alternative 2—removal and disposal/recycling—is the recommended cleanup alternative for HHW in all of site buildings.

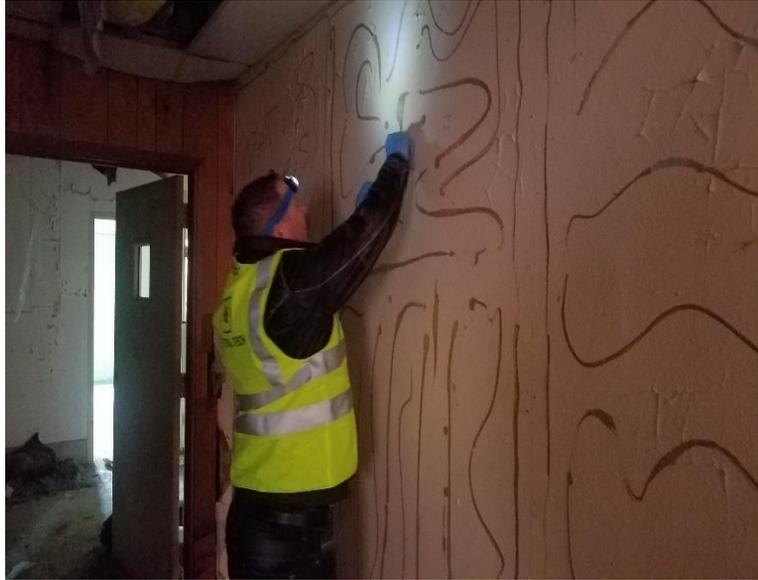
TETRA TECH PROJECT NO. 103X9025140002.048 Direction: NA	DESCRIPTION	This photograph shows brown wall mastic on the 3 rd floor of the north building.	75
	CLIENT	U.S. Environmental Protection Agency Region 7	Date
	PHOTOGRAPHER	Kaitlyn Mitchell	3/6/2018

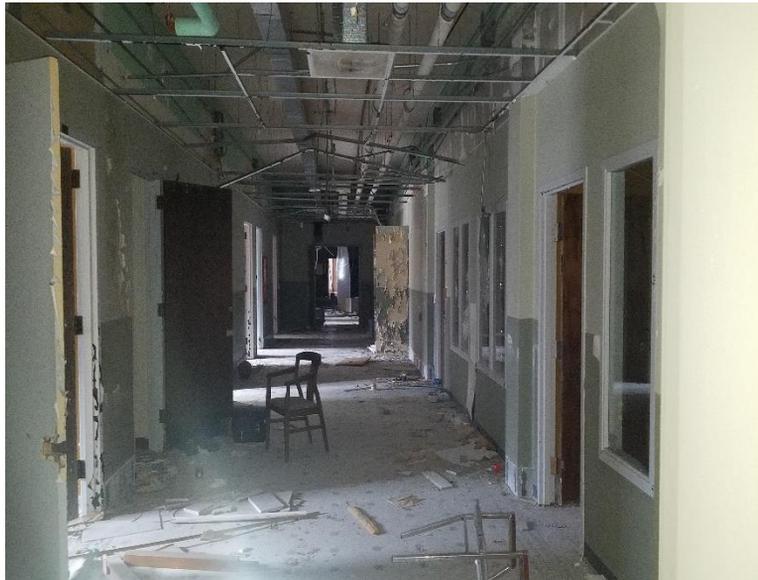
TETRA TECH PROJECT NO. 103X9025140002.048 Direction: NA	DESCRIPTION	This photograph shows drywall and associated joint compound in the 2 nd -floor hallway of the north building.	76
	CLIENT	U.S. Environmental Protection Agency Region 7	Date
	PHOTOGRAPHER	Kaitlyn Mitchell	3/6/2018

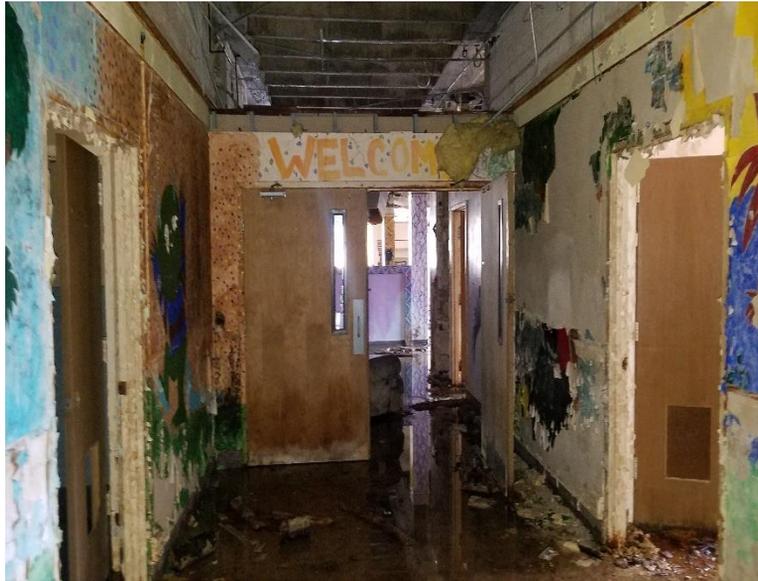
TETRA TECH PROJECT NO. 103X9025140002.048 Direction: NA	DESCRIPTION	This photograph shows plaster and associated skim coat, 4" brown cove base and associated mastic, and water intrusion in a 2 nd -floor hallway of the north building.	77
	CLIENT	U.S. Environmental Protection Agency Region 7	Date
	PHOTOGRAPHER	Kaitlyn Mitchell	3/6/2018

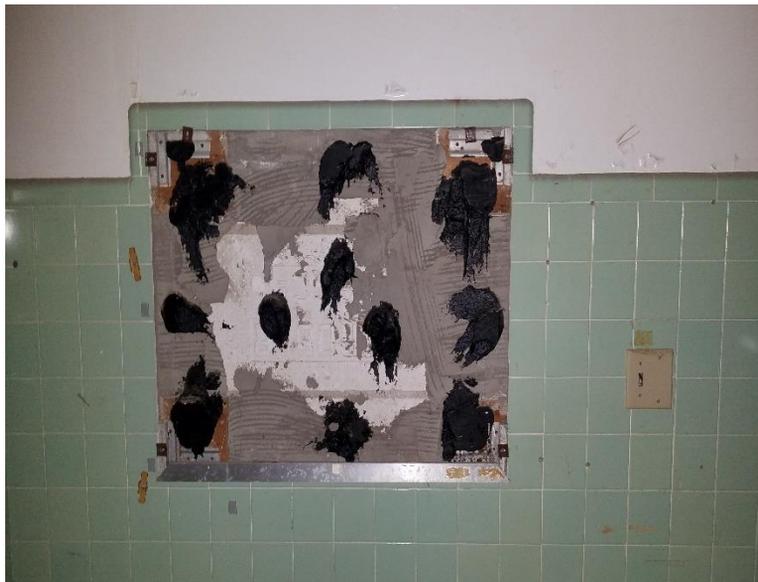
TETRA TECH PROJECT NO. 103X9025140002.048 Direction: NA	DESCRIPTION	This photograph shows asbestos-containing black wall mastic on the 3 rd floor of the north building.	78
	CLIENT	U.S. Environmental Protection Agency Region 7	Date
	PHOTOGRAPHER	Kaitlyn Mitchell	3/6/2018

Alternative 3—abatement of ACM—is the recommended cleanup alternative for ACM associated with all site buildings. Future plans at the site include either rehabilitation/renovation or demolition of those buildings; therefore, removal of the identified ACM would be required prior to commencing those activities.
