**Subject: Analysis of Brownfields Cleanup Alternatives
Old St. Elizabeth Hospital, Hannibal, Missouri
EPA Region 7, START 4, Contract No. EP-S7-13-06, Task Order No. 0002.048
Task Monitor: Todd Davis, Site Assessment Manager**

ANALYSIS OF BROWNFIELDS CLEANUP ALTERNATIVES

**OLD ST. ELIZABETH HOSPITAL
HANNIBAL, MISSOURI**

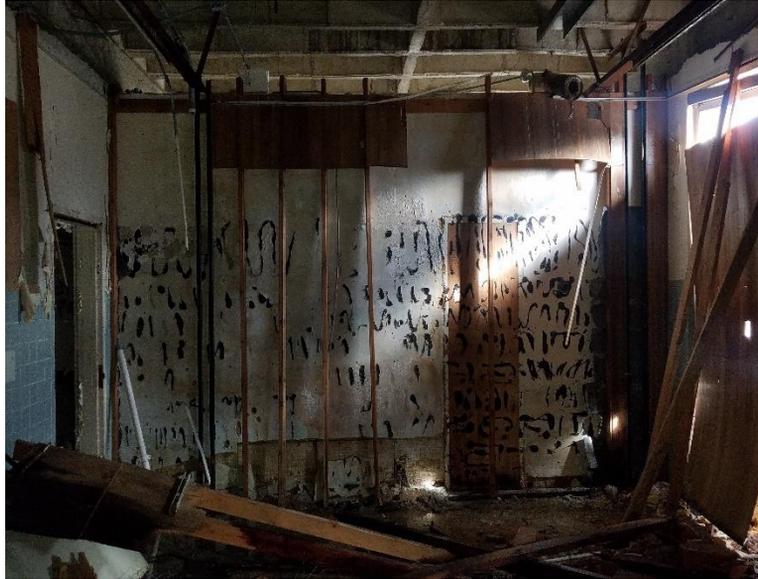
TETRA TECH PROJECT NO. 103X9025140002.048 Direction: NA	DESCRIPTION	This photograph shows asbestos-containing black wall mastic in 3 rd -floor room 324 of the north building.	79
	CLIENT	U.S. Environmental Protection Agency Region 7	Date
	PHOTOGRAPHER	Kaitlyn Mitchell	3/6/2018

Alternative 3—abatement of ACM—is the recommended cleanup alternative for ACM associated with all site buildings. Future plans at the site include either rehabilitation/renovation or demolition of those buildings; therefore, removal of the identified ACM would be required prior to commencing those activities.

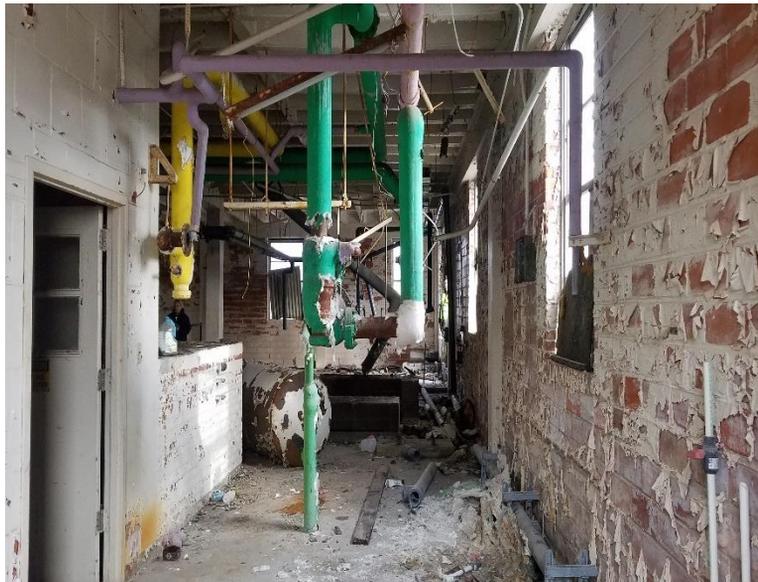
TETRA TECH PROJECT NO. 103X9025140002.048 Direction: NA	DESCRIPTION	This photograph shows asbestos-containing TSI in the attic of the north building.	80
	CLIENT	U.S. Environmental Protection Agency Region 7	Date
	PHOTOGRAPHER	Kaitlyn Mitchell	3/6/2018

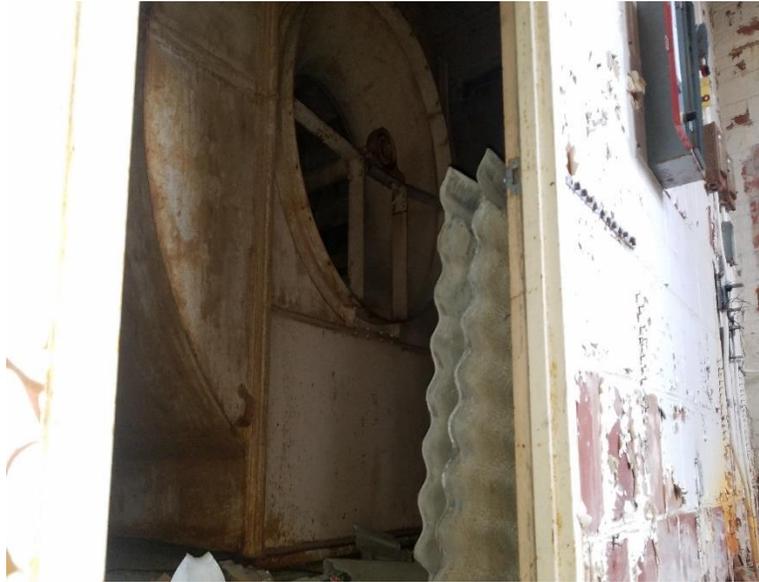
TETRA TECH PROJECT NO. 103X9025140002.048 Direction: NA	DESCRIPTION	This photograph shows asbestos-containing Transite panels stored in the attic of the north building.	81
	CLIENT	U.S. Environmental Protection Agency Region 7	Date
	PHOTOGRAPHER	Kaitlyn Mitchell	3/6/2018

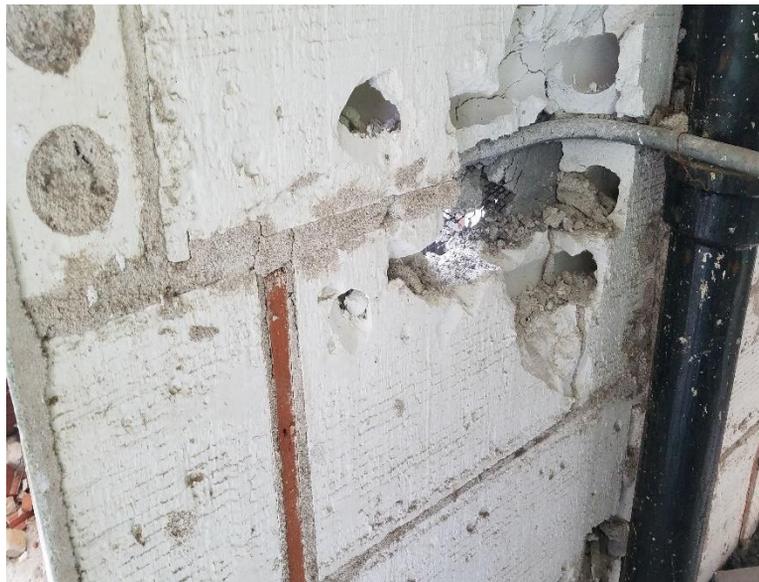
TETRA TECH PROJECT NO. 103X9025140002.048 Direction: NA	DESCRIPTION	This photograph shows fire blocks on the 2 nd floor of the north building.	82
	CLIENT	U.S. Environmental Protection Agency Region 7	Date
	PHOTOGRAPHER	Kaitlyn Mitchell	3/6/2018

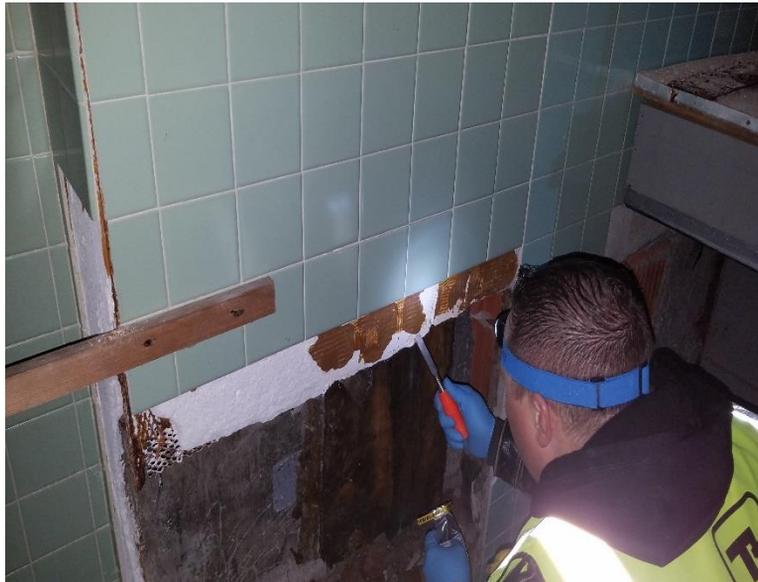
TETRA TECH PROJECT NO. 103X9025140002.048 Direction: NA	DESCRIPTION	This photograph shows ceramic tile and associated mastic in the basement of the north building.	84
	CLIENT	U.S. Environmental Protection Agency Region 7	Date
	PHOTOGRAPHER	Kaitlyn Mitchell	3/6/2018

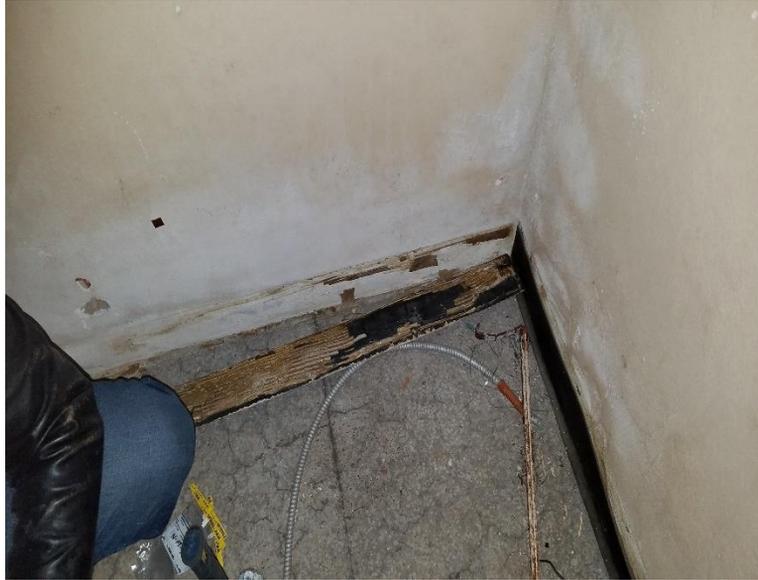
TETRA TECH PROJECT NO. 103X9025140002.048 Direction: NA	DESCRIPTION	This photograph shows 4" brown cove base and associated mastic on the 1 st floor of the north building.	85
	CLIENT	U.S. Environmental Protection Agency Region 7	Date
	PHOTOGRAPHER	Kaitlyn Mitchell	3/6/2018

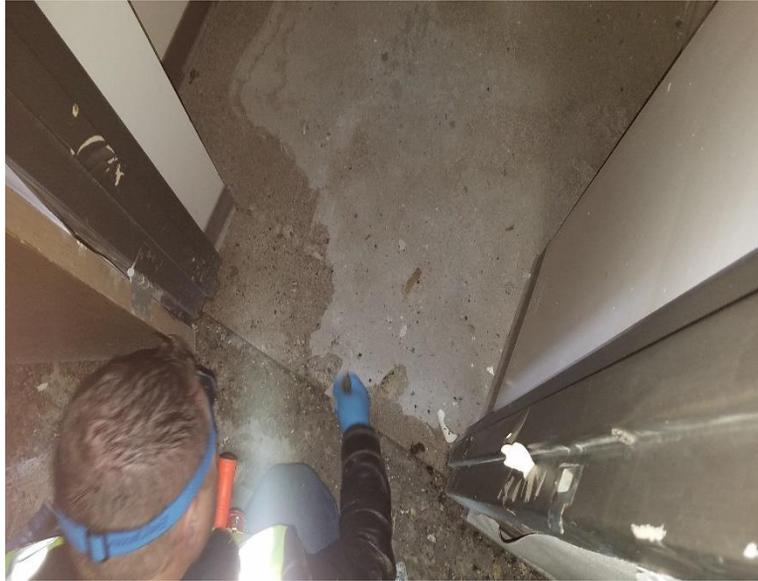
TETRA TECH PROJECT NO. 103X9025140002.048 Direction: NA	DESCRIPTION	This photograph shows linoleum in the 2 nd -floor northeast bathrooms of the north building.	87
	CLIENT	U.S. Environmental Protection Agency Region 7	Date
	PHOTOGRAPHER	Kaitlyn Mitchell	3/6/2018

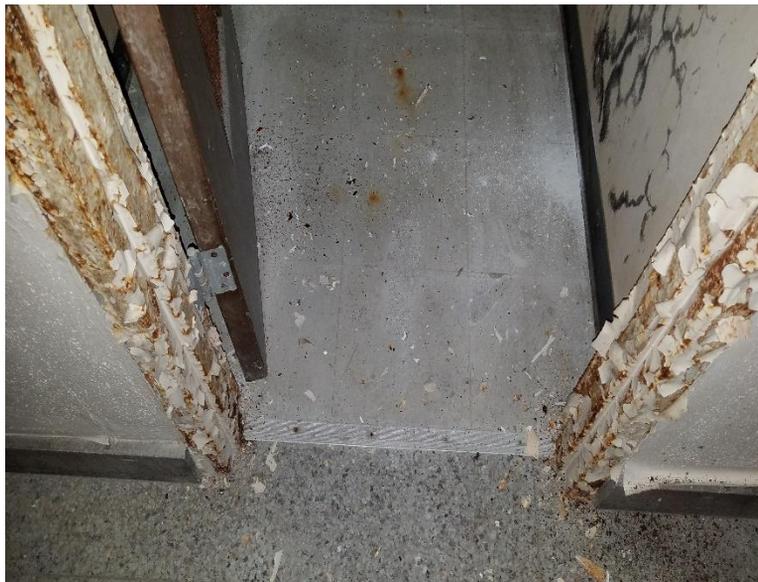
TETRA TECH PROJECT NO. 103X9025140002.048 Direction: NA	DESCRIPTION	This photograph shows 12" x 12" tan floor tile in the basement bathroom of the north building.	88
	CLIENT	U.S. Environmental Protection Agency Region 7	Date
	PHOTOGRAPHER	Kaitlyn Mitchell	3/6/2018

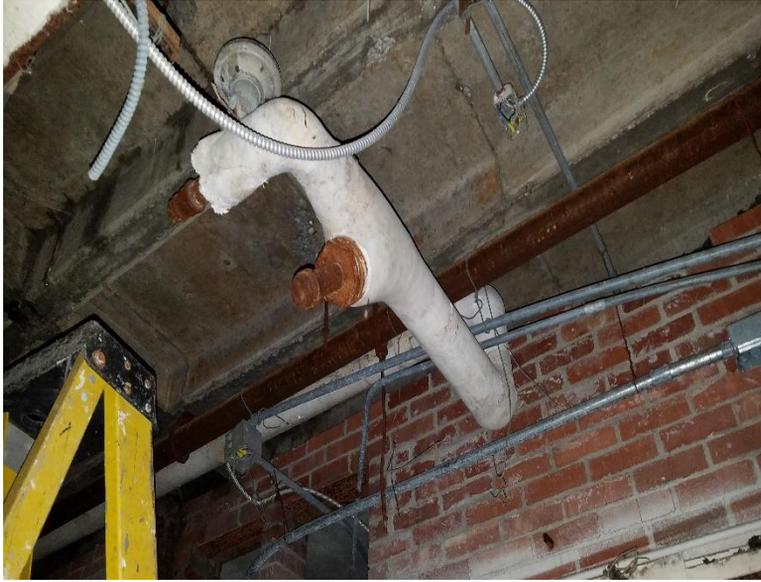
TETRA TECH PROJECT NO. 103X9025140002.048 Direction: NA	DESCRIPTION	This photograph shows asbestos-containing TSI runs and joints in the basement of the north building.	89
	CLIENT	U.S. Environmental Protection Agency Region 7	Date
	PHOTOGRAPHER	Kaitlyn Mitchell	3/6/2018

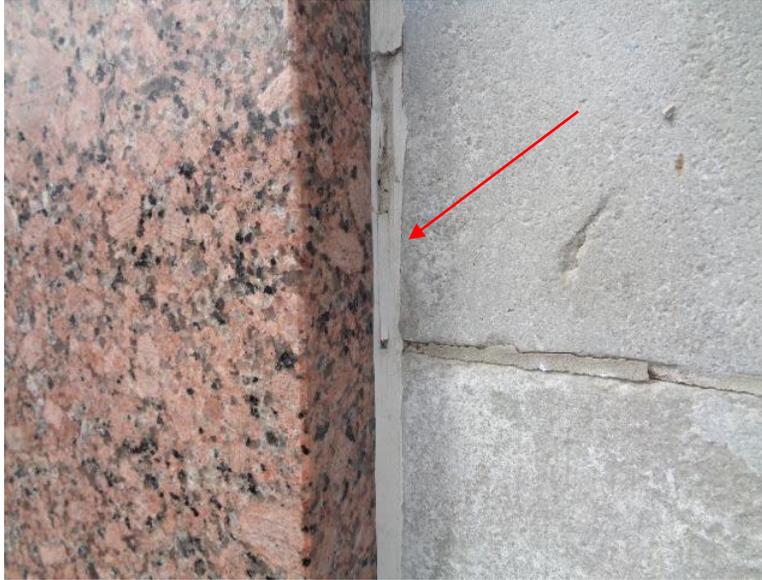
TETRA TECH PROJECT NO. 103X9025140002.048 Direction: NA	DESCRIPTION	This photograph shows polychlorinated biphenyl (PCB)-containing tan expansion joint caulk (red arrow) around a door frame of the north building.	91
	CLIENT	U.S. Environmental Protection Agency Region 7	Date
	PHOTOGRAPHER	Kaitlyn Mitchell	3/30/2018

Alternative 2—abatement of PCB-containing caulk materials—is the recommended cleanup alternative for PCB-containing caulk materials associated with the north building. Future plans at the site include rehabilitation/renovation; therefore, removal of the identified PCB-containing caulk material would be required prior to commencing those activities.

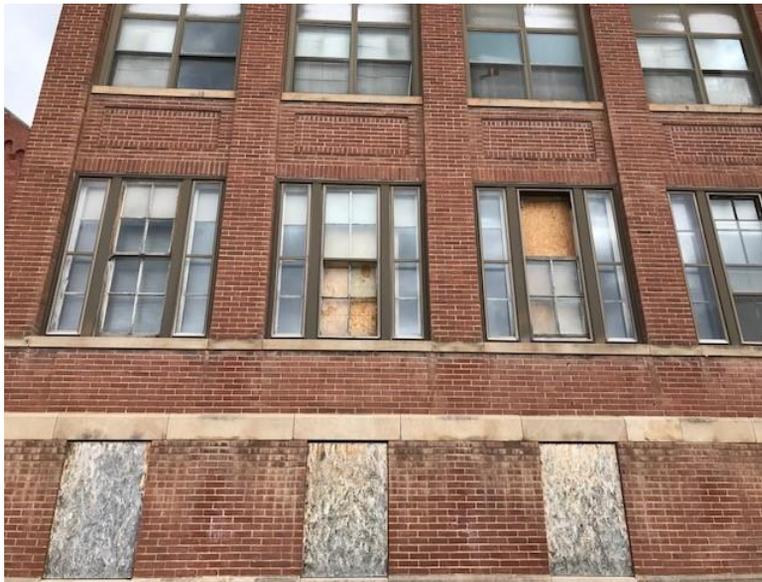
TETRA TECH PROJECT NO. 103X9025140002.048 Direction: NA	DESCRIPTION	This photograph shows PCB-containing window caulk on the exterior of the north building.	92
	CLIENT	U.S. Environmental Protection Agency Region 7	Date
	PHOTOGRAPHER	Kaitlyn Mitchell	3/6/2018

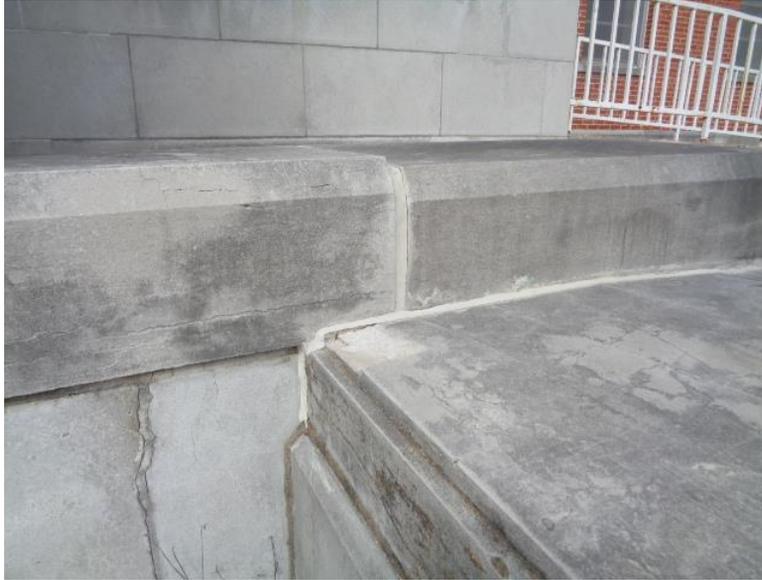
TETRA TECH PROJECT NO. 103X9025140002.048 Direction: NA	DESCRIPTION	This photograph shows PCB-containing light tan expansion caulk on the exterior entrance side walls of the north building.	93
	CLIENT	U.S. Environmental Protection Agency Region 7	Date
	PHOTOGRAPHER	Kaitlyn Mitchell	3/30/2018

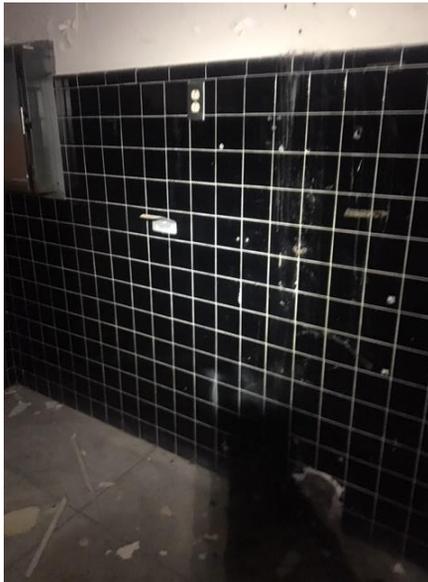
TETRA TECH PROJECT NO. 103X9025140002.048 Direction: NA	DESCRIPTION	This photograph shows black LBP on ceramic tile on 3 rd -floor room 326 of the north building.	94
	CLIENT	U.S. Environmental Protection Agency Region 7	Date
	PHOTOGRAPHER	Jeffrey Mitchell	2/27/2018

Alternative 3—removal by renovation/demolition—is the recommended cleanup alternative for LBP associated with the main building, north building, and southwest building. Building materials containing LBP would be demolished and disposed of as demolition waste. This alternative could be implemented by general construction/demolition workers. Based on presence of lead, construction/demolition work must accord with Occupational Safety and Health Administration (OSHA) guidelines for protection of workers.

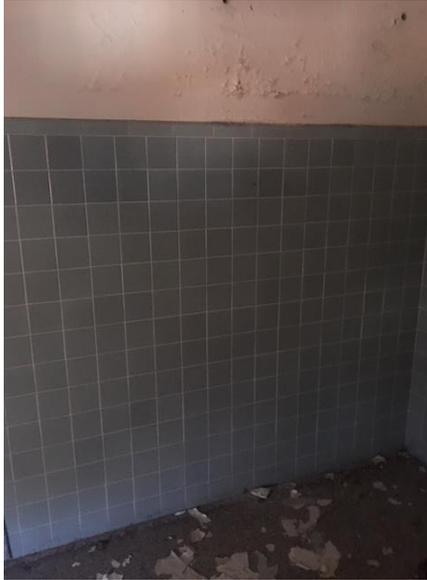
TETRA TECH PROJECT NO. 103X9025140002.048 Direction: NA	DESCRIPTION	This photograph shows blue LBP on ceramic tile in 3 rd -floor rooms 324 and 328 of the north building.	95
	CLIENT	U.S. Environmental Protection Agency Region 7	Date
	PHOTOGRAPHER	Jeffrey Mitchell	2/27/2018

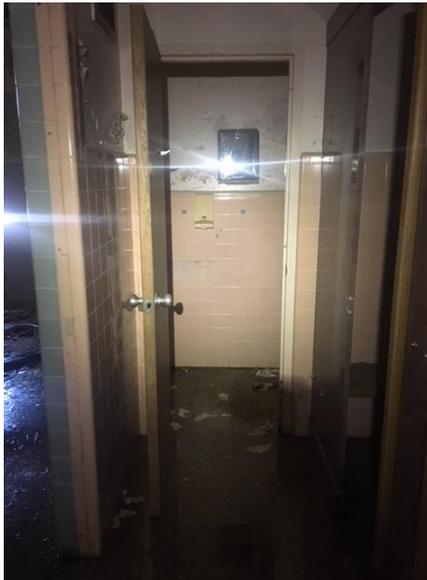
TETRA TECH PROJECT NO. 103X9025140002.048 Direction: NA	DESCRIPTION	This photograph shows peach LBP on ceramic tile in the restroom on the 3 rd floor next to room 324 of the north building.	96
	CLIENT	U.S. Environmental Protection Agency Region 7	Date
	PHOTOGRAPHER	Jeffrey Mitchell	2/27/2018

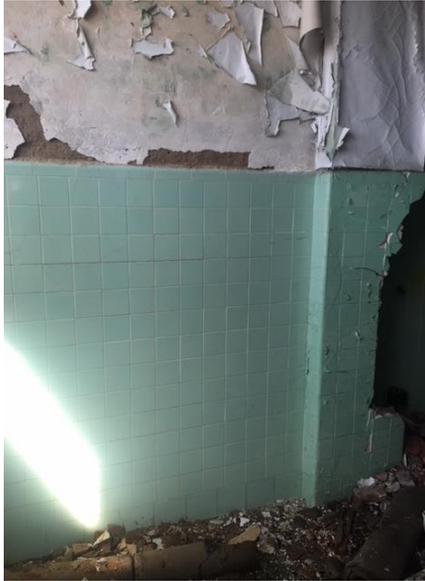
TETRA TECH PROJECT NO. 103X9025140002.048 Direction: NA	DESCRIPTION	This photograph shows teal LBP on ceramic tile in the 3 rd -floor hallway of the north building.	97
	CLIENT	U.S. Environmental Protection Agency Region 7	Date
	PHOTOGRAPHER	Jeffrey Mitchell	2/27/2018

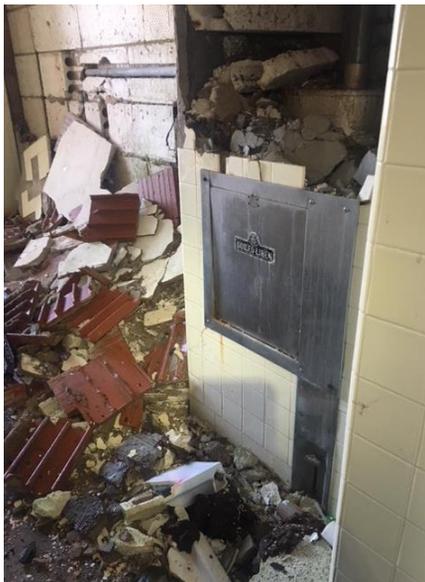
TETRA TECH PROJECT NO. 103X9025140002.048 Direction: NA	DESCRIPTION	This photograph shows white LBP on ceramic tile in 3 rd -floor room 306 of the north building.	98
	CLIENT	U.S. Environmental Protection Agency Region 7	Date
	PHOTOGRAPHER	Jeffrey Mitchell	2/27/2018

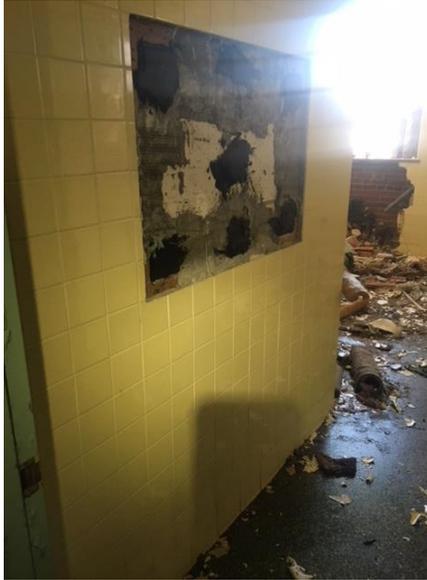
TETRA TECH PROJECT NO. 103X9025140002.048 Direction: NA	DESCRIPTION	This photograph shows yellow LBP on ceramic tile in 3 rd -floor rooms 310 and 314 of the north building.	99
	CLIENT	U.S. Environmental Protection Agency Region 7	Date
	PHOTOGRAPHER	Jeffrey Mitchell	2/27/2018

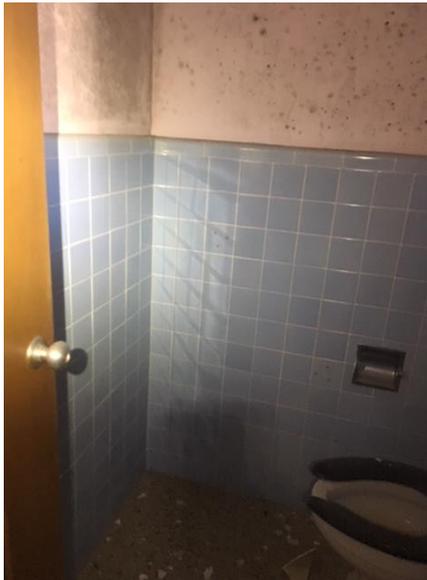
TETRA TECH PROJECT NO. 103X9025140002.048 Direction: NA	DESCRIPTION	This photograph shows blue LBP on ceramic tile in 2 nd -floor rooms 227 and 235 of the north building.	100
	CLIENT	U.S. Environmental Protection Agency Region 7	Date
	PHOTOGRAPHER	Jeffrey Mitchell	2/27/2018

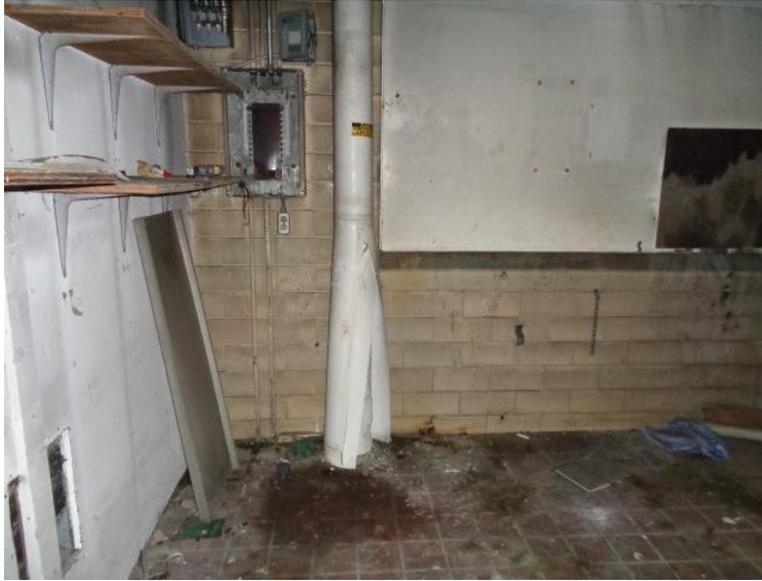
TETRA TECH PROJECT NO. 103X9025140002.048 Direction: NA	DESCRIPTION	This photograph shows asbestos-containing TSI in the northwest building.	101
	CLIENT	U.S. Environmental Protection Agency Region 7	Date
	PHOTOGRAPHER	Kaitlyn Mitchell	3/30/2018

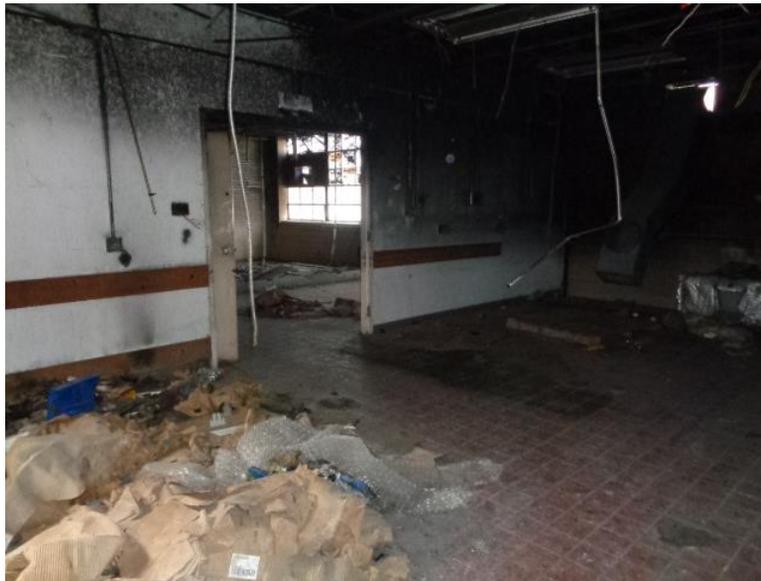
TETRA TECH PROJECT NO. 103X9025140002.048 Direction: NA	DESCRIPTION	This photograph shows 4" brown cove base and associated mastic and drywall, and associated joint compound in the northwest building.	102
	CLIENT	U.S. Environmental Protection Agency Region 7	Date
	PHOTOGRAPHER	Kaitlyn Mitchell	3/30/2018

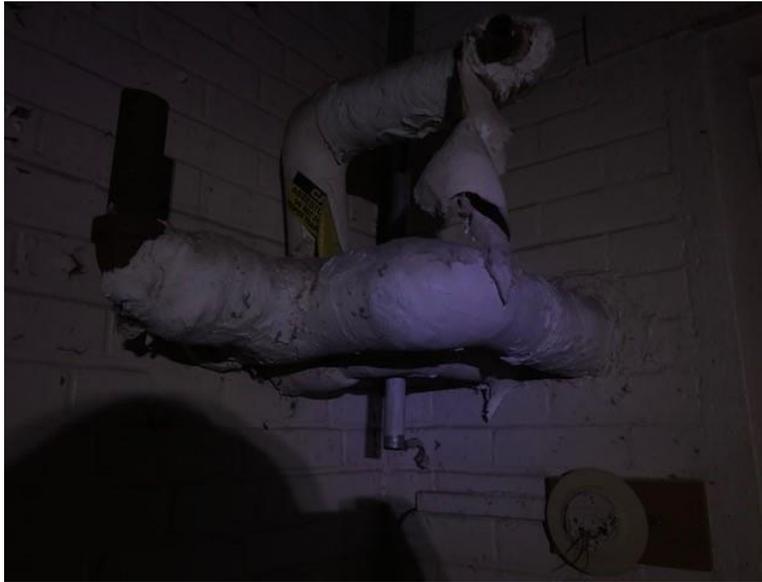
TETRA TECH PROJECT NO. 103X9025140002.048 Direction: NA	DESCRIPTION	This photograph shows asbestos-containing TSI joints in the northwest building.	103
	CLIENT	U.S. Environmental Protection Agency Region 7	Date
	PHOTOGRAPHER	Kaitlyn Mitchell	3/6/2018

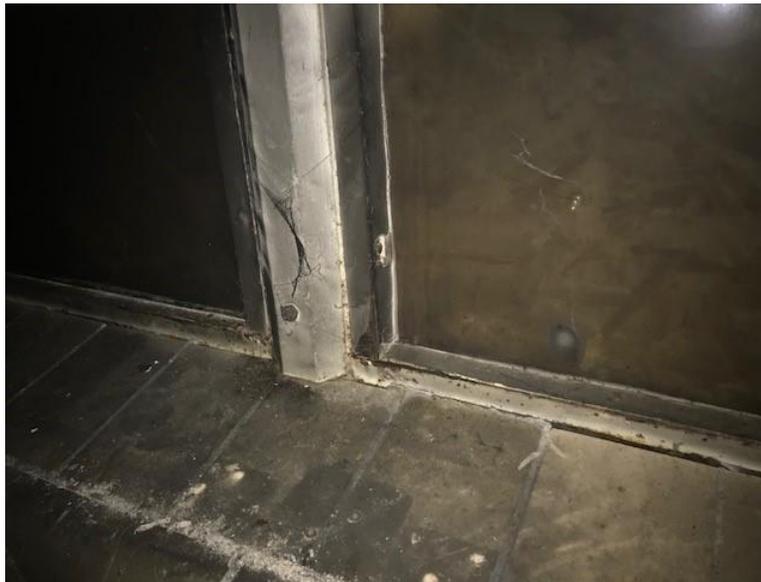
TETRA TECH PROJECT NO. 103X9025140002.048 Direction: NA	DESCRIPTION	This photograph shows window caulk in the northwest building.	104
	CLIENT	U.S. Environmental Protection Agency Region 7	Date
	PHOTOGRAPHER	Kaitlyn Mitchell	3/6/2018

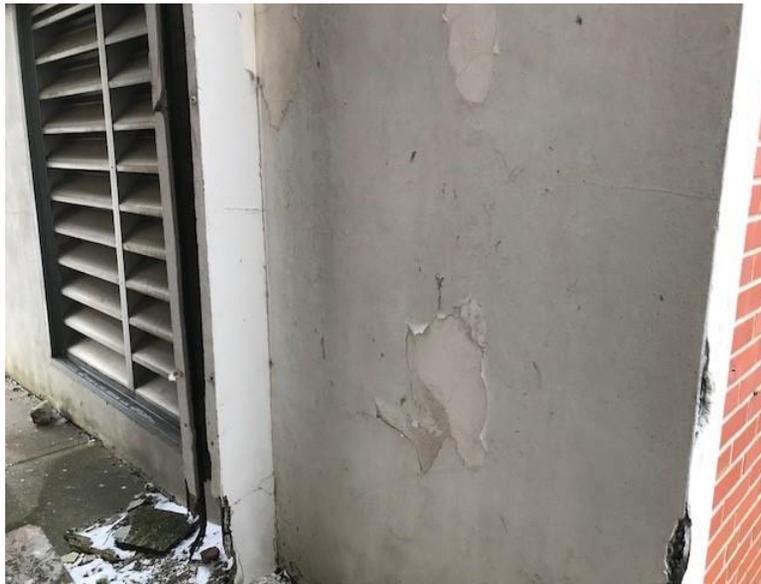
TETRA TECH PROJECT NO. 103X9025140002.048 Direction: NA	DESCRIPTION	This photograph shows plaster with skim coat on the exterior of the northwest building.	106
	CLIENT	U.S. Environmental Protection Agency Region 7	Date
	PHOTOGRAPHER	Kaitlyn Mitchell	3/6/2018

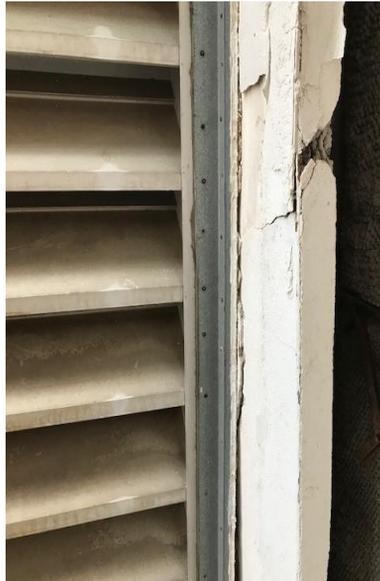
TETRA TECH PROJECT NO. 103X9025140002.048 Direction: NA	DESCRIPTION	This photograph shows caulk around exterior vents on the northwest building.	107
	CLIENT	U.S. Environmental Protection Agency Region 7	Date
	PHOTOGRAPHER	Kaitlyn Mitchell	3/6/2018

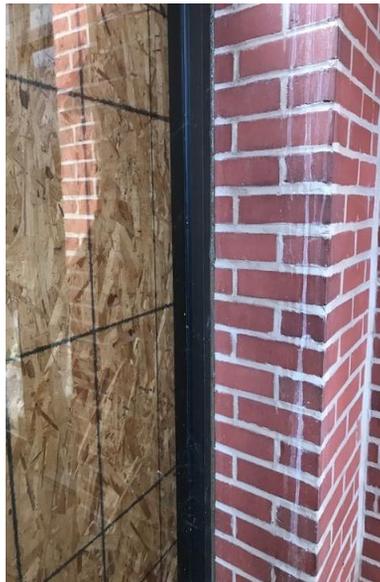
TETRA TECH PROJECT NO. 103X9025140002.048 Direction: NA	DESCRIPTION	This photograph shows window caulk on the exterior of the northwest building.	108
	CLIENT	U.S. Environmental Protection Agency Region 7	Date
	PHOTOGRAPHER	Kaitlyn Mitchell	3/6/2018

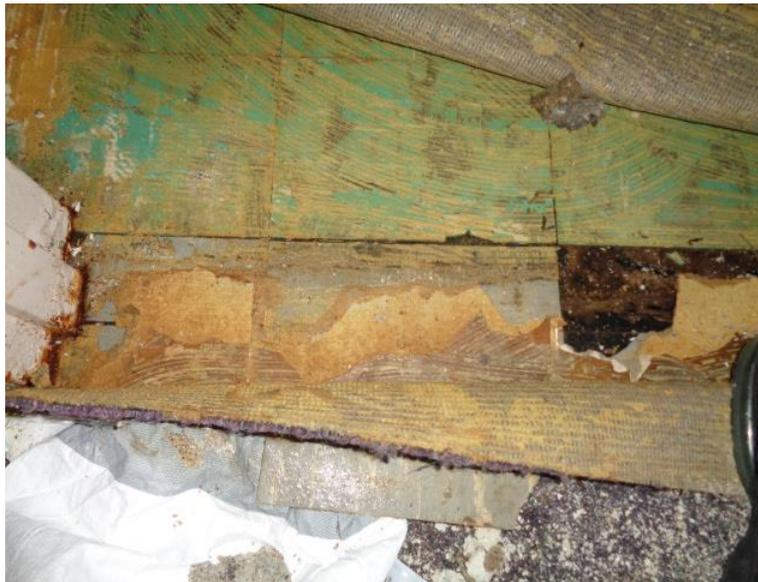
TETRA TECH PROJECT NO. 103X9025140002.048 Direction: NA	DESCRIPTION	This photograph shows 9" x 9" green floor tile, 9" x 9" grey floor tile, linoleum, and carpet with associated adhesive in the hallway/north room of the southwest building.	110
	CLIENT	U.S. Environmental Protection Agency Region 7	Date
	PHOTOGRAPHER	Kaitlyn Mitchell	3/30/2018

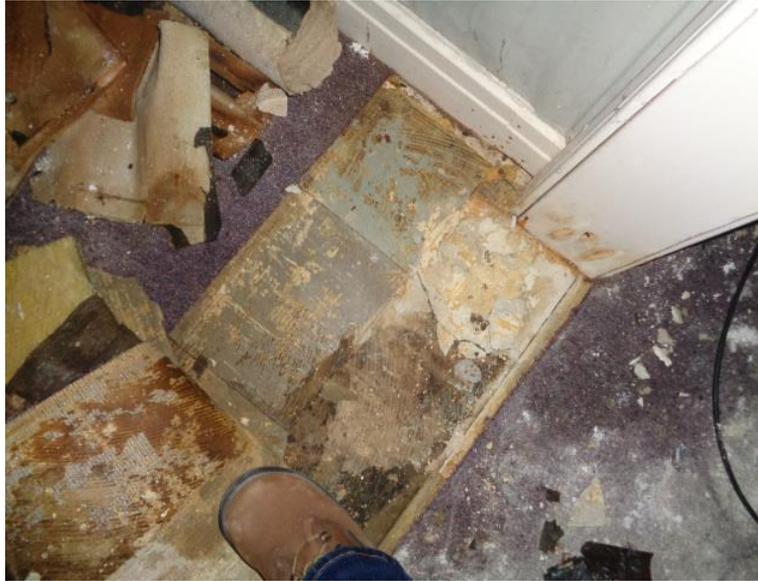
TETRA TECH PROJECT NO. 103X9025140002.048 Direction: NA	DESCRIPTION	This photograph shows 12" x 12" grey floor tile under carpet in the north room of the southwest building.	111
	CLIENT	U.S. Environmental Protection Agency Region 7	Date
	PHOTOGRAPHER	Kaitlyn Mitchell	3/30/2018

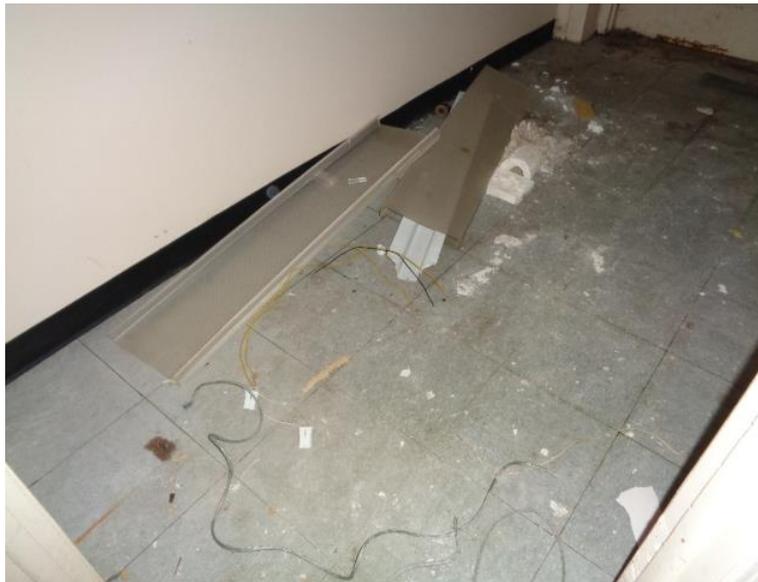
TETRA TECH PROJECT NO. 103X9025140002.048 Direction: NA	DESCRIPTION	This photograph shows 12" x 12" grey floor tile and 4" black cove base and associated mastic in the northwest room of the southwest building.	112
	CLIENT	U.S. Environmental Protection Agency Region 7	Date
	PHOTOGRAPHER	Kaitlyn Mitchell	3/30/2018

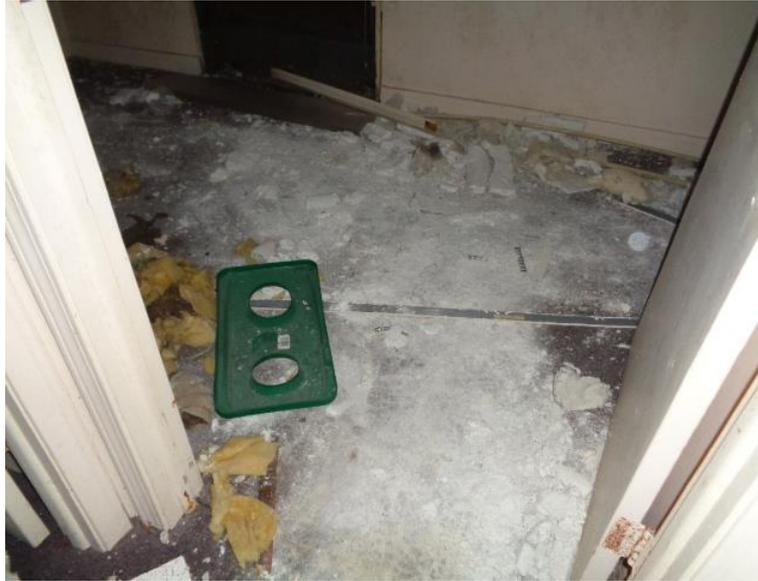
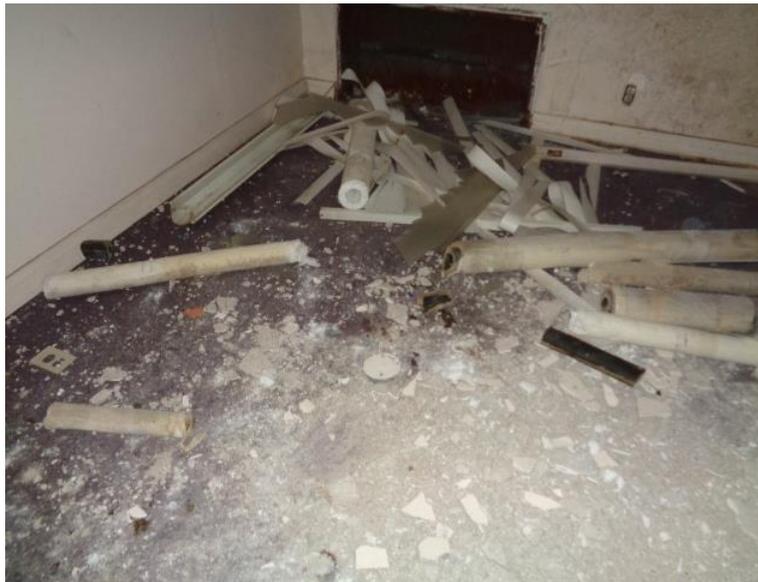
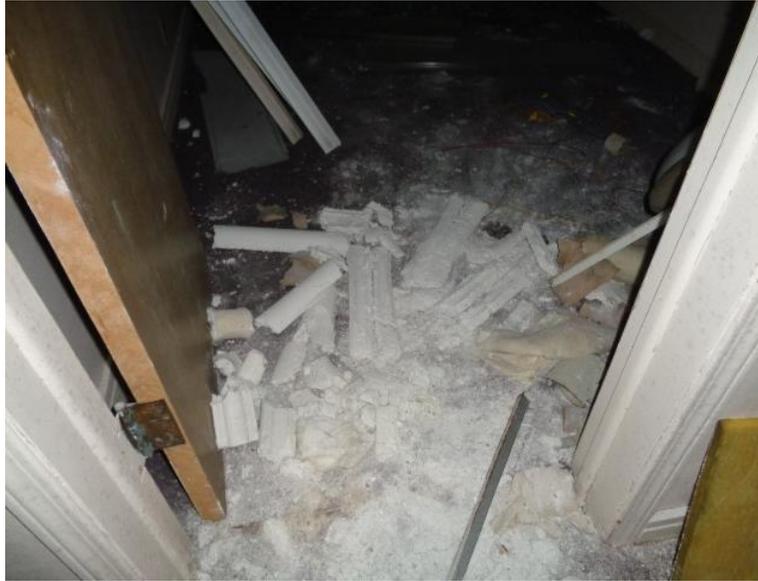
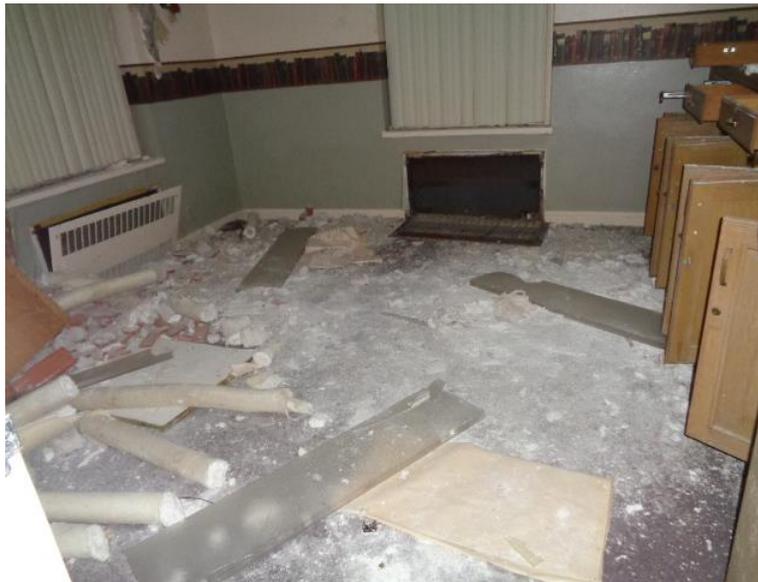
TETRA TECH PROJECT NO. 103X9025140002.048 Direction: NA	DESCRIPTION	This photograph shows spilled TSI throughout the southwest building.	113
	CLIENT	U.S. Environmental Protection Agency Region 7	Date
	PHOTOGRAPHER	Kaitlyn Mitchell	3/30/2018

TETRA TECH PROJECT NO. 103X9025140002.048 Direction: NA	DESCRIPTION	This photograph shows spilled TSI throughout the southwest building.	114
	CLIENT	U.S. Environmental Protection Agency Region 7	Date
	PHOTOGRAPHER	Kaitlyn Mitchell	3/30/2018

TETRA TECH PROJECT NO. 103X9025140002.048 Direction: NA	DESCRIPTION	This photograph shows spilled TSI throughout the southwest building.	115
	CLIENT	U.S. Environmental Protection Agency Region 7	Date
	PHOTOGRAPHER	Kaitlyn Mitchell	3/30/2018

TETRA TECH PROJECT NO. 103X9025140002.048 Direction: NA	DESCRIPTION	This photograph shows spilled TSI throughout the southwest building.	116
	CLIENT	U.S. Environmental Protection Agency Region 7	Date
	PHOTOGRAPHER	Kaitlyn Mitchell	3/30/2018

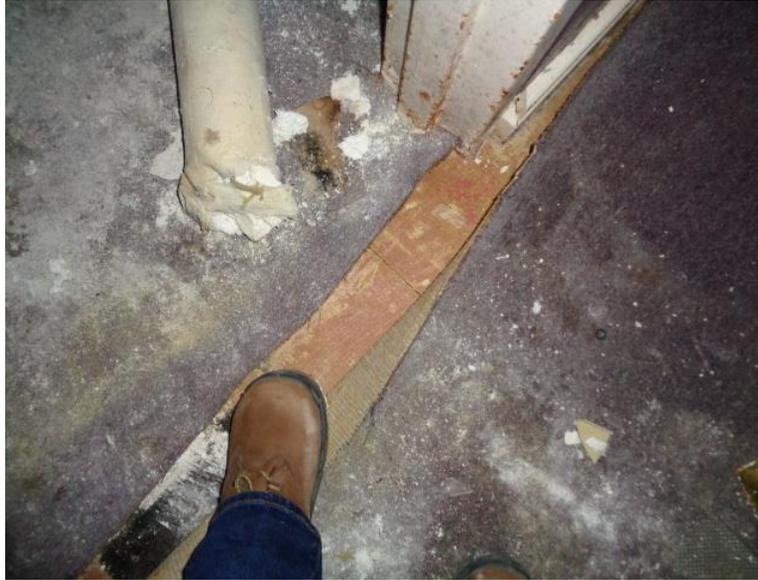
TETRA TECH PROJECT NO. 103X9025140002.048 Direction: NA	DESCRIPTION	This photograph shows 9" x 9" red floor tile in the southwest room under carpet in the southwest building.	117
	CLIENT	U.S. Environmental Protection Agency Region 7	Date
	PHOTOGRAPHER	Kaitlyn Mitchell	3/30/2018

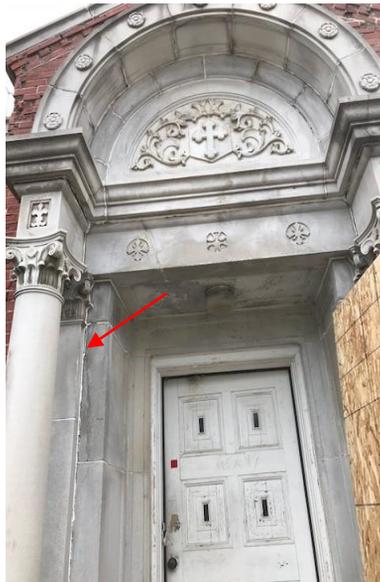
TETRA TECH PROJECT NO. 103X9025140002.048 Direction: NA	DESCRIPTION	This photograph shows expansion joint caulk (red arrow) on the exterior of the southwest building.	118
	CLIENT	U.S. Environmental Protection Agency Region 7	Date
	PHOTOGRAPHER	Kaitlyn Mitchell	3/30/2018

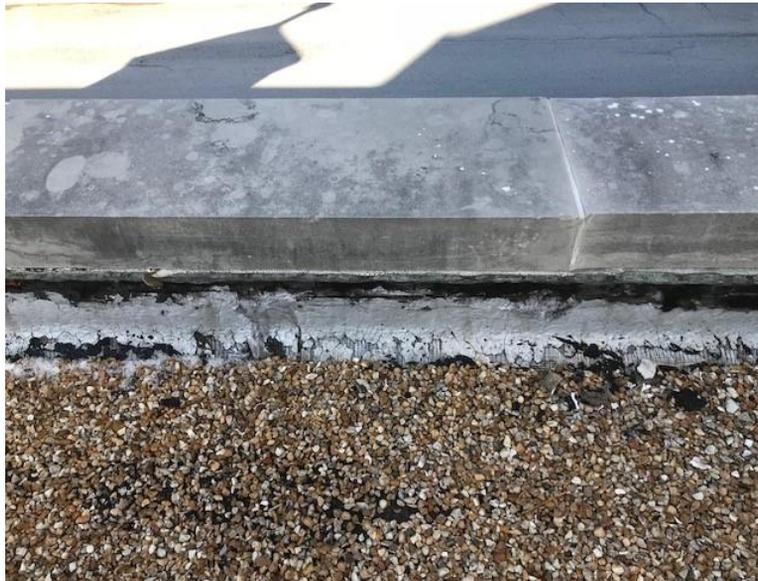
TETRA TECH PROJECT NO. 103X9025140002.048 Direction: NA	DESCRIPTION	This photograph shows silver roof flashing on the roof of the southwest building.	120
	CLIENT	U.S. Environmental Protection Agency Region 7	Date
	PHOTOGRAPHER	Kaitlyn Mitchell	3/30/2018
