SUBJECT: Calumet & Hecla (C&H) Mineral Building
Request for Assistance
Hubbell, Houghton County, Michigan
DEQ Site ID 31000081

Figure 1
Sample Analytical Result Map
Hubbell Processing Area - Mineral Building Property
Hubbell, Houghton County, Michigan

Waste Pile Photograph Log
Hubbell Processing Area – Mineral Building
Hubbell, Michigan

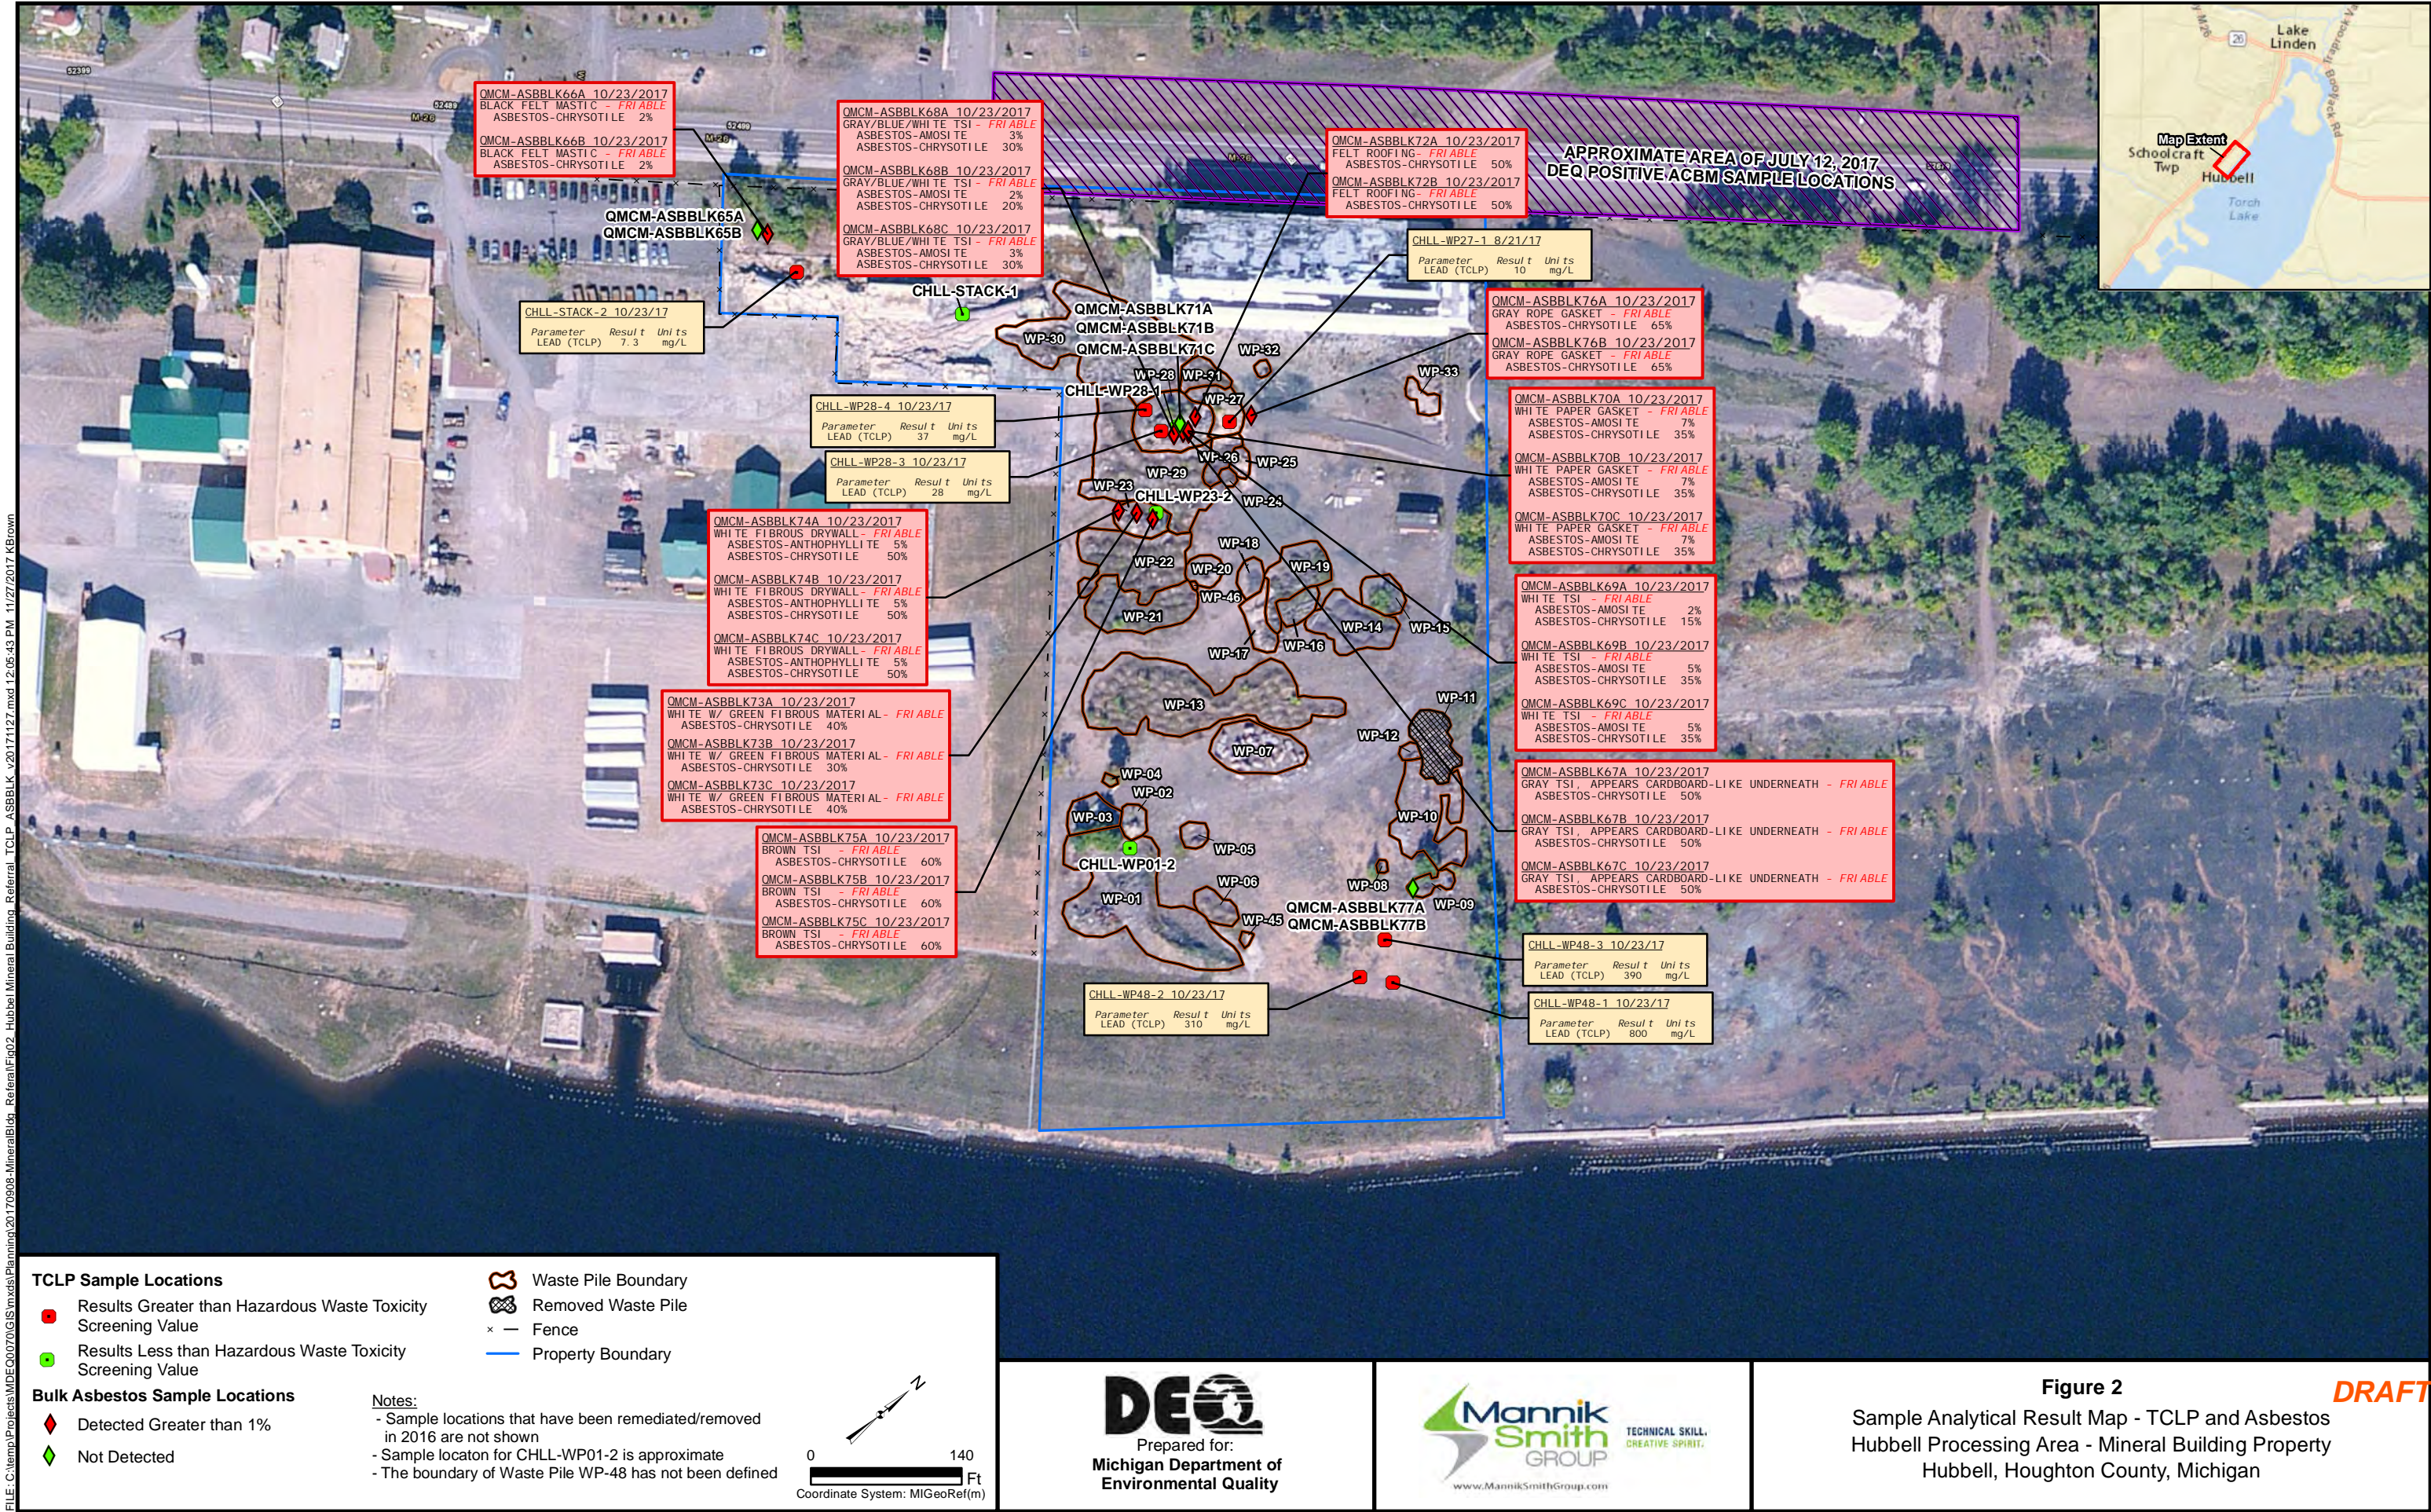
RRD's 2017 investigation results indicate most of the waste piles contain polychlorinated biphenyls (PCBs) and/or lead, arsenic, other metals and semi-volatile organic compounds (SVOCs). We have recently compiled the available data and the attached figures highlight the locations and concentrations of contaminants and asbestos present at the property. Also attached is an inventory and photographic log detailing each of the waste piles. We continue to supplement the data set with results from samples collected on October 23, 2017 (additional PCB, arsenic, lead and asbestos sample results are still pending). Of this recent data, seven of the twelve additional waste pile samples were characterized as hazardous waste for lead by the Resource Conservation and Recovery Act (RCRA) toxicity characteristic leaching procedure (TCLP).
