SITE VISIT REPORT
NAVAJO ABANDONED MINE LANDS RECLAMATION PROGRAM

DATE (S) OF VISIT:	04 February 2019
MINE/PROJECT NAME:	USEPA Region 9, Cove Mesa V Haul Shaft Closure Project
DURATION OF VISIT:	1:00 pm – 2:00 pm
PURPOSE OF VISIT:	Construction Progress Inspection

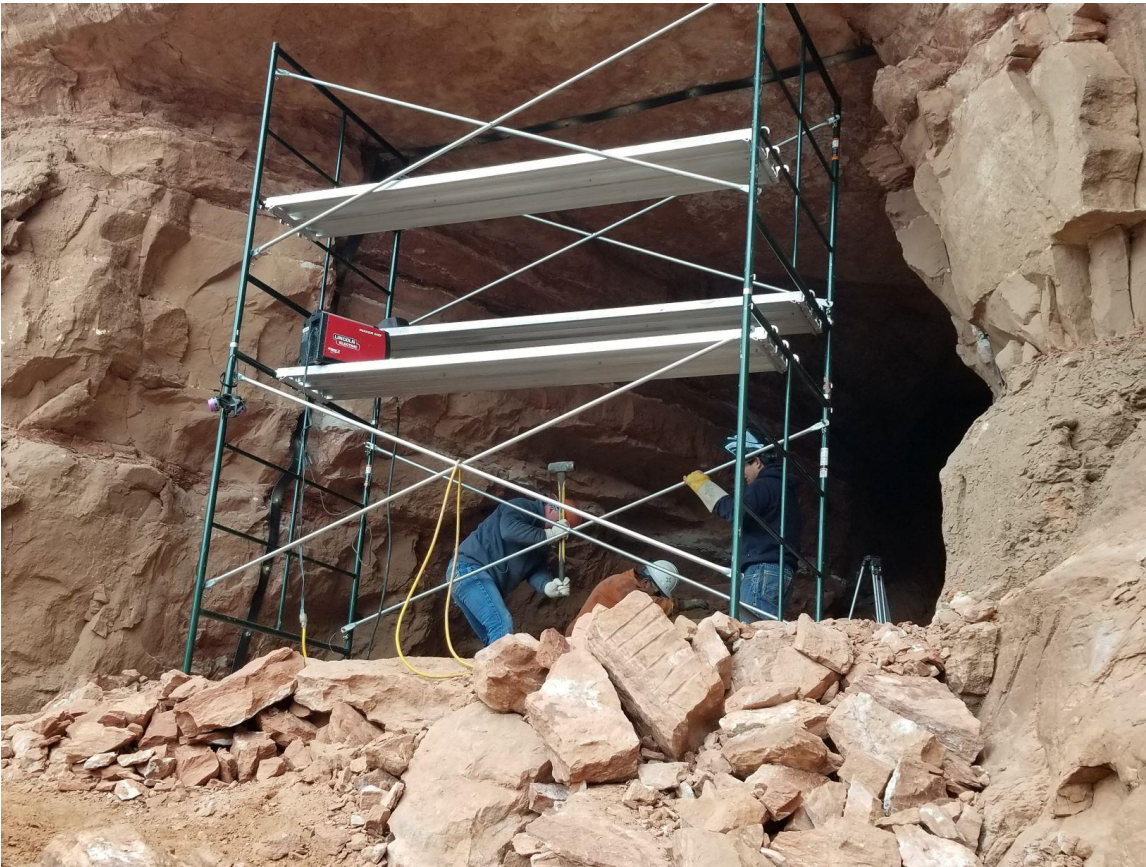
The contractor completed the outer frame of the wire rope (cable) closure. The contractor was securing the bottom plate to the floor of the haul shaft, but he could not find enough competent rock to drill, and secure the plate. He also mentioned that haul shaft ceiling was not hard enough to permanently secure the top plate. Since both the top and bottom plates were not positively secured to the haul shaft entry, NAMLRD staff inspection team recommend installing three vertical support columns. The contractor will install three 2" pipe 4 foot on center from the bottom plate to the top plates. When the wire rope (5/16" galvanized cable) is tighten in place both the top and bottom plates will be secured in place with the pipe taking the compression forces from the wire rope tension. In this manner the anchor bolts (top plate fasteners) and concrete reinforcing bars (bottom plate fasteners) will not be subject to any tension forces. The three vertical support columns will be added to the closure design and a field order will be issued to the contractor.

Rebar to secure bottom plate, not successful.
