**Subject: Targeted Brownfields Assessment
Hazardous Materials Survey
Oak Street City Hall Site
Poplar Bluff, Butler County, Missouri
U.S. EPA Region 7 START 5, Contract No. 68HE0719D0001
Task Order No. 19F0101.005
Task Monitor: Todd Davis, Site Assessment Manager**

**TARGETED BROWNFIELDS ASSESSMENT
HAZARDOUS MATERIALS SURVEY**

**OAK STREET CITY HALL
POPLAR BLUFF, BUTLER COUNTY, MISSOURI**

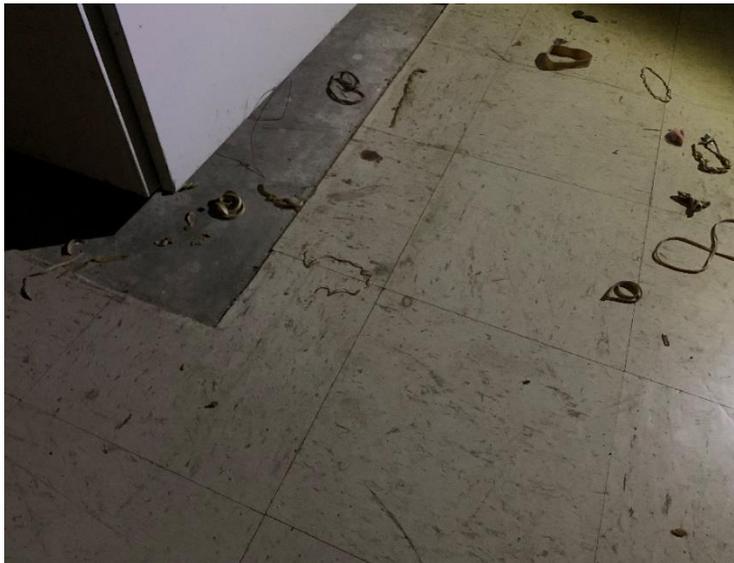
TETRA TECH PROJECT NO. X9030.19F.0101.005 Direction: NA	DESCRIPTION	This photograph shows 12" X 12" white and black streak floor tile typical of the southwest hallway, Rooms 16 (front), 17, 18, 19, 21, 22, 27, 28, 29, 30, 39, 86, and 87.	2
	CLIENT	EPA	Date
	PHOTOGRAPHER	Zach Usher	11/6/2019

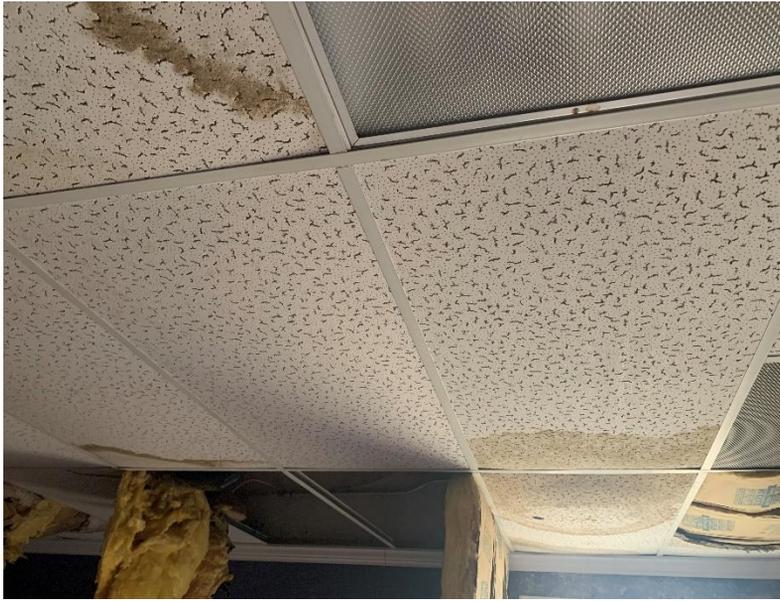
TETRA TECH PROJECT NO. X9030.19F.0101.005 Direction: NA	DESCRIPTION	This photograph shows 2' X 4' pinhole-fissured ceiling tile of a type found throughout the first floor.	7
	CLIENT	EPA	Date
	PHOTOGRAPHER	Zach Usher	11/6/2019

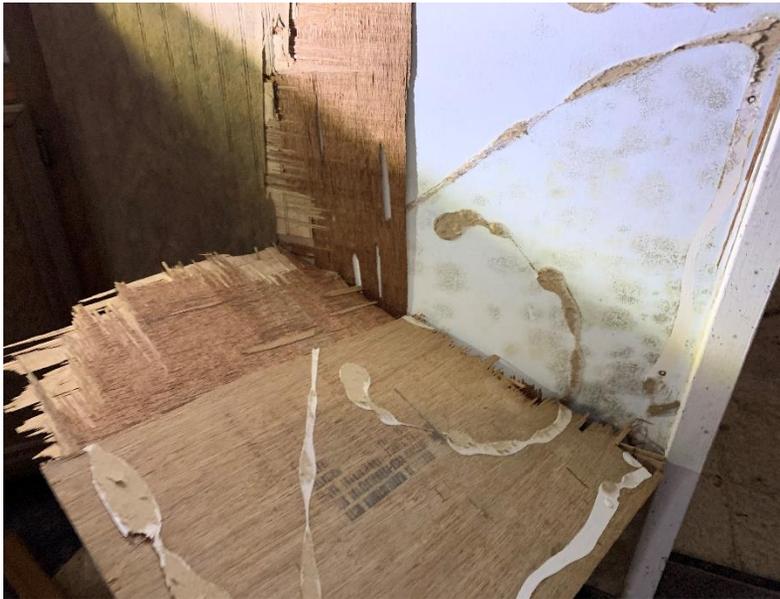
TETRA TECH PROJECT NO. X9030.19F.0101.005 Direction: NA	DESCRIPTION	This photograph shows wood wall panel mastic typical of Room 10 and Room 16.	8
	CLIENT	EPA	Date
	PHOTOGRAPHER	Zach Usher	11/6/2019

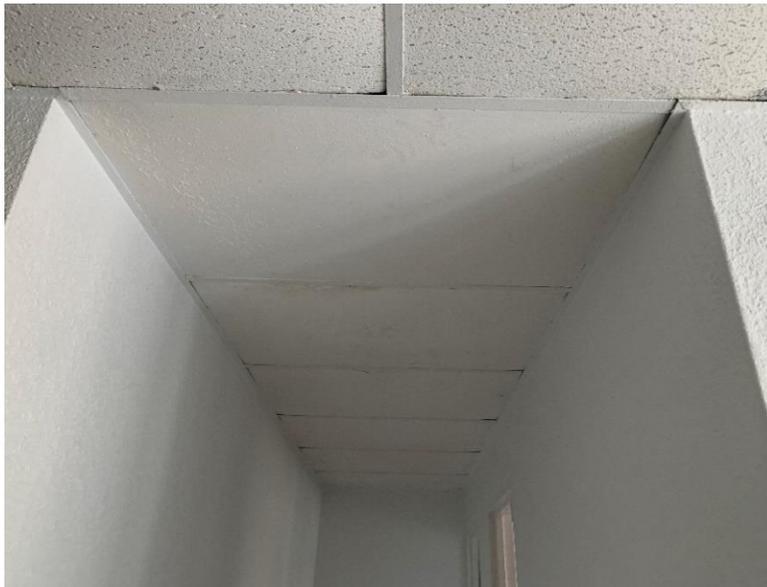
TETRA TECH PROJECT NO. X9030.19F.0101.005 Direction: NA	DESCRIPTION	This photograph shows 2' X 4' white gypsum ceiling typical of Room 21 bathroom, Room 22, and hallway storage near Elm Street entrance.	14
	CLIENT	EPA	Date
	PHOTOGRAPHER	Zach Usher	11/6/2019

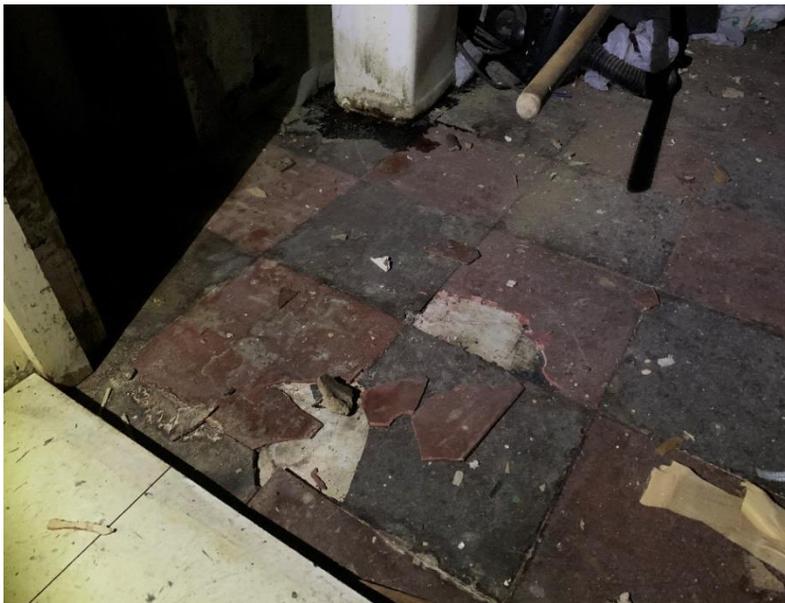
TETRA TECH PROJECT NO. X9030.19F.0101.005 Direction: NA	DESCRIPTION	This photograph shows 9" X 9" red floor tile and 9" X 9" black floor tile under 12" X 12" white floor tile typical of Rooms 21 and 22.	16
	CLIENT	EPA	Date
	PHOTOGRAPHER	Zach Usher	11/6/2019

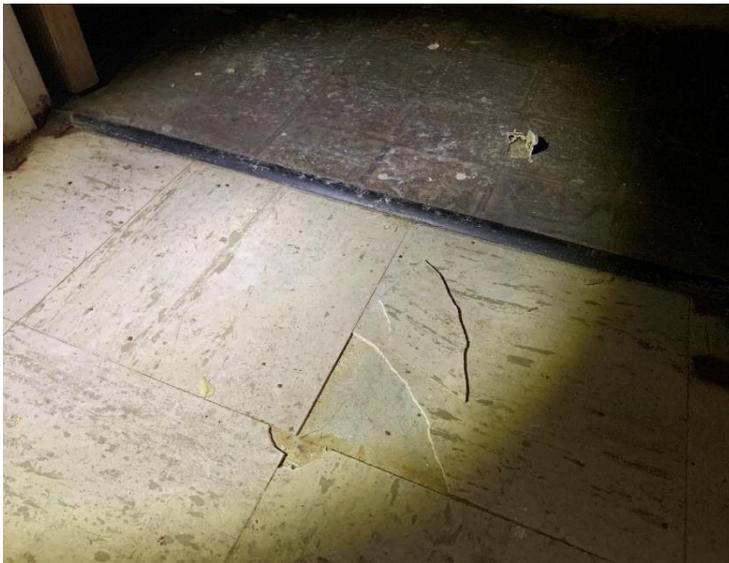
TETRA TECH PROJECT NO. X9030.19F.0101.005 Direction: NA	DESCRIPTION	This photograph shows 12" X 12" tan and brown streak floor tile typical of the hallway outside Room 48 and Room 10.	18
	CLIENT	EPA	Date
	PHOTOGRAPHER	Zach Usher	11/6/2019

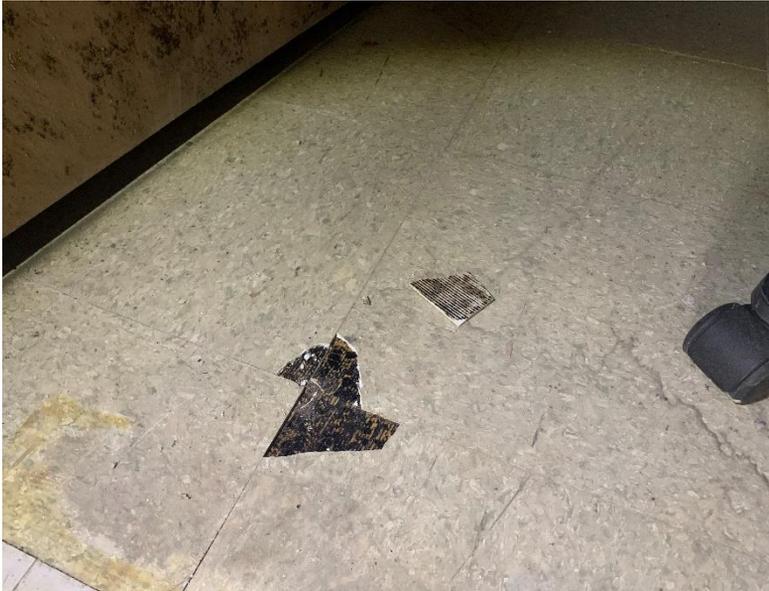
TETRA TECH PROJECT NO. X9030.19F.0101.005 Direction: NA	DESCRIPTION	This photograph shows 12" X 12" beige and tan cobblestone floor tile typical of Rooms 9, 11, and 13.	19
	CLIENT	EPA	Date
	PHOTOGRAPHER	Zach Usher	11/6/2019

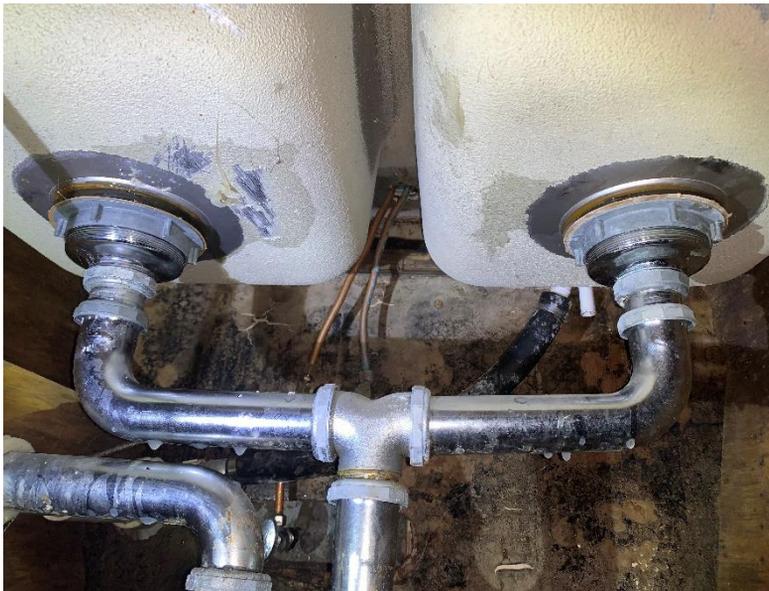
TETRA TECH PROJECT NO. X9030.19F.0101.005 Direction: NA	DESCRIPTION	This photograph shows white sink coating in Room 48.	20
	CLIENT	EPA	Date
	PHOTOGRAPHER	Zach Usher	11/6/2019

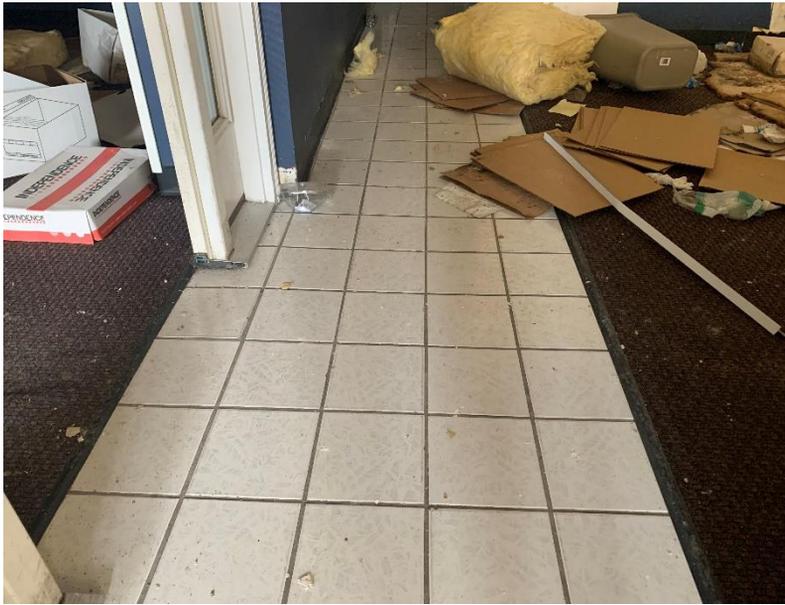
TETRA TECH PROJECT NO. X9030.19F.0101.005 Direction: NA	DESCRIPTION	This photograph shows white ceramic tile grout in Room 3.	21
	CLIENT	EPA	Date
	PHOTOGRAPHER	Zach Usher	11/6/2019

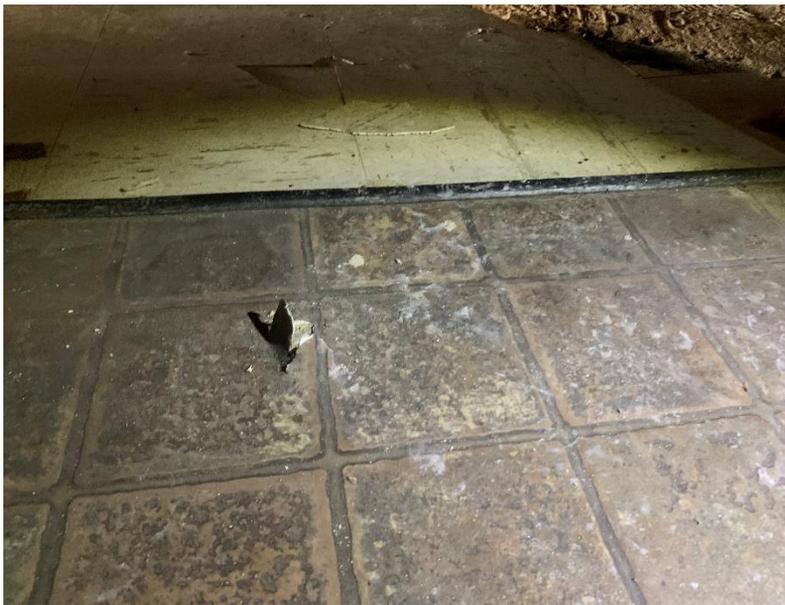
TETRA TECH PROJECT NO. X9030.19F.0101.005 Direction: NA	DESCRIPTION	This photograph shows brown linoleum typical of Rooms 48, B67, and 68.	22
	CLIENT	EPA	Date
	PHOTOGRAPHER	Zach Usher	11/6/2019

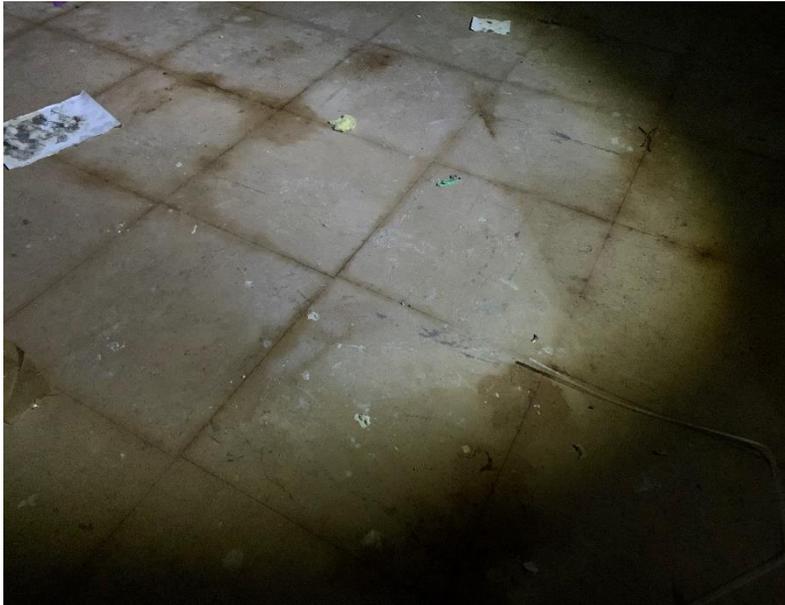
TETRA TECH PROJECT NO. X9030.19F.0101.005 Direction: Southwest	DESCRIPTION	This photograph shows 9" X 9" brown and black streak floor tile typical of Rooms 43, 46, 89, 88 and hallway; the hallway near Room 43; the hallway of the north exit near Elm Street; the hallway south of the boiler room; and the hallway west of the boiler room.	23
	CLIENT	EPA	Date
	PHOTOGRAPHER	Zach Usher	11/6/2019

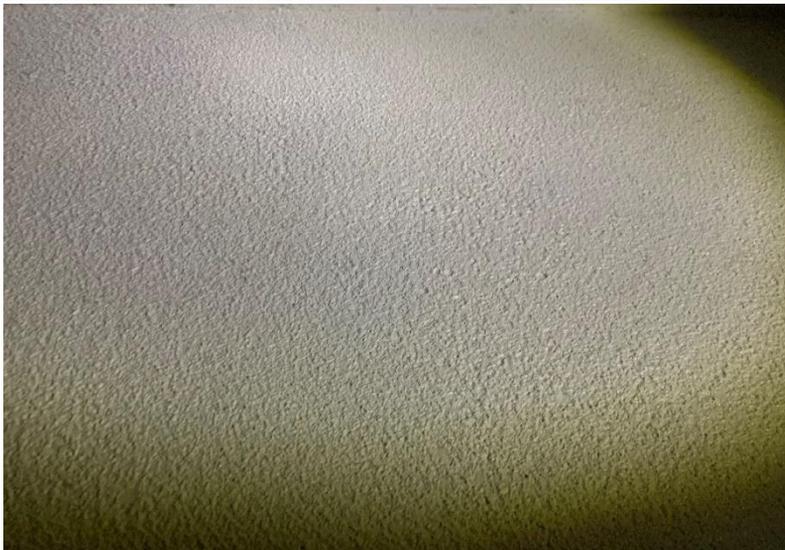
TETRA TECH PROJECT NO. X9030.19F.0101.005 Direction: North	DESCRIPTION	This photograph shows white ceiling texture typical of Room 88 and hallway and the hallway west of the boiler room.	24
	CLIENT	EPA	Date
	PHOTOGRAPHER	Zach Usher	11/6/2019

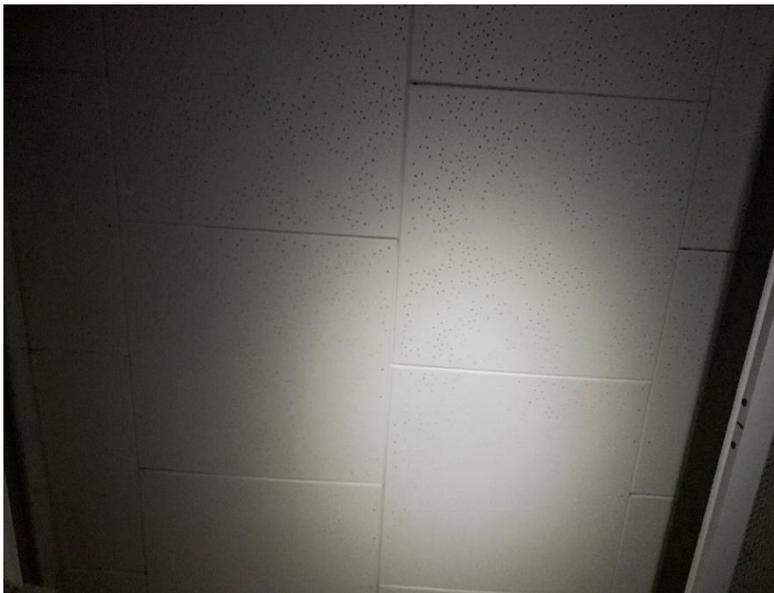
TETRA TECH PROJECT NO. X9030.19F.0101.005 Direction: NA	DESCRIPTION	This photograph shows 12" X 12" white pinhole ceiling tile typical of the north hallway, the hallway east of Room 41, and the hallway north of Room 70.	28
	CLIENT	EPA	Date
	PHOTOGRAPHER	Zach Usher	11/6/2019

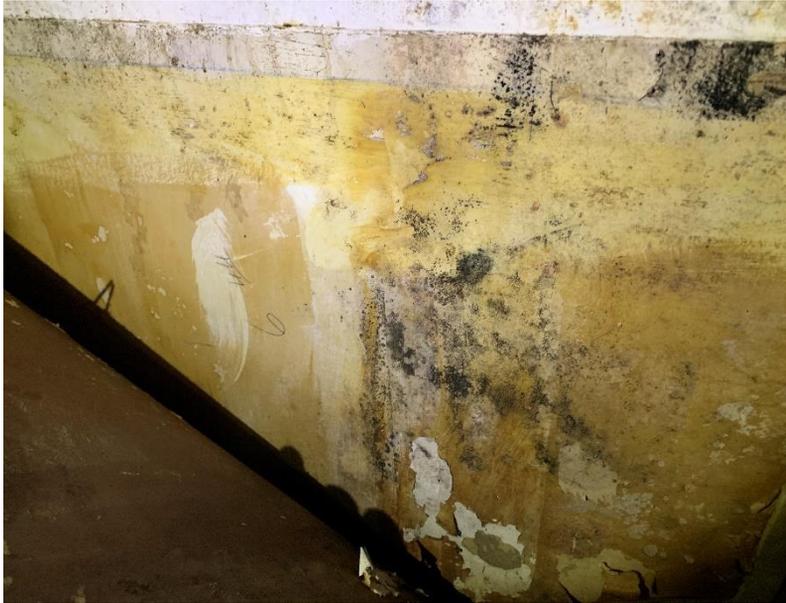
TETRA TECH PROJECT NO. X9030.19F.0101.005 Direction: NA	DESCRIPTION	This photograph shows white plastic wall panel mastic in the hallway south of the boiler Room.	29
	CLIENT	EPA	Date
	PHOTOGRAPHER	Zach Usher	11/6/2019

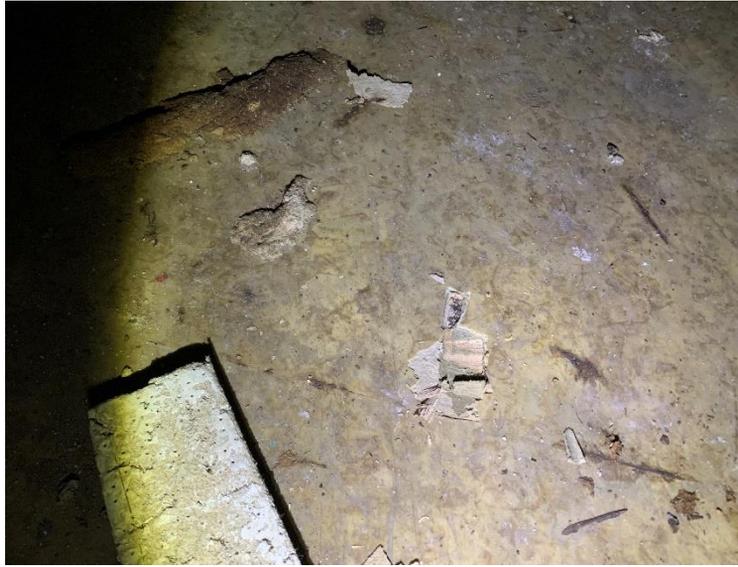
TETRA TECH PROJECT NO. X9030.19F.0101.005 Direction: NA	DESCRIPTION	This photograph shows tan linoleum on top of 12" X 12" white floor tile and 9" X 9" red floor tile typical of the mechanical maintenance area and the hallway west of the mechanical maintenance area.	31
	CLIENT	EPA	Date
	PHOTOGRAPHER	Zach Usher	11/6/2019

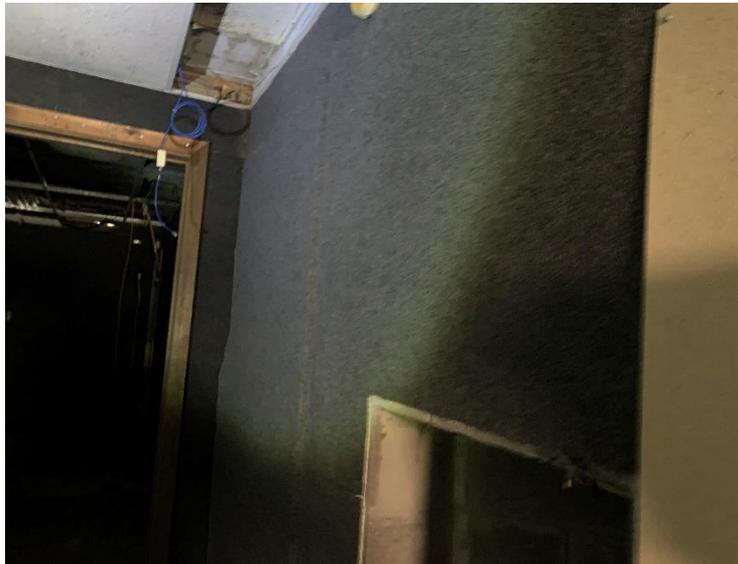
TETRA TECH PROJECT NO. X9030.19F.0101.005 Direction: NA	DESCRIPTION	This photograph shows wall carpet mastic in the holding cell area.	32
	CLIENT	EPA	Date
	PHOTOGRAPHER	Zach Usher	11/6/2019

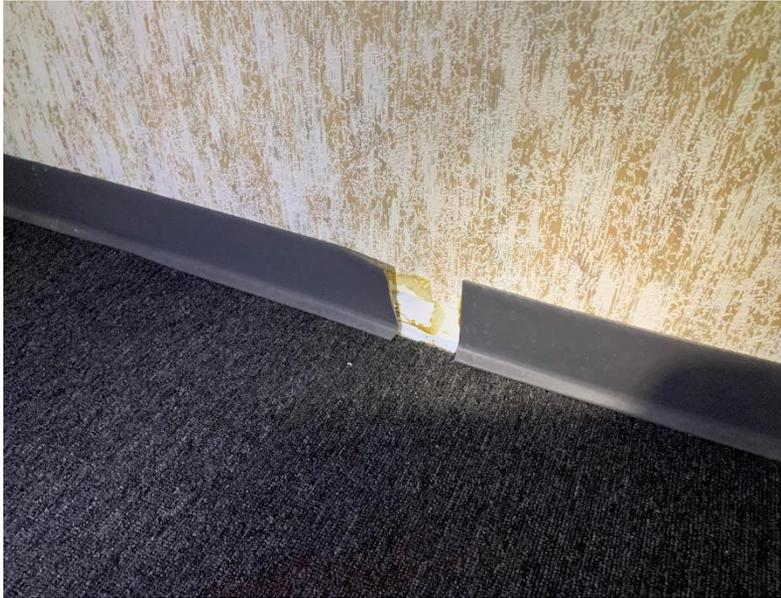
TETRA TECH PROJECT NO. X9030.19F.0101.005 Direction: NA	DESCRIPTION	This photograph shows 4" grey cove base typical of Room 39 and Room 46.	33
	CLIENT	EPA	Date
	PHOTOGRAPHER	Zach Usher	11/6/2019

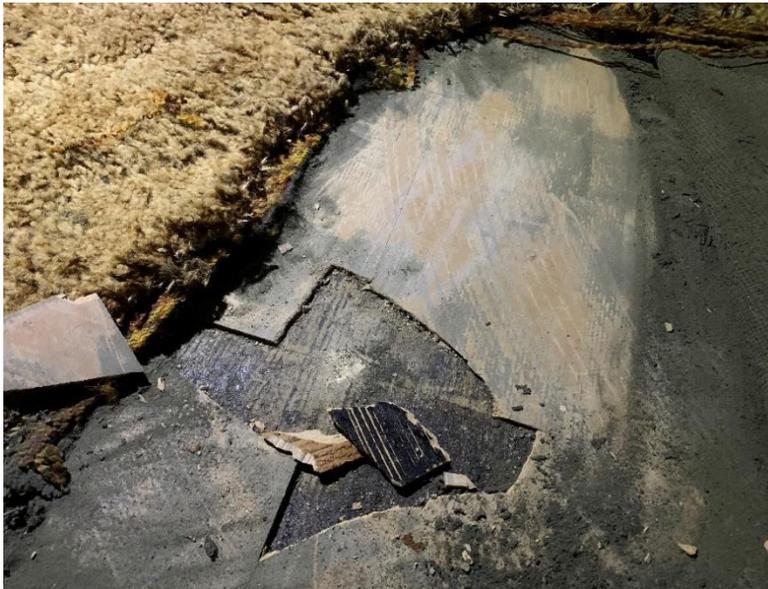
TETRA TECH PROJECT NO. X9030.19F.0101.005 Direction: NA	DESCRIPTION	This photograph shows 9" X 9" tan floor tile under carpet typical of the hallway east of Room 46 and of Rooms 39, 40, 41, 42, and 70.	34
	CLIENT	EPA	Date
	PHOTOGRAPHER	Zach Usher	11/6/2019

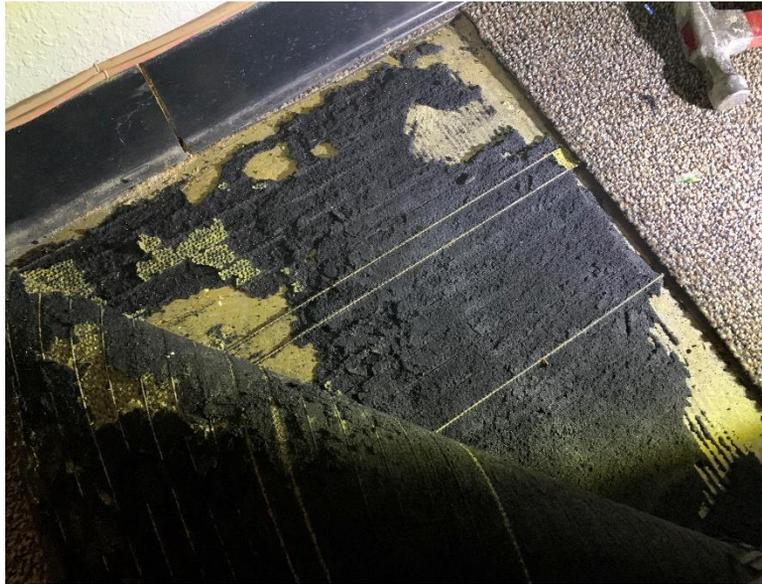
TETRA TECH PROJECT NO. X9030.19F.0101.005 Direction: NA	DESCRIPTION	This photograph shows black carpet mastic in the northeast section of the building.	41
	CLIENT	EPA	Date
	PHOTOGRAPHER	Zach Usher	11/6/2019

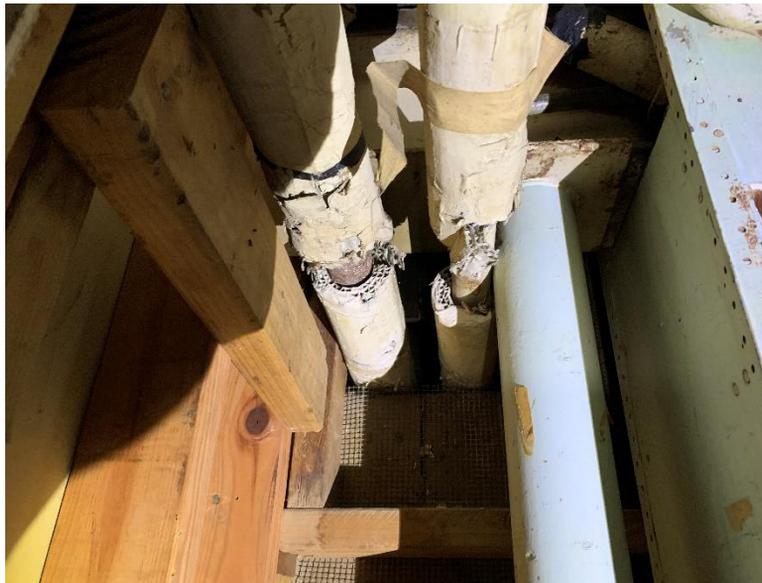
TETRA TECH PROJECT NO. X9030.19F.0101.005 Direction: NA	DESCRIPTION	This photograph shows aircell pipe insulation in the west building area.	42
	CLIENT	EPA	Date
	PHOTOGRAPHER	Zach Usher	11/6/2019

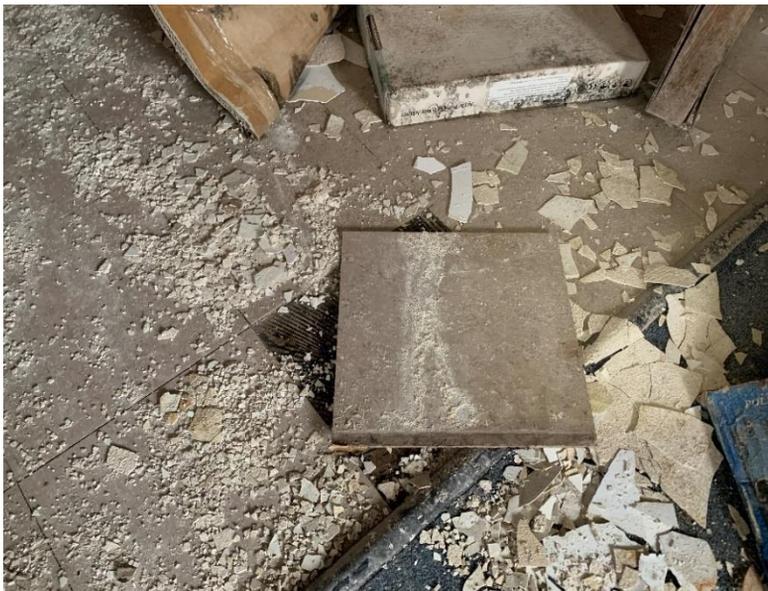
TETRA TECH PROJECT NO. X9030.19F.0101.005 Direction: NA	DESCRIPTION	This photograph shows 9" X 9" beige and brown streak floor tile typical of the second floor hallway and of Rooms 74, 75, 76, and 78.	46
	CLIENT	EPA	Date
	PHOTOGRAPHER	Zach Usher	11/6/2019

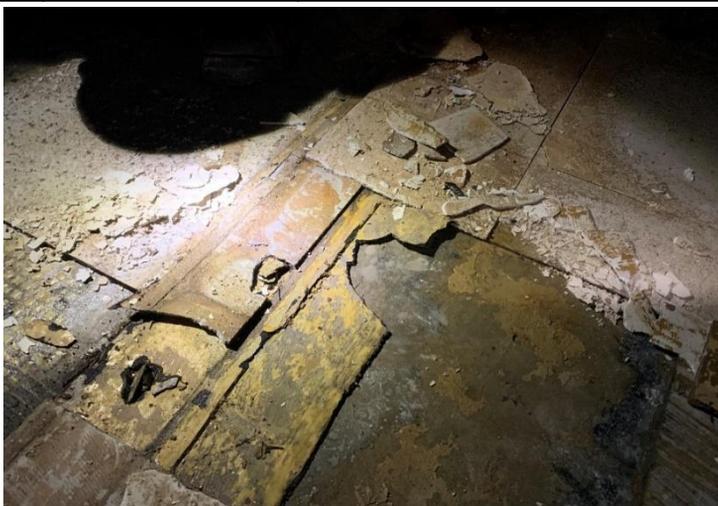
TETRA TECH PROJECT NO. X9030.19F.0101.005 Direction: NA	DESCRIPTION	This photograph shows brown linoleum under 12" X 12" white floor tile and 12" X 12" blue with black and white speck floor tile typical of all second floor hallway entry strips.	58
	CLIENT	EPA	Date
	PHOTOGRAPHER	Zach Usher	11/6/2019

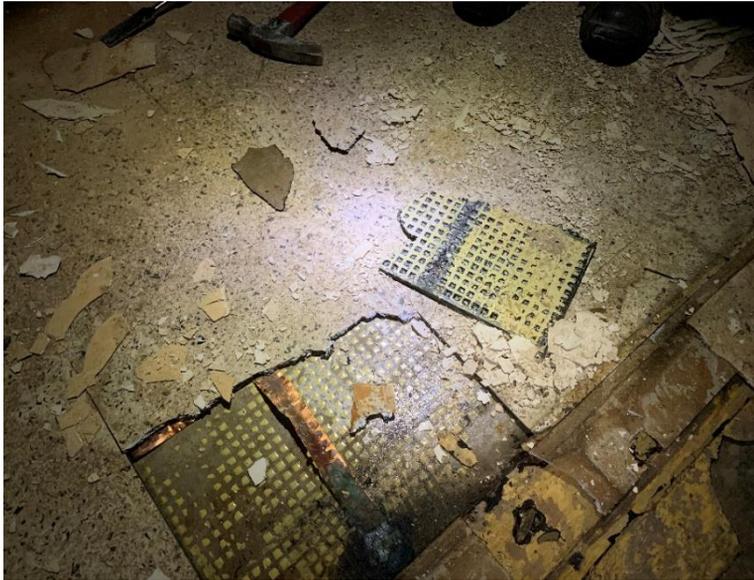
TETRA TECH PROJECT NO. X9030.19F.0101.005 Direction: NA	DESCRIPTION	This photograph shows 12" X 12" tan with black, grey and white pattern floor tile with grid bottom typical of the second floor north and central hallway; the hallway near Room 85; the hallway south of the north stairwell; and Rooms 82, 83, and 85.	59
	CLIENT	EPA	Date
	PHOTOGRAPHER	Zach Usher	11/6/2019

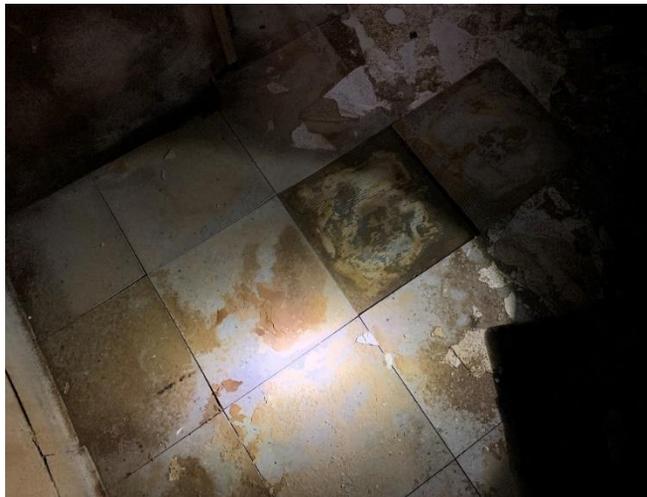
TETRA TECH PROJECT NO. X9030.19F.0101.005 Direction: NA	DESCRIPTION	This photograph shows 9" X 9" grey with white and black streak floor tile and 4" light blue cove base typical of the north stairwell, second floor hallway south of the north stairwell, and Room 85.	60
	CLIENT	EPA	Date
	PHOTOGRAPHER	Zach Usher	11/6/2019

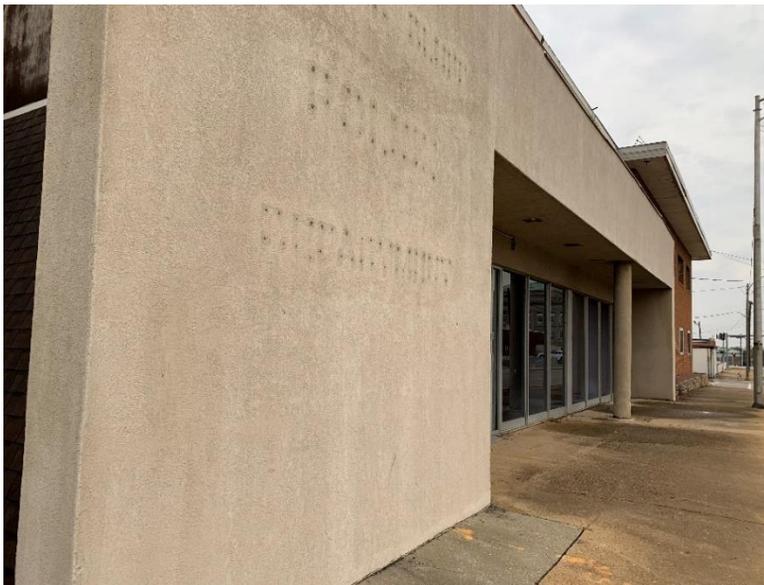
TETRA TECH PROJECT NO. X9030.19F.0101.005 Direction: NA	DESCRIPTION	This photograph shows tan stucco on the west exterior police department entrance and the northwest entrance wall and awning.	74
	CLIENT	EPA	Date
	PHOTOGRAPHER	Zach Usher	11/6/2019

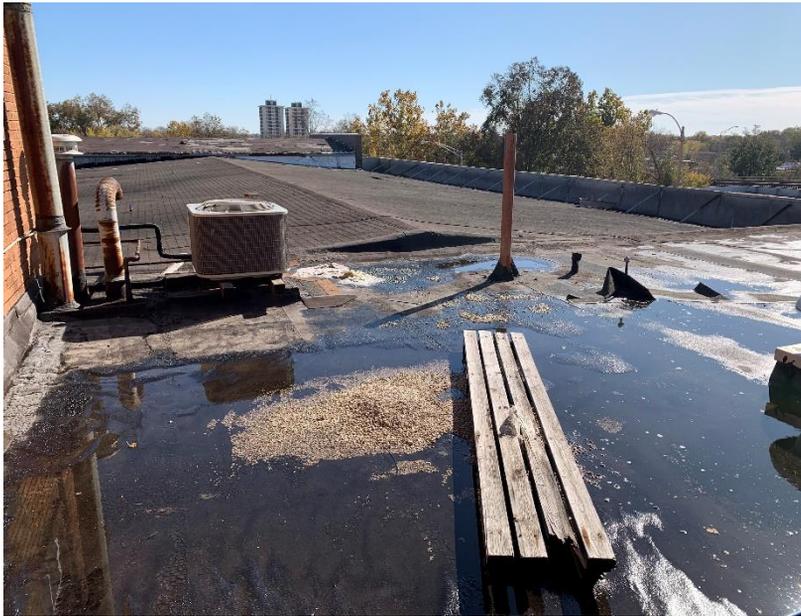
TETRA TECH PROJECT NO. X9030.19F.0101.005 Direction: NA	DESCRIPTION	This photograph shows the built-up asphalt roof on the police department.	81
	CLIENT	EPA	Date
	PHOTOGRAPHER	Zach Usher	11/6/2019

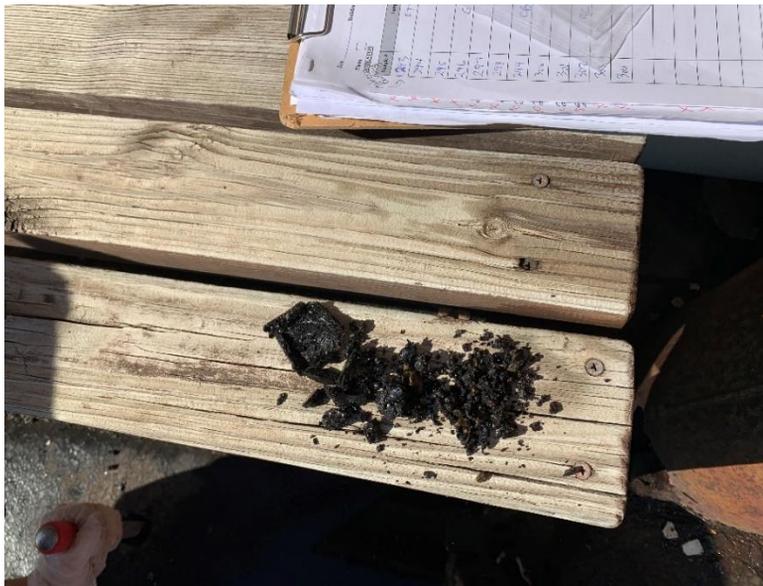
TETRA TECH PROJECT NO. X9030.19F.0101.005 Direction: NA	DESCRIPTION	This photograph shows the various layers of the built-up asphalt roof, including asphalt shingles, tar, and a loose tar and rock mix.	82
	CLIENT	EPA	Date
	PHOTOGRAPHER	Zach Usher	11/6/2019

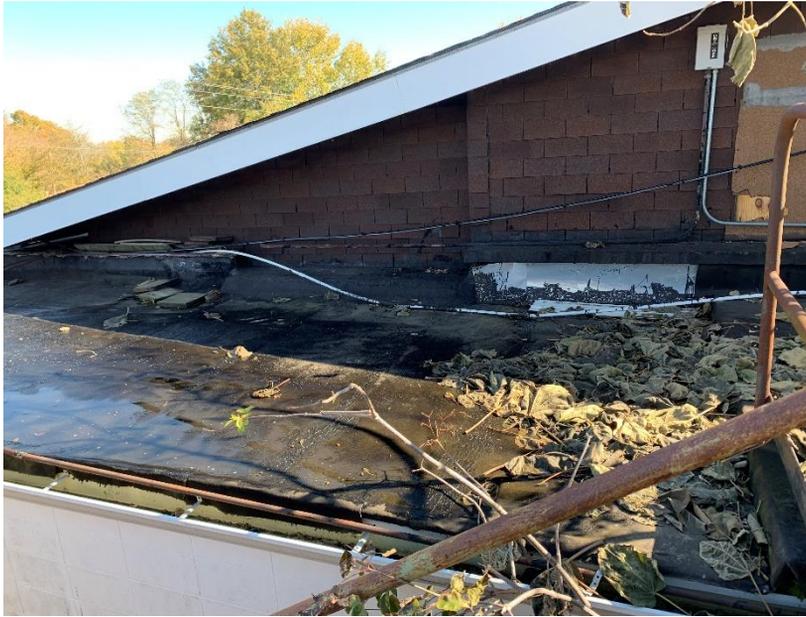
TETRA TECH PROJECT NO. X9030.19F.0101.005 Direction: NA	DESCRIPTION	This photograph shows tar curb sealant on the police department roof.	83
	CLIENT	EPA	Date
	PHOTOGRAPHER	Zach Usher	11/6/2019

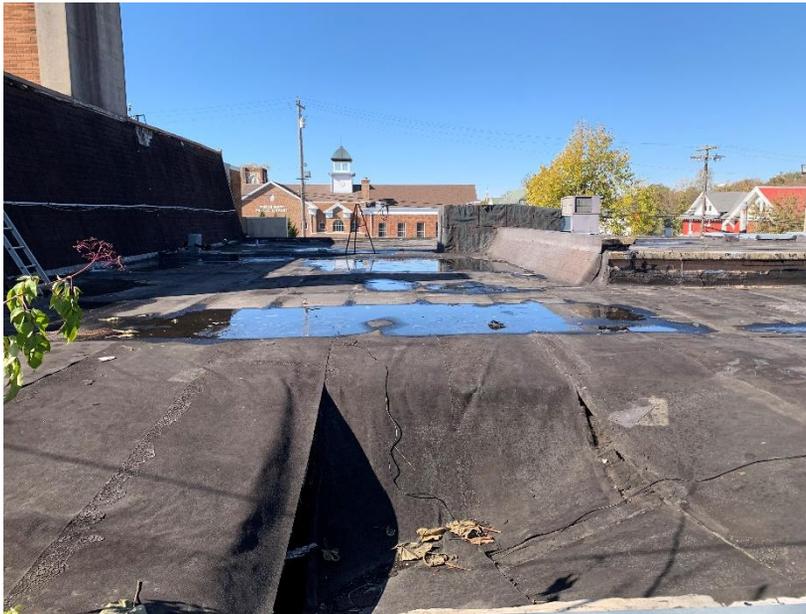
TETRA TECH PROJECT NO. X9030.19F.0101.005 Direction: NA	DESCRIPTION	This photograph shows the built-up roof on the north side of the police station.	84
	CLIENT	EPA	Date
	PHOTOGRAPHER	Zach Usher	11/6/2019

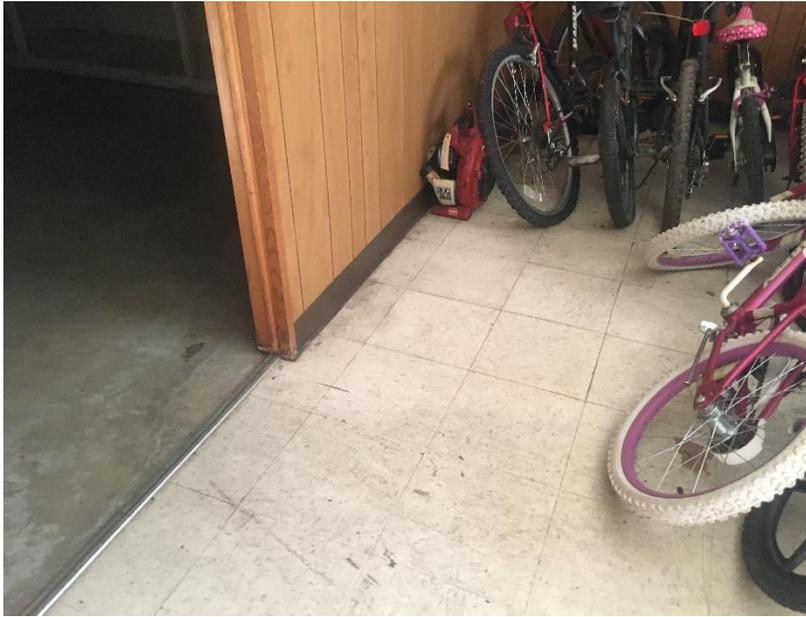
TETRA TECH PROJECT NO. X9030.19F.0101.005 Direction: NA	DESCRIPTION	This photograph shows 12" X 12" floor tile and 4" brown cove base in the back room of the evidence building.	85
	CLIENT	EPA	Date
	PHOTOGRAPHER	Zach Usher	11/6/2019

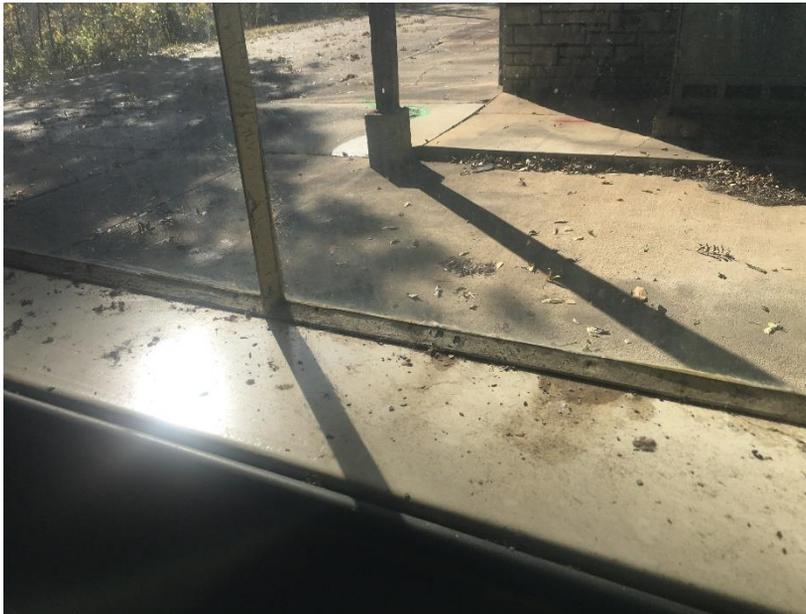
TETRA TECH PROJECT NO. X9030.19F.0101.005 Direction: NA	DESCRIPTION	This photograph shows white window glaze on the southeast window of the evidence building.	86
	CLIENT	EPA	Date
	PHOTOGRAPHER	Zach Usher	11/6/2019

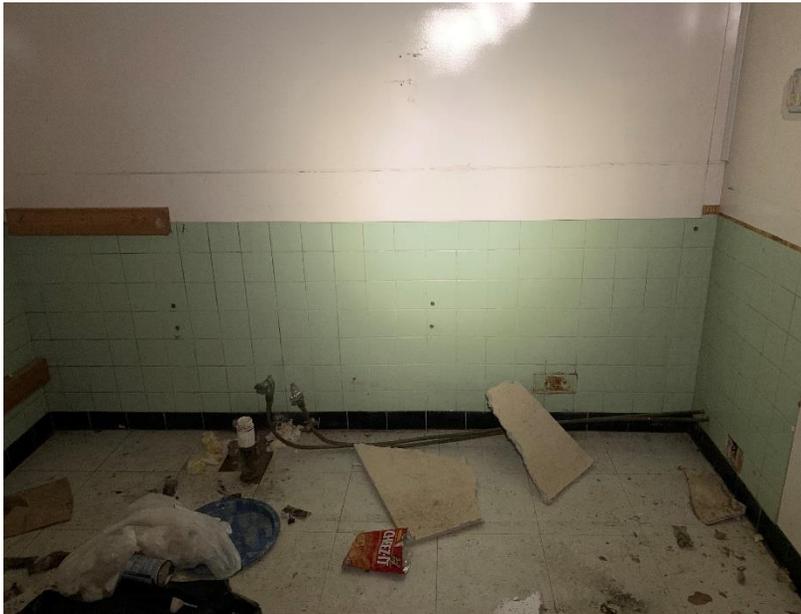
TETRA TECH PROJECT NO. X9030.19F.0101.005 Direction: NA	DESCRIPTION	This photograph shows green ceramic wall tile in Room 22.	87
	CLIENT	EPA	Date
	PHOTOGRAPHER	Zach Usher	11/6/2019

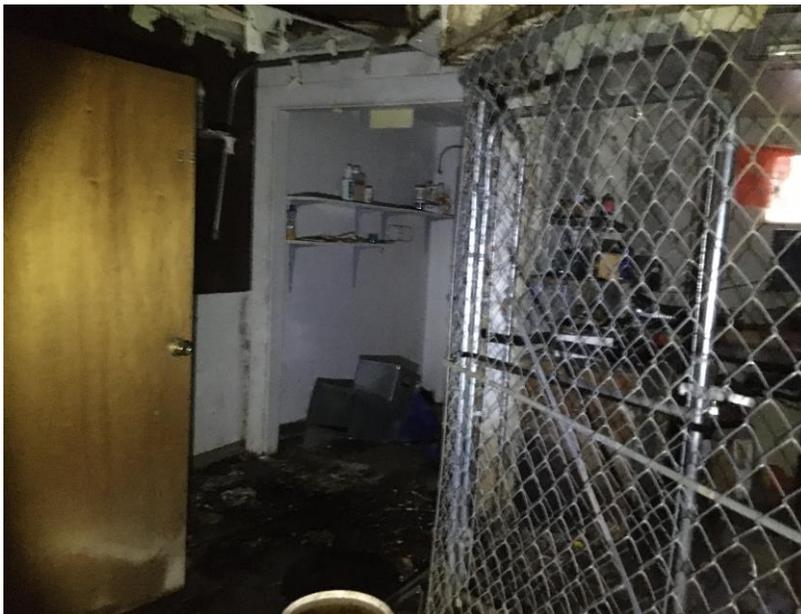
TETRA TECH PROJECT NO. X9030.19F.0101.005 Direction: NA	DESCRIPTION	This photograph shows white wall plaster in the maintenance area.	88
	CLIENT	EPA	Date
	PHOTOGRAPHER	Zach Usher	11/6/2019

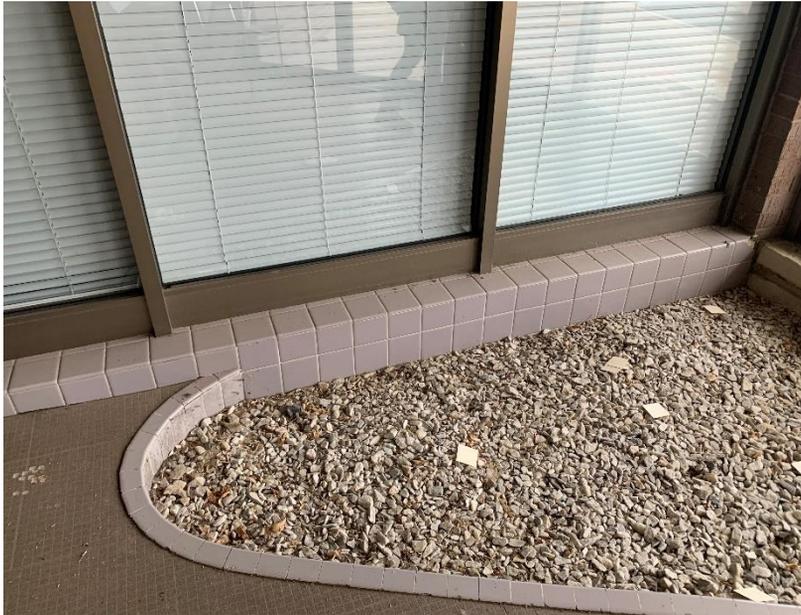
TETRA TECH PROJECT NO. X9030.19F.0101.005 Direction: NA	DESCRIPTION	This photograph shows beige ceramic floor tile in the south entryway.	89
	CLIENT	EPA	Date
	PHOTOGRAPHER	Zach Usher	11/6/2019

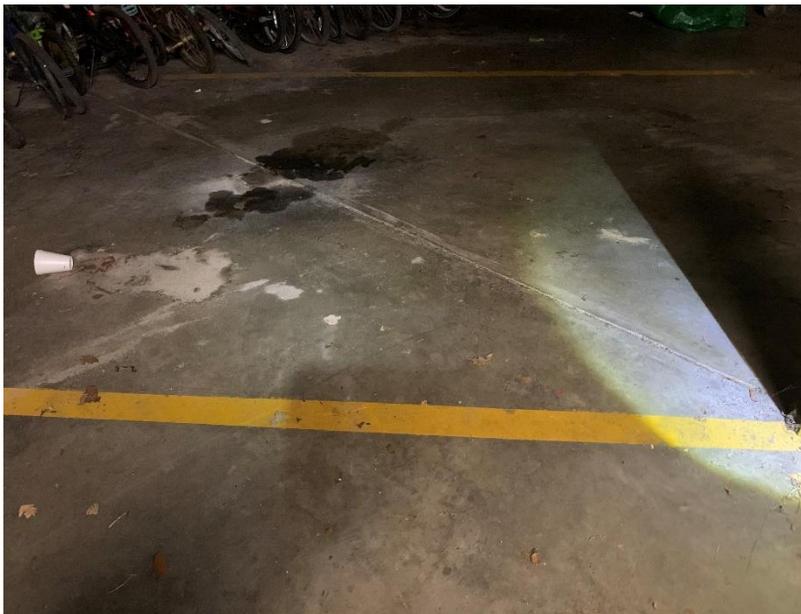
TETRA TECH PROJECT NO. X9030.19F.0101.005 Direction: NA	DESCRIPTION	This photograph shows yellow parking lines on concrete in the garage.	90
	CLIENT	EPA	Date
	PHOTOGRAPHER	Zach Usher	11/6/2019

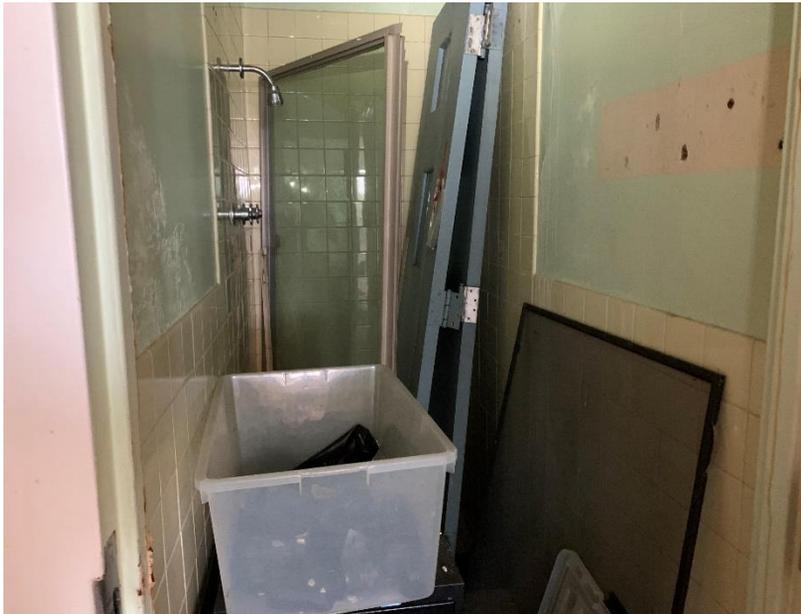
TETRA TECH PROJECT NO. X9030.19F.0101.005 Direction: NA	DESCRIPTION	This photograph shows yellow ceramic wall tile in Room 72.	91
	CLIENT	EPA	Date
	PHOTOGRAPHER	Zach Usher	11/6/2019

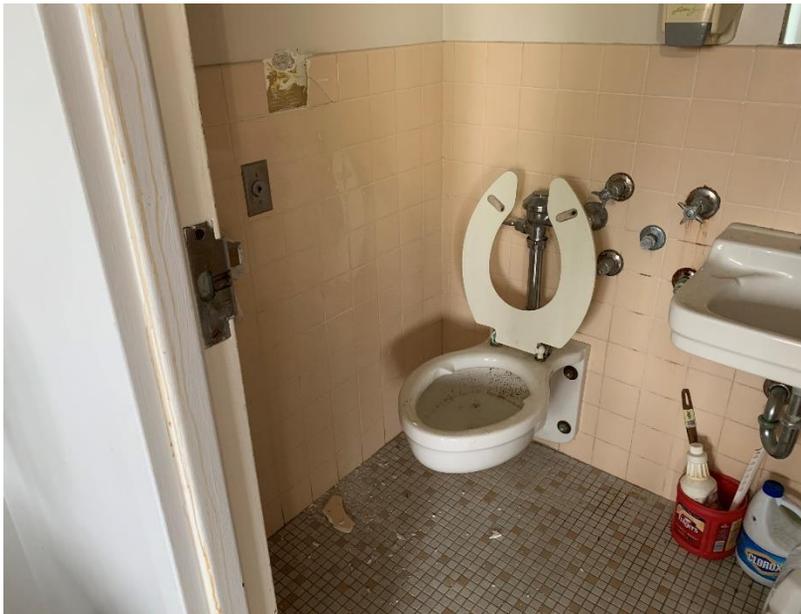
TETRA TECH PROJECT NO. X9030.19F.0101.005 Direction: NA	DESCRIPTION	This photograph shows light pink ceramic wall tile typical of the Room 71 and Room 74 bathrooms.	92
	CLIENT	EPA	Date
	PHOTOGRAPHER	Zach Usher	11/6/2019

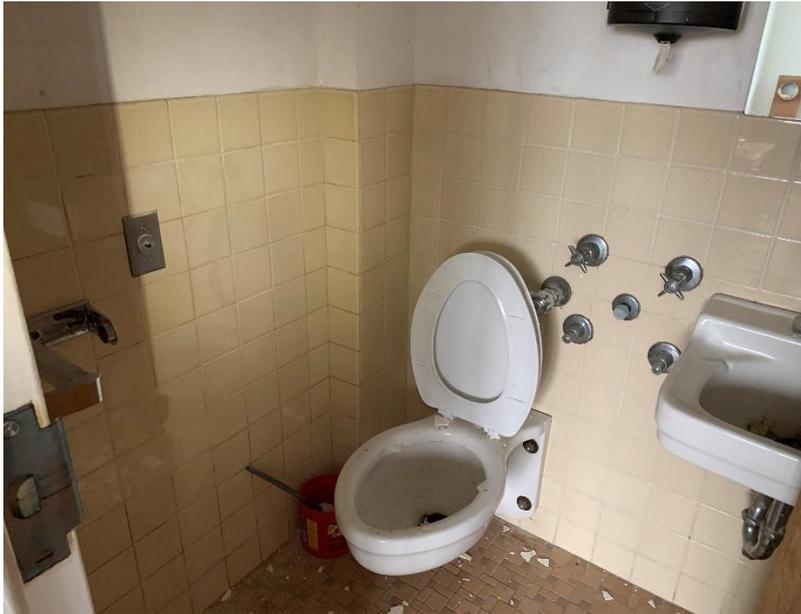
TETRA TECH PROJECT NO. X9030.19F.0101.005 Direction: NA	DESCRIPTION	This photograph shows cream ceramic wall tile typical of the bathrooms of Rooms 75, 77, 78, and 79.	93
	CLIENT	EPA	Date
	PHOTOGRAPHER	Zach Usher	11/6/2019

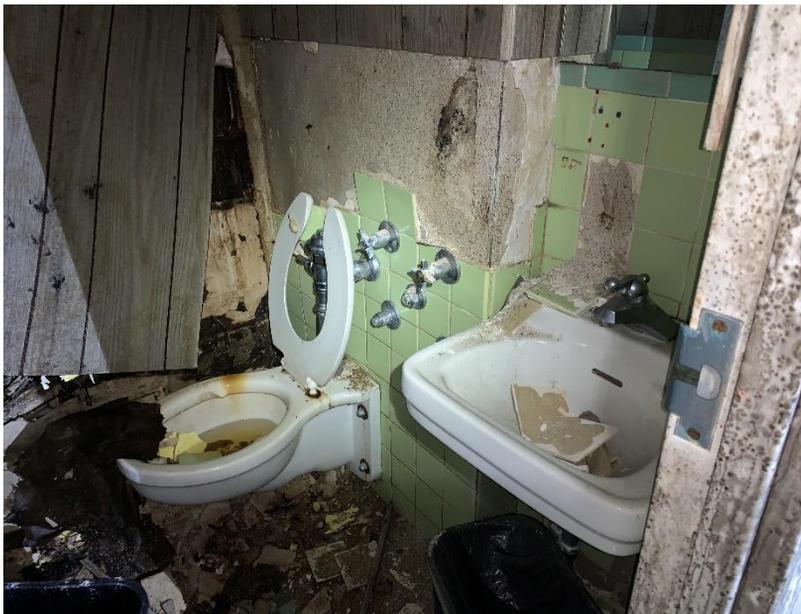
TETRA TECH PROJECT NO. X9030.19F.0101.005 Direction: NA	DESCRIPTION	This photograph shows green ceramic wall tile in the second floor center hall bathroom.	94
	CLIENT	EPA	Date
	PHOTOGRAPHER	Zach Usher	11/6/2019

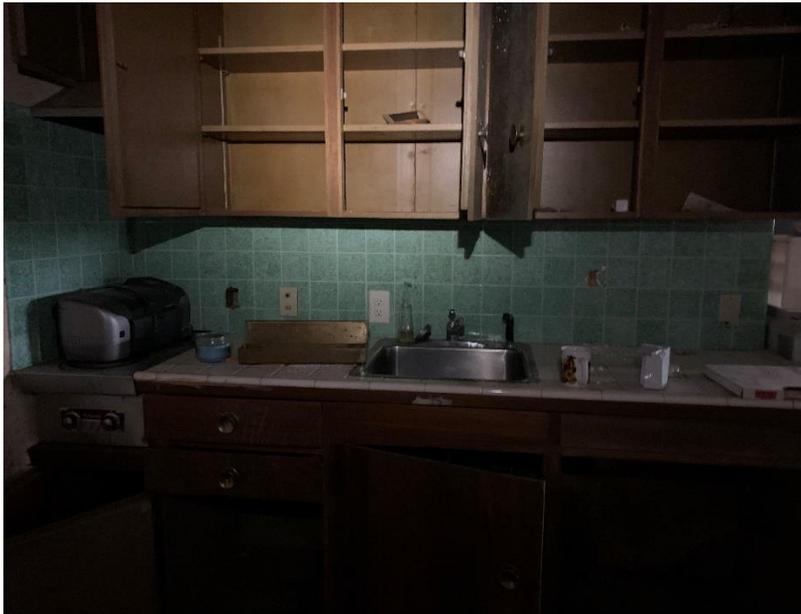
TETRA TECH PROJECT NO. X9030.19F.0101.005 Direction: NA	DESCRIPTION	This photograph shows green ceramic wall tile in the narcotics room.	95
	CLIENT	EPA	Date
	PHOTOGRAPHER	Zach Usher	11/6/2019

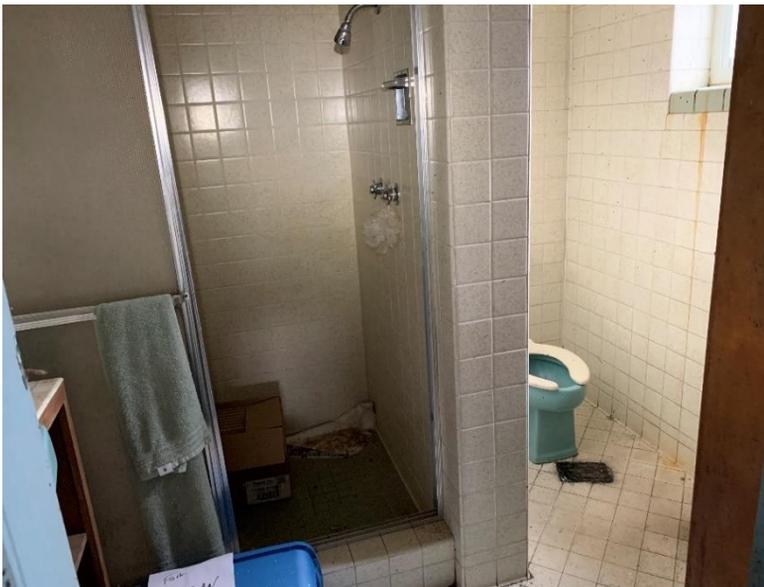
TETRA TECH PROJECT NO. X9030.19F.0101.005 Direction: NA	DESCRIPTION	This photograph shows cream with yellow ceramic wall tile and white ceramic floor tile in the narcotics bathroom.	96
	CLIENT	EPA	Date
	PHOTOGRAPHER	Zach Usher	11/6/2019

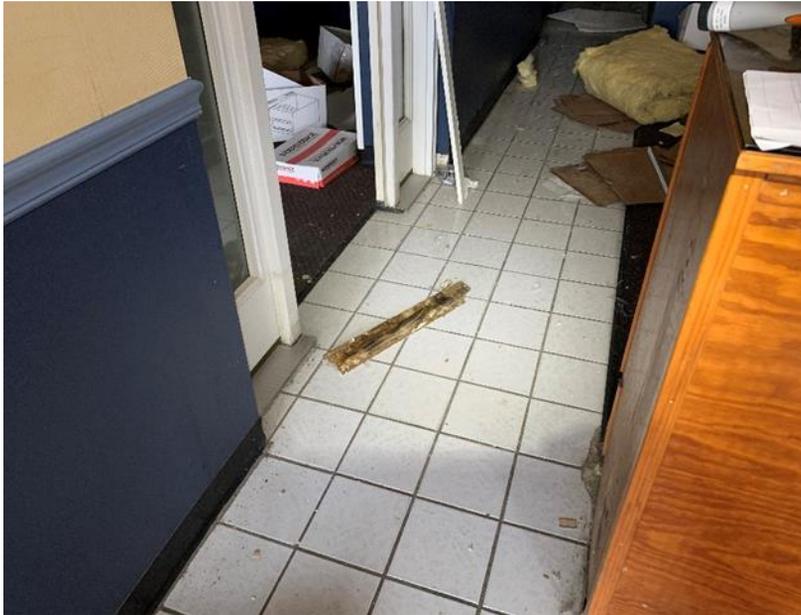
TETRA TECH PROJECT NO. X9030.19F.0101.005 Direction: NA	DESCRIPTION	This photograph shows white ceramic floor tile in Room 3.	97
	CLIENT	EPA	Date
	PHOTOGRAPHER	Zach Usher	11/6/2019

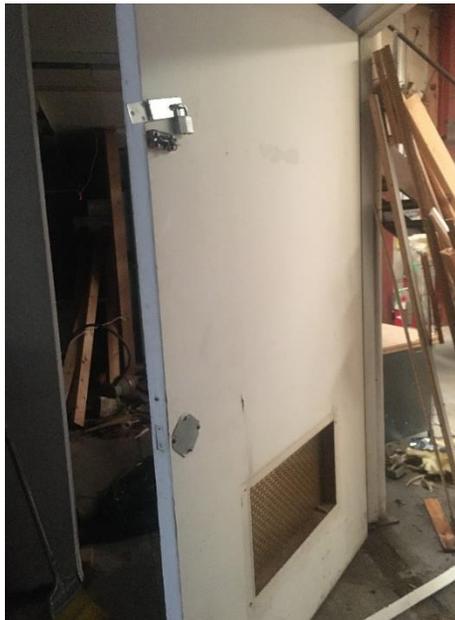
TETRA TECH PROJECT NO. X9030.19F.0101.005 Direction: NA	DESCRIPTION	This photograph shows the white wood door in the back room of the evidence building.	98
	CLIENT	EPA	Date
	PHOTOGRAPHER	Zach Usher	11/6/2019
