F/V
A.E. CLIFFORD
RESPONSE
JANUARY 2019

MSU Duluth Case Study

*F/V
A.E.
CLIFFORD*

*Hughitt Slip
Superior, WI*

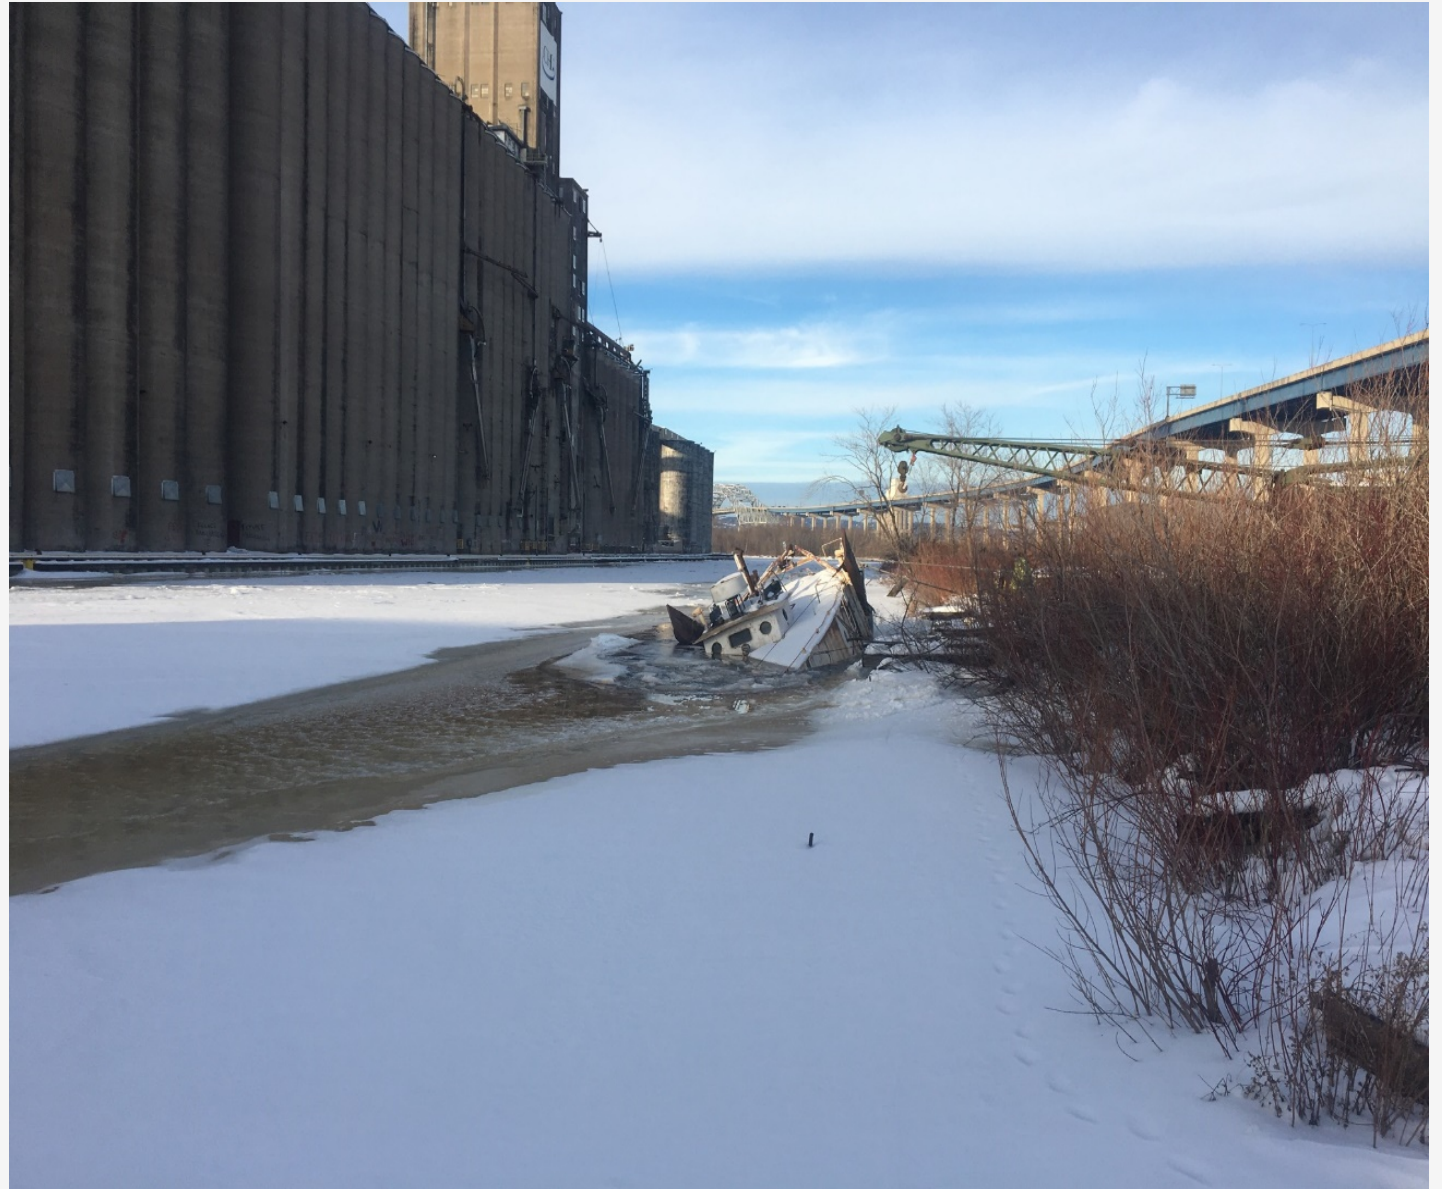
- At approximately 1300 hours the A.E. CLIFFORD was observed sunk in Hughitt Slip in Superior, WI.
- At approximately 1430 hours, MSU Duluth was notified. NRC #1234569.
- Arrived on-site at approximately 1500 hours. STA Duluth and the Superior FD were on-scene attempting to dewater the vessel.

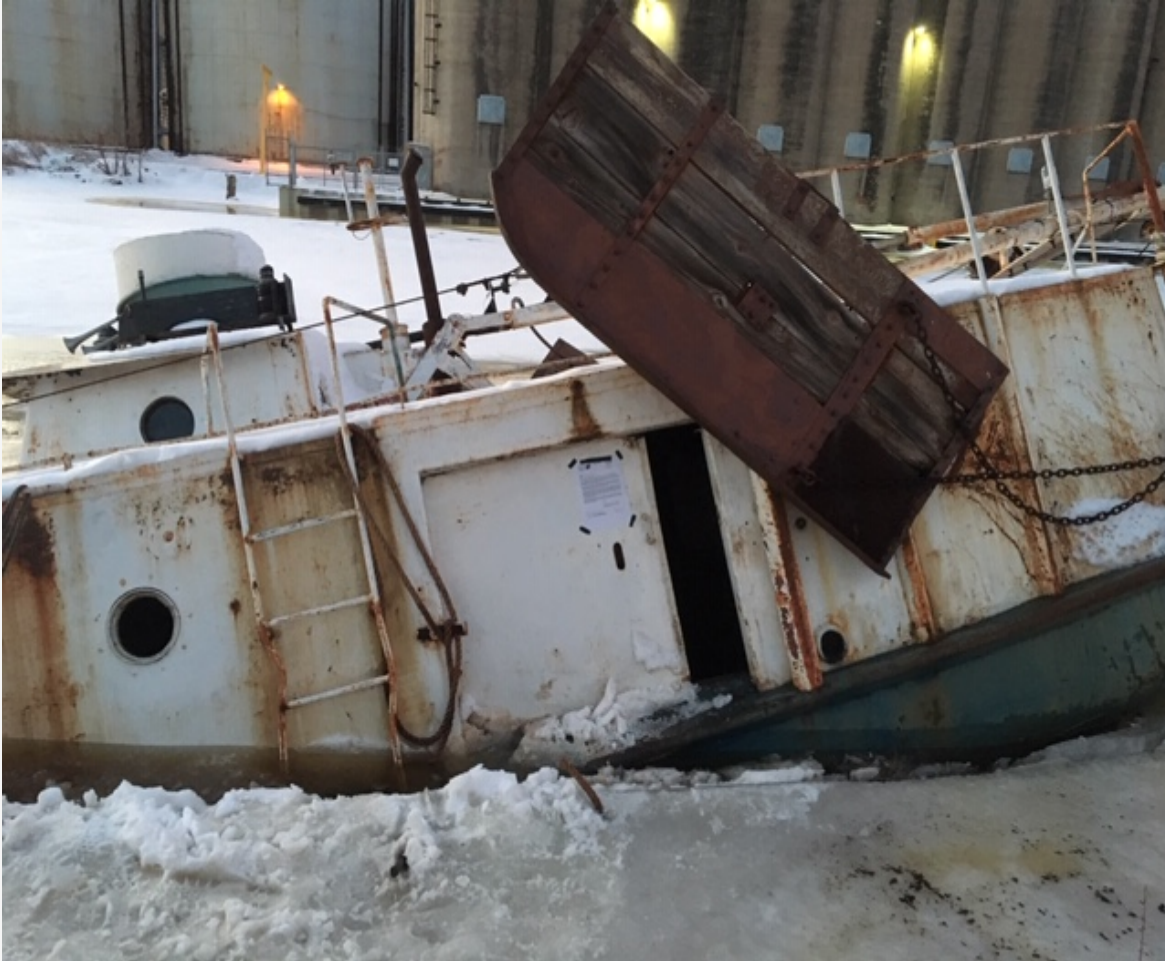
Situation

- Actively Sheening Vessel
- Owner/Operator Unknown
 - Tribal?
 - Commercial Entity?
- Water Depth: 13-15 feet
- Ice Thickness: 12 inches (estimate)
- Moored along Central Harvest States (CHS) property. (MTSA 105 facility)
- Weather: 37 degrees Fahrenheit
- Incoming winter storm & cold

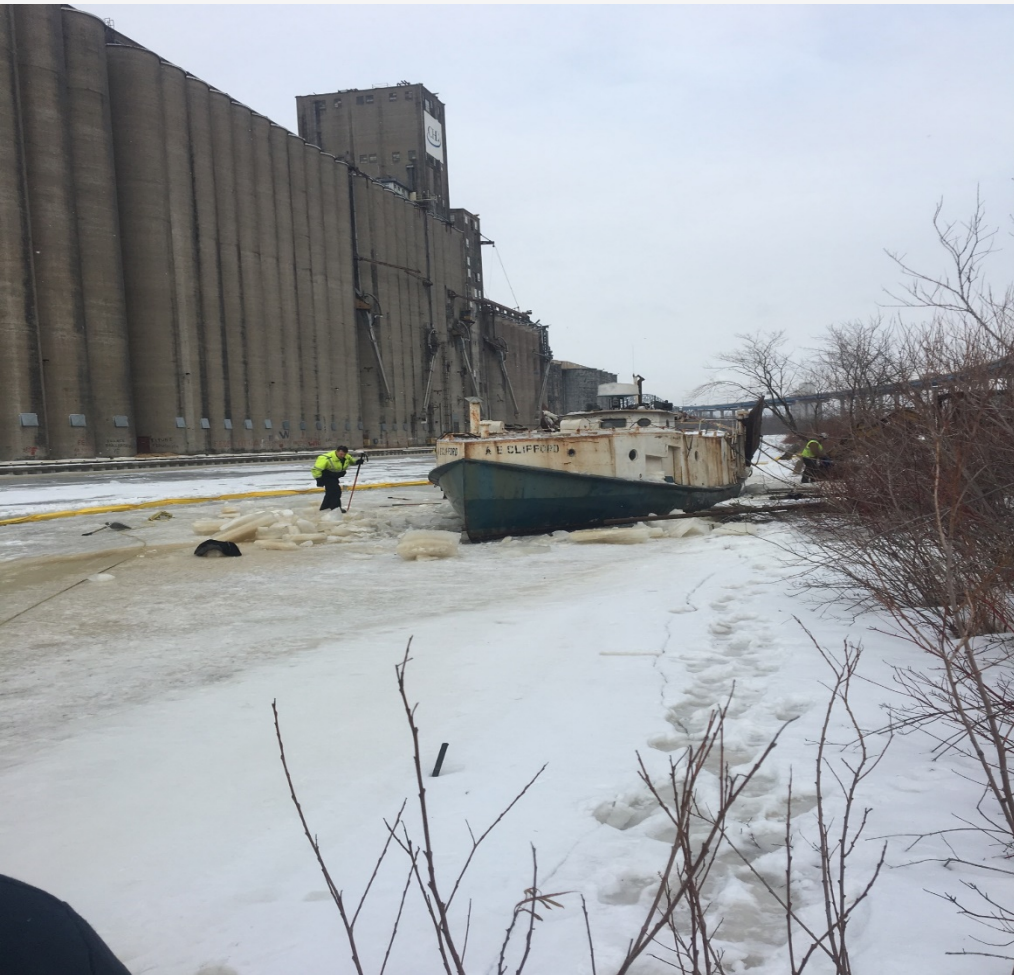
Results

- Estimated 200 gallons of diesel recovered from port fuel tank
- Estimated 200 gallons of diesel/water mixture recovered from starboard fuel tank
- Estimated 20 gallons of hydraulic fluid removed
- Estimated 5,400 gallons of oily water removed from the interior of the vessel during lift process and once interior ice melted
- Vessel sank on 01APR19 at the same location within containment boom
