**PHASE II ENVIRONMENTAL SITE ASSESSMENT  
FOR  
SAN HAVEN  
DUNSEITH, ROULETTE COUNTY, NORTH DAKOTA  
TURTLE MOUNTAIN BAND OF CHIPPEWA INDIANS  
RESERVATION**

Date Prepared	October 2020
TDD No.	0003/2006-05
Document Control No.	W0820.1A.02377
Contract No.	EP-S8-13-01
U.S. EPA Work Assignment Manager	Ted Lanzano

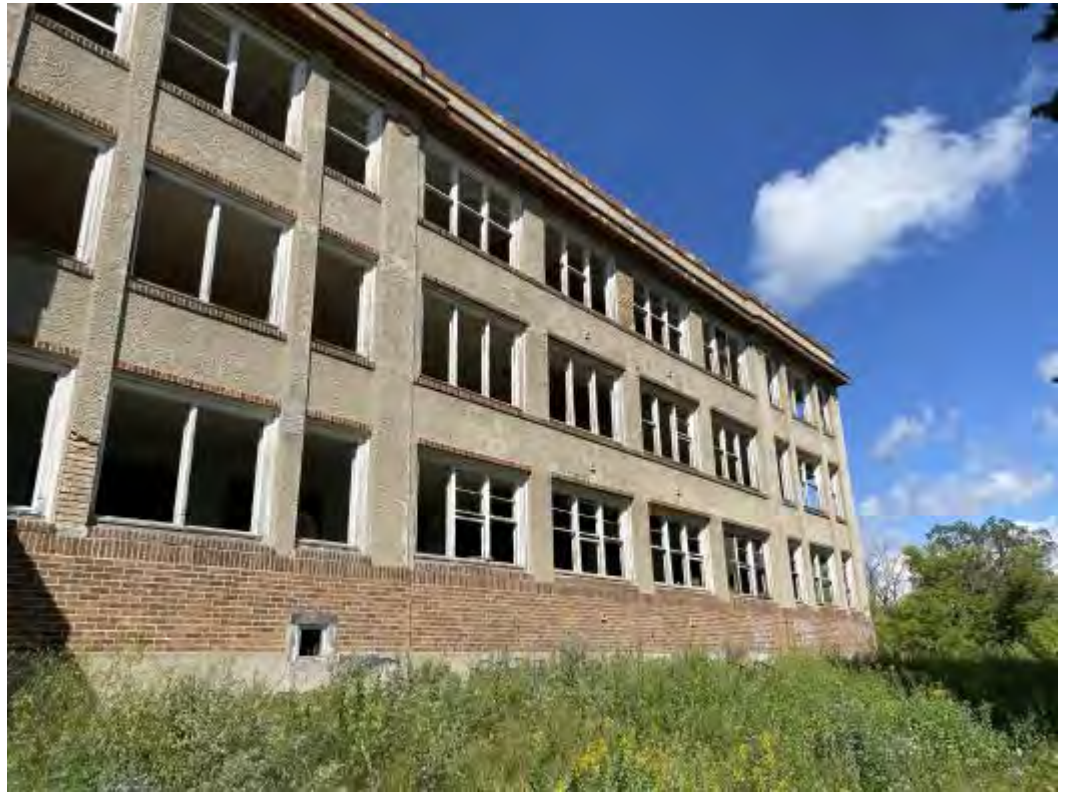
<b>Photo No.</b> <b>1</b>	<b>Date:</b> 08/14/2020
<b>Photo Coordinates</b>	
<b>Lat</b>	48.835289
<b>Long</b>	-100.041367
<b>Direction Photo Taken:</b> 50.179931640625	
<b>Description:</b>  Exterior of Building 1 with asbestos window caulking.

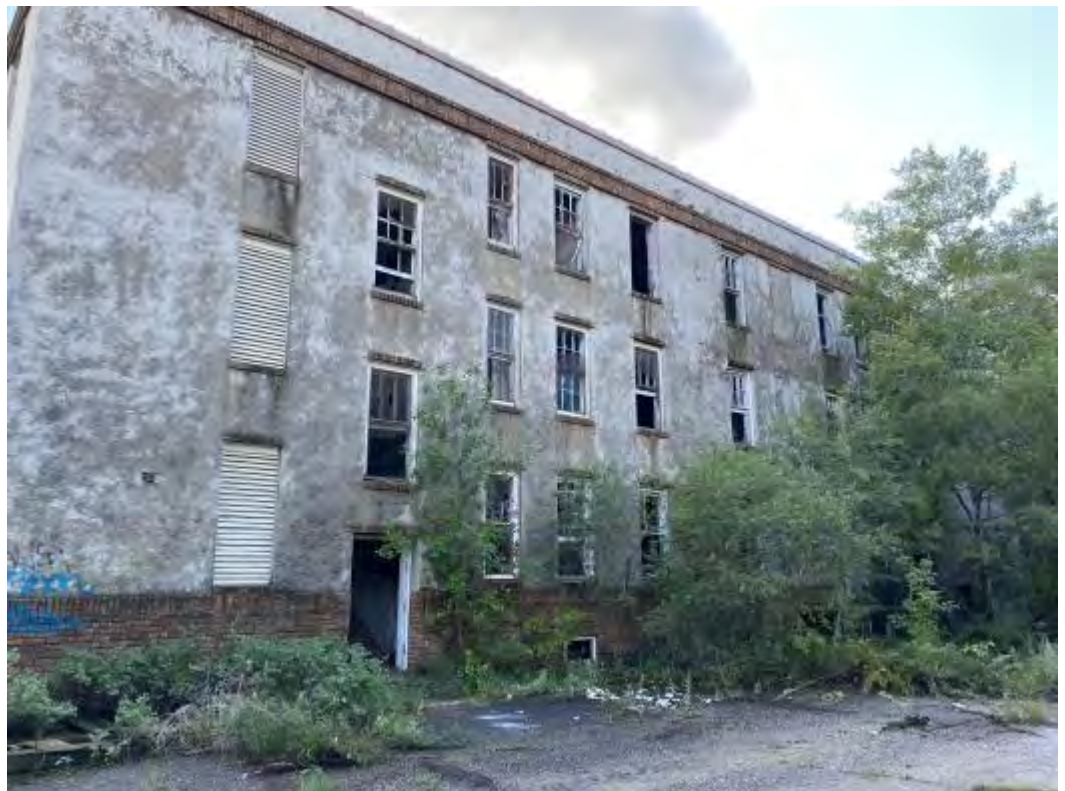
<b>Photo No.</b> <b>2</b>	<b>Date:</b> 08/14/2020
<b>Photo Coordinates</b>	
<b>Lat</b>	48.835556
<b>Long</b>	-100.040925
<b>Direction Photo Taken:</b> 222.21519475511	
<b>Description:</b>  Exterior of Building 1 with asbestos window caulking.

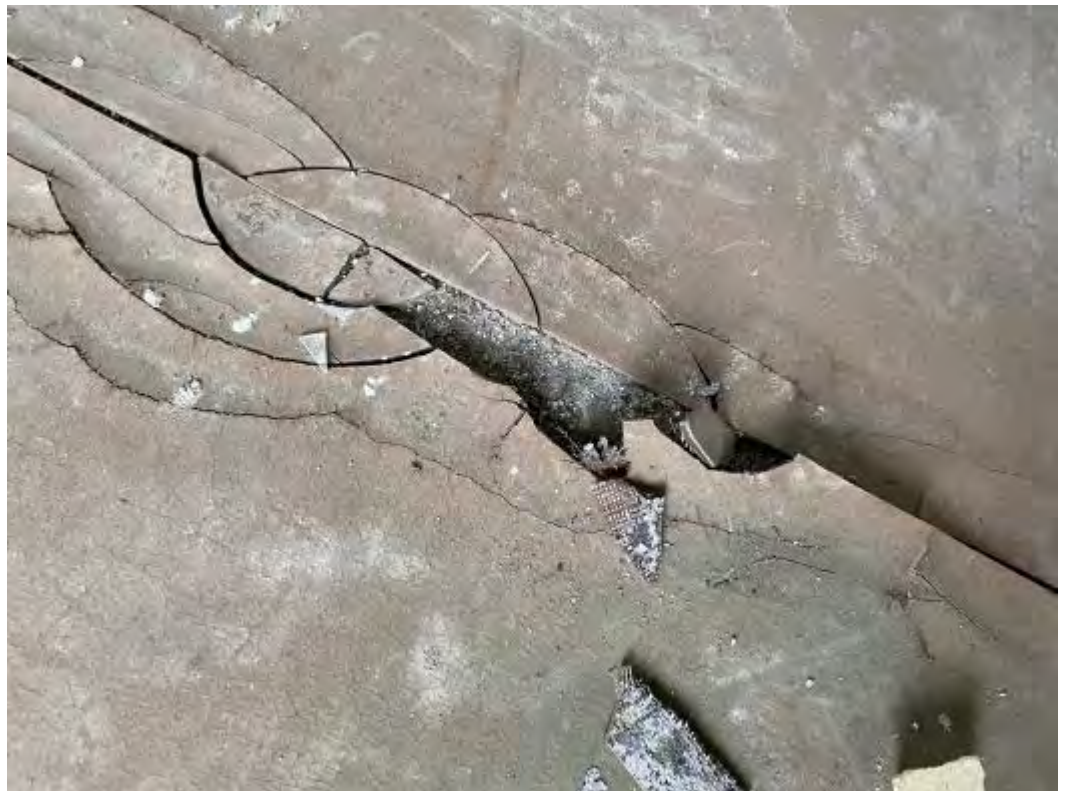
<b>Photo No.</b> <b>4</b>	<b>Date:</b> 08/14/2020
<b>Photo Coordinates</b>	
<b>Lat</b>	48.835378
<b>Long</b>	-100.041092
<b>Direction Photo Taken:</b> 216.025848398351	
<b>Description:</b>  Asbestos in flooring mastic.

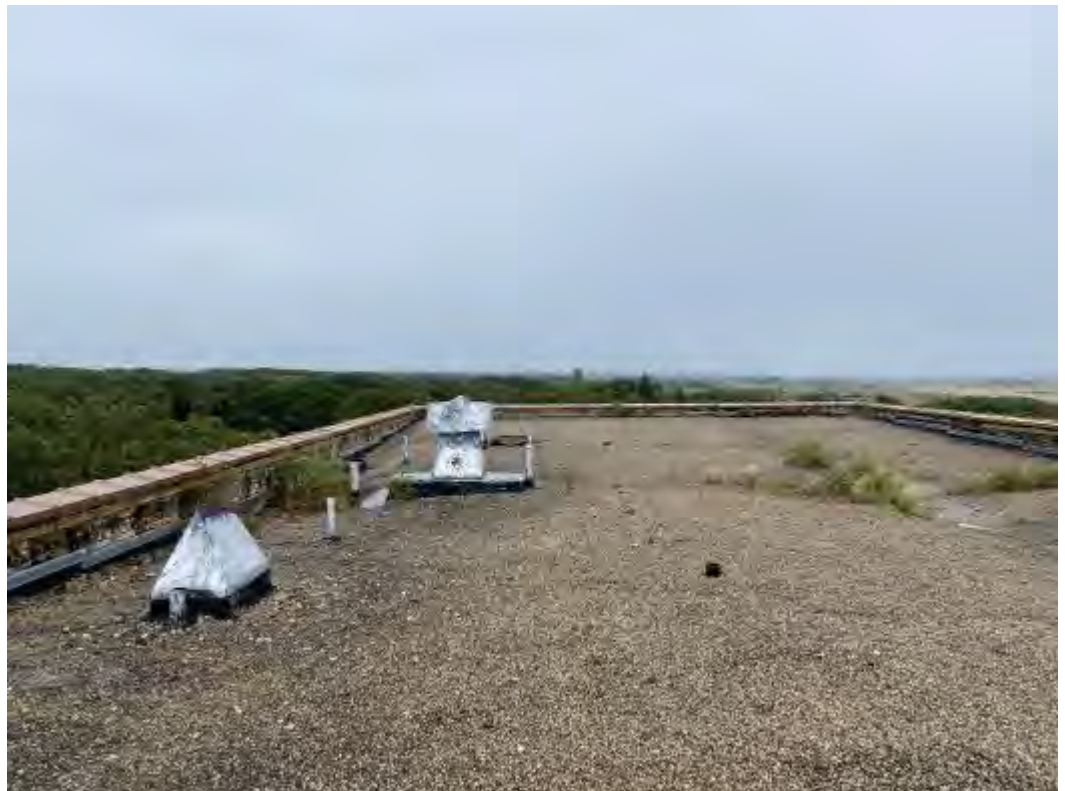
<b>Photo No.</b> <b>8</b>	<b>Date:</b> 08/14/2020
<b>Photo Coordinates</b>	
<b>Lat</b>	48.835442
<b>Long</b>	-100.041161
<b>Direction Photo Taken:</b> 155.53512575889	
<b>Description:</b>  Asbestos in roofing material and sealant.

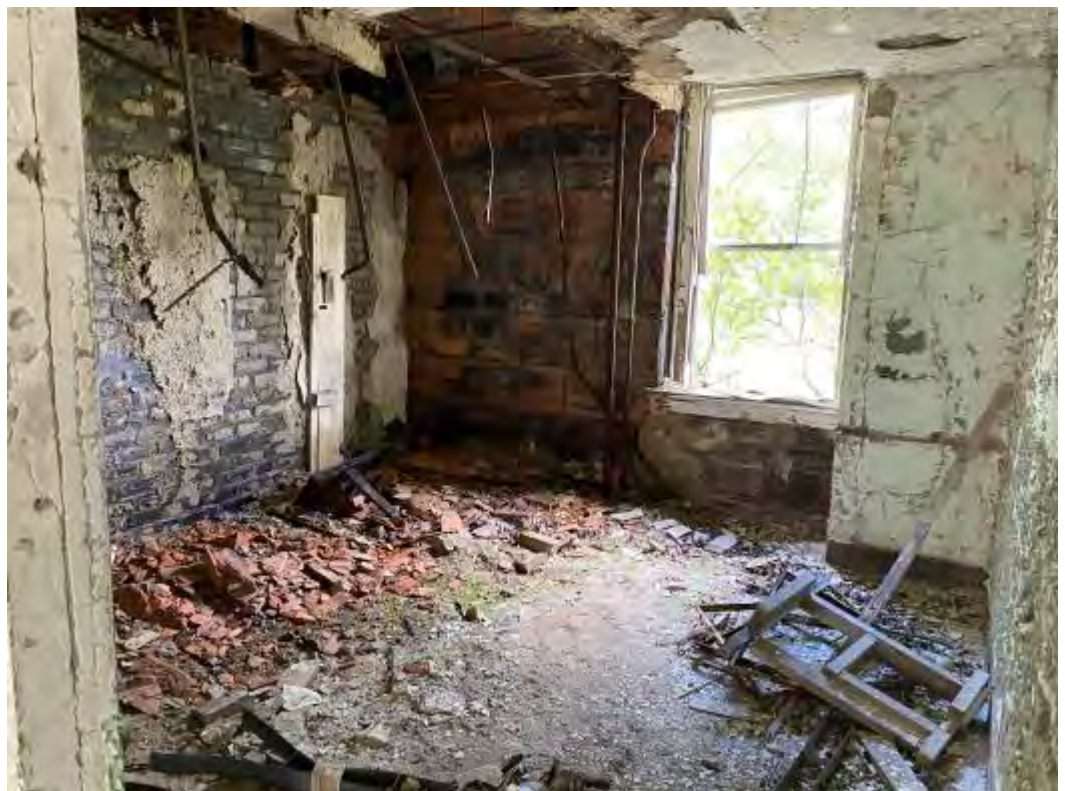
<b>Photo No.</b> <b>10</b>	<b>Date:</b> 08/14/2020
<b>Photo Coordinates</b>	
<b>Lat</b>	48.808978
<b>Long</b>	-100.067353
<b>Direction Photo Taken:</b> 305.209182736455	
<b>Description:</b>  Typical room in the building with water damage.

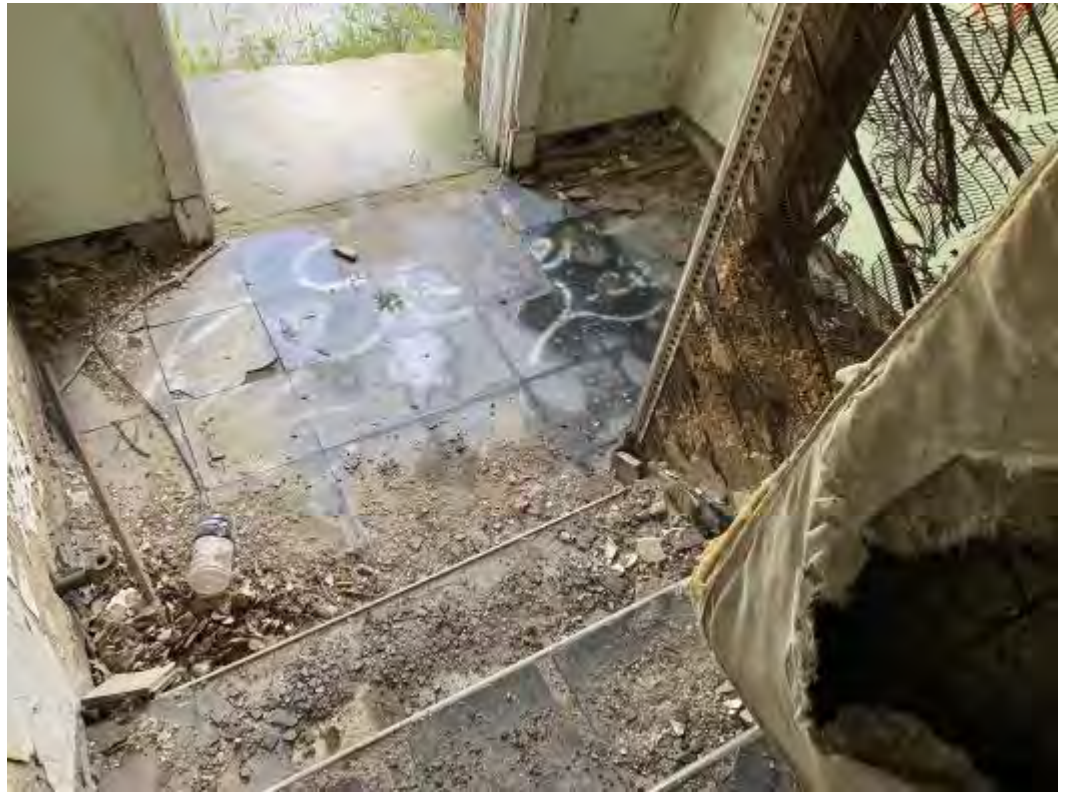
<b>Photo No.</b> <b>11</b>	<b>Date:</b> 08/14/2020
<b>Photo Coordinates</b>	
<b>Lat</b>	48.808978
<b>Long</b>	-100.067353
<b>Direction Photo Taken:</b> 31.3025207519531	
<b>Description:</b>  Asbestos in floor tile and mastic as well as the door caulk.

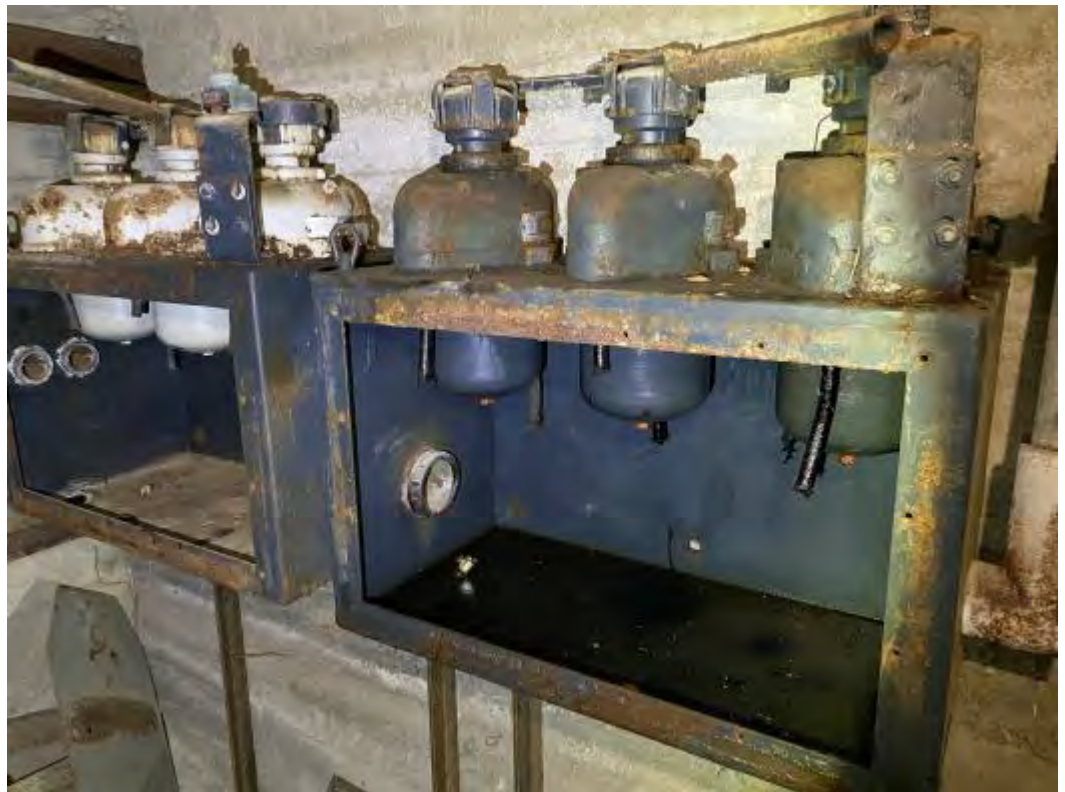
<b>Photo No.</b> <b>13</b>	<b>Date:</b> 08/14/2020
<b>Photo Coordinates</b>	
<b>Lat</b>	48.712094
<b>Long</b>	-99.982514
<b>Direction Photo Taken:</b> 321.679702970297	
<b>Description:</b>  Assumed to be a 3-phase PCB transformer located in the basement of the building.

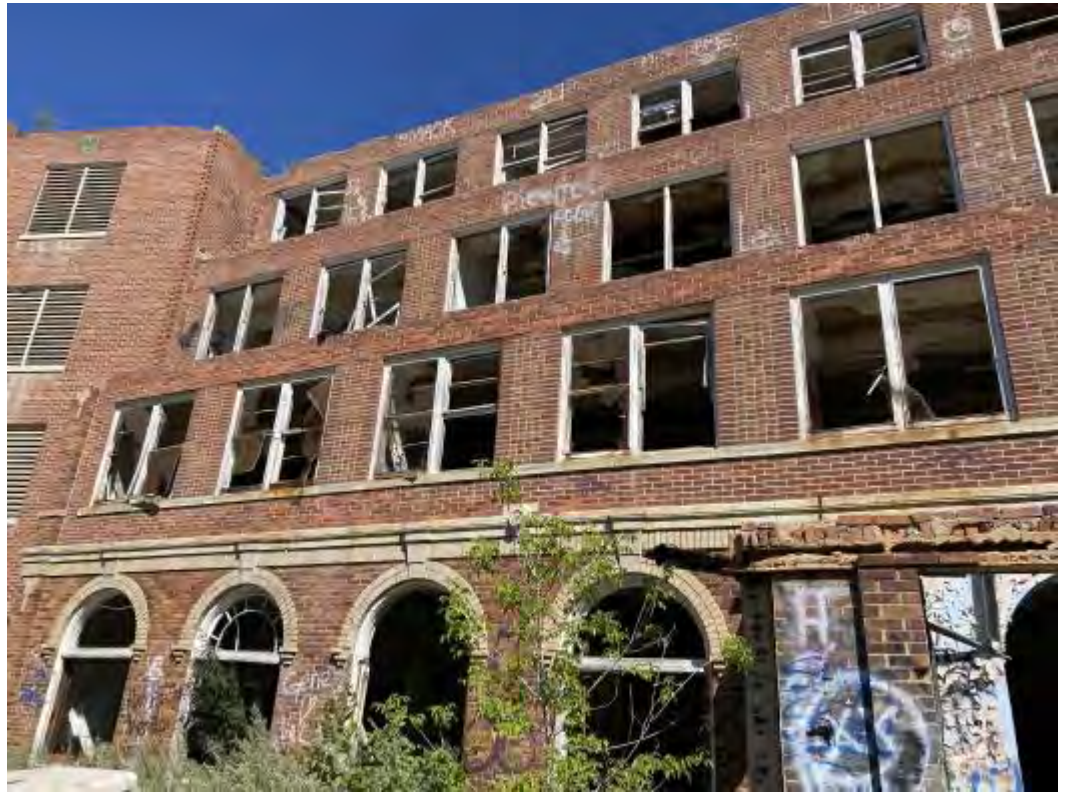
<b>Photo No.</b> <b>1</b>	<b>Date:</b> 08/17/2020
<b>Photo Coordinates</b>	
<b>Lat</b>	48.835208
<b>Long</b>	-100.041528
<b>Direction Photo Taken:</b> 349.373504652193	
<b>Description:</b>  Exterior of Building 2 with asbestos window glazing.

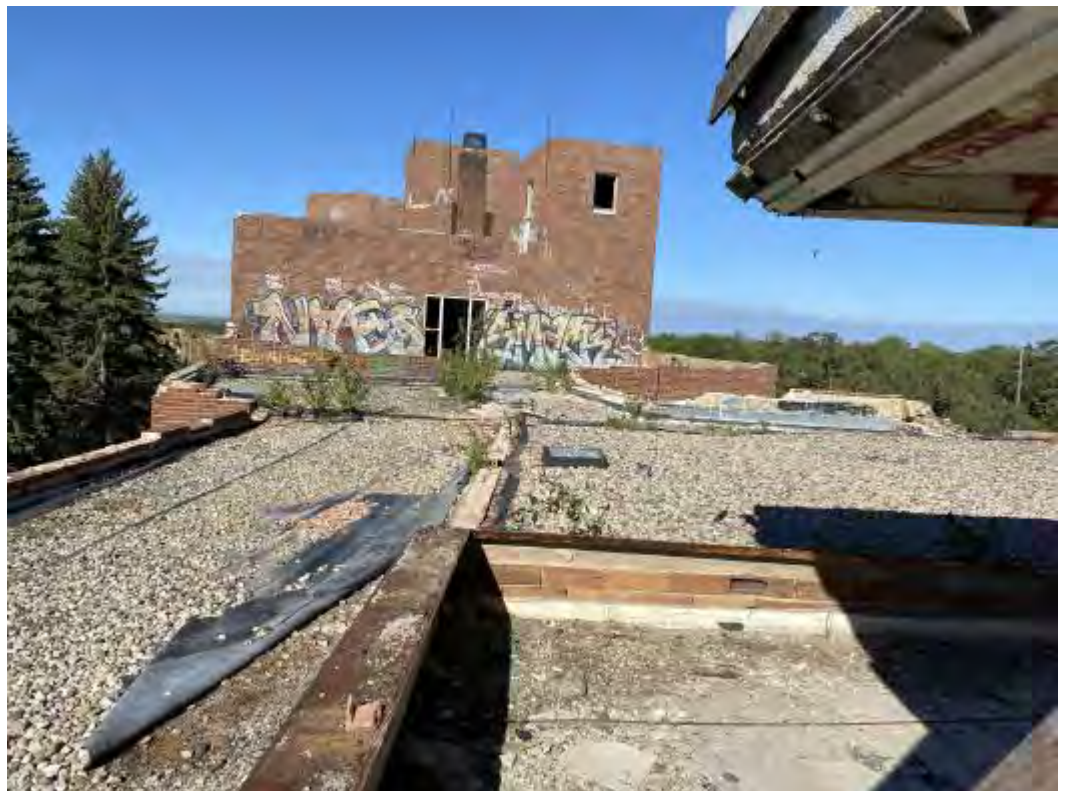
<b>Photo No.</b> <b>2</b>	<b>Date:</b> 08/16/2020
<b>Photo Coordinates</b>	
<b>Lat</b>	48.835275
<b>Long</b>	-100.041436
<b>Direction Photo Taken:</b> 296.079544046587	
<b>Description:</b>  Roof of building 2 with asbestos roofing sealant.

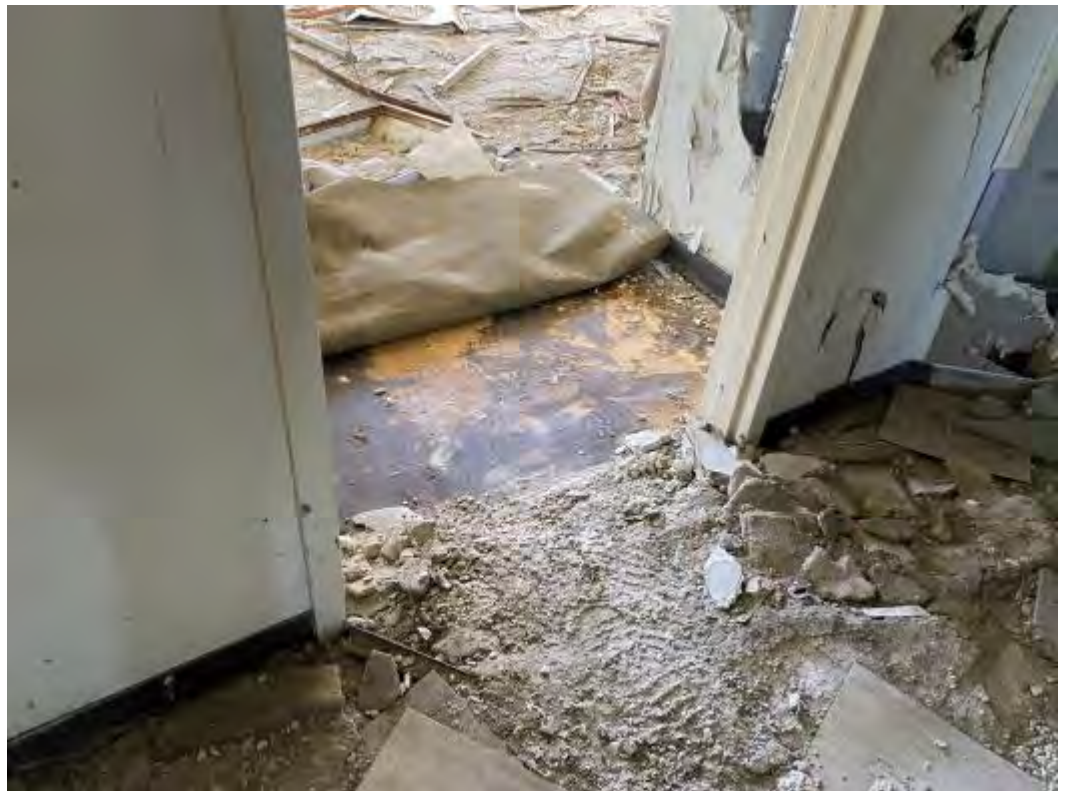
<b>Photo No.</b> <b>4</b>	<b>Date:</b> 08/16/2020
<b>Photo Coordinates</b>	
<b>Lat</b>	48.835369
<b>Long</b>	-100.041642
<b>Direction Photo Taken:</b> 234.318817204301	
<b>Description:</b>  Asbestos in black mastic on the 4 <sup>th</sup> floor.

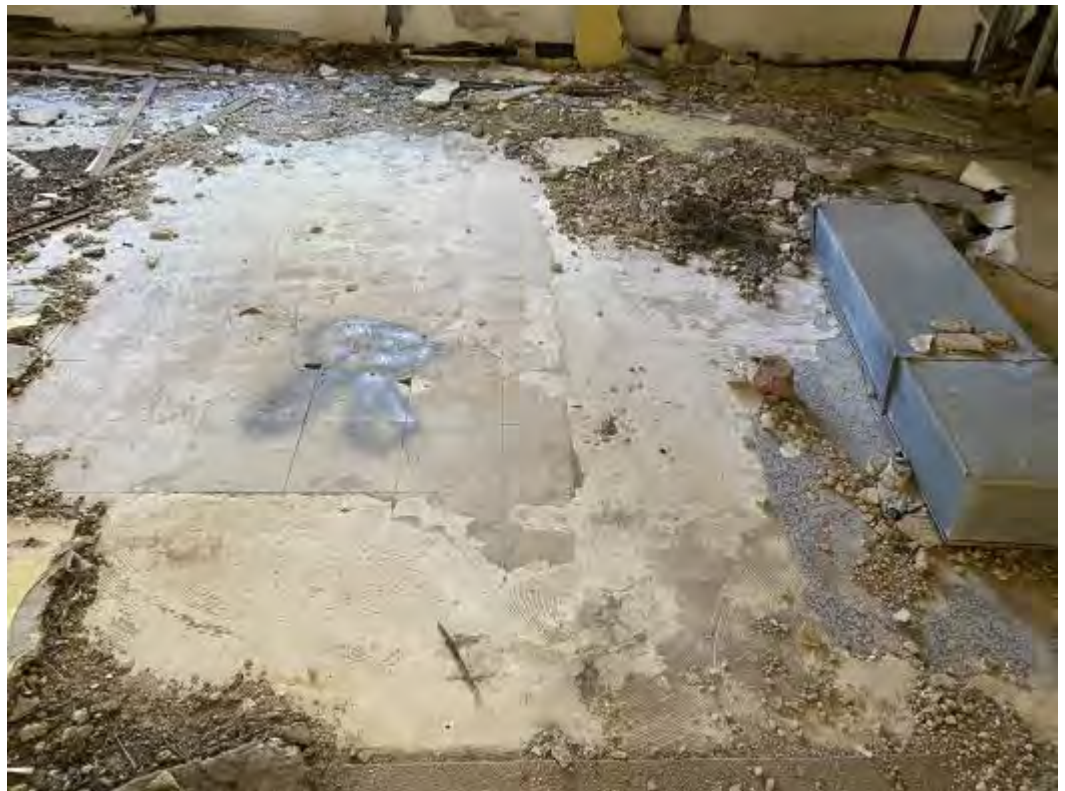
<b>Photo No.</b> <b>6</b>	<b>Date:</b> 08/16/2020
<b>Photo Coordinates</b>	
<b>Lat</b>	48.835311
<b>Long</b>	-100.04135
<b>Direction Photo Taken:</b> 347.583252190847	
<b>Description:</b>  Asbestos in floor tiles on the 3 <sup>rd</sup> floor.

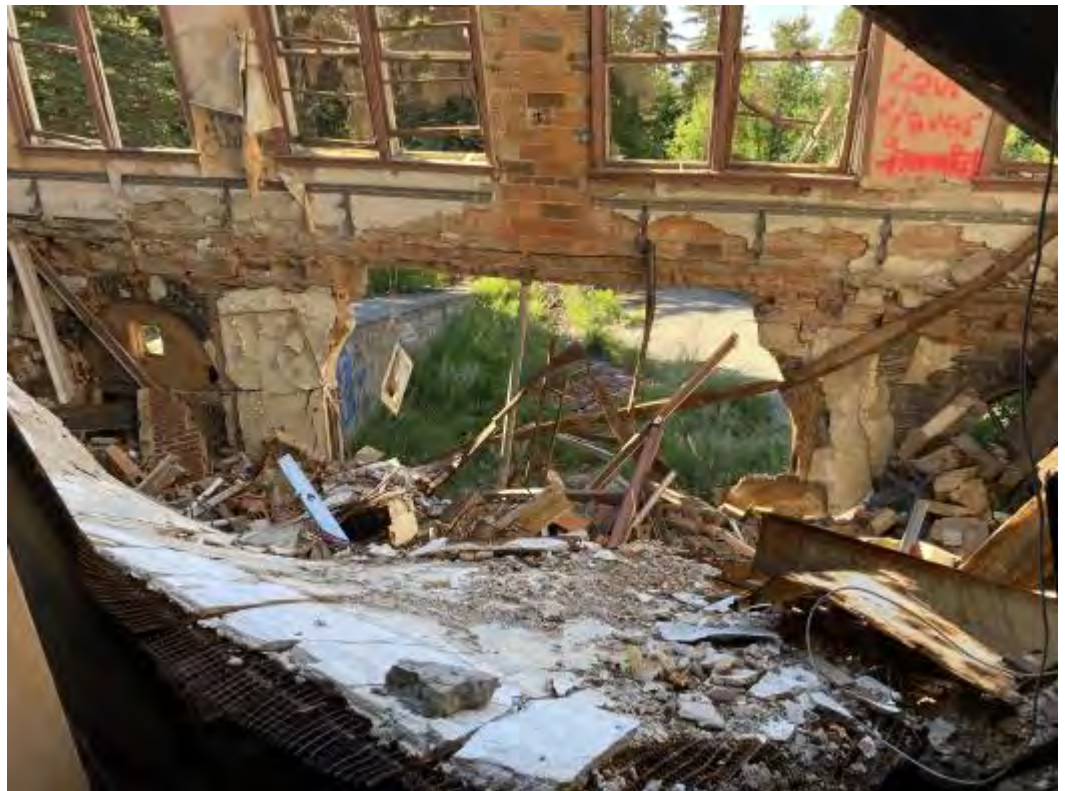
<b>Photo No.</b> <b>8</b>	<b>Date:</b> 08/17/2020
<b>Photo Coordinates</b>	
<b>Lat</b>	48.8087
<b>Long</b>	-100.066969
<b>Direction Photo Taken:</b> 132.345222369	
<b>Description:</b>  Collapsed portion of the building.

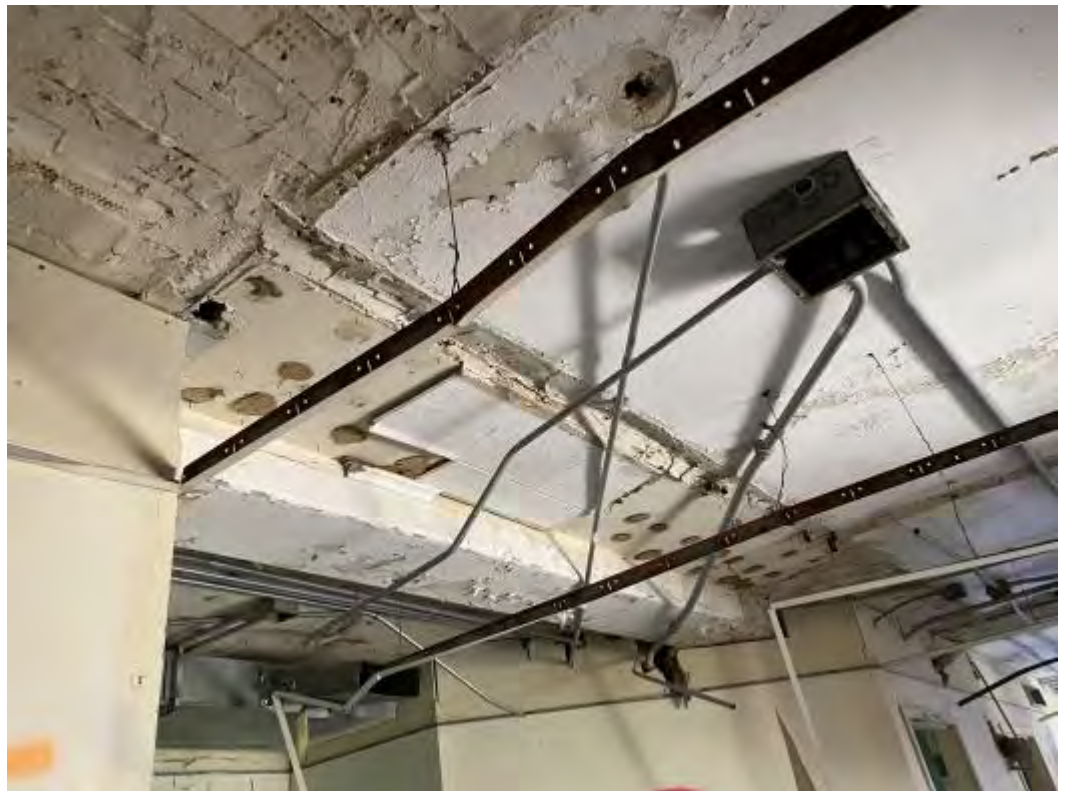
<b>Photo No.</b> <b>10</b>	<b>Date:</b> 08/17/2020
<b>Photo Coordinates</b>	
<b>Lat</b>	48.835358
<b>Long</b>	-100.041231
<b>Direction Photo Taken:</b> 74.816253628042	
<b>Description:</b>  Asbestos in residual glue pucks on the 2 <sup>nd</sup> floor.

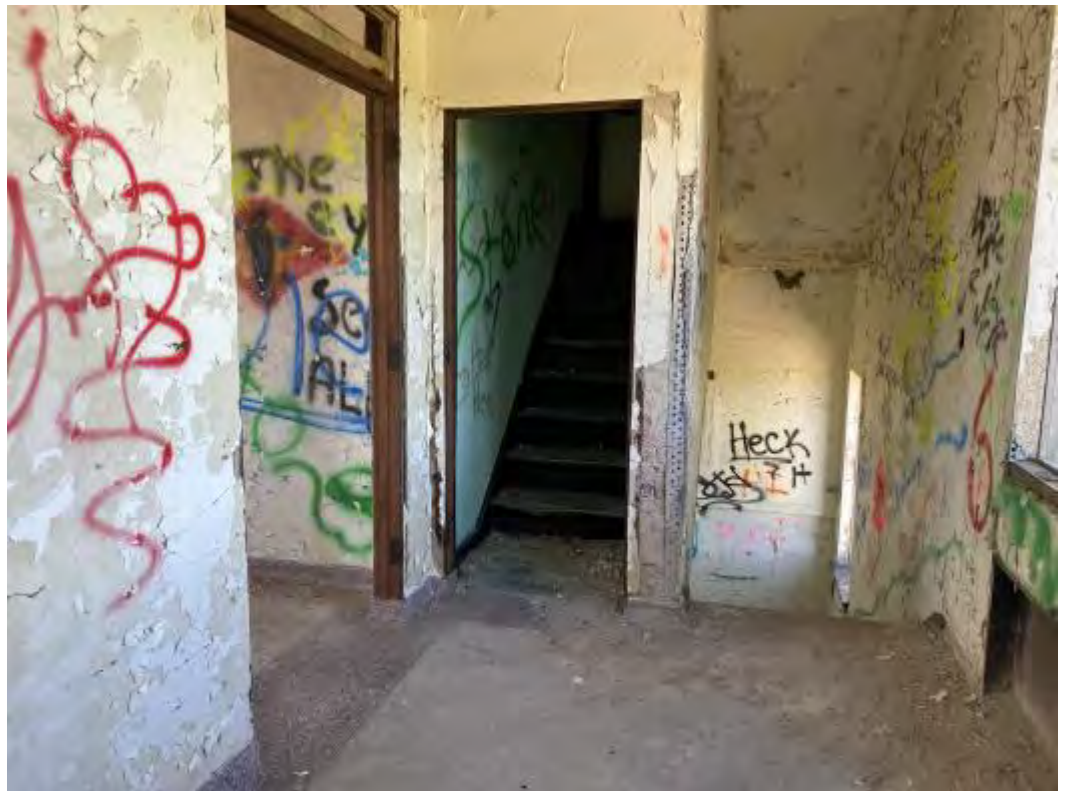
<b>Photo No.</b> <b>4</b>	<b>Date:</b> 08/17/2020
<b>Photo Coordinates</b>	
<b>Lat</b>	48.835342
<b>Long</b>	-100.0421
<b>Direction Photo Taken:</b> 258.572173913043	
<b>Description:</b>  Asbestos in stair treads going up to the elevator room.

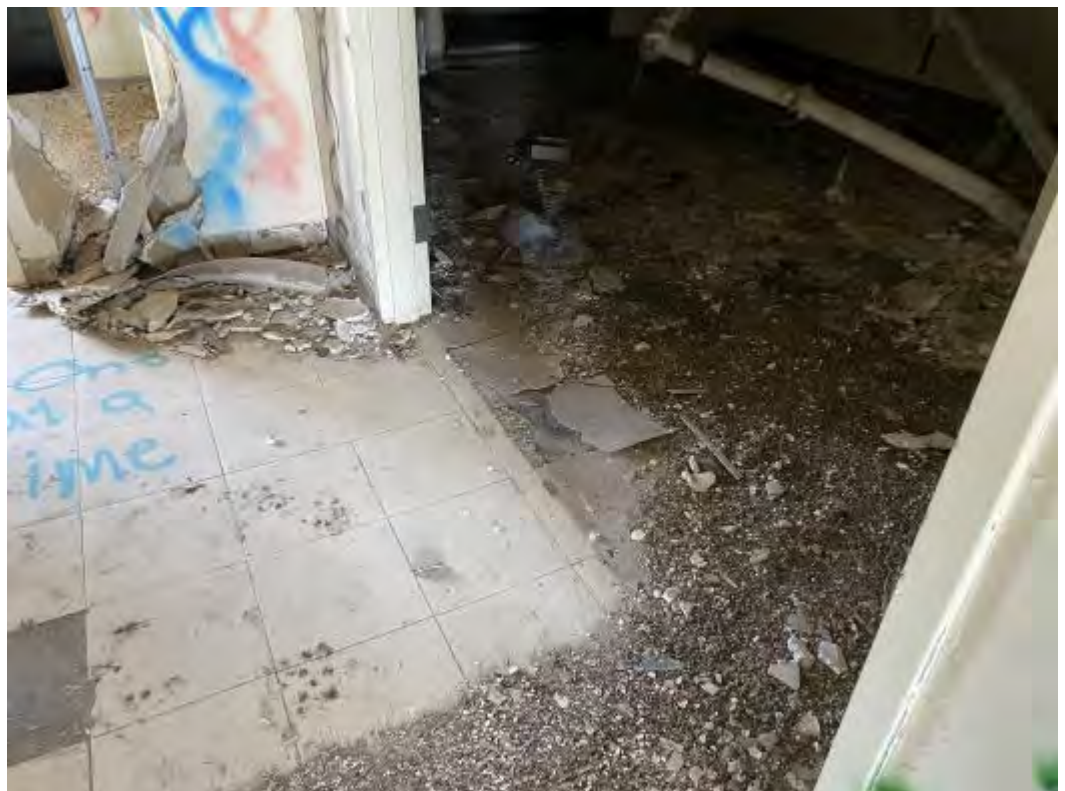
<b>Photo No.</b> <b>6</b>	<b>Date:</b> 08/17/2020
<b>Photo Coordinates</b>	
<b>Lat</b>	48.835319
<b>Long</b>	-100.042114
<b>Direction Photo Taken:</b> 60.0262451535938	
<b>Description:</b>  Asbestos in black mastic on the 6 <sup>th</sup> floor.

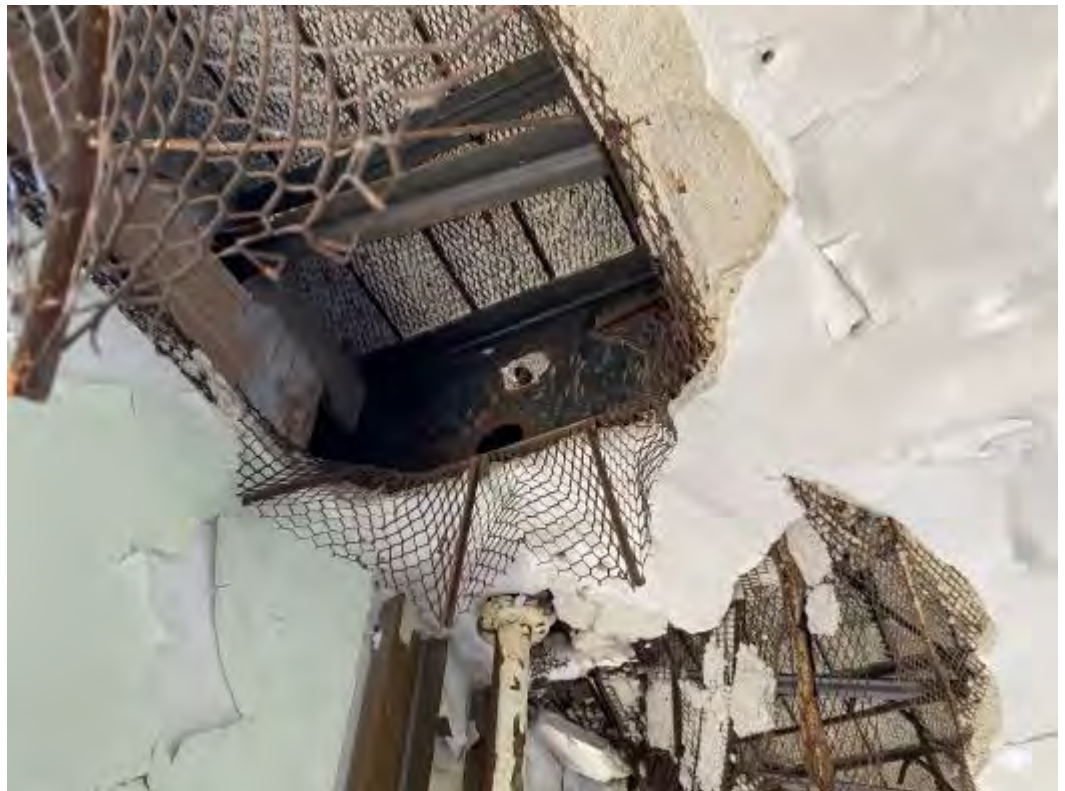
<b>Photo No.</b> <b>10</b>	<b>Date:</b> 08/17/2020
<b>Photo Coordinates</b>	
<b>Lat</b>	48.835208
<b>Long</b>	-100.041992
<b>Direction Photo Taken:</b> 60.0262451535938	
<b>Description:</b>  Air cell inside beam.

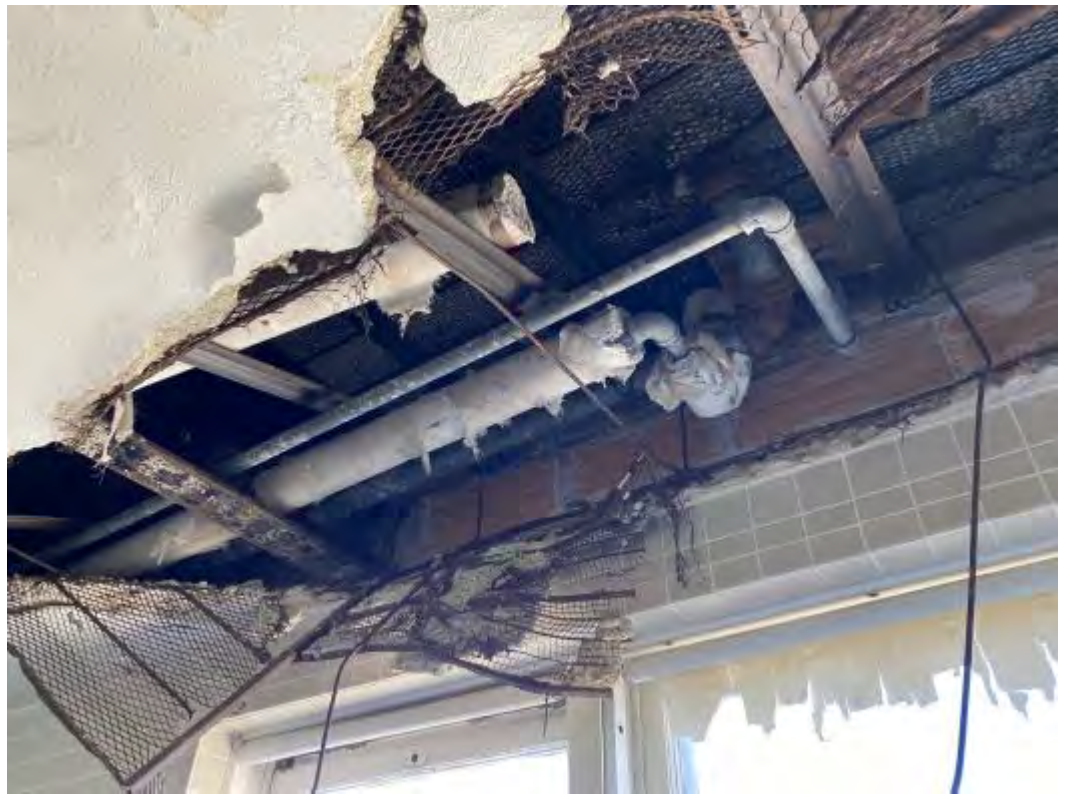
<b>Photo No.</b> <b>11</b>	<b>Date:</b> 08/17/2020
<b>Photo Coordinates</b>	
<b>Lat</b>	48.835361
<b>Long</b>	-100.041978
<b>Direction Photo Taken:</b> 60.0262451535938	
<b>Description:</b>  Air cell pipe insulation.

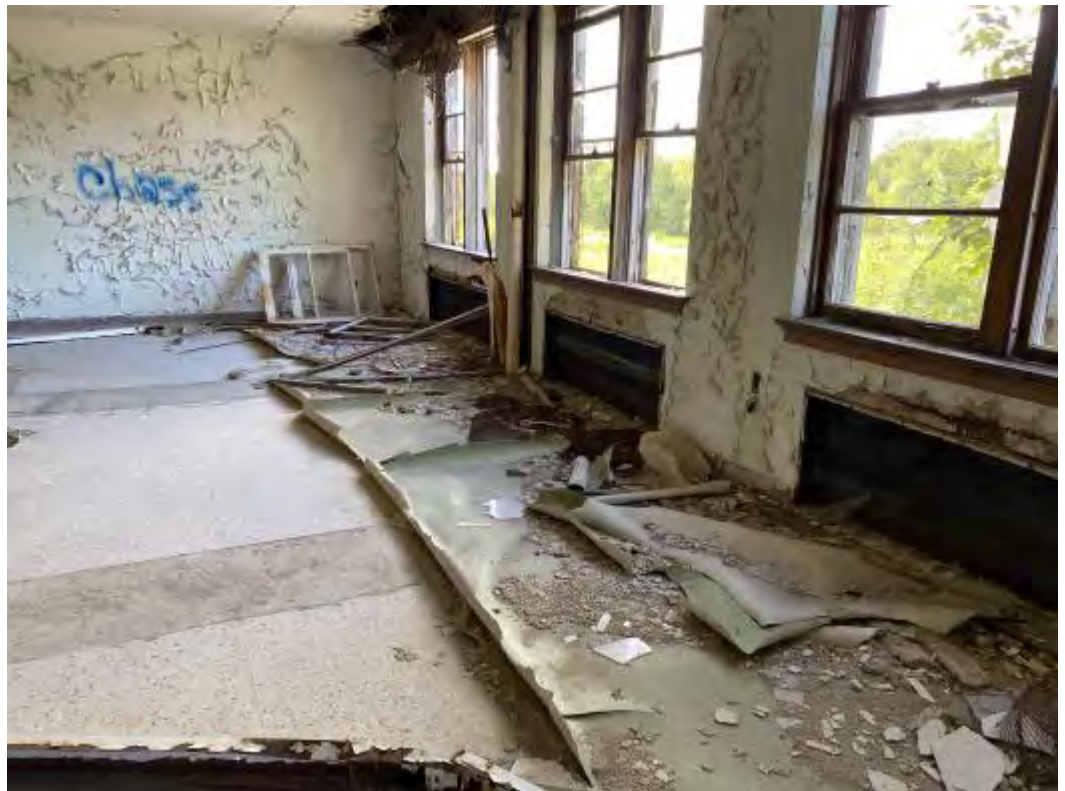
<b>Photo No.</b> <b>12</b>	<b>Date:</b> 08/17/2020
<b>Photo Coordinates</b>	
<b>Lat</b>	48.835336
<b>Long</b>	-100.042389
<b>Direction Photo Taken:</b> 60.0262451535938	
<b>Description:</b>  Asbestos in linoleum on the 4 <sup>th</sup> floor.

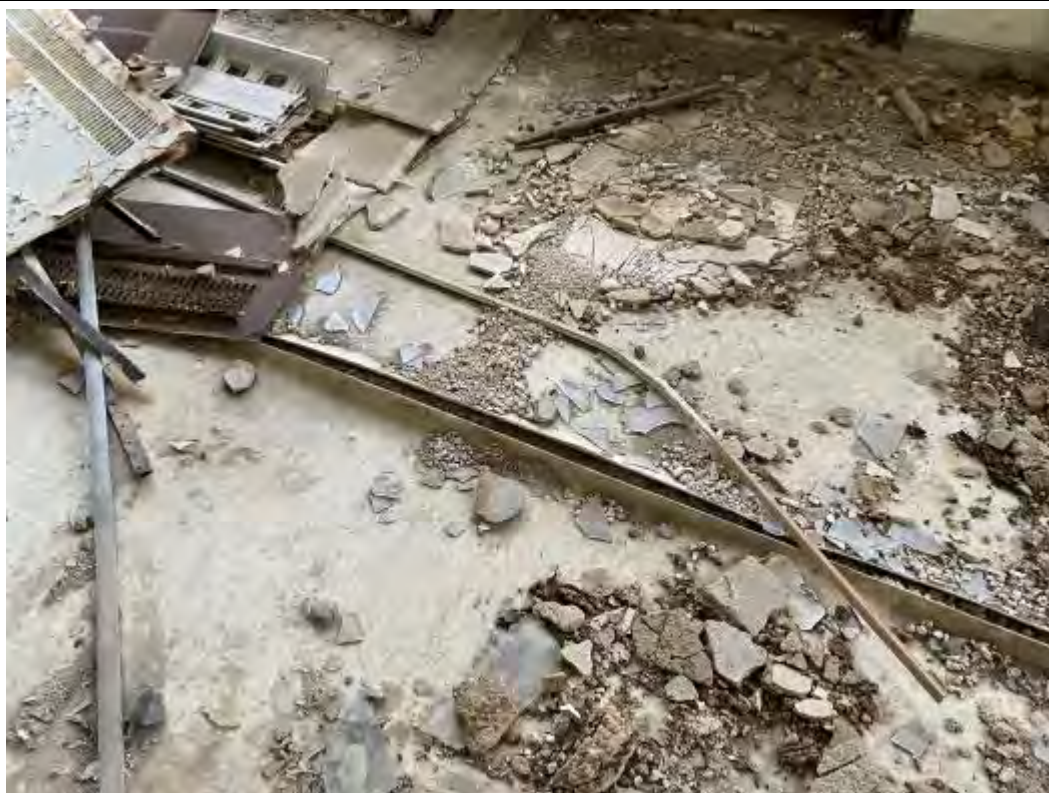
<b>Photo No.</b> <b>13</b>	<b>Date:</b> 08/18/2020
<b>Photo Coordinates</b>	
<b>Lat</b>	48.835236
<b>Long</b>	-100.042375
<b>Direction Photo Taken:</b>	
<b>Description:</b>  Asbestos in linoleum on the 3 <sup>rd</sup> floor.

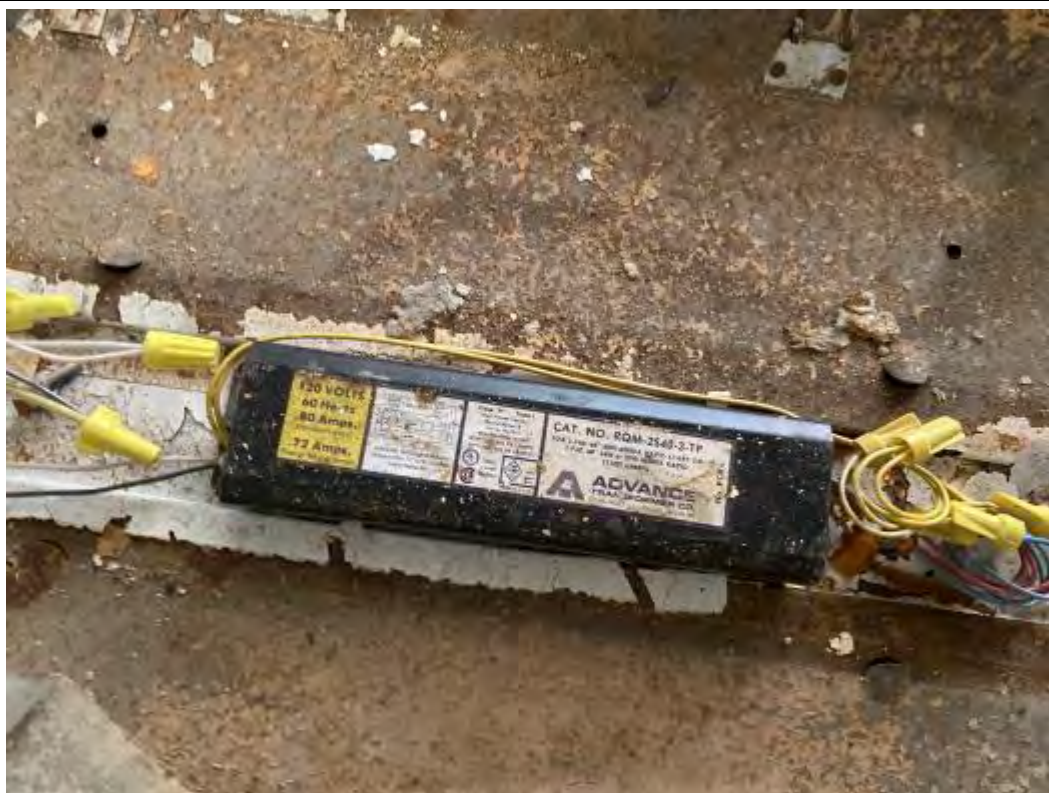
<b>Photo No.</b> <b>14</b>	<b>Date:</b> 08/18/2020
<b>Photo Coordinates</b>	
<b>Lat</b>	48.808769
<b>Long</b>	-100.067664
<b>Direction Photo Taken:</b>	
<b>Description:</b>  Ballast with a No PCB's label.

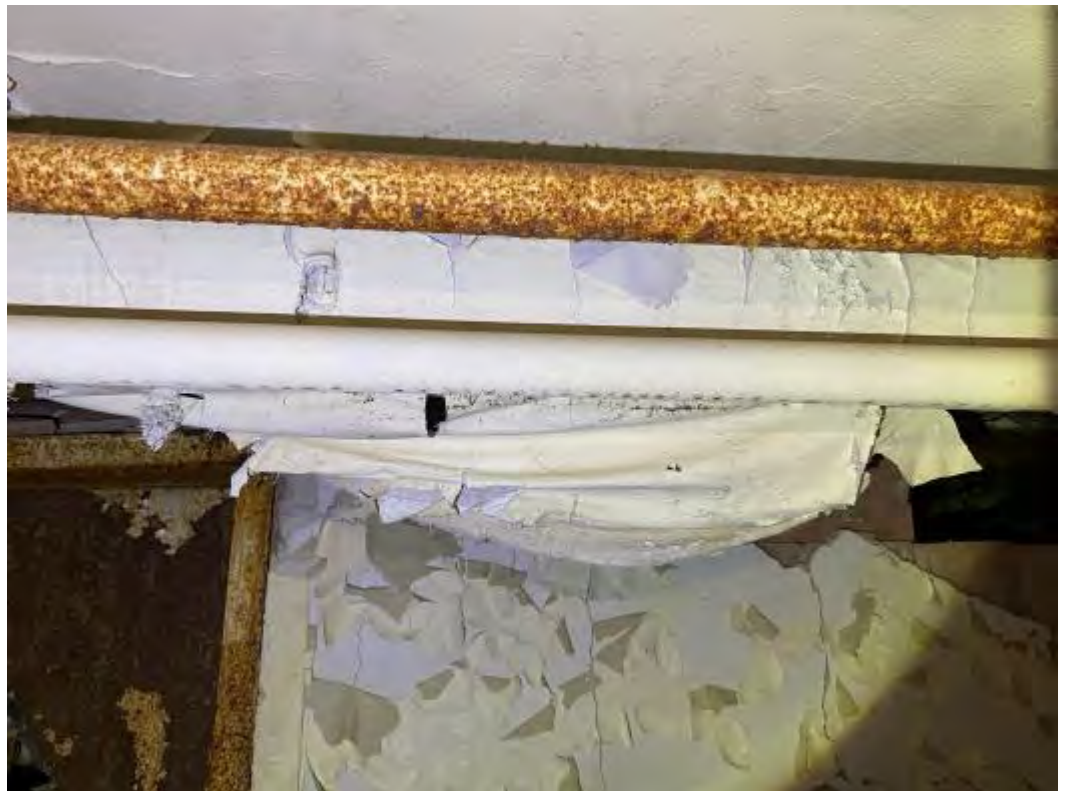
<b>Photo No.</b> <b>16</b>	<b>Date:</b> 08/18/2020
<b>Photo Coordinates</b>	
<b>Lat</b>	48.808769
<b>Long</b>	-100.067664
<b>Direction Photo Taken:</b>	
<b>Description:</b>  Air cell pipe insulation in the basement.

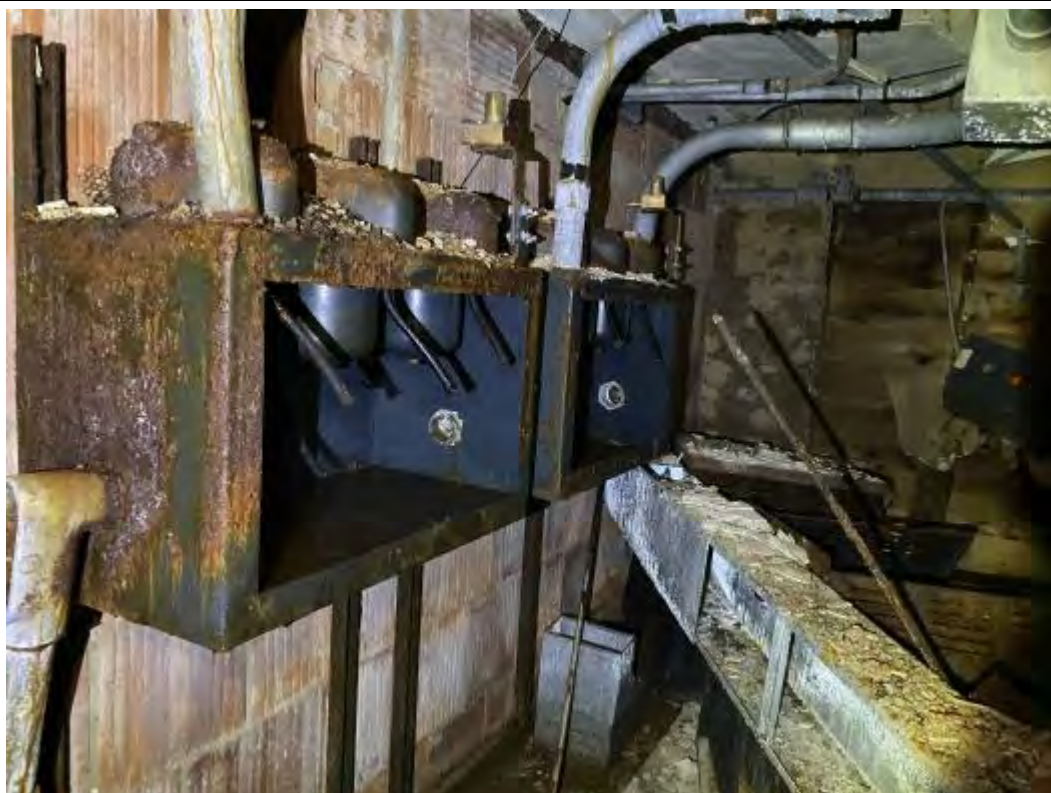
<b>Photo No.</b> <b>17</b>	<b>Date:</b> 08/18/2020
<b>Photo Coordinates</b>	
<b>Lat</b>	48.808769
<b>Long</b>	-100.067664
<b>Direction Photo Taken:</b>	
<b>Description:</b>  Assumed to be a 3-phase PCB transformer located in the basement of the building.

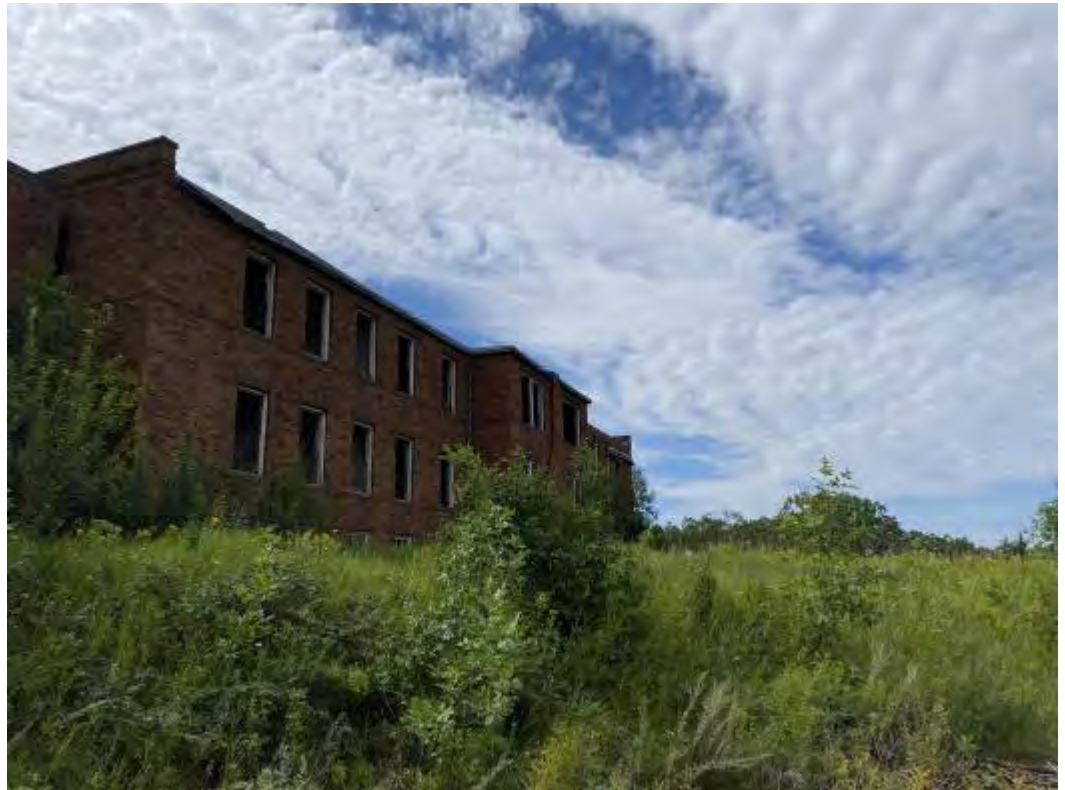
<b>Photo No.</b> <b>1</b>	<b>Date:</b> 08/15/2020
<b>Photo Coordinates</b>	
<b>Lat</b>	48.835311
<b>Long</b>	-100.042642
<b>Direction Photo Taken:</b> 200.762893503014	
<b>Description:</b>  Exterior of building 4 with asbestos in window caulk.

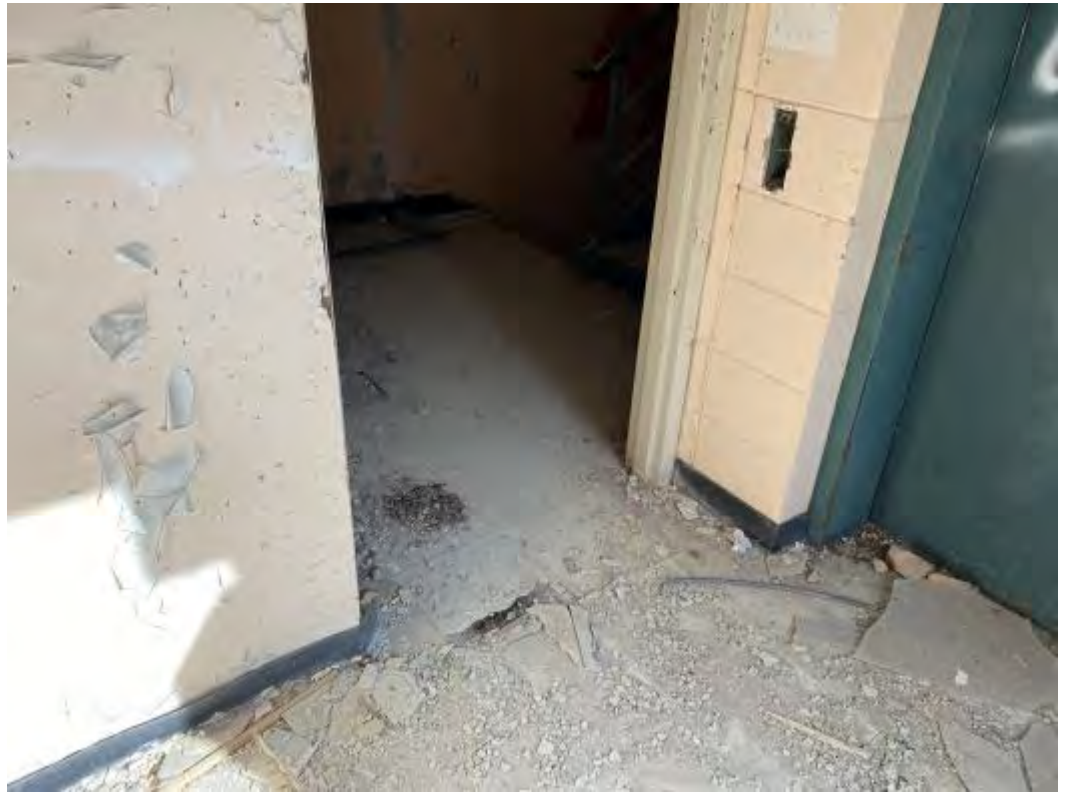
<b>Description:</b>  Asbestos in floor tile mastic in the stairwell.
--

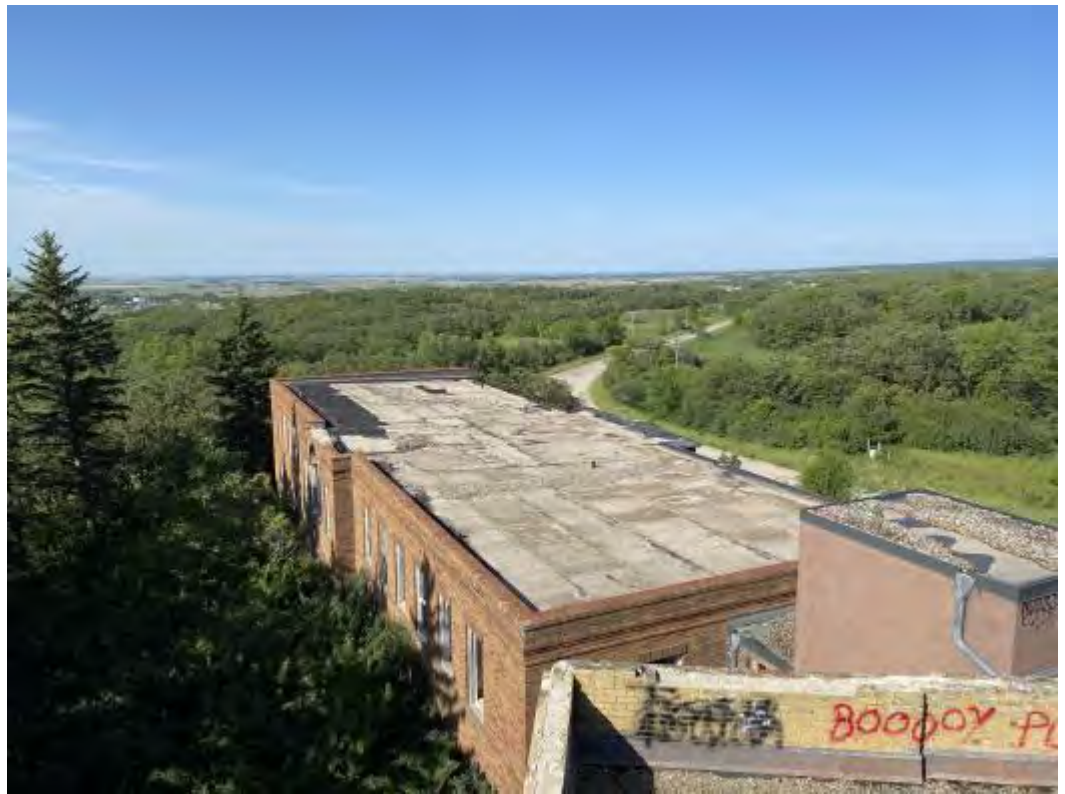
<b>Photo No.</b> <b>5</b>	<b>Date:</b> 08/15/2020
<b>Photo Coordinates</b>	
<b>Lat</b>	48.835175
<b>Long</b>	-100.042381
<b>Direction Photo Taken:</b> 238.255752794214	
<b>Description:</b>  Asbestos in roofing sealant.
