**PHASE II ENVIRONMENTAL SITE ASSESSMENT  
FOR  
SAN HAVEN  
DUNSEITH, ROULETTE COUNTY, NORTH DAKOTA  
TURTLE MOUNTAIN BAND OF CHIPPEWA INDIANS  
RESERVATION**

Date Prepared	October 2020
TDD No.	0003/2006-05
Document Control No.	W0820.1A.02377
Contract No.	EP-S8-13-01
U.S. EPA Work Assignment Manager	Ted Lanzano

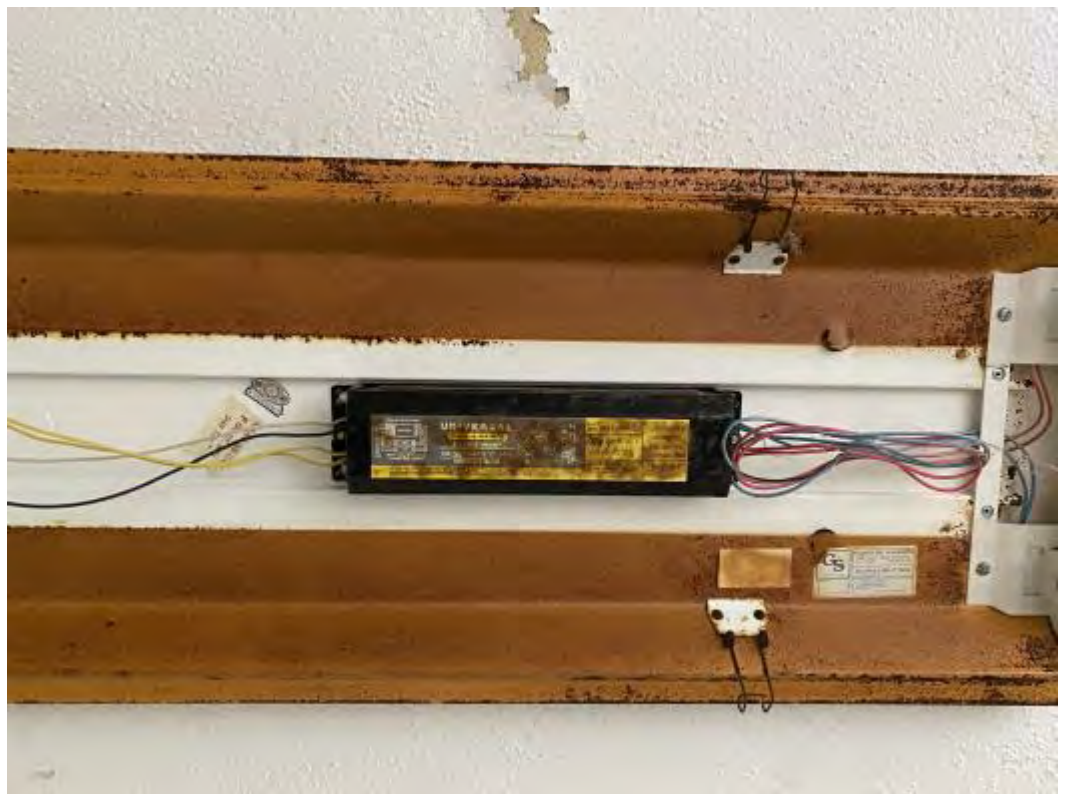
<b>Photo No.</b> <b>7</b>	<b>Date:</b> 08/15/2020
<b>Photo Coordinates</b>	
<b>Lat</b>	48.808978
<b>Long</b>	-100.067353
<b>Direction Photo Taken:</b> 294.70135501355	
<b>Description:</b>  Ballast with a No PCB's label.

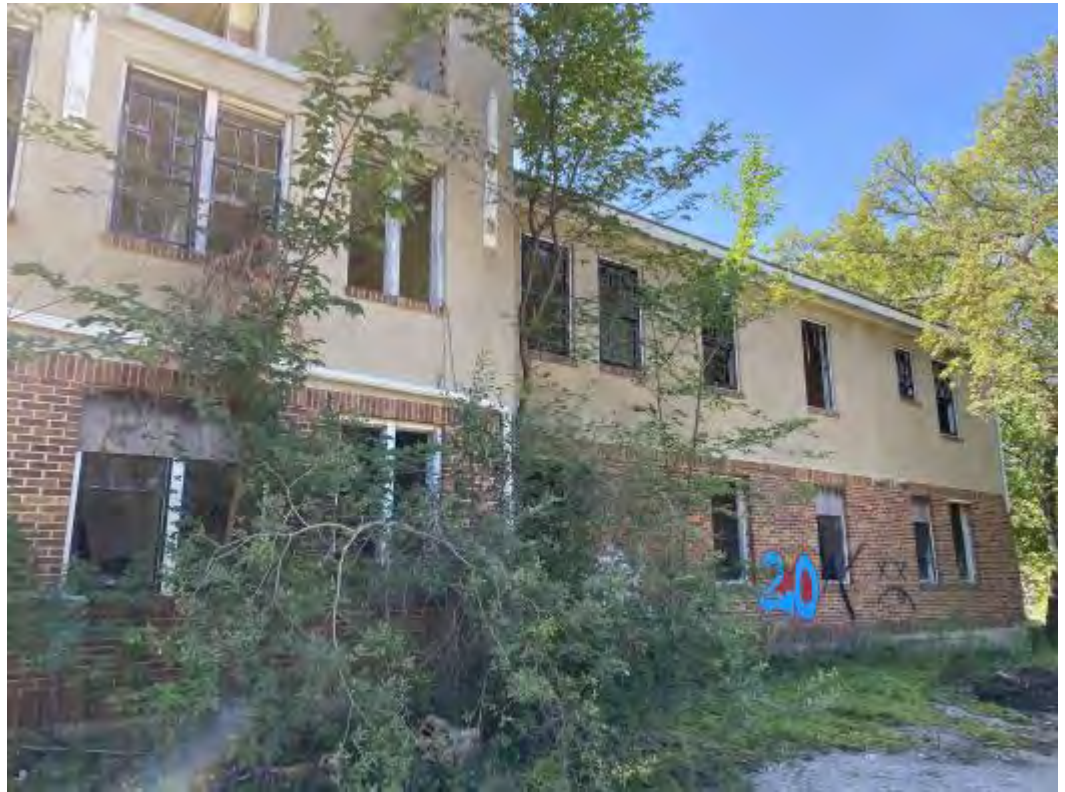
<b>Photo No.</b> <b>1</b>	<b>Date:</b> 08/19/2020
<b>Photo Coordinates</b>	
<b>Lat</b>	48.834208
<b>Long</b>	-100.04245
<b>Direction Photo Taken:</b> 209.37657920311	
<b>Description:</b>  Exterior of building 5 with asbestos window caulk.

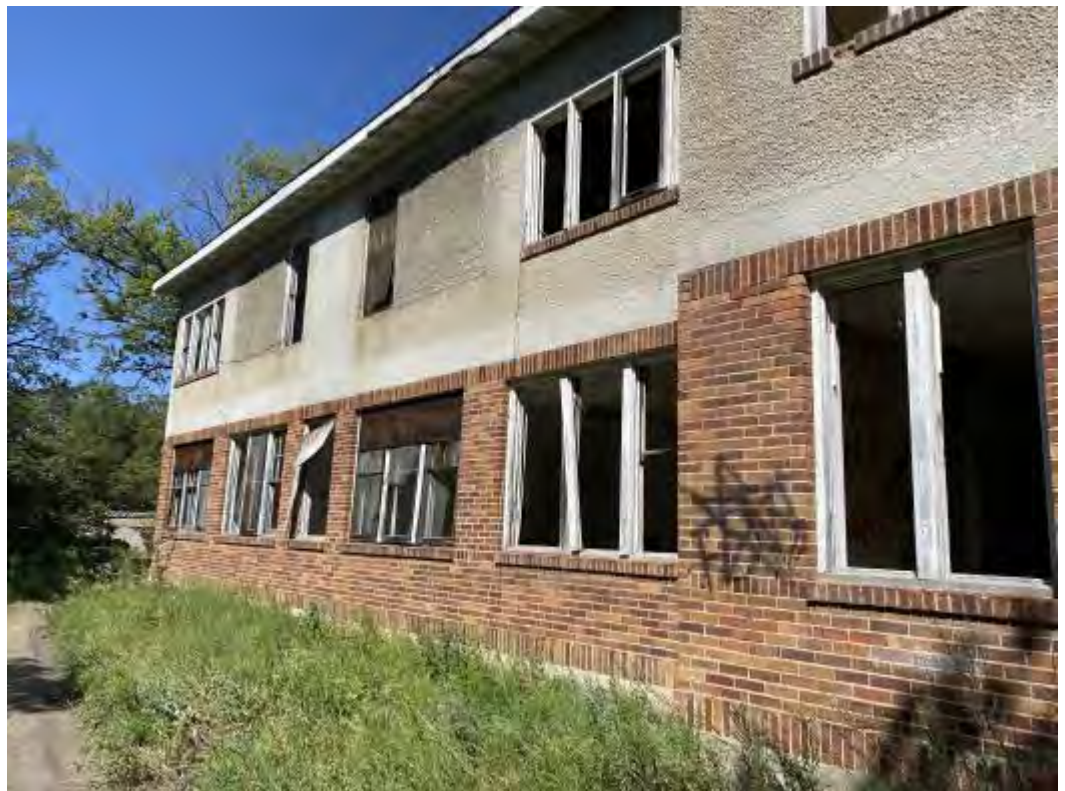
<b>Photo No.</b> <b>2</b>	<b>Date:</b> 08/19/2020
<b>Photo Coordinates</b>	
<b>Lat</b>	48.833936
<b>Long</b>	-100.042389
<b>Direction Photo Taken:</b> 297.572326660156	
<b>Description:</b>  Exterior of building 5 with asbestos window caulk.

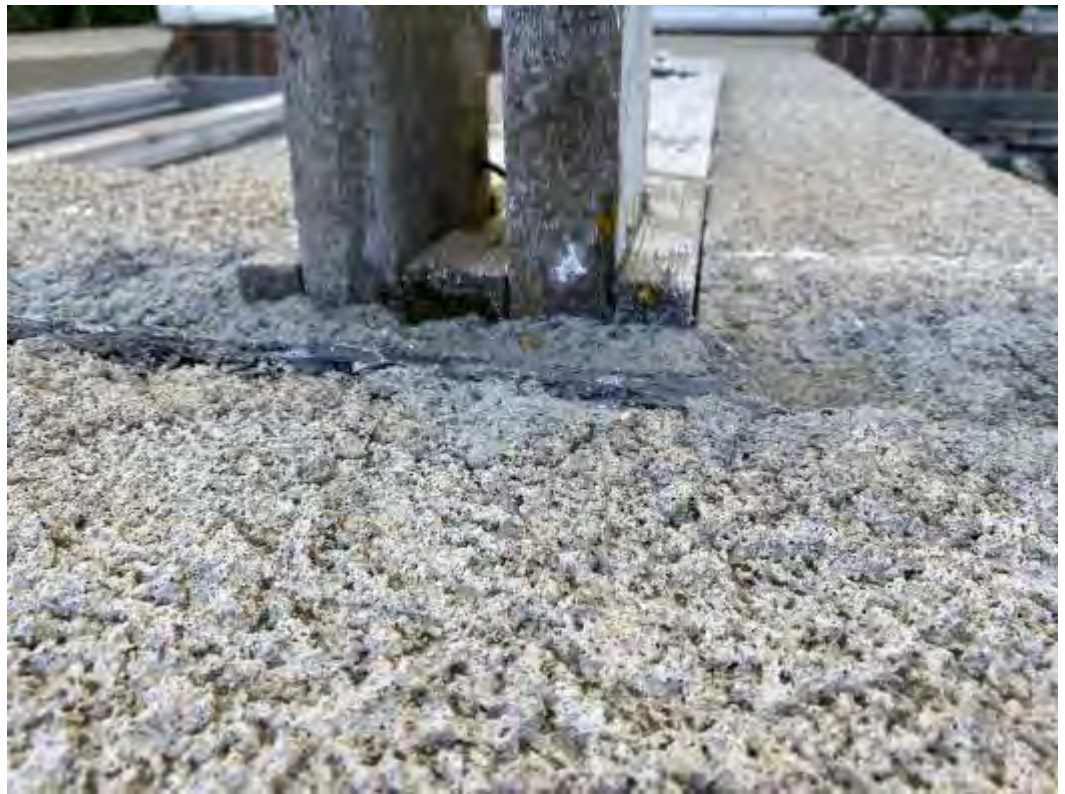
<b>Photo No.</b> <b>3</b>	<b>Date:</b> 08/18/2020
<b>Photo Coordinates</b>	
<b>Lat</b>	48.834208
<b>Long</b>	-100.042481
<b>Direction Photo Taken:</b>	
<b>Description:</b>  Asbestos in caulking on the 3 <sup>rd</sup> floor.

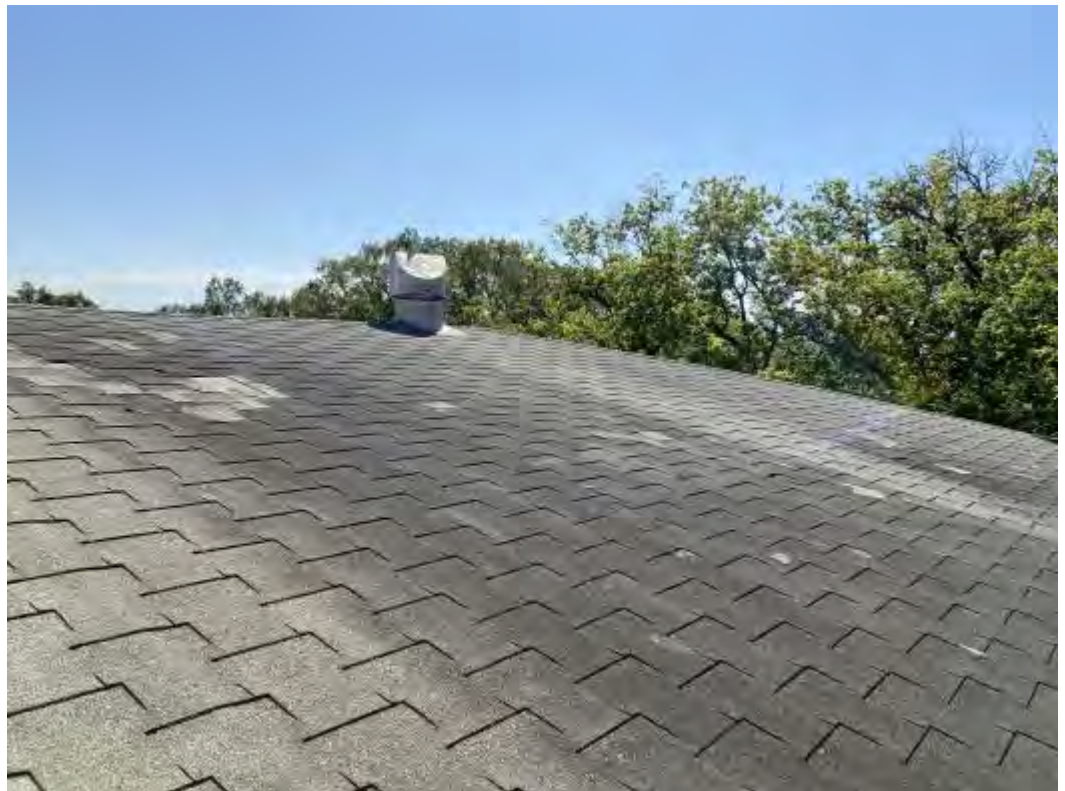
<b>Photo No.</b> <b>4</b>	<b>Date:</b> 08/18/2020
<b>Photo Coordinates</b>	
<b>Lat</b>	48.834244
<b>Long</b>	-100.042481
<b>Direction Photo Taken:</b>	
<b>Description:</b>  Asbestos in sealant around duct.

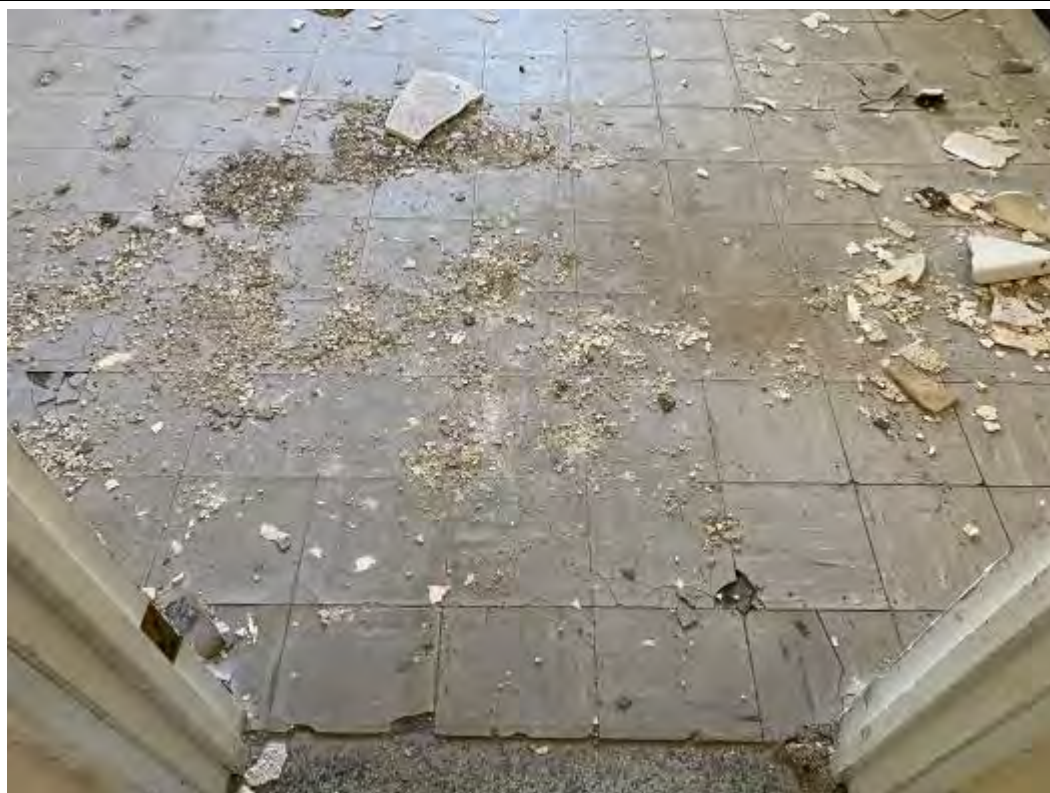
<b>Photo No.</b> <b>6</b>	<b>Date:</b> 08/19/2020
<b>Photo Coordinates</b>	
<b>Lat</b>	48.834014
<b>Long</b>	-100.042586
<b>Direction Photo Taken:</b> 335.122375524895	
<b>Description:</b>  Asbestos floor tiles on the 2 <sup>nd</sup> floor.

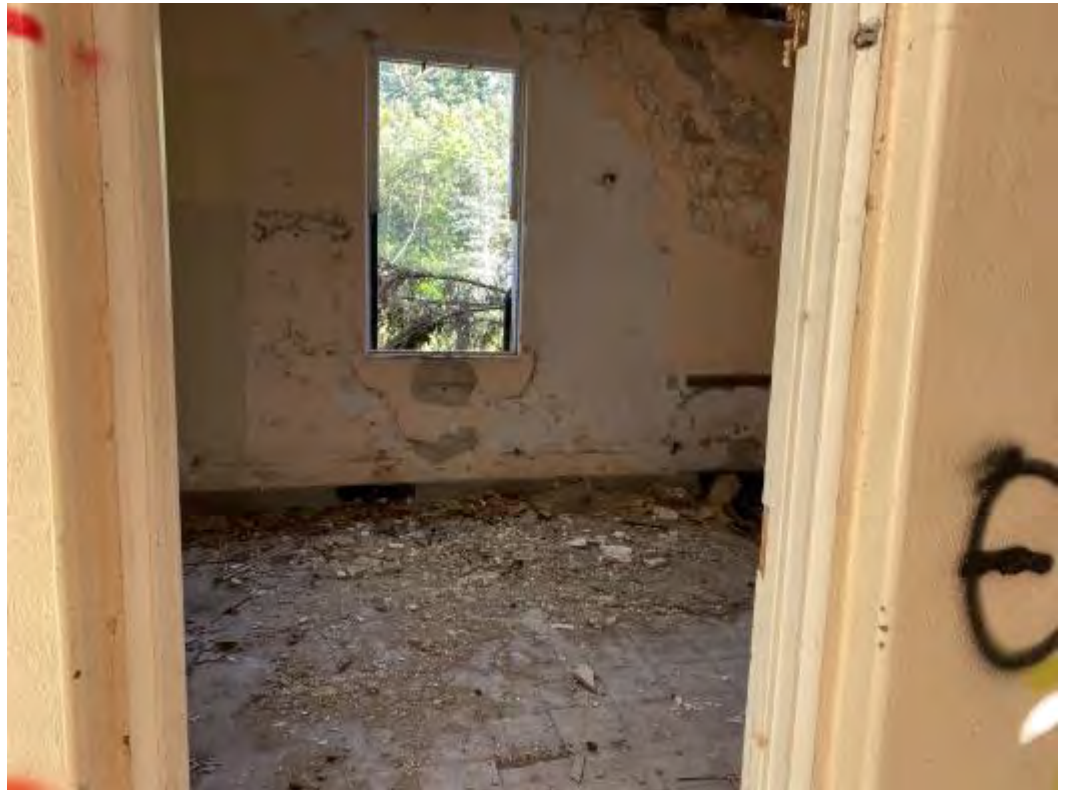
<b>Photo No.</b> <b>7</b>	<b>Date:</b> 08/19/2020
<b>Photo Coordinates</b>	
<b>Lat</b>	48.834031
<b>Long</b>	-100.042314
<b>Direction Photo Taken:</b> 338.833358790286	
<b>Description:</b>  Asbestos floor tiles on the 2 <sup>nd</sup> floor.

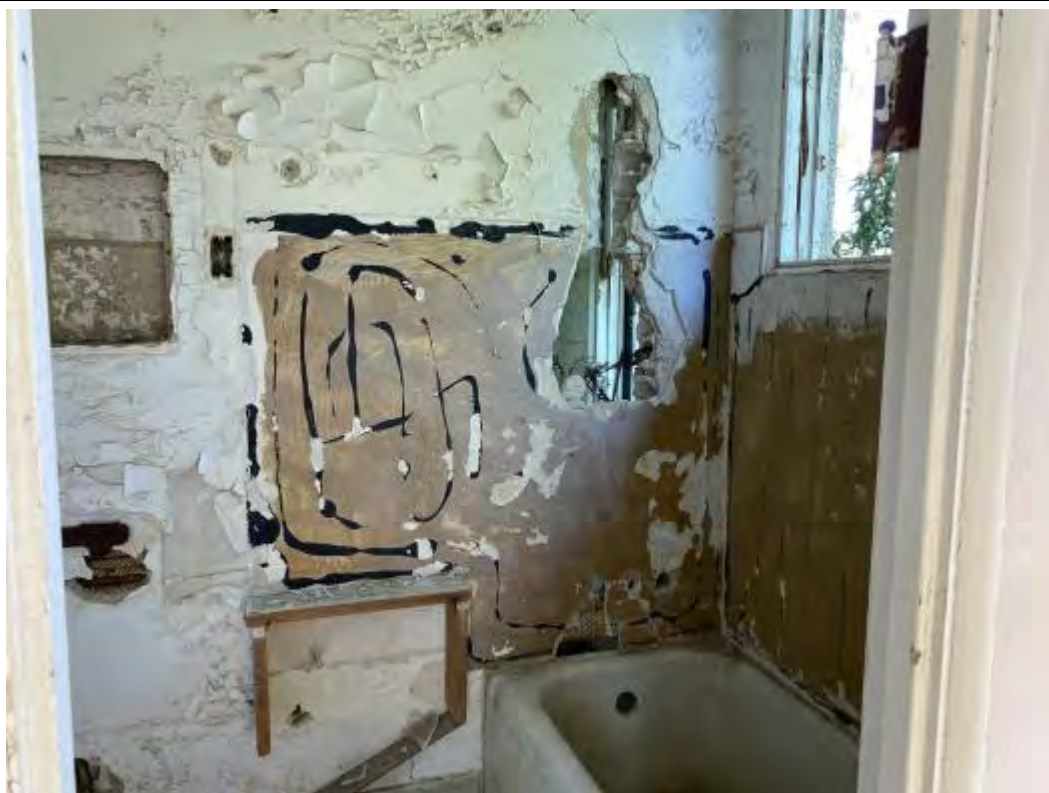
<b>Photo No.</b> <b>9</b>	<b>Date:</b> 08/19/2020
<b>Photo Coordinates</b>	
<b>Lat</b>	48.834081
<b>Long</b>	-100.042228
<b>Direction Photo Taken:</b> 236.483855872719	
<b>Description:</b>  Asbestos in mastic on the 2 <sup>nd</sup> floor.

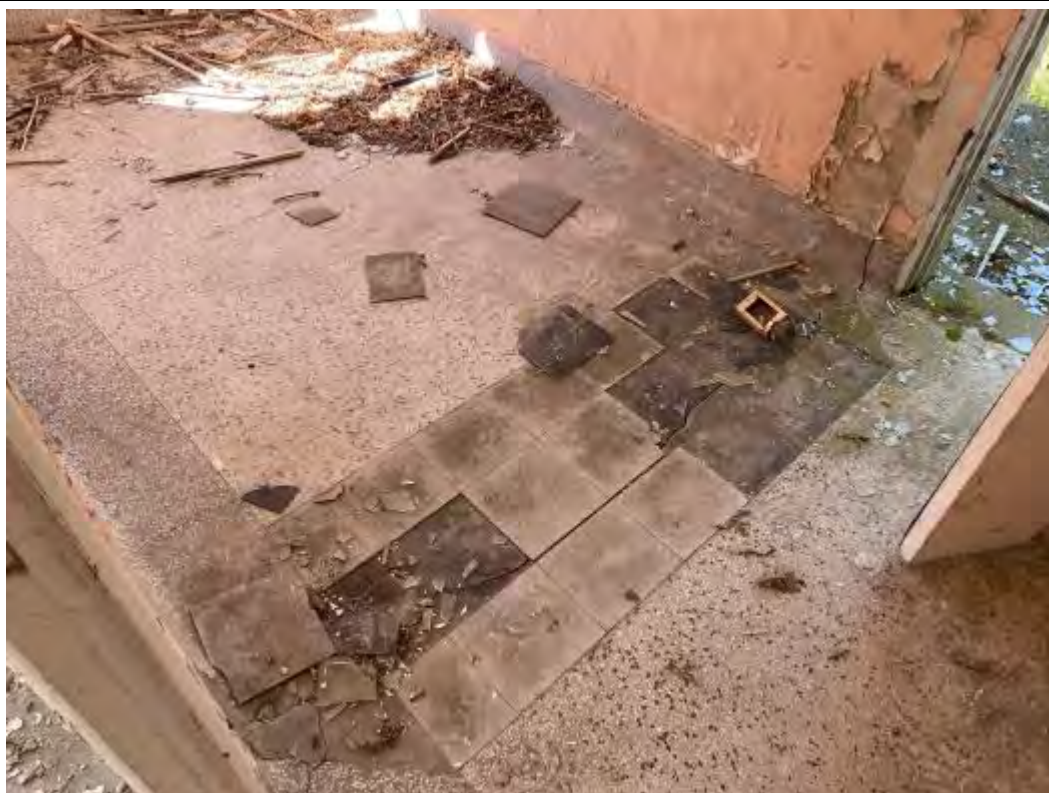
<b>Photo No.</b> <b>10</b>	<b>Date:</b> 08/19/2020
<b>Photo Coordinates</b>	
<b>Lat</b>	48.808769
<b>Long</b>	-100.067664
<b>Direction Photo Taken:</b> 69.6900634249471	
<b>Description:</b>  Asbestos floor tiles on the 1 <sup>st</sup> floor.

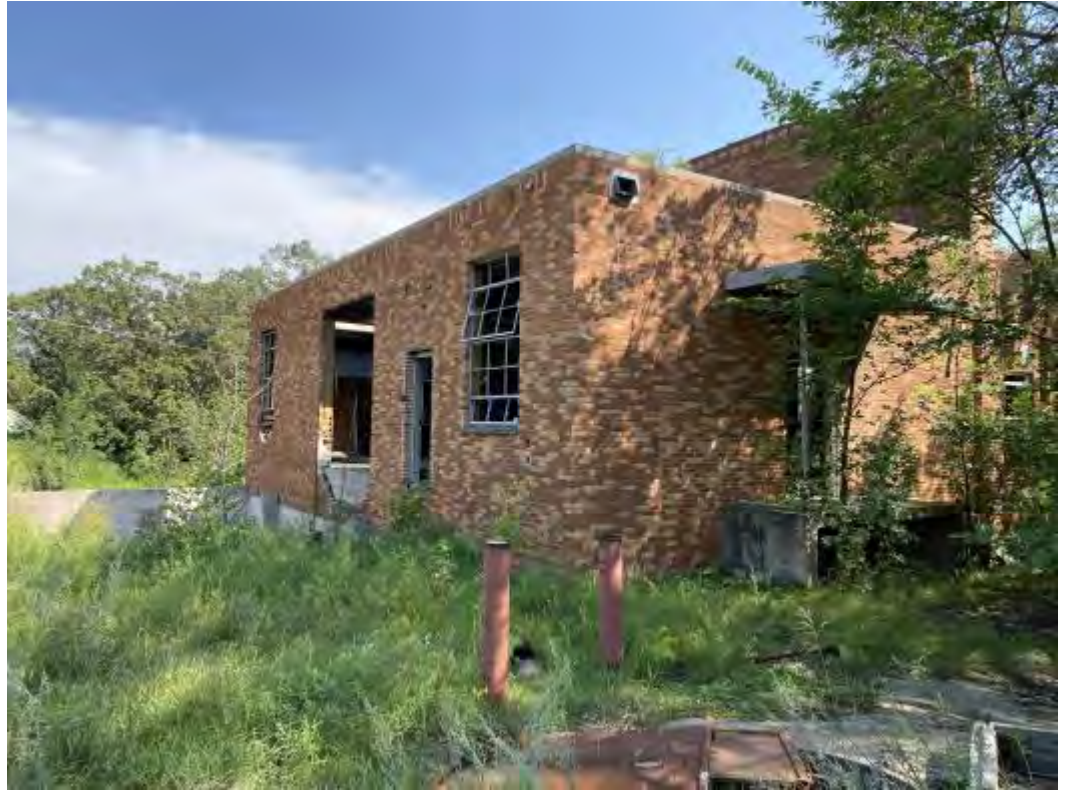
<b>Photo No.</b> <b>1</b>	<b>Date:</b> 08/21/2020
<b>Photo Coordinates</b>	
<b>Lat</b>	48.835647
<b>Long</b>	-100.040267
<b>Direction Photo Taken:</b> 130.576259489303	
<b>Description:</b>  Exterior of building 7 with asbestos on window and door caulk.

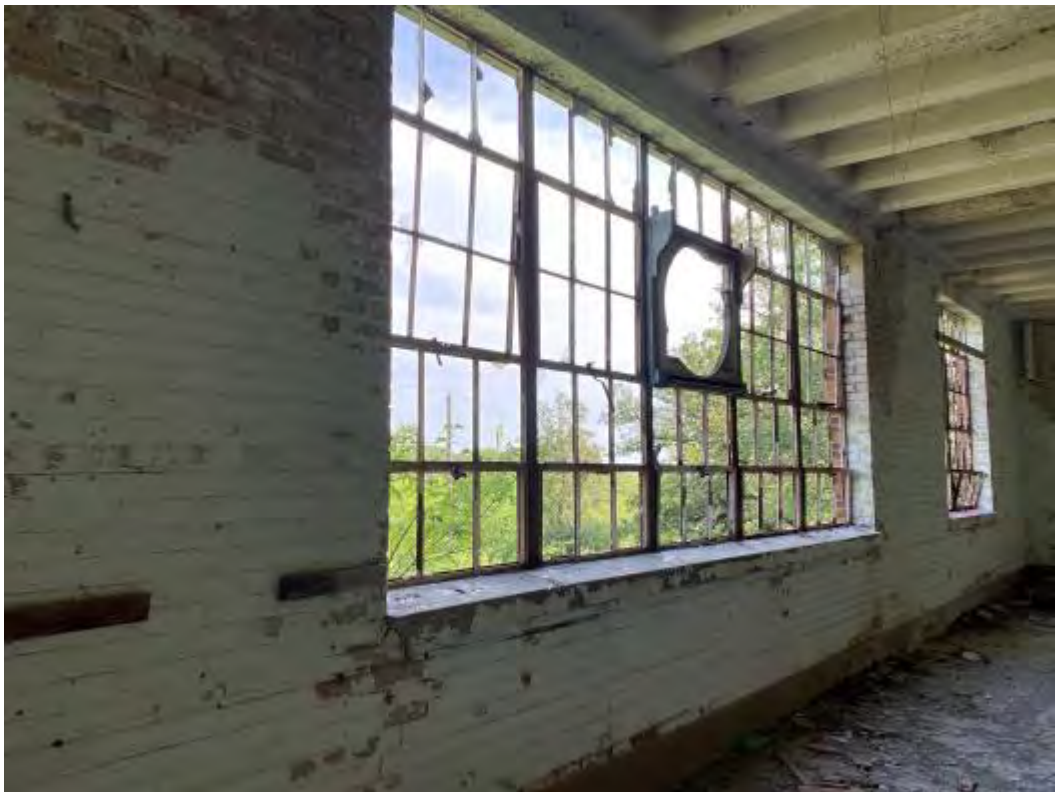
<b>Photo No.</b> <b>3</b>	<b>Date:</b> 08/21/2020												
<b>Photo Coordinates</b>													
<b>Lat</b>	48.835442												
<b>Long</b>	-100.040031												
<b>Direction Photo Taken:</b> 136.974765681327													
<b>Description:</b>  Asbestos in window caulking.

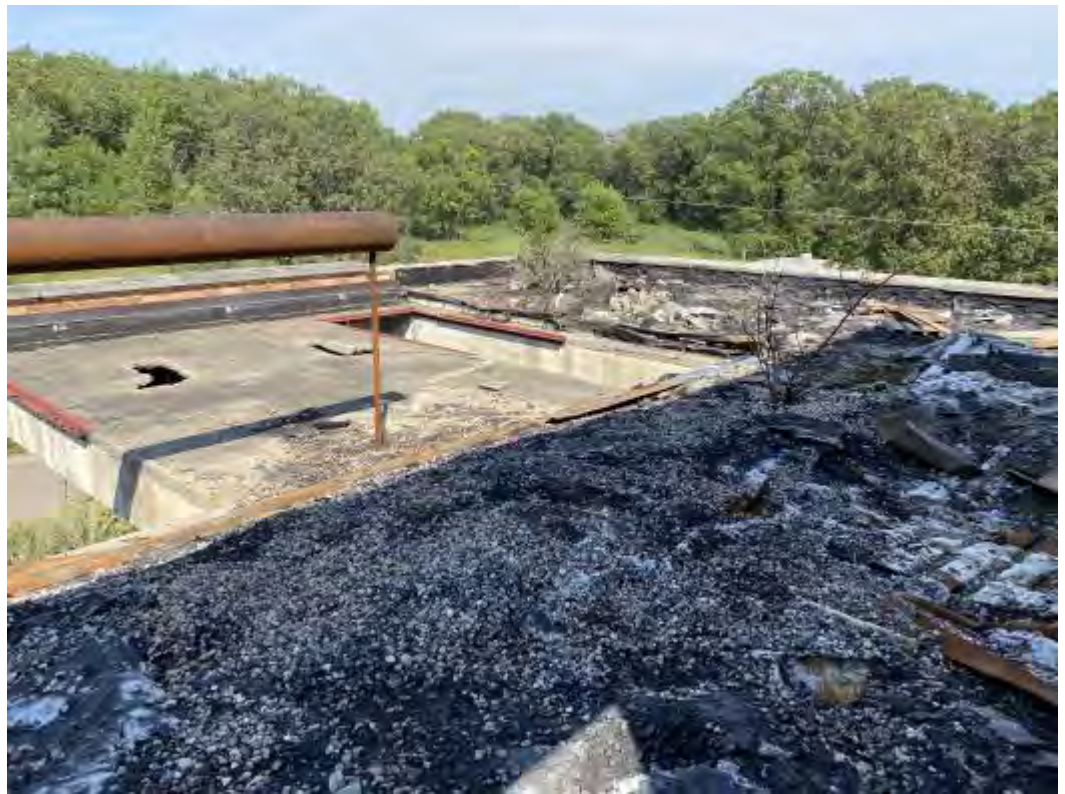
<b>Photo No.</b> <b>5</b>	<b>Date:</b> 08/21/2020
<b>Photo Coordinates</b>	
<b>Lat</b>	48.835486
<b>Long</b>	-100.040069
<b>Direction Photo Taken:</b> 37.8240356083086	
<b>Description:</b>  Roof area with asbestos in sealant.

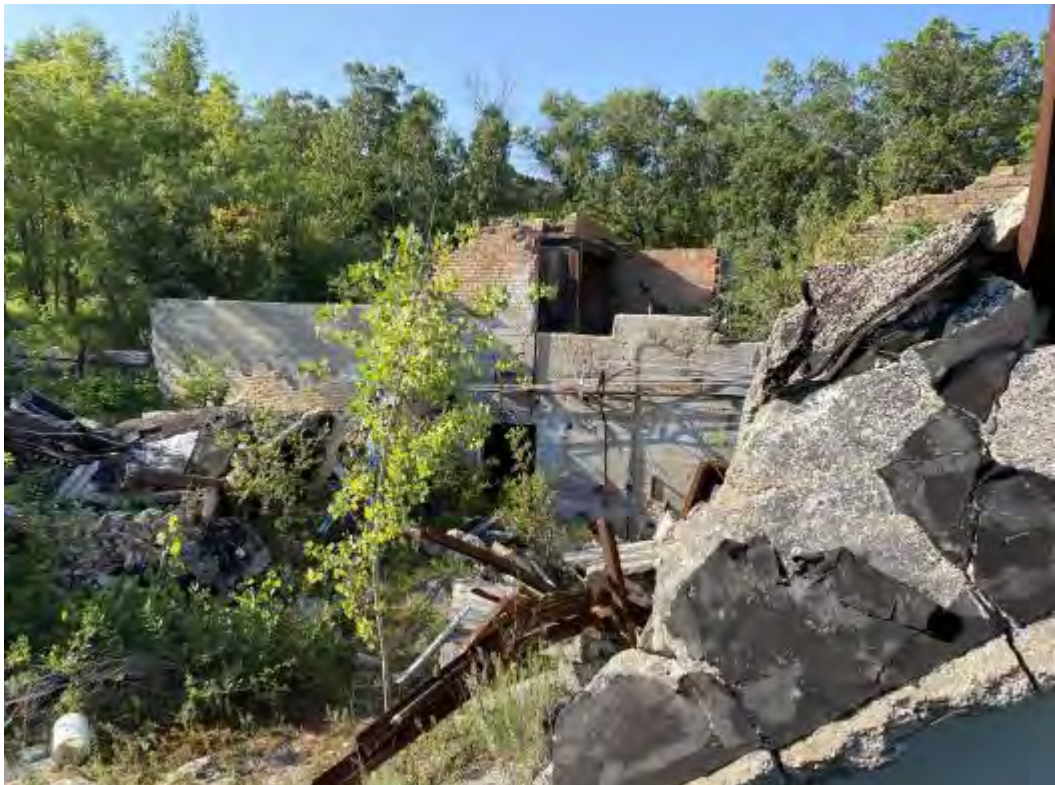
<b>Photo No.</b> <b>2</b>	<b>Date:</b> 08/21/2020												
<b>Photo Coordinates</b>													
<b>Lat</b>	48.834858												
<b>Long</b>	-100.038728												
<b>Direction Photo Taken:</b> 321.763702359347													
<b>Description:</b>  Building debris scattered throughout.

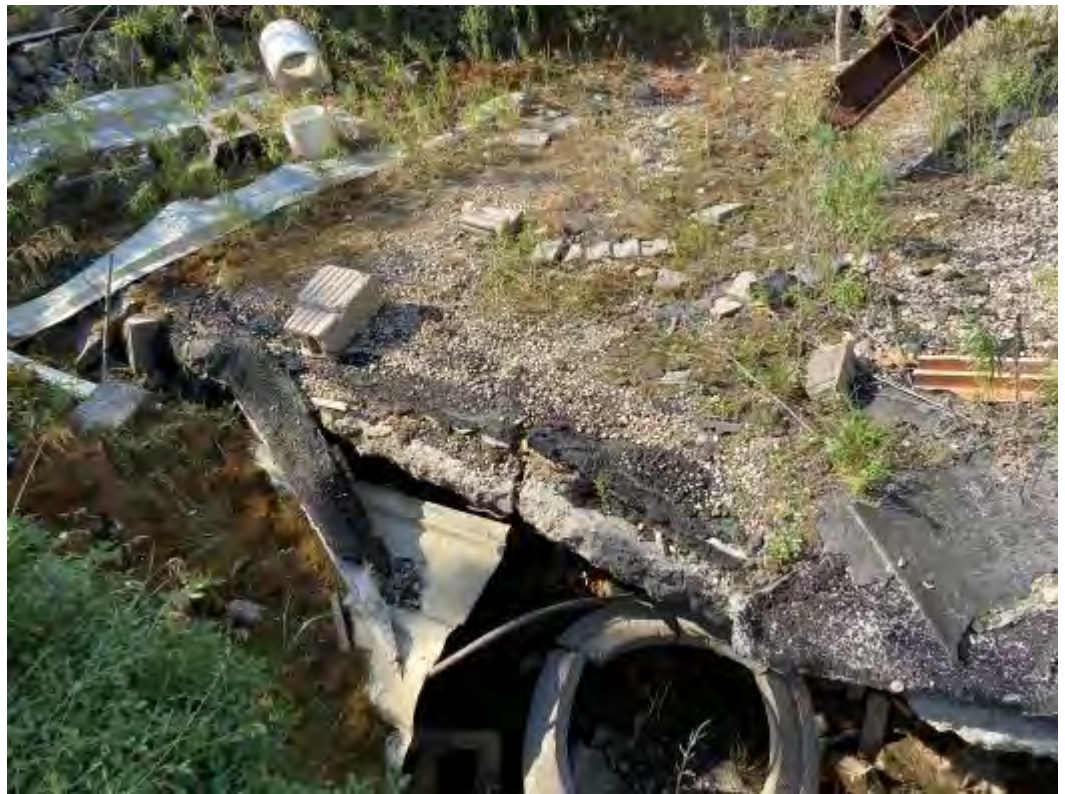
<b>Photo No.</b> <b>3</b>	<b>Date:</b> 08/21/2020
<b>Photo Coordinates</b>	
<b>Lat</b>	48.834842
<b>Long</b>	-100.038758
<b>Direction Photo Taken:</b> 333.071365638767	
<b>Description:</b>  Asbestos in roofing material.

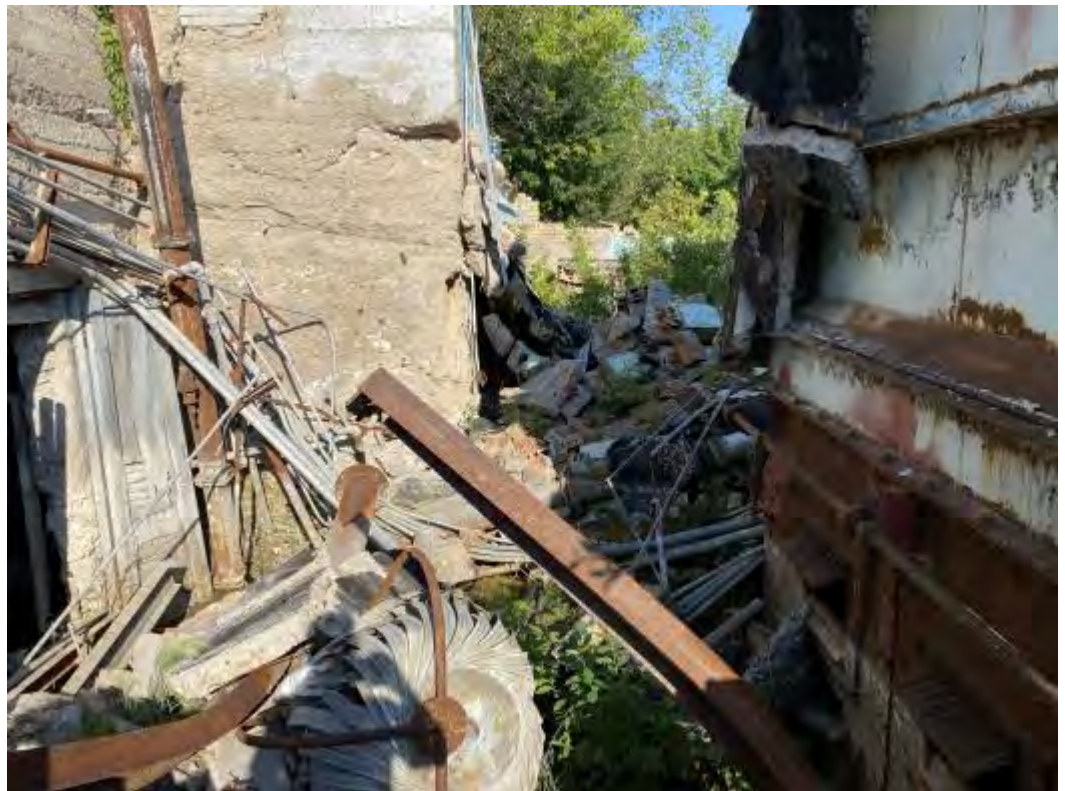
<b>Photo No.</b> <b>4</b>	<b>Date:</b> 08/21/2020
<b>Photo Coordinates</b>	
<b>Lat</b>	48.834931
<b>Long</b>	-100.03875
<b>Direction Photo Taken:</b> 91.8481941309255	
<b>Description:</b>  Asbestos in pipe flange gasket.

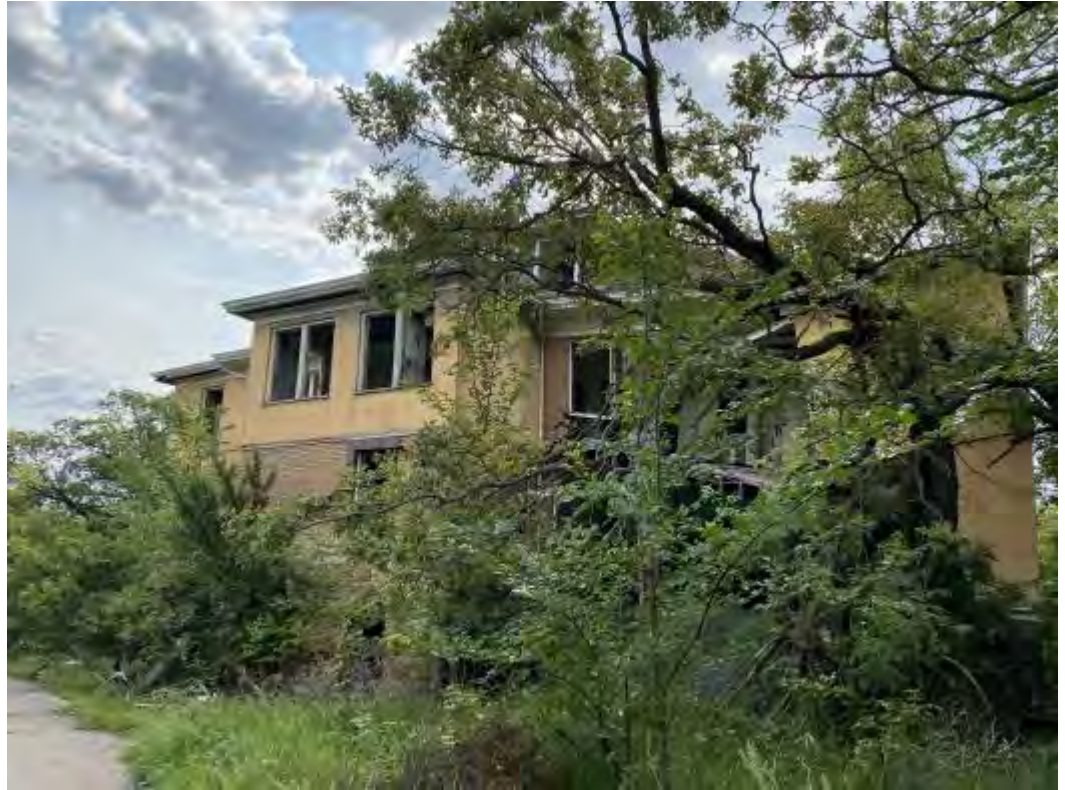
<b>Photo No.</b> <b>1</b>	<b>Date:</b> 08/21/2020
<b>Photo Coordinates</b>	
<b>Lat</b>	48.834714
<b>Long</b>	-100.040261
<b>Direction Photo Taken:</b> 124.545616113744	
<b>Description:</b>  Exterior of building 9 with asbestos in exterior plaster.

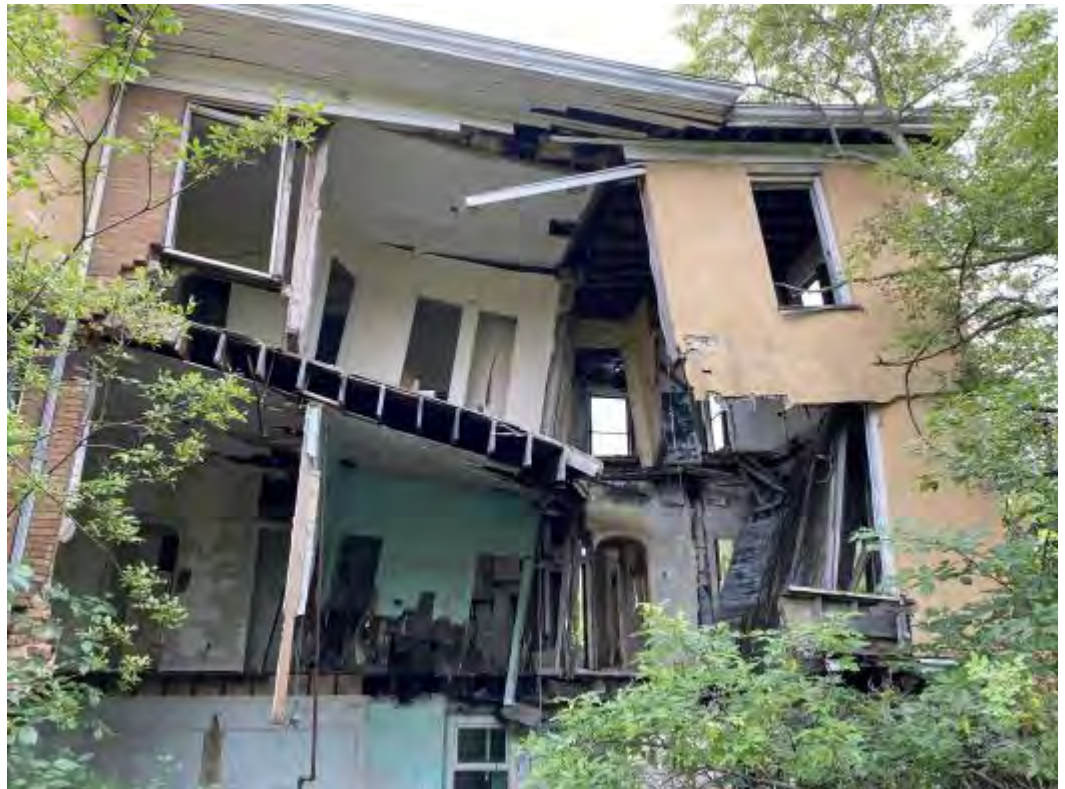
<b>Photo No.</b> <b>2</b>	<b>Date:</b> 08/21/2020
<b>Photo Coordinates</b>	
<b>Lat</b>	48.834644
<b>Long</b>	-100.040153
<b>Direction Photo Taken:</b> 171.877494838266	
<b>Description:</b>  Structural instability of the building.

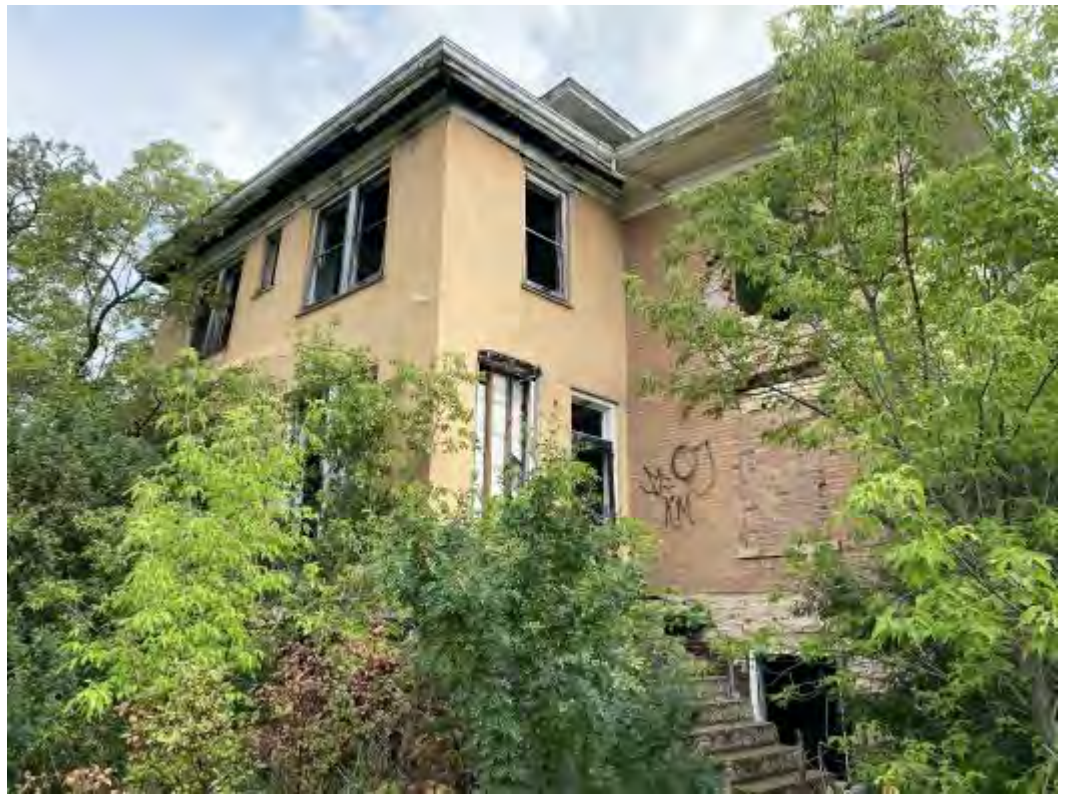
<b>Photo No.</b> <b>3</b>	<b>Date:</b> 08/21/2020
<b>Photo Coordinates</b>	
<b>Lat</b>	48.8345
<b>Long</b>	-100.040169
<b>Direction Photo Taken:</b> 14.7074279785156	
<b>Description:</b>  Exterior of building 9 with asbestos in exterior plaster and window glazing.

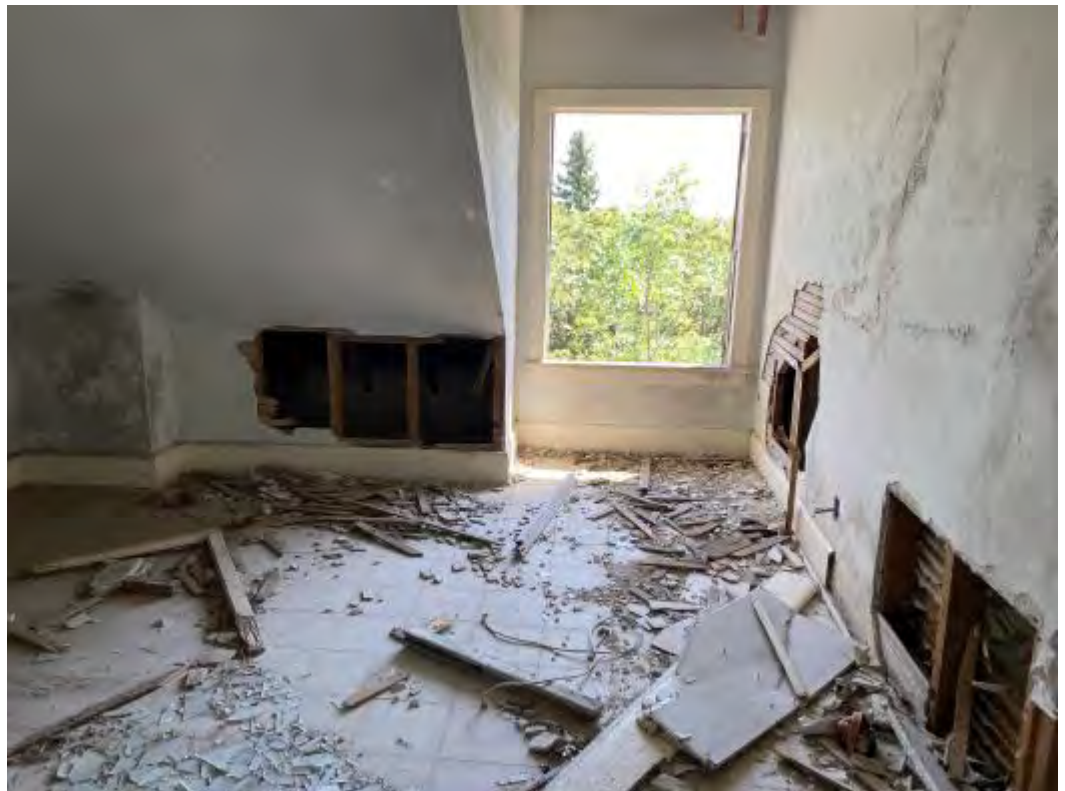
<b>Photo No.</b> <b>4</b>	<b>Date:</b> 08/20/2020
<b>Photo Coordinates</b>	
<b>Lat</b>	48.834531
<b>Long</b>	-100.039994
<b>Direction Photo Taken:</b> 154.155769230769	
<b>Description:</b>  Asbestos floor tiles and mastic on the 4 <sup>th</sup> floor.

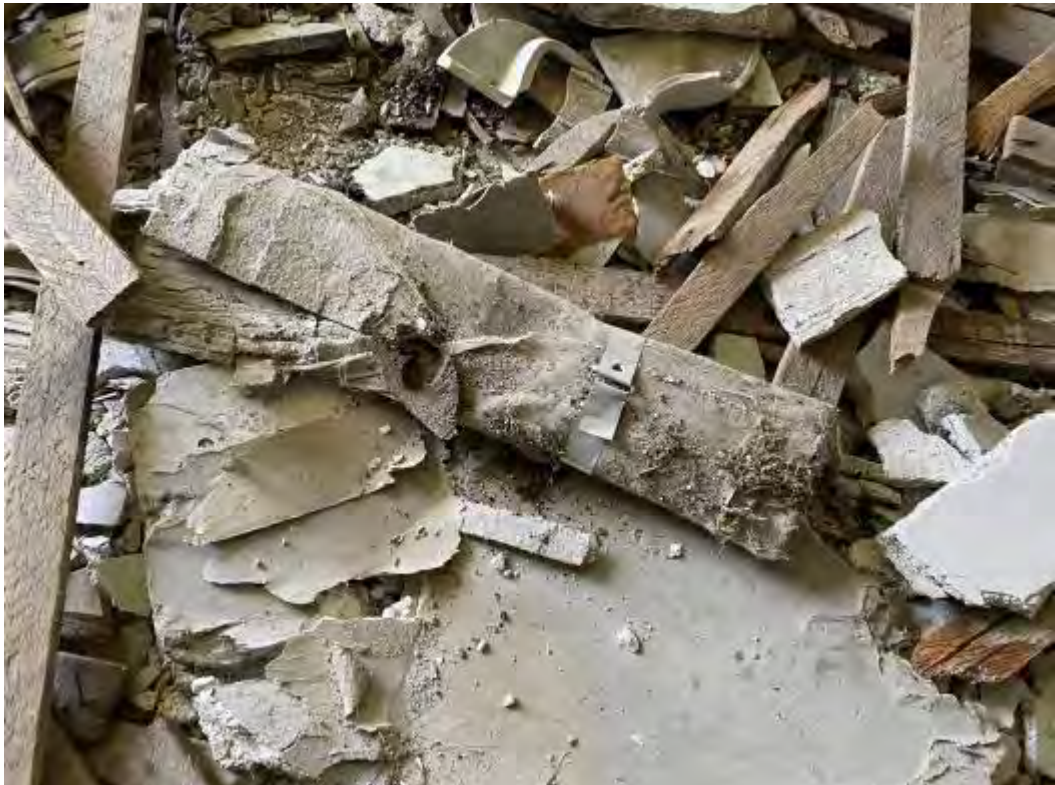
<b>Long</b>	-100.039969												
<b>Direction Photo Taken:</b> 325.785842831434													
<b>Description:</b>  Air cell debris observed on the 4 <sup>th</sup> floor.

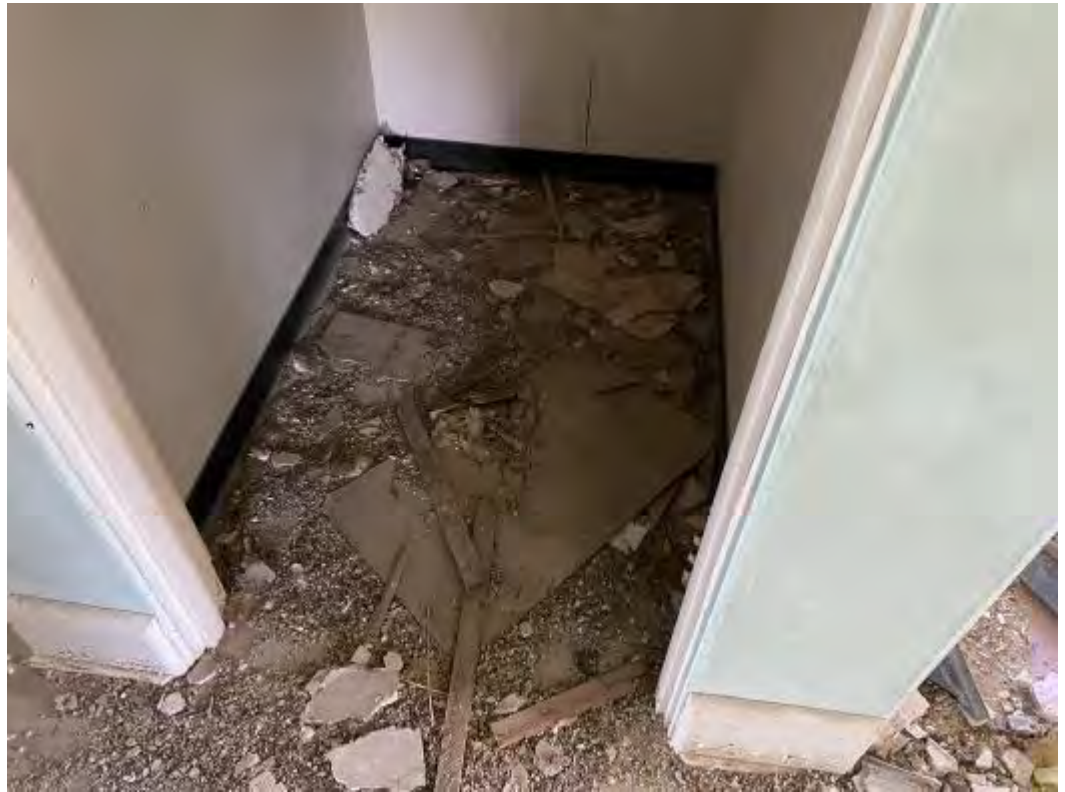
<b>Photo No.</b> <b>7</b>	<b>Date:</b> 08/20/2020
<b>Photo Coordinates</b>	
<b>Lat</b>	48.834561
<b>Long</b>	-100.039978
<b>Direction Photo Taken:</b> 151.059146877748	
<b>Description:</b>  Asbestos in cove base.

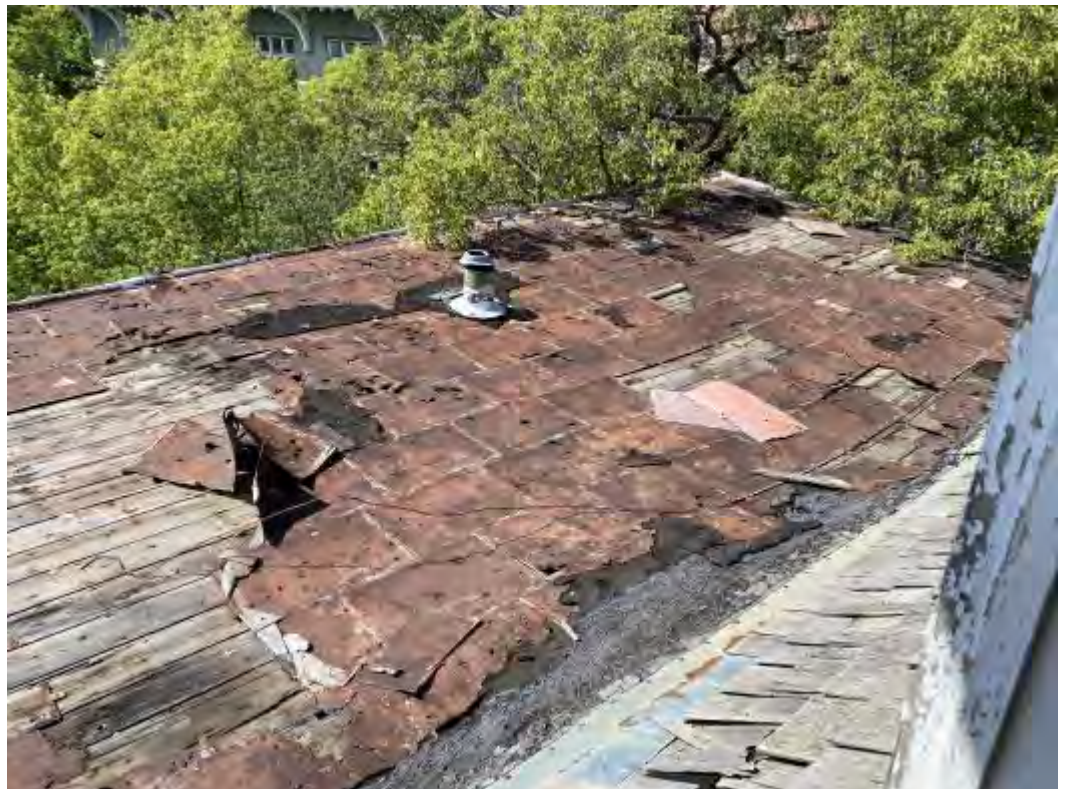
<b>Photo No.</b> <b>8</b>	<b>Date:</b> 08/20/2020
<b>Photo Coordinates</b>	
<b>Lat</b>	48.834539
<b>Long</b>	-100.040069
<b>Direction Photo Taken:</b> 275.101272827892	
<b>Description:</b>  Asbestos in roofing material and sealant.

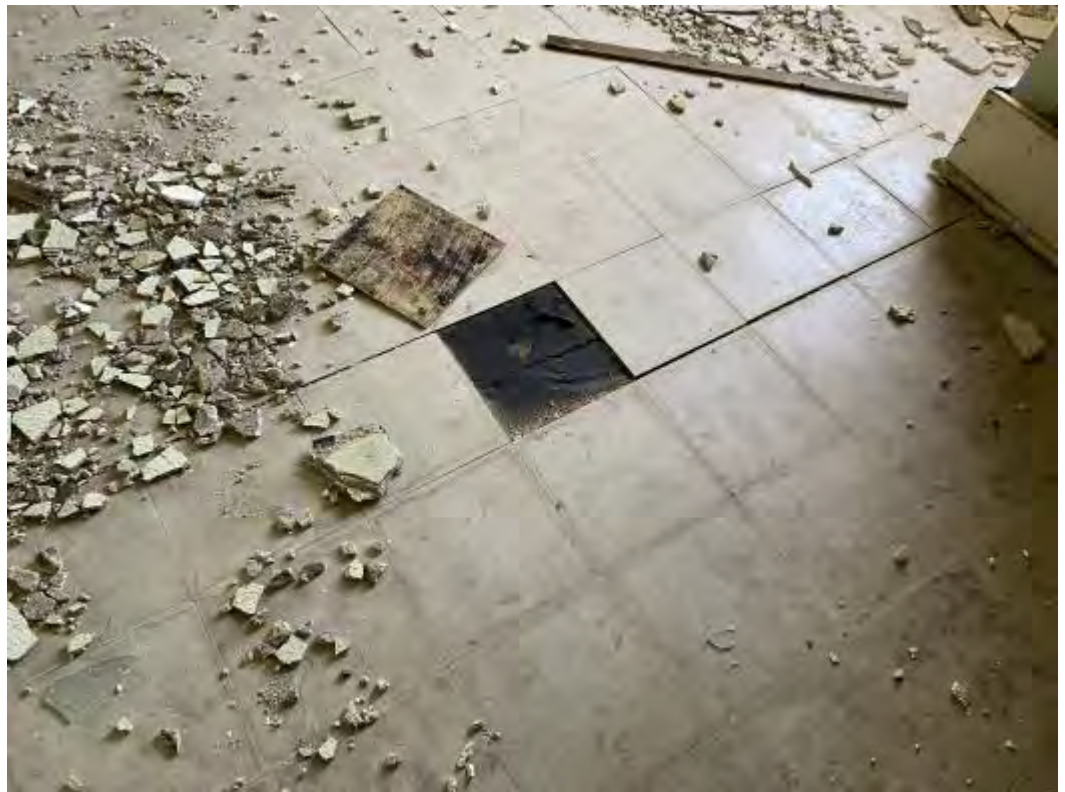
<b>Photo No.</b> <b>9</b>	<b>Date:</b> 08/20/2020
<b>Photo Coordinates</b>	
<b>Lat</b>	48.834564
<b>Long</b>	-100.040008
<b>Direction Photo Taken:</b> 274.906433105469	
<b>Description:</b>  Asbestos in underlayment throughout the 4 <sup>th</sup> floor.

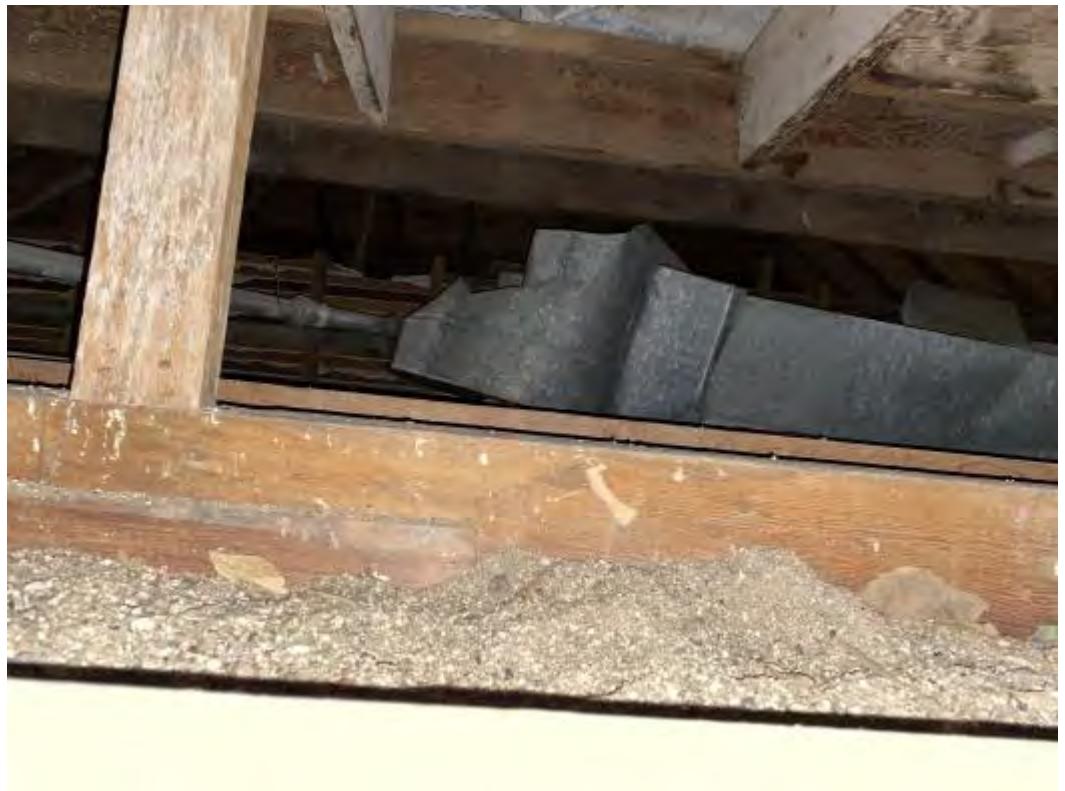
<b>Photo No.</b> <b>10</b>	<b>Date:</b> 08/20/2020
<b>Photo Coordinates</b>	
<b>Lat</b>	48.834556
<b>Long</b>	-100.039994
<b>Direction Photo Taken:</b> 78.5277709811598	
<b>Description:</b>  Vermiculite in the attic.

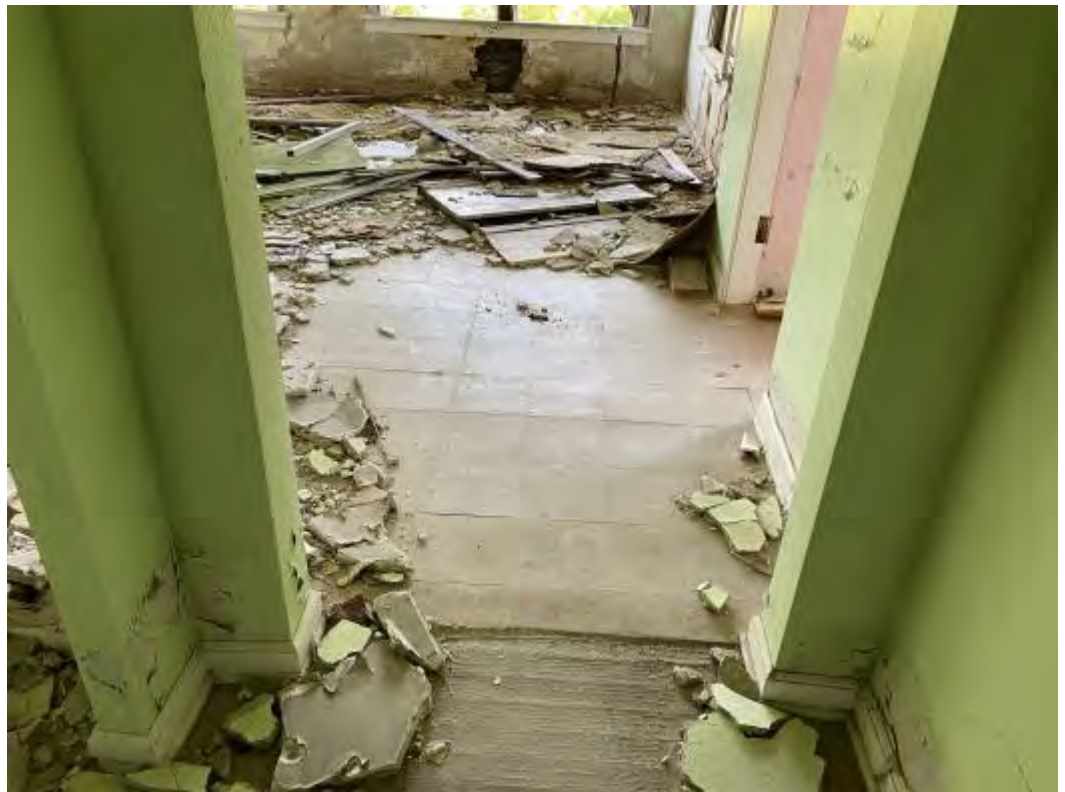
<b>Photo No.</b> <b>11</b>	<b>Date:</b> 08/20/2020
<b>Photo Coordinates</b>	
<b>Lat</b>	48.834636
<b>Long</b>	-100.04
<b>Direction Photo Taken:</b> 326.69163545568	
<b>Description:</b>  Asbestos floor tiles on the 3 <sup>rd</sup> floor.
