**PHASE II ENVIRONMENTAL SITE ASSESSMENT  
FOR  
SAN HAVEN  
DUNSEITH, ROULETTE COUNTY, NORTH DAKOTA  
TURTLE MOUNTAIN BAND OF CHIPPEWA INDIANS  
RESERVATION**

Date Prepared	October 2020
TDD No.	0003/2006-05
Document Control No.	W0820.1A.02377
Contract No.	EP-S8-13-01
U.S. EPA Work Assignment Manager	Ted Lanzano

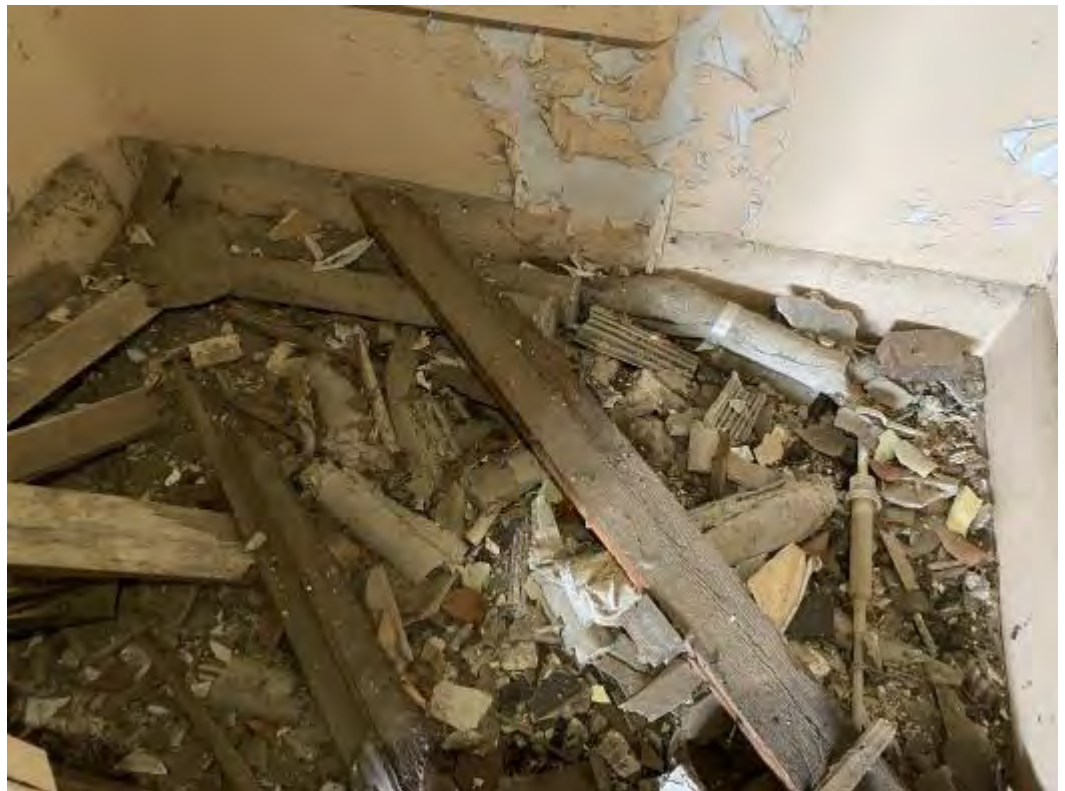
<b>Photo No.</b> <b>14</b>	<b>Date:</b> 08/21/2020
<b>Photo Coordinates</b>	
<b>Lat</b>	48.834964
<b>Long</b>	-100.040367
<b>Direction Photo Taken:</b> 311.528228924981	
<b>Description:</b>  Air cell debris observed.

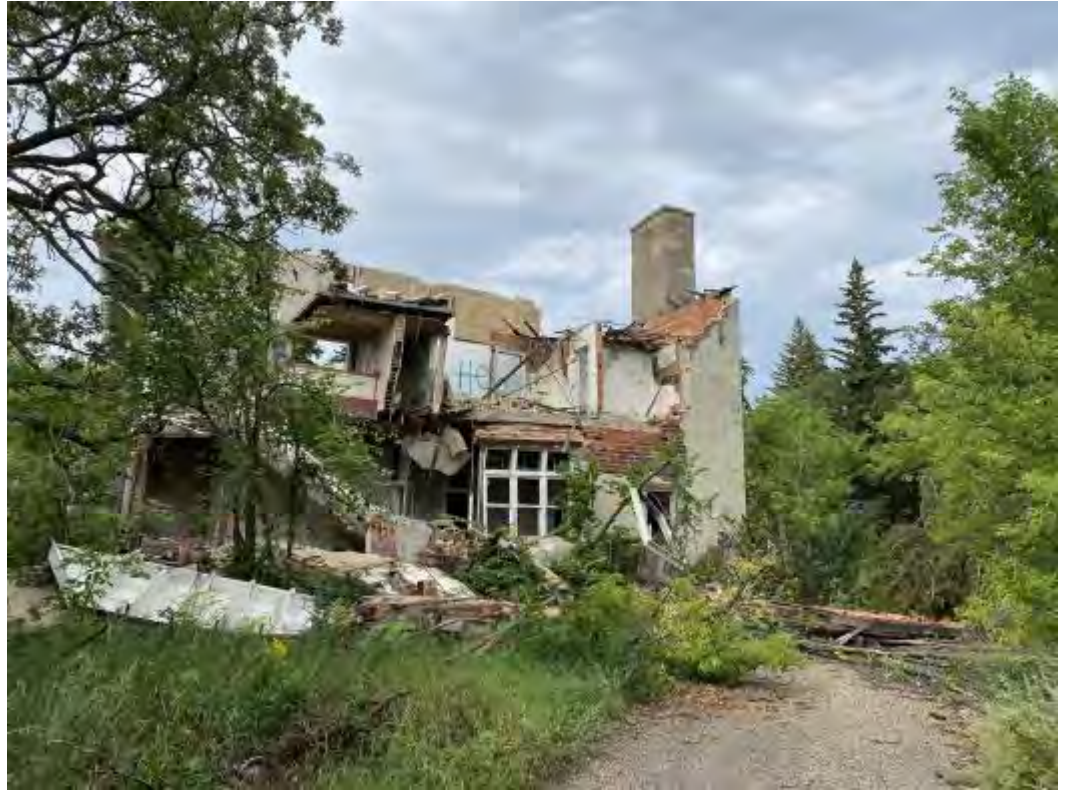
<b>Photo No.</b> <b>1</b>	<b>Date:</b> 08/21/2020
<b>Photo Coordinates</b>	
<b>Lat</b>	48.834706
<b>Long</b>	-100.040153
<b>Direction Photo Taken:</b> 267.715850986121	
<b>Description:</b>  Exterior of building 19 with asbestos in window caulk.

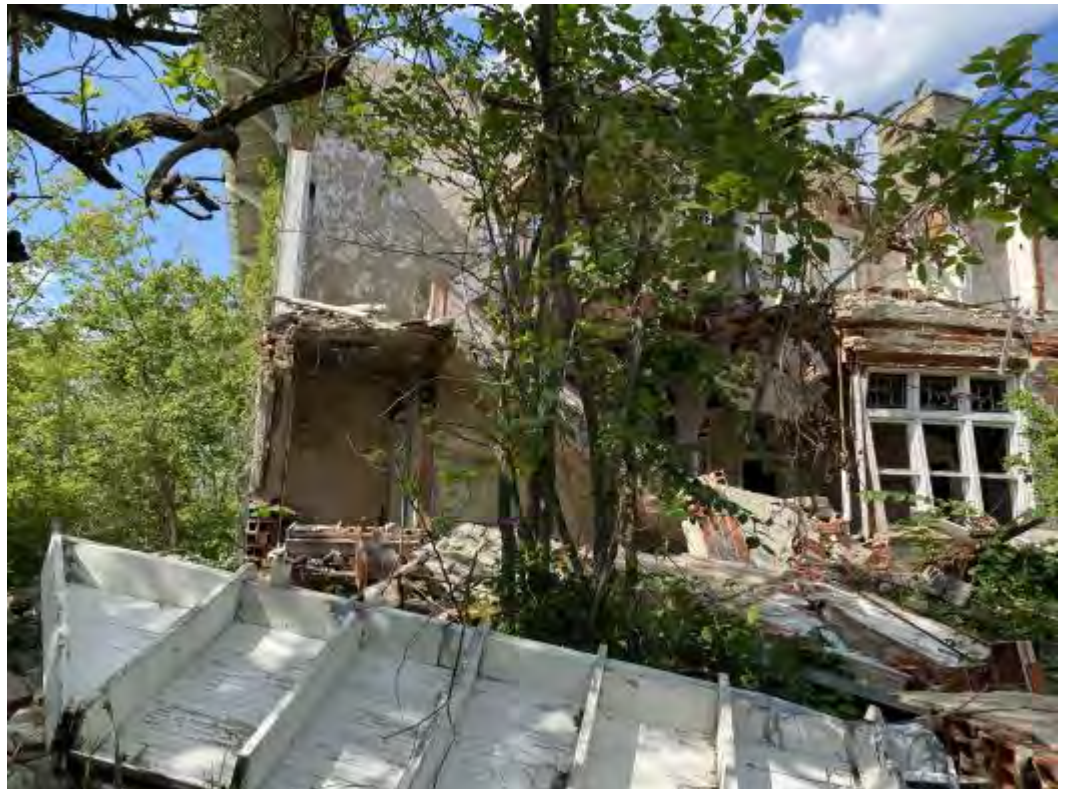
<b>Photo No.</b> <b>2</b>	<b>Date:</b> 08/20/2020
<b>Photo Coordinates</b>	
<b>Lat</b>	48.834653
<b>Long</b>	-100.040267
<b>Direction Photo Taken:</b> 245.661956811517	
<b>Description:</b>  Exterior of building 19 with asbestos in window caulk.

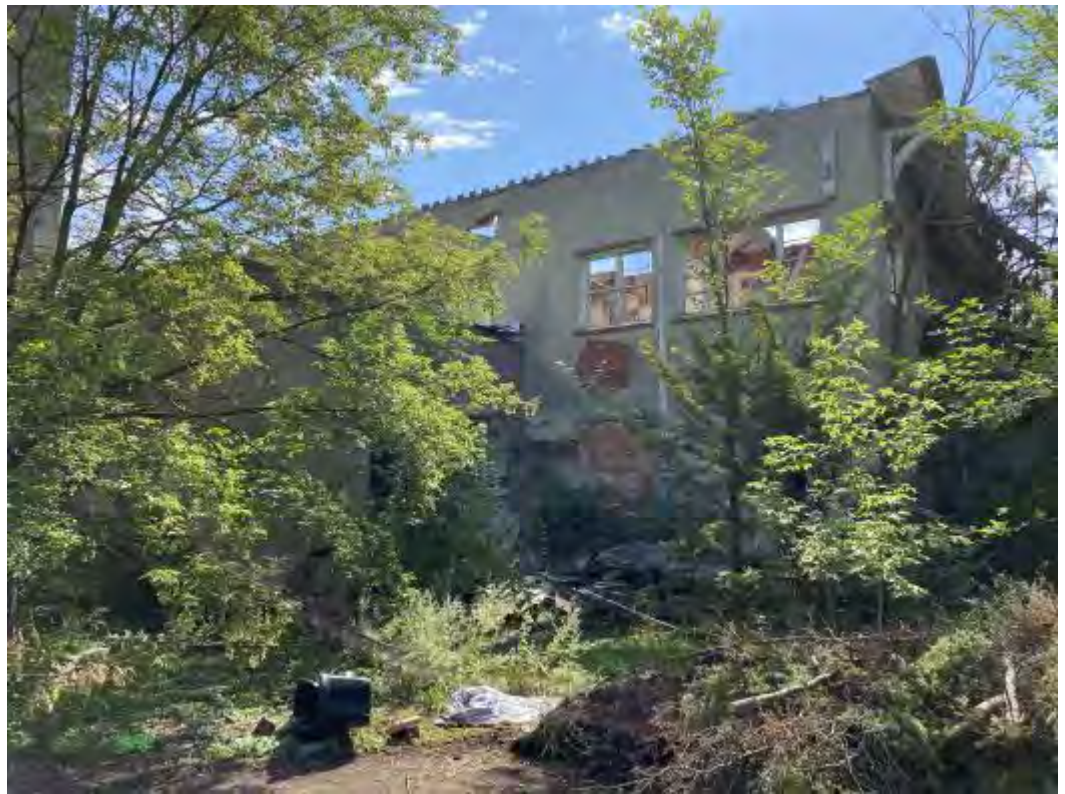
<b>Photo No.</b> <b>3</b>	<b>Date:</b> 08/20/2020
<b>Photo Coordinates</b>	
<b>Lat</b>	48.834694
<b>Long</b>	-100.040961
<b>Direction Photo Taken:</b> 123.565567010309	
<b>Description:</b>  Exterior of building 19 with asbestos in window caulk.

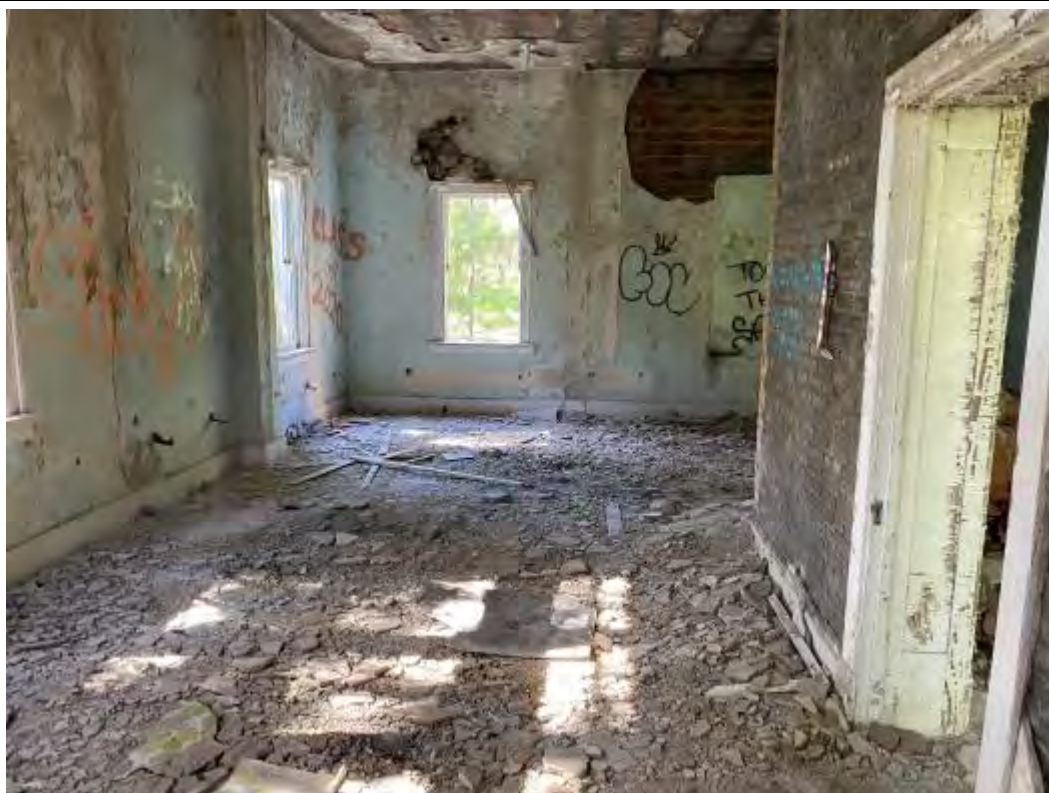
<b>Photo No.</b> <b>5</b>	<b>Date:</b> 08/19/2020
<b>Photo Coordinates</b>	
<b>Lat</b>	48.808769
<b>Long</b>	-100.067664
<b>Direction Photo Taken:</b> 305.724853645556	
<b>Description:</b>  Asbestos floor tiles on the first floor.

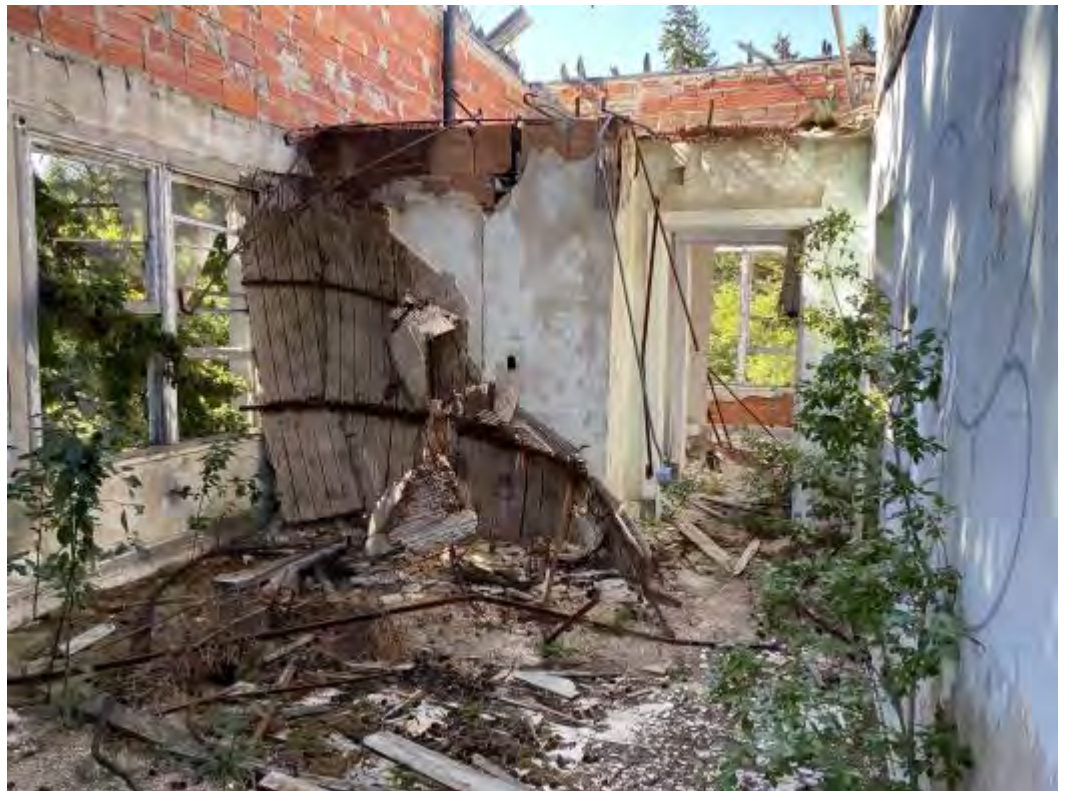
<b>Photo No.</b> <b>8</b>	<b>Date:</b> 08/19/2020
<b>Photo Coordinates</b>	
<b>Lat</b>	48.834617
<b>Long</b>	-100.040633
<b>Direction Photo Taken:</b> 284.42024238454	
<b>Description:</b>  Asbestos floor tiles and mastic on the 2 <sup>nd</sup> floor of the building.

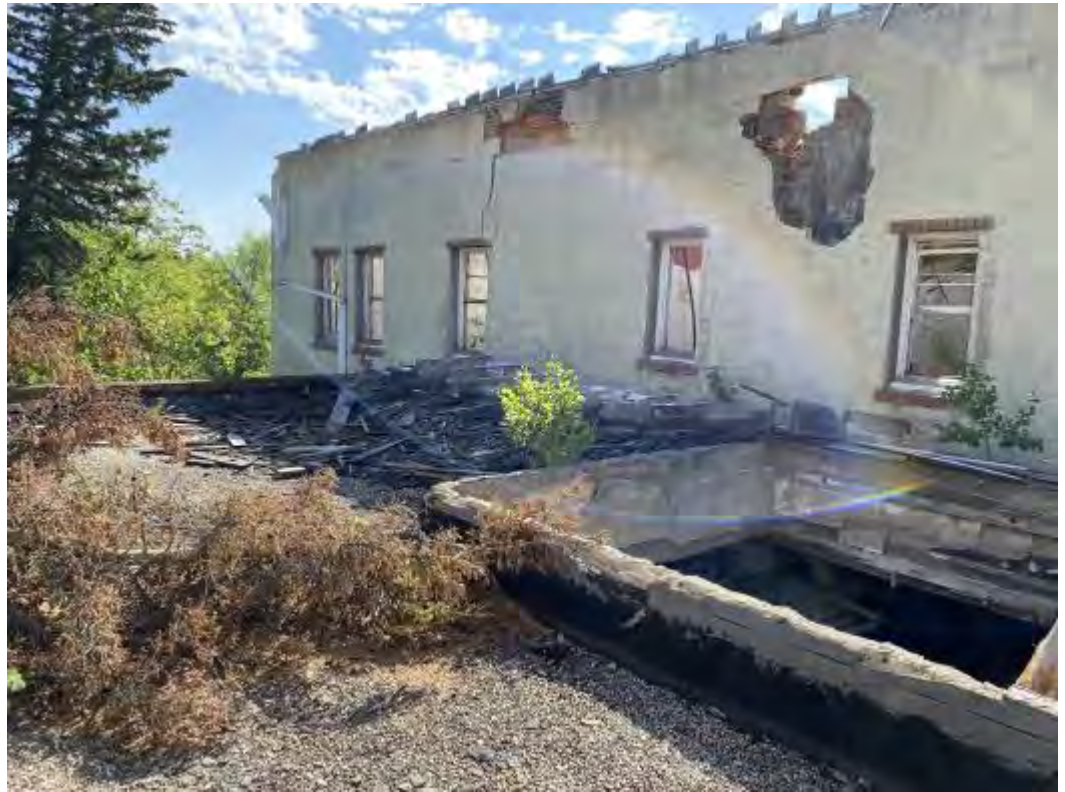
<b>Photo No.</b> <b>9</b>	<b>Date:</b> 08/20/2020
<b>Photo Coordinates</b>	
<b>Lat</b>	48.834689
<b>Long</b>	-100.040672
<b>Direction Photo Taken:</b> 124.981586402266	
<b>Description:</b>  Asbestos in roofing material.

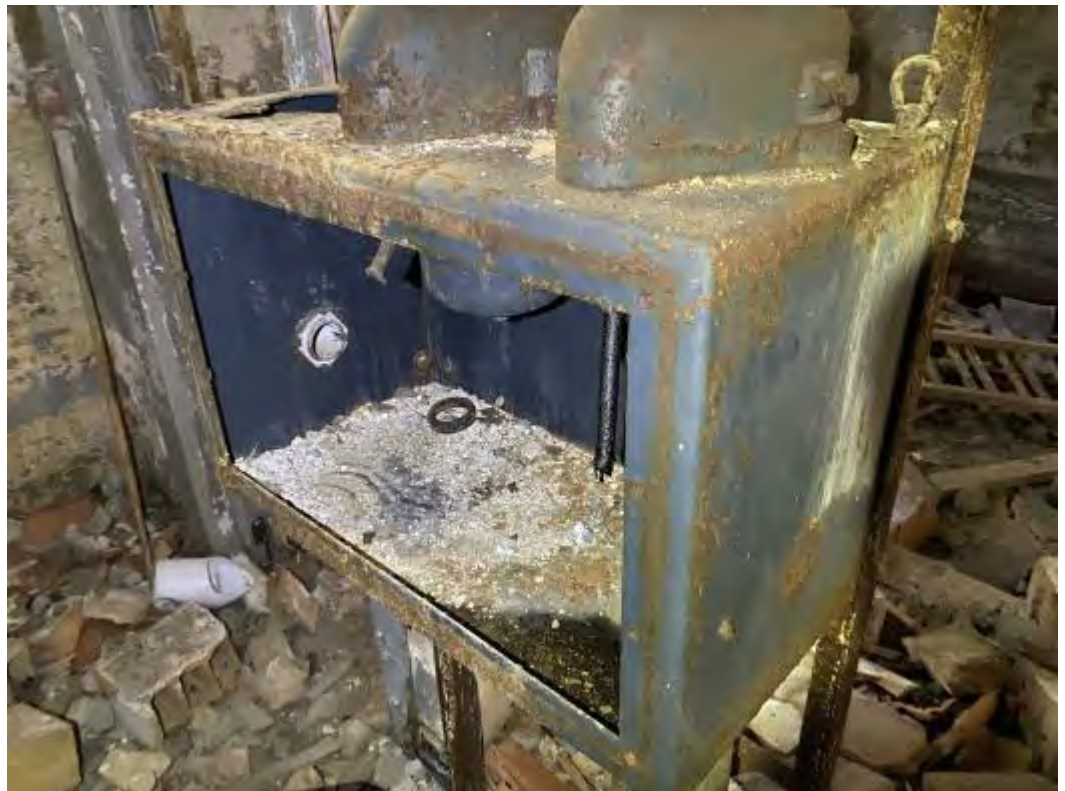
<b>Photo No.</b> <b>10</b>	<b>Date:</b> 08/20/2020
<b>Photo Coordinates</b>	
<b>Lat</b>	48.808797
<b>Long</b>	-100.067633
<b>Direction Photo Taken:</b> 5.472900390625	
<b>Description:</b>  Assumed to be a 3-phase PCB transformer located in the basement of the building.

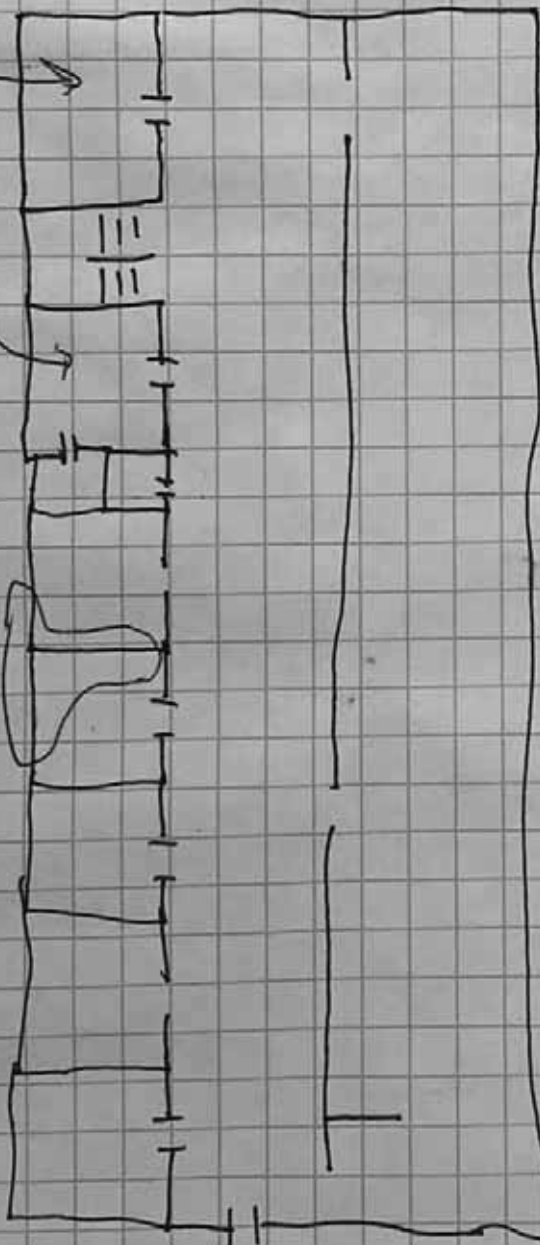
CLIENT/SUBJECT Building 1 - 2nd Floor W.O. NO. \_\_\_\_\_

- plaster  
missing

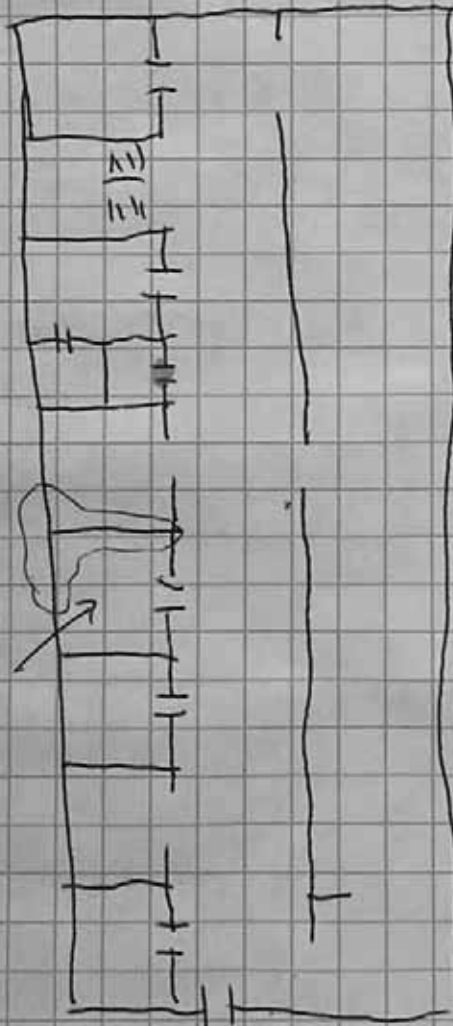
CLIENT/SUBJECT Building 1- 3rd Floor W.O. NO. \_\_\_\_\_

- plaster missing  
- plaster gone from ceiling

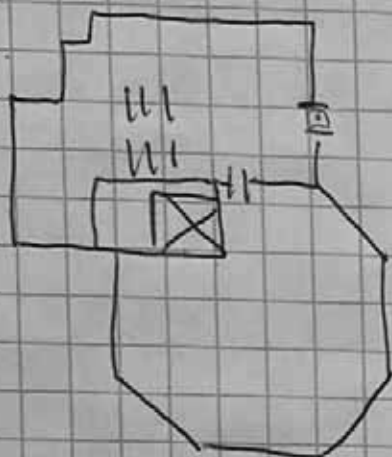
Positive LBP

white wood window frame  
 red wood ~~windo~~ door frame  
 black wood door frame

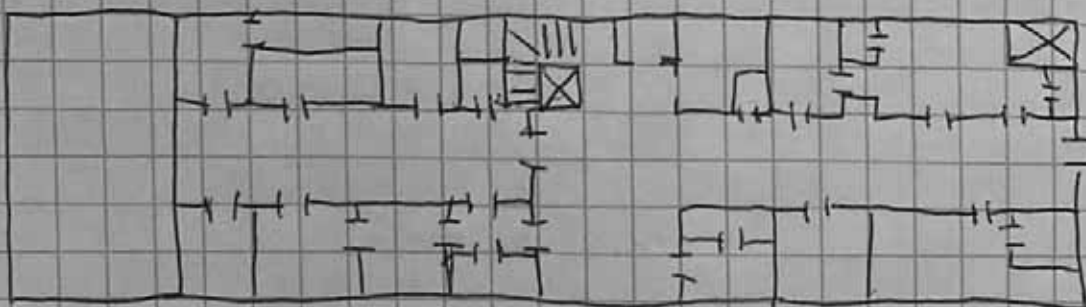
Positive LBP

white wood window frame

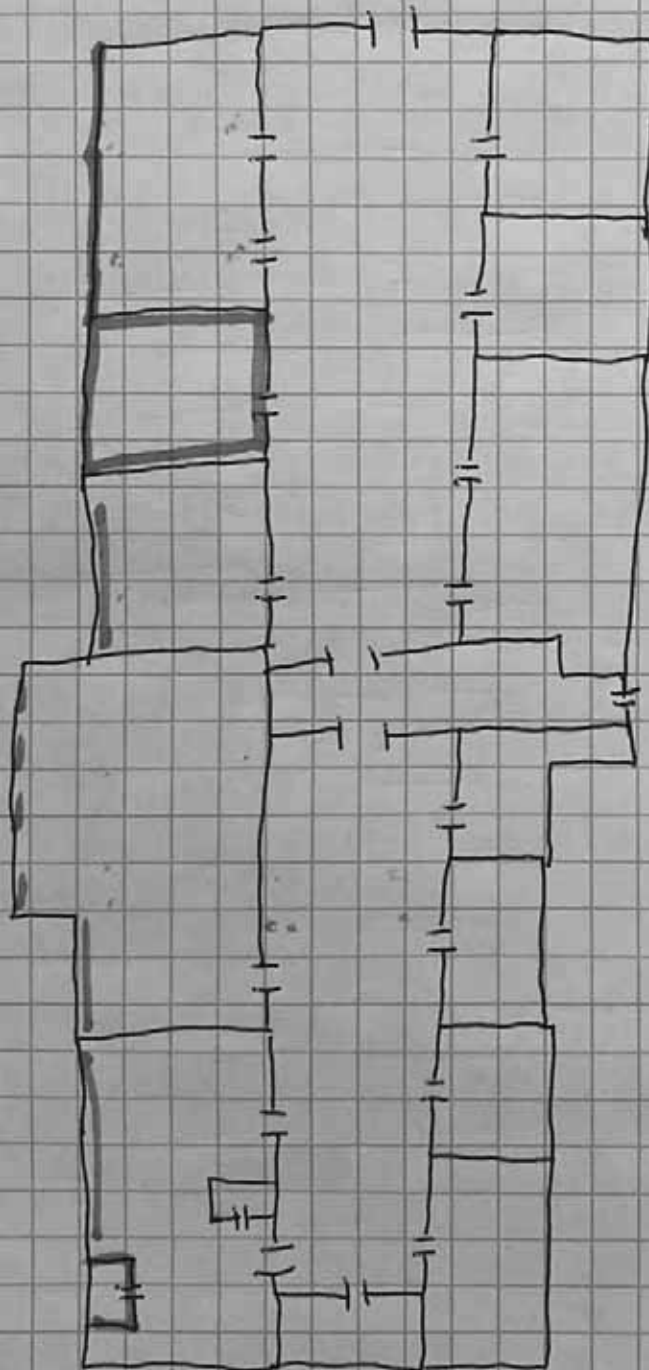
Plaster walls 3rd Floor

- pink
- white
- H blue
- green
- yellow
- white wood door frames & doors
- white window frames

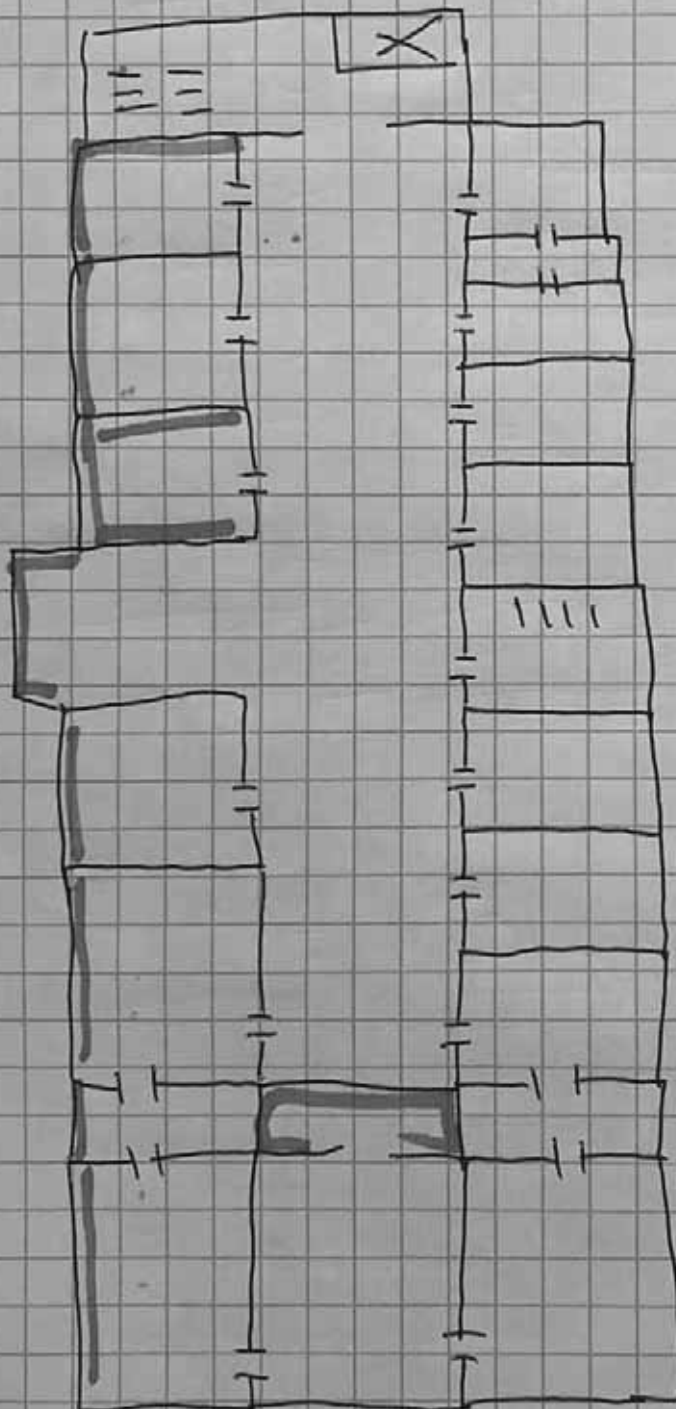
Plaster Walls

1+ blue  
pink  
white w/ pink  
white w/ yellow  
green

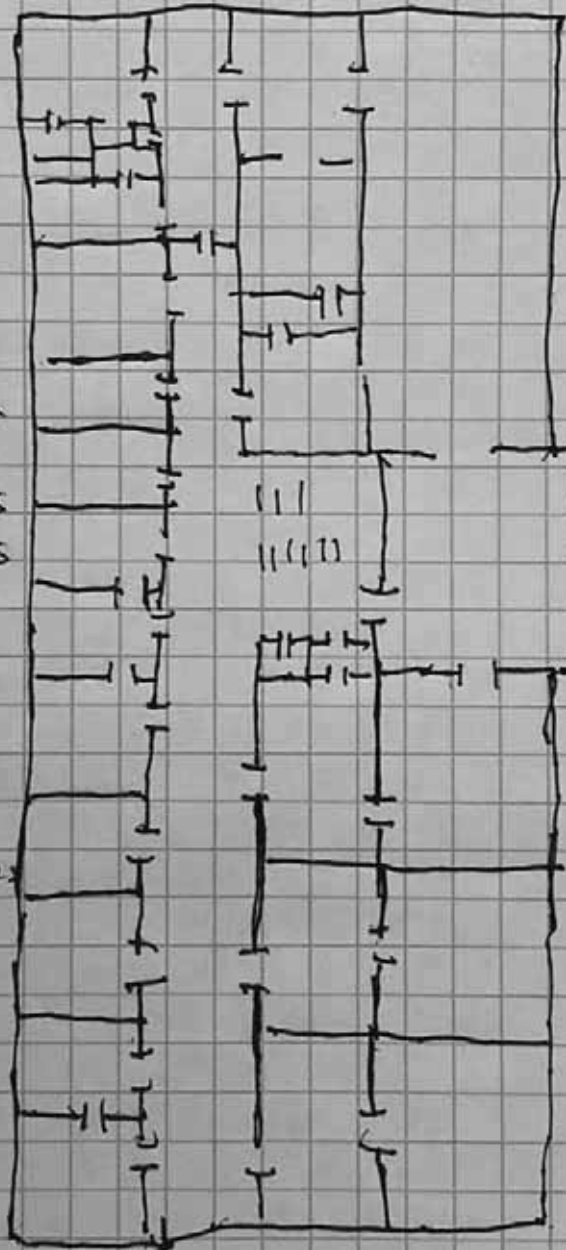
White wood door/  
door frames

Light blue Plaster  
walls

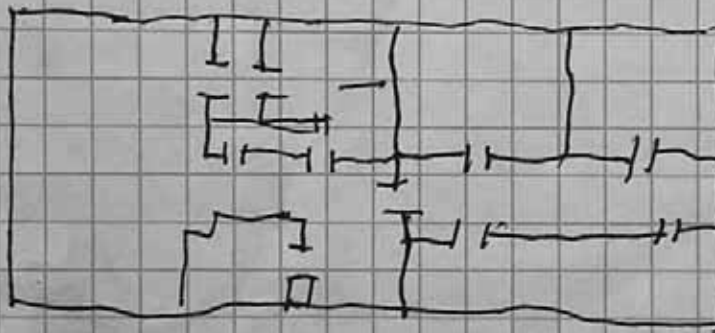
Positive LBP

Yellow Plaster walls  
Light blue Plaster walls  
Green Plaster walls  
Pink Plaster walls  
white wood window frames  
white wood door/door frames

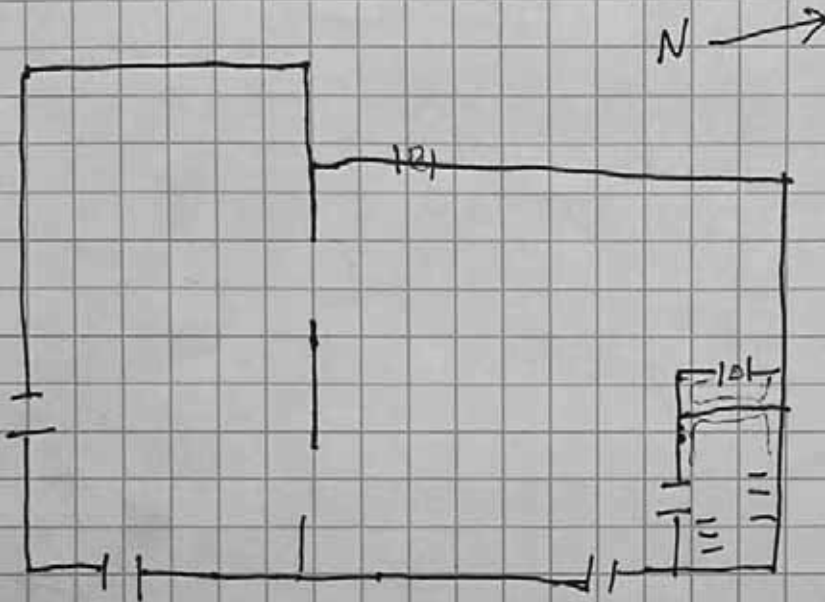
Positive CBP  
 white Plaster walls  
 Light Blue Plaster walls  
 Light blue wood ~~door frames~~  
 door frames

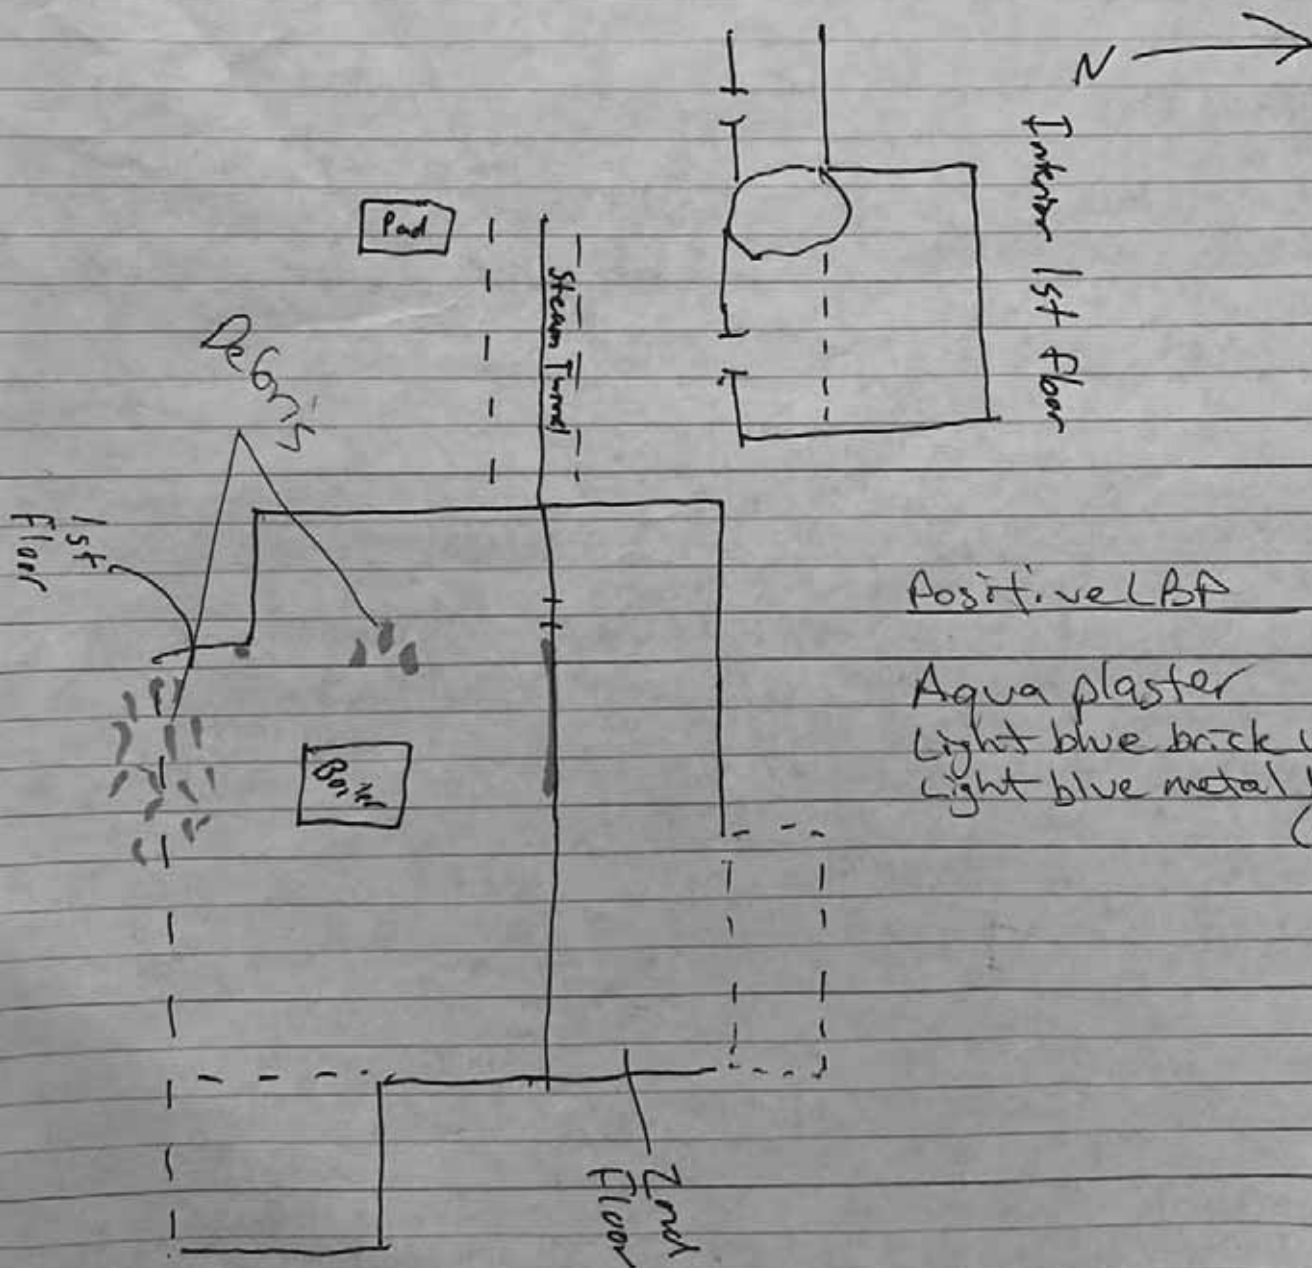
# Power Plant (Building 8)

Positive LBP

Aqua plaster  
Light blue brick walls  
Light blue metal building  
(piping)

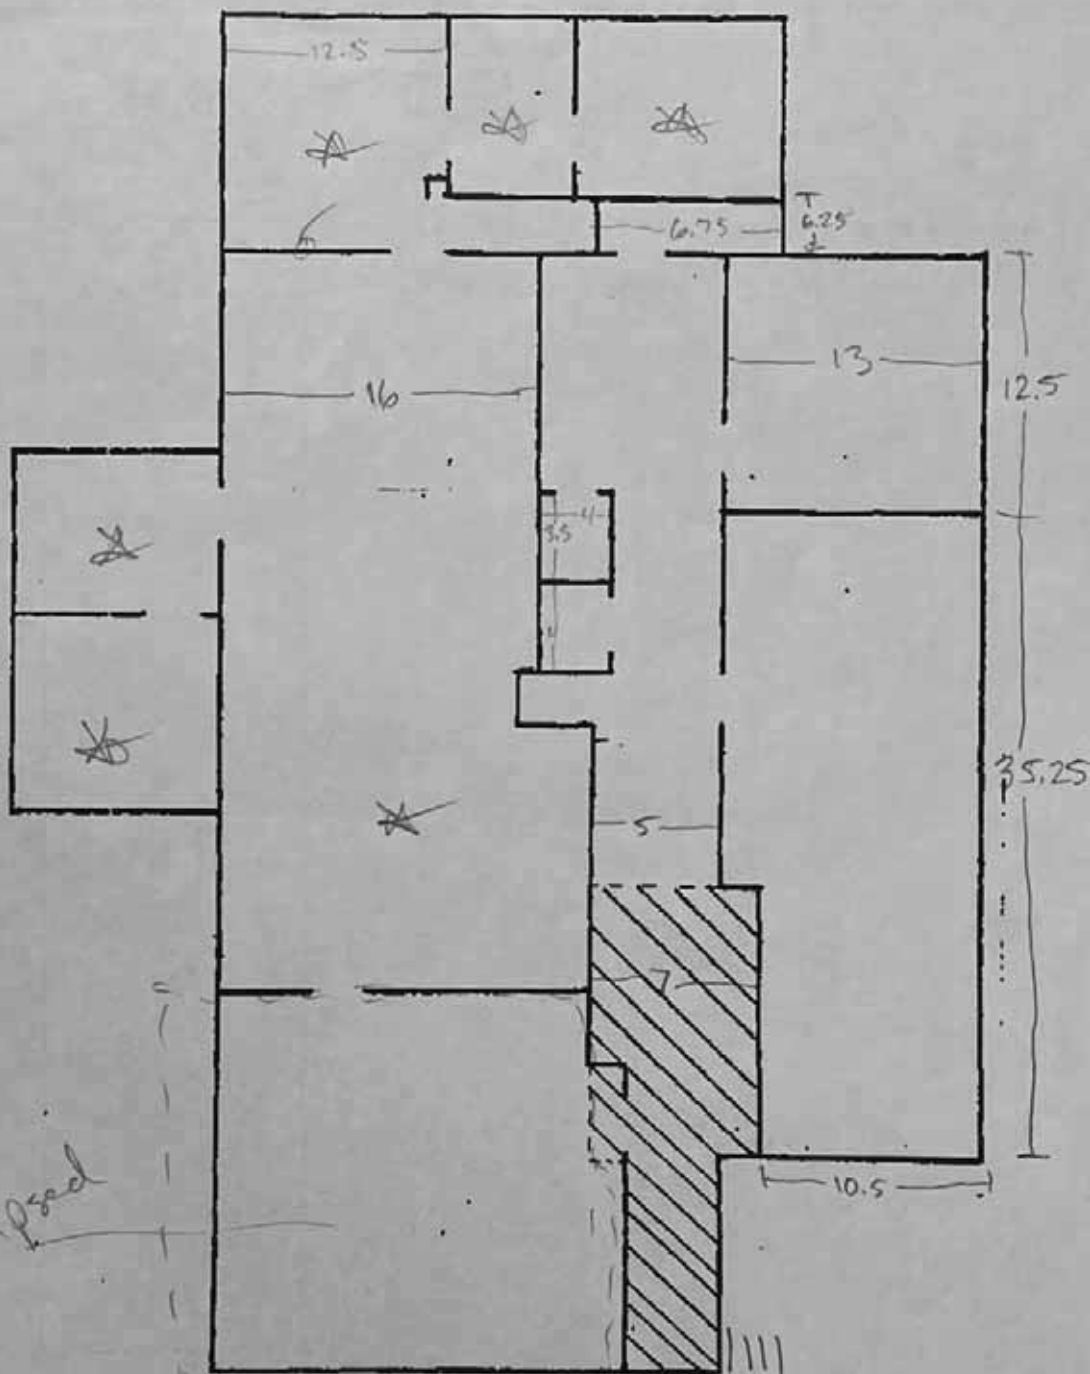
PL02 (smooth/white)  
 FT01 (orange 9x9)  
 FT02 (grey 9x9)

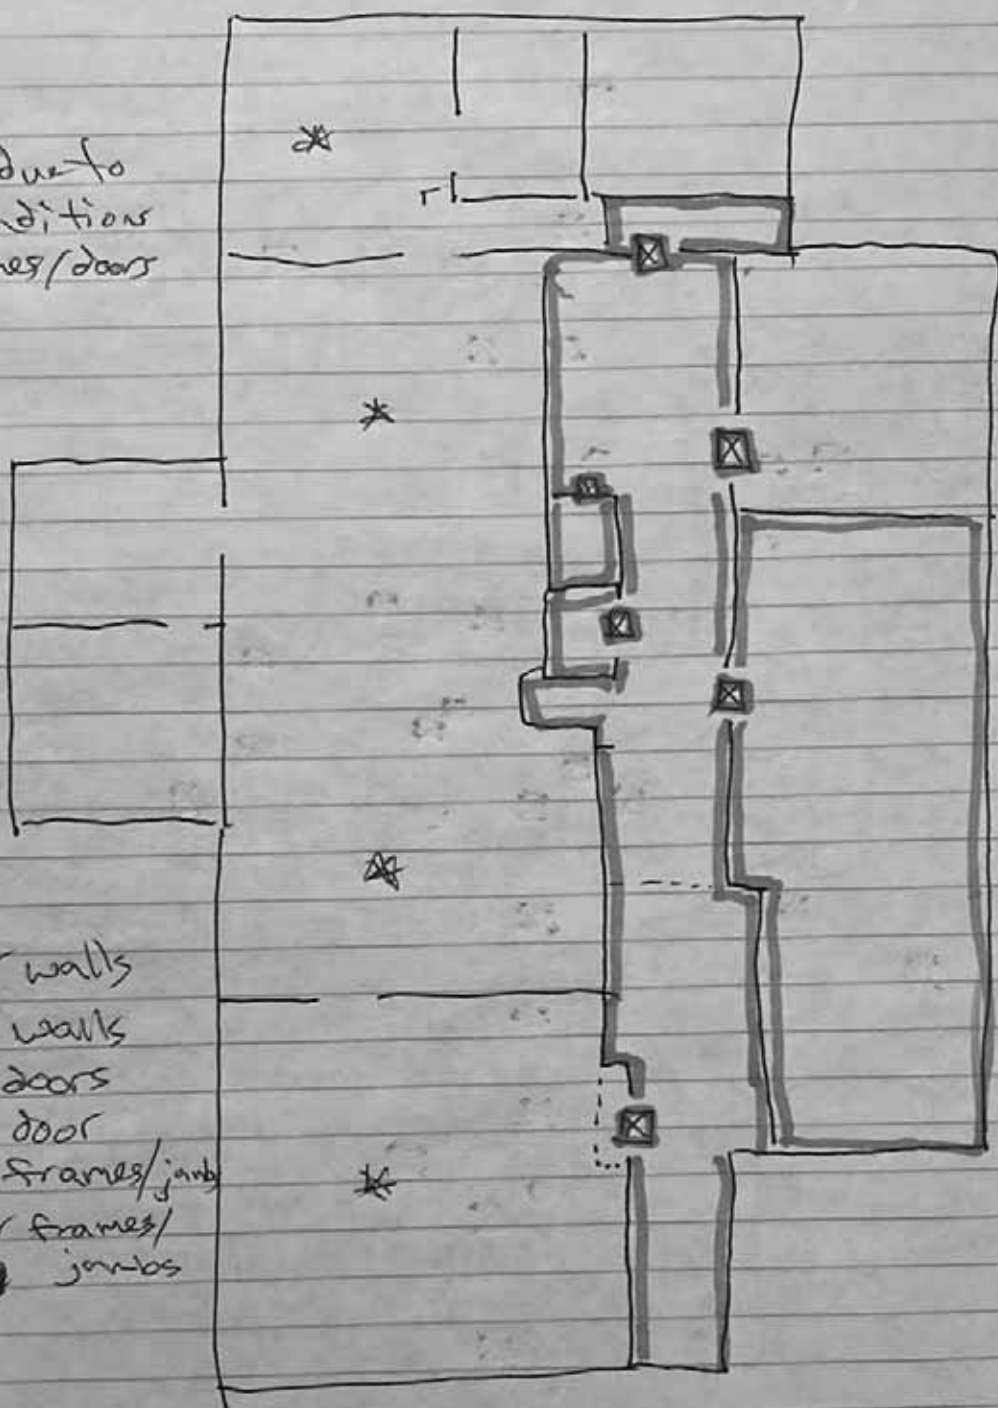
Exterior

- white wood doors
- white wood door frames
- white wood window frames

Post-fire LBP  
white wood doors  
white wood door  
frames  
white wood window  
frames

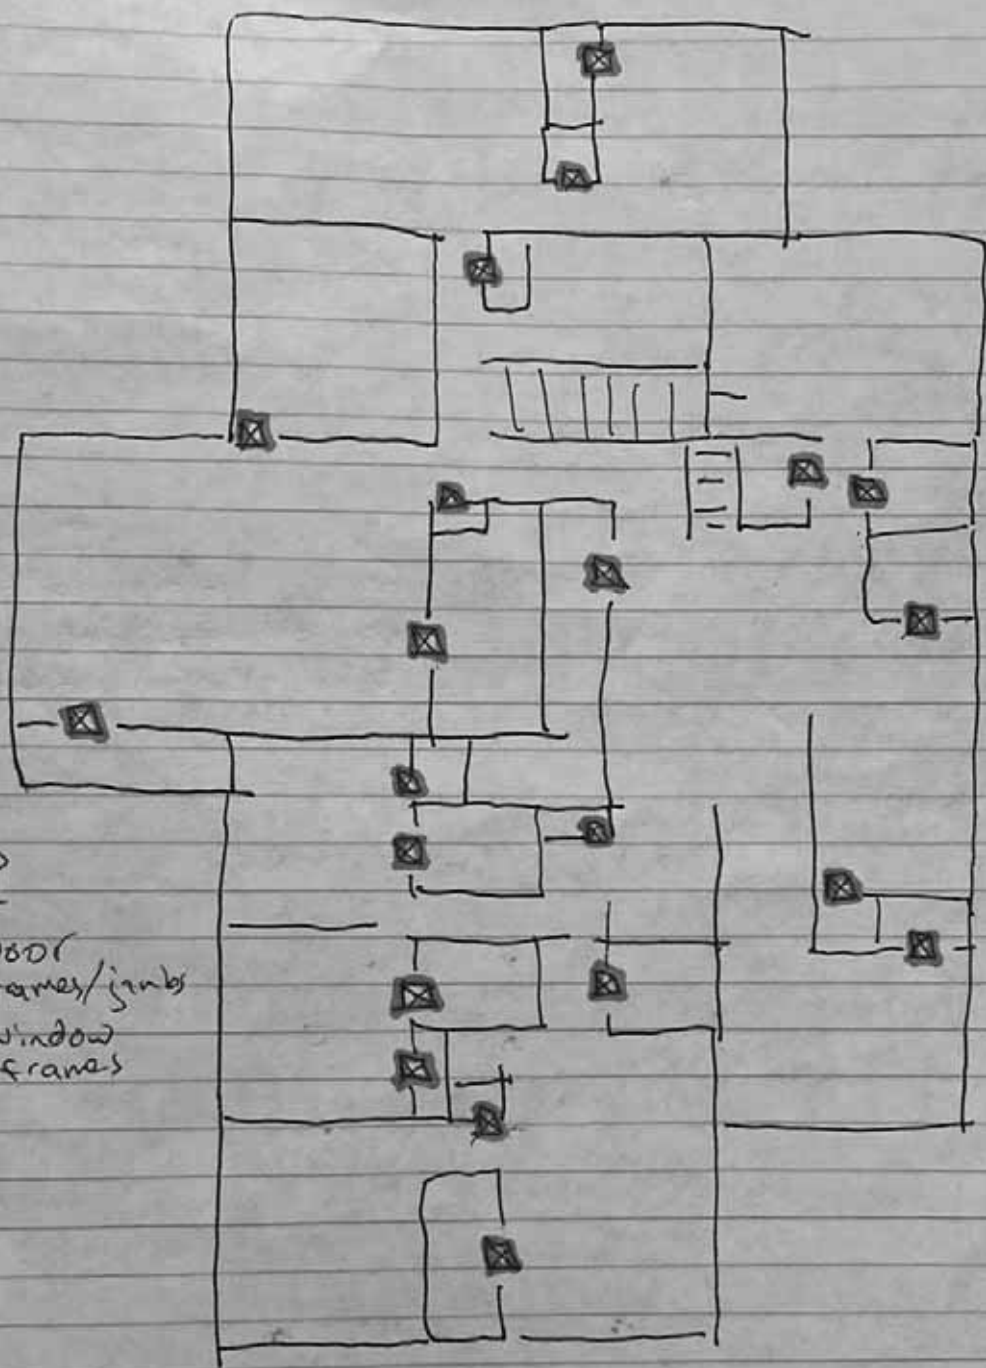
San Haven

Positive LRP

white wood door  
frames/jamb

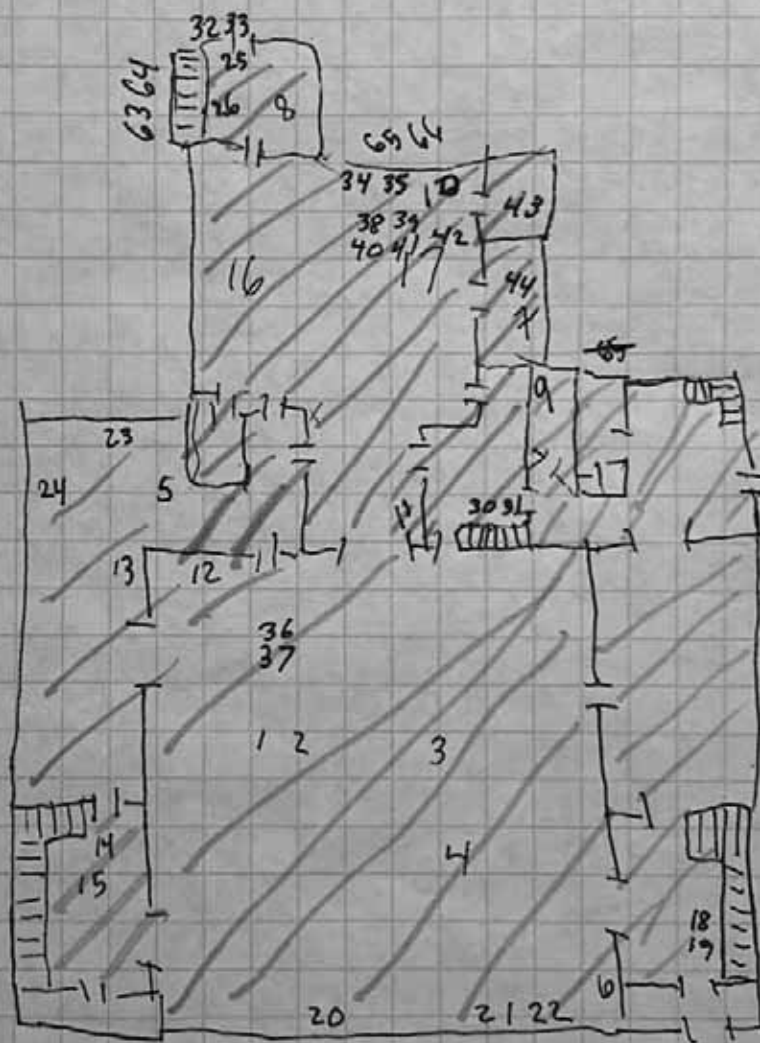
Building 19 - 2nd

/// Floor Tile 3 (9x9)

/// Tile 1

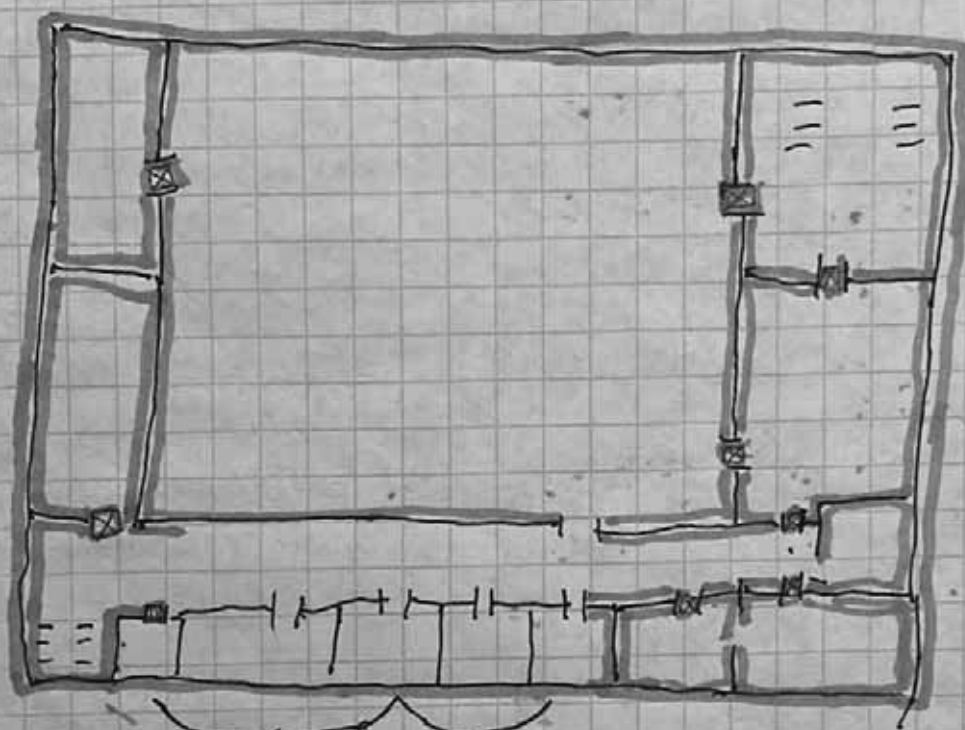
# Building 19 - 2nd Floor

Inaccessible

## Positive LBP
