**Subject: Contract No. 68HERH19D0018; Task Order (TO) No. 68HE0719F0190
Cyclonic Building, 3201-3207 Locust Street, St. Louis, Missouri
Targeted Brownfields Assessment Hazardous Materials Survey**

**TARGETED BROWNFIELDS ASSESSMENT
HAZARDOUS MATERIALS SURVEY**

**CYCLONIC BUILDING
3201-3207 LOCUST BOULEVARD, ST. LOUIS, MISSOURI**

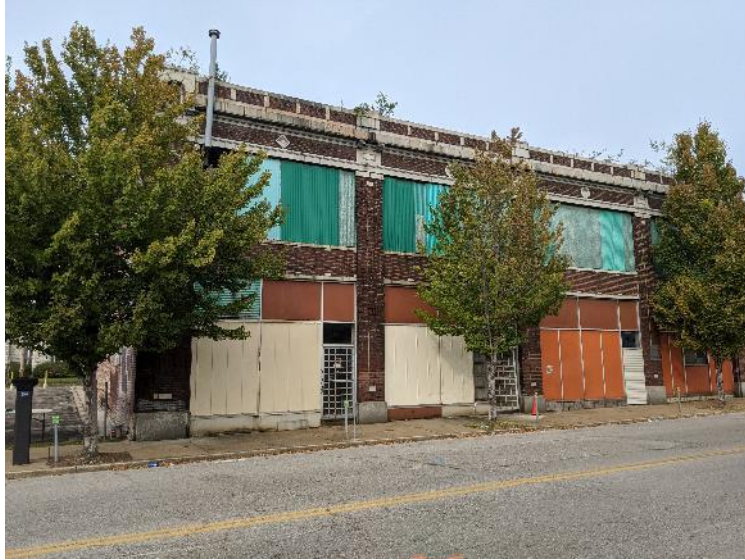
<p>SUBTASK NO. 01.05</p> <p>Direction: North</p>	DESCRIPTION	This photograph shows an overview of the Cyclonic Building.	1
	CLIENT	U.S. Environmental Protection Agency (EPA)	Date
	PHOTOGRAPHER	Ryan Slanczka	9/14/2020
