**Subject: Contract No. 68HERH19D0018; Task Order (TO) No. 68HE0719F0190
WE Building, 3230-3232 Washington Boulevard, St. Louis, Missouri
Targeted Brownfields Assessment Hazardous Materials Survey**

**TARGETED BROWNFIELDS ASSESSMENT
HAZARDOUS MATERIALS SURVEY**

**WE BUILDING
3230-3232 WASHINGTON BOULEVARD, ST. LOUIS, MISSOURI**

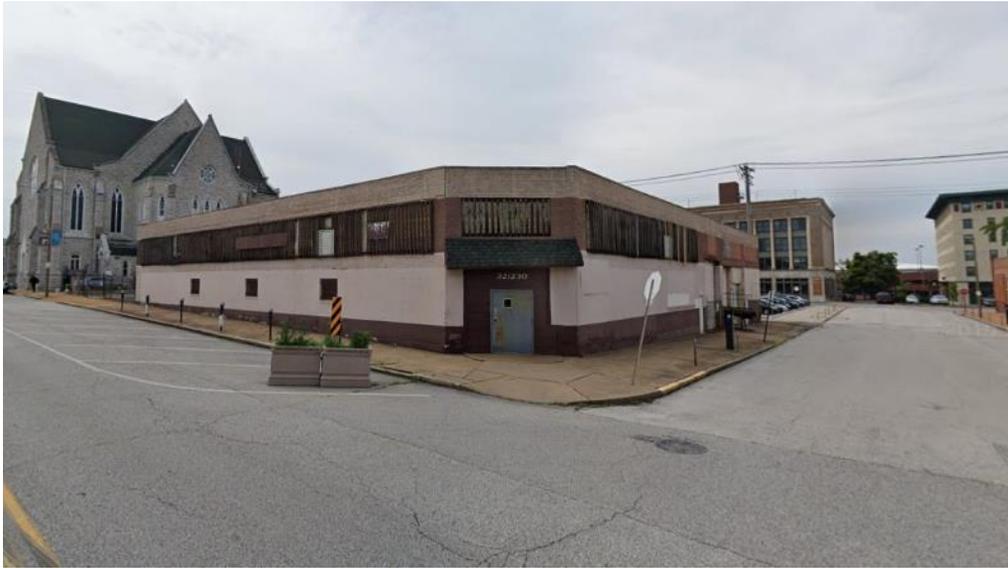
SUBTASK NO. 03.05 DIRECTION: Southeast	DESCRIPTION	This photograph shows the WE Building at 3230 Washington Avenue, St. Louis, Missouri.	1
	CLIENT	U.S. Environmental Protection Agency (EPA)	Date
	PHOTOGRAPHER	Ryan Slanczka	9/17/2020
