**Subject: Contract No. 68HERH19D0018; Task Order (TO) No. 68E0719F0190
Pine Lawn, 6109 Natural Bridge Road, Pine Lawn, Missouri
Targeted Brownfields Assessment Hazardous Materials Survey**

**TARGETED BROWNFIELDS ASSESSMENT
HAZARDOUS MATERIALS SURVEY**

**PINE LAWN
6109 NATURAL BRIDGE ROAD, PINE LAWN, MISSOURI**

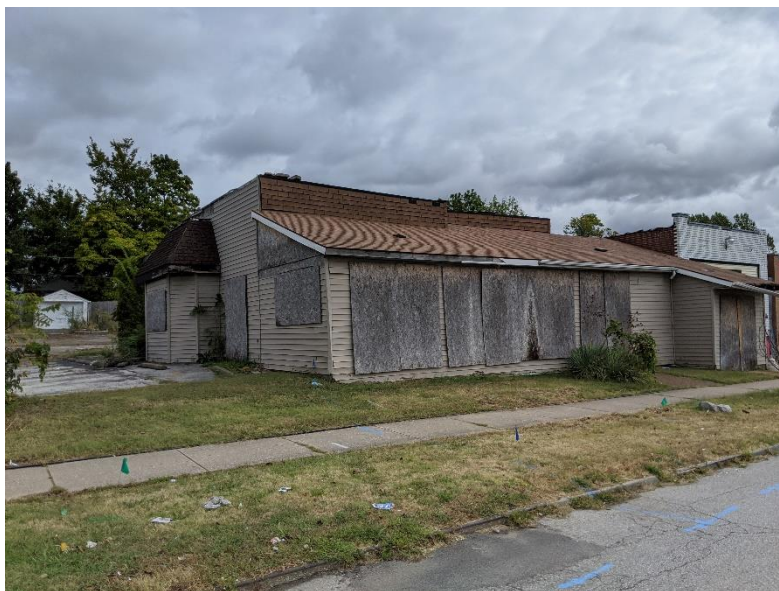
SUBTASK NO. 02.05 Direction: East	DESCRIPTION	This photograph shows the building at 6109 Natural Bridge Road in Pine Lawn.	1
	CLIENT	U.S. Environmental Protection Agency (EPA)	Date
	PHOTOGRAPHER	Ryan Slanczka	9/29/2020
