**Subject: Contract No. 68HERH19D0018; Task Order (TO) No. 68E0719F0190
Pine Lawn, 6261 Natural Bridge Road, Pine Lawn, Missouri
Targeted Brownfields Assessment Hazardous Materials Survey**

**TARGETED BROWNFIELDS ASSESSMENT
HAZARDOUS MATERIALS SURVEY**

**PINE LAWN
6261 NATURAL BRIDGE ROAD, PINE LAWN, MISSOURI**

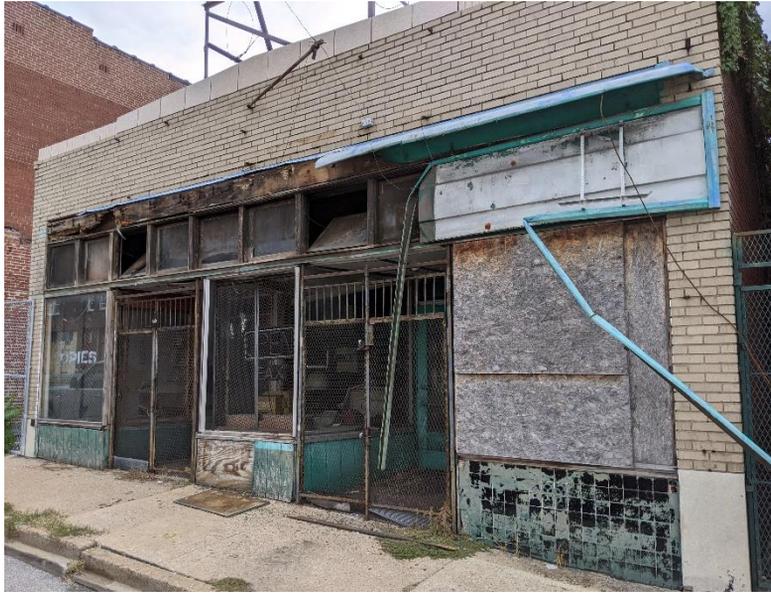
SUBTASK NO. 02.05 Direction: Northwest	DESCRIPTION	This photograph shows the front of the building at 6261 Natural Bridge Road in Pine Lawn.	1
	CLIENT	U.S. Environmental Protection Agency (EPA)	Date
	PHOTOGRAPHER	Ryan Slanczka	9/29/2020

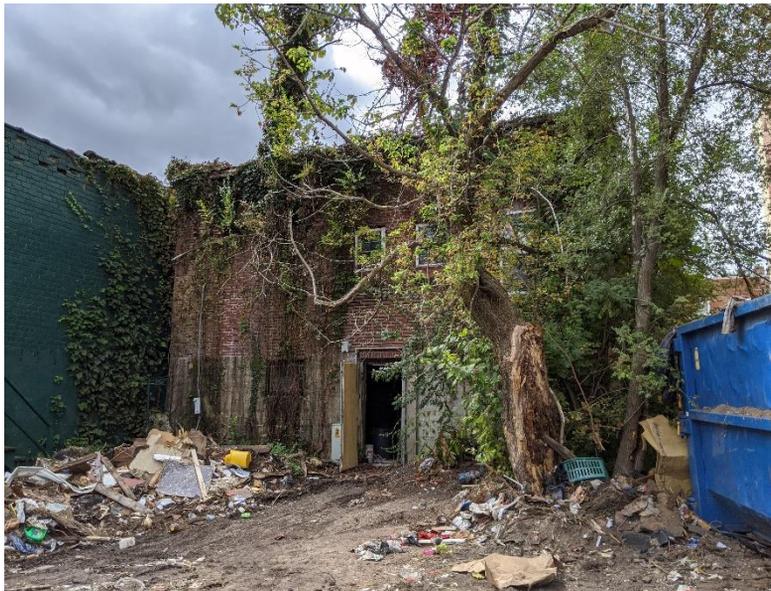
SUBTASK NO. 02.05 Direction: South	DESCRIPTION	This photograph shows the back of the building at 6261 Natural Bridge Road in Pine Lawn.	2
	CLIENT	EPA	Date
	PHOTOGRAPHER	Ryan Slanczka	9/29/2020
