October 20, 2006

**Subject: Site Activity/Removal Report – Anaconda Mine Site, Yerington, Nevada
TDD TO1-09-06-04-0004**

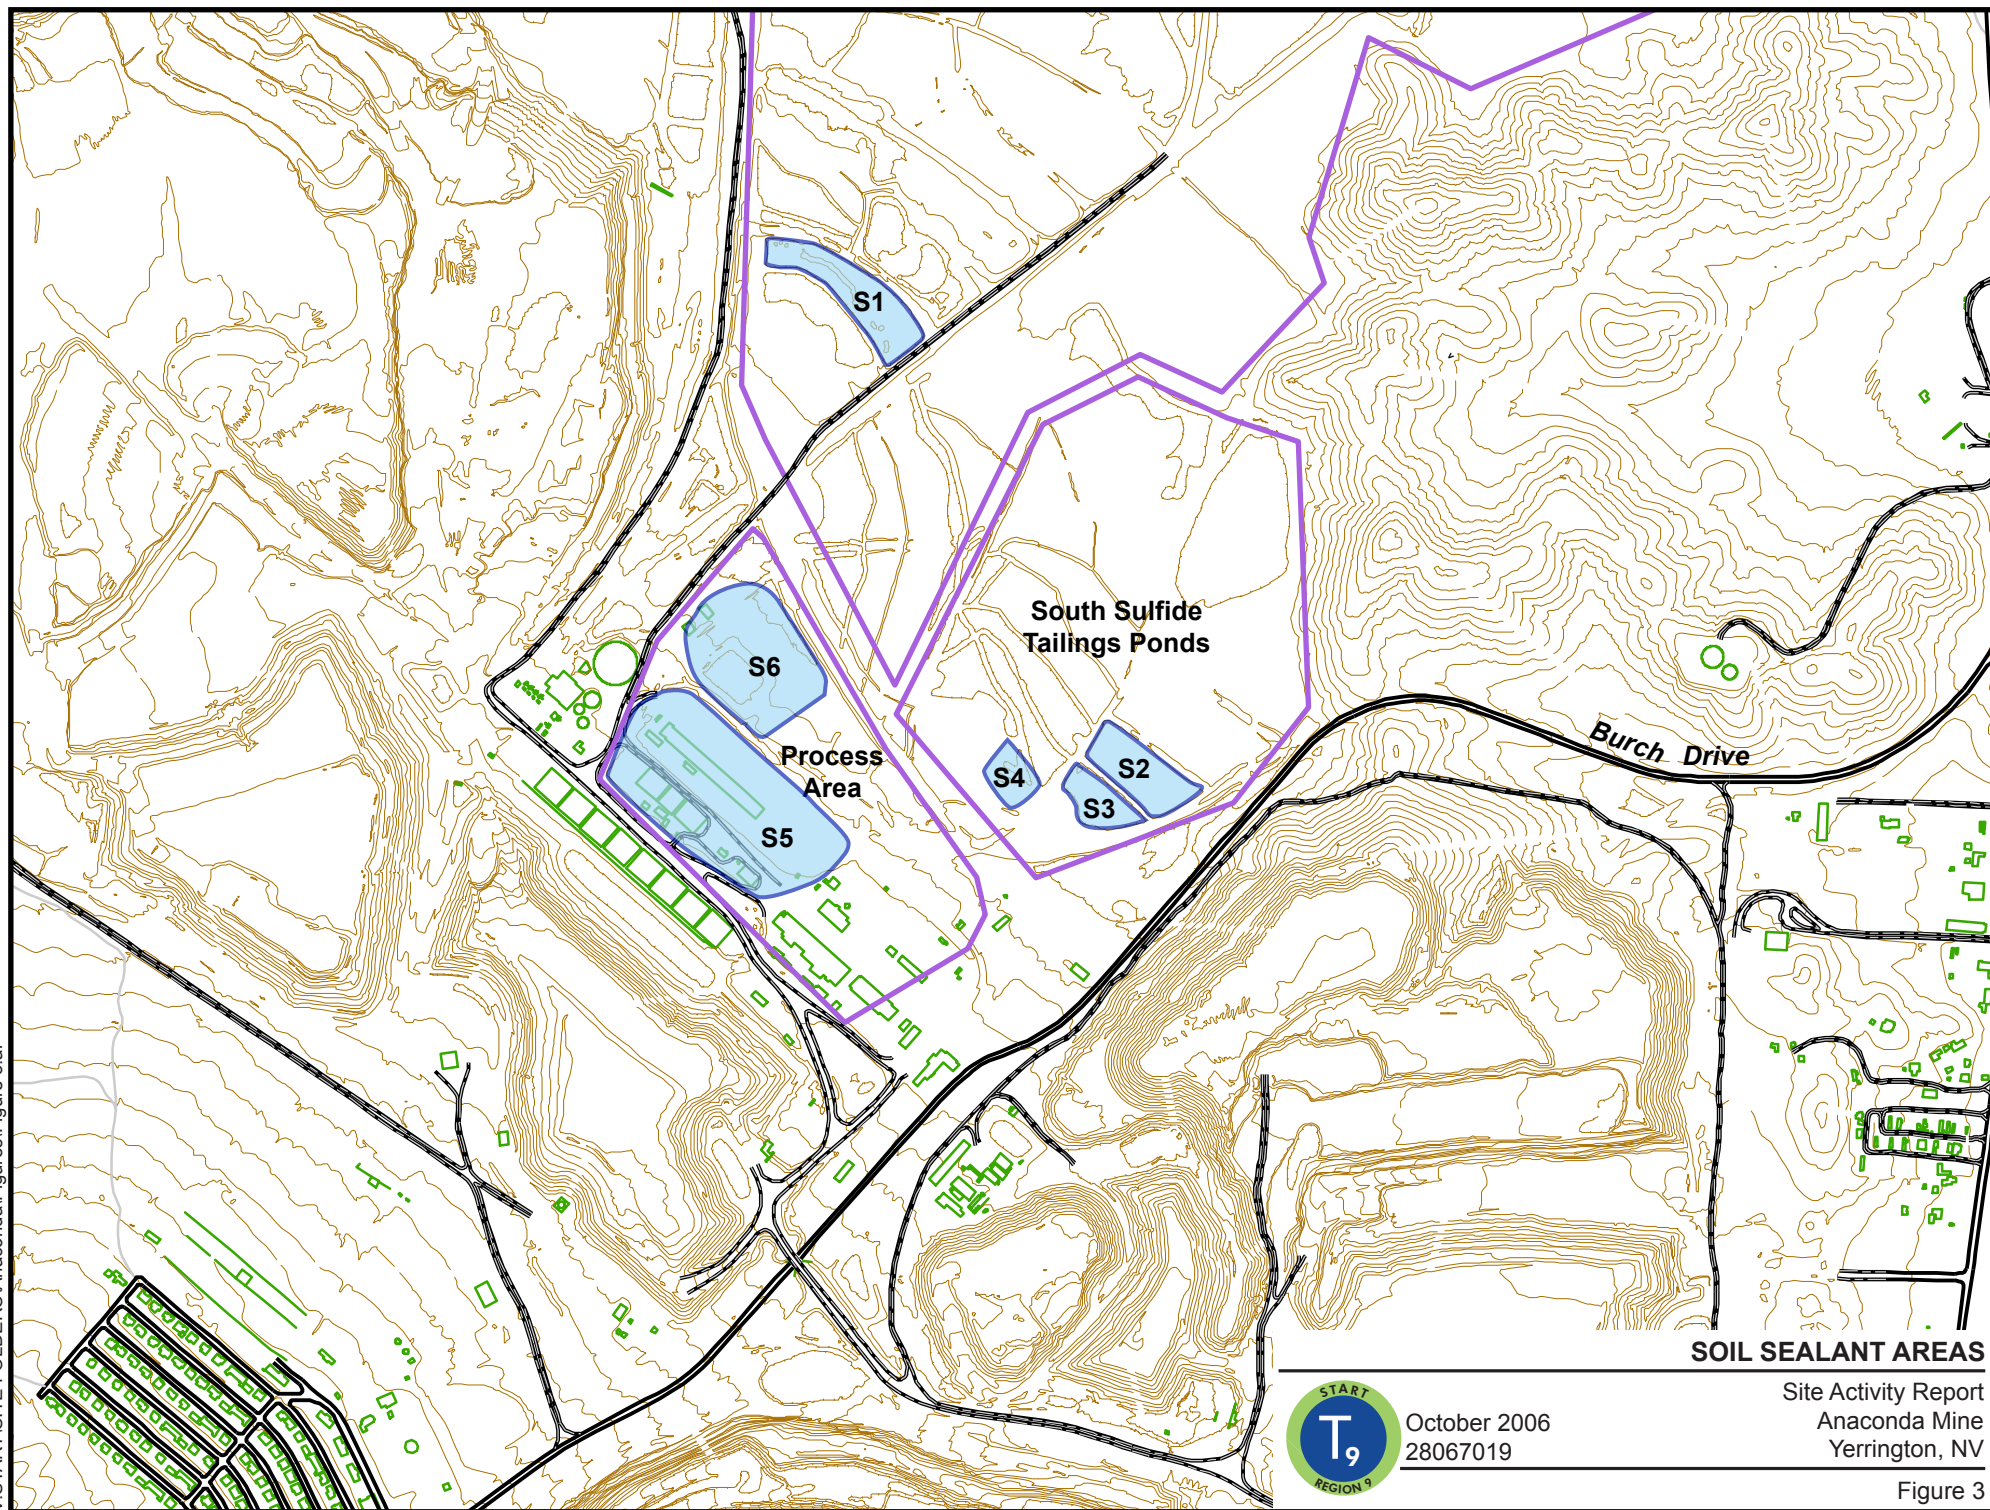
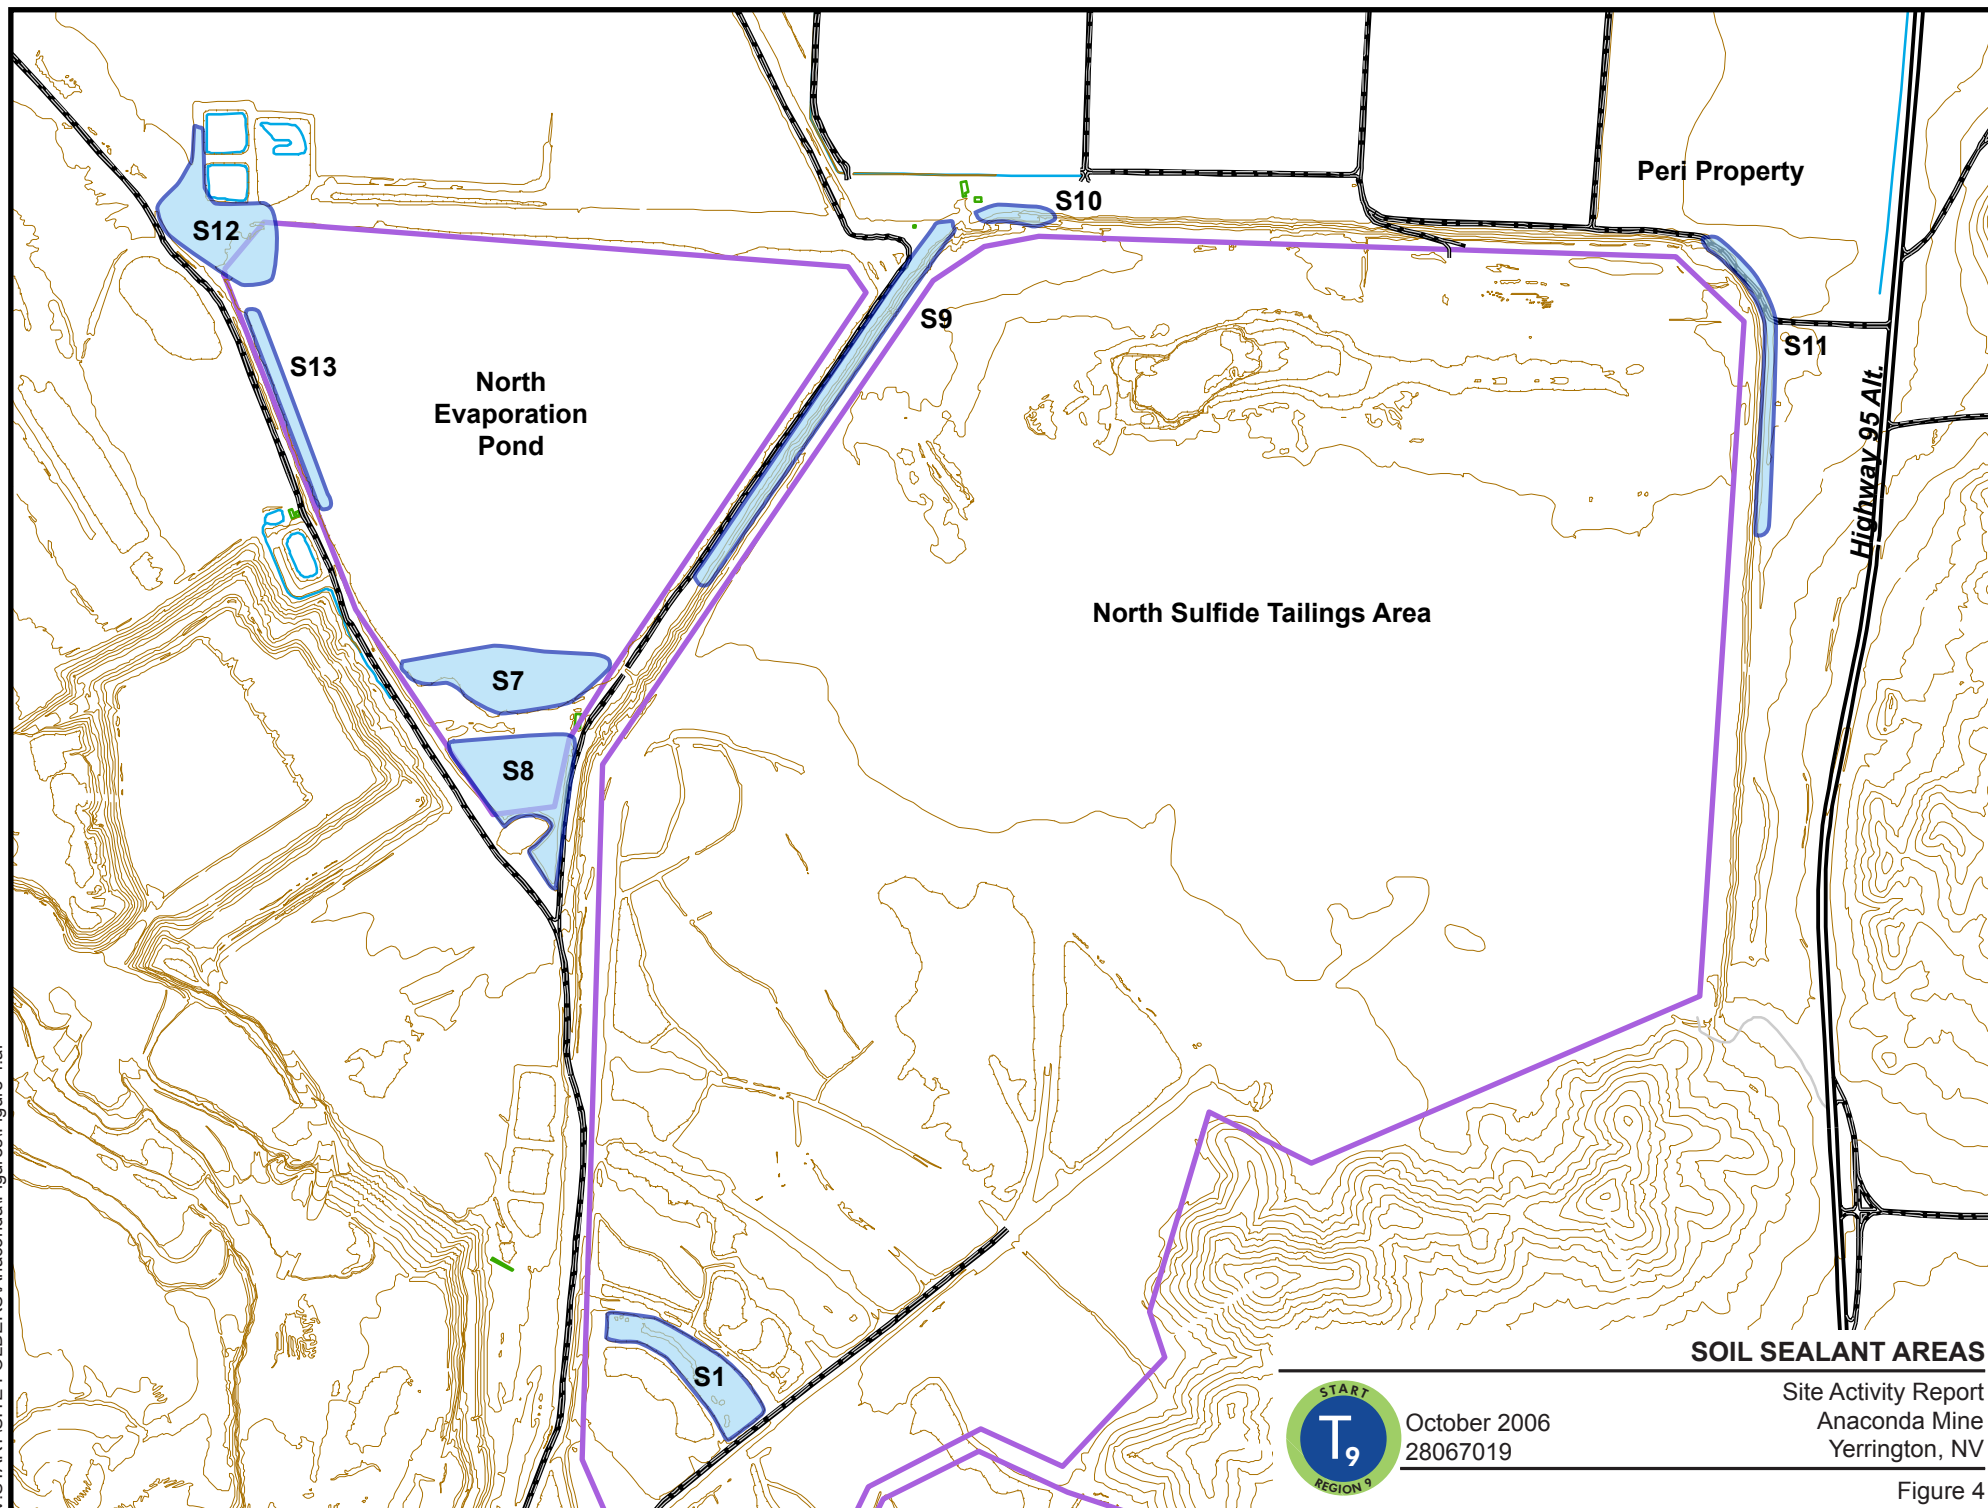
Figure 4

Area S7 is the southern corner of the North Evaporation Pond and consists of approximately 150,000 ft² (Figure 4). Area S8 is a small basin south of the North Evaporation Pond, just south of Area S7, and consists of approximately 60,000 ft² (Figure 4). Both areas contain fine, loose-gained sandy material that was discovered to potentially contribute to off-site dust migration. Both areas were sprayed with the soil sealant on May 11, 2006; however, the North Evaporation Pond was wet in the area of S7, and the water truck got stuck in the soft material. As a result, only portions of Area S7 accessible from the roadway were sprayed with the soil sealant (Photos 13 and 14).

Area S12, located at the northern corner of the Northern Evaporation Pond, is approximately 40,000 ft², and contains areas with dark red dirt material, which is thought to have elevated levels of radiation (Figure 4) based on the Scanner Van Survey. Area S13 contains loose, sandy material along the western side wall of the evaporation pond, just south of area S12, and consists of a rectangular area of approximately 30,000 ft² (Figure 4). Both areas were sprayed with the soil sealant on May 12, 2006; however, due to soft, wet material inside the North Evaporation Pond, areas of S12 and S13 were only sprayed in portions that were accessible from the roadway (Photos 15 and 16).

Area S9 is located at the toe of the sulfide tailings along the western edge or face, just east of the eastern edge of the North Evaporation Pond, and contains a long rectangular area of loose, sandy material. Area S9 is approximately 60,000ft² (Figure 4). Area S10 is located just northeast of Area S9, along the northern face of the Sulfide Tailings, facing the neighboring Peri property to the north (Figure 4). Area S10 is approximately 6,000 ft². Areas S9 and S10 were determined to potentially contribute to fugitive dust migration at the site. Area S9 and S10 were sprayed with soil sealant on May 11, 2006 (Photo 17).

Area S11 is at the base of the Sulfide Tailings along the northern edge, which fronts Highway 95A, and is approximately 40,000 ft² (Figure 4). The face of the Sulfide Tailings along Interstate 95 Alt, Area S11, consists of loose, sandy material that is believed to contribute to fugitive dust migration offsite. Area S11 was sprayed with soil sealant on May 12, 2006 (Photo 18).
