NAVAJO FOREST **PRODUCTS BUILDING** **ASSESSMENT**

VISUAL STRUCTURAL EVALUATION

JULY 2018

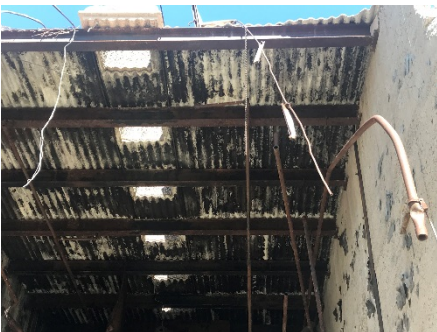
TYPICAL ROOF STRUCTURE

2. The beams supporting the corrugated asbestos roof appeared to have some corrosion. To what extent is unknown, since the beams could not be measured or closely observed. If the beams are to be reused or repurposed, we recommend further studies after decontamination to ensure they are adequate.

3. The corrugated asbestos roof, with what appeared to be a gypsum or lightweight concrete topping reinforced with welded wire fabric, appeared to be in poor condition and not positively attached to the beams or walls. The underside of the deck exhibited a varied amount of deterioration and distress, with signs of damage to both the deck, topping and wire mesh. Not only is the structural roof deck in very poor condition, it does not act as an engineered diaphragm. A lateral diaphragm is an essential element in providing support for structural elements subject to wind or seismic elements and distributing those

Lastly, the roof deck is in poor condition and does not act as an engineered roof diaphragm. It is recommended the roof diaphragm be removed and replaced with a properly designed diaphragm.

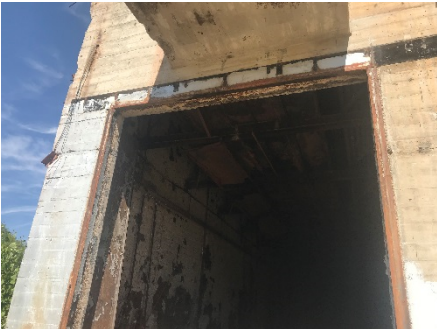
TYPICAL OPENING IN WALL 12

Wall 12 is 12 inches thick and reinforcement was observed at the top of the wall on the northeast side. The rebar that was exposed appeared to be reinforcement for a lintel that was removed. The diameter of the bars were between 1/2 inch and 5/8 inch. As far as jamb reinforcement between the openings, it is unknown. The jamb width was approximately 5 feet to 6 feet wide, and the openings were approximately 10 feet wide by 14 feet tall. Another characteristic of wall 12 is the embed channels on the lower portion of the lintel, and angle embeds on the sides of the jambs. They appear to have been installed to prevent damage to the jamb and lintel. The wall had concrete chutes over the openings; however, only two exist today at the southeast side; see photo 5.

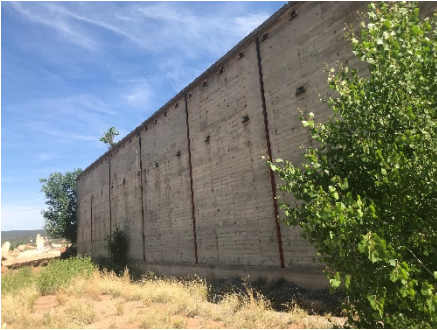
TYPICAL WALL 11 AND 13

For walls 2 thru 11, as well as 13, no exposed rebar was observed and the thickness of the wall could not be determined. Pending additional studies, the walls are assumed to be as thick as the adjacent walls, and are more than likely reinforced, similar to other walls. This will need to be confirmed.

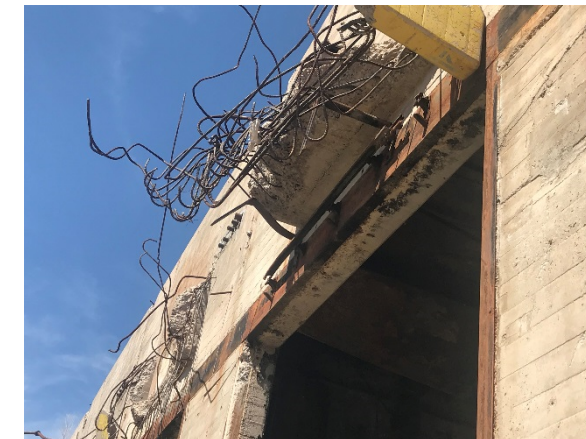
Photo 6 (REMOVED CHUTE)

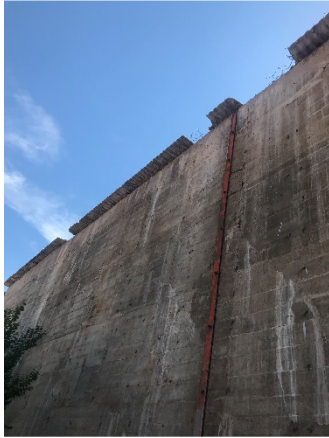
Photo 13 (TYPICAL BOLTED PLATE)

and moisture issues. Also, the walls had approximately 4 inch wide continuous vertical plates bolted to the surface at approximately 10 feet to 12 feet on center. It is thought these plates cover the construction joints between concrete panels. See photo 8. Furthermore, the condition of the reinforcement connecting the foundation stem wall to the concrete wall is unknown.

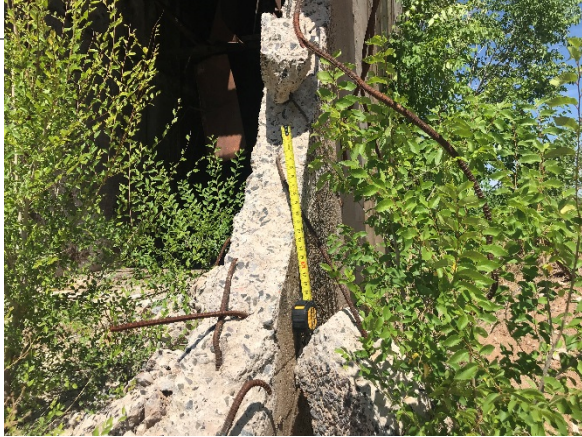
Photo 19 (HORIZ. REINF. SPACING WALL 1)

Since wall 1 was damaged, the thickness and reinforcement was easily observed. Wall 1 is 8 inches thick, with a single mat of reinforcement approximately centered in the wall. The horizontal and vertical reinforcement appears to be either 1/2 inch or 5/8 inch in diameter, with a bamboo rib pattern at roughly 18 inches to 20 inches OC.
