# **TIME-CRITICAL REMOVAL ACTION REPORT**

*Onalaska Wood Pyrolysis  
Onalaska, Lewis County, Washington*

Prepared by:

December 2021

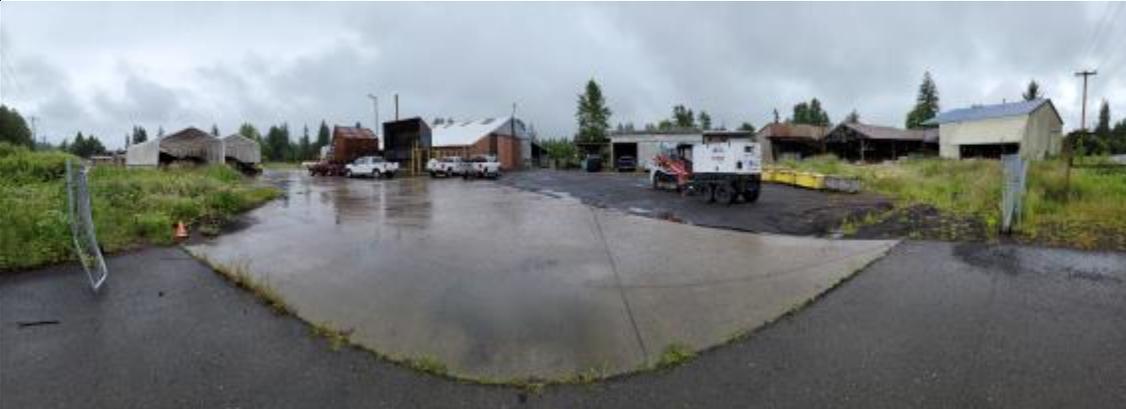
<b>Photo No.</b> <b>1</b>	<b>Date:</b> 06/14/2021

<b>Photo Coordinates</b>		
<b>Lat</b>	46.572531	
<b>Long</b>	-122.72936	
<b>Direction Photo Taken:</b> <b>SE</b>		
<b>Description:</b> Site viewed from the entrance gate.

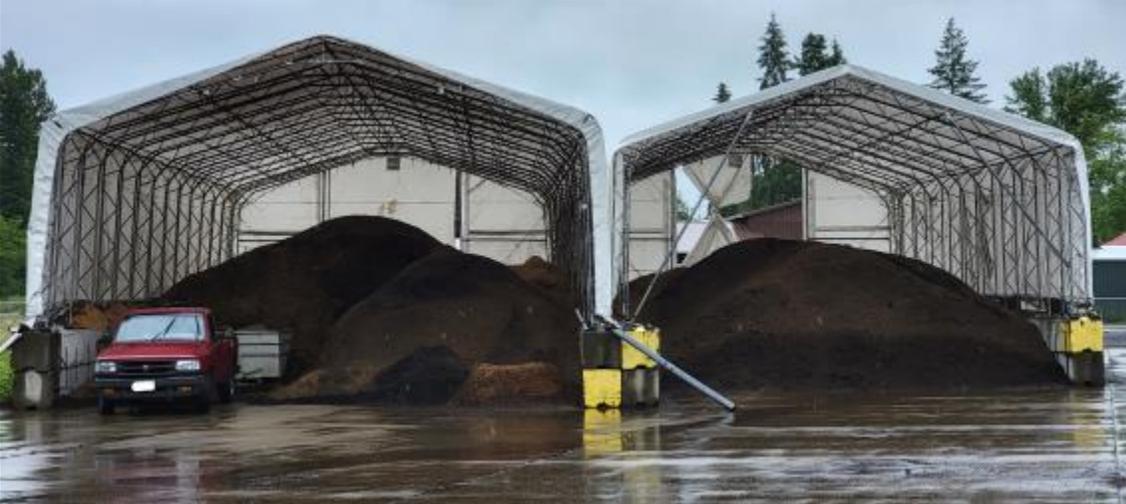
<b>Photo No.</b> <b>2</b>	<b>Date:</b> 06/14/2021

<b>Photo Coordinates</b>		
<b>Lat</b>	46.572526	
<b>Long</b>	-122.729495	
<b>Direction Photo Taken:</b> <b>NE</b>		
<b>Description:</b> Wood Chip Storage Area.

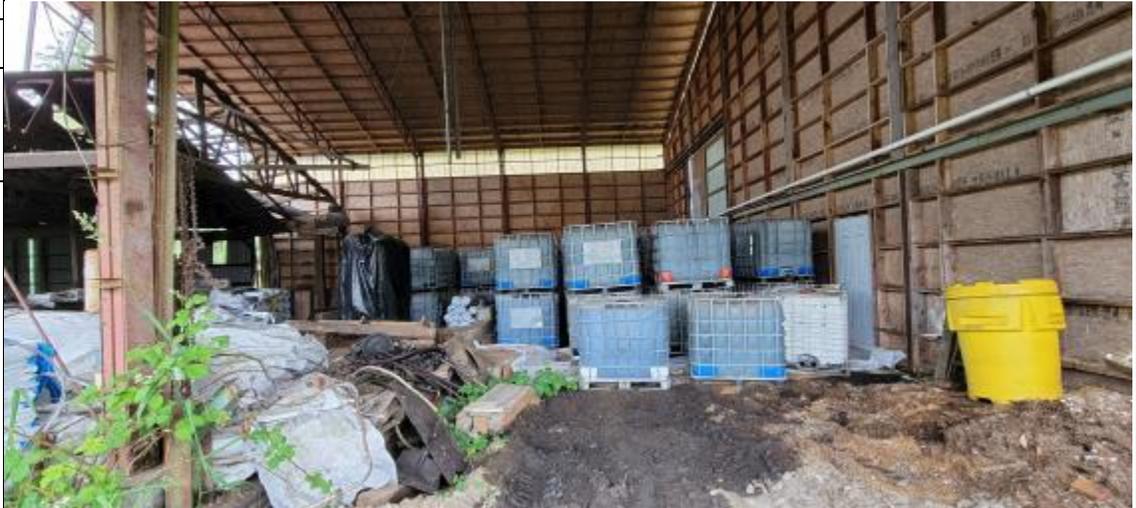
<b>Photo No.</b> <b>3</b>	<b>Date:</b> 06/14/2021
<b>Photo Coordinates</b>	
<b>Lat</b>	46.572356
<b>Long</b>	-122.729788
<b>Direction Photo Taken:</b> <b>W</b>	
<b>Description:</b>  TG01 Tote Area in the North Warehouse.

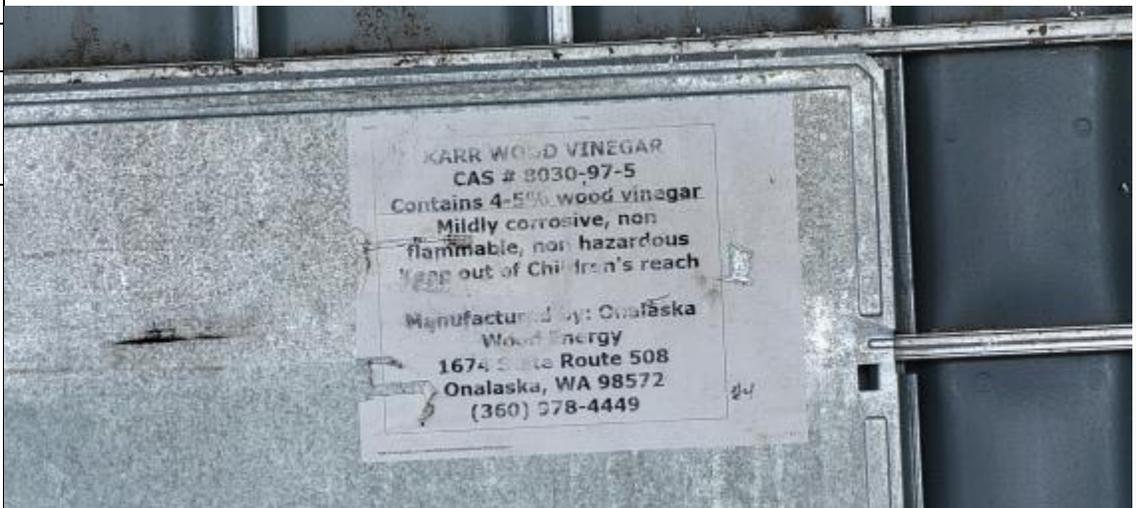
<b>Photo No.</b> <b>4</b>	<b>Date:</b> 06/14/2021
<b>Photo Coordinates</b>	
<b>Lat</b>	46.572356
<b>Long</b>	-122.729788
<b>Direction Photo Taken:</b> <b>W</b>	
<b>Description:</b>  Label on a tote located in the TG01 Tote Area.

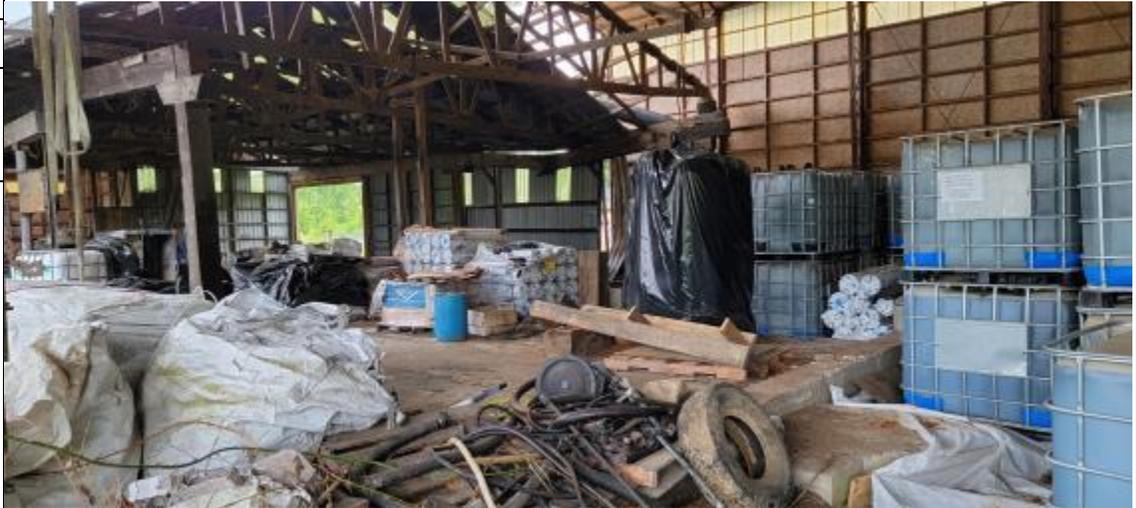
<b>Photo No.</b> <b>5</b>	<b>Date:</b> 06/14/2021
<b>Photo Coordinates</b>	
<b>Lat</b>	46.572356
<b>Long</b>	-122.729788
<b>Direction Photo Taken:</b> <b>SW</b>	
<b>Description:</b>  Totes, large containers, and debris stored in the North Warehouse area.

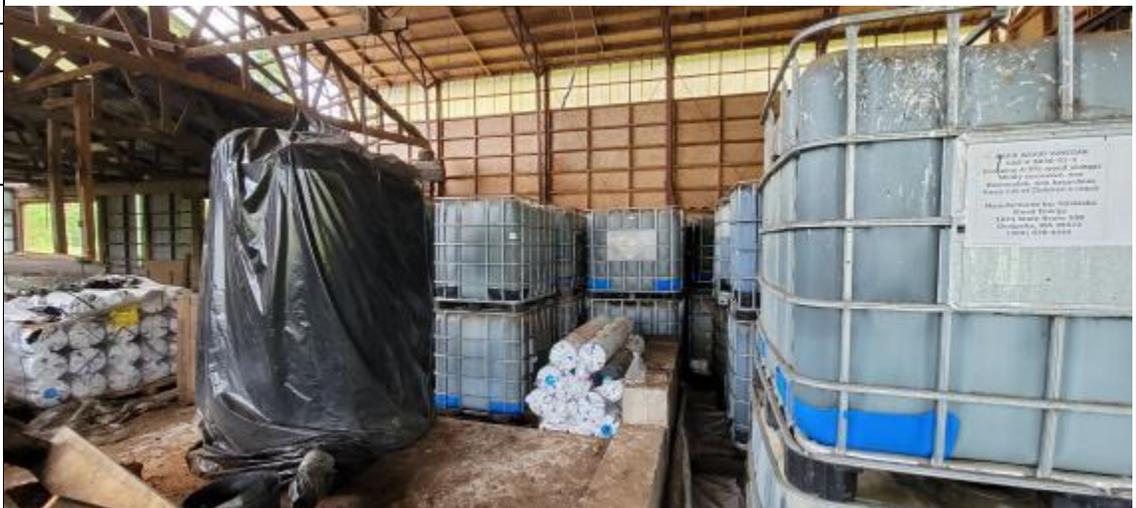
<b>Photo No.</b> <b>6</b>	<b>Date:</b> 06/14/2021
<b>Photo Coordinates</b>	
<b>Lat</b>	46.572356
<b>Long</b>	-122.729788
<b>Direction Photo Taken:</b> <b>W</b>	
<b>Description:</b>  Totes, large container, and debris stored in the North Warehouse area.

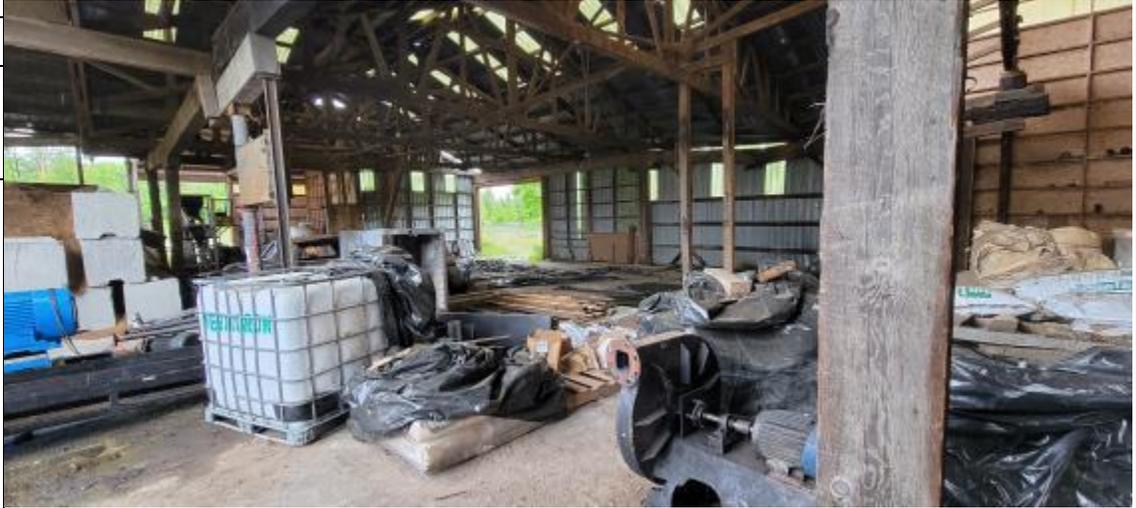
<b>Photo No.</b> <b>7</b>	<b>Date:</b> 06/14/2021
<b>Photo Coordinates</b>	
<b>Lat</b>	46.572347
<b>Long</b>	-122.730354
<b>Direction Photo Taken:</b> <b>SW</b>	
<b>Description:</b>  Tote and debris stored in the North Warehouse area.

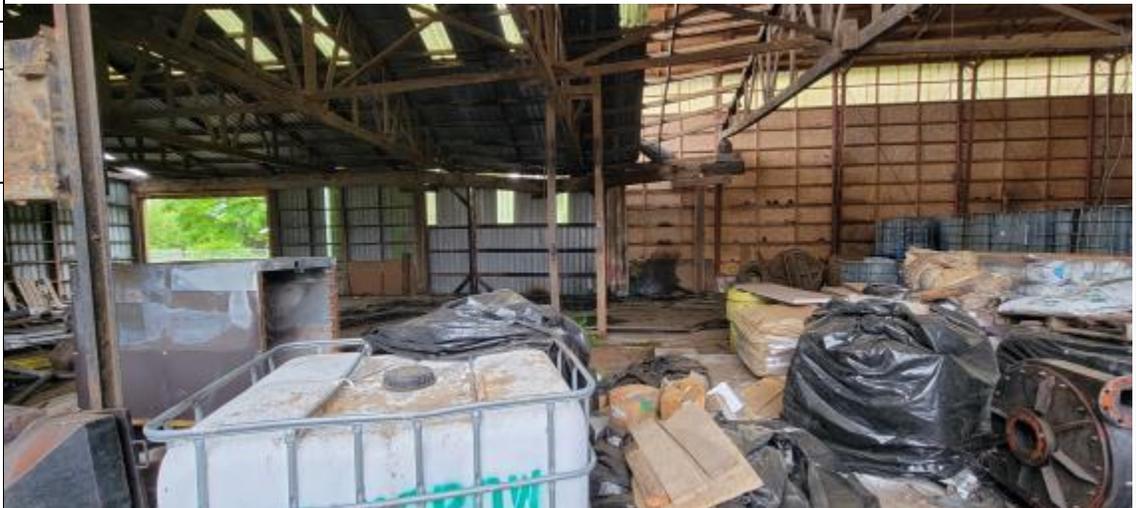
<b>Photo No.</b> <b>8</b>	<b>Date:</b> 06/14/2021
<b>Photo Coordinates</b>	
<b>Lat</b>	46.572347
<b>Long</b>	-122.730354
<b>Direction Photo Taken:</b> <b>SW</b>	
<b>Description:</b>  Totes and debris stored in the North Warehouse area.

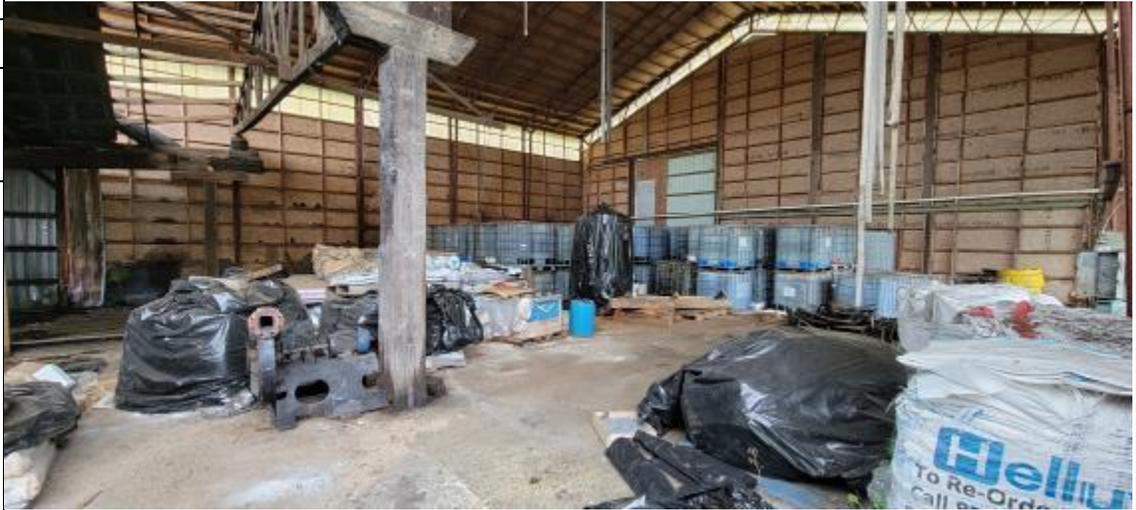
<b>Photo No.</b> <b>9</b>	<b>Date:</b> 06/14/2021
<b>Photo Coordinates</b>	
<b>Lat</b>	46.572347
<b>Long</b>	-122.730354
<b>Direction Photo Taken:</b> <b>W</b>	
<b>Description:</b>  Totes, containers, and debris stored in the North Warehouse area.

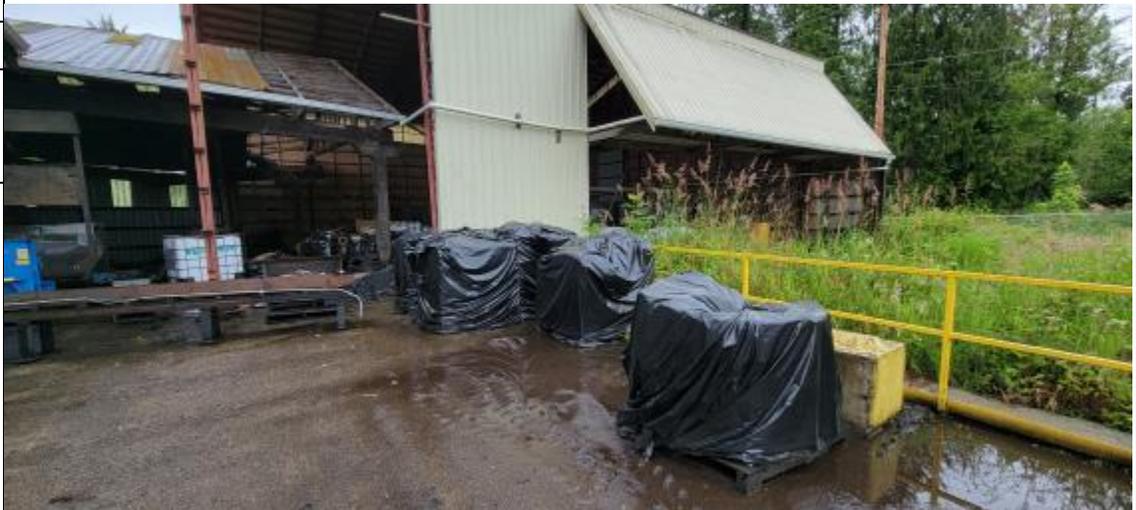
<b>Photo No.</b> <b>10</b>	<b>Date:</b> 06/14/2021
<b>Photo Coordinates</b>	
<b>Lat</b>	46.572347
<b>Long</b>	-122.730354
<b>Direction Photo Taken:</b> <b>W</b>	
<b>Description:</b>  North Warehouse in the background. Equipment and covered waste in the foreground.

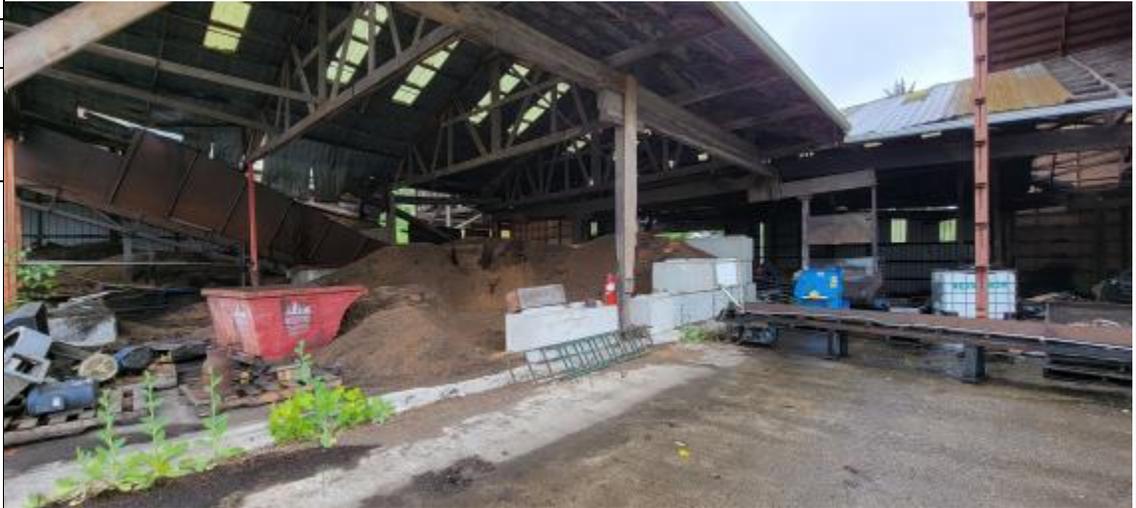
<b>Photo No.</b> <b>11</b>	<b>Date:</b> 06/14/2021
<b>Photo Coordinates</b>	
<b>Lat</b>	46.57233
<b>Long</b>	-122.729753
<b>Direction Photo Taken:</b> <b>SW</b>	
<b>Description:</b> Equipment and wood chips stored in the condemned warehouse area.

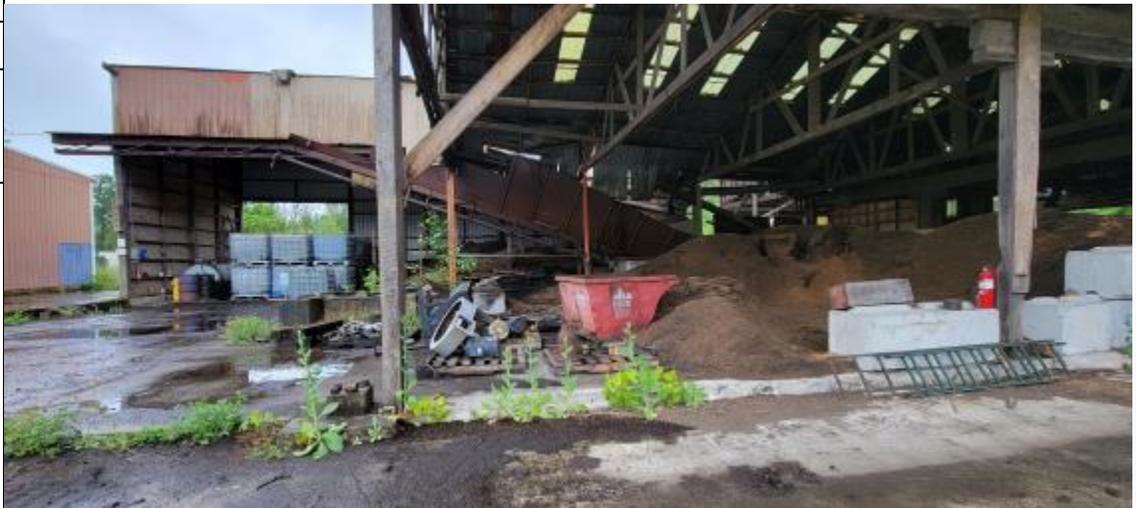
<b>Photo No.</b> <b>12</b>	<b>Date:</b> 06/14/2021
<b>Photo Coordinates</b>	
<b>Lat</b>	46.57233
<b>Long</b>	-122.729753
<b>Direction Photo Taken:</b> <b>S</b>	
<b>Description:</b> Condemned warehouse area in the foreground. South Warehouse TG02 Tote Area with totes, drums, and a diesel tank in the background.

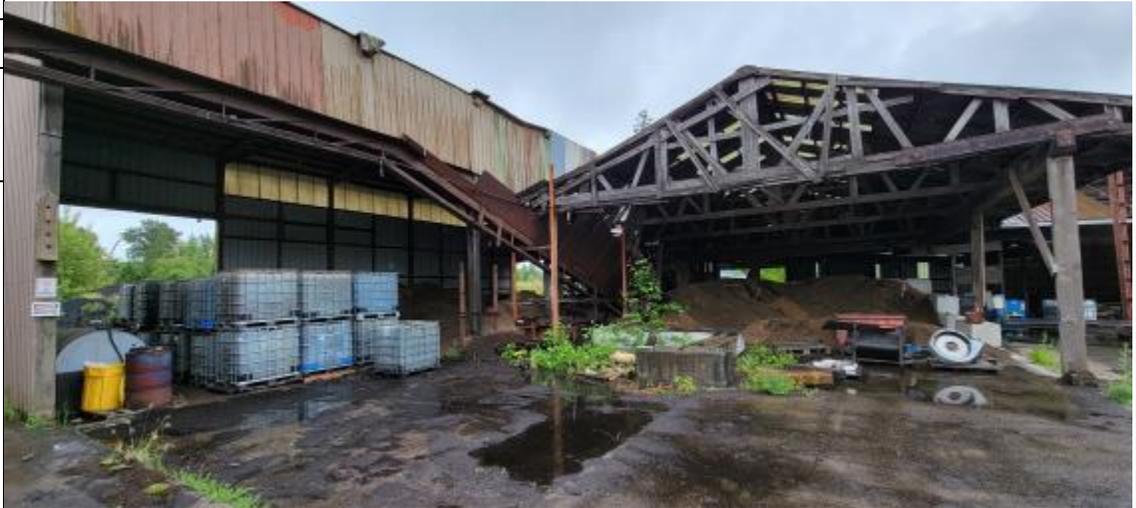
<b>Photo No.</b> <b>13</b>	<b>Date:</b> 06/14/2021
<b>Photo Coordinates</b>	
<b>Lat</b>	46.572245
<b>Long</b>	-122.729601
<b>Direction Photo Taken:</b> <b>SW</b>	
<b>Description:</b>  South Warehouse on the left and condemned warehouse area on the right.

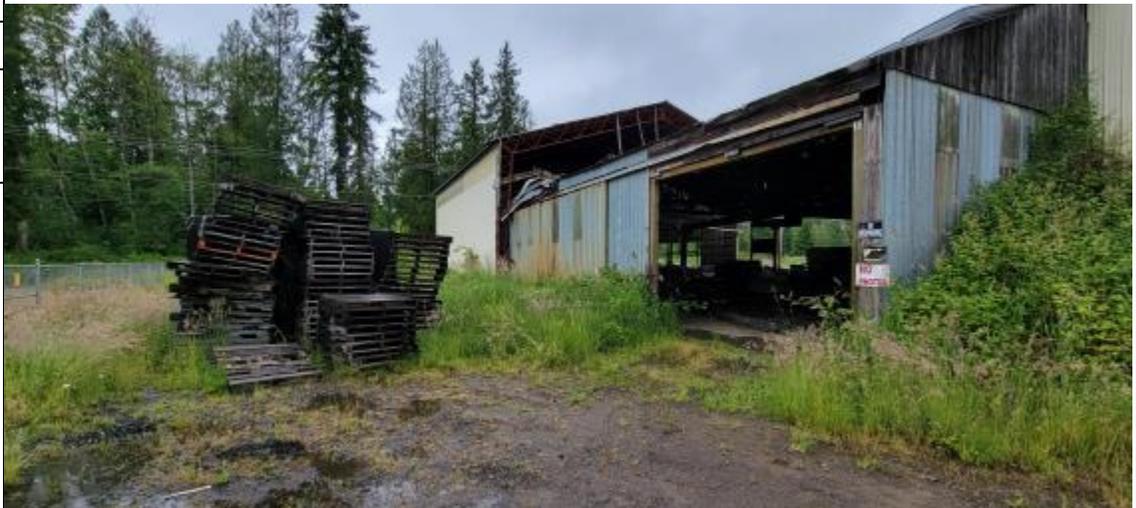
<b>Photo No.</b> <b>14</b>	<b>Date:</b> 06/14/2021
<b>Photo Coordinates</b>	
<b>Lat</b>	46.572039
<b>Long</b>	-122.729863
<b>Direction Photo Taken:</b> <b>NE</b>	
<b>Description:</b>  North Warehouse and condemned warehouse area viewed from the southwest. Abandoned pallets on the left.

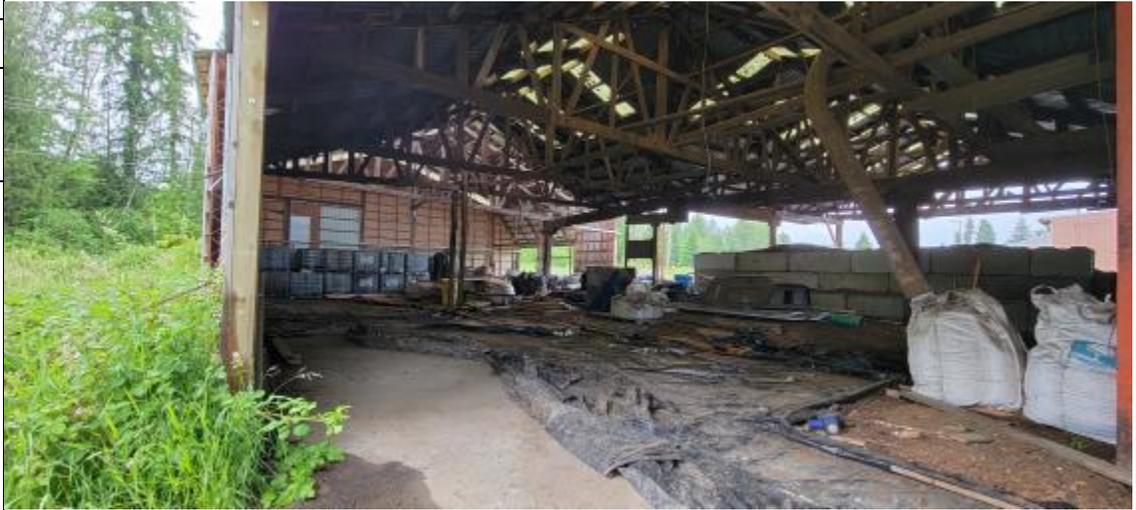
<b>Photo No.</b> <b>15</b>	<b>Date:</b> 06/14/2021
<b>Photo Coordinates</b>	
<b>Lat</b>	46.572039
<b>Long</b>	-122.729863
<b>Direction Photo Taken:</b> <b>N</b>	
<b>Description:</b>  Debris in the condemned warehouse area. Concrete retaining wall holding back wood chips on the right. Totes in the North Warehouse to the background left.

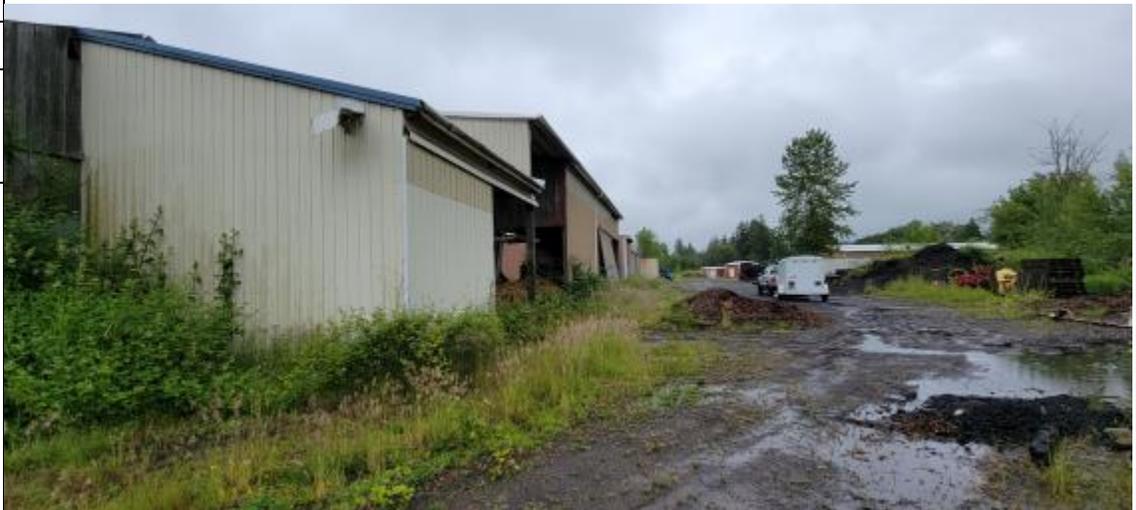
<b>Photo No.</b> <b>16</b>	<b>Date:</b> 06/14/2021
<b>Photo Coordinates</b>	
<b>Lat</b>	46.571939
<b>Long</b>	-122.729985
<b>Direction Photo Taken:</b> <b>E</b>	
<b>Description:</b>  Back area of the Site. South Warehouse area to the left.

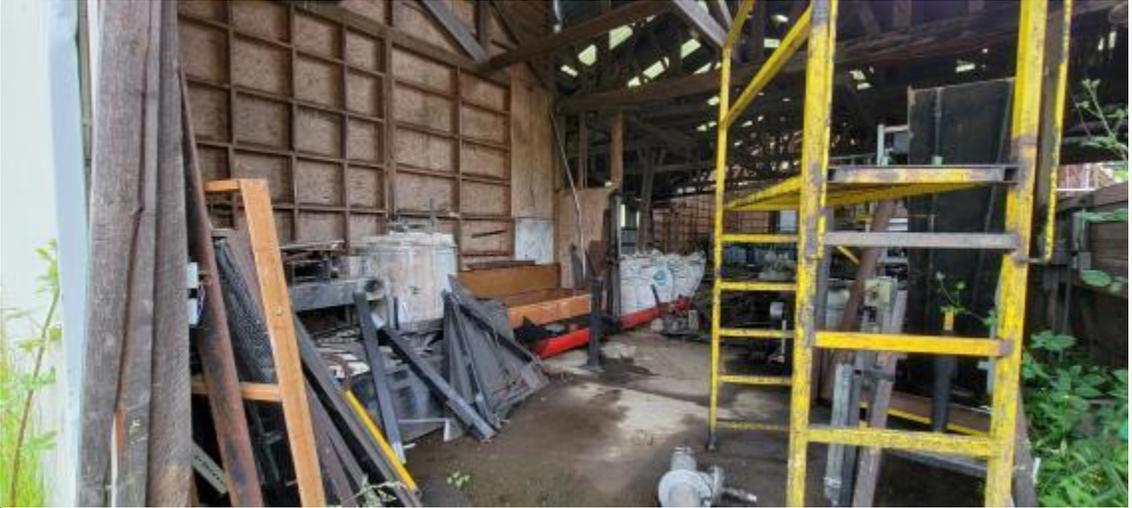
<b>Photo No.</b> <b>17</b>	<b>Date:</b> 06/14/2021
<b>Photo Coordinates</b>	
<b>Lat</b>	46.571939
<b>Long</b>	-122.729985
<b>Direction Photo Taken:</b> <b>N</b>	
<b>Description:</b>  Debris in the back southwest end of the South Warehouse.

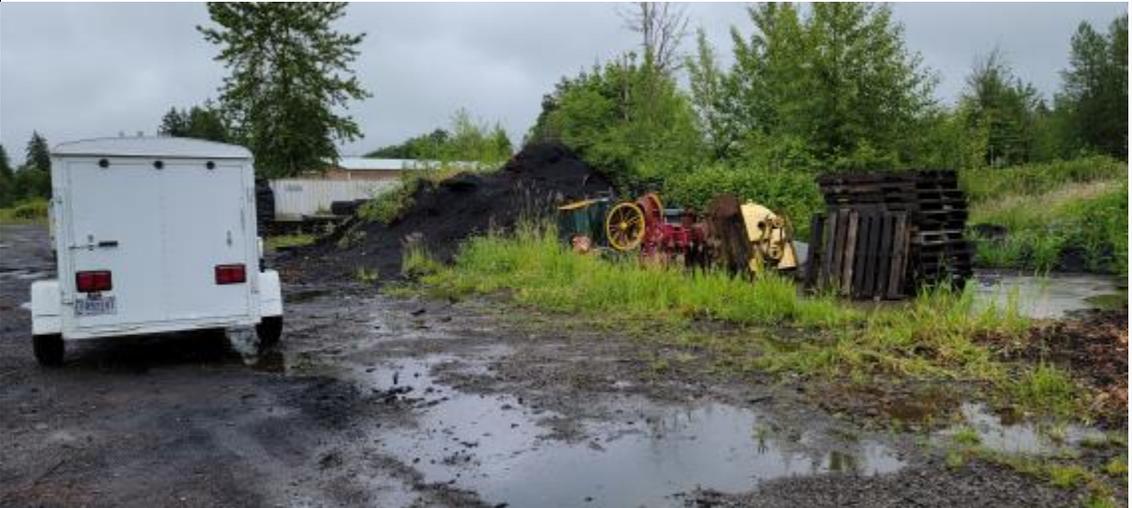
<b>Photo No.</b> <b>18</b>	<b>Date:</b> 06/14/2021
<b>Photo Coordinates</b>	
<b>Lat</b>	46.571939
<b>Long</b>	-122.729985
<b>Direction Photo Taken:</b> <b>SE</b>	
<b>Description:</b>  Biochar pile, abandoned equipment and pallets, and EPA equipment trailer.

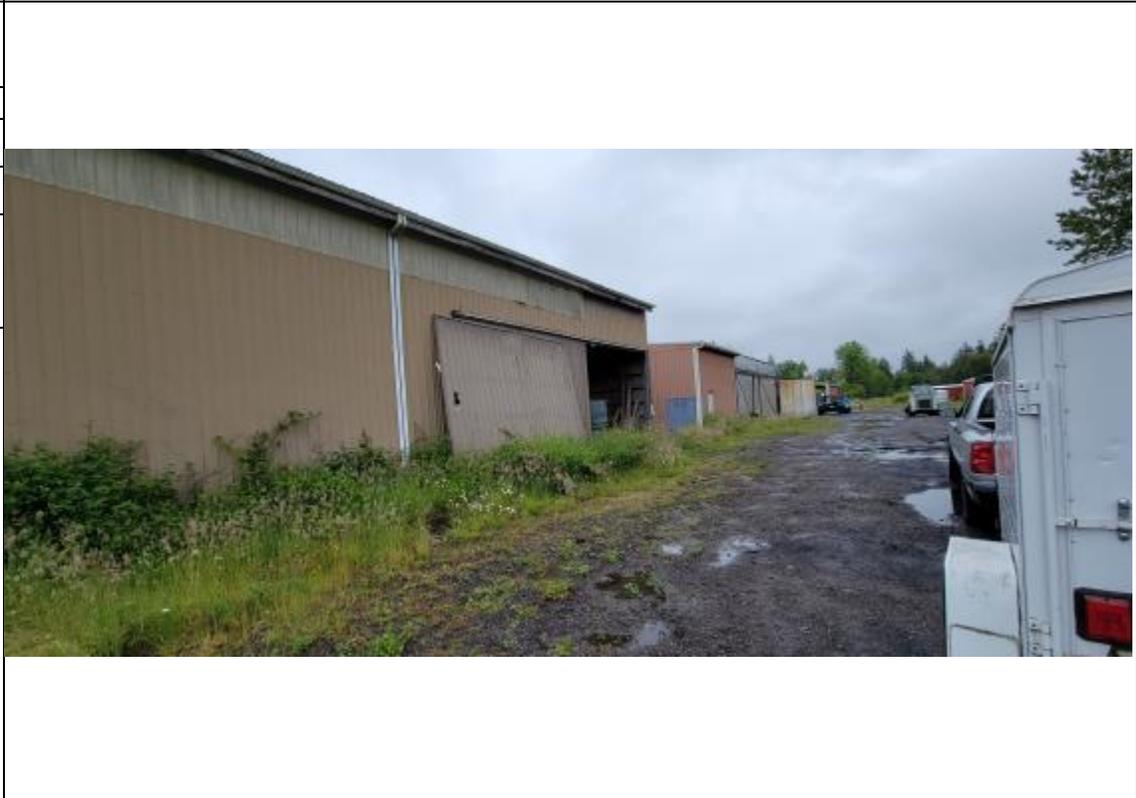
<b>Photo No.</b> <b>20</b>	<b>Date:</b> 06/14/2021
<b>Photo Coordinates</b>	
<b>Lat</b>	46.57193
<b>Long</b>	-122.729974
<b>Direction Photo Taken:</b> <b>NE</b>	
<b>Description:</b>  South Warehouse TG02 Tote Area exposed at center. Dry Kiln Building in the background.

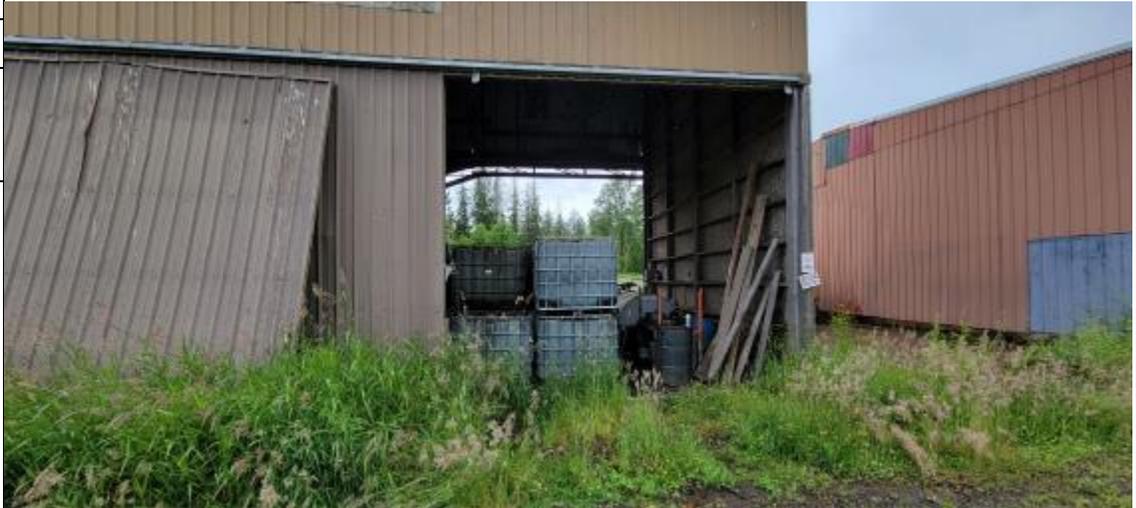
<b>Photo No.</b> <b>21</b>	<b>Date:</b> 06/14/2021
<b>Photo Coordinates</b>	
<b>Lat</b>	46.572013
<b>Long</b>	-122.729805
<b>Direction Photo Taken:</b> <b>N</b>	
<b>Description:</b>  Totes, drums, diesel tank, and debris stored in TG02 Tote Area of the South Warehouse area.

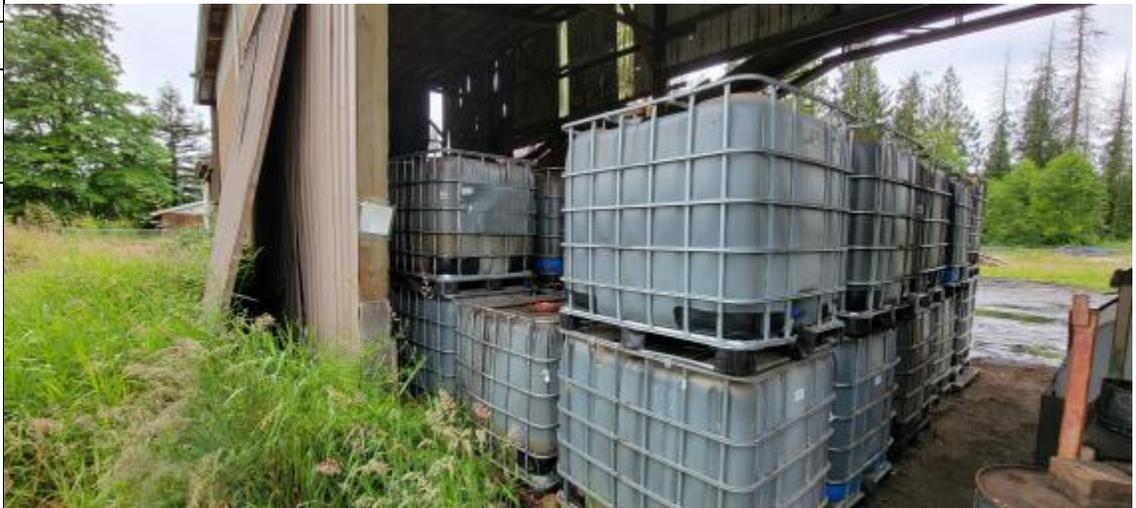
<b>Photo No.</b> <b>22</b>	<b>Date:</b> 06/14/2021
<b>Photo Coordinates</b>	
<b>Lat</b>	46.572177
<b>Long</b>	-122.729635
<b>Direction Photo Taken:</b> <b>W</b>	
<b>Description:</b>  TG02 Tote Area in the South Warehouse

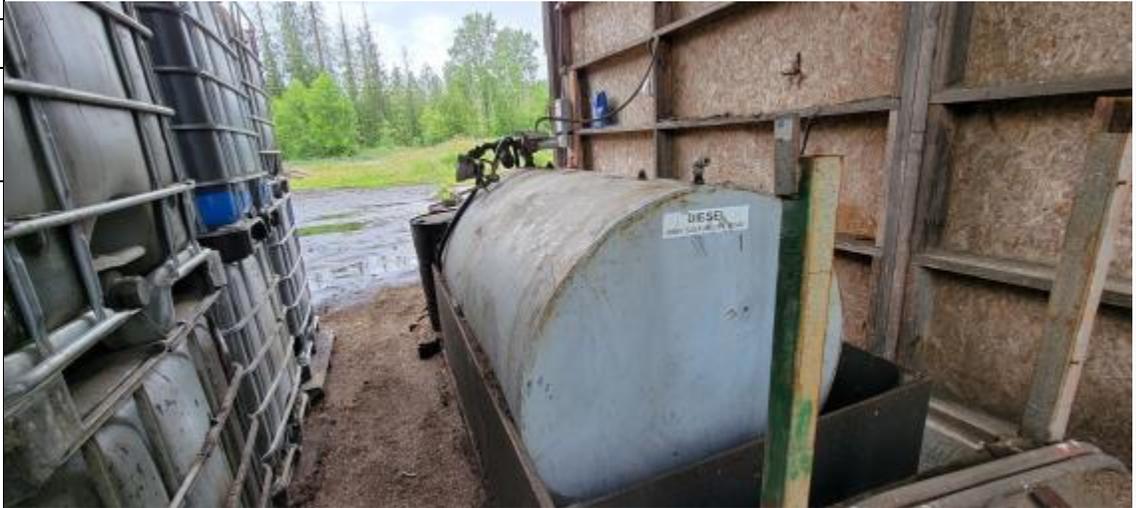
<b>Photo No.</b> <b>23</b>	<b>Date:</b> 06/14/2021
<b>Photo Coordinates</b>	
<b>Lat</b>	46.572179
<b>Long</b>	-122.729649
<b>Direction Photo Taken:</b> <b>N</b>	
<b>Description:</b>  Diesel tank in TG02 Tote Area.

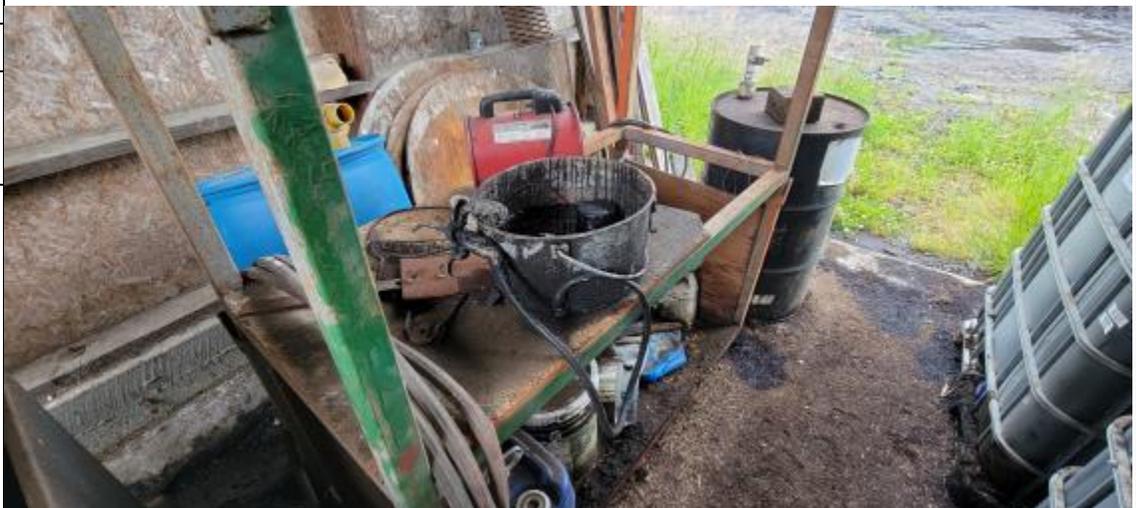
<b>Photo No.</b> <b>24</b>	<b>Date:</b> 06/14/2021
<b>Photo Coordinates</b>	
<b>Lat</b>	46.572179
<b>Long</b>	-122.729649
<b>Direction Photo Taken:</b> <b>SE</b>	
<b>Description:</b>  Drums and small containers of waste in the TG02 Tote Area

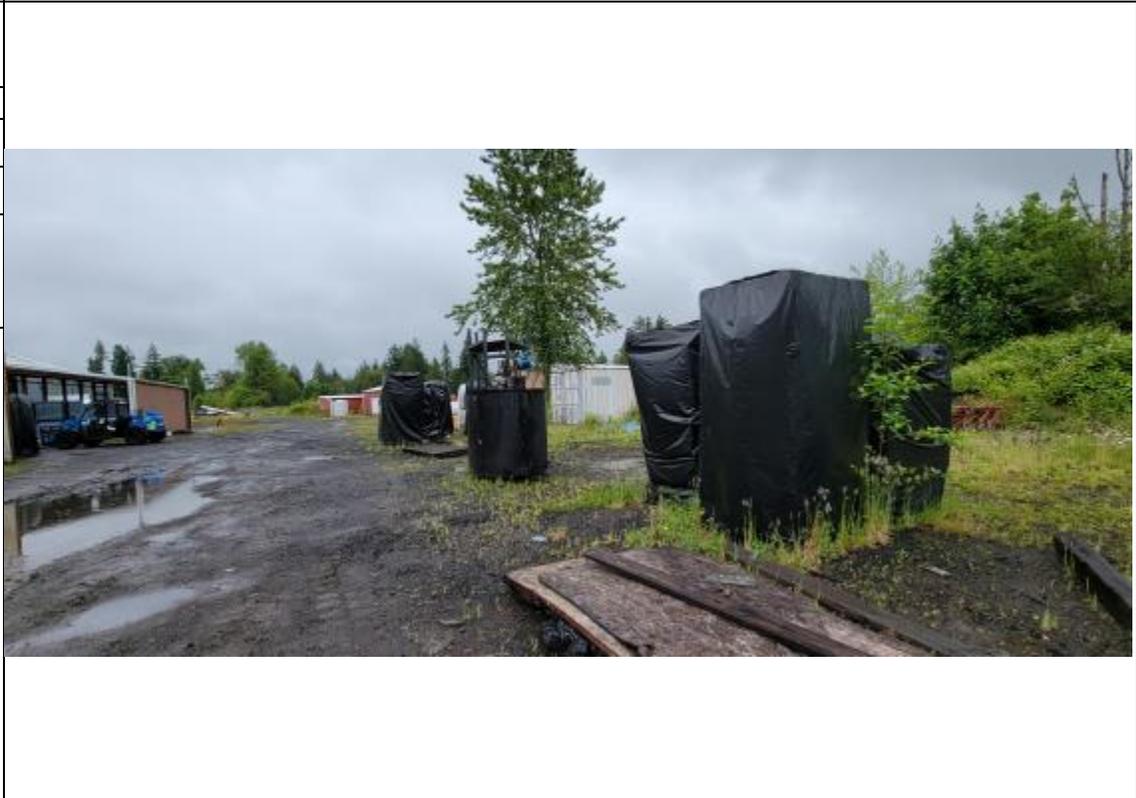
<b>Photo No.</b> <b>26</b>	<b>Date:</b> 06/14/2021
<b>Photo Coordinates</b>	
<b>Lat</b>	46.572161
<b>Long</b>	-122.729597
<b>Direction Photo Taken:</b> <b>E</b>	
<b>Description:</b>  Covered pallets of biochar, abandoned equipment, and storage container in the foreground. Lean-to TG04 Tote Area in the middle ground at left, behind the telehandler

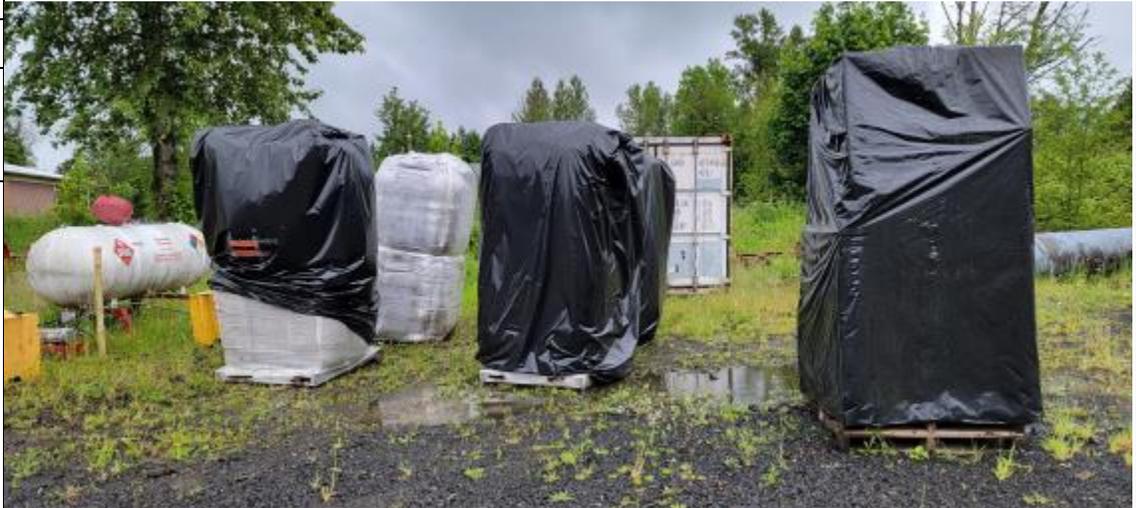
Covered pallets of biochar, abandoned equipment, and storage container south of the Dry Kiln Building.

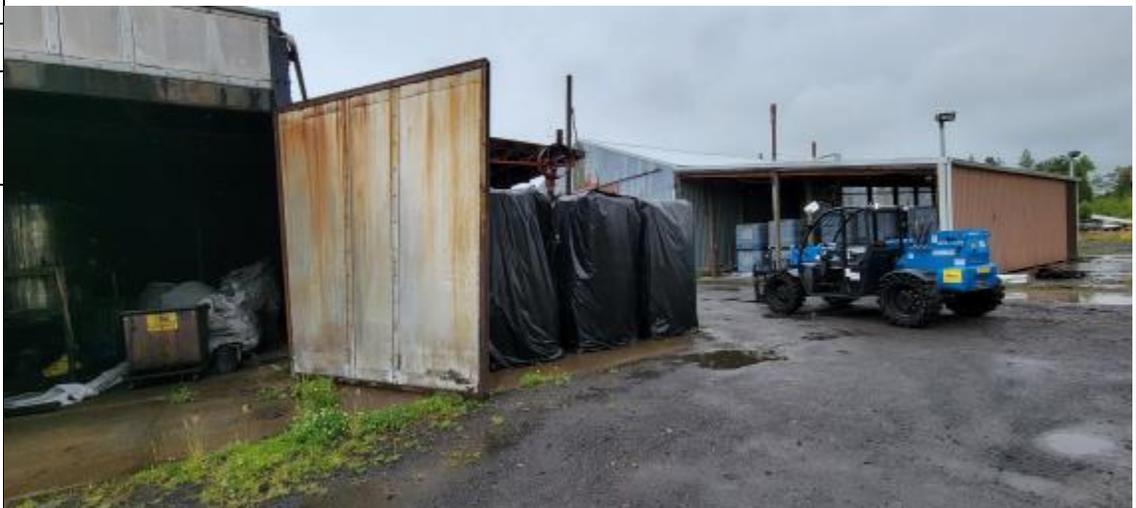
<b>Photo No.</b> <b>28</b>	<b>Date:</b> 06/14/2021
<b>Photo Coordinates</b>	
<b>Lat</b>	46.572161
<b>Long</b>	-122.729597
<b>Direction Photo Taken:</b> <b>NE</b>

Dry Kiln Building TG03 Tote Area on the left. Lean-to TG04 Tote Area on the right.

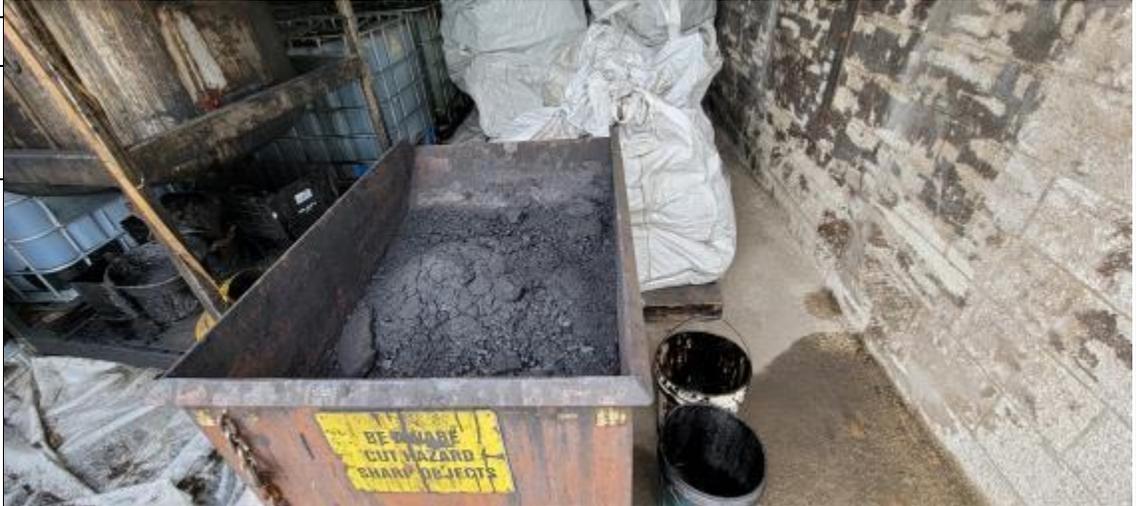
<b>Photo No.</b> <b>29</b>	<b>Date:</b> 06/14/2021
<b>Photo Coordinates</b>	
<b>Lat</b>	46.572165
<b>Long</b>	-122.729296
<b>Direction Photo Taken:</b> <b>N</b>	
<b>Description:</b>  Bin of biochar among totes, tanks, and buckets of wood tar and wood vinegar in the Dry Kiln Building.

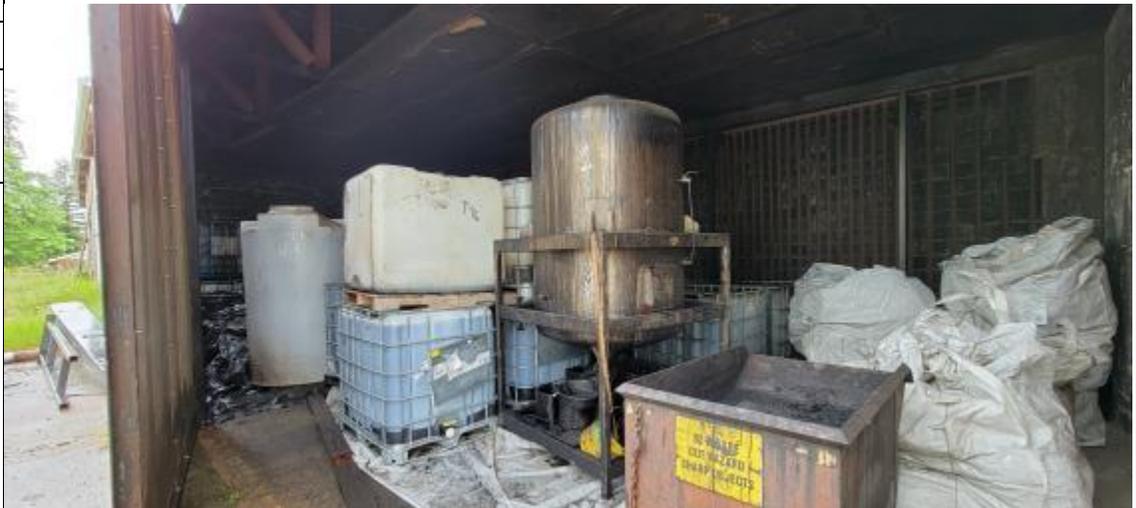
<b>Photo No.</b> <b>30</b>	<b>Date:</b> 06/14/2021
<b>Photo Coordinates</b>	
<b>Lat</b>	46.572165
<b>Long</b>	-122.729296
<b>Direction Photo Taken:</b> <b>SW</b>	
<b>Description:</b>  Bin of biochar among totes, tanks, and buckets of wood tar and wood vinegar in the Dry Kiln Building.

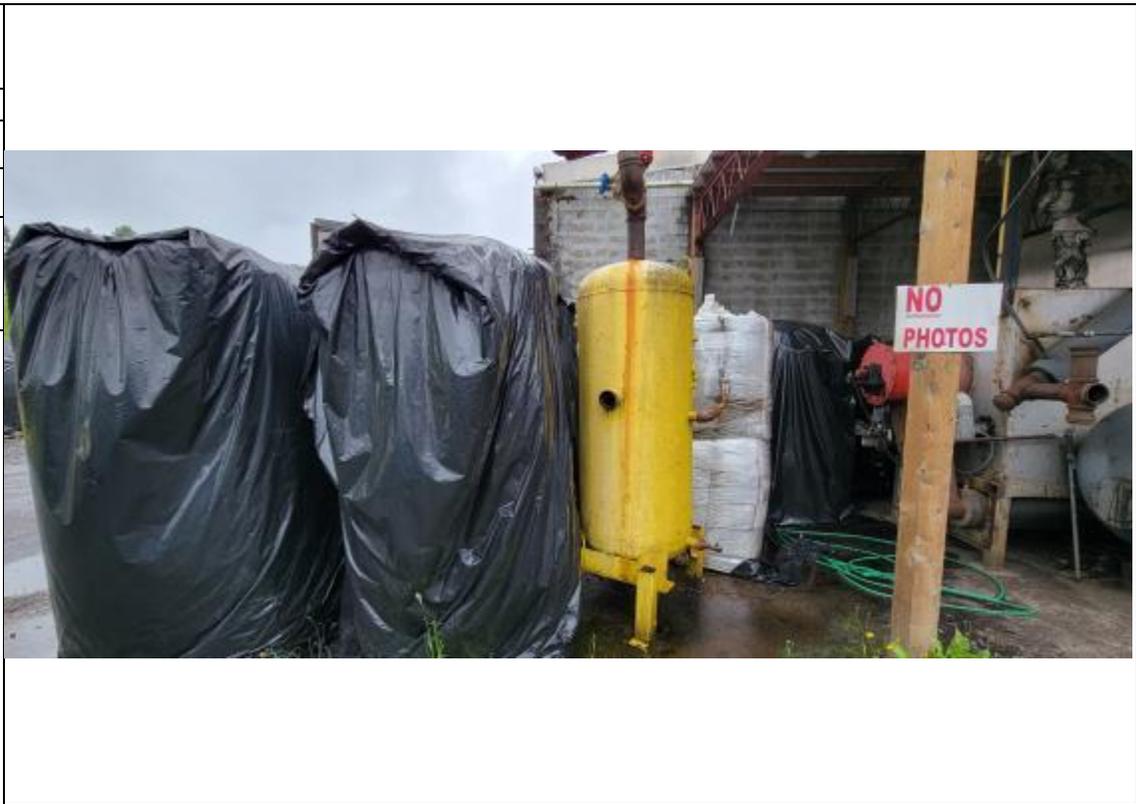
<b>Photo No.</b> <b>31</b>	<b>Date:</b> 06/14/2021
<b>Photo Coordinates</b>	
<b>Lat</b>	46.572165
<b>Long</b>	-122.729296
<b>Direction Photo Taken:</b> <b>E</b>	
<b>Description:</b>  Covered pallets of biochar and equipment located at the east corner of the Dry Kiln Building.

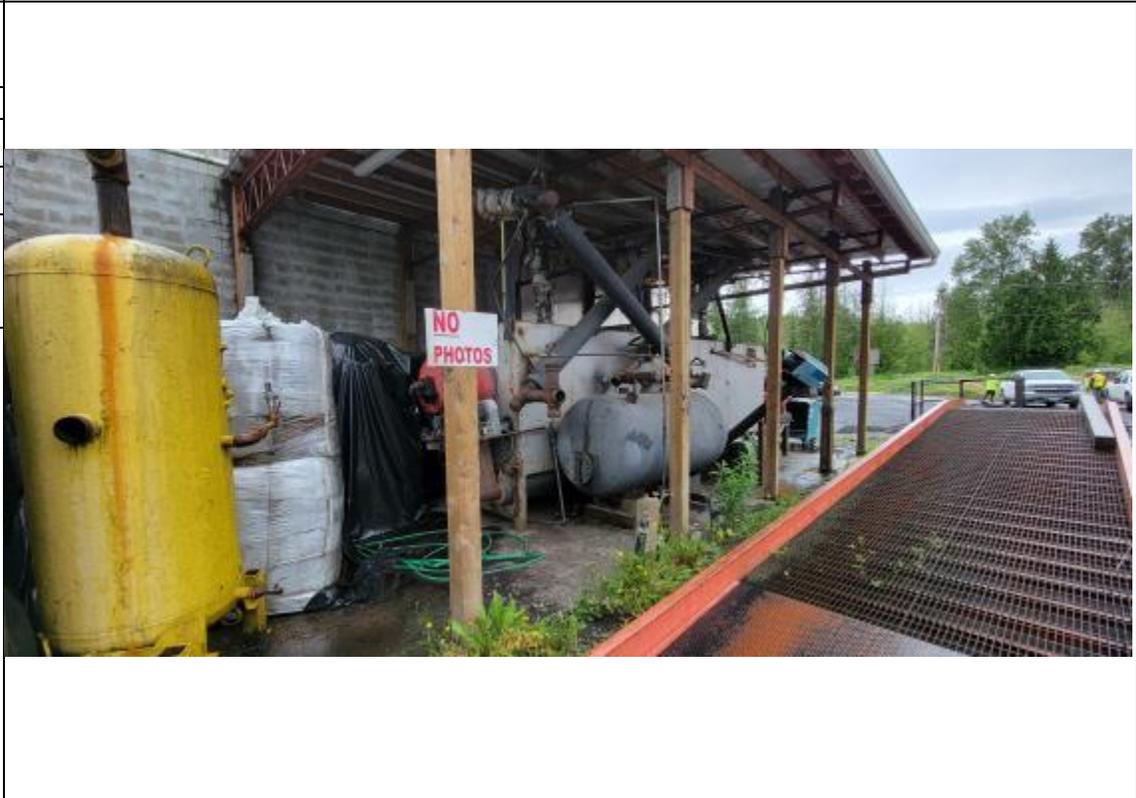
<b>Photo No.</b> <b>32</b>	<b>Date:</b> 06/14/2021
<b>Photo Coordinates</b>	
<b>Lat</b>	46.572165
<b>Long</b>	-122.729296
<b>Direction Photo Taken:</b> <b>E</b>	
<b>Description:</b>  Covered biochar on pallets and equipment located at the east wall of the Dry Kiln Building.

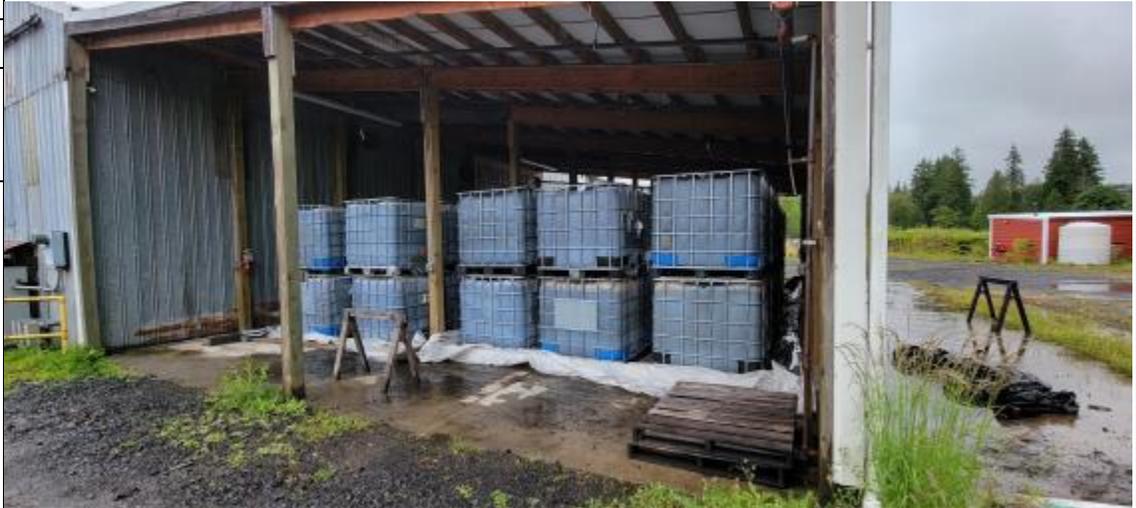
<b>Photo No.</b> <b>33</b>	<b>Date:</b> 06/14/2021
<b>Photo Coordinates</b>	
<b>Lat</b>	46.572189
<b>Long</b>	-122.729027
<b>Direction Photo Taken:</b> <b>NE</b>	
<b>Description:</b> TG04 Tote Area at the Lean-to Area.

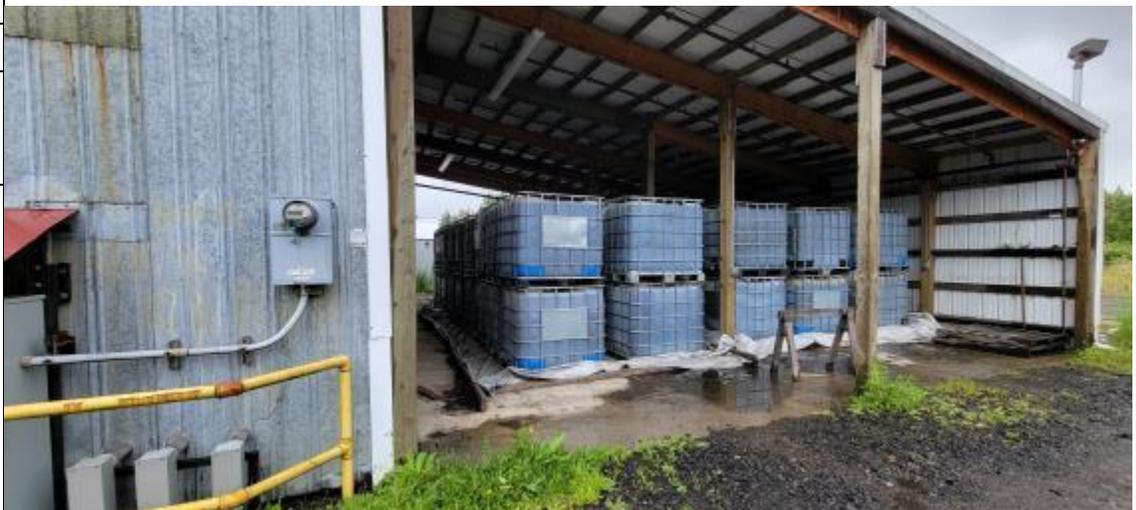
<b>Photo No.</b> <b>34</b>	<b>Date:</b> 06/14/2021
<b>Photo Coordinates</b>	
<b>Lat</b>	46.572189
<b>Long</b>	-122.729027
<b>Direction Photo Taken:</b> <b>E</b>	
<b>Description:</b> TG04 Tote Area at the Lean-to Area.

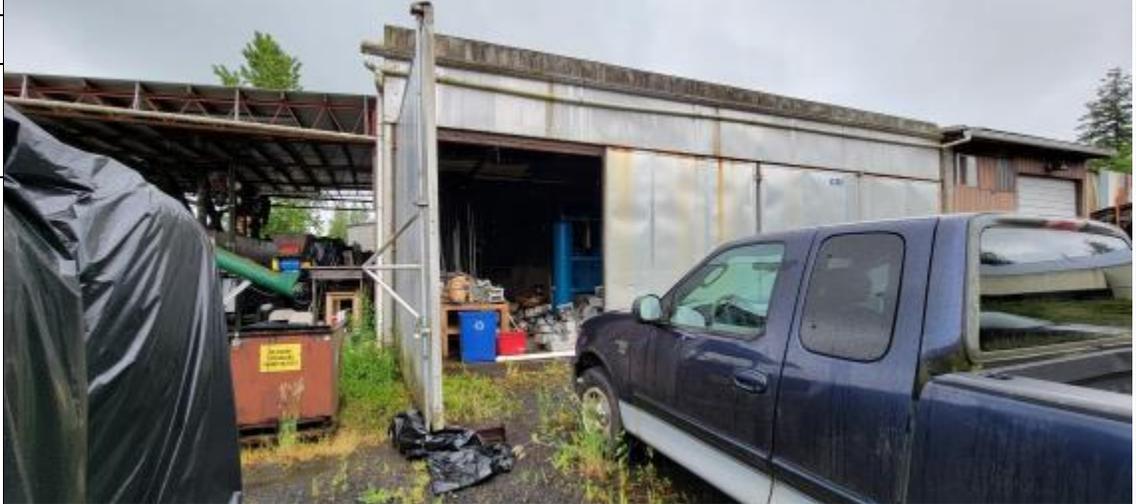
<b>Photo No.</b> <b>35</b>	<b>Date:</b> 06/14/2021
<b>Photo Coordinates</b>	
<b>Lat</b>	46.572189
<b>Long</b>	-122.729027
<b>Direction Photo Taken:</b> <b>S</b>	
<b>Description:</b>  Debris and equipment in the north section of the Dry Kiln Building. Abandoned truck parked north of the Dry Kiln Building.
