# **TIME-CRITICAL REMOVAL ACTION REPORT**

*Onalaska Wood Pyrolysis  
Onalaska, Lewis County, Washington*

Prepared by:

December 2021

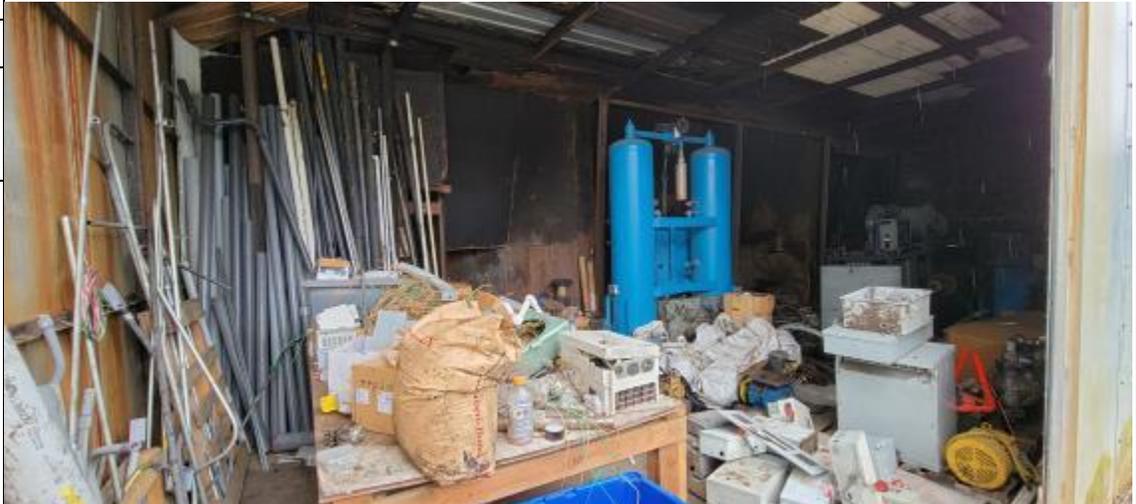
<b>Photo No.</b> <b>36</b>	<b>Date:</b> 06/14/2021
<b>Photo Coordinates</b>	
<b>Lat</b>	46.572418
<b>Long</b>	-122.729449
<b>Direction Photo Taken:</b> <b>S</b>	
<b>Description:</b>  Debris and equipment in the north section of the Dry Kiln Building.

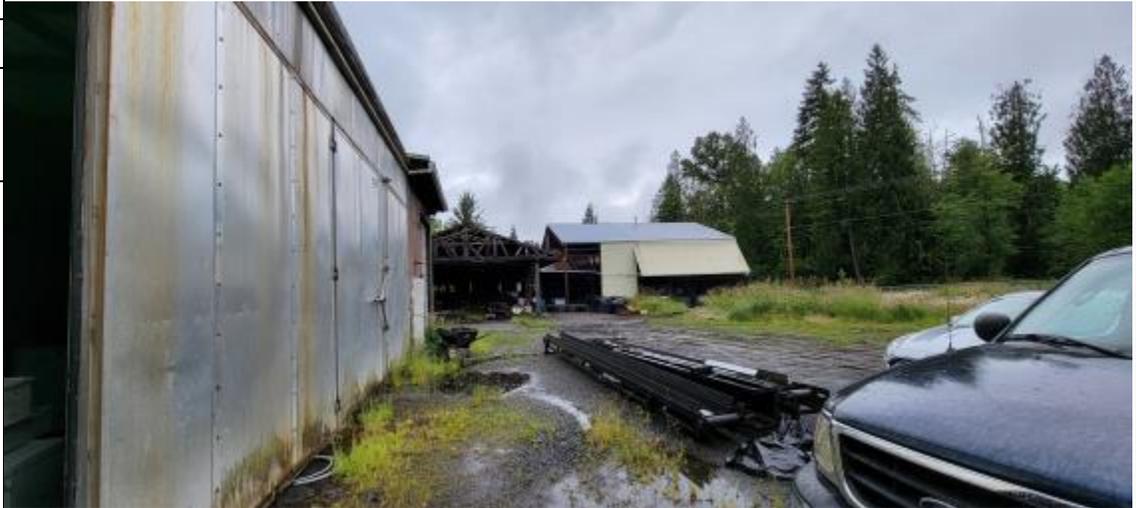
North Warehouse and condemned warehouse area in the background. Dry Kiln Building in the left foreground. Abandoned equipment in the center foreground. Abandoned truck in the right foreground.

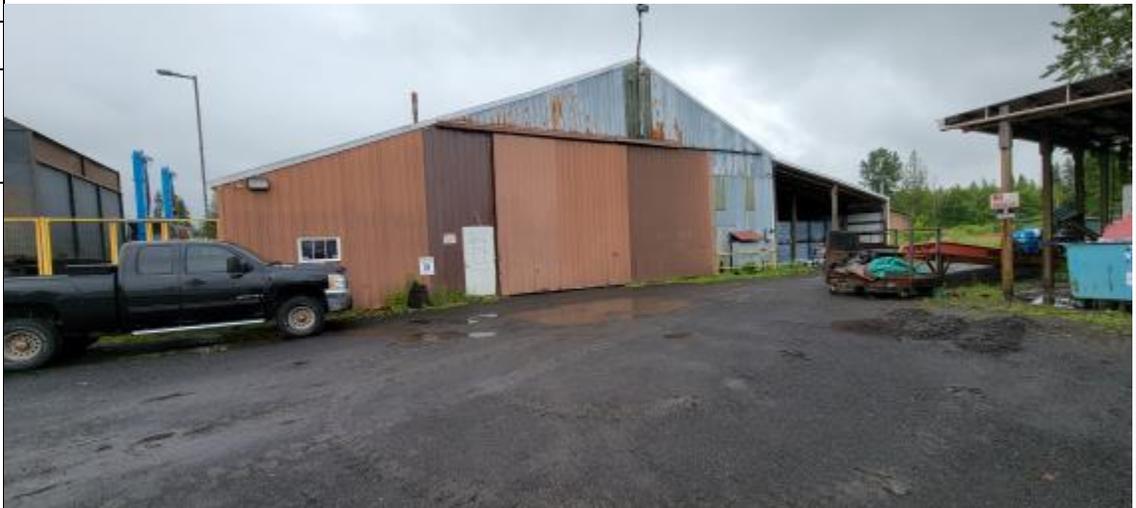
<b>Photo No.</b> <b>38</b>	<b>Date:</b> 06/14/2021
<b>Photo Coordinates</b>	
<b>Lat</b>	46.572418
<b>Long</b>	-122.729449
<b>Direction Photo Taken:</b> <b>E</b>

Pyrolysis Building with Lean-to Area extending to the right. Abandoned equipment at the right foreground.

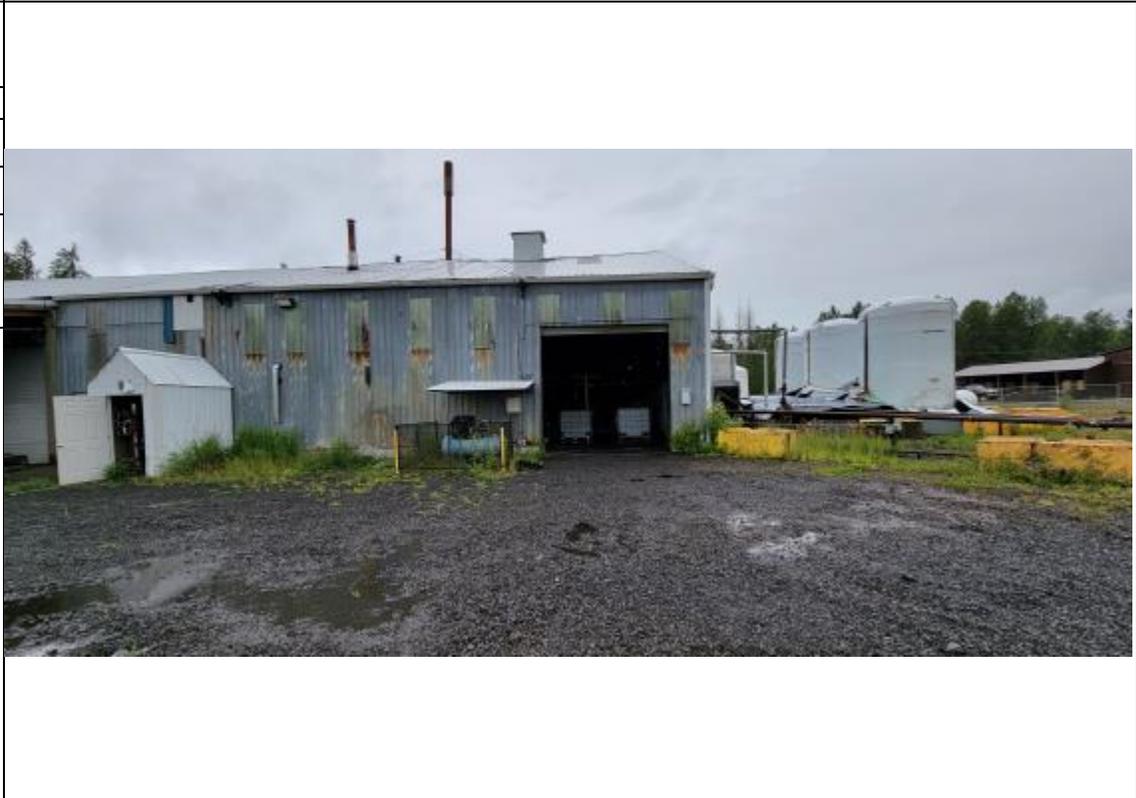
<b>Photo No.</b> <b>42</b>	<b>Date:</b> 06/14/2021
<b>Photo Coordinates</b>	
<b>Lat</b>	46.572092
<b>Long</b>	-122.728898
<b>Direction Photo Taken:</b> <b>N</b>	
<b>Description:</b>  Exposed interior seen through the south door of the Pyrolysis Building. Two totes located at center. Tank Farm located in the Secondary Containment Area at right.

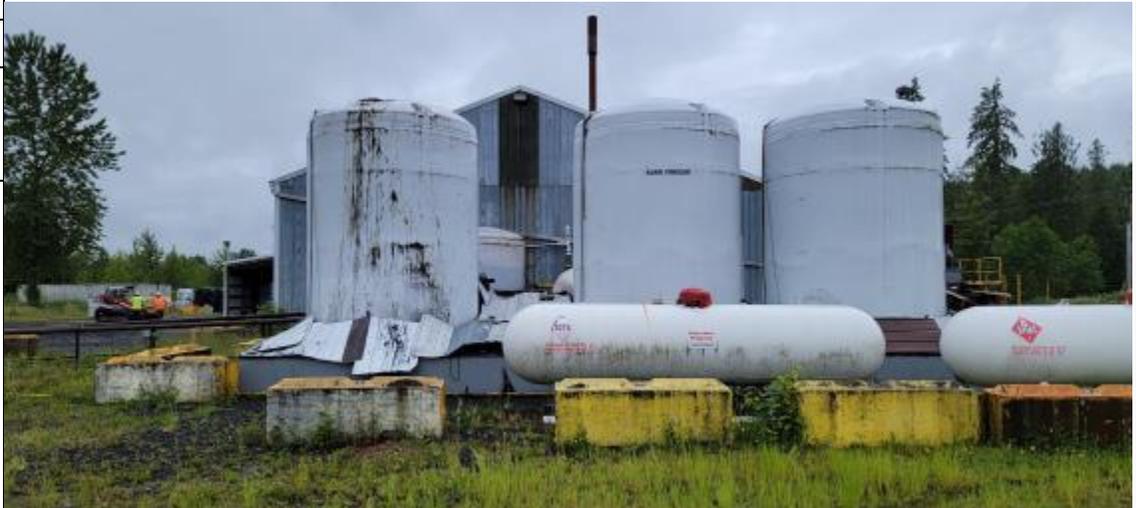
<b>Photo No.</b> <b>46</b>	<b>Date:</b> 06/14/2021
<b>Photo Coordinates</b>	
<b>Lat</b>	46.572322
<b>Long</b>	-122.728593
<b>Direction Photo Taken:</b> <b>SW</b>	
<b>Description:</b>  Tank Farm in Secondary Containment Area. Three 8,000-gallon aboveground storage tanks (ASTs) in the middle ground. Two propane tanks are in the foreground.

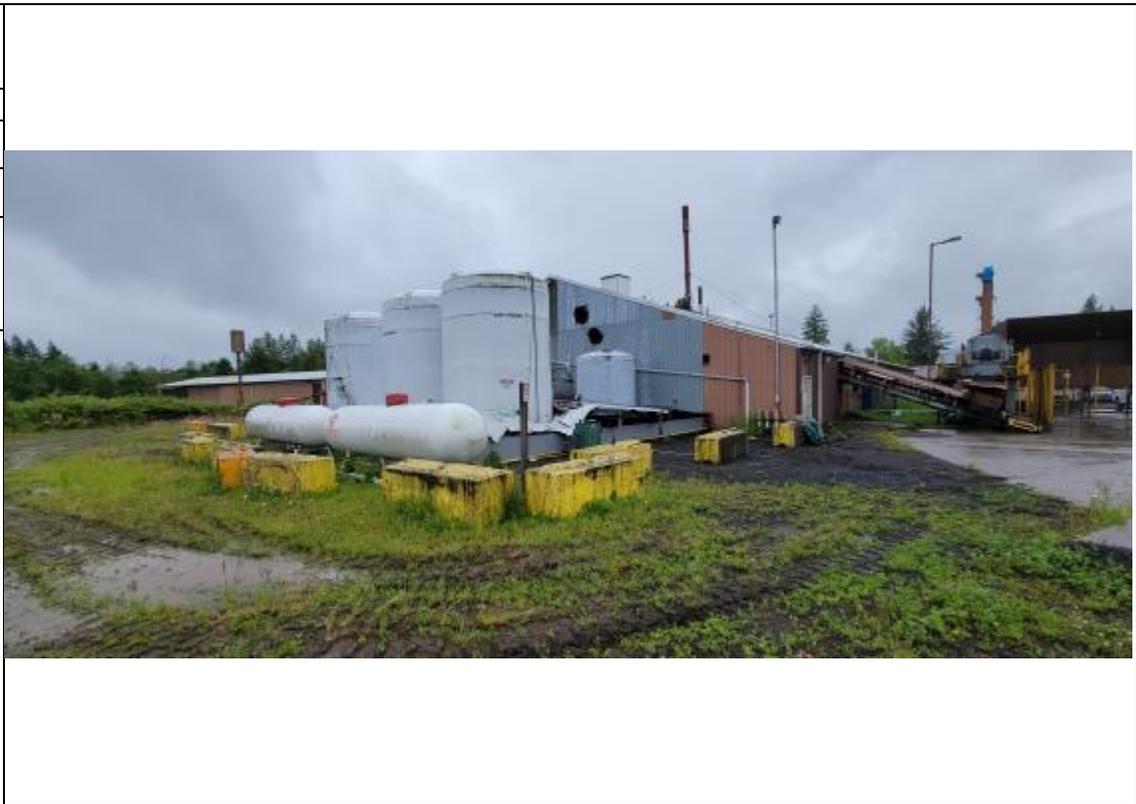
<b>Photo No.</b> <b>47</b>	<b>Date:</b> 06/14/2021
<b>Photo Coordinates</b>	
<b>Lat</b>	46.572322
<b>Long</b>	-122.728593
<b>Direction Photo Taken:</b> <b>SW</b>	
<b>Description:</b>  Secondary Containment Area. Two propane tanks, three 8,000-gallon aboveground storage tanks (ASTs), and a 3,000-gallon AST can be seen.

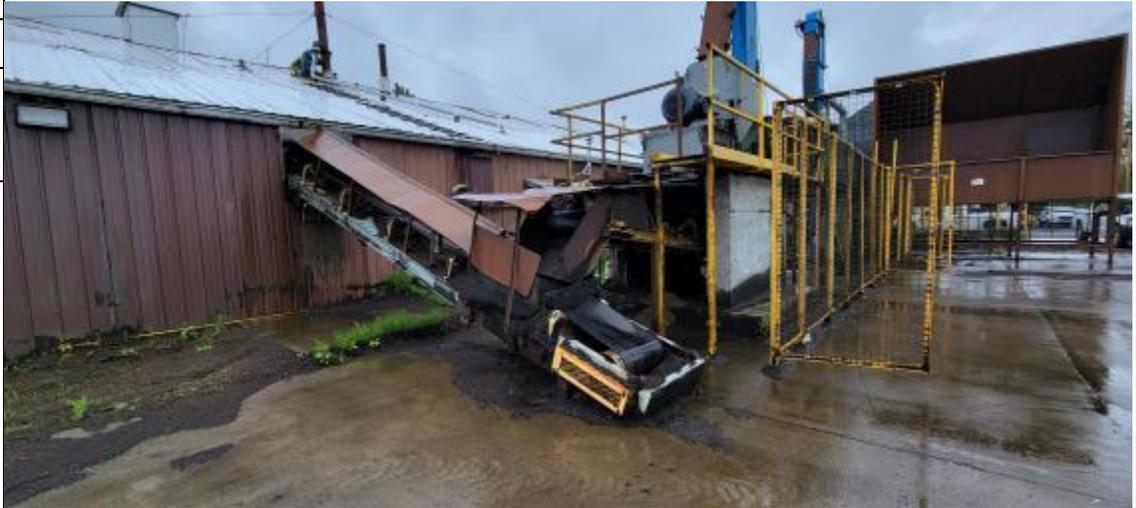
<b>Photo No.</b> <b>53</b>	<b>Date:</b> 06/14/2021
<b>Photo Coordinates</b>	
<b>Lat</b>	46.572619
<b>Long</b>	-122.728987
<b>Direction Photo Taken:</b> <b>SW</b>	
<b>Description:</b>  Abandoned processing equipment at the north face of the Pyrolysis Building.

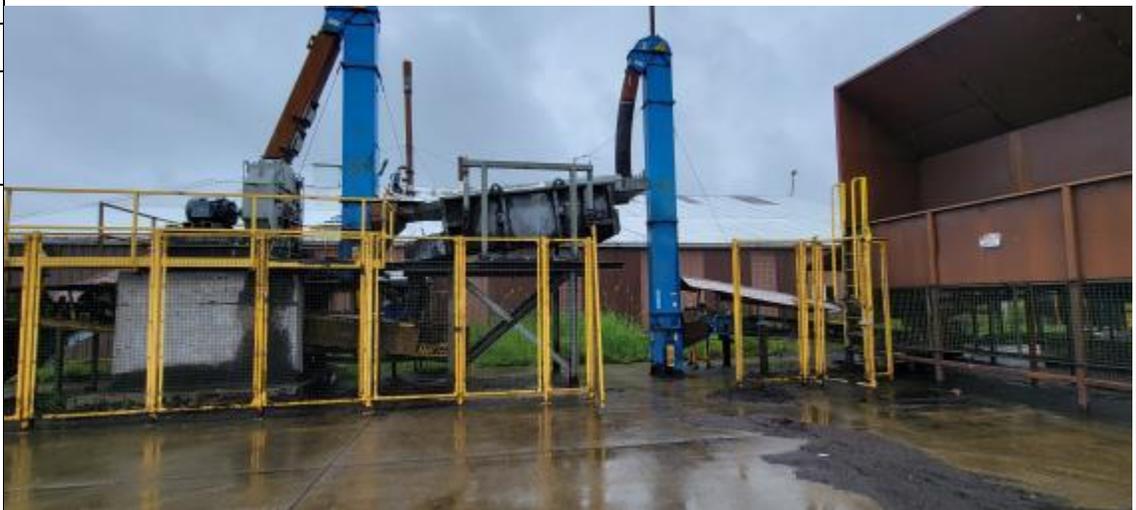
<b>Photo No.</b> <b>54</b>	<b>Date:</b> 06/14/2021
<b>Photo Coordinates</b>	
<b>Lat</b>	46.572619
<b>Long</b>	-122.728987
<b>Direction Photo Taken:</b> <b>S</b>	
<b>Description:</b>  Abandoned processing equipment at the north face of the Pyrolysis Building.

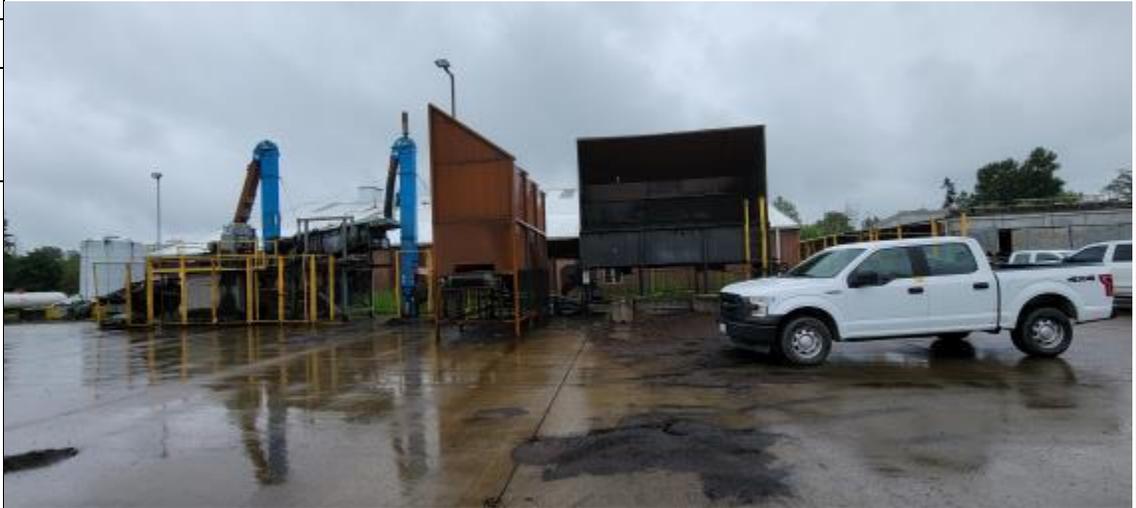
<b>Photo No.</b> <b>55</b>	<b>Date:</b> 06/14/2021
<b>Photo Coordinates</b>	
<b>Lat</b>	46.572634
<b>Long</b>	-122.729214
<b>Direction Photo Taken:</b> <b>SE</b>	
<b>Description:</b>  Abandoned processing equipment at the north face of the Pyrolysis Building.

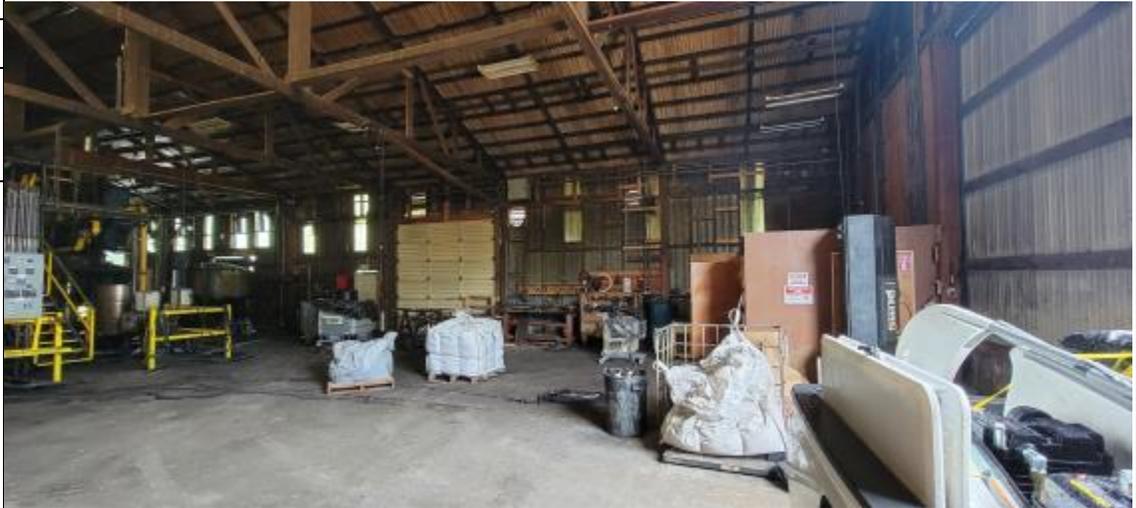
<b>Photo No.</b> <b>57</b>	<b>Date:</b> 06/14/2021
<b>Photo Coordinates</b>	
<b>Lat</b>	46.572504
<b>Long</b>	-122.729253
<b>Direction Photo Taken:</b> <b>SE</b>	
<b>Description:</b>  Totes of wood vinegar, super sacks of biochar, and abandoned equipment in the interior of the Pyrolysis Building.

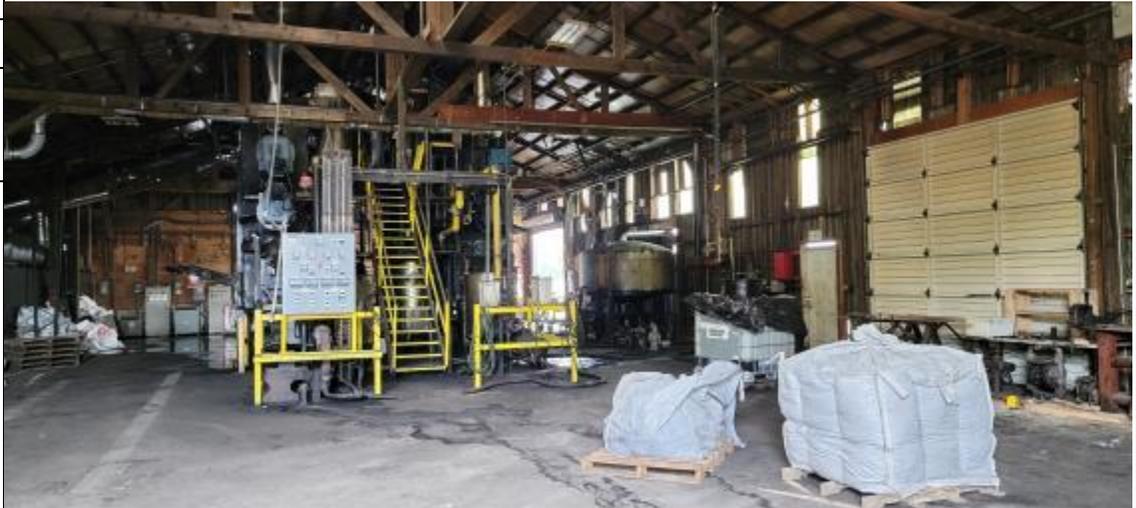
<b>Photo No.</b> <b>59</b>	<b>Date:</b> 06/14/2021
<b>Photo Coordinates</b>	
<b>Lat</b>	46.572504
<b>Long</b>	-122.729253
<b>Direction Photo Taken:</b> <b>E</b>	
<b>Description:</b>  Totes of wood vinegar, super sacks of biochar, and abandoned equipment in the interior of the Pyrolysis Building.

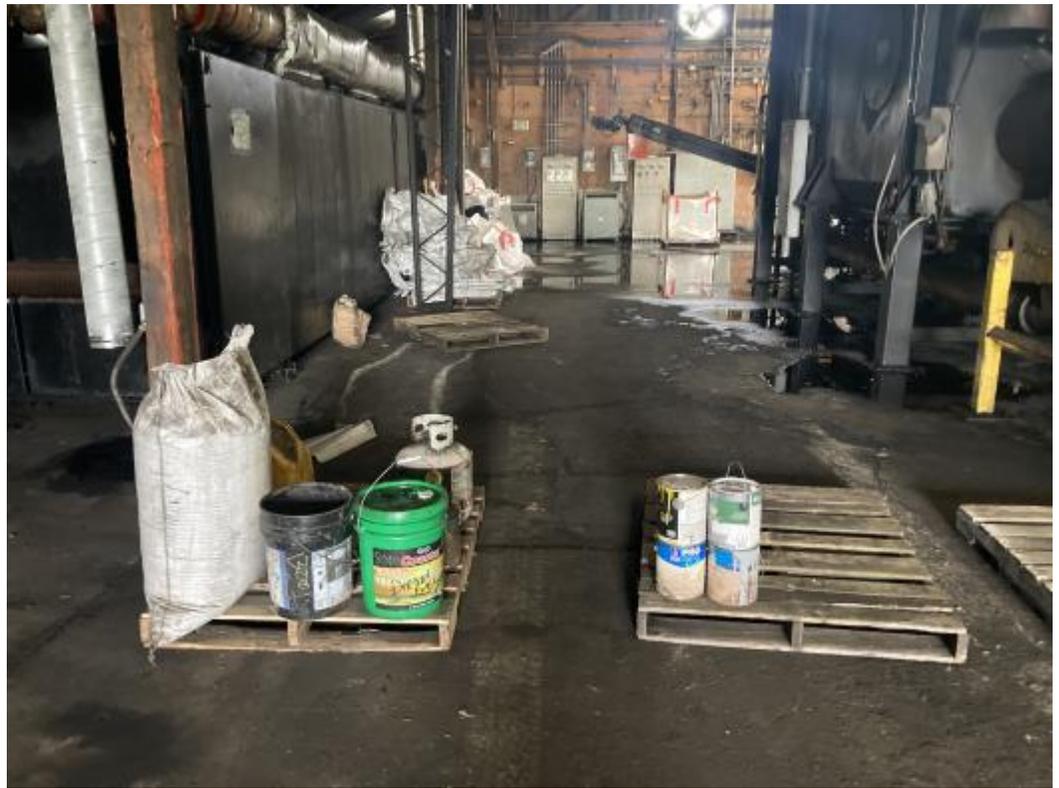
<b>Photo No.</b> <b>63</b>	<b>Date:</b> 06/14/2021
<b>Photo Coordinates</b>	
<b>Lat</b>	46.5919
<b>Long</b>	-122.75145
<b>Direction Photo Taken:</b> <b>NE</b>	
<b>Description:</b>  Inventoried waste staged in the Pyrolysis Building.

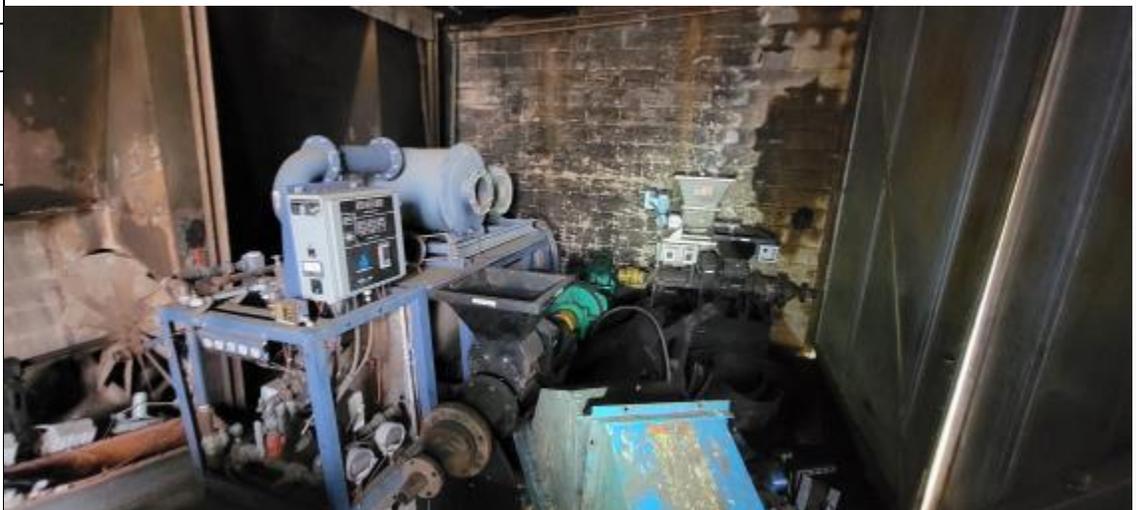
<b>Photo No.</b> <b>66</b>	<b>Date:</b> 06/14/2021
<b>Photo Coordinates</b>	
<b>Lat</b>	46.574436
<b>Long</b>	-122.71431
<b>Direction Photo Taken:</b> <b>SW</b>	
<b>Description:</b>  Abandoned equipment located in the north section of the Dry Kiln Building.

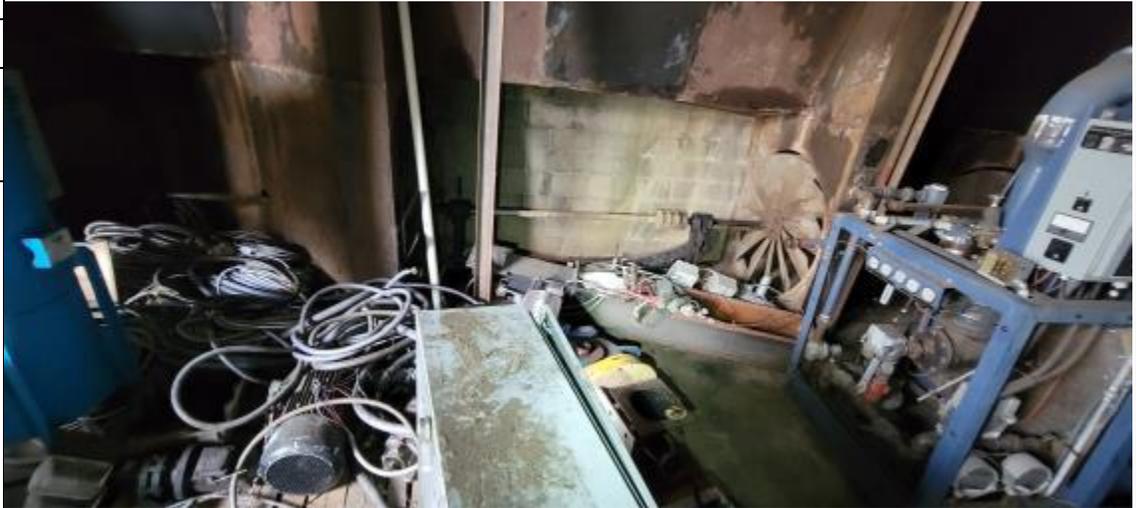
<b>Photo No.</b> <b>67</b>	<b>Date:</b> 06/14/2021
<b>Photo Coordinates</b>	
<b>Lat</b>	46.574436
<b>Long</b>	-122.71431
<b>Direction Photo Taken:</b> <b>S</b>	
<b>Description:</b>  Abandoned equipment located in the north section of the Dry Kiln Building.

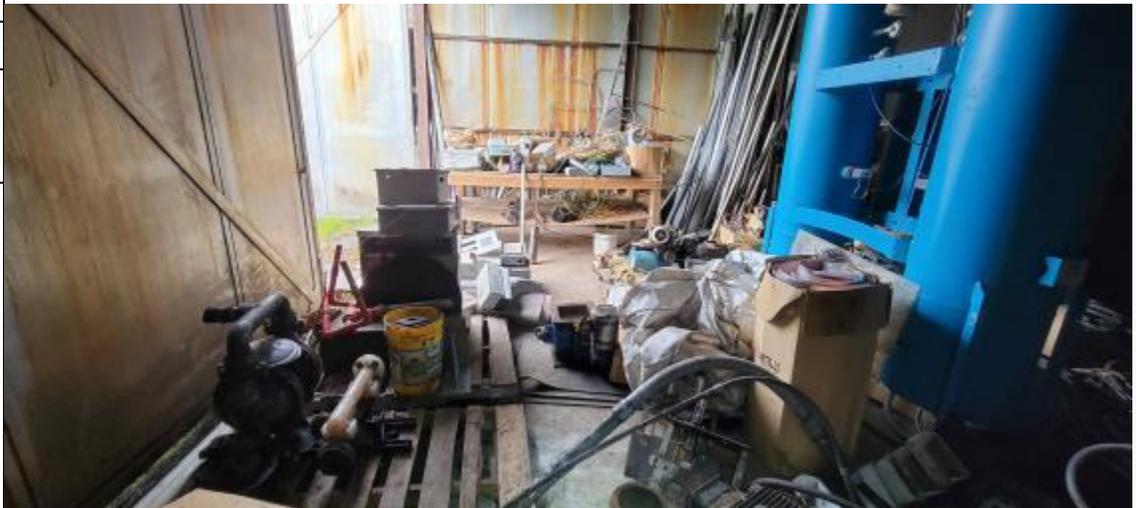
<b>Photo No.</b> <b>68</b>	<b>Date:</b> 06/14/2021
<b>Photo Coordinates</b>	
<b>Lat</b>	46.574436
<b>Long</b>	-122.71431
<b>Direction Photo Taken:</b> <b>E</b>	
<b>Description:</b>  Abandoned equipment located in the north section of the Dry Kiln Building.

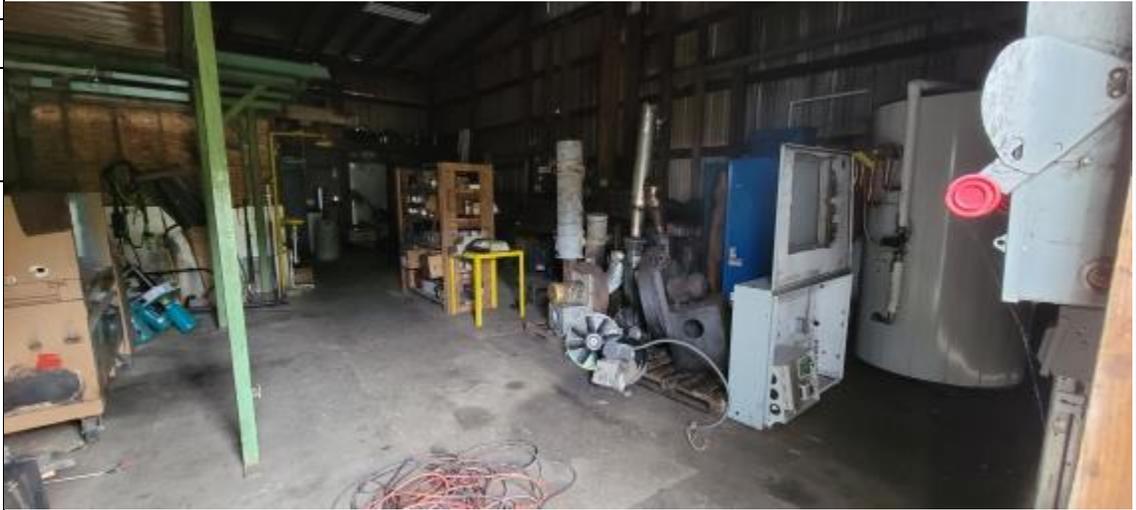
<b>Photo No.</b> <b>71</b>	<b>Date:</b> 06/14/2021
<b>Photo Coordinates</b>	
<b>Lat</b>	46.572364
<b>Long</b>	-122.729541
<b>Direction Photo Taken:</b> <b>S</b>	
<b>Description:</b>  Interior of the workshop.

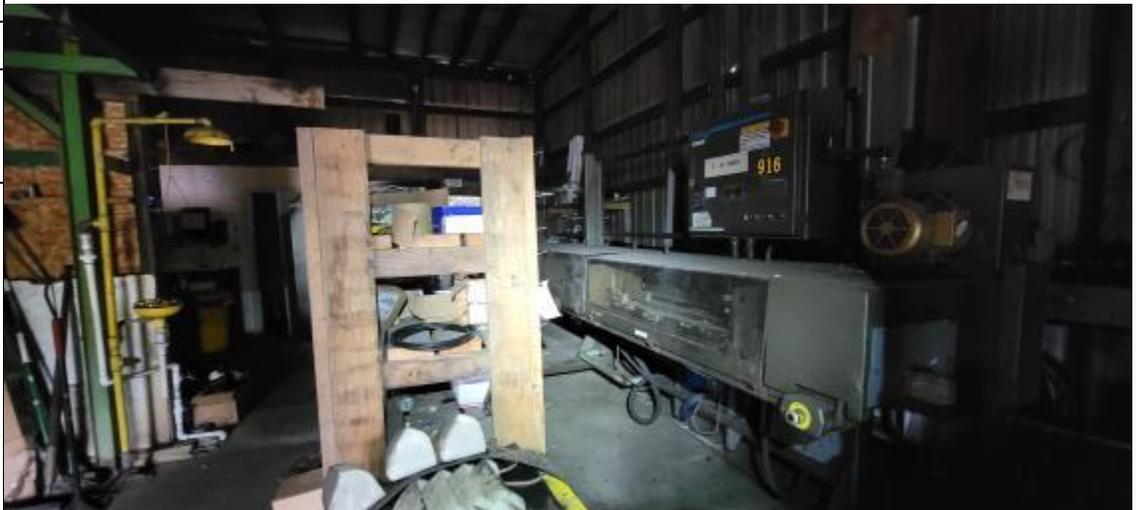
<b>Photo No.</b> <b>72</b>	<b>Date:</b> 06/14/2021
<b>Photo Coordinates</b>	
<b>Lat</b>	46.572364
<b>Long</b>	-122.729541
<b>Direction Photo Taken:</b> <b>S</b>	
<b>Description:</b>  Interior of the workshop.

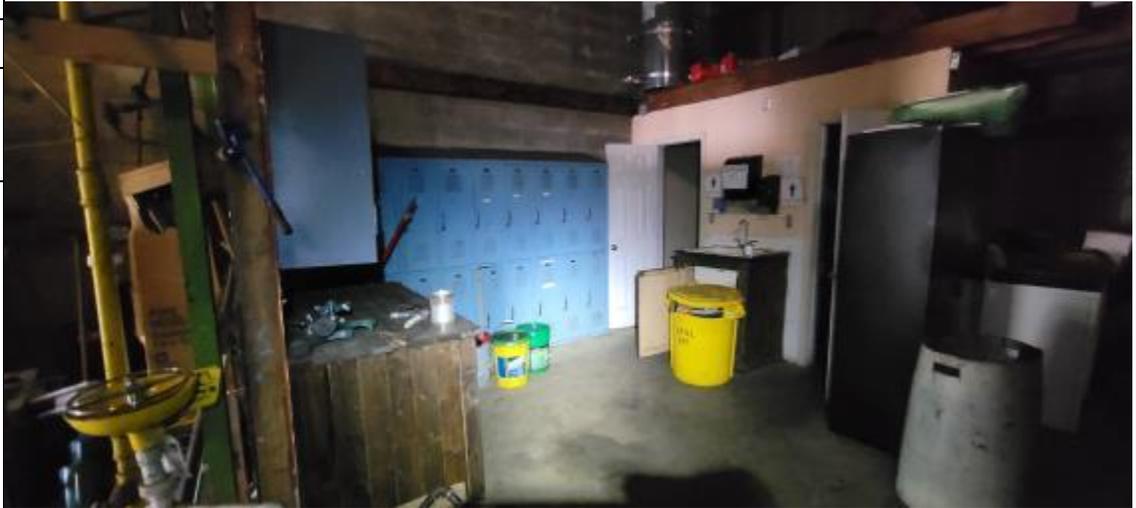
<b>Photo No.</b> <b>73</b>	<b>Date:</b> 06/14/2021
<b>Photo Coordinates</b>	
<b>Lat</b>	46.572364
<b>Long</b>	-122.729541
<b>Direction Photo Taken:</b> <b>SE</b>	
<b>Description:</b>  Lockers and bathrooms at the back of the workshop.

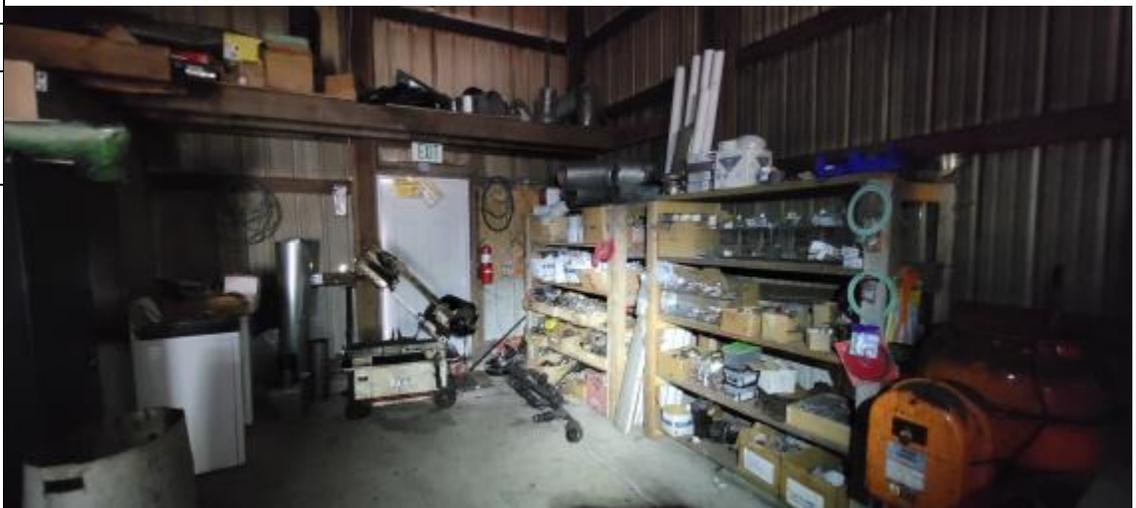
<b>Photo No.</b> <b>74</b>	<b>Date:</b> 06/14/2021
<b>Photo Coordinates</b>	
<b>Lat</b>	46.572364
<b>Long</b>	-122.729541
<b>Direction Photo Taken:</b> <b>S</b>	
<b>Description:</b>  Abandoned equipment and parts bins located in the back of the workshop.

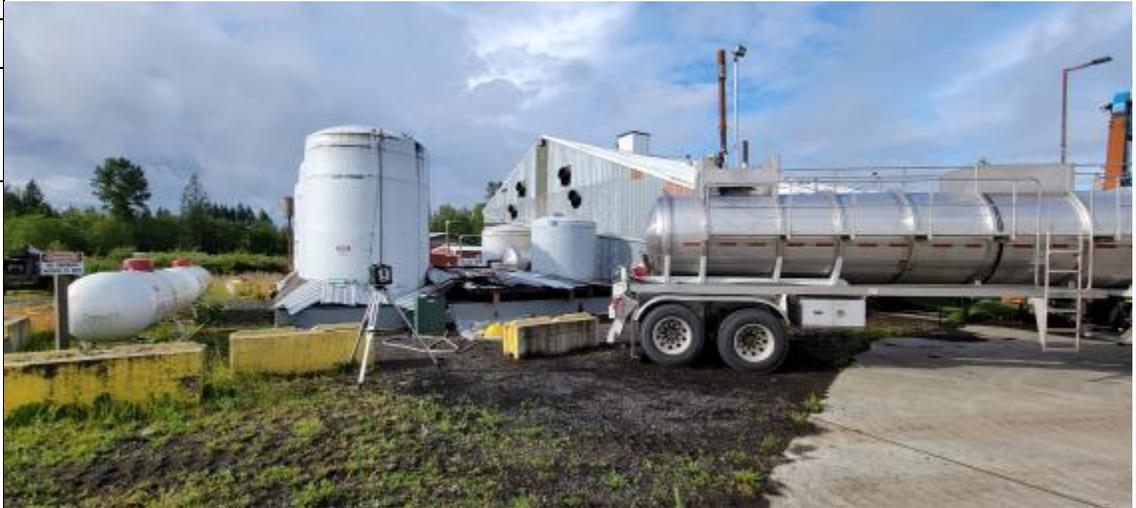
<b>Photo No.</b> <b>75</b>	<b>Date:</b> 06/15/2021
<b>Photo Coordinates</b>	
<b>Lat</b>	N/A
<b>Long</b>	N/A
<b>Direction Photo Taken:</b> <b>S</b>	
<b>Description:</b>  Vacuum truck pumping out wastewater from the Secondary Containment Area.

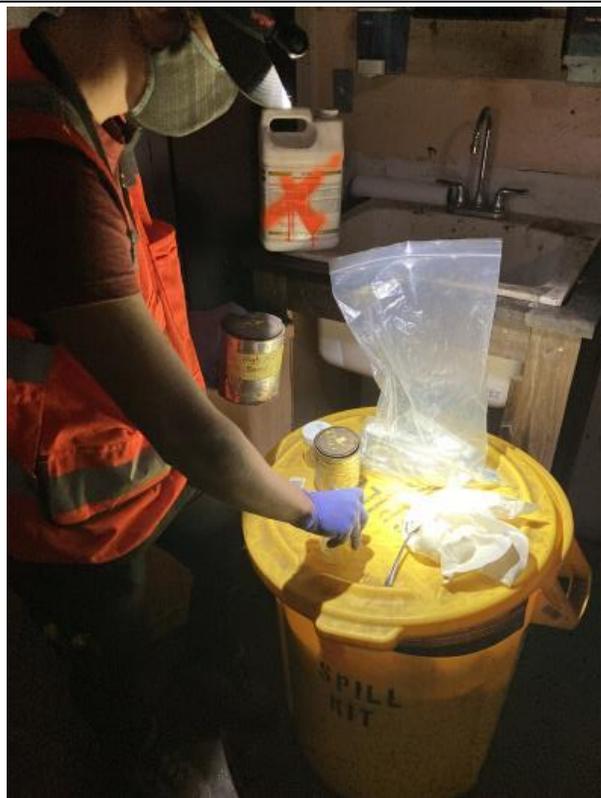
<b>Photo No.</b> <b>76</b>	<b>Date:</b> 06/15/2021
<b>Photo Coordinates</b>	
<b>Lat</b>	46.574528
<b>Long</b>	-122.709031
<b>Direction Photo Taken:</b> <b>SE</b>	
<b>Description:</b>  START contractor collecting hazardous waste sample for field chemical identification.

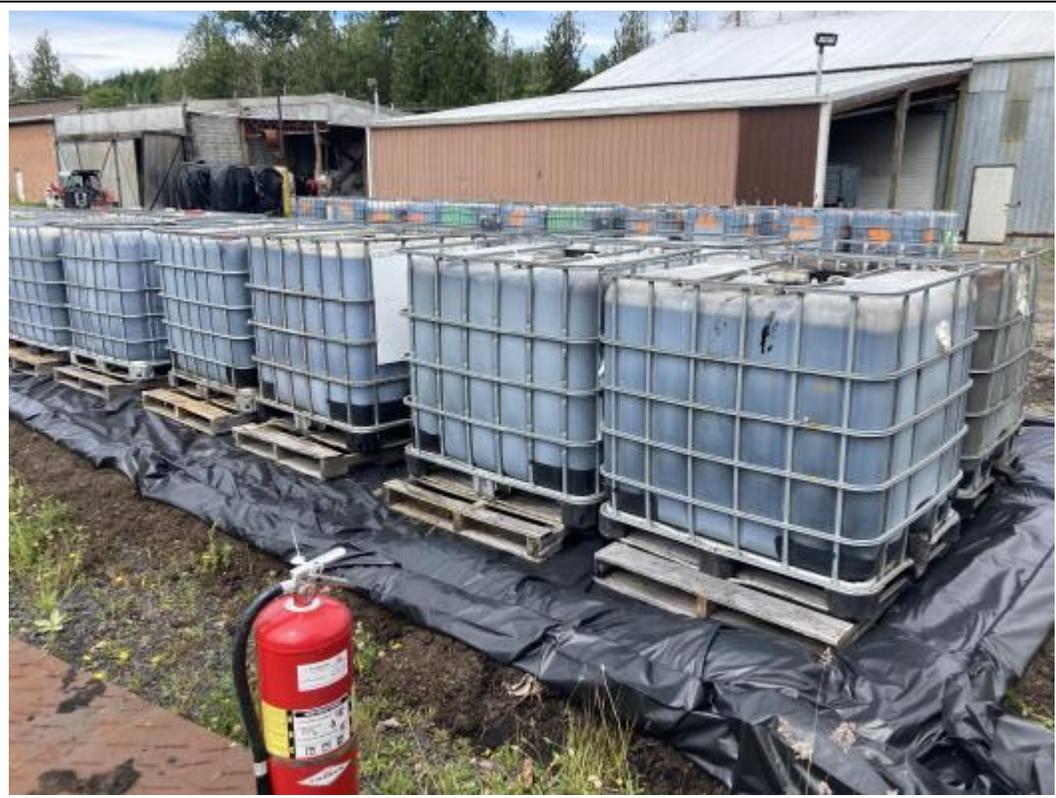
<b>Photo No.</b> <b>78</b>	<b>Date:</b> 06/15/2021
<b>Photo Coordinates</b>	
<b>Lat</b>	46.572225
<b>Long</b>	-122.7287
<b>Direction Photo Taken:</b> <b>N</b>	
<b>Description:</b>  Staged totes in secondary containment in the tote staging area.

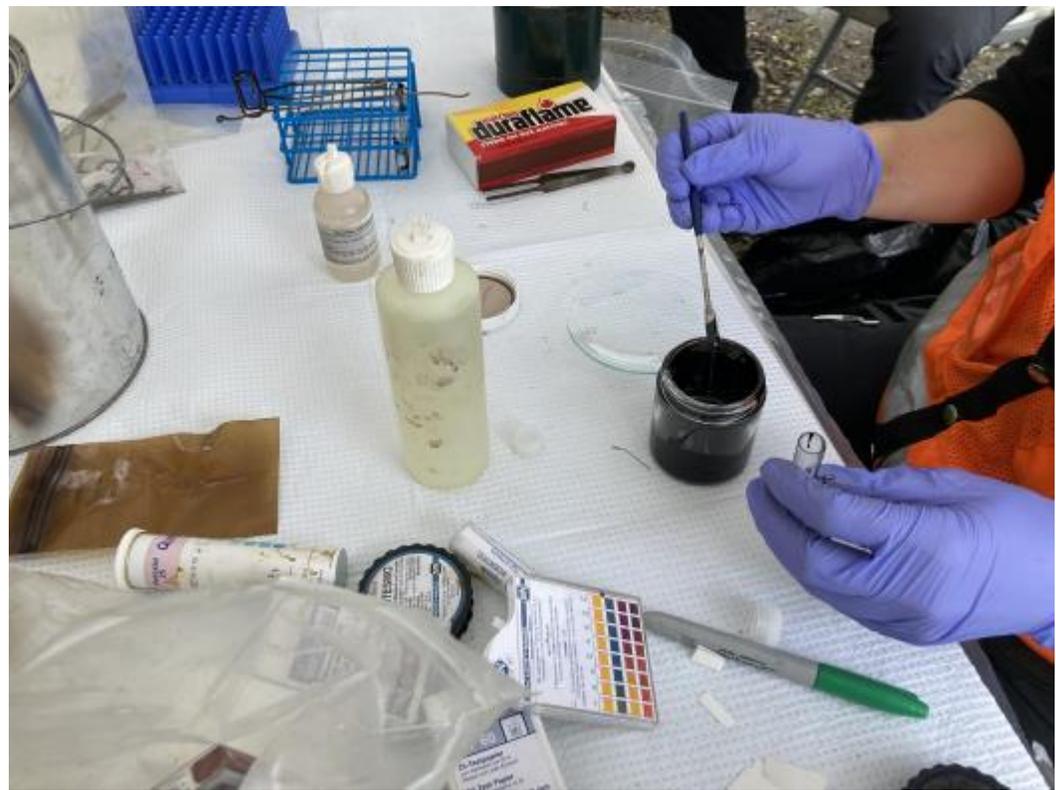
<b>Photo No.</b> <b>79</b>	<b>Date:</b> 06/15/2021
<b>Photo Coordinates</b>	
<b>Lat</b>	46.572175
<b>Long</b>	-122.729828
<b>Direction Photo Taken:</b> <b>E</b>	
<b>Description:</b>  START contractor conducting field chemical identification on samples collected from inventoried hazardous waste.

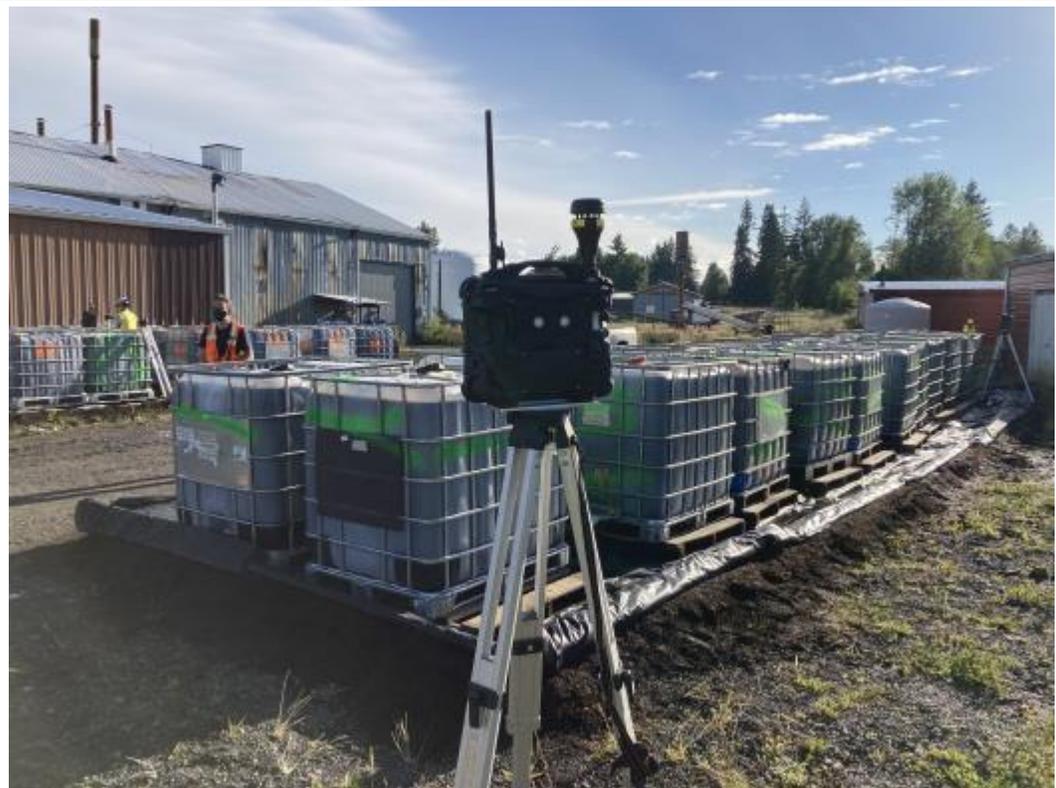
<b>Photo No.</b> <b>80</b>	<b>Date:</b> 06/16/2021
<b>Photo Coordinates</b>	
<b>Lat</b>	46.57215
<b>Long</b>	-122.729011
<b>Direction Photo Taken:</b> <b>NE</b>	
<b>Description:</b>  START contractors setting up air monitoring equipment at the tote staging area.

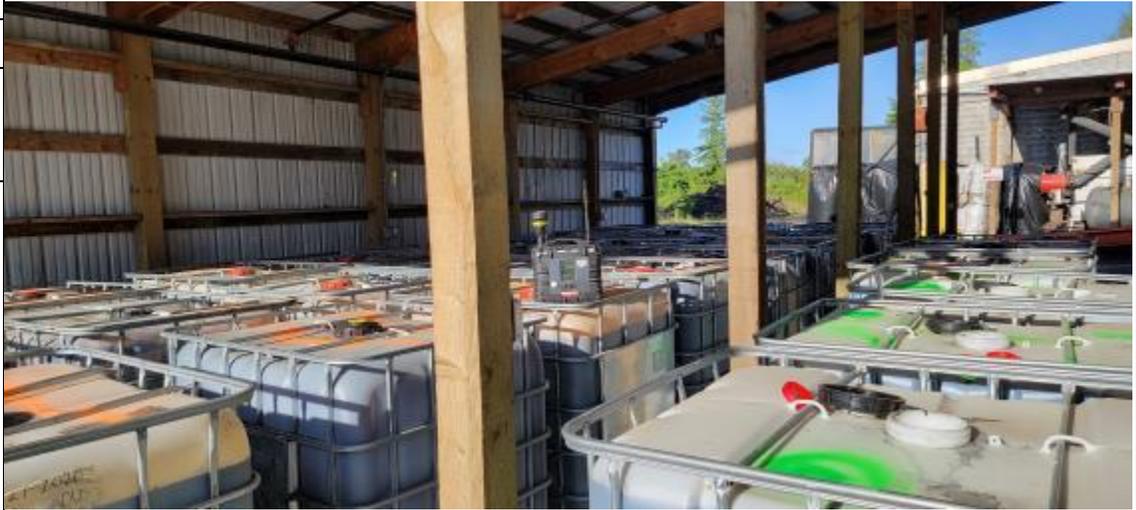
<b>Photo No.</b> <b>81</b>	<b>Date:</b> 06/16/2021
<b>Photo Coordinates</b>	
<b>Lat</b>	46.572321
<b>Long</b>	-122.728635
<b>Direction Photo Taken:</b> <b>SW</b>	
<b>Description:</b>  Marked totes indicating pH level category in the Lean-to Area.

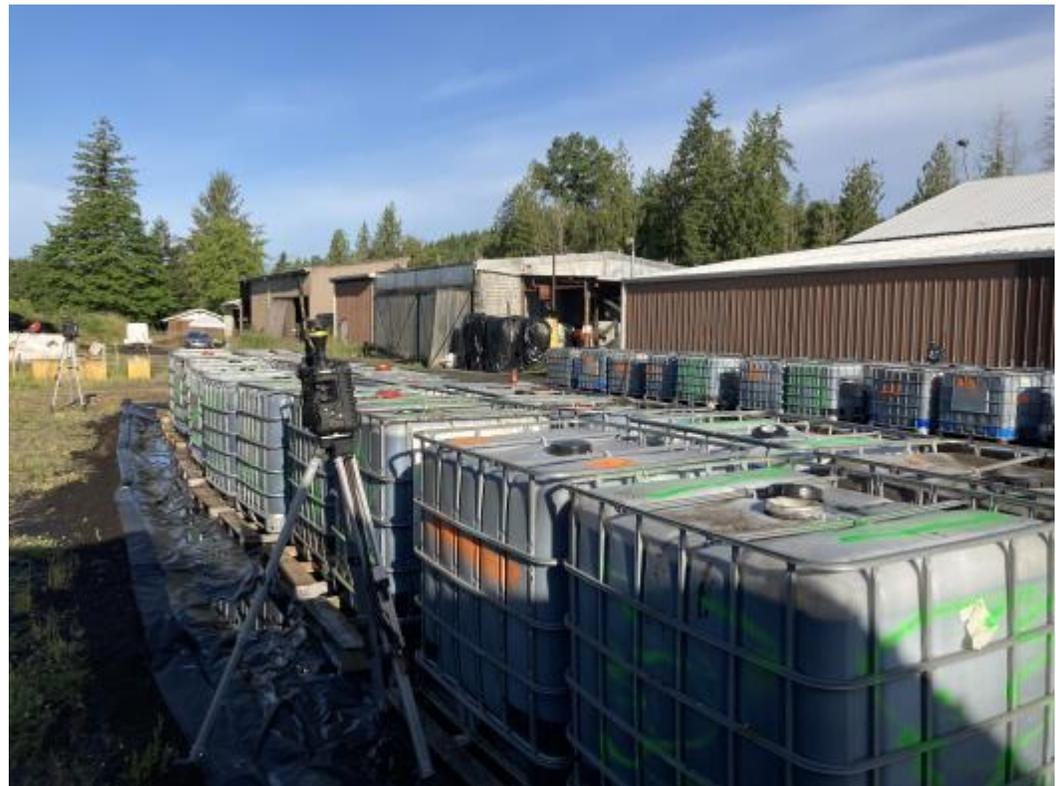
<b>Photo No.</b> <b>82</b>	<b>Date:</b> 06/16/2021
<b>Photo Coordinates</b>	
<b>Lat</b>	46.572225
<b>Long</b>	-122.728736
<b>Direction Photo Taken:</b> <b>W</b>	
<b>Description:</b>  Tote staging area.

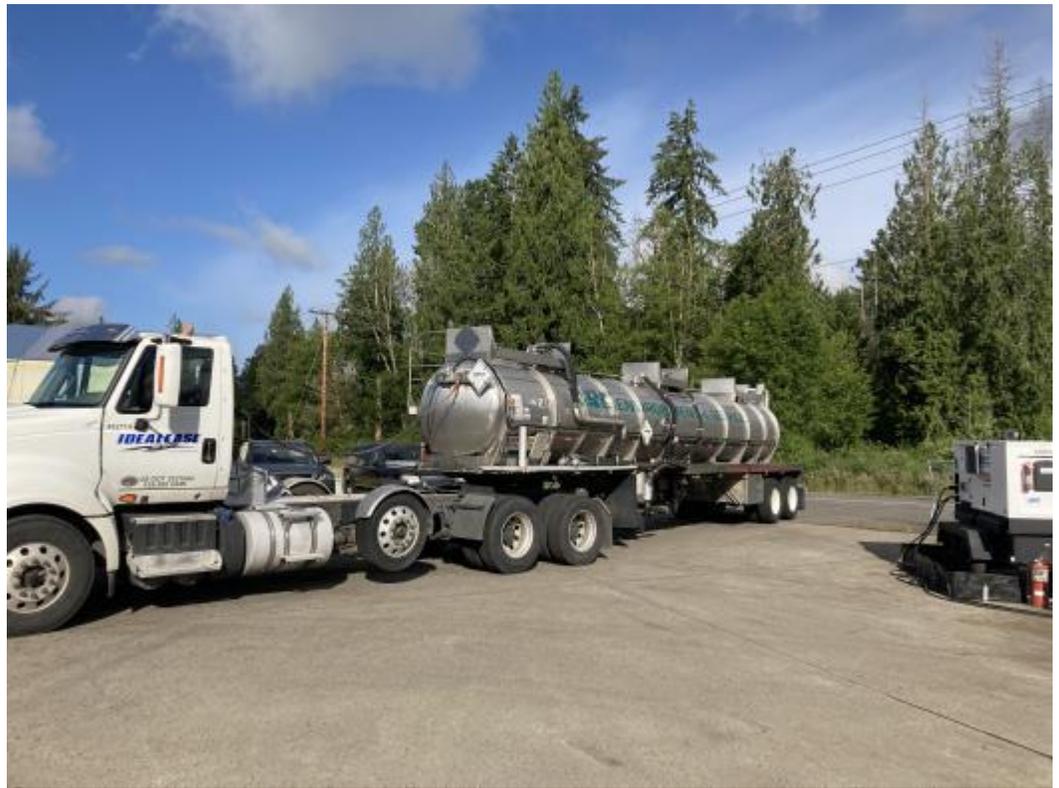
<b>Photo No.</b> <b>83</b>	<b>Date:</b> 06/16/2021
<b>Photo Coordinates</b>	
<b>Lat</b>	46.5726
<b>Long</b>	-122.729233
<b>Direction Photo Taken:</b> <b>NW</b>	
<b>Description:</b>  Vacuum truck arriving on-site to pump contents from totes staged in the staging area.

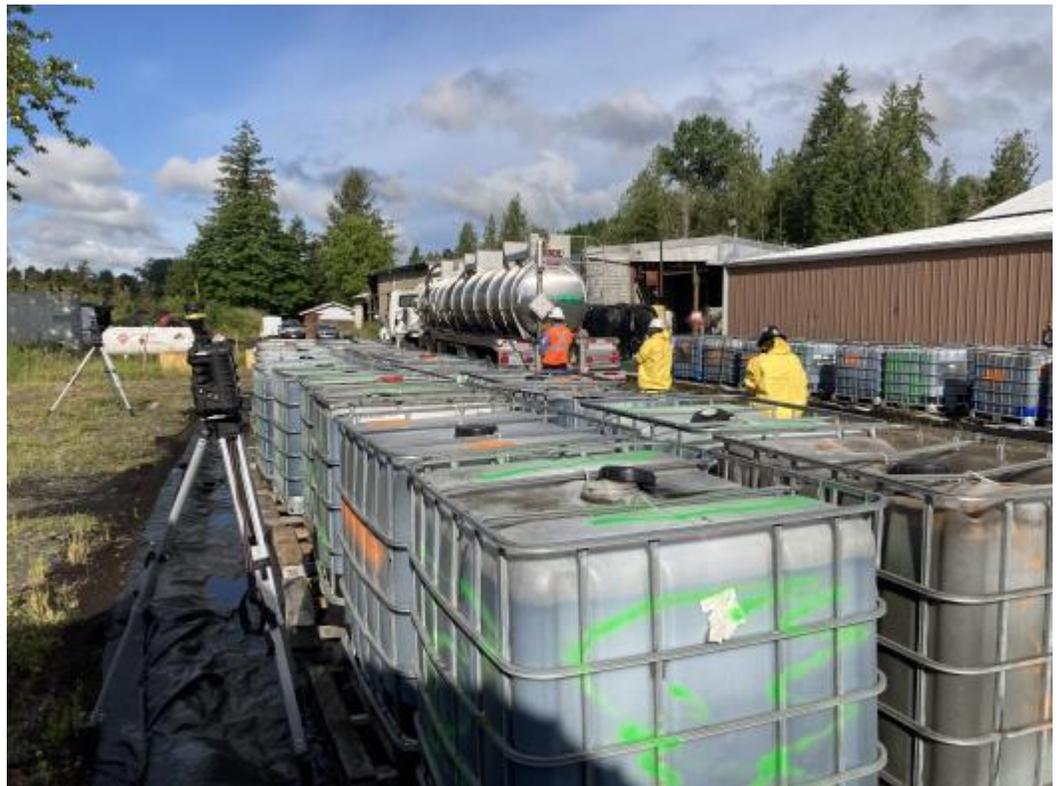
<b>Photo No.</b> <b>84</b>	<b>Date:</b> 06/16/2021
<b>Photo Coordinates</b>	
<b>Lat</b>	46.572147
<b>Long</b>	-122.728675
<b>Direction Photo Taken:</b> <b>W</b>	
<b>Description:</b>  Vacuum truck operator and ERRS contractors preparing to transfer tote contents into vacuum truck.

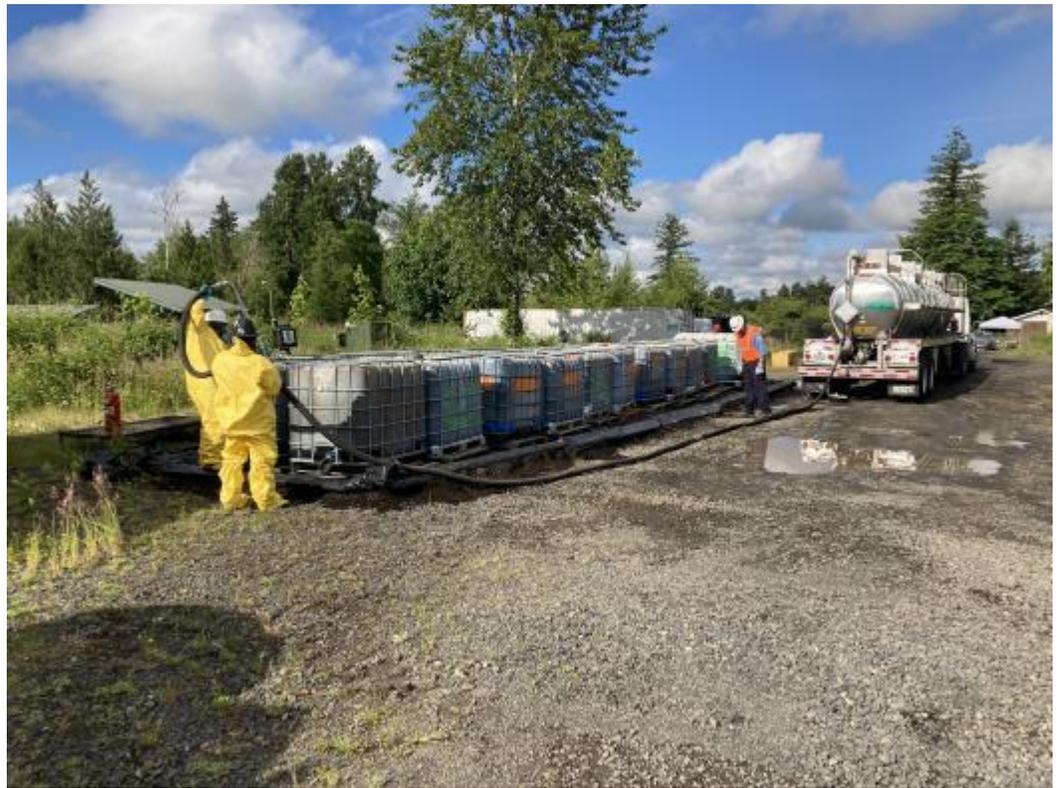
<b>Photo No.</b> <b>85</b>	<b>Date:</b> 06/16/2021
<b>Photo Coordinates</b>	
<b>Lat</b>	46.572358
<b>Long</b>	-122.728761
<b>Direction Photo Taken:</b> <b>SW</b>	
<b>Description:</b>  Vacuum truck operator and ERRS contractors conducting waste transfer activities.

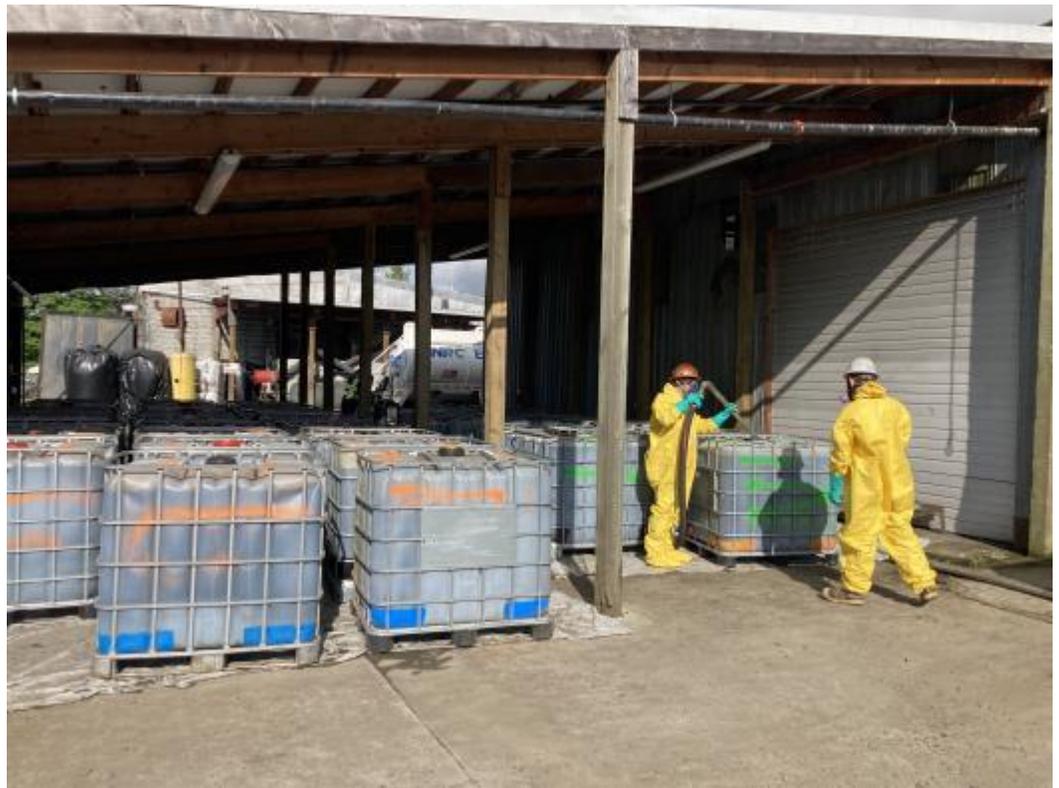
<b>Photo No.</b> <b>86</b>	<b>Date:</b> 06/16/2021
<b>Photo Coordinates</b>	
<b>Lat</b>	46.572375
<b>Long</b>	-122.728972
<b>Direction Photo Taken:</b> <b>W</b>	
<b>Description:</b>  Vacuum truck operator and ERRS contractors conducting waste transfer activities at the Lean-to Area.
