# **TIME-CRITICAL REMOVAL ACTION REPORT**

*Onalaska Wood Pyrolysis  
Onalaska, Lewis County, Washington*

Prepared by:

December 2021

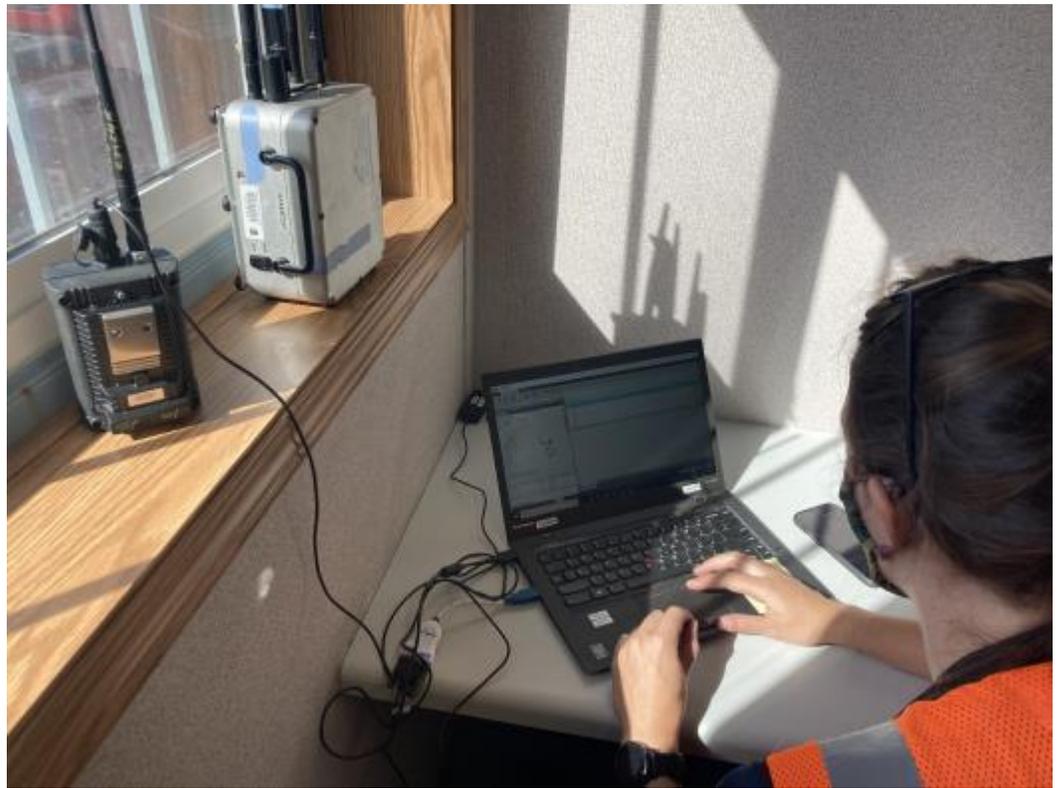
<b>Photo No.</b> <b>87</b>	<b>Date:</b> 06/16/2021
<b>Photo Coordinates</b>	
<b>Lat</b>	
<b>Long</b>	
<b>Direction Photo Taken:</b> <b>SW</b>	
<b>Description:</b>  START contractor remotely monitoring air quality.

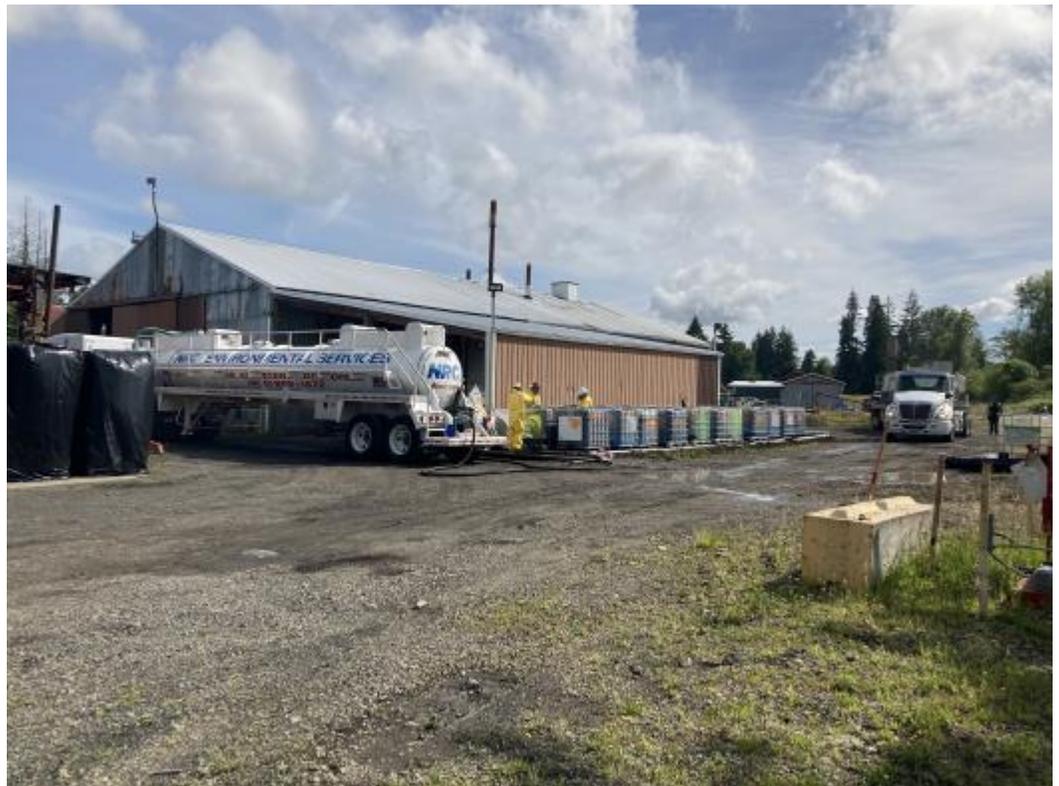
<b>Photo No.</b> <b>88</b>	<b>Date:</b> 06/16/2021
<b>Photo Coordinates</b>	
<b>Lat</b>	46.572117
<b>Long</b>	-122.729181
<b>Direction Photo Taken:</b> <b>NE</b>	
<b>Description:</b>  ERRS contractors conducting waste transfer activities at the tote staging area.

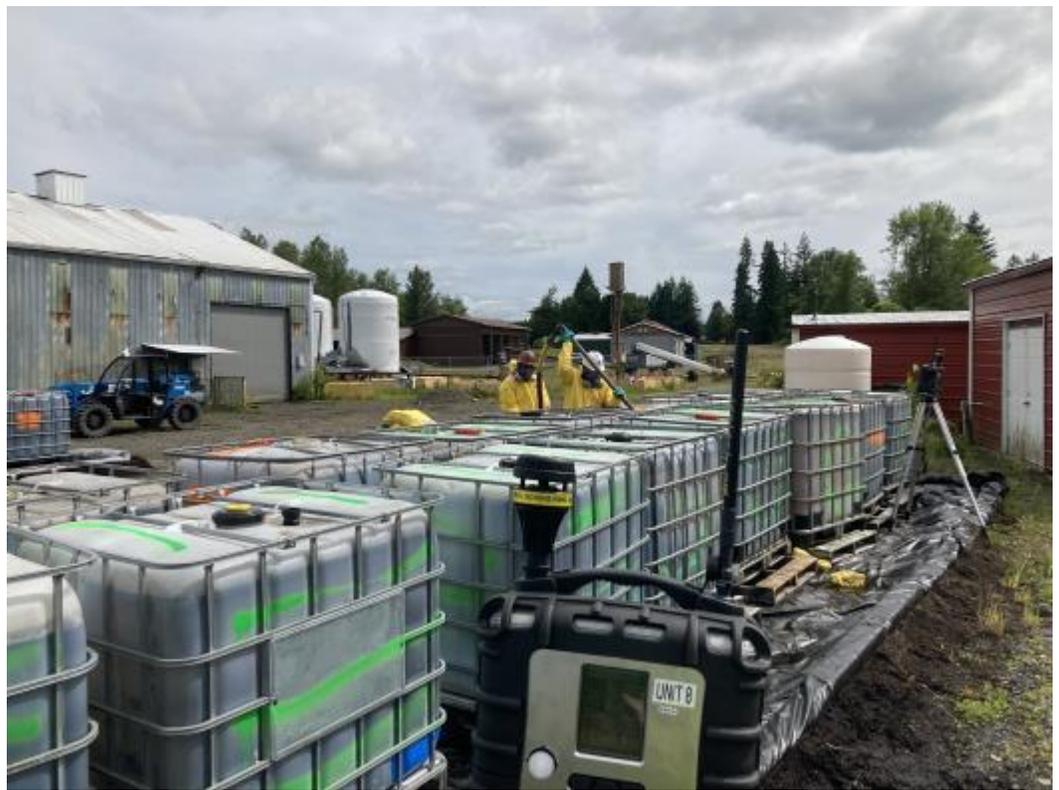
<b>Photo No.</b> <b>89</b>	<b>Date:</b> 06/16/2021
<b>Photo Coordinates</b>	
<b>Lat</b>	46.572117
<b>Long</b>	-122.728844
<b>Direction Photo Taken:</b> <b>NE</b>	
<b>Description:</b>  ERRS contractors conducting waste transfer activities at the tote staging area.

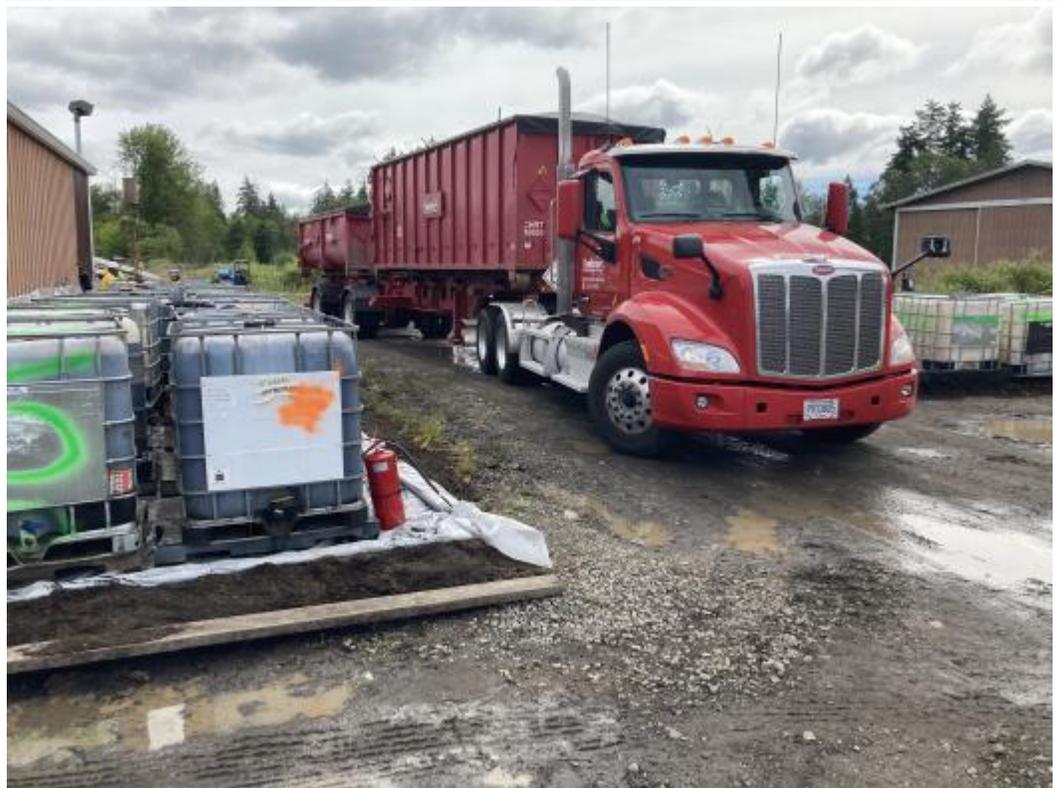
<b>Photo No.</b> <b>90</b>	<b>Date:</b> 06/16/2021
<b>Photo Coordinates</b>	
<b>Lat</b>	46.57225
<b>Long</b>	-122.729072
<b>Direction Photo Taken:</b> <b>E</b>	
<b>Description:</b>  Roll-off dumpsters being delivered to Site.

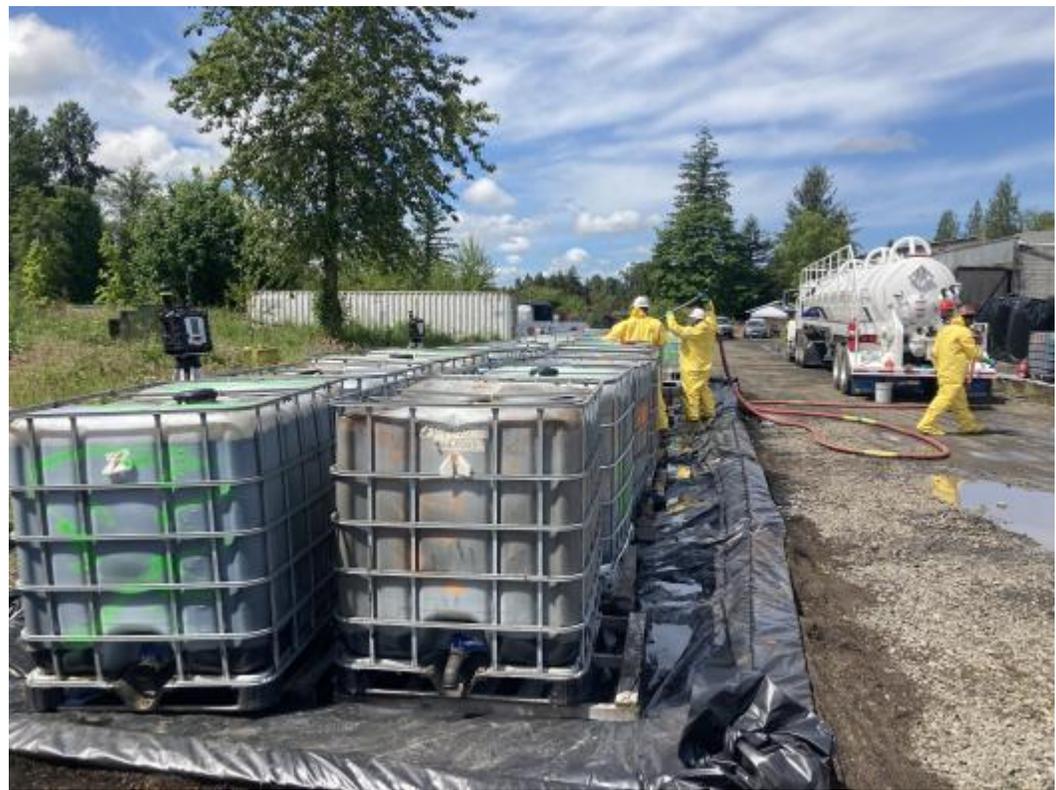
<b>Photo No.</b> <b>91</b>	<b>Date:</b> 06/16/2021
<b>Photo Coordinates</b>	
<b>Lat</b>	46.572167
<b>Long</b>	-122.728614
<b>Direction Photo Taken:</b> <b>SW</b>	
<b>Description:</b>  ERRS contractors conducting waste transfer activities at the tote staging area.

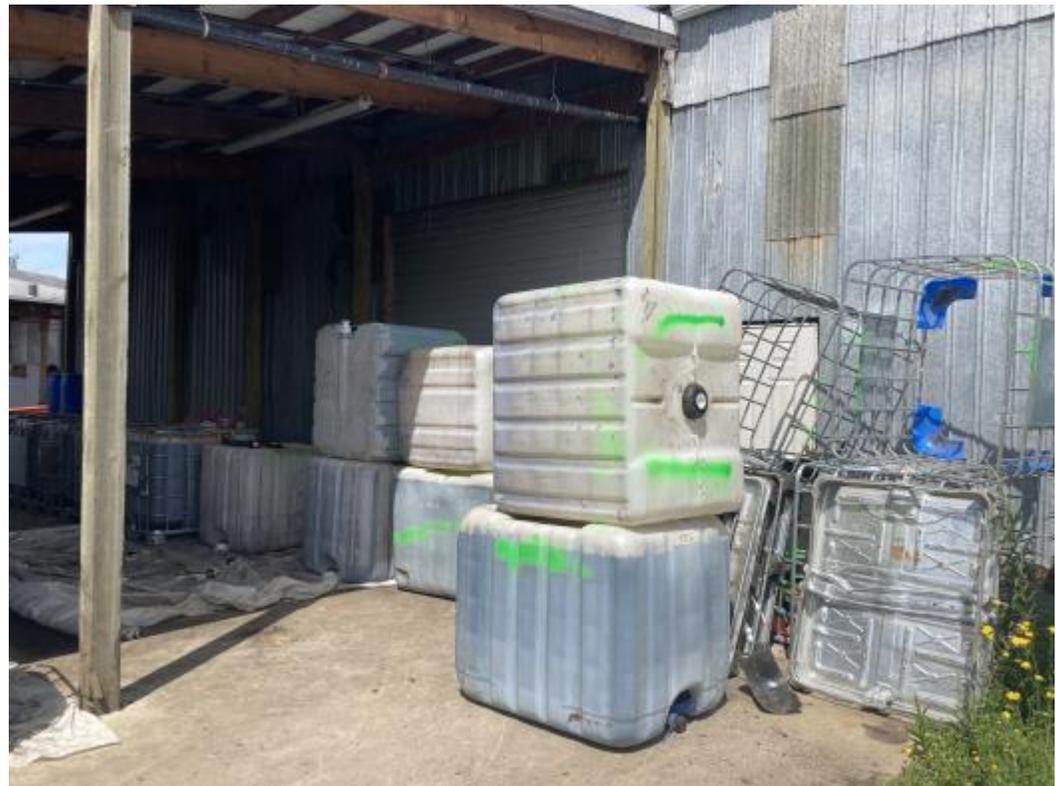
<b>Photo No.</b> <b>92</b>	<b>Date:</b> 06/16/2021
<b>Photo Coordinates</b>	
<b>Lat</b>	46.572381
<b>Long</b>	-122.728819
<b>Direction Photo Taken:</b> <b>NW</b>	
<b>Description:</b>  Emptied totes that have been deconstructed at the Lean-to Area.

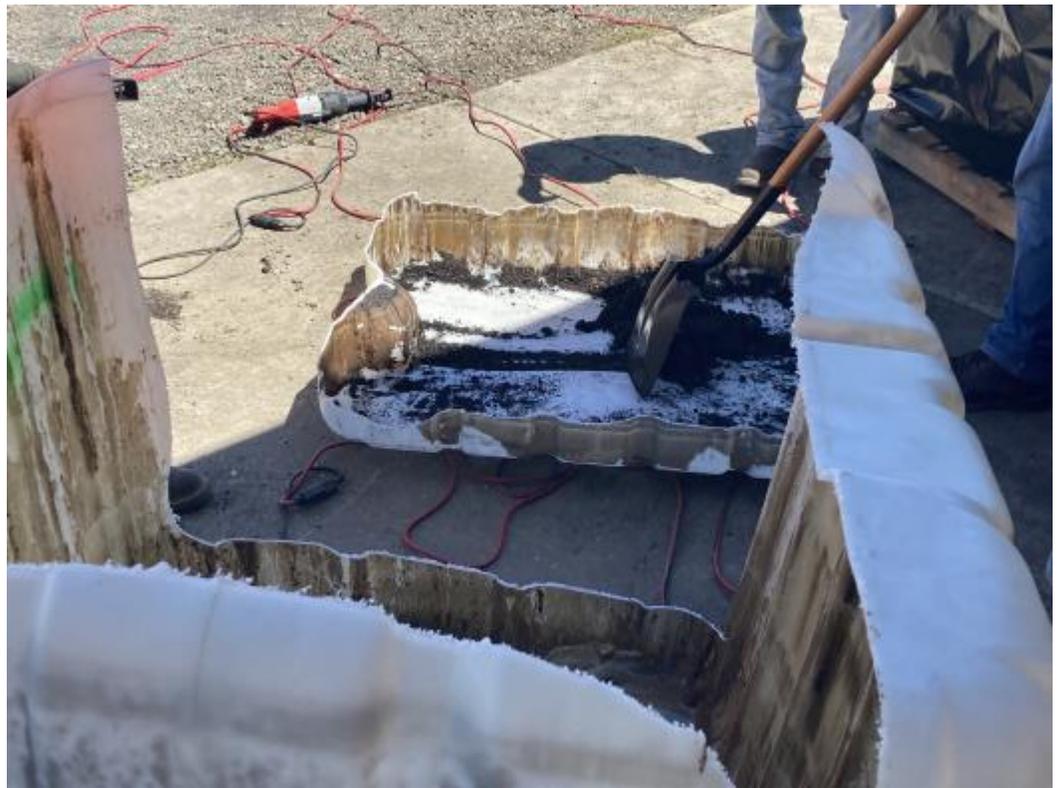
<b>Photo No.</b> <b>94</b>	<b>Date:</b> 06/16/2021
<b>Photo Coordinates</b>	
<b>Lat</b>	46.572381
<b>Long</b>	-122.728911
<b>Direction Photo Taken:</b> <b>SE</b>	
<b>Description:</b>  ERRS contractors cutting up empty totes and scraping settled material from the bottom panels.

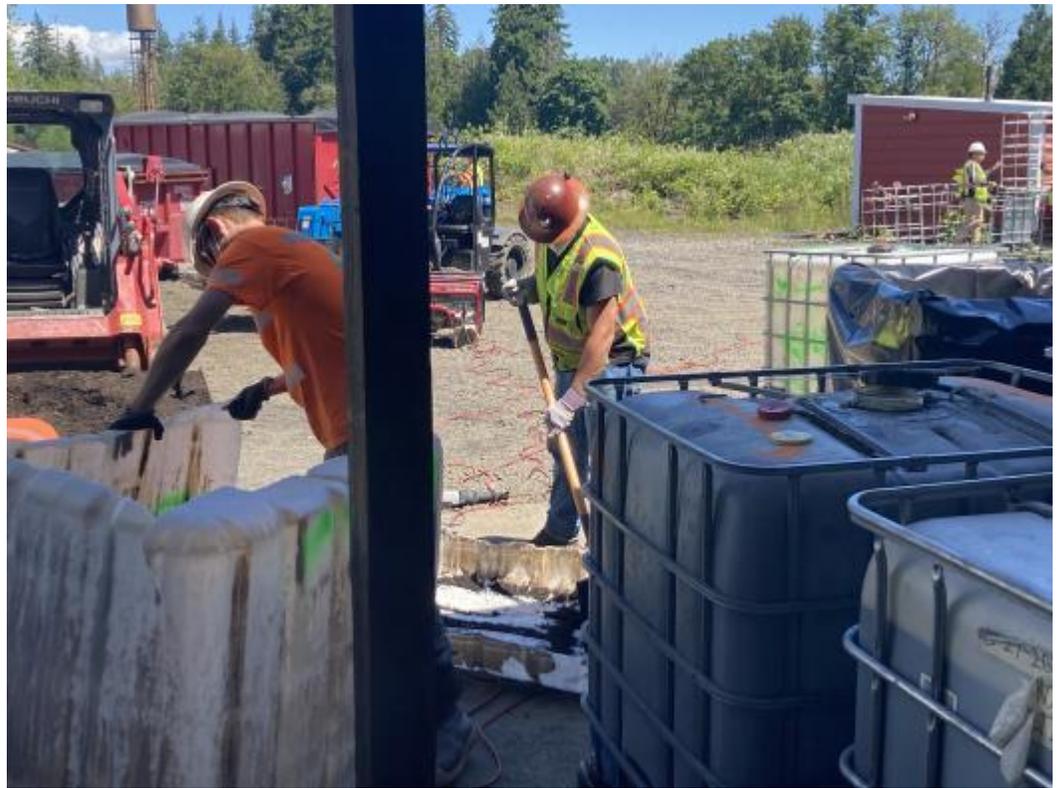
<b>Photo No.</b> <b>95</b>	<b>Date:</b> 06/16/2021
<b>Photo Coordinates</b>	
<b>Lat</b>	46.572394
<b>Long</b>	-122.728889
<b>Direction Photo Taken:</b> <b>E</b>	
<b>Description:</b>  ERRS contractors cutting up empty totes and scraping settled material from the bottom panels.

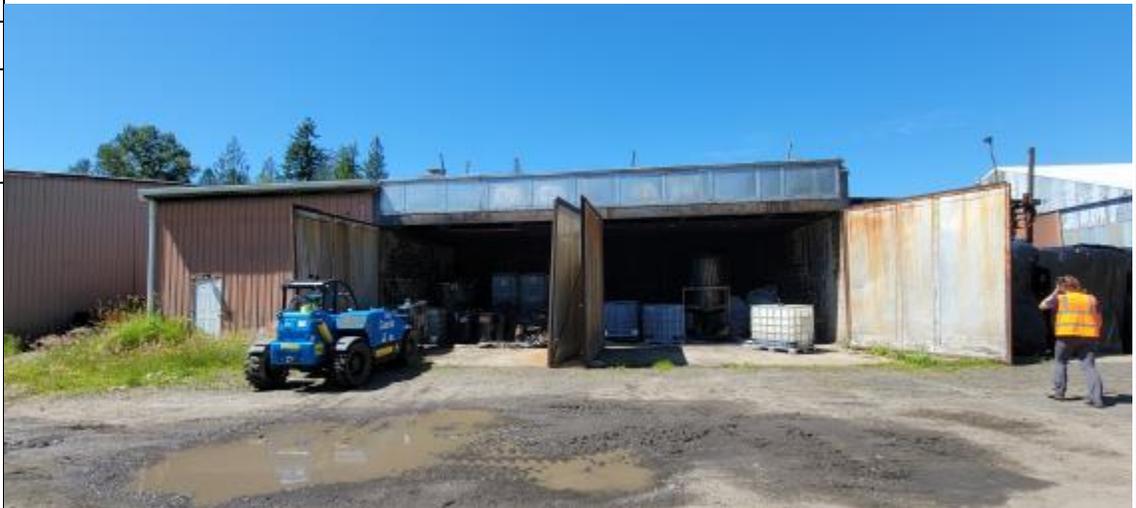
<b>Photo No.</b> <b>96</b>	<b>Date:</b> 06/16/2021
<b>Photo Coordinates</b>	
<b>Lat</b>	N/A
<b>Long</b>	N/A
<b>Direction Photo Taken:</b> <b>N</b>

<b>Description:</b>  ERRS removing totes from the Dry Kiln Building to be transferred to the staging area.	
--	--

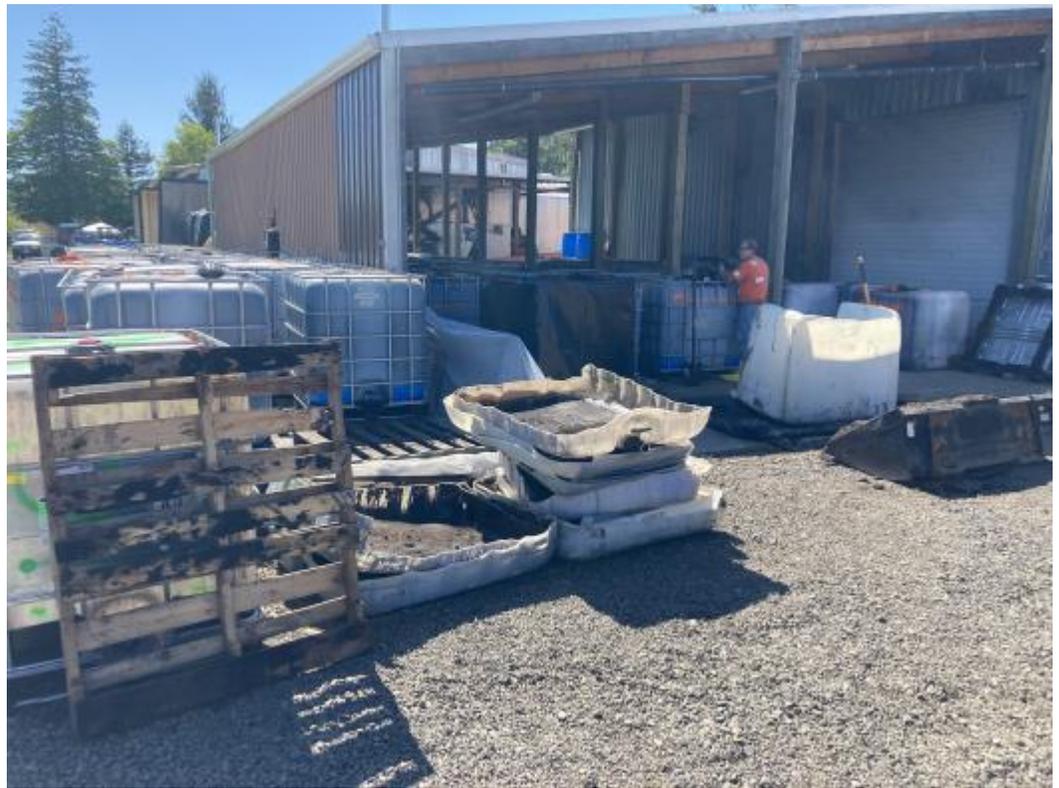
<b>Photo No.</b> <b>97</b>	<b>Date:</b> 06/16/2021
<b>Photo Coordinates</b>	
<b>Lat</b>	46.572331
<b>Long</b>	-122.728797
<b>Direction Photo Taken:</b> <b>W</b>	
<b>Description:</b>  Deconstructed totes at the tote staging area.

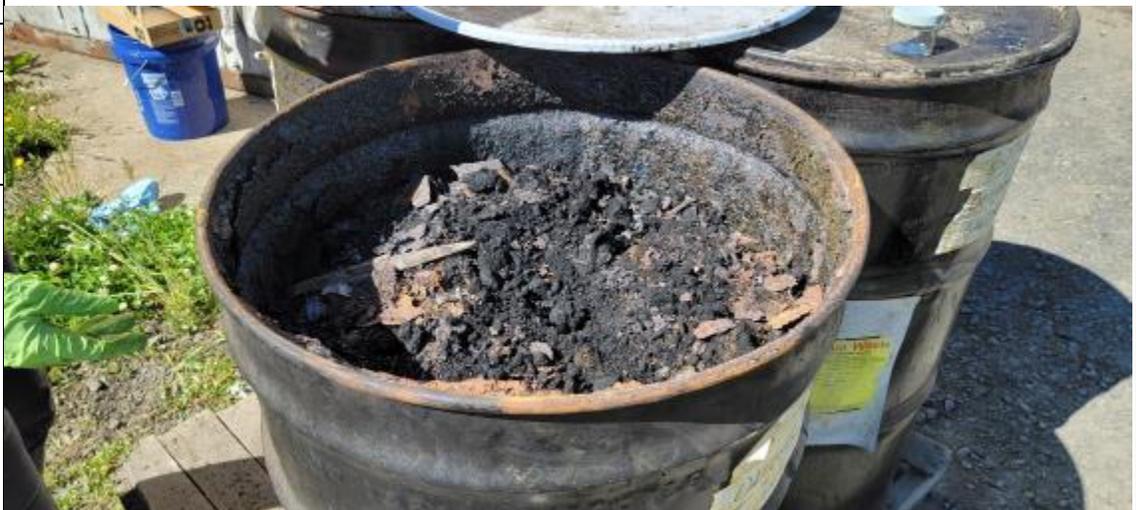
<b>Photo No.</b> <b>98</b>	<b>Date:</b> 06/16/2021
<b>Photo Coordinates</b>	
<b>Lat</b>	N/A
<b>Long</b>	N/A
<b>Direction Photo Taken:</b> <b>N/A</b>	
<b>Description:</b>  Drum of biochar pulled from the Dry Kiln Building.

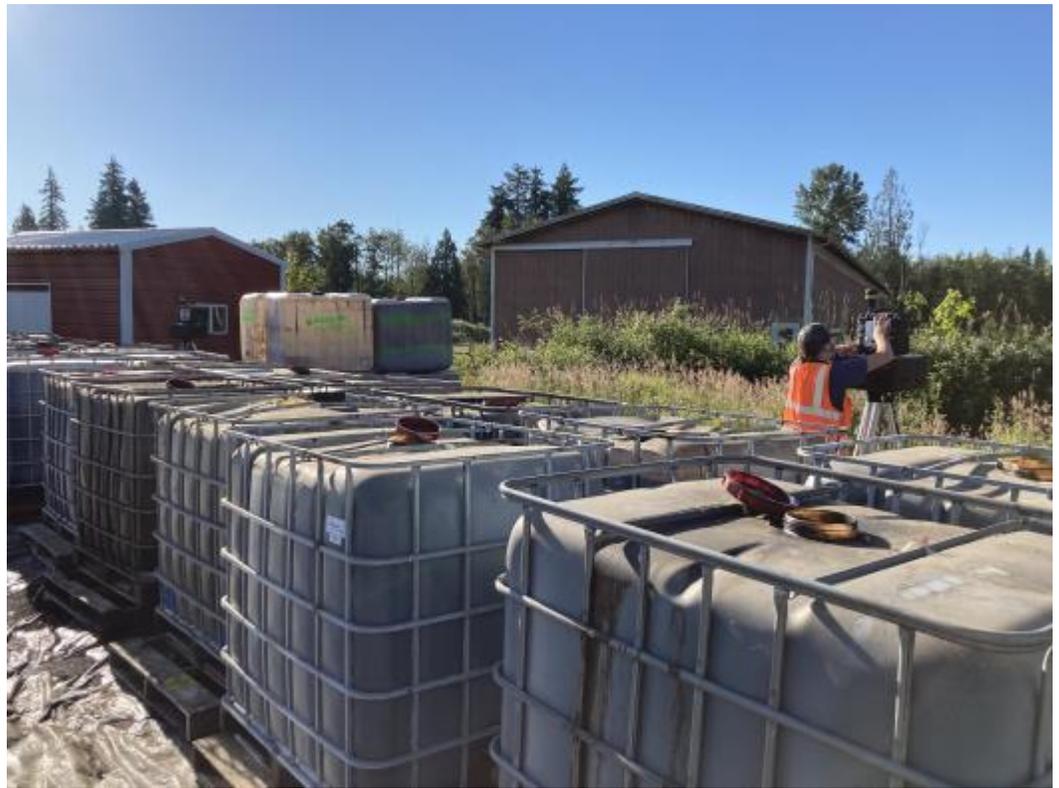
<b>Photo No.</b> <b>99</b>	<b>Date:</b> 06/17/2021
<b>Photo Coordinates</b>	
<b>Lat</b>	46.572147
<b>Long</b>	-122.728972
<b>Direction Photo Taken:</b> <b>SE</b>	
<b>Description:</b>  START contractors maintaining air monitoring equipment at the tote staging area.

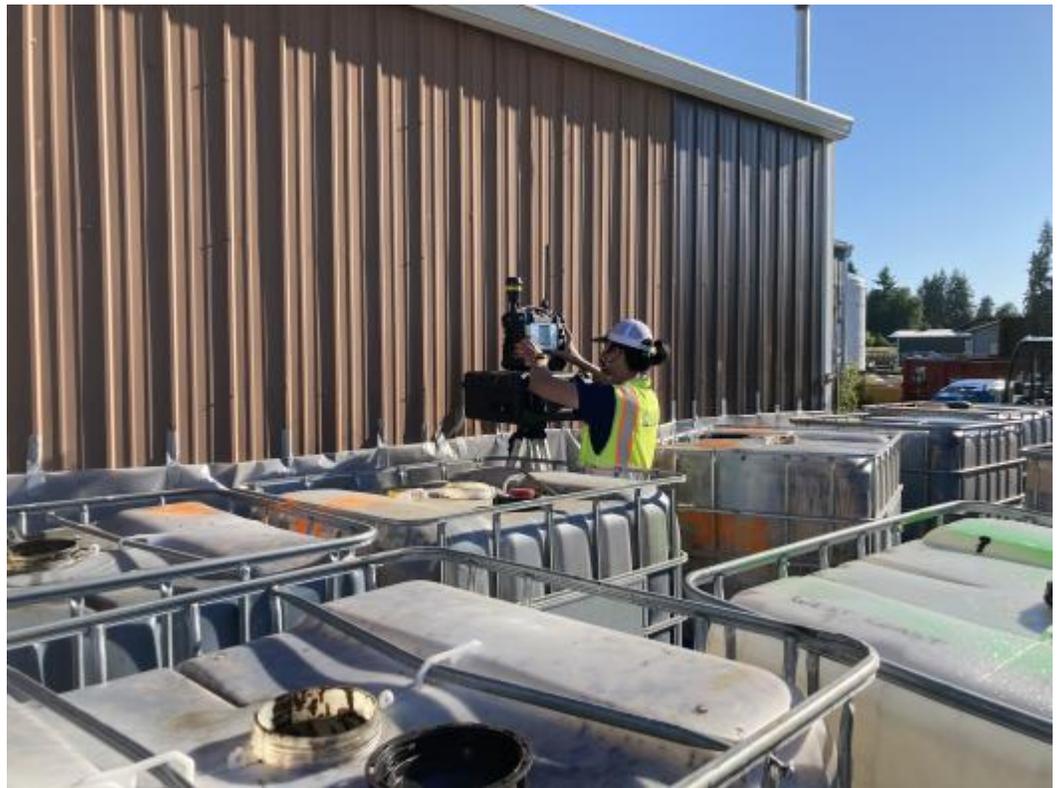
<b>Photo No.</b> <b>100</b>	<b>Date:</b> 06/17/2021
<b>Photo Coordinates</b>	
<b>Lat</b>	46.572281
<b>Long</b>	-122.728942
<b>Direction Photo Taken:</b> <b>NE</b>	
<b>Description:</b>  START contractors maintaining air monitoring equipment at the tote staging area.

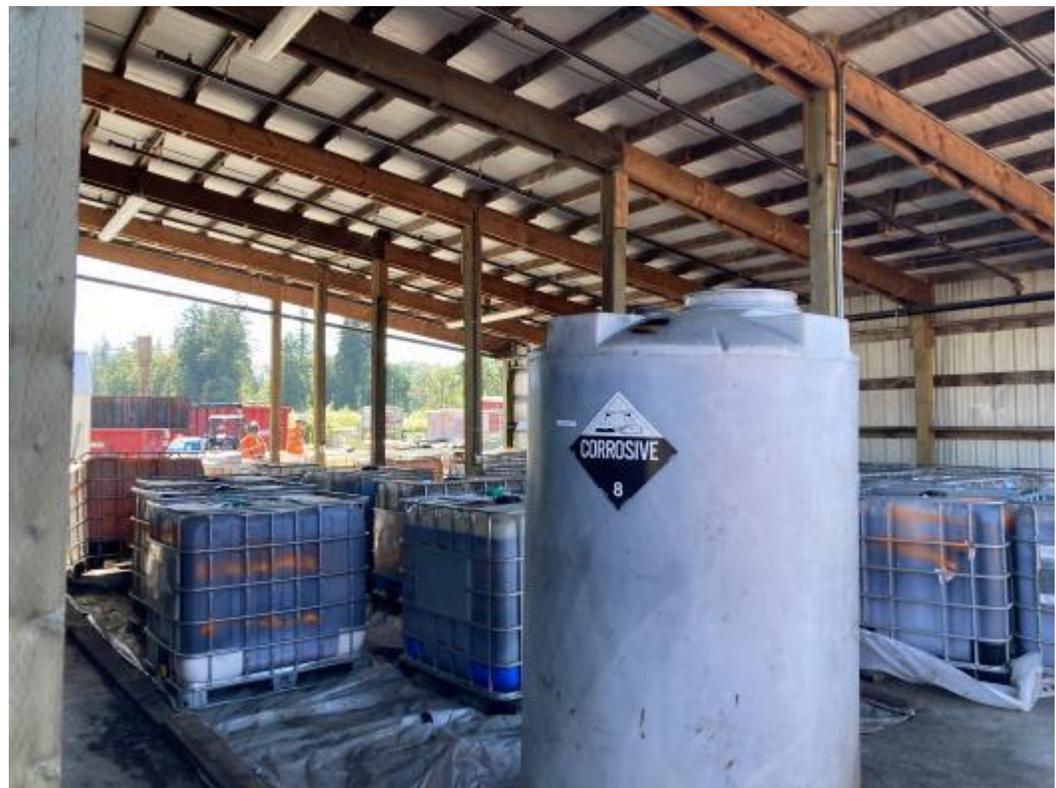
<b>Photo No.</b> <b>101</b>	<b>Date:</b> 06/17/2021
<b>Photo Coordinates</b>	
<b>Lat</b>	46.572311
<b>Long</b>	-122.729142
<b>Direction Photo Taken:</b> <b>E</b>	
<b>Description:</b>  Tank of unidentified waste that had been moved from the Dry Kiln Building to the Lean-to Area.

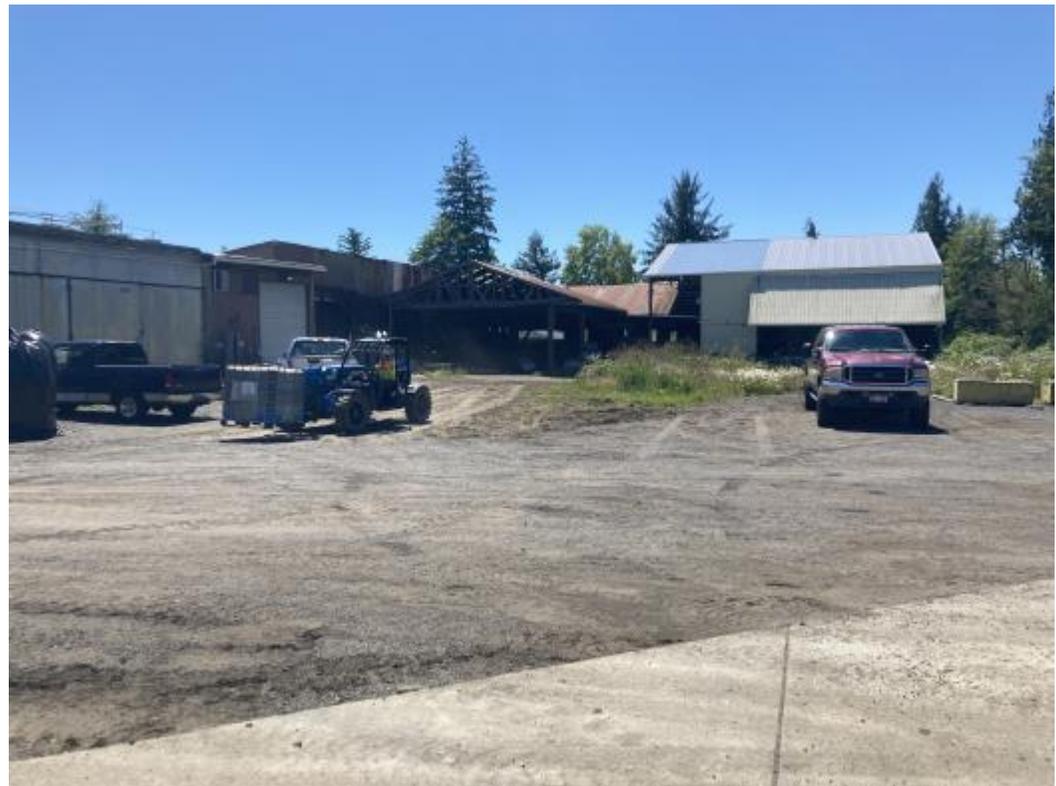
<b>Photo No.</b> <b>102</b>	<b>Date:</b> 06/17/2021
<b>Photo Coordinates</b>	
<b>Lat</b>	46.572628
<b>Long</b>	-122.729172
<b>Direction Photo Taken:</b> <b>SW</b>	
<b>Description:</b>  ERRS contractors moving totes from the North Warehouse TG01 Tote Area to the tote staging area.

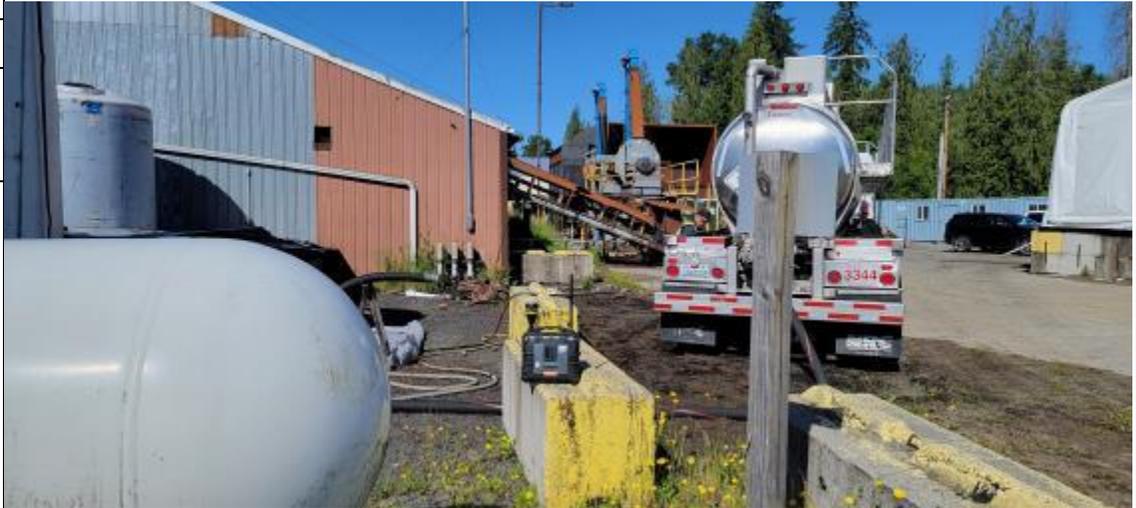
<b>Photo No.</b> <b>103</b>	<b>Date:</b> 06/18/2021
<b>Photo Coordinates</b>	
<b>Lat</b>	46.572515
<b>Long</b>	-122.728486
<b>Direction Photo Taken:</b> <b>W</b>	
<b>Description:</b>  Vacuum truck pumping out wastewater from the Secondary Containment Area.

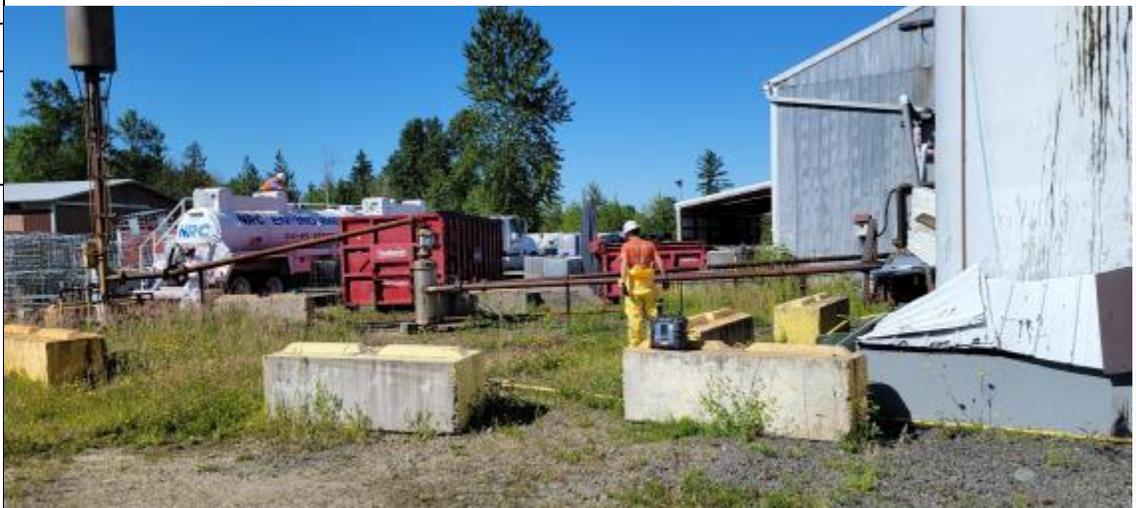
<b>Photo No.</b> <b>104</b>	<b>Date:</b> 06/18/2021
<b>Photo Coordinates</b>	
<b>Lat</b>	46.574648
<b>Long</b>	-122.720992
<b>Direction Photo Taken:</b> <b>SW</b>	
<b>Description:</b>  ERRS contractors preparing to pump out wastewater from the Secondary Containment Area.

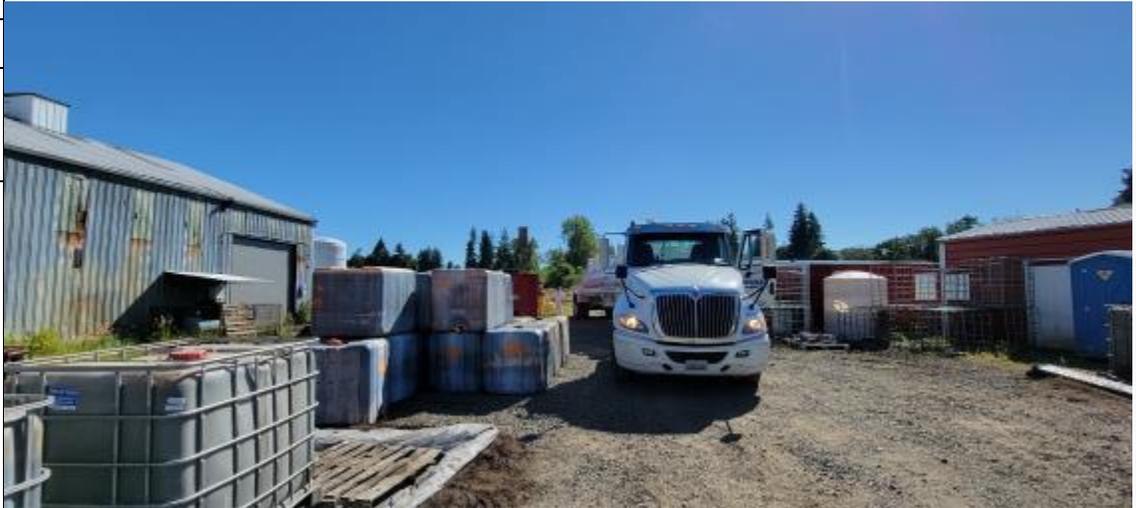
<b>Photo No.</b> <b>105</b>	<b>Date:</b> 06/18/2021
<b>Photo Coordinates</b>	
<b>Lat</b>	46.572232
<b>Long</b>	-122.72877
<b>Direction Photo Taken:</b> <b>E</b>	
<b>Description:</b>  Vacuum truck preparing to pump out wastewater from Secondary Containment Area.

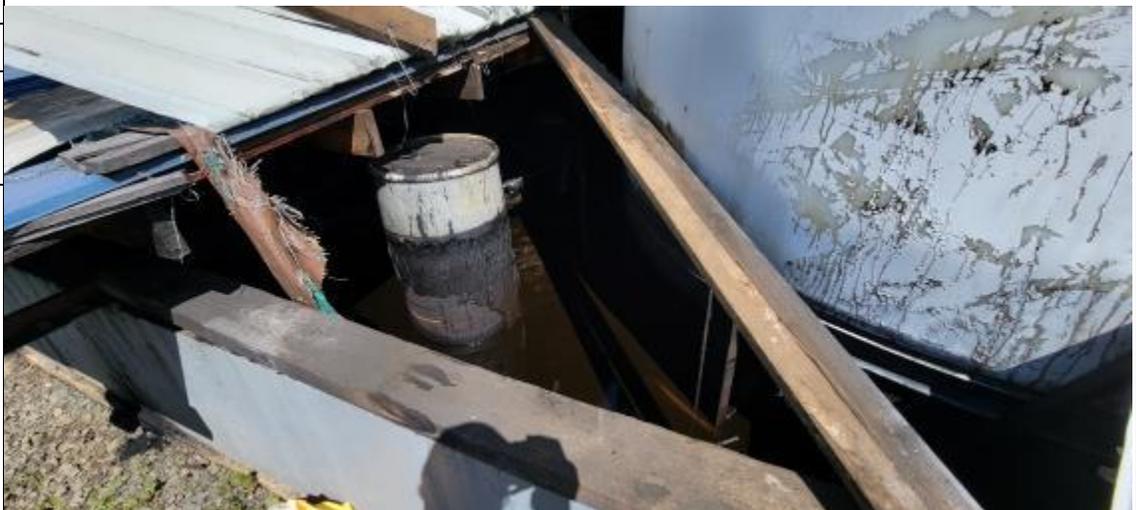
<b>Photo No.</b> <b>106</b>	<b>Date:</b> 06/18/2021
<b>Photo Coordinates</b>	
<b>Lat</b>	46.572506
<b>Long</b>	-122.728743
<b>Direction Photo Taken:</b> <b>NW</b>	
<b>Description:</b>  Drum of waste abandoned to the Secondary Containment Area.

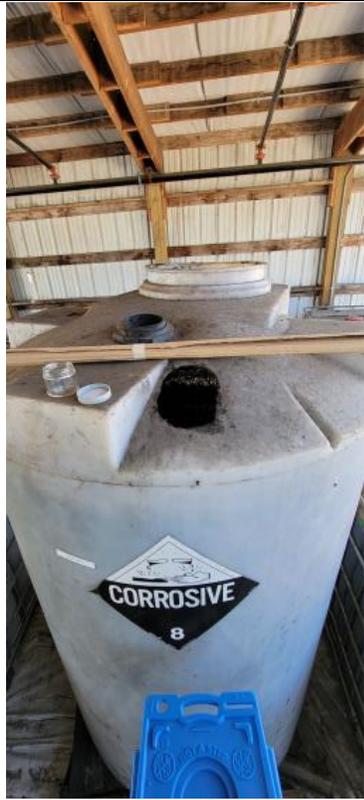
<b>Photo No.</b> <b>107</b>	<b>Date:</b> 06/18/2021
<b>Photo Coordinates</b>	
<b>Lat</b>	N/A
<b>Long</b>	N/A
<b>Direction Photo Taken:</b> <b>S</b>	
<b>Description:</b> Tank being sampled at the Lean-to Area.

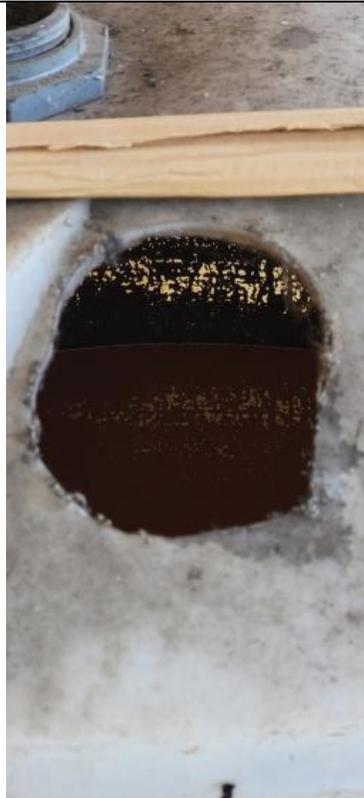
<b>Photo No.</b> <b>108</b>	<b>Date:</b> 06/18/2021
<b>Photo Coordinates</b>	
<b>Lat</b>	N/A
<b>Long</b>	N/A
<b>Direction Photo Taken:</b> <b>S</b>	
<b>Description:</b> Waste contents inside tank being sampled.

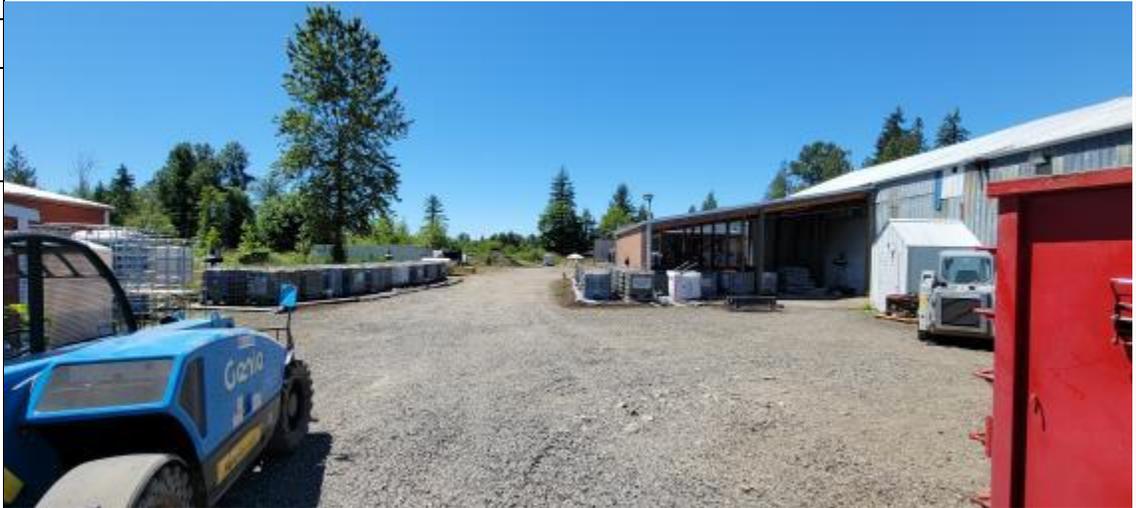
<b>Photo No.</b> <b>109</b>	<b>Date:</b> 06/19/2021
<b>Photo Coordinates</b>	
<b>Lat</b>	46.572301
<b>Long</b>	-122.728571
<b>Direction Photo Taken:</b> <b>SE</b>

**Description:**  
Tote staging area.

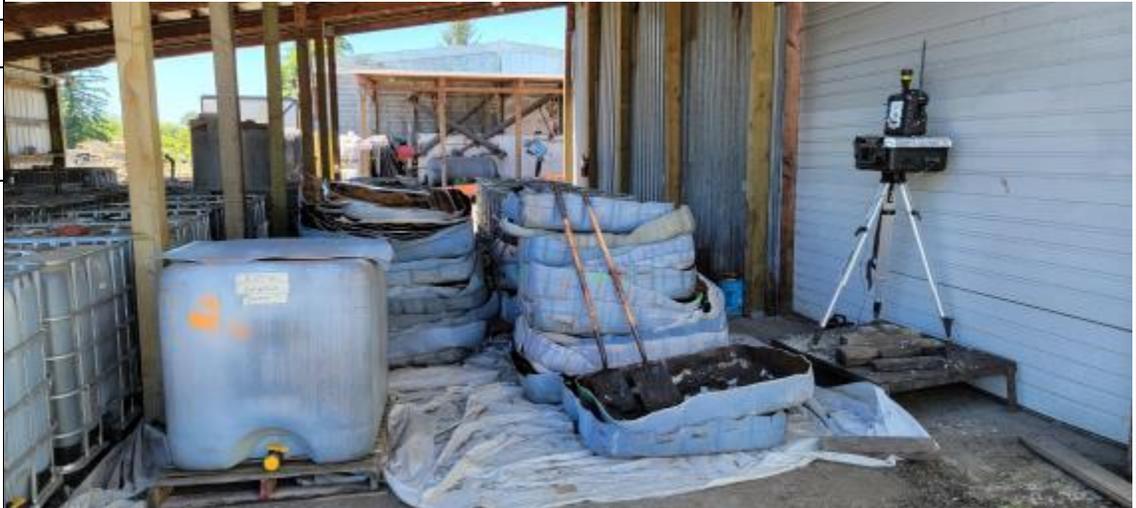
<b>Photo No.</b> <b>110</b>	<b>Date:</b> 06/19/2021
<b>Photo Coordinates</b>	
<b>Lat</b>	46.572301
<b>Long</b>	-122.728571
<b>Direction Photo Taken:</b> <b>SE</b>

**Description:**  
Deconstructed totes staged in the Lean-to Area.

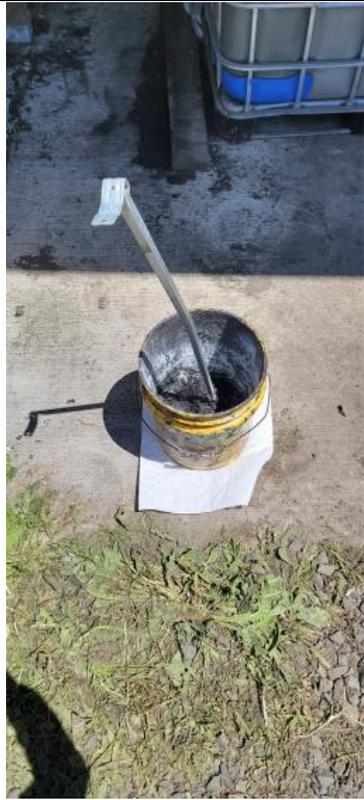
<b>Photo No.</b> <b>111</b>	<b>Date:</b> 06/19/2021
<b>Photo Coordinates</b>	
<b>Lat</b>	46.572211
<b>Long</b>	-122.729126
<b>Direction Photo Taken:</b> <b>NE</b>	
<b>Description:</b>  ERRS determining appropriate waste solidification ratios in a bucket.

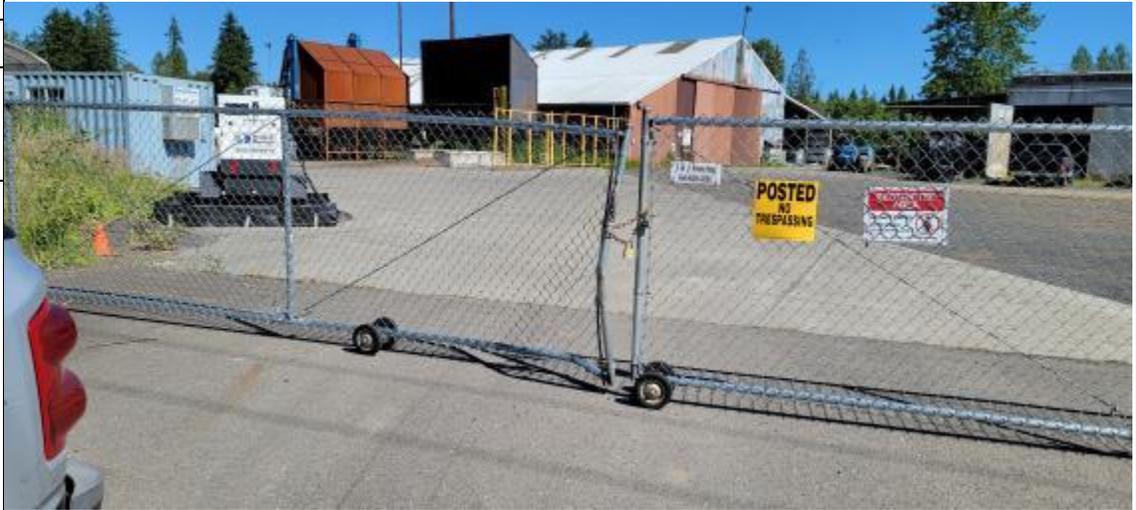
<b>Photo No.</b> <b>112</b>	<b>Date:</b> 06/19/2021
<b>Photo Coordinates</b>	
<b>Lat</b>	N/A
<b>Long</b>	N/A
<b>Direction Photo Taken:</b> <b>SE</b>	
<b>Description:</b>  Site entrance secured at the end of a workday.

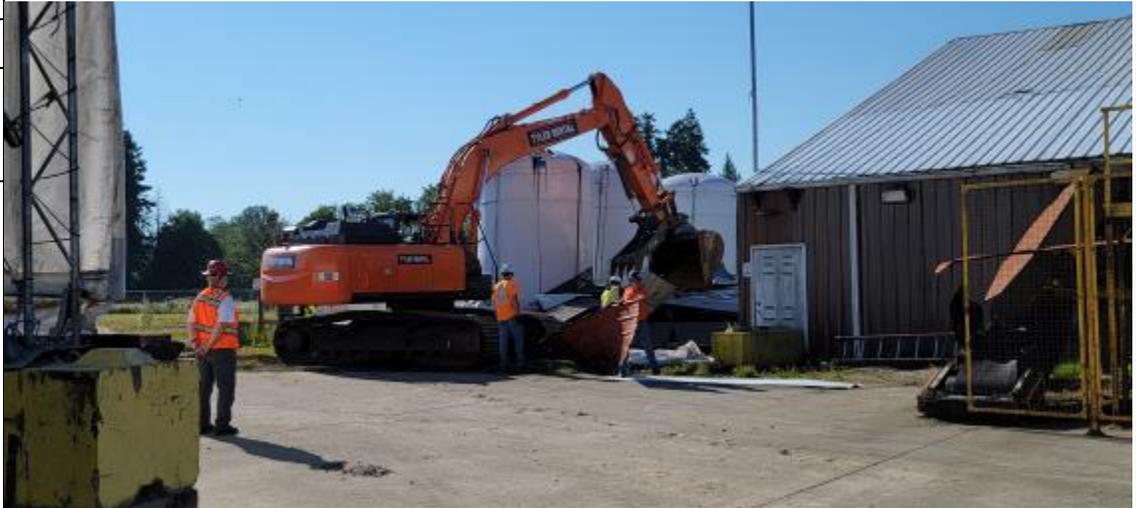
<b>Photo No.</b> <b>113</b>	<b>Date:</b> 06/21/2021
<b>Photo Coordinates</b>	
<b>Lat</b>	46.572804
<b>Long</b>	-122.729086
<b>Direction Photo Taken:</b> <b>SE</b>	
<b>Description:</b>  OSC overseeing ERRS contractors removing makeshift roof covering the Secondary Containment Area.

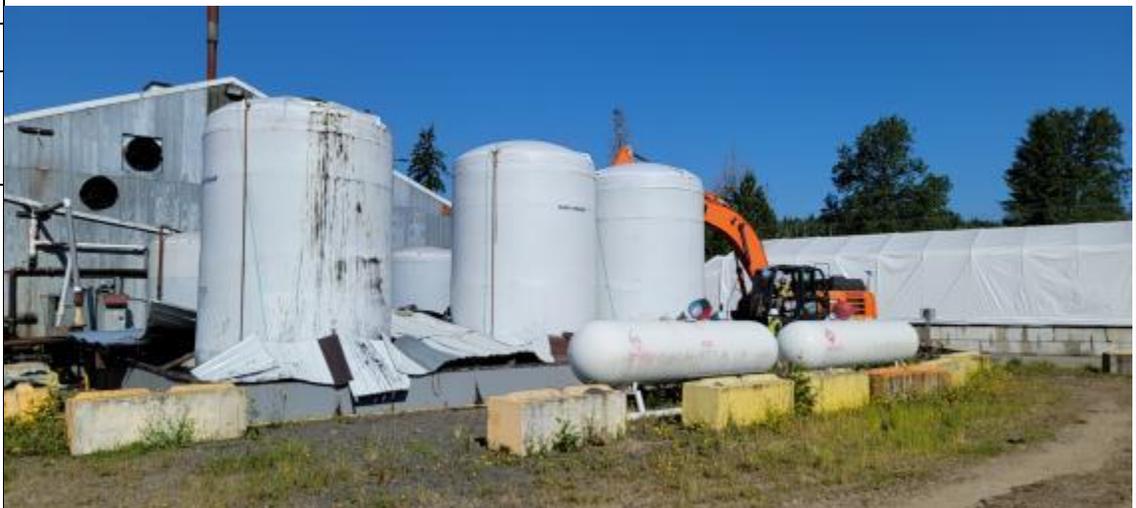
<b>Photo No.</b> <b>114</b>	<b>Date:</b> 06/21/2021
<b>Photo Coordinates</b>	
<b>Lat</b>	46.572556
<b>Long</b>	-122.728544
<b>Direction Photo Taken:</b> <b>NW</b>	
<b>Description:</b>  ERRS contractors removing makeshift roof over Secondary Containment Area.

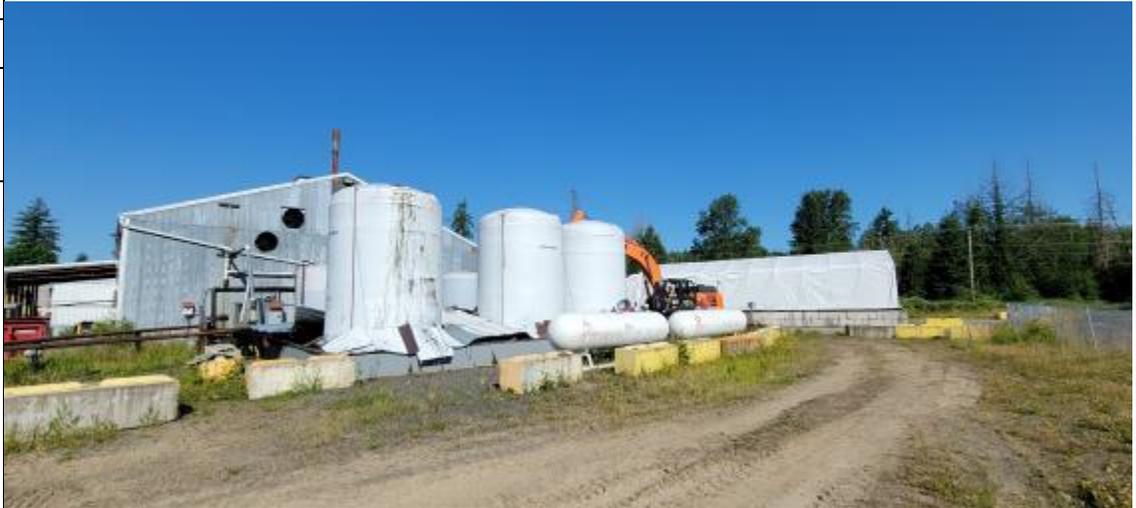
<b>Photo No.</b> <b>115</b>	<b>Date:</b> 06/21/2021
<b>Photo Coordinates</b>	
<b>Lat</b>	46.572556
<b>Long</b>	-122.728544
<b>Direction Photo Taken:</b> <b>NW</b>	
<b>Description:</b>  ERRS contractors removing makeshift roof over Secondary Containment Area.

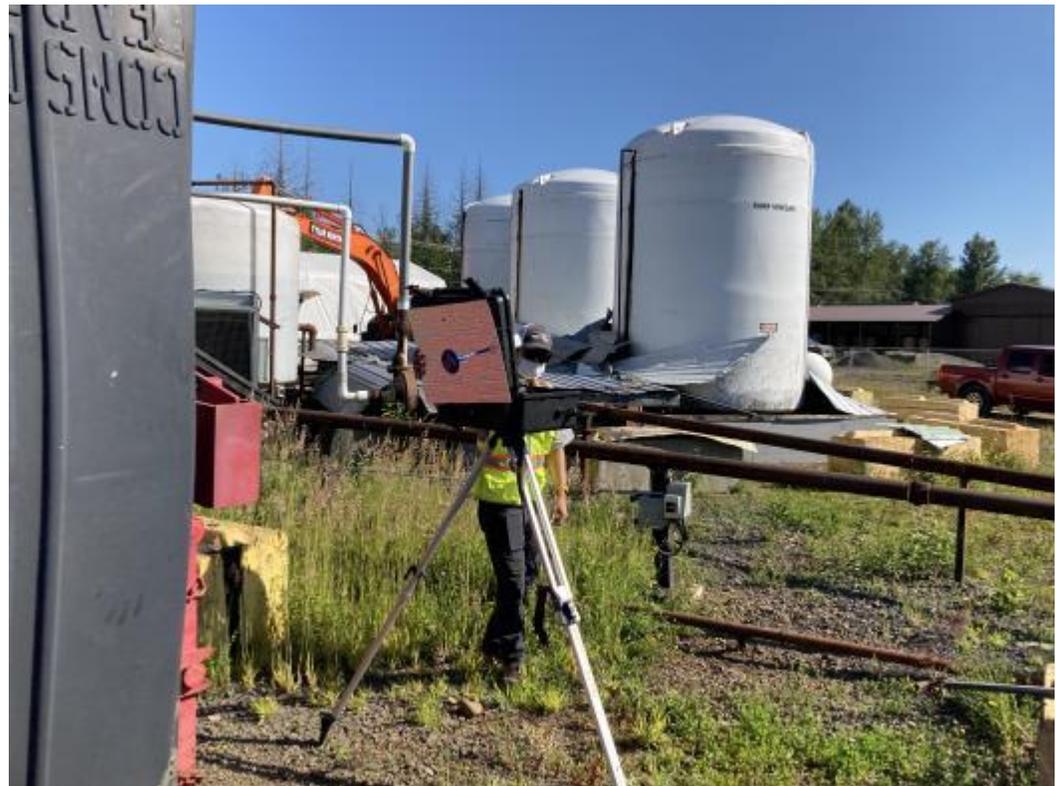
<b>Photo No.</b> <b>116</b>	<b>Date:</b> 06/21/2021
<b>Photo Coordinates</b>	
<b>Lat</b>	46.572425
<b>Long</b>	-122.728653
<b>Direction Photo Taken:</b> <b>N</b>	
<b>Description:</b>  START contractor maintaining air monitoring instrument while ERRS contractors are removing makeshift roof over Secondary Containment Area in the background.

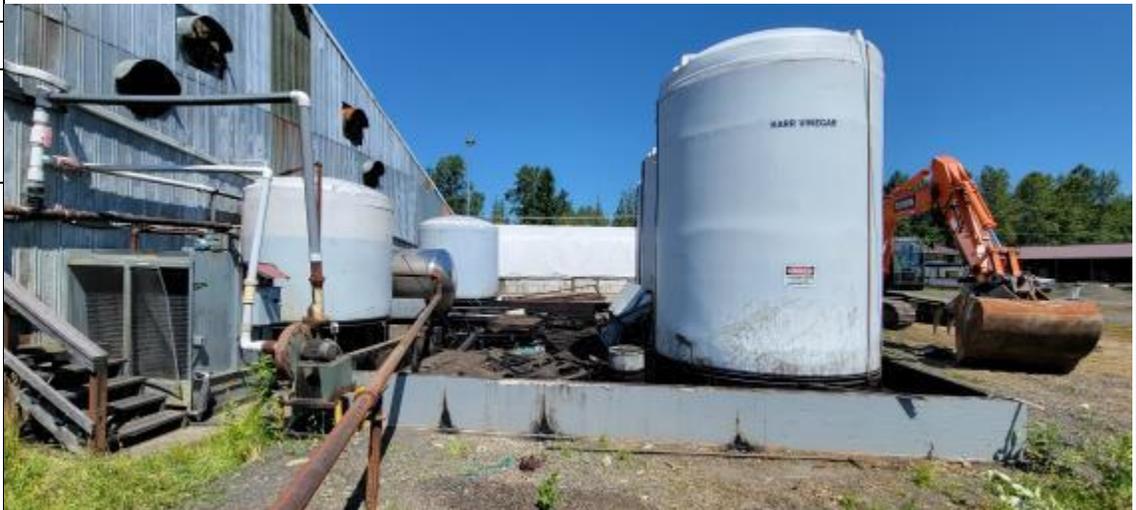
<b>Photo No.</b> <b>118</b>	<b>Date:</b> 06/21/2021
<b>Photo Coordinates</b>	
<b>Lat</b>	46.572505
<b>Long</b>	-122.728657
<b>Direction Photo Taken:</b> <b>N</b>	
<b>Description:</b>  Uncovered Secondary Containment Area reveals debris.

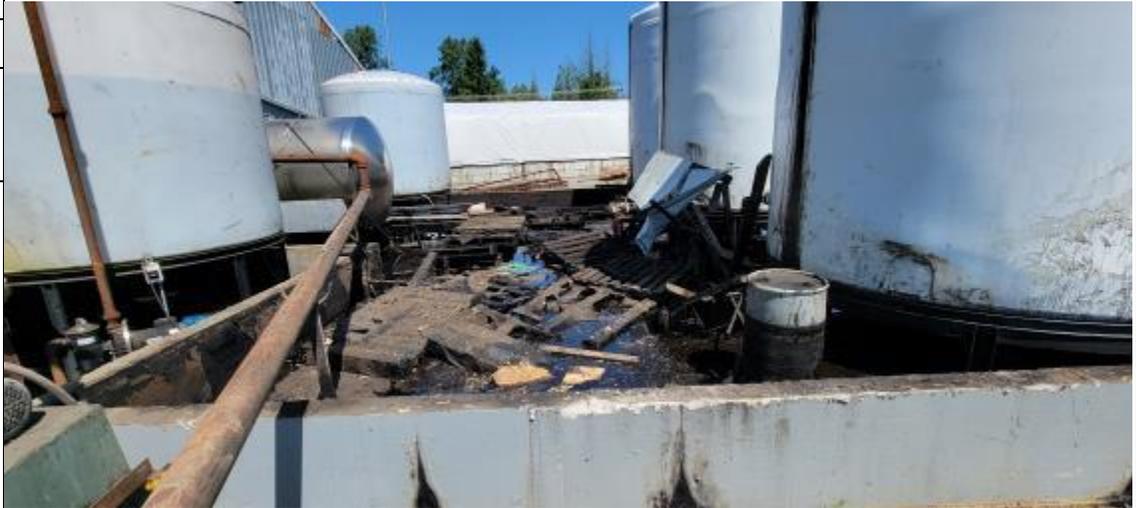
<b>Photo No.</b> <b>119</b>	<b>Date:</b> 06/21/2021
<b>Photo Coordinates</b>	
<b>Lat</b>	46.572505
<b>Long</b>	-122.728657
<b>Direction Photo Taken:</b> <b>N</b>	
<b>Description:</b>  Debris, drum, and wastewater in the Secondary Containment Area.
