# **TIME-CRITICAL REMOVAL ACTION REPORT**

*Onalaska Wood Pyrolysis  
Onalaska, Lewis County, Washington*

Prepared by:

December 2021

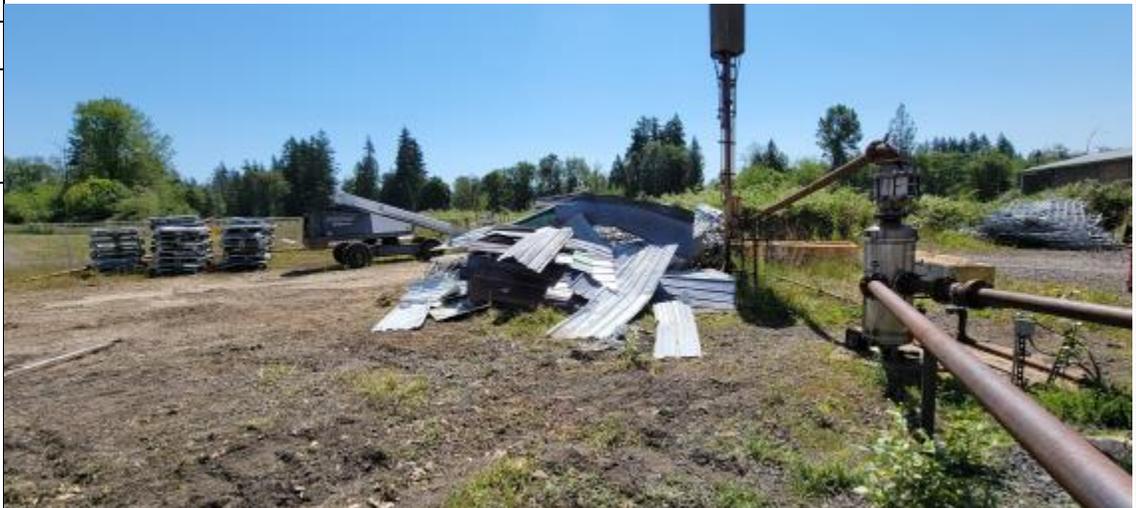
<b>Photo No.</b> <b>120</b>	<b>Date:</b> 06/21/2021
<b>Photo Coordinates</b>	
<b>Lat</b>	46.572505
<b>Long</b>	-122.728657
<b>Direction Photo Taken:</b> <b>SE</b>	
<b>Description:</b>  Removed roofing material staged at the east-southeast end of the Site.

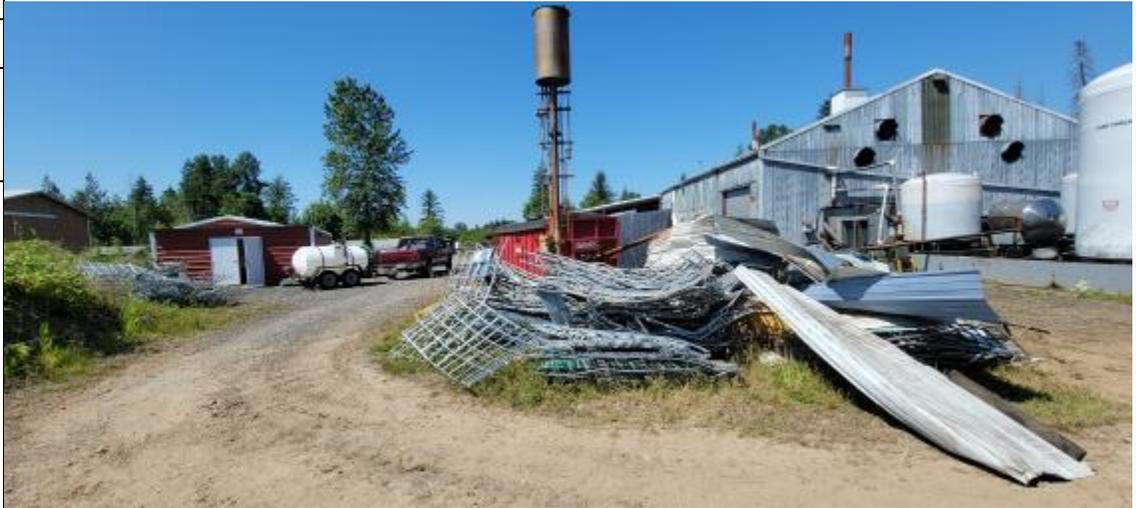
<b>Photo No.</b> <b>121</b>	<b>Date:</b> 06/21/2021
<b>Photo Coordinates</b>	
<b>Lat</b>	46.572505
<b>Long</b>	-122.728657
<b>Direction Photo Taken:</b> <b>W</b>	
<b>Description:</b>  Removed roofing material and tote cages staged at the east-southeast end of the Site.

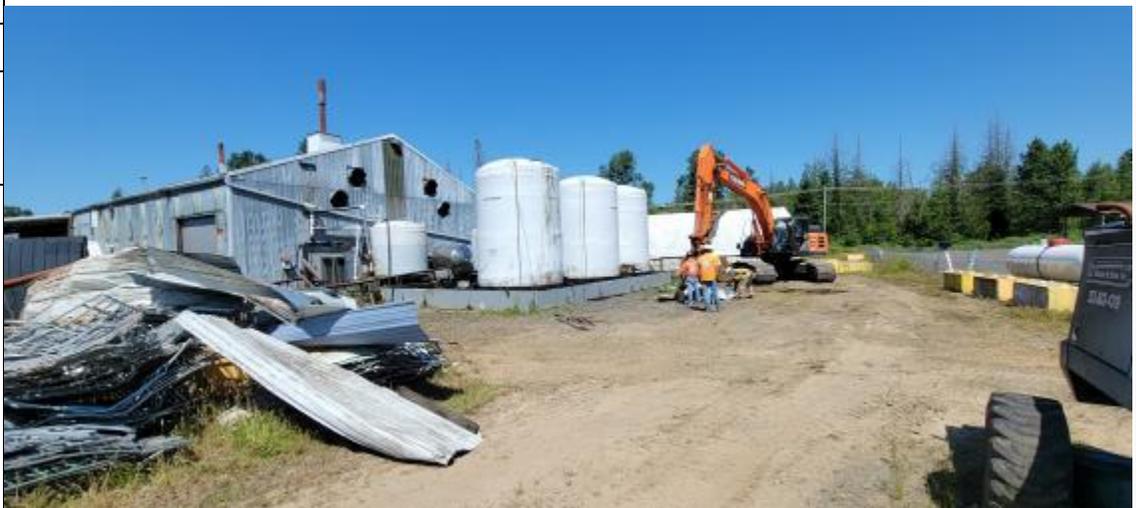
<b>Photo No.</b> <b>122</b>	<b>Date:</b> 06/21/2021
<b>Photo Coordinates</b>	
<b>Lat</b>	46.572505
<b>Long</b>	-122.728657
<b>Direction Photo Taken:</b> <b>N</b>	
<b>Description:</b>  Removed roofing material and tote cages staged at the east-southeast end of the Site.

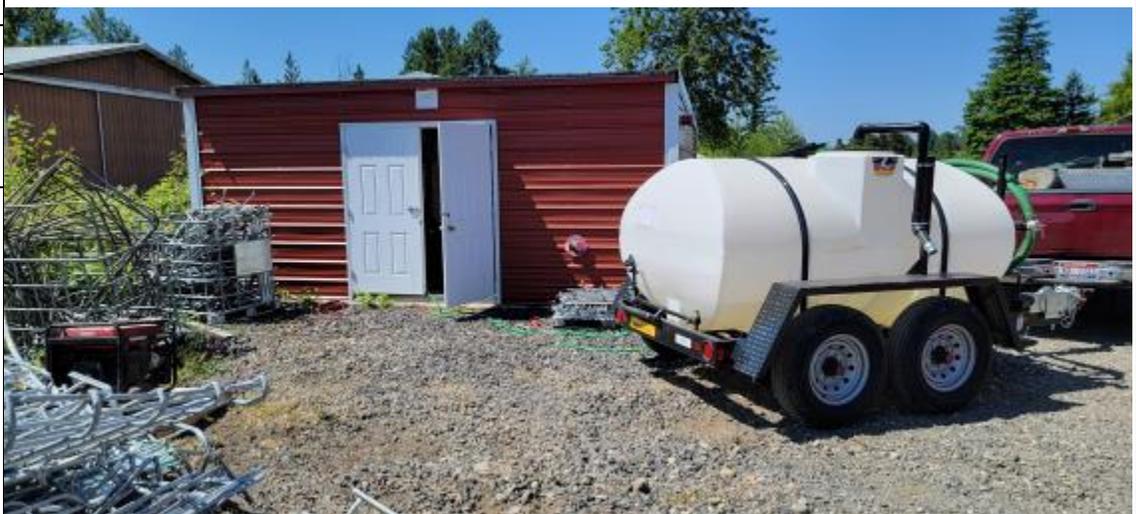
ERRS contractors pumping out water from the Fire Station Pump House into a water buffalo.

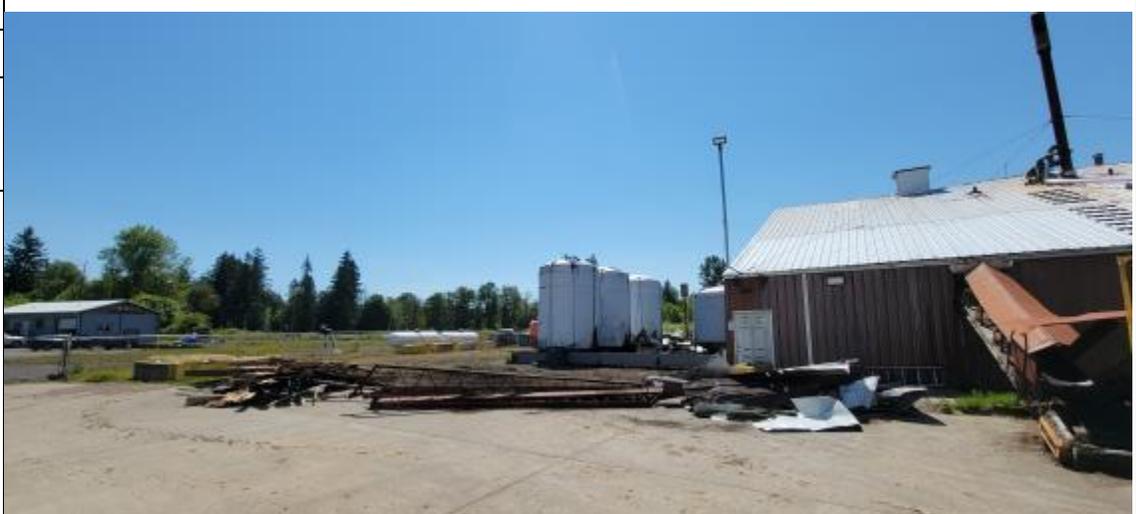
Debris removed from the Secondary Containment Area staged on the concrete area just south of the sawdust storage area.

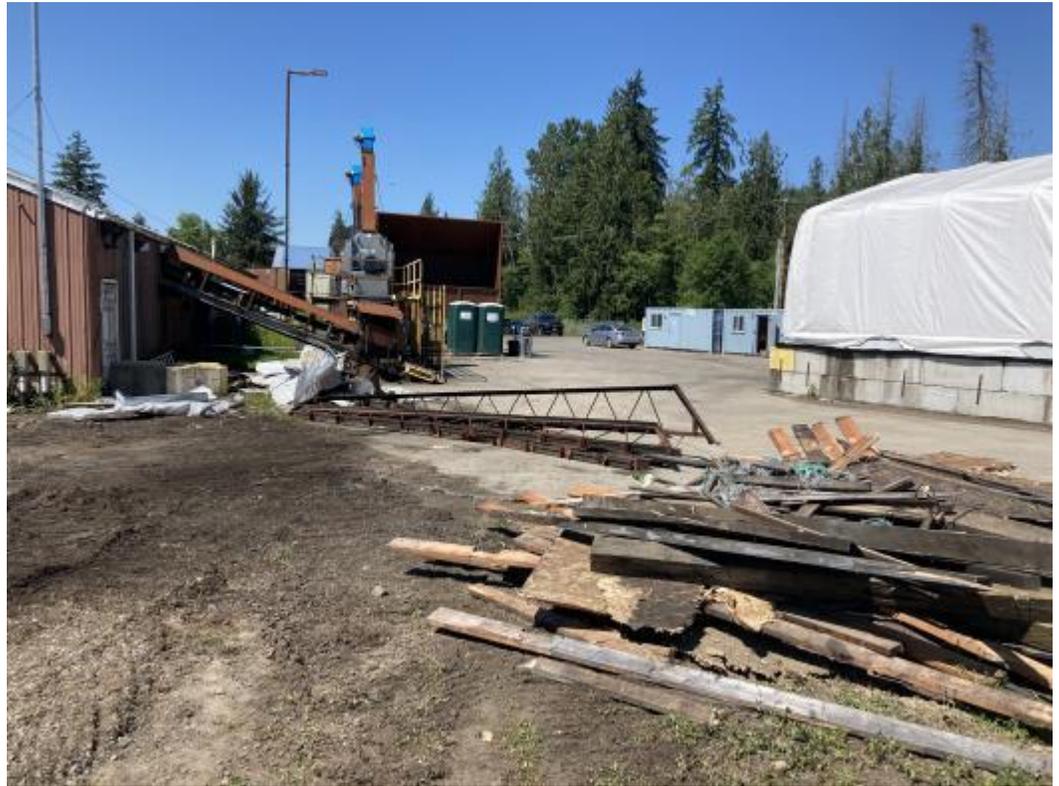
<b>Photo No.</b> <b>125</b>	<b>Date:</b> 06/21/2021
<b>Photo Coordinates</b>	
<b>Lat</b>	46.572678
<b>Long</b>	-122.728644
<b>Direction Photo Taken:</b> <b>SW</b>	
<b>Description:</b>  Debris removed from the Secondary Containment Area staged on the concrete area just south of the Wood Chip Storage Area.

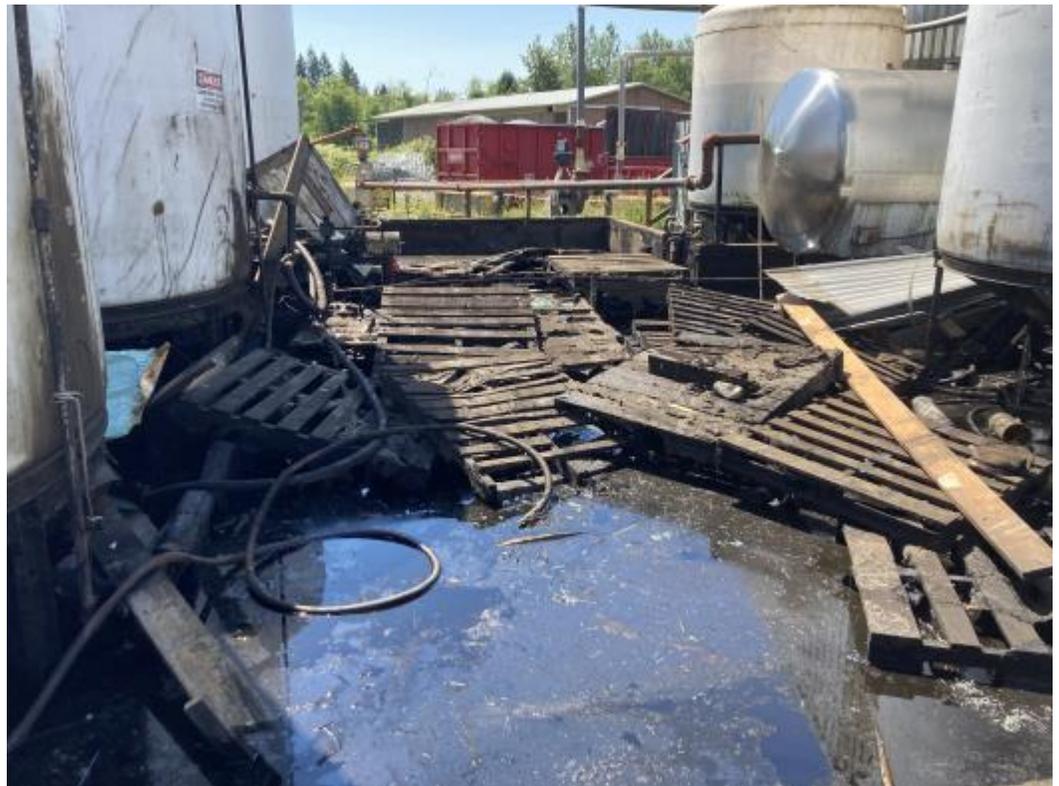
<b>Photo No.</b> <b>126</b>	<b>Date:</b> 06/21/2021
<b>Photo Coordinates</b>	
<b>Lat</b>	46.572569
<b>Long</b>	-122.7287
<b>Direction Photo Taken:</b> <b>S</b>	
<b>Description:</b>  Debris in the Secondary Containment Area.

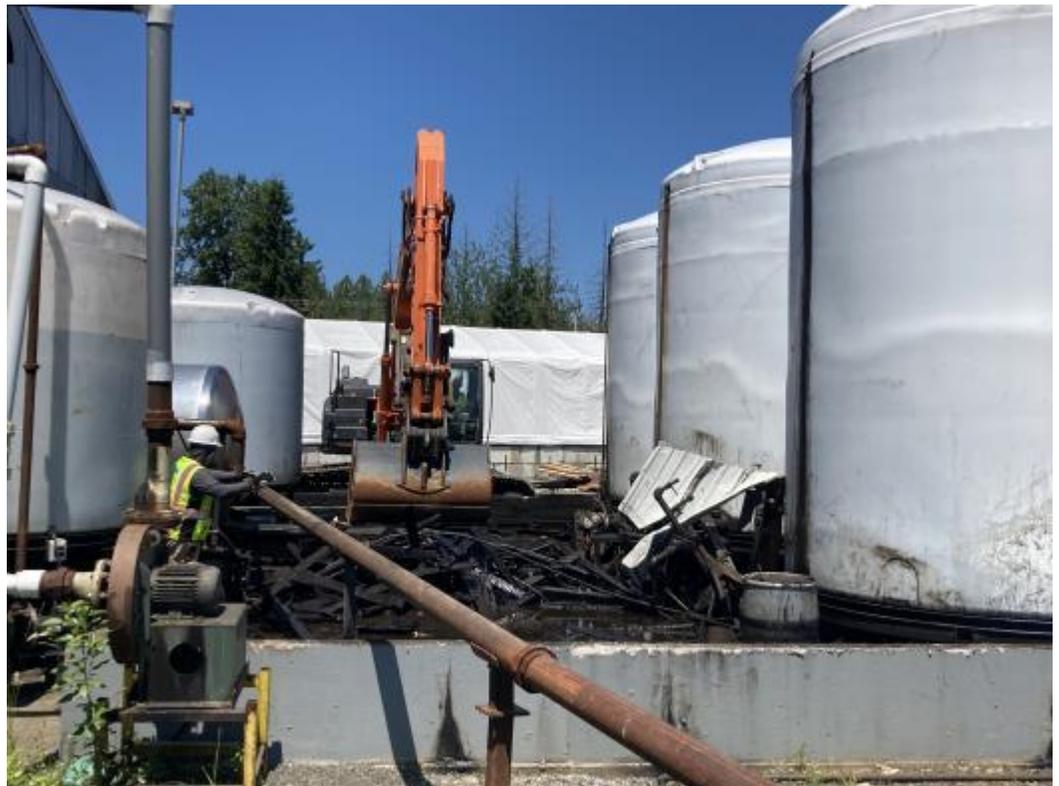
<b>Photo No.</b> <b>128</b>	<b>Date:</b> 06/21/2021
<b>Photo Coordinates</b>	
<b>Lat</b>	46.572464
<b>Long</b>	-122.728522
<b>Direction Photo Taken:</b> <b>N</b>	
<b>Description:</b>  Debris being removed from the Secondary Containment Area.

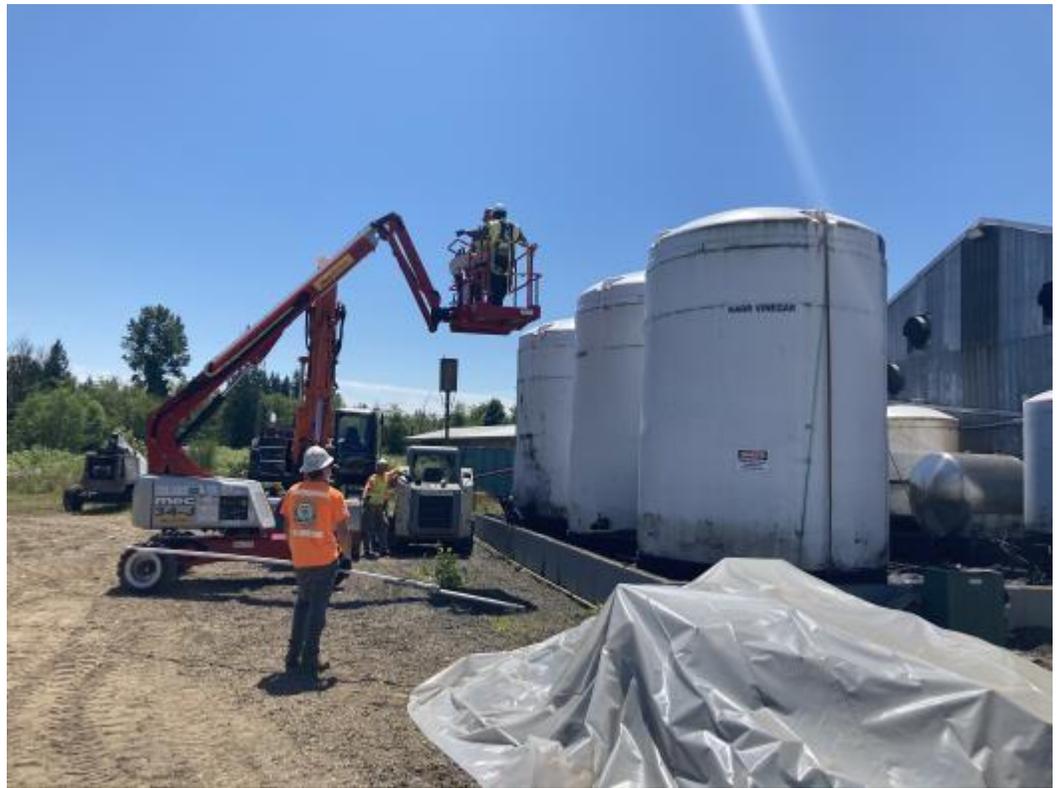
<b>Photo No.</b> <b>129</b>	<b>Date:</b> 06/22/2021
<b>Photo Coordinates</b>	
<b>Lat</b>	46.572636
<b>Long</b>	-122.728722
<b>Direction Photo Taken:</b> <b>S</b>	
<b>Description:</b>  ERRS contractors preparing to determine volume of AST2.

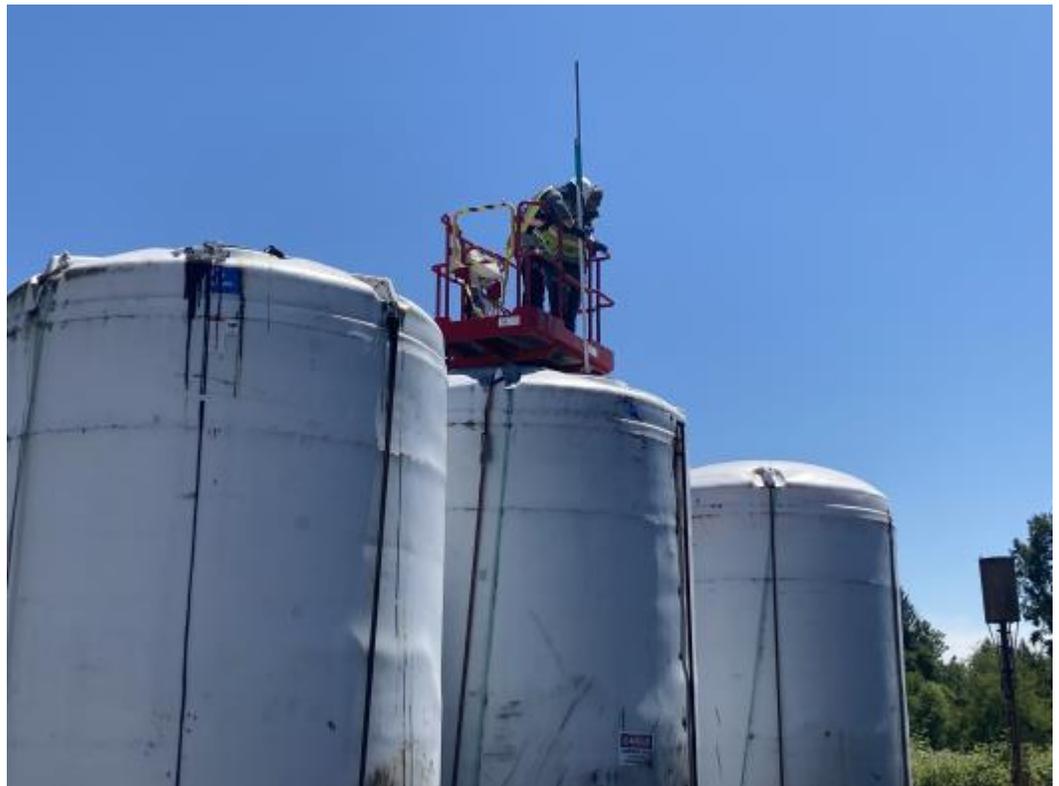
<b>Photo No.</b> <b>130</b>	<b>Date:</b> 06/22/2021
<b>Photo Coordinates</b>	
<b>Lat</b>	46.572589
<b>Long</b>	-122.728836
<b>Direction Photo Taken:</b> <b>SE</b>	
<b>Description:</b>  ERRS contractors determining volume of AST2.

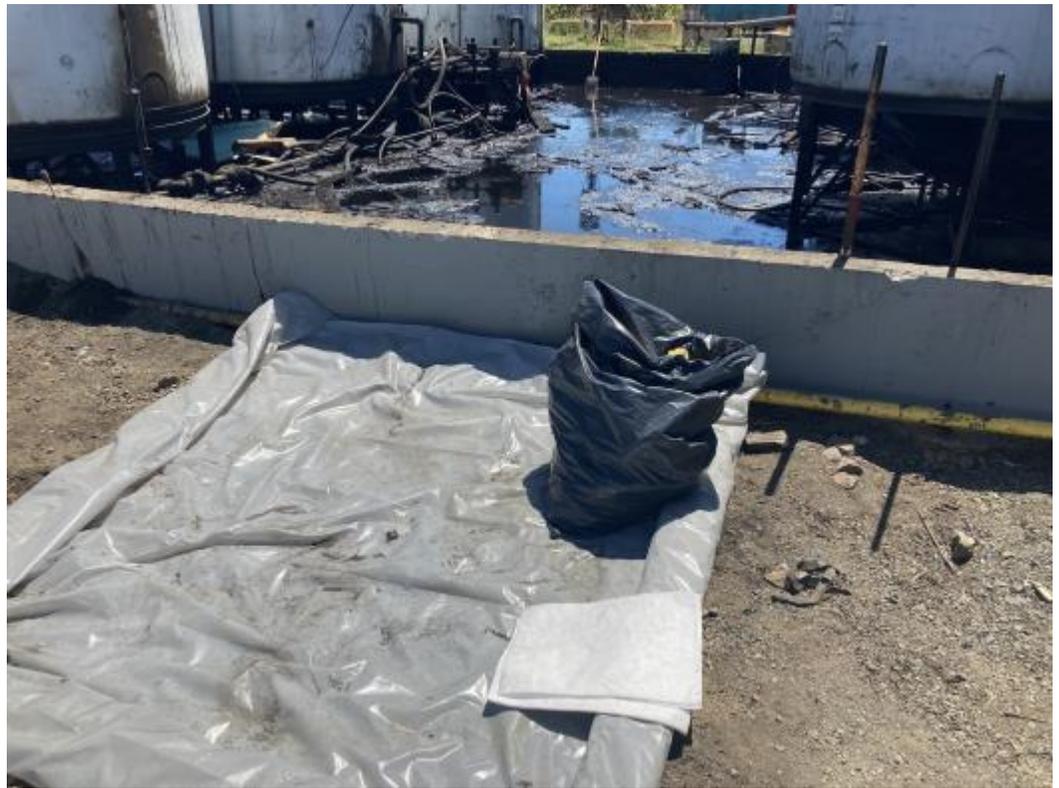
<b>Photo No.</b> <b>131</b>	<b>Date:</b> 06/22/2021
<b>Photo Coordinates</b>	
<b>Lat</b>	46.572619
<b>Long</b>	-122.728736
<b>Direction Photo Taken:</b> <b>SE</b>	
<b>Description:</b>  Temporary staging area for equipment used to determine volume of an AST.

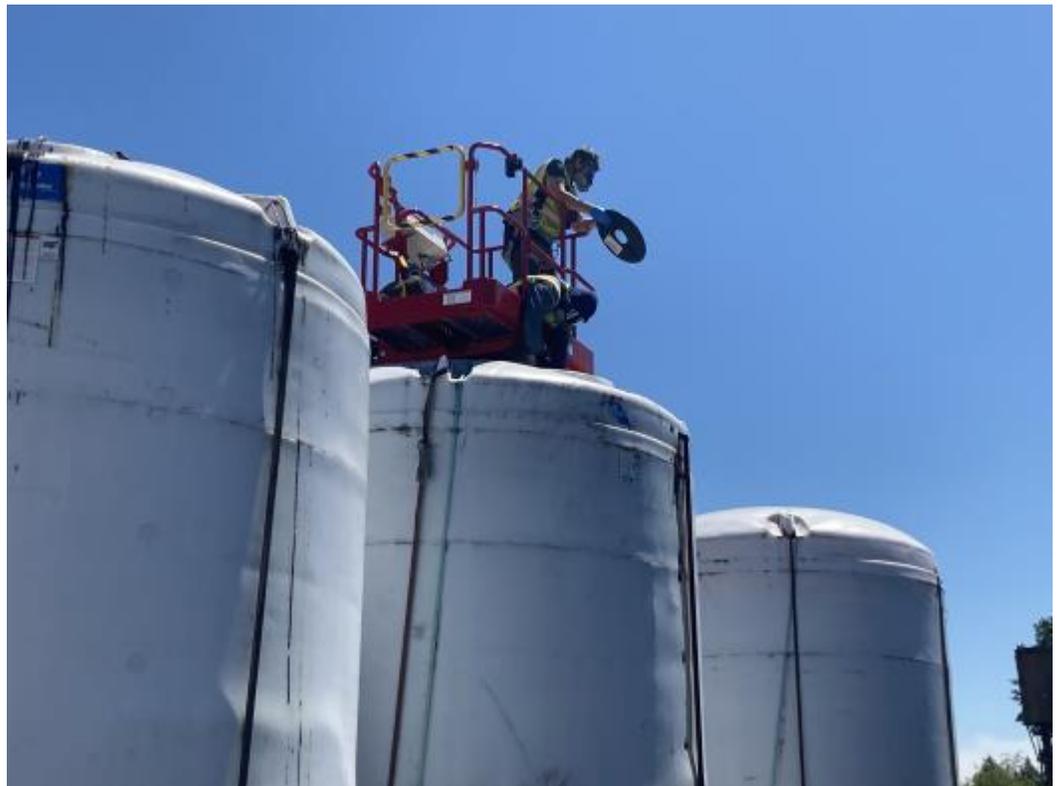
<b>Photo No.</b> <b>132</b>	<b>Date:</b> 06/22/2021
<b>Photo Coordinates</b>	
<b>Lat</b>	46.572586
<b>Long</b>	-122.728722
<b>Direction Photo Taken:</b> <b>SE</b>	
<b>Description:</b>  ERRS contractors determining volume of AST2.

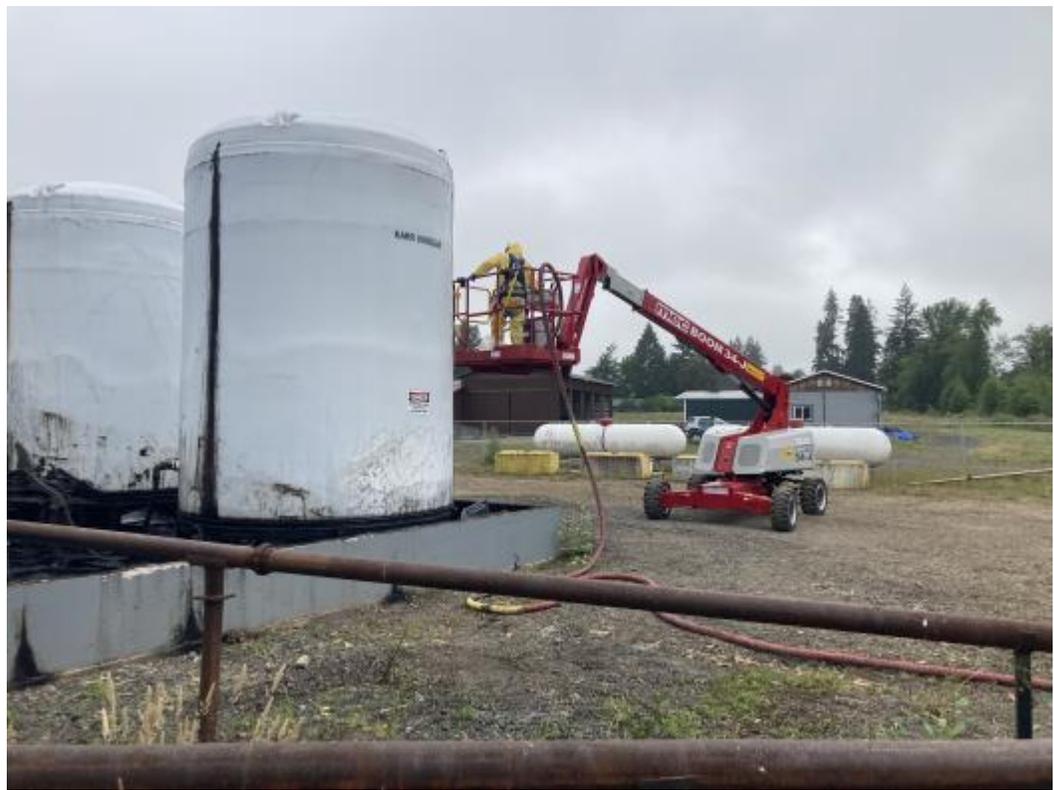
<b>Photo No.</b> <b>133</b>	<b>Date:</b> 06/23/2021
<b>Photo Coordinates</b>	
<b>Lat</b>	46.572436
<b>Long</b>	-122.728669
<b>Direction Photo Taken:</b> <b>N</b>	
<b>Description:</b>  ERRS contractors preparing to transfer wood vinegar from AST1.

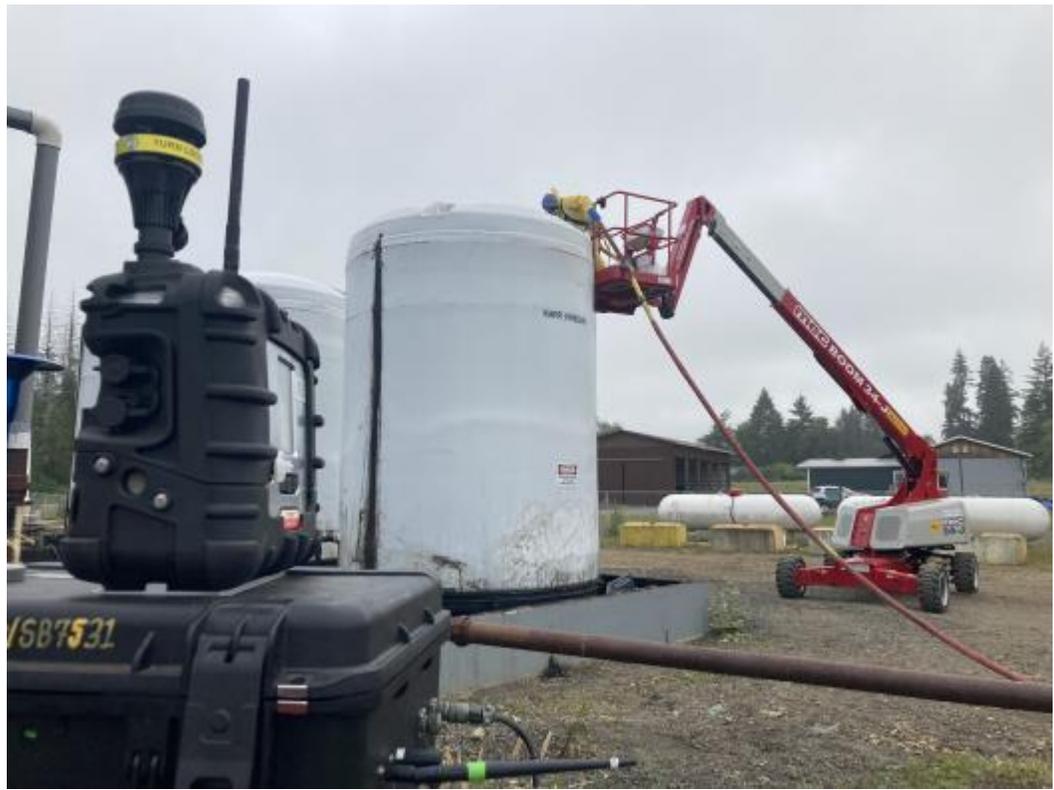
<b>Photo No.</b> <b>134</b>	<b>Date:</b> 06/23/2021
<b>Photo Coordinates</b>	
<b>Lat</b>	46.572411
<b>Long</b>	-122.728692
<b>Direction Photo Taken:</b> <b>N</b>	
<b>Description:</b>  ERRS contractors transferring wood vinegar from AST1.

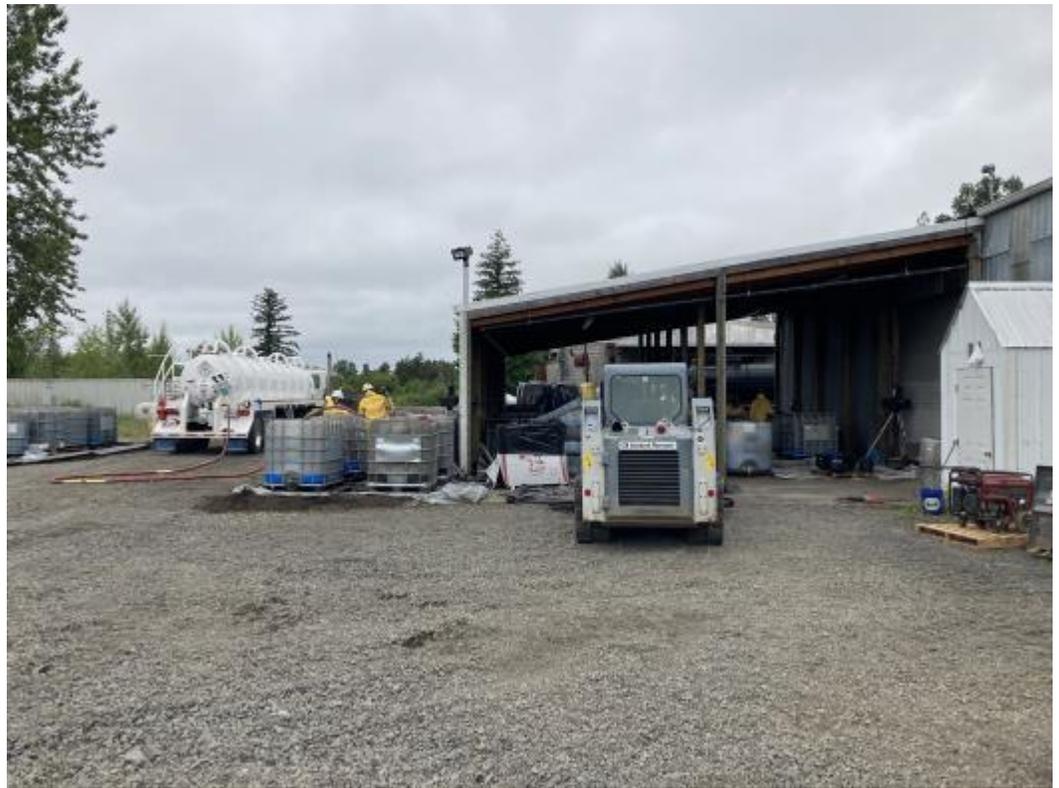
<b>Photo No.</b> <b>135</b>	<b>Date:</b> 06/23/2021
<b>Photo Coordinates</b>	
<b>Lat</b>	46.57235
<b>Long</b>	-122.728714
<b>Direction Photo Taken:</b> <b>SW</b>	
<b>Description:</b>  ERRS contractors conducting waste transfer activities at the tote staging area.

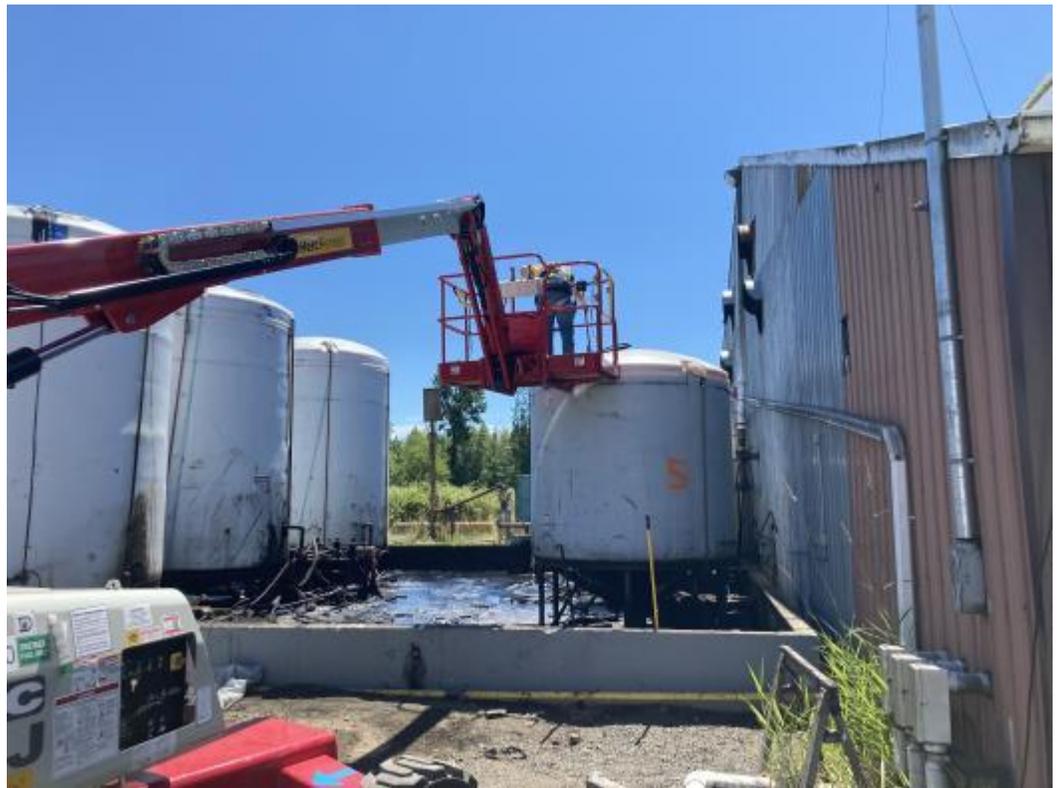
<b>Photo No.</b> <b>136</b>	<b>Date:</b> 06/23/2021
<b>Photo Coordinates</b>	
<b>Lat</b>	46.572617
<b>Long</b>	-122.728792
<b>Direction Photo Taken:</b> <b>S</b>	
<b>Description:</b>  ERRS contractors determining volume of AST5.

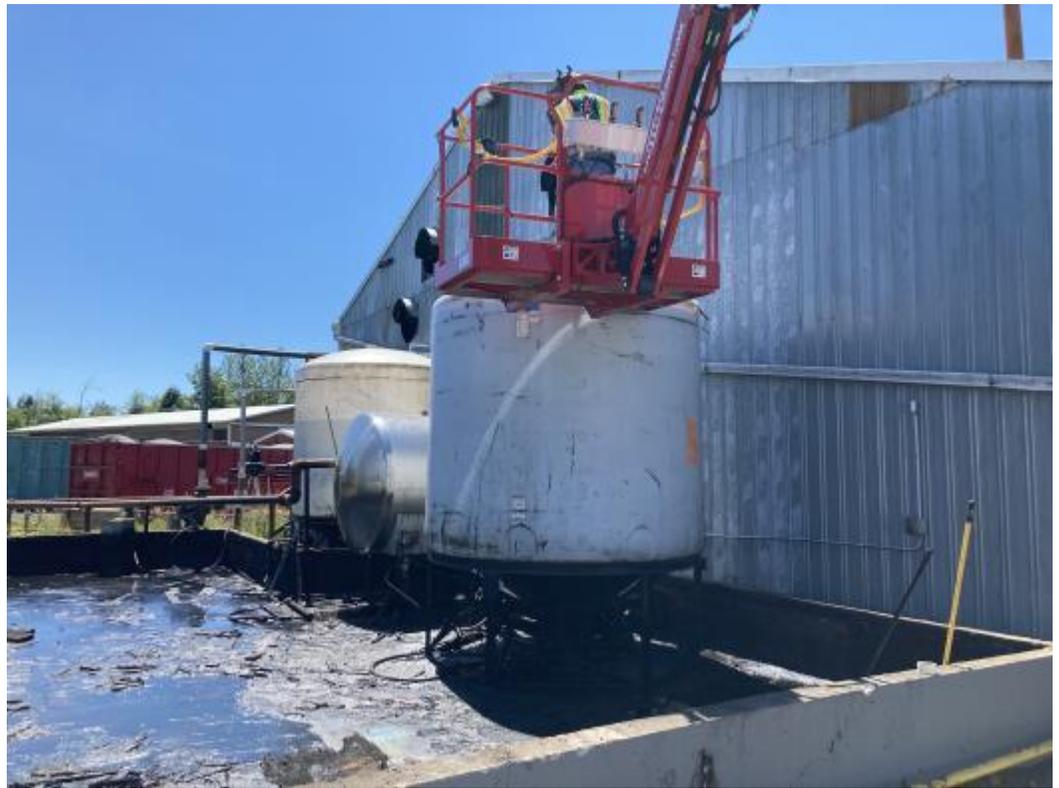
<b>Photo No.</b> <b>137</b>	<b>Date:</b> 06/23/2021
<b>Photo Coordinates</b>	
<b>Lat</b>	46.572533
<b>Long</b>	-122.728844
<b>Direction Photo Taken:</b> <b>S</b>	
<b>Description:</b>  ERRS contractors determining volume of AST5.

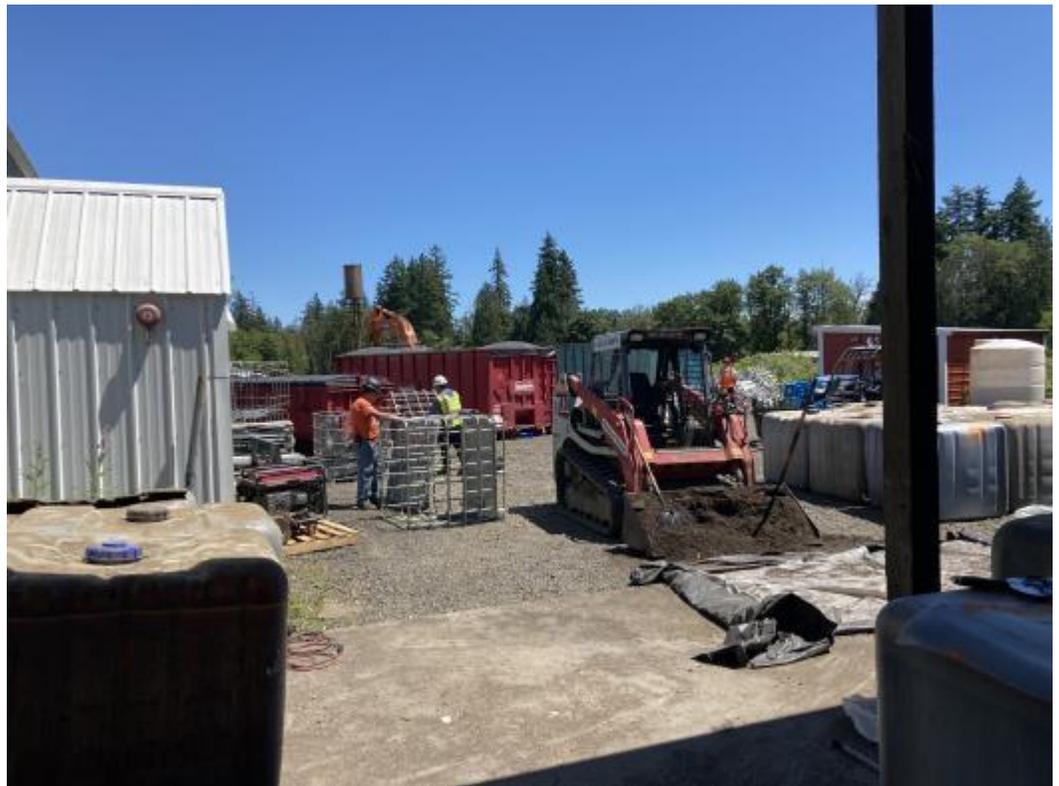
<b>Photo No.</b> <b>138</b>	<b>Date:</b> 06/23/2021
<b>Photo Coordinates</b>	
<b>Lat</b>	46.572261
<b>Long</b>	-122.729072
<b>Direction Photo Taken:</b> <b>E</b>	
<b>Description:</b>  ERRS contractors cutting up empty totes and deconstructing tote cages.

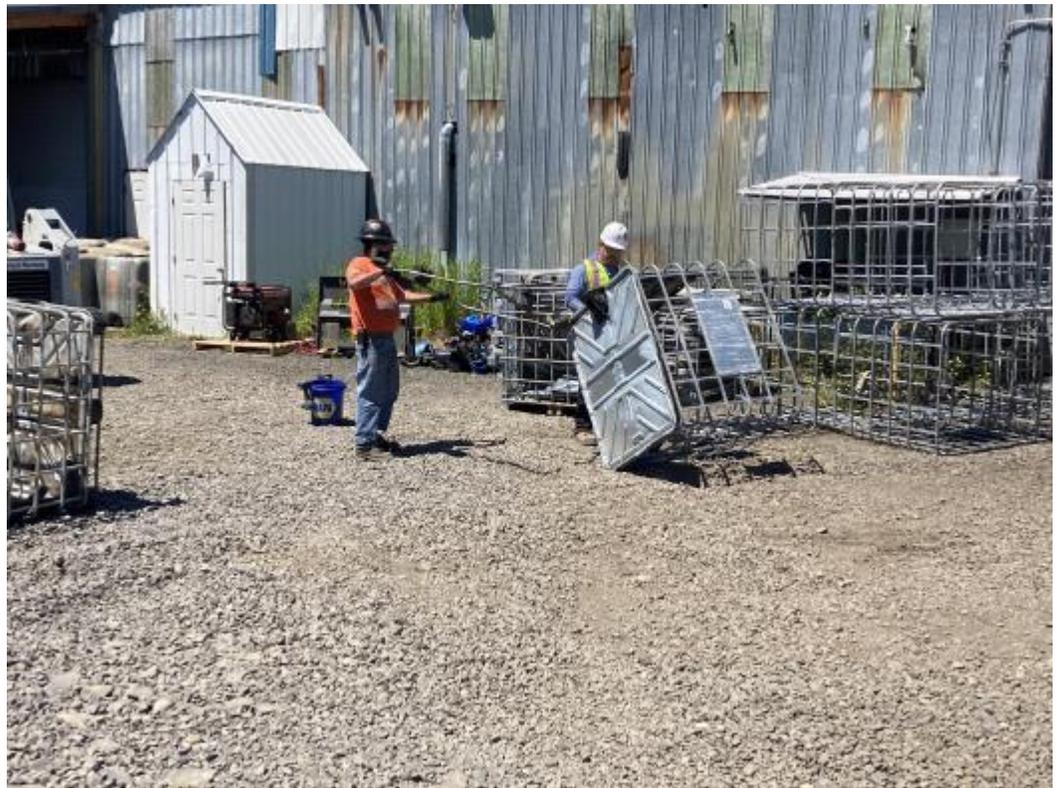
<b>Photo No.</b> <b>139</b>	<b>Date:</b> 06/23/2021
<b>Photo Coordinates</b>	
<b>Lat</b>	46.572261
<b>Long</b>	-122.728622
<b>Direction Photo Taken:</b> <b>NW</b>	
<b>Description:</b>  ERRS contractors deconstructing tote cages.

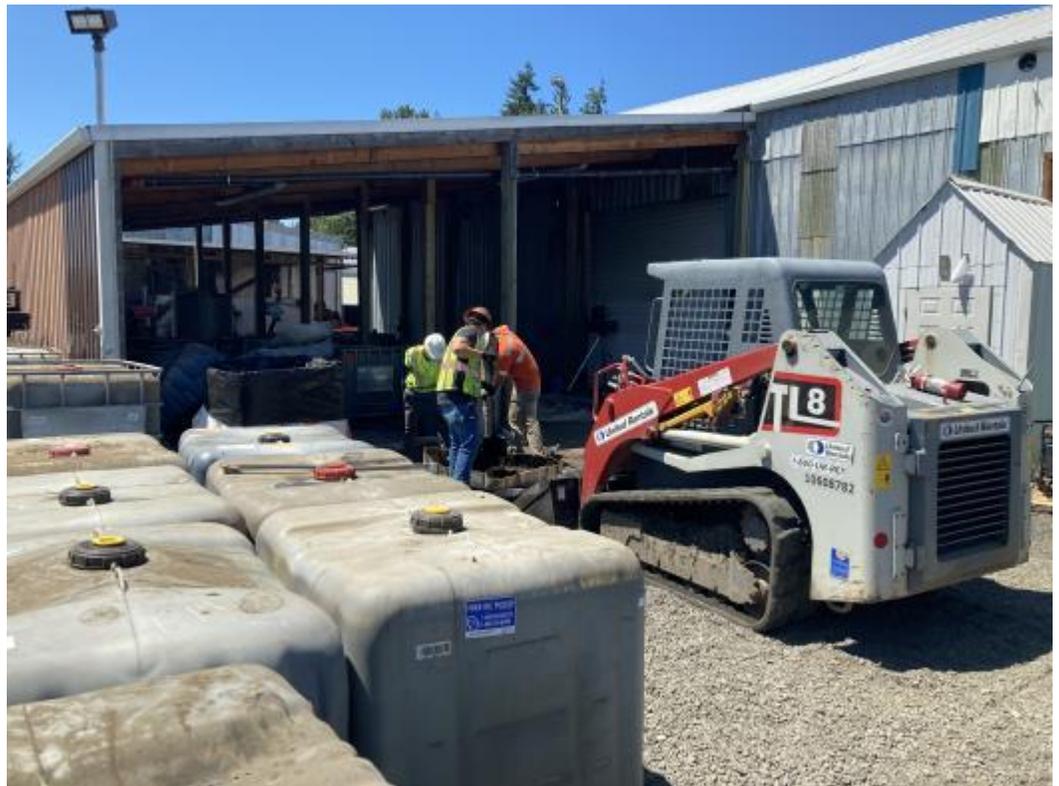
<b>Photo No.</b> <b>140</b>	<b>Date:</b> 06/23/2021
<b>Photo Coordinates</b>	
<b>Lat</b>	46.572361
<b>Long</b>	-122.728661
<b>Direction Photo Taken:</b> <b>NW</b>	
<b>Description:</b>  ERRS contractors scraping the bottom panel of a cut up tote.

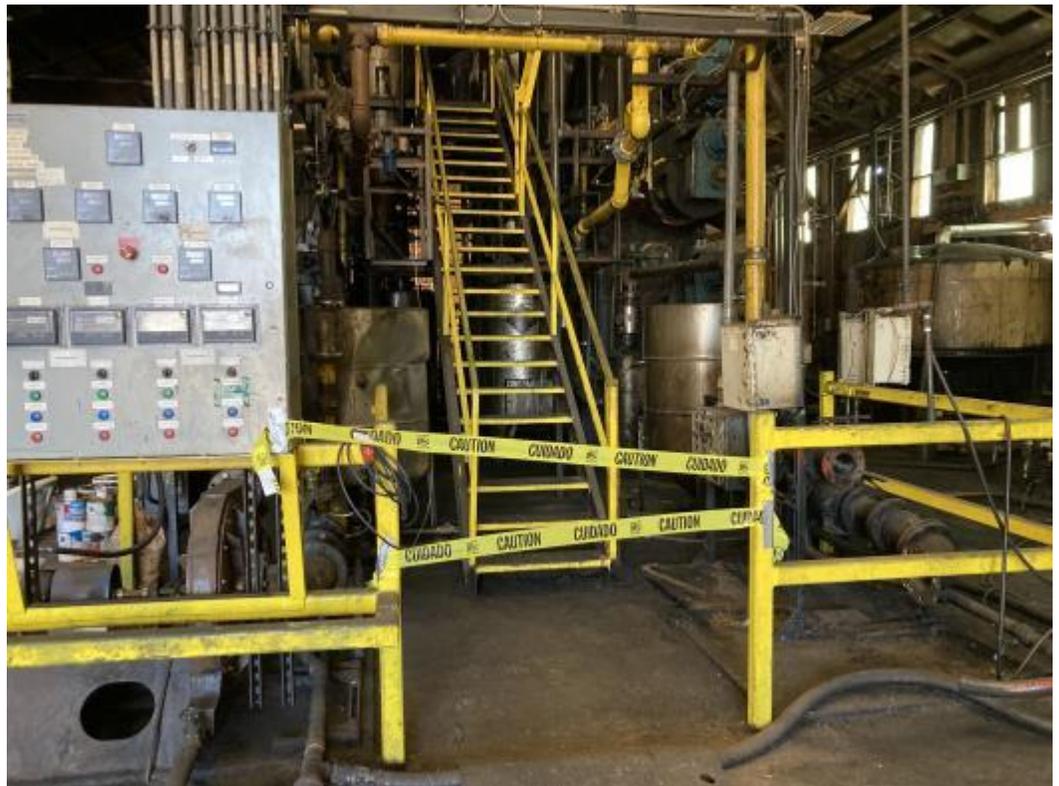
<b>Photo No.</b> <b>142</b>	<b>Date:</b> 06/23/2021
<b>Photo Coordinates</b>	
<b>Lat</b>	46.561347
<b>Long</b>	-122.692131
<b>Direction Photo Taken:</b> <b>E</b>	
<b>Description:</b>  Entrance to processing equipment in the Pyrolysis Building taped off to block access.

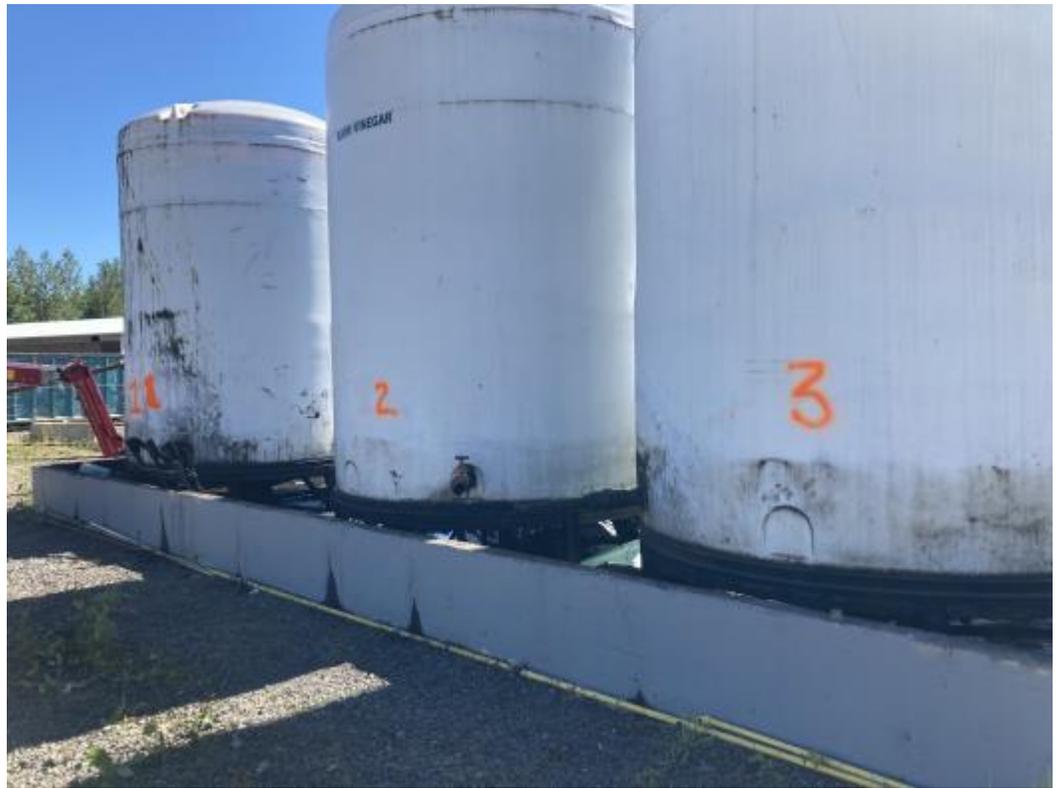
<b>Photo No.</b> <b>143</b>	<b>Date:</b> 06/23/2021
<b>Photo Coordinates</b>	
<b>Lat</b>	46.572783
<b>Long</b>	-122.728508
<b>Direction Photo Taken:</b> <b>SW</b>	
<b>Description:</b>  ASTs in the Secondary Containment that have been marked for inventory.

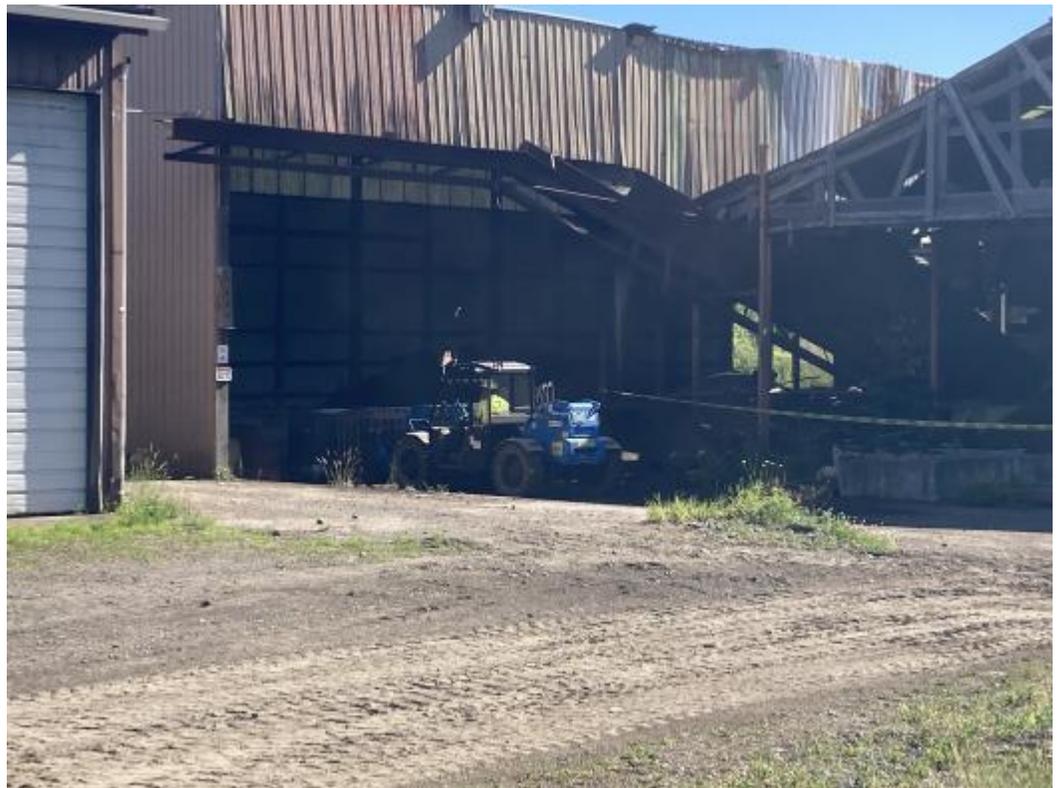
<b>Photo No.</b> <b>144</b>	<b>Date:</b> 06/23/2021
<b>Photo Coordinates</b>	
<b>Lat</b>	46.572467
<b>Long</b>	-122.729514
<b>Direction Photo Taken:</b> <b>SW</b>	
<b>Description:</b>  ERRS contractor moving a tote from the South Warehouse TG02 Tote Area.

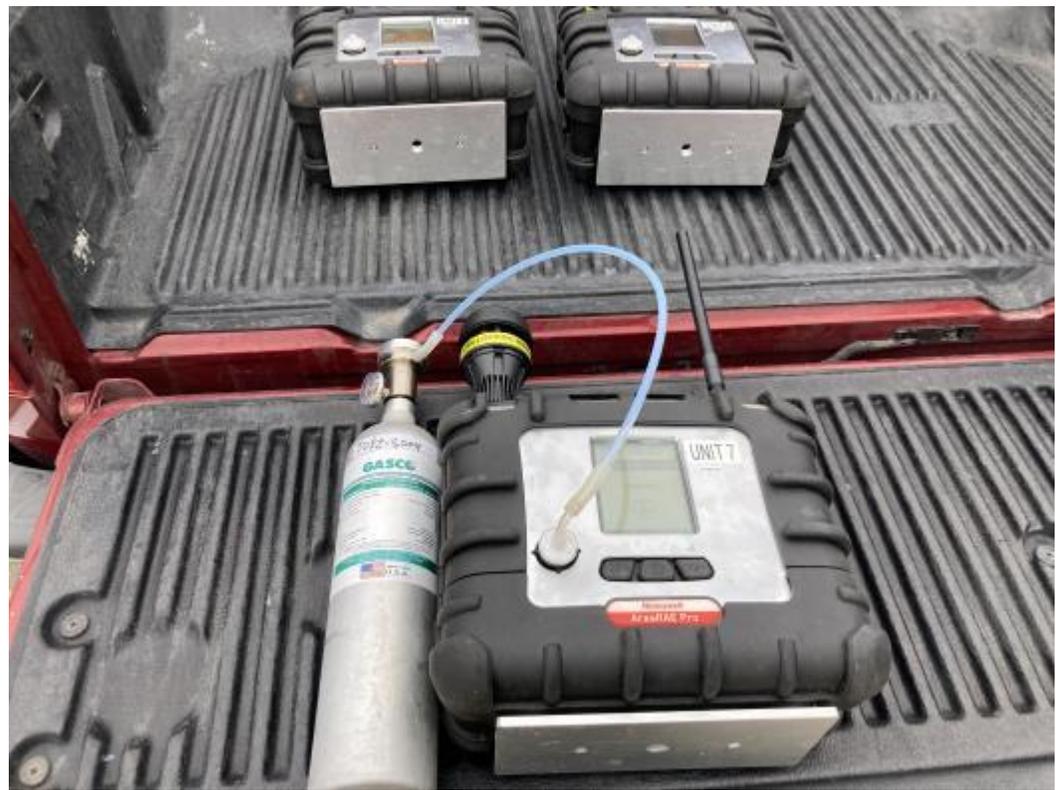
<b>Photo No.</b> <b>145</b>	<b>Date:</b> 06/24/2021
<b>Photo Coordinates</b>	
<b>Lat</b>	46.598594
<b>Long</b>	-122.759231
<b>Direction Photo Taken:</b> <b>W</b>	
<b>Description:</b>  START contractor calibrating air monitoring instrument.

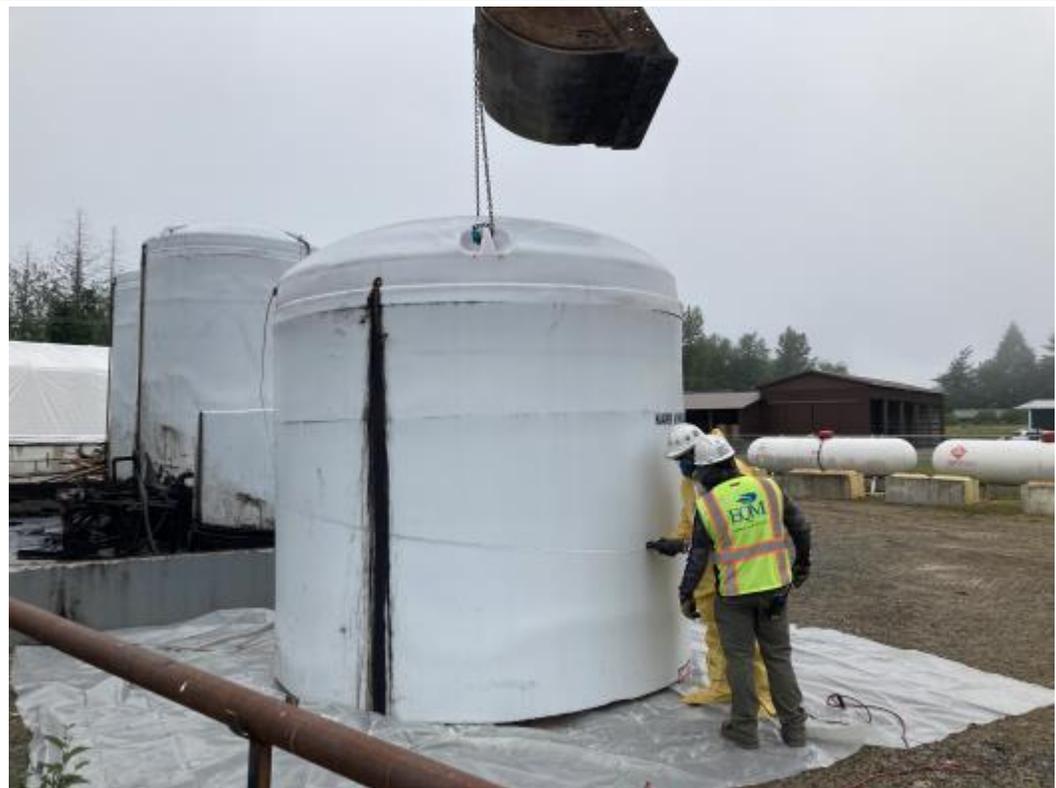
<b>Photo No.</b> <b>147</b>	<b>Date:</b> 06/24/2021
<b>Photo Coordinates</b>	
<b>Lat</b>	46.572414
<b>Long</b>	-122.728736
<b>Direction Photo Taken:</b> <b>NE</b>	
<b>Description:</b>  Middle section of AST1 is being cut up by an ERRS contractor. The top section is being raised back over the remaining AST1 to cover.

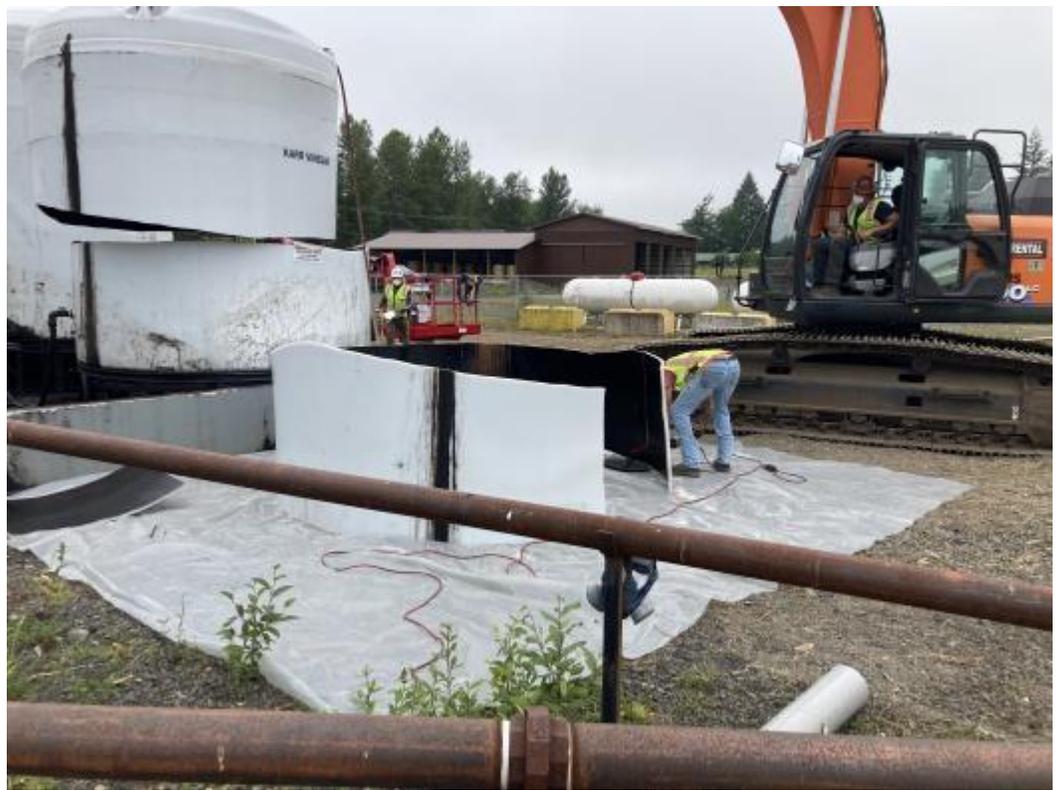
<b>Photo No.</b> <b>148</b>	<b>Date:</b> 06/24/2021
<b>Photo Coordinates</b>	
<b>Lat</b>	46.572503
<b>Long</b>	-122.728447
<b>Direction Photo Taken:</b> <b>W</b>	
<b>Description:</b>  Top of AST1 being removed to have another middle section cut off.

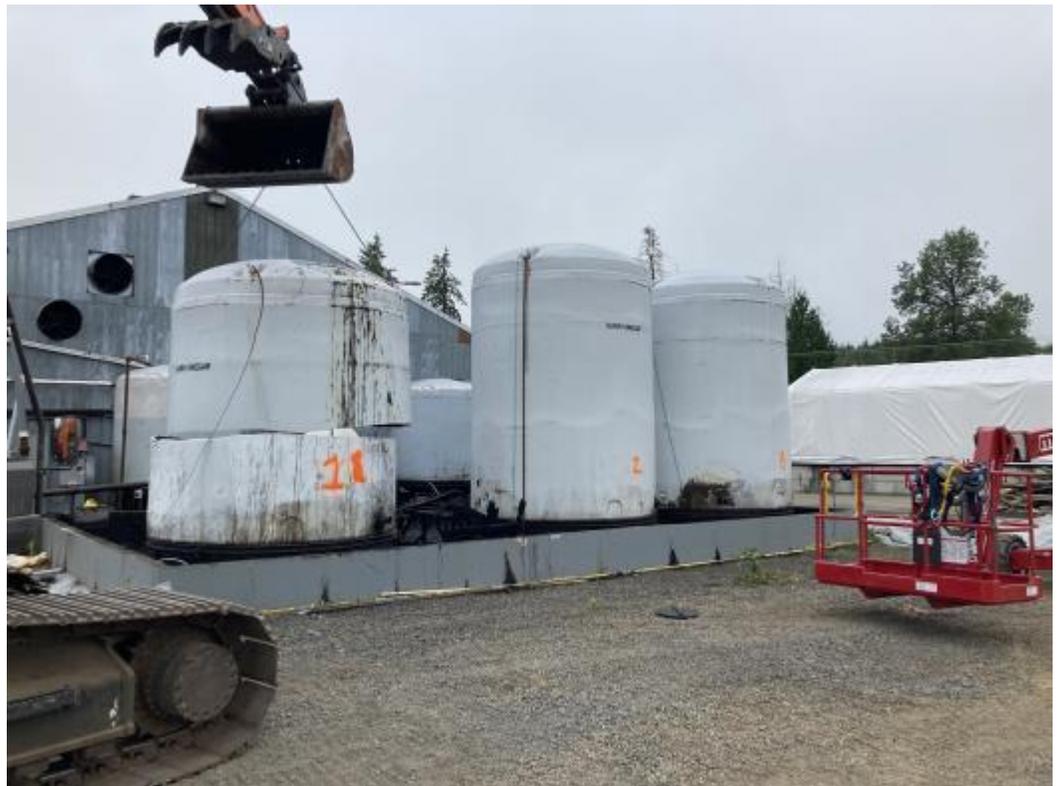
<b>Photo No.</b> <b>149</b>	<b>Date:</b> 06/24/2021
<b>Photo Coordinates</b>	
<b>Lat</b>	46.572308
<b>Long</b>	-122.728522
<b>Direction Photo Taken:</b> <b>NE</b>	
<b>Description:</b>  The top section is being raised back over the remaining AST1 to cover.
