# **TIME-CRITICAL REMOVAL ACTION REPORT**

*Onalaska Wood Pyrolysis  
Onalaska, Lewis County, Washington*

Prepared by:

December 2021

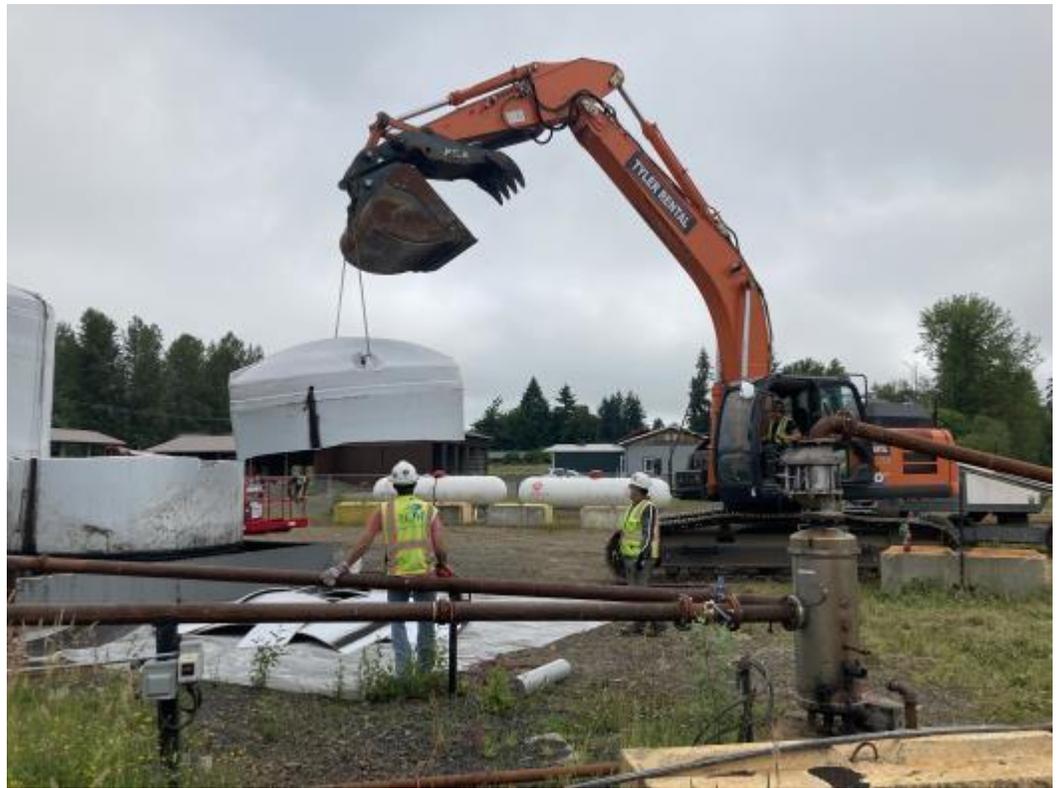
<b>Photo No.</b> <b>150</b>	<b>Date:</b> 06/24/2021
<b>Photo Coordinates</b>	
<b>Lat</b>	46.572406
<b>Long</b>	-122.728706
<b>Direction Photo Taken:</b> <b>N</b>	
<b>Description:</b>  Middle section of AST1 is being cut up by ERRS contractors.

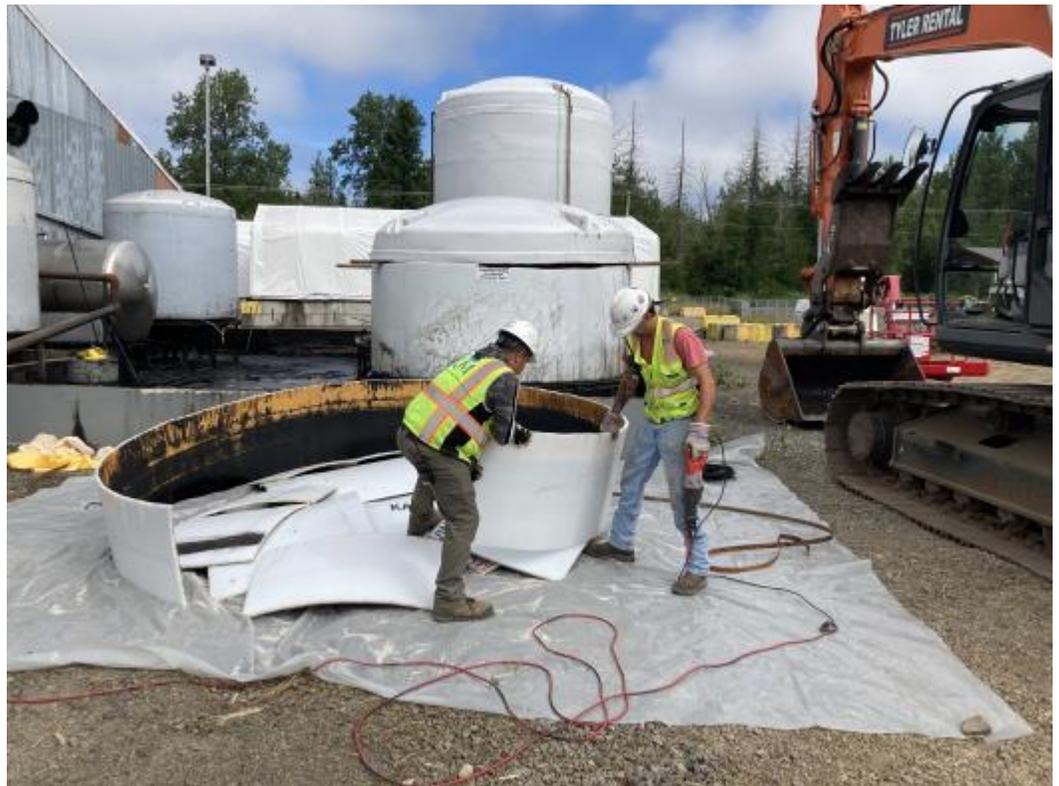
<b>Photo No.</b> <b>151</b>	<b>Date:</b> 06/24/2021
<b>Photo Coordinates</b>	
<b>Lat</b>	46.572636
<b>Long</b>	-122.728561
<b>Direction Photo Taken:</b> <b>SW</b>	
<b>Description:</b>  ERRS contractors preparing to cut up AST2.

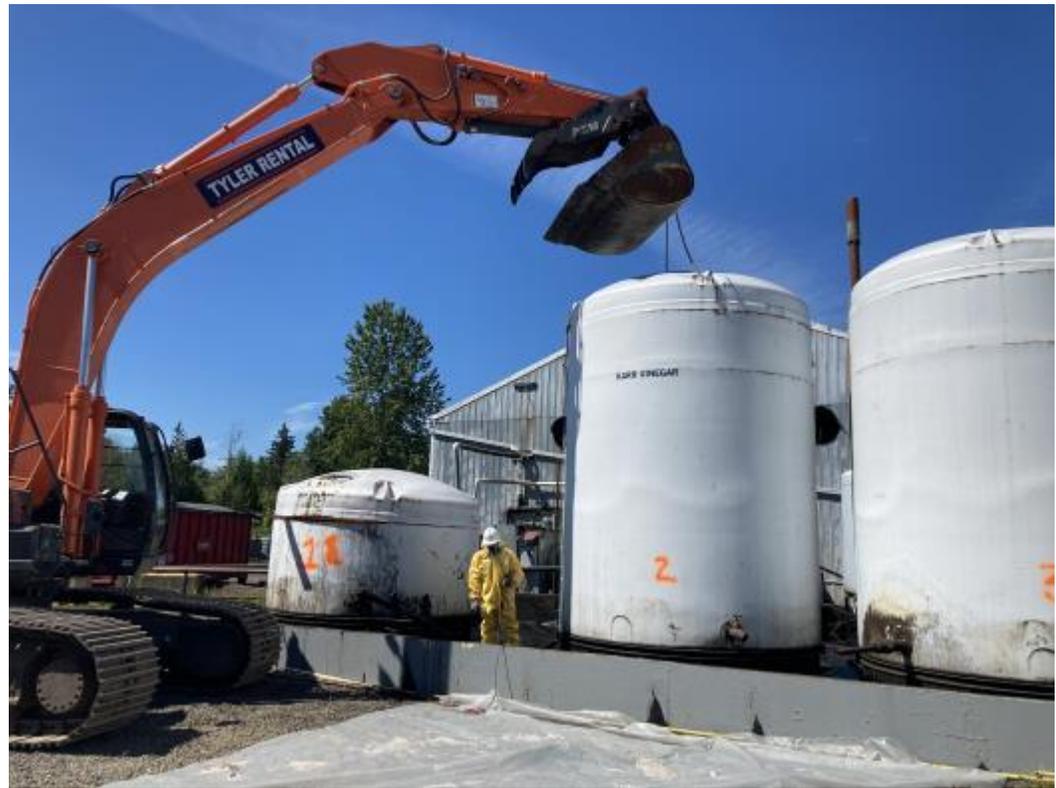
<b>Photo No.</b> <b>152</b>	<b>Date:</b> 06/24/2021
<b>Photo Coordinates</b>	
<b>Lat</b>	46.572675
<b>Long</b>	-122.728317
<b>Direction Photo Taken:</b> <b>W</b>	
<b>Description:</b>  Top of AST2 being removed to have middle section cut off.

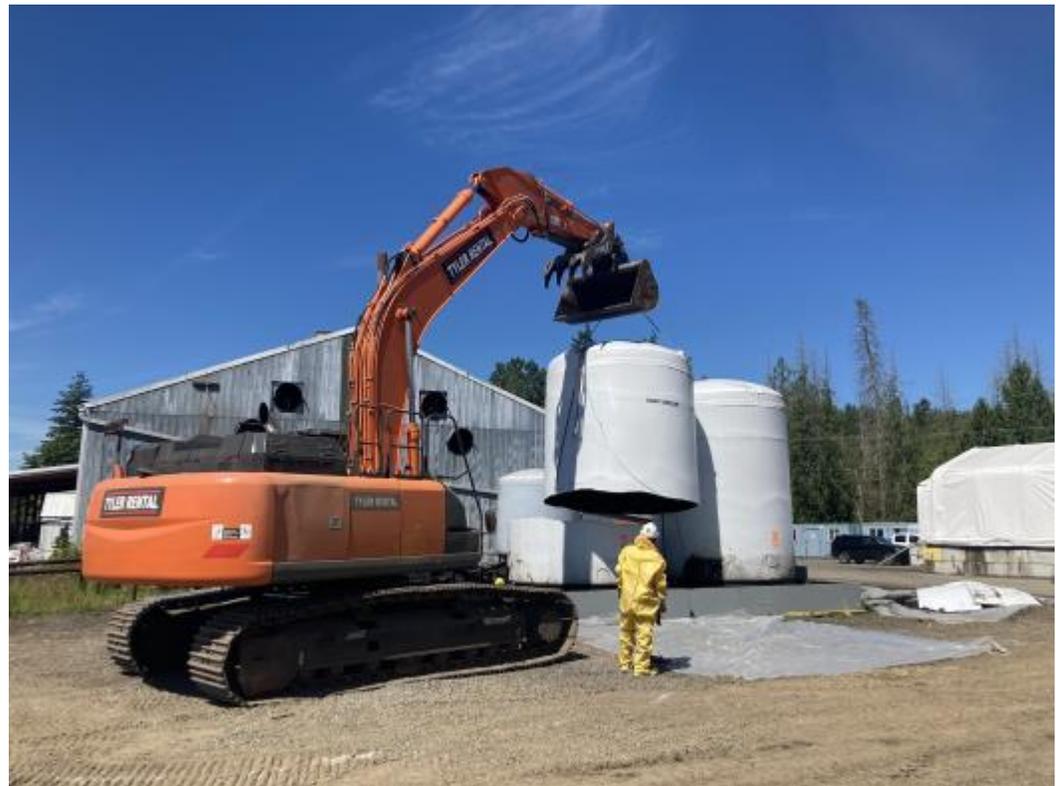
<b>Photo No.</b> <b>153</b>	<b>Date:</b> 06/24/2021
<b>Photo Coordinates</b>	
<b>Lat</b>	46.572583
<b>Long</b>	-122.728806
<b>Direction Photo Taken:</b> <b>SE</b>	
<b>Description:</b>  AST1 and AST2 remain covered with middle sections removed. AST3 and AST5 have not undergone demolition.

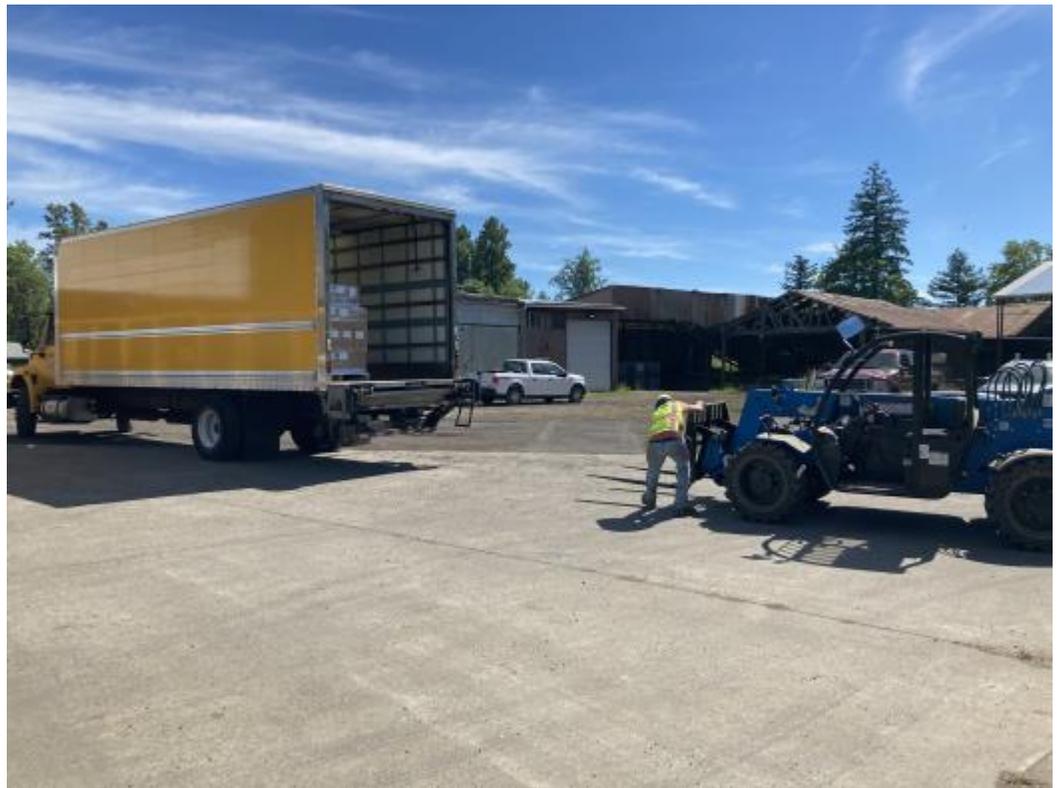
<b>Photo No.</b> <b>155</b>	<b>Date:</b> 06/24/2021
<b>Photo Coordinates</b>	
<b>Lat</b>	46.572628
<b>Long</b>	-122.729242
<b>Direction Photo Taken:</b> <b>SW</b>	
<b>Description:</b>  ERRS contractors moving totes from South Warehouse TG02 Tote Area.

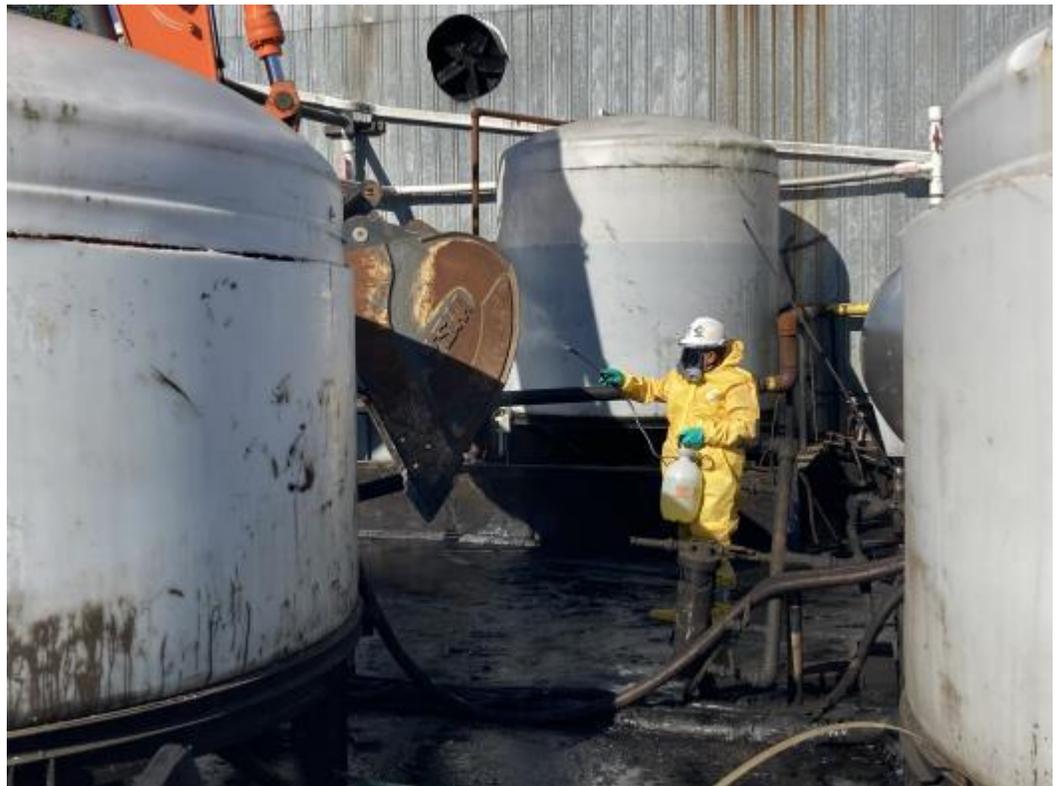
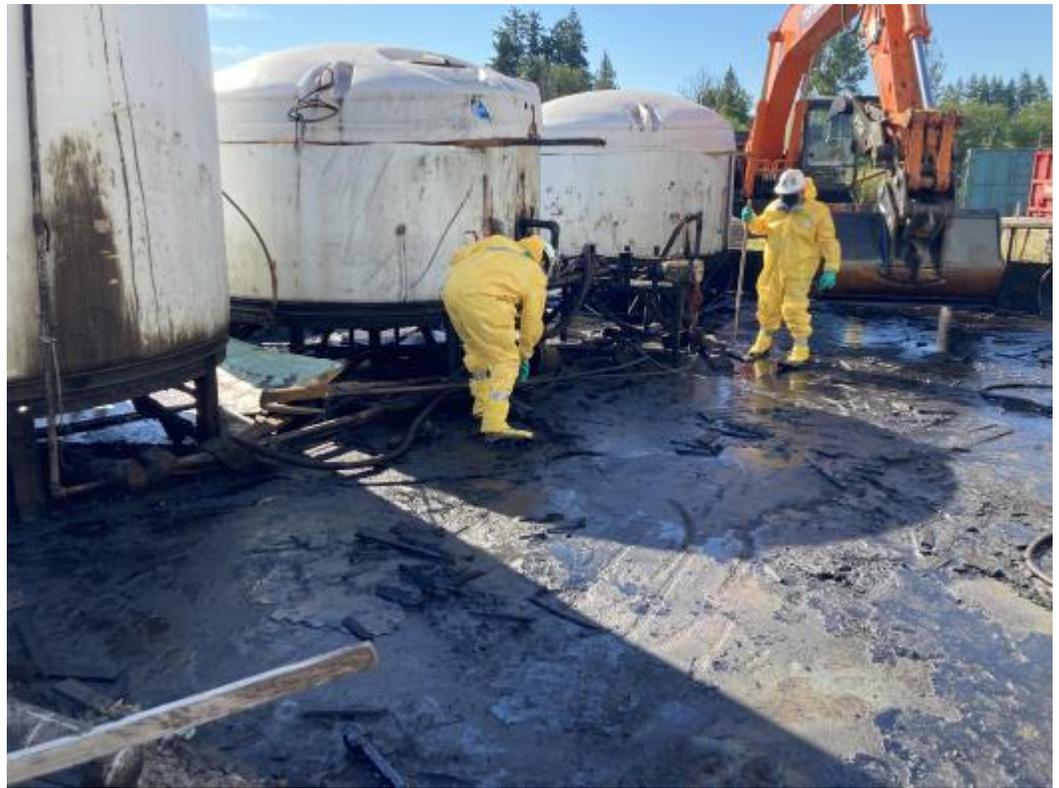
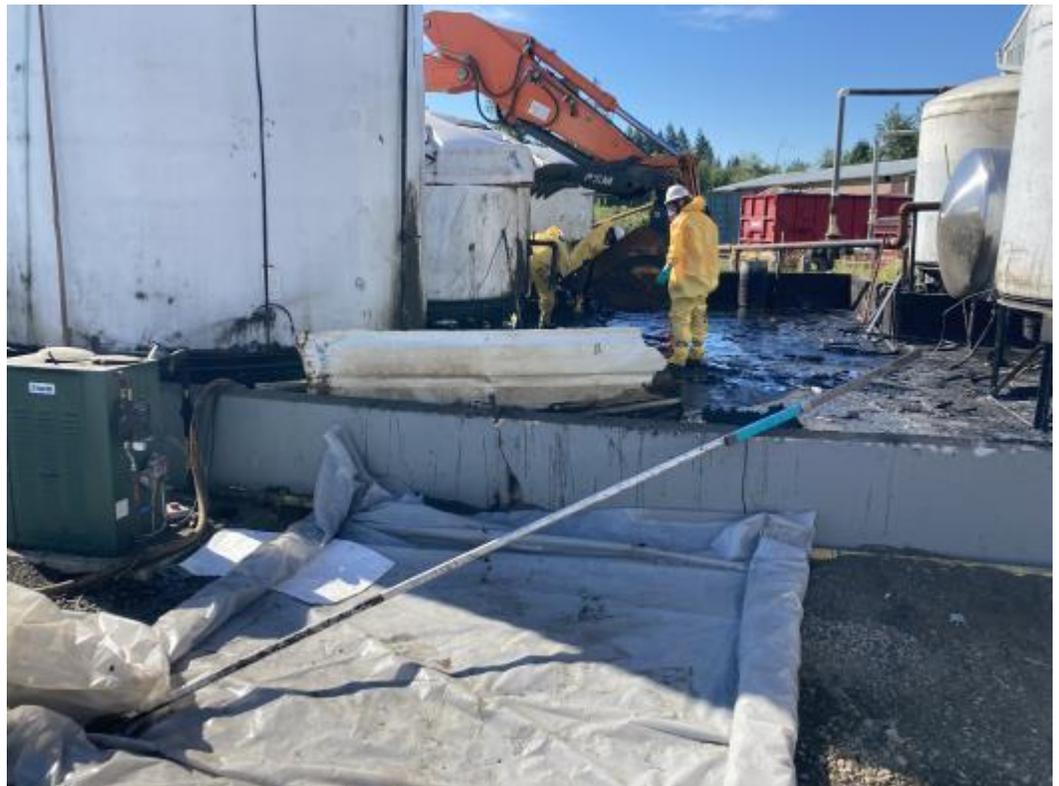
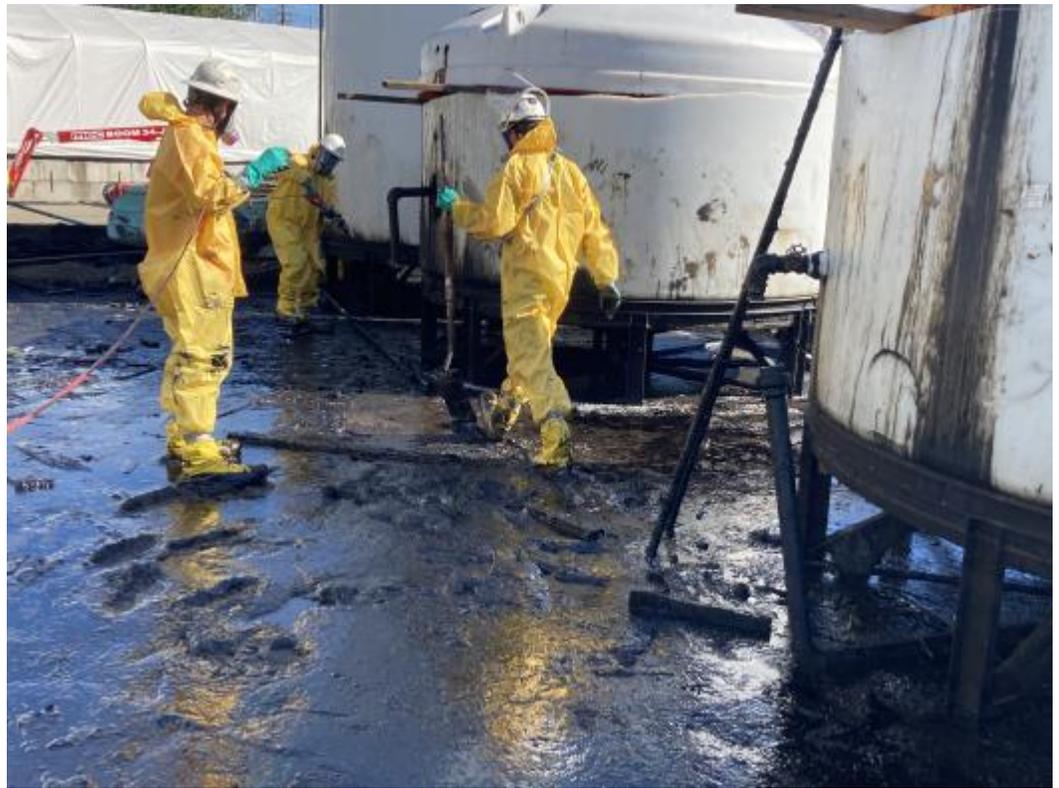
<b>Photo No.</b> <b>157</b>	<b>Date:</b> 06/25/2021
<b>Photo Coordinates</b>	
<b>Lat</b>	46.572578
<b>Long</b>	-122.728775
<b>Direction Photo Taken:</b> <b>SE</b>	
<b>Description:</b>  ERRS contractors removing debris from under AST platforms.

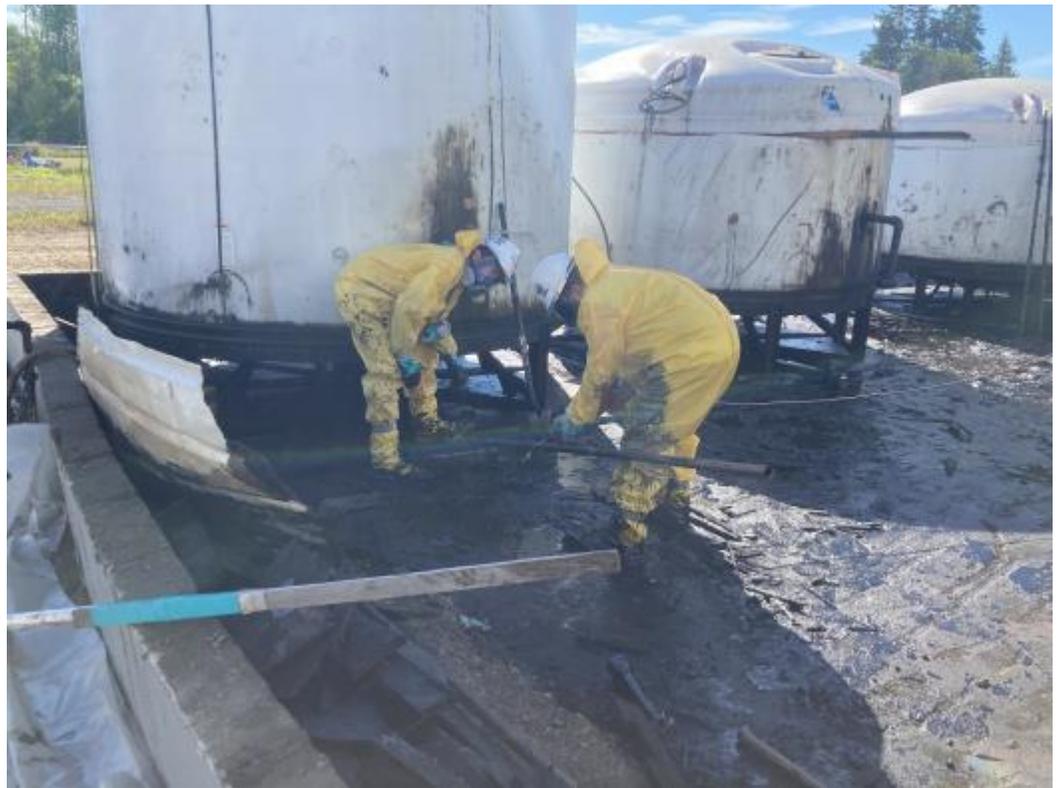
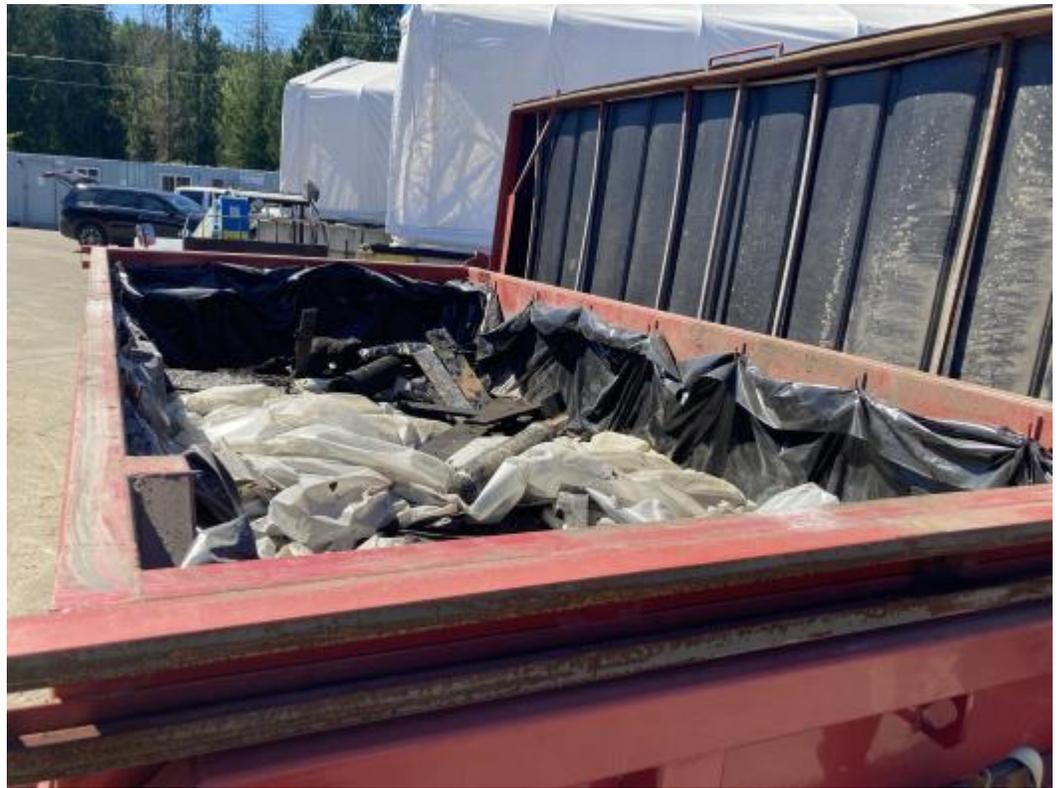
<b>Photo No.</b> <b>161</b>	<b>Date:</b> 06/25/2021
<b>Photo Coordinates</b>	
<b>Lat</b>	46.572578
<b>Long</b>	-122.728942
<b>Direction Photo Taken:</b> <b>SE</b>	
<b>Description:</b>  ERRS contractors mixing solidification material in with sludge left in the Secondary Containment Area.

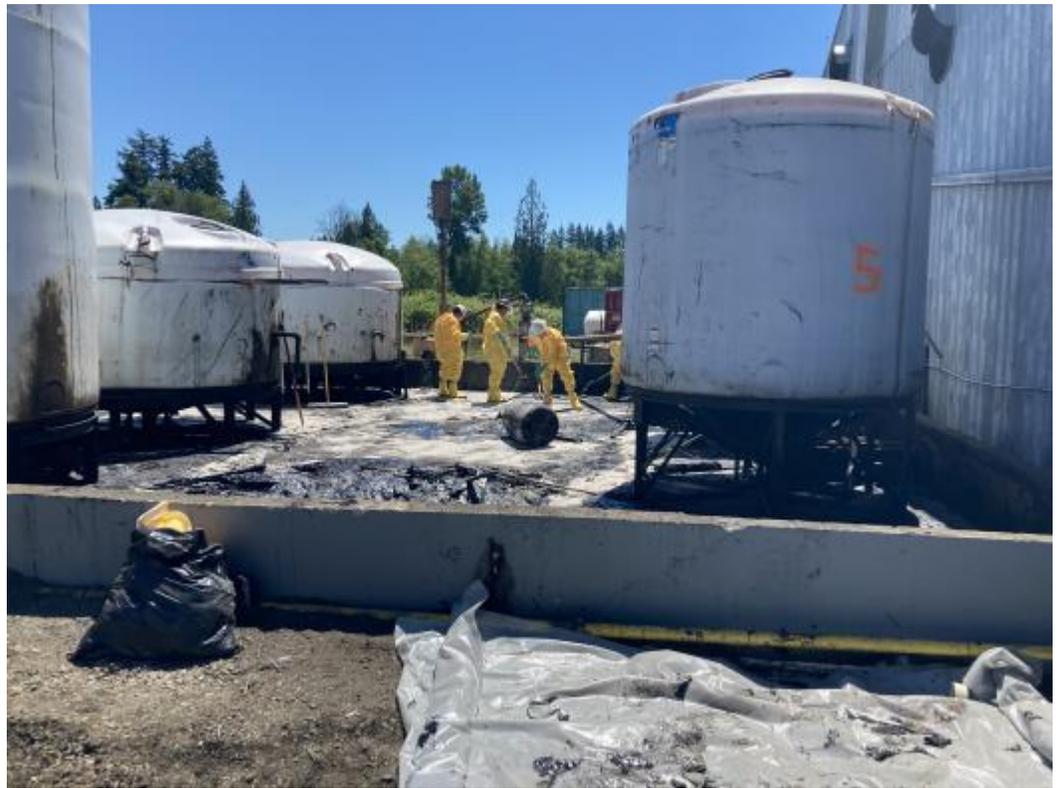
<b>Photo No.</b> <b>162</b>	<b>Date:</b> 06/25/2021
<b>Photo Coordinates</b>	
<b>Lat</b>	46.572631
<b>Long</b>	-122.728806
<b>Direction Photo Taken:</b> <b>SE</b>	
<b>Description:</b>  ERRS contractor using excavator to solidify, scrape, and remove sludge from the Secondary Containment Area. Drum left inside containment has been emptied.

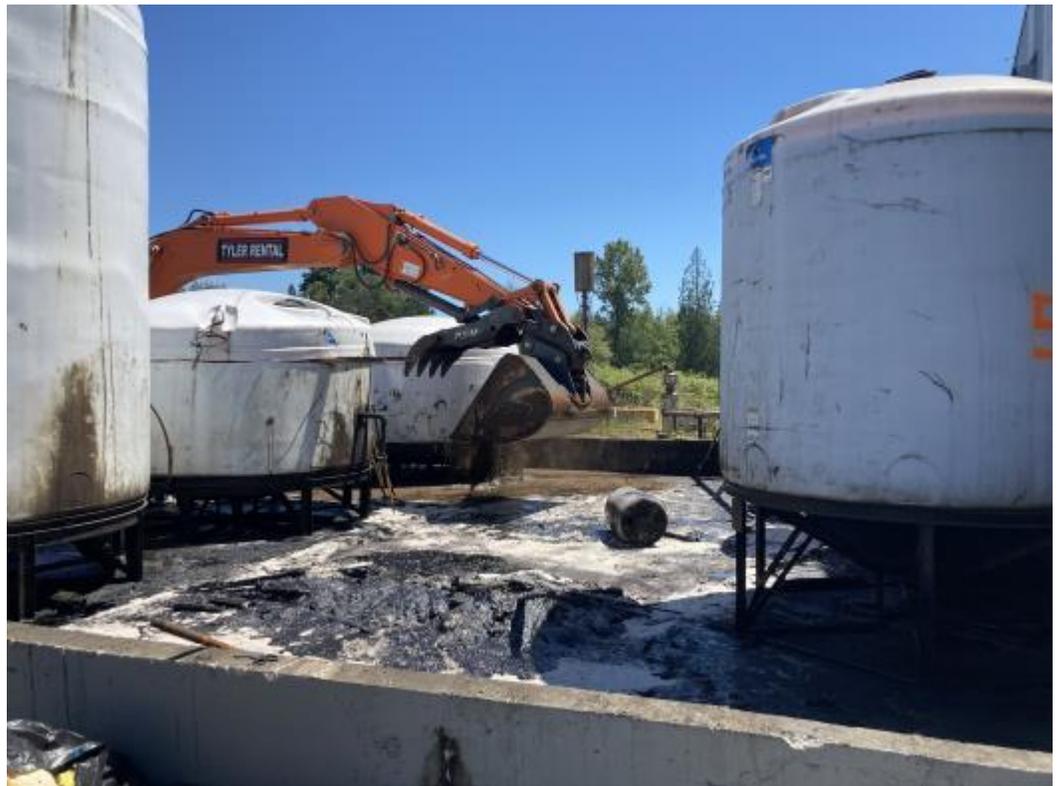
<b>Photo No.</b> <b>163</b>	<b>Date:</b> 06/25/2021
<b>Photo Coordinates</b>	
<b>Lat</b>	46.572608
<b>Long</b>	-122.728767
<b>Direction Photo Taken:</b> <b>SE</b>	
<b>Description:</b>  ERRS contractor using excavator to solidify, scrape, and remove sludge from the Secondary Containment Area.

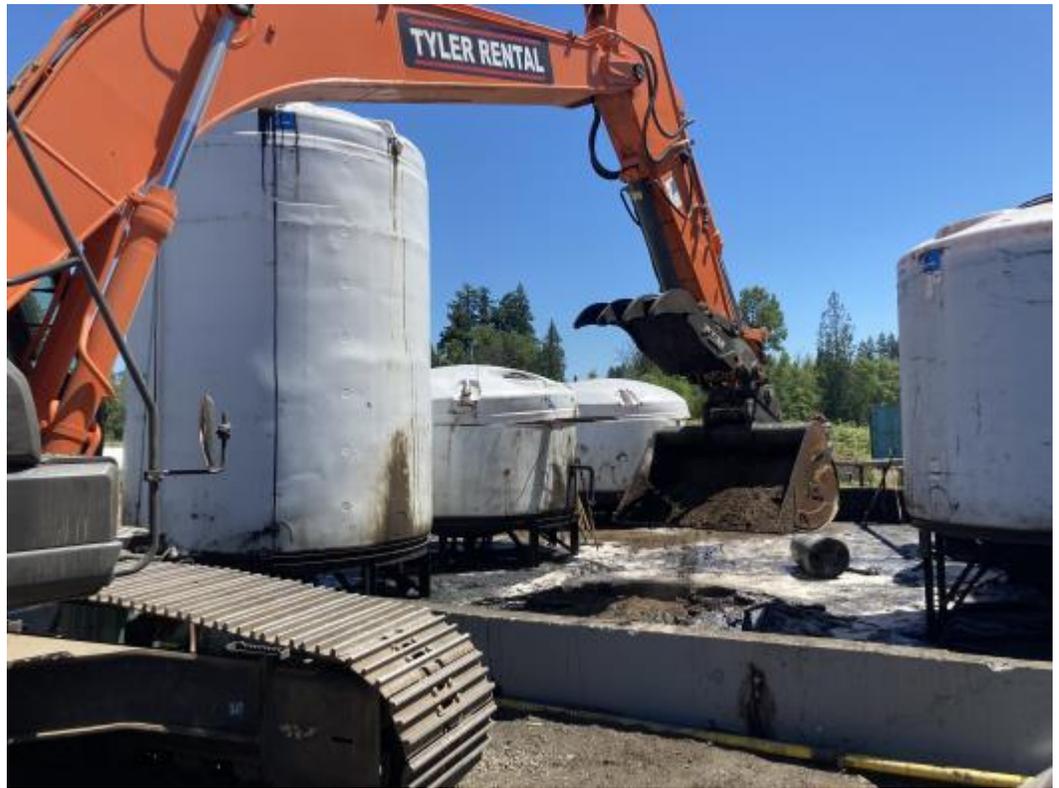
<b>Photo No.</b> <b>164</b>	<b>Date:</b> 06/25/2021
<b>Photo Coordinates</b>	
<b>Lat</b>	46.572564
<b>Long</b>	-122.728714
<b>Direction Photo Taken:</b> <b>E</b>	
<b>Description:</b>  ERRS contractor using excavator to remove solidified material and debris.

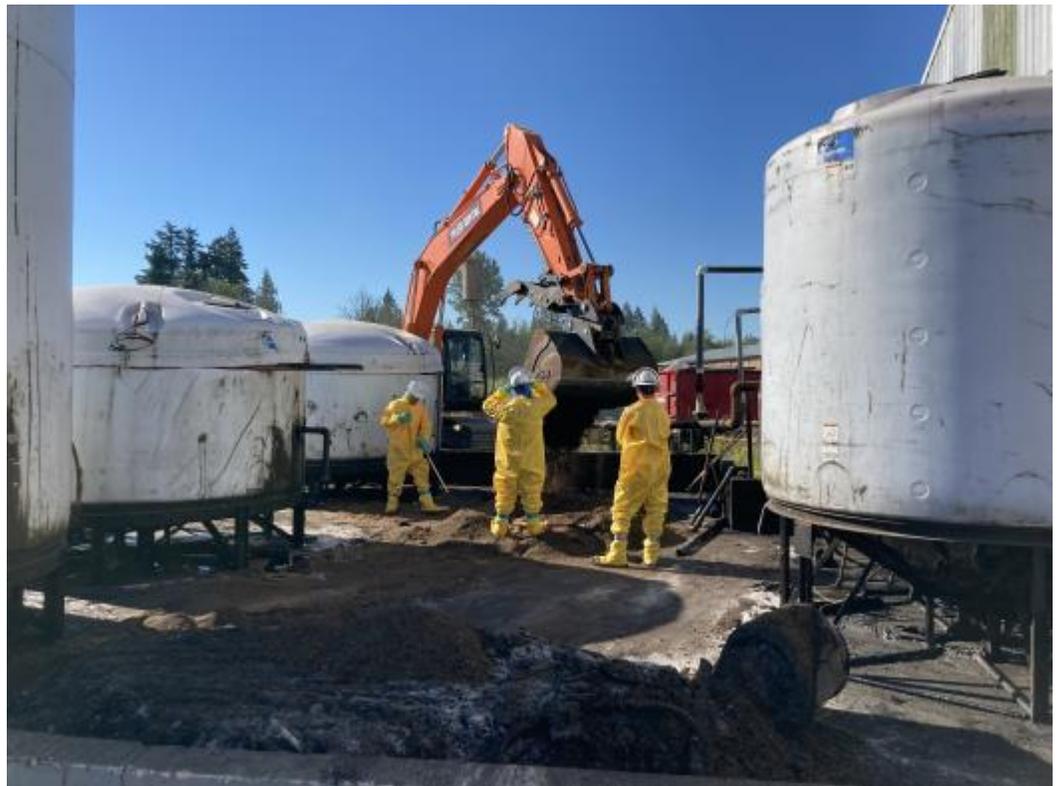
<b>Photo No.</b> <b>167</b>	<b>Date:</b> 06/26/2021
<b>Photo Coordinates</b>	
<b>Lat</b>	46.572542
<b>Long</b>	-122.728456
<b>Direction Photo Taken:</b> <b>W</b>	
<b>Description:</b>  Bucket and solidification material staged outside of the Secondary Containment Area. Excavator is building a berm around AST1 to catch sludge that will be released once demolished.

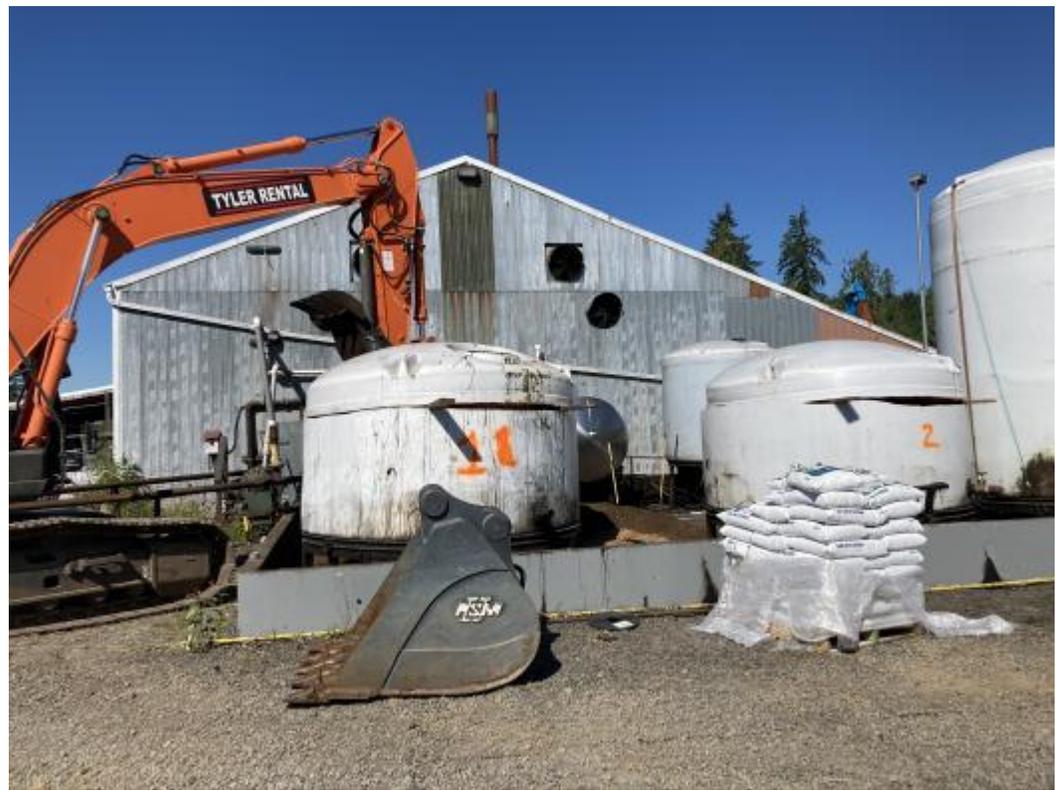
<b>Photo No.</b> <b>168</b>	<b>Date:</b> 06/26/2021
<b>Photo Coordinates</b>	
<b>Lat</b>	46.572556
<b>Long</b>	-122.728608
<b>Direction Photo Taken:</b> <b>SW</b>	
<b>Description:</b>  Staged solidification material outside of the Secondary Containment Area. Excavator is building a berm around AST1 to catch sludge that will be released once demolished.

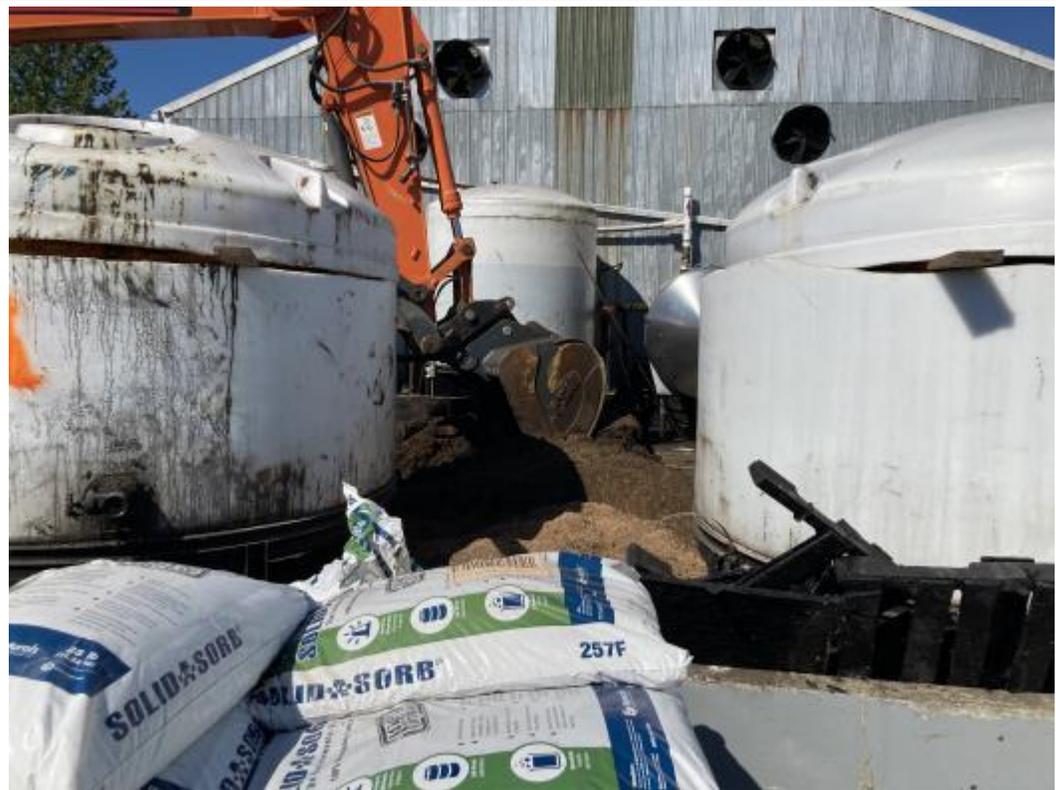
<b>Photo No.</b> <b>169</b>	<b>Date:</b> 06/26/2021
<b>Photo Coordinates</b>	
<b>Lat</b>	46.572639
<b>Long</b>	-122.7287
<b>Direction Photo Taken:</b> <b>SE</b>	
<b>Description:</b>  The remainder of AST1 being demolished within the berm area.

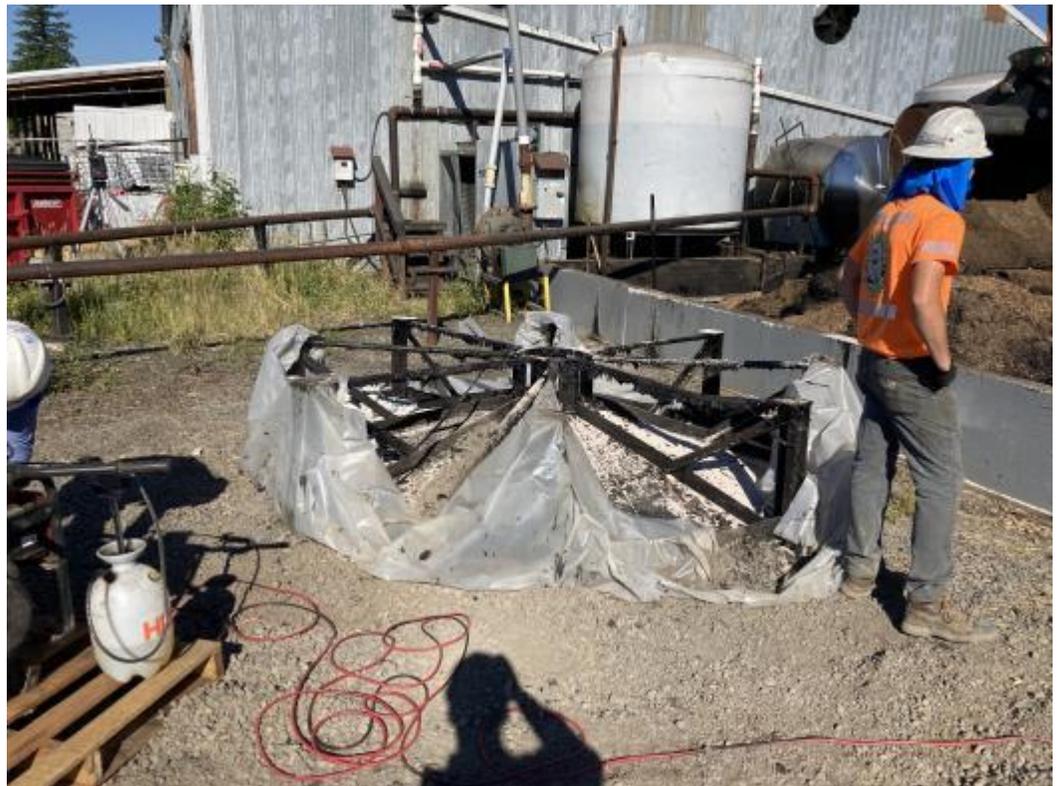
<b>Photo No.</b> <b>173</b>	<b>Date:</b> 06/28/2021
<b>Photo Coordinates</b>	
<b>Lat</b>	46.572494
<b>Long</b>	-122.7286
<b>Direction Photo Taken:</b> <b>NW</b>	
<b>Description:</b>  AST1 sludge material being further solidified.

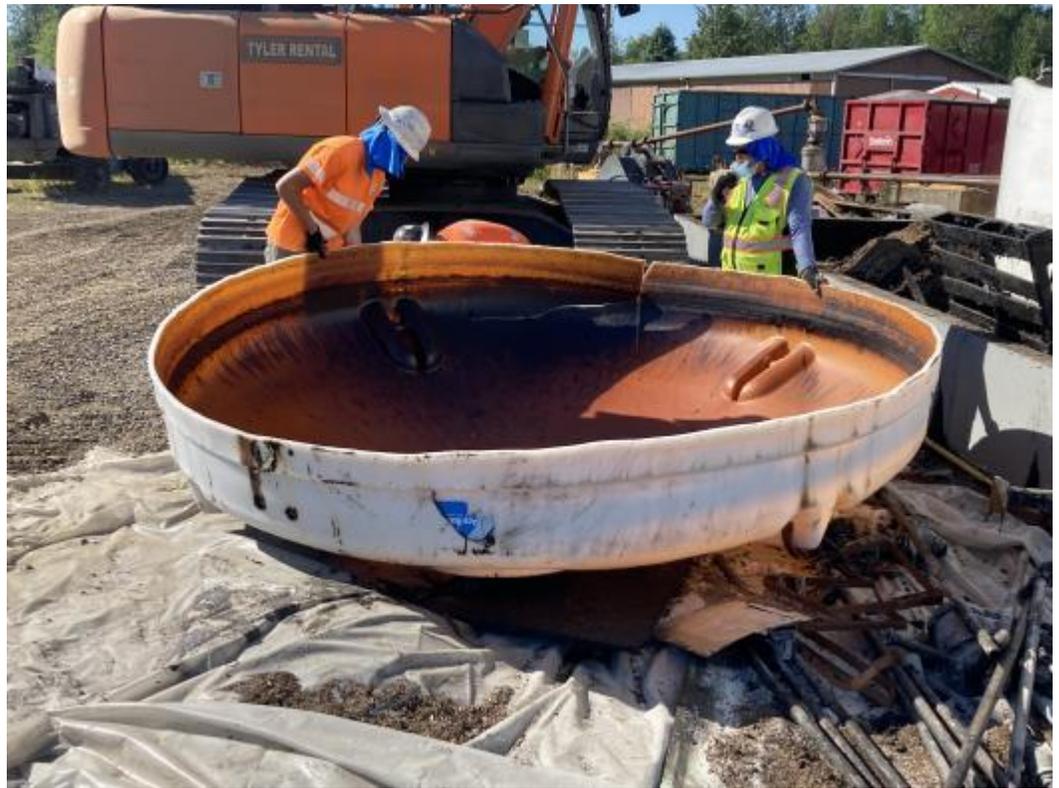
<b>Photo No.</b> <b>176</b>	<b>Date:</b> 06/28/2021
<b>Photo Coordinates</b>	
<b>Lat</b>	46.572617
<b>Long</b>	-122.728692
<b>Direction Photo Taken:</b> <b>S</b>	
<b>Description:</b>  ERRS contractors cutting up the base of AST2.

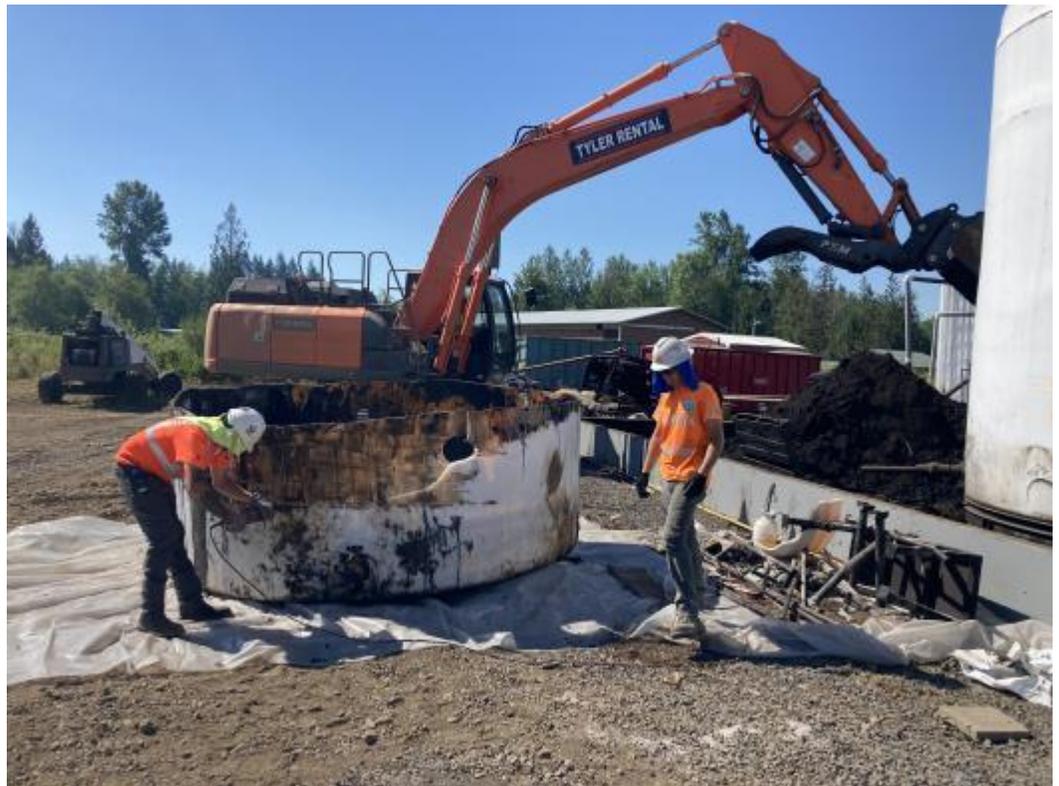
<b>Photo No.</b> <b>177</b>	<b>Date:</b> 06/28/2021
<b>Photo Coordinates</b>	
<b>Lat</b>	46.572589
<b>Long</b>	-122.728631
<b>Direction Photo Taken:</b> <b>S</b>	
<b>Description:</b>  AST2 sludge material being solidified and consolidated.

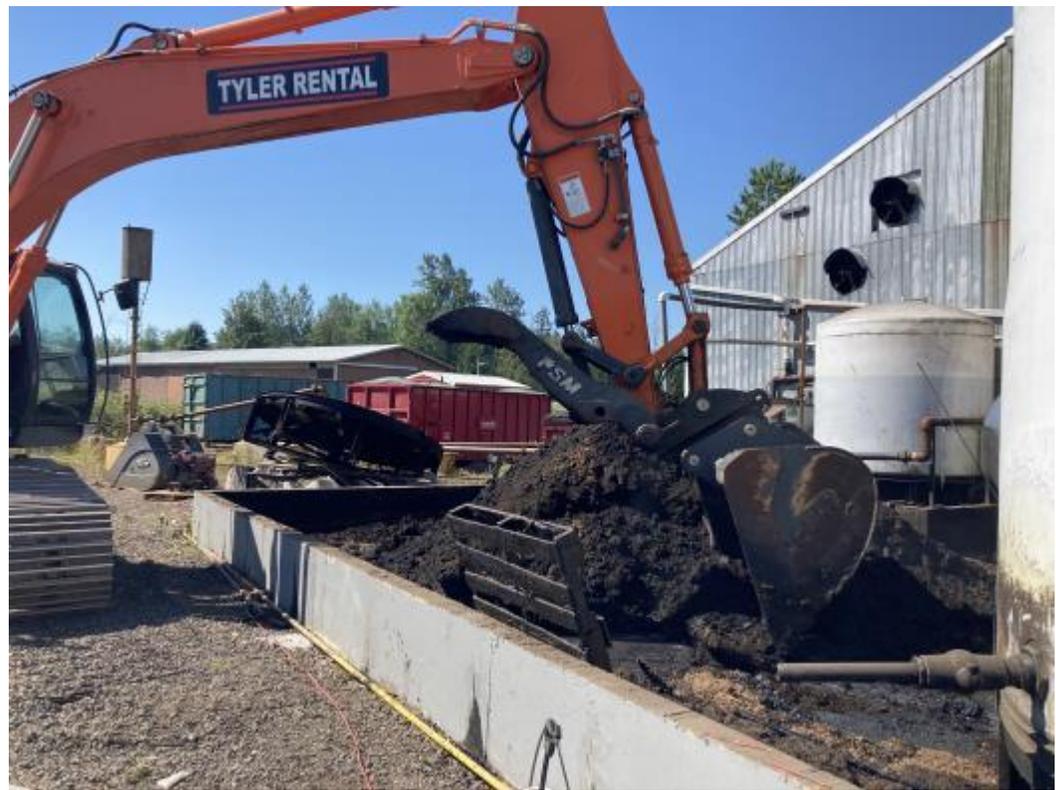
<b>Photo No.</b> <b>178</b>	<b>Date:</b> 06/28/2021
<b>Photo Coordinates</b>	
<b>Lat</b>	46.572442
<b>Long</b>	-122.7286
<b>Direction Photo Taken:</b> <b>NW</b>	
<b>Description:</b>  AST2 platform stacked on top of AST1 platform. AST2 sludge material being solidified and consolidated inside Secondary Containment Area.

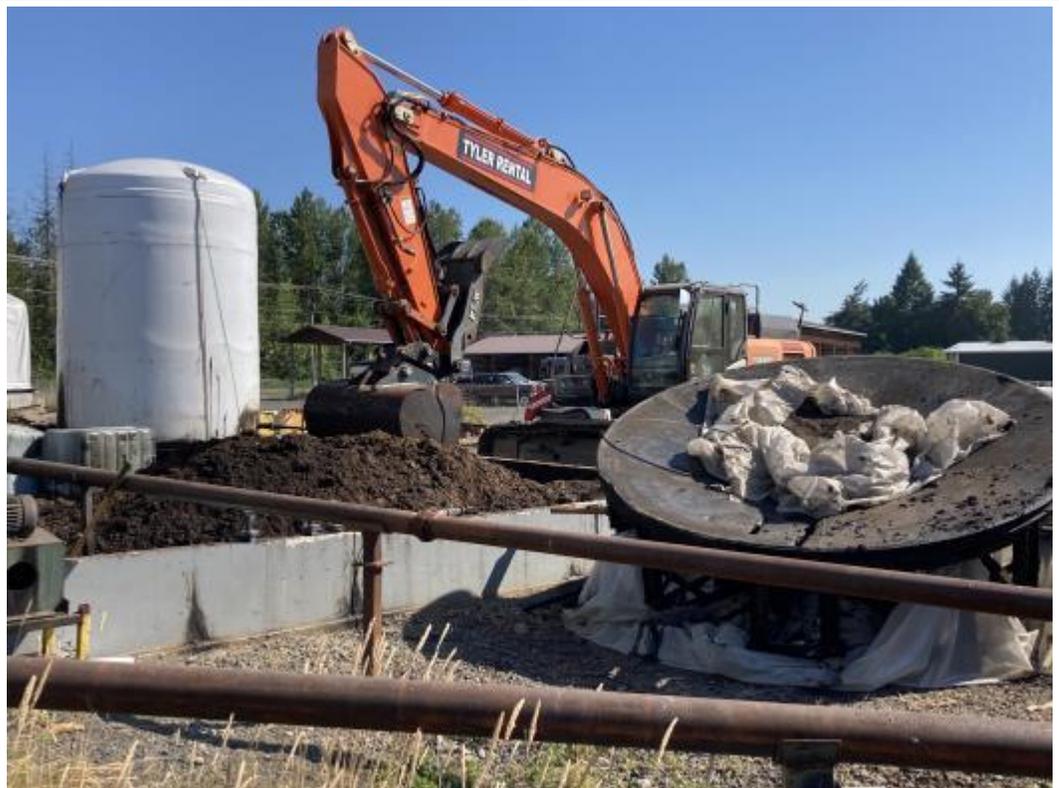
<b>Photo No.</b> <b>180</b>	<b>Date:</b> 06/29/2021
<b>Photo Coordinates</b>	
<b>Lat</b>	46.5724
<b>Long</b>	-122.728592
<b>Direction Photo Taken:</b> <b>N</b>	
<b>Description:</b>  AST2 sludge material being solidified and consolidated.

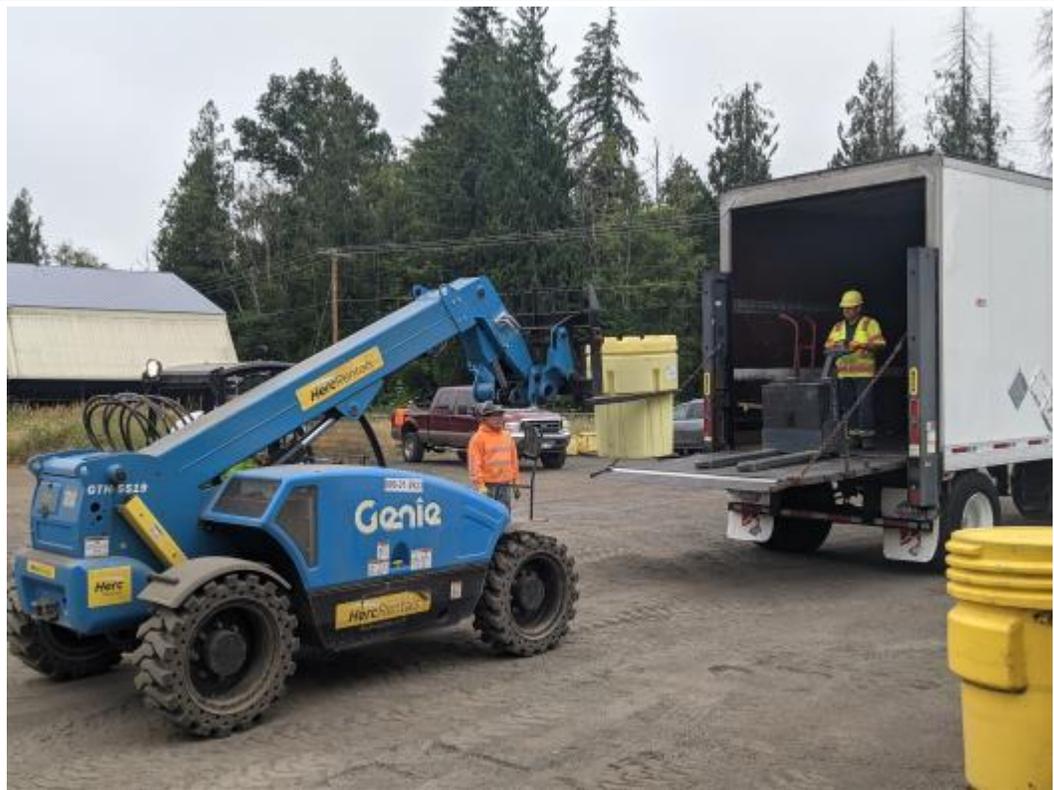
<b>Photo No.</b> <b>217</b>	<b>Date:</b> 07/06/2021
<b>Photo Coordinates</b>	
<b>Lat</b>	46.572472
<b>Long</b>	-122.729114
<b>Direction Photo Taken:</b> <b>W</b>	
<b>Description:</b>  ERRS contractors loading an overpack drum onto a truck to be delivered to the appropriate waste disposal facility.

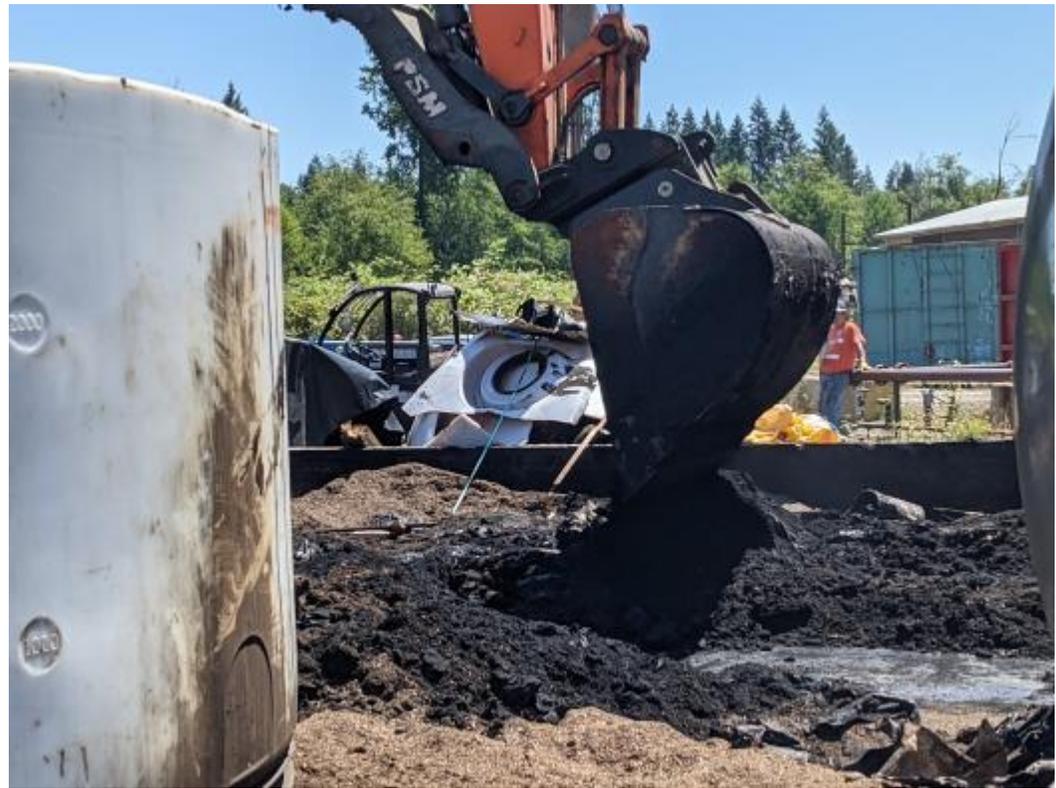
<b>Photo No.</b> <b>220</b>	<b>Date:</b> 07/06/2021
<b>Photo Coordinates</b>	
<b>Lat</b>	46.572586
<b>Long</b>	-122.729233
<b>Direction Photo Taken:</b> <b>SE</b>	
<b>Description:</b>  ERRS contractors emptying containers to be solidified at the Secondary Containment Area.

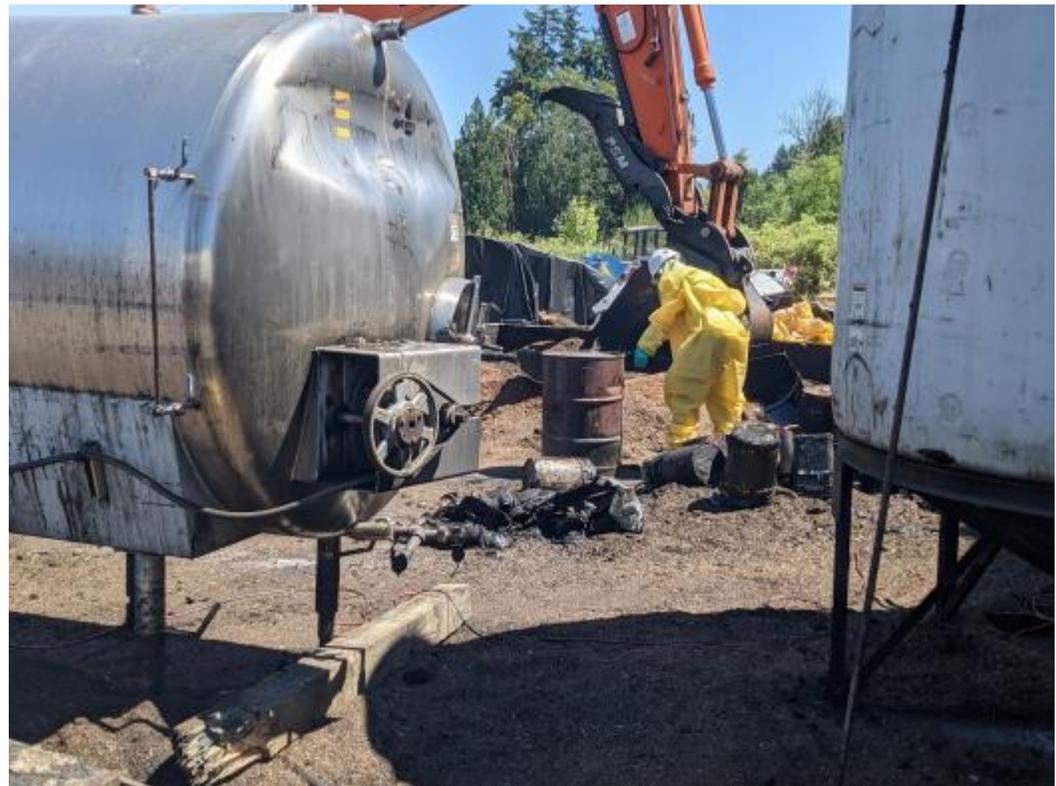
<b>Photo No.</b> <b>221</b>	<b>Date:</b> 07/06/2021
<b>Photo Coordinates</b>	
<b>Lat</b>	46.572586
<b>Long</b>	-122.729214
<b>Direction Photo Taken:</b> <b>N</b>	
<b>Description:</b>  Sludge material being solidified and consolidated.
