# **TIME-CRITICAL REMOVAL ACTION REPORT**

*Onalaska Wood Pyrolysis  
Onalaska, Lewis County, Washington*

Prepared by:

December 2021

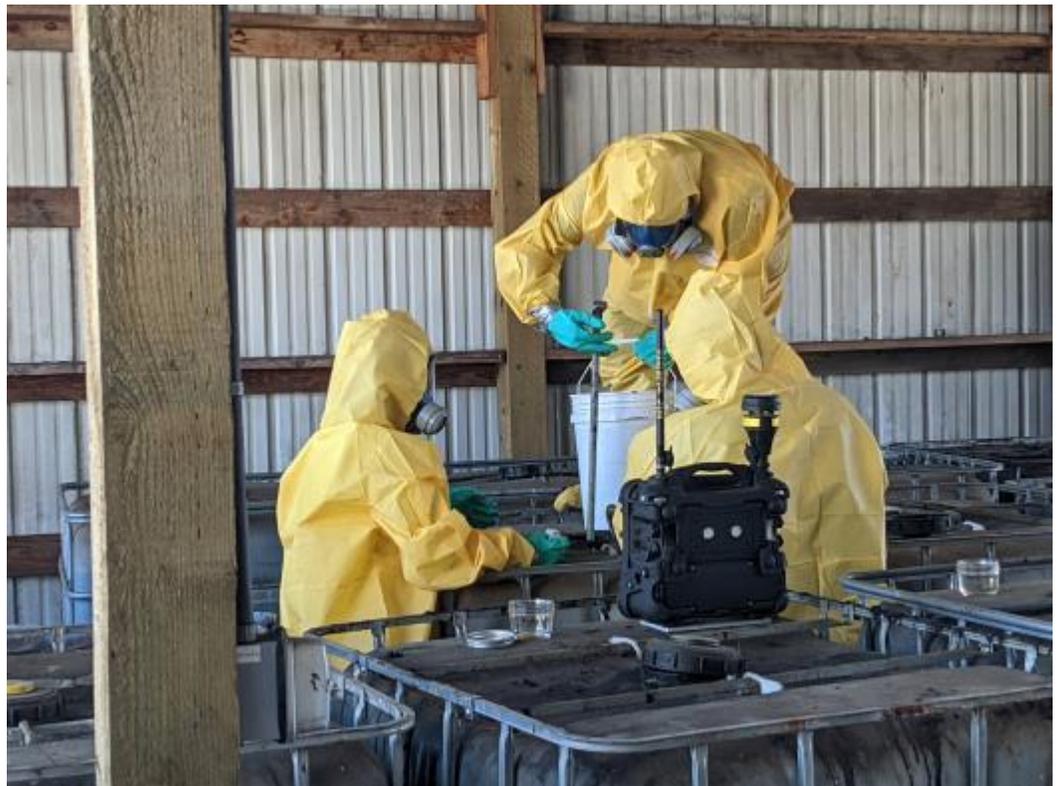
<b>Photo No.</b> <b>223</b>	<b>Date:</b> 07/06/2021
<b>Photo Coordinates</b>	
<b>Lat</b>	46.572603
<b>Long</b>	-122.729197
<b>Direction Photo Taken:</b> <b>S</b>	
<b>Description:</b>  ERRS contractors collecting a sample from a tote staged at the Lean-to Area. Sample was to be used to check pH level.

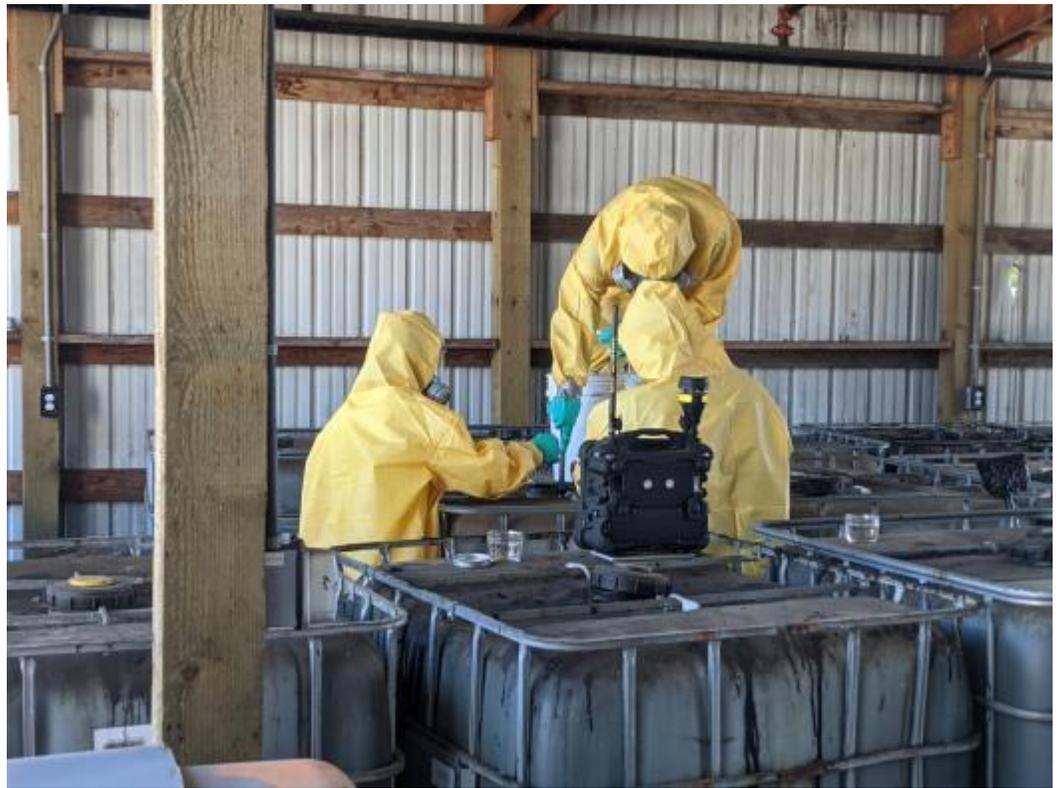
<b>Photo No.</b> <b>224</b>	<b>Date:</b> 07/08/2021
<b>Photo Coordinates</b>	
<b>Lat</b>	46.572292
<b>Long</b>	-122.72885
<b>Direction Photo Taken:</b> <b>NW</b>	
<b>Description:</b>  ERRS contractors at the tote staging area pumping NaOH into a tote of wood vinegar raise the pH to 6.

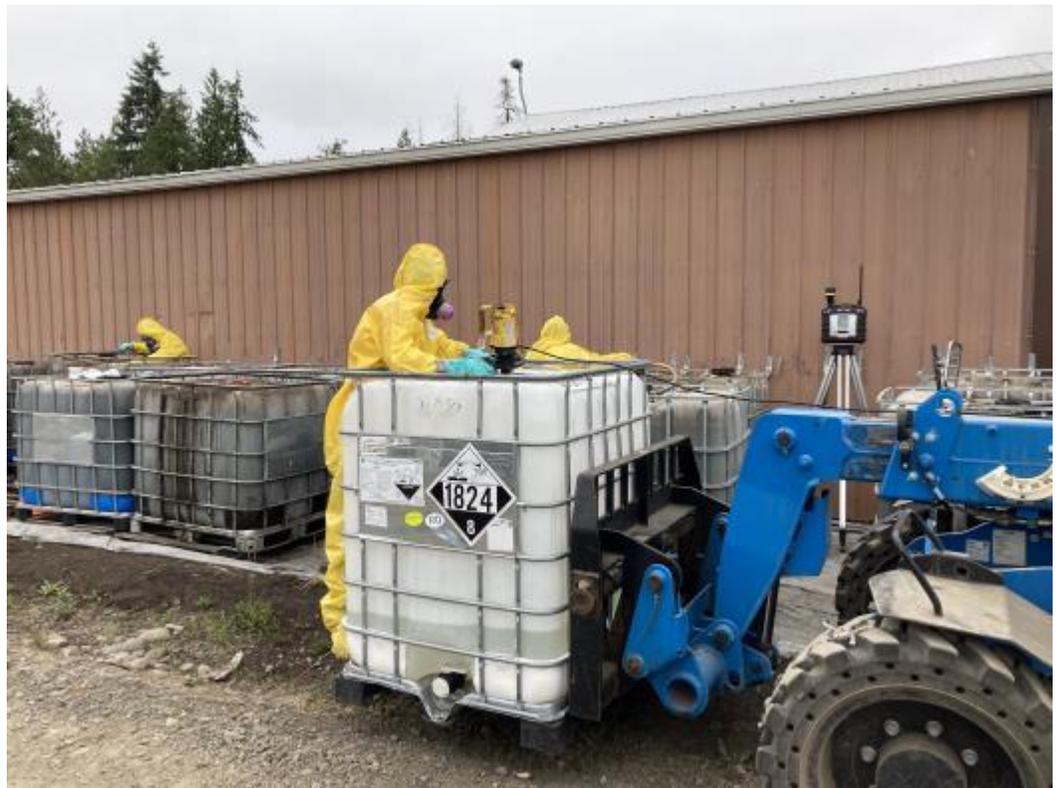
<b>Photo No.</b> <b>225</b>	<b>Date:</b> 07/08/2021
<b>Photo Coordinates</b>	
<b>Lat</b>	46.57225
<b>Long</b>	-122.728936
<b>Direction Photo Taken:</b> <b>N</b>	
<b>Description:</b>  ERRS contractors at the tote staging area pumping NaOH into a tote of wood vinegar to raise the pH to 6.

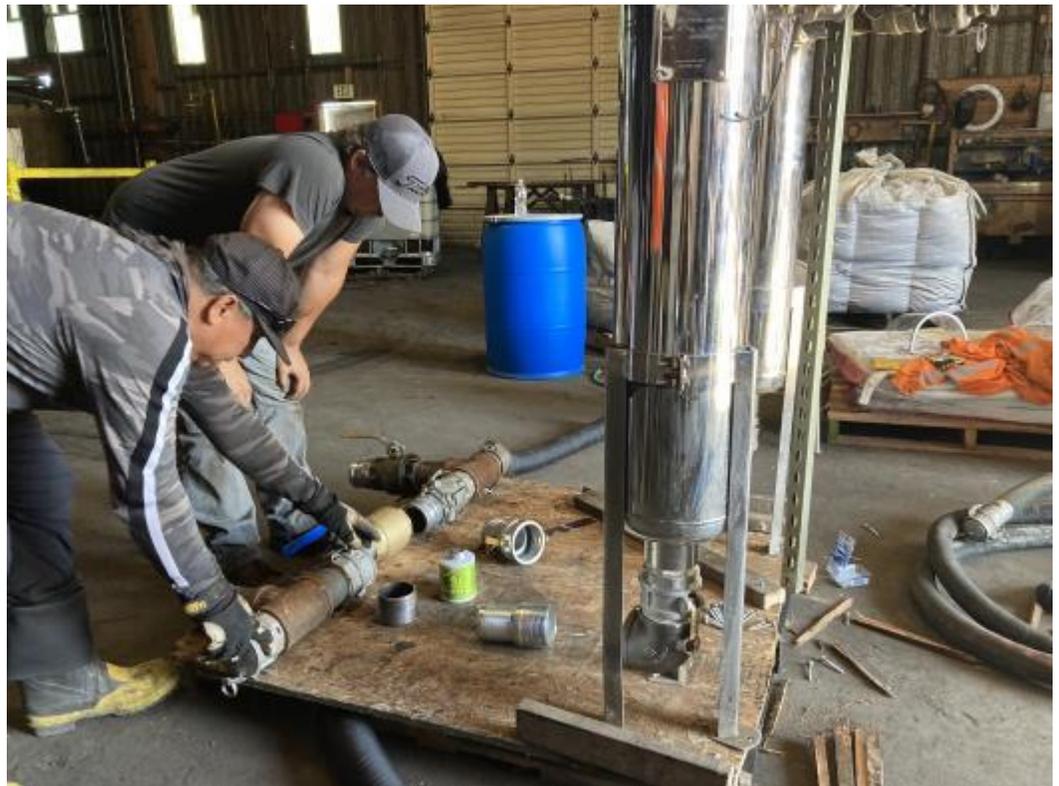
<b>Photo No.</b> <b>227</b>	<b>Date:</b> 07/09/2021
<b>Photo Coordinates</b>	
<b>Lat</b>	46.57235
<b>Long</b>	-122.729194
<b>Direction Photo Taken:</b> <b>W</b>	
<b>Description:</b>  ERRS contractors pumping pH balanced wood vinegar from totes, through the sock filtration system, and into a vacuum truck.

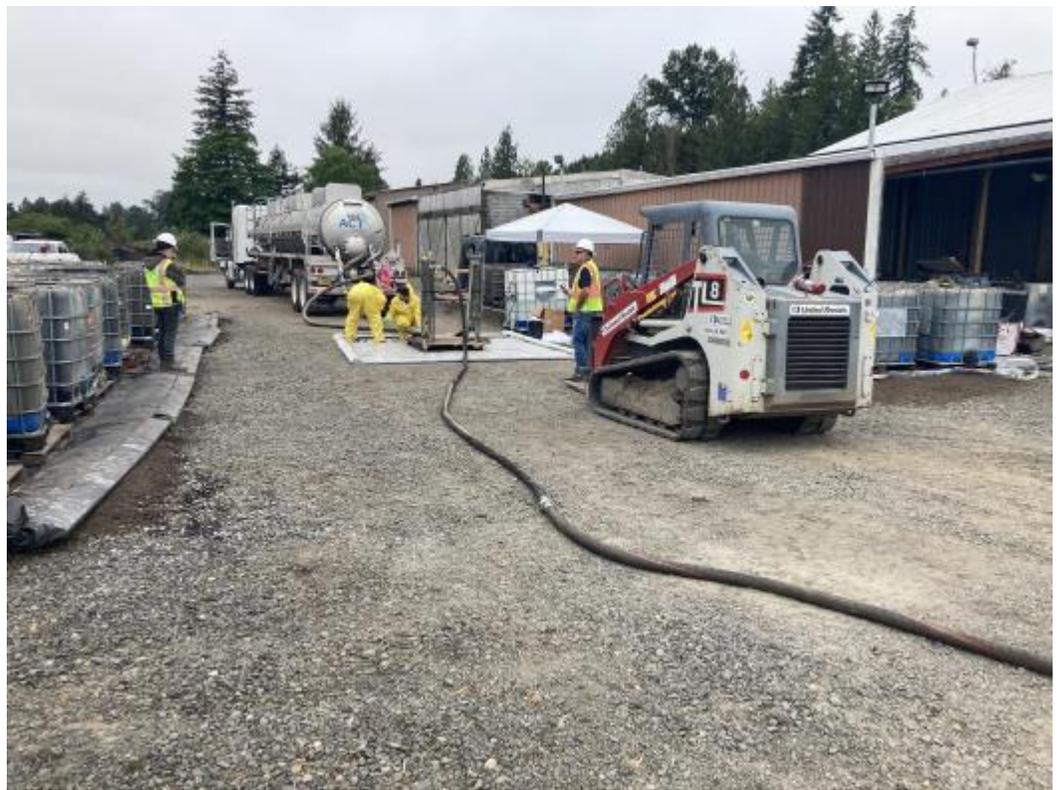
<b>Photo No.</b> <b>228</b>	<b>Date:</b> 07/09/2021
<b>Photo Coordinates</b>	
<b>Lat</b>	46.572292
<b>Long</b>	-122.728753
<b>Direction Photo Taken:</b> <b>SW</b>	
<b>Description:</b>  ERRS contractors pumping pH balanced wood vinegar from totes, through the sock filtration system, and into a vacuum truck.

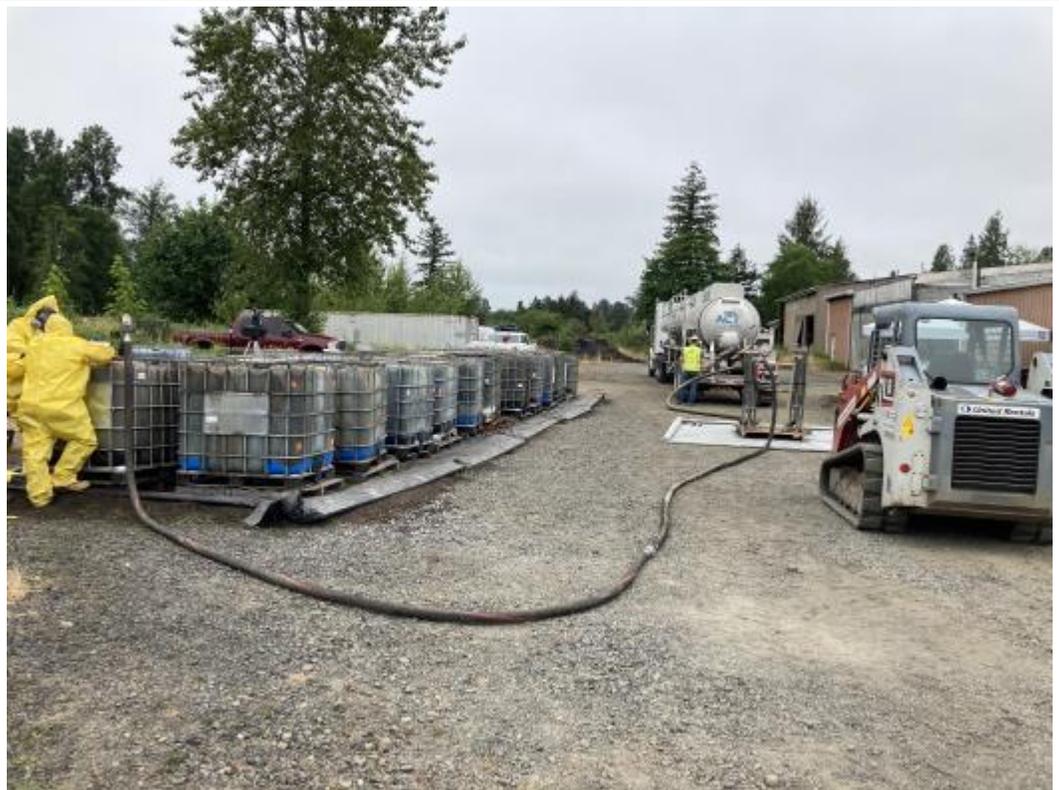
<b>Photo No.</b> <b>229</b>	<b>Date:</b> 07/09/2021
<b>Photo Coordinates</b>	
<b>Lat</b>	46.572258
<b>Long</b>	-122.728906
<b>Direction Photo Taken:</b> <b>SW</b>	
<b>Description:</b>  ERRS contractors pumping pH balanced wood vinegar from totes, through the sock filtration system, and into a vacuum truck. Secondary containment has been constructed around the sock filtration system.

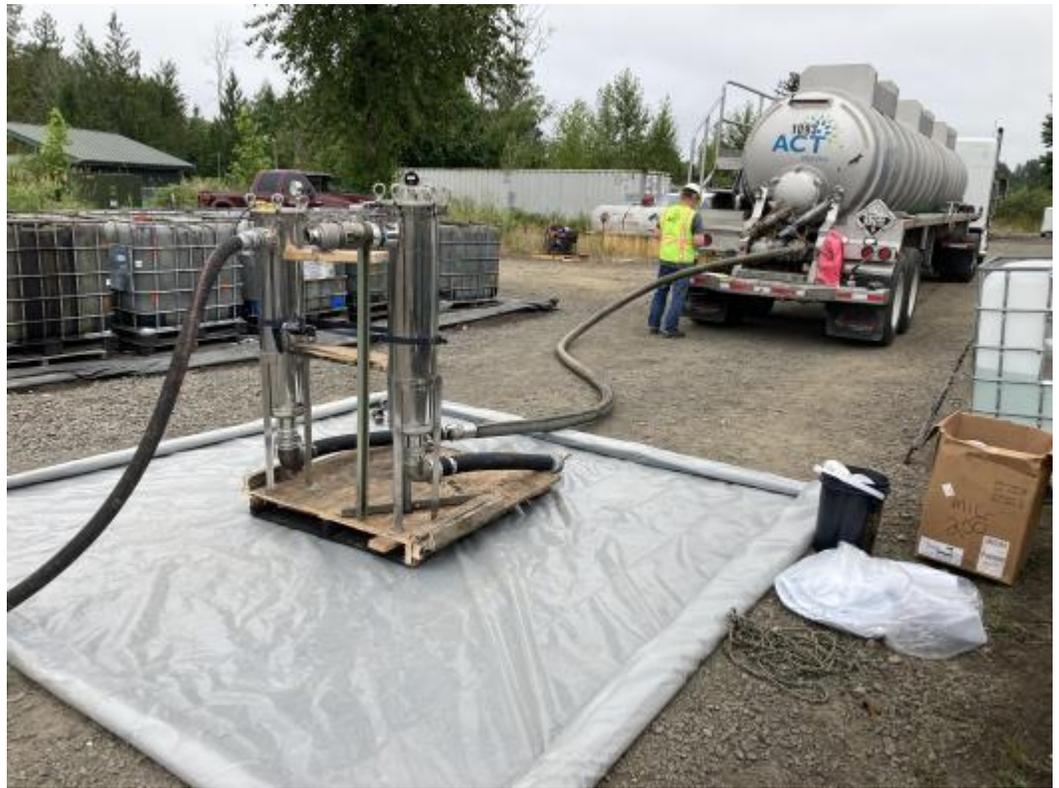
<b>Photo No.</b> <b>230</b>	<b>Date:</b> 07/09/2021
<b>Photo Coordinates</b>	
<b>Lat</b>	46.572239
<b>Long</b>	-122.728911
<b>Direction Photo Taken:</b> <b>S</b>	
<b>Description:</b>  ERRS contractors pumping pH balanced wood vinegar from totes, through the sock filtration system, and into a vacuum truck. Filtered solids staged at the edge of secondary containment in the immediate foreground.

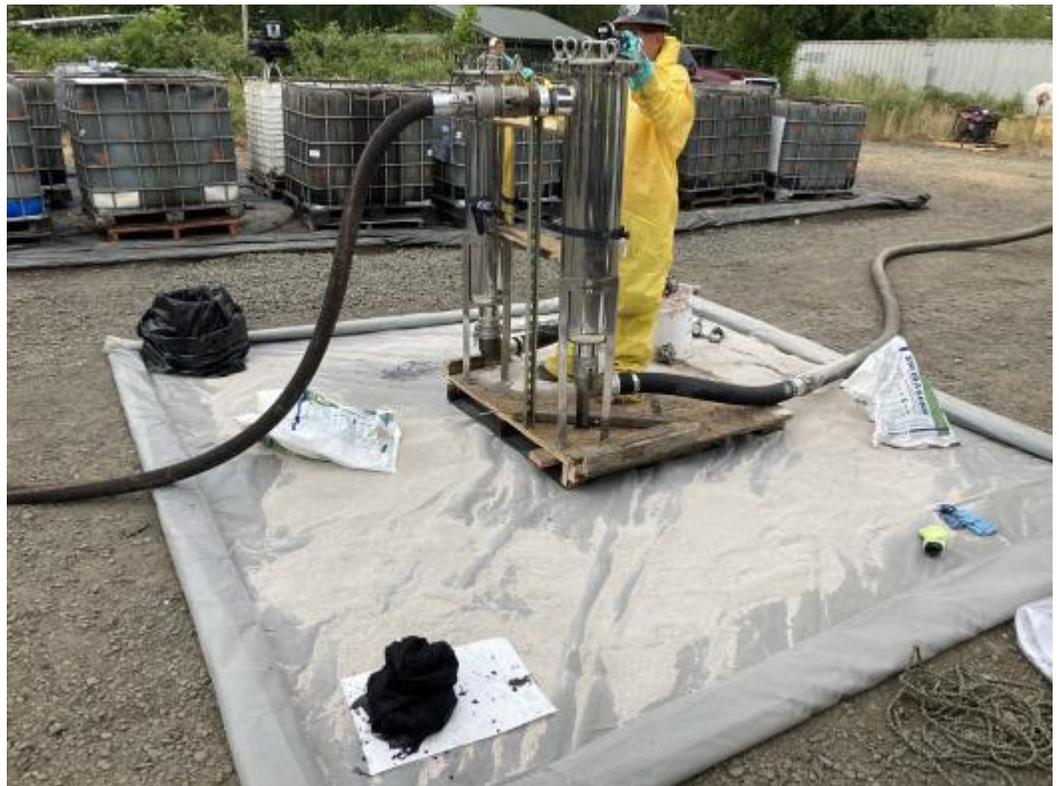
<b>Photo No.</b> <b>231</b>	<b>Date:</b> 07/09/2021
<b>Photo Coordinates</b>	
<b>Lat</b>	46.572239
<b>Long</b>	-122.728889
<b>Direction Photo Taken:</b> <b>SE</b>	
<b>Description:</b>  ERRS contractors conducting waste transfer activities.

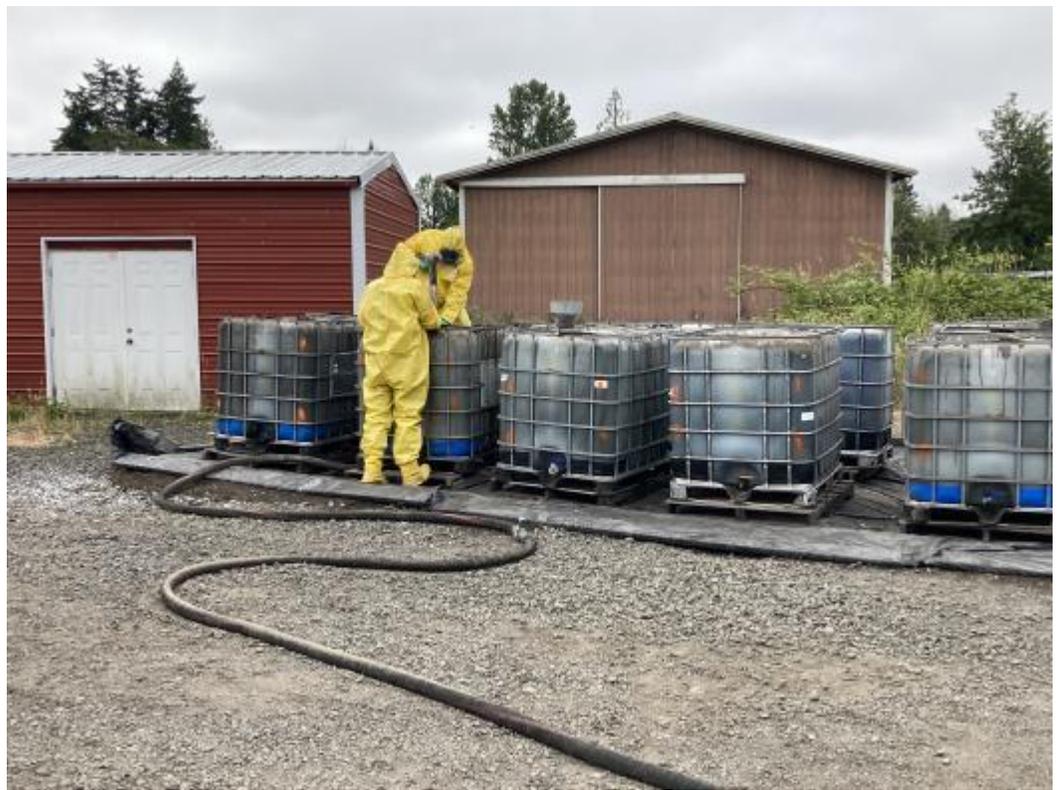
<b>Photo No.</b> <b>232</b>	<b>Date:</b> 07/09/2021
<b>Photo Coordinates</b>	
<b>Lat</b>	46.57235
<b>Long</b>	-122.728797
<b>Direction Photo Taken:</b> <b>SE</b>	
<b>Description:</b>  ERRS contractors conducting waste transfer activities.

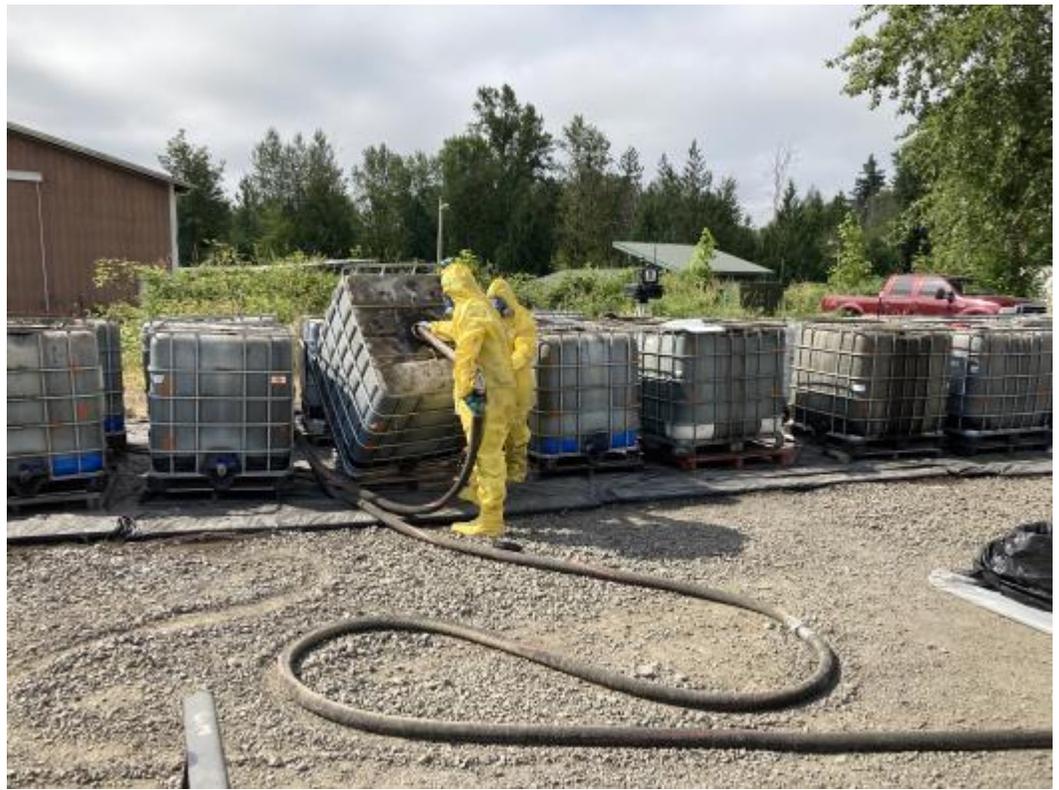
<b>Photo No.</b> <b>233</b>	<b>Date:</b> 07/09/2021
<b>Photo Coordinates</b>	
<b>Lat</b>	46.572281
<b>Long</b>	-122.728889
<b>Direction Photo Taken:</b> <b>S</b>	
<b>Description:</b>  ERRS contractors pumping pH balanced wood vinegar from totes, through the sock filtration system, and into a vacuum truck.

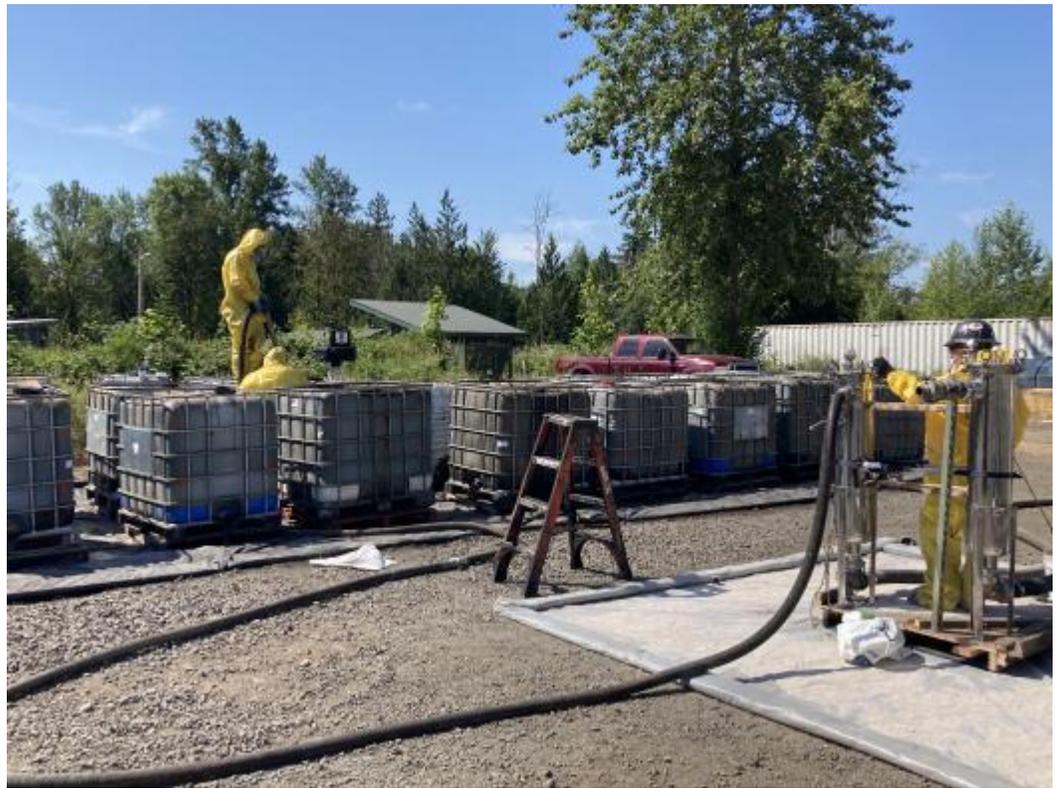
<b>Photo No.</b> <b>234</b>	<b>Date:</b> 07/09/2021
<b>Photo Coordinates</b>	
<b>Lat</b>	46.572369
<b>Long</b>	-122.728631
<b>Direction Photo Taken:</b> <b>N</b>	
<b>Description:</b>  Solidified waste inside the Secondary Containment Area.

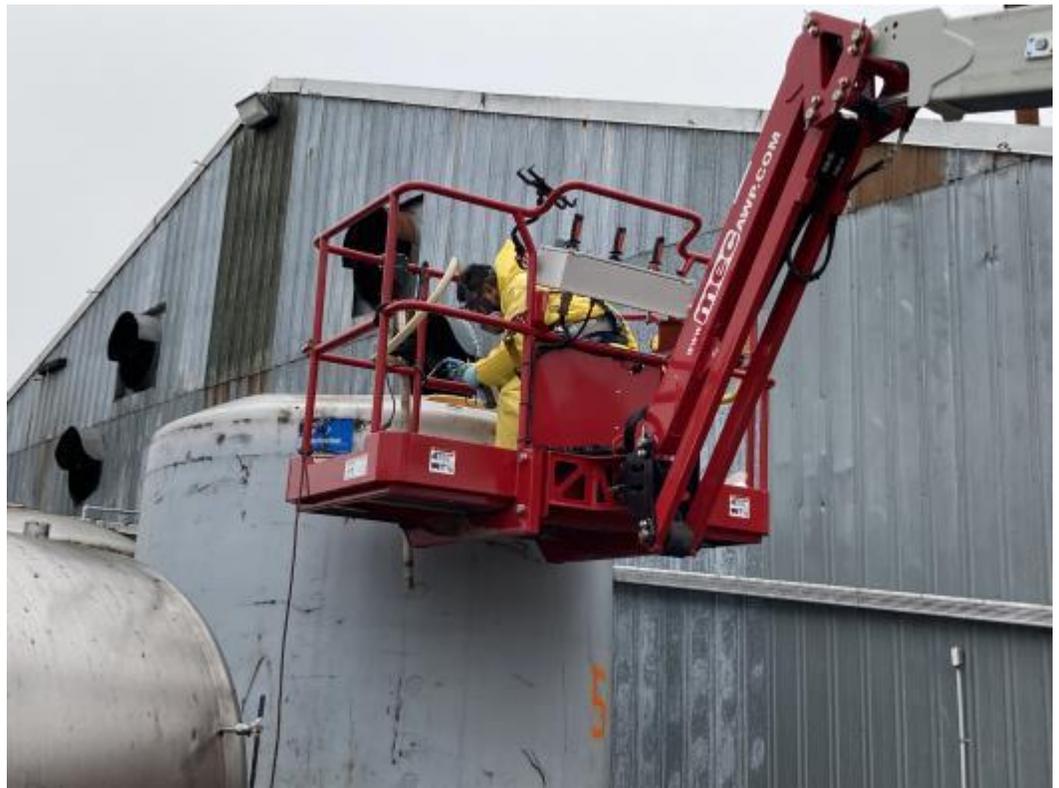
<b>Photo No.</b> <b>237</b>	<b>Date:</b> 07/10/2021
<b>Photo Coordinates</b>	
<b>Lat</b>	46.572411
<b>Long</b>	-122.728631
<b>Direction Photo Taken:</b> <b>N</b>	
<b>Description:</b>  ERRS contractor preparing to mix wood vinegar with liquid NaOH in order to balance to pH of 6.

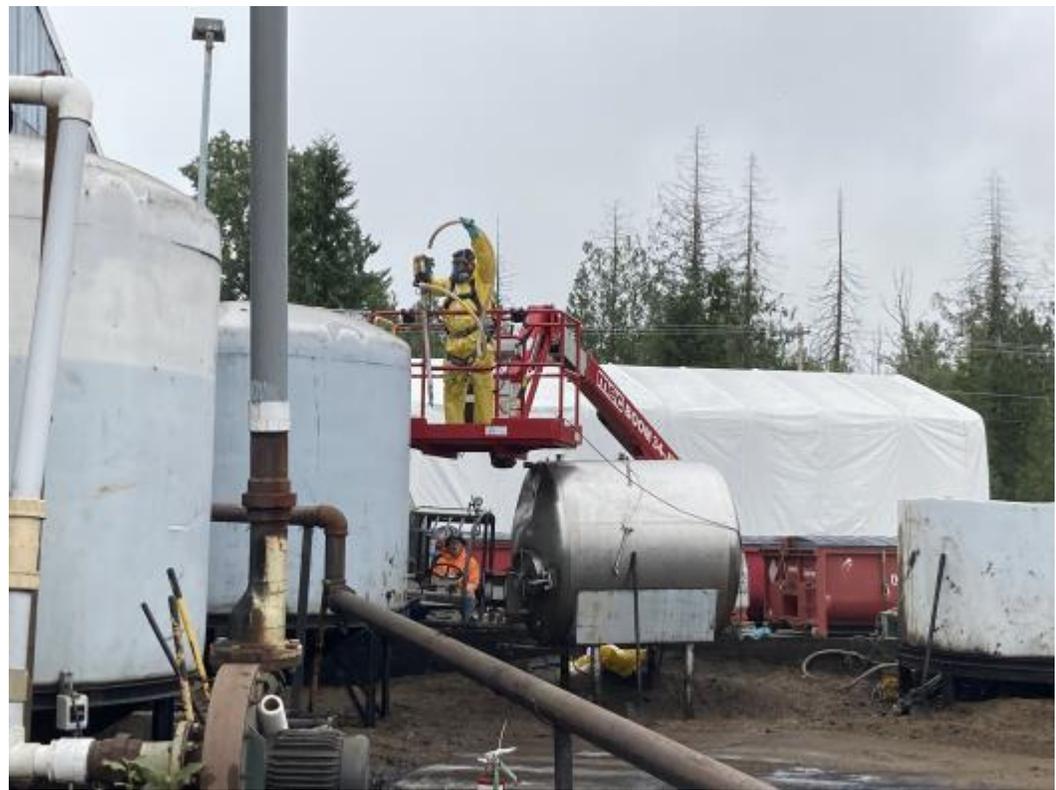
<b>Photo No.</b> <b>238</b>	<b>Date:</b> 07/10/2021
<b>Photo Coordinates</b>	
<b>Lat</b>	46.572425
<b>Long</b>	-122.728714
<b>Direction Photo Taken:</b> <b>N</b>	
<b>Description:</b>  ERRS contractor preparing to mix wood vinegar with liquid NaOH in order to balance to pH of 6.

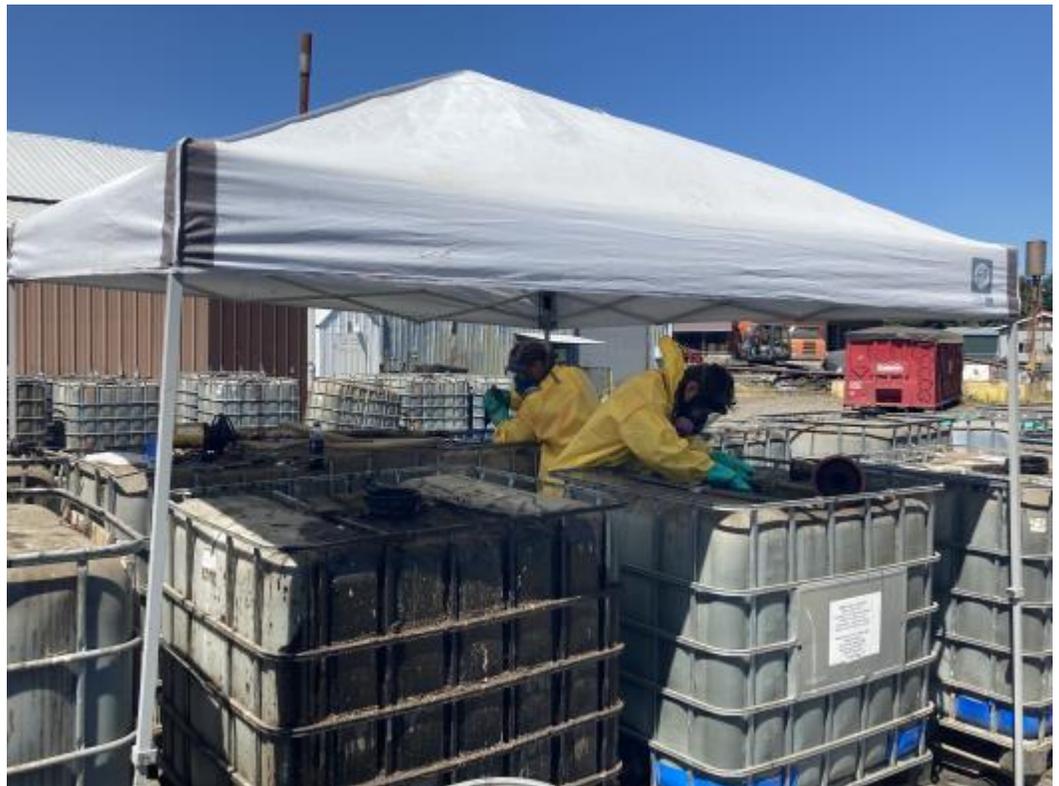
<b>Photo No.</b> <b>243</b>	<b>Date:</b> 07/12/2021
<b>Photo Coordinates</b>	
<b>Lat</b>	46.572189
<b>Long</b>	-122.728875
<b>Direction Photo Taken:</b> <b>NE</b>	
<b>Description:</b>  ERRS contractors mixing tote wood vinegar with liquid NaOH in order to balance to pH of 6.

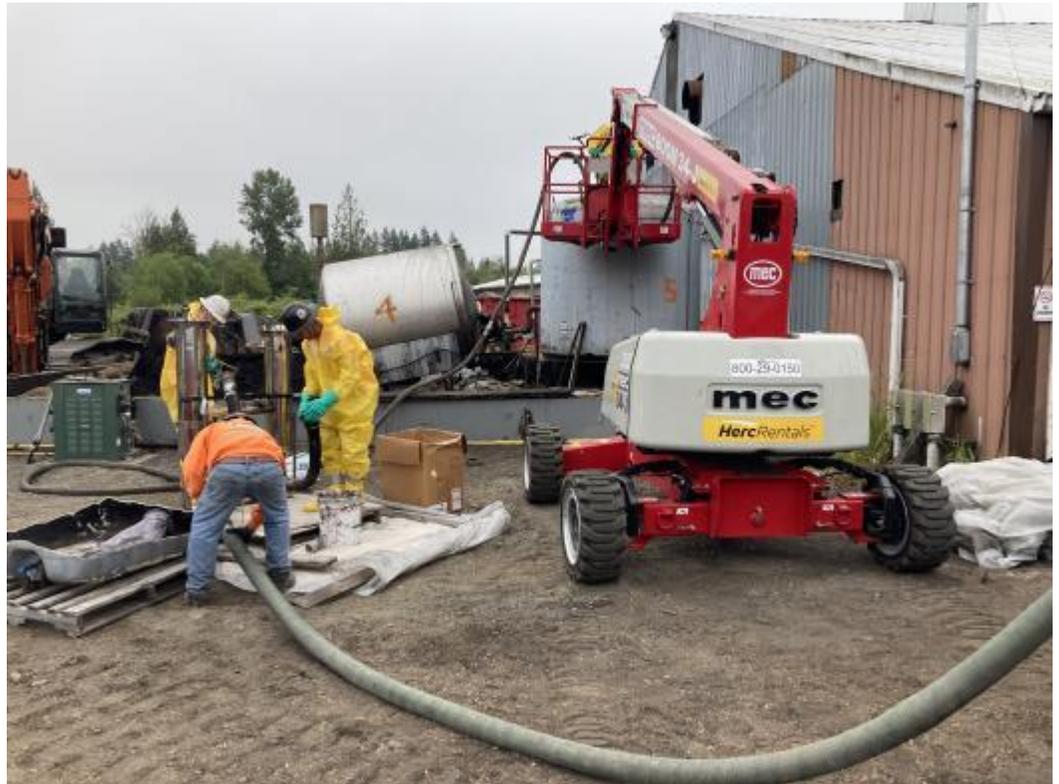
<b>Photo No.</b> <b>245</b>	<b>Date:</b> 07/13/2021
<b>Photo Coordinates</b>	
<b>Lat</b>	46.572608
<b>Long</b>	-122.728683
<b>Direction Photo Taken:</b> <b>W</b>	
<b>Description:</b>  ERRS contractors pumping waste from AST5, through the sock filtration system, and into a vacuum truck.

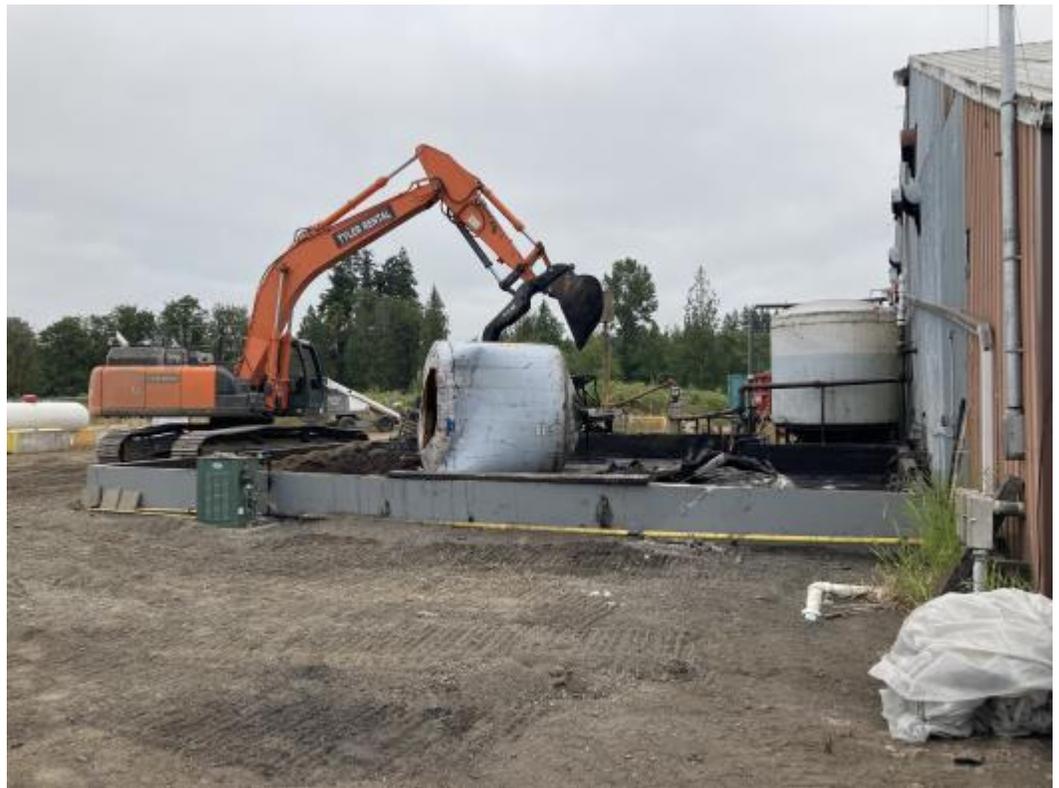
# PHOTOGRAPH LOG

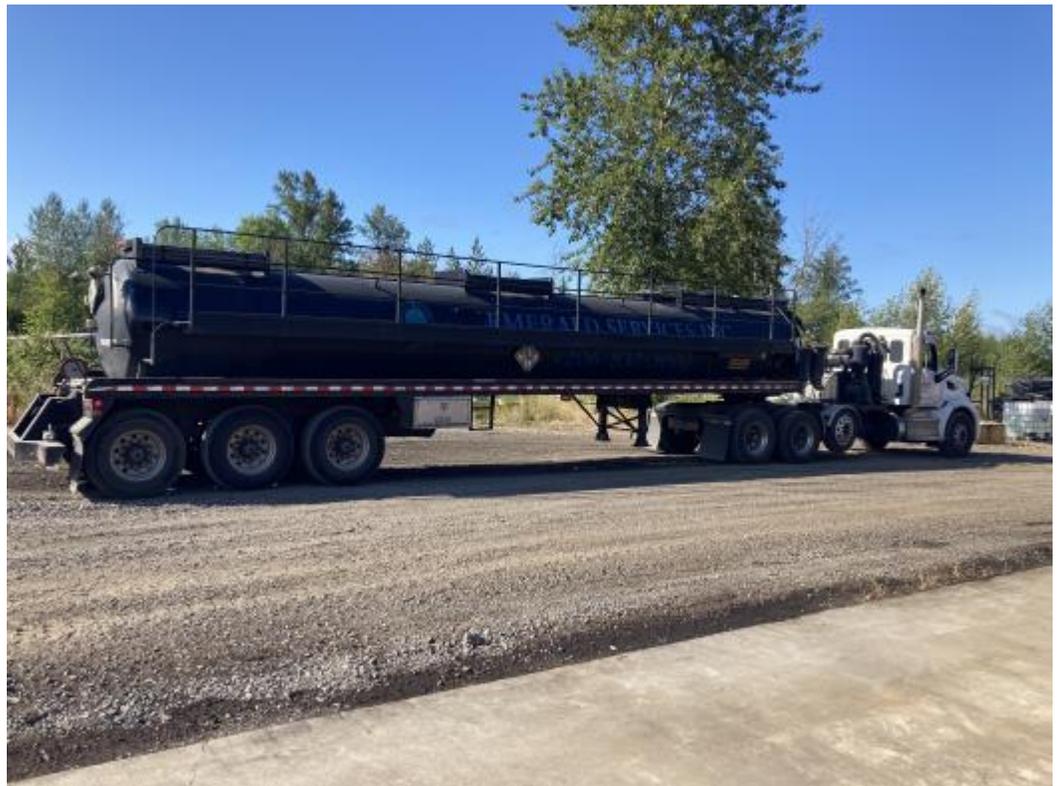
<b>Photo No.</b> <b>290</b>	<b>Date:</b> 07/21/2021
<b>Photo Coordinates</b>	
<b>Lat</b>	46.572436
<b>Long</b>	-122.729028
<b>Direction Photo Taken:</b> <b>S</b>	
<b>Description:</b>  Vacuum truck that arrived back on Site due to wood tar blocking the valve of the tank.

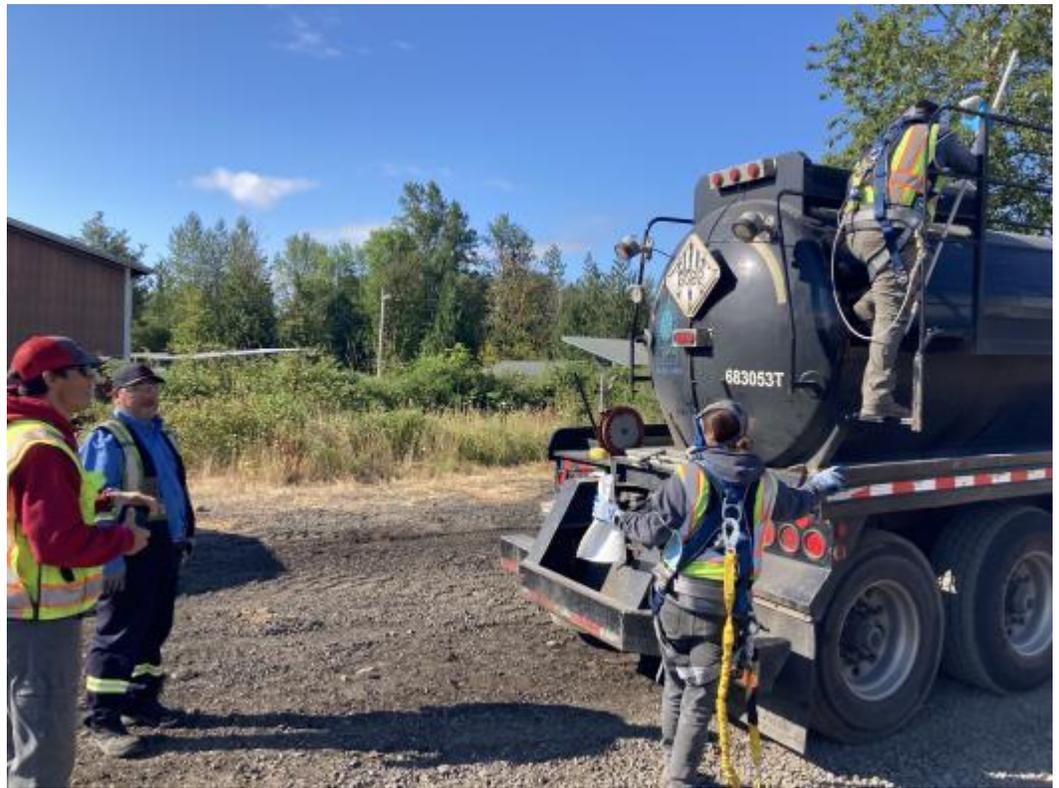
<b>Photo No.</b> <b>291</b>	<b>Date:</b> 07/21/2021
<b>Photo Coordinates</b>	
<b>Lat</b>	46.572281
<b>Long</b>	-122.728761
<b>Direction Photo Taken:</b> <b>S</b>	
<b>Description:</b>  ERRS contractors prepare to conduct confined space entry into the tank of the vacuum truck to clean out the wood tar blocking the tank valve.

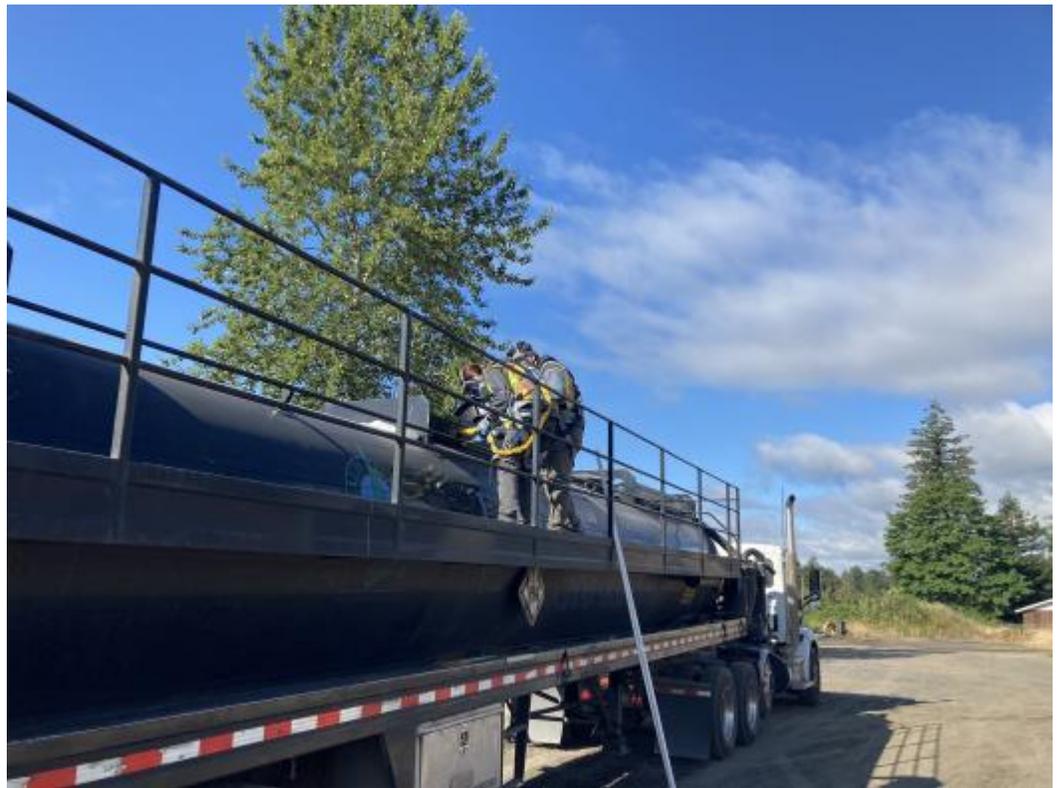
<b>Photo No.</b> <b>292</b>	<b>Date:</b> 07/21/2021
<b>Photo Coordinates</b>	
<b>Lat</b>	46.572283
<b>Long</b>	-122.72885
<b>Direction Photo Taken:</b> <b>SW</b>	
<b>Description:</b>  ERRS contractors prepare to conduct confined space entry into the tank of the vacuum truck to clean out the wood tar blocking the tank valve.

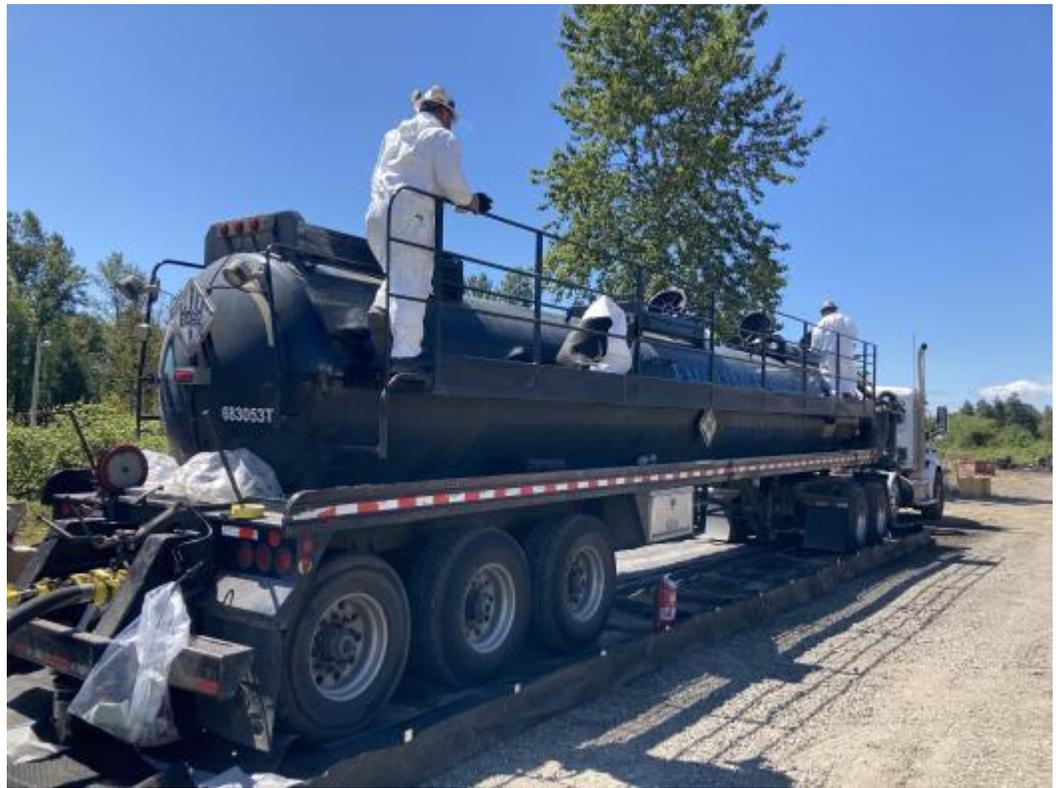
<b>Photo No.</b> <b>305</b>	<b>Date:</b> 07/22/2021
<b>Photo Coordinates</b>	
<b>Lat</b>	46.5722
<b>Long</b>	-122.728881
<b>Direction Photo Taken:</b> <b>SW</b>	
<b>Description:</b>  Clean Harbors contractors prepare to conduct confined space entry into the tank of the vacuum truck to clean out the wood tar blocking the tank valve.

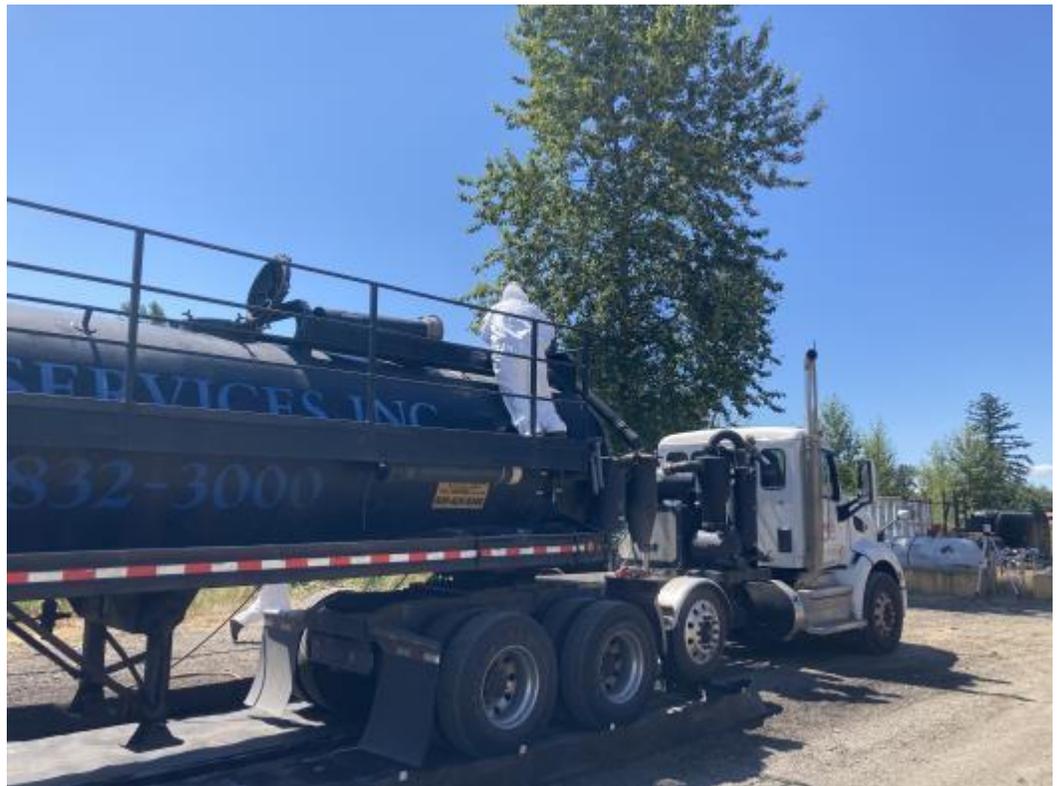
<b>Photo No.</b> <b>306</b>	<b>Date:</b> 07/22/2021
<b>Photo Coordinates</b>	
<b>Lat</b>	46.572269
<b>Long</b>	-122.728775
<b>Direction Photo Taken:</b> <b>SW</b>	
<b>Description:</b>  Clean Harbors contractors prepare to conduct confined space entry into the tank of the vacuum truck to clean out the wood tar blocking the tank valve.

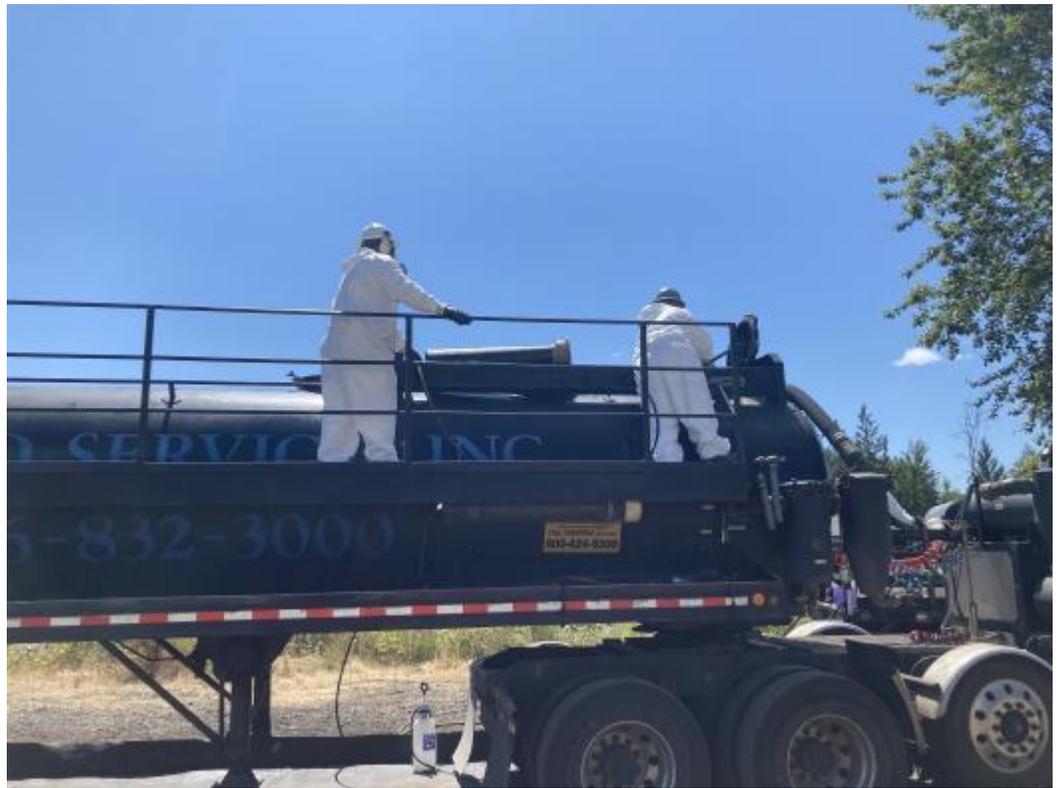
<b>Photo No.</b> <b>307</b>	<b>Date:</b> 07/22/2021
<b>Photo Coordinates</b>	
<b>Lat</b>	46.572444
<b>Long</b>	-122.729089
<b>Direction Photo Taken:</b> <b>S</b>	
<b>Description:</b>  Clean Harbors contractors prepare to conduct confined space entry into the tank of the vacuum truck to clean out the wood tar blocking the tank valve.

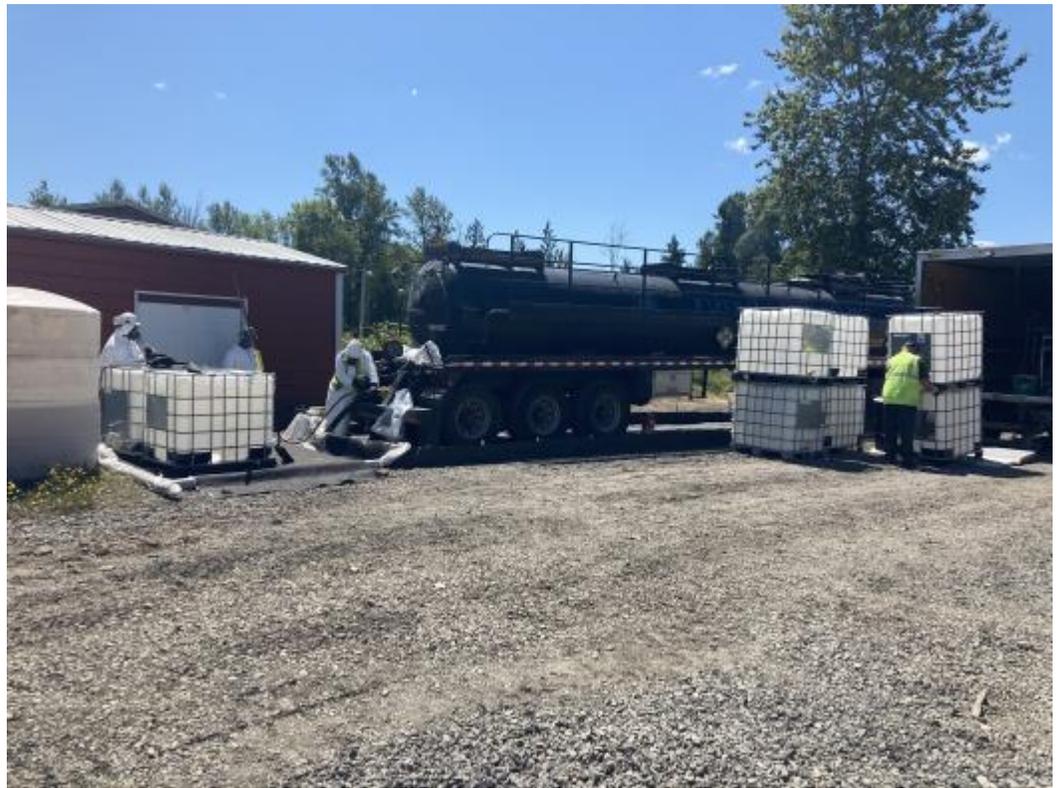
<b>Photo No.</b> <b>309</b>	<b>Date:</b> 07/22/2021
<b>Photo Coordinates</b>	
<b>Lat</b>	46.572228
<b>Long</b>	-122.72905
<b>Direction Photo Taken:</b> <b>S</b>	
<b>Description:</b>  Clean Harbors contractors prepare to conduct confined space entry into the tank of the vacuum truck to clean out the wood tar blocking the tank valve.

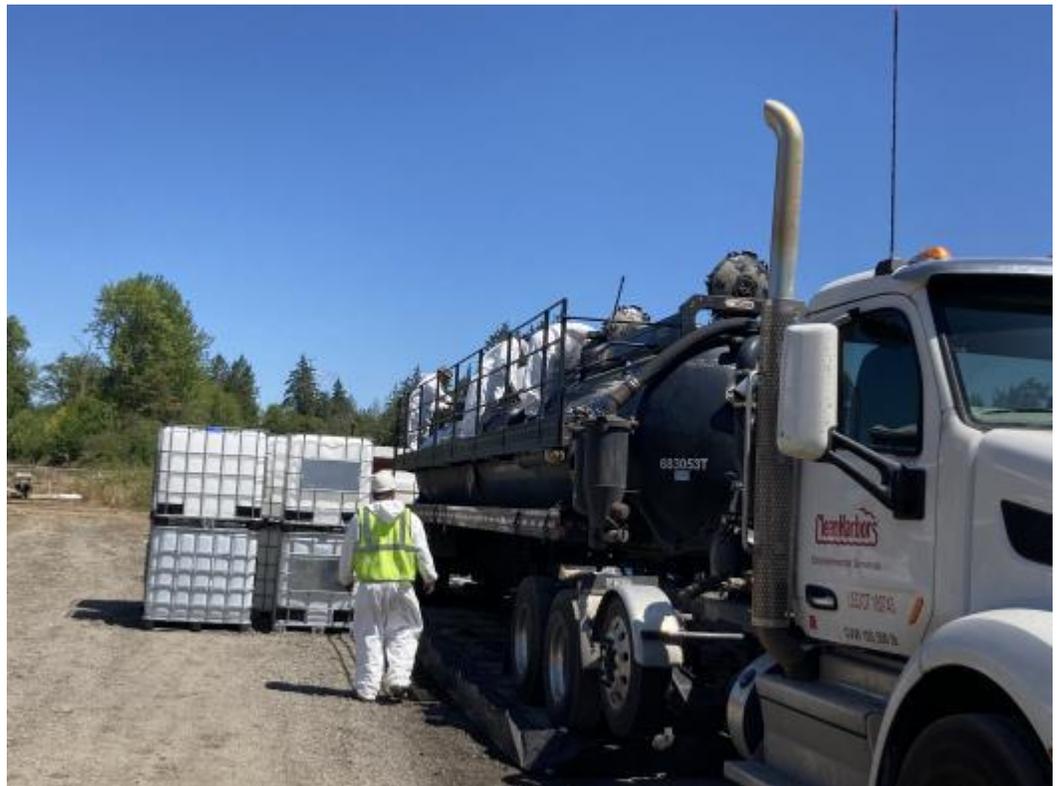
<b>Photo No.</b> <b>312</b>	<b>Date:</b> 07/22/2021
<b>Photo Coordinates</b>	
<b>Lat</b>	46.572117
<b>Long</b>	-122.729011
<b>Direction Photo Taken:</b> <b>E</b>	
<b>Description:</b>  Clean Harbors contractors conducting confined space entry into the tank of the vacuum truck to clean out the wood tar blocking the tank valve.

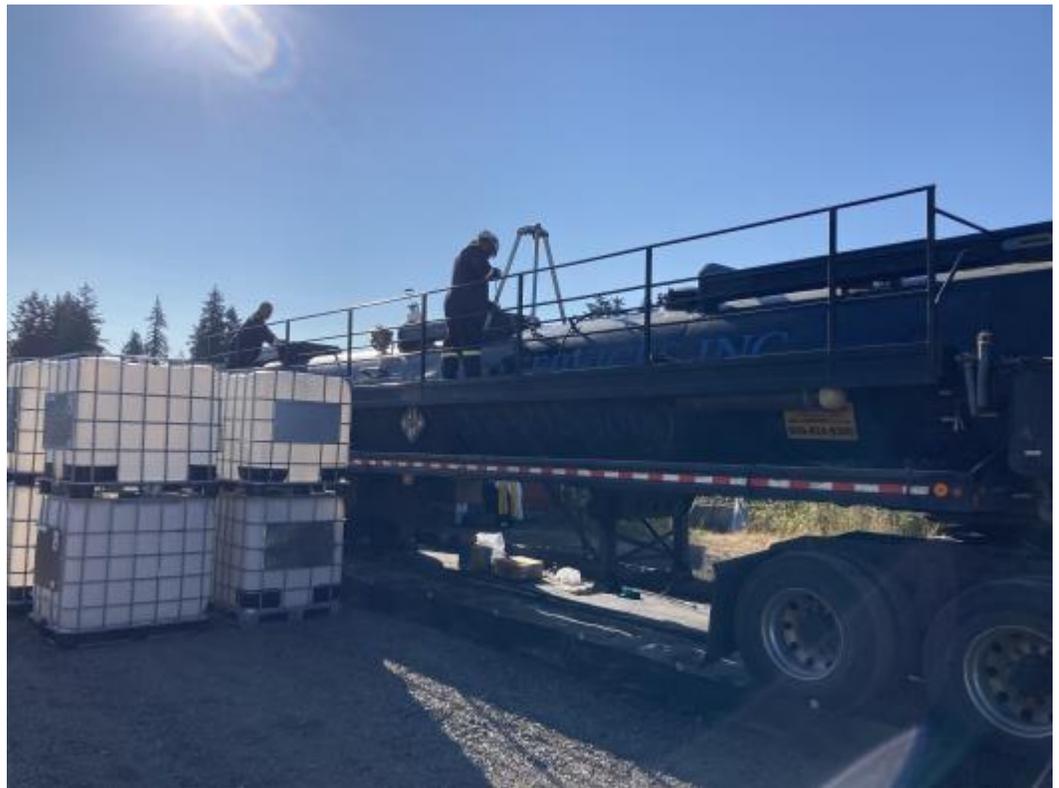
<b>Photo No.</b> <b>316</b>	<b>Date:</b> 07/23/2021
<b>Photo Coordinates</b>	
<b>Lat</b>	46.572206
<b>Long</b>	-122.728792
<b>Direction Photo Taken:</b> <b>SE</b>	
<b>Description:</b>  Clean Harbors contractors conducting confined space entry into the tank of the vacuum truck to clean out the wood tar blocking the tank valve.
